Upper Big Branch Mine–South Mine ID: 46-08436

April 5, 2010 Accident

Public Briefing

June 29, 2011

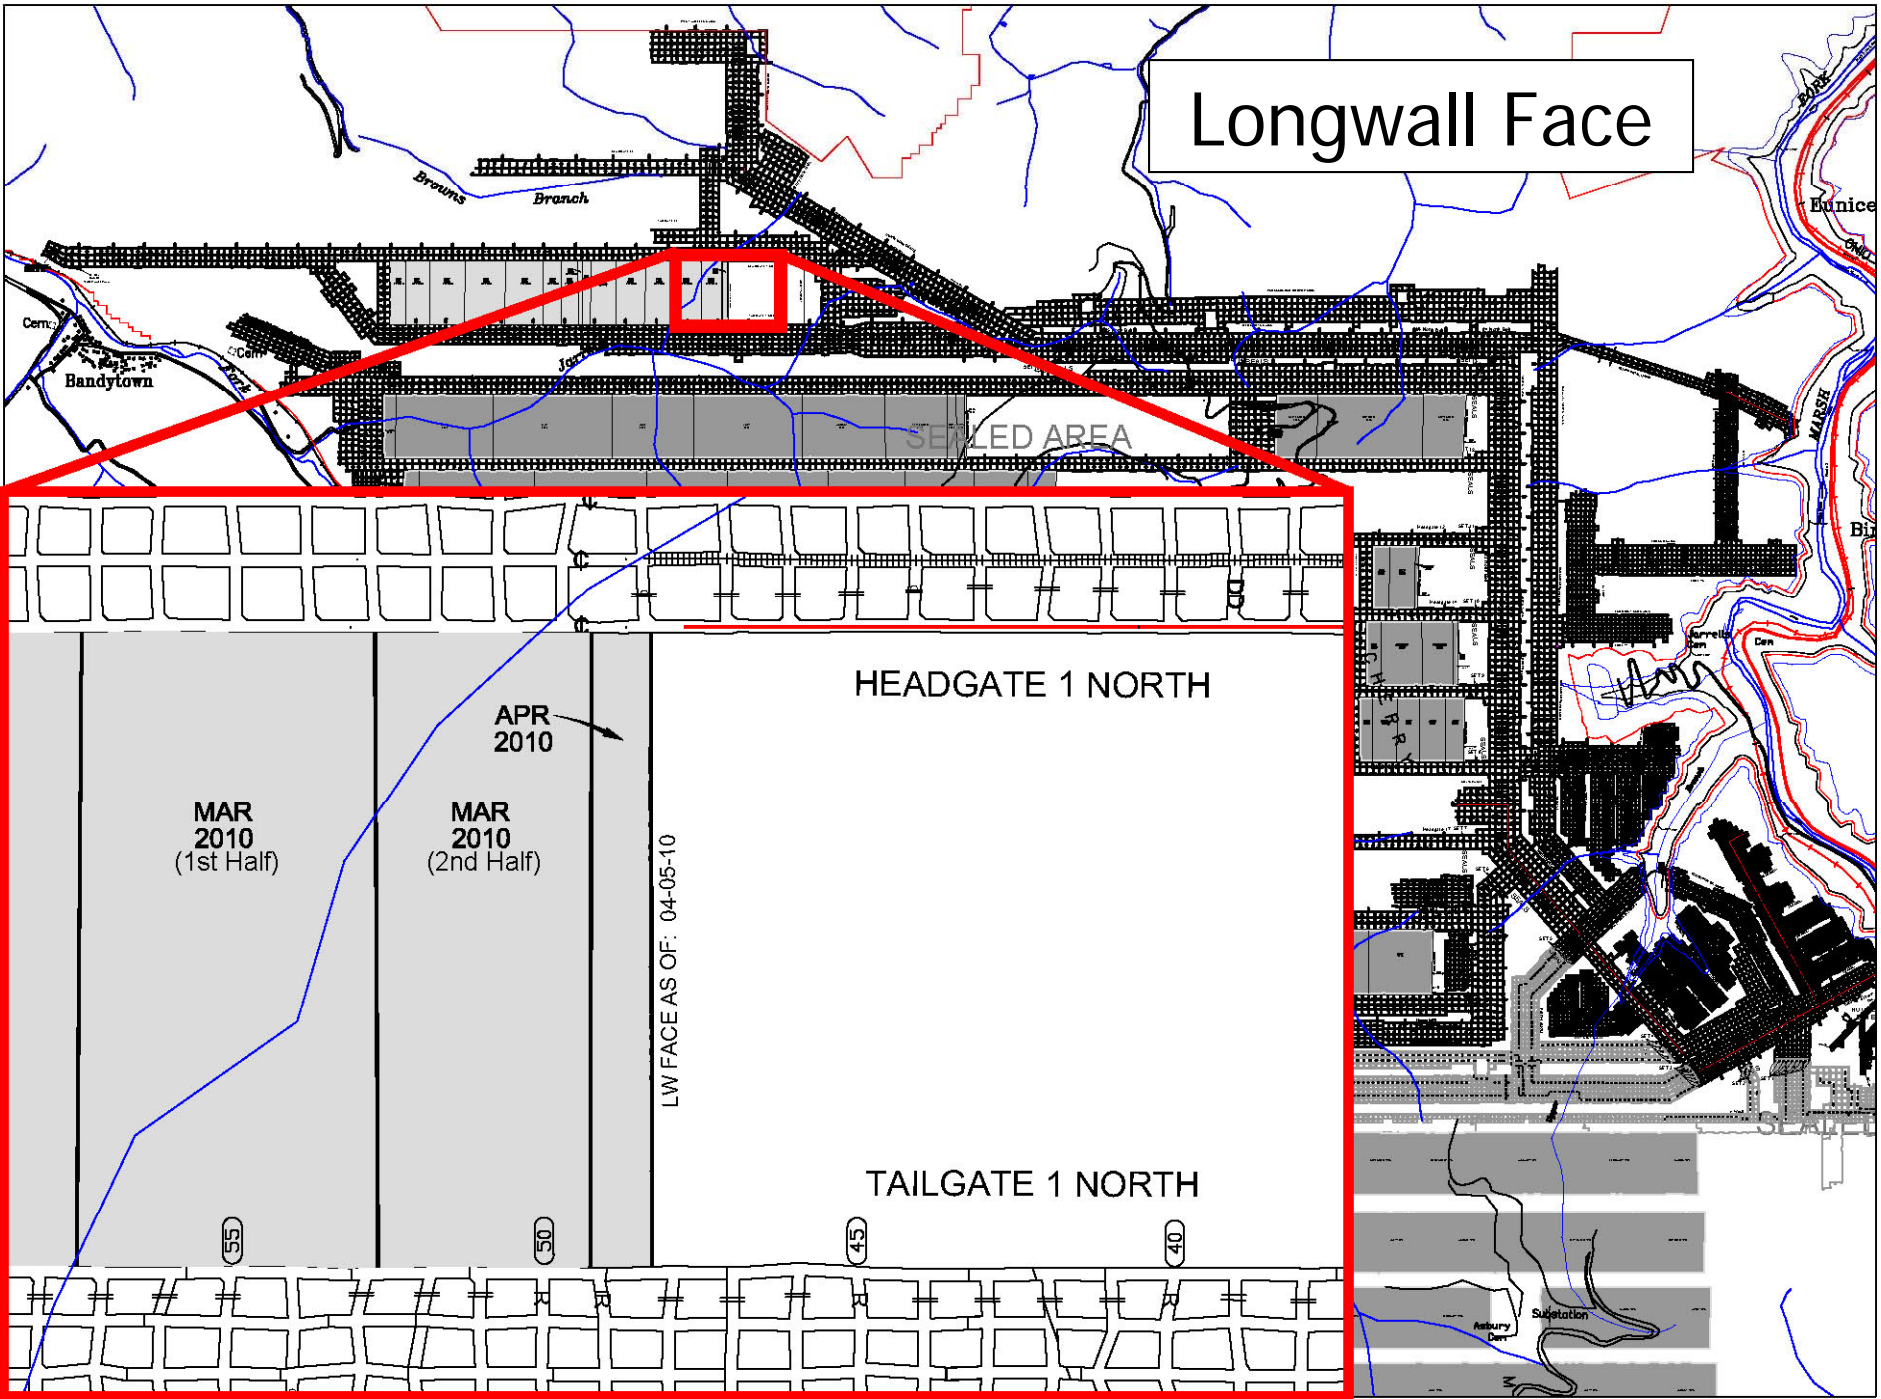
- LW
 - Shearer just cutting out on tail, cutting sandstone
 - Shearer shut off by TG side remote control at approximately 3:00 PM
 - Water supply manually shut-off at headgate
 - Shearer high-voltage power manually disconnected
- Face operators traveled 400 feet from tailgate prior to the explosion
 - About 2 minutes
- TG 22 crew in mantrip called out for track clearance
 - 78 crosscut (XC) at 3:00 pm
- HG 22
 - Six miners in mantrip, ready to leave section

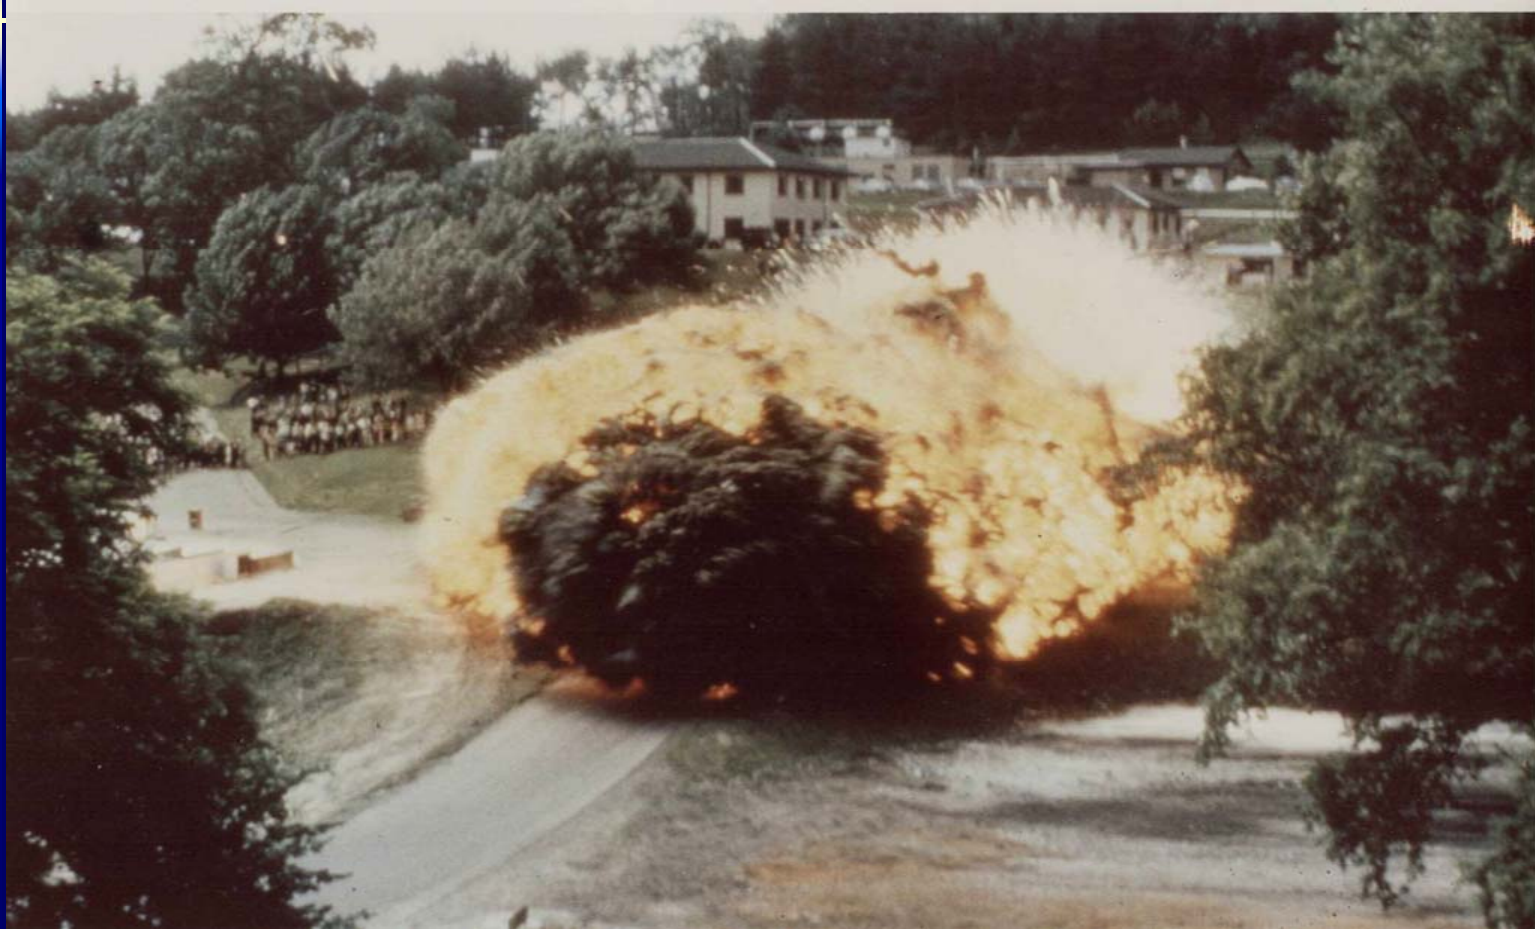
Bruceston Explosion Test

- LW tailgate had a low roof
 - Extensive floor heaving
 - Bulk duster could not be used on TG of LW
- Each LW pass generates float coal dust even with effective water sprays
- No evidence of rock dust applied to TG after development
 - No records were found during the investigation
 - Confirmed by statements of UBB Manager and others
