**UNITED STATES
DEPARTMENT OF LABOR
MINE SAFETY AND HEALTH ADMINISTRATION**

REPORT OF INVESTIGATION

**Fatal Roof Fall
June 16, 2008**

**Harmony Mine
UAE Coalcorp Associates
Mount Carmel, Northumberland County, PA
ID No. 36-07838**

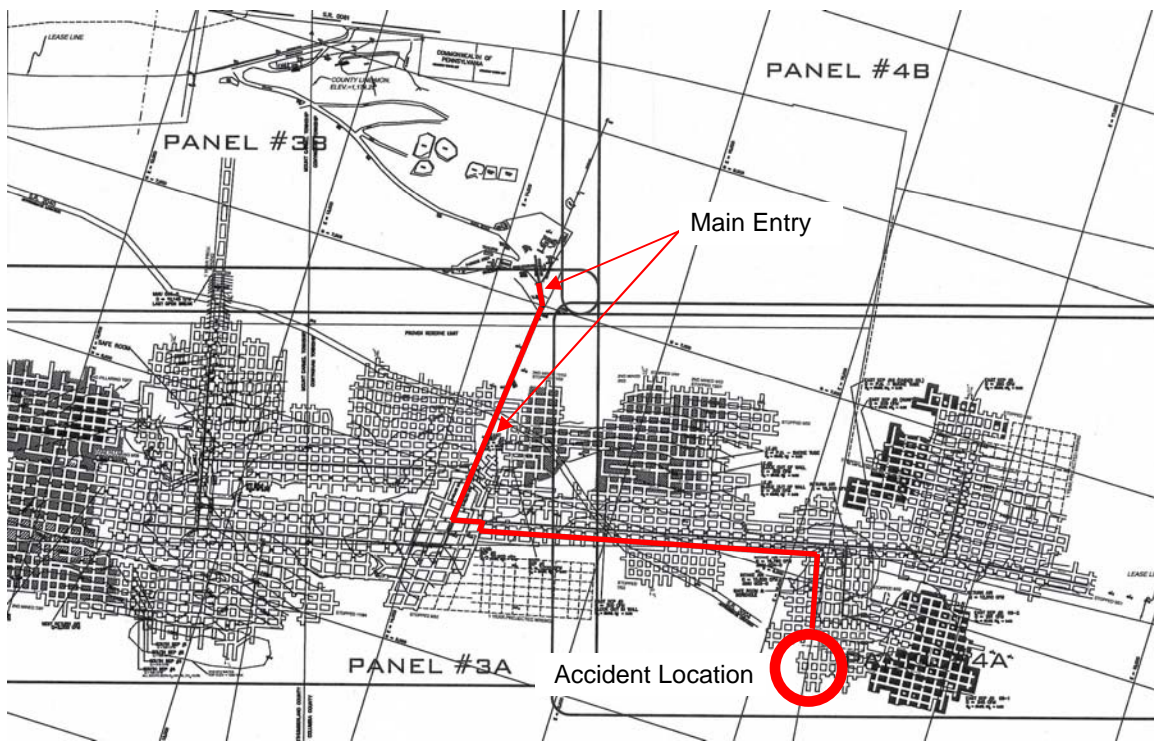
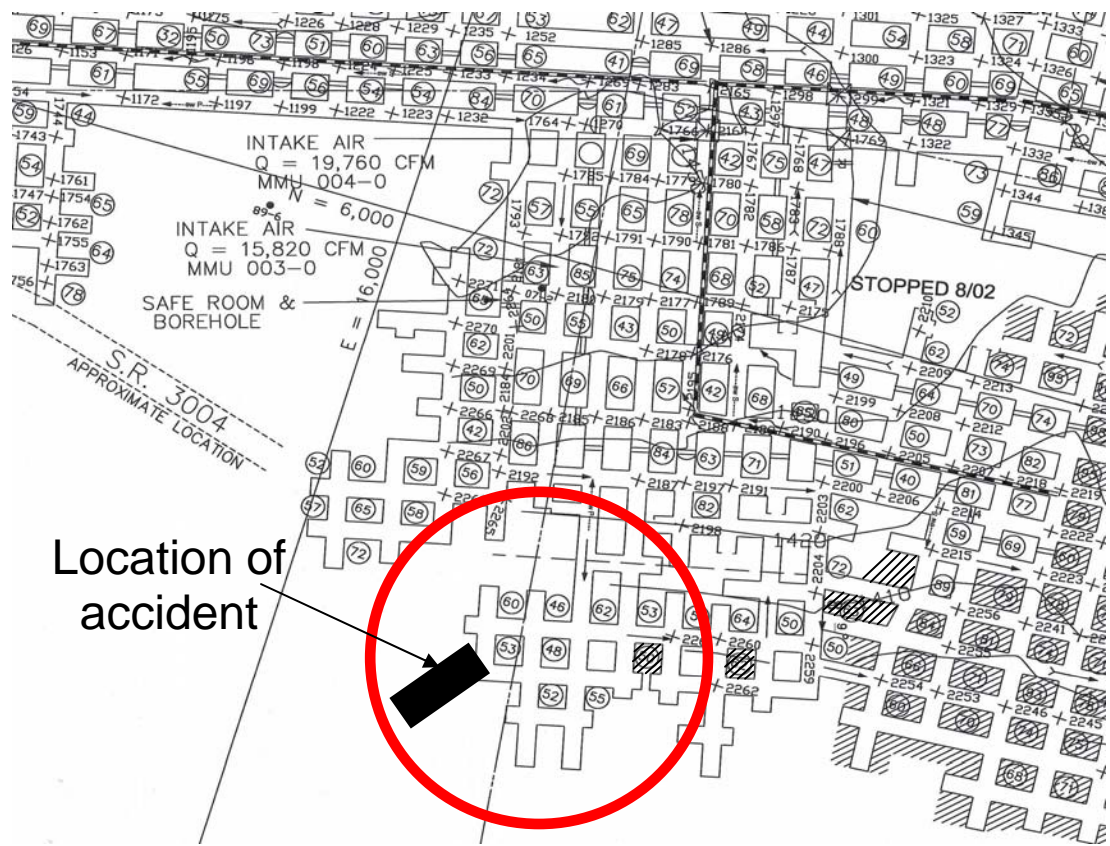
APPENDIX B - Map Location of the Accident Scene

Condition or Practice: "A fatal accident occurred on June 16, 2008. The location of the accident was retreat mining section 003-0, No. 1 southeast entry between No. 7 and 8 crosscuts. The accident investigation revealed the deepest point of penetration from the last permanent roof support was

approximately 47 feet. This is a violation of the mine's roof control plan approved on June 6, 2001. Page 15, pillar removal precautions – solid rib and pillar states: “The miner operator shall not advance the controls of the continuous miner in by the last permanent roof supports. Individual cuts to be taken the width of the miner's head, approximately 11 feet, with standing coal between the cuts. The mining being conducted was at a cut depth of up to approximately 47 feet in the solid. The width of the cut was fanning right to left creating a width of approximately 34 feet in the affected area. This resulted in the de-stabilization of the roof, causing the roof to fall. Acting Section Foreman Robert Carey engaged in aggravated conduct constituting more than ordinary negligence when he knew adverse conditions existed in the area being mined and that the mining performed was not done in accordance with the approved roof control plan. This violation is an unwarrantable failure to comply with a mandatory safety standard. This action contributed to the fatal accident that occurred on June 16, 2008. This condition was observed on June 17, 2008.”
