NATIONAL TRANSPORTATION SAFETY BOARD

RAILROAD ACCIDENT REPORT

DERAILMENT OF CSX FREIGHT TRAIN Q316 AND
SUBSEQUENT HAZARDOUS MATERIAL RELEASE
AT COX LANDING, WEST VIRGINIA
JUNE 20, 1998

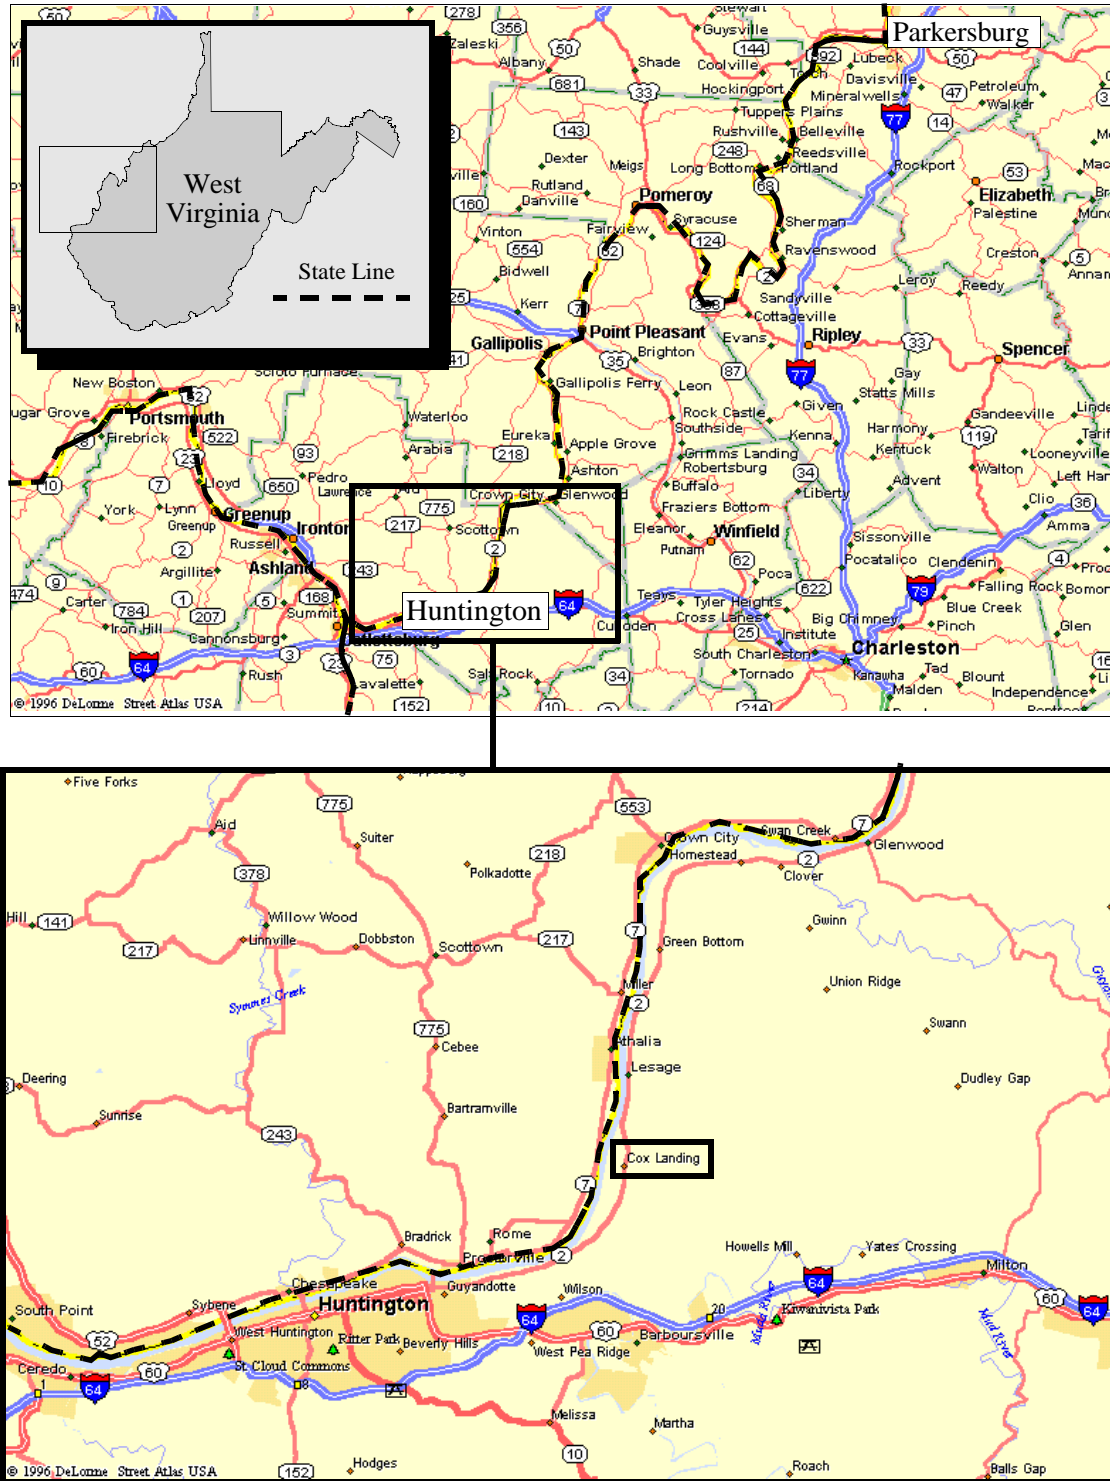
Figure 1.

At 11 a.m. eastern daylight time on June 20, 1998, a two-person train crew consisting of an engineer and a conductor went on duty at Huntington, West Virginia, to take CSX Transportation, Inc., (CSX) freight train Q316 to Parkersburg, West Virginia. (See figure 1, top.) The crew received the train, consisting of 2 locomotives, 97 loads, and 51 empties, from the inbound crew at 11:30 a.m. The train contained several types of hazardous materials, including several carloads of formaldehyde and a 14-car block of liquefied petroleum gas. The conductor recorded a departure time from Huntington Yard of 12:01 p.m.

Cox Landing (figure 1, bottom) is about 7 miles north of Huntington and about 2 miles south of the town of Lesage, West Virginia. In the area of the derailment, MP 207.9, the railroad is bounded by the Ohio River to the west and West Virginia State Route 2 to the east. The grade of the railroad is undulating, with slight, short, and varying grades. The average grade is nearly identical to that of the river. Curvature includes left and right curves of 1° to 3°, interspersed by tangent track in 1/4- to 1/2-mile increments. A small stream, Four Mile Creek, passes under the railroad through a 5-foot stone arch at MP 207.88.
