Existing Projects Review

Lower Entiat River

U.S. Department of the Interior
Bureau of Reclamation
Pacific Northwest Region
Pacific Northwest Regional Office
Boise, Idaho

April 2012

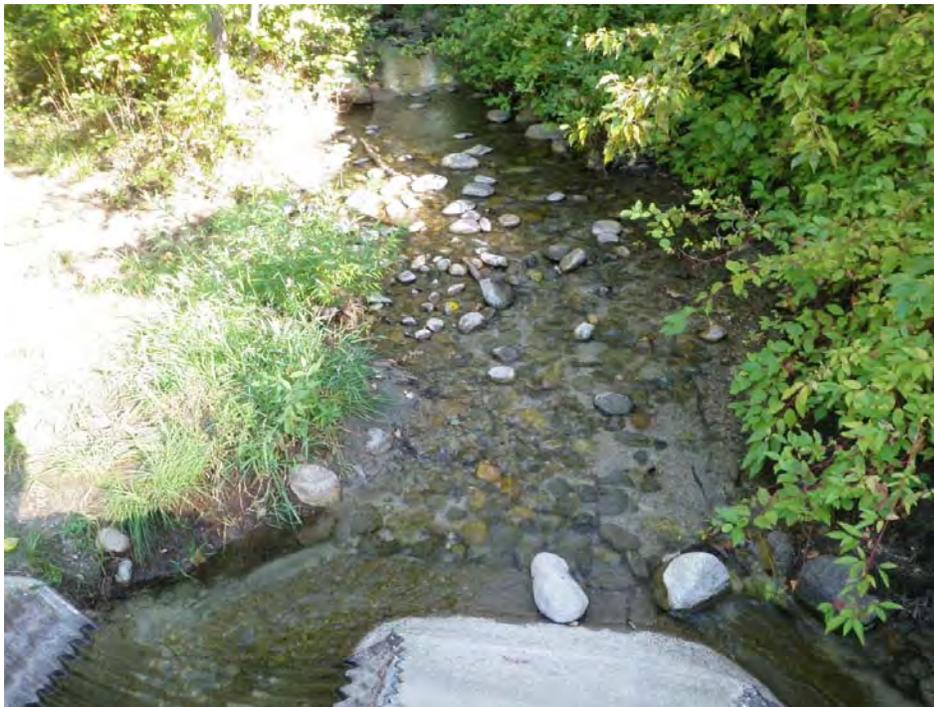
Figure 8. Wilson Side Channel. Photo of the Wilson side channel looking upstream at the point where it passes beneath Roaring Creek Road in September 2011.

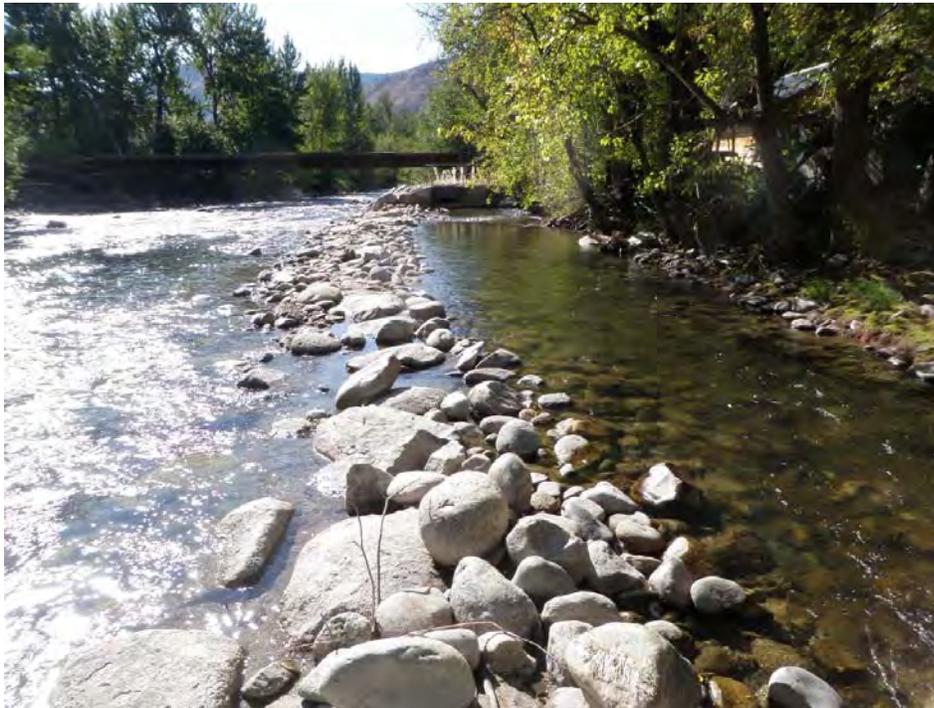
Figure 11. Knapp-Wham Diversion. Photo of the new wing-dam with the headworks and private bridge in the background. Photo taken facing downstream in September 2011.

The Knapp-Wham diversion is functioning very well, and should continue to function well in the future, although conditions may change over time, especially following large floods. Key to the success of the structure has been its ability to convey both flow and sediment without significantly altering the hydraulic or sediment transport characteristics of the project site unlike many channel-spanning diversion structures which create a depositional environment upstream of the diversion. Constructing the tip of the wing dam with large rocks has helped maintain the smaller and slightly lower elevation rocks composing the remainder of the wing dam. The elevation of the wing dam allows overtopping of seasonal high flows, preventing excessive flow and sediment from entering the diversion ditch. Sufficient flow velocity is maintained and sediment deposition at the intake is reduced by allowing high flows to overtop the wing wall, using stoplogs, and building the sediment sluice into the wing-dam adjacent the diversion orifice. The size and location of the headworks orifice structure itself also prevents excessive flow from entering the diversion, because the elevation of the structure matches that of the floodplain, ensuring the diversion will not direct excessive floodwater into the irrigation ditch. The entire floodplain, including the irrigation ditch, will already be inundated before the intake structure is overtopped. Also aiding the function of the diversion is its location in a relatively straight transport-dominated reach with stable banks.

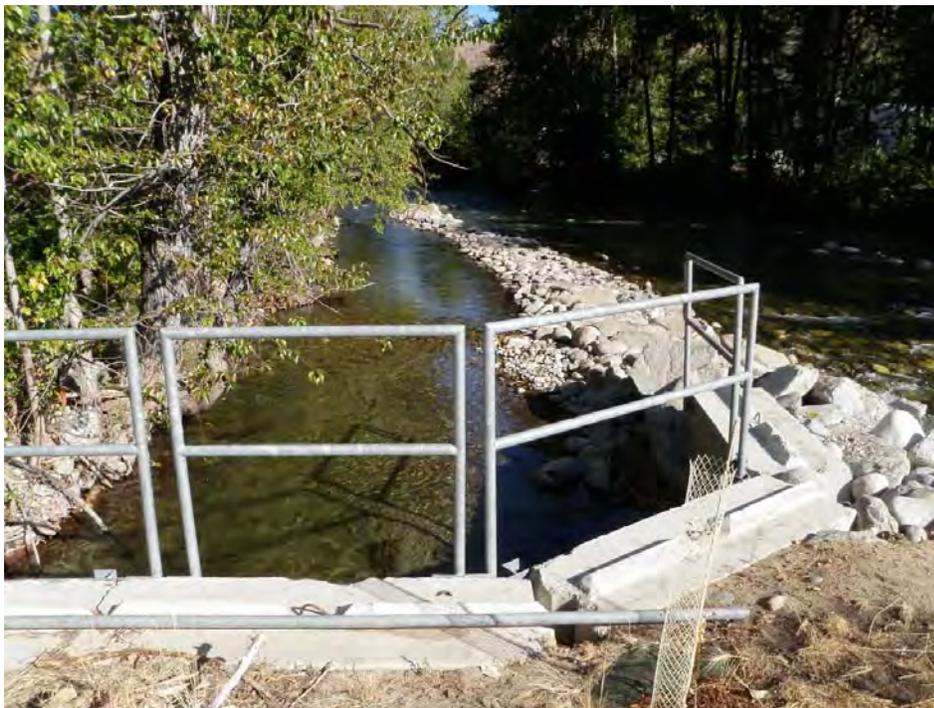
Figure 12. Knapp-Wham Diversion. Photo looking upstream at the new Knapp-Wham headworks and wing-dam (September 2011).

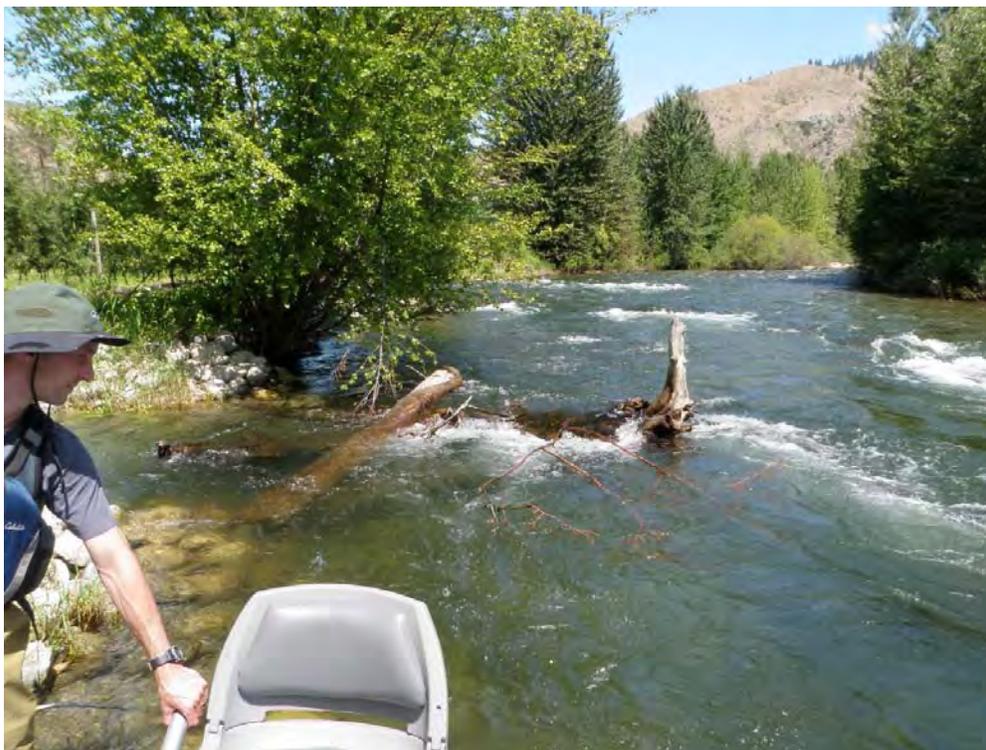
Figure 14. Small Pond. Photo looking upstream at the confluence of the pond outlet channel and the Entiat River. A 3-log LWM structure spans the outlet of the pond channel. Photo taken in July 2011 with the Entiat River flowing at approximately 1,000 cfs.

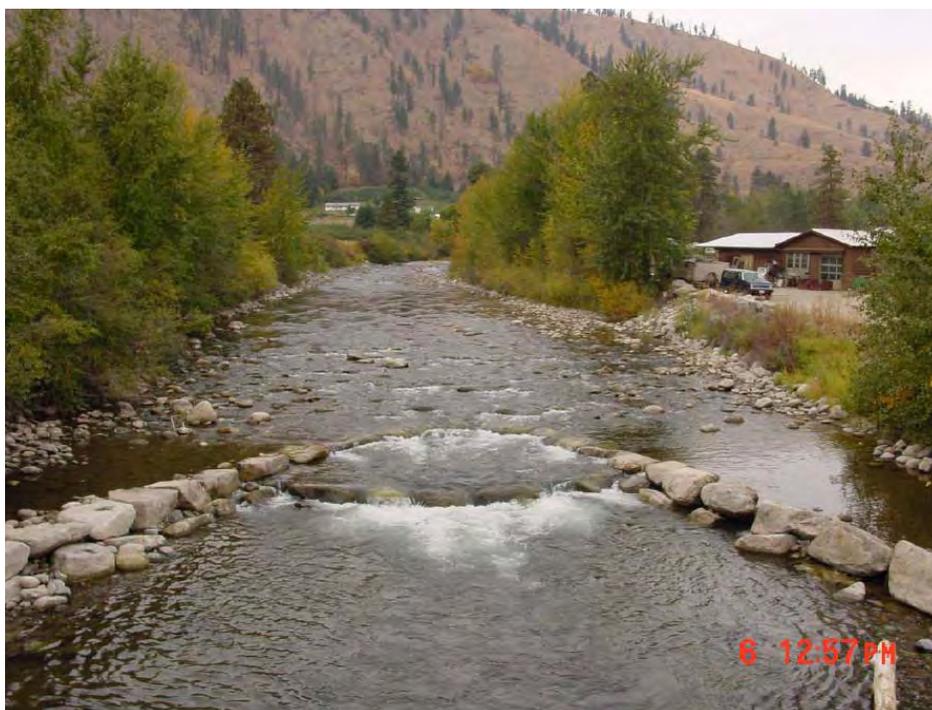
Since its installation in 2001, the lower Entiat River has experienced 7 floods exceeding the 2-year recurrence interval, one of which was roughly a 10-year recurrence interval flood peaking on May 19, 2006 at 4,780 cfs (USGS Gauge No.12452990). NRCS monitoring efforts show that the excavated pool was maintained by the cross vane until the 2006 flood which mobilized sufficient bedload to partially fill the pool (Figure 23 and Figure 24). An explanation of the hydraulics of this process was provided under the previous section about the Existing Conditions Assessment for the Hanan-Detwiler Diversion.

Figure 23. Dinkleman Weir. Photo from October 2005, roughly 4 years after construction.

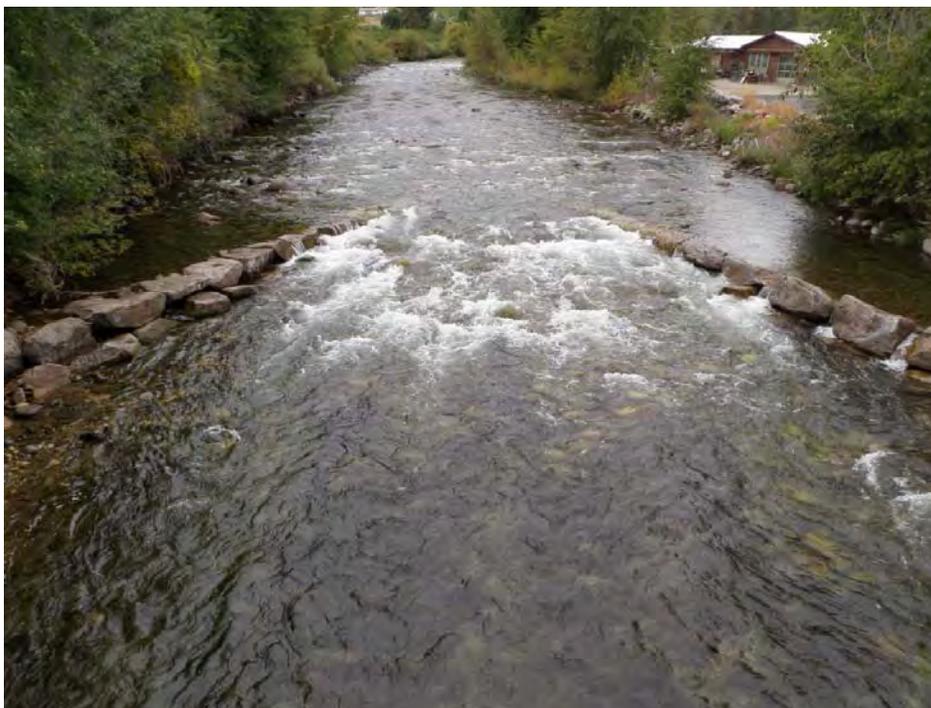
Figure 24. Dinkleman Weir. Photo from October 2011 roughly 10 years after construction.

Theoretically, a smaller deflection angle (narrower weir) and steeper slopes along the weir arms focus greater volumes of flow toward the center of the channel and influence local hydraulics at higher flows, increasing scour potential. The deflection angle of the Dinkleman weir is roughly halfway between the deflection angles of the other two demonstration weirs at RM 2.3, while the slope of the weir arms is significantly less which may account in part for the weir filling with sediment during the 2006 flood event. Additionally, the close spacing between the first drop at the apex of the weir and the second drop at the cross bar does not appear to be sufficient to allow for adequate pool formation.

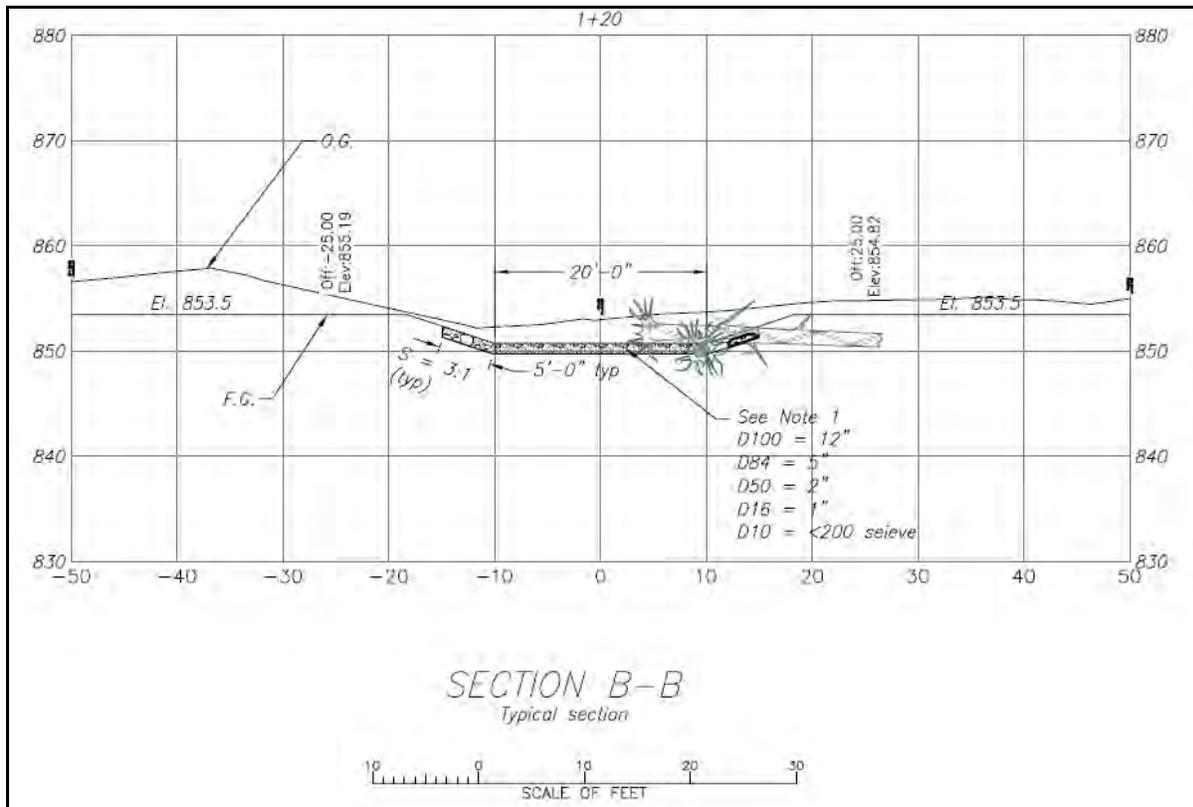
Figure 27. Bridge-to-Bridge, Phase II (Harrison Side Channel). Design cross section through the inlet channel illustrating the consistent floodplain cut elevation of 853.5 feet.

Hydraulic modeling of the proposed inlet design suggested that sufficient flow would pass through the inlet into the historic oxbow to pass fine sediment and maintain side channel function over time through periodic flushing. The two-dimensional hydraulic model terrain included a small ridge along the right bank of the side channel inlet which forced overbank flow into the side channel (Figure 28 and Figure 29). The elevation of the small ridge along the right bank in the hydraulic model was approximately 856 feet, while the actual right bank elevation after construction was built to the design specification of 853.5 feet, a difference of approximately 2.5 feet.

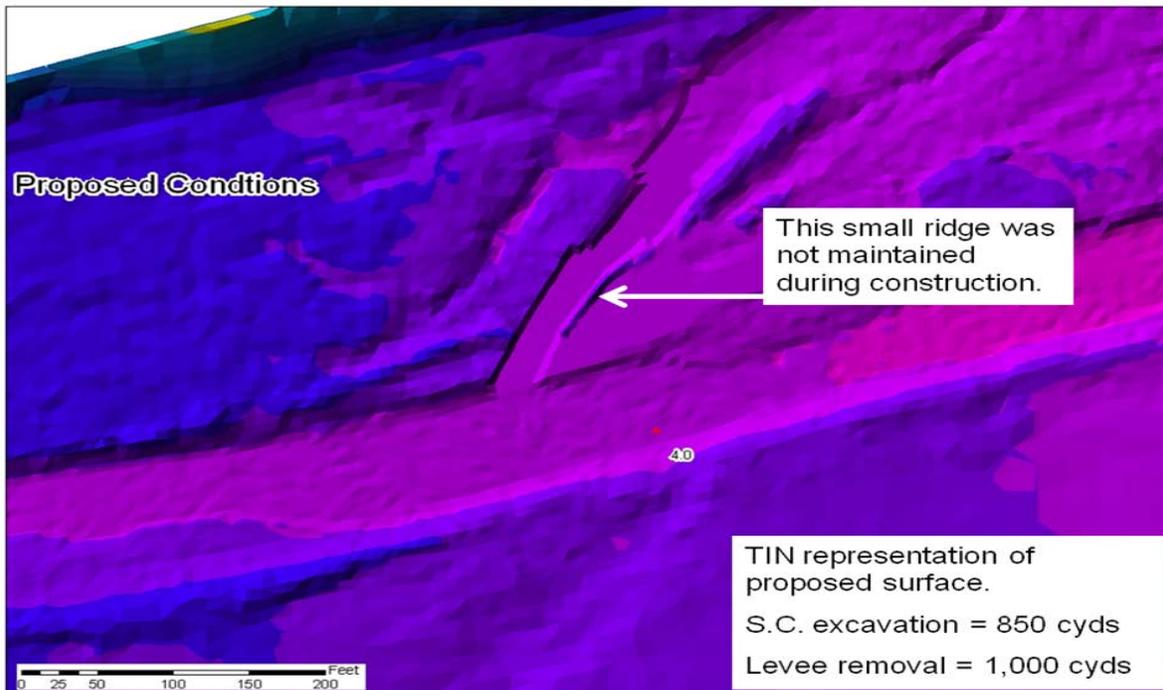
Figure 28. Bridge-to-Bridge, Phase II (Harrison Side Channel). LiDAR view of project area.

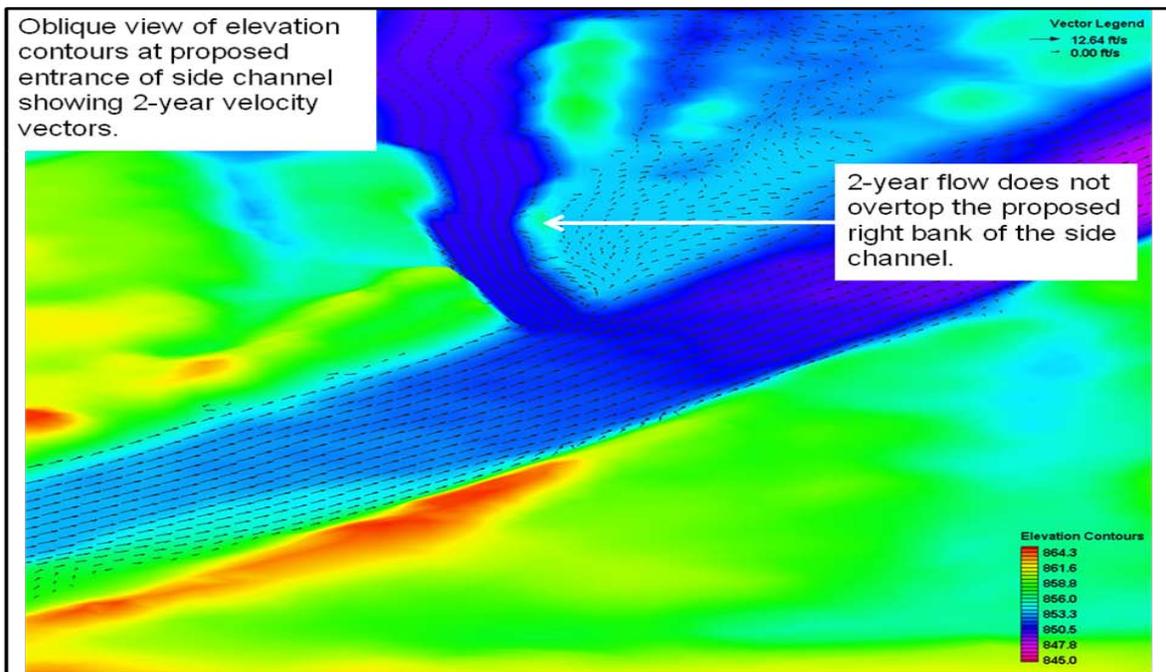
Figure 29. Bridge-to-Bridge, Phase II (Harrison Side Channel). Two-dimensional modeling results illustrating proposed side channel inlet topography and velocity vectors calculated from a 2-year flood.

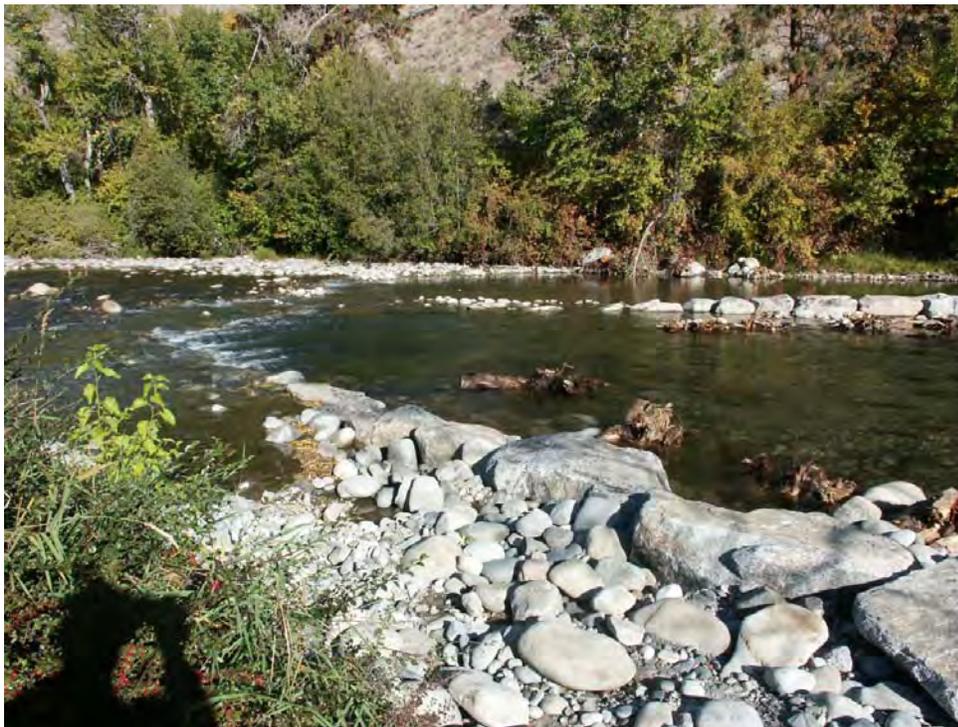
The U-shaped cross vane was designed with a deflection angle of 22° and both right and left vanes with a slope of 4.44 percent. This represents a slightly narrower vane without the cross-bar A-shape like the Dinkleman weir, while the other design elements were very similar. Project goals for the weir included establishment of a large pool incorporating LWM for cover and complexity. During construction, eight root wads were anchored to the river bed below either arm of the U-shaped cross vane and a pool was excavated immediately downstream of the weir (Figure 33). The design intent was to create a pool with a maximum bankfull depth of 8 feet (4 feet deeper than the surrounding bed) centered approximately between the downstream end of the weir arms (Figure 34), but according to personal communication with NRCS, the completed pool was excavated deeper than designed at the upstream end and shallower than designed at the downstream end (Figure 35).

Figure 35. Bridge-to-Bridge Phase I (Whitehall Weir). Photo taken shortly after construction in 2006 looking across the weir from the right bank.

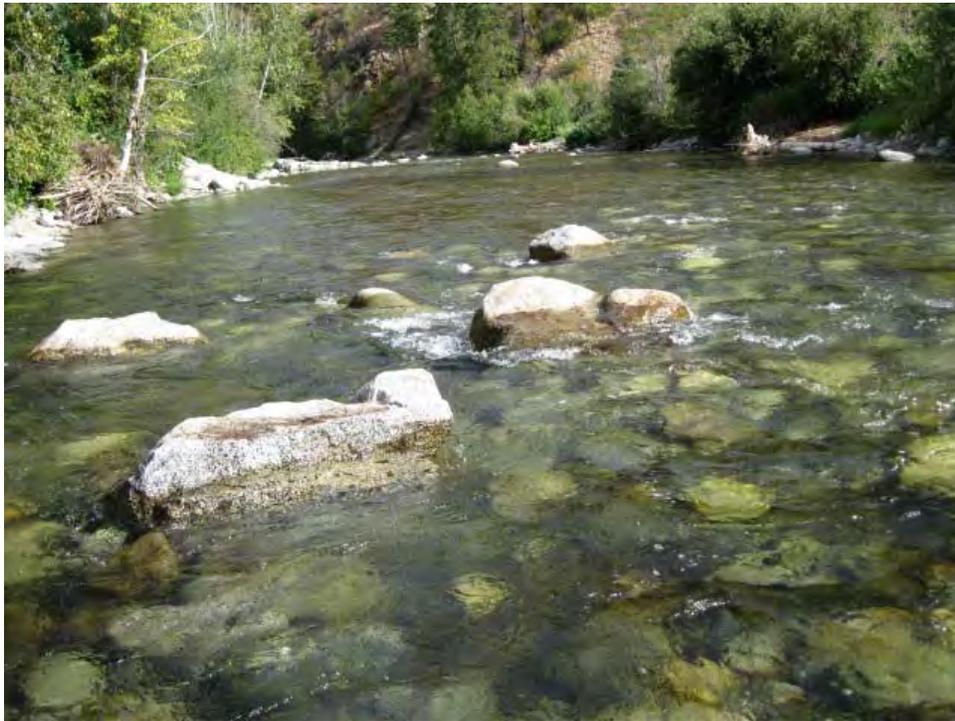
Figure 47. Milne. Boulder cluster looking downstream at low-water. Photo taken in August of 2009.

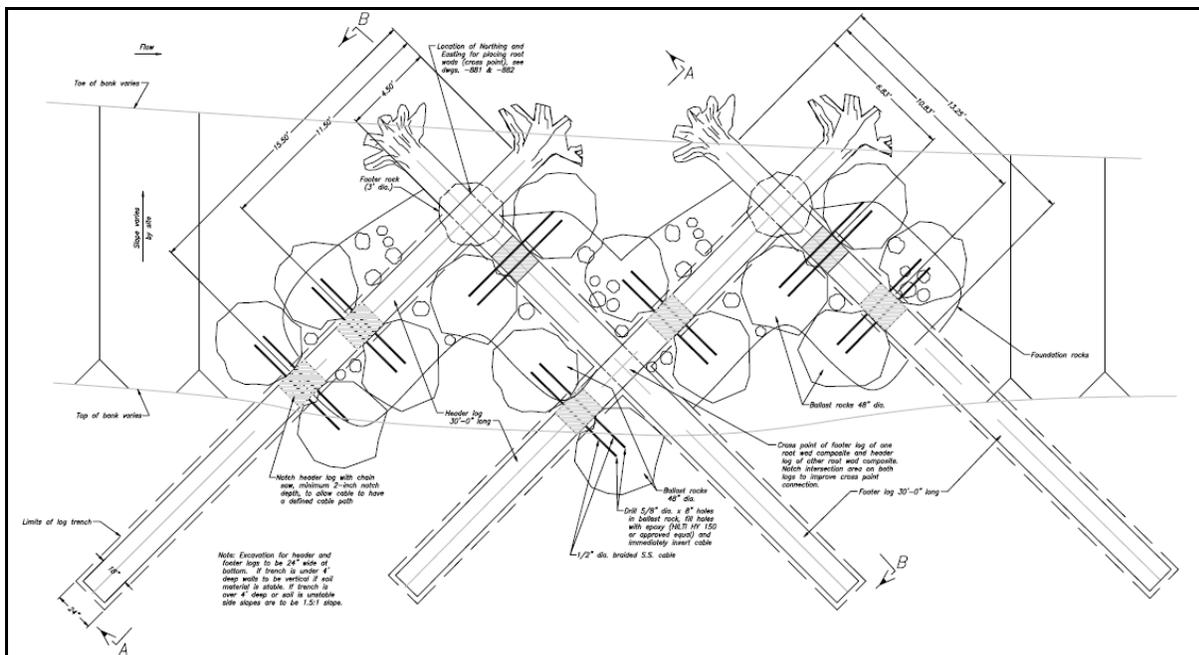
Figure 48. Milne. Pair of root wad structures (each structure consists of two overlapping logs with root wads). In every instance, the upstream log was installed overlapping the downstream log.

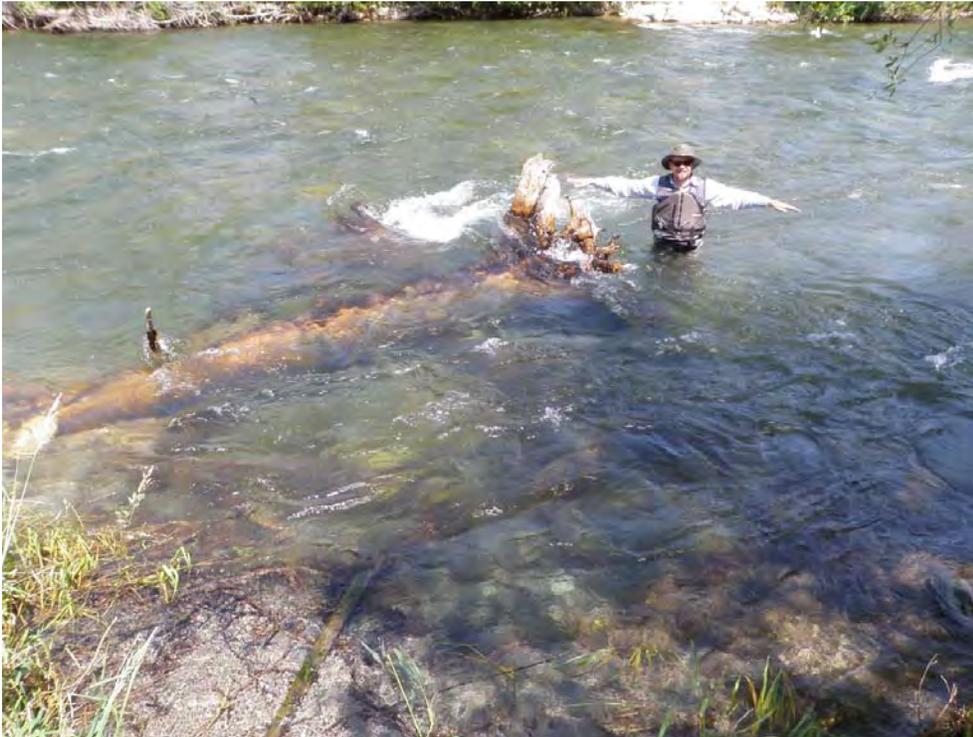
The root wad structures are performing relatively well. Each structure provides cover and hydraulic diversity, and several of the structures have maintained a pool beneath the pair of root wads at the apex of the structure (Figure 50 and Figure 51). The pools were initially excavated by machinery during the installation of the structures. It is unclear if the pools will be maintained in the long term since there has not been a large flood that would mobilize the armored bed since the installation of these structures, but they are currently meeting design objectives and providing more complexity and hydraulic diversity than the rock barbs. All of the root wad structures were built with the upstream log overlapping the downstream log, which may increase the potential for bank erosion below the structure as water spilling over the top log is directed toward the bank. During field reconnaissance in 2011, no significant bank erosion was observed below the log structures, and as vegetation continues to become established, bank erosion potential will decrease. Similar to the rock barbs, these root wad structures are relatively small and are effective at lower flows, but will likely produce minimal or negligible hydraulic effect during large floods.

Figure 50. Milne. Single 2-log rootwad structure along the right bank (photo taken September 2011 at about 1,000 cfs).

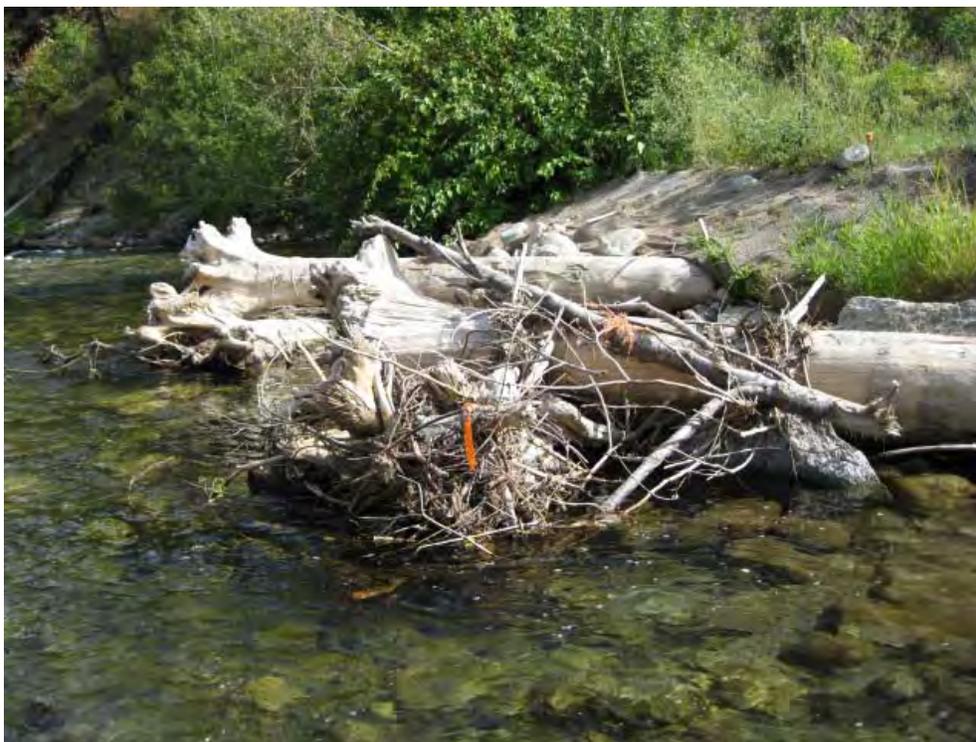
Figure 51. Milne. Photo of double root wad log structure showing the pool maintained at apex of root wads. Photo was taken at low flow in September 2010.

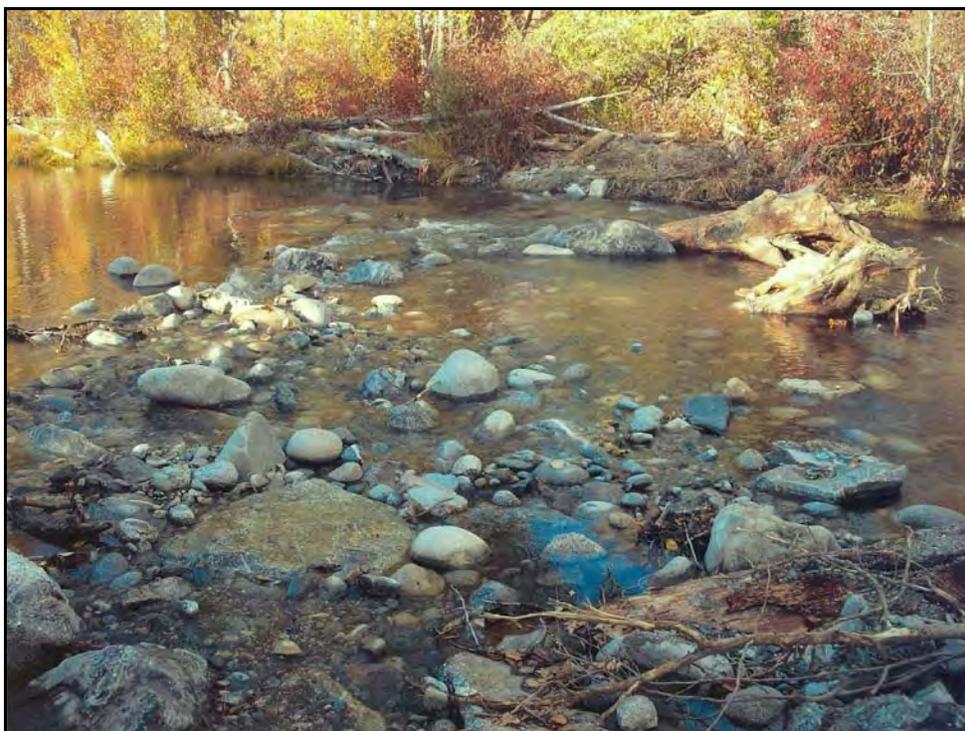
Figure 57. Below the Bridge. Photo of the rock and log diversion structure taken immediately after construction in 2010. Flow is from left to right, and the point of diversion and sediment sluice are located out of the photo below the frame. Note three of the incorporated root wads, two in the background and part of one visible in the foreground.

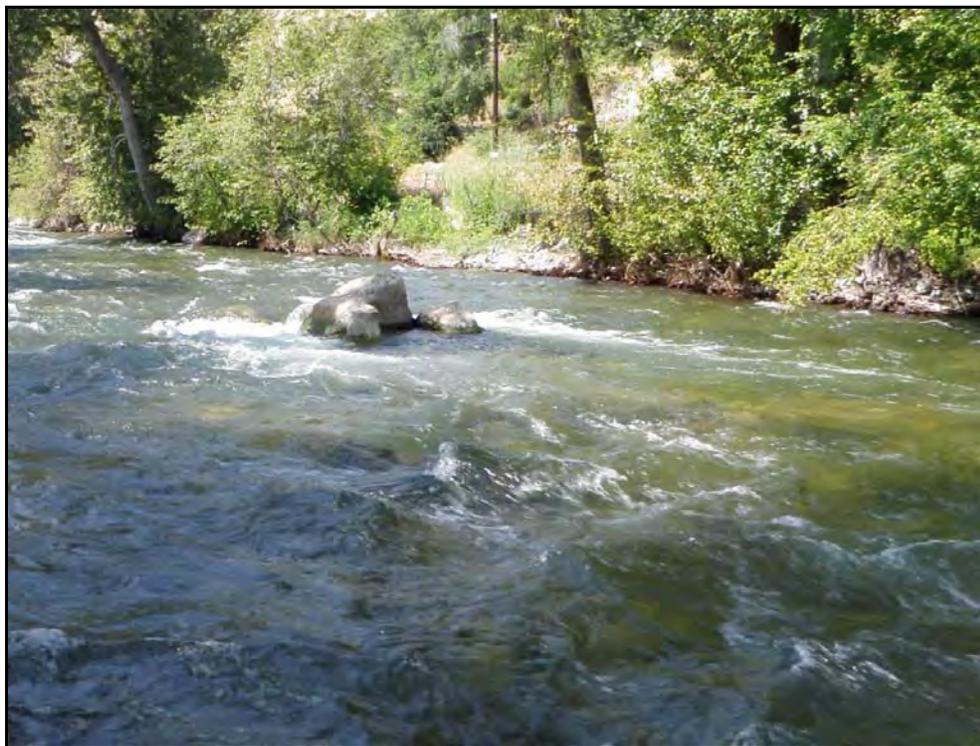
Figure 58. Below the Bridge. Photo of a single large boulder with two smaller flanking boulders comprising a single cluster taken at about 1,000 cfs in July 2011. Flow is from left to right. Based on estimates from field observations during high flow, this particular structure is overtopped at flows above approximately 2,500 cfs. Note the relatively large area of slow-velocity water in the lee of the structure.

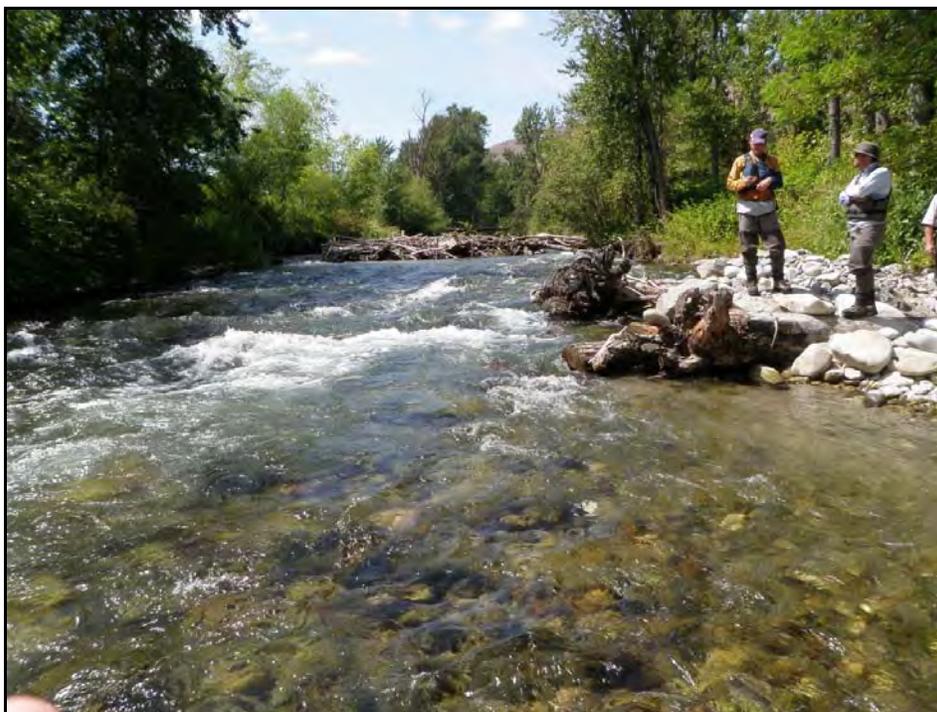
Figure 59. Below the Bridge. Photo looking upstream at a large woody debris complex on the left bank (island). Upstream of the LWM complex is the diversion structure which had racked a significant amount of wood at that time. The photo taken at in September 2011 at approximately 1,000 cfs.
