Stormy Reach Assessment Entiat River

Chelan County, Washington

U.S. Department of the Interior
Bureau of Reclamation
Pacific Northwest Region
Boise, Idaho

November 2009

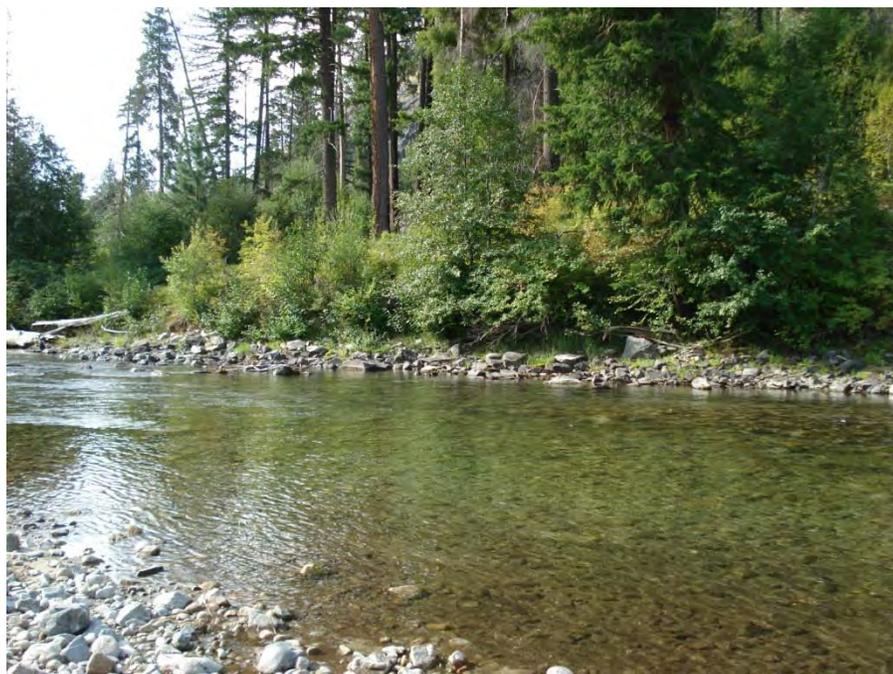
Photograph No. 2. View to the southwest of alluvial material that includes gravel and cobbles with boulders along both banks. Stormy Reach – Entiat Subbasin, Washington – Bureau of Reclamation. Photograph by R. McAfee, August 5, 2008.

Option	Habitat Action	Prioritized Habitat Actions	VSP Parameters Addressed	Geomorphic Potential
1	Protection	Protect and maintain current levels of geomorphic, hydrologic, and vegetative function.	4; Productivity, Abundance, Diversity, and Structure	High

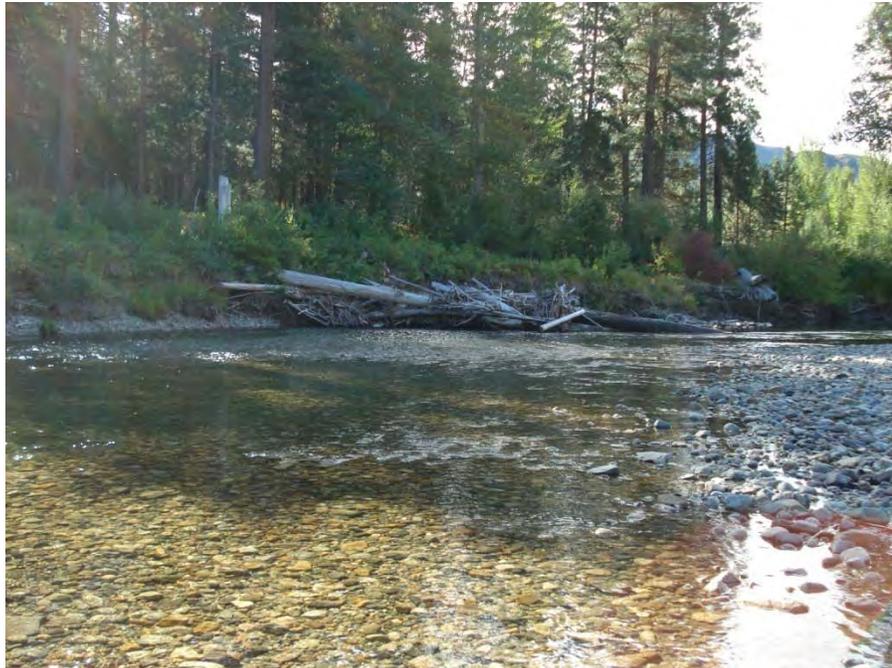
Inner zone SR-IZ-3 is located between RM 19.79 and 20.1 and covers about 6 acres of the active channel (Figure 10). This inner zone is a transition-to-deposition subreach with a relatively lower gradient when compared to SR-IZ-1, with predominantly gravel and cobble substrate (Photograph No. 3). The only human feature along the banks or in the active channel in this subreach is a small section of highway along the left bank at the top of the reach. The highway slightly reduces the channel migration width; therefore, increasing stream energy and promoting local incision. Large wood loading or log/boulder placement could be implemented to help dissipate stream energy and promote floodplain interaction by raising the bed elevation through detainment of sediment (Table 14). Large wood recruitment potential and shading are impeded in the large adjacent subreach (see SR-OZ-4 description) and could be improved through riparian planting.

Photograph No. 3. View to the south of a cobble and gravel point bar along the right bank and wood accumulation along the left bank. The channel unit sequence is run to riffle. Stormy Reach – Entiat Subbasin, Washington – Bureau of Reclamation. Photograph by R. McAfee, August 6, 2008.

Option	Habitat Action	Prioritized Habitat Actions	VSP Parameters Addressed	Geomorphic Potential
1	Rehabilitation	Reconnect processes: Strategically place unanchored/anchored “key members” (large wood greater than 30-inch diameter at breast height and a length of 30 or more feet with rootwad attached) on point and medial bars, and allowing the river to naturally adjust their position.	4; Productivity and Abundance	Moderate
2	Protection	Protect and maintain rehabilitated levels of geomorphic, hydrologic, and vegetative function.	2; Productivity, Abundance, Diversity, and Structure	High

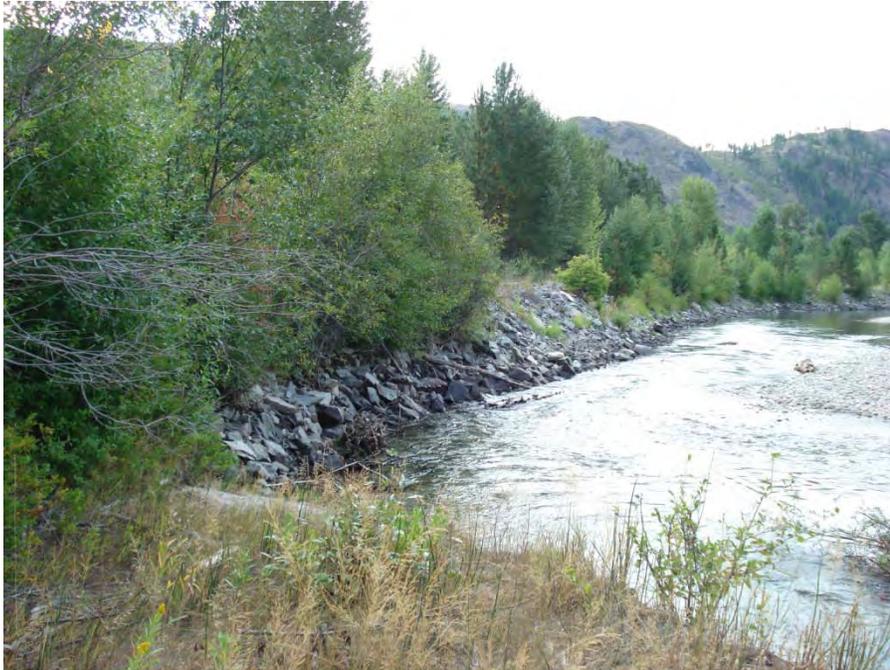
Photograph No. 4. View is to the south of a levee along the left bank and a gravel point bar along the right. Stormy Reach – Entiat Subbasin, Washington – Bureau of Reclamation. Photograph by R. McAfee, August 6, 2008.

Option	Habitat Action	Prioritized Habitat Actions	VSP Parameters Addressed	Geomorphic Potential
1	Rehabilitation	Reconnect Processes: Remove or modify the levee to reconnect floodplain. Following removal or modification of the levee, large wood could be installed to further aid in energy dissipation and promote sediment retention. Upon addressing the levee, the subreach could be Protected and Maintained.	2; Productivity and Abundance	High

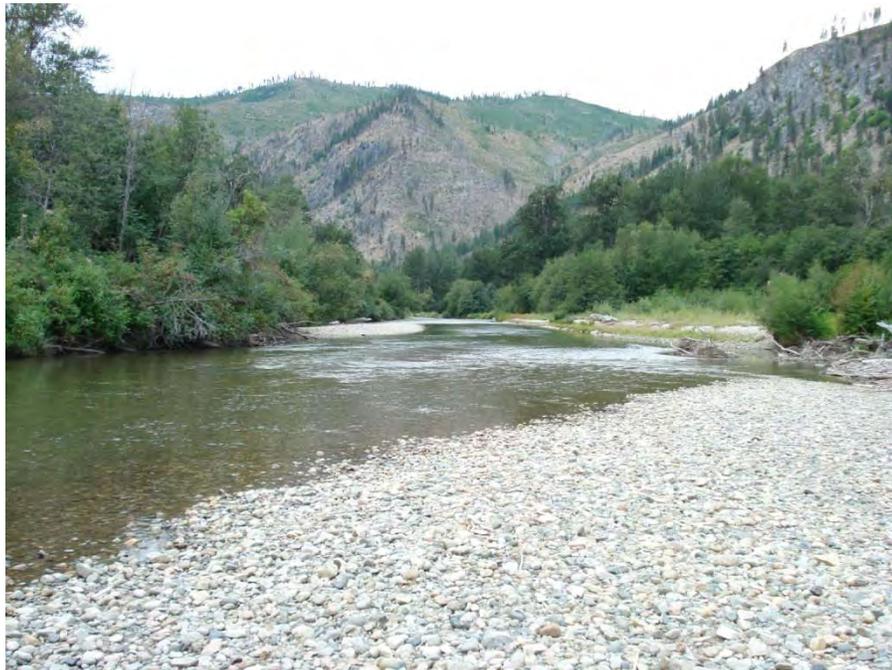
Photograph No. 5. View is to the south of a gravel and cobble point bar along the right bank and a channel unit sequence of glide-riffle-glide. Stormy Reach – Entiat Subbasin, Washington – Bureau of Reclamation. Photograph by R. McAfee, August 6, 2008.

Option	Habitat Action	Prioritized Habitat Actions	VSP Parameters Addressed	Geomorphic Potential
1	Rehabilitation	Reconnect Processes: Strategically place unanchored/anchored “key members” (large wood greater than 30-inch diameter at breast height and a length of 30 or more feet with rootwad attached) on point and medial bars, and allowing the river to naturally adjust their position. Upon placing the wood, the subreach could be Protected and Maintained .	2; Productivity and Abundance	Moderate

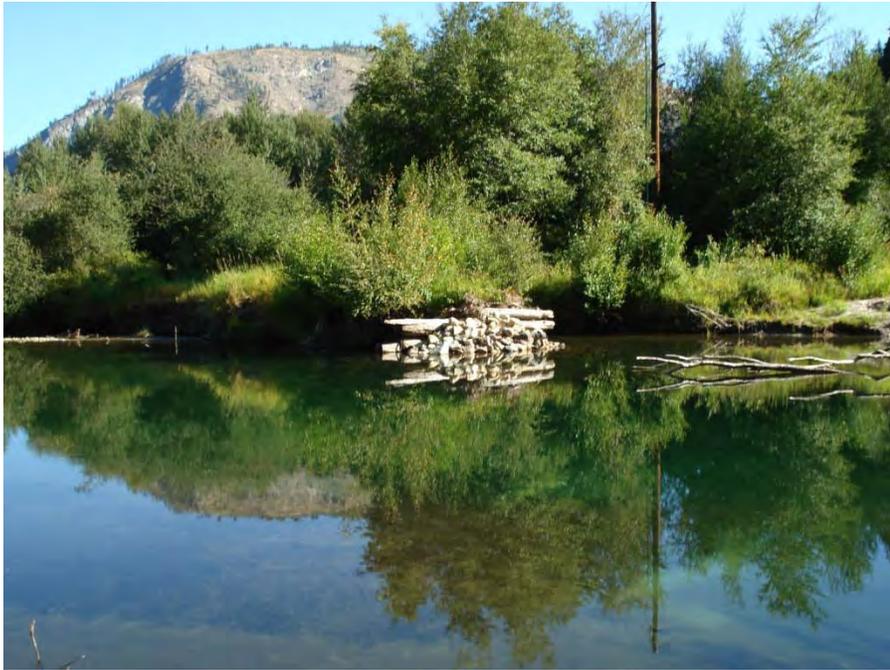
Photograph No. 7. View is to the east showing a rock spur near RM 18.73 along the right bank. Stormy Reach – Entiat Subbasin, Washington – Bureau of Reclamation. Photograph by R. McAfee, August 7, 2008.

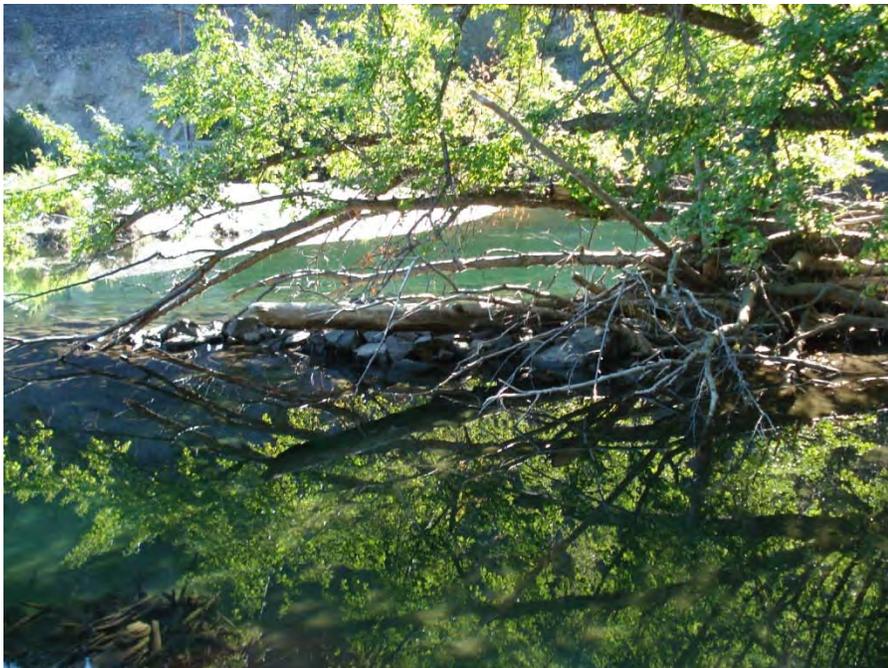
Photograph No. 8. View is to the north of a historic bridge abutment near RM 18.73 along the left bank. Stormy Reach – Entiat Subbasin, Washington – Bureau of Reclamation. Photograph by R. McAfee, August 7, 2008.

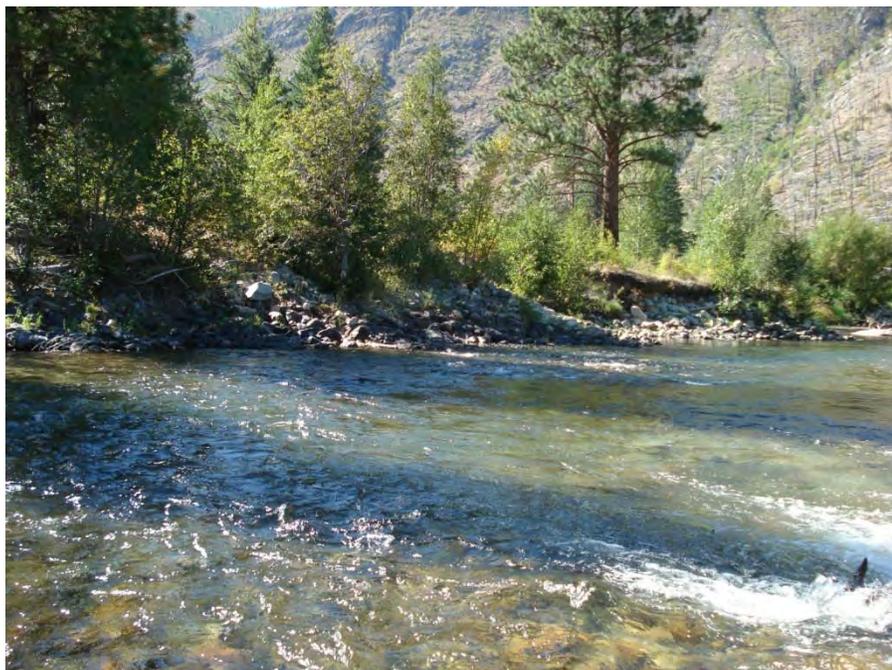
Photograph No. 9. View to the southwest showing a channel unit of rapids and three rock spurs along the left bank. Stormy Reach – Entiat Subbasin, Washington – Bureau of Reclamation. Photograph by R. McAfee, August 7, 2008.

Option	Habitat Action	Prioritized Habitat Actions	VSP Parameters Addressed	Geomorphic Potential
1	Rehabilitation	Reconnect Isolated Habitat Units: Modify rock spur with wood placements to increase habitat units and still provide bank protection for infrastructure.	2; Productivity and Abundance	Moderate
2	Protection	Protect and maintain rehabilitated levels of geomorphic, hydrologic, and improved vegetative function.	4; Productivity, Abundance, Diversity, and Structure	Low

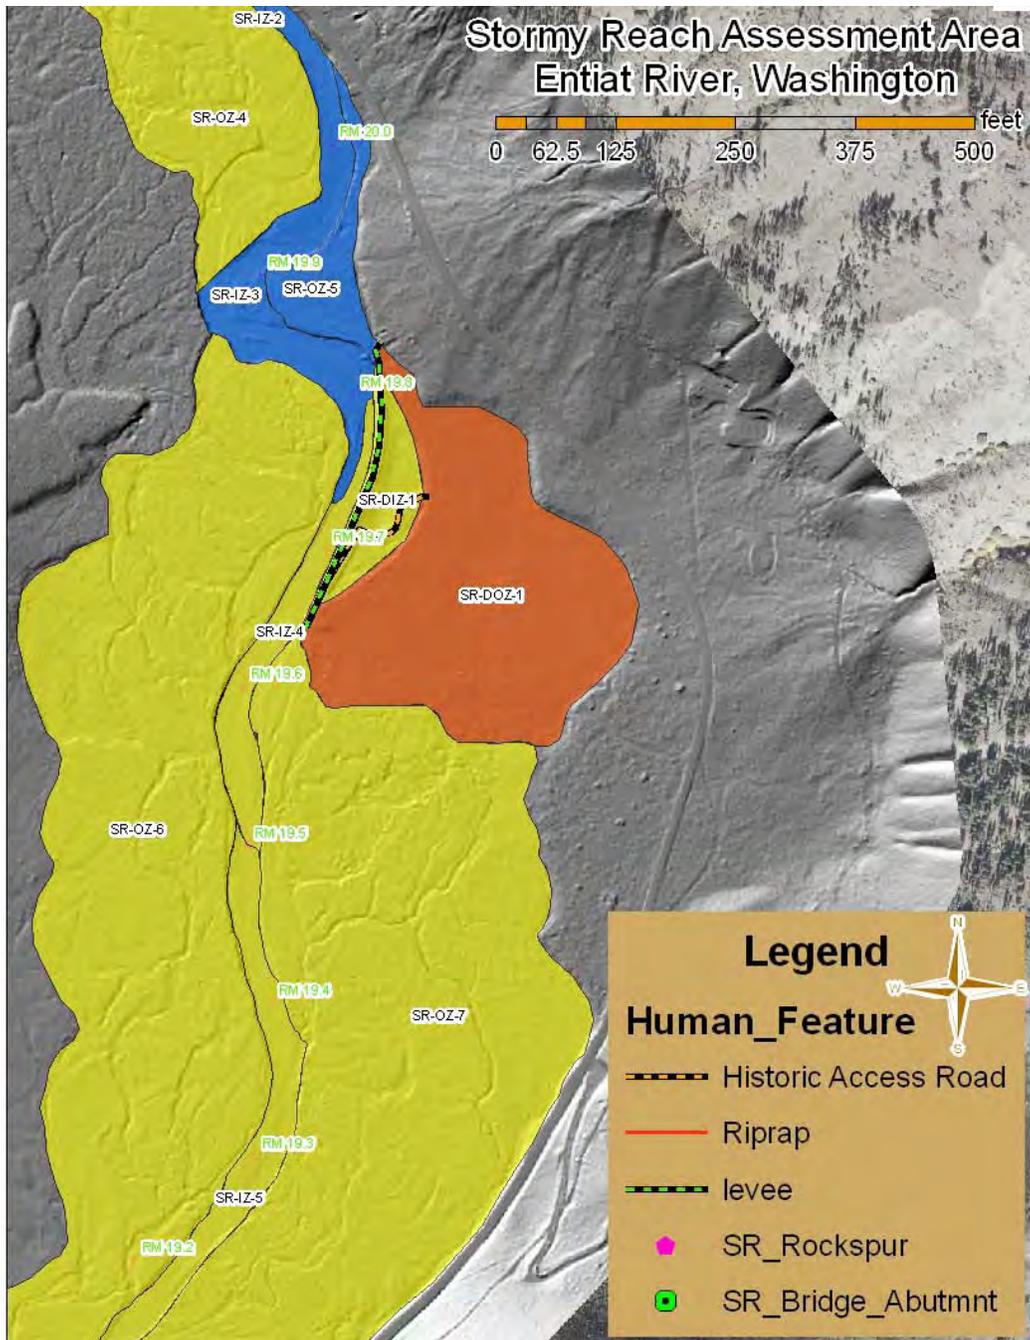
Figure 2. Subreach unit map with human features. The subreaches are color-coded based on the dominant proposed habitat action (i.e. green is reconnect processes and protect or reconnect isolated habitat, yellow is reconnect processes, orange is reconnect isolated habitat units, etc.).

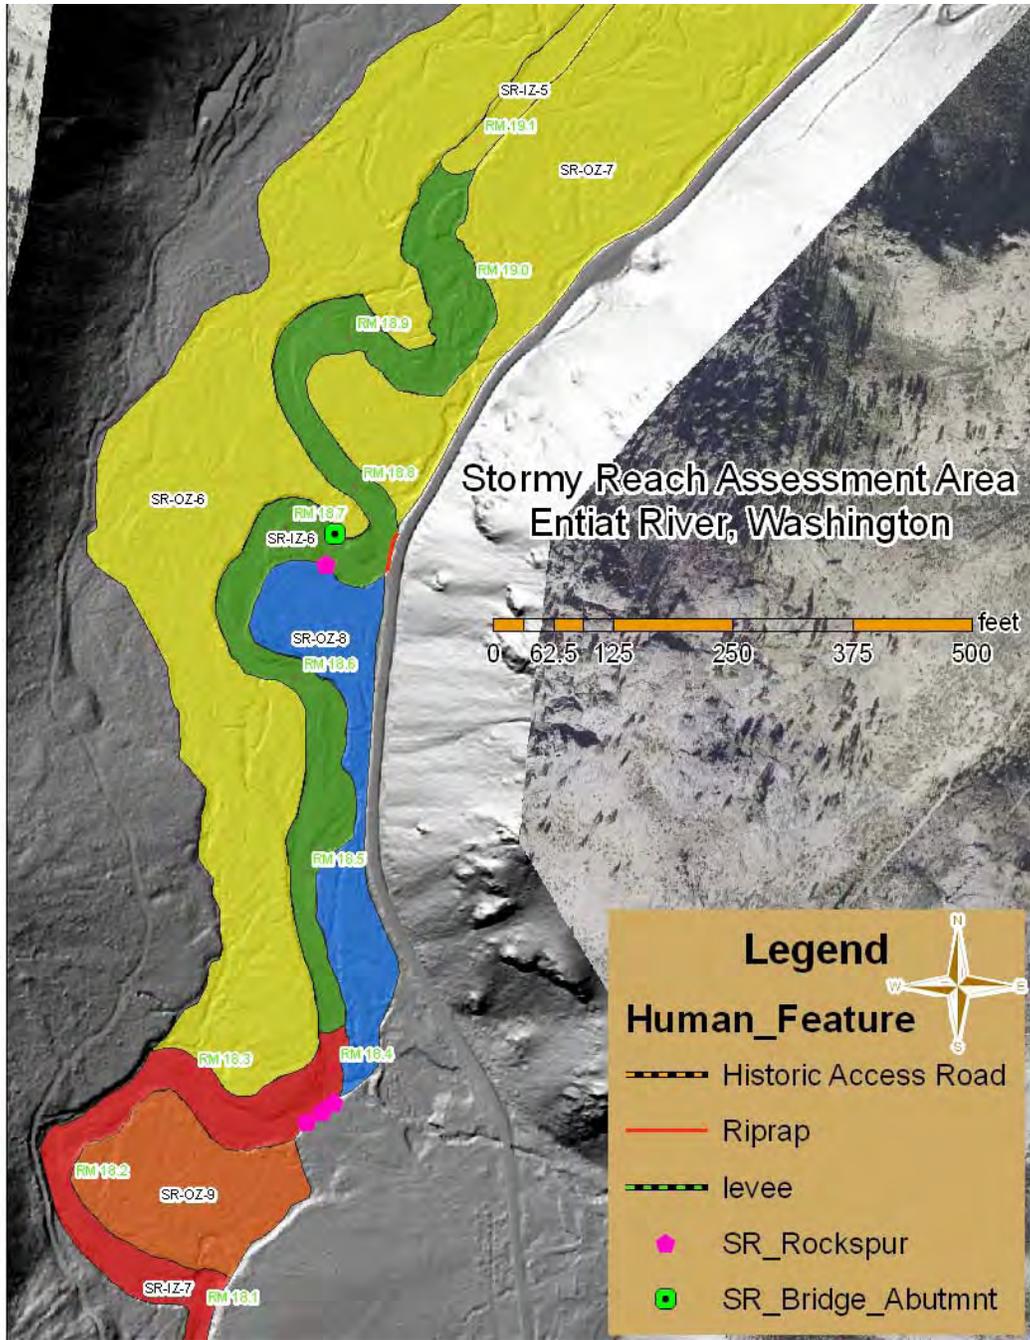
Figure 3. Subreach unit map with human features. The subreaches are color-coded based on the dominant proposed habitat action (i.e. blue is protect and maintain, green is reconnect processes and protect or reconnect isolated habitat, yellow is reconnect processes, orange is reconnect isolated habitat units, etc.).

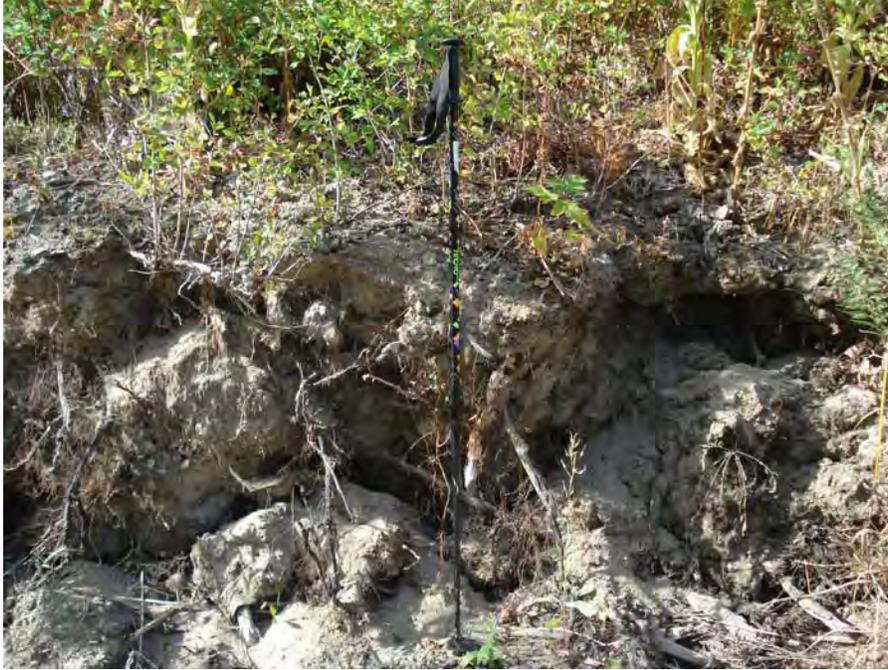
Photograph No. 1. View to the southwest looking at erosion of the right bank which contains high levels of fine-grained material. Stormy Reach – Entiat Subbasin, Washington – Bureau of Reclamation Photograph by R. McAfee, August 5, 2008.

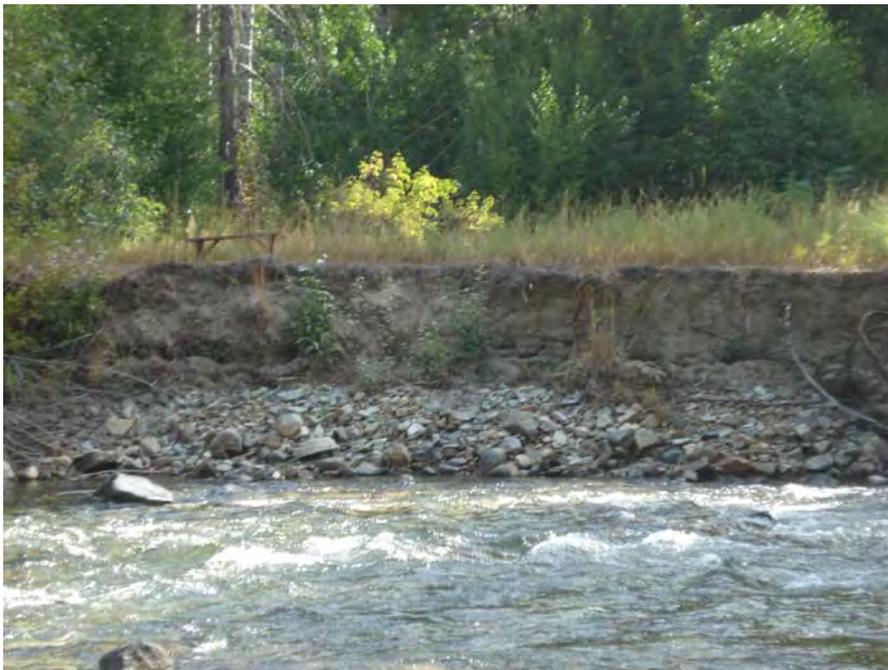
Photograph No. 2. View to the east looking at local erosion along the left bank. Note the apparent clearing of riparian vegetation. Stormy Reach – Entiat Subbasin, Washington – Bureau of Reclamation Photograph by R. McAfee, August 5, 2008.

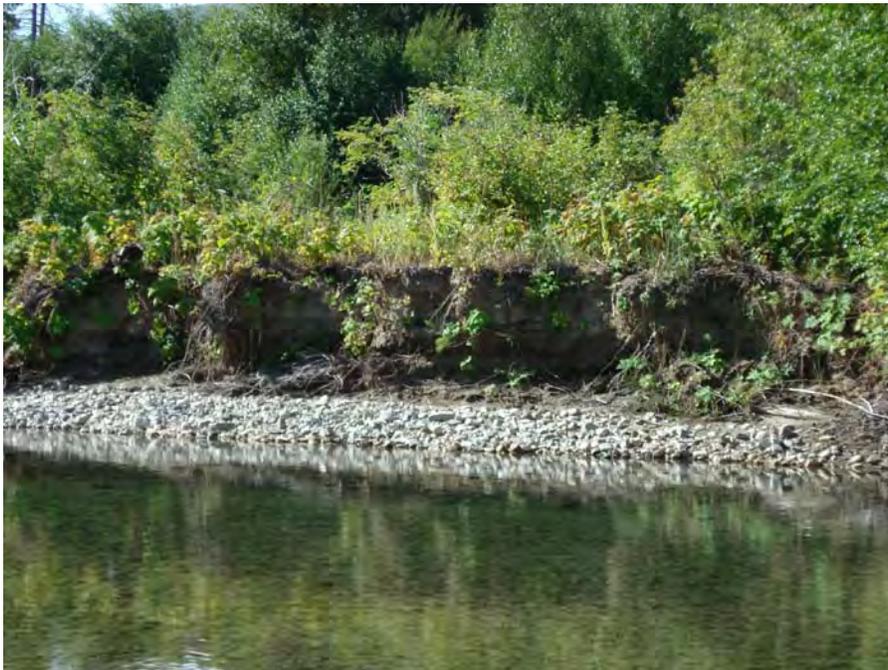
Photograph No. 6. View to the southwest of local erosion along the right bank. Stormy Reach – Entiat Subbasin, Washington – Bureau of Reclamation Photograph by R. McAfee, August 5, 2008.

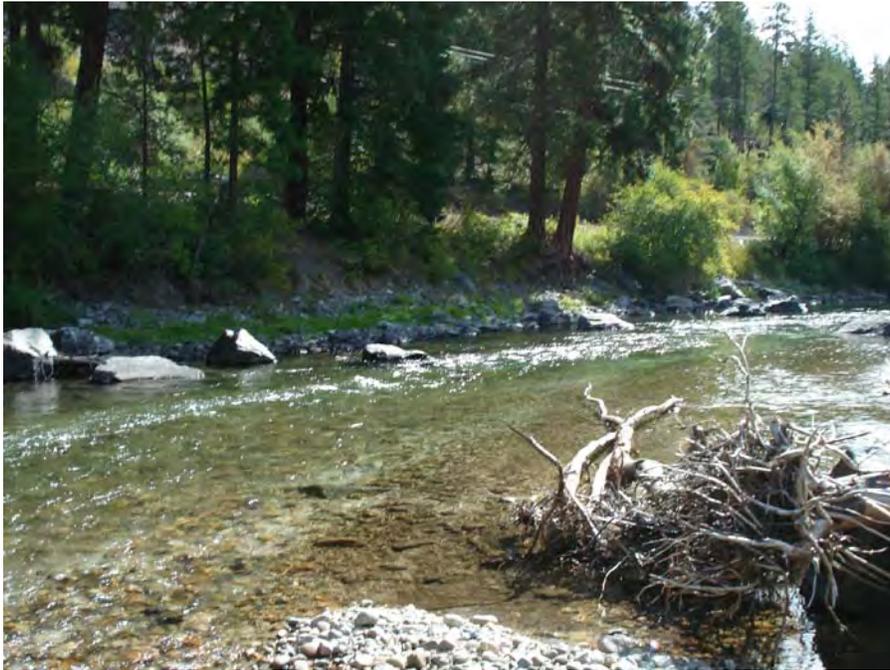
Photograph No. 16. View to the southeast of the highway along the left bank and boulders in the channel. Stormy Reach – Entiat Subbasin, Washington – Bureau of Reclamation Photograph by R. McAfee, August 5, 2008.

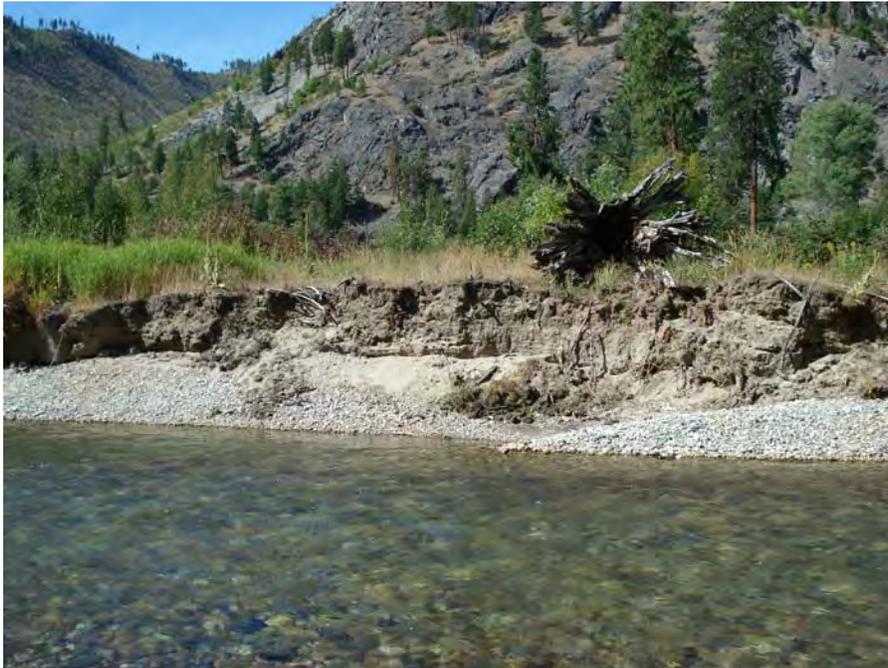
Photograph No. 18. View to the southwest of local bank erosion along the right bank. Note the lack of mature vegetation. Stormy Reach – Entiat Subbasin, Washington – Bureau of Reclamation Photograph by R. McAfee, August 5, 2008.

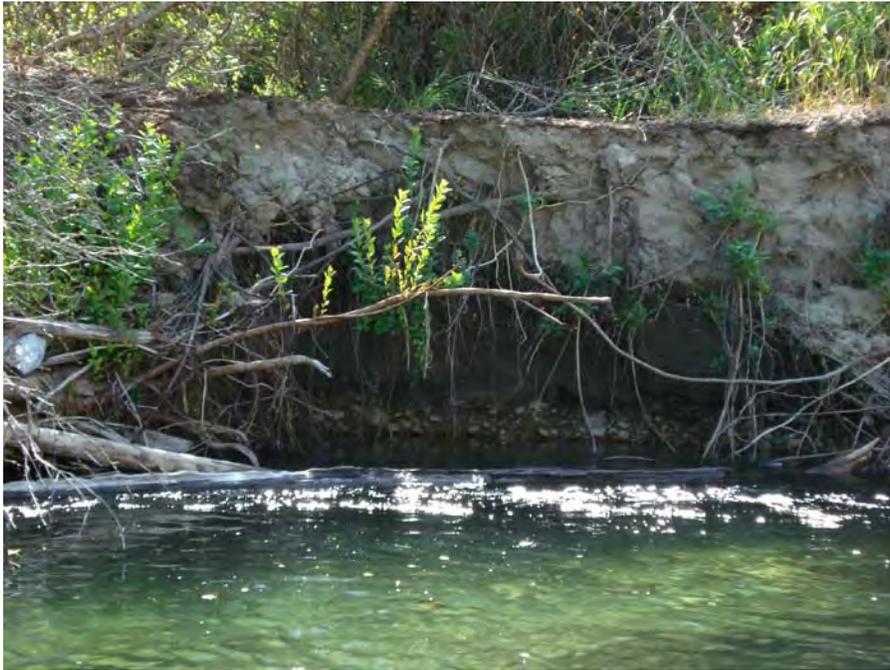
Photograph No. 22. View to the south of local bank erosion along the right bank. Stormy Reach – Entiat Subbasin, Washington – Bureau of Reclamation Photograph by R. McAfee, August 5, 2008.

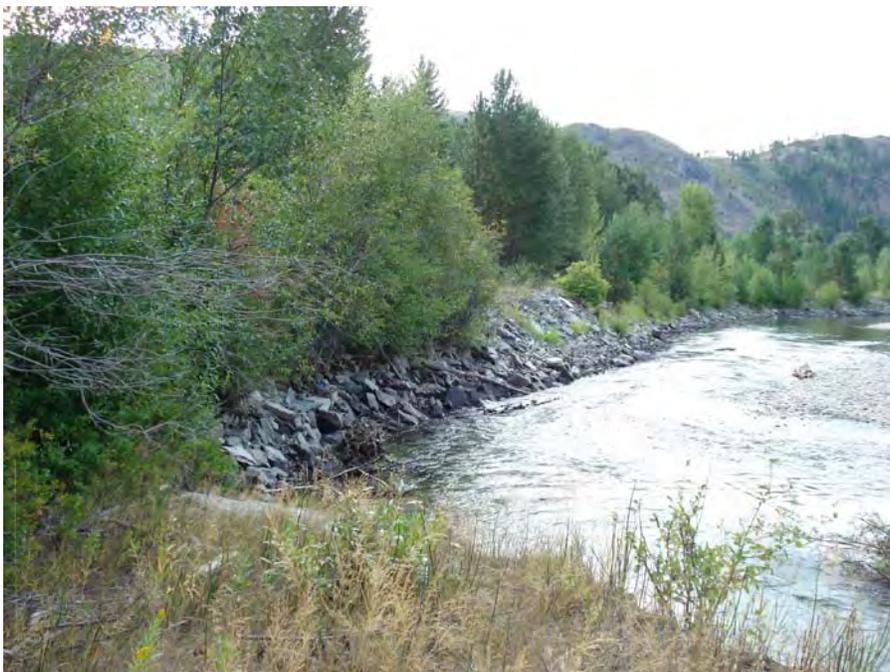
Photograph No. 34. View to the south of a levee along the left bank and a gravel point bar along the right. Stormy Reach – Entiat Subbasin, Washington – Bureau of Reclamation Photograph by R. McAfee, August 6, 2008.

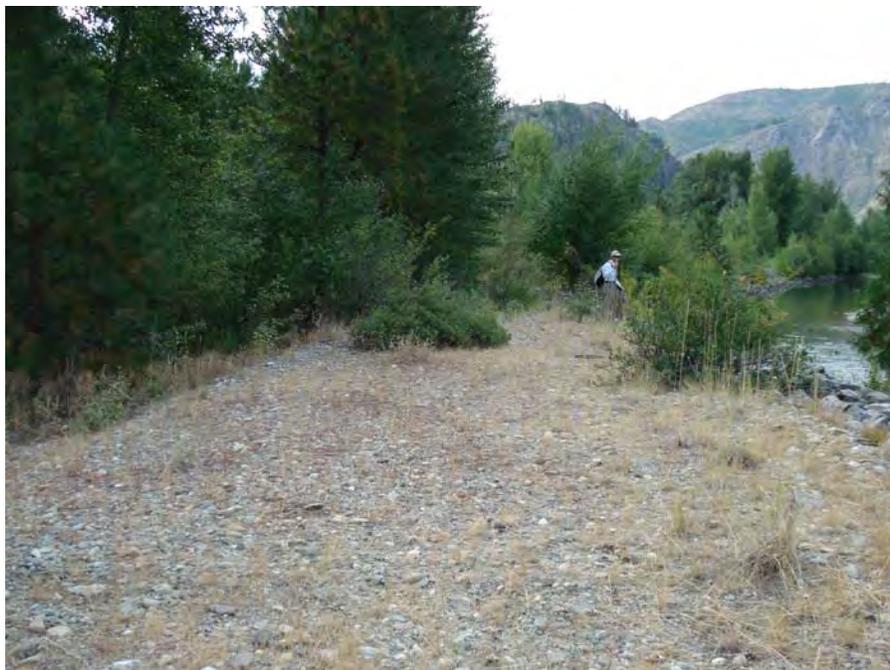
Photograph No. 35. View to the south along the crest a levee located along the left bank of the channel. Stormy Reach – Entiat Subbasin, Washington – Bureau of Reclamation Photograph by R. McAfee, August 6, 2008.

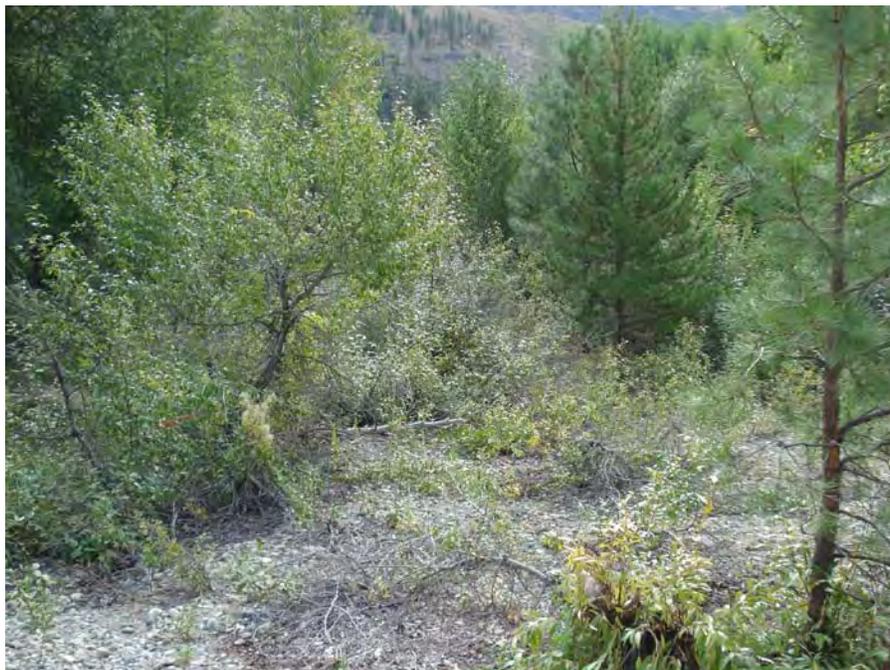
Photograph No. 36. View to the east of an access road that is connected to the back side of the levee. Stormy Reach – Entiat Subbasin, Washington – Bureau of Reclamation Photograph by R. McAfee, August 6, 2008.

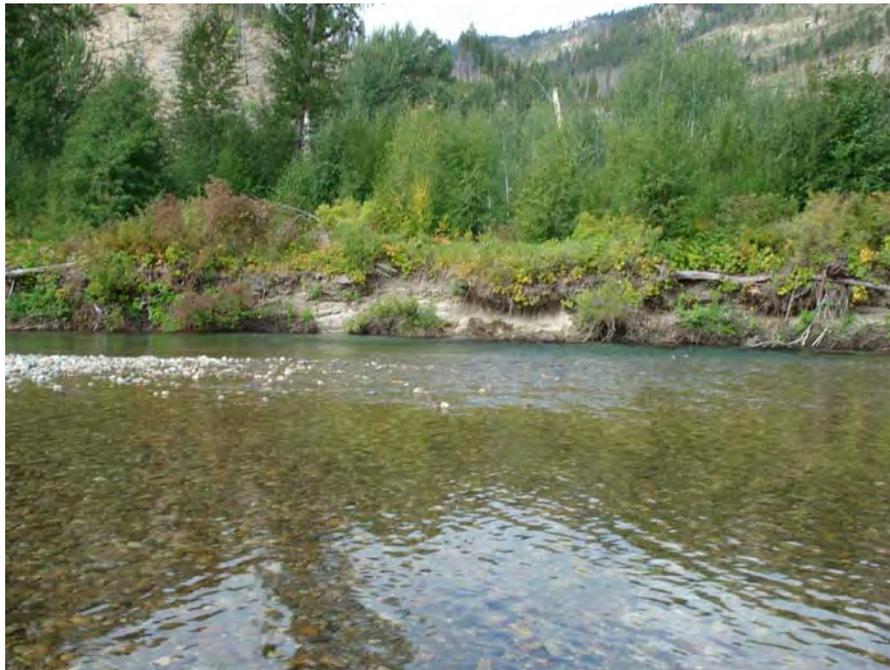
Photograph No. 38. View to the west of a channel unit sequence of run-riffle pool, and local bank erosion along the left bank. Stormy Reach – Entiat Subbasin, Washington – Bureau of Reclamation Photograph by R. McAfee, August 6, 2008.

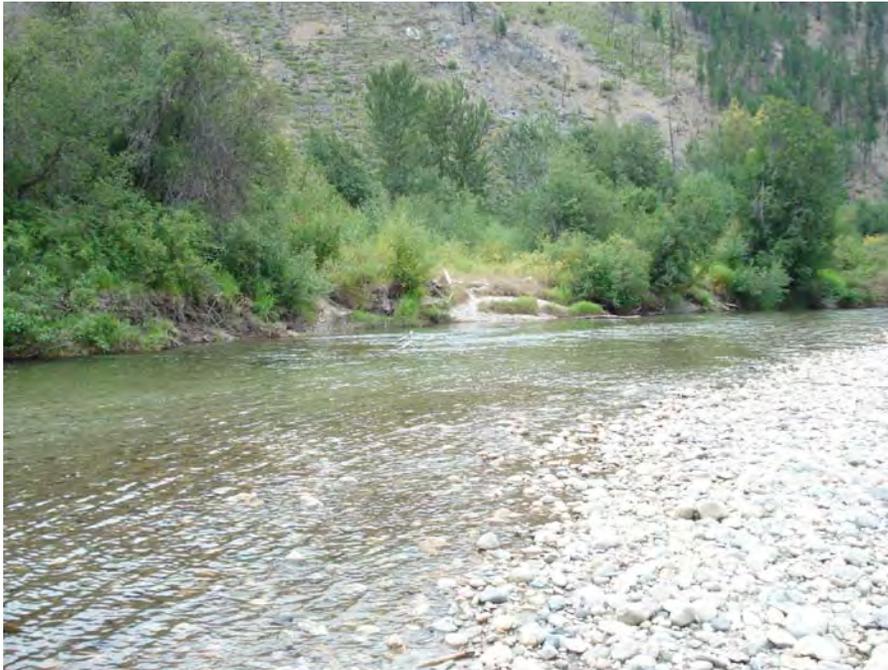
Photograph No. 40. View to the south of a gravel and cobble point bar along the right bank and local bank erosion along the left. Stormy Reach – Entiat Subbasin, Washington – Bureau of Reclamation Photograph by R. McAfee, August 6, 2008.

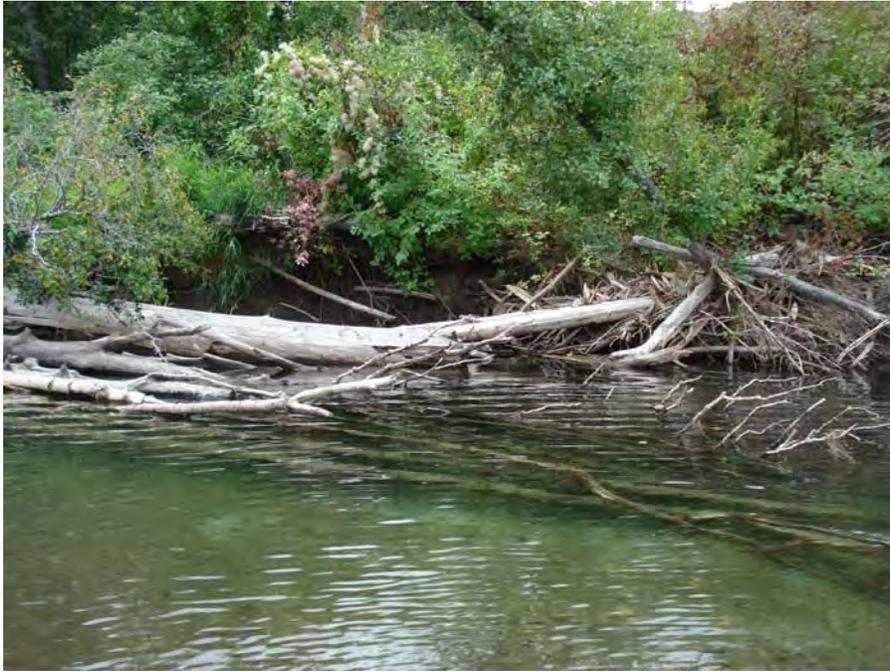
Photograph No. 49. Close up view showing wood accumulation and local erosion along the left bank. Stormy Reach – Entiat Subbasin, Washington – Bureau of Reclamation Photograph by R. McAfee, August 6, 2008.

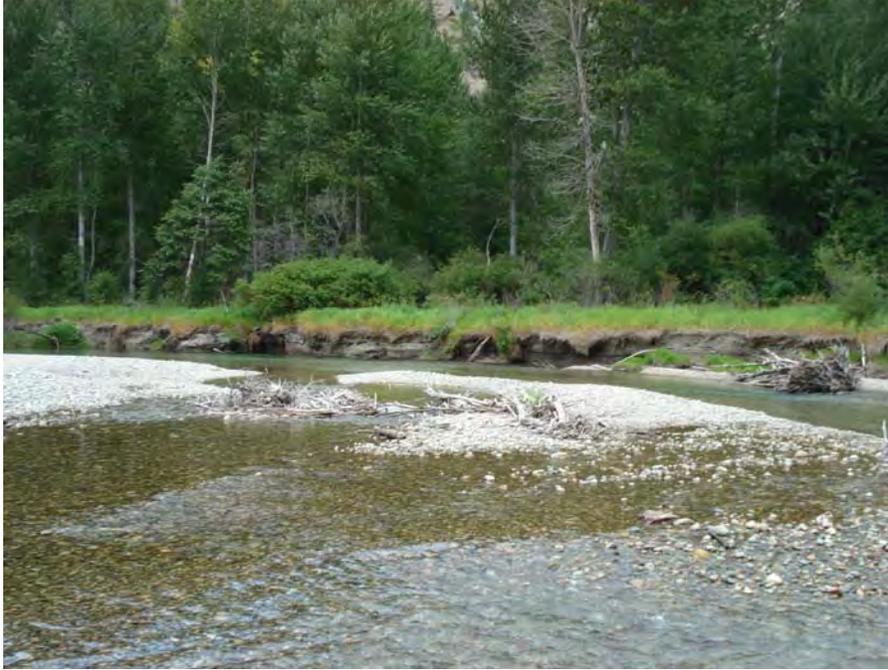
Photograph No. 51. View to the west of a channel unit sequence of riffle-to-run and local erosion along the right bank. Note the vegetation consisting of grass/forbes. Stormy Reach – Entiat Subbasin, Washington – Bureau of Reclamation Photograph by R. McAfee, August 6, 2008.

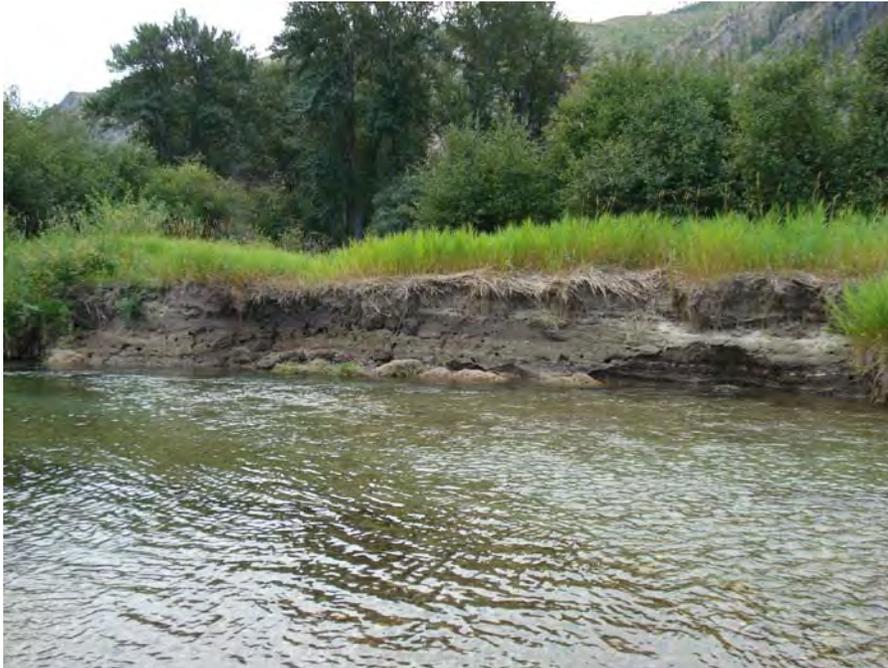
Photograph No. 52. View to the southwest of a channel unit of a run and local erosion along the right bank. Note the gestation of grass/forbes. Stormy Reach – Entiat Subbasin, Washington – Bureau of Reclamation Photograph by R. McAfee, August 6, 2008.

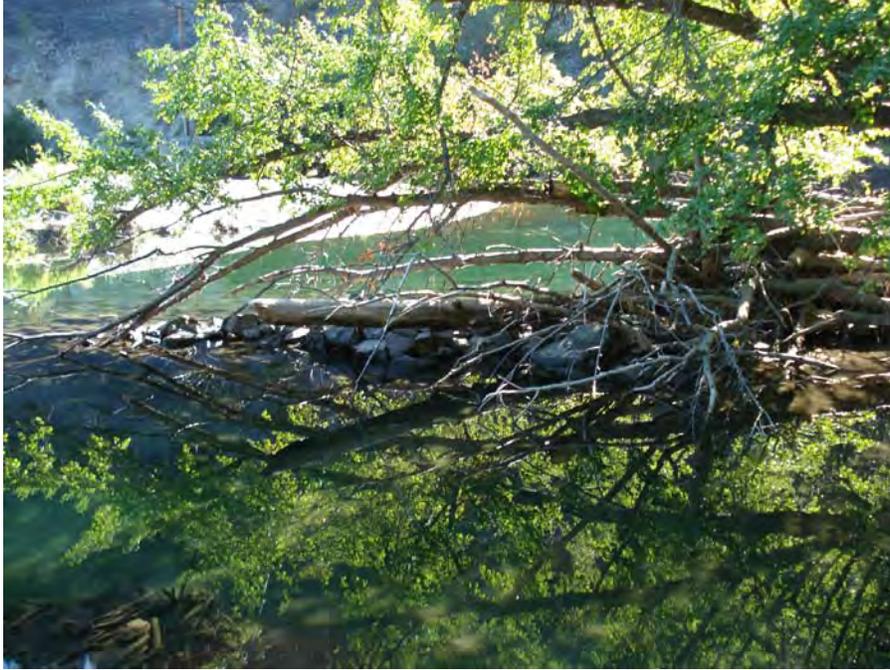
Photograph No. 57. View to the east showing a rock spur near RM 18.73 along the right bank. Stormy Reach – Entiat Subbasin, Washington – Bureau of Reclamation Photograph by R. McAfee, August 7, 2008.

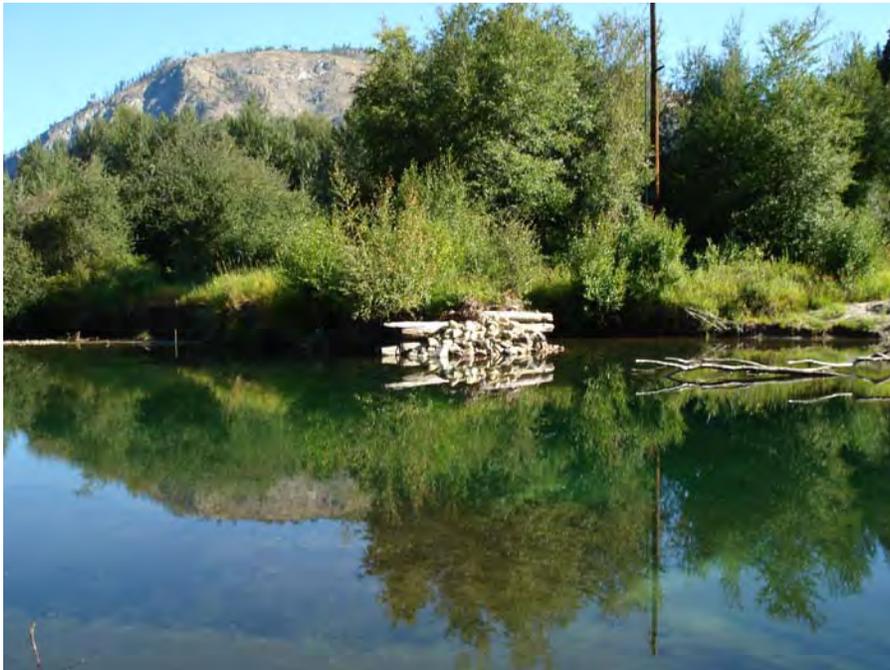
Photograph No. 58. View to the north of a historic bridge abutment near RM 18.73 along the left bank. Stormy Reach – Entiat Subbasin, Washington – Bureau of Reclamation Photograph by R. McAfee, August 7, 2008.

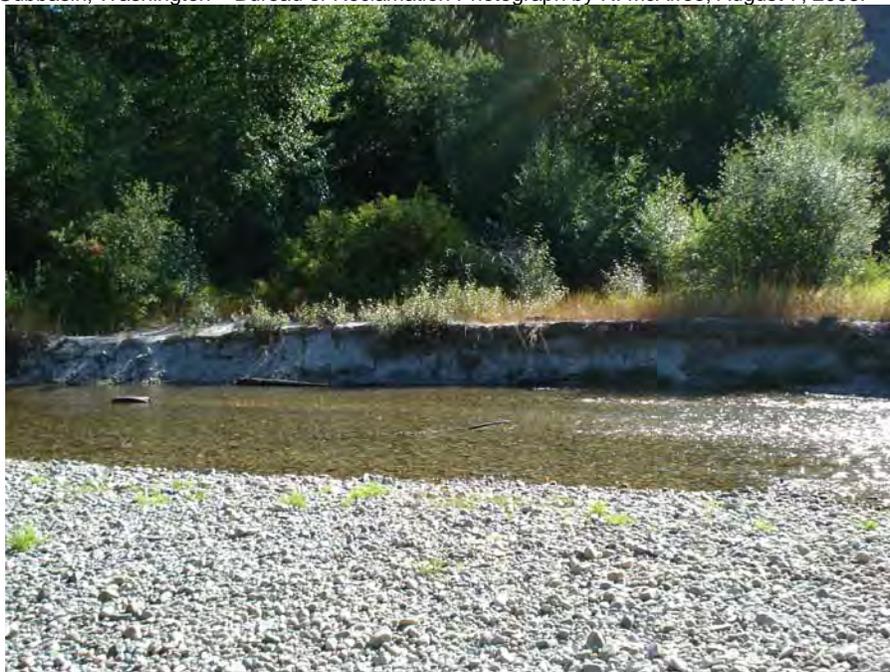
Photograph No. 60. View to the southeast of a channel unit transition from run to riffle and local erosion along the left bank of the left split flow. Stormy Reach – Entiat Subbasin, Washington – Bureau of Reclamation Photograph by R. McAfee, August 7, 2008.

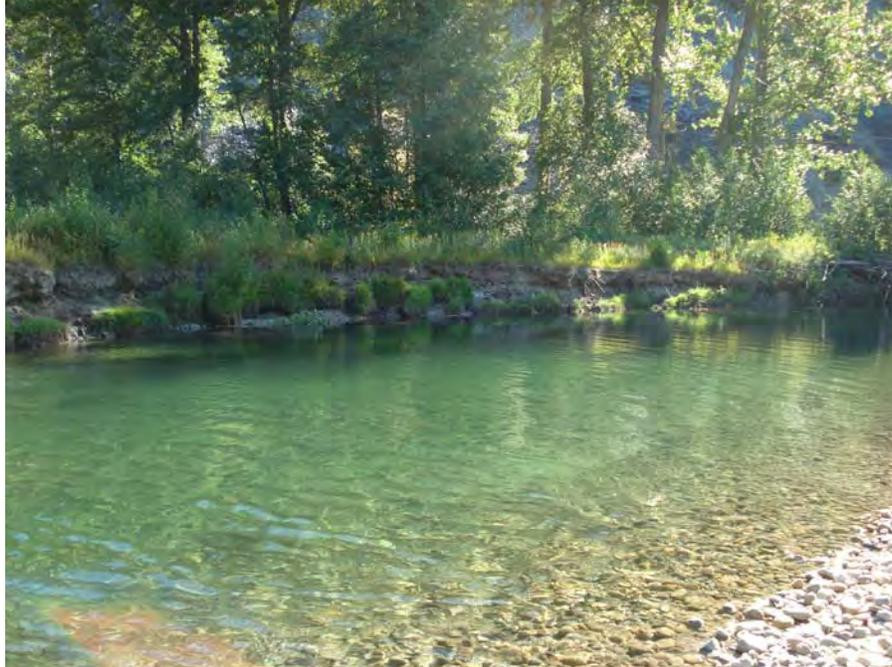
Photograph No. 63. View to the east of a channel unit of run, and local erosion along the left bank. Stormy Reach – Entiat Subbasin, Washington – Bureau of Reclamation Photograph by R. McAfee, August 7, 2008.

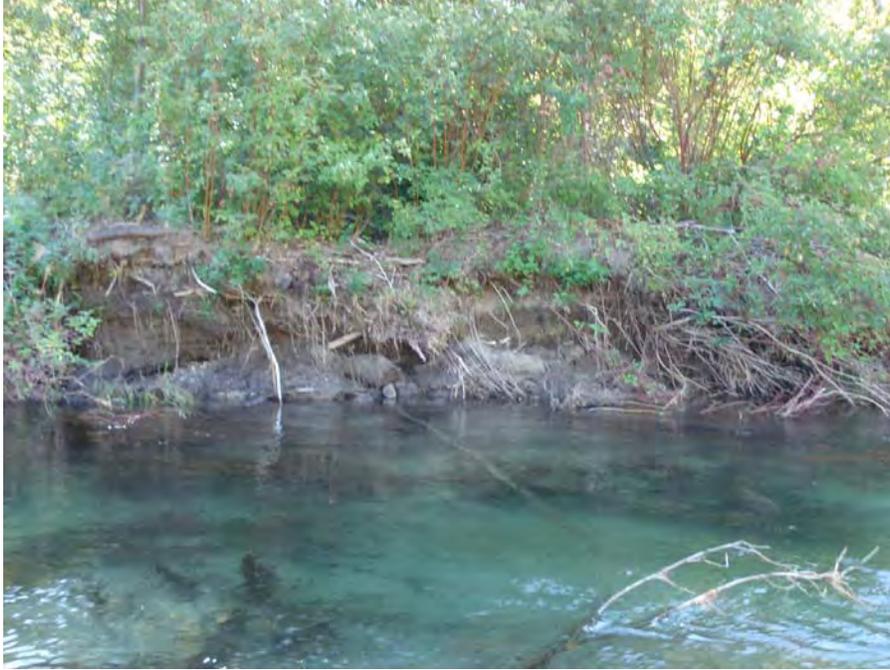
Photograph No. 67. View to the southeast of local vertical scour and erosion of the left bank. Stormy Reach – Entiat Subbasin, Washington – Bureau of Reclamation Photograph by R. McAfee, August 7, 2008.

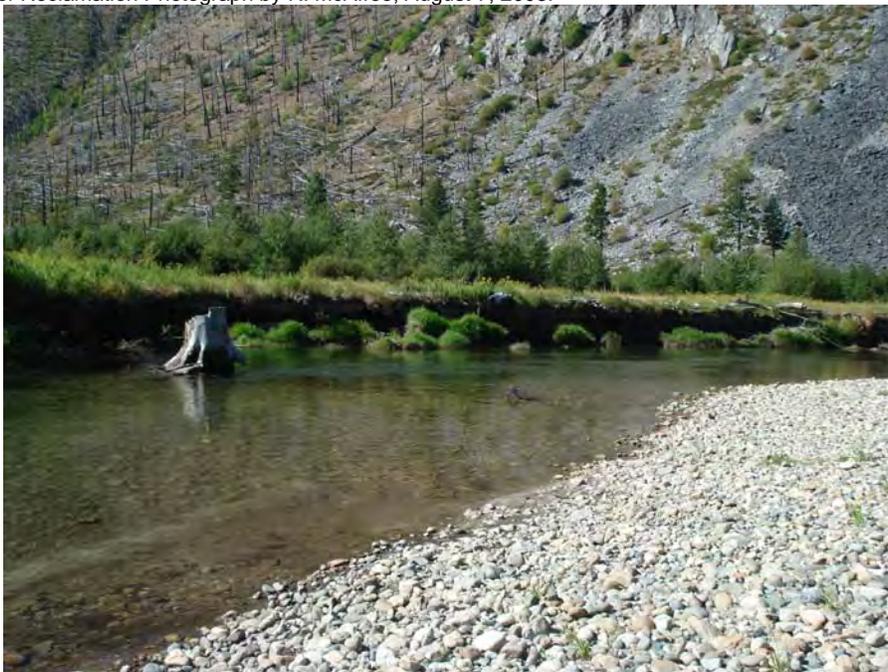
Photograph No. 72. View to the west showing a gravel and cobble point bar along the right bank and local erosion along the left bank. Note the grass/forbes vegetation along the left bank. Stormy Reach – Entiat Subbasin, Washington – Bureau of Reclamation Photograph by R. McAfee, August 7, 2008.

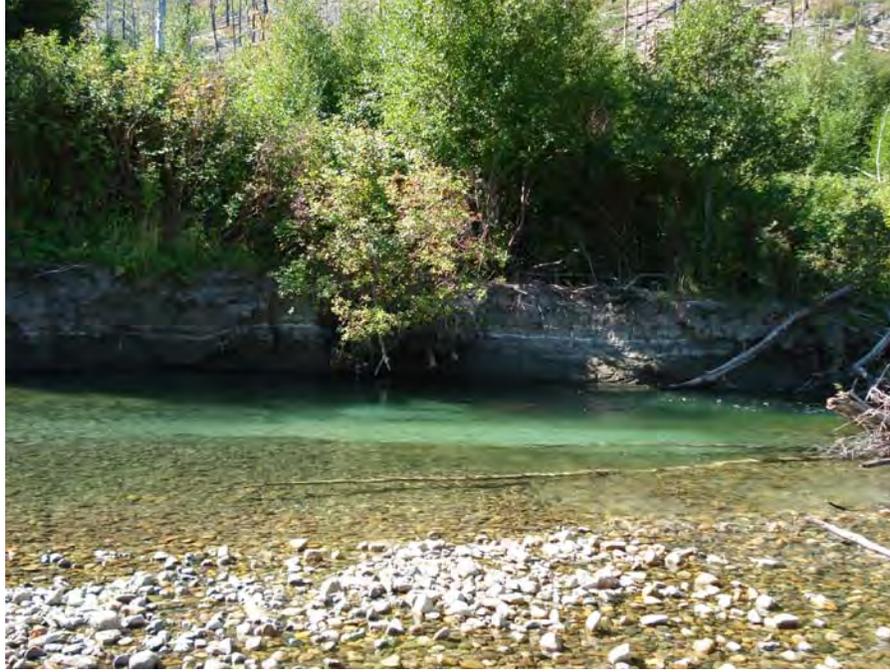
Photograph No. 75. View to the south of local scour and erosion along the right bank. Stormy Reach – Entiat Subbasin, Washington – Bureau of Reclamation Photograph by R. McAfee, August 7, 2008.

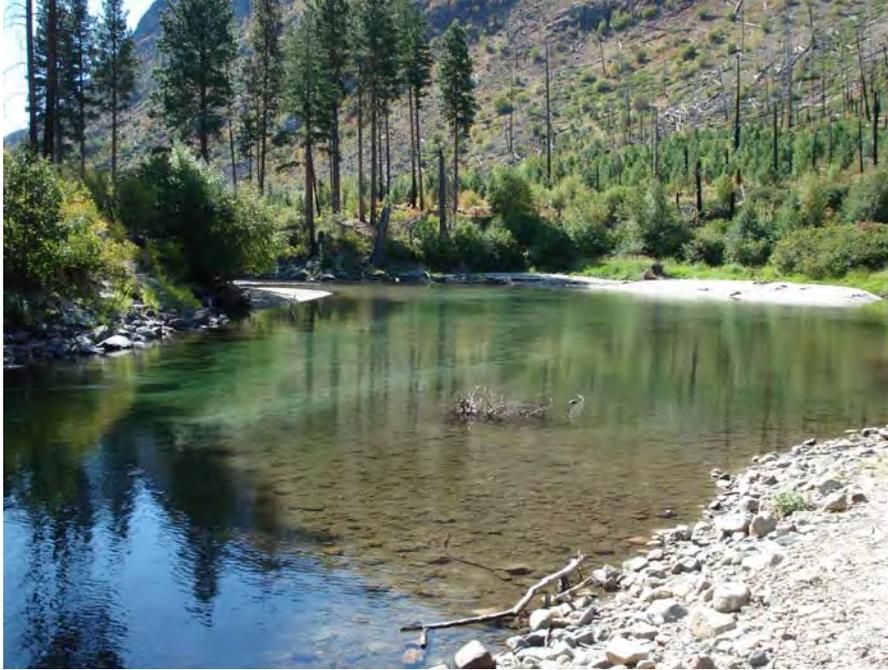
Photograph No. 77. View to the south of a transition from run to pool and ravel/sand bars. Stormy Reach – Entiat Subbasin, Washington – Bureau of Reclamation Photograph by R. McAfee, August 7, 2008.
