Stormy Reach Assessment Entiat River

Chelan County, Washington

U.S. Department of the Interior
Bureau of Reclamation
Pacific Northwest Region
Boise, Idaho

November 2009

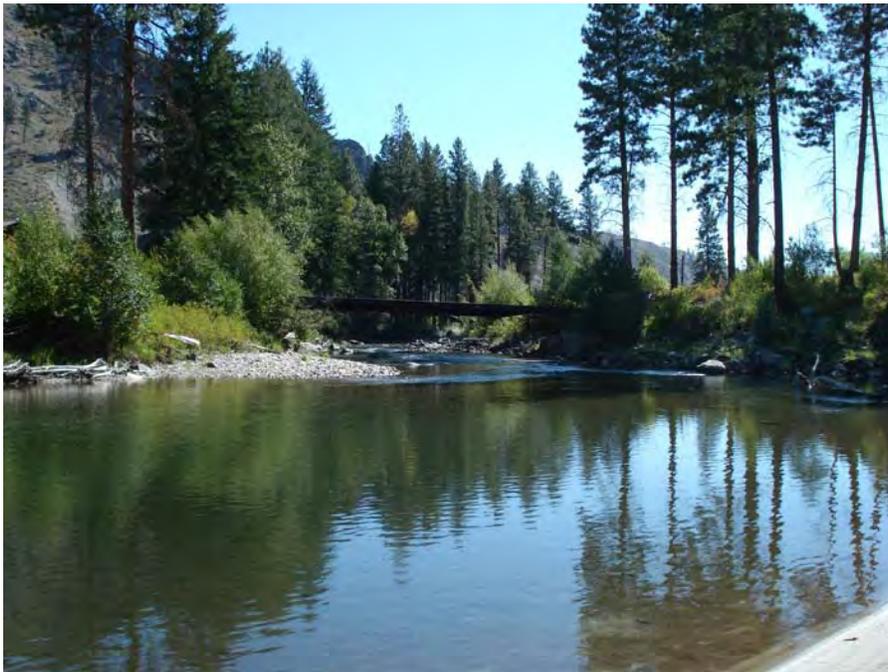
Photograph No. 78. View to the southeast showing a transition from pool to riffle, a gravel point bar along the left bank a bridge. Stormy Reach – Entiat Subbasin, Washington – Bureau of Reclamation Photograph by R. McAfee, August 7, 2008.

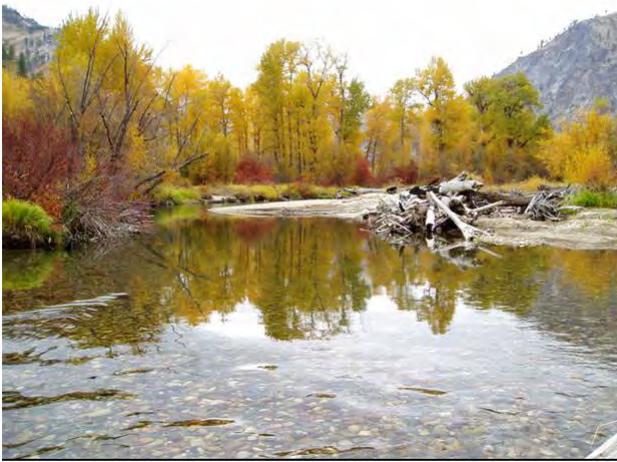
Small log jam on bar at top of pool at RM 19

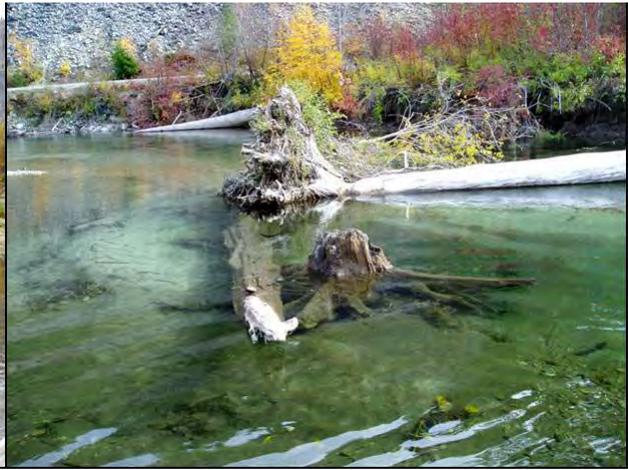
Wood providing good cover and scour in pool

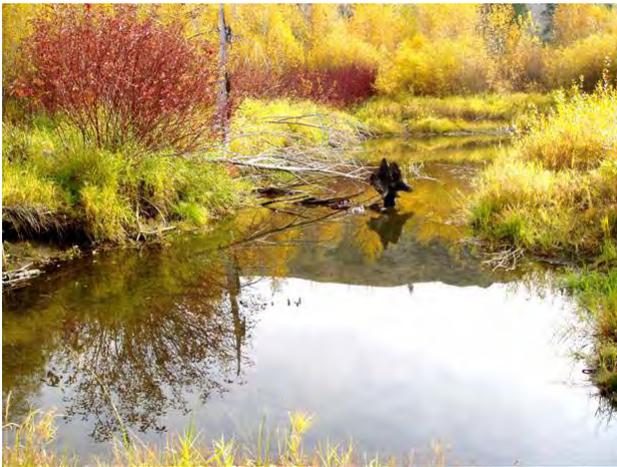
Pond in side channel at RM 18.3

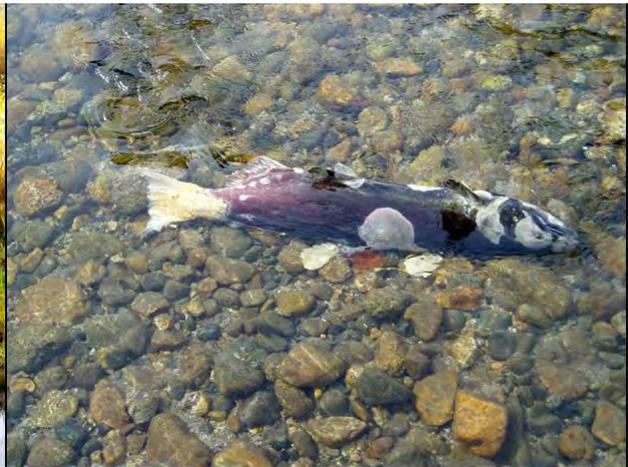
Spawning substrate and dead salmon in Reach 1

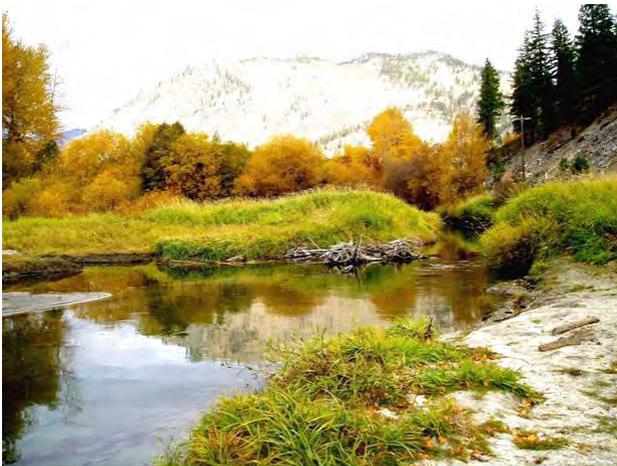
Mouth of side channel and old beaver activity at RM 18.8

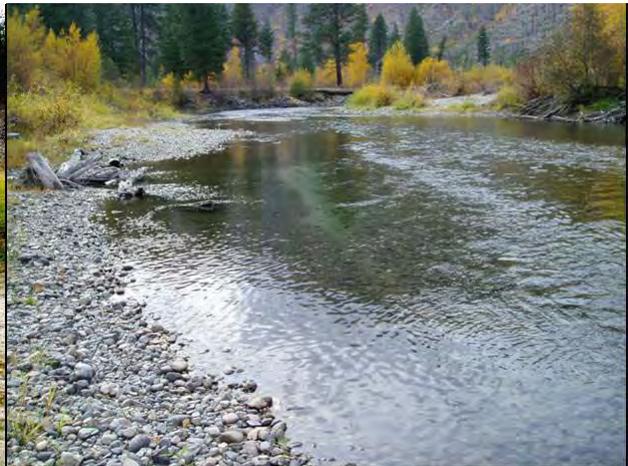
Run habitat in reach 1

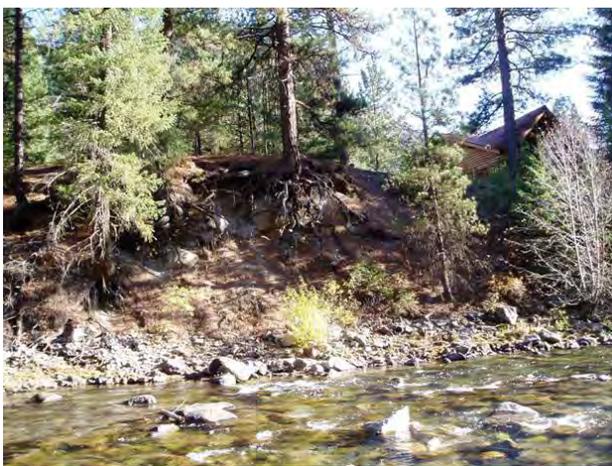
Confined stream channel and larger substrate in reach

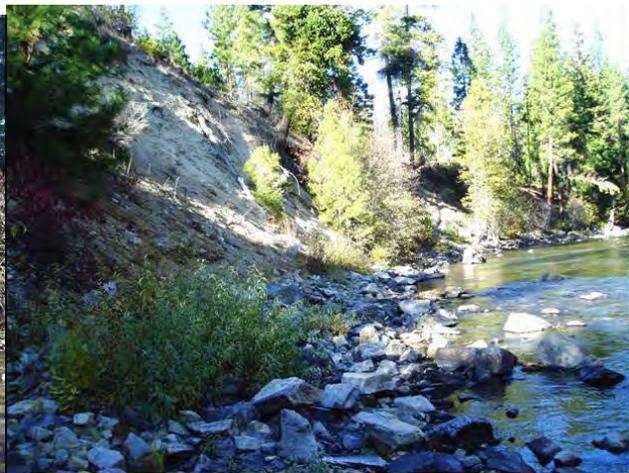
Bank erosion in reach 2

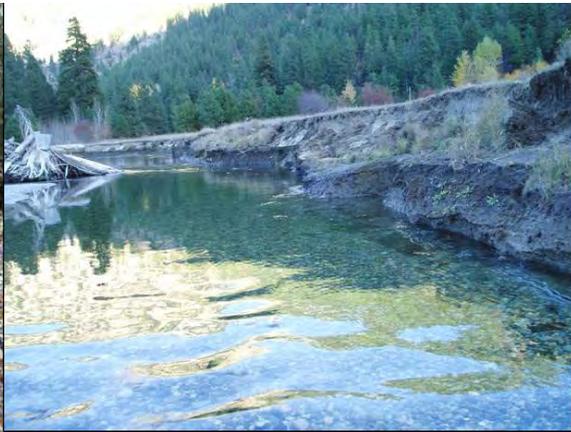
A serious consequence of bank erosion is the concern of landowners losing their property to the river, which can lead to the installation of rip rap to protect the banks. A 500' segment of the left bank of the river between RM 21.4 and RM 21.5 is eroding at a very fast rate (an average rate of 2.25 feet/year, range 0 to 8.8 feet/year, 3/22/07 to 4/28/08 [CCD 2008]) due to the lack of root structure on the banks. The 4 landowners at this site are planting trees beyond the bank, but it appears as if bank structures may be needed to stop the erosion. The banks of the river directly upstream of the eroding bank are being protected by wood structures that were installed to protect the banks. The wood structures consist of a "Christmas tree revetment", overlain by larger stems and interplanted with willows (see photo below). Velocity measurements made on 3/10/06 by Phil Archibald conclude that the wood structures are reducing velocities on the eroding bank downstream at low flow. Installing wood structures on the banks (which is preferable to rip rap), along with tree planting, may be necessary to protect the eroding bank below the bank with the installed wood structures.

Eroding bank at RM 21.4

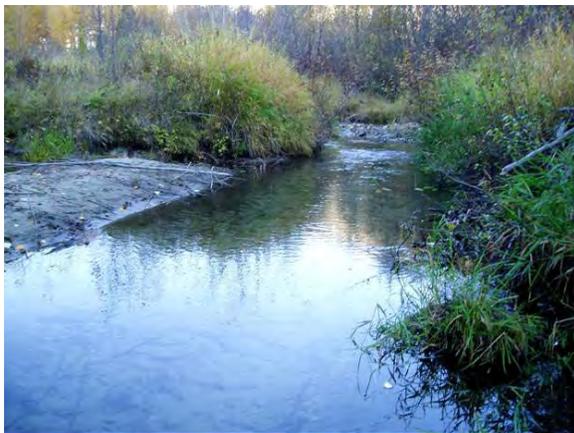
Side channel habitat and beaver dam at RM 21.3

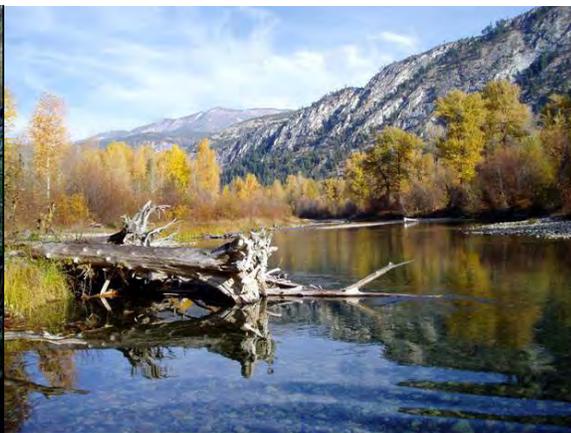
Pool with large wood in Reach 3

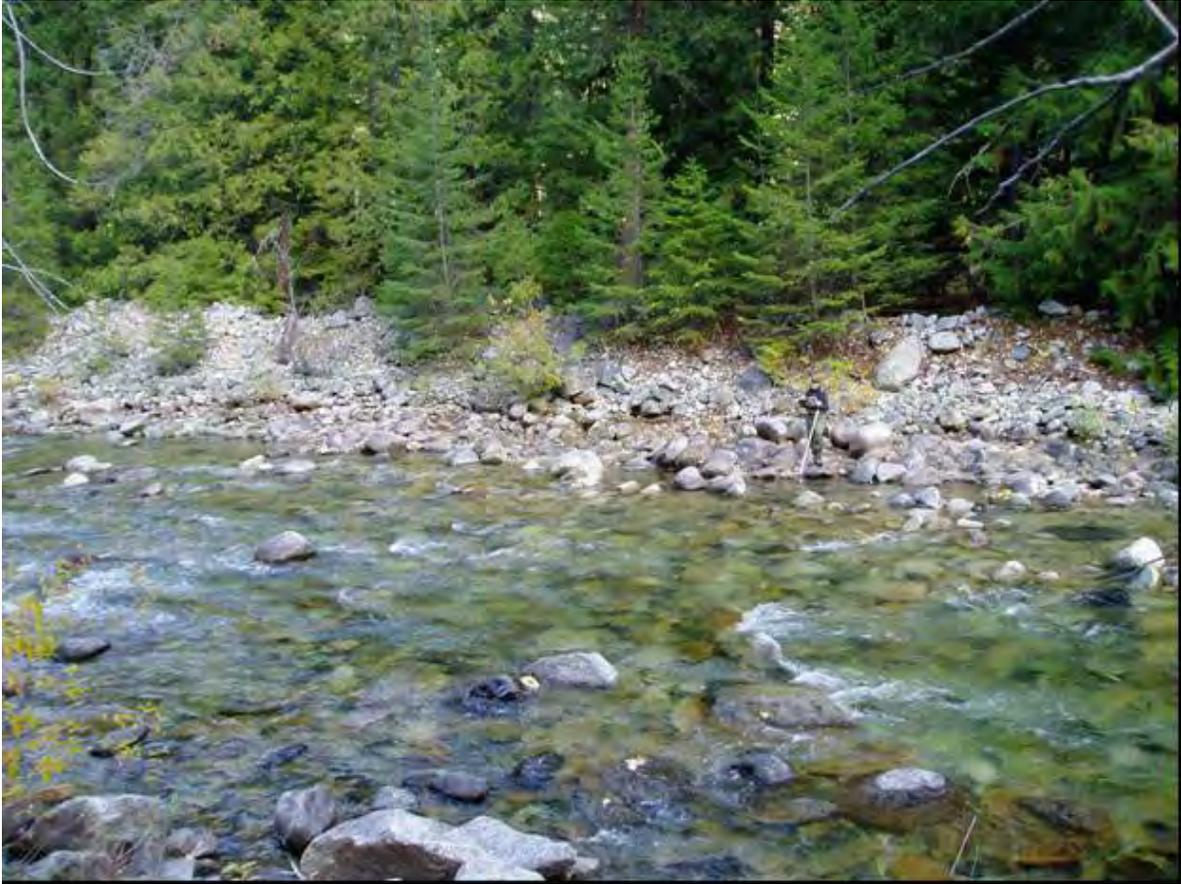
Confined channel and riffle habitat in upper half of reach 4

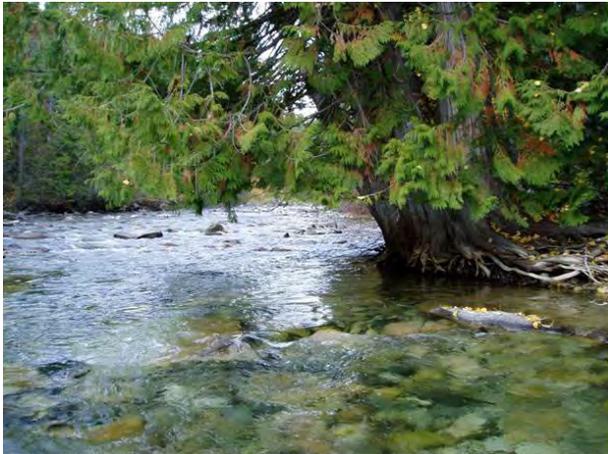
Standing trees in river in reach 4

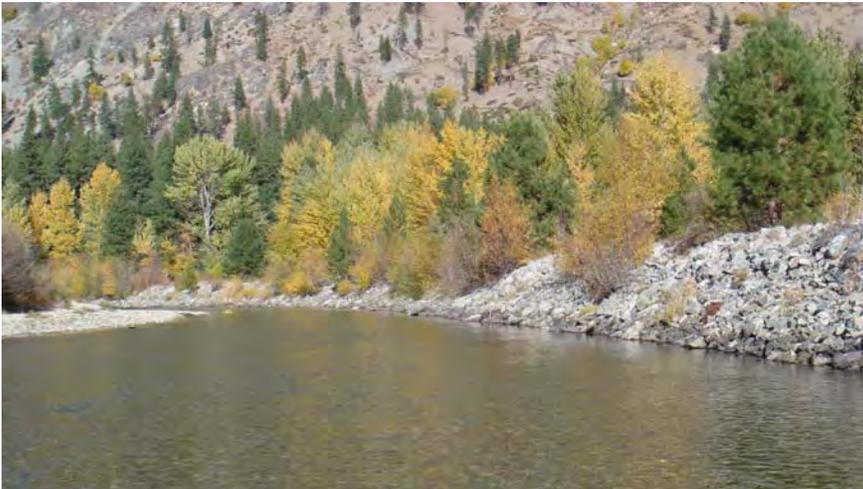
The significant present impacts to the channel and floodplain in the Stormy Reach include the Bremer Levee (RM 19.65-19.8; left bank) along with various areas of bank protection that limit channel migration and alter instream hydraulics and channel geometry, accompanied by localized areas of cleared vegetation resulting in increased bank instabilities. The Bremer Levee (Figures 3 and 4) was built in 1973 by the Soil Conservation Service (SCS) and overtopped in a February 1974 flood after which time it was raised by an unknown amount (Bountry et al. 2009). This armored levee, located directly across from the Tye Creek alluvial fan, has not only prevented the river from accessing part of its active floodplain, but has also limited channel migration, likely playing a role in the channel planform change from a high sinuosity channel in 1945 to a low sinuosity channel with sparse large woody debris (LWD). This section of river has also likely incised.

Figure 4. Bremer Levee. (Photo looking upstream).
