# COMPLETION REPORT Wolf Creek Diversion Dam FCRPS Habitat Improvement Program Wolf Creek, Methow Subbasin, WA

# COMPLETION REPORT WOLF CREEK DIVERSION DAM FCRPS HABITAT IMPROVEMENT PROGRAM WOLF CREEK, METHOW SUBBASIN, WA

PREPARED BY
U.S. BUREAU OF RECLAMATION
PACIFIC NORTHWEST REGION
COLUMBIA/SNAKE SALMON RECOVERY OFFICE,
BOISE, IDAHO

**MARCH 2009**

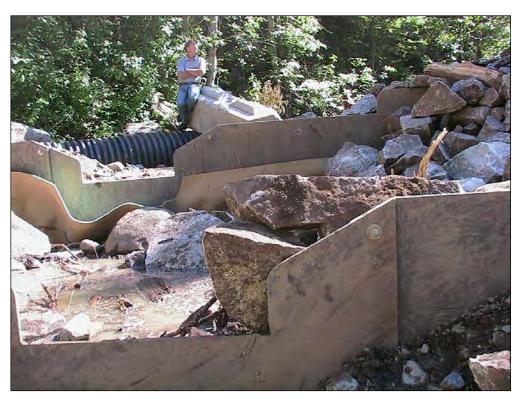
Photo A-14. A view looking downstream toward the entrance to the ditch. A large rock was placed on the creek bank upstream of the ditch entrance to block debris and logs from being forced into the ditch by the current.
