**COMPLETION REPORT  
MILL CREEK DITCH  
FISH PASSAGE IMPROVEMENT PROJECT  
MILL CREEK, PESHATIN CREEK  
WENTATCHEE SUBBASIN, WASHINGTON**

**PREPARED FOR  
CHELAN COUNTY CONSERVATION DISTRICT  
WENATCHEE, WASHINGTON**

**BY U.S. BUREAU OF RECLAMATION  
PACIFIC NORTHWEST REGION  
UPPER COLUMBIA AREA OFFICE  
WENATCHEE FIELD STATION**

**JULY 2005**

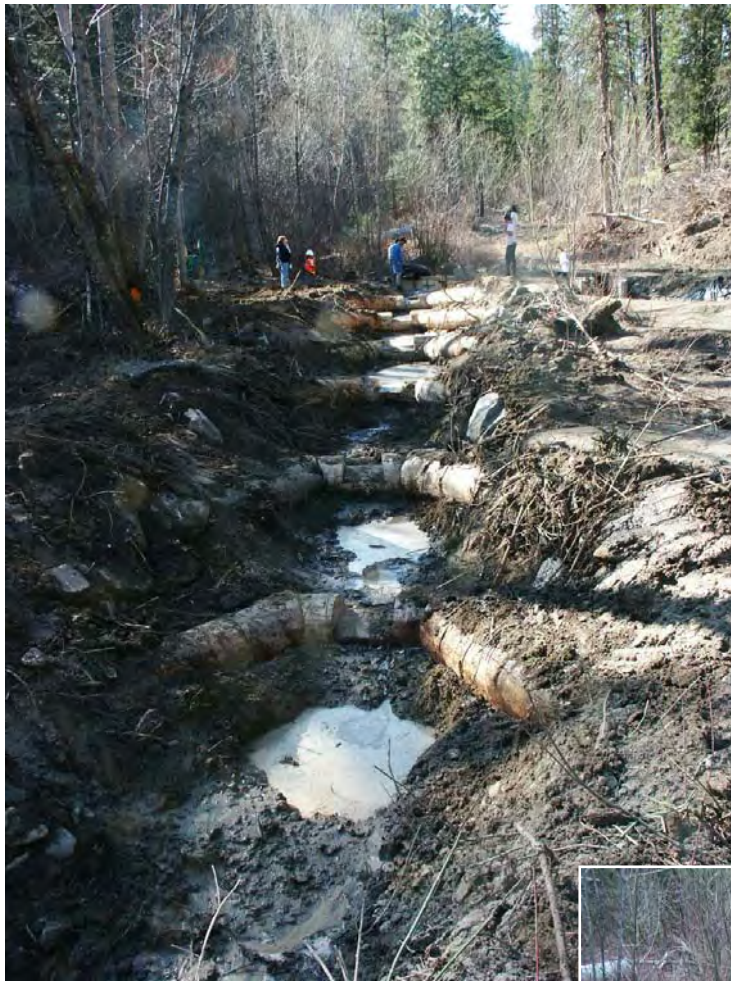
**Photo A-13. Looking upstream at completed weirs; groundwater has filled the individual scour holes.**

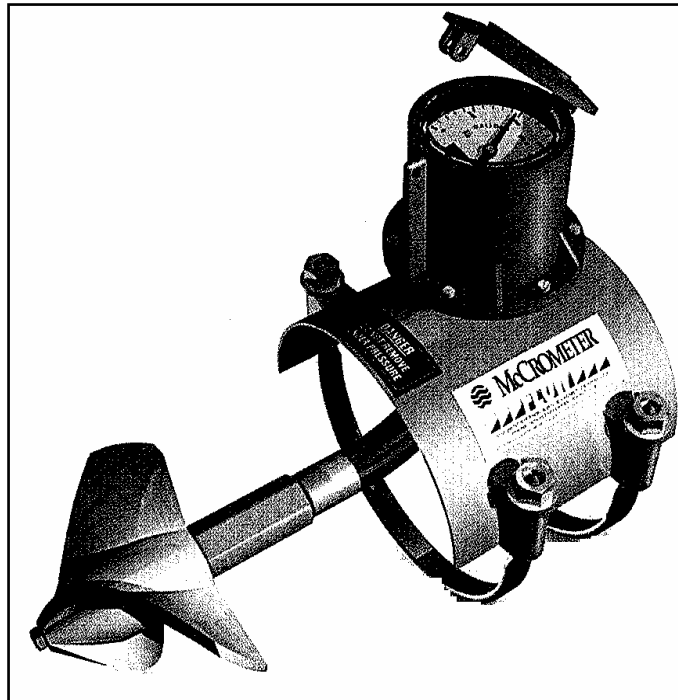
**Photo A-21. Flow meter installed downstream from the diversion structure near the point-of-diversion.**

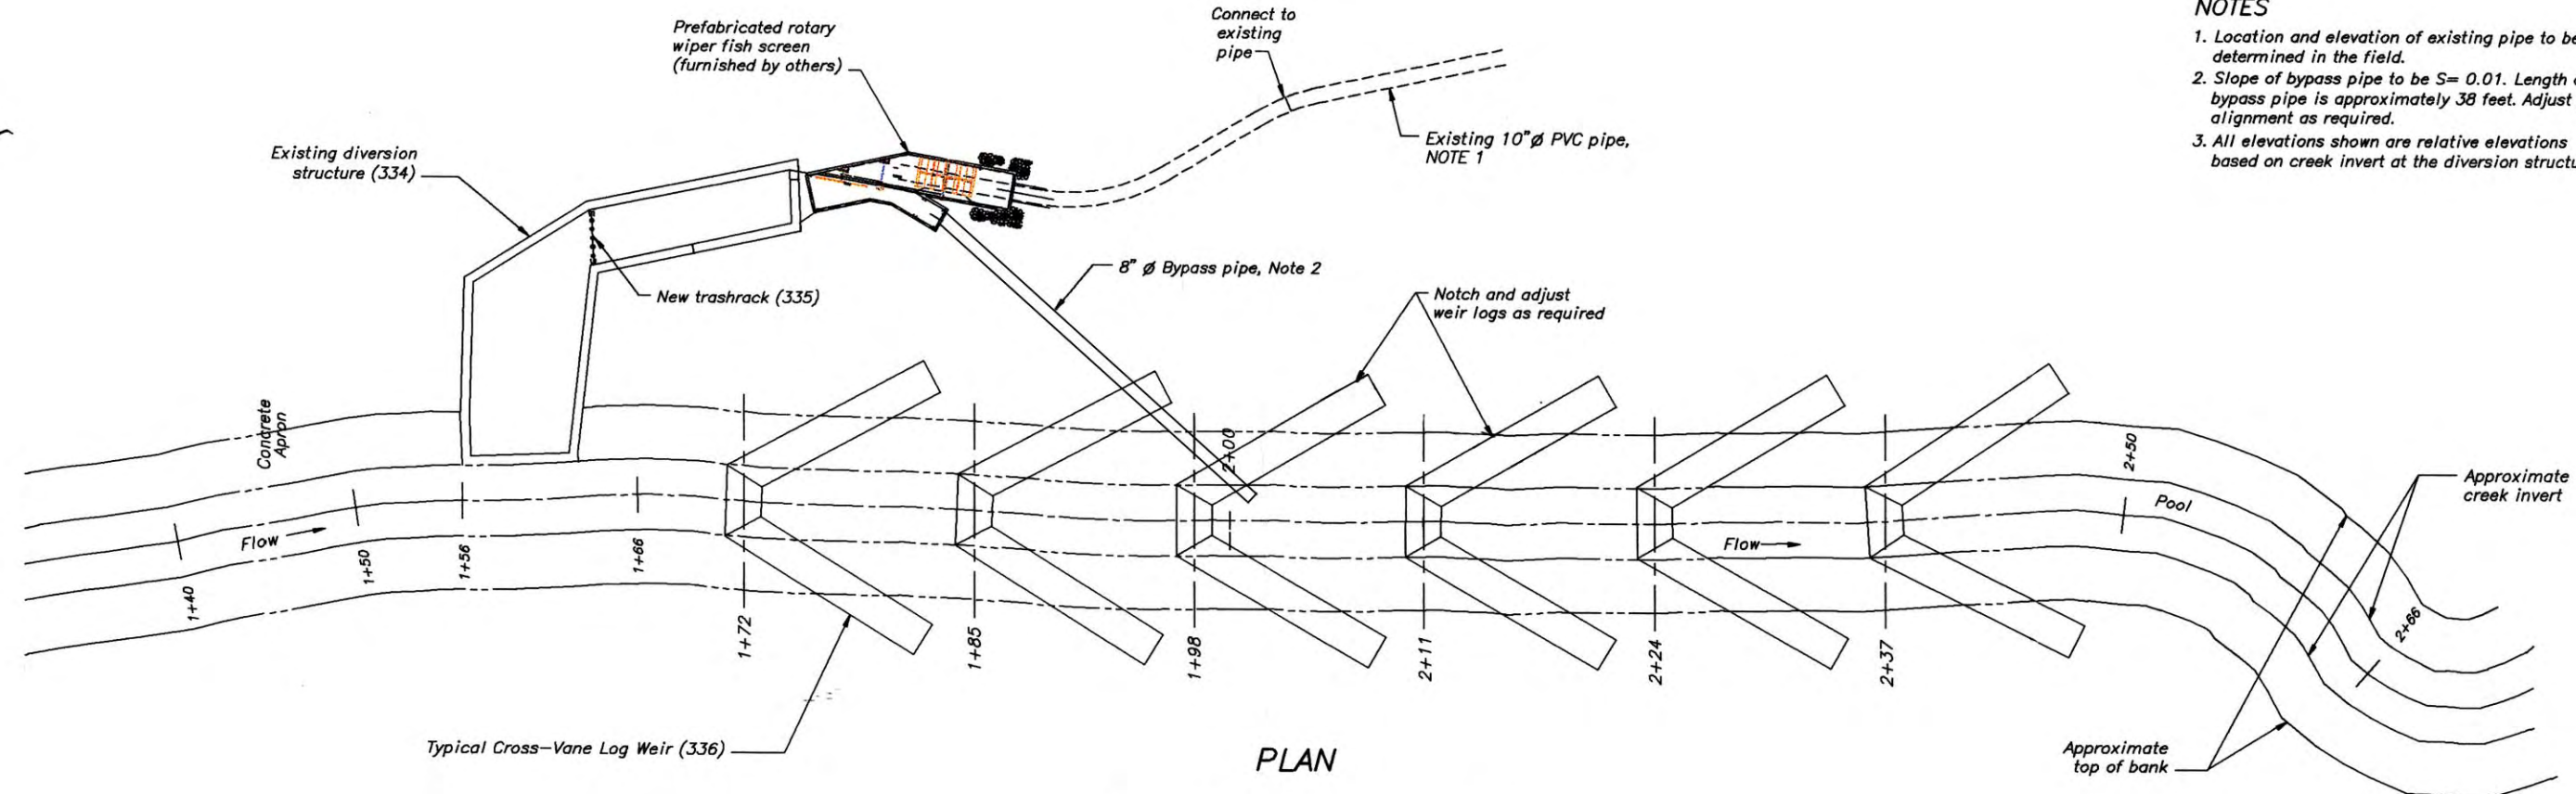
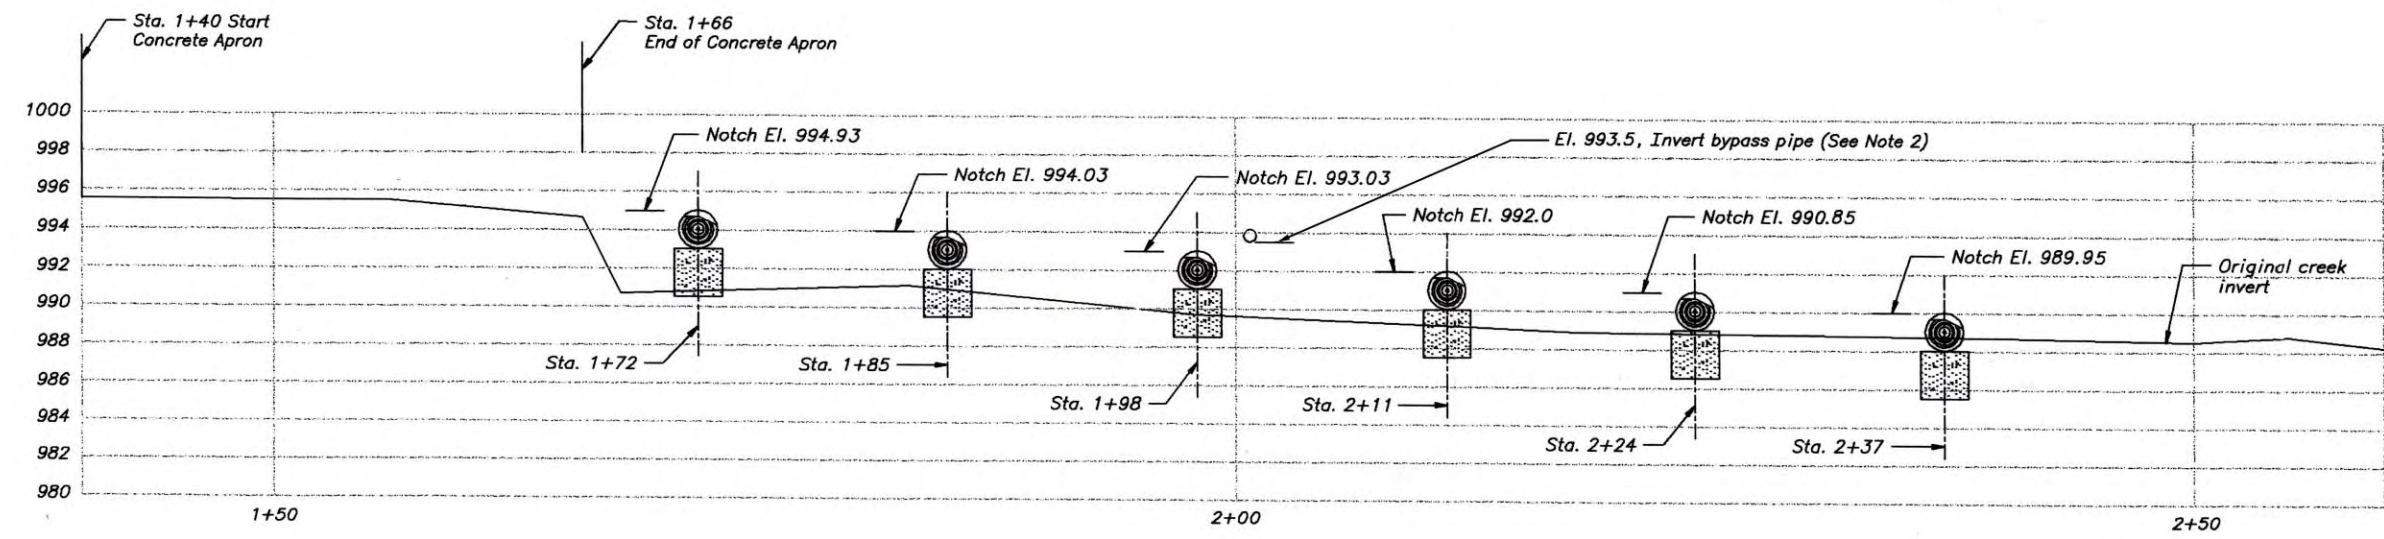
REV NO 1	2005-2-23 100-SEM	AS BUILT BY 109. REVISED BYPASS PIPE AND NOTCH ELEVATIONS.
<b>ALWAYS THINK SAFETY</b>		
UNITED STATES DEPARTMENT OF THE INTERIOR BUREAU OF RECLAMATION COLUMBIA/SNAKE RIVER SALMON RECOVERY PROGRAM WENATCHEE SUBBASIN - WASHINGTON		
<b>MILL CREEK DIVERSION MODIFICATIONS GENERAL PLAN &amp; PROFILE</b>		
DESIGNED: Steve E. Montague	CHECKED: Dennis Hawkins	
DRAWN: Carlos Haue	EDM: TECH. APPROVAL: Steve E. Montague	
APPROVAL: Dave Jennings PROGRAM MANAGER		
CADD SYSTEM AutoCAD 2004, 16.0 BOISE, IDAHO	CADD FILENAME 1678-100-333.dwg FEBRUARY 4, 2003	1678-100-333

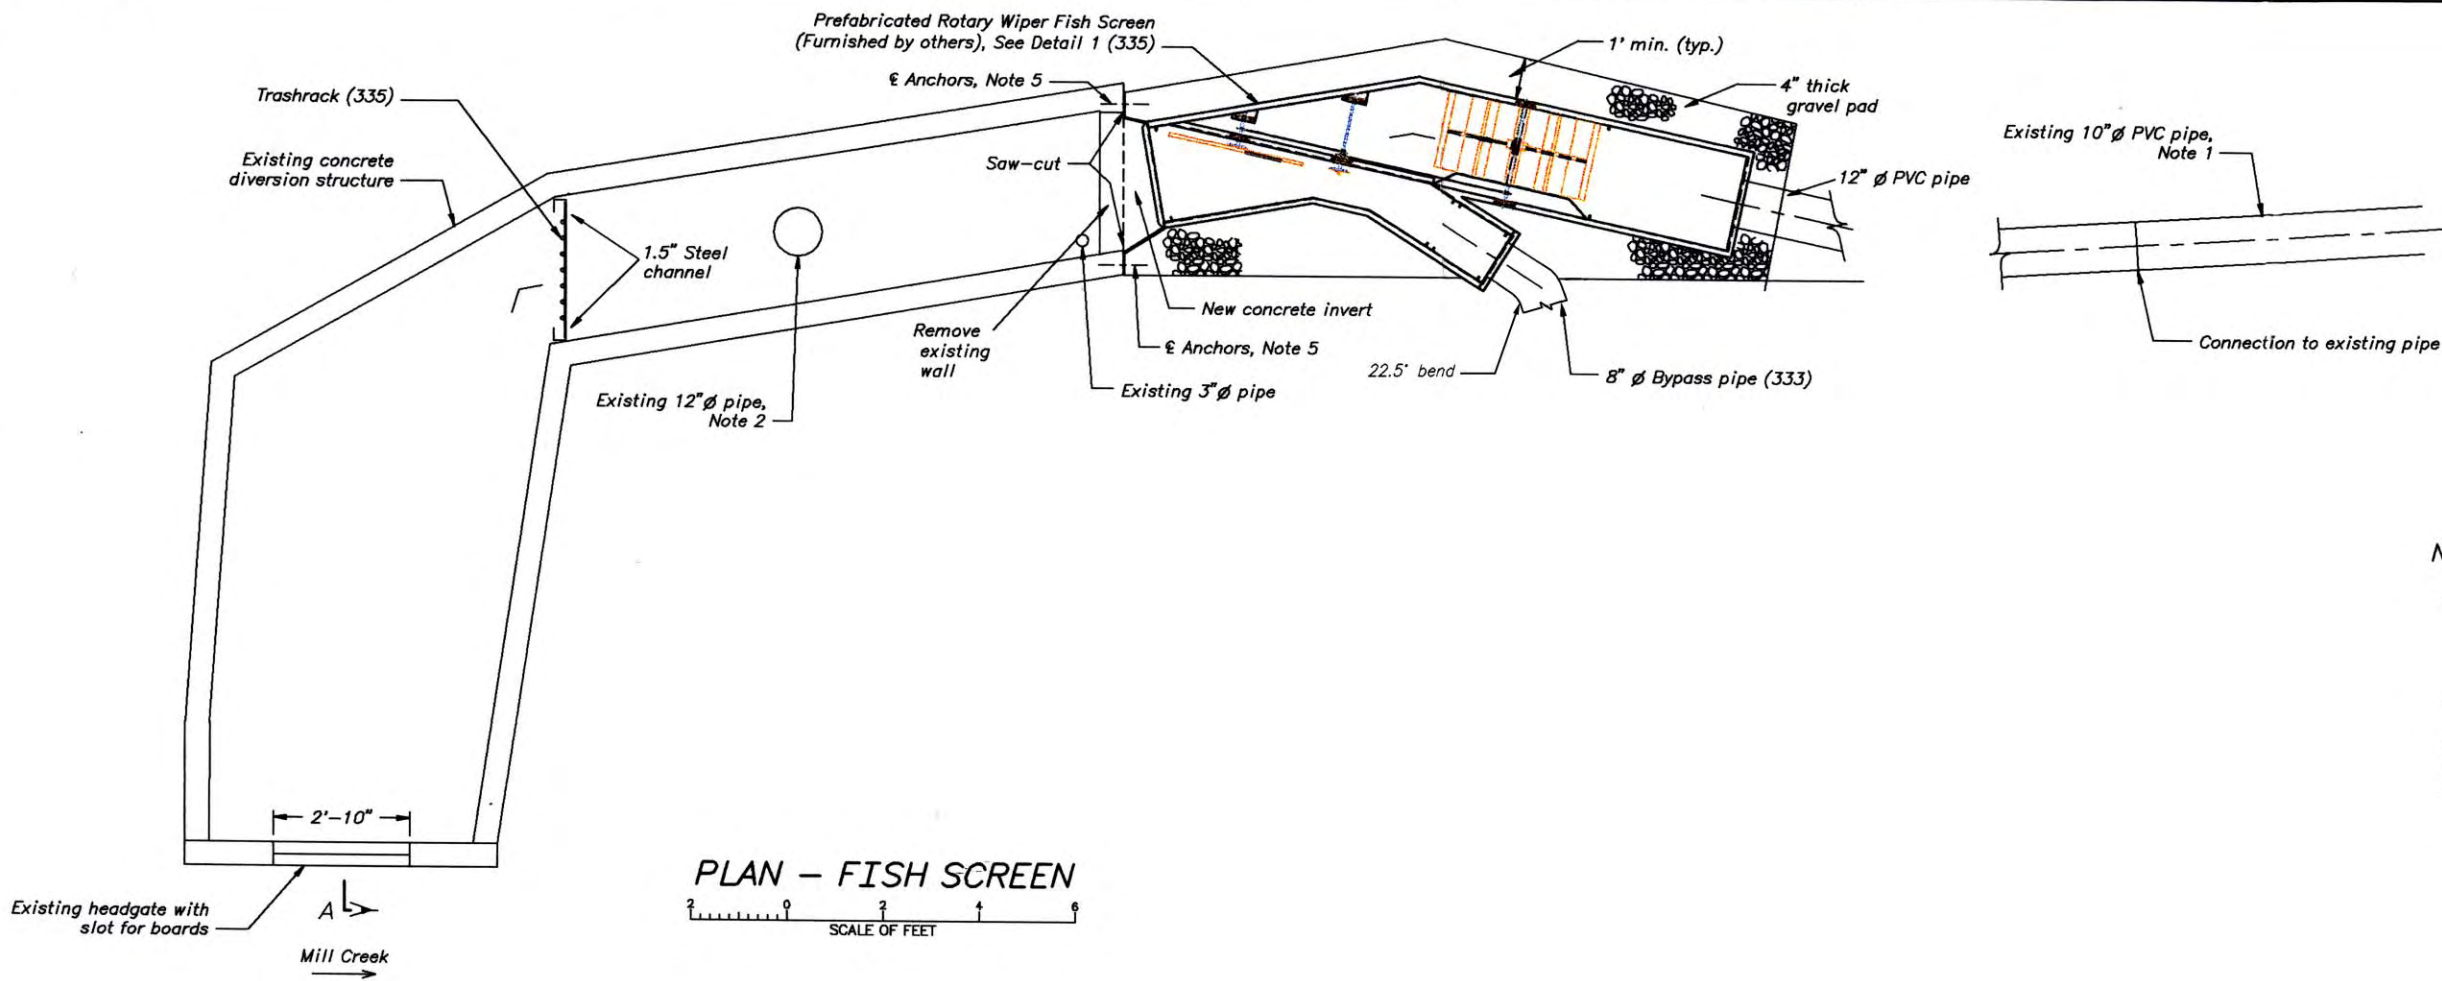
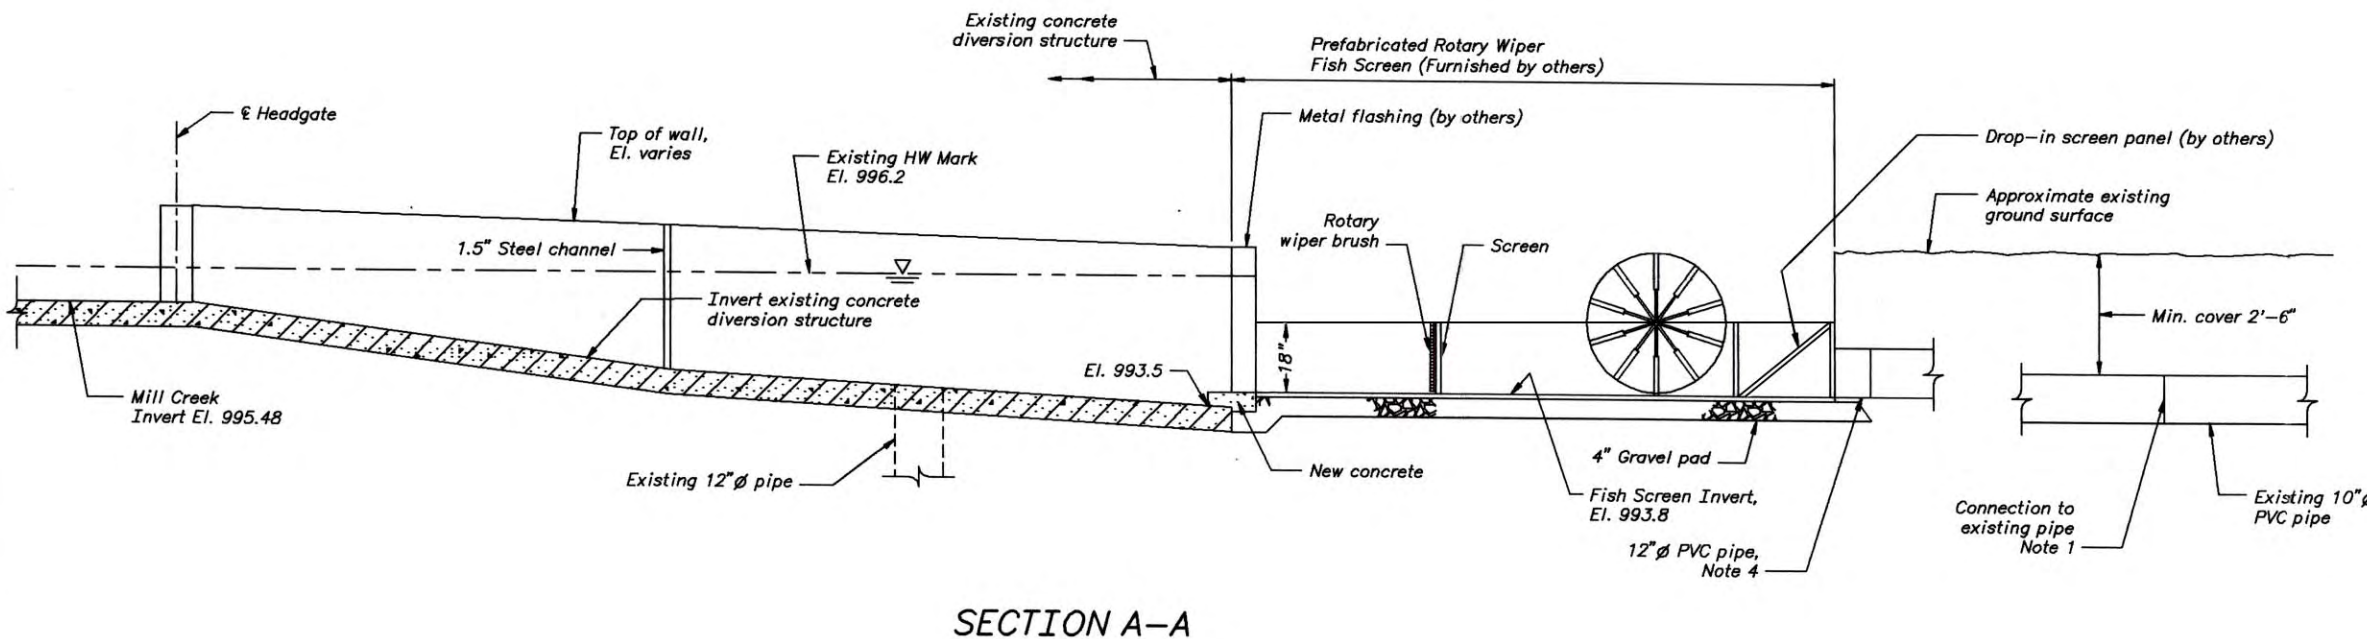
REV NO 1	2005-2-23 100-SEM	AS BUILT BY 109. REVISED HEIGHT OF FISH SCREEN. REVISED BYPASS.
<b>ALWAYS THINK SAFETY</b>		
UNITED STATES DEPARTMENT OF THE INTERIOR BUREAU OF RECLAMATION COLUMBIA/SNAKE RIVER SALMON RECOVERY PROJECT WENATCHEE SUBBASIN, WASHINGTON		
<b>MILL CREEK DIVERSION MODIFICATIONS FISH SCREEN PLAN AND SECTION</b>		
DESIGNED: Steve E. Montague	CHECKED: Dennis Hawkins	
DRAWN: Carlos Hove	EDM. TECH. APPROVAL: Steve E. Montague	
APPROVAL: Dave Jennings		PROGRAM MANAGER
CADD SYSTEM AutoCAD Rev. 18.0 BOISE, IDAHO	CADD FILENAME 1678-100-334.dwg FEBRUARY 4, 2003	1678-100-334
