# **NATIONAL TRANSPORTATION SAFETY BOARD**

## **AIRCRAFT ACCIDENT REPORT**

**RUNWAY COLLISION  
UNITED EXPRESS FLIGHT 5925  
AND BEECHCRAFT KING AIR A90  
QUINCY MUNICIPAL AIRPORT  
QUINCY, ILLINOIS  
NOVEMBER 19, 1996**

**Adopted: July 1, 1997  
Notation 6793C**

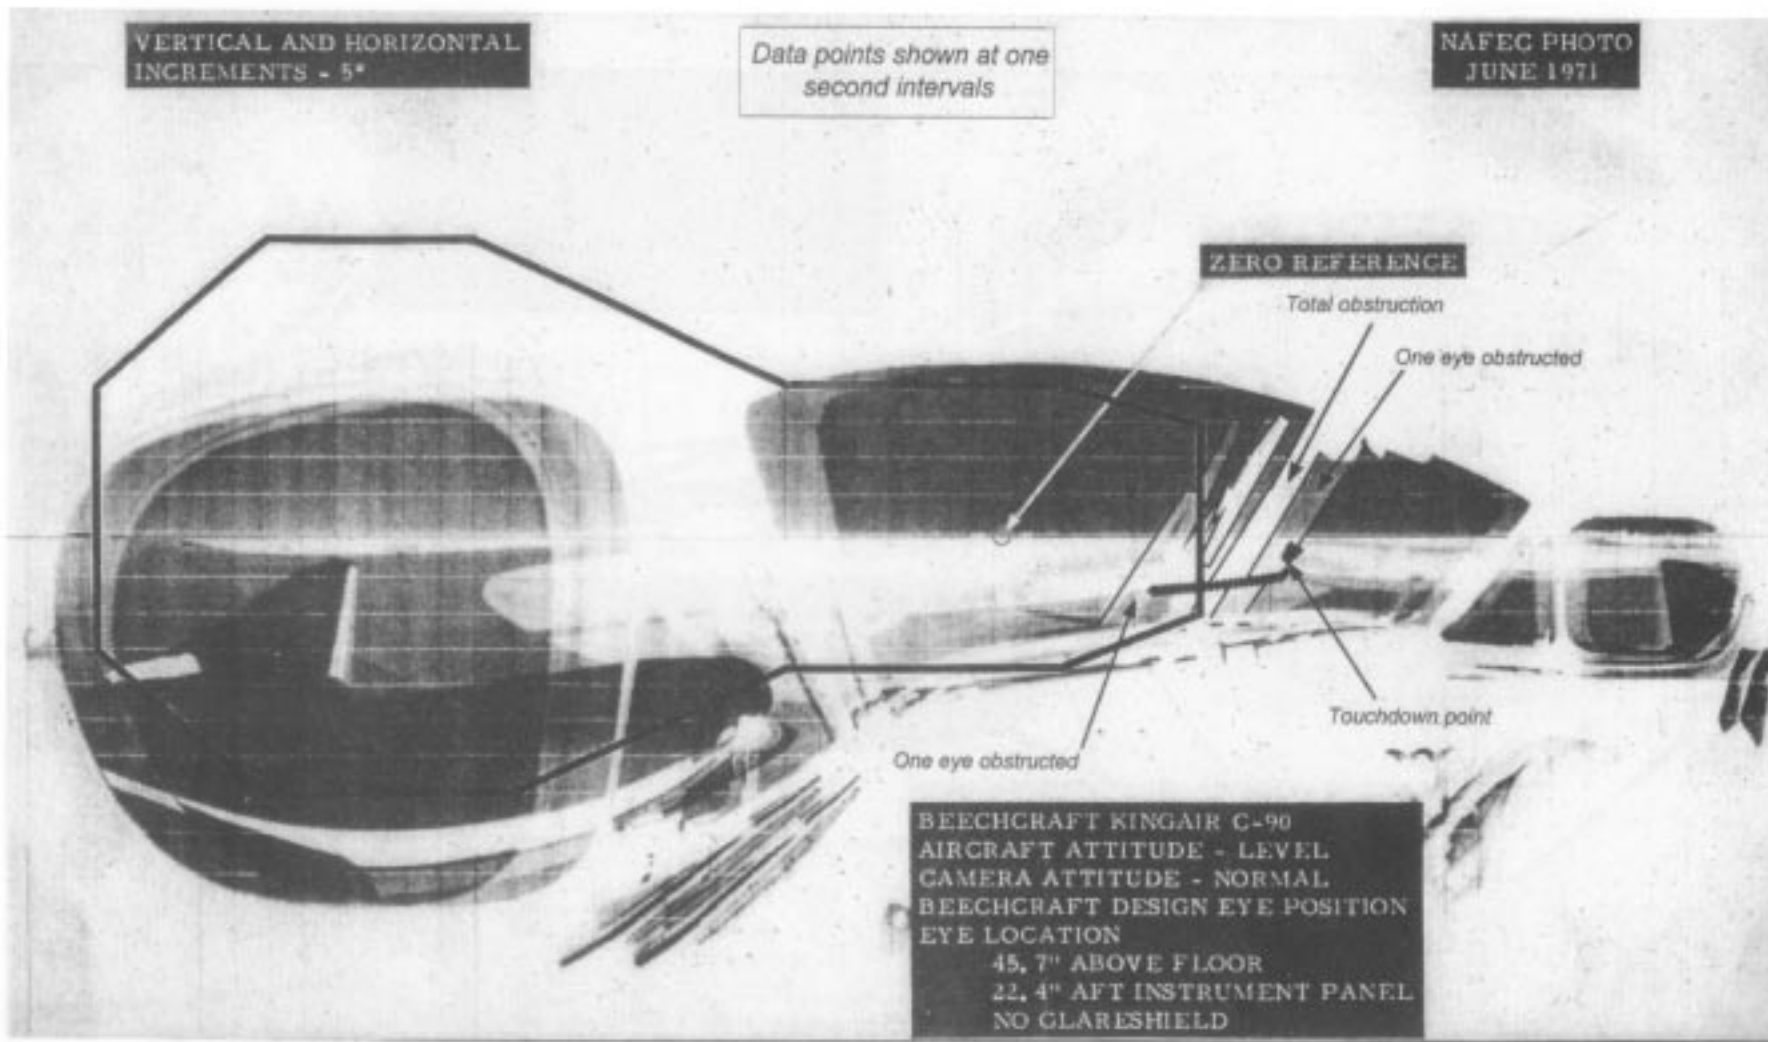
As shown in figure 6, the Safety Board's study using its VIZPC computer program indicated that the view of the King Air from the Beech 1900C captain's position would have been partially obstructed by the center post and windshield wipers during the airplane's final approach and would have been totally obscured by the center post for 6 seconds, starting about 17:00:43. Approximately 10 seconds before touchdown,<sup>36</sup> at 1700:49, until the time of the

Figure 6.—Beech 1900C captain's view of King Air.

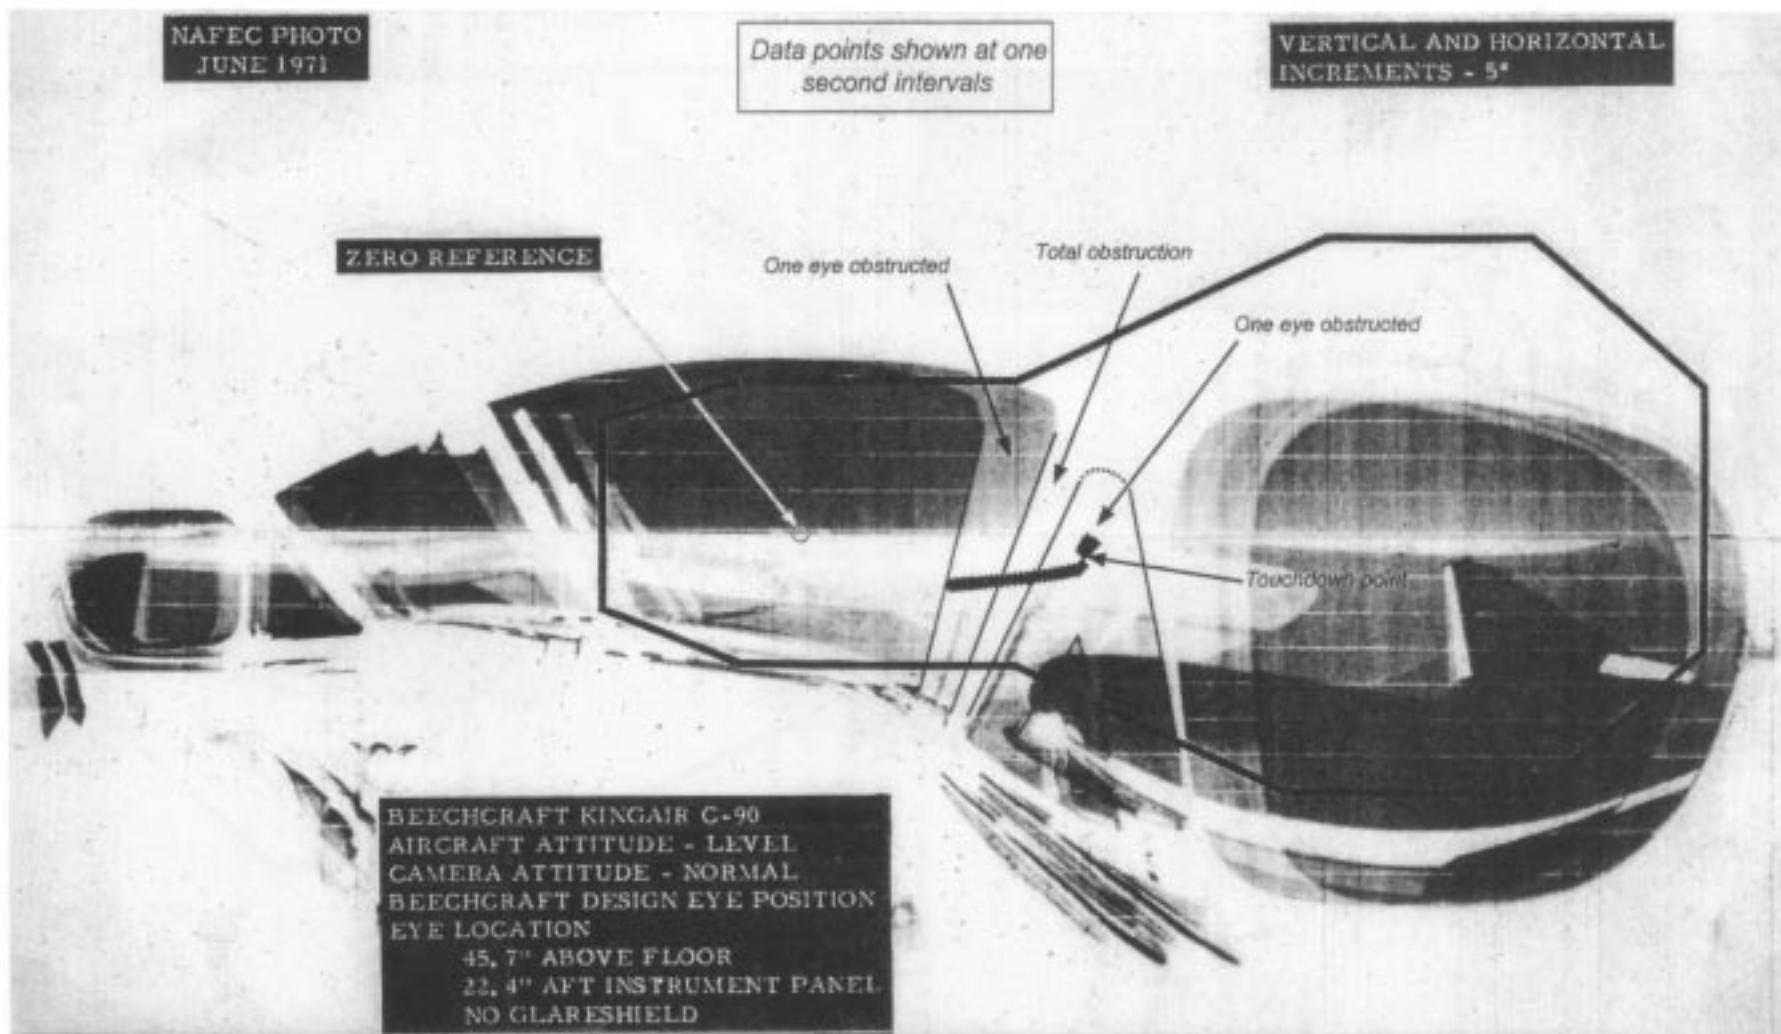
As shown in figure 7, the view from the Beech 1900C first officer's position would have been partially obstructed by the first officer's side posts for nearly 30 seconds before touchdown until impact, including 6 seconds starting at 17:00:42 when the first officer's view of the King Air would have been totally obstructed by the front windshield side post.

Figure 7.—Beech 1900C first officer's view of King Air.

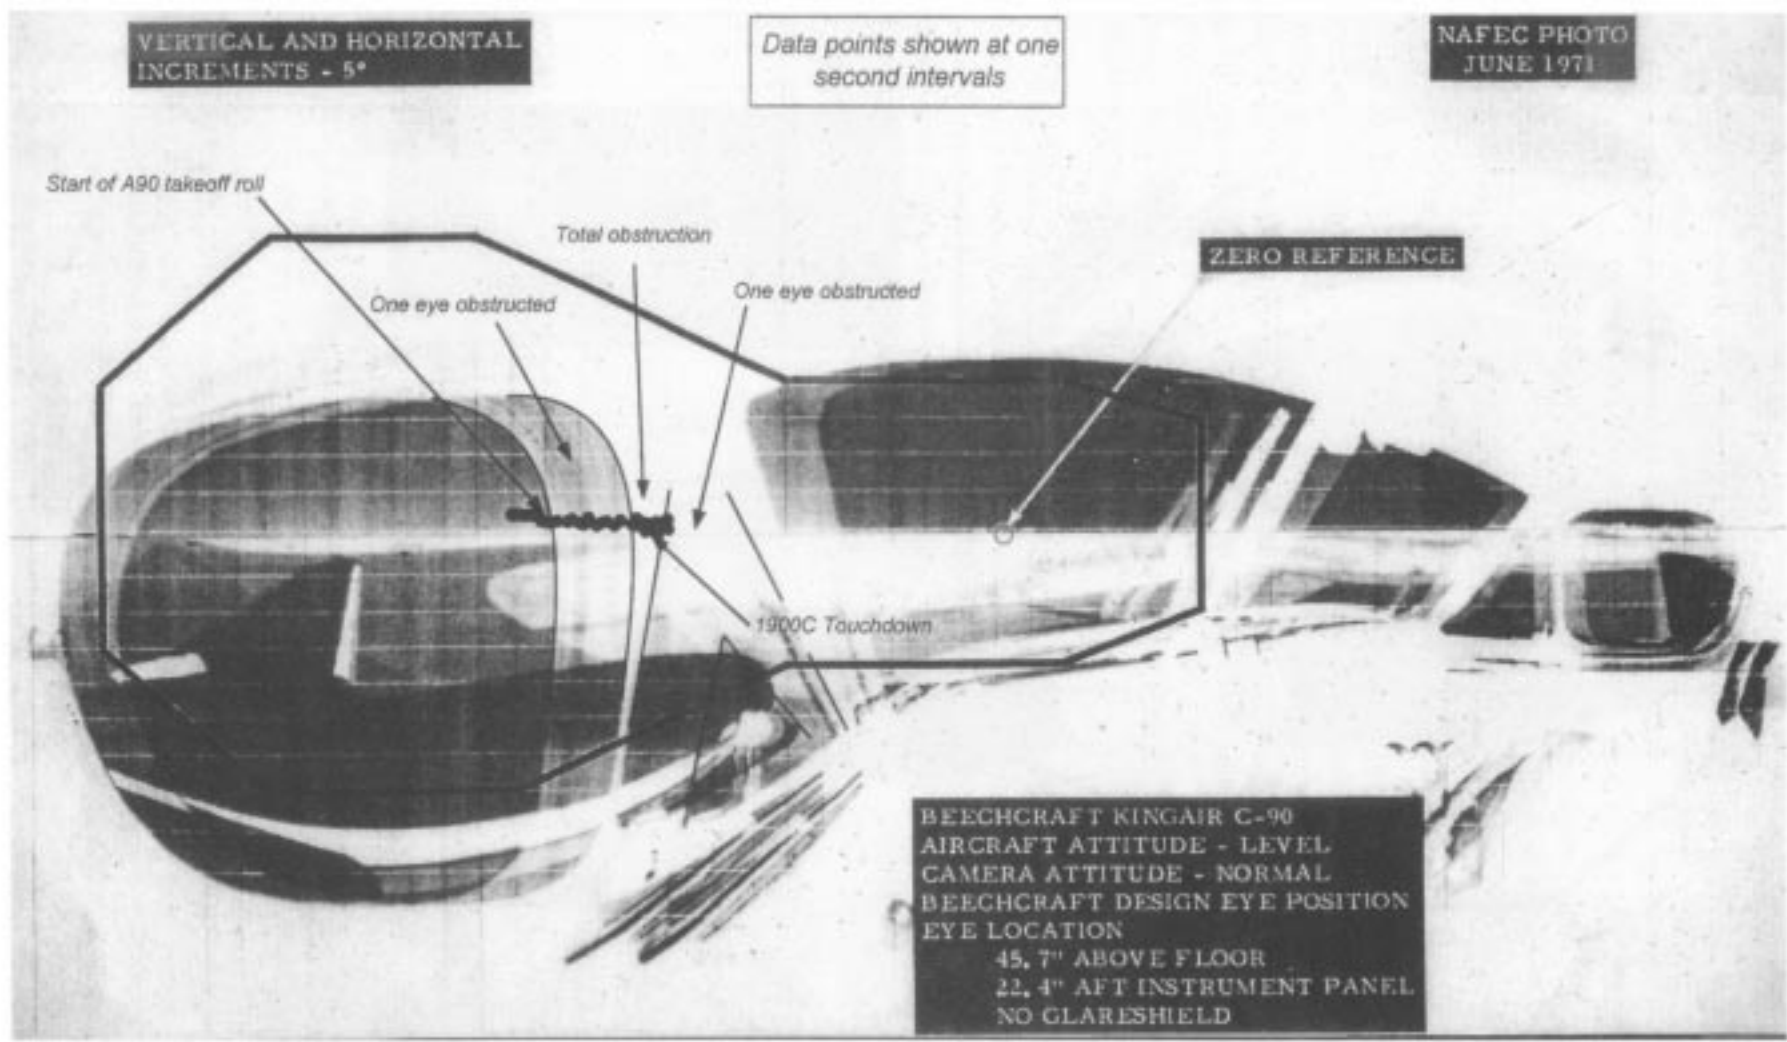
The VIZPC study also indicates that while the King Air was stationary near the end of runway 04, the left seat occupant's<sup>37</sup> view of the Beech 1900C would have been unobstructed at nearly 72° to the left, as viewed through the side window of the King Air. (See figure 8). About 17:00:40, 4 seconds before the King Air began its takeoff roll, the view of the Beech 1900C from the left seat occupant's position would have become partially obstructed at nearly 68° to the left, and fully obstructed at 17:00:54, about 55° to the left, when the King Air would have been accelerating during the roll; this time is immediately before the touchdown of the Beech 1900C. The view of the Beech 1900C from the left seat occupant's position would have been fully obstructed from 17:00:54 until impact at 17:01:09, except for 2 seconds at 17:01:02 when the view would have been partially obstructed.

Figure 8.—King Air left seat occupant's view of Beech 1900C.

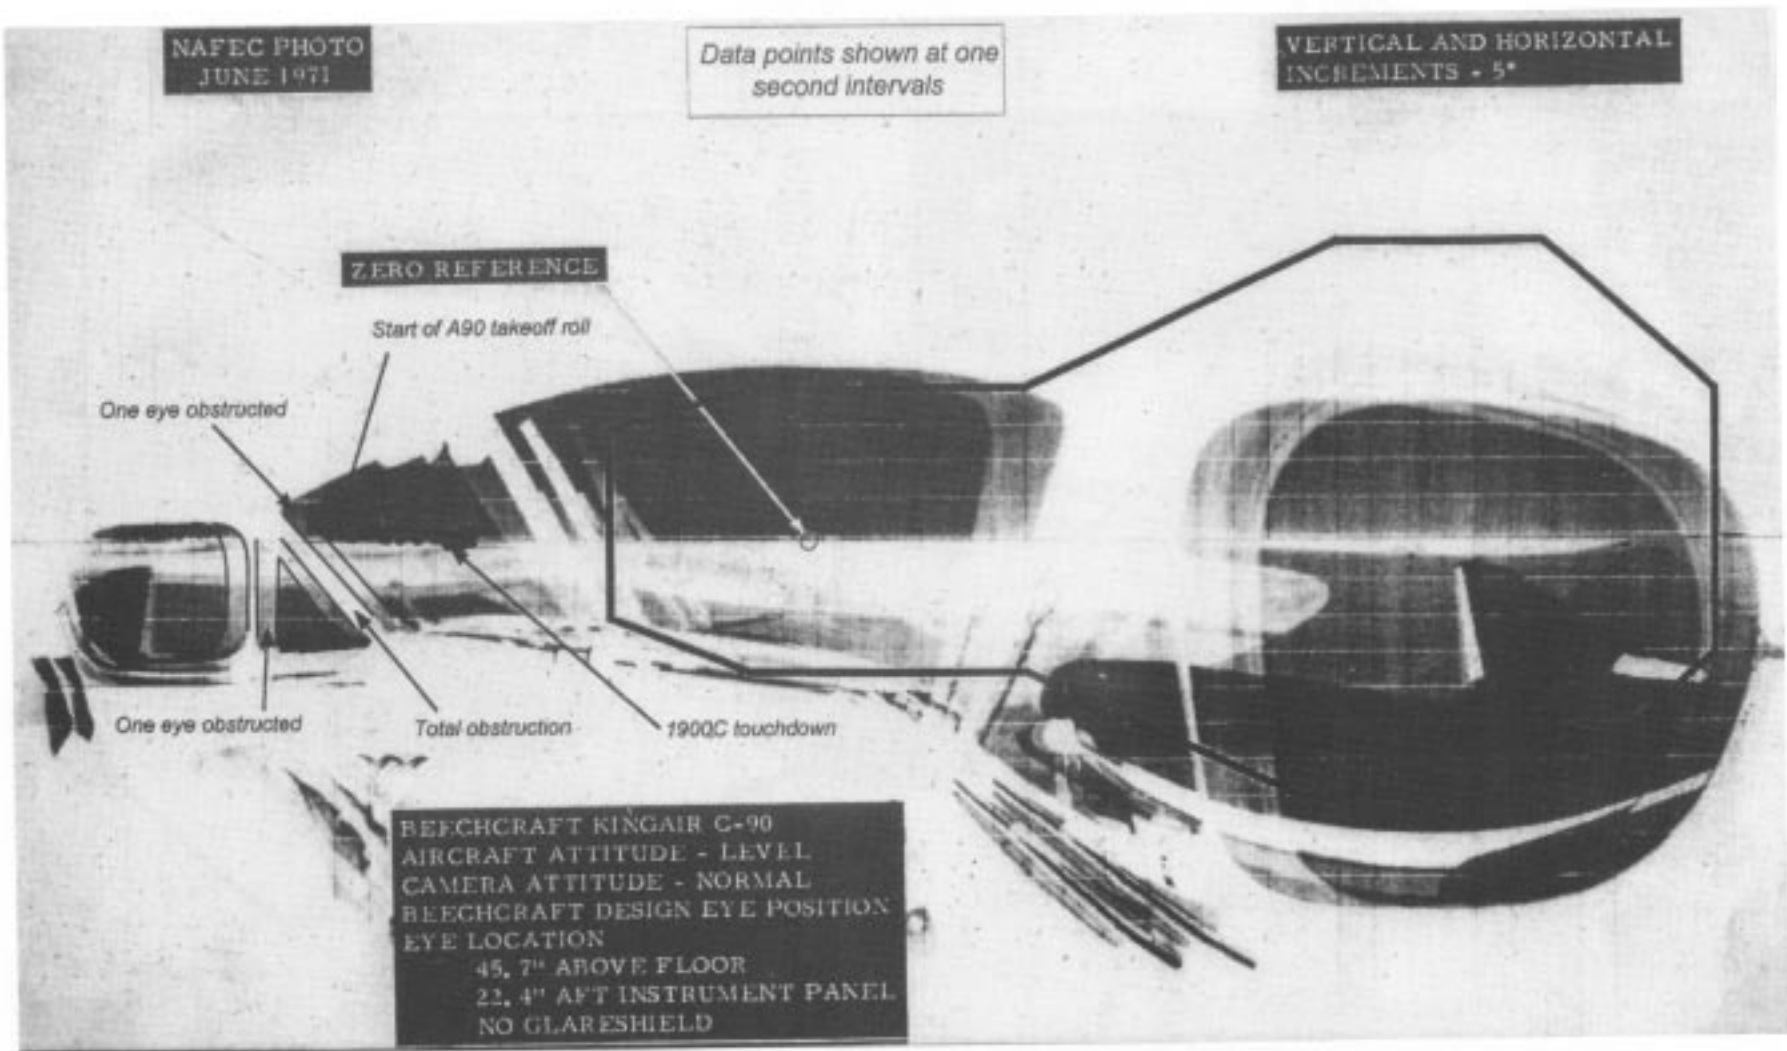
As shown in figure 9, the King Air right seat occupant's view of the Beech 1900C would have been partially obstructed by the left seat occupant's side posts until just before the start of the King Air's takeoff roll. At 17:00:39, the Beech 1900C would have emerged into clear view in the left front windshield. It was noted that when the right seat occupant's view would have been obstructed, the left seat occupant's view would have been clear, and vice versa. At the start of engine throttle back by the King Air pilot, the Beech 1900C would have been about 50° to the left of the King Air. This position would have been fully obstructed from the King Air left seat occupant's position, but in clear view from the right seat occupant's position.

Figure 9.—King Air right seat occupant's view of Beech 1900C.
