Corrosion Investigation in Man-Rated Percussion Ignition Devices

NSWC IHEODTD, E2 CAD/PAD Division
11th CAD/PAD TECHNICAL EXCHANGE WORKSHOP
MAY 2016
CADPAD@navy.mil

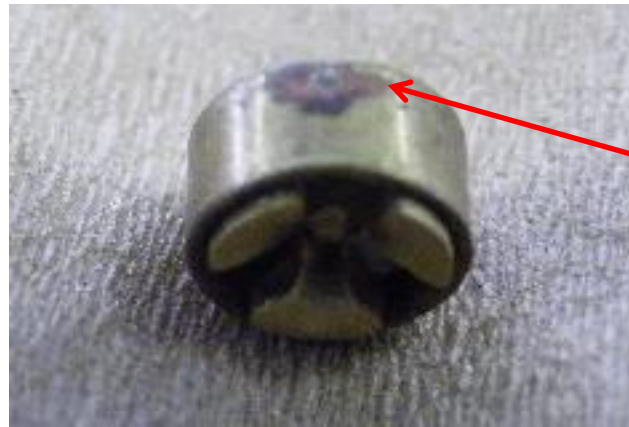
Discoloration Examples

- 2014 - GFM PVU ignition devices reported visual discoloration from vendors – Red
- 2014 – GFM 72M ignition devices reported visual discoloration from vendors – Green
- 2015 – Investigation into PVU series visual discoloration initiated
 - Determine root causes
 - Identify/recommend corrective actions to prevent future discoloration
 - Recommend disposition of discolored items.

Red Discoloration

Green Discoloration

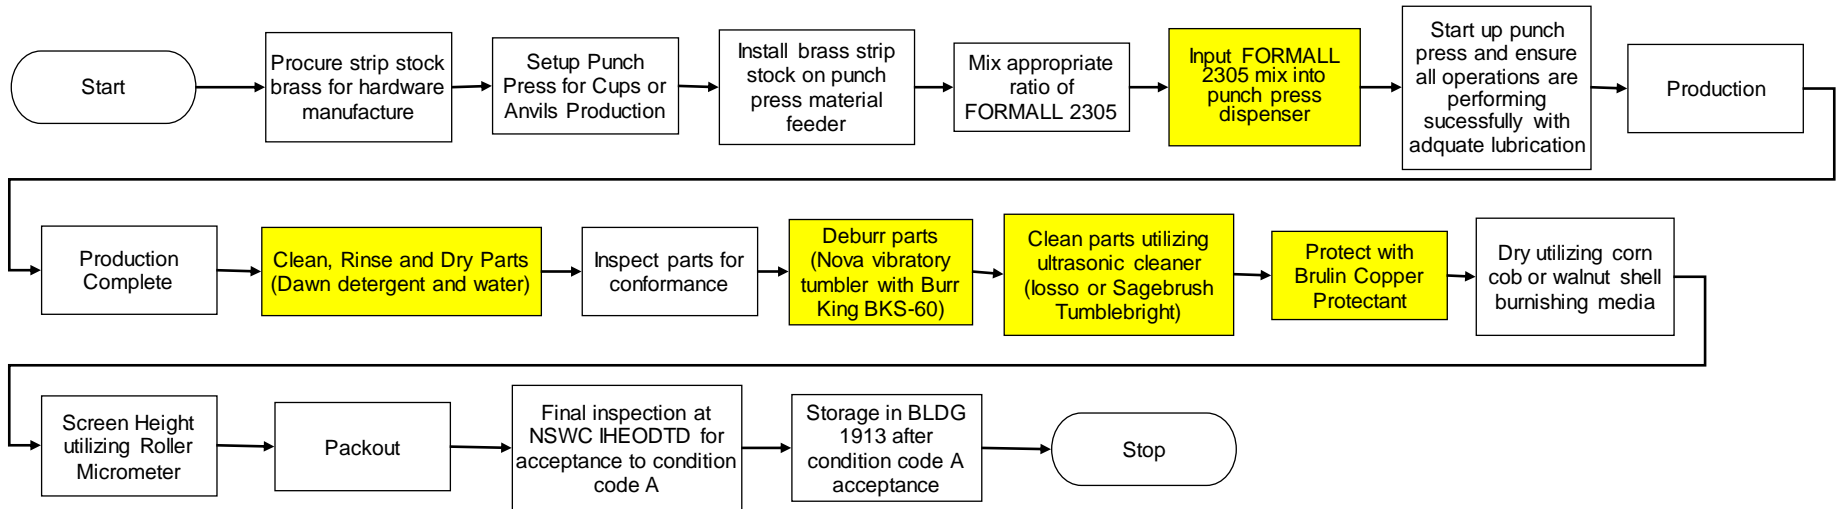
Analysis – Hardware Manufacture

- Functional Process Map: PVU Hardware Manufacture and Storage
- Highlighted : Potential acid / chemical area in process

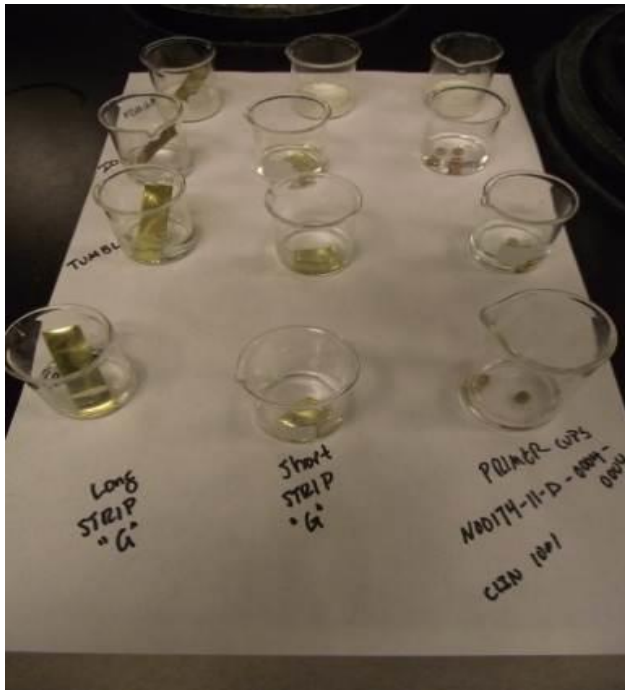
Corrosion Testing – Diluted Solutions

- Handling contamination was removed via ethanol soak
- Solution of 3 suspect processing chemical were prepared as used in PVU processing
- Series of soak and removal were performed. Results were documented

Green patina colored corrosion product

Severe red corrosion product

- Iosso Case Cleaner most corrosive in testing.
- Diluted Sagebrush Tumble Bright had developed green patina.
- Formall 2035 was the least corrosive.
- Brulin Copper Protectant was used as a baseline during the testing.

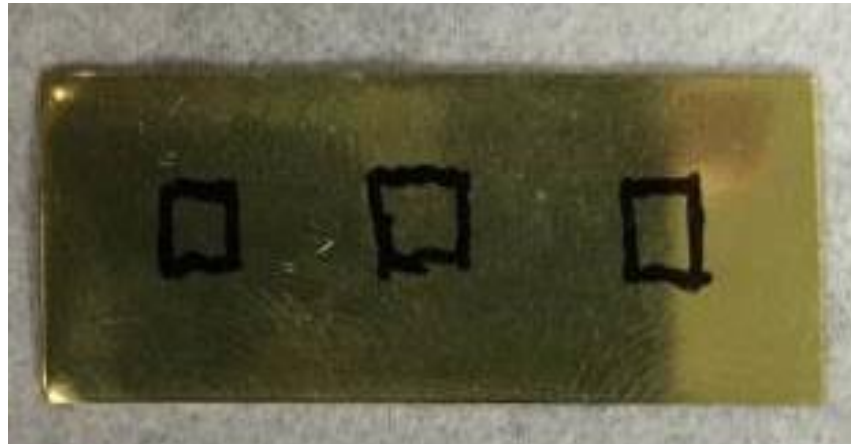
Analysis of Stock (XRD Phase)

- XRD Analysis for corrosion-prone brass phase (β -brass)
 - A strip stock sample used for X-Ray Diffraction (XRD).
- XRD scan was performed within each square marker (Bruker D8 Advance Diffractometer)
- A Rietveld analysis was performed on the XRD data to determine if an extraordinarily corrosion-prone brass phase (β -brass) was present in any strip stock samples. If so, the β -brass phase fraction was calculated.
