### Missouri River Reported Channel Problem Areas

7 Problem Areas Reported

#### Areas of Concern

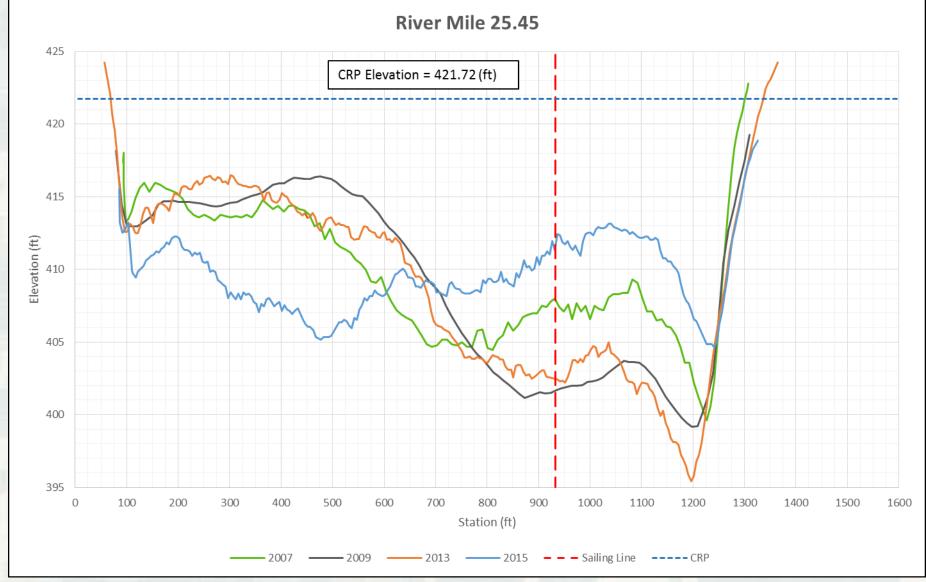
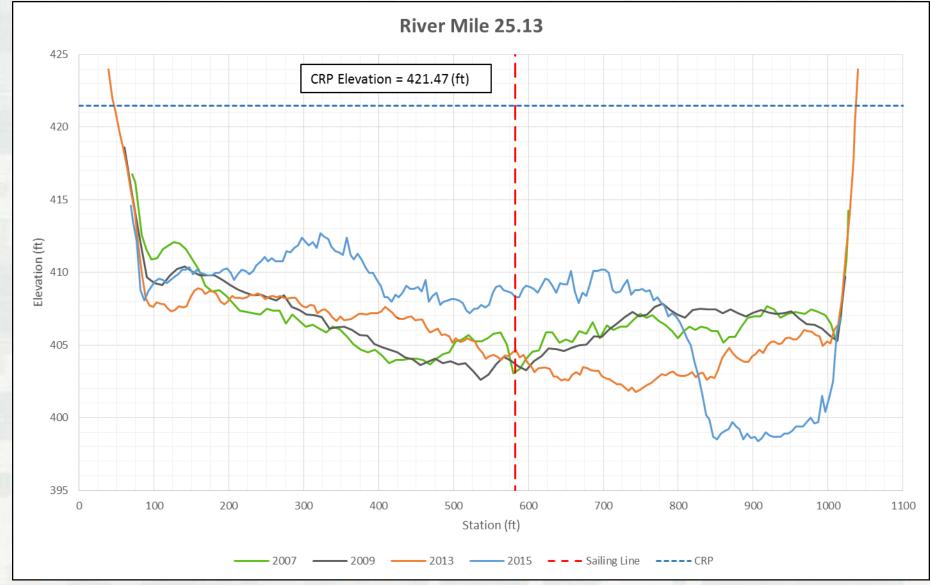
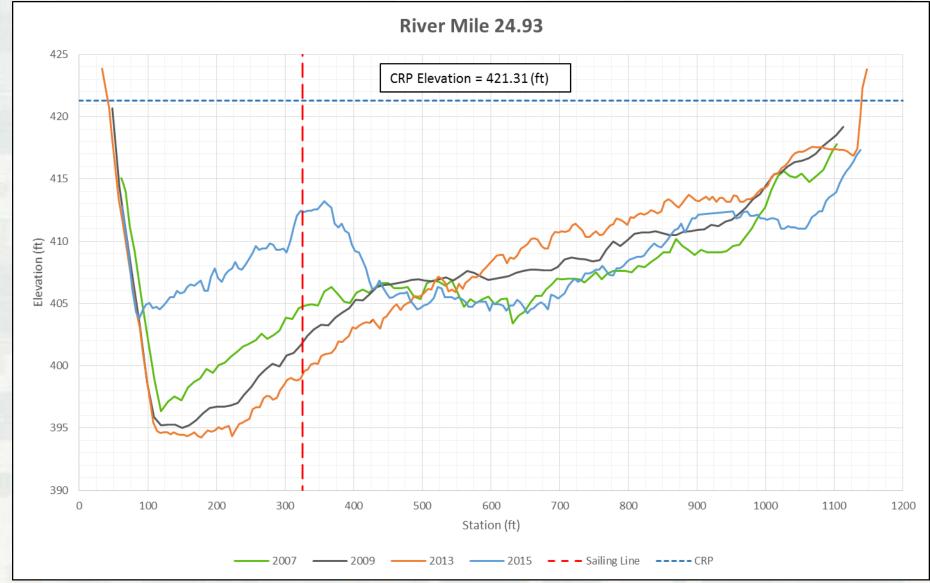
#### Area of Concern RM 25.5

"Brian Island. Crossing is the main Problem"

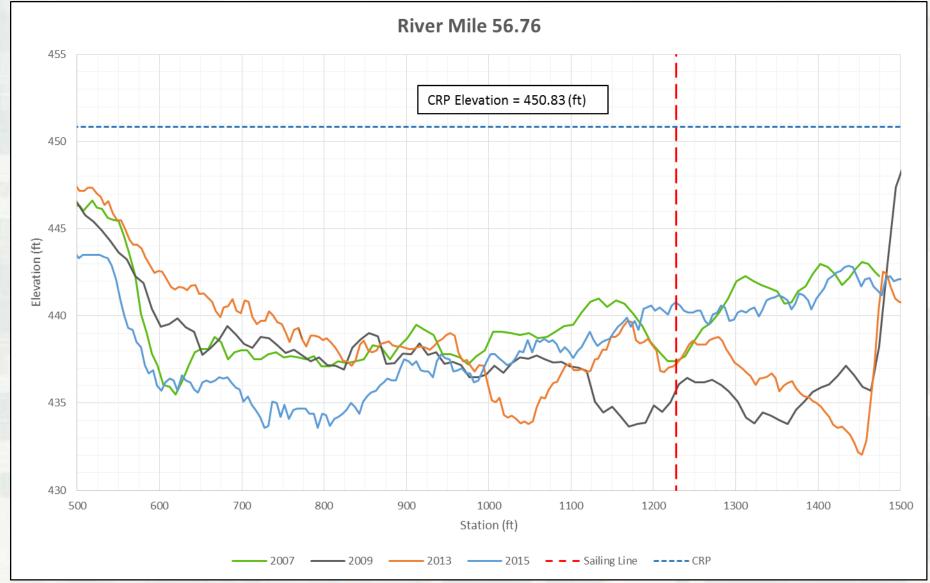
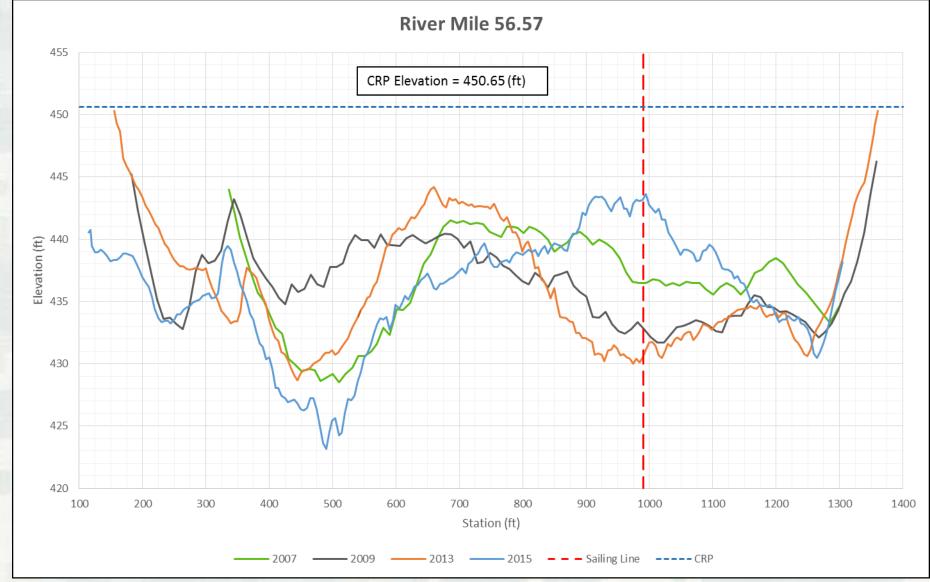
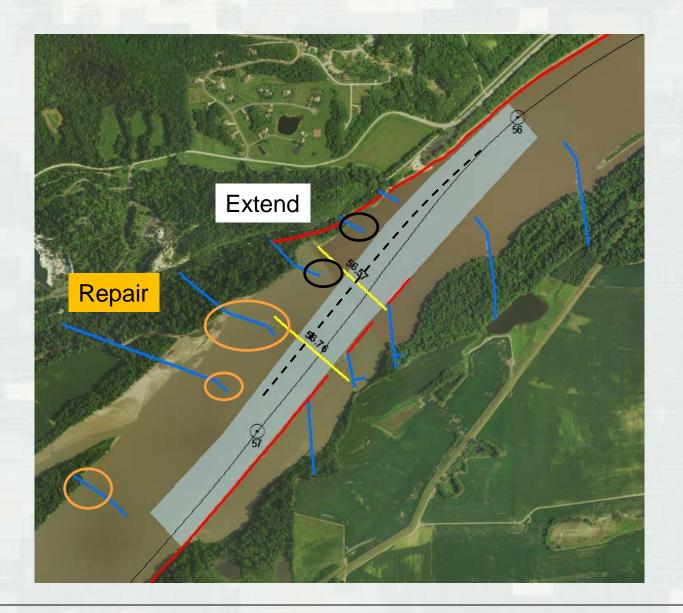
"Crossing is unstable"

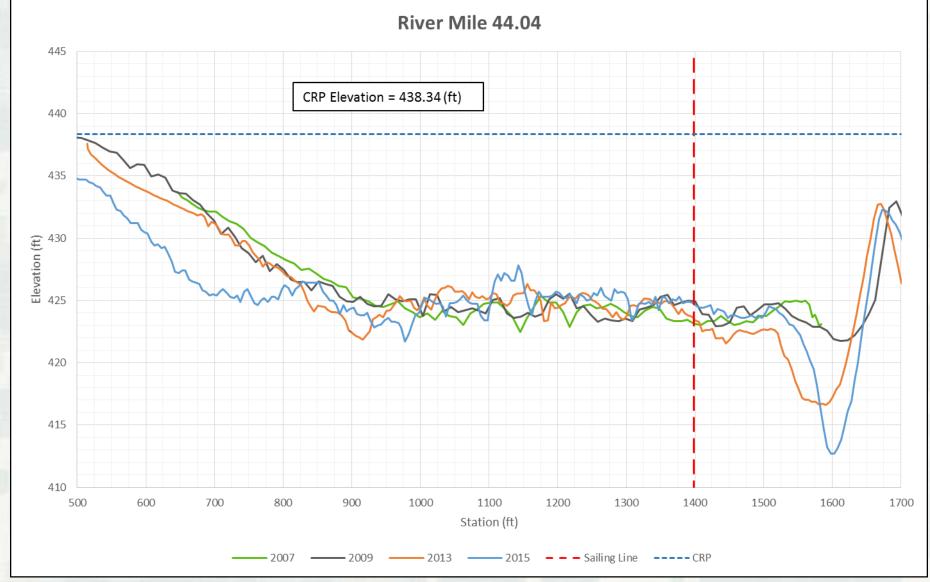
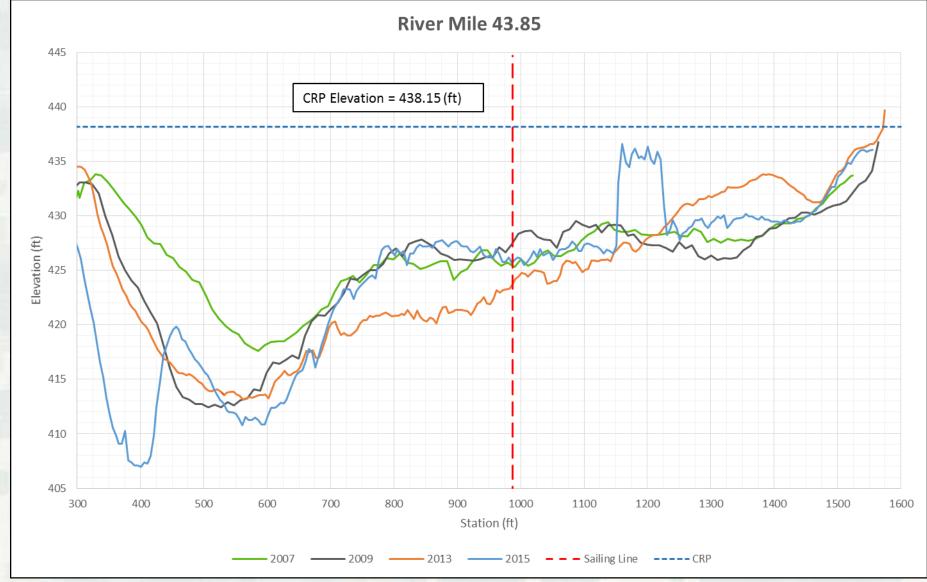
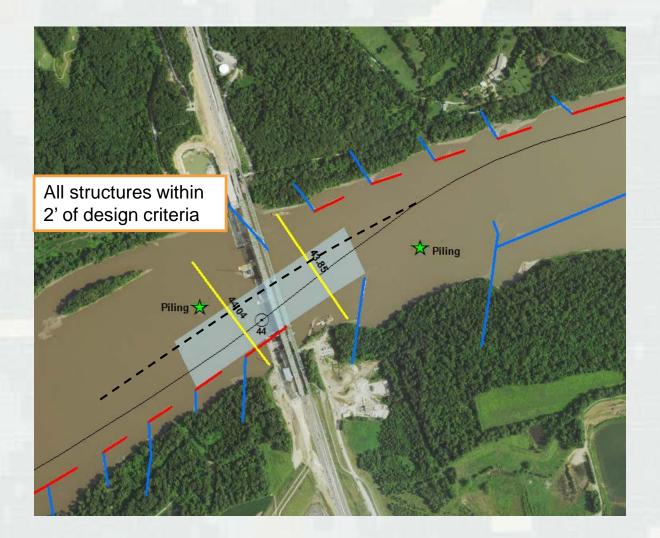
"Piling in river near Bridge. Right Side is Marked as Channel. Right descending bank shoals. 10' St. Charles gage will be problem. Wing dike notched DS of bridge"

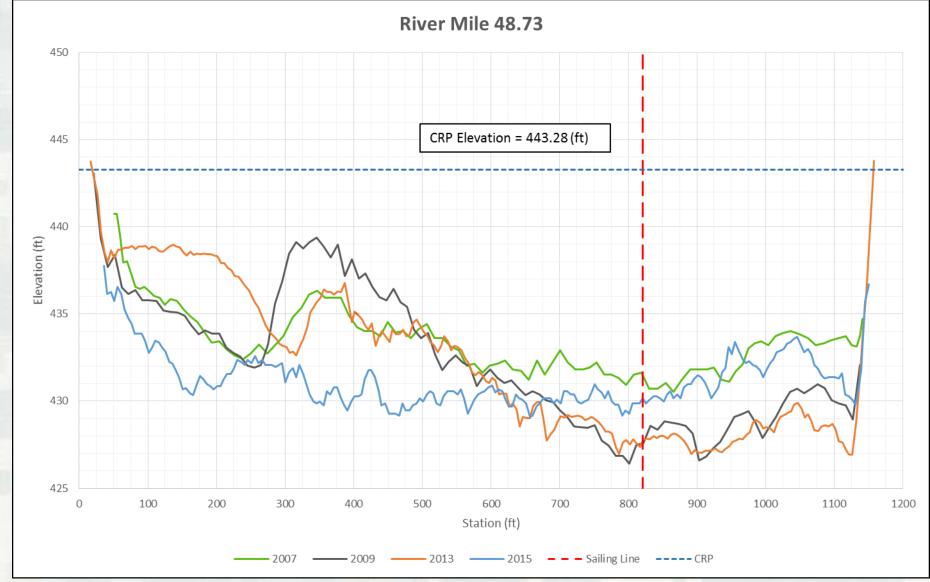
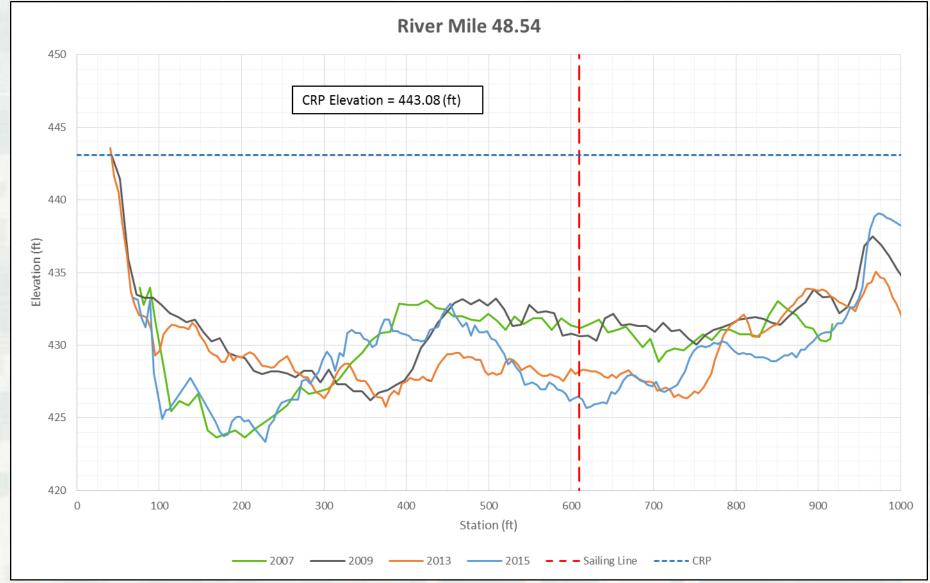
#### Area of Concern RM 48.5

"Shallower than in past. Flushed out currently. When the river drops from high to low, the crossing fills in"

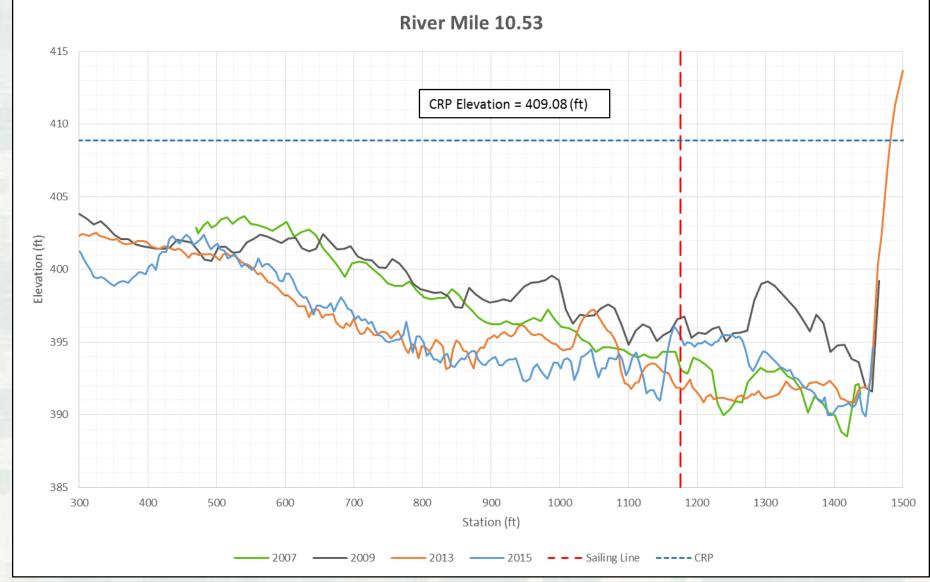
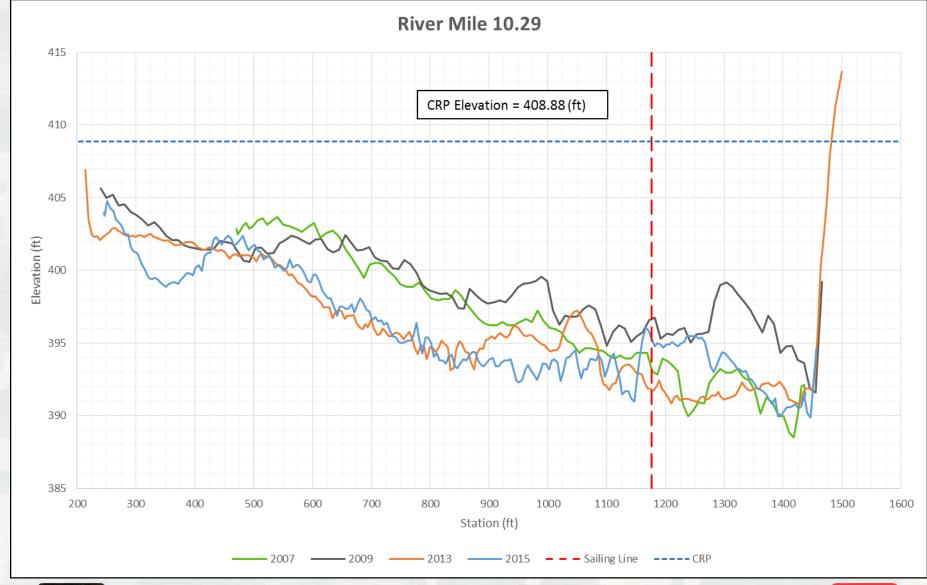
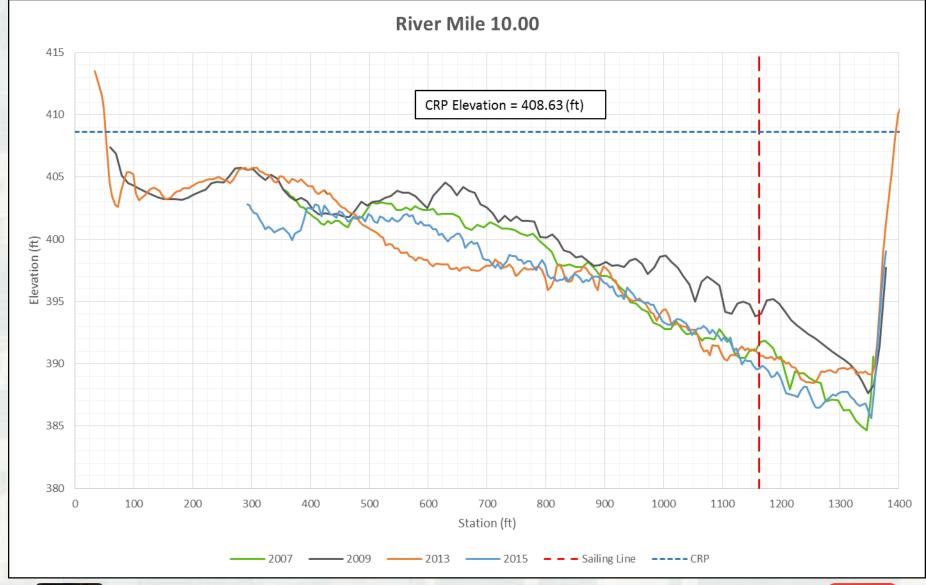
#### Area of Concern RM 10-10.5

"Historic problem area, close to chute exit. Check new dike at bridge and sills in area"

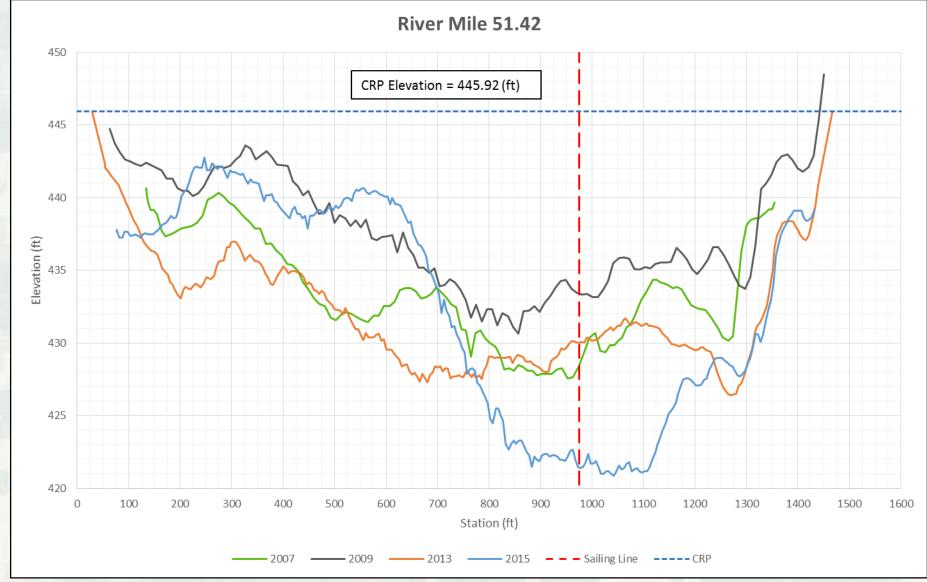
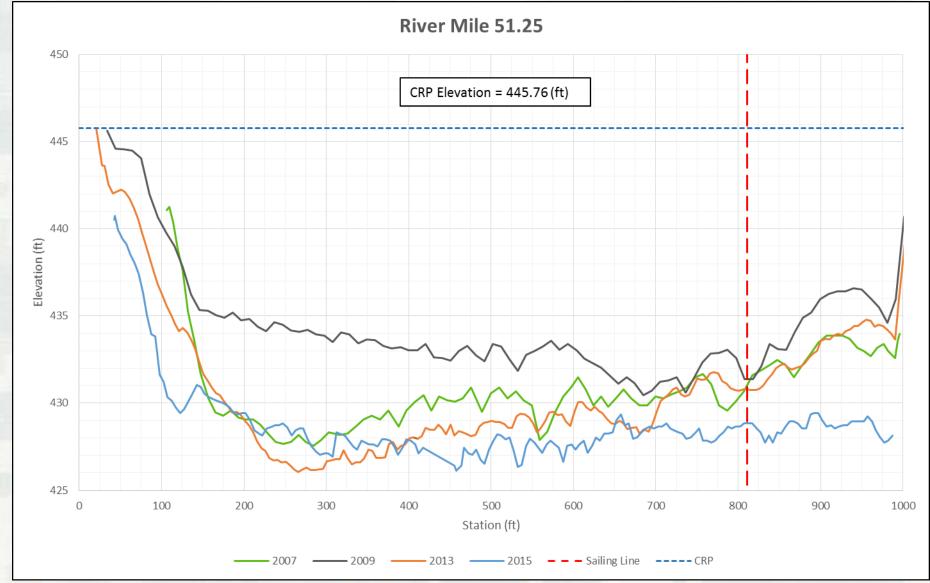
#### Area of Concern RM 51 - 53

"Crossing unstable."
