**Hurricane Alicia
Galveston and Houston, Texas
August 17-18, 1983**

**Committee on Natural Disasters
Commission on Engineering and Technical Systems
National Research Council**

NATIONAL ACADEMY PRESS
Washington, D.C. 1984

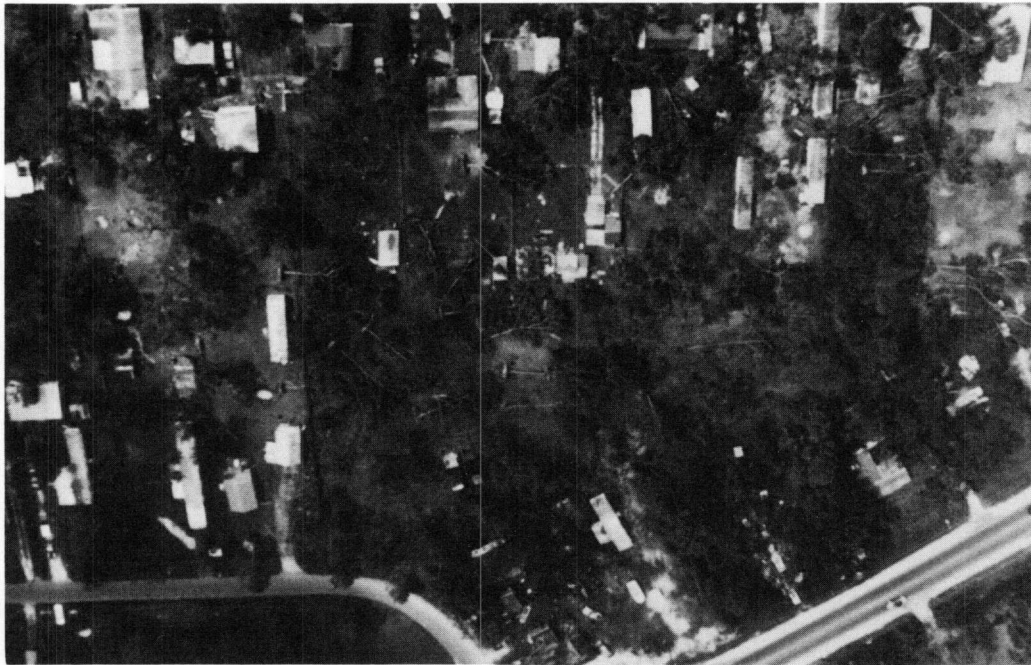
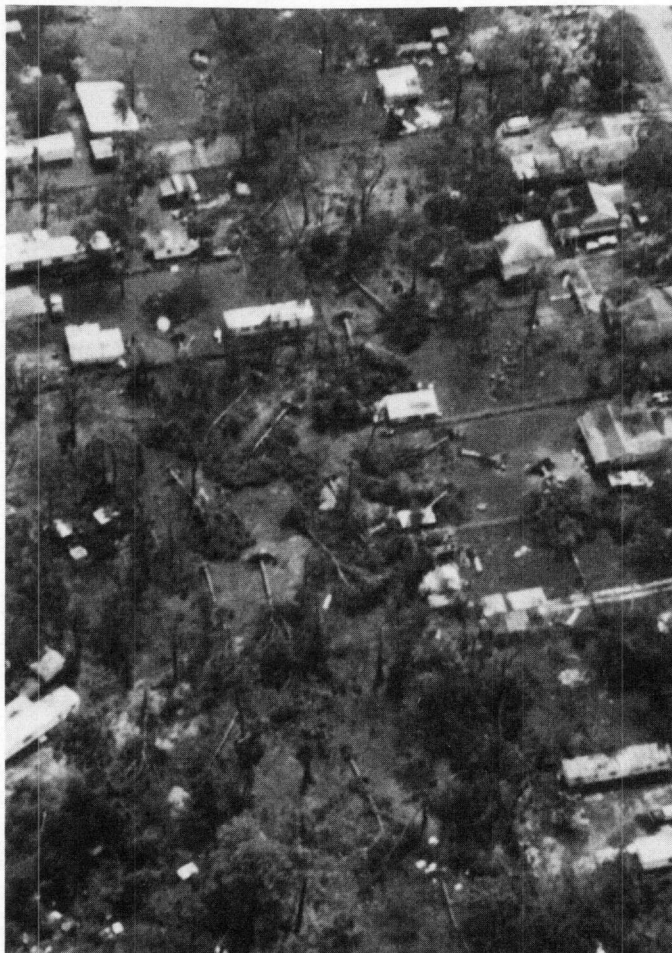
FIGURES 2.11A-2.11B Aerial damage photographs taken from a NOAA helicopter at 1,000 ft on August 25, 1983.

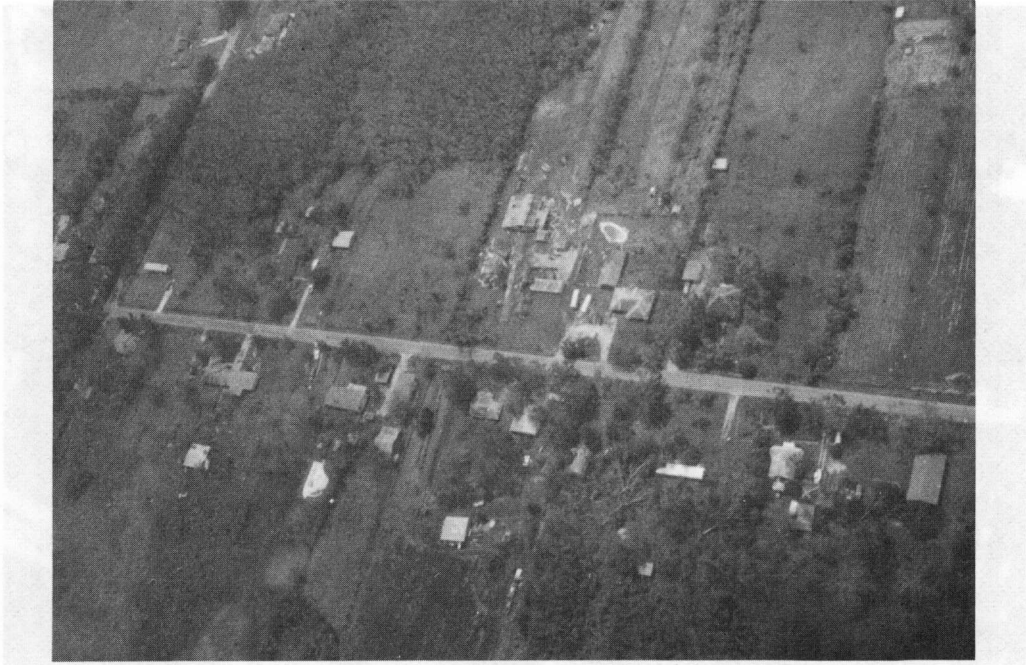
FIGURE 2.11C Aerial damage photograph taken from a NOAA helicopter at 1,000 ft on August 25, 1983.

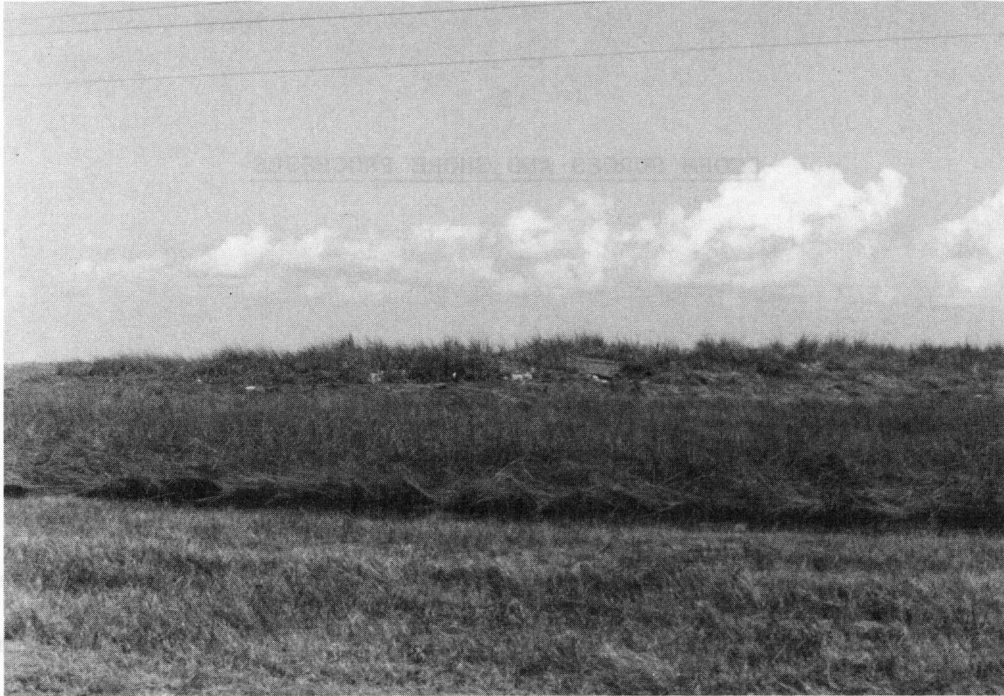
FIGURE 3.1 Debris line on bay (north) side of the foredune on Follets Island about 1-1/2 miles east of San Luis Pass.

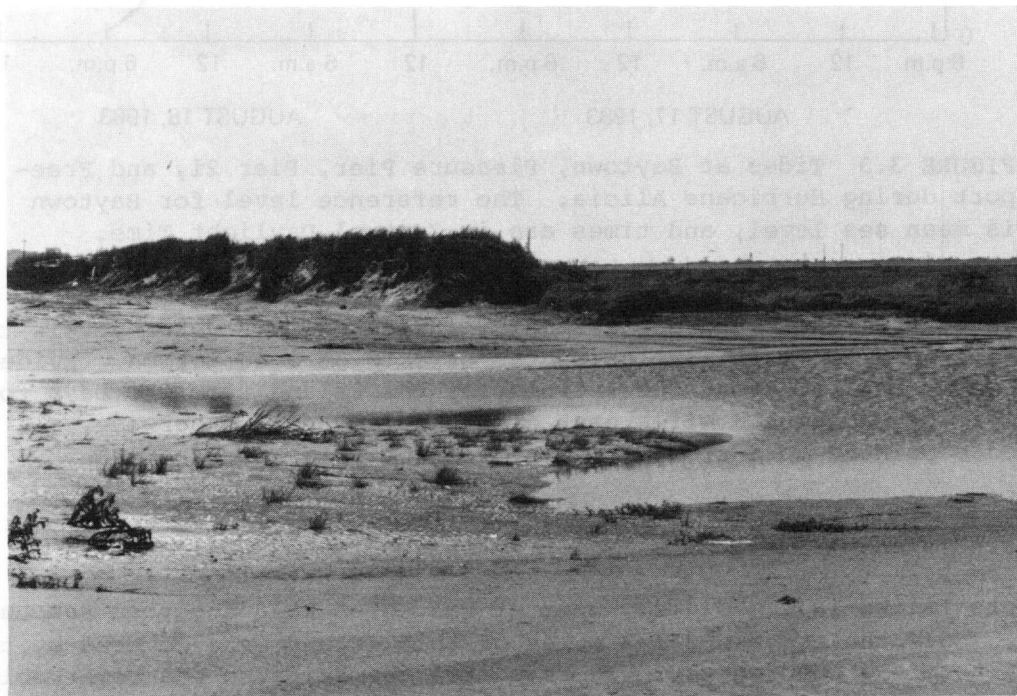
Some of the higher dunes on the front of East Beach were not overtopped. However, they were partially eroded while acting as headlands and causing accelerated flow in lower areas between high dunes and between high dunes and adjacent structures. Figure 3.5 shows the seaward side of an eroded high dune and the seaward portion of the associated erosion channel. Figure 3.6 shows the body and landward end of the same erosion channel looking toward the Gulf. This channel was between the dune shown and a condominium immediately to the east.

FIGURE 3.5 Front of scour channel and frontal dune on East Beach showing dune erosion. Scour channel was caused by flow confined between the dune and an adjacent beachfront condominium.

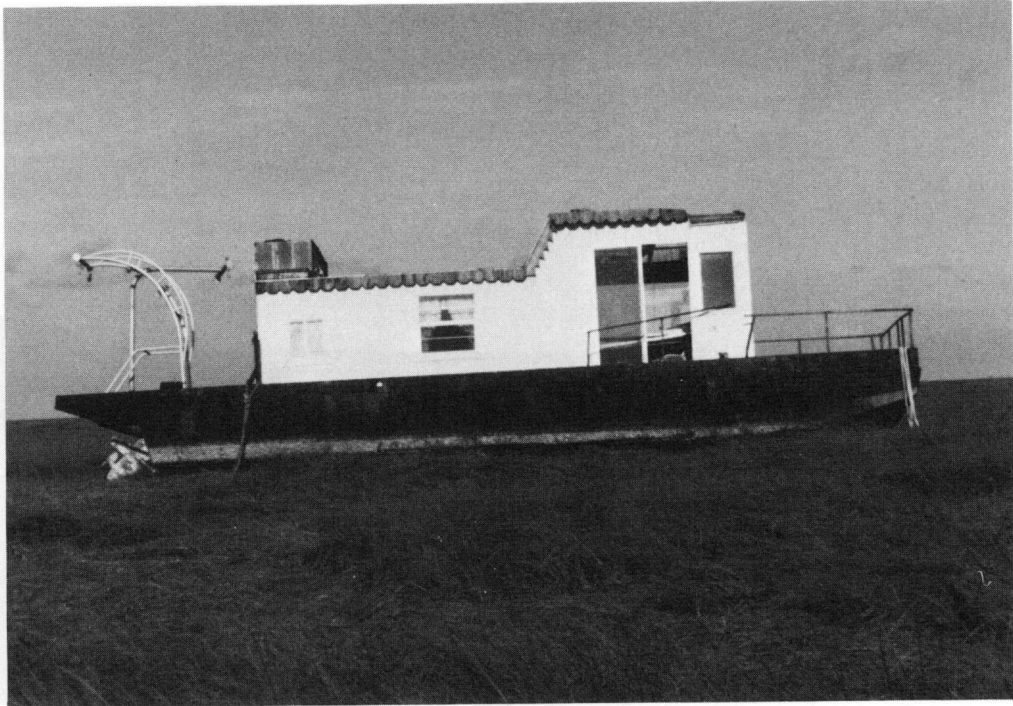
elevations in the bays were about 10 ft. Evidence of water levels consisted of debris lines on the bay side of the dunes at distances of 1.5, 2.0, 4.5, 7.5, and 8.5 miles from the east end of the island, as well as a stranded houseboat between the highway and the dunes fronting the Gulf at the 4.5-mile point (see Figure 3.7). Highway elevations were estimated from USGS quadrangle sheets.

FIGURE 3.7 Houseboat grounded between the highway and the Gulf about 4-1/2 miles west of San Luis Pass on Follets Island. Note fresh barnacles on the bottom of the boat.

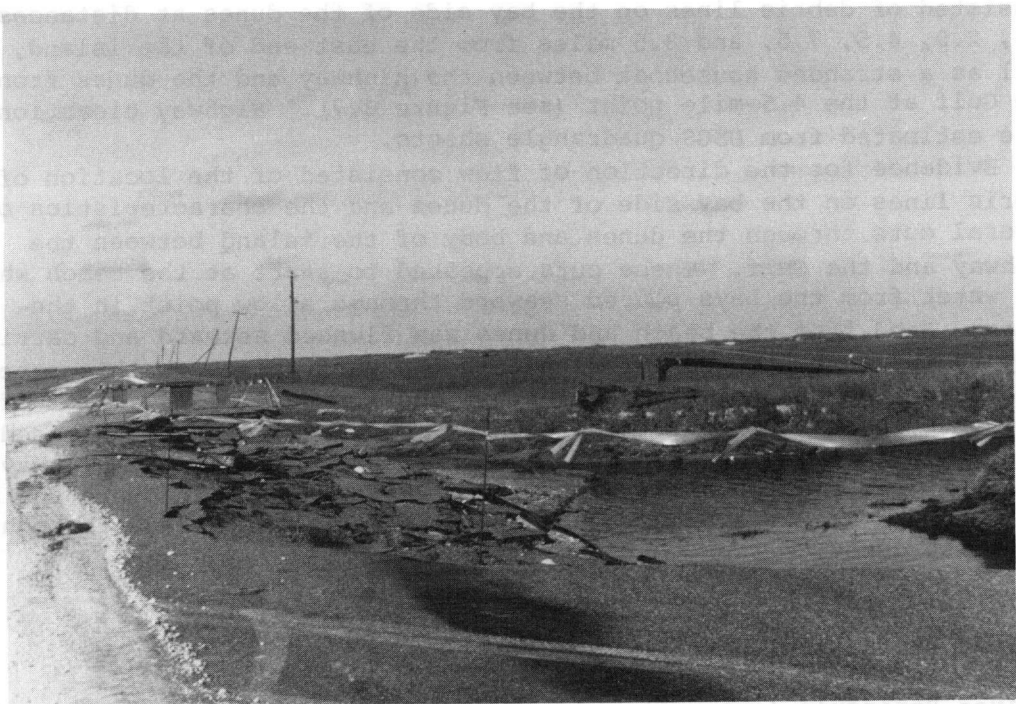
Evidence for the direction of flow consisted of the location of debris lines on the bay side of the dunes and the characteristics of several cuts through the dunes and body of the island between the highway and the Gulf. These cuts appeared to start at the beach when the water from the bays poured seaward through a low point in the dunes. Sand from the beach and dunes was flushed seaward and carried away by the currents and turbulence in the surf zone. As this process continued, the channel was cut further and further inland. Most of the cuts ended seaward of or at the highway. However, one cut extended completely through the highway, and other cuts ended in the highway pavement (see Figures 5.1-5.3). Figure 3.8 shows the landward end of one cut, and Figure 3.9 shows the extent of the breach made through the backbeach dunes.

FIGURE 3.8 Washout channel looking south toward the Gulf about 7 miles west of San Luis Pass on Follets Island.

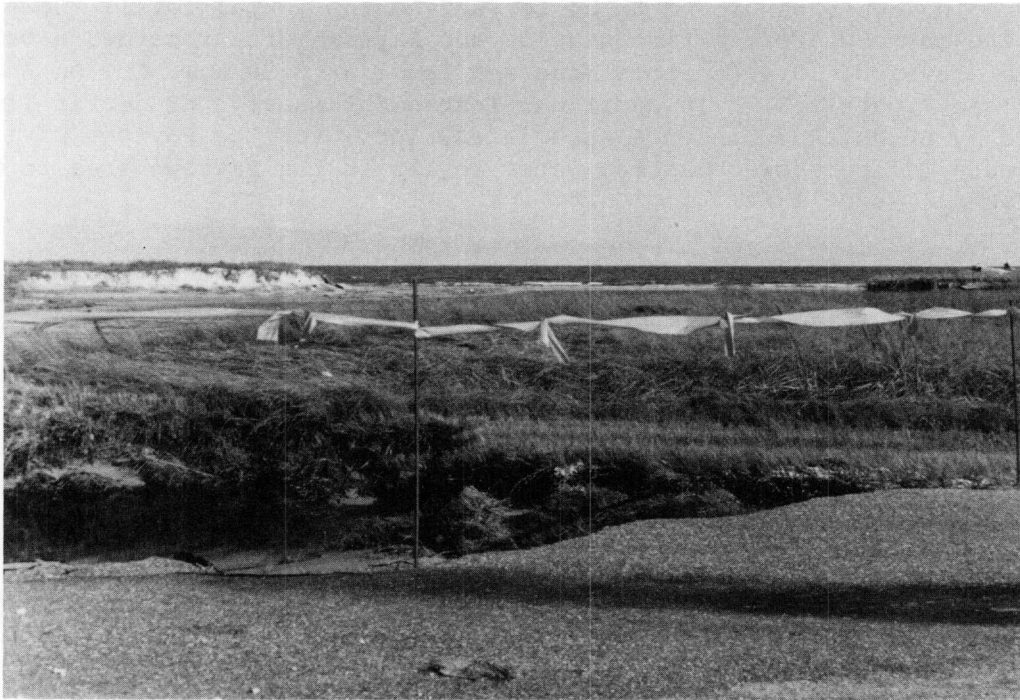
FIGURE 3.9 Portion of the channel shown in Figure 3.8 looking toward the Gulf. Note dune erosion in the vicinity of the beach.

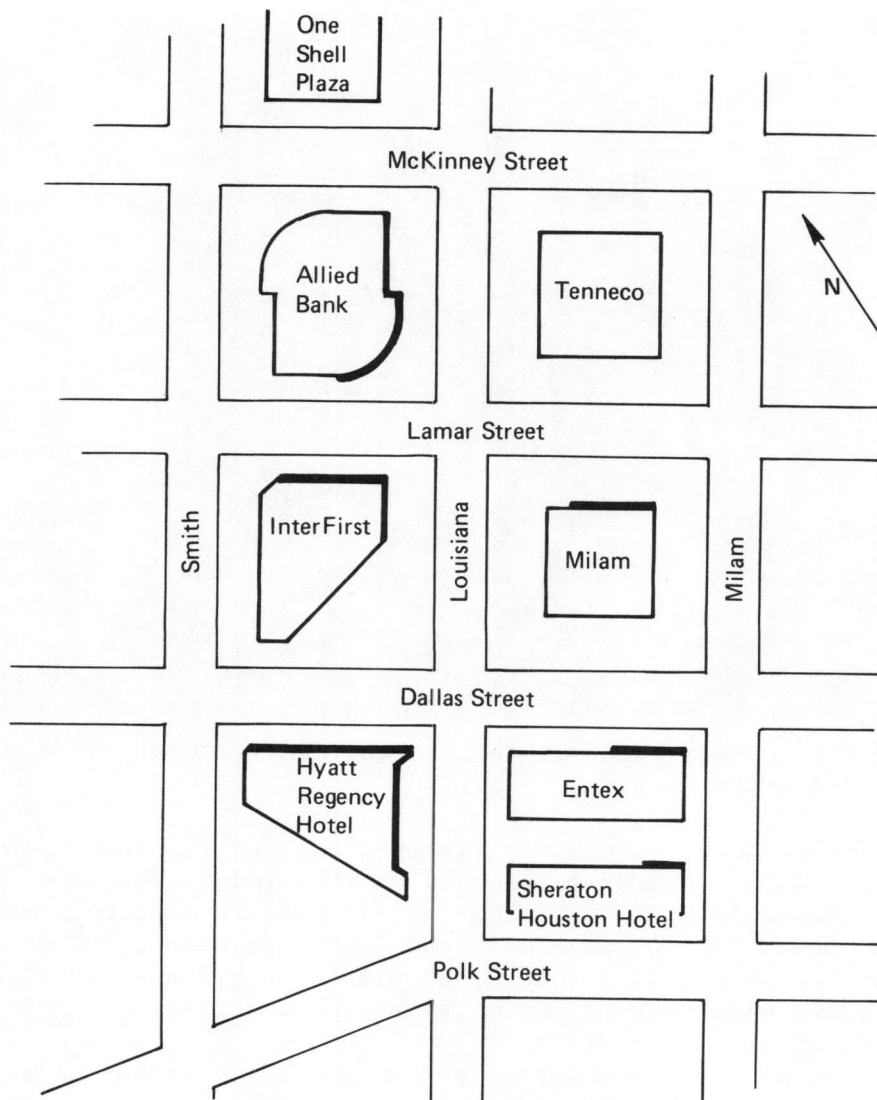
The area of the Houston central business district in which substantial windowpane and glass cladding breakage occurred is bounded by McKinney Street on the northeast, Polk Street on the southwest, and Smith and Milam streets on the northwest and southeast respectively (Figure 4.1). The high-rise buildings in this area are the Allied Bank Plaza, the InterFirst Plaza, the Hyatt Regency Hotel, the Tenneco, Milam, and Entex

FIGURE 4.1 Areas of extensive glass breakage, indicated by bold lines, in the Houston central business district.

buildings, and the Sheraton-Houston Hotel. All are fully engineered buildings. Figure 4.2 is an aerial photograph of this block. There was substantial glass breakage on at least one face of all these buildings except the Tenneco Building. Faces with regions of intense glass breakage are identified in Figure 4.1 by bold lines. Damage to these buildings is described in the following sections.

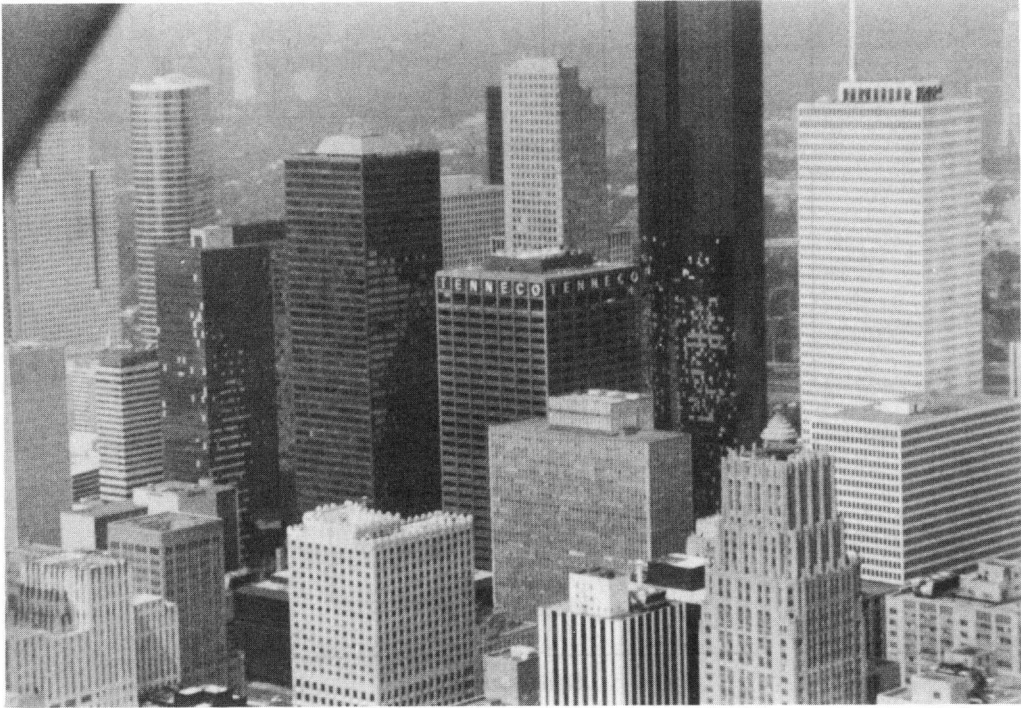
FIGURE 4.2 General view of the Houston central business district toward the west.

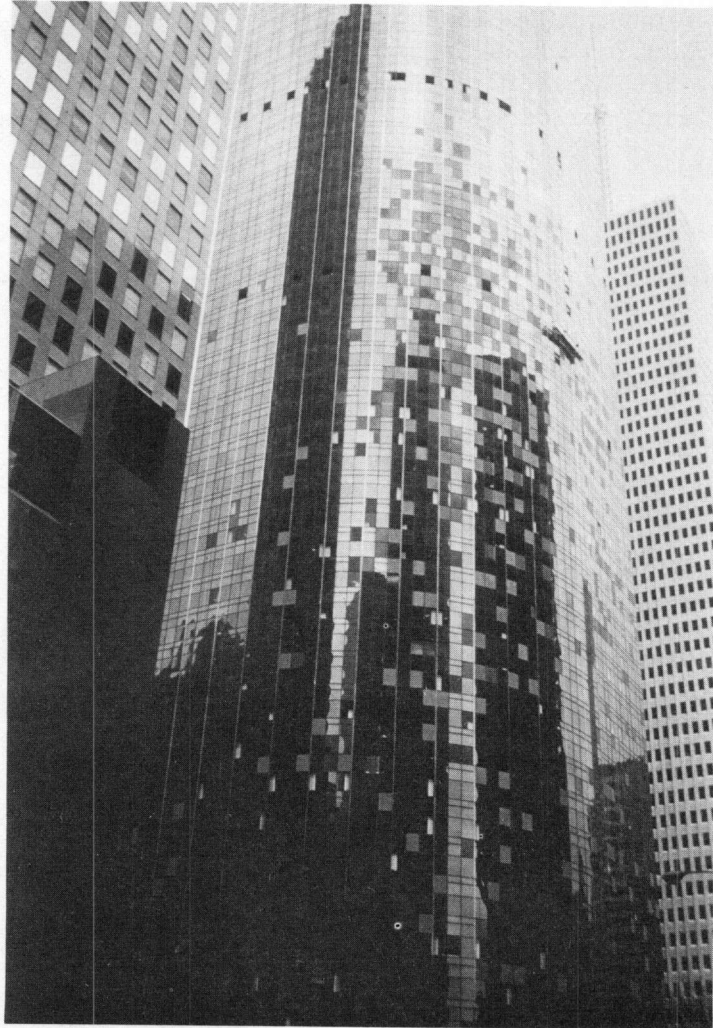
tempered, double-pane, insulating vision glass and tempered spandrel glass (Figure 4.3). Approximately 300 to 400 windowpanes were damaged. However, a closer inspection of the curtain wall by a curtain wall design and consulting company indicated that more than 1,100 to 1,200 lights were broken and more than 3,000 pieces of glass would have to be replaced, along with most of the metal strips and gaskets (Engineering News-Record, 1983).

FIGURE 4.3 Glass damage on the southwest face of the Allied Bank Building. Dark shapes are reflections of adjacent buildings.

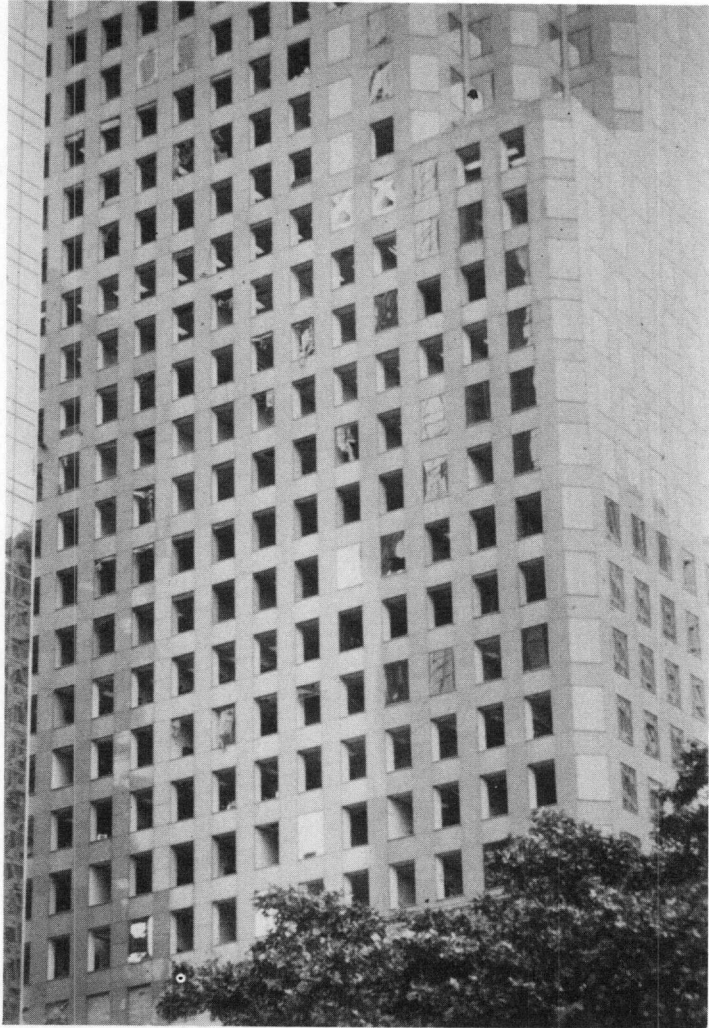
FIGURE 4.5 Glass damage to the northeast face of the InterFirst Tower.

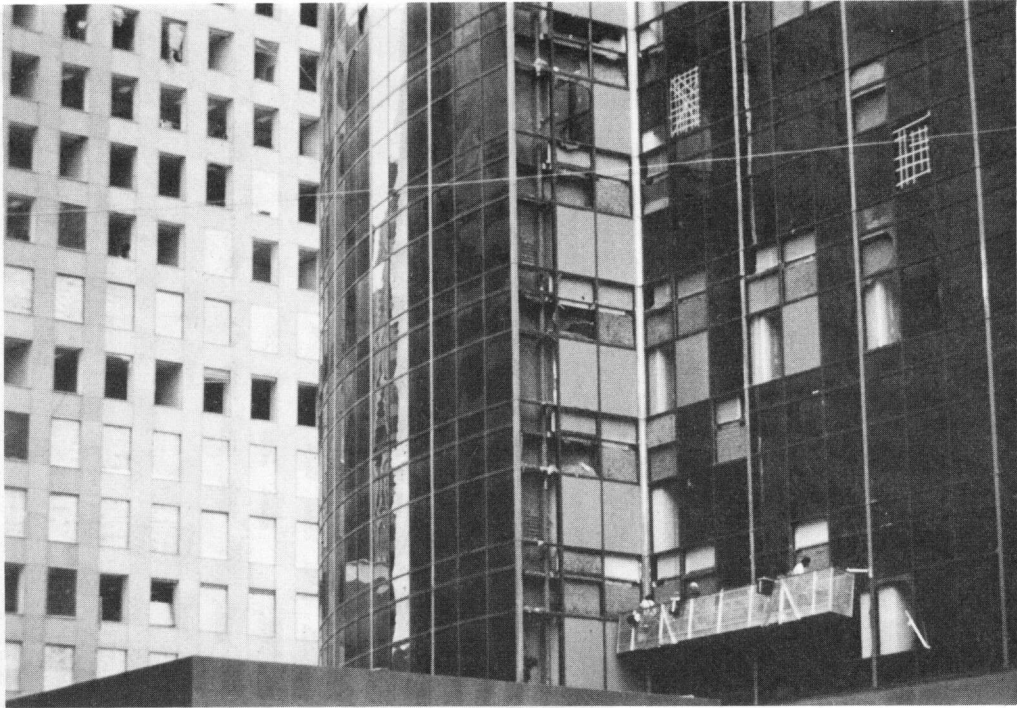
FIGURE 4.6 Closeup of damaged glass on the Allied and Inter-First towers.

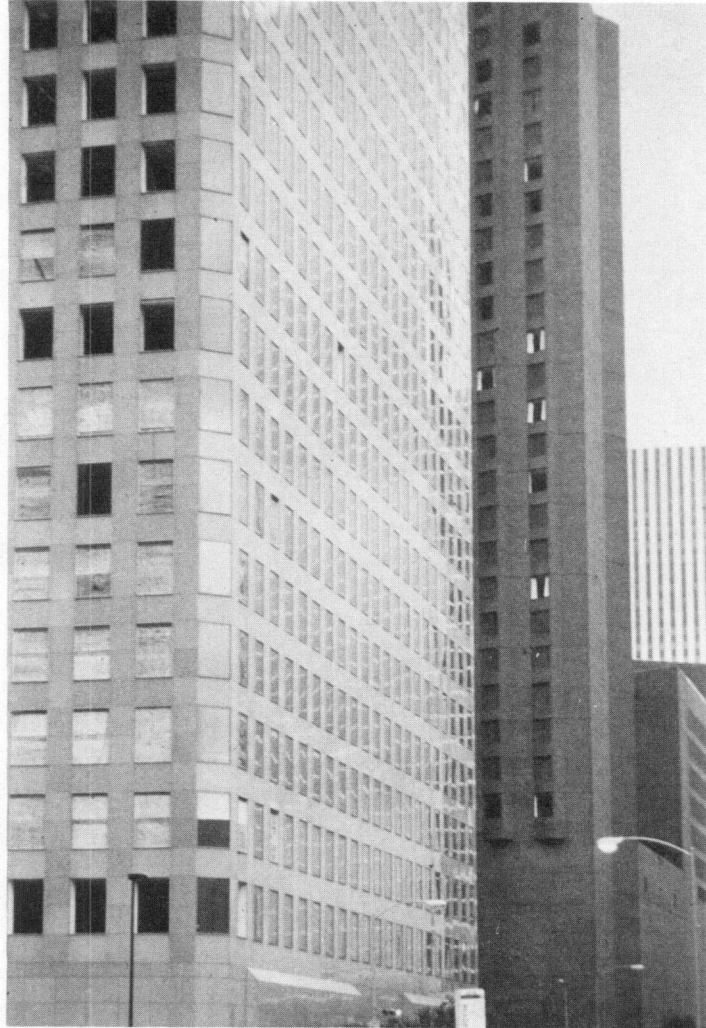
FIGURE 4.7 Window damage to the Hyatt Regency Hotel (the building in the background).

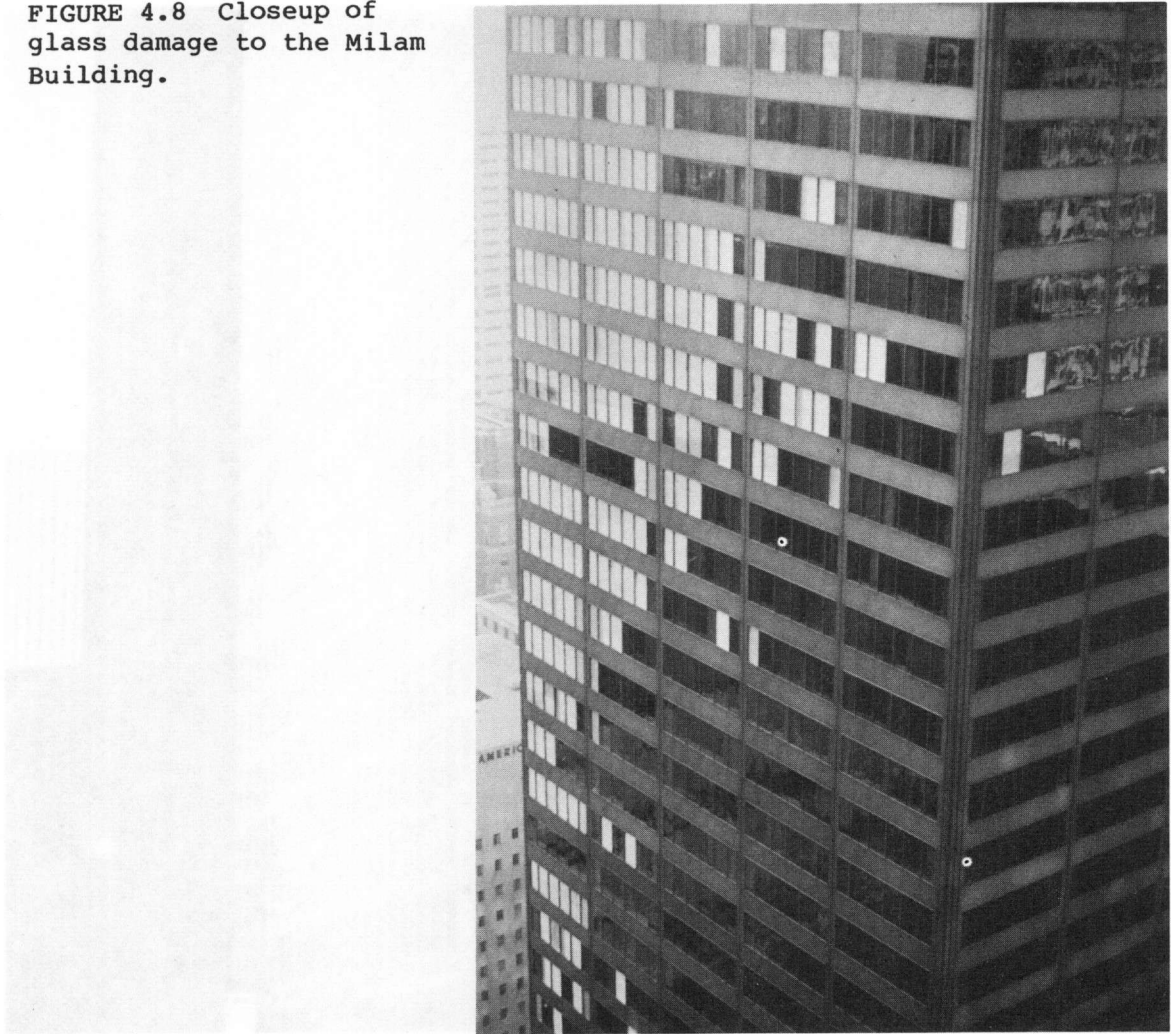
Breakage on the Milam building was concentrated on the northeast face around the level of the top of the Tenneco Building. Figure 4.8 shows

the bell-shaped damage pattern. Laminated sloped glazing at the plaza level of the Milam Building developed many cracks but stayed in place.

FIGURE 4.8 Closeup of glass damage to the Milam Building.

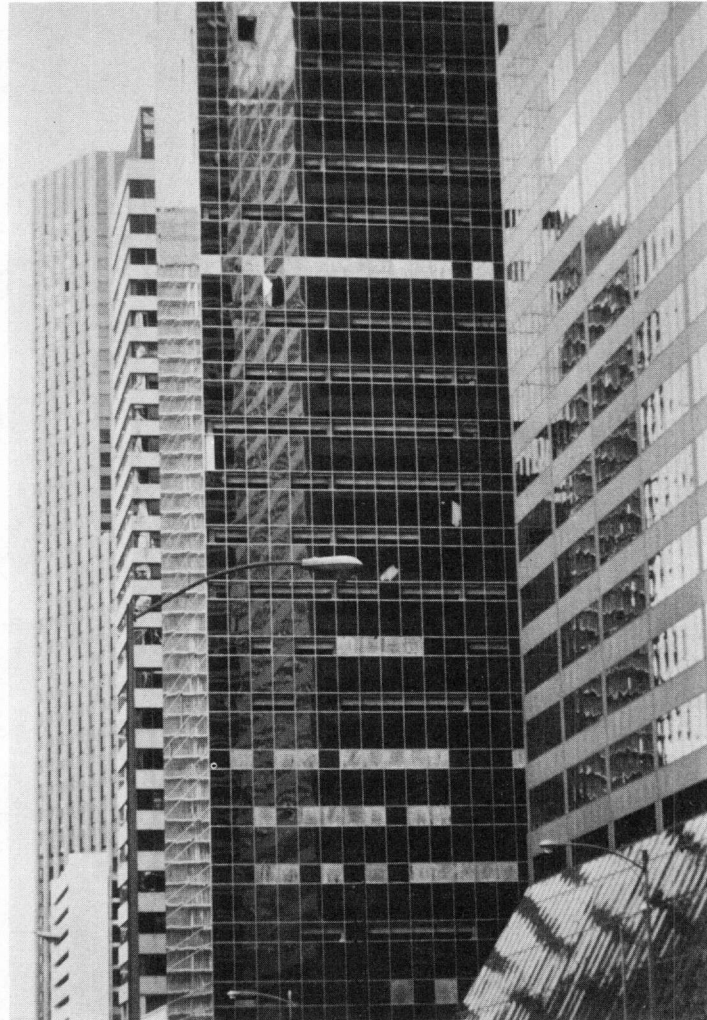
There was general glass breakage on the Entex Building, but damage was concentrated along the east corner of the northeast face (Figure 4.9). The breakage was more prevalent in the tempered spandrel glass. It should be noted that this building has a history of occasionally losing a glass panel.

FIGURE 4.9 Glass damage to the northeast face of the Entex Building.

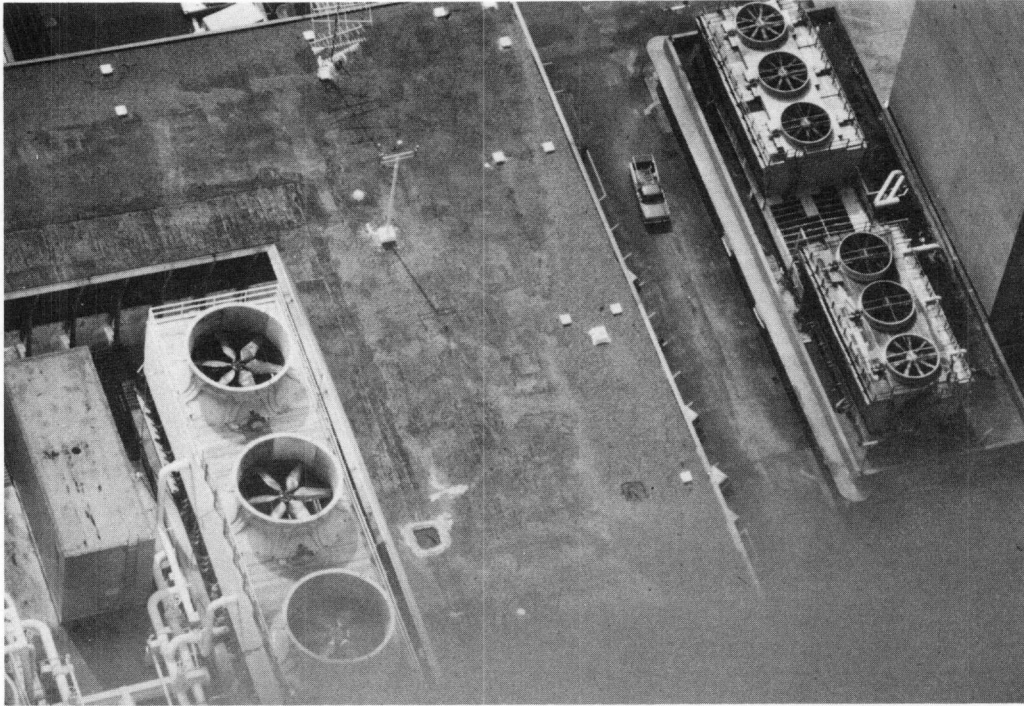
FIGURE 4.11 General view of the roof of the Tenneco Building.

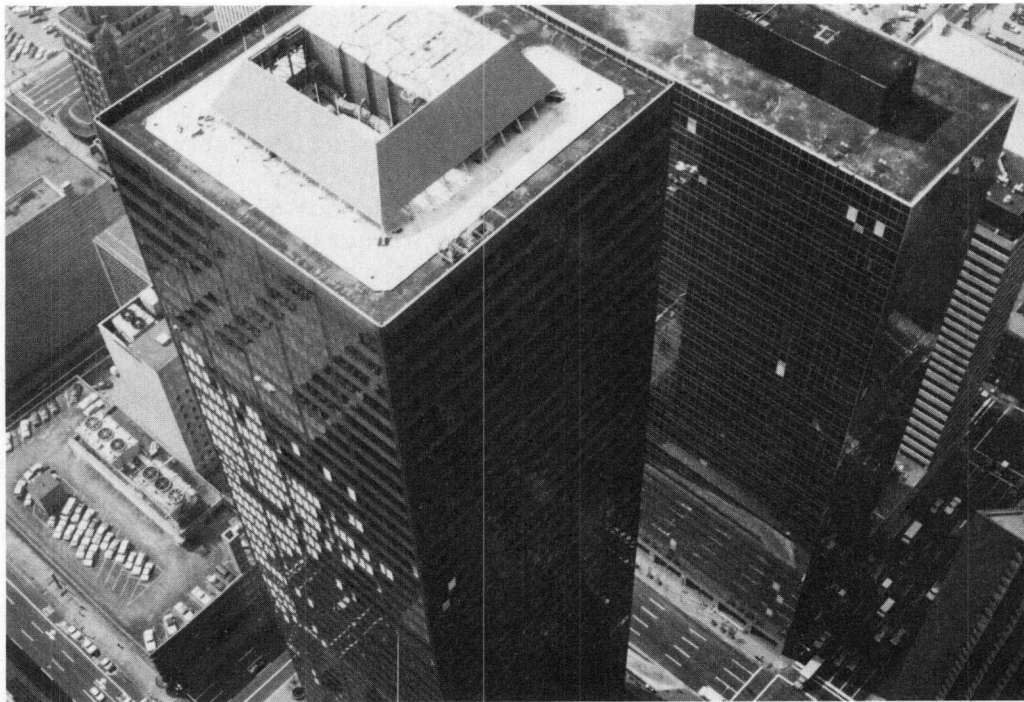
FIGURE 4.12 General view of the roofs of the Milam and Entex buildings.

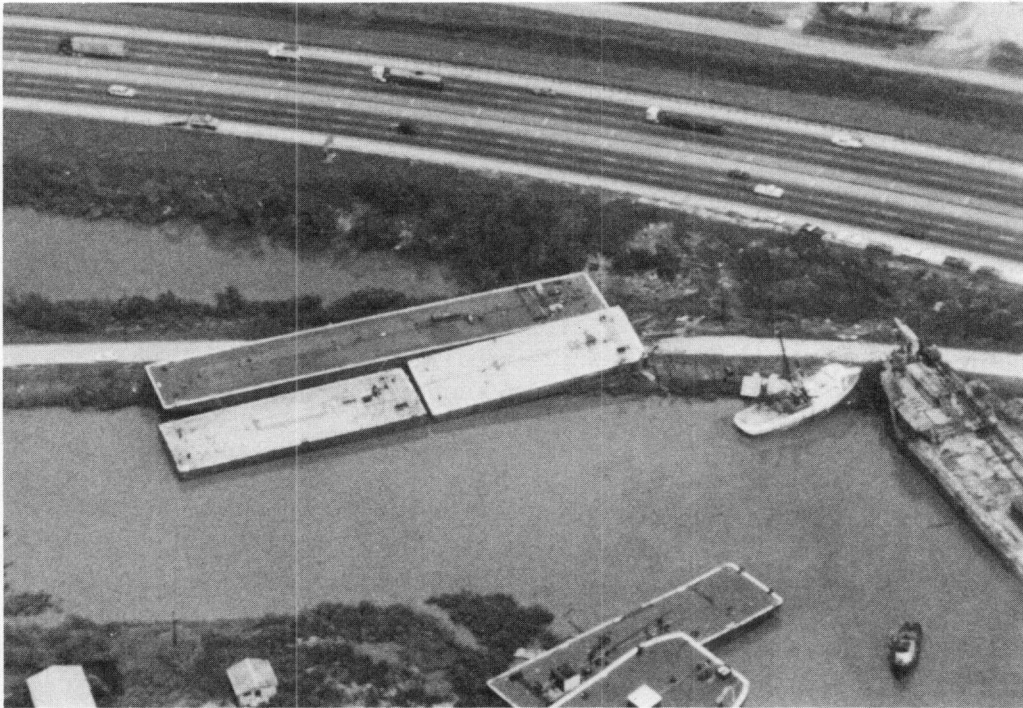
Destruction of boats in the Houston Yacht Club marina was almost total as Hurricane Alicia ripped through the area and piled boats on top of each other. Boats moored in individual docking bays were picked up and hurled about by winds and surge. Some large barges in the Houston ship channel got loose as well during the storm, resulting in damage to dock facilities (Figure 4.17). Some of the oil storage tanks near the Houston ship channel were floated from their original locations by high water (Figure 4.18).

FIGURE 4.17 Barges and a tanker in the Houston ship channel area.

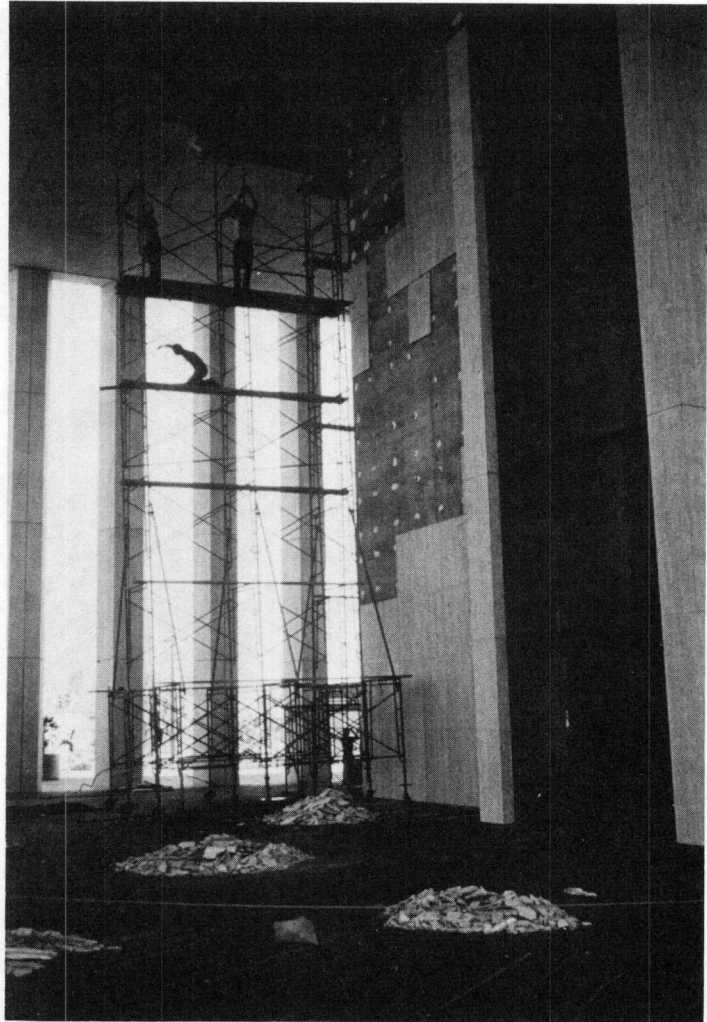
The American National Insurance Building, which is located behind the seawall on Market Street, is the tallest building in Galveston. Completed in 1971, it has a large expanse of glass in the lobby that is recessed approximately 40 ft from the exterior walls of the building. Around the elevator shaft, large panels of glass were broken. The damage was not restricted to the glass; large granite facade panels were also dislodged from their seats, and the ceiling tiles of the open lobby were damaged (Figure 4.21). The survey indicated that damage was initiated by high wind pressure excursions due to flow separation and/or by wind channelization, perhaps coupled with some improper installation.

FIGURE 4.21 Damage to facade and glass of the American National Insurance Building.

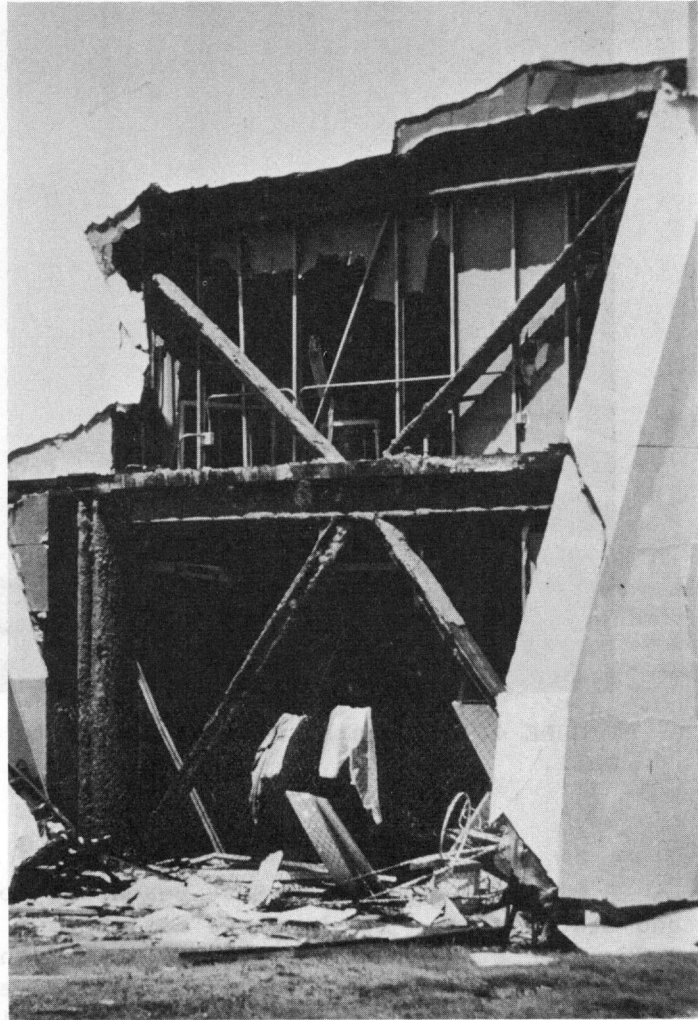
FIGURE 4.25 Closeup of damage to the facade of By-the-Sea Condominium.

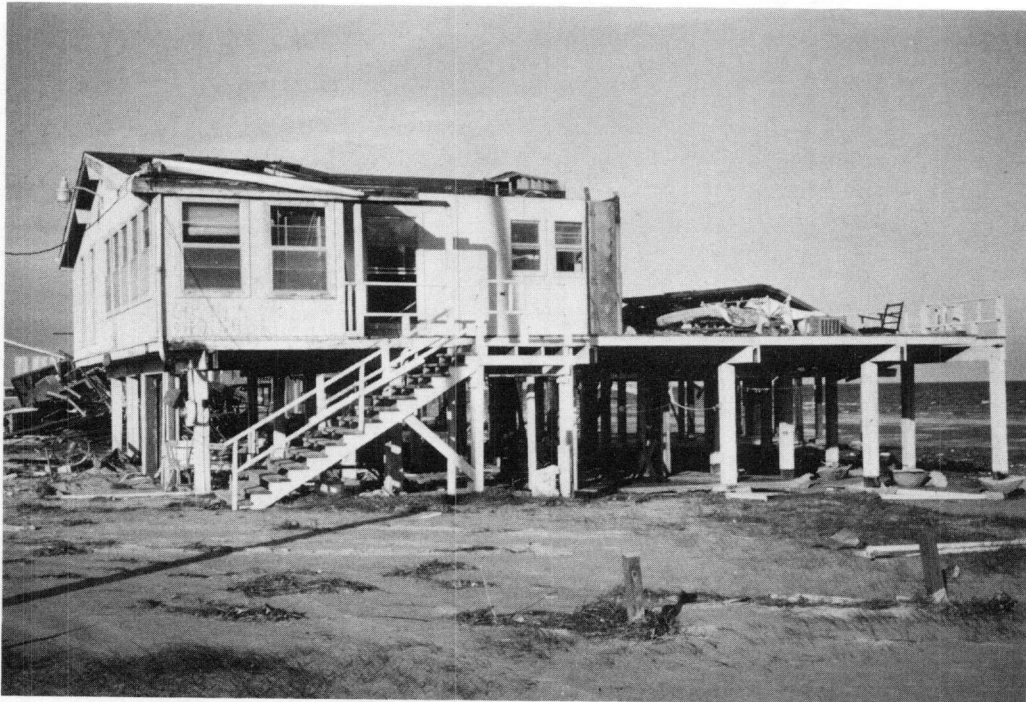
The seafront side of the house in Figure 4.42 was totally destroyed due to wind. The partial survival of the landward portion was perhaps a result of the large size of the house and its number of interior walls. These could have stiffened the structure and kept the leeward portion from blowing away. The house next door was a complete disaster. The foundation slab was partially washed away, and the rest of the foundation was exposed due to erosion and wave action. This did not have any bearing on the overall catastrophic failure of the house (Figure 4.43). The connections of the studs to the base and top plates and the roof to the top plate were poor, with no hurricane anchors. Figure 4.44 shows the details of some of the connections and corroded nails in studs.

FIGURE 4.42 Typical example of partial collapse of a large house in Terramar Beach.

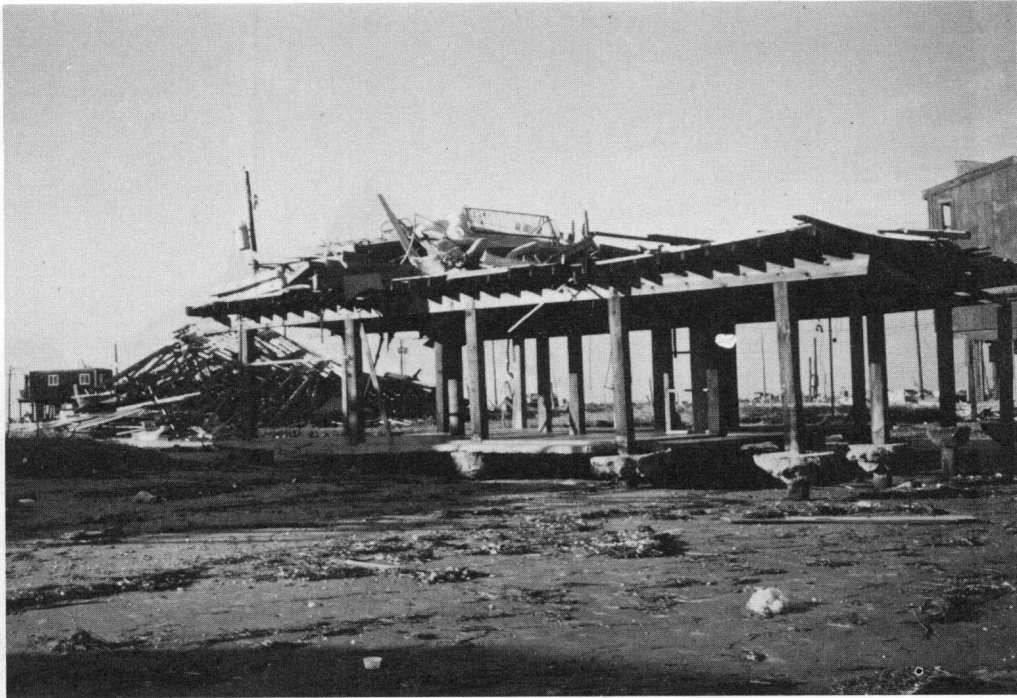
FIGURE 4.43 Example of a superstructure blown away by the wind. A mound of lumber, furniture, and appliances is in the backyard of the house.

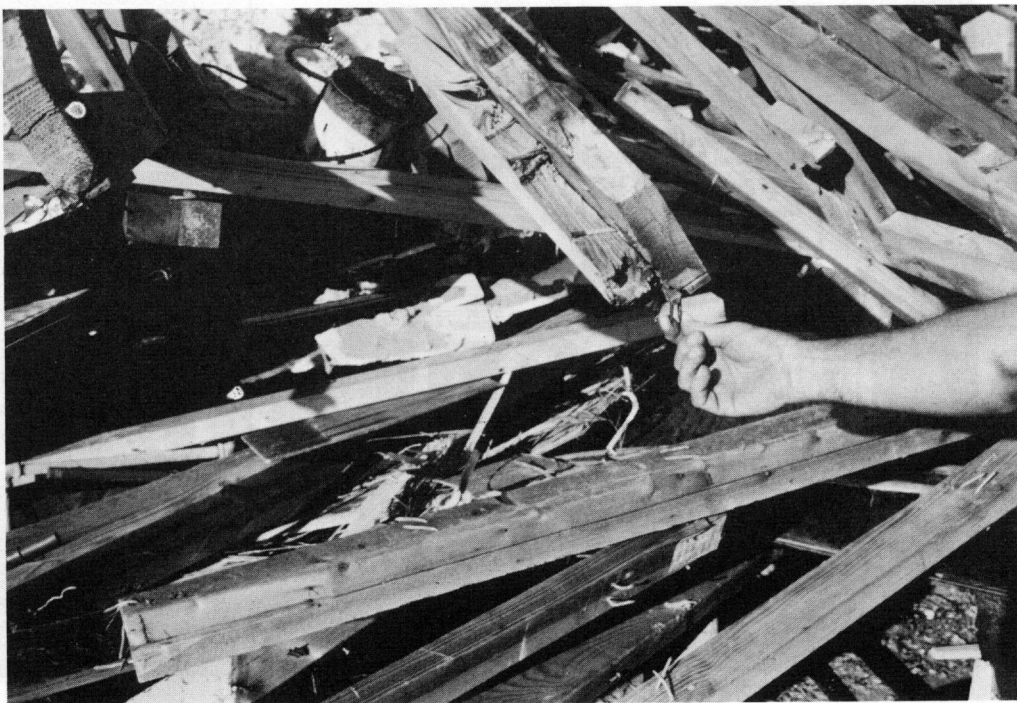
FIGURE 4.44 Details of toe nail connections.

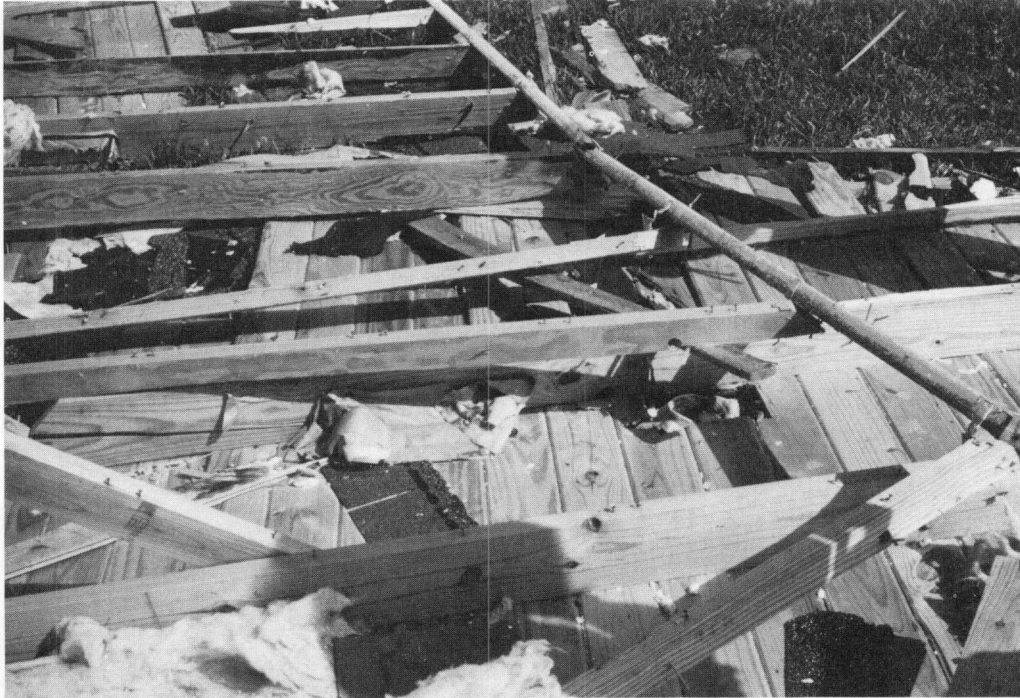
FIGURE 4.47 Details of end plate connections with rafters and hurricane clips.

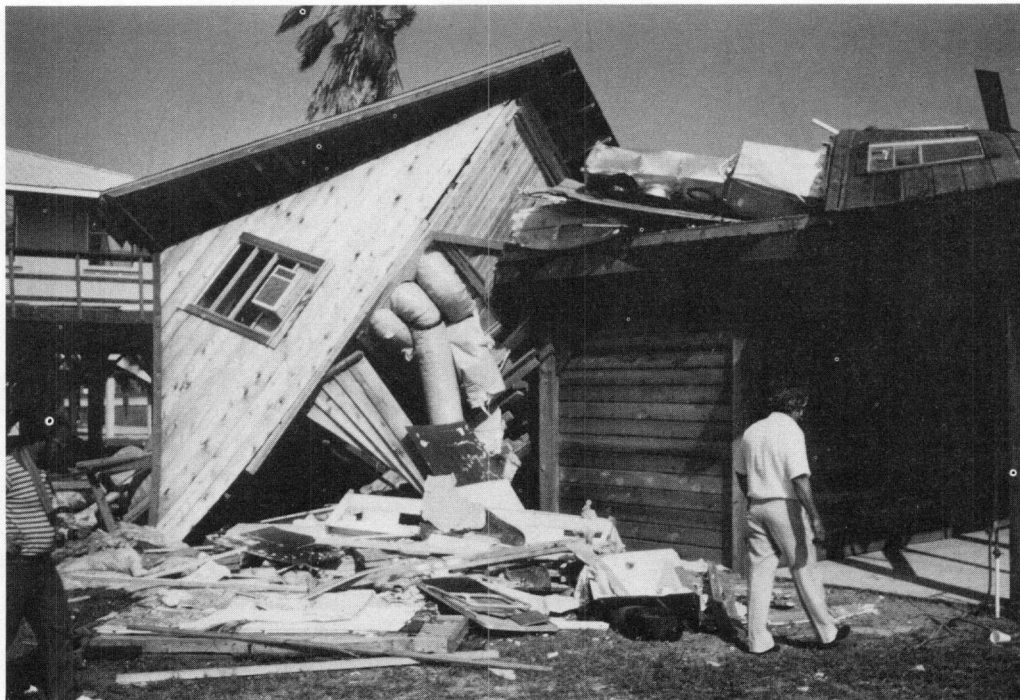
Figures 4.45 to 4.48 exemplify some of the damage in Sea Isle. Figure 4.45 shows an oceanfront house that lost a good portion of its superstructure to wind forces. The extent of damage decreased for houses inside the subdivision (Figure 4.46), which experienced lesser wind speeds because of being sheltered. Figure 4.47 shows part of a roof lying on the ground. There were hurricane clips, but they did not extend to the wall studs and the end plate was dislodged from the wall system. On the bay side of the subdivision, a house had lost its second story completely (Figure 4.48) due to poor linkage between subsystems.

FIGURE 4.48 Typical example of poor connections between sub-systems.

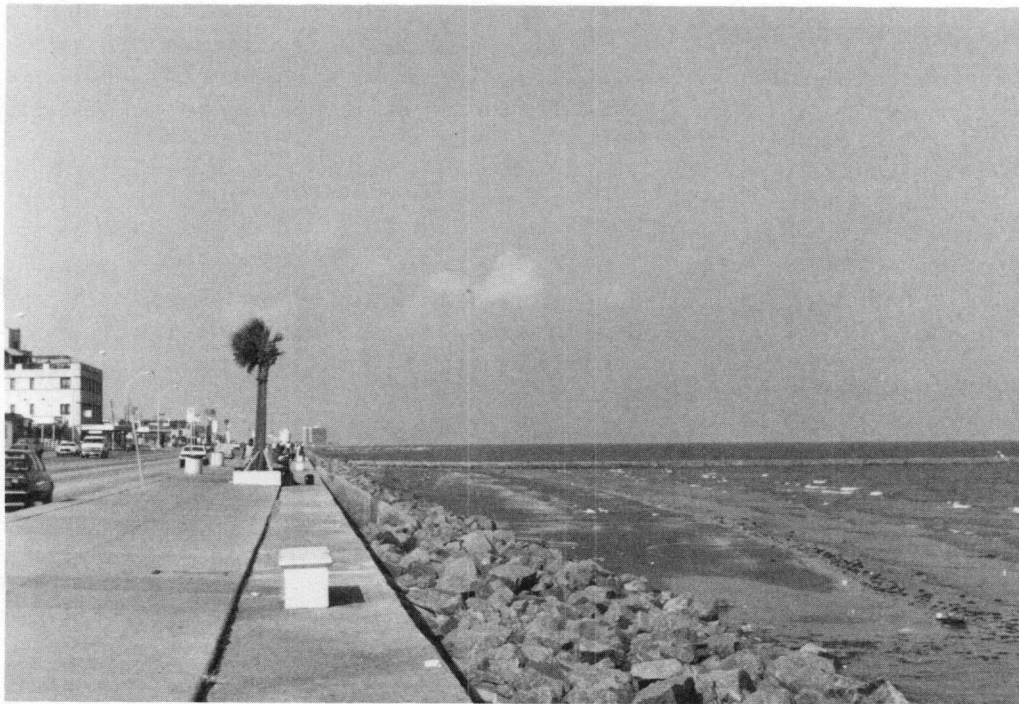
FIGURE 4.56 Galveston seawall and groin.
