**Hurricane Alicia
Galveston and Houston, Texas
August 17-18, 1983**

**Committee on Natural Disasters
Commission on Engineering and Technical Systems
National Research Council**

NATIONAL ACADEMY PRESS
Washington, D.C. 1984

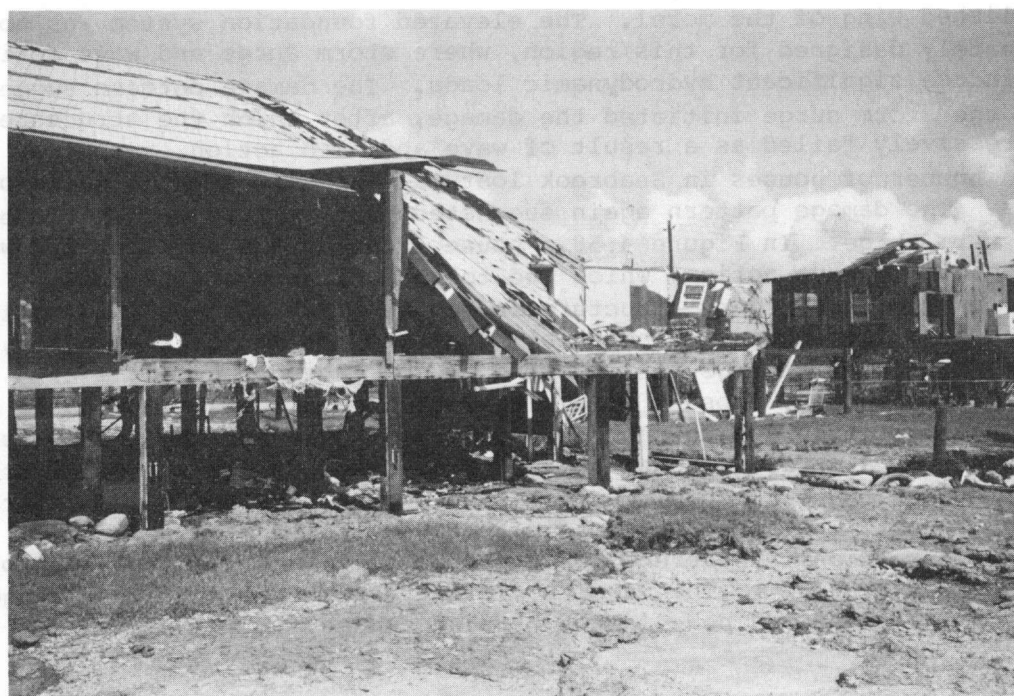
A number of houses in Seabrook lost part or all of their walls or roofs. The damage pattern again suggested that failure was initiated by the storm surge. In Figure 4.58 a house fronting the bay lost its wall system due to wave action, which led to the collapse of the roof system. The three-story structure in Figure 4.59, perhaps marginally engineered, lost a brick veneer wall that was not properly anchored, and a combination of storm surge and wind action caused heavy damage. Figure 4.60 shows a closeup of a slab with anchor bolts. Obviously the house was uplifted due to poor connections. A view of the ground-level enclosure of a bayfront house shows damage due to storm surge (Figure 4.61). Once the enclosure lost one side, winds tore apart the interior of the house. The house on top did receive minor damage from high winds. A mansion in Seabrook, on top of a hill, survived the fury of Alicia (Figure 4.62). The mansion did not experience any storm surge effects and there was no evidence of wind damage.

FIGURE 4.58 Bayfront house with a collapsed roof.

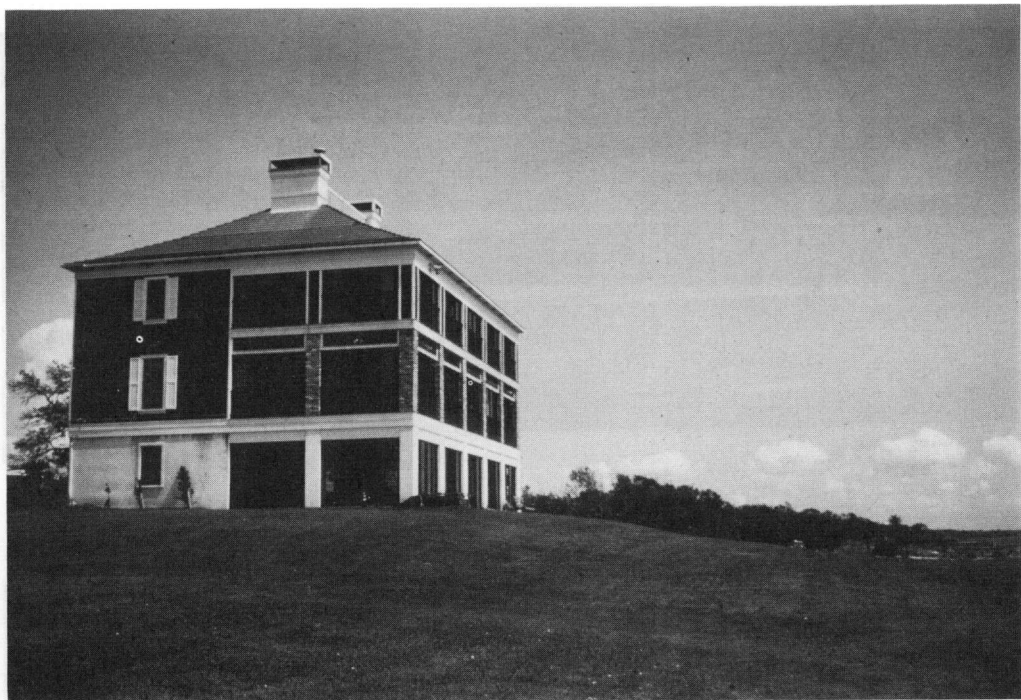
FIGURE 4.62 This mansion survived the storm very well.

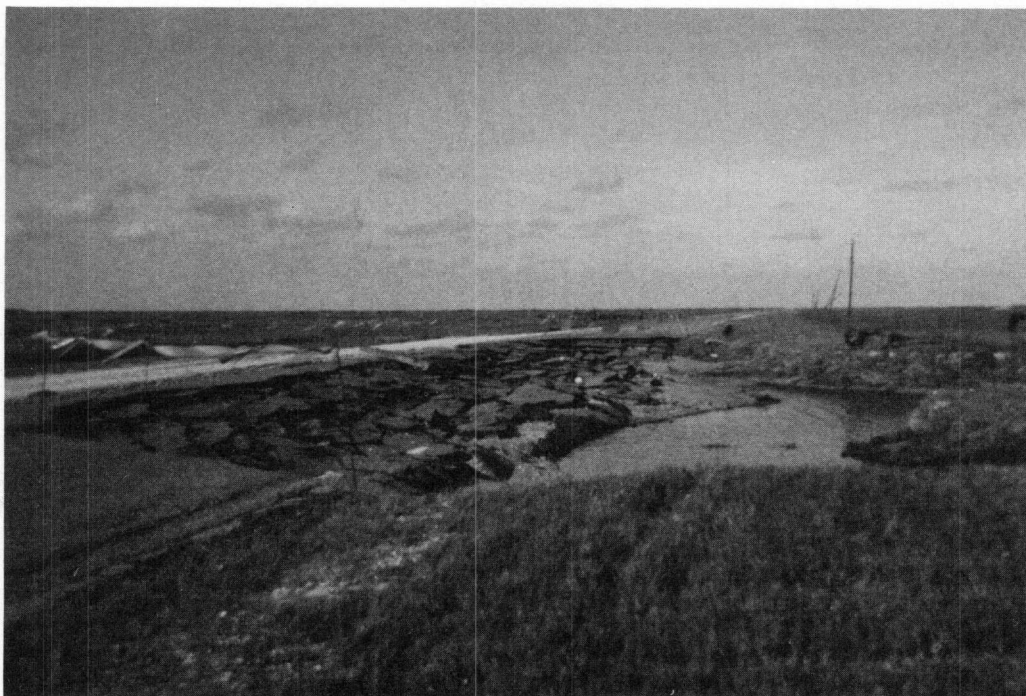
The storm did not cut any highways, but some roadbeds were undercut on the main highway on Follets Island (see Figures 5.1-5.3). This undercutting occurred when the high water that ponded behind the island flowed into the Gulf. In one case, the undercutting extended through

FIGURE 5.2 Typical undercut of roadbed on San Luis Pass Road, Follets Island.

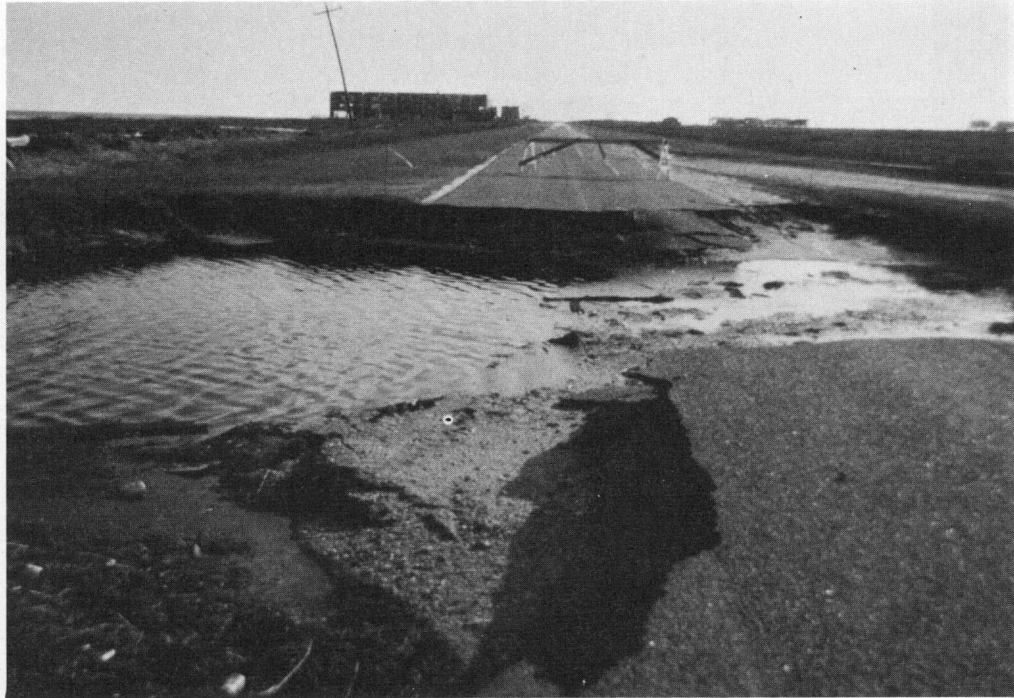
FIGURE 5.3 Total washout of shoulder and road on San Luis Pass Road, Follets Island.

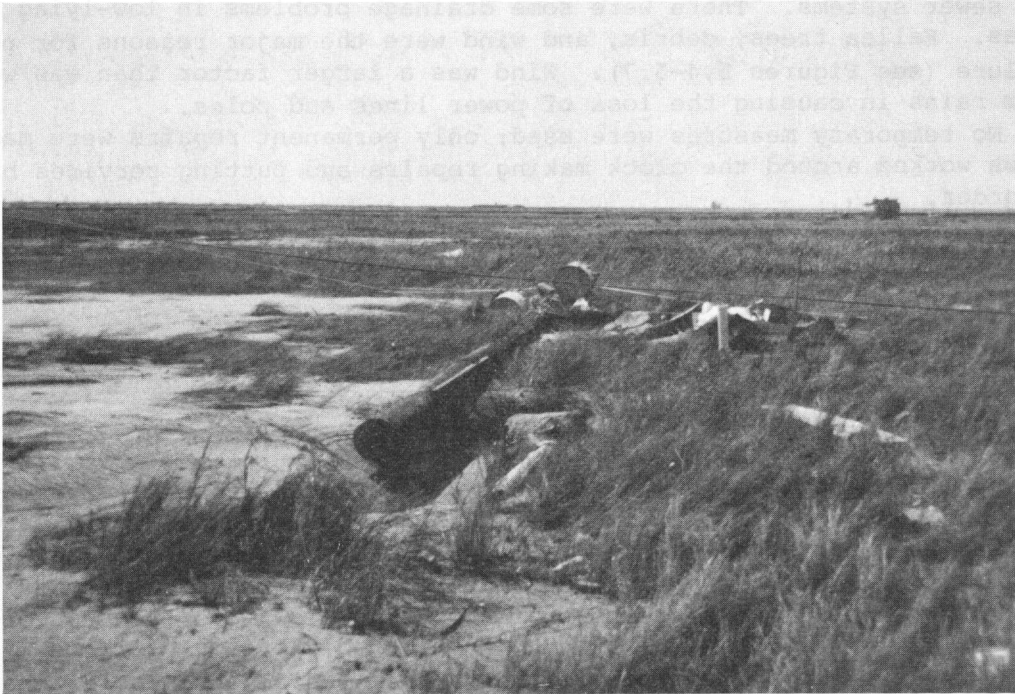
and sewer systems. There were some drainage problems in low-lying areas. Fallen trees, debris, and wind were the major reasons for power failure (see Figures 5.4-5.7). Wind was a larger factor than was water from rains in causing the loss of power lines and poles.

FIGURE 5.4 Typical failure of transformer pole on East Beach, Galveston Island.

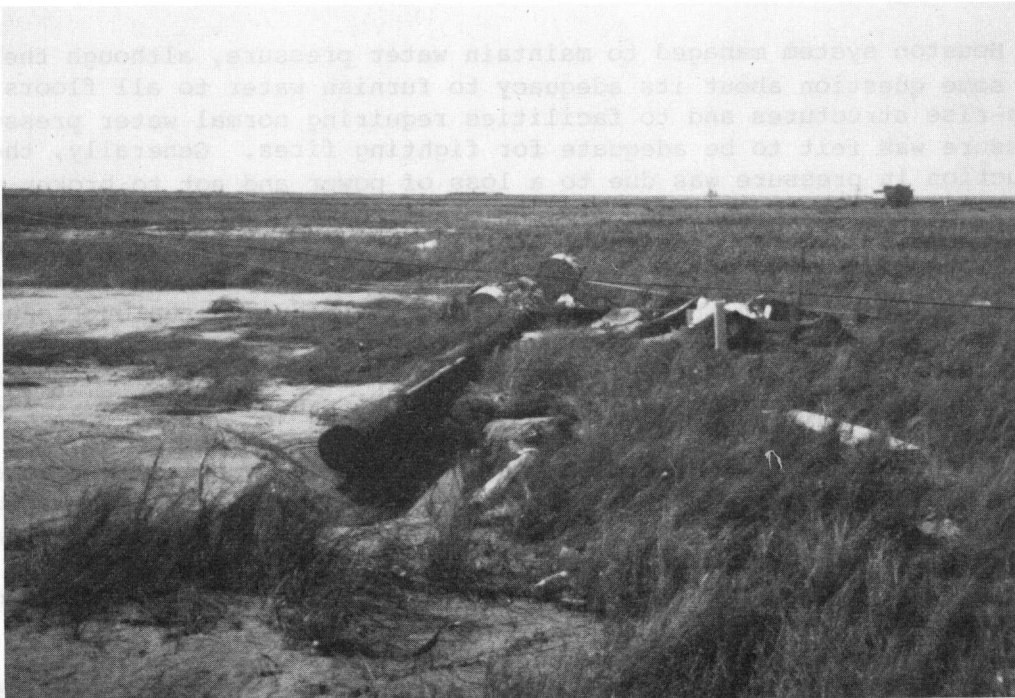
FIGURE 5.5 Typical failure of utility pole on East Beach, Galveston Island.
