## Track Record of In-Line Inspection as a Means of ERW Seam Integrity Assessment

J. F. Kiefner, K.M. Kolovich, C.J. Macrory-Dalton, D.C. Johnston,  
C.J. Maier, and J.A. Beavers  
November 15, 2012

**AS THE DELIVERABLE OF SUBTASK 1.3 ON  
U.S. DEPARTMENT OF TRANSPORTATION  
OTHER TRANSACTION AGREEMENT NO. DTPH56-11-T-000003**

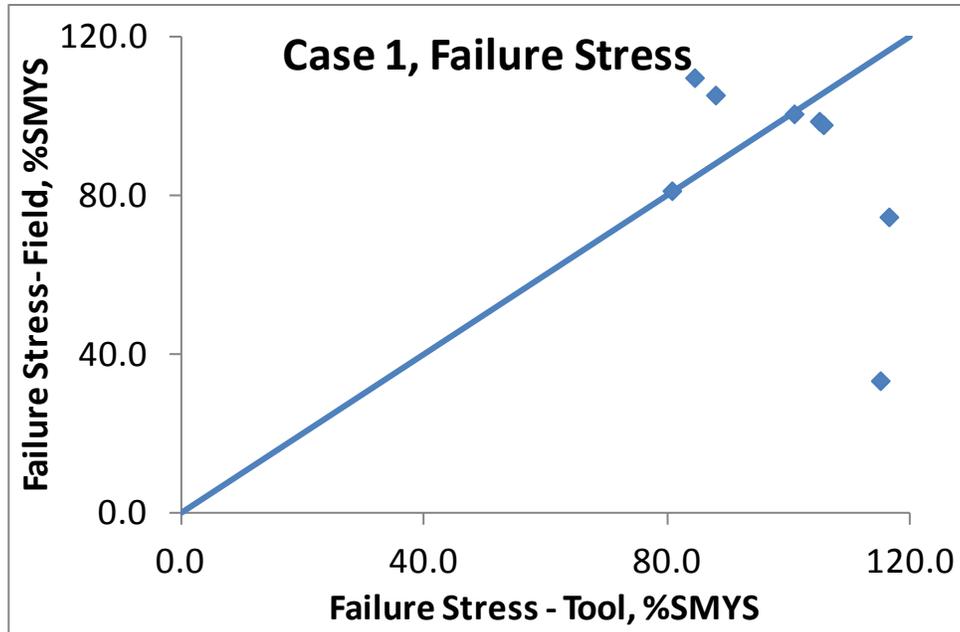
**Figure 4. Comparisons between Predicted Failure Stresses Based on Field-Measured Anomaly Dimensions and Those Based on ILI Dimensions, Case 1**

A comparison between failure stresses of the anomalies calculated on the basis of ILI dimensions and those calculated on the basis of field-measured dimensions is presented in Figure 4. Failure stress levels for these anomalies were calculated using the Modified Ln-Sec Equation Elliptical C-Equivalent model with a full-size-equivalent Charpy upper shelf energy of 20 ft-lb<sup>2</sup>. In one case (Anomaly No. 12), the calculated failure stress based on the ILI dimensions was 105% of SMYS. In contrast, the calculated failure stress based on the field-measured dimensions was 33% of SMYS. The disparity is largely the result of the large difference between the ILI depth (12.5% of wall thickness) and the field-measured depth (70% of wall thickness).

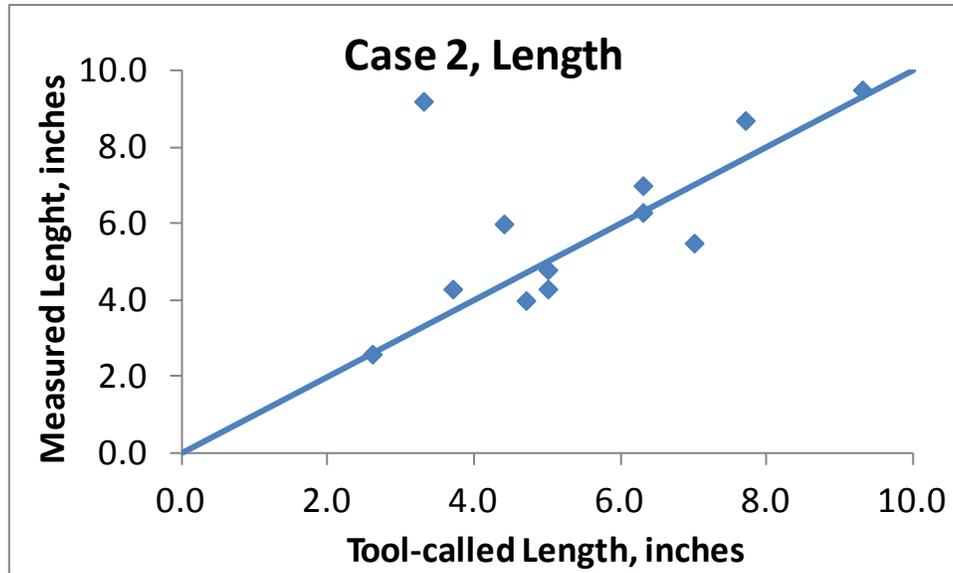
**Figure 6. Comparisons between Field-determined Anomaly Length and ILI Anomaly Length, Case 2**

Except in one case, the ILI lengths were in reasonable agreement with the field-measured lengths as shown in Figure 6. In the single case where the agreement was not so good, a lack-of-fusion anomaly was measured to be 9.2 inches in length upon field examination whereas the ILI-indicated length was 3.3 inches.

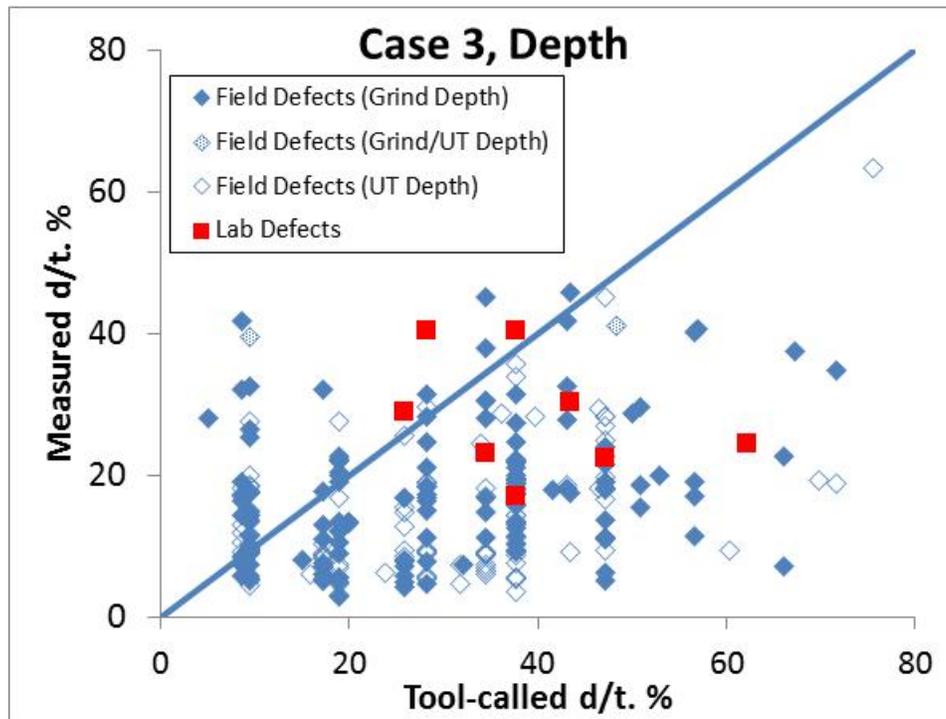
**Figure 8. Comparisons between Field-determined Anomaly Depth and ILI Anomaly Depth, Case 3**

As seen in Figure 8, for the majority of the anomalies (77%), the depths reported by ILI were deeper than the depths determined by field NDE. In fact, the ILI depths of 42% of features exceeded the depths determined by field NDE by a factor of 2 or more. It is also clear that a number of features reported by ILI with a shallow depth were indicated by field NDE to be deeper (i.e., features with a reported depth of approximately 10% WT were indicated to have depths as much as 42% WT). One interesting observation is that relatively deep anomalies (between 40% and 45% WT) were indicated by field NDE for most depth ranges reported by the ILI. Further, the distribution of field NDE indications is similar to that of the grind measurements, possibly an indication that the field NDE measurements were reasonably accurate (although a separate grind or lab vs. ultrasonic depth correlation would be required in order to be conclusive).

For those anomalies (corresponding with hook cracks) sent to the lab for examination (red symbols in Figure 8), approximately 63% were reported by the ILI as deeper than they actually were. The general sizing performance is similar to that for those anomalies that were examined in the field.

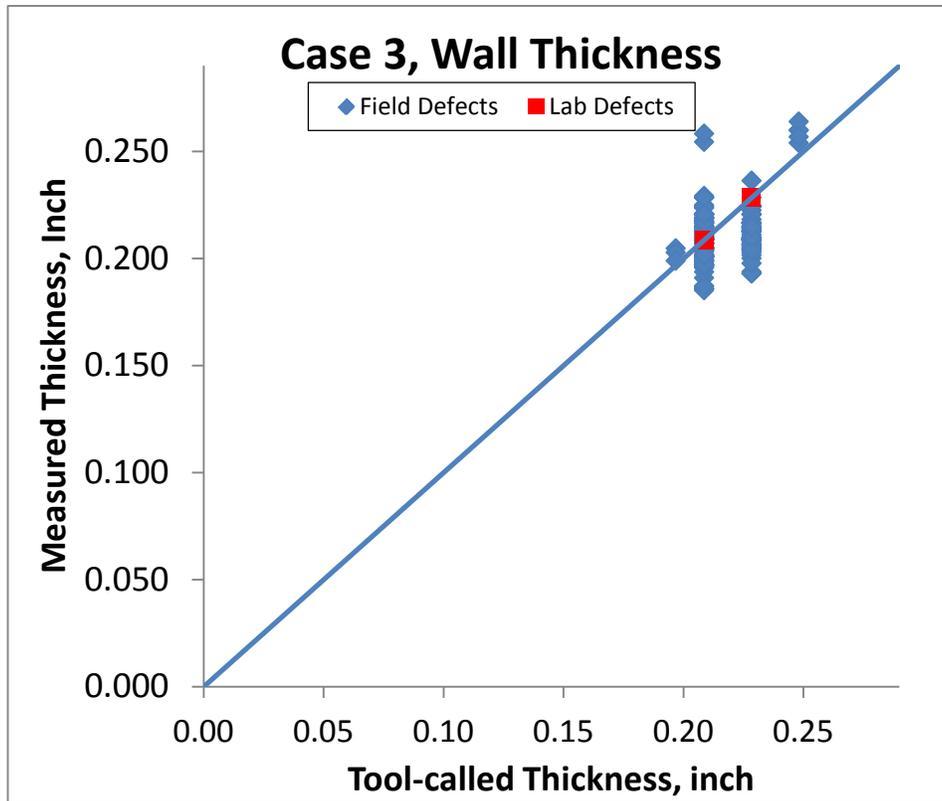
**Figure 10. Comparisons between Field-determined Wall Thickness and ILI Wall Thickness, Case 3**

Figure 10 shows a comparison of the pipe wall thickness measurements from the field with the ILI wall thickness values. On the basis of the data associated with the field examinations (blue symbols in Figure 10), the field-measured wall thickness values were within 15% of the ILI-reported value. The largest deviation was 22%, with no apparent explanation. As for the data associated with the lab examinations (red symbols in Figure 10), the lab-measured values matched the ILI-reported values.

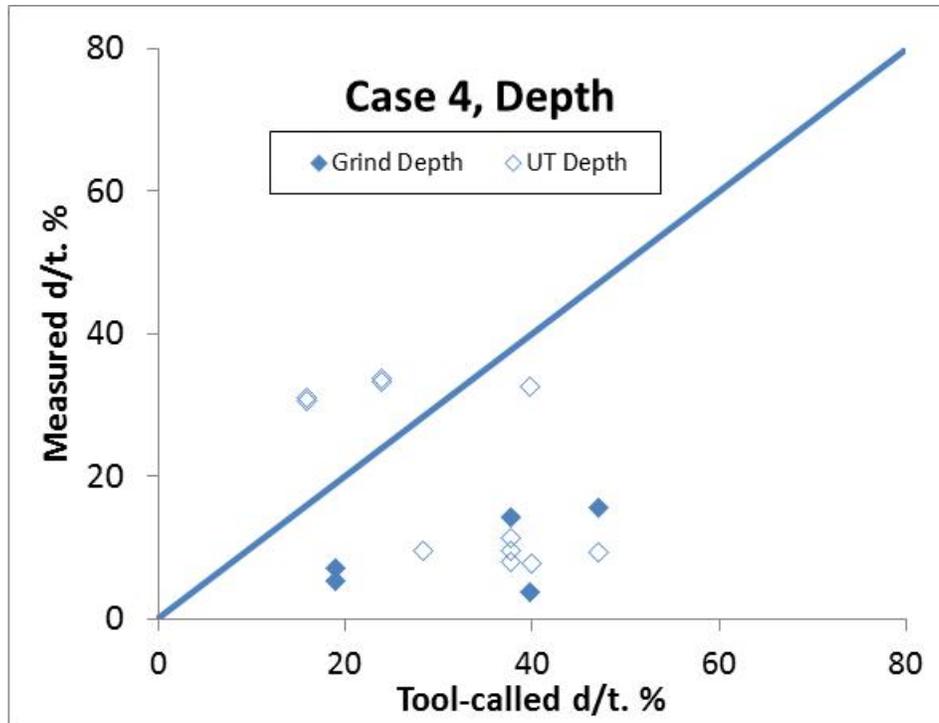
**Figure 12. Comparisons between Field-determined Anomaly Depth and ILI Anomaly Depth, Case 4**

As shown in Figure 12, the majority of depths (75%) reported by the ILI exceed those measured by field NDE. In fact, 69% of ILI depths exceeded those determined by field NDE by a factor of 2 or more. Thus, the tool appears to have overcalled the depths if the field NDE depths are to be believed accurate. In contrast, one feature reported with a shallow depth was actually found to be twice the reported depth. Although the Case 4 data set is smaller than the Case 3 data set, one can make the same observation that relatively deep anomalies (approximately 30% WT) were found for several depth ranges reported by the ILI tool. Further, it is difficult to say whether the distribution of field NDE indications is similar to that of the grind measurements based on the data provided. A separate grind vs. field-NDE depth correlation would be required in order to evaluate the accuracy of the ultrasonic measurements.

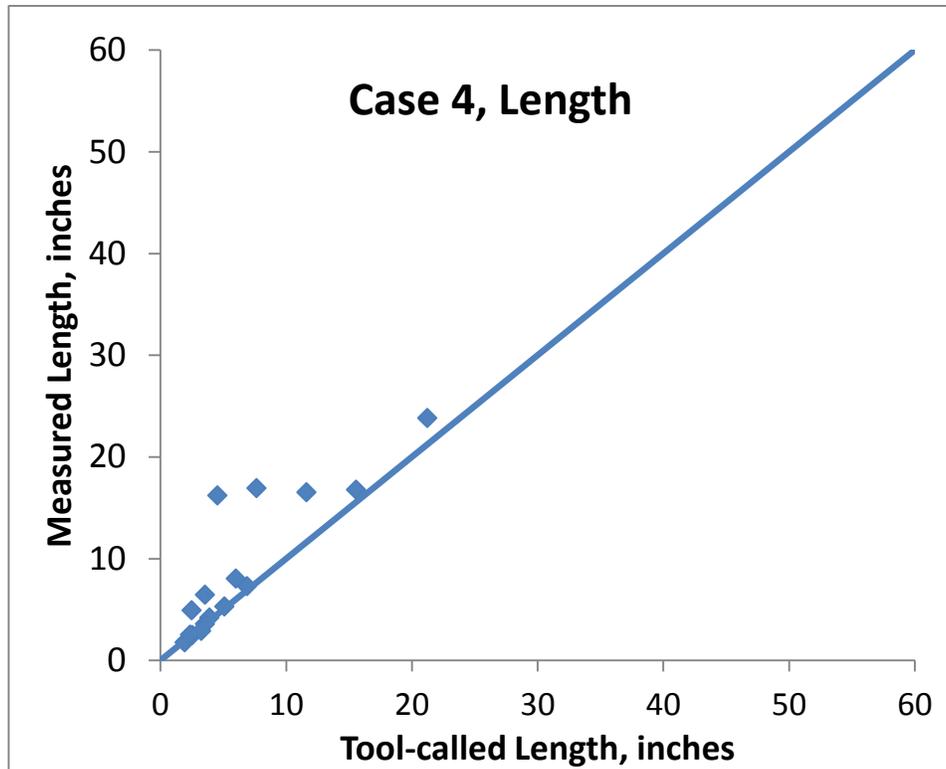
**Figure 13. Comparisons between Field-determined Anomaly Length and ILI Anomaly Length, Case 4**

Figure 13 shows that most (81%) of the anomalies were measured to be longer than what the ILI reported. Further, most data are aligned within a reasonable scatter band. Again, the trending suggests that most lengths are under-reported, which can be attributable to the tool’s inability to detect shallow parts of the cracks.

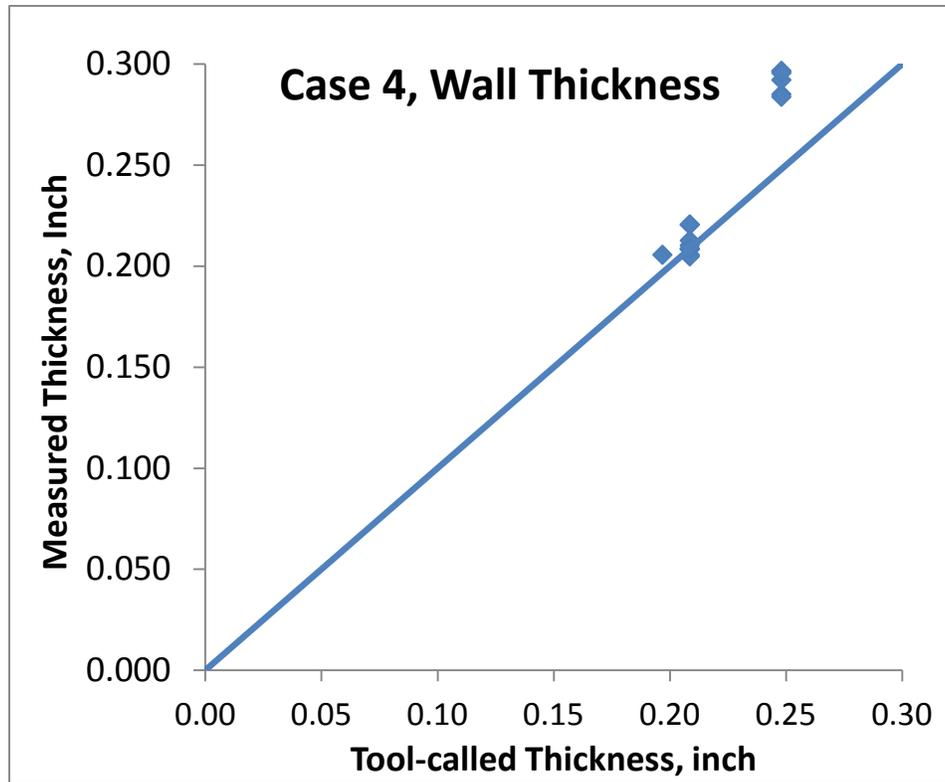
**Figure 14. Comparisons between Field-determined Wall Thickness and ILI Wall Thickness, Case 4**

The data shown in Figure 14 indicate that approximately half of the wall thicknesses measured by field NDE fluctuated within 5% of the ILI-reported values, while the other half appeared to be about 19% higher than the ILI-reported values. Thus, the tool appeared to under-call the wall thickness in half of the cases.

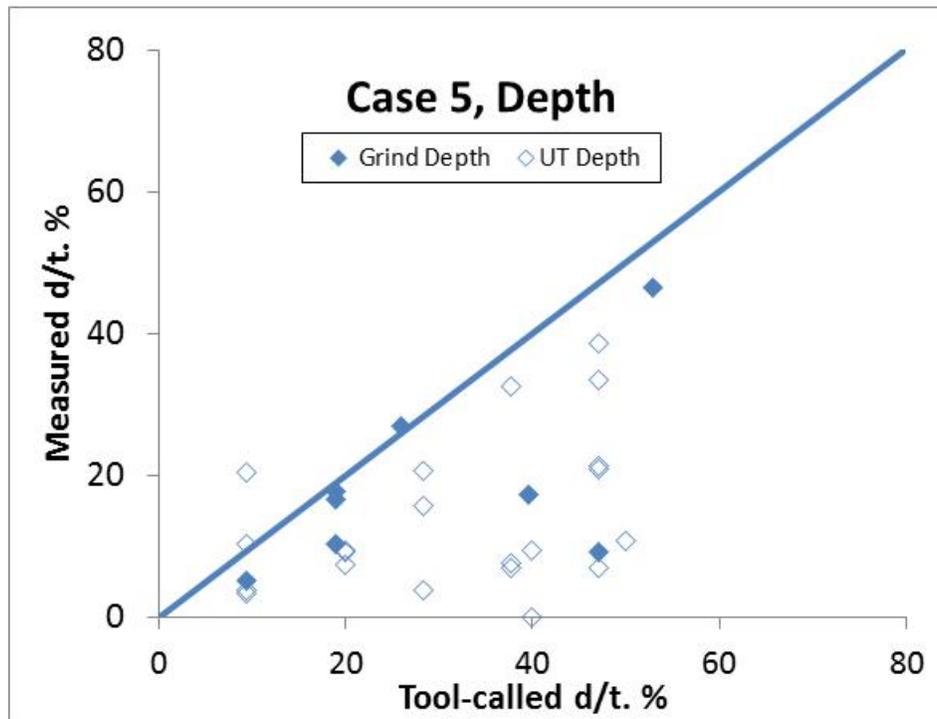
**Figure 16. Comparisons between Field-determined Anomaly Depth and ILI Anomaly Depth, Case 5**

As shown in Figure 16, the majority of features (90%) were reported by the ILI as being deeper than indicated by the field NDE. In fact, 55% of features were over-sized by a factor of 2 or more. In contrast, one feature reported with a shallow depth was found by field NDE to be twice as deep. Unlike the Case 3 and Case 4 data, the Case 5 data show that the upper bound field-measured depth increases with increasing tool-reported depths. Further, the distribution of field-NDE ultrasonic measurements is similar to that of the grind measurements, possibly an indication that the field-NDE measurements were reasonably accurate (although a separate grind vs. field-NDE depth correlation would be required in order to be conclusive).

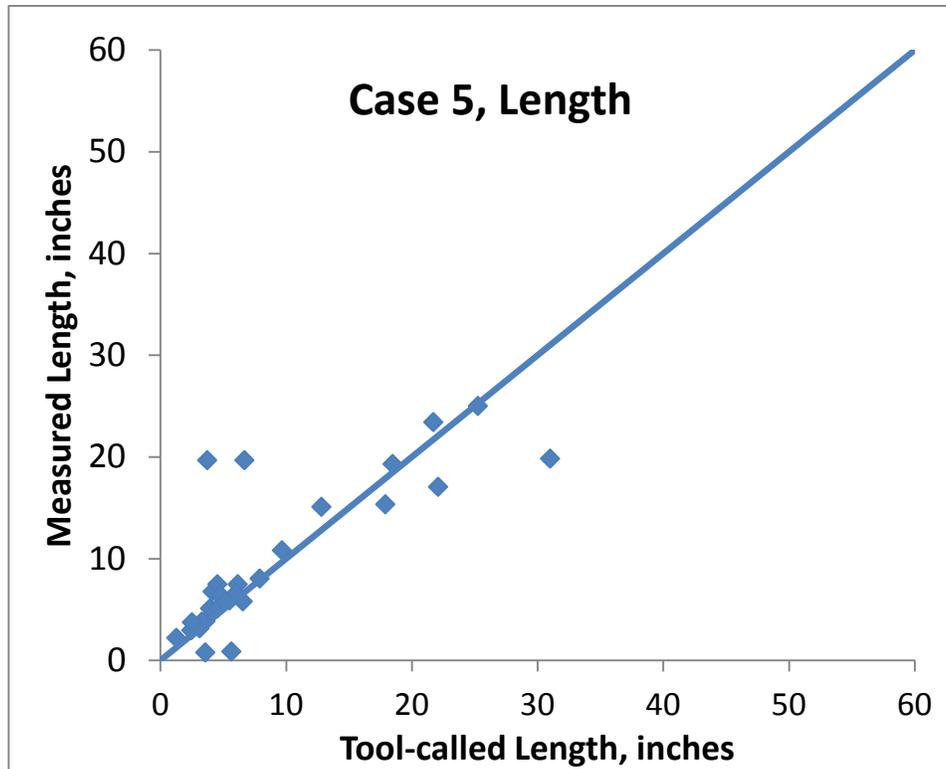
**Figure 17. Comparisons between Field-determined Anomaly Length and ILI Anomaly Length, Case 5**

Figure 17 is a plot of the field versus ILI-reported anomaly lengths, which indicates most data are aligned within a reasonable scatter band. Only 24% were reported by the ILI as being longer than they appeared to be on the basis of field NDE. Of those whose length was under-reported, two anomalies (corresponding to under/over-trim anomalies) had field-measured lengths that were considerably longer than what the ILI reported (between 3 and 5 times longer). The trend suggests reasonable length accuracy, but under-reported values can be attributable to the tool’s inability to detect shallow parts of the cracks.

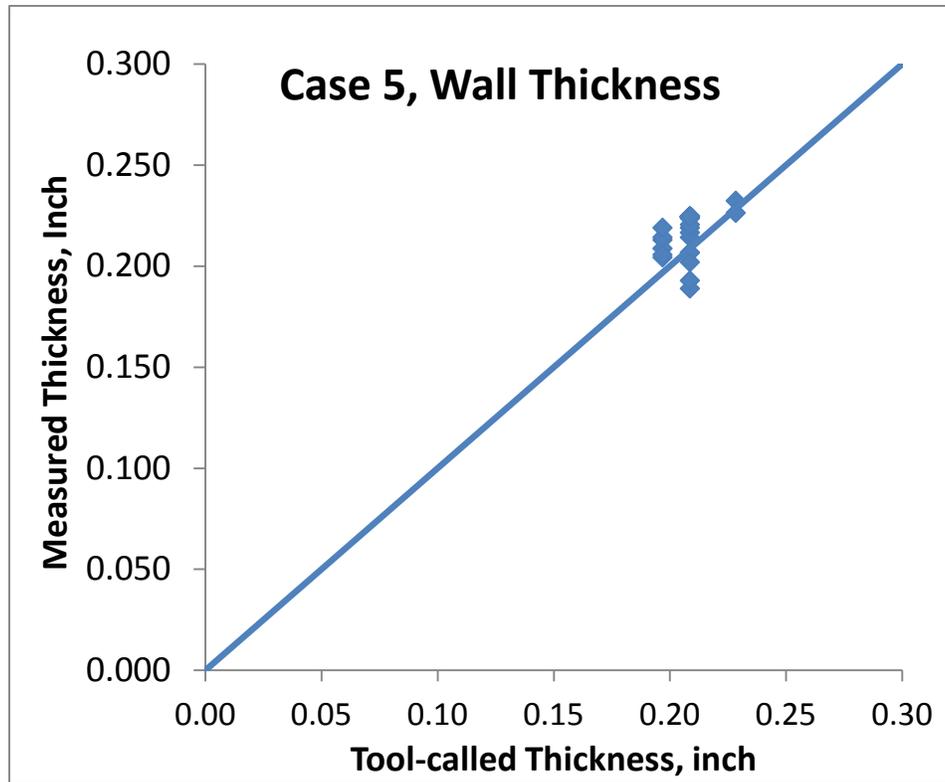
**Figure 18. Comparisons between Field-determined Wall Thickness and ILI Wall Thickness, Case 5**

Based on a review of the ILI-reported and field measured wall thickness values (shown in Figure 18), all the field-measured wall thickness values fluctuated within 10% of the ILI-reported values.

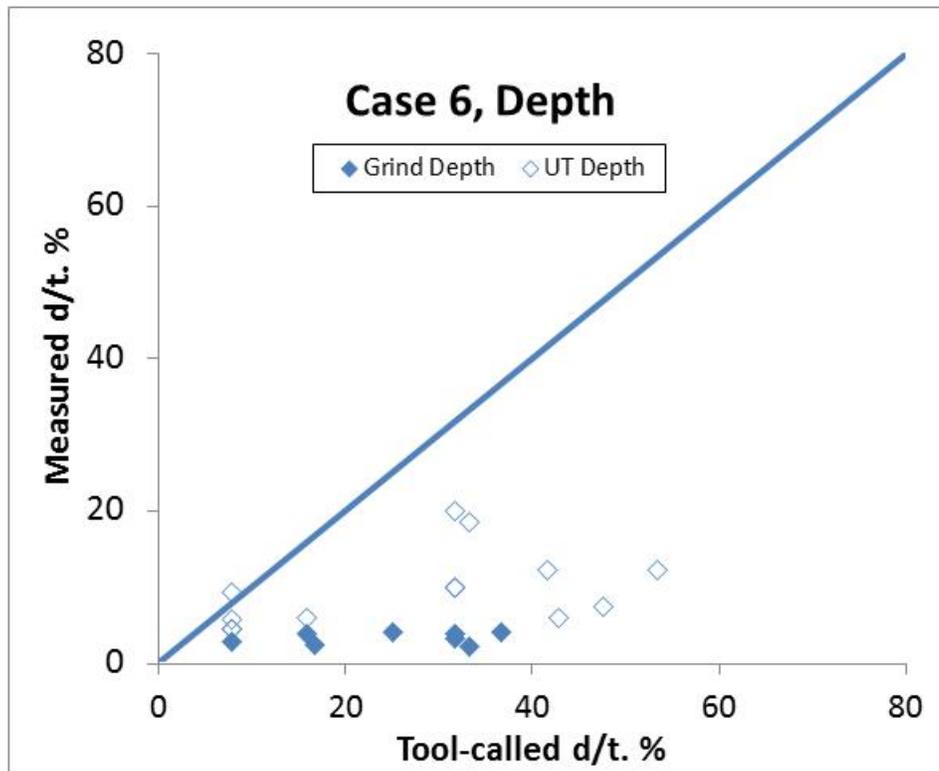
**Figure 20. Comparisons between Field-determined Anomaly Depth and ILI-called Anomaly Depth, Case 6**

All but one (95%) of the features were reported by the ILI as being deeper than the depths measured by field NDE. In fact, 71% of features were oversized by a factor of 2 or more. Thus, depth sizing was conservative if the field measure depths are to be believed accurate. One anomaly was reported by the ILI as being shallower than the field-measure depth by about 15%. With few exceptions, the ILI-reported depths do not seem to correlate well with the field measured values. Further, it is difficult to say whether the distribution of field-NDE ultrasonic measurements is similar to that of the grind measurements based on the data provided. A separate grind vs. ultrasonic depth correlation would be required in order to evaluate the accuracy of the ultrasonic measurements.

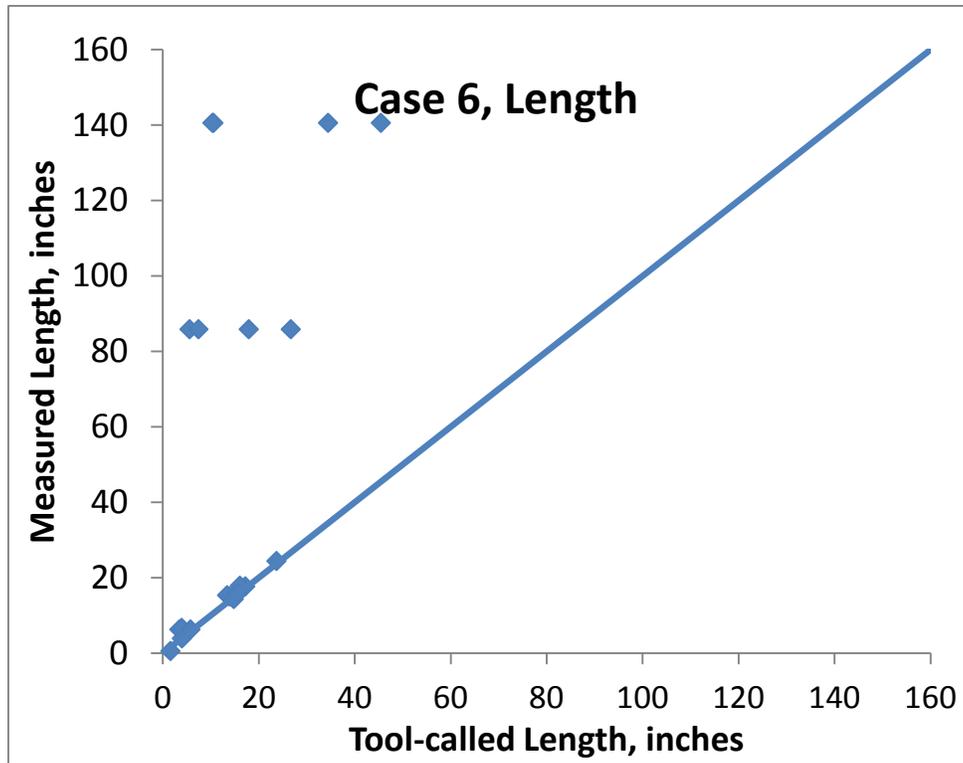
**Figure 21. Comparisons between Field-determined Anomaly Length and ILI Anomaly Length, Case 6**

Regarding the comparisons shown in Figure 21, only 14% were reported by the ILI as being longer than the field-measured lengths. While 62% of the data aligned within a reasonable scatter band, more than a third represented ILI-reported lengths that were smaller than the field-measure lengths by a factor of three or more. The trending suggests that the lengths of approximately one third of anomalies could be under-reported, which could be attributable to the tool’s inability to detect shallow parts of the features.

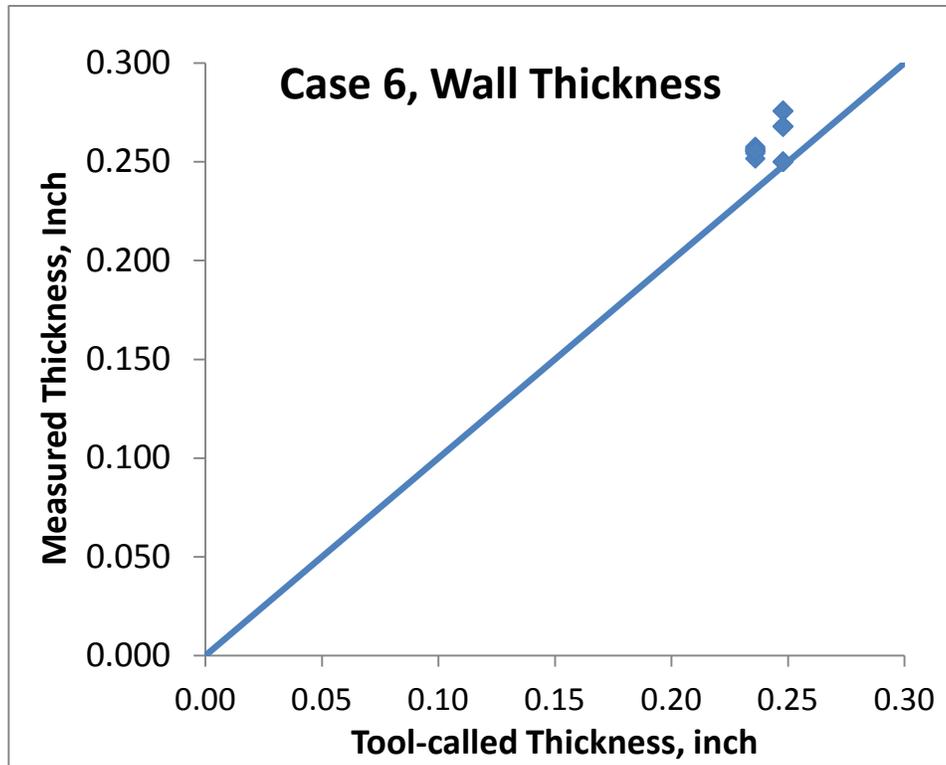
**Figure 22. Comparisons between Field-determined Wall Thickness and ILI Wall Thickness, Case 6**

The wall thickness comparisons for Case 6 show that the field-measured wall thickness values generally fluctuated within 11% of the ILI-reported value. This is typical of the range observed by the investigating team.

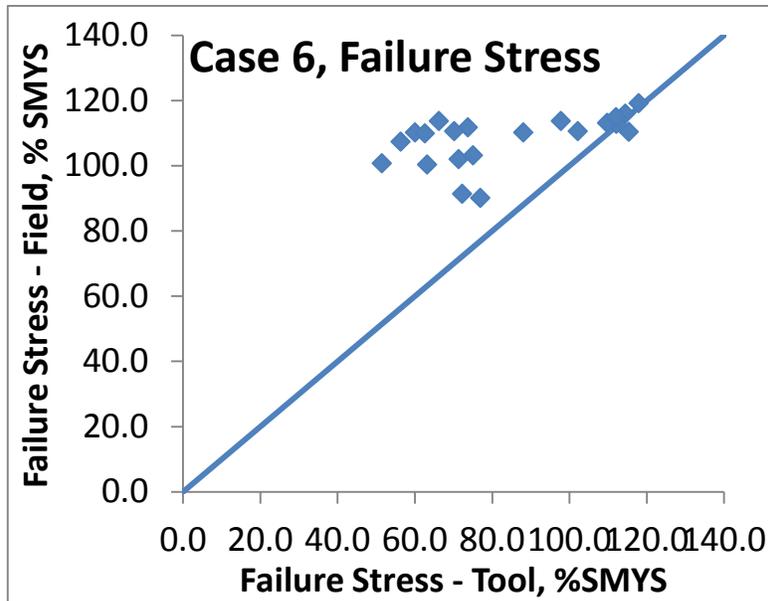
**Figure 23. Comparisons between Predicted Failure Stresses Based on Field-Measured Anomaly Dimensions and Those Based on ILI Dimensions, Case 6**

Figure 23 shows a comparison between failure stresses of the anomalies calculated on the basis of ILI dimensions and those calculated on the basis of field-measured dimensions. Failure stress levels for these anomalies were calculated using the Modified Ln-Sec Elliptical C-Equivalent model with a full-size-equivalent Charpy upper shelf energy of 20 ft-lb (based on Charpy v-notch test results). As can be seen in Figure 23, the failure stress levels based on field-measured dimensions are above 90% SMYS. The plot shows a tendency for the ILI-based failure stress to be lower than the field-based failure stress. This is the result of anomaly depths reported by the tool being deeper than those measured by field NDE.

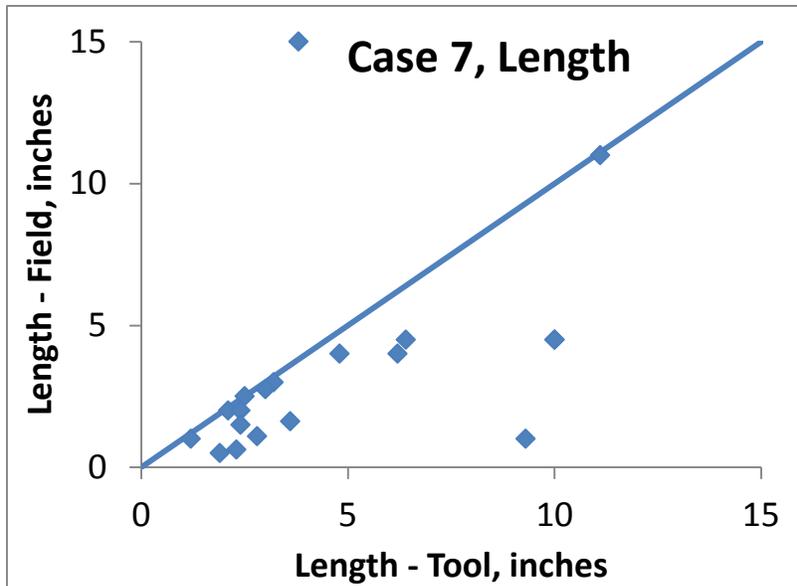
**Figure 25. Comparisons between Field-determined Anomaly Length and ILI Anomaly Length, Case 7**

Unlike in most of the previously-examined cases, the ILI lengths were almost always longer than the field-measured lengths as shown in Figure 25. The reason for this was not apparent to the investigating team member.

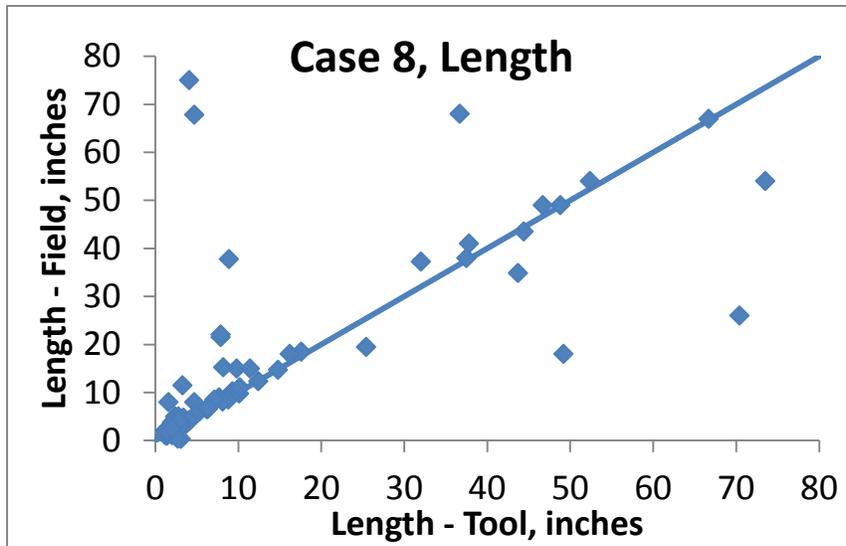
**Figure 29. Comparisons between Field-determined Anomaly Length and ILI Anomaly Length, Case 8**

As seen in Figure 29, many of the ILI lengths line up with the field-measured lengths, but in a few cases the lengths do not agree well. One reason for this could be that most of the anomalies were short but closely spaced such that the manner in which the lengths were interpreted by the ILI could have differed from the manner in which the lengths were interpreted by the UT technician in the field.

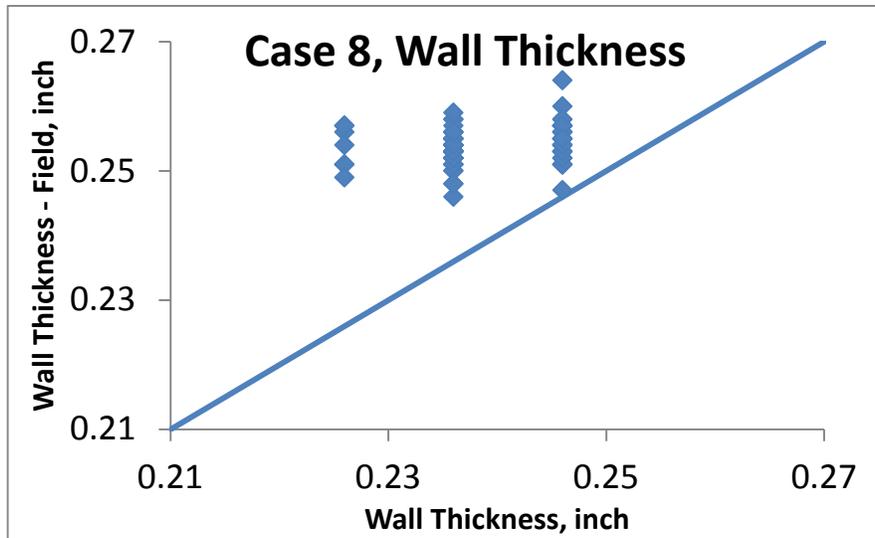
**Figure 30. Comparisons between Field-determined Wall Thickness and ILI Wall Thickness, Case 8**

Figure 30 illustrates the degree to which the wall thicknesses indicated by the ILI aligned with those measured in the field. The ILI thicknesses tended to be less than the field-measured thicknesses, although not more than 12 % (much less in most cases). The ILI thicknesses were stratified as 0.226, 0.236, or 0.246 inch.

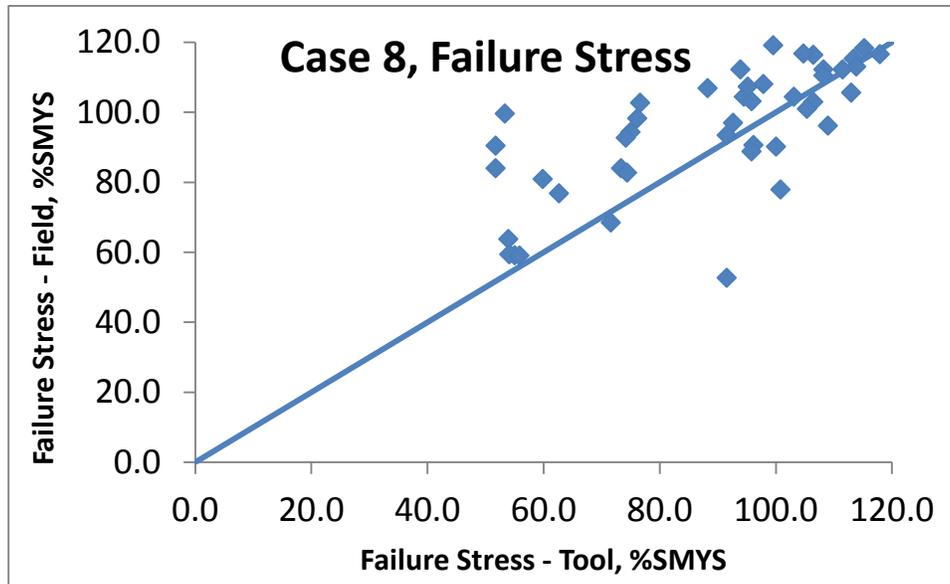
**Figure 31. Comparisons between Predicted Failure Stresses Based on Field-Measured Anomaly Dimensions and Those Based on ILI Dimensions, Case 8**

A comparison between failure stresses of the anomalies calculated on the basis of ILI dimensions and those calculated on the basis of field-measured dimensions is presented in Figure 31. Failure stress levels for these anomalies were calculated using the Modified Ln-Sec Equation Elliptical C-Equivalent model with a full-size-equivalent Charpy upper shelf energy of 20 ft-lb. In many cases the predicted failure stresses based on ILI anomaly dimensions are below those predicted on the basis of the field-measured anomaly dimensions. Most likely that is because the ILI anomaly depths in many cases exceeded the field-measured anomaly depths. It is noted that the comparisons in Figure 31 are limited to the cases where the ILI depths and lengths were available. As one can see by scanning Table 13, there were numerous cases where an ILI depth and/or length were not given.

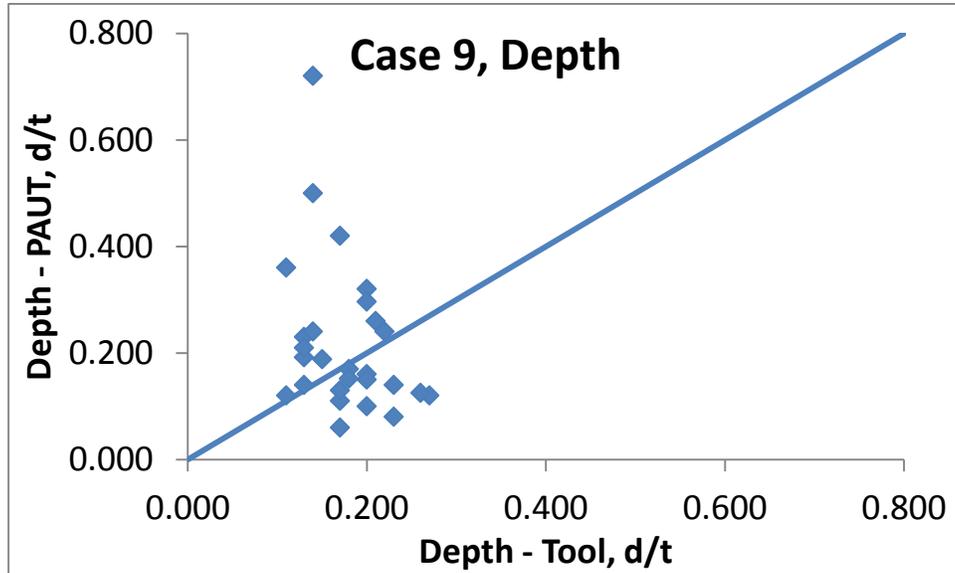
Figure 32. Comparisons of Depths as Indicated by the ILI and Those Found by Phased-Array UT

was found to correspond to the ILI indications. Comparisons between ILI depths and depths measured by NDE are shown in Figure 32. Comparisons between ILI lengths and NDE lengths measured are shown in Figure 33.

There is no consistent relationship between the ILI dimensions and those measured by means of phased-array UT.

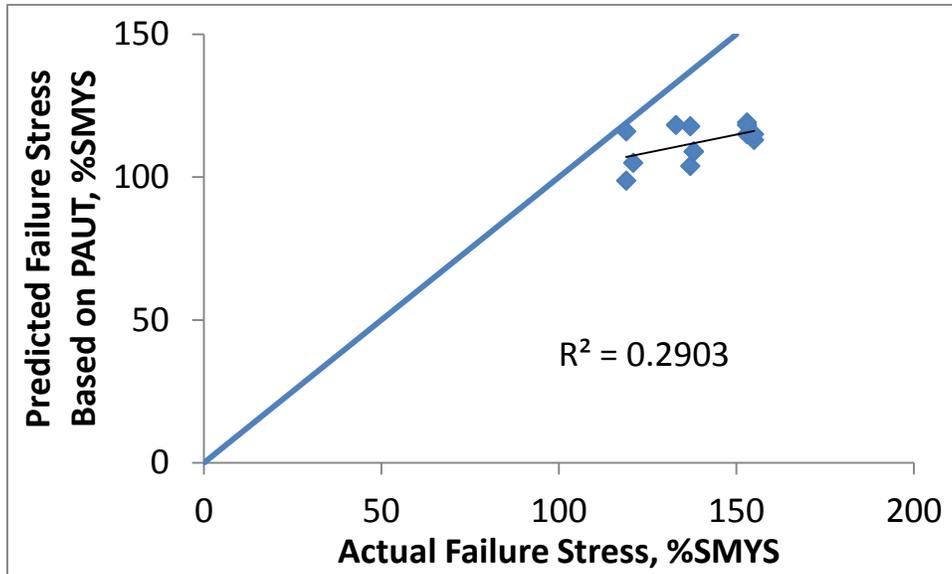
**Figure 34. Comparisons of Predicted Failure Stress Levels Based on Anomaly Dimensions Determined by Phased-Array UT with Actual Failure Stress Levels Observed in Burst Tests**

The fact that the predicted failure stress levels for the UT anomalies are consistently lower than the actual failure stresses is a function of how “flow stress” is defined in the Modified Ln-Sec Equation. Because it is defined as SMYS+10,000 psi, the maximum value of failure stress predicted for an X52 material will be 119.2 % of SMYS corresponding to a defect-free pipe. Also, the actual yield strengths of the materials tended to exceed SMYS (tests conducted by

Laboratory A showed yield strengths consistently above 60,000 psi). Therefore, the comparisons of actual failure stresses in the burst tests to predicted failure stresses should not be expected to follow a 1-to-1 relationship. A comparison of the predicted failure stresses to actual failure stresses is shown in Figure 34. The correlation coefficient “R<sup>2</sup>” is only 0.29. An R<sup>2</sup> of 1 is a perfect correlation; an R<sup>2</sup> of zero is no correlation. The value of 0.29 represents a very poor correlation. So, there is really not much one can conclude from these comparisons about the capabilities of the phased-array UT technology as applied in this case.

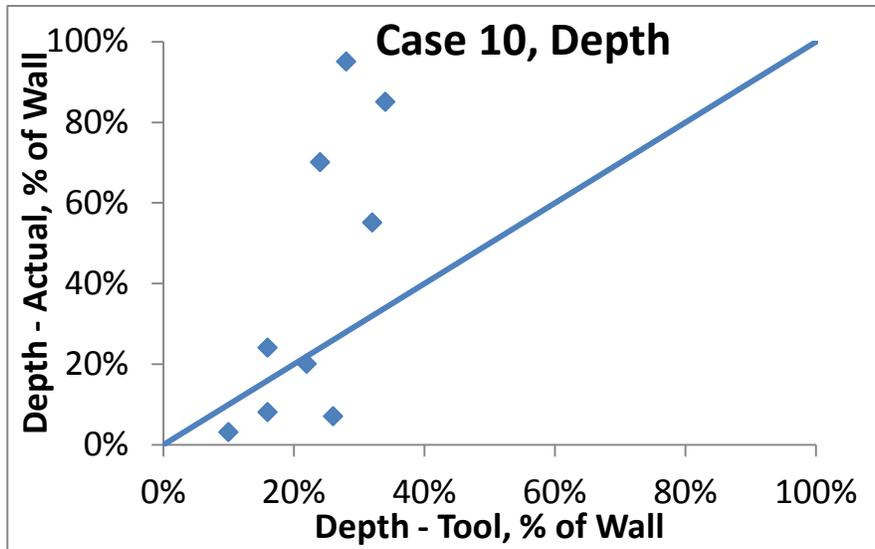
**Figure 35. Actual Anomaly Depths Compared to Those Indicated by the CMFL ILI**

Comparisons of actual depths to ILI depths are shown in Figure 35. As can be seen in the figure, the tool depths for shallow defects were pretty close to the actual depths, but the tool significantly under-estimated the depths of the deeper anomalies.

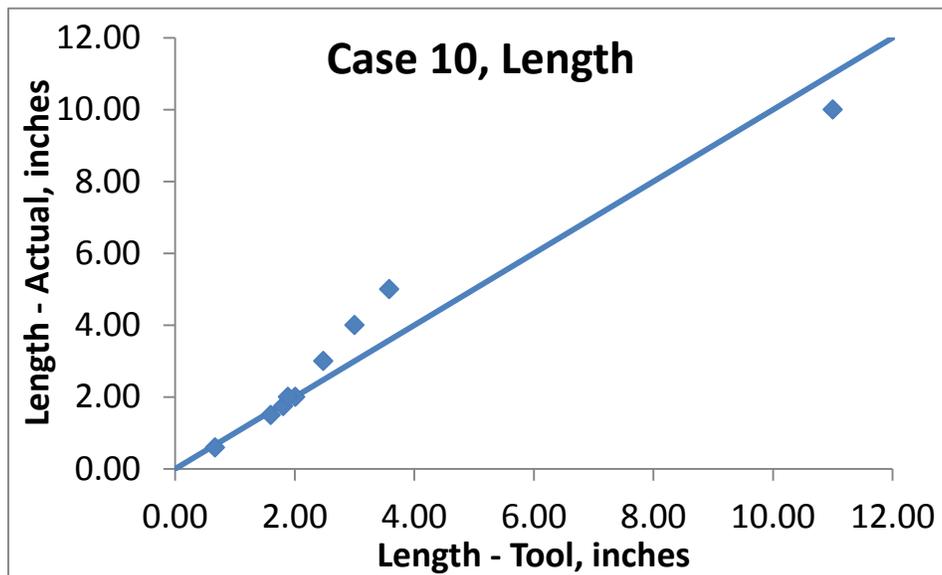
**Figure 36. Actual Anomaly Lengths Compared to Those Indicated by the CMFL ILI**

Comparisons of actual lengths to ILI lengths are shown in Figure 36. It is seen that the ILI lengths were in reasonable agreement with the actual lengths.

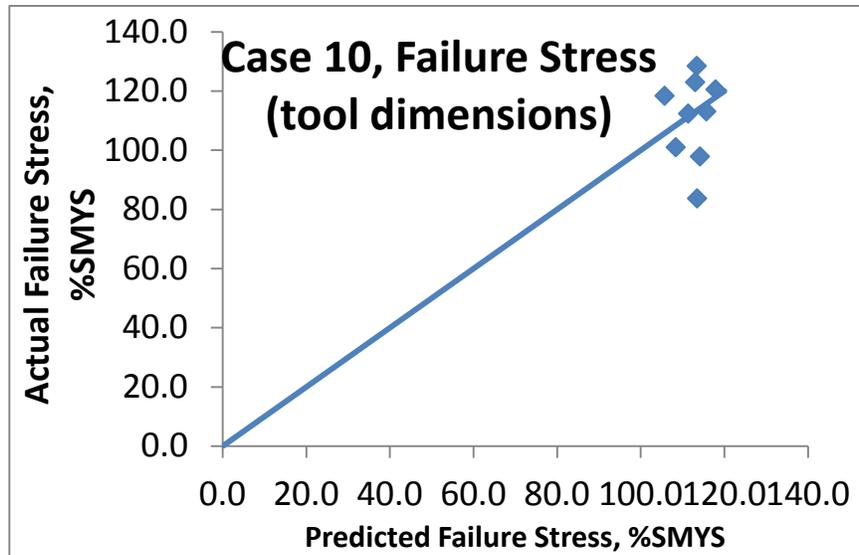
**Figure 37. Actual Anomaly Failure Stresses Compared to Those Calculated on the Basis of Dimensions Indicated by the CMFL ILI**

Comparisons of actual failure stresses to those predicted on the basis of ILI dimensions using the Modified Ln-Sec Elliptical C-Equivalent model with 20 ft lb of Charpy energy assumed are shown in Figure 37. One of the predictions based on the ILI dimensions (Joint 1300) significantly over-estimated the actual failure stress. This is a result of the fact that the ILI significantly under-estimated the depth of the anomaly.

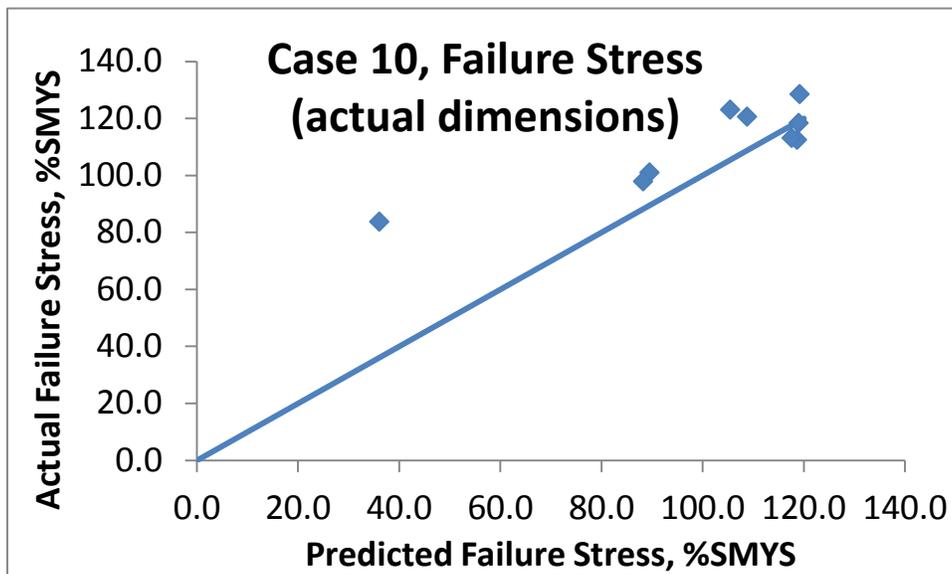
**Figure 38. Actual Anomaly Failure Stresses Compared to Those Calculated on the Basis of the Actual Dimensions of the Anomaly**

Comparisons of actual failure stresses to those predicted on the basis of actually measured dimensions using the Modified Ln-Sec Elliptical C-Equivalent with 20 ft lb of Charpy energy assumed are shown in Figure 38. The model provided reasonable predictions of the failure stress in most cases but significantly under-estimated the burst strength in one case (Joint 1300).

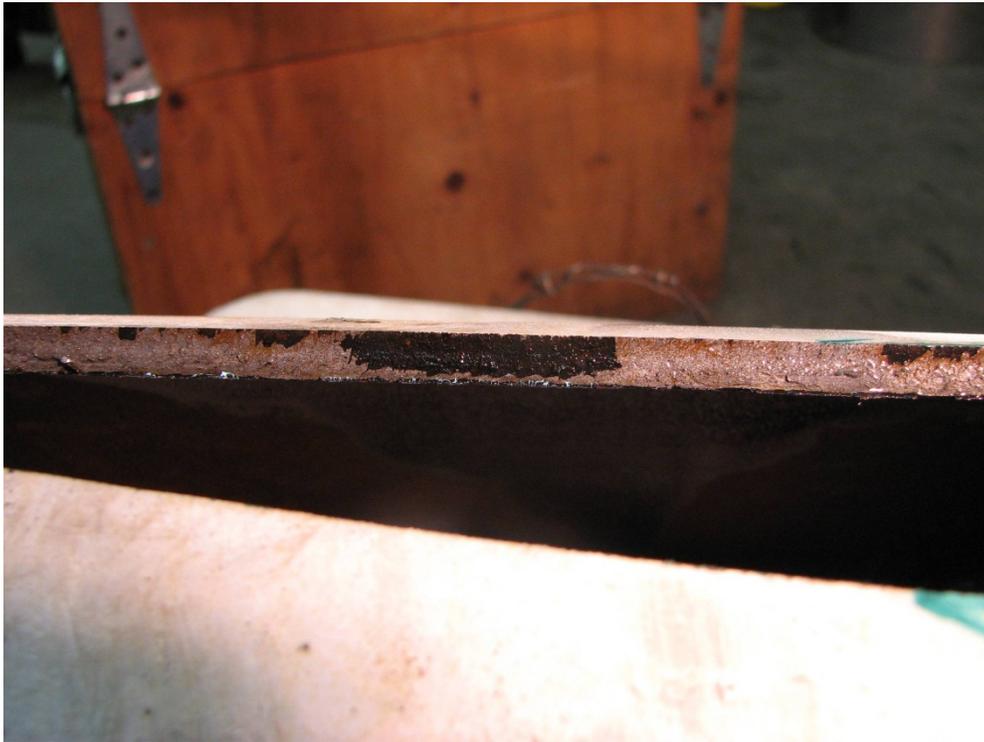
**Figure 39. Appearance of the Anomaly in Joint 1300**

The deepest anomaly exposed by the burst tests and the one which also exhibited the lowest failure stress level (84% of SMYS) is shown in Figure 39. This anomaly was a cold weld in Joint 1300 that penetrated 95% of the wall thickness at the point of deepest penetration. The

Modified Ln-Sec Elliptical C-Equivalent model underestimated the failure stress by a significant amount. It predicted a failure stress of 36% of SMYS.

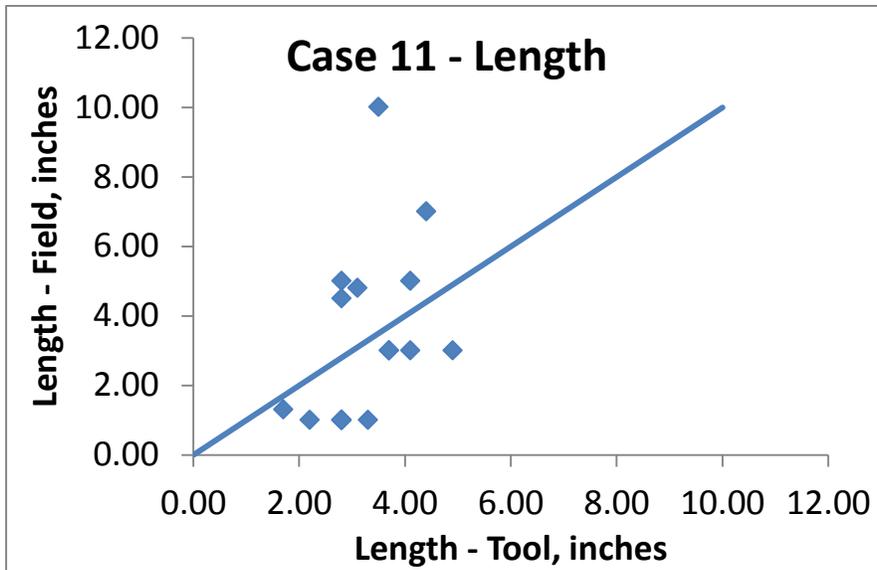
**Figure 40. Lengths Measured in the Field Compared to Those Indicated by the EMAT ILI**

The comparison between lengths measured in the field to those indicated by the EMAT ILI (21 anomalies) is shown in Figure 40. There is no correlation between the reported lengths and the actual lengths.

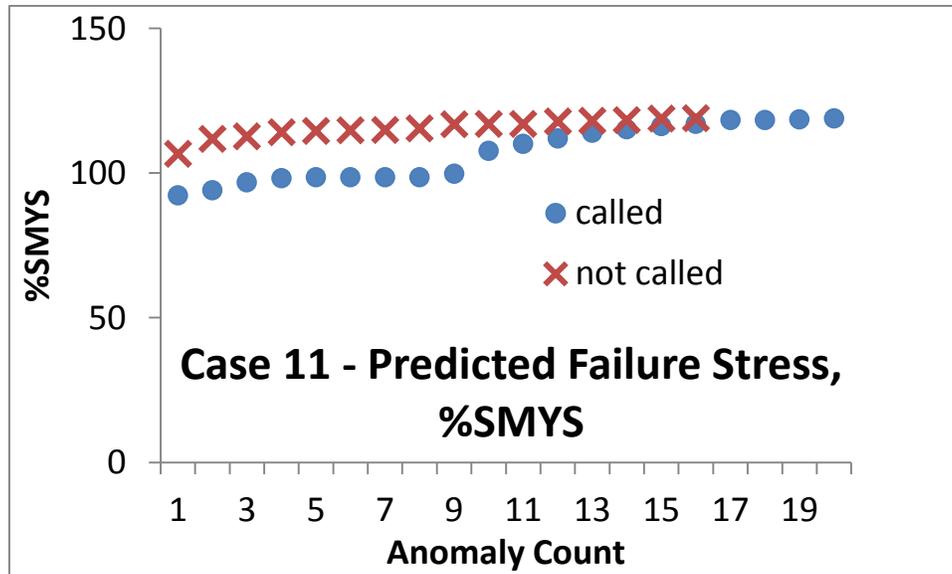
**Figure 41. Predicted Failure Stress Levels for Anomalies Based on Field Measurement with MT and UT**

In the absence of ILI depths, predicted failure stresses can be calculated based only on field measurements of the lengths and depths of the anomalies. This was done for two sets of anomalies found by field scans of the seams. One was for the anomalies that had been indicated by the ILI, and the other was for the anomalies that had not been indicated (recalling that the vendor may not have reported it if there was a larger SCC anomaly on the same joint). There were 21 ILI anomalies and 16 anomalies not indicated by ILI that were found and characterized in the field. The predicted failure stress levels for the 21 ILI anomalies ranged from 92.2% of SMYS to 118.5% of SMYS. The predicted failure stress levels for the 16 anomalies not called ranged from 106.6 % of SMYS to 119.0 % of SMYS. These failure stresses are shown graphically in ascending order in Figure 41.

It appears that the ILI anomalies were generally more of a threat to pipeline integrity than the anomalies not indicated by ILI, although none of them appeared to be a significant threat.

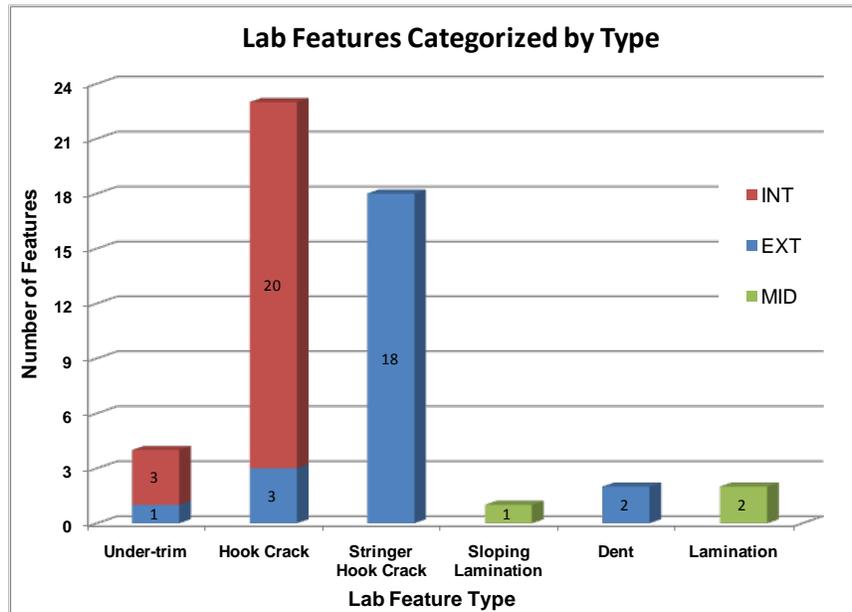
**Figure 42. Total Lab Indications Categorized by Feature Type**

Most of the 50 features found in the ERW seams were hook cracks. Both internal hook cracks and external hook cracks were identified. The 50 features as categorized by the laboratory examinations (including breaking open anomalies and metallographically sectioning anomalies) are illustrated in Figure 42.

Several crack features appeared stepped. It is possible multiple laminations/inclusions across multiple planes were at one time separate features that extended into a single feature. Ductile tearing of the material between the adjacent defects could have occurred during a high-pressure event like a hydrostatic test. One crack showed signs of such growth. Indication 38 from Sample 1-C exhibited what looks like ductile crack extension, possibly from a prior hydrostatic test. No sign of fatigue crack growth was seen on the fracture surfaces of this anomaly after it was broken open and examined by means of a scanning electron microscope. No other feature showed evidence of fatigue crack growth.

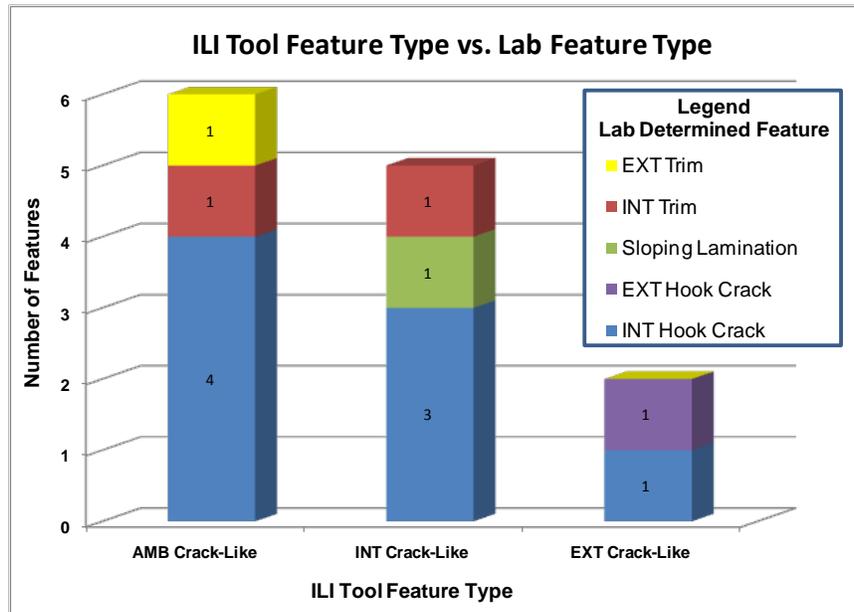
**Figure 43. ILI Tool Feature Type vs. Lab Determined Feature Type**

The classification of crack-like features by the ultrasonic crack tool ILI correlated well with the actual feature type determined by destructive testing. Approximately 70 percent of the features classified as crack-like were actually cracks in the ERW seam (Figure 43). The single sloping

lamination in Figure 43 was the indication from Sample 2 that had characteristics of a hook crack, but was not connected to either the inside surface or the outside surface.
