## Track Record of In-Line Inspection as a Means of ERW Seam Integrity Assessment

J. F. Kiefner, K.M. Kolovich, C.J. Macrory-Dalton, D.C. Johnston,  
C.J. Maier, and J.A. Beavers  
November 15, 2012

**AS THE DELIVERABLE OF SUBTASK 1.3 ON  
U.S. DEPARTMENT OF TRANSPORTATION  
OTHER TRANSACTION AGREEMENT NO. DTPH56-11-T-000003**

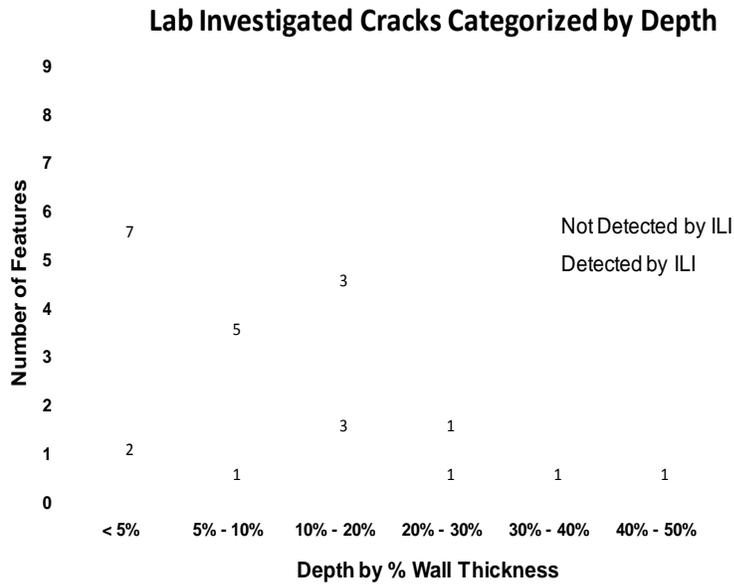
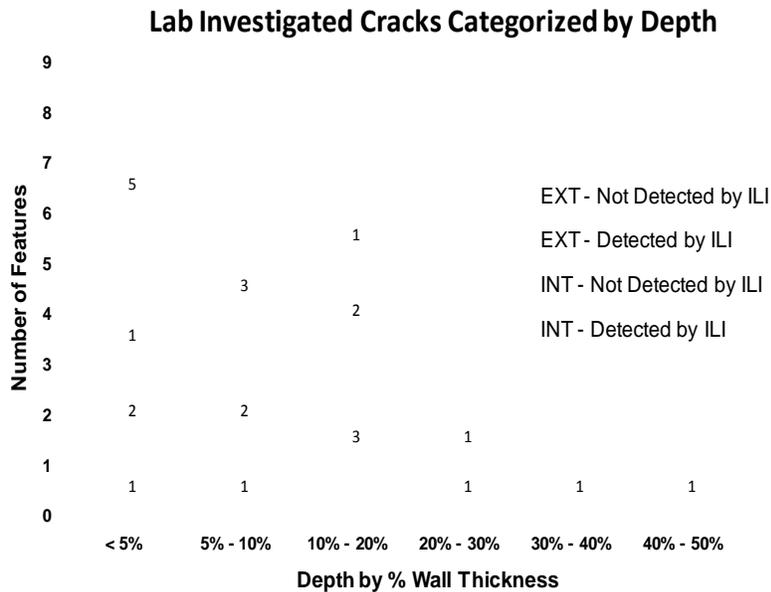
Maximum depths of 25 cracks were directly measured and are categorized below in terms of percent wall thickness (Figure 44). The majority of the cracks identified in the lab but not detected by ILI were less than 10 percent deep. Indication 27 from Sample 1-C was the one feature in the 30 percent to 40 percent depth range not detected by ILI. This was due to the length of Indication 27 being below the ILI length detection capabilities. Figure 45 is based on the same data set as Figure 44 but further defines the features by surface location. The deepest cracks investigated were open to the inside surface.

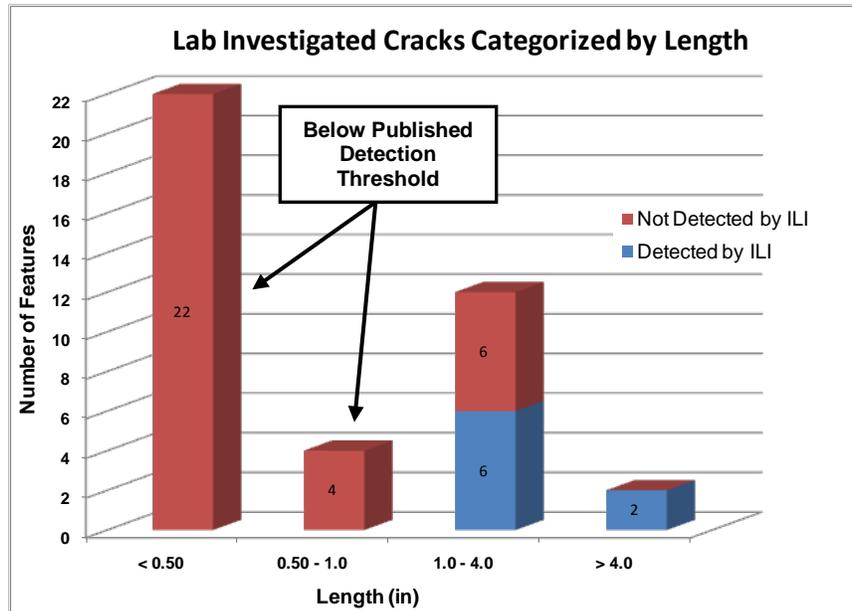
**Figure 46. Lab Investigated Cracks Categorized by Length and Detection**

The lengths of 40 cracks were measured and are categorized below in Figure 46. The majority of the cracks not detected by ILI were less than 1.0 inch. The longest cracks, those greater than 4 inches, were open to the inside surface of the pipe.

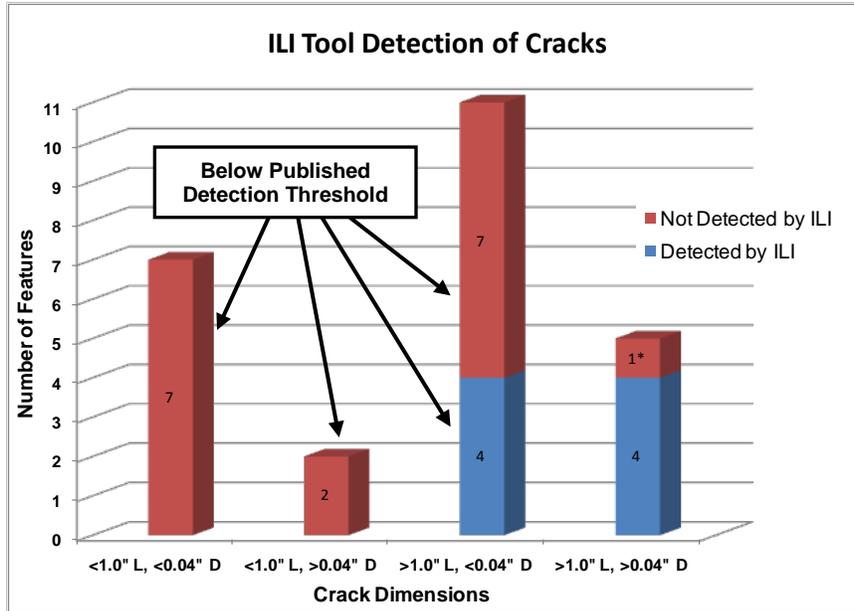
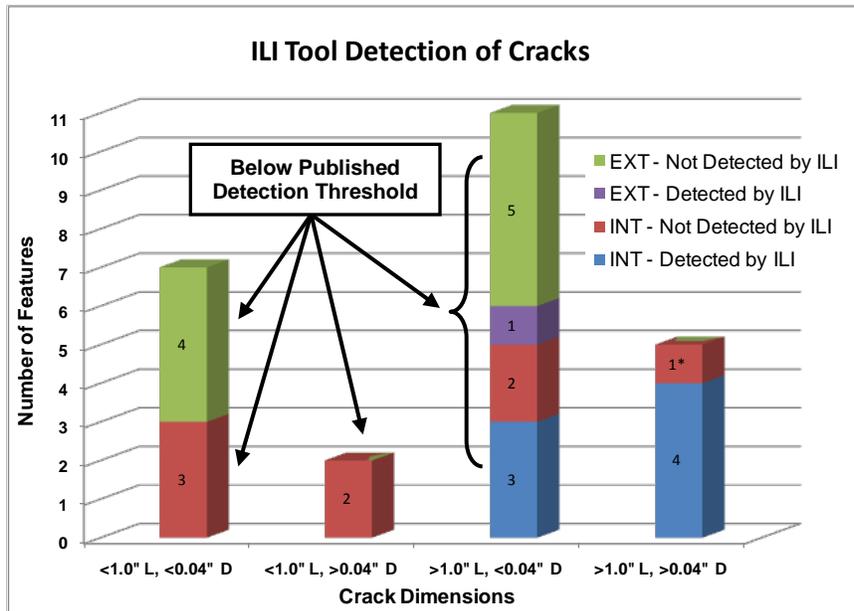
The minimum detectible crack size in weld material for the ultrasonic crack tool used in this case is 1.2-inch-long, 0.04-inch-deep (if the anomaly is located in base metal), and 0.08-inch deep (on the basis of the crack being located in the weld zone). For this particular tool run, it is apparent that the third-party analysts (not the vendor’s analysts) regarded 0.04 inch as the depth-detection threshold for anomalies in the weld as well as for anomalies in the base metal. Another representation of the results that compares both length and depth is shown in Figure 47. Four cracks detected by ILI were below the published detection threshold (Figure 47). The majority of the crack indications detected by ILI were internal hook cracks (Figure 48). Only one feature met the minimum detection criteria for length and depth but was not identified by ILI. This feature was Indication 6 from Sample 1-C. Indication 6 was a non-uniform crack with multiple peaks and valleys. It is possible that this feature was not detected by ILI since the peak depth was not continuous along the entire length of the defect. Rather the crack had two separate areas where the minimum depth criteria were met but not the minimum length criteria (one approximately 0.20 inch long and another approximately 0.75 inch long).

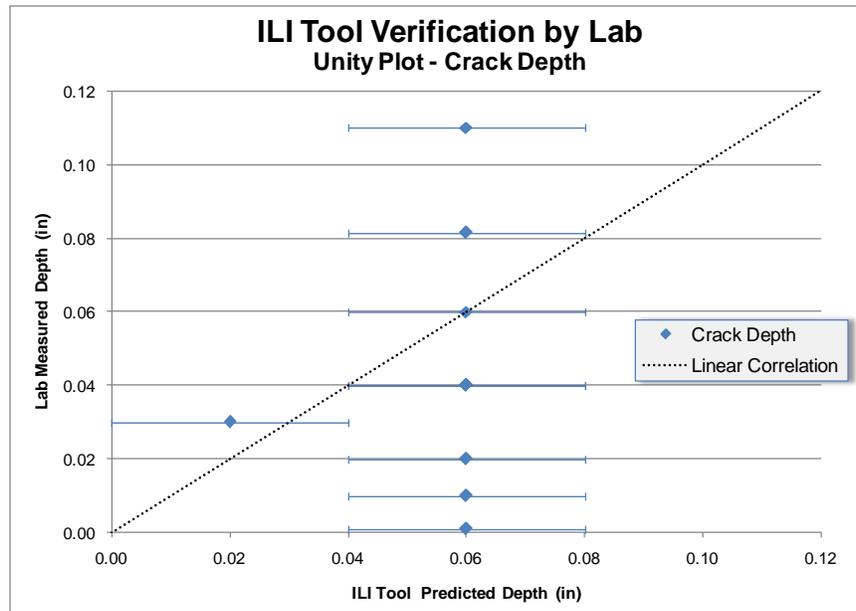
**Figure 49. Crack Depth Unity Plot – Lab Measured Depth to ILI Predicted Depth**

The unity plot below compares the predicted depth by ILI to the actual depth of features determined to be cracks (Figure 49). The ultrasonic crack-tool depths are reported in terms of ranges, less than 0.04 inch or 0.04 inch to 0.08 inch. The depth ranges are represented by the error bars. The diamond-shaped points are the mid-points of the ranges. The plot suggests that the ILI accurately sized 50 percent of the features in terms of depth. In general, the ILI trended towards over-stating depth. The depth of one feature was under-stated, Indication 38 from

Sample 1-C. Indication 38 was the deepest crack investigated (50% of the wall thickness) and had a tight crack tip. The ultrasonic technology does not have a minimum detection criterion for crack width. However, if the crack were under compression by residual stresses at the time of inspection the crack tip could have had essentially no width and would have not been detected by ILI. It cannot be proved that this was the scenario for Indication 6, so the data point remains as a single under-stated depth by ILI.

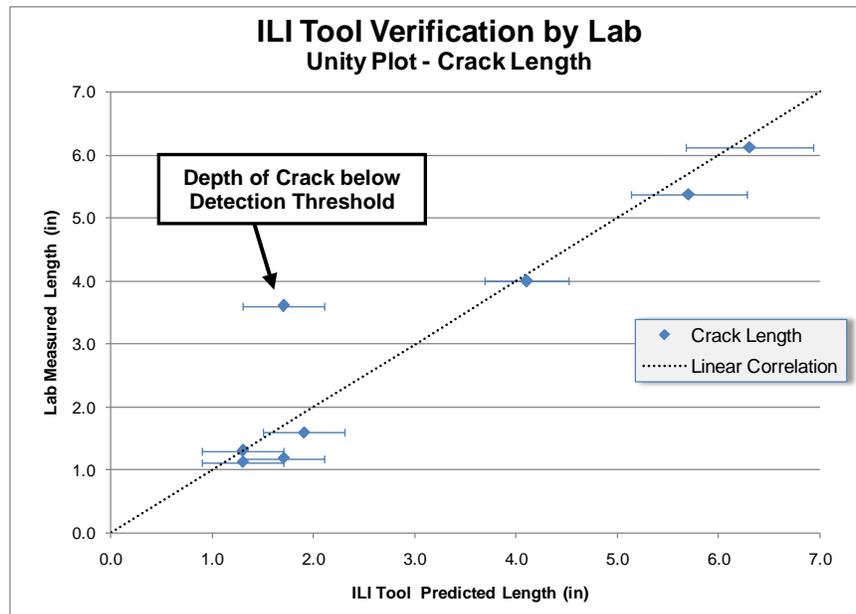
**Figure 50. Crack Length Unity Plot – ILI Predicted Length to Lab Measured Length**

The unity plot below compares the length predicted by ILI to the actual length of features determined to be cracks (Figure 50). Stated length tolerance for the ultrasonic crack-detection tool used in this case is plus or minus 0.40 inch for cracks less than or equal to 4.0 inches long or 10 percent of the total length for cracks greater than 4.0 inches long. The appropriate tool tolerances for the crack features are represented by error bars. When tool tolerance is considered in this manner, the ILI accurately predicted length for 88 percent of the cracks detected. When only anomalies that met the minimum depth criteria for detection are considered, the ILI accurately predicted length for 100 percent of the cracks detected.

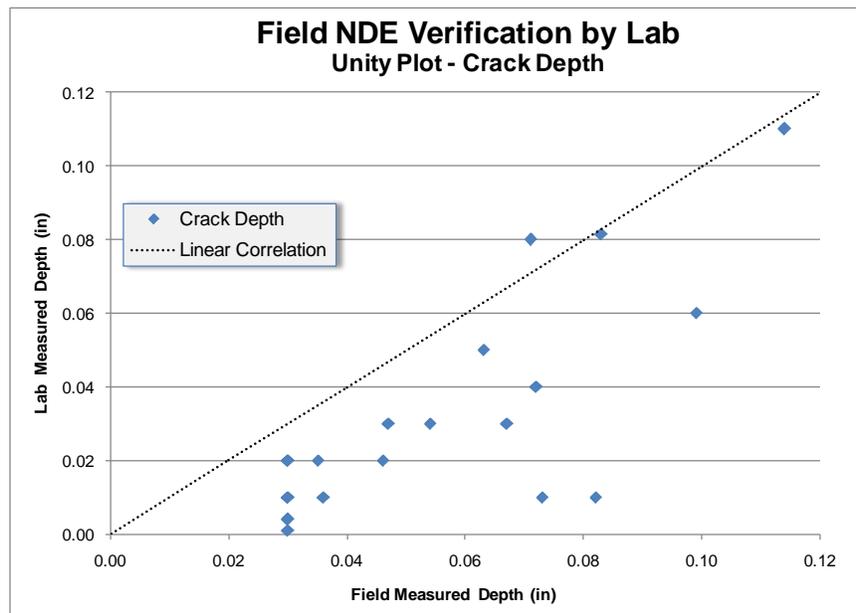
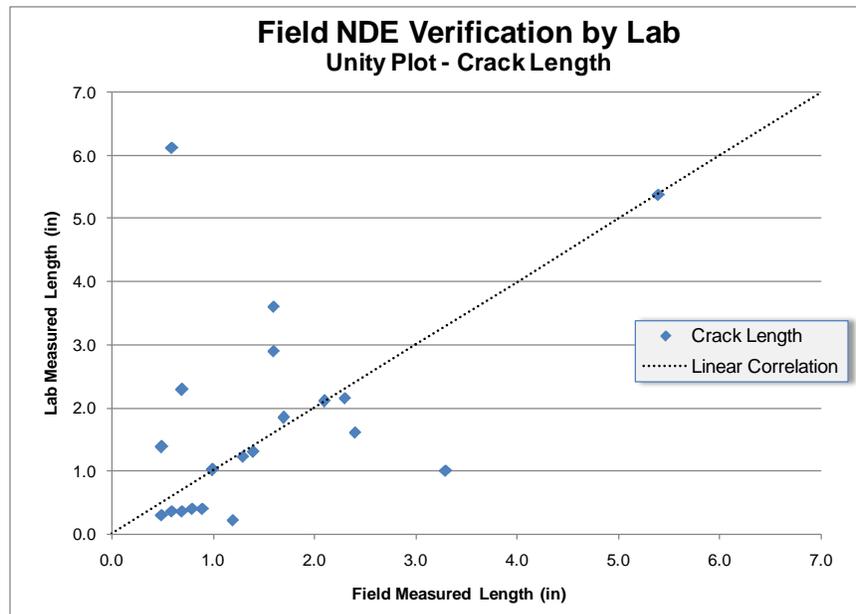
Field measurements of depth and length compared to actual depth and length are shown in Figure 51 and Figure 52, respectively. The depth data suggest that the field NDE generally overstated depth of crack features. The length data are quite scattered suggesting that field NDE length results are not reliable.

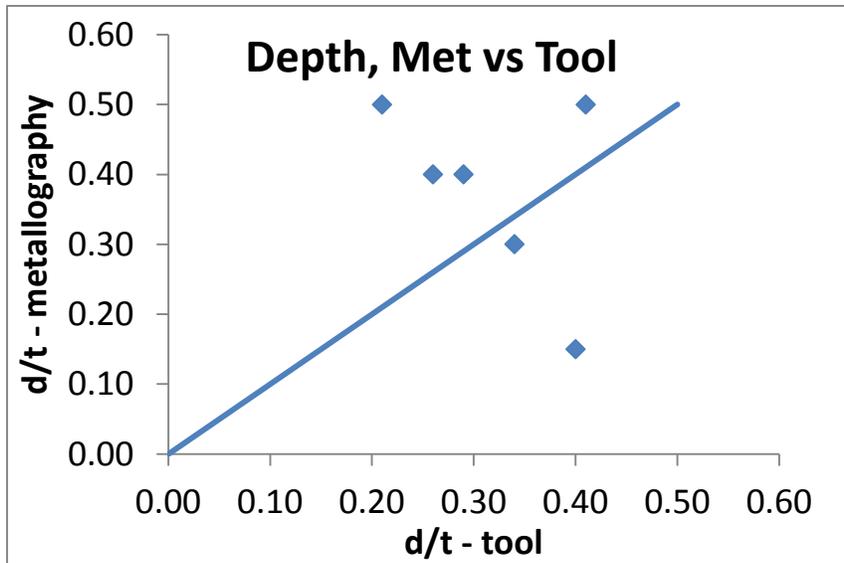
**Figure 53. Comparisons of Depths Found by Metallography with Those Found by CMFL Tool**

As seen in Figure 53, there is no correlation between the actual depths and those indicated by the ILI. In several cases the ILI depth significantly underestimated the depth of the anomaly. The ILI lengths, however, seemed to correlate well with the actual lengths of the anomalies as shown in Figure 54.

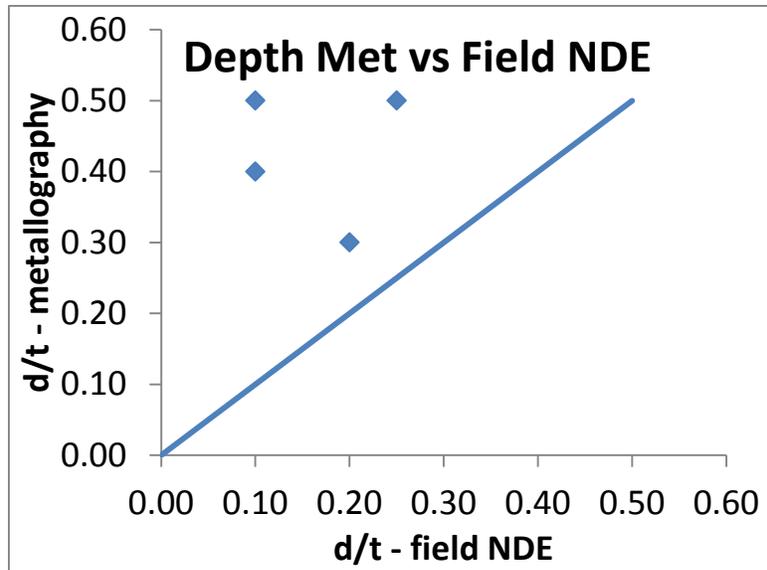
**Figure 55. Comparisons of Depths Found by Metallography with Those Found by Field NDE**

It is seen in Figure 55 that the field NDE significantly under-estimated the depths of the anomalies. Except for one anomaly, as shown in Figure 56, the lengths determined by the field NDE correlated fairly well with the actual lengths of the anomalies.

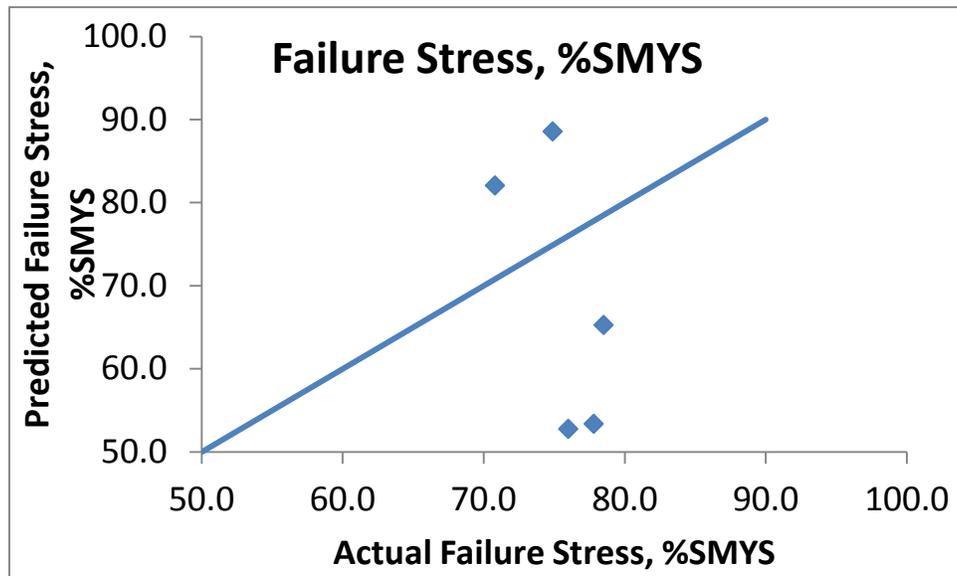
**Figure 57. Comparisons of Predicted Failure Stress Levels to Actual Failure Stress Levels for the Test Failures**

the predicted to actual failure stress levels for the 5 defects where dimensions and failure stress levels were available are shown in Figure 57.

There is no correlation between the predicted and the actual failure stress levels. It is suspected that none of the other ductile flaw assessment models would perform any better. This situation arises because of the extremely brittle behavior exhibited in conjunction with failures of defects in and around ERW seams, especially LF-ERW and DC-ERW seams. The problem this creates for using ILI tools for ERW seam integrity assessment is that even if the tools were capable of accurately predicting the sizes of defects, it would not be feasible to prioritize the defects for remediation based on the predicted failure stress levels or fatigue lives. A better approach to defect assessment is needed for flaws in or around ERW seams.
