Federal Highway Administration
Every Day Counts
Innovation Initiative

Safety Edge_{SM}
Demonstration Project
Seaford, Delaware

Field Report
January 30, 2011

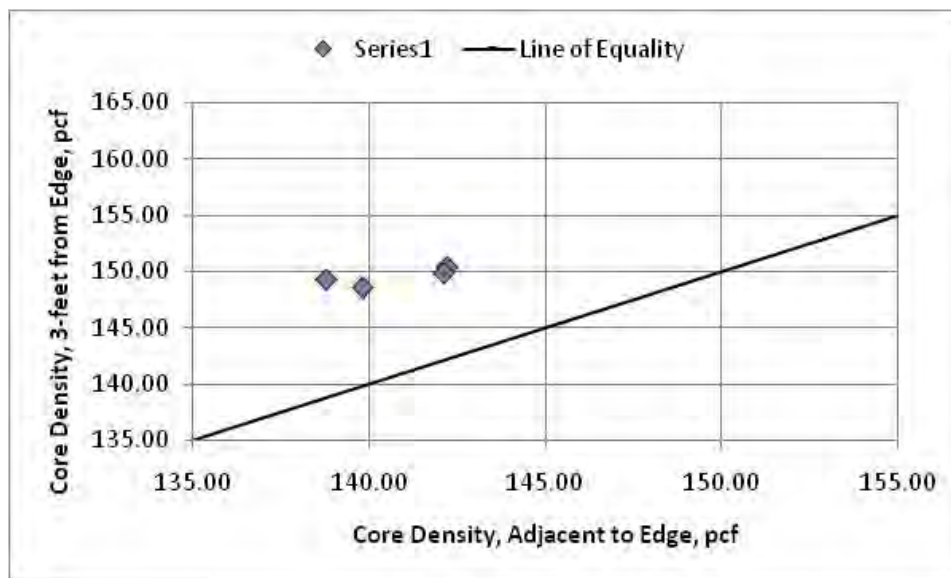
A total of eight cores were drilled along the project. Two cores were taken at each station or location; in the same areas where the densities were measured with the Troxler nuclear density gauge. These cores were taken to measure the bulk specific gravity of the WMA for developing a correction factor for the nuclear density gauge readings taken adjacent to the edge and within the center of the mat. Figure 10 shows the location of the cores and nuclear density gauge readings relative to the edge of the WMA mat. Photographs of all eight cores recovered from the roadway are included in the appendix. A summary of these test results; core thickness and bulk specific gravities (saturated surface dry) converted to bulk densities is included in Table A-4 in Appendix A. Figure 11 is a comparison of the core densities taken along the edge and 3 ft from the edge (center of the steel drum breakdown roller) for the Safety Edge_{SM} sections. As expected, densities 3 ft from the edge are higher than along the edge of the mat (unconfined edge).

Figure 11. Comparison of core densities adjacent to the edge of pavement and 3 ft from the edge.

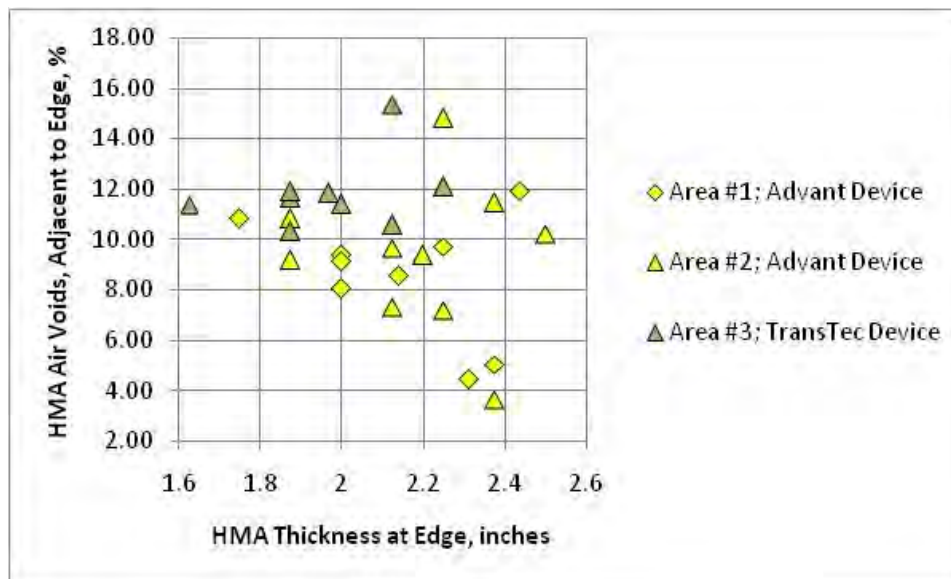
Figure 9 included a comparison between the WMA thickness (near the Safety Edge_{SM}) and slope of the Safety Edge_{SM}. The thickness of the WMA has little to no effect on the slope of the Safety Edge_{SM}. Figure 14 shows a comparison of the density and WMA overlay thickness. As shown, there is also little correspondence between the overlay thickness and air voids or densities.

Figure 14. Comparison of WMA thickness at the edge of the mat and WMA air voids.
