DOT US Department of Transportation  
PHMSA Pipelines and Hazardous Materials Safety Administration  
OPS Office of Pipeline Safety  
Western Region

**Principal Investigator** Peter J. Katchmar  
**Regional Accident Coordinator** Peter J. Katchmar  
**Region Director** Chris Hoidal  
**Date of Report** October 30, 2012  
**Subject** ExxonMobil Silvertip Pipeline Crude Oil Release into the Yellowstone River in Laurel, MT on 7/1/2011

## **Executive Summary**

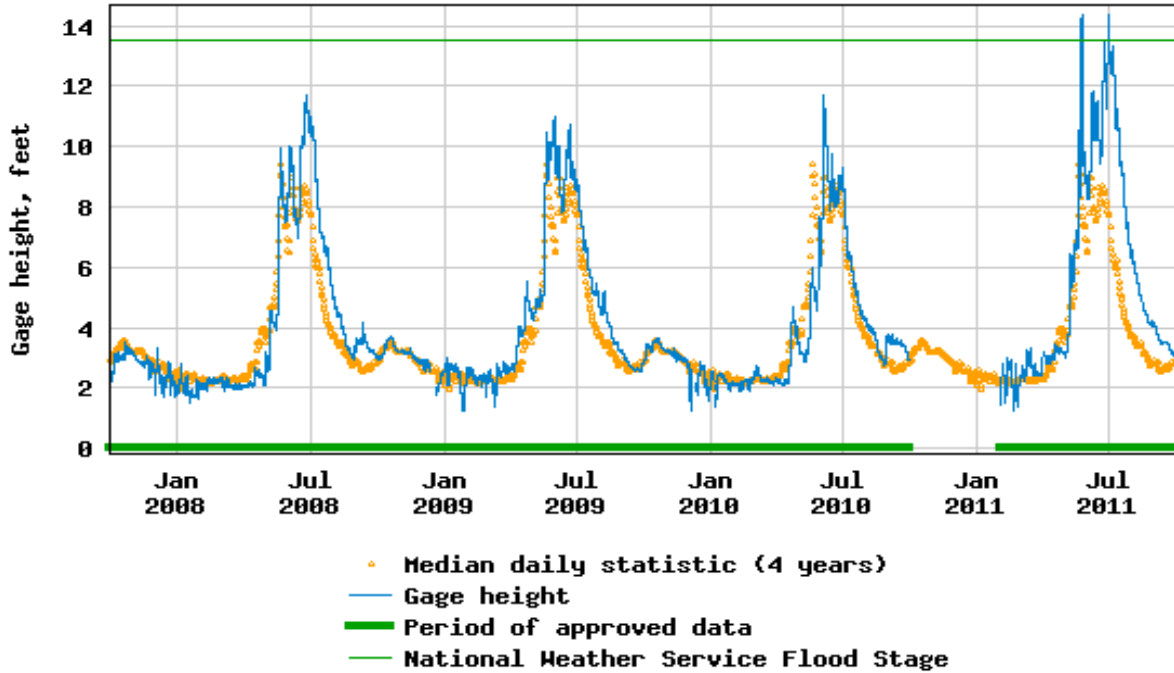
It appears that 2011 was the only year that the flood stage was exceeded at the gauge point. Of note is the fact that flood stage was exceeded 3 times in 36 days in 2011. In previous years the river would rise and then fall again in a relatively short time period and the water level did not rise above the twelve foot level. In 2011, the river rose and remained high for over a month. The prolonged high water level caused the river bottom downstream of the Highway 212 Bridge to scour and ultimately undermine the EMPCo pipeline.

Graph of gage height for 2008 through 2011 overlaid with the 4 year median statistic.

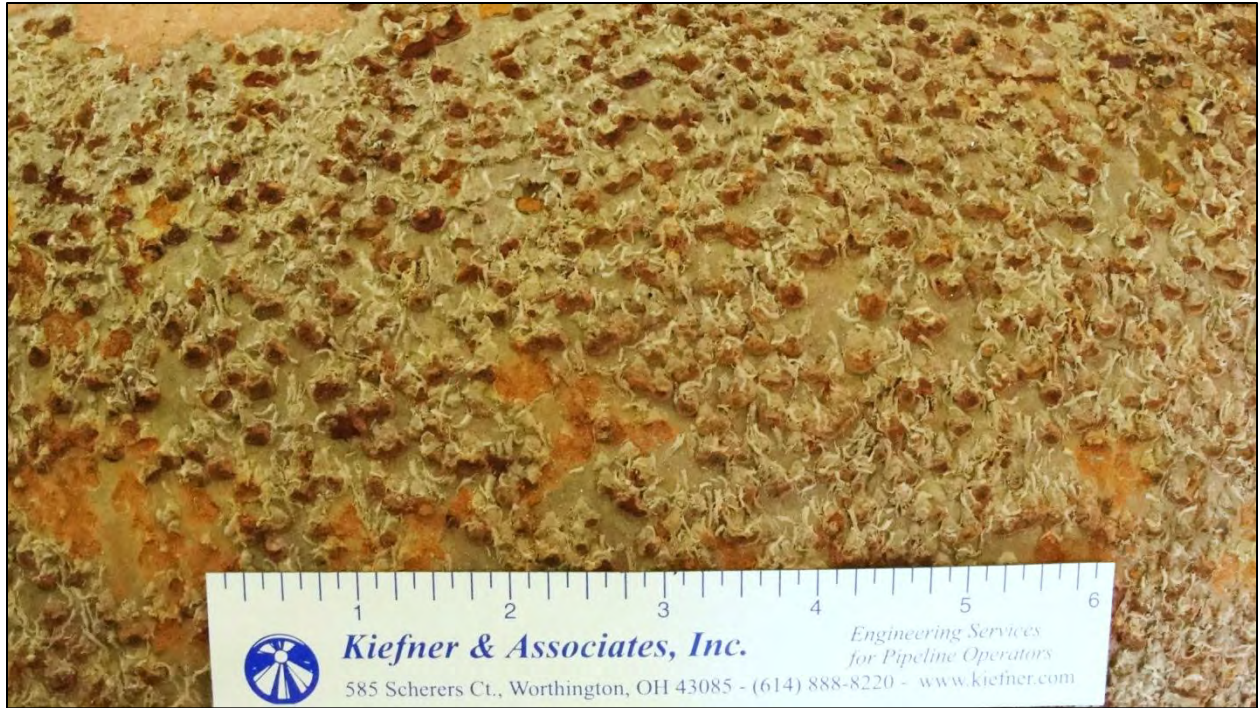
**Figure 6. Organisms on Surface of Pipe 024**

The bare steel surfaces were covered with numerous white colored elongated objects, each approximately 1/8 to 1/2 inch long, that appeared to be the remains of some type of fresh-water biota presenting worm-like or tube-like features emanating from adhered masses. We were unable to identify the species. The remains of the organisms (“worms”) were present in prolific quantities on most pipe exterior surfaces where the coating was absent, some interior surfaces, and the fracture surfaces of the failed girth weld. The adhered organisms are shown in Figure 6 through Figure 8 on the pipe exterior. The pipe surface was pitted underneath the individual masses associated with the organisms, as shown in Figure 9.

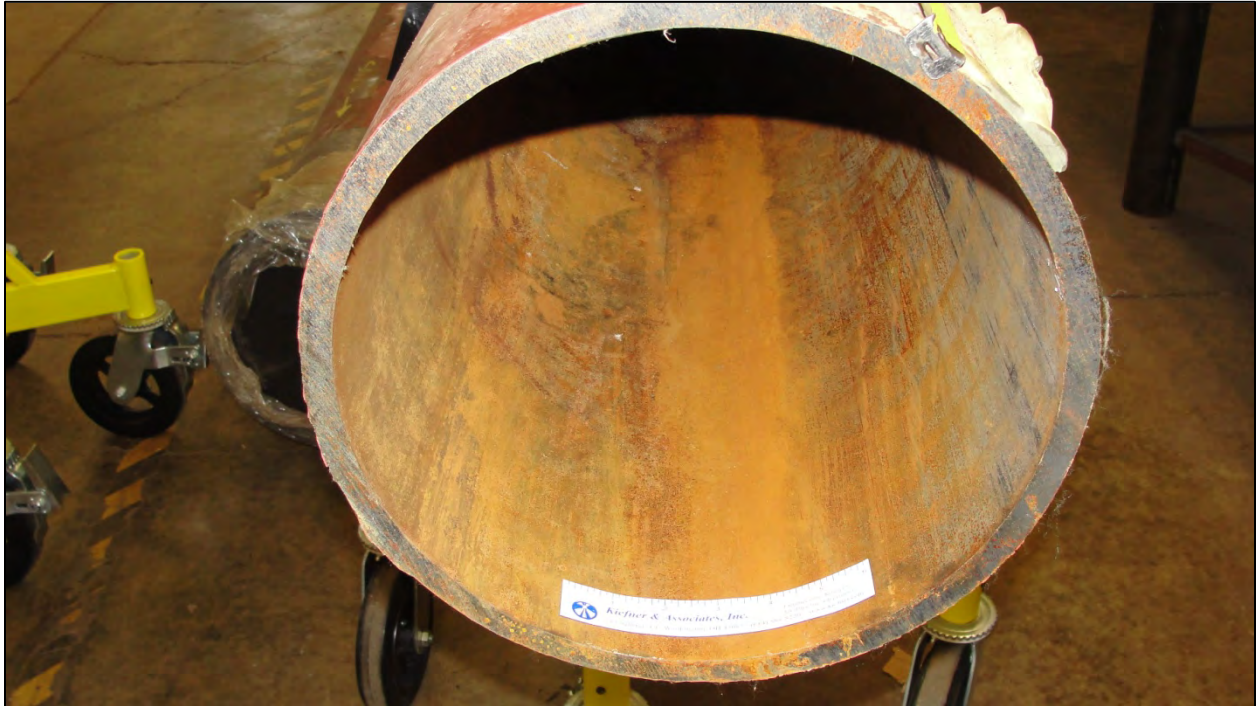
**Figure 10. Internal surface of Pipe 024**

The protocol called for examining the interior surface of Pipe 014 and Pipe 024 near the fracture. The interior of the pipe was bare and was covered in a layer of orange-colored film, likely a surface rust from exposure to water and air, visible in Figure 10 as observed typically. The interior pipe surfaces exhibited light surface pitting, similar to the pitting observed on the exterior surface of the pipe where the coating had been removed. The metal loss was superficial in depth.

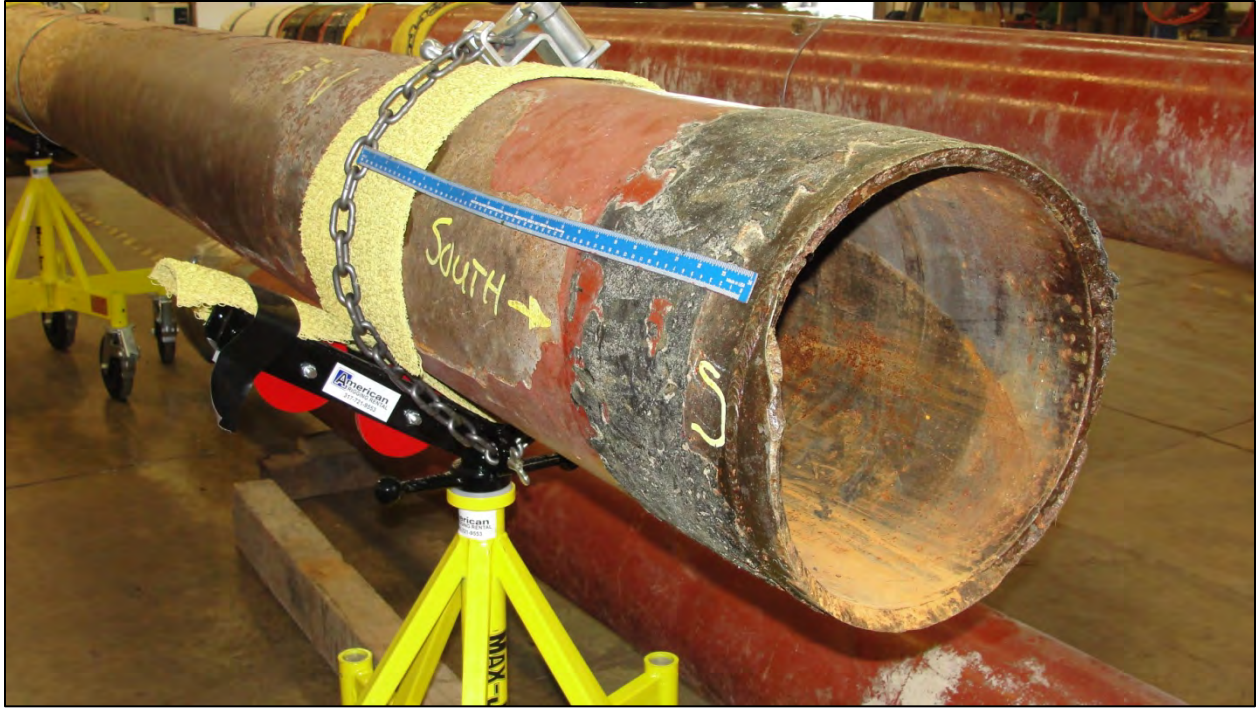
**Figure 12. Fractured end of Pipe 024**

The failure occurred as a circumferential fracture in and adjacent to the girth weld joining Pipe 014 and Pipe 024. The fracture propagated in the girth weld for a distance of approximately 28 inches and in the adjacent pipe (Pipe 014) for a distance of approximately 12 inches. The fracture is shown in Figure 12 through Figure 14. The markings visible in the figures indicate the orientation of the pipe in service. The positioning in Figure 14 is approximately the same as in service.

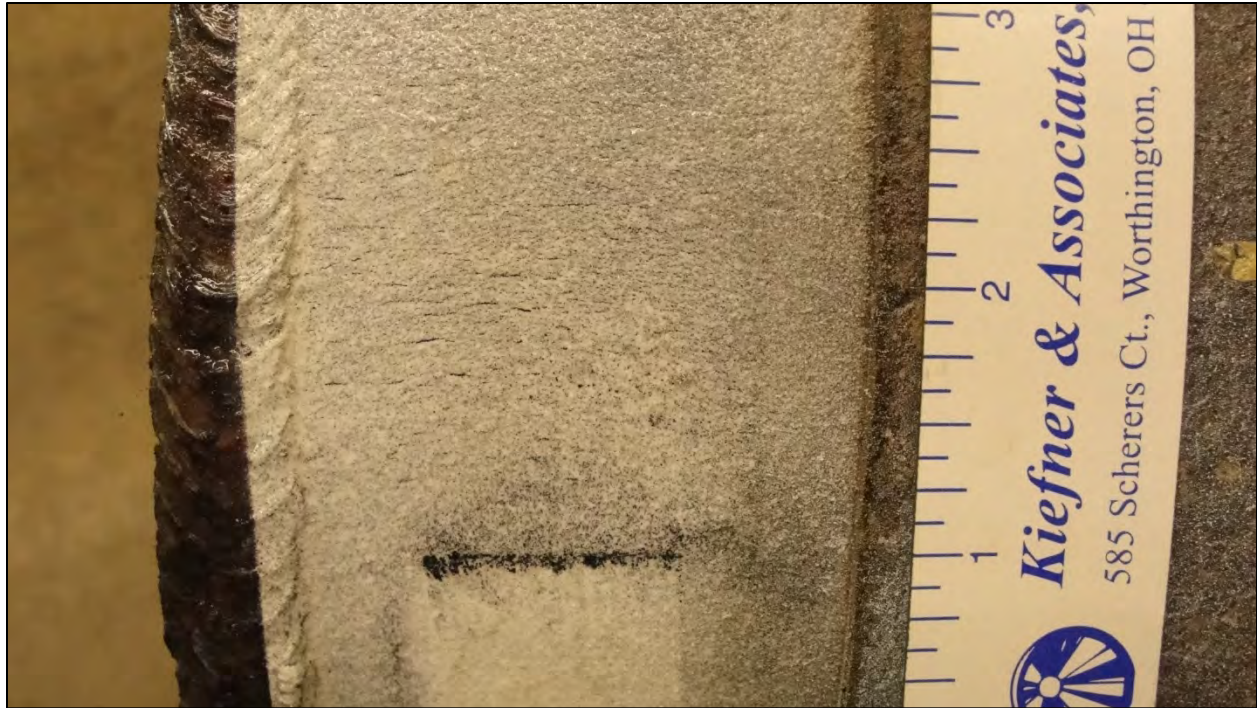
**Figure 15. Magnetic Particle Examination Surface Features**

The ends of Pipe 014 and Pipe 024 were examined adjacent to the fracture with magnetic particle testing (MT) where the steel was bare. To prepare the exterior portions of the pipe ends for MT, portions of the black girth weld coating (which appeared to be the remnants of a shrink sleeve) were removed by cutting through them with a utility knife and peeling the coating off of the bare pipe steel at the FBE-cutback area of both pipes. No attempt was made to remove the intact FBE coating beneath the black girth weld coating. The pipe was cleaned with naphtha to remove any remaining adhesive that still clung to pipe surface. The ends were inspected inside and out first with dry MT. The ends were then coated with white contrast paint and were inspected by a wet, black on white contrast MT method. Several features were found on the external surface of both pipe ends. The features were oriented longitudinally and measured less than 1/8-inch long. Several typical features are shown in Figure 15. The features were not located adjacent to the fracture surface, were not of a significant length, and resembled artifacts of pipe manufacturing, and therefore were not evaluated further at the time of the investigation.

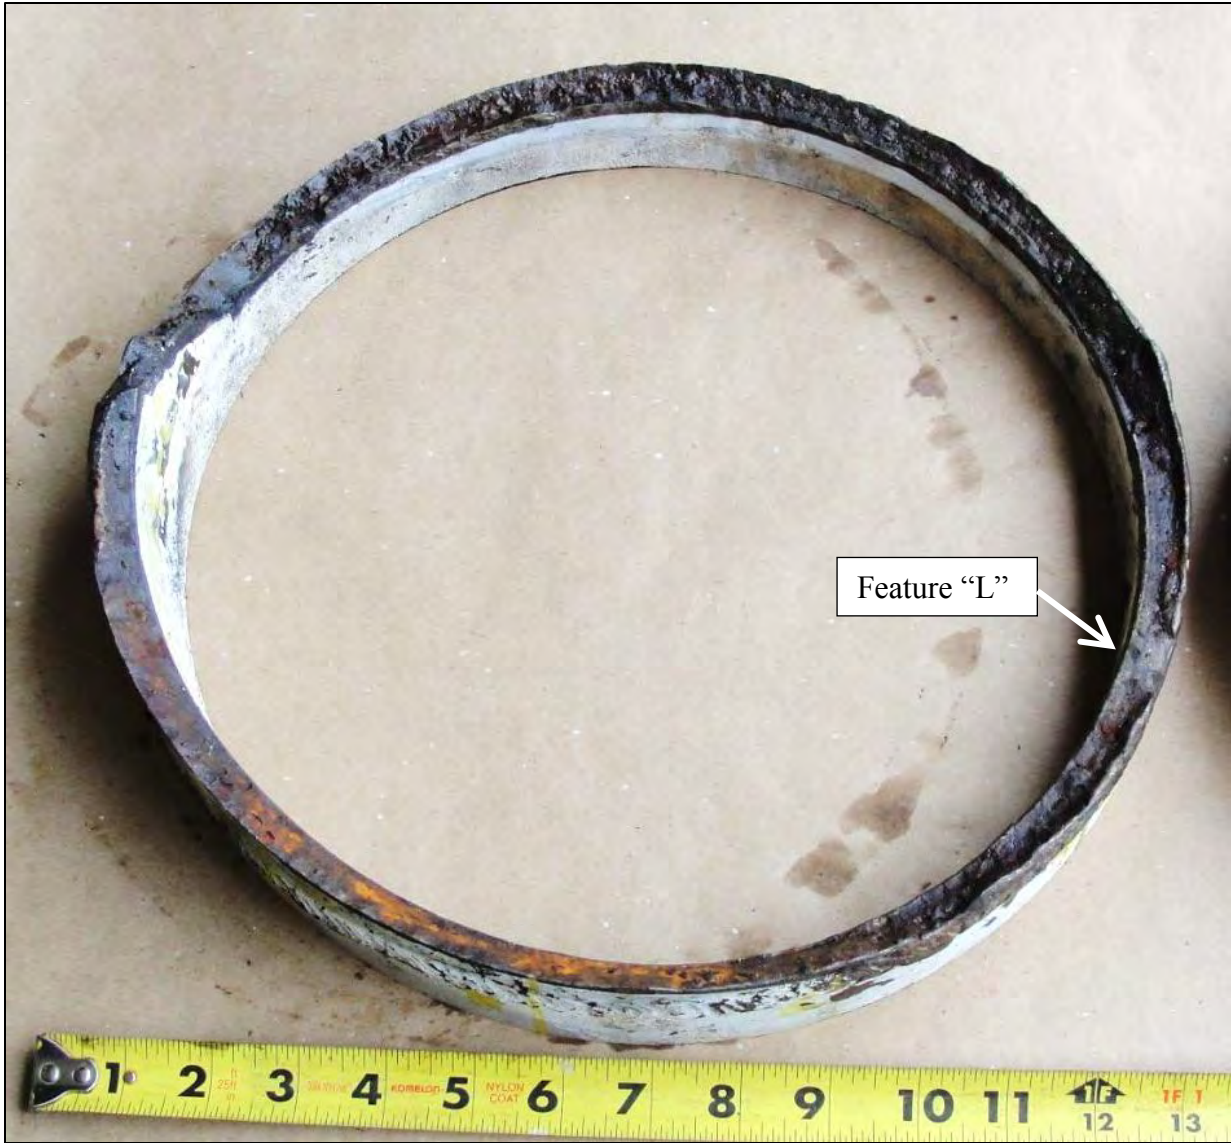
**Figure 20. Fracture surface of Pipe 024**

The fracture surfaces were examined visually and with an optical microscope. The fracture appeared to propagate in the girth weld for a distance of approximately 28 inches and in the pipe base metal for a distance of 12 inches. The portion of the fracture that propagated in the pipe exhibited a ductile, 45 degree slant fracture appearance. The appearance of the portion of the fracture that propagated in the girth weld was ductile along the outer portion of the wall thickness, near the girth weld cap. The balance of the propagating fracture surface was too obscured by the biota masses, protective coating, and corrosion to determine the mode of fracture.

Two areas of relatively flat fracture were present on the fracture surfaces. The areas were not in equal condition, such that one feature was more visible on one side of the fracture, and the other feature was more visible on the opposite side. The larger of the two features, labeled feature “L”, is shown in Figure 20 and measured 10.5 inches long on the interior pipe surface. This feature was through-thickness near the mid-length. The smaller of the two features, labeled feature “S” is shown in Figure 21 and measured 3.1 inches long by approximately 70% of the wall thickness in depth.

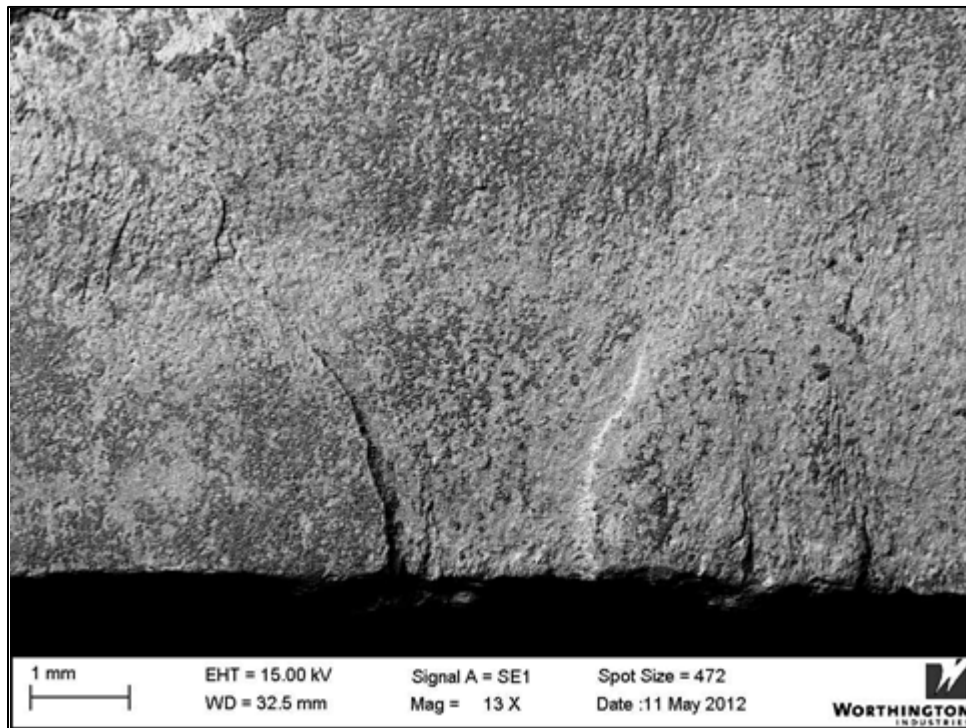
**Figure 29. SEM Image, Feature S1, Origin (13X)**

A detail of the origin region of the flat feature S1 is shown in Figure 29. Radial fracture features are prominently visible. Figure 30 shows the surface of the flat region at midwall. It appears to be corroded and covered with adherent deposit. Figure 31 shows the outer edge of the flat feature. A striated or banded feature is prominently visible. Pitting is visible above the banded feature. Figure 32 and Figure 33 show details of the banded feature at higher magnification. Figure 34 and Figure 35 present an elemental analysis using energy-dispersive spectroscopy (EDS) of the dark and light regions in the banded feature. The EDS analysis shows that the dark bands are a foreign deposit consisting primarily of calcium (Ca), silicon (Si), and oxygen (O). The regions between the dark bands are primarily iron (Fe) with traces of oxide. Figure 36 is a detail of the pitted region above the banded feature. Figure 37 is a detail of the surface within the pit, showing primarily etched surface. An EDS analysis shows the pit surface to be exposed metal with no deposits, Figure 38.

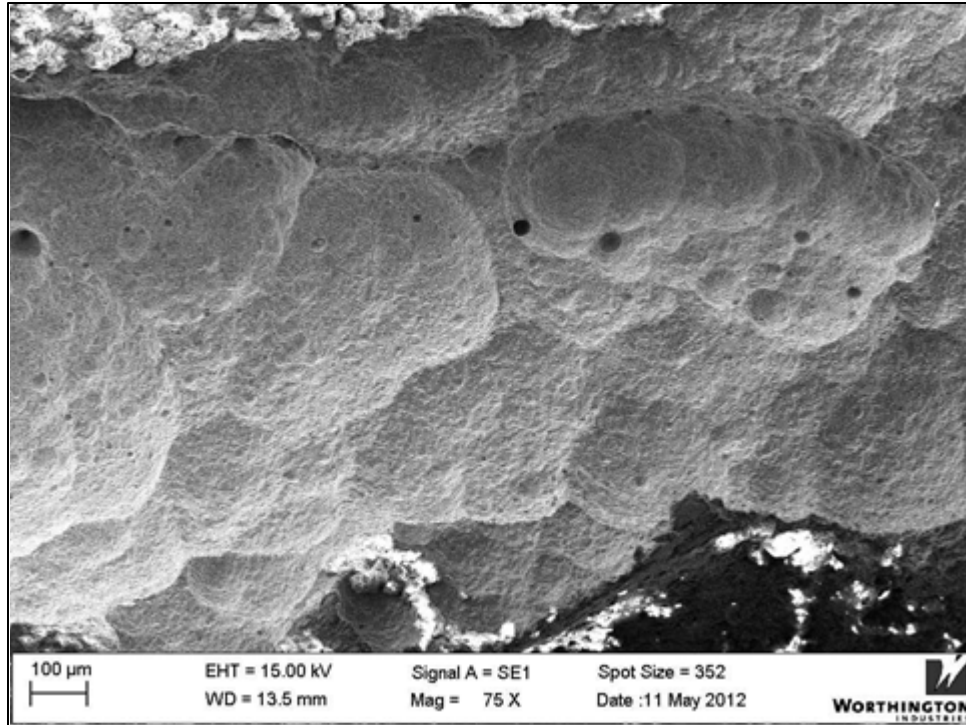
**Figure 36. SEM Image, Pitting on Flat Feature**

The SEM examination was unable to confirm a mode of crack growth and fracture, due to the corroded surfaces. Significant pitting occurred under regions where biotic species had adhered to the steel. The pitted surfaces were severely etched, suggesting a low-pH environment.

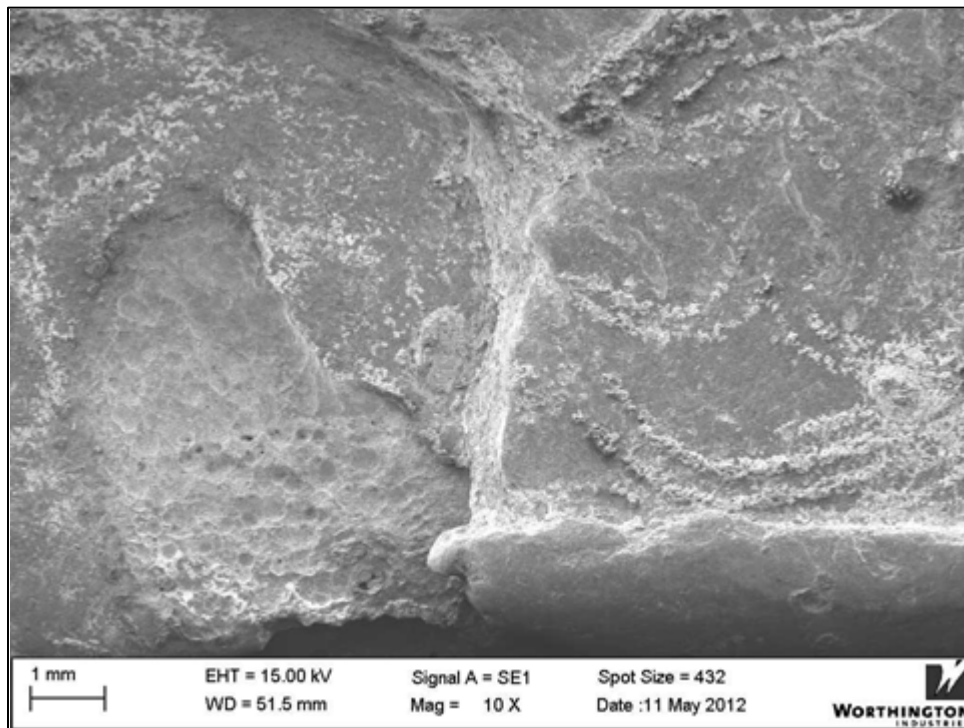
**Figure 39. SEM Image, Specimen L1, Thumbnail Near Pipe ID**

Specimen L1 was also examined in the SEM. Its surface was in worse condition than Specimen S1 and yielded virtually no information about fracture modes. Traces of biotic residue were plentiful, e.g. Figure 39, typical. Figure 40 and Figure 41 show details of this feature in backscatter and normal modes. Figure 42 presents an EDS analysis of the feature.

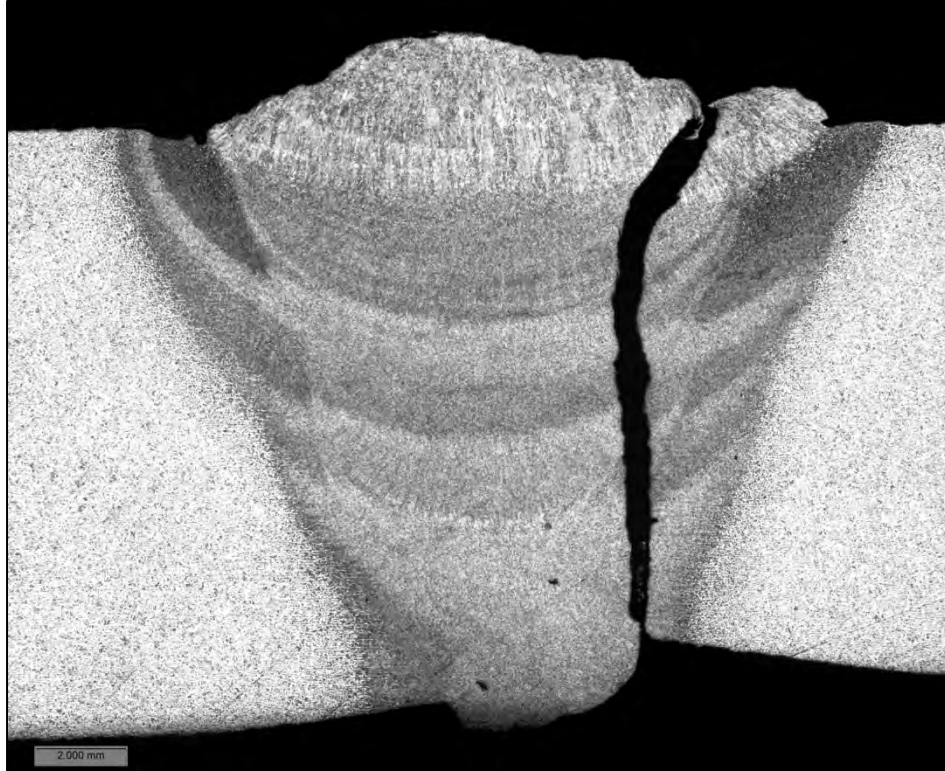
**Figure 51. Metallographic section through Feature L**

The metallographic section through Feature L, Figure 51, shows approximately the same morphology. The feature, a crack, initiated at the toe of the root pass and propagated relatively flat and straight through approximately 80% of the deposited girth weld metal thickness before exhibiting ductile shear fracture in the outer 20% of the weld thickness.

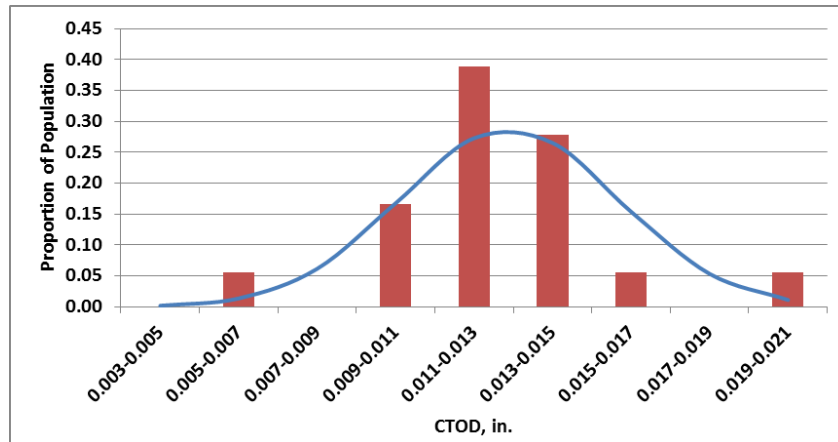
**Figure 54. Distribution of CTOD Measurements**

The results of the CTOD tests are given in Table 11 and Table 12. The CTOD test reports are presented in Appendix 7. The CTOD results were similar in WM and HAZ samples, and did not vary greatly among the three welds. The mean value was 0.013 inch with a standard deviation of 0.0028 inch. The minimum and maximum single observed CTOD were 0.006 and 0.020 inch, respectively, corresponding to the mean plus or minus 2.5 standard deviations (approximately). The distribution of observed CTOD appears to be normally distributed, as shown in Figure 54. All observed CTOD measurements were in the ductile range.

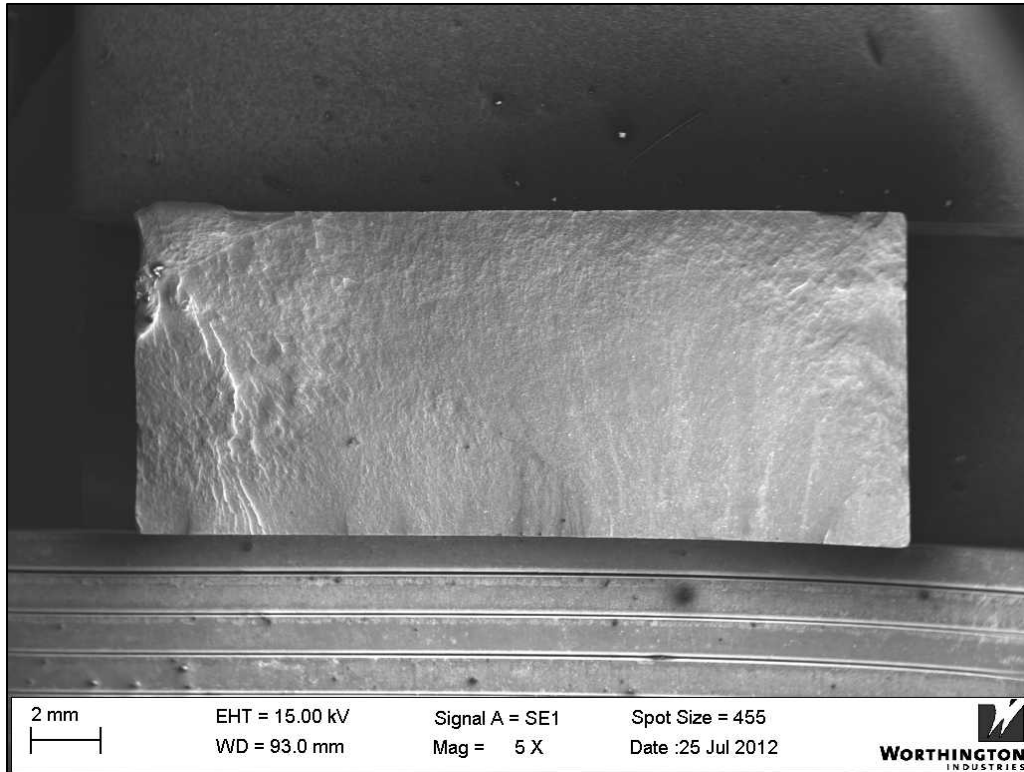
**Figure 56. Overview of Cracked CTOD Specimen Viewed on SEM**

A portion of the CTOD specimen containing the crack surface was cut off to facilitate examination in the SEM. The surface was cleaned in an ultrasonic cleaner in a solution of Alconox and water. The surface exhibited features similar to those of feature S, including surface corrosion damage. Figure 56 shows an overview of the cracked surface of the CTOD sample. No

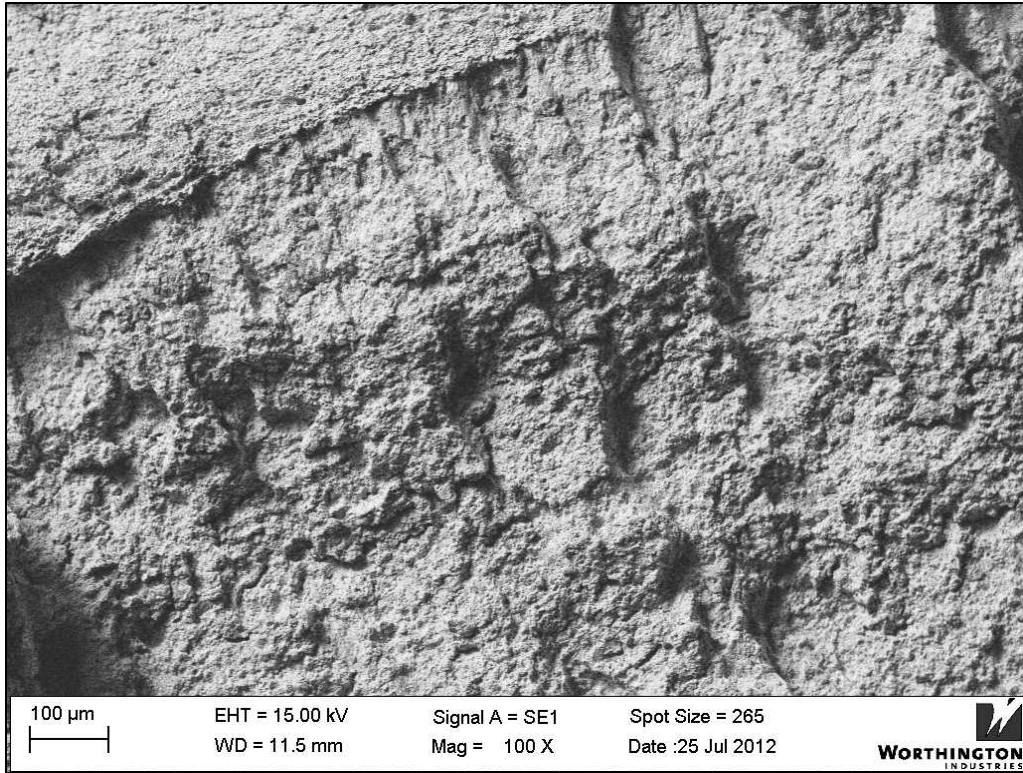
**Figure 57. Edge of fracture surface near intact corner**

weld defect was present on the surfaces. The upper left corner of the specimen was the intact portion that broke during machining. Figure 57 shows the leading edge of the crack near this corner at 100X magnification. A detail of this area is shown in Figure 58. The fracture surface shows evidence of corrosion damage even in the part of the crack that would have been expected to be tight and most protected from corrosion damage.

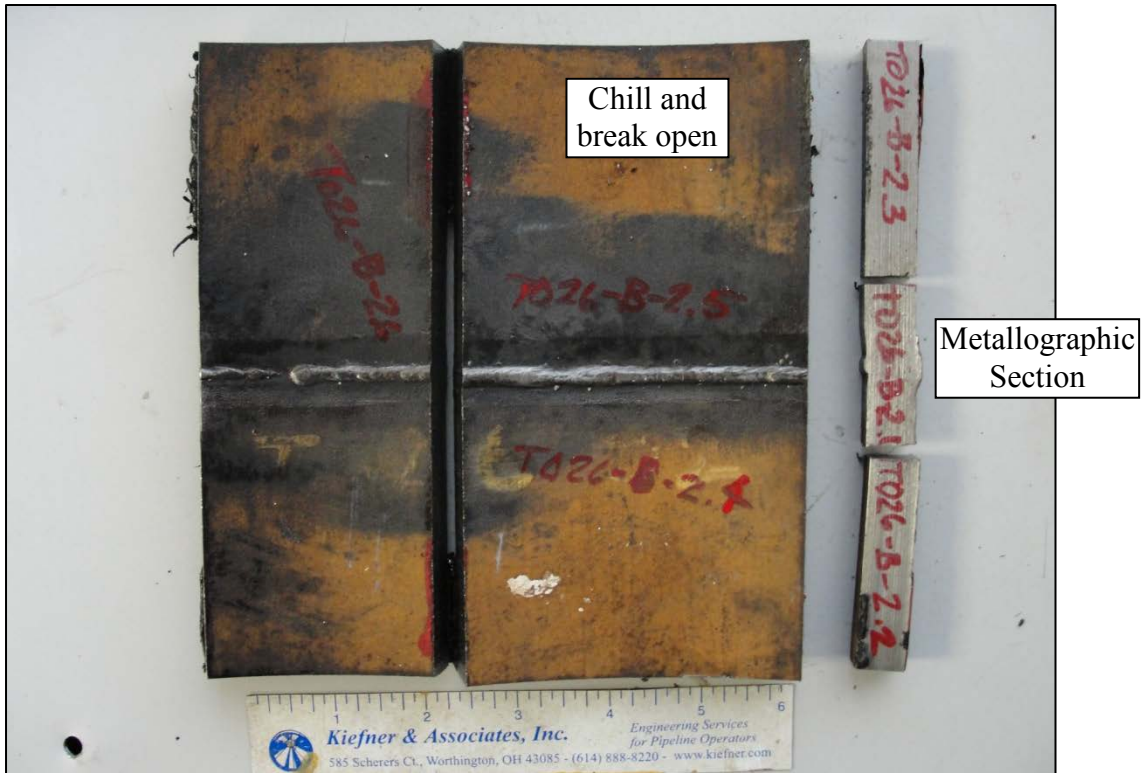
**Figure 60. Coupon T026-B-2 cut for additional examination**

The coupon was cut to provide a sample for metallographic examination and the remaining portion was chilled and broken open. Figure 60 shows how the coupon was cut and the locations of the metallographic section and the sample that was broken open.

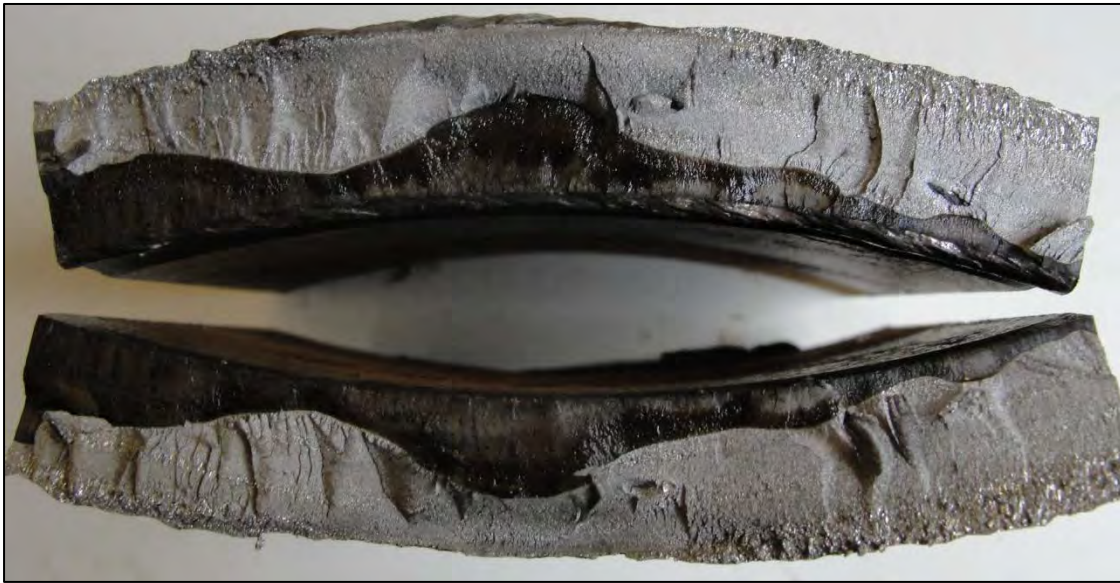
**Figure 63. Crack surfaces, Coupon T026-B-2 after breaking open**

A portion of the crack indication was chilled in liquid nitrogen to promote brittle behavior and broken open to reveal the surfaces of the crack. The exposed surfaces are shown in Figure 63 placed ID to ID. The crack is seen to be continuous along the internal pipe surface with varying depth along its length. The crack is stained a dark color and appears to contain crude oil along the deepest portion of the crack. The crack surfaces are relatively smooth and flat with radially-oriented features.

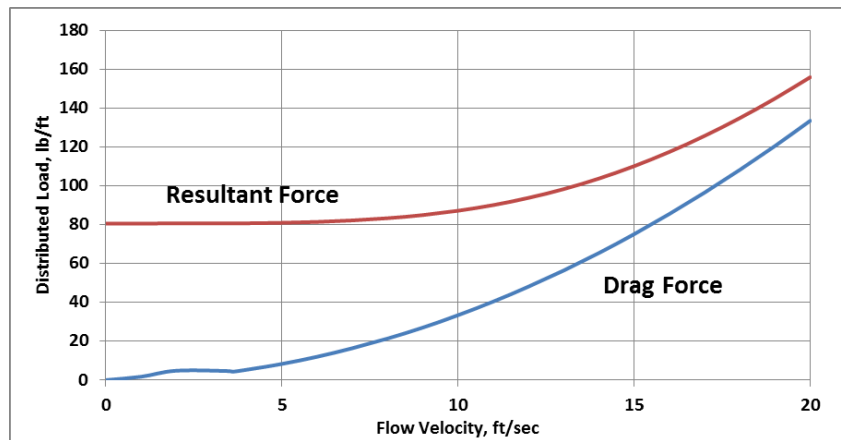
**Figure 65. Applied Loading on Pipe Due to River Current**

The drag coefficient  $C_D$  was estimated in accordance with published data as summarized in the curve shown in Figure 64.<sup>2</sup> The resultant of the steady drag force with the buoyant weight was determined, as shown in Figure 65. A gap between the pipe and the river bottom of less than one pipe diameter can reduce the velocity of the fluid acting against the pipe and the resulting drag forces. The actual bottom separation during the flood was not known so this effect, if present, was unaccounted for.

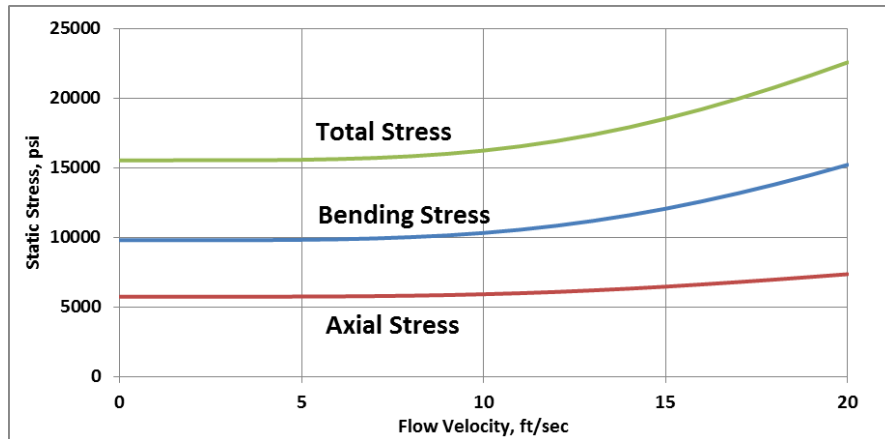
**Figure 66. Static Stresses Due to Spanning and Current Impingement**

The stress due to buoyant weight acts in the vertical plane and produces a net stress of 15,524 psi and a sag or deflection of 2.29 ft in the 207-ft exposed span length. The axial and bending stress induced by flow impingement varies with the stream velocity, which acts in the horizontal plane. The resultant produces the net static stress due to spanning. These are shown in Figure 66, not including the axial stress due to internal pipe pressure. The effect of the flow-induced drag forces on total stress is minor with flow velocities below 10 ft/sec.

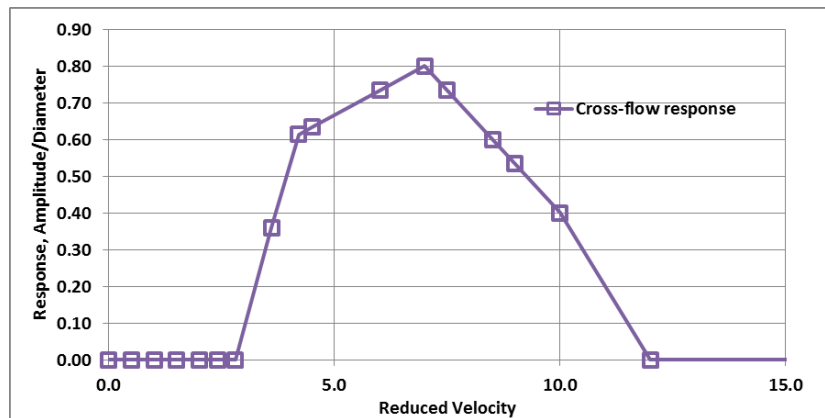
**Figure 67. Cross-flow Dynamic Response**

amplitude applied in this analysis<sup>6</sup> is shown in Figure 67 as a function of Reduced Velocity. Susceptibility to VIV is greatest where  $V_r$  is between values of 4 and 10.

The first-mode peak response of A/D = 0.8 from Figure 67 corresponds to a stress in the pipe of around 5.8 ksi based on the ratio of static stress and deflection. Second and third modes would broaden the response to higher water velocities with peak responses around 7 and 10 ft/sec, respectively. Concurrent excitation of higher modes would add to the dynamic stresses.

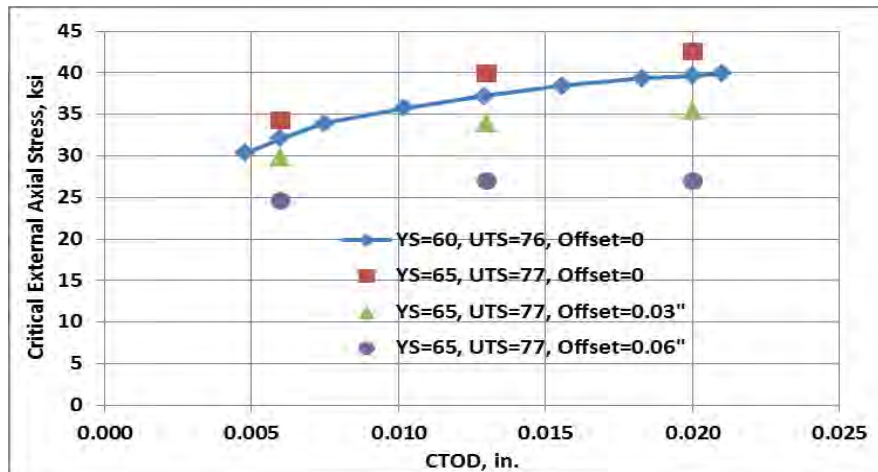
Figure 68. API 579 Critical Load Analysis

API 579, a recognized fitness for service standard,<sup>10</sup> was used to estimate the critical load that would cause failure in the remaining pipe cross section. The analysis applied the Failure Assessment Diagram (FAD) approach for a circumferentially-oriented surface crack on a pipe cross section, in accordance with Section C.13.5. Mechanical strength and weld ductility data from the exemplar welds, reported earlier, were used with the analysis. The analysis was performed for a circumferential flaw 10 inches long and having a depth of 80% of the wall thickness approximately representing the large fatigue crack at the 5:30 position. The smaller fatigue crack at the 1:00 position was not accounted for. The estimated critical stresses are presented in Figure 68.

The solid curve gives results considering the lowest observed yield strength (YS) and ultimate tensile strength (UTS), and using the mean CTOD (0.013 inch) plus or minus one, two, and three standard deviations, and also the lowest (0.006 inch) and highest (0.020 inch) measured CTOD. The square symbols above the curve represent results considering the highest YS and UTS, and the lowest, average, and highest CTOD. The triangle and circle symbols represent the same strength and ductility properties but with high-low across the weld joint of 0.03 inch (1/32 inch) and 0.06 inch (1/16 inch), respectively, which bracket the amount of high-low observed in metallographic cross sections where high-low was present.
