Principal Investigator Edwin D. Clarkson, WV PSC
Region Director Byron Coy
Date of Report 8/2/2011
Subject Failure Investigation Report – Columbia Gas Well Line Rupture

Failure Investigation Report – Columbia Gas Transmission Well Line Rupture
Failure Date: 01/04/2009

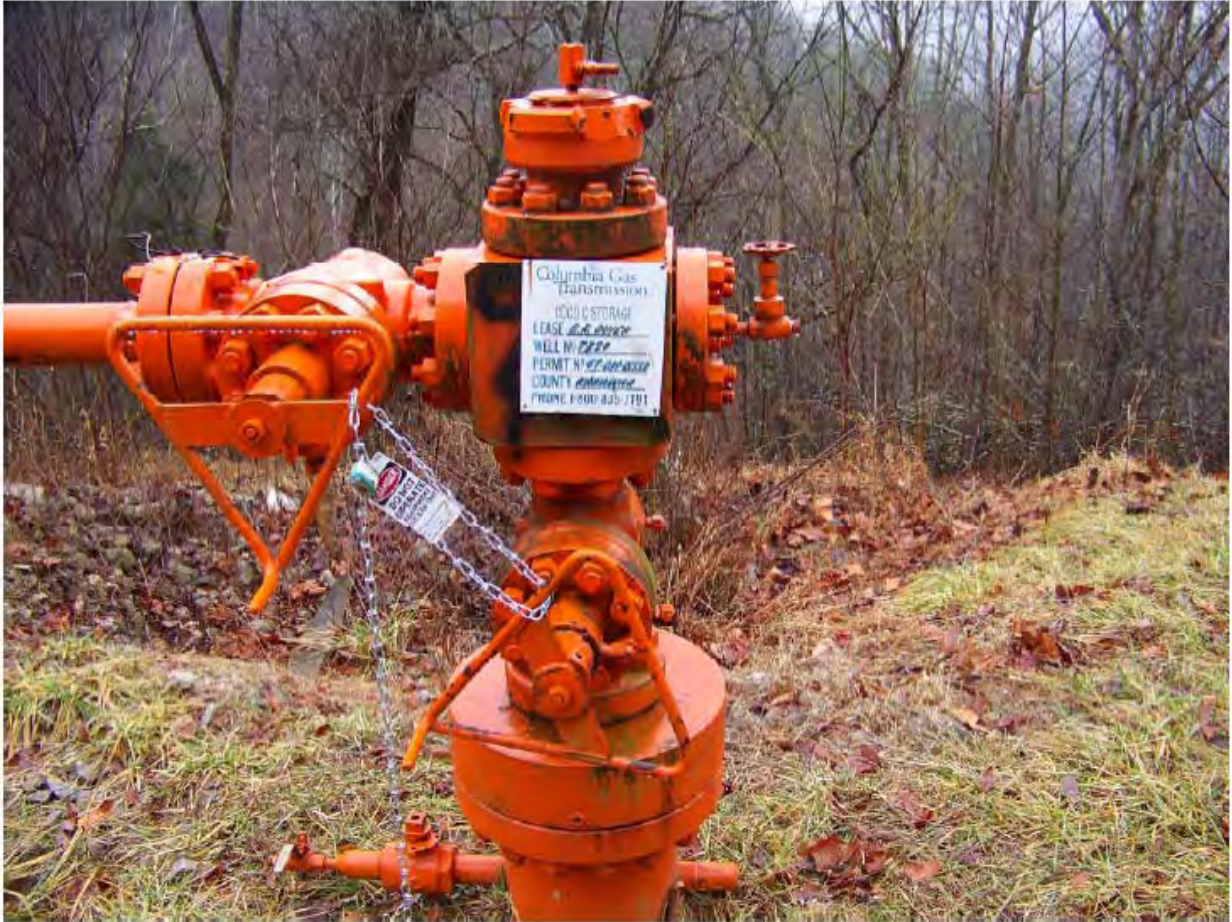
Line number X-52C-W7329 diameter 6.625 inches, .280 inch wall thickness, X-35

Description of photo – Meter house for well 7329
