Enbridge Mackinac Straits ILI Review

NPS 20 Pipeline
Enbridge Line 5;
East and West Mackinac Straits

Report May 12, 2016

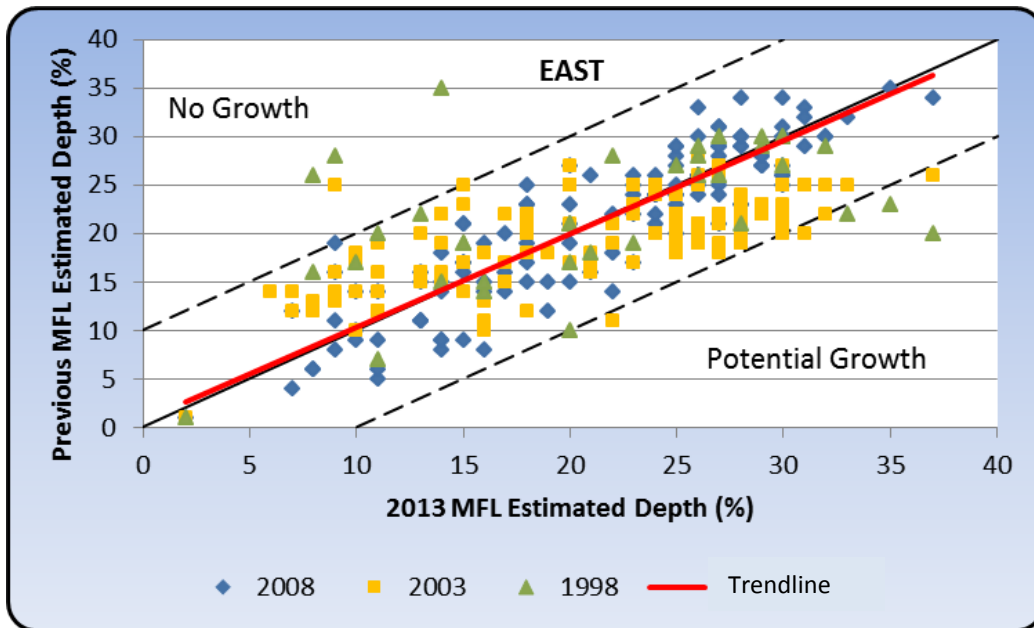
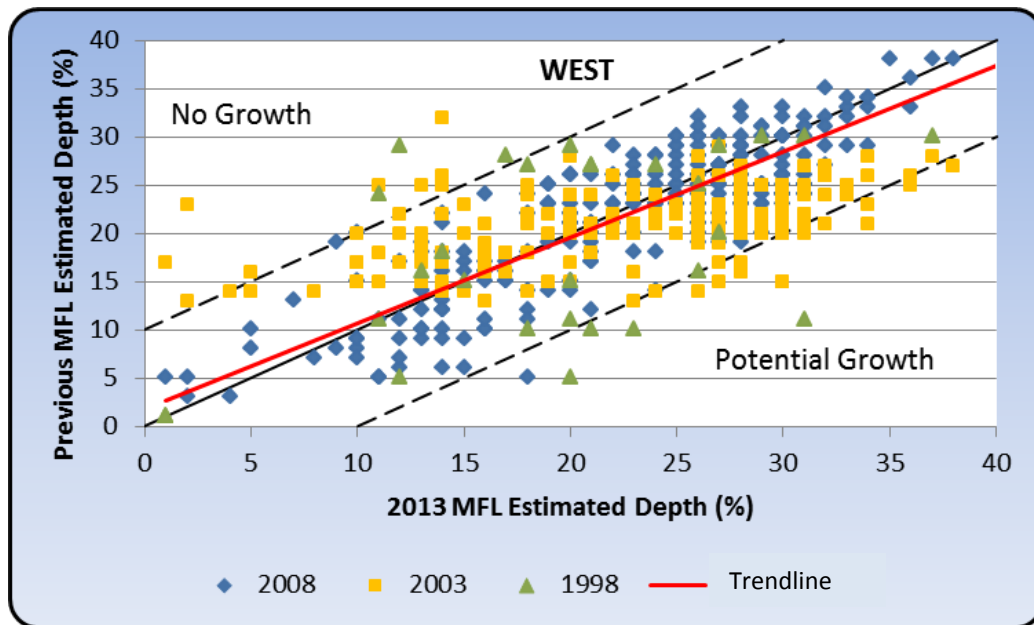
Corrosion growth rates were investigated by analyzing the growth of matched metal loss anomalies between the 2008 MFL and 2013 MFL inspections. All variances in depth were found to be within the ±10% error of the tool. Therefore considering tool error there is no growth as would be expected if these are all manufacturing anomalies. The trendlines for both the East and West segments approximate unity as seen in the following unity plots.

No excavations of metal loss were deemed necessary based on the 2013 MFL inspection sizing and no apparent corrosion growth. Even considering the greatest deviation in depths within all inspections and not allowing for tool tolerance, an extremely conservative growth rate of 0.019 in/yr was determined. Applying this extraordinary rate to the length and depth of each anomaly, the lowest estimated failure pressure of any anomaly after a 10 year growth period is 1350 psi (2.25 safety factor relative to the maximum operating pressure (MOP)).

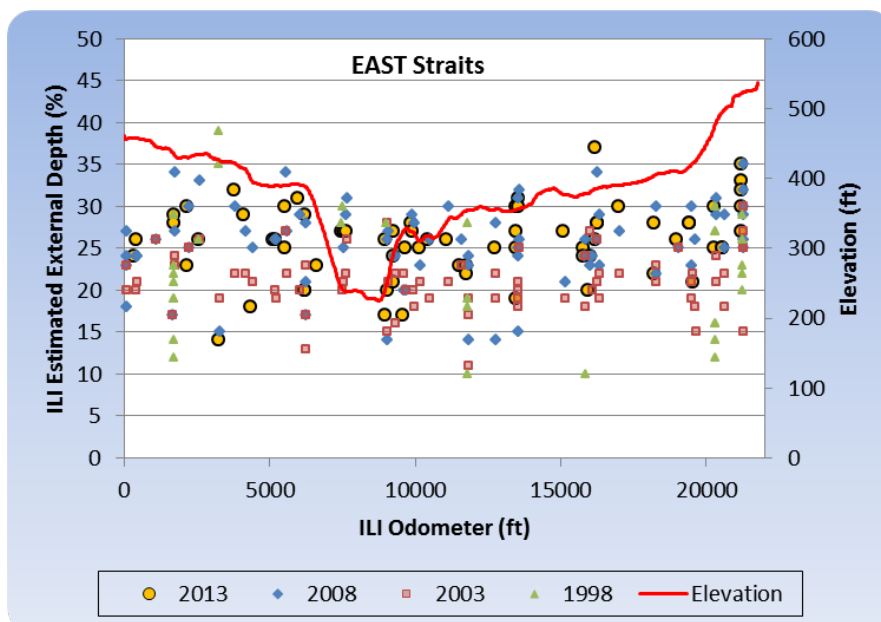
Figure 1. Distribution of external metal loss anomalies in the East Straits.

The distribution of the metal loss anomalies from the four inspections are detailed in Figures 1 through 4. Figures 1 and 2 detail the external and internal metal loss distributions along the length of the East Straits, respectively. Likewise, Figures 3 and 4 detail the external and internal metal loss distributions along the length of the West Straits, respectively.

Note that the older 1998 MFL technology detailed many fewer metal loss features than the more recent technologies. The average lengths are greater in the 2013 inspection than in 1998, verifying that the quantity of anomalies is not a result of interaction method variations. The quantities of anomalies are similar in the 2003, 2008 and 2013 inspections. The locations of higher densities of anomalies tend to agree between inspections. Also, there are a few discrepancies between metal loss being called either internal or external in the MFL inspections. Generally, this is typical and not of great concern as the remaining strength is not governed by the side of pipe the metal loss is on and the interaction of anomalies should not depend on this either. Many locations of higher density internal metal loss are at local low

elevation areas. This implies that there may have been corrosion at some point in time, particularly when there is more than one pipe joint included.

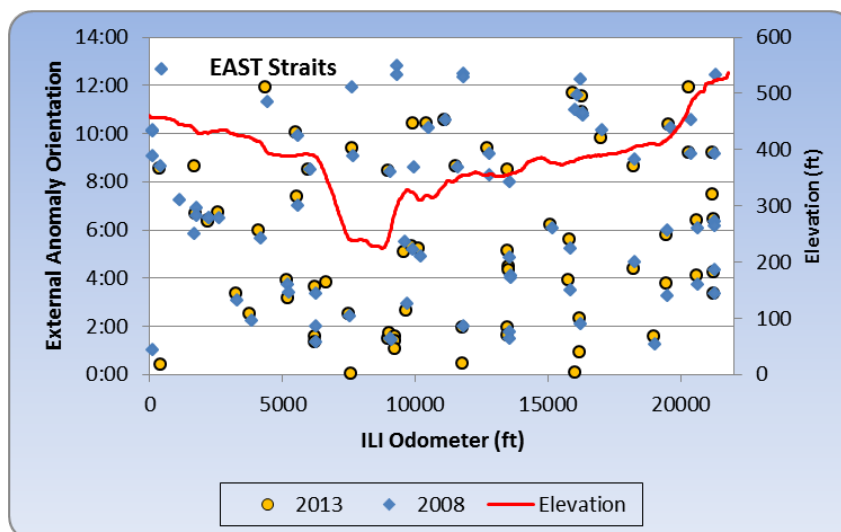
Figure 5. Orientation of external metal loss anomalies in the East Straits.

A check of the distribution of the metal loss anomalies by clock position in Figures 5 through 8, showed no distinct preferred orientations of external nor internal metal loss. Figures 5 and 6 detail the external and internal metal loss orientations along the length of the East Straits, respectively. Likewise, Figures 7 and 8 detail the external and internal metal loss orientations along the length of the West Straits, respectively.

The potential internal corrosion noted above would typically be seen to occur about a preferred orientation which is not the case. It is seen, particularly in Figure 8 that the metal loss orientation is spread throughout the full circumference of the pipe. This then signifies that it is a manufacturing issue. Seamless pipe is known to cause minor metal loss anomalies to be delineated in areas where the wall thickness is non-uniform due to the pipe manufacturing process.

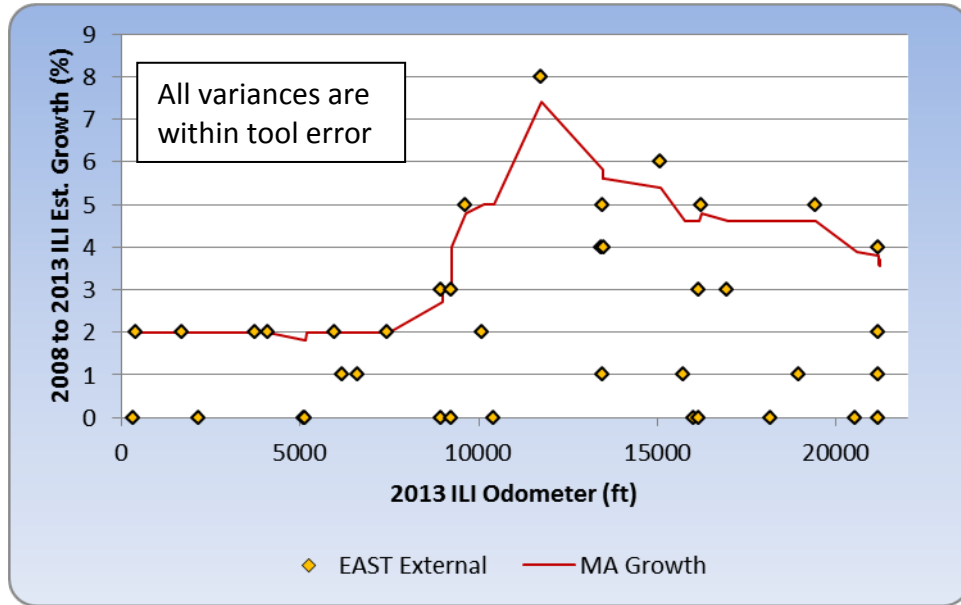
Figure 11. Determinate analysis of growth East external.

If tool error is not considered, the external growth was found to be between 0.0016 – 0.015 in/yr and the internal between 0.0016 – 0.019 in/yr. The corrosion rates for both the external and internal anomalies were calculated using a moving 95th percentile scale as presented in

Figures 11-14. All growth rates were determined to be the 95% confidence interval of growth. Again, the depth variances were within tool error and these rates noted cannot be stated as actual, just used as a worst case estimate.

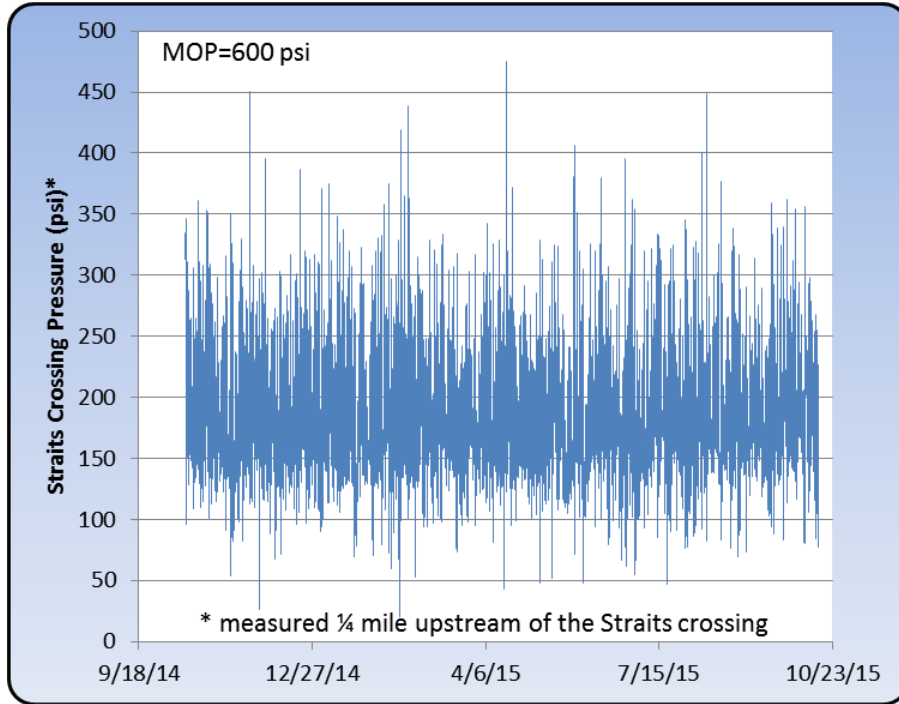
Figure 16. Actual operating pressure of both Straits lines for the period shown.

A fatigue analysis was made employing the most recent years' operating pressures (Figure 16) and considering the dimensions of the crack-like indications. All of the 35 delineated anomalies had a remaining life of greater than 50 years using ASME FFS/API 579. API Recommended Practice 579 (RP579), Fitness-For-Service, provides guidance for conducting Fitness-For-Service (FFS) assessments using methodologies specifically prepared for equipment in the refining and petrochemical industry. FFS assessments are quantitative engineering assessments which are performed to demonstrate the structural integrity of an in-service component such as pipe, containing a flaw or damage. The results of the ASME FFS/API 579 assessment are shown in the Failure Assessment Diagram in Figure 17. All of the anomalies are grouped in a tight area as a result of the similar dimensions, particularly depth, of each “crack-like” anomaly.

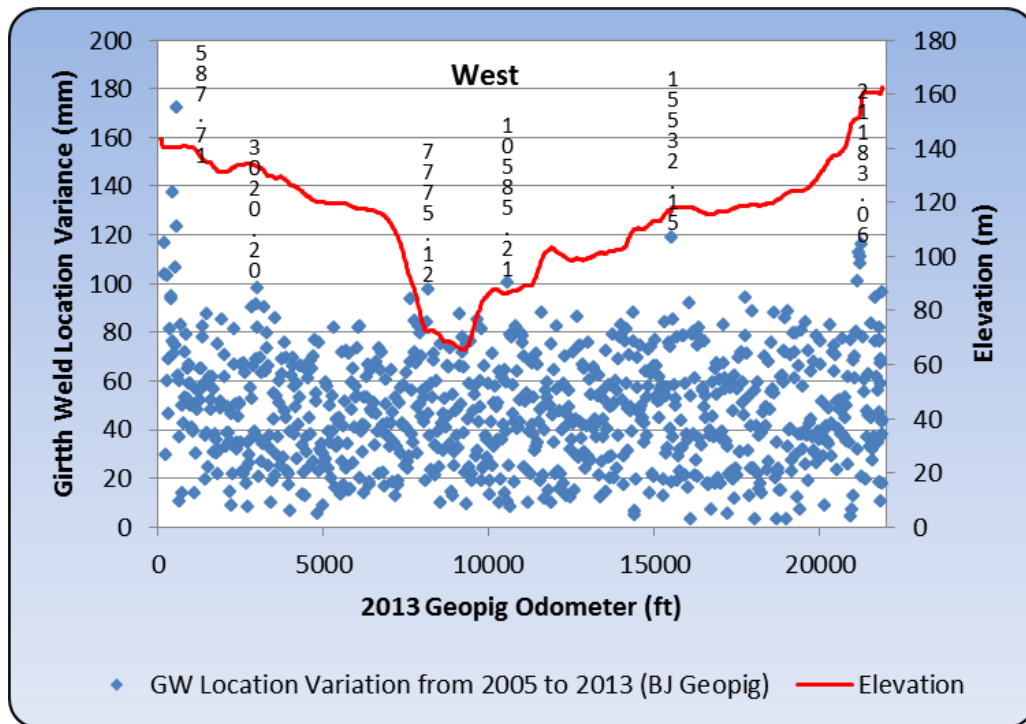
Figure 19. Pipeline horizontal movement as measured by the BJ Geopig in the West crossing.

Comparing previous Geopig inspections to the 2013 data it was found that the greatest horizontal displacement in the data was noted in the East segment (Figure 17) at the end of the inspection and was 163mm (6.4") and in the West segment (Figure 18) at the beginning of the inspection and was 172mm (6.8"). This amount of deviation has been determined to impart less than 0.02% strain as it acts over a long length. Both of these locations are onshore. The 2013 odometers for the greatest deviations are noted in the figures.

Continued vigilance with respect to pipe movement is warranted. Unless a specific event occurs which may cause pipe movement, the present inspection frequency is appropriate.

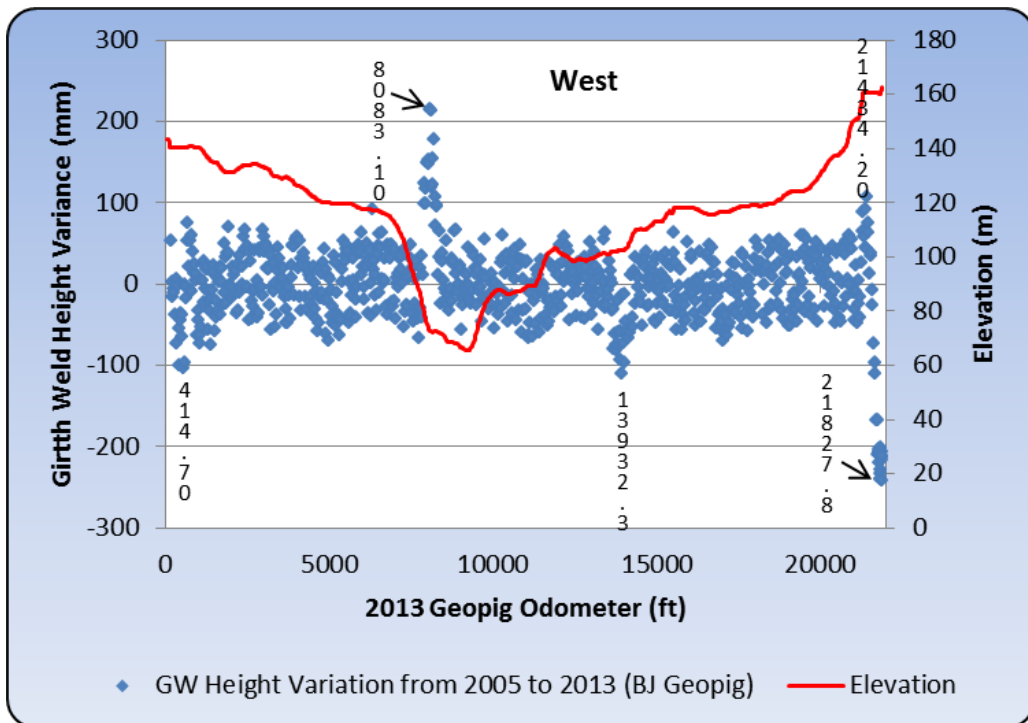
Figure 21. Pipeline vertical movement as measured by the BJ Geopig in the West crossing.

The vertical deviations are slightly greater. The greatest vertical deviation in the data was noted in the East segment (Figure 19) at both ends of the inspection with the greatest being 370mm (14.6") and in the West segment (Figure 20) at one third of the inspection length and was 214mm (8.4"). Note that all of the horizontal and vertical deviations include many pipe joints. These are smooth transitions as many joints over 100's of feet are moving. The pipe therefore has negligible added stress or strain imparted. Some of the underwater variations in height may have been corrected during 2014 maintenance in which both segments had new anchor points installed so as to have no unanchored spans greater than 75' in length.
