DOT US Department of Transportation
PHMSA Pipelines and Hazardous Materials Safety Administration
OPS Office of Pipeline Safety
Southern Region

Principal Investigators Gabriel Kotsis and Chris Taylor
Region Director Wayne T. Lemoi
Date of Report April 21, 2011
Subject Failure Investigation Report – Southern Natural Gas Wrinkle Bend Failure

Failure Investigation Report – Southern Natural Gas, Wrinkle Bend Failure

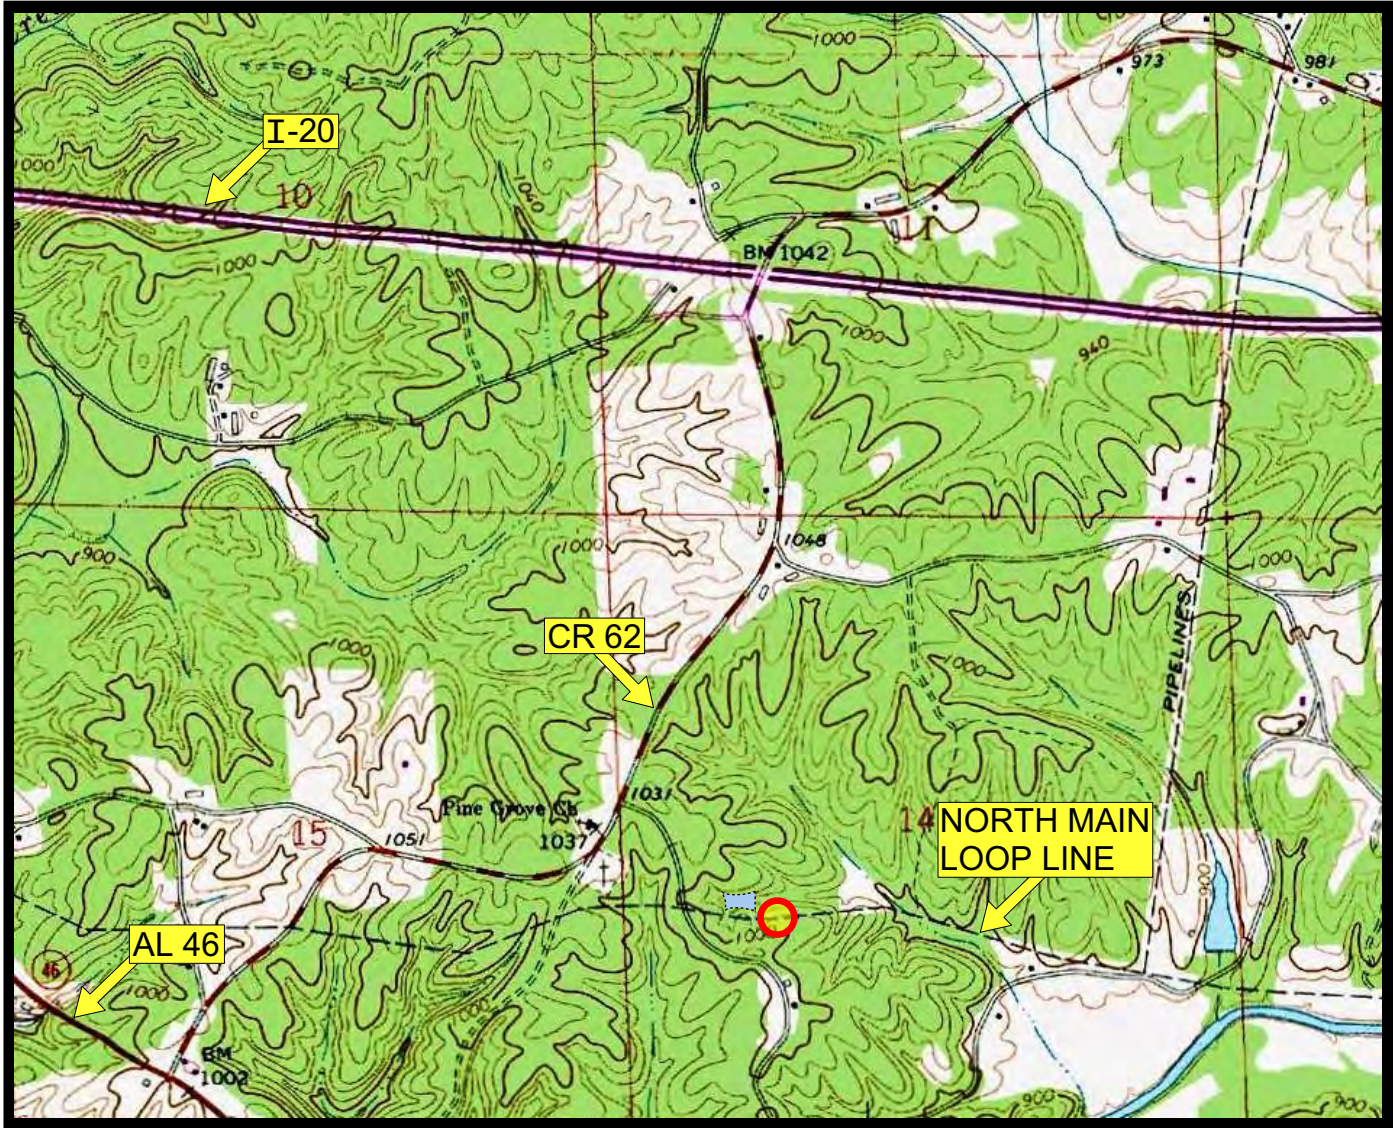
FIGURE 1. TOPOGRAPHY NEAR MILEPOST 399.642

A 24-inch gas pipeline leaked at milepost 399.642 on the Southern Natural Gas North Main Loop Line in sec. 14, T. 16 S., R. 11 E., Cleburne County, Alabama (Figure 1), on December 31, 2009. To evaluate the possible influence of hydrogeologic conditions on the failure, an examination of local conditions was performed.

Publications (maps and reports) on the geology and hydrogeology of the region were obtained and reviewed. After the regional setting was established, information at the local scale was reviewed. Topographic contour maps were studied to relate specific landforms in the area to the movement of ground water and surface water. A U.S.G.S. 7.5-minute quadrangle map was used as a base map for this effort (Figure 1).

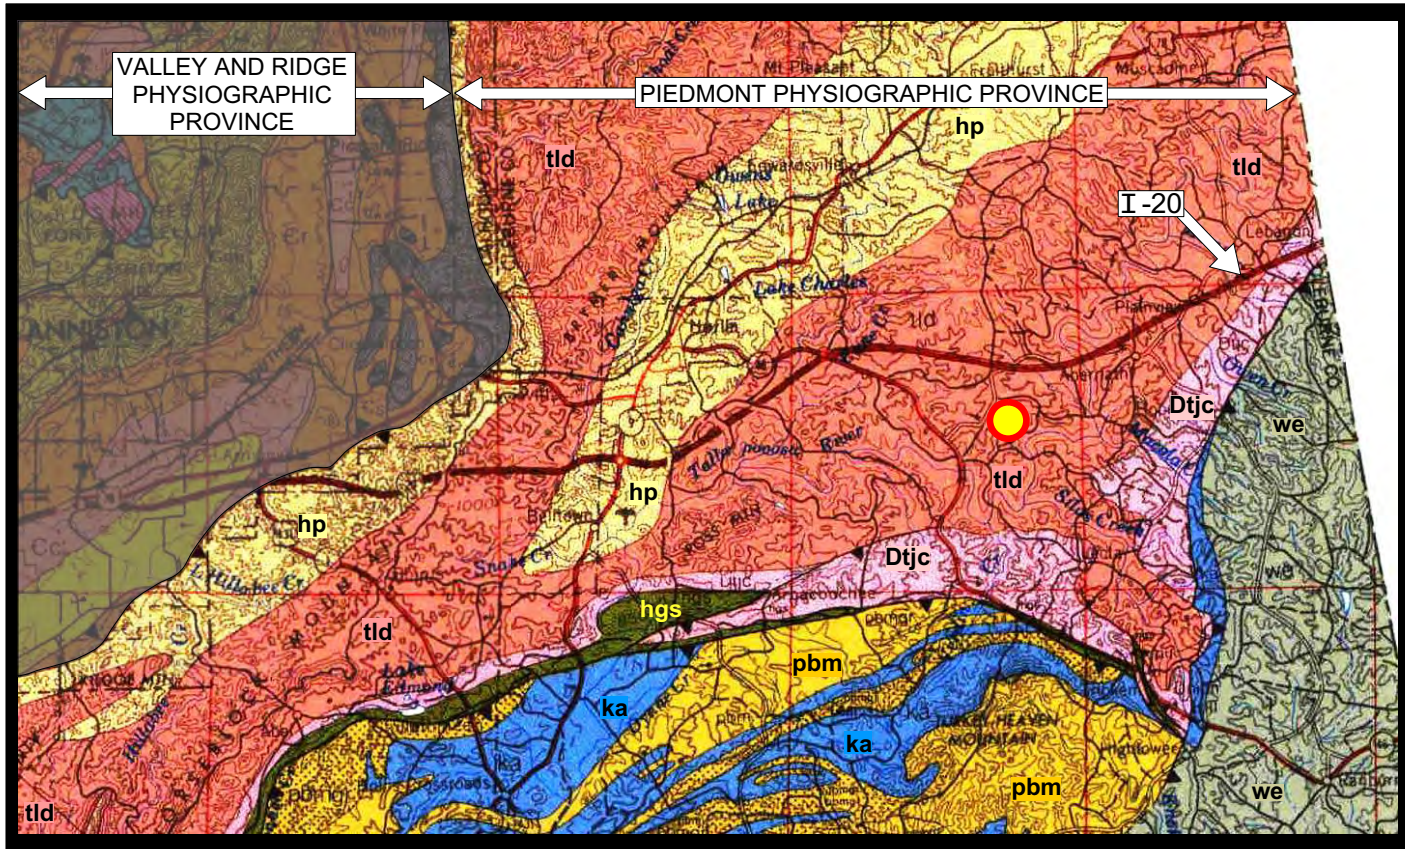
FIGURE 2. GEOLOGIC MAP

The Lay Dam Formation of the Talladega Group in Cleburne County (Figure 2) consists of irregularly bedded metamorphic rocks, including phyllite, metasilstone, greywacke, and quartzite. Rocks observed at land surface and in the excavation at milepost 399.642 are consistent with those comprising the Lay Dam Formation.
