DOT US Department of Transportation
PHMSA Pipeline and Hazardous Materials Safety Administration
OPS Office of Pipeline Safety
Southwest Region

Date of Report 7/31/2011
Subject Failure Investigation Report – Tennessee Gas Pipeline Co. - Internal Corrosion

Failure Investigation Report – Tennessee Gas Pipeline Co. - Internal Corrosion
Failure Date 12/08/2010

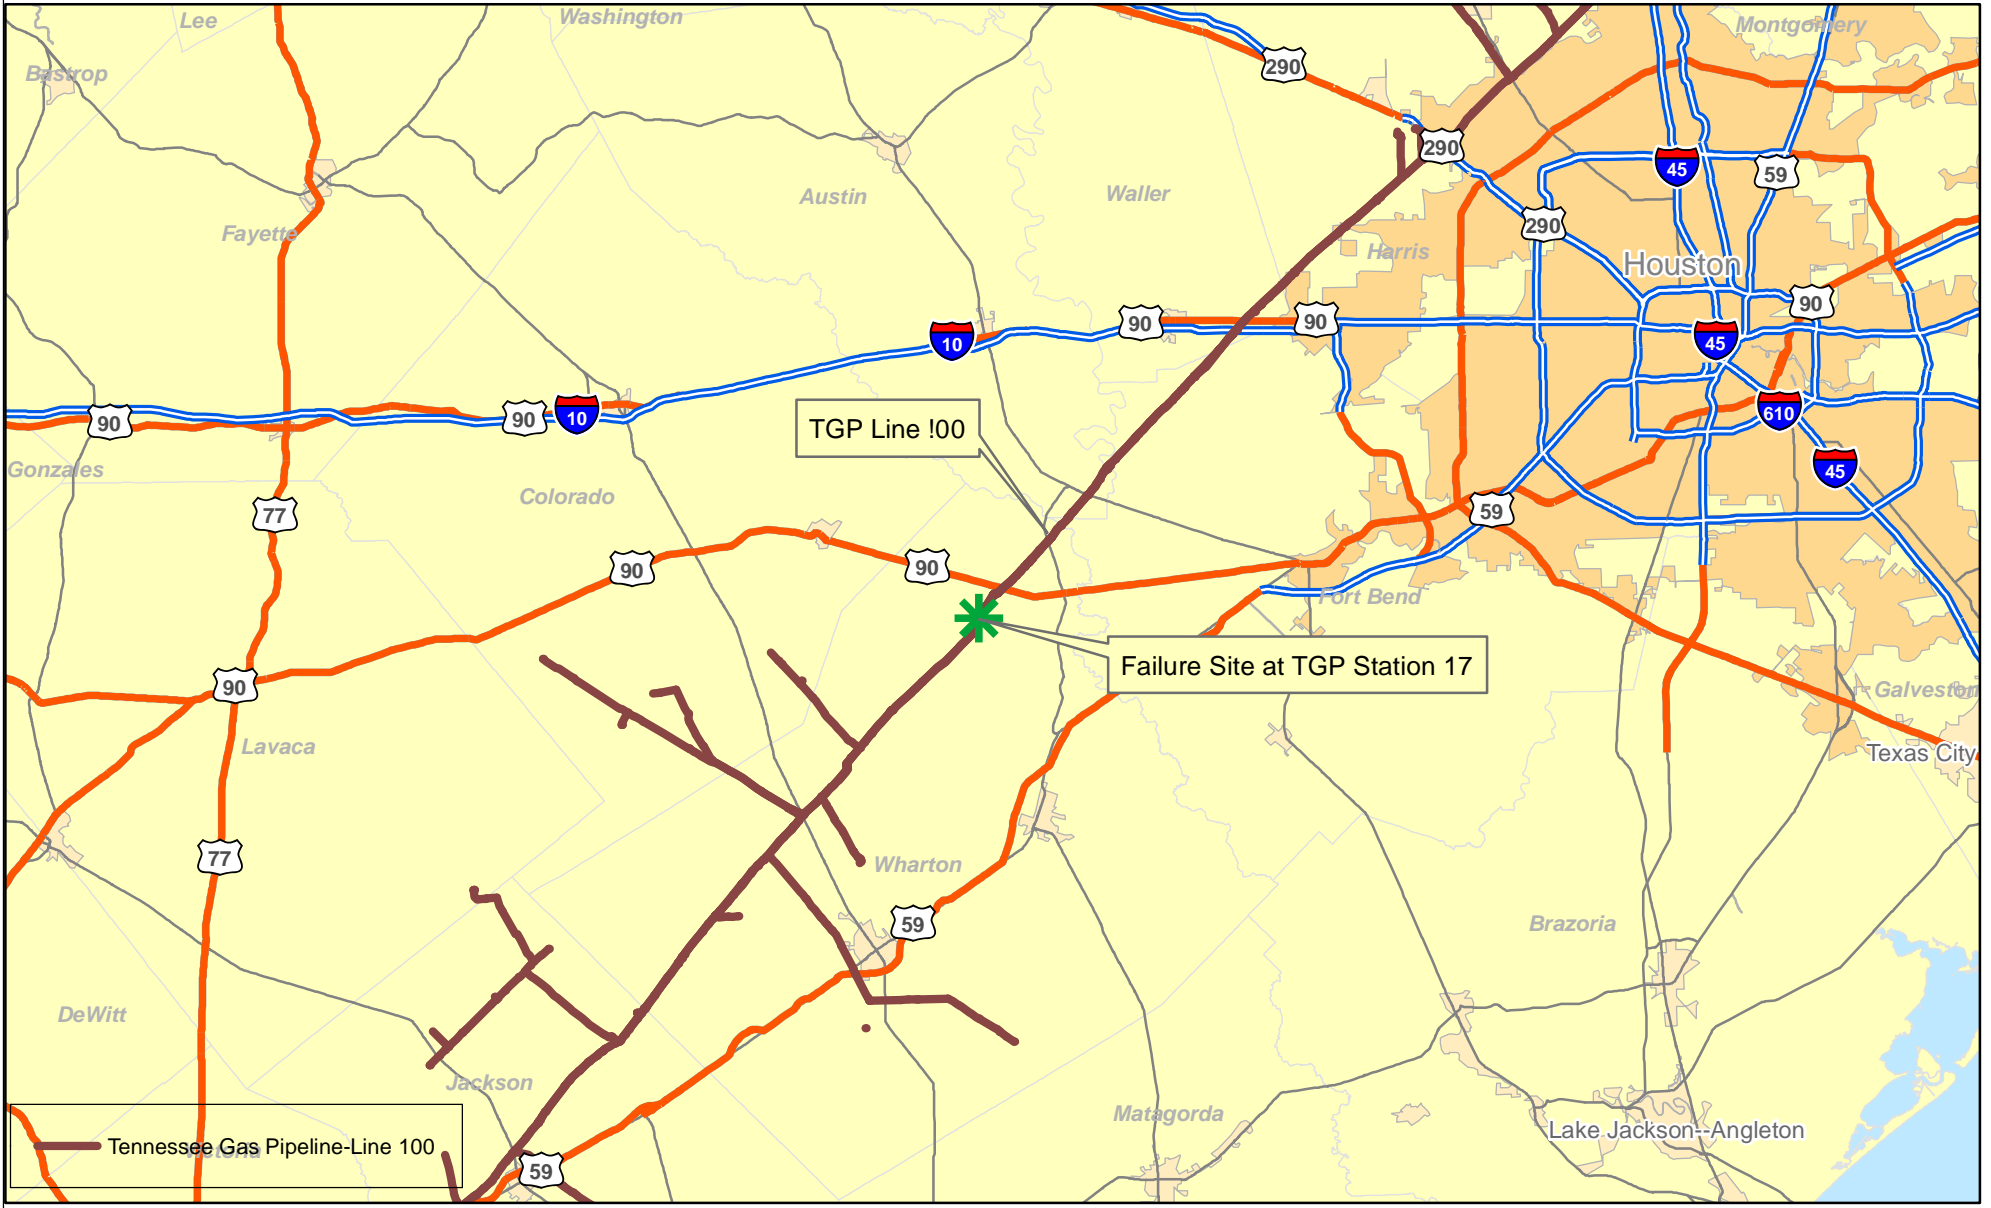
Figure D1 - Rupture Location

The MAOP of the Station piping is 750 psig and the incident occurred at 720 psig. The incident was a sudden rupture, leaving a 100' X 25' hole around the pipeline and extricating approximately a 12' section of pipe from the ditch. No injuries or fire was associated with this incident and all damages were contained within the station site.

The PHMSA Investigator was able to view the site with the operator. The failure was a full guillotine failure of the pipeline. Photos of the failed section can be seen in Appendix D.
