#### Federal Aviation Administration Airfield Pavement Working Group

Airport Authority Pavement Perspective Seattle-Tacoma International Airport Ralph L. Wessels, PE

#### **#1 Runway Pavement Pop-Outs**

## Evaluation of RW 16R/34L

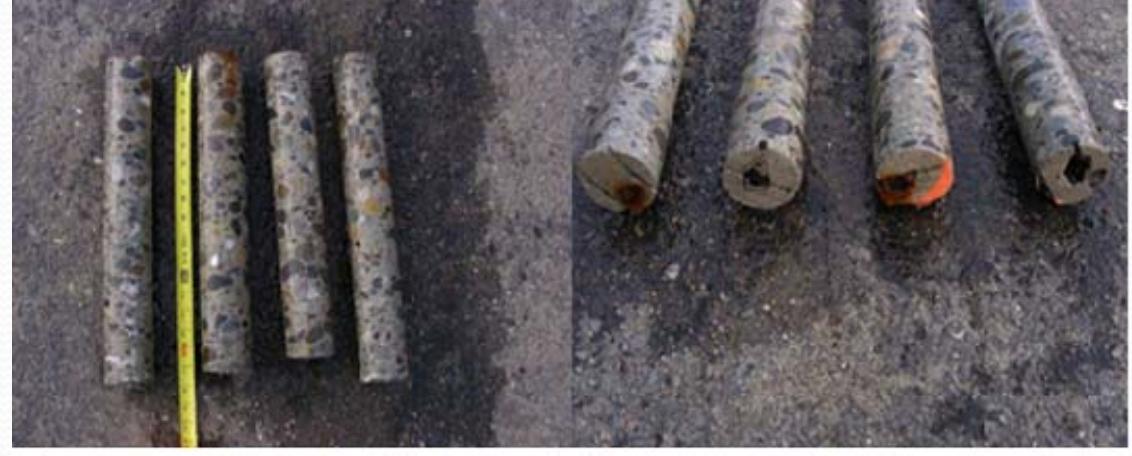
- Forensic evaluation of records.
- Literature and case study review.
- Limitations on availability of project personnel.
- Two visual surveys.
- Samples taken for petrographic examination, scanning electron microscope, and chemical

analysis.

- Elevated level of sulfur and iron in dark, soft aggregate.
- Mostly granitic and siliceous metamorphic rock.
- Some coal throughout slab with higher concentration near the surface.
- No alkali-silica reaction.
- Visit to fly ash plant revealed that there was no opportunity for coal to be introduced there.

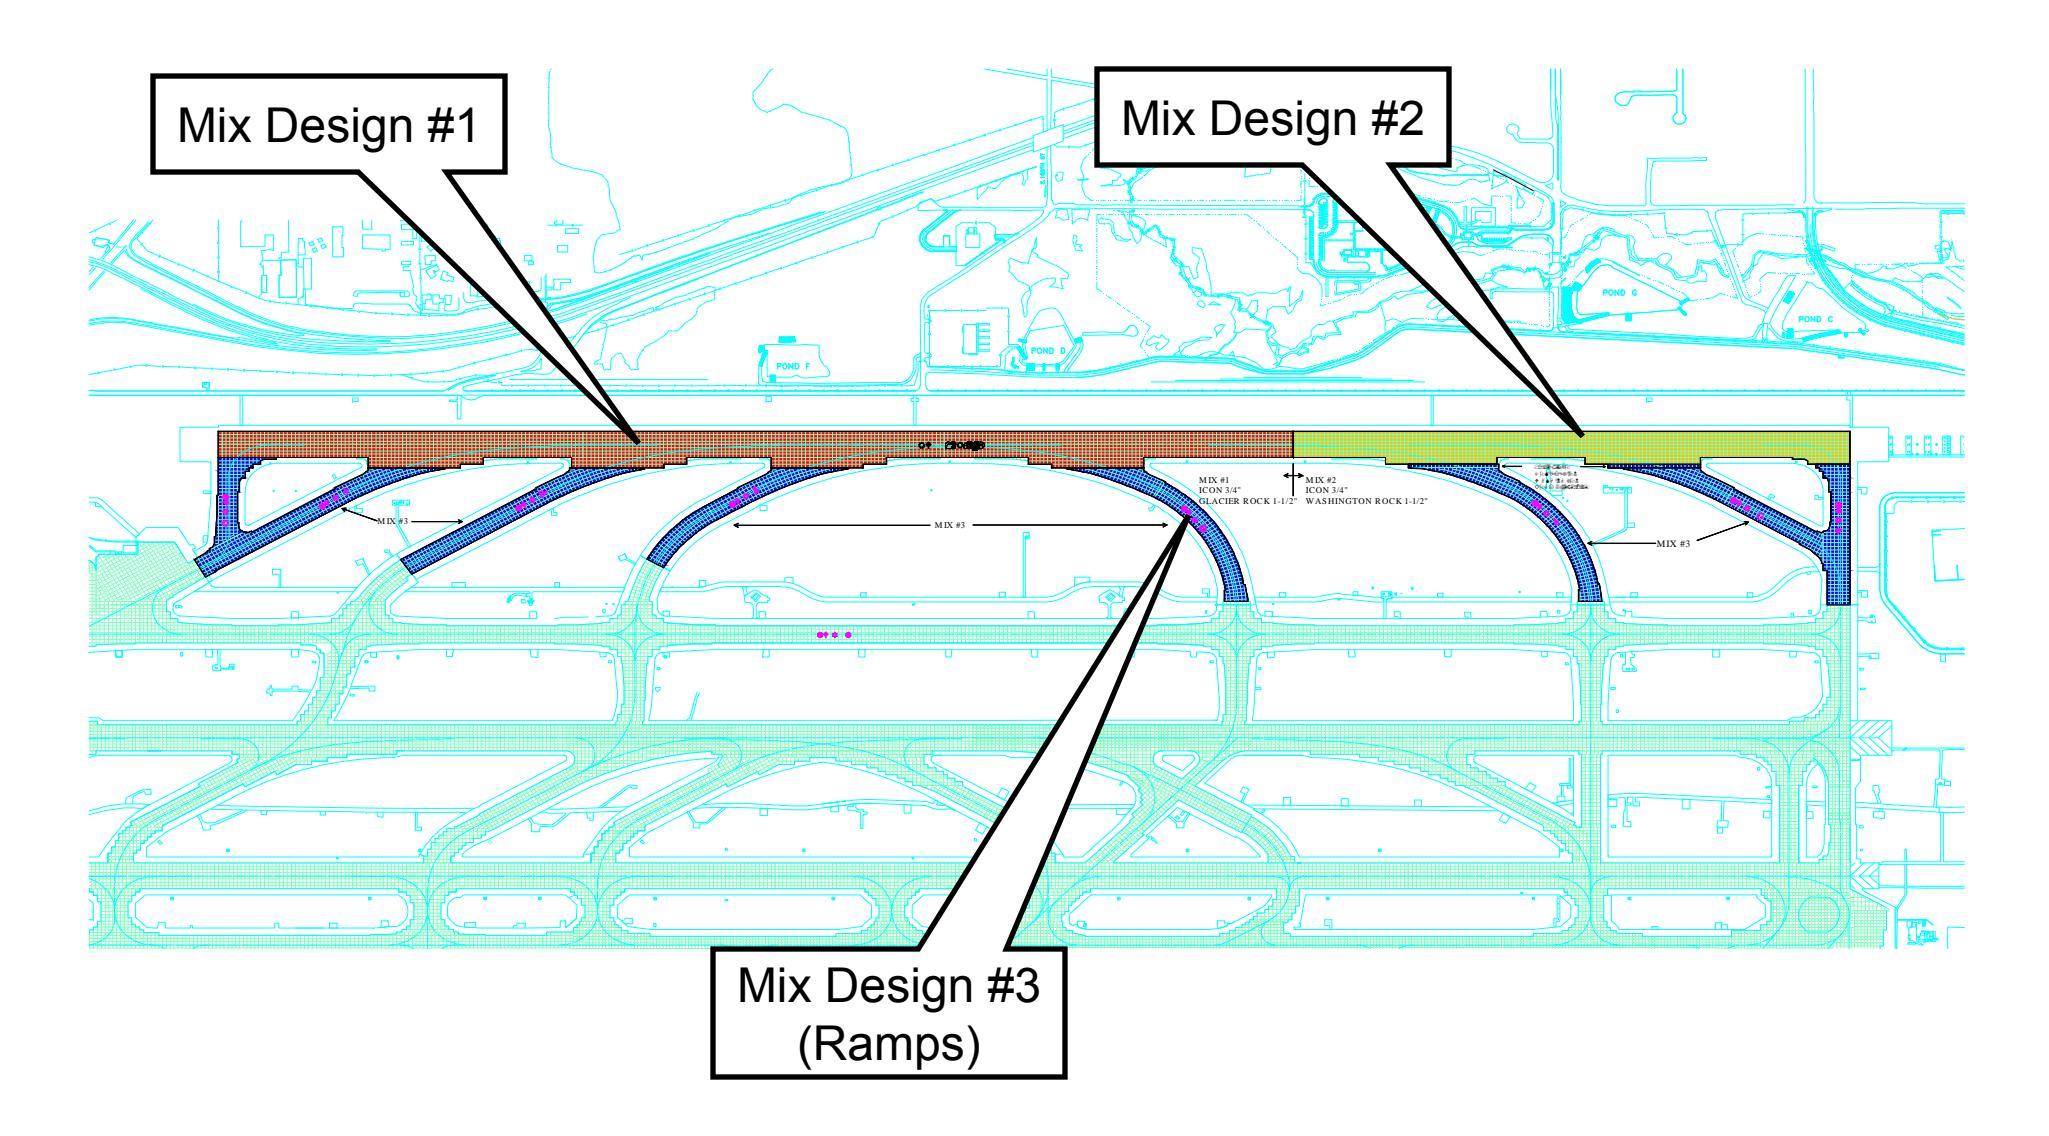
## Mix Design Locations

- Loss specific to pavement that used mix design #1 or #2
- Minimal loss where mix design #3 used.
- The source of aggregate is different for the three mixes.
- Other concrete components not changed between mixes.
- Logic and examination of concrete indicate that aggregate is the issue!
- Confirmation glaciation resulted in some coal being distributed in the pit.
