NCHRP Report 350 Test Report Compilation

Full-Scale Crash Evaluations of the ET Plus[®] End Terminal with 4-inch Wide Guide Channel Installed with a Rail Height of 31 Inches

Test Level 3, Test 3-33, 3-31, 3-32, and 3-30

SwRI[®] Project No. 18.20887

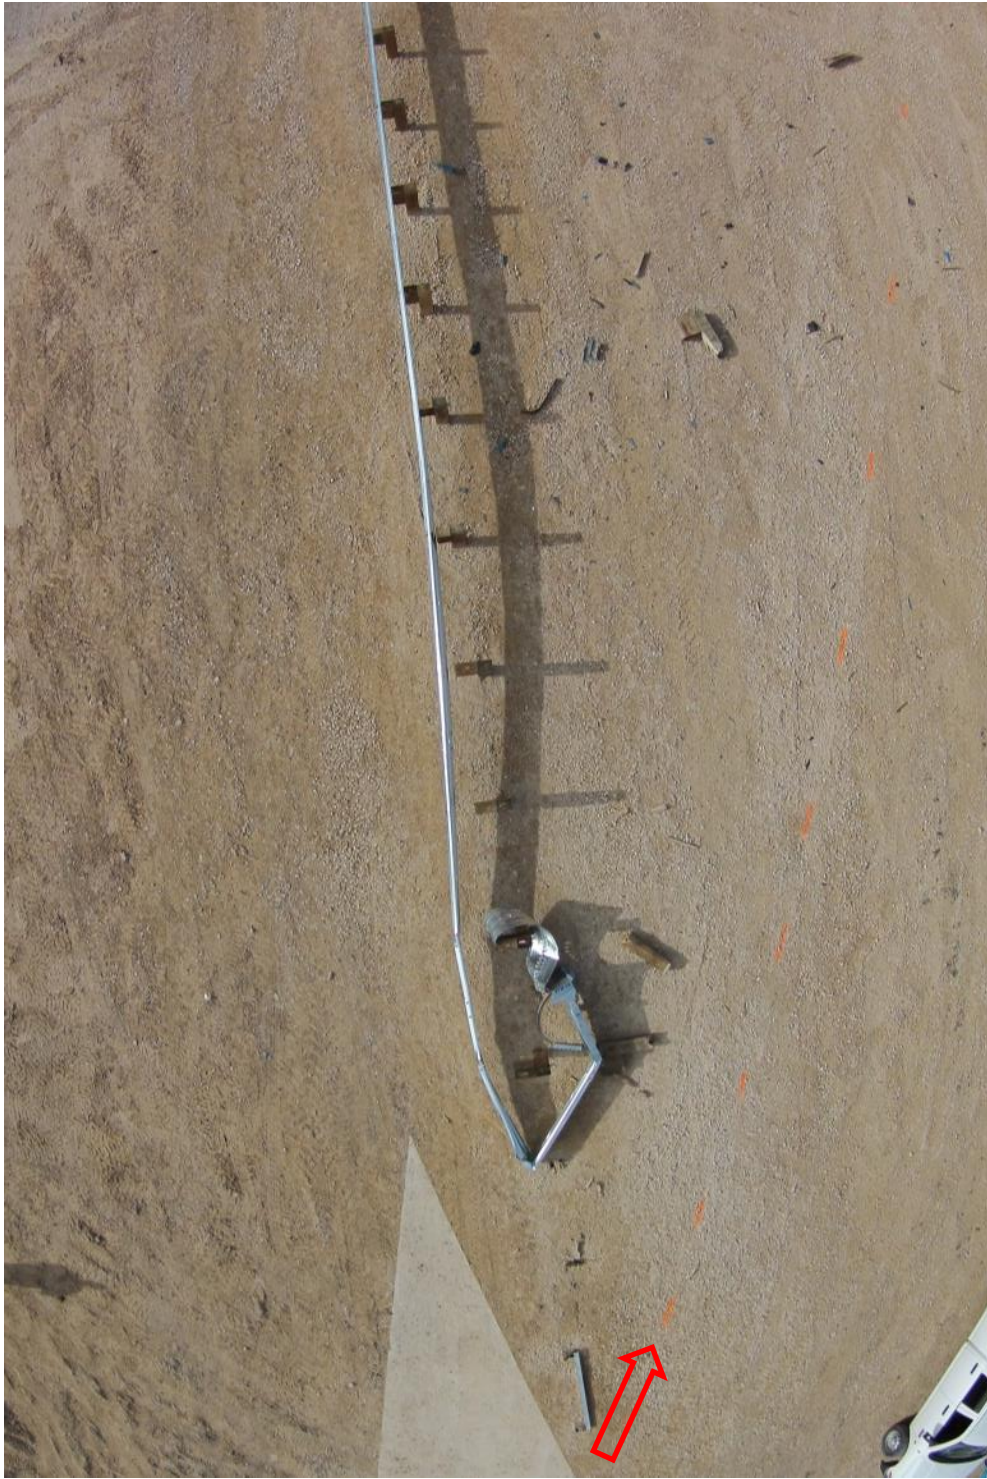
Figure 3.6: Post Test – Debris Field on Non-Traffic Side and Vehicle Path (Orange Paint)

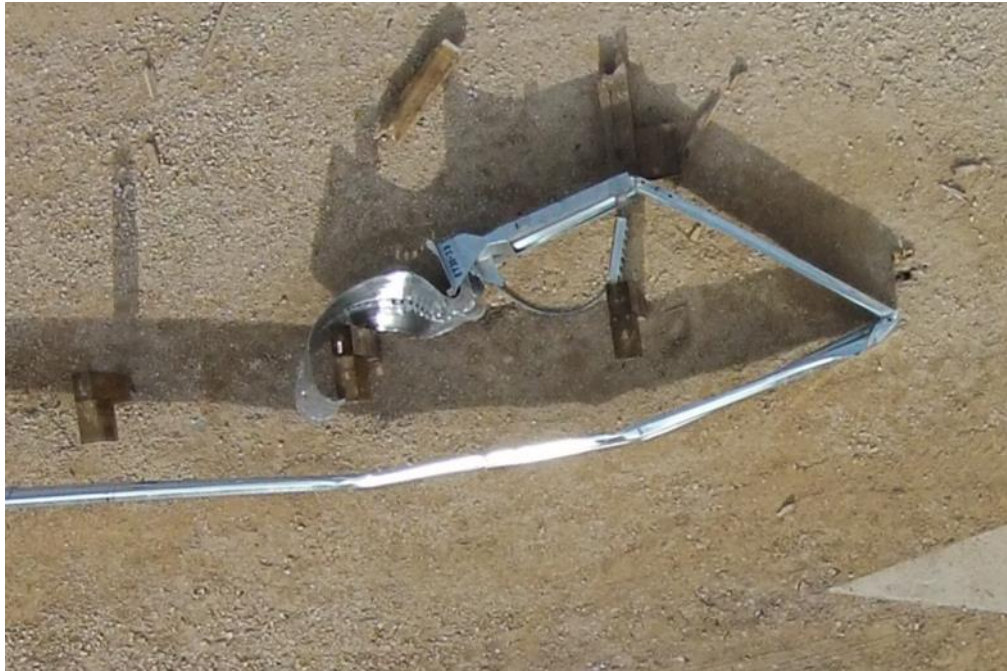
Figure 3.7: Post Test – Overhead View of Gated Terminal

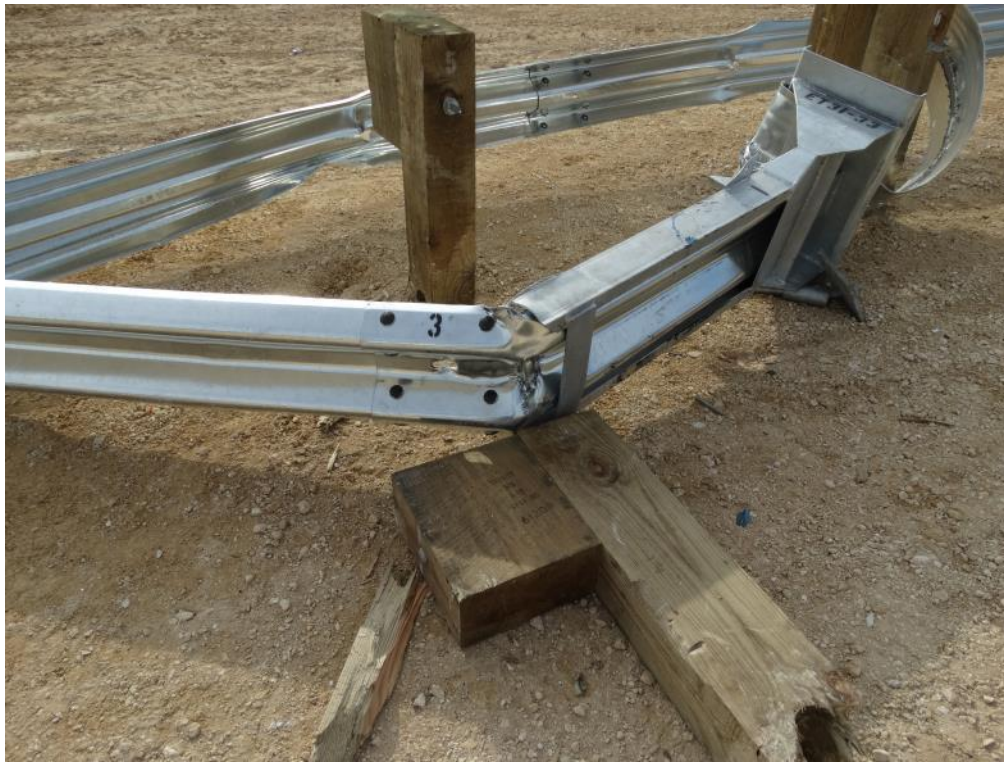
Figure 3.9: Post Test – Traffic Side of Guide Channel Entrance (Post 4 in Foreground)

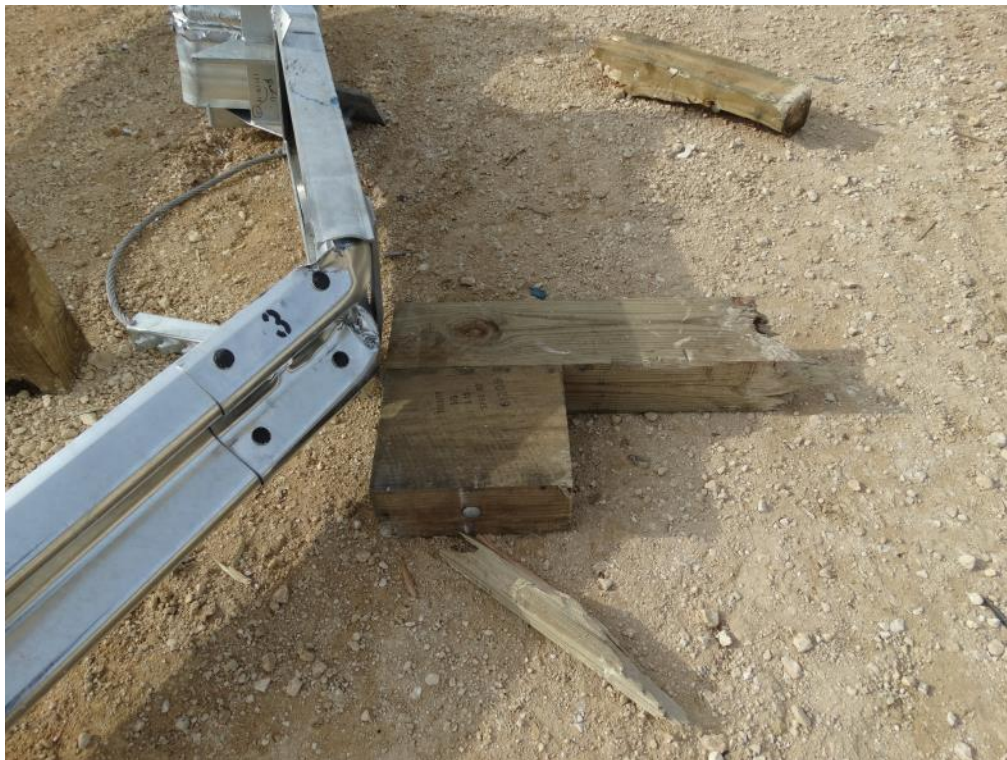
Figure 3.16: Post Test – Traffic Side View of First Splice (Bolts Painted for Visibility in Video)

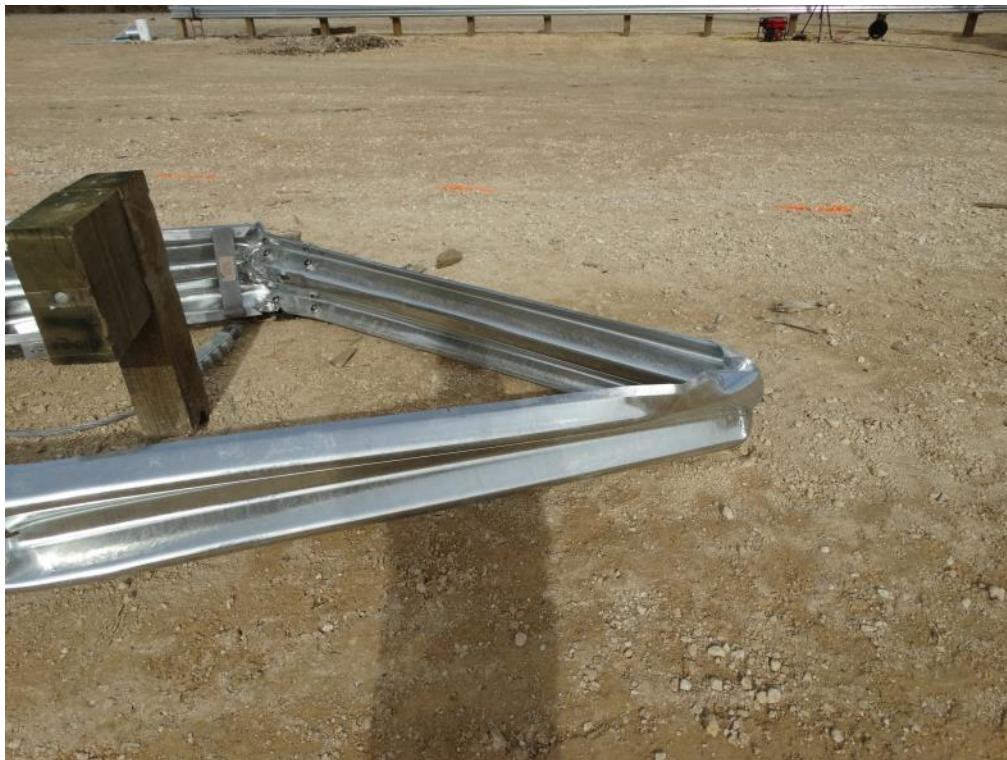
Figure 3.18: Post Test – Traffic Side View of W Beam Fold at Post 4

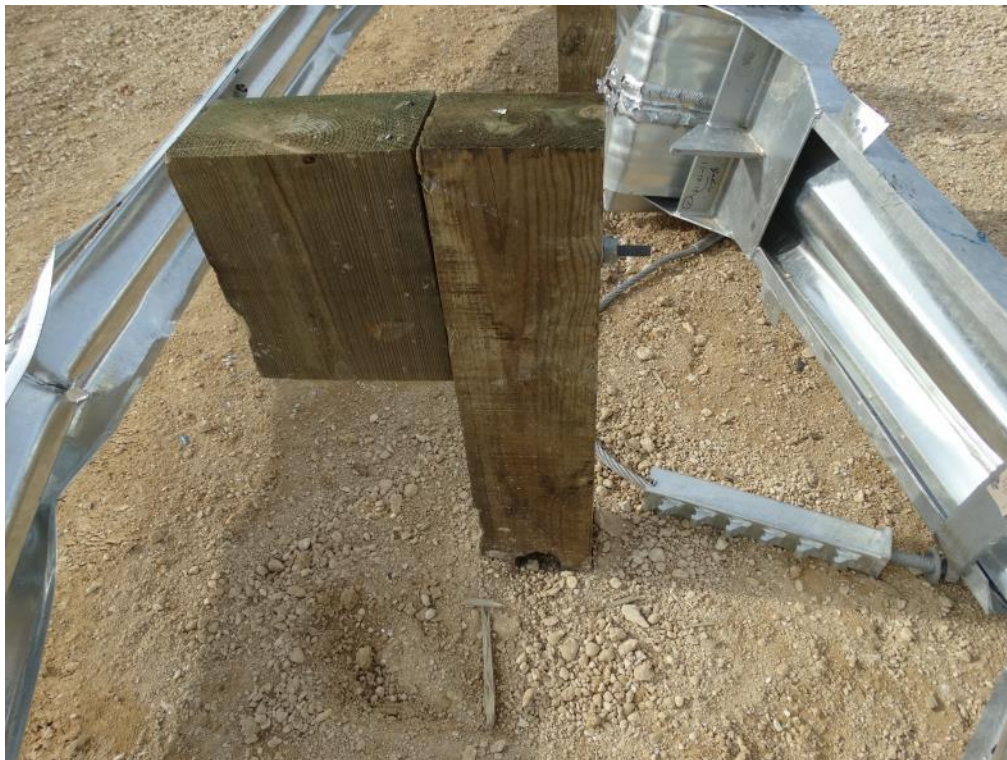
Figure 3.20: Post Test – Side View of Post 5 and Anchor Cable

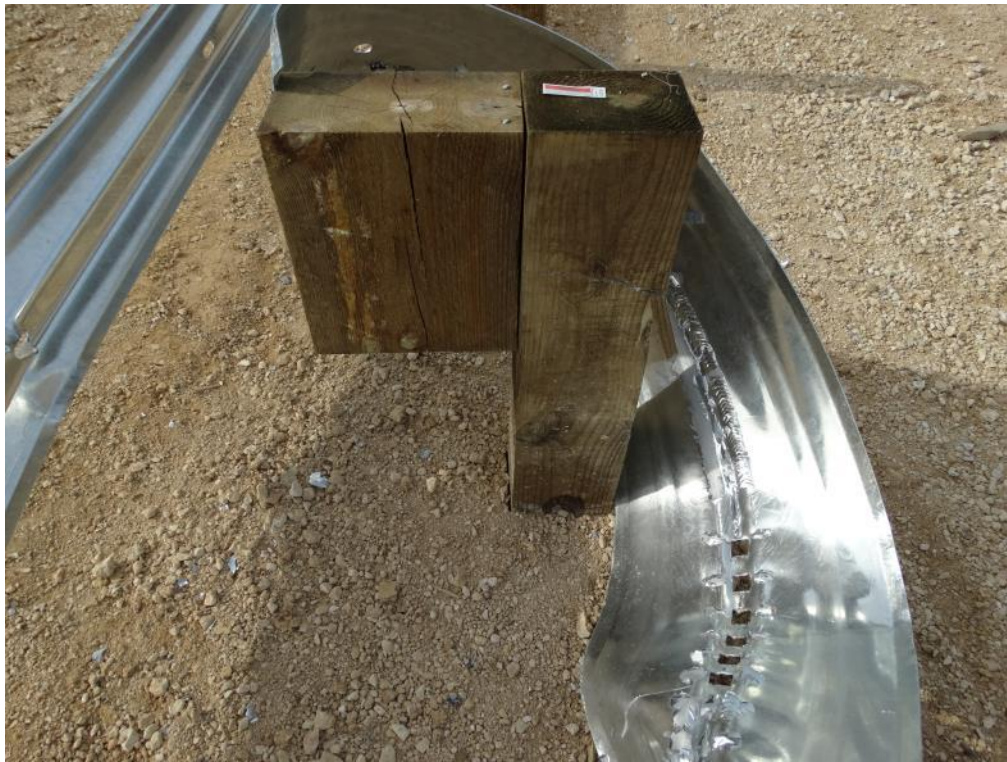
Figure 3.23: Post Test – Side View of Post 6

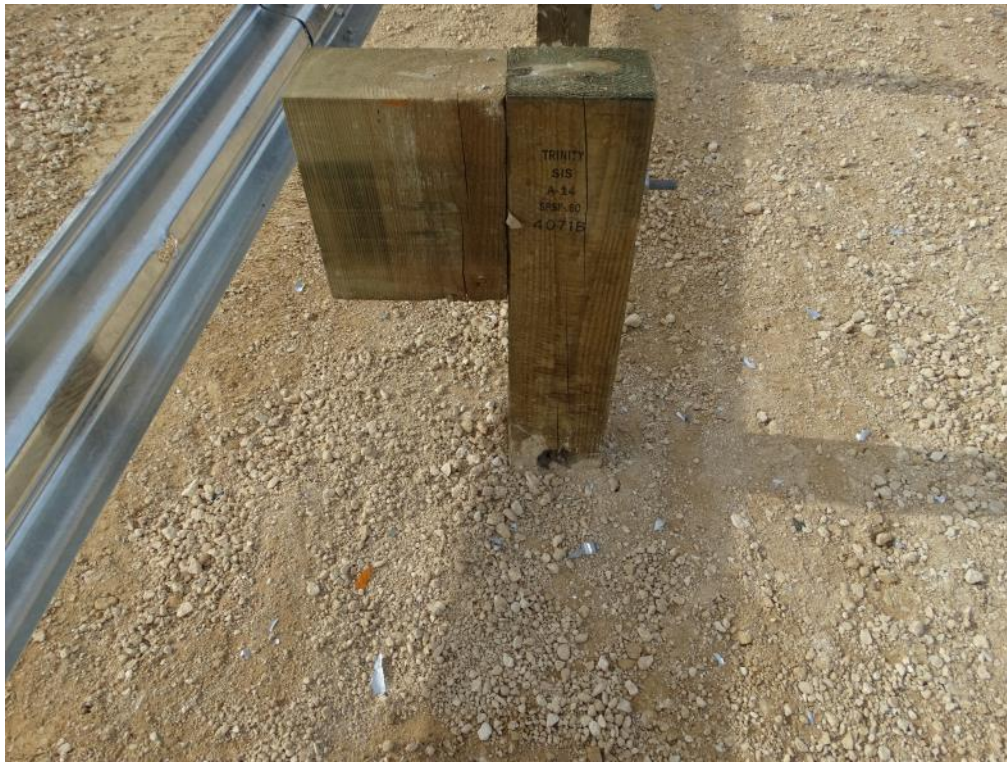
Figure 3.25: Post Test – Side View of Post 7

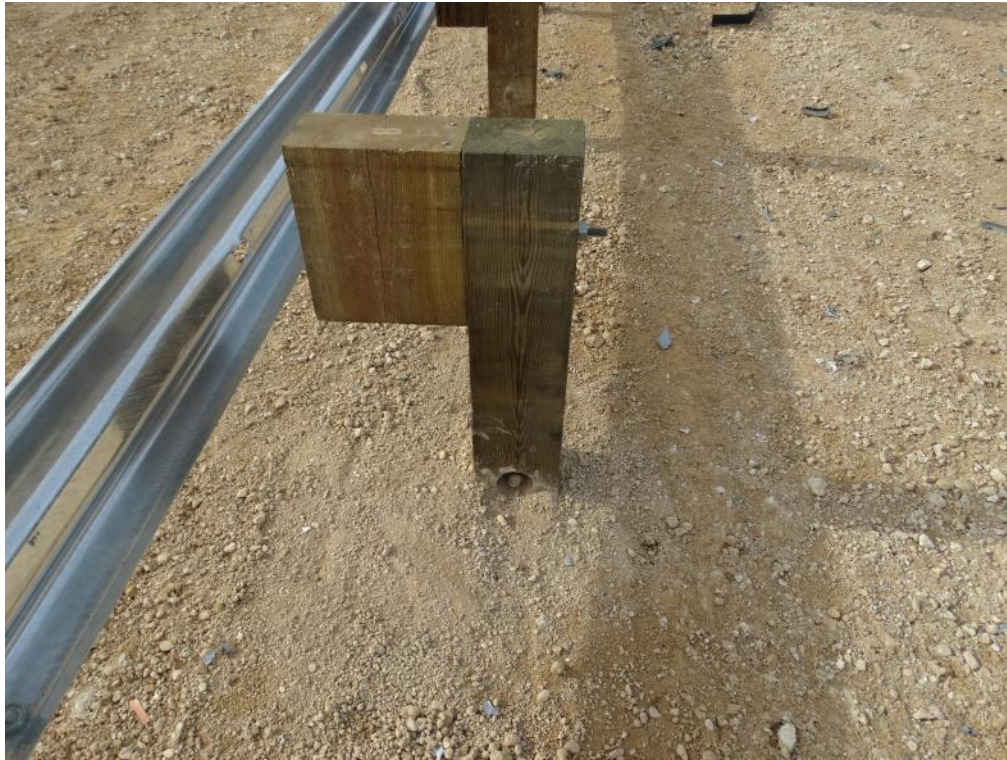
Figure 3.27: Post Test – Side View of Post 8

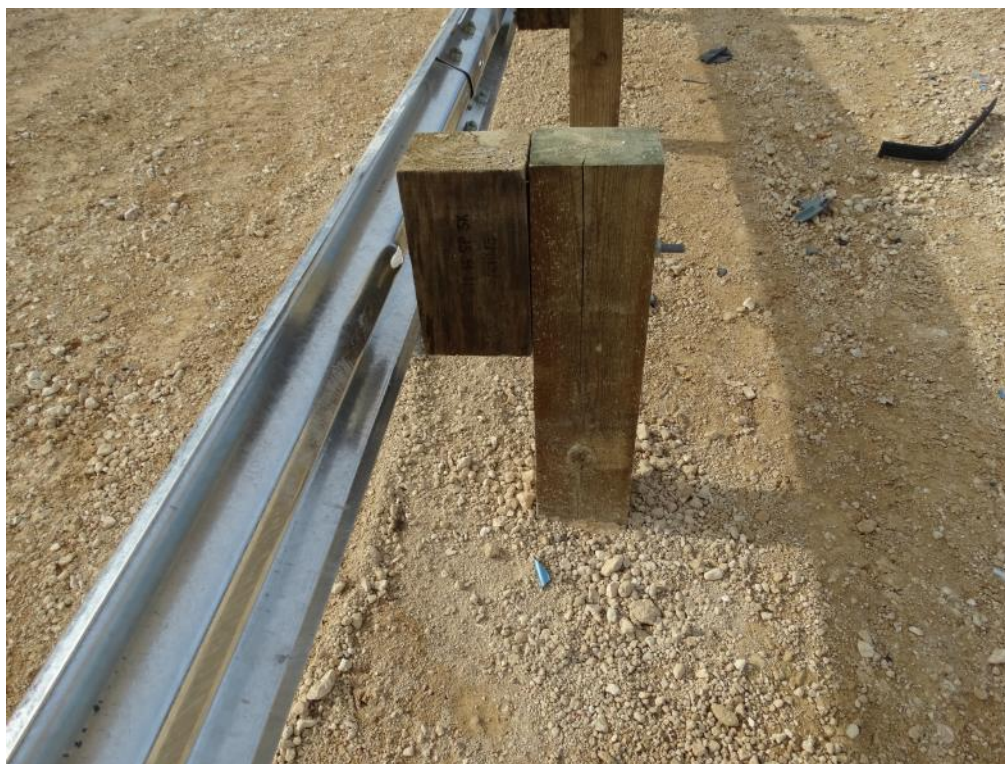
Figure 3.29: Post Test – Side View of Post 9

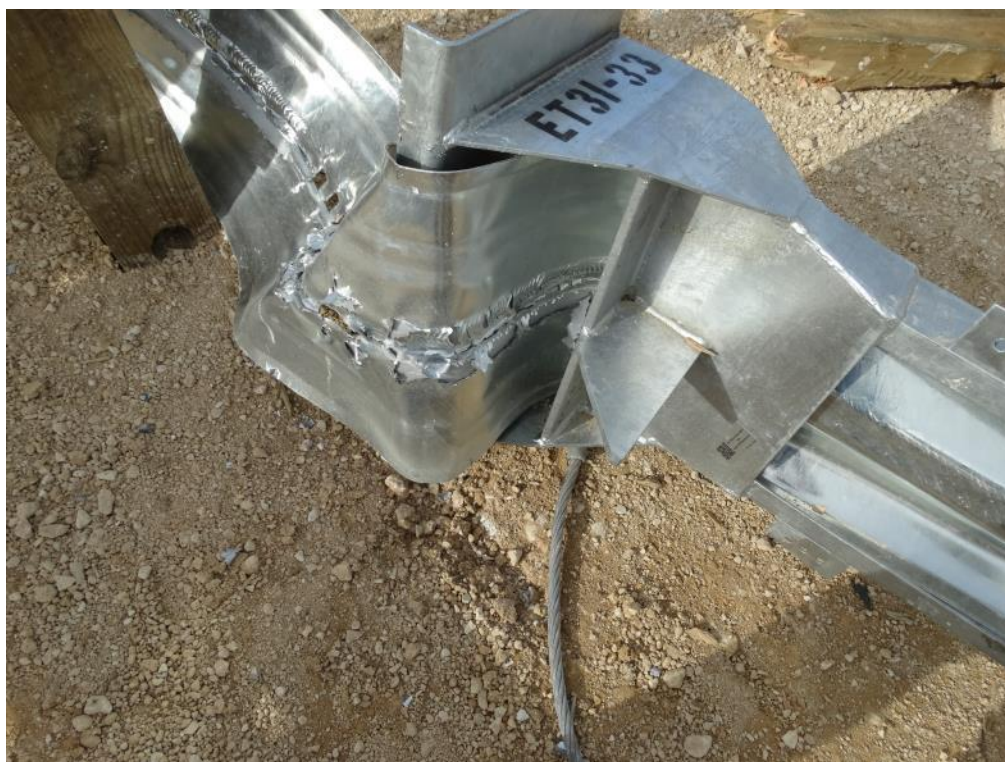
Figure 3.30: Post Test – ET Plus Head and Extruded Rail, Non-Traffic Side

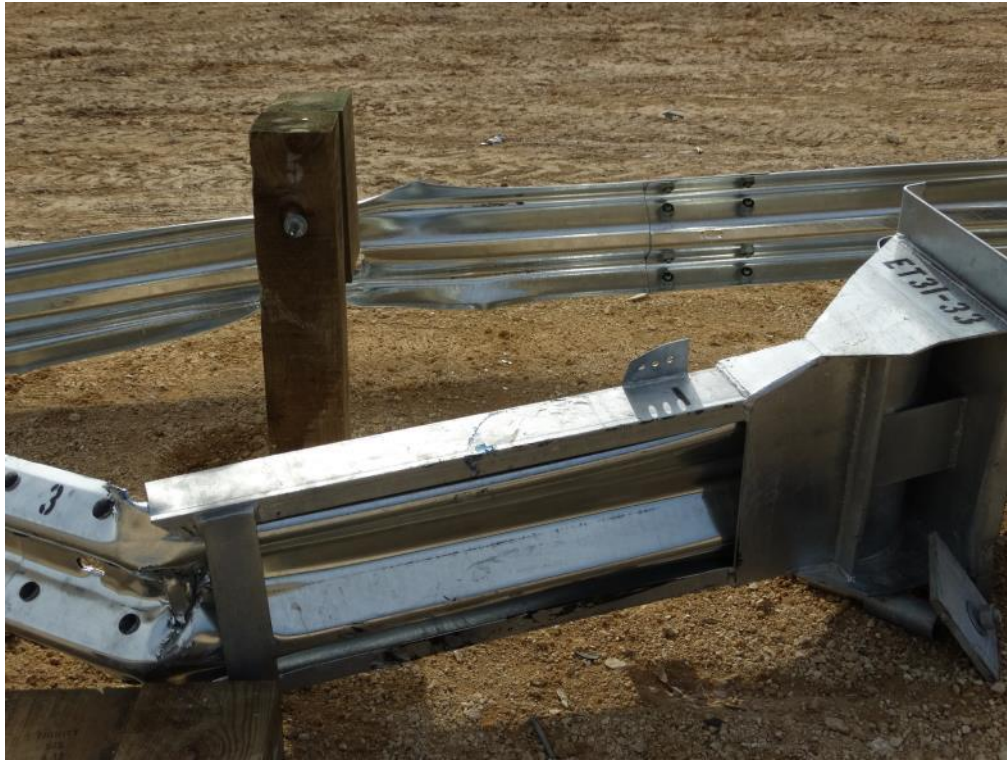
Figure 3.31: Post Test – ET Plus Head Guide Channels, Traffic Side

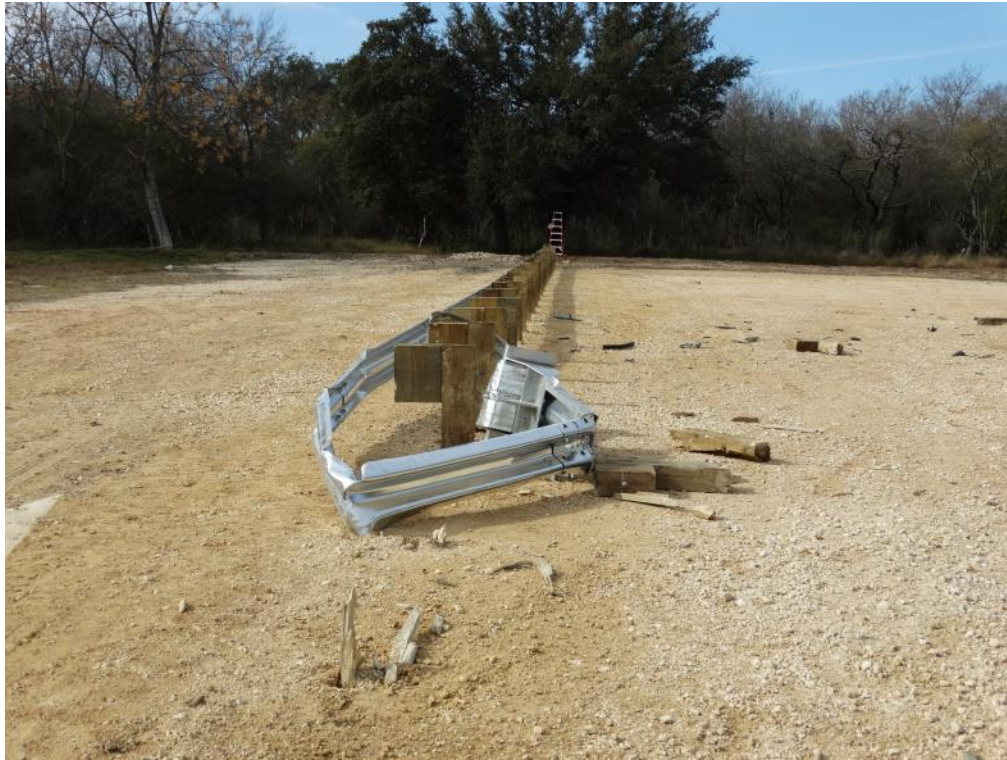
Figure 3.35: Post Test – Debris Field on Non-Traffic Side

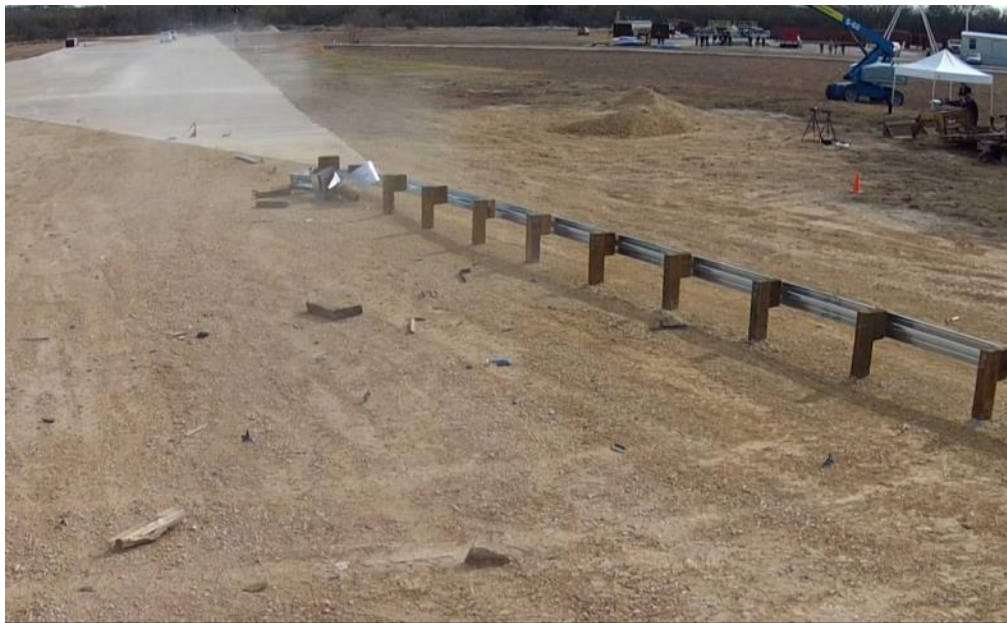
Figure 3.36: Post Test – Debris Field on Non-Traffic Side Viewed from Downstream

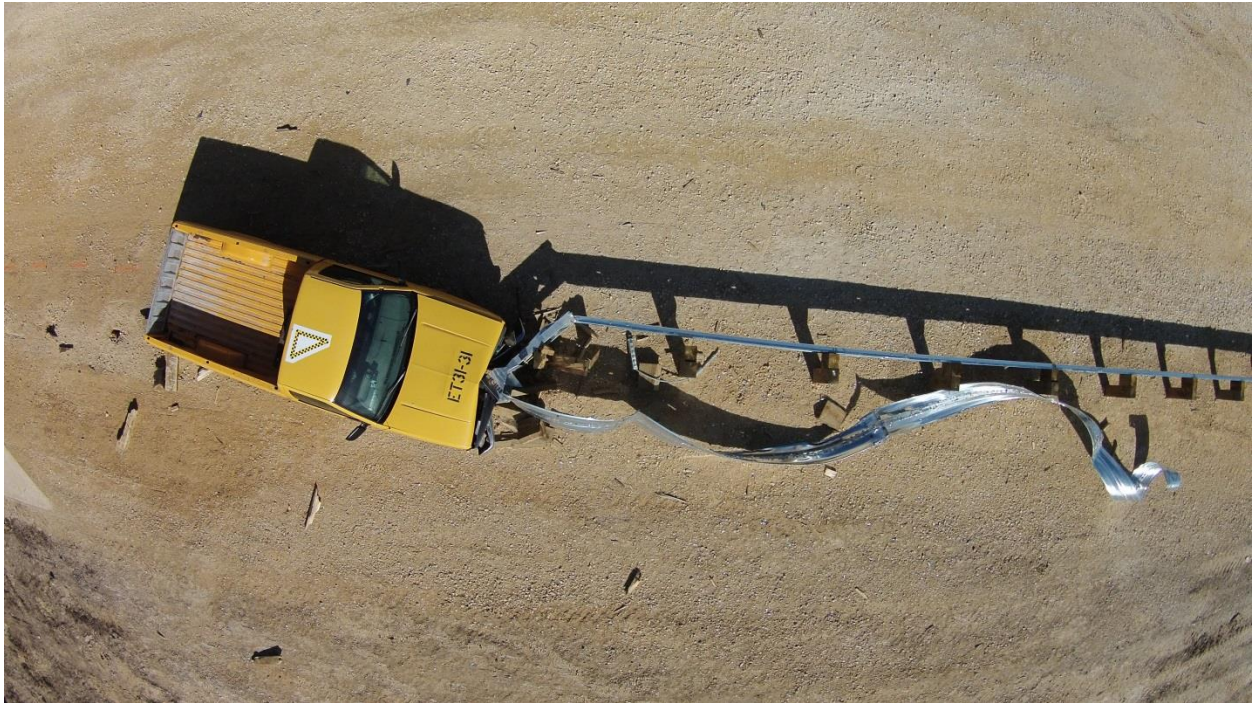
Figure 3.6: Post-Impact Condition of the Test Article and Vehicle

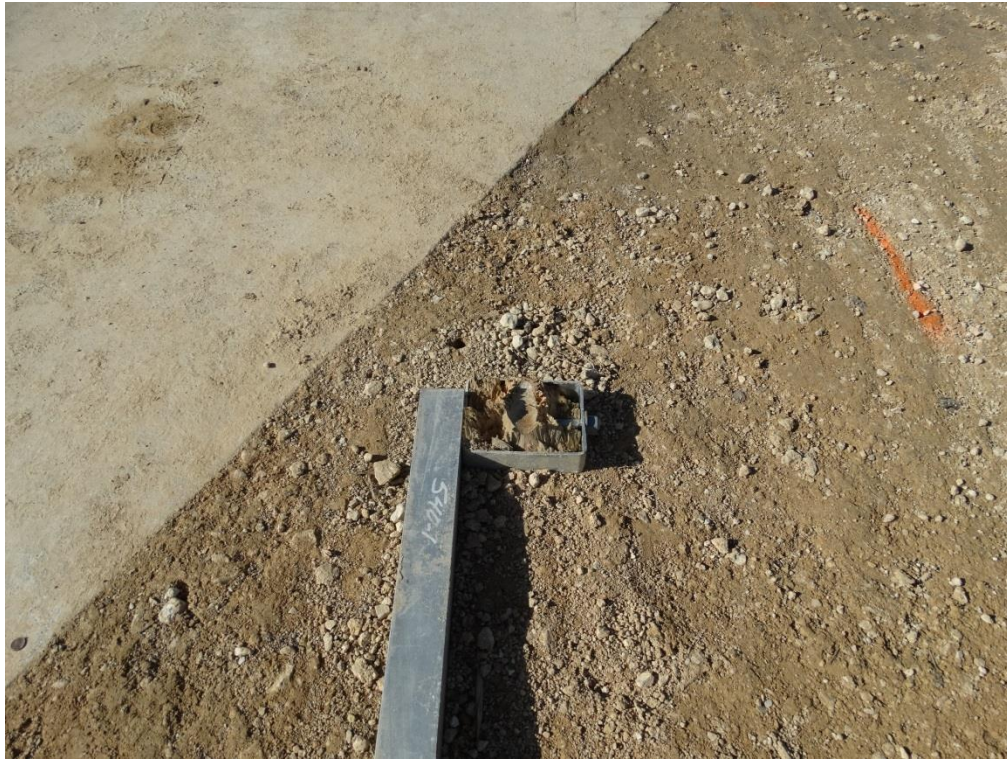
Figure 3.8: Post Test – Post 1 Foundation Sleeve

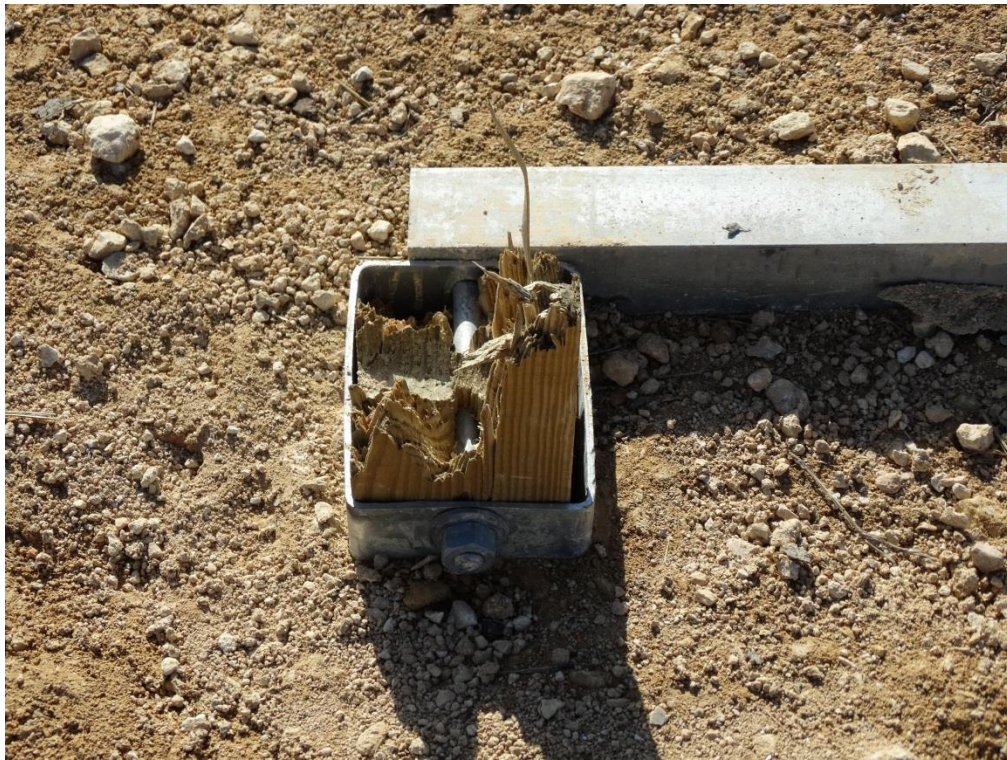
Figure 3.9: Post Test – Post 2 Foundation Sleeve

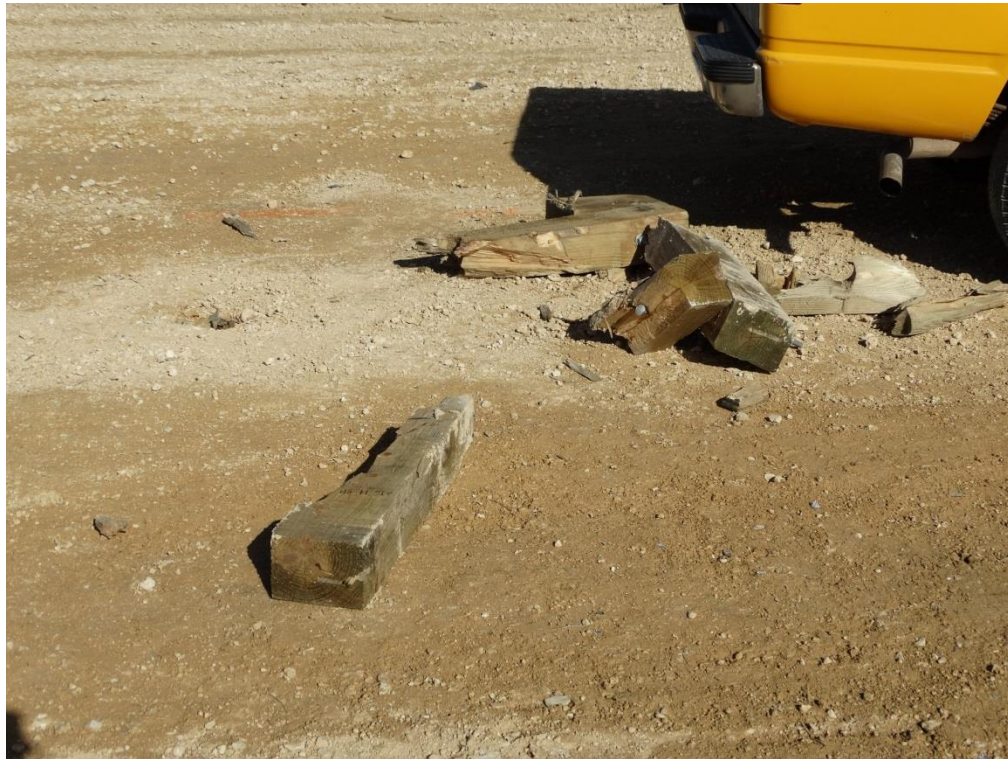
Figure 3.11: Post Test – Posts 1, 2, 3 and 4 at Rear of Truck

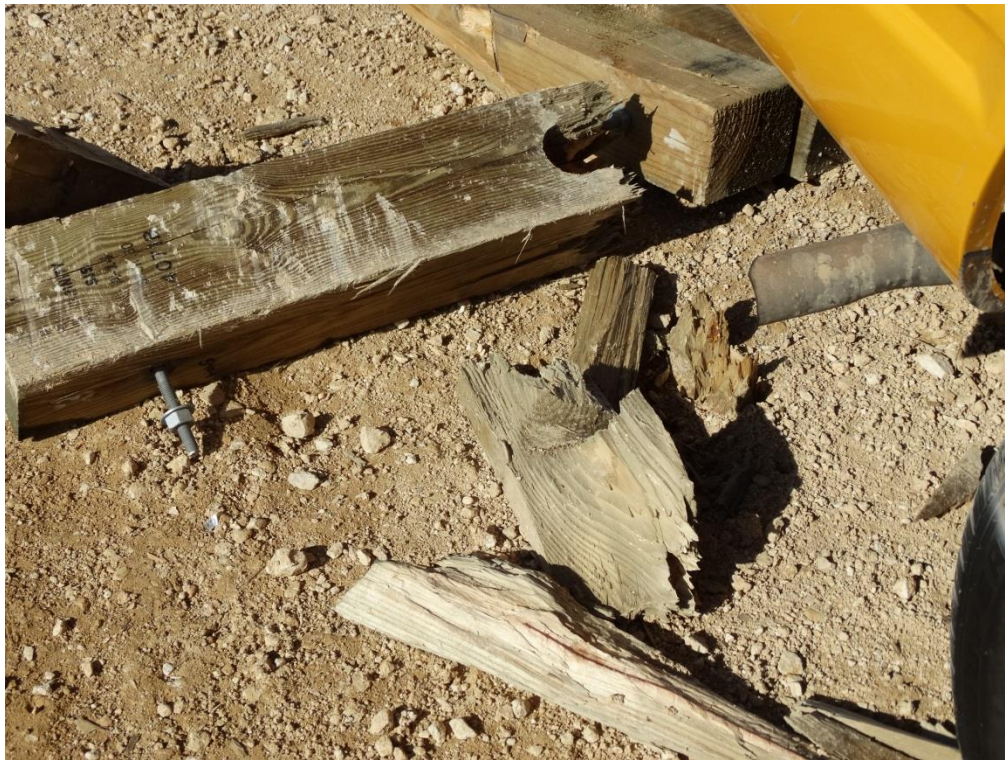
Figure 3.12: Post Test – Posts 3 and 4 at Rear of Vehicle

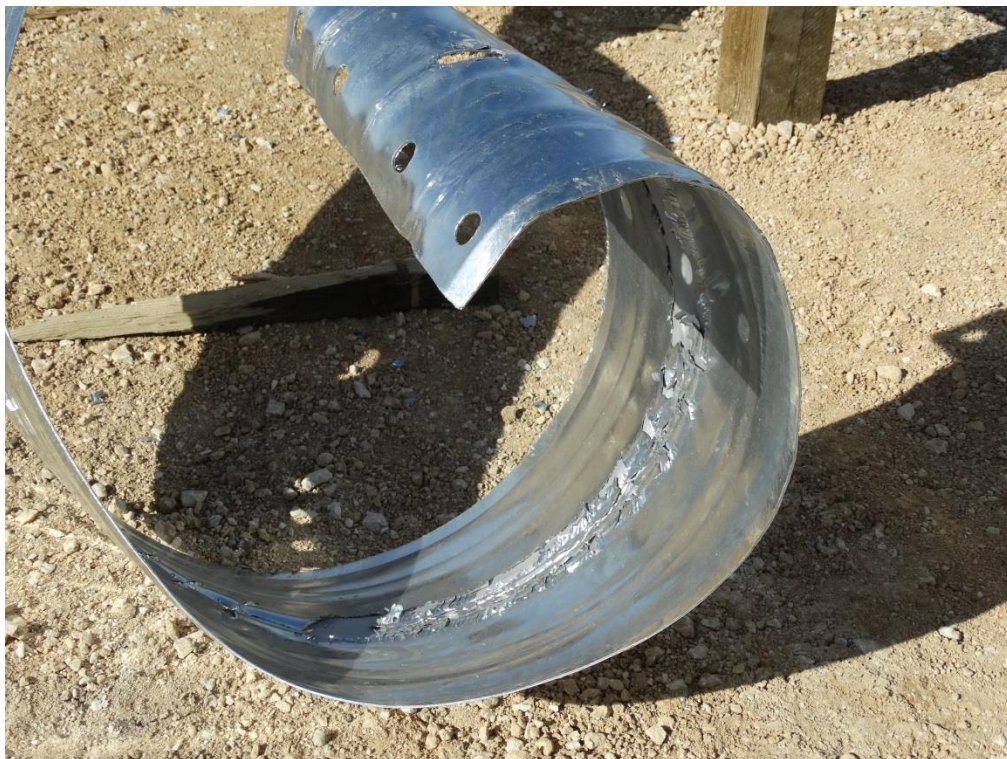
Figure 3.21: Post Test – Extruded Guardrail Coil

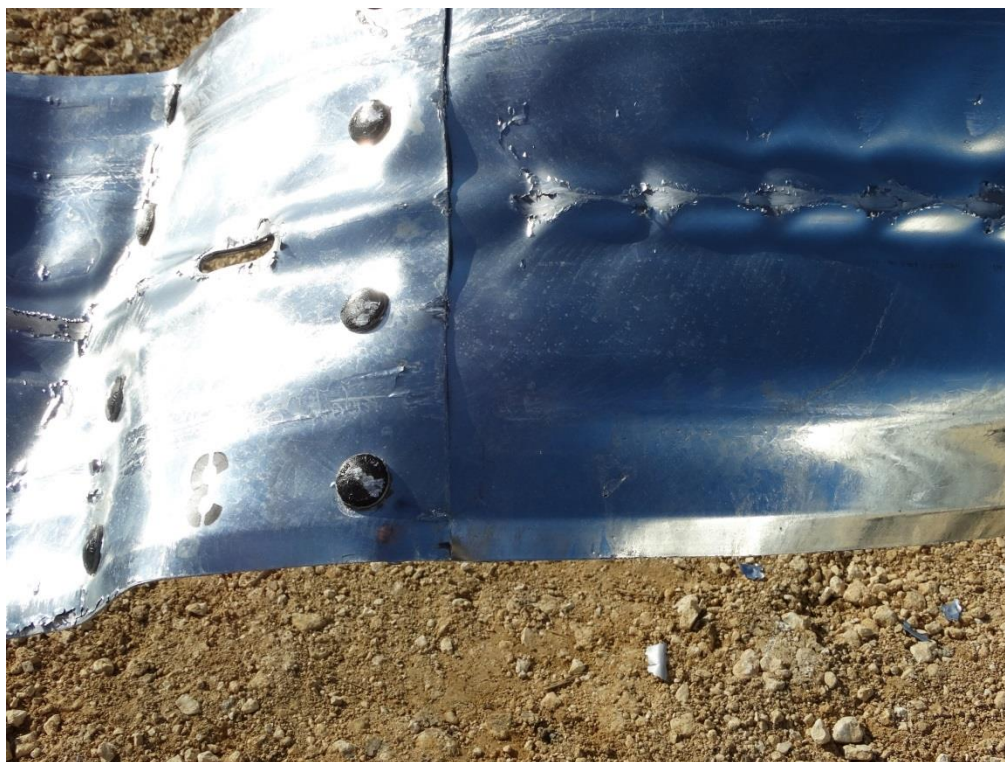
Figure 3.22: Post Test – Extruded Guardrail Splice from Post 3 (Splice Bolts Painted Pre-Test for Visibility in Video)

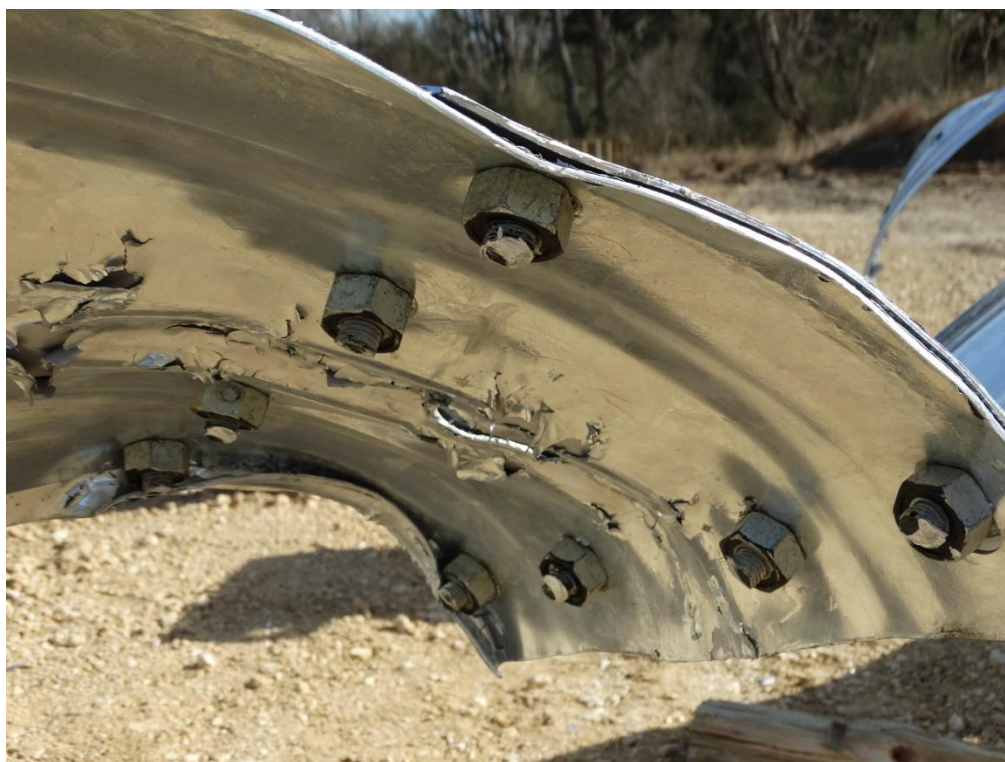
Figure 3.23: Post Test – Extruded Guardrail Splice from Post 3 (Splice Nuts Painted Pre-Test for Visibility in Video)

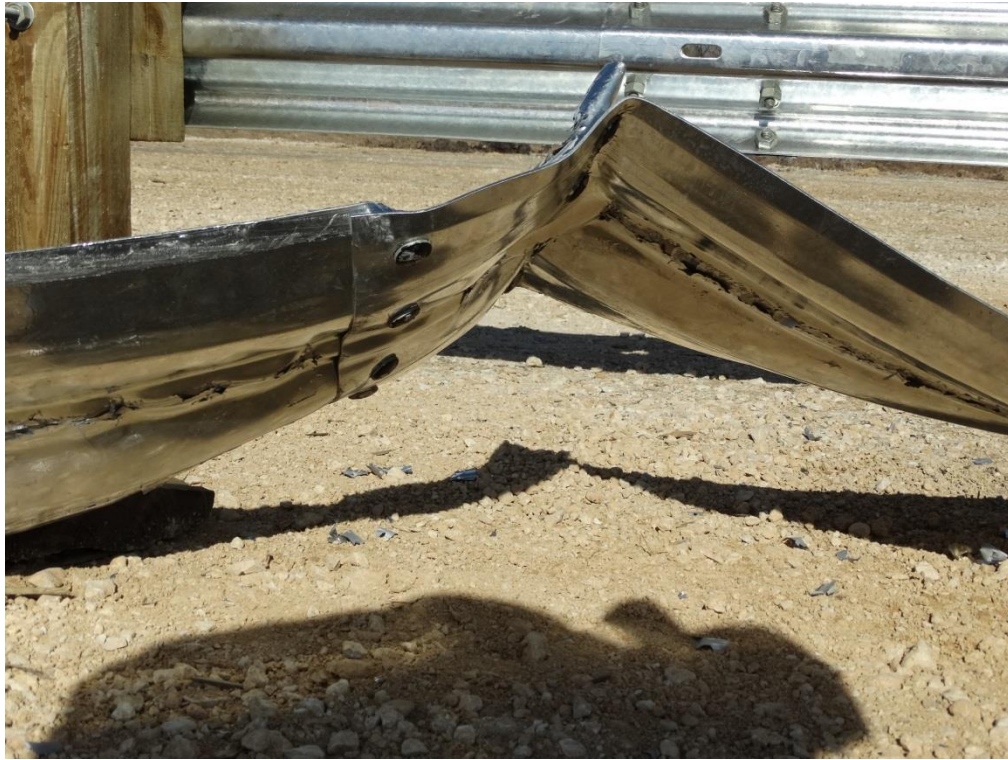
Figure 3.24: Post Test – Extruded Guardrail Splice from between Posts 5 & 6 (Splice Bolts Painted Pre-Test for Visibility in Video)

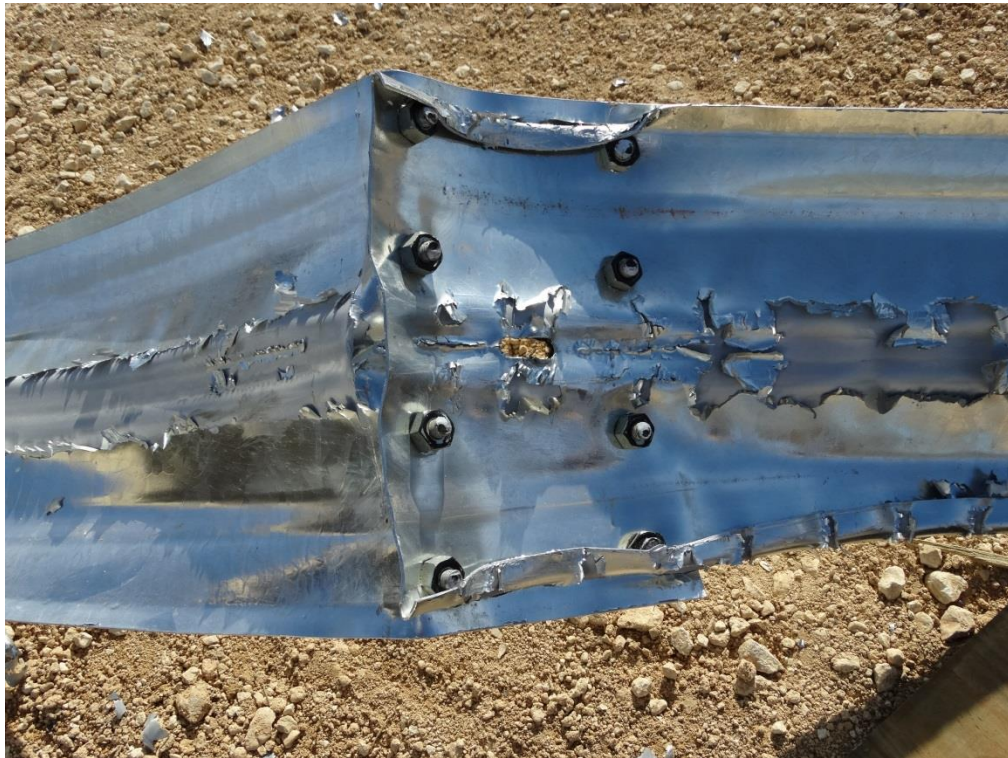
Figure 3.25: Post Test – Extruded Guardrail Splice from between Posts 5 & 6 (Splice Nuts Painted Pre-Test for Visibility in Video)

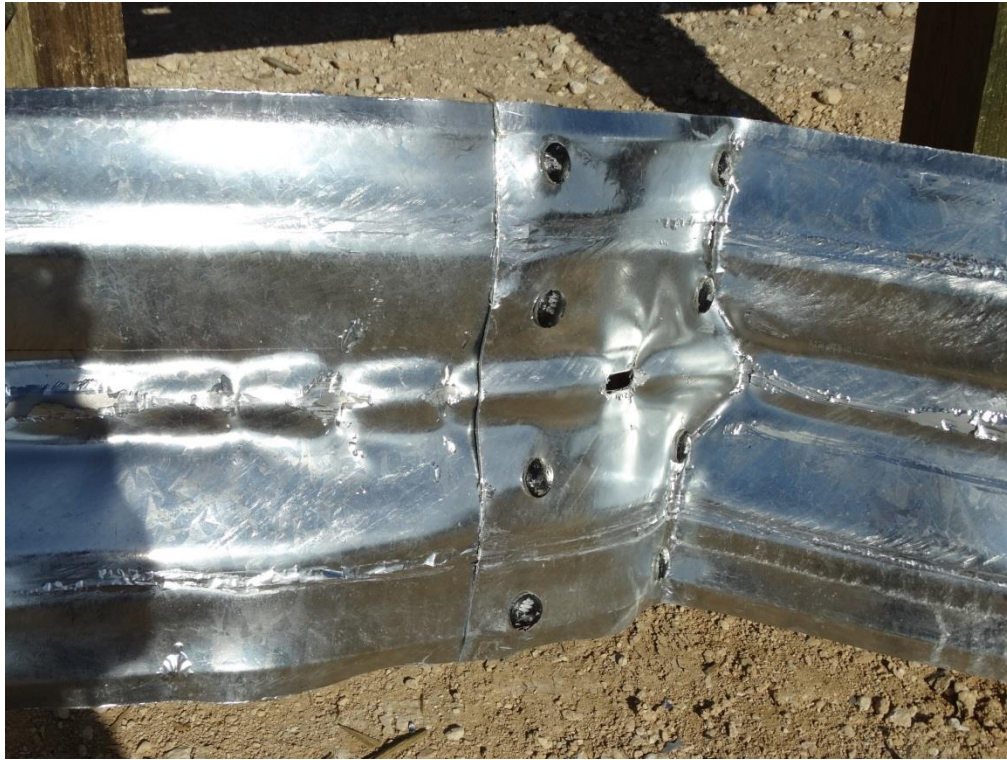
Figure 3.26: Post Test – Extruded Guardrail Splice from between Posts 7 & 8 (Splice Bolts Painted Pre-Test for Visibility in Video)

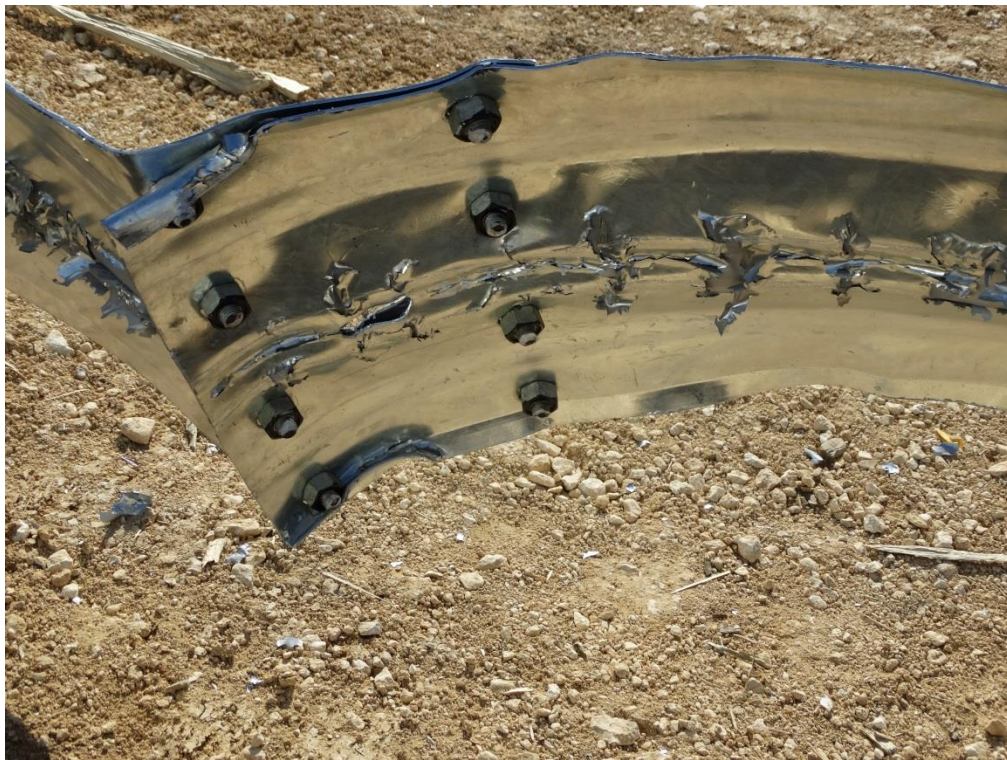
Figure 3.27: Post Test – Extruded Guardrail Splice from between Posts 7 & 8 (Splice Nuts Painted Pre-Test for Visibility in Video)

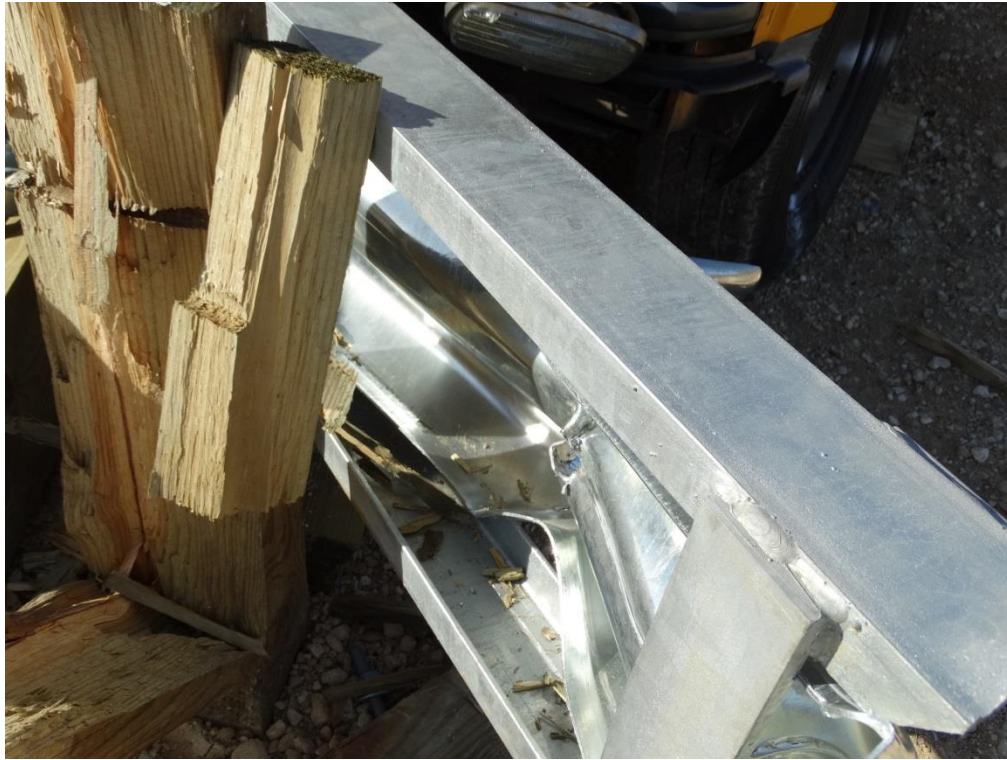
Figure 3.32: Post-Test – ET Plus Head, Non-Traffic Side, Close-up

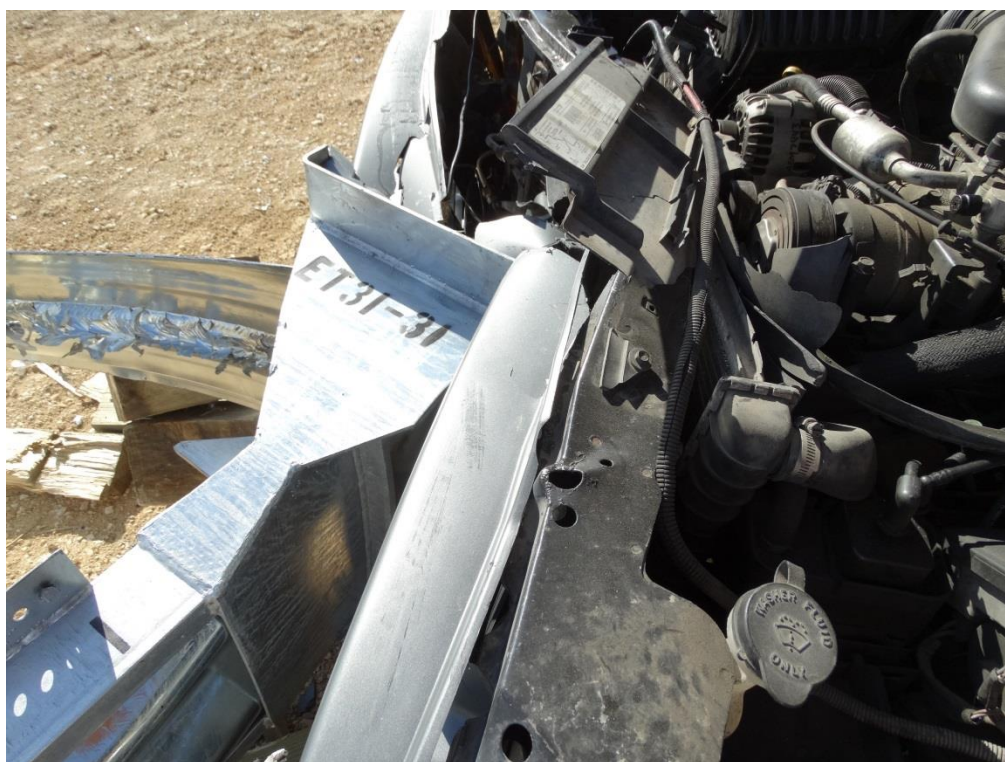
Figure 3.35: Post-Test – ET Plus Head at Front of Vehicle
