NCHRP Report 350 Test Report Compilation

Full-Scale Crash Evaluations of the ET Plus[®] End Terminal with 4-inch Wide Guide Channel Installed with a Rail Height of 31 Inches

Test Level 3, Test 3-33, 3-31, 3-32, and 3-30

SwRI[®] Project No. 18.20887

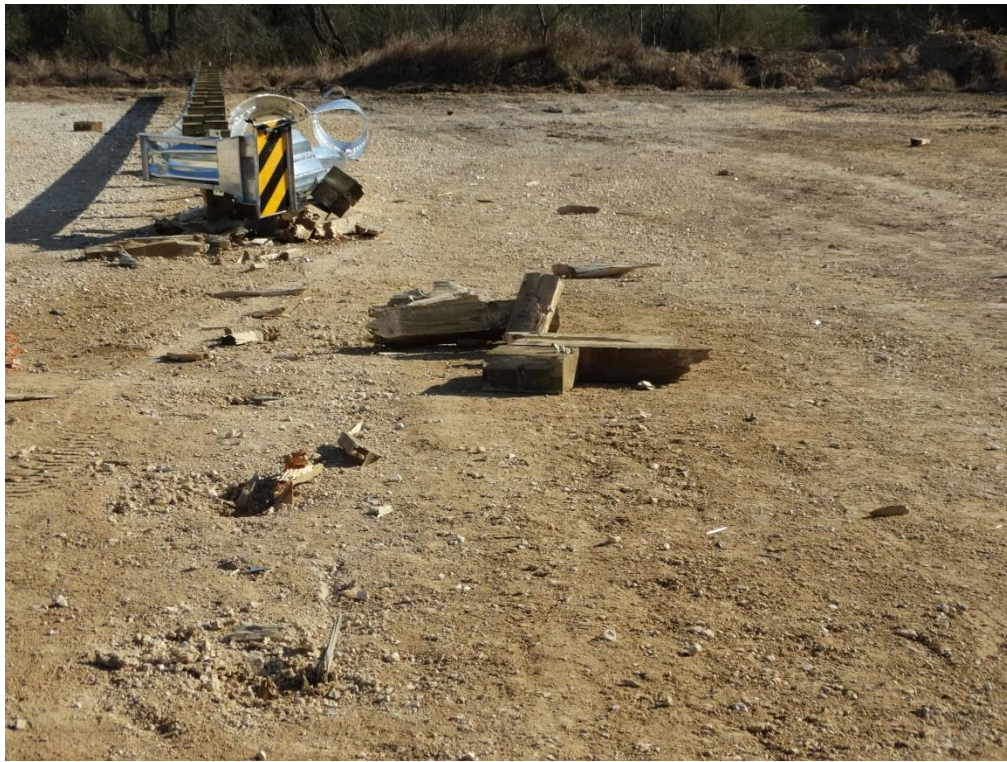
Figure 3.36: Post Test – Debris Field

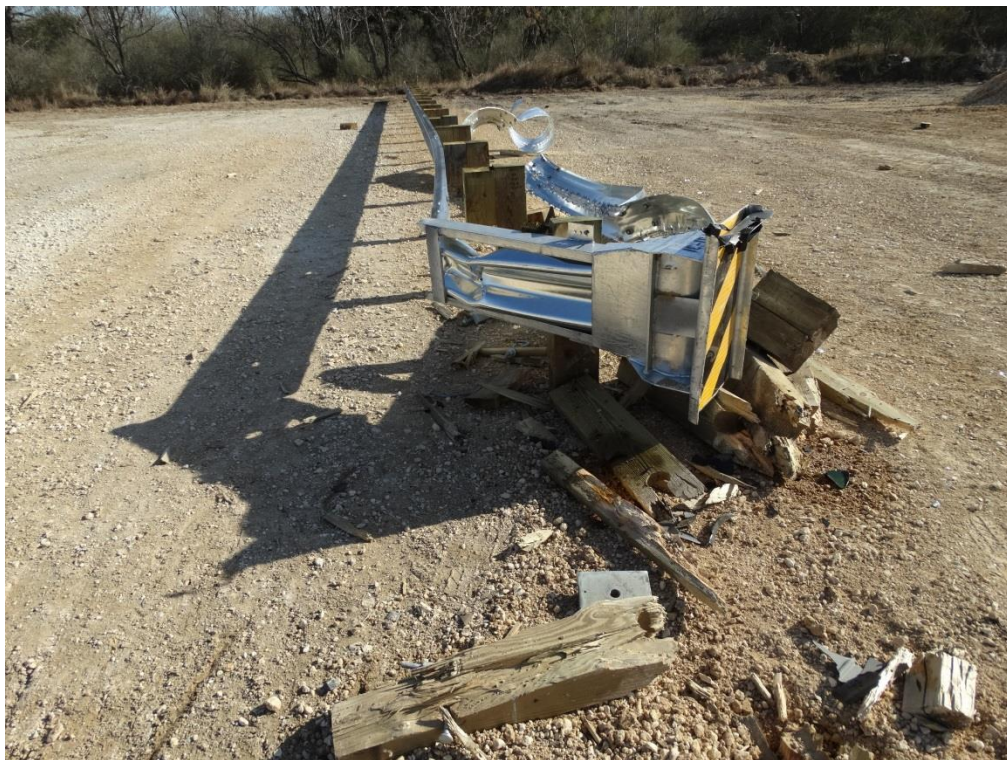
Figure 3.37: Post-Impact Test Article after Vehicle Removed

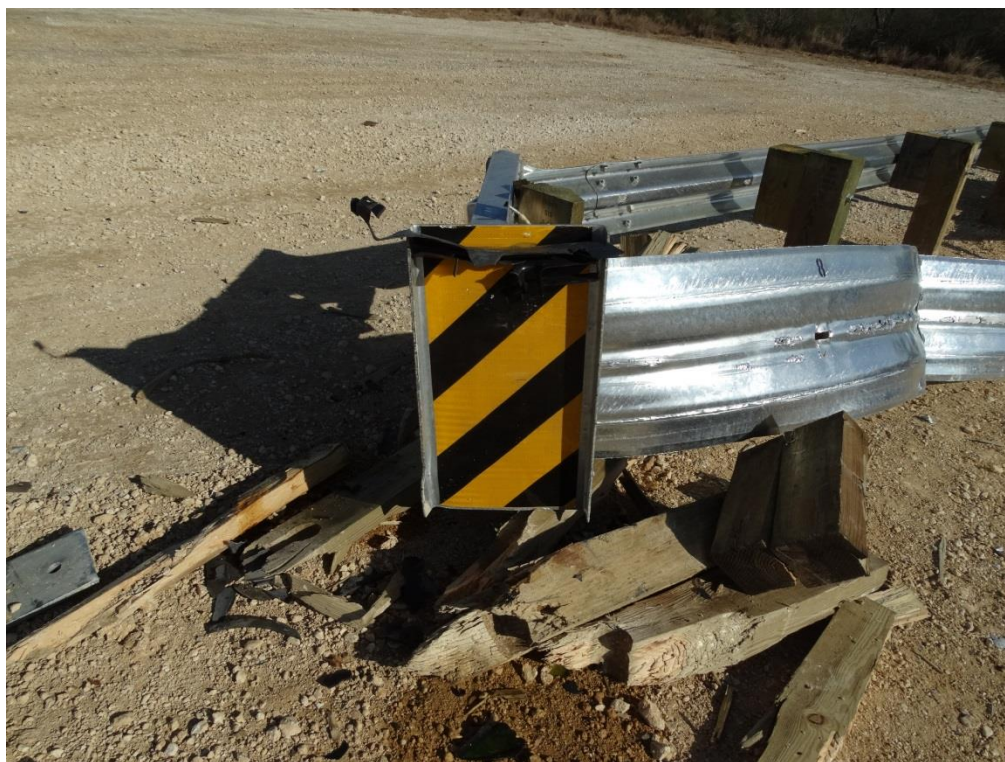
Figure 3.40: Post-Impact Test Article after Vehicle Removed – Impact Plate

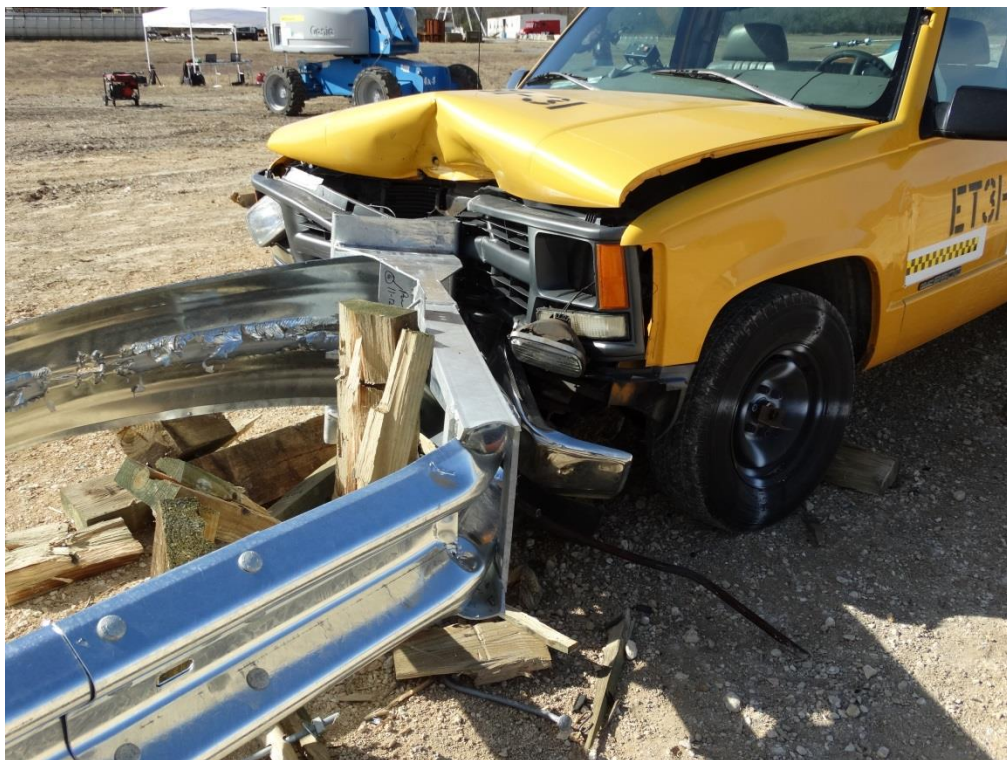
Figure 3.45: Post Test Vehicle – Front View Close-up

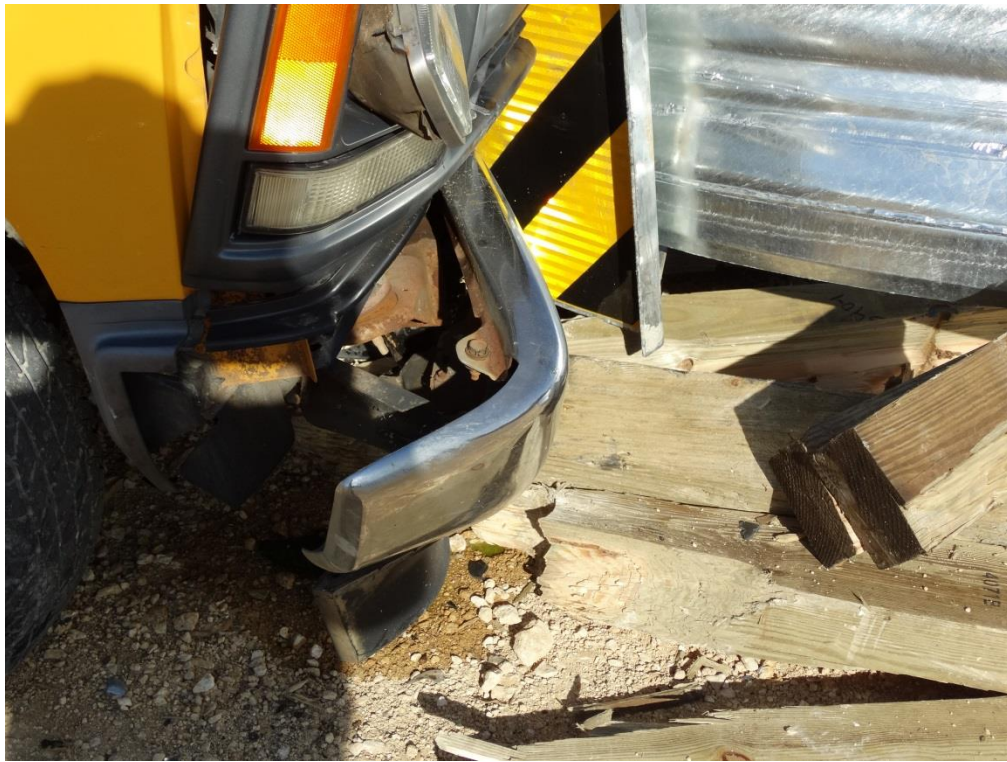
Figure 3.48: Post Test Vehicle – Accumulated Posts at Front of Vehicle

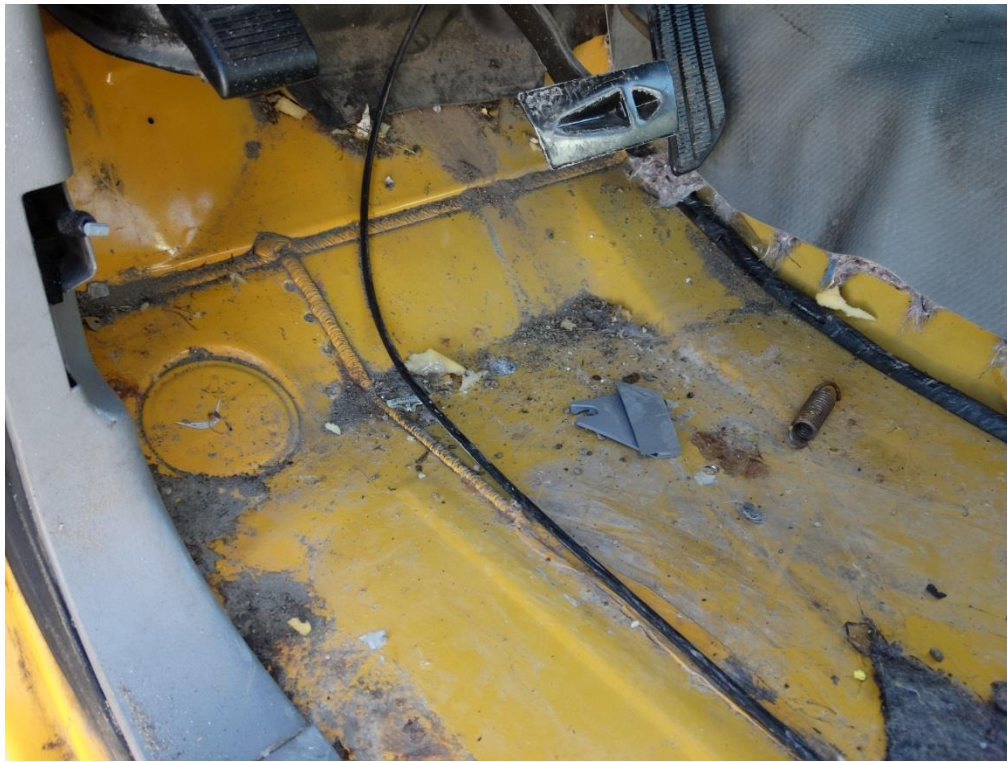
Figure 3.54: Post Test Vehicle – Driver Side Floorboard

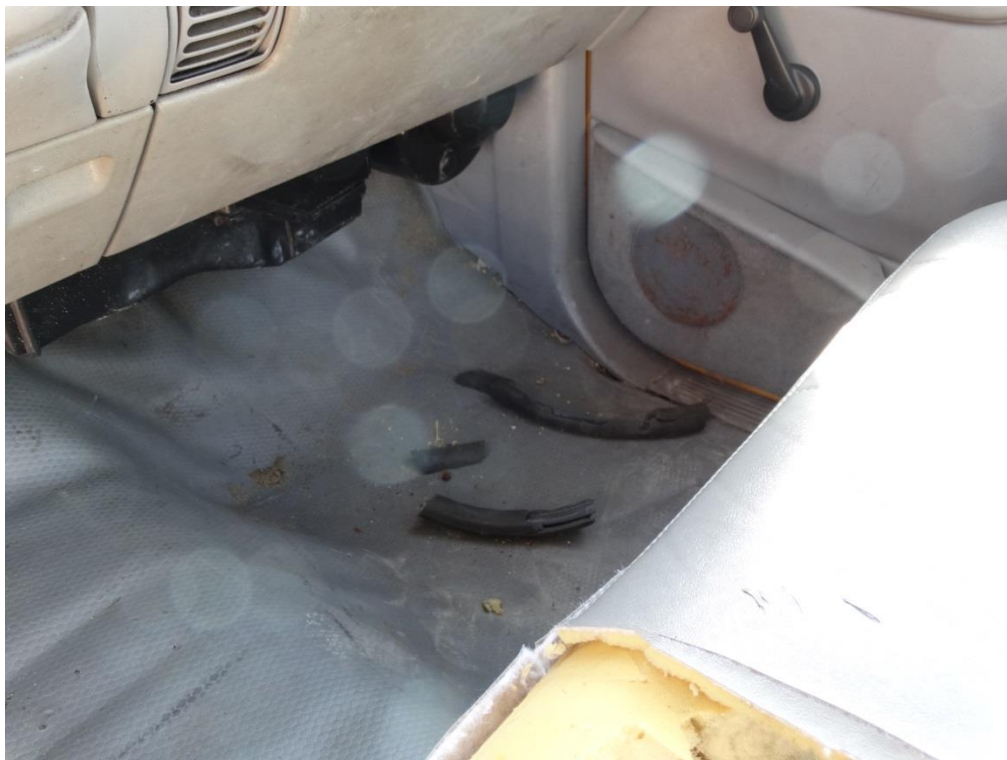
Figure 3.55: Post Test Vehicle – Passenger Side Floorboard

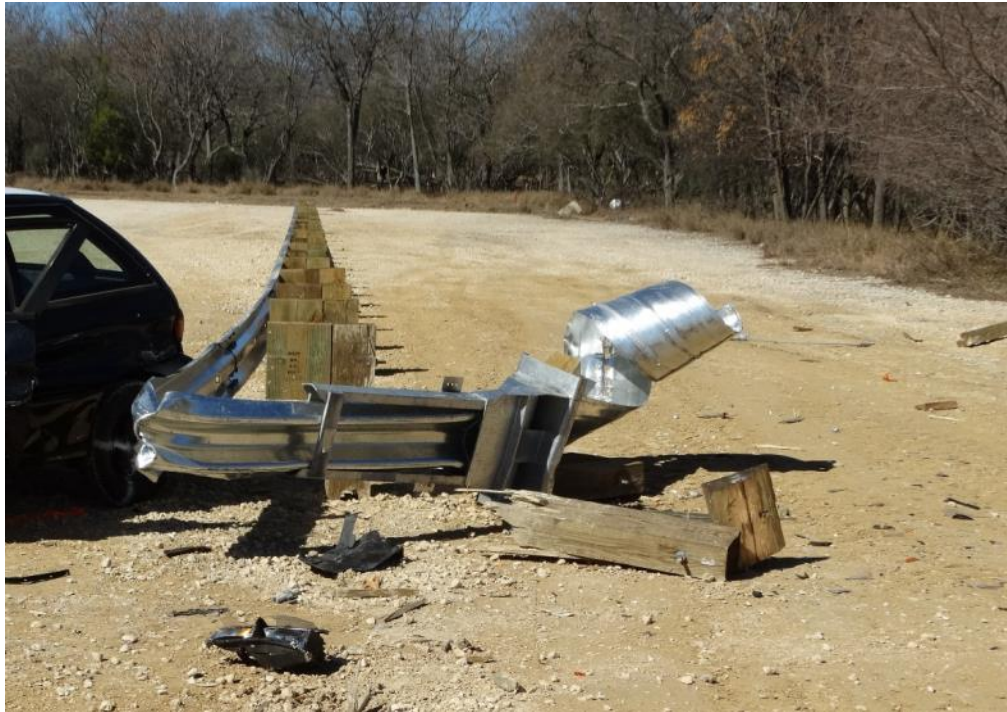
Figure 3.9: Post Test – Downstream Traffic Side View of Extruder Head

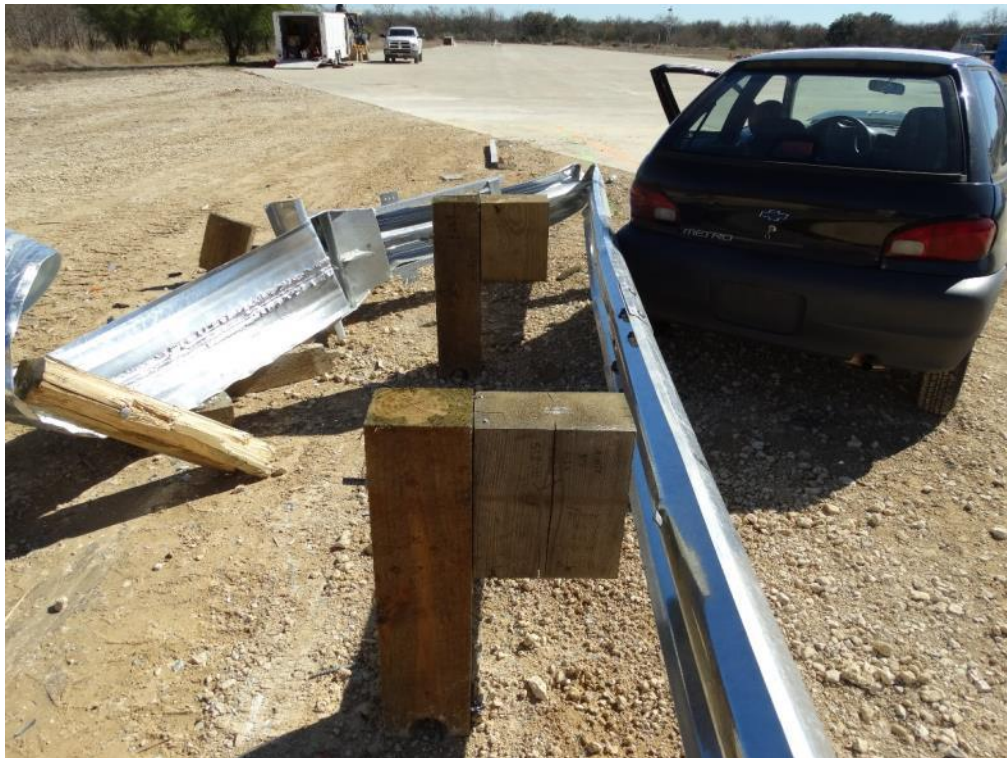
Figure 3.10: Post Test – Upstream Non-Traffic Side View of Extruder Head

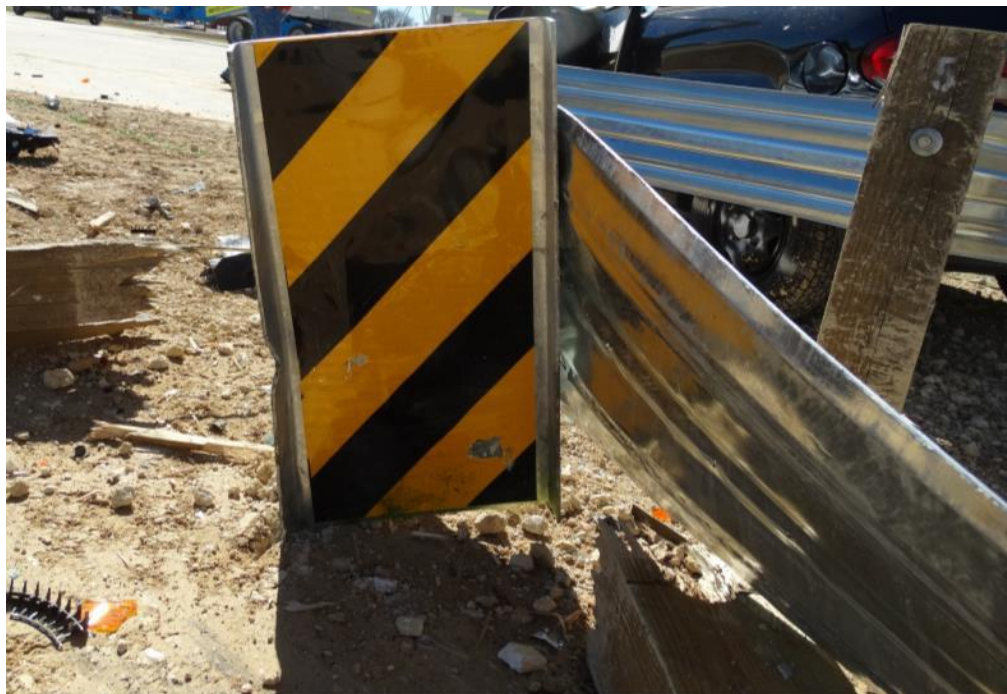
Figure 3.12: Post Test – End View of Impact Plate

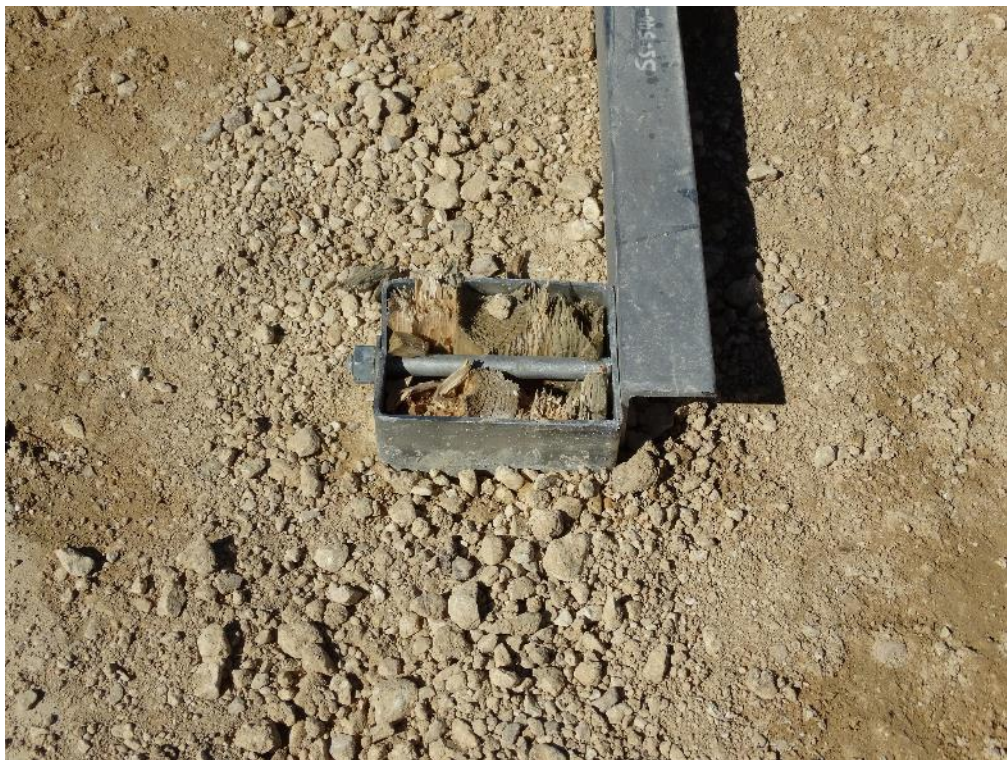
Figure 3.16: Post Test – Foundation Sleeve at Post 1

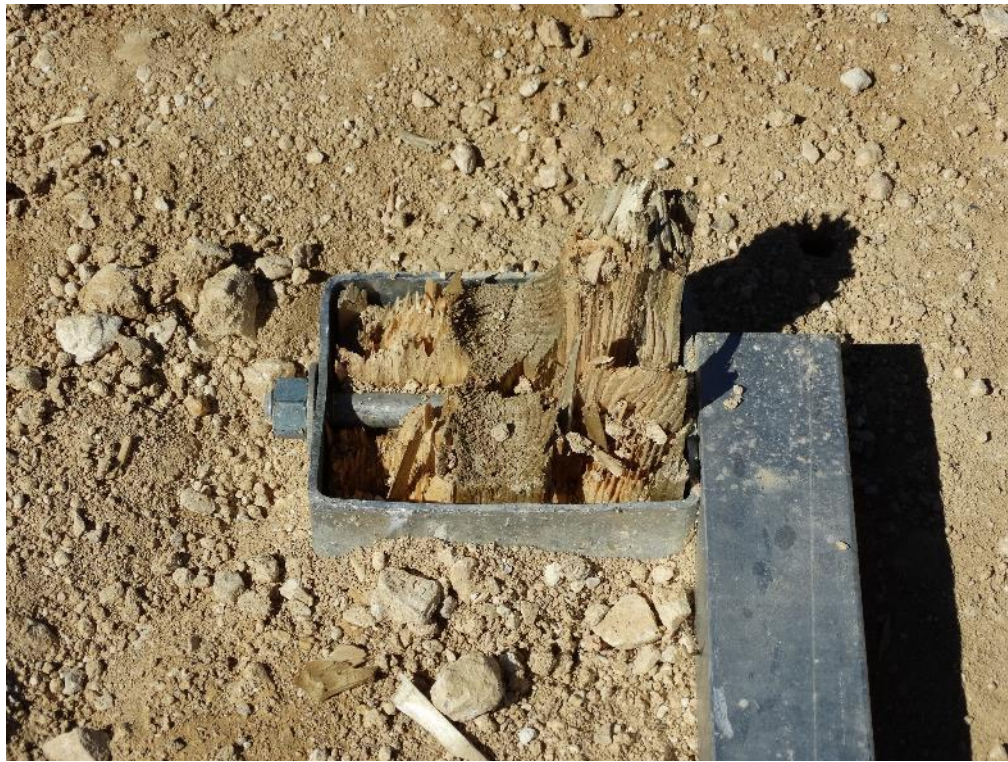
Figure 3.17: Post Test – Foundation Sleeve at Post 2

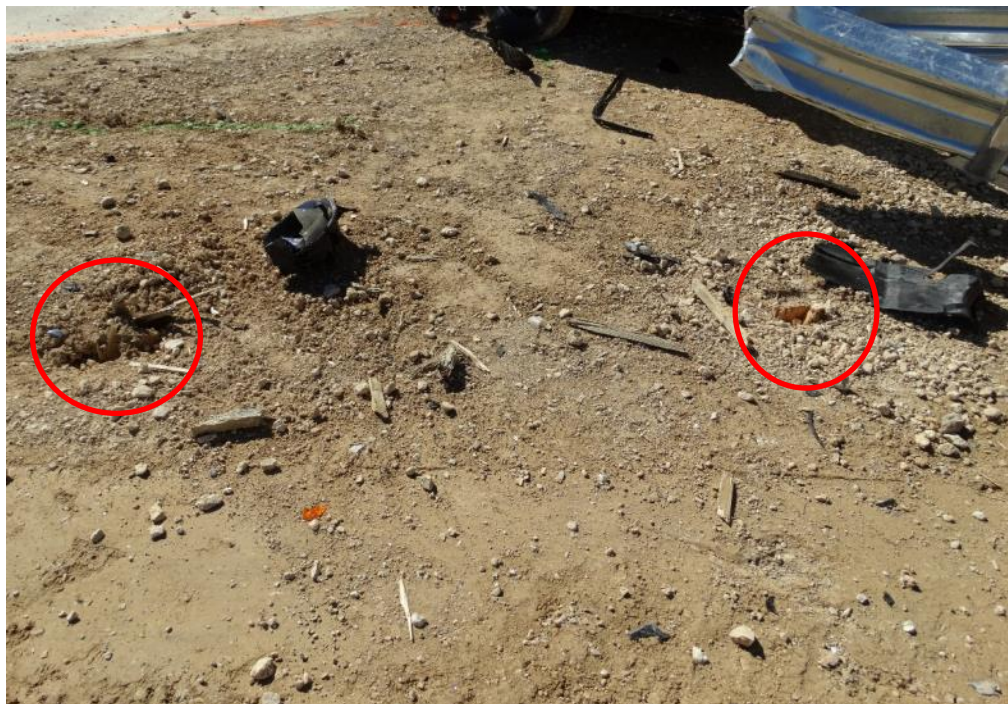
Figure 3.18: Post Test – Non-Traffic View of Post 3 (Left) and Post 4 (Right)

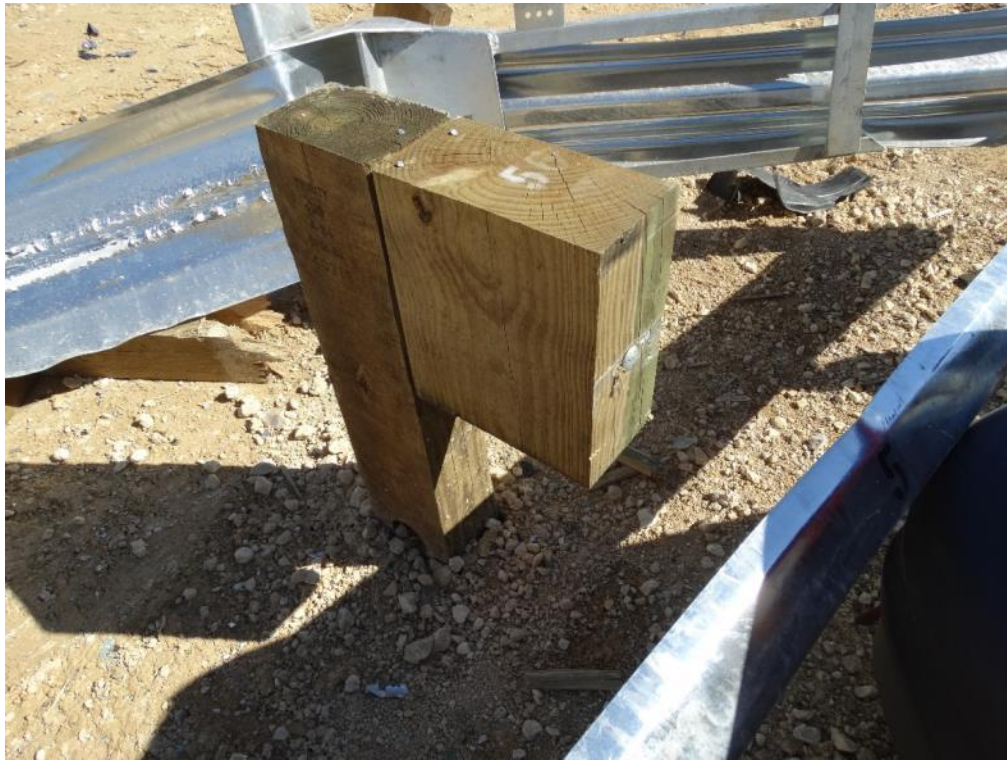
Figure 3.21: Post Test – Traffic View of Post 5 Blockout

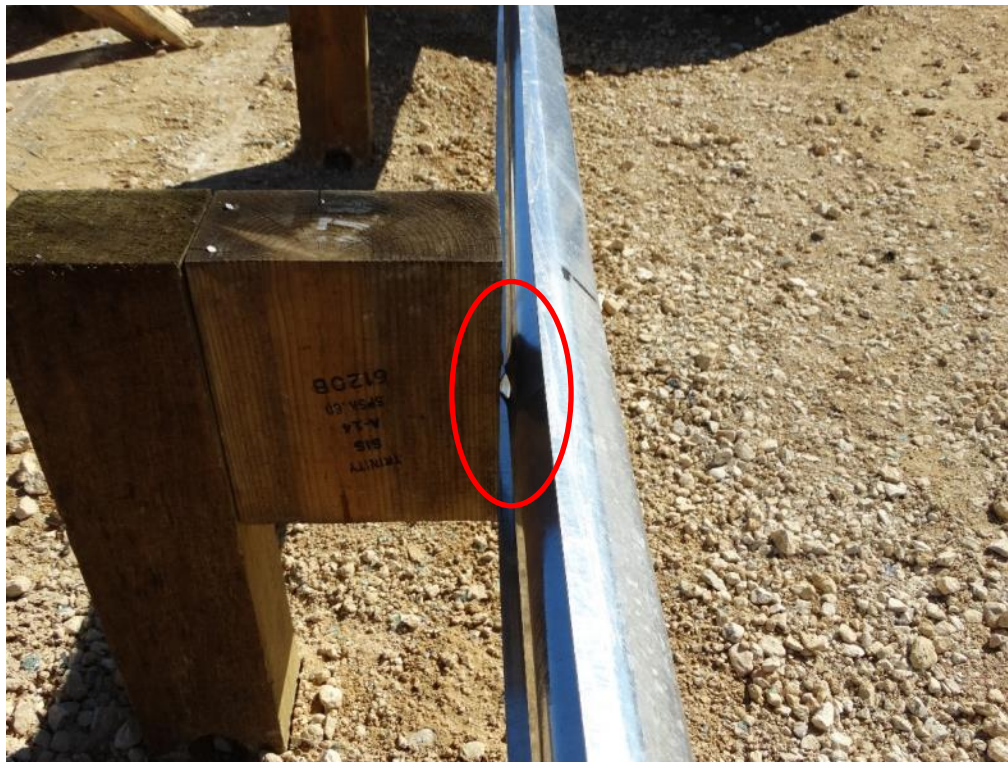
Figure 3.25: Post Test – Side View of Post 7

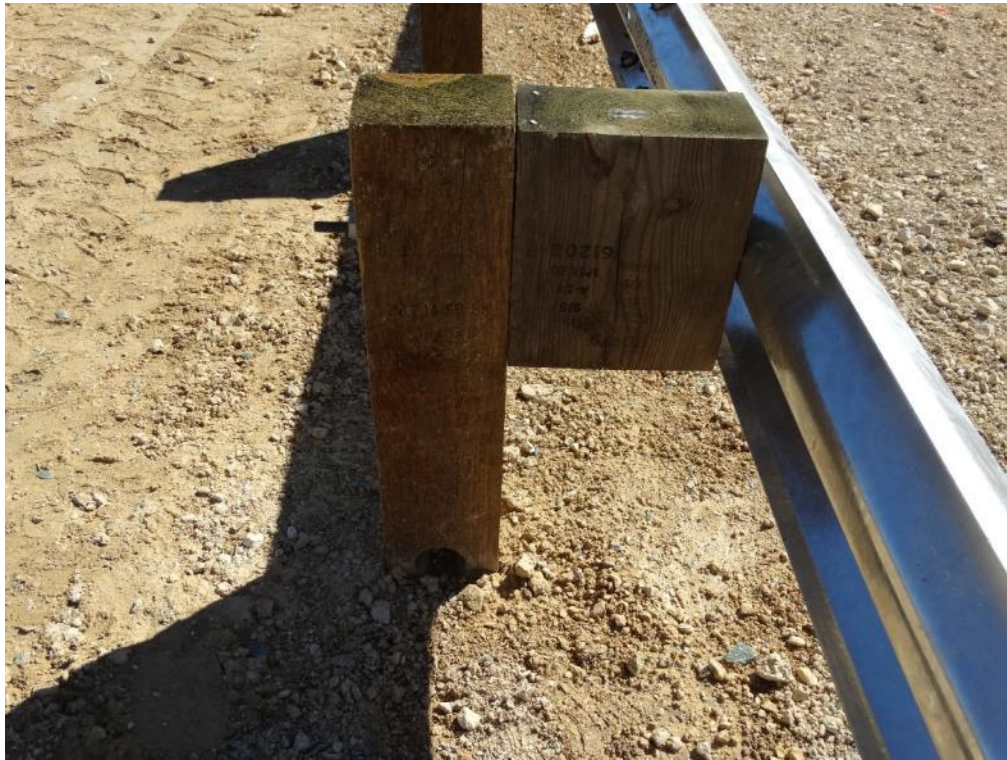
Figure 3.27: Post Test – Side View of Post 8

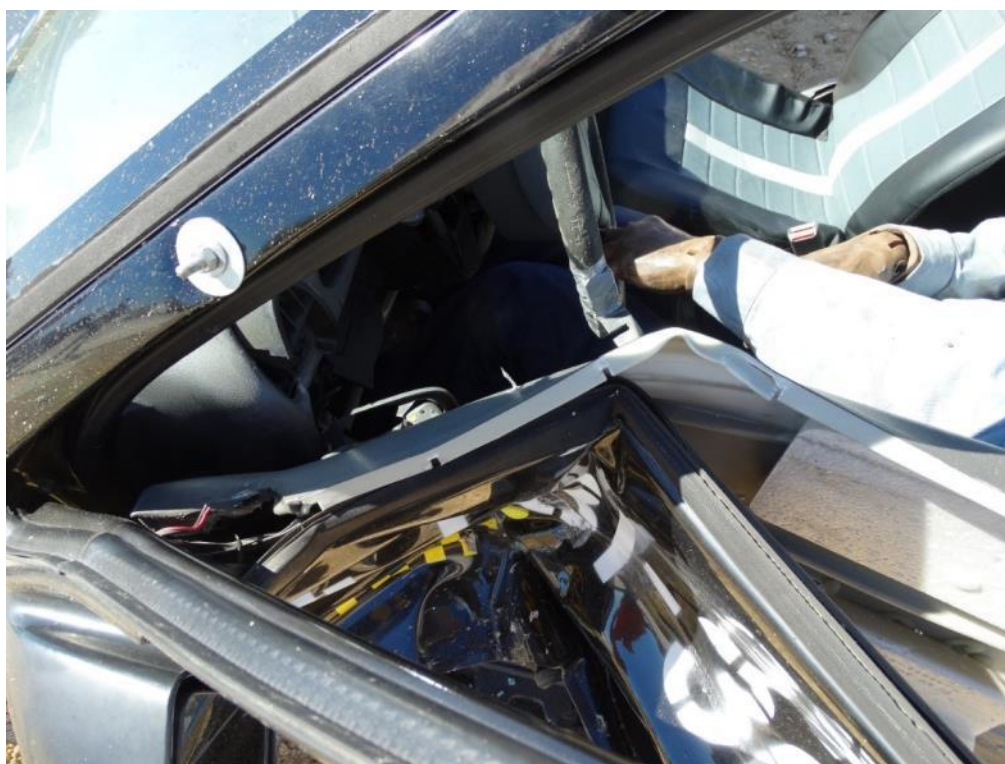
Figure 3.69: Post Test Vehicle – Left Side Door and Door Panel

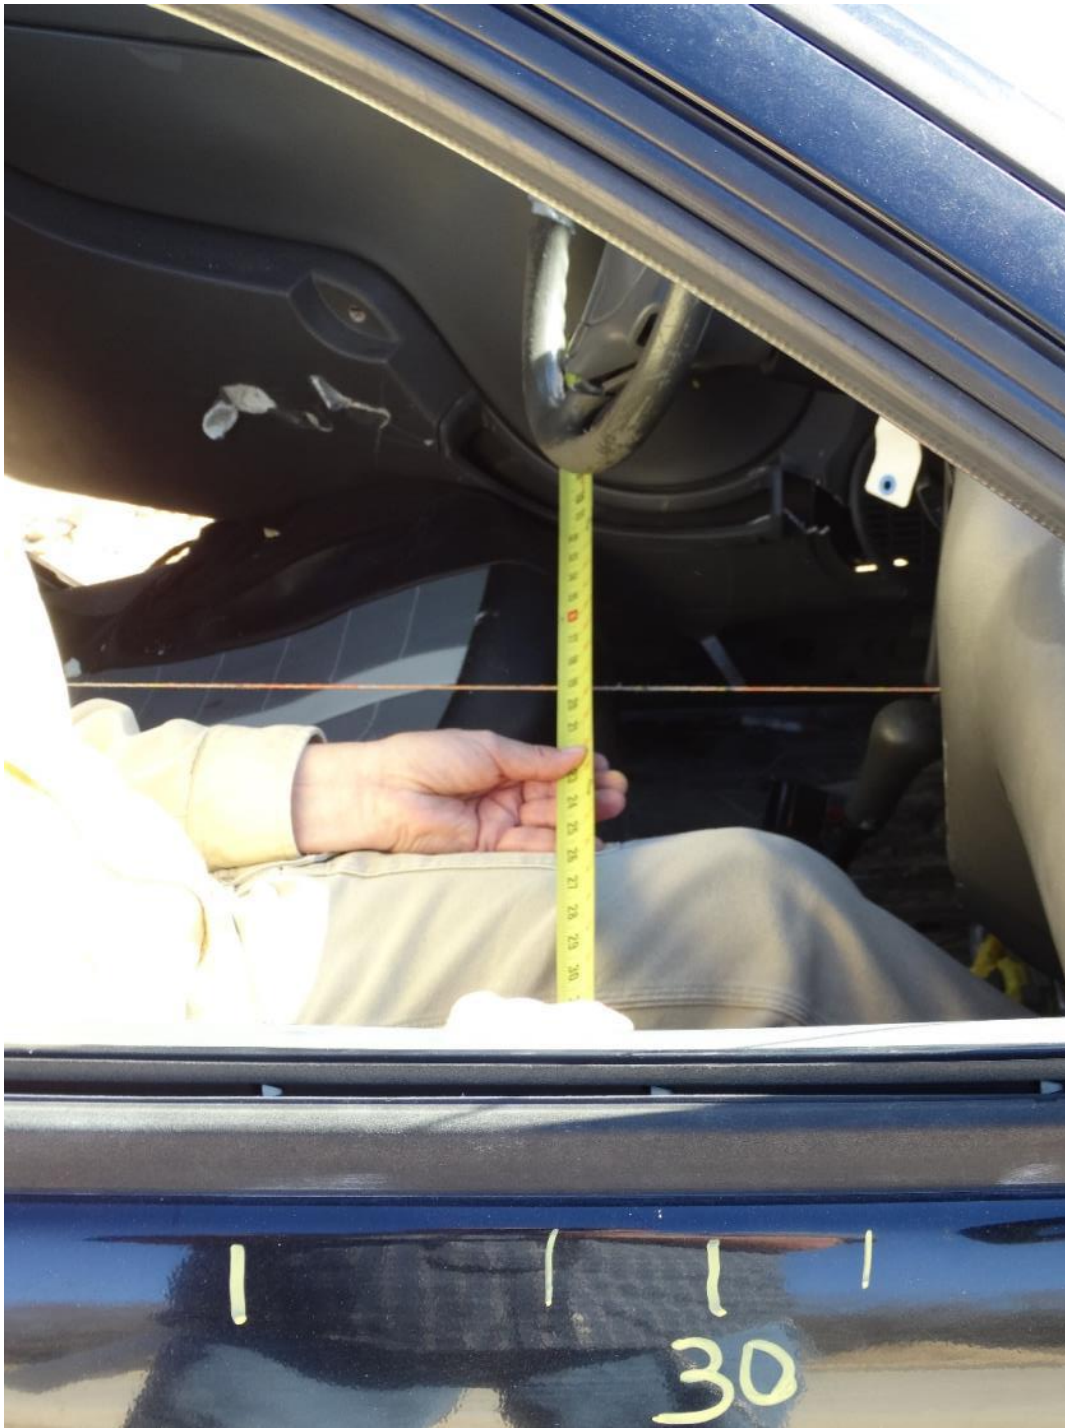
Figure 3.81: Measuring Interior Deformation

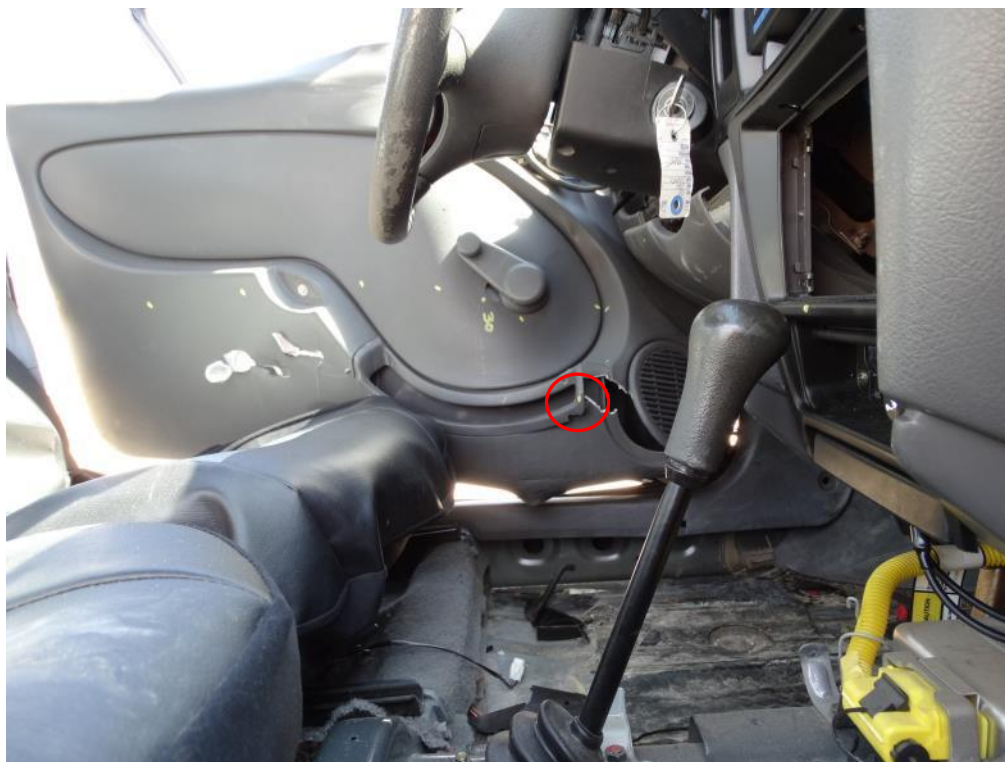
Figure 3.82: Location of Maximum Interior Deformation

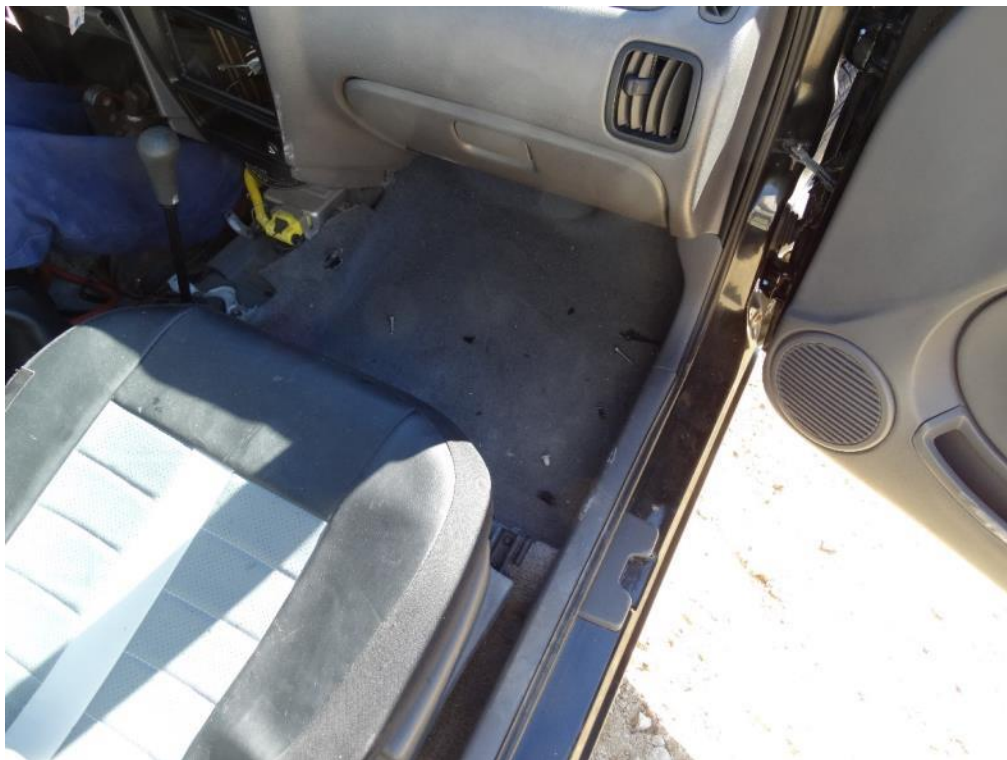
Figure 3.87: Post-Test – Passenger Side Floorboard, Close-up
