### Post Inspection Memorandum (PIM)

**Synopsis:** On Monday, March 1, 2010 crude oil was released in the Enbridge pipelines, Clearbrook Terminal. At approximately 9:16 AM CST, an accidental valve closure occurred as a result of controller error at their Edmonton, Canada control center, causing line 81 to build up enough back pressure to force the thermal reliefs and rupture pin to relieve to the station sump. The station sump overflowed and approximately 3 barrels were released. The spill was contained in the facility and cleaned within 27 hours.

**Rupture of Enbridge Pipeline and Release of Crude Oil  
near Cohasset, Minnesota  
July 4, 2002**

**NTSB/PAR-04/01**

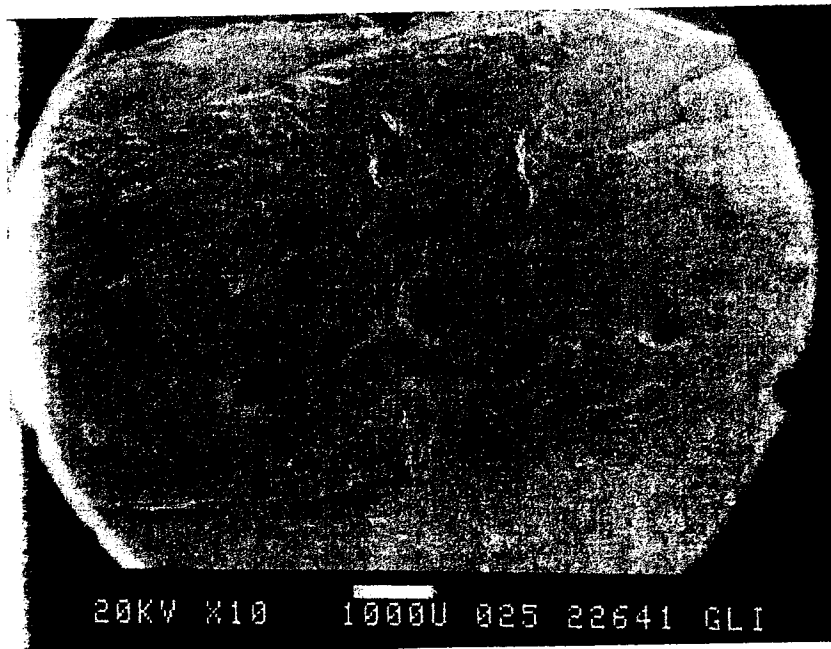
Figure 12. Overview of weld fracture on Sample SEM 1.

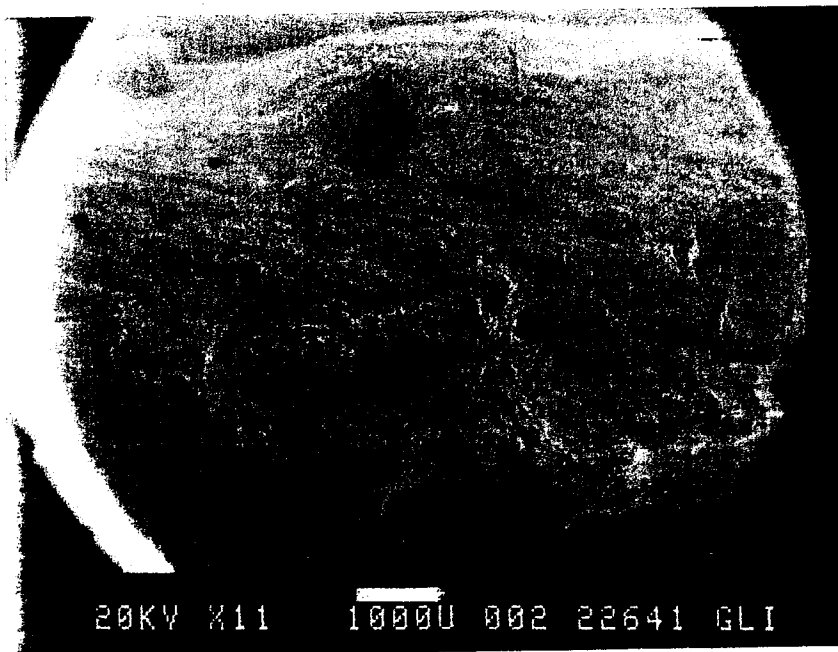
Figure 16. Overview of weld fracture on Sample SEM 2.

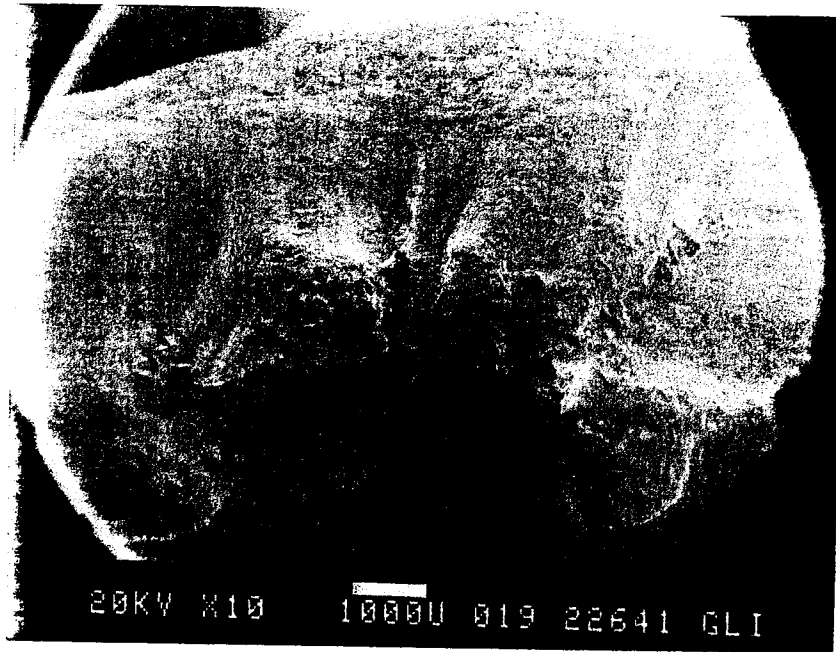
Figure 21. Overview of weld fracture on Sample SEM 3.
