**Re: CPF 5-2009-5001**

Your office conducted an inspection of our Sidney, Montana pipeline system in July, 2008. As a result of this inspection you issued a Notice of Probable Violation and Proposed Compliance Order for three items which required remedial action. On February 9, 2009, SemStream, L.P. sent you a letter outlining actions SemStream had either taken or planned to take to remedy the alleged violations. The purpose of this letter is to provide follow-up information as indicated in our February 9, 2009 letter. The remaining two open items and SemStream's remedy are as follows:

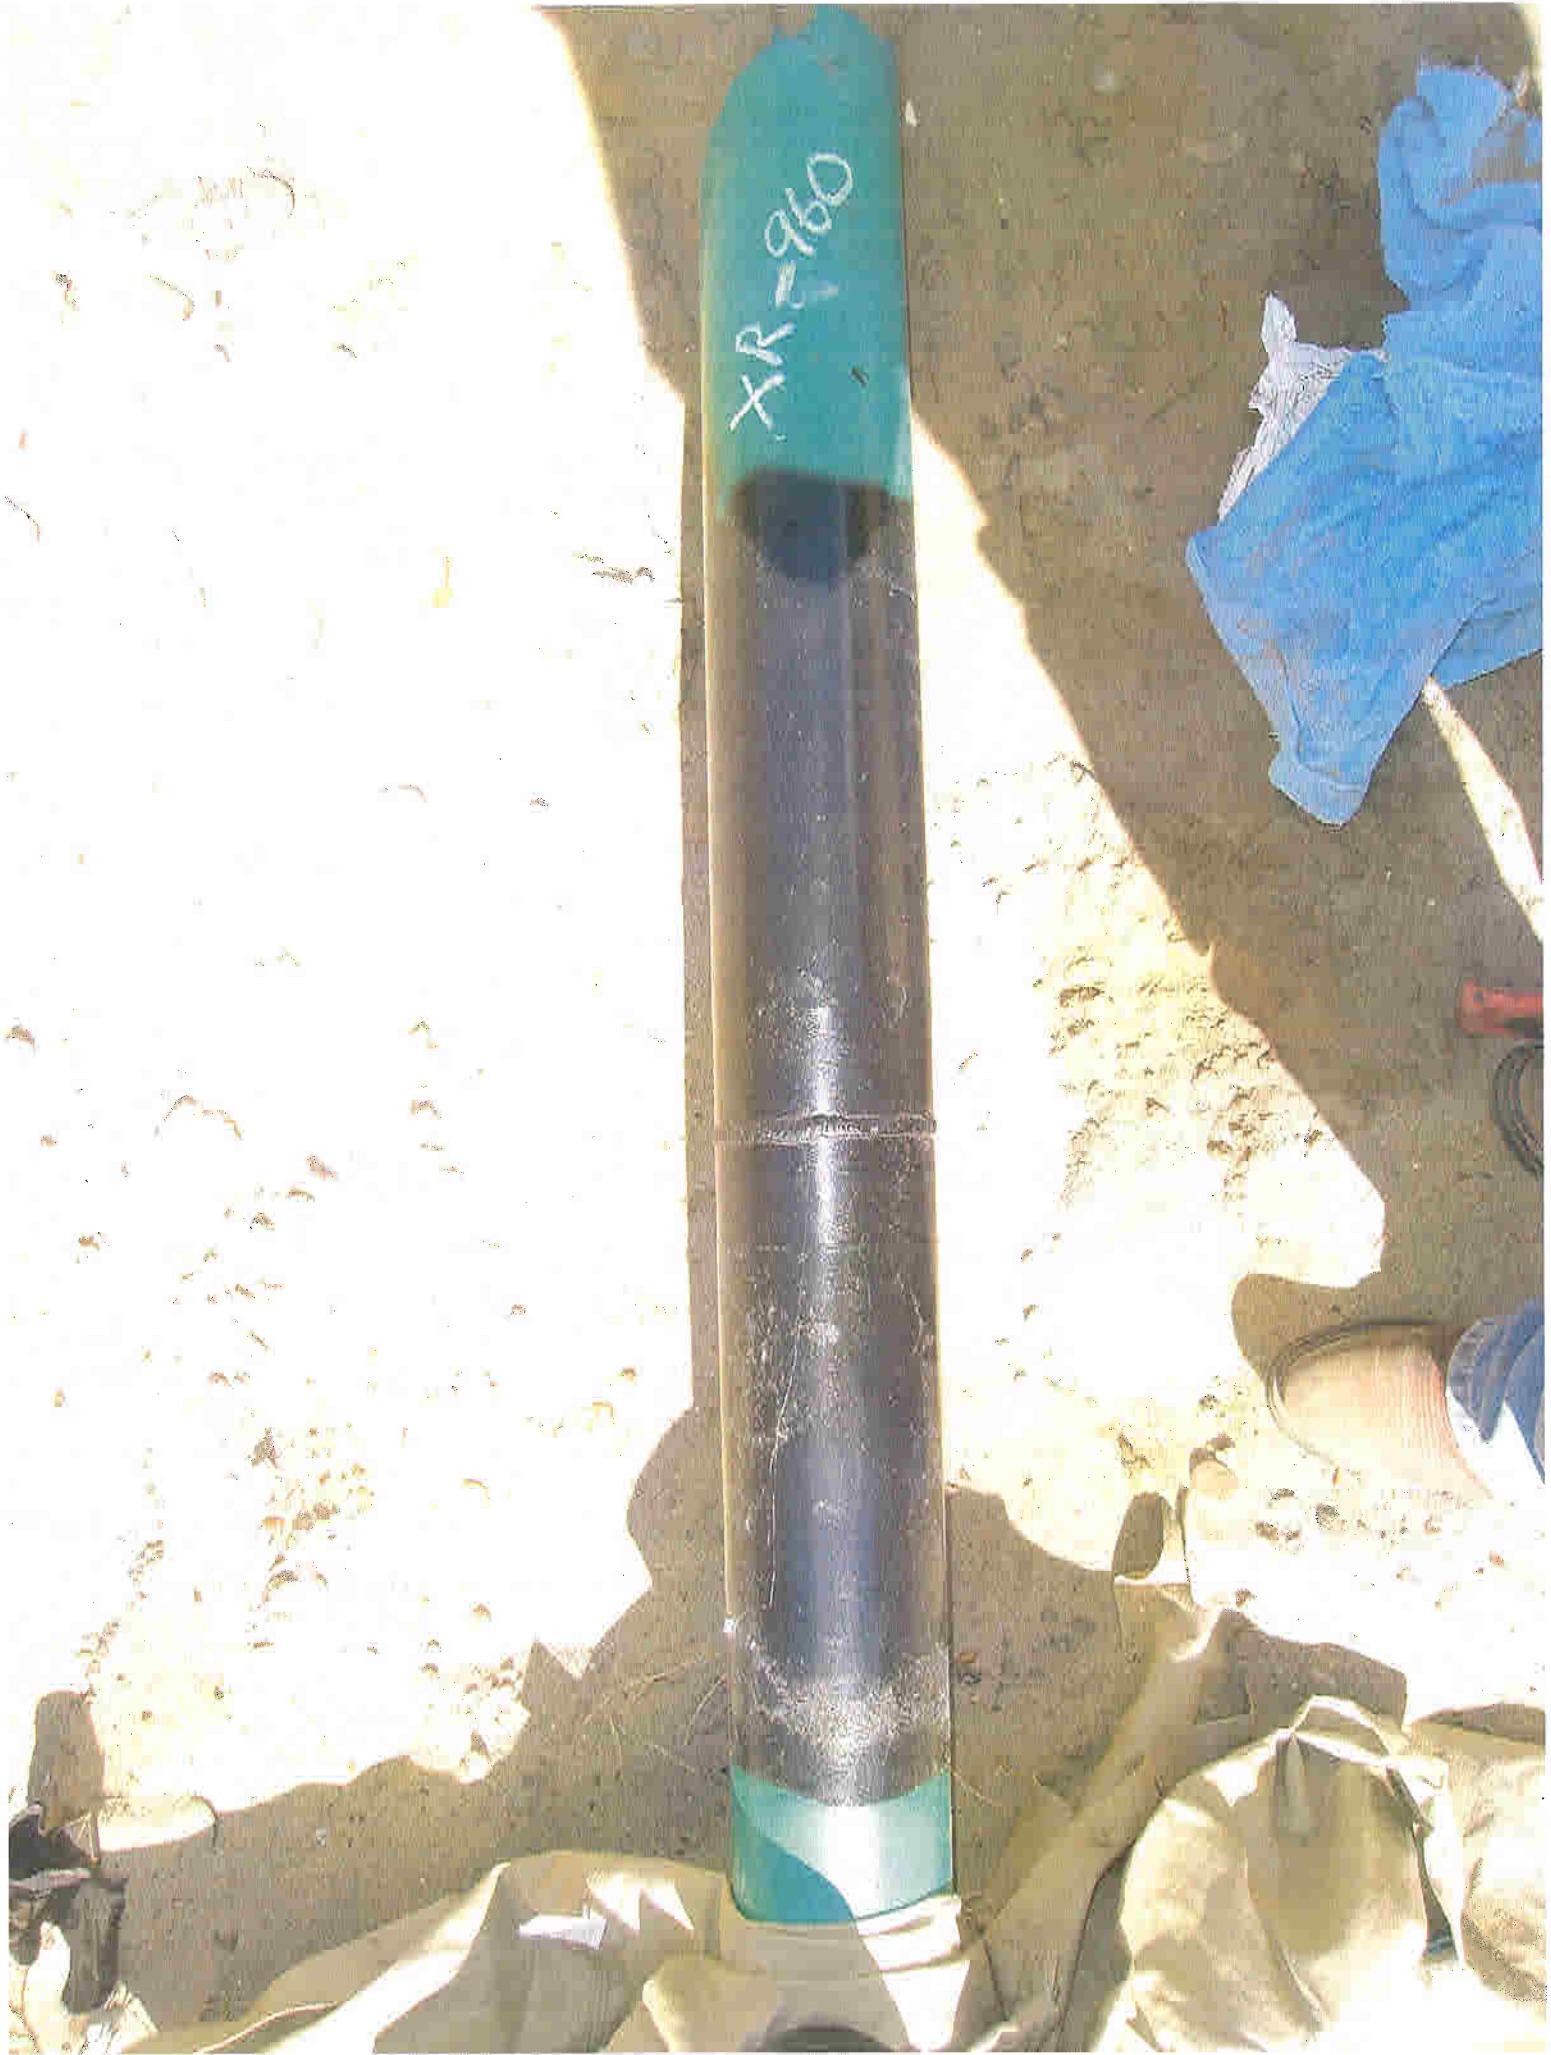
SemStream construction records for their HVL Pipeline System reveal that two (2) butt welds (numbers 999 and 960) were rejected because of low caps. SemStream had no record of the repair of these two welds.

As per the plan outlined in our response dated February 9, 2009, SemStream has excavated welds 999 and 960, inspected them and documented the condition of the welds. Based on the inspection made by TK Inspection Services, neither weld required additional repair. Photographs of the welds as well as the inspection report from TK Inspection Services is attached.
