Automated Track Video Inspection Pilot Project

SEPTEMBER 2013

FTA Report No. 0049
Federal Transit Administration

PREPARED BY
MTA-NYCT

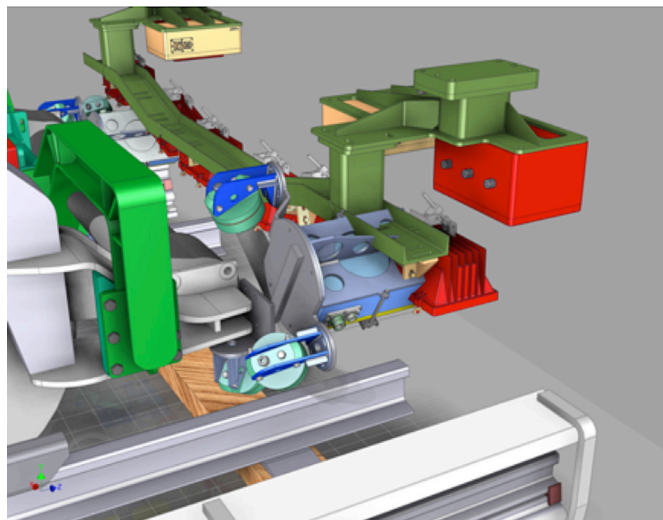
Figure 1-1

In the next step, PAC created a 3D CADD model of the truck, the mounting hardware, and the video cameras, including the existing rail view video system. The 3D model showed that the Field Side View and Gauge Side View video systems would conflict with the existing Rail View video system, as can be seen in Figures 1-1 and 1-2. The mounting location was, therefore, changed to axle #10 of the same truck.

Field Side and Power Rail video components (grey and light blue) conflict with existing Rail View video equipment (red and olive green)

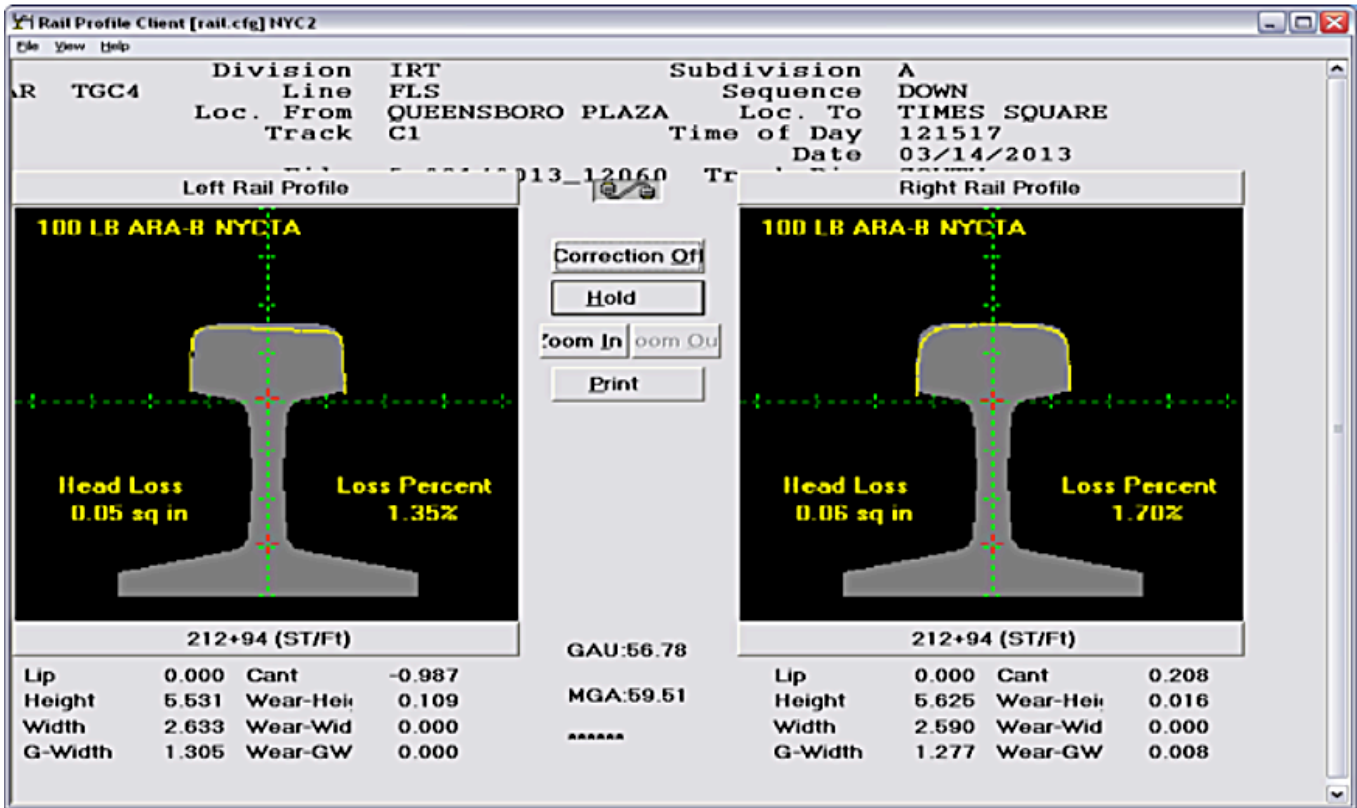
Figure 4-3
Rail wear measured on track C1

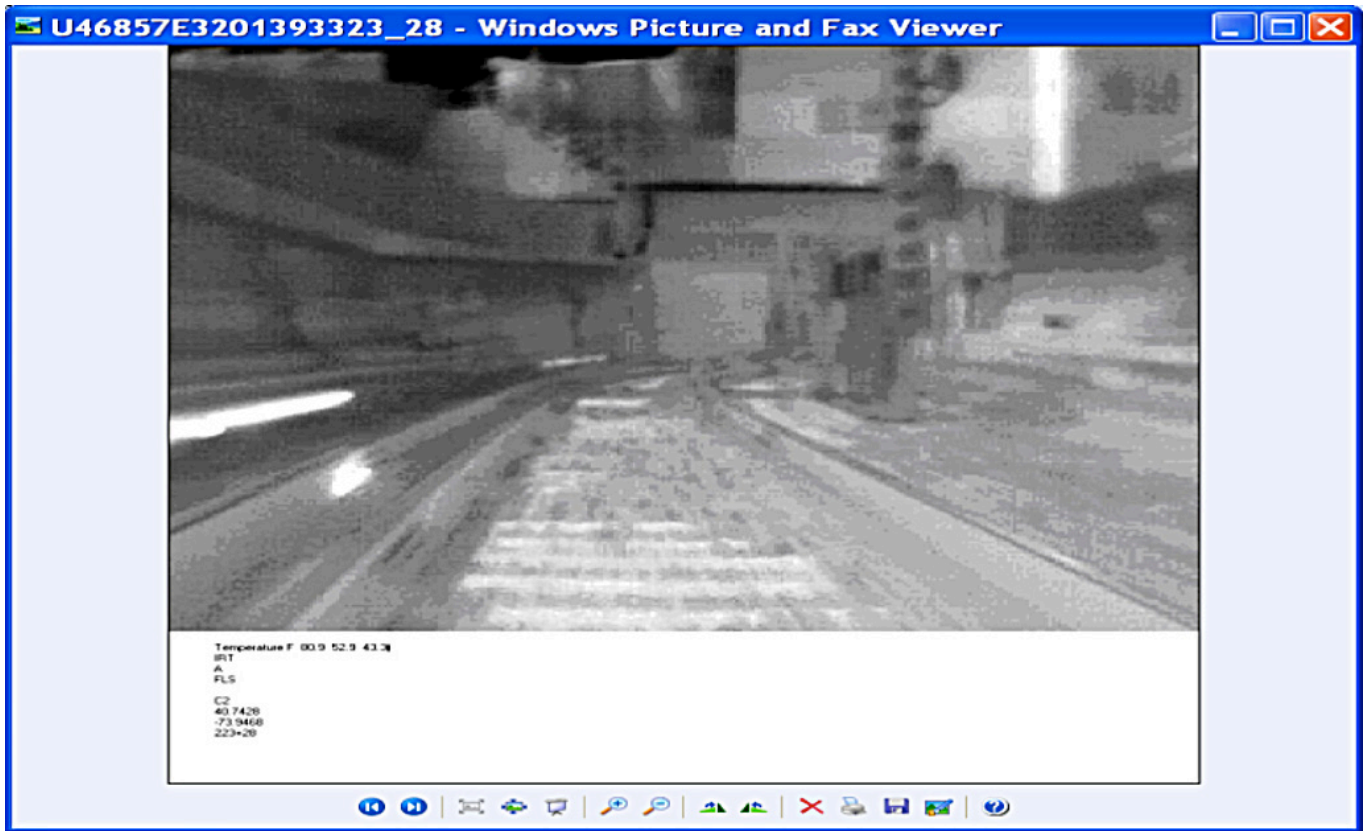
Figure 4-4

Hot third rail insulator N/O Hunters Point on track C2

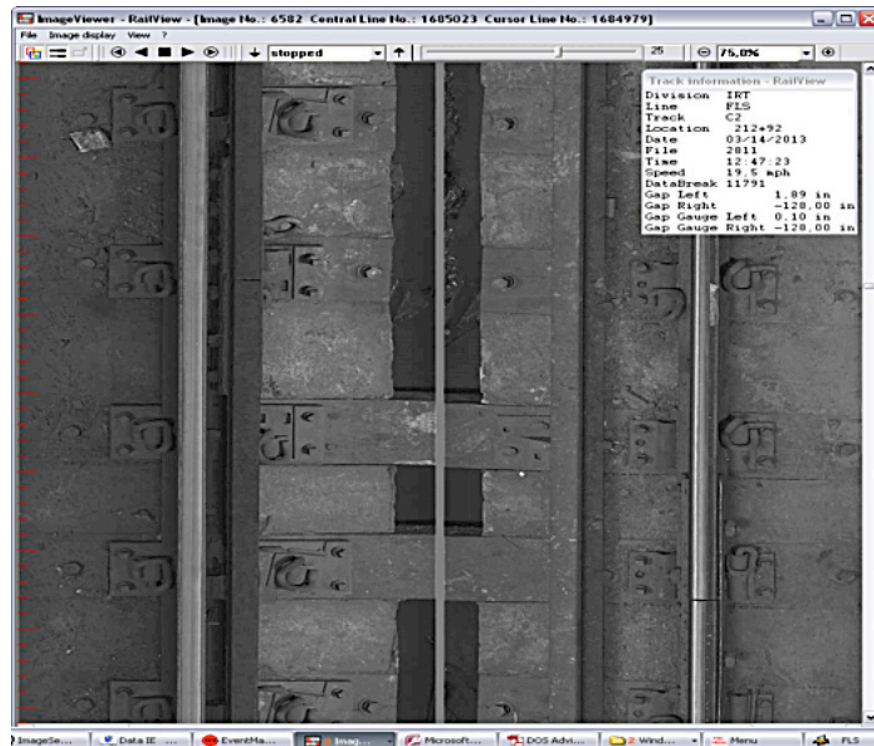
Figure 4-8

Rail View video image of track C2 at station # 212+92 (seen in Figure 4-3)

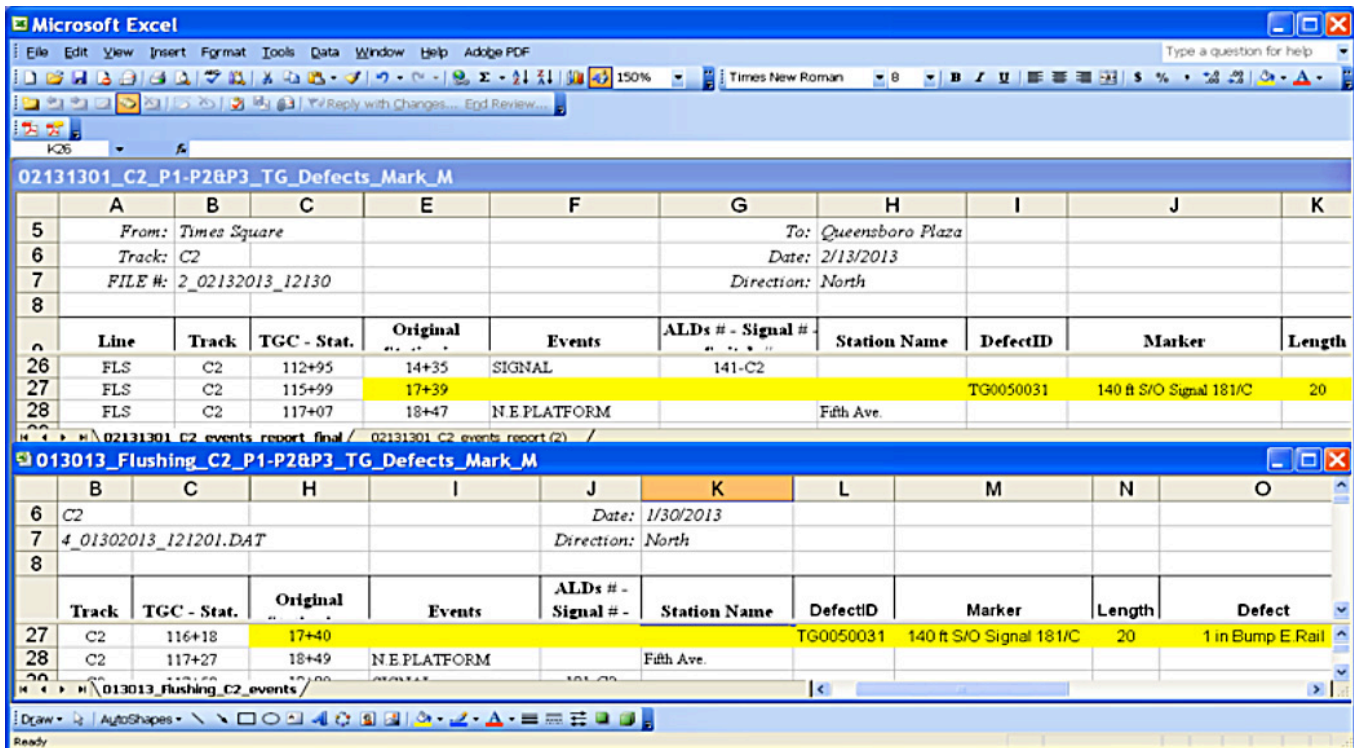
Track geometry Excel databases for the 1/30/13 and 2/13/13 inspection runs

The reference ALD (0+00 Station) tag placed at Times Square Station, detected automatically by the TGC4, assured that the corrected stationing numbers could be computed relative to this reference point, therefore allowing for the correlation of the defects' locations between the two inspection runs. All repeated defects or conditions could be observed at exactly the same location in both inspection runs. The calculated corrected stationing numbers correlated between the second and first inspection runs within 1 ft. accuracy. Figure 4-20 shows that defect TG0050031 can be found at the TGC stationing number 116+18 in the 1/30/2013

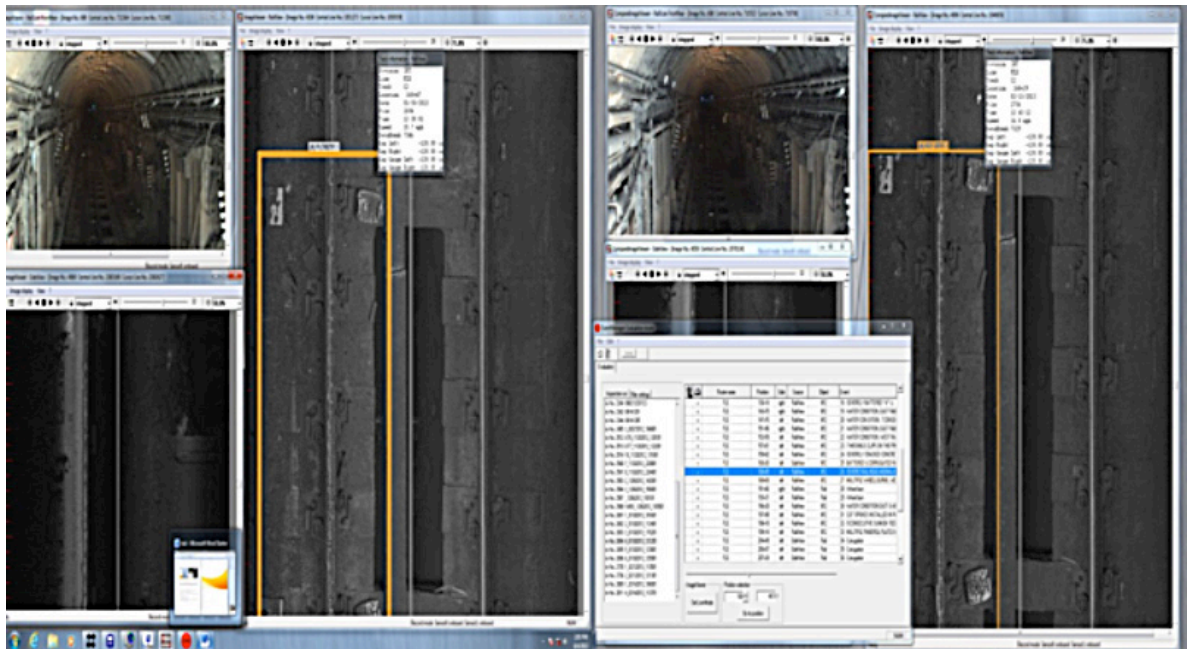
Figure 4-21

Compare Viewer transferring defects between Rail View video inspection runs of 1/30/13 (left) and 2/13/2013 (right)

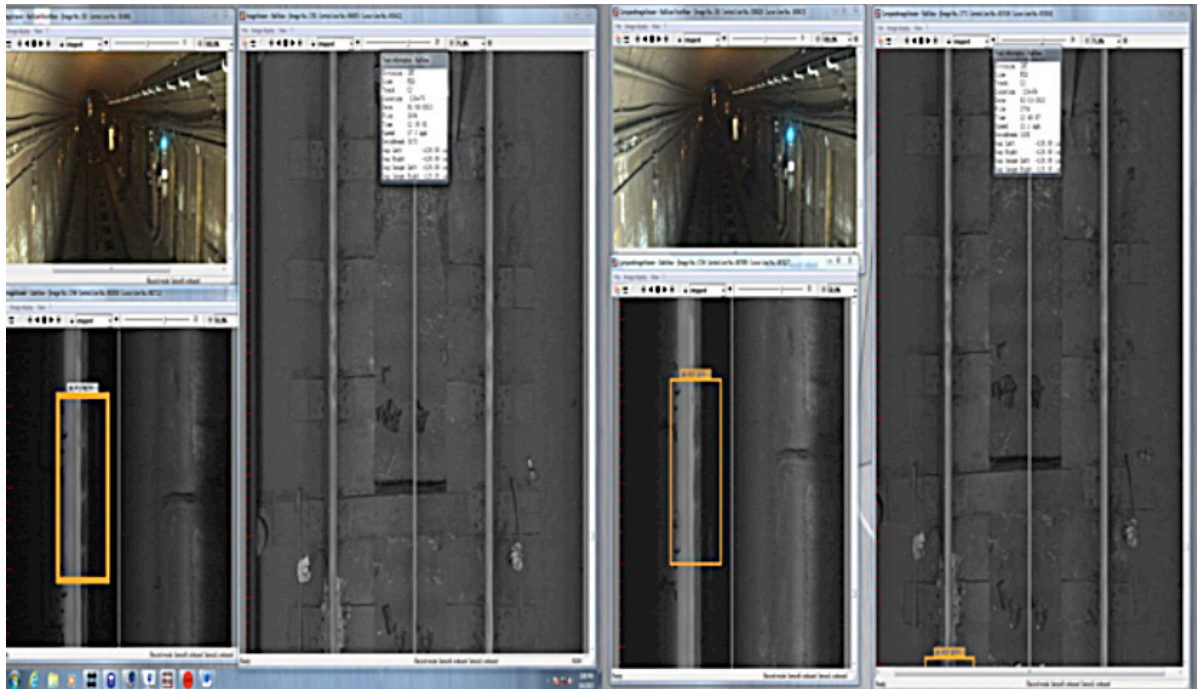
Figure 4-22

Compare Viewer transferring marked defects between Field Side Rail View video inspection runs of 1/30/13 (left) and 2/13/2013 (right)

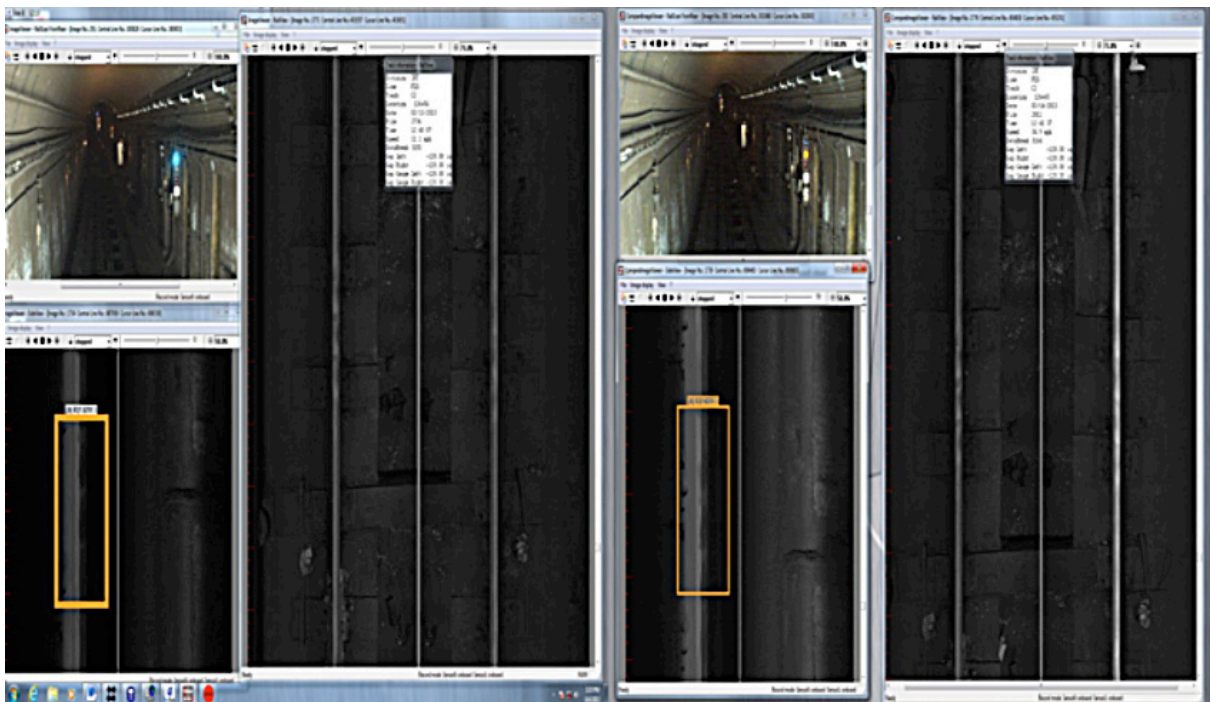
Figure 4-26

Compare Viewer transferring defects between 2/13/2013 (left side) and 3/14/2013 (right side) video inspection runs

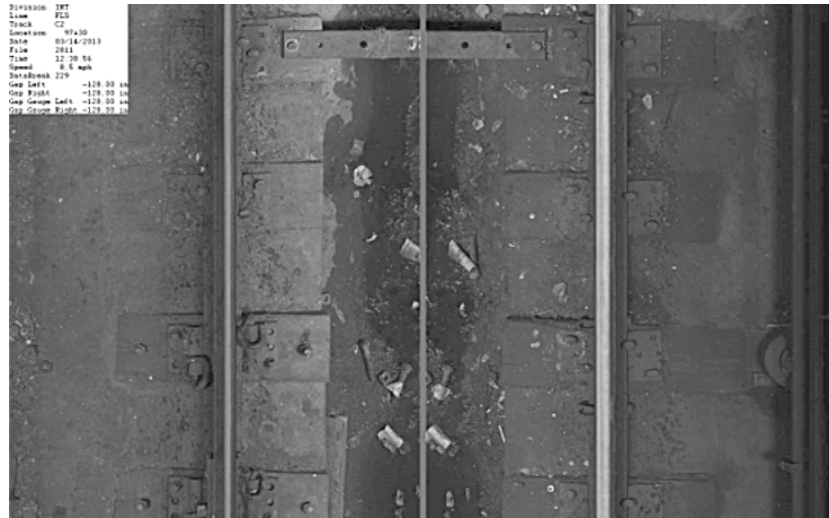
Figure 4-29
*Picture link of defect
on final database*

As an example, clicking on the first defect in the Picture Link column of the Final Excel database above (Figure 4-28) opens the picture with the location of the defect (see Figure 4-29).

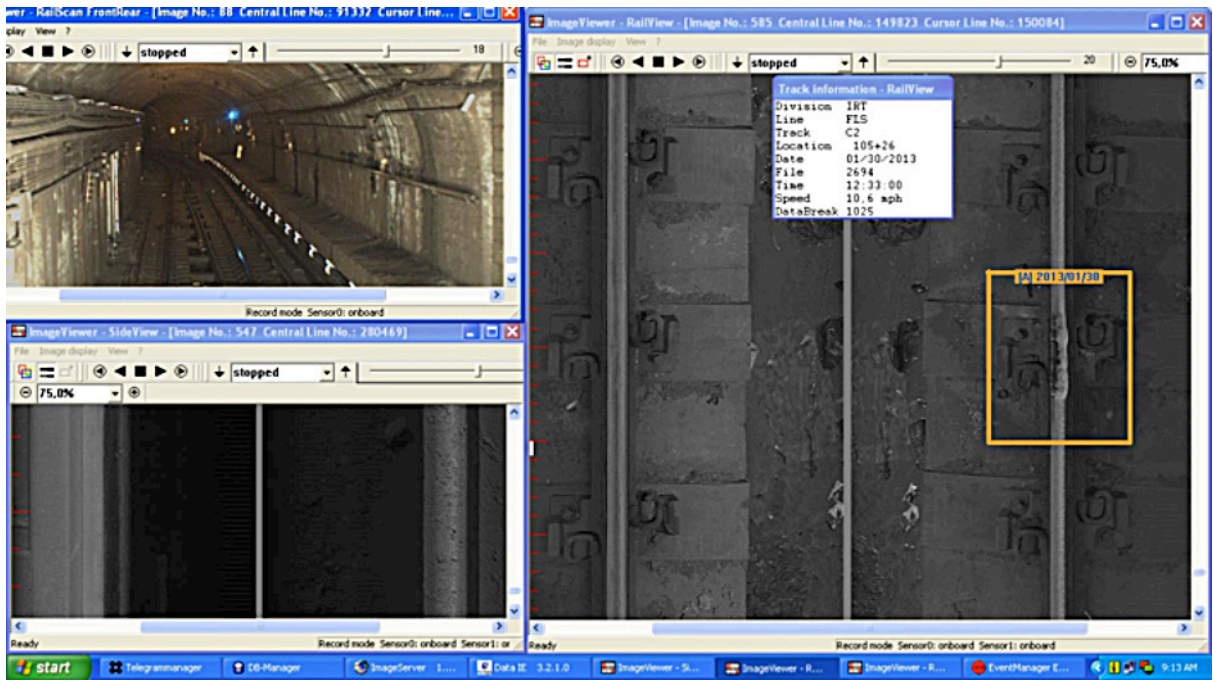
Figure 4-35
Rail View defect detected and marked in 1/30/2013 inspection run
