Collapse of I-35W Highway Bridge
Minneapolis, Minnesota
August 1, 2007

ACCIDENT REPORT

NTSB/HAR-08/03
PB2008-916203

Highway Accident Report

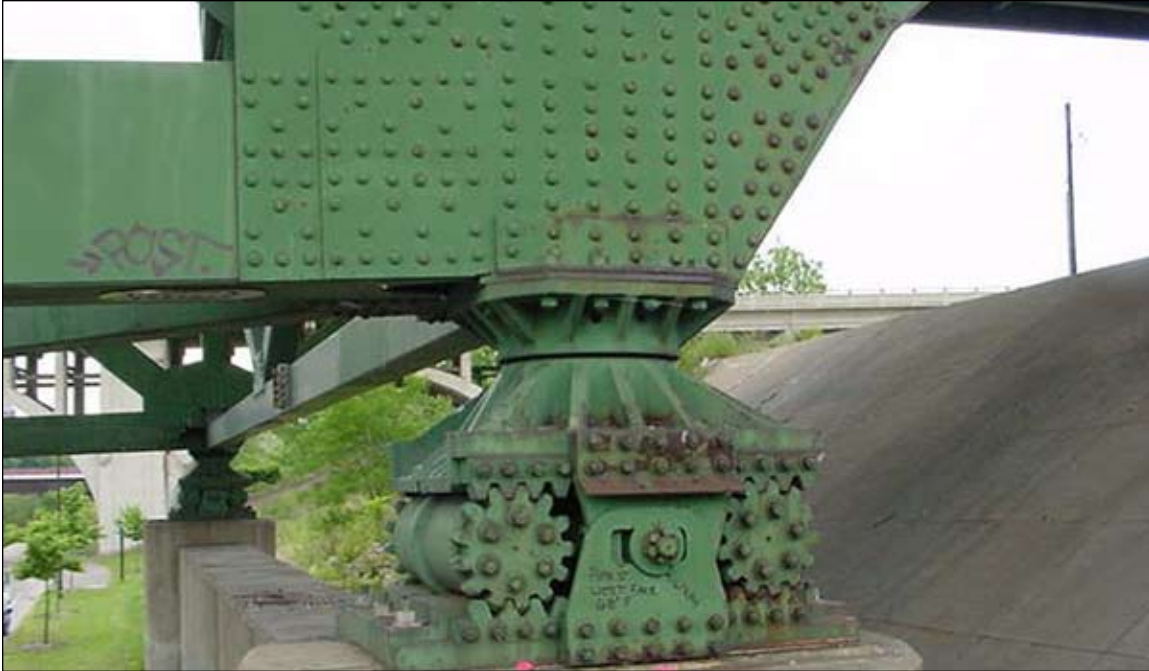
Figure 5. Expansion roller bearings at pier 5, looking east. (Source: URS Corporation)

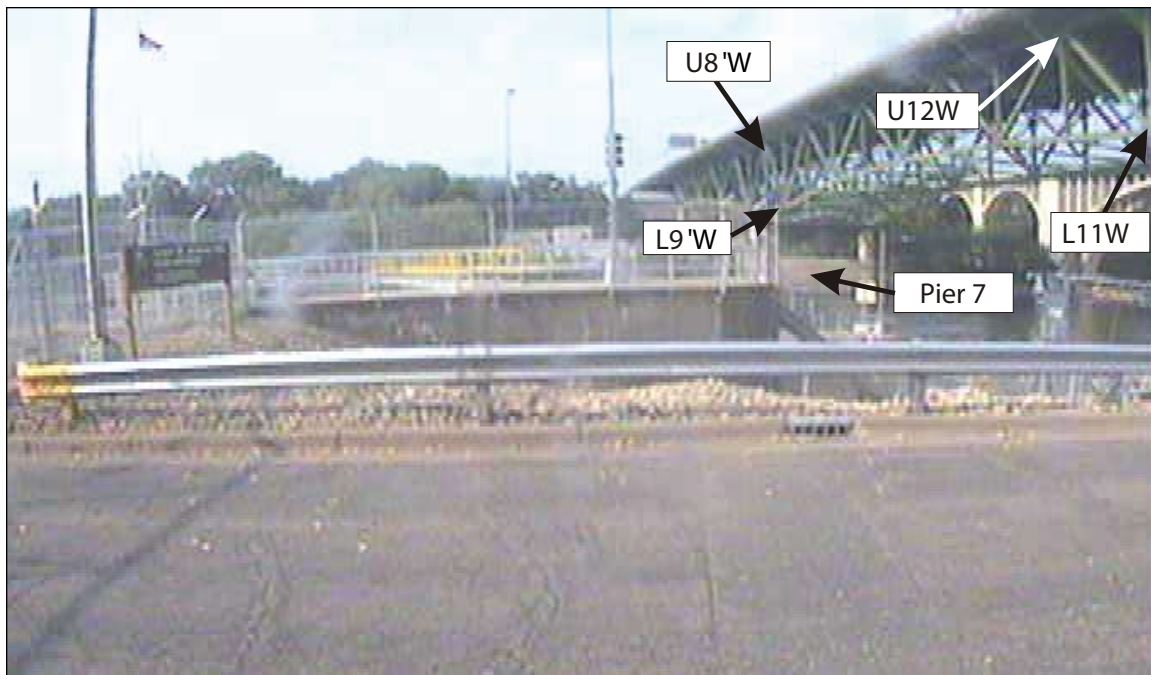
Figure 9. View of a portion of the west side of I-35W bridge center span about 8 minutes before collapse. (Image extracted from surveillance camera video.)

The video does not show any element of the west truss south of vertical member U11/L11W or any element of the east truss south of the L13E node. None of the lower nodes on the west truss north of L9'W can be seen. Most of the east truss upper nodes that are visible to the camera are either too dark or blurred to be identified or are obscured by the west truss.

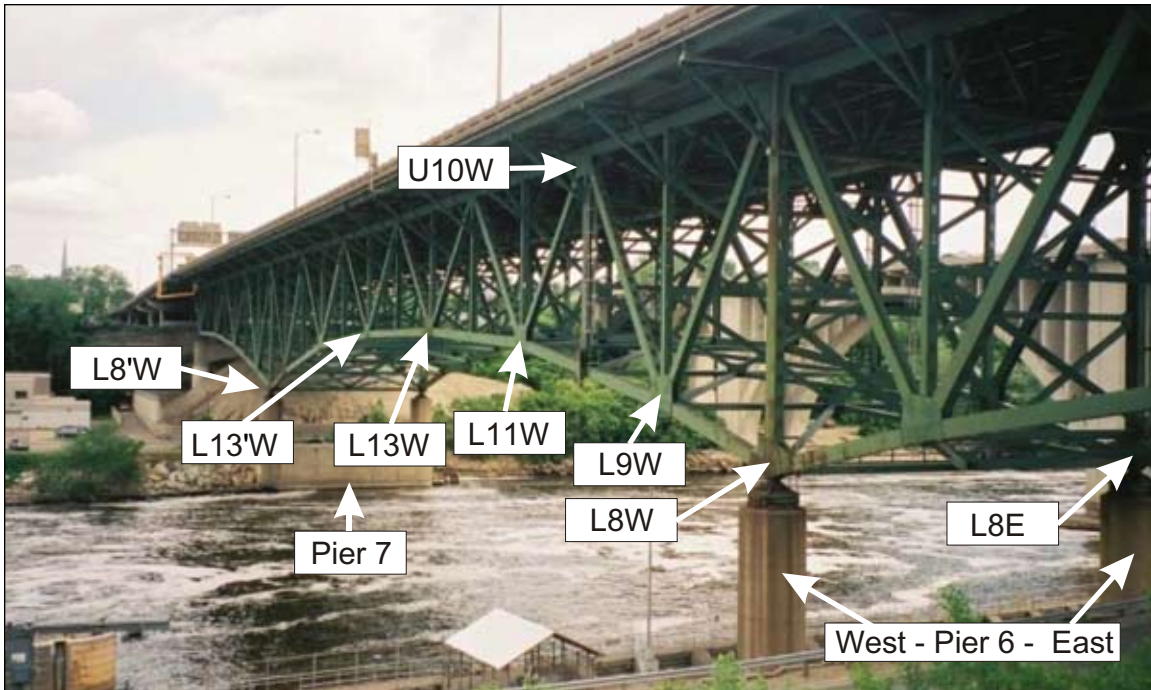
Center Section. See figure 13 for a photograph of the center span before collapse. In the postcollapse position, the center section of the truss was relatively flat and almost directly below its original location. (See figure 14.) As noted previously, the video of a portion of the collapse sequence captured by a nearby surveillance camera showed that the south end of the center section (just north of pier 6) dropped before the north end (just south of pier 7) and that the center section remained relatively level east to west as it fell. Many of the vehicles in the inner northbound lanes of the bridge remained in their lanes as the collapse occurred, indicating that the east and west main trusses at the south end of the center section fractured at about the same time and that the center section dropped into the river with a minimum of lateral roll.

Figure 13. Center span of I-35W bridge (before collapse), looking northeast, with certain nodes labeled.
