LTPP Pavement Maintenance Materials: SHRP Joint Reseal Experiment, Final Report

PUBLICATION NO. FHWA-RD-99-142

SEPTEMBER 1999

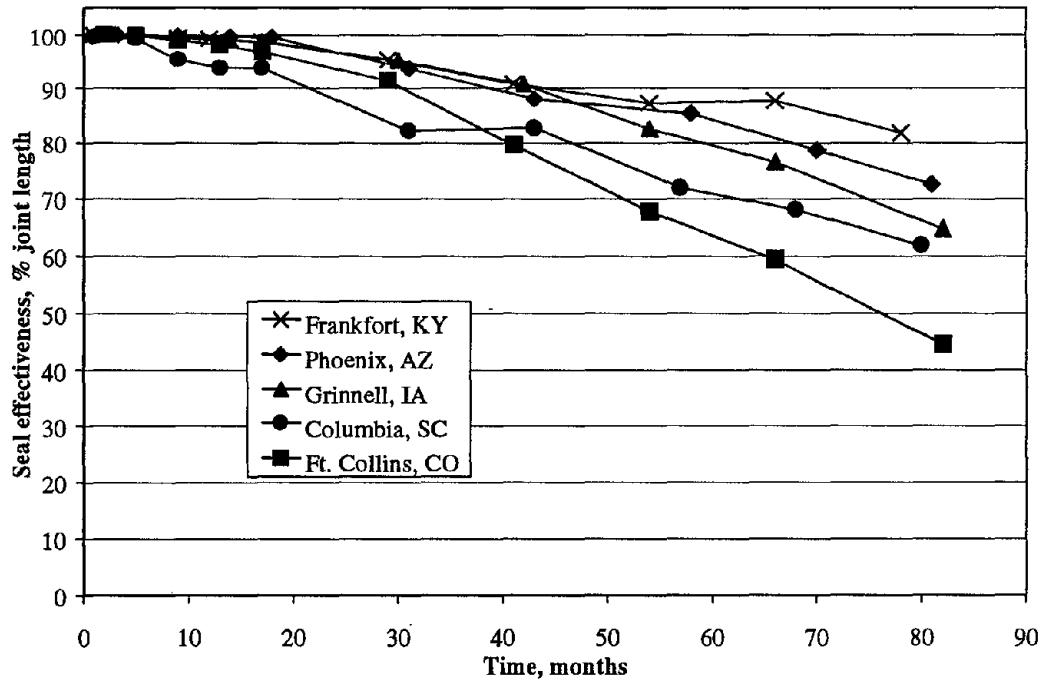
Figure 27. Overall performance of primary seals at each test site.

As seen in figure 27, a comparison by State of the overall performance of the primary seals indicates that the effectiveness has continued to decrease now that the seals have weathered six to seven winters and seven summers. Moreover, the seals at South Carolina and Colorado were not performing as well as those at other sites. A primary reason for the large amount of failure at the South Carolina site was the excessive adhesion failure in the configuration 3 joints. In these joints, unfailed silicone sealant was incompletely removed by the available plowing equipment. The silicone that remained on the joint walls inhibited bonding of the new hot-applied sealants and led to significant adhesion loss. The failure at the Colorado site was possibly due to the large amount of joint movement and the rapid temperature changes that occur as storm fronts cross the mountains into the plains. This test site is situated just east of the foothills of the Colorado Rocky Mountains. Another possible reason for the large Colorado site failure was the low quality of the available sandblasting equipment.

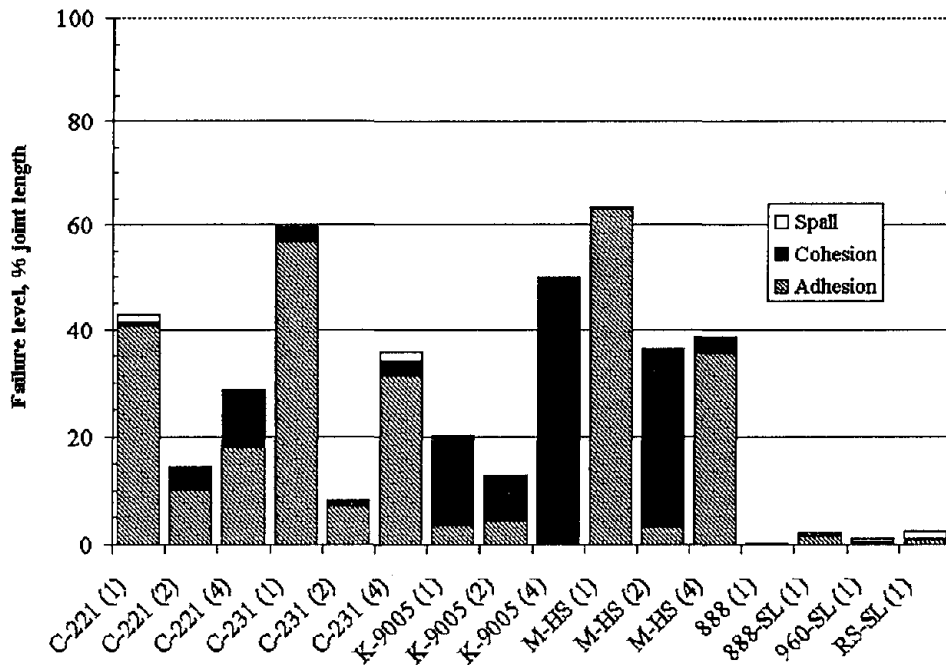
Figure 28. Overall failure at Arizona I-17 site after 81 months.

Unshaded rows in this table represent a summation for each treatment replicate—10 joints prepared with the same materials and preparation procedures. Shaded rows are an average of the percent joint length effectiveness for both replicates of a treatment. The remaining performance summary tables for each site and distress are included in appendix D. Summaries of the full-depth adhesion, cohesion, and spall failures after 82 months for each site, material, and installation method are shown in figures 28 through 32.
