Methods for Evaluating and Treating ASR-Affected Structures: Results of Field Application and Demonstration Projects

Volume II: Details of Field Applications and Analysis

Final Report

U.S. Department of Transportation
Federal Highway Administration

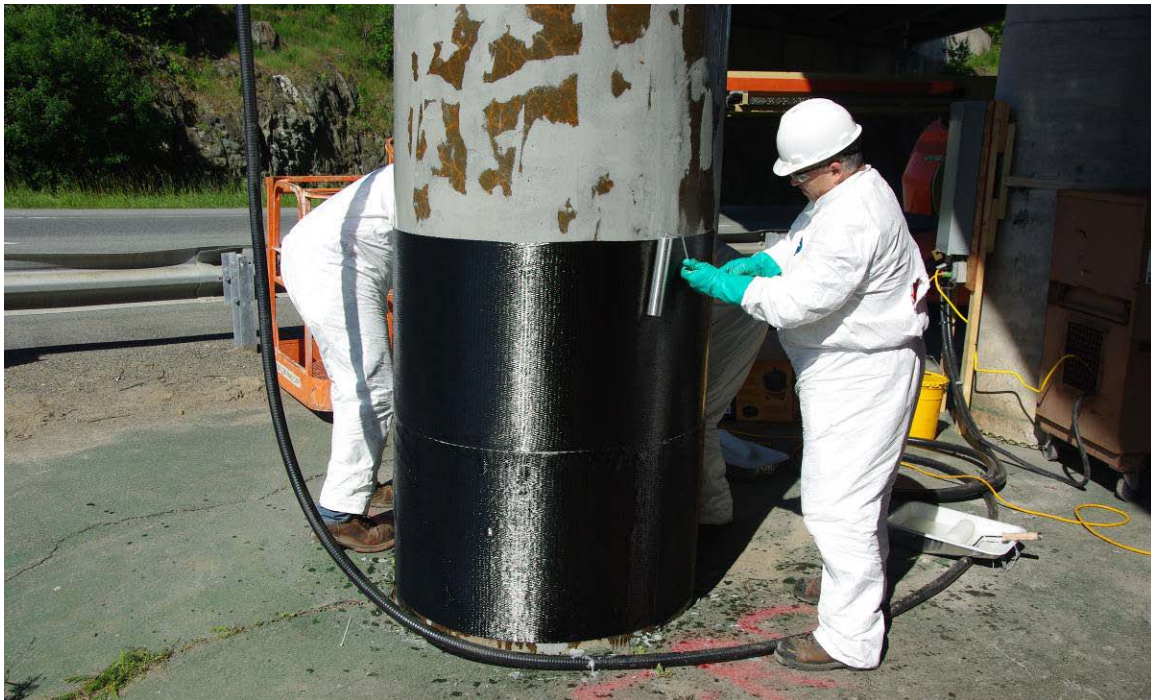
Figure 27. Application of FRP to bridge column in Maine.

One of the columns on the bridge carrying South Parkway over I-395 near Bangor, ME was wrapped using a carbon-fiber reinforced polymer (CFRP) wrap (see Figure 27). The product used was a high-strength, unidirectional carbon fiber fabric impregnated with a two-component, high-modulus epoxy resin. Four plies, each with an approximate thickness of 1 mm (0.04 in.), of the material were wrapped around the column. The reported properties of carbon fiber and the impregnated laminate (after curing) are given in Table 4. More details for the treatment near Bangor, ME are presented in chapter 7.

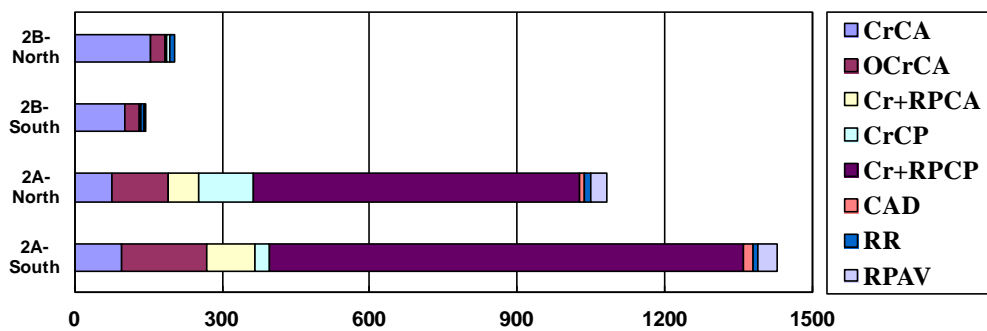
Grattan-Bellew¹⁾ confirmed that the cracking in the 5th span was due to ASR and that the concrete in the 4th span exhibited no significant signs of ASR. Dr. Grattan-Bellew's report concluded that the aggregate mineralogy and the water-soluble alkalis of the concrete in the two spans was similar and could offer no explanation for why the damage was restricted to the concrete in the arch for the 5th span.

Figure 30. Results of the Damage Rating Index (DRI) for the Alabama cores. The colored cells give the proportions of each petrographic feature to the DRI value. (CrCA: cracking in the coarse aggregate particles; OCrCA: opened cracking in the coarse aggregate particles; Cr+RPCA: cracking in the coarse aggregate particles + reaction product; CrCP: cracking in the cement paste; Cr+RPCP: cracking in the cement paste + reaction product; CAD: coarse aggregate debonded; RR: reaction rim; RPAV: reaction products in air void of the cement paste).

Cores extracted from the 4th span showed no significant signs of deterioration (2B North and South - Figure 30; Figure 31A&B), as indicated by the low DRI values of 141 and 205. On the other hand, cores extracted from the 5th span show several large cracks (up to 1 mm [0.04 in.] in size) that run through the cement paste and the coarse aggregate particles (2A North and South - Figure 30; Figure 31C&D). The DRI values of 1430 and 1081 are indicative of a very high degree of damage in the concrete. Dark reaction rims and extensive cracking were observed for several chert and quartzite coarse aggregate particles. Cracks in the cement paste were often found to be filled with secondary reaction products revealed to be ettringite and alkali-silica gel under the scanning electron microscope (SEM).

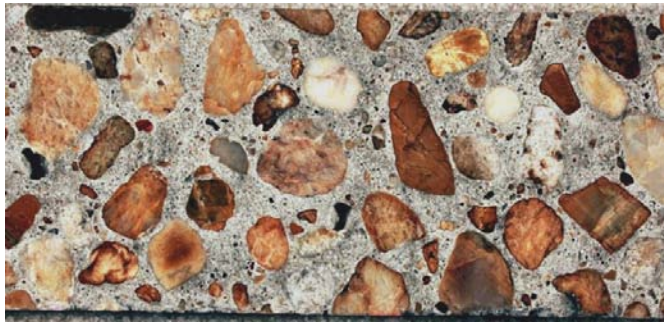
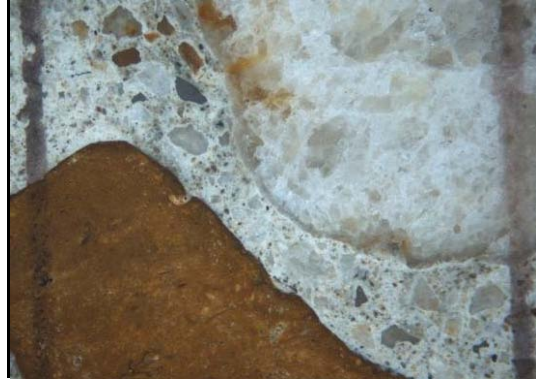
Figure 31. Polished concrete core surfaces. A&B: Core from South span #4 showing very limited cracking in the concrete aggregates and cement paste. C&D: Core from South span #5 showing extensive cracking and secondary reaction products.

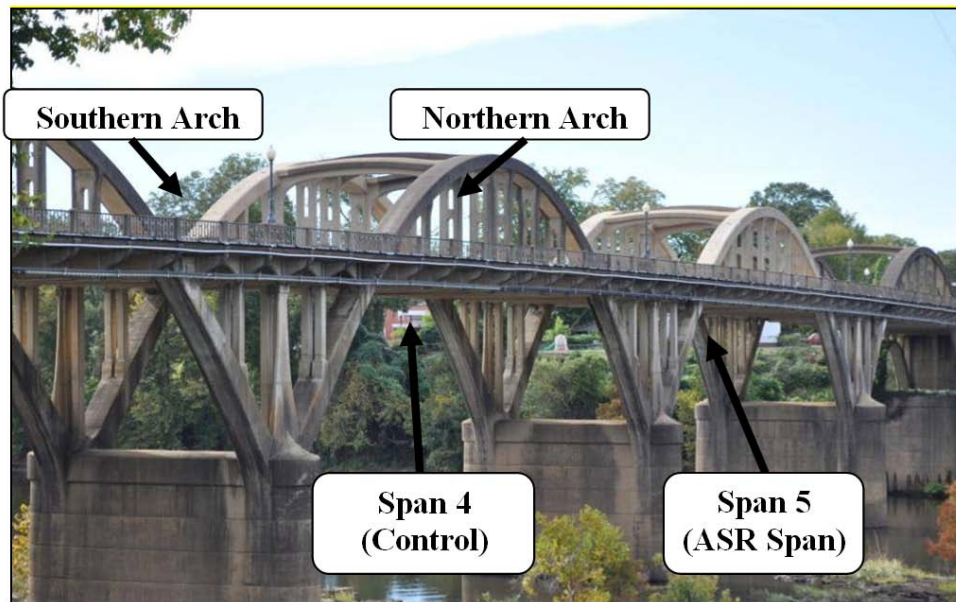
Figure 32. Photograph showing location of treated and control sections.
 (Photo courtesy of Warnock and Anton K. Schindler, 2012.)

In November 2010 the following treatment was applied to both ASR-affected arches on the 5th span and the south arch of the 4th span as a control, as shown (see Figure 32):

1. Water-blast all concrete surfaces to clean concrete surfaces and remove loose impediments, efflorescence, ASR gel, algae, etc.
2. Apply silane to all surfaces after a 72-hour drying period. A water-based, 40 percent silane penetrating sealer was applied using a low-pressure garden sprayer.
3. Seal all cracks 0.04 inches (1 millimeter) and wider with a UV-resistant, flexible sealant. The flexible sealant utilized was a structural silicone glazing and weatherproofing sealant, suitable for use for sealing expansion and control joints in precast concrete panels. A bead of sealant was applied onto the crack using a caulk gun, and the bead was then forced into the crack and smoothed by hand.

4. Apply an epoxy flood coat to the top arch surface to seal the cracks on this surface. The epoxy used was a 2-component, 100 percent-solids, low-modulus, highly-penetrating (low-viscosity), epoxy polymer. This two-part epoxy was combined using a 1:1 ratio. Before application, the mixture was blended for three minutes. The epoxy was then applied using a paint roller.
5. Installation of instrumentation for monitoring.

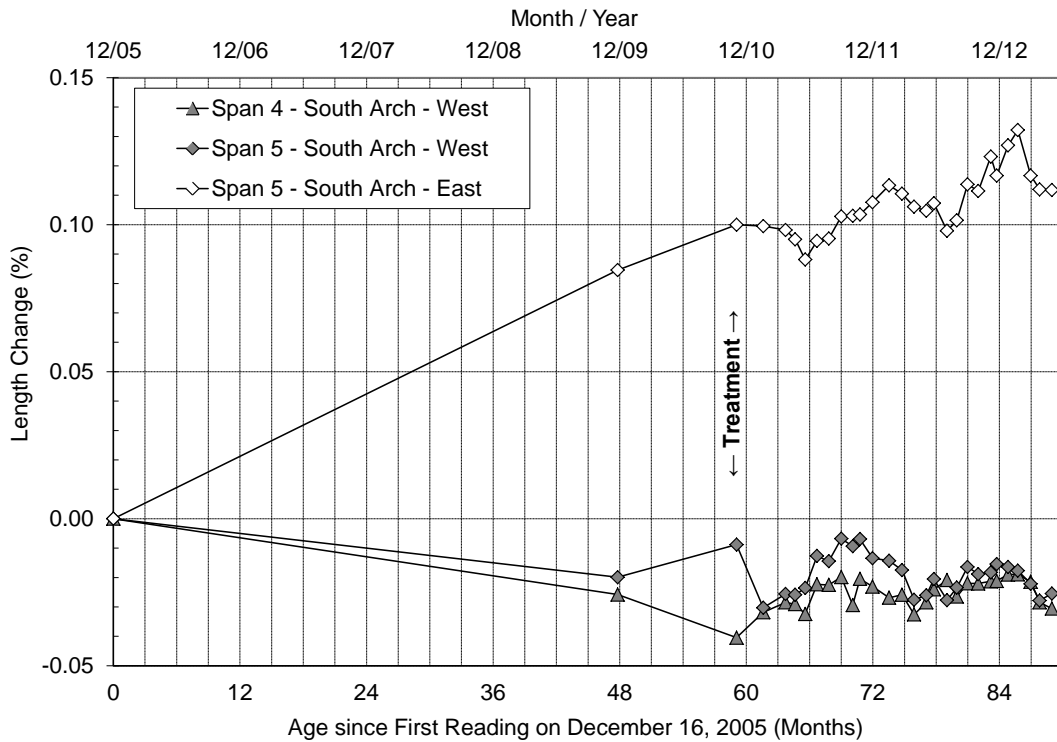
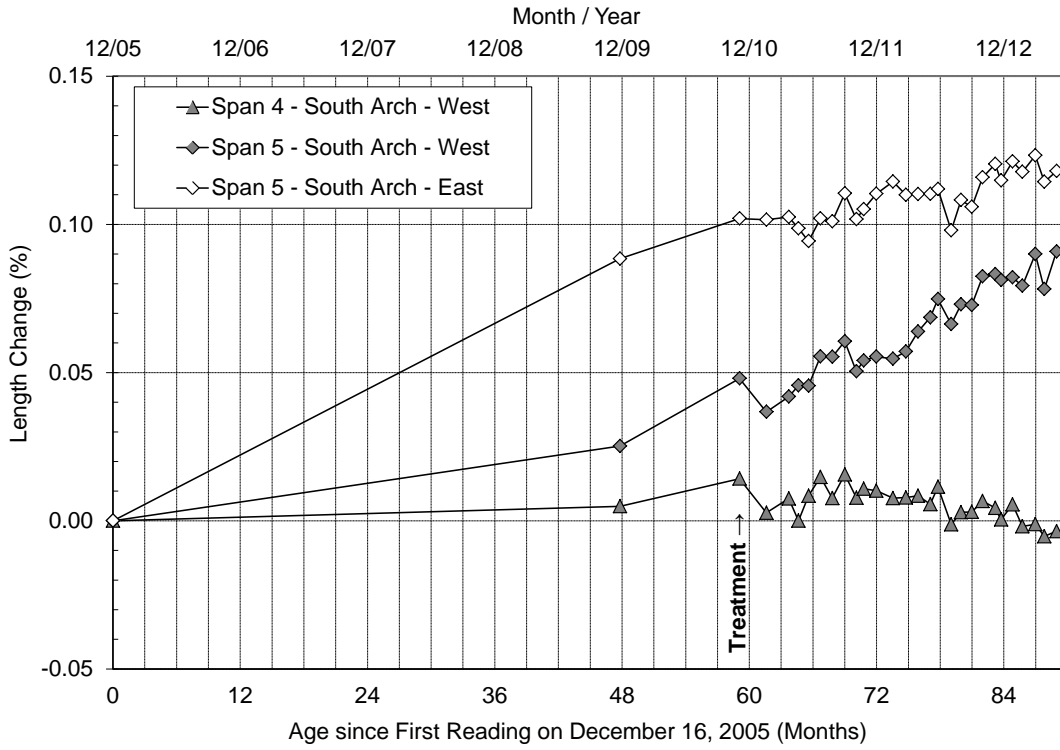
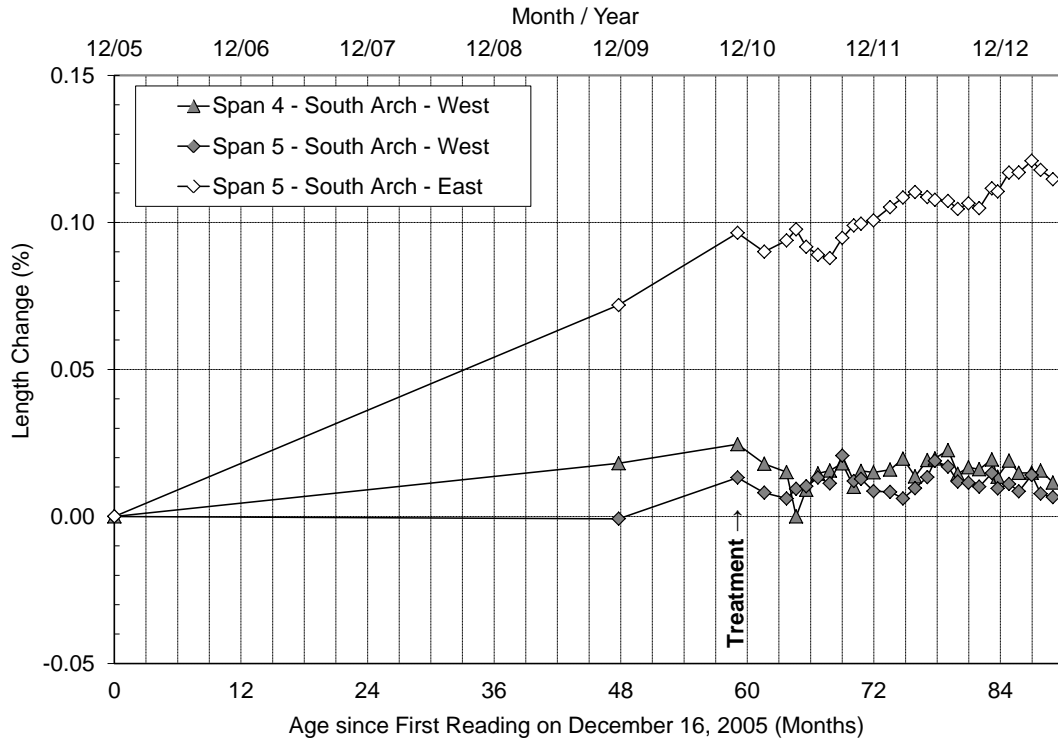
between 2005 and 2010 were corrected to supplement the data collected monthly since 2010. These data indicate significant expansion of the ASR-affected concrete in the 5th span between 2005 and the time of treatment. Generally, the concrete in this span appears to continue to expand after treatment and the rate does not appear to be significantly affected by the treatment, at least during the 2.5 years that have elapsed since treatment. Additional readings are required to confirm the post-treatment expansion rate. Little significant expansion has been observed before or after treatment for the concrete in the 4th span (unaffected by ASR).

The relative humidity data indicate that the treatment has not had a significant impact in terms of reducing the internal humidity within the concrete. In addition, expansion data indicate that the ASR-affected concrete arches supporting the 5th span are continuing to expand at most locations where gauge pins have been installed. New cracks have formed and existing cracks have widened since implementation of the treatment. These cracks allow for the ingress of rain water, which maintains a high humidity within the concrete and permits the alkali-silica reaction to continue unabated. Given the rate of expansion of the concrete and appearance of new cracks to provide for moisture ingress, any attempt to dry the concrete would probably require the provision of external cladding over the concrete. Further attempts to “seal” the concrete with coatings are likely to prove to be ineffective.

The ASR damage to the concrete arches is quite advanced and, since the arches are directly exposed to precipitation, attempts to reduce the internal humidity do not appear to have been successful. Successful drying of the concrete arches may be possible by cladding or covering the affected arches to protect them from rainfall. Given the extent of ASR, it is recommended that a structural analysis is conducted to determine the structural adequacy of the affected arches supporting the 5th span. It may be necessary to provide additional shoring (possibly a truss beneath the roadway supported on the existing piers) to support this span.

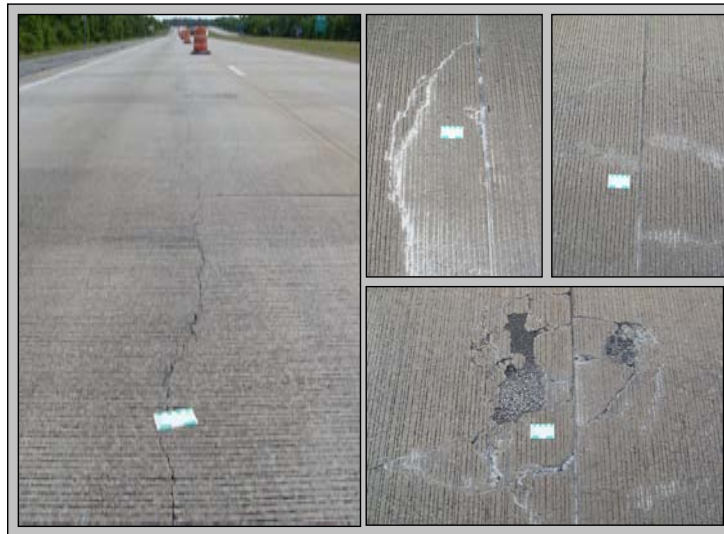
In November 2011, a 19.3 km (12 mi) long section of pavement on I-530 near Pine Bluff, AR was visually inspected to assess whether the observed distress was potentially triggered by ASR. The pavement is a jointed plain concrete pavement (JPCP), with joint spacing of approximately 4.6 m (15.0 ft) and a nominal thickness of 280 mm (11 in.) Distress was quite common in much of the pavement, with a range of distress from minimal to moderate to severe. Figure 43 shows some of the typical features of distress observed in various pavement sections. Evidence was found of map cracking, joint cracking and failure, and efflorescence/gel staining. There was some significant longitudinal cracking in isolated pavement sections, including the left photo in Figure 43; however, it is highly unlikely that this longitudinal cracking was caused by ASR and more likely that the cracking was caused by construction/design factors.

Figure 43. Typical distress observed from visual inspection of pavement.

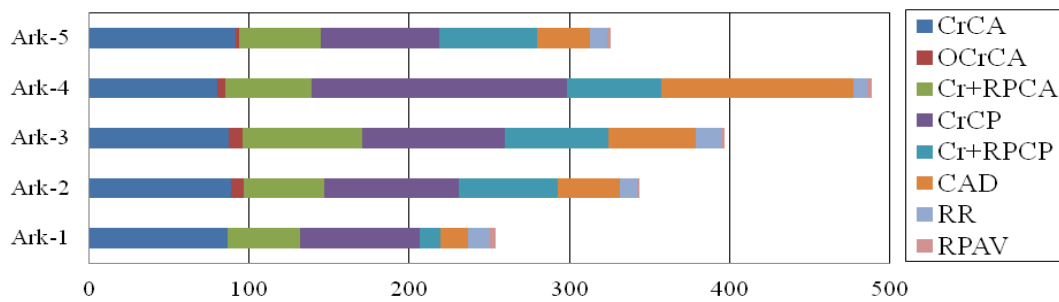
Damage Rating Indices ranging from 254 to 489 were obtained for the cores Ark-1 to Ark-5 (Figure 44), thus suggesting low to moderate degree of deterioration/damage due to ASR. Signs of ASR were found in chert particles of the coarser fraction of the sand in the concrete. Typical petrographic features of ASR correspond to cracking with ASR gel and reaction rims in the chert particles within the fine aggregate portion, as well as cracking in the cement paste with reaction products associated to the reactive chert particles (Figure 45). Tight/closed cracks were observed in several coarse aggregate particles, consisting of granitic gneiss; this cracking is thought to be associated to the aggregate processing operations and not to ASR.

Figure 44. Results of the Damage Rating Index (DRI) for the Arkansas cores. The colored cells give the proportions of each petrographic feature to the DRI value. (CrCA: cracking in the coarse aggregate particles; OCrCa: opened cracking in the coarse aggregate particles; Cr+RPCA: cracking in the coarse aggregate particles + reaction product; CrCP: cracking in the cement paste; Cr+RPCP: cracking in the cement paste + reaction product; CAD: coarse aggregate debonded; RR: reaction rim; RPAV: reaction products in air void of the cement paste).

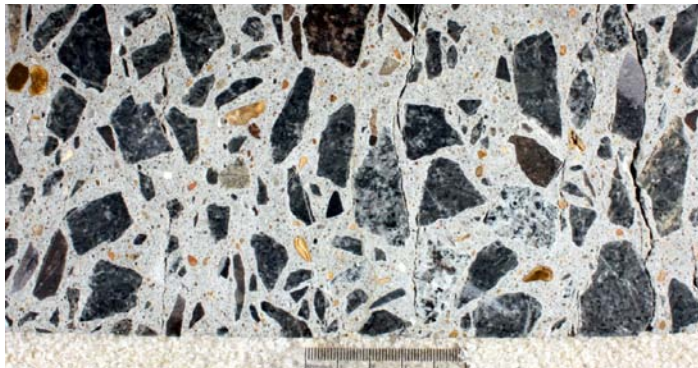
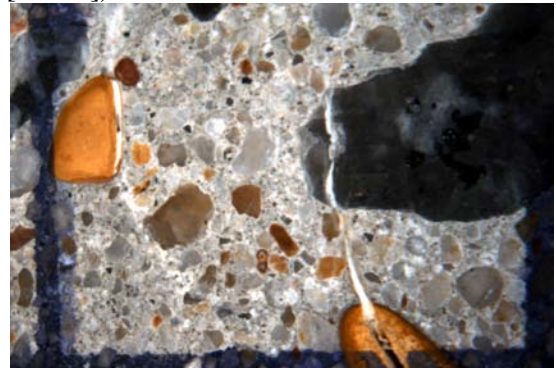
Figure 45. A: Polished core showing macrocracks parallel to the surface. B: Visible cracking and secondary reaction products in cracks of the fine aggregate particles of the cement paste.

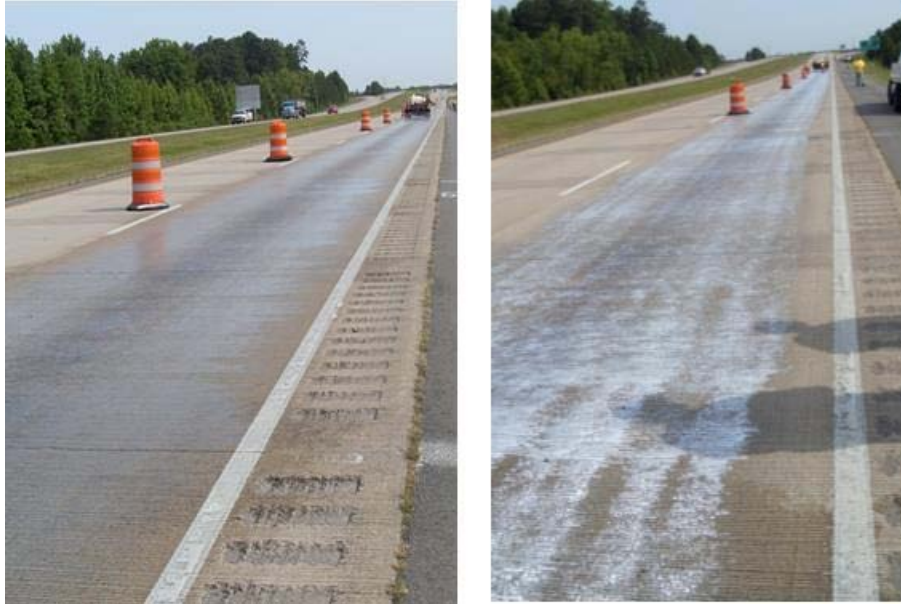
Figure 50 shows photographs of the pavement sections taken shortly after the application of the two silane products, with the 100 percent silane on the left and the 40 percent silane on the right. The 100 percent silane was applied as a clear liquid and appeared to dry within an hour. The surface seemed somewhat slippery when walked on while still wet. After drying, walking on the pavement gave no indication of lasting slippery conditions. The 40 percent silane was applied as white liquid, and as it dried, it became clear. However, the surface of the pavement remained wet for an extended time and was very slippery while wet. To ensure the traveling public's safety, the lane-closure was kept in place for 48 hours after the application of the 40 percent silane. Fortunately, this section of pavement is not heavily congested, and as such, the lane closures did not result in significant delays or traffic congestion. Reports by AHTD several weeks after silane treatment confirm that the sections did not show any signs of being slippery once the lane-closures were removed, even after several rainfall events.

Figure 50. Photograph of pavement sections treated topically with 100 percent silane (left) and 40 percent silane (right). The slow drying of the 40 percent silane section resulted in a slick surface that required lane closures for about 48 hours.

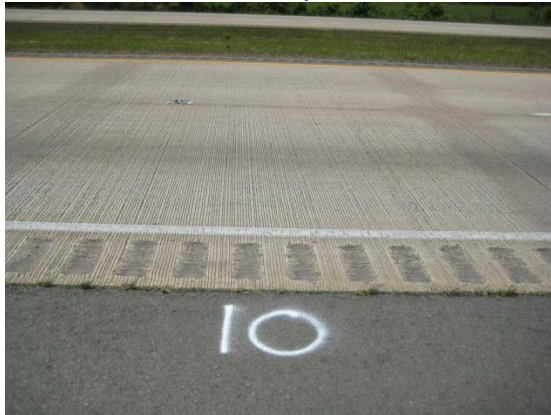
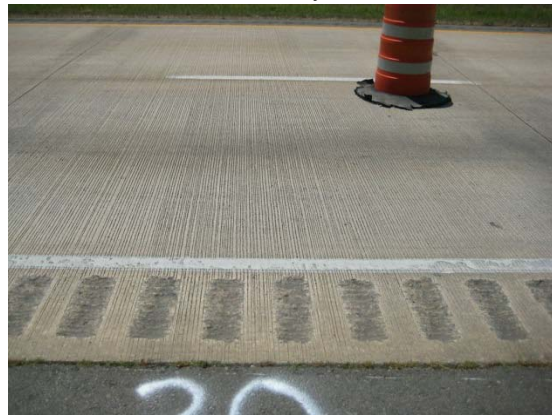
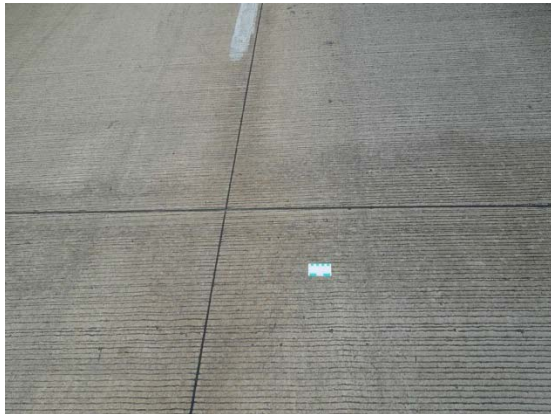
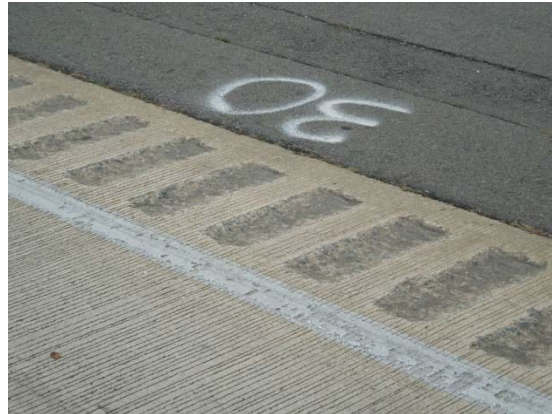
Figure 51. Visual evaluations of Section 1 (control). A: May 2012. B: May 2012. C: December 2012. D: December 2012.

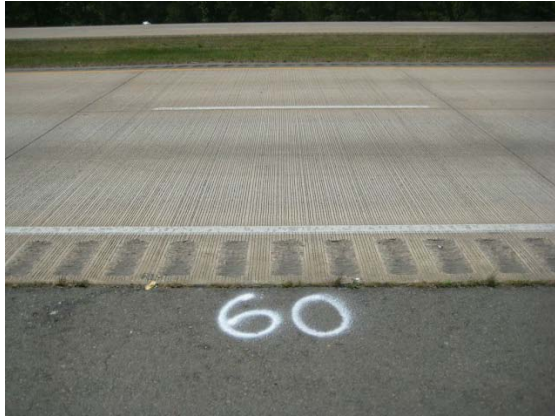
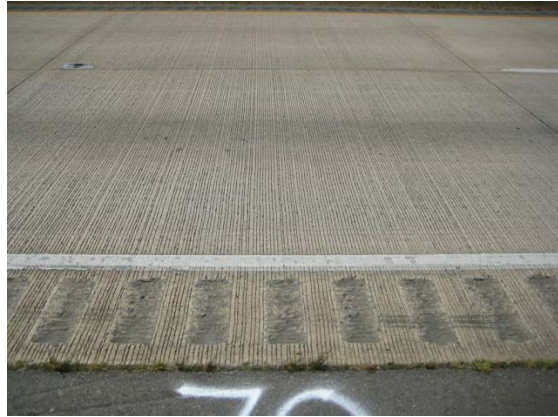
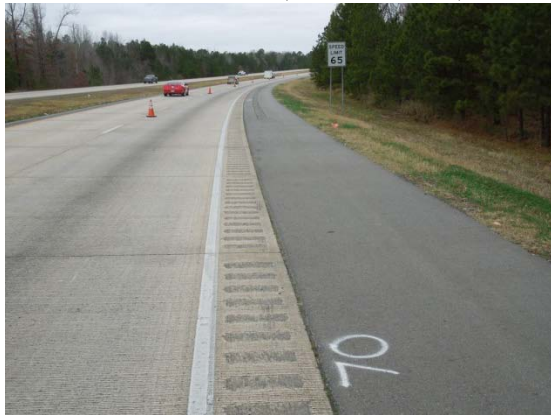
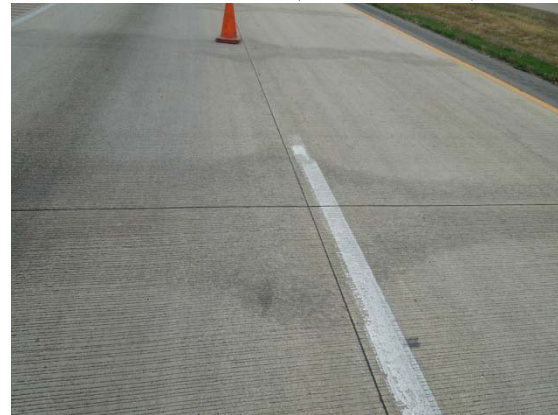
Figure 52. Visual evaluations of Section 1 (100 percent silane). A: May 2012. B: May 2012. C: December 2012. D: December 2012.

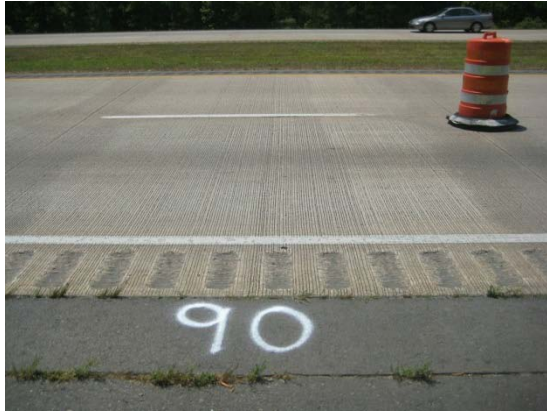
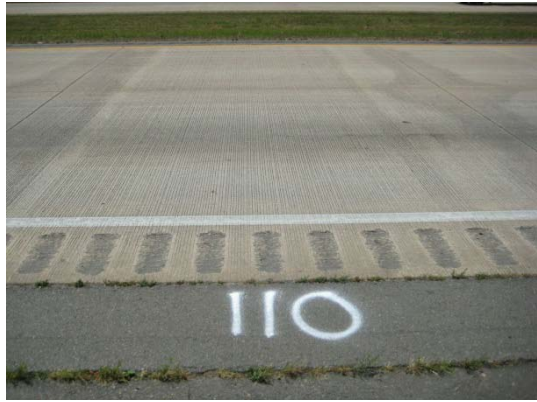
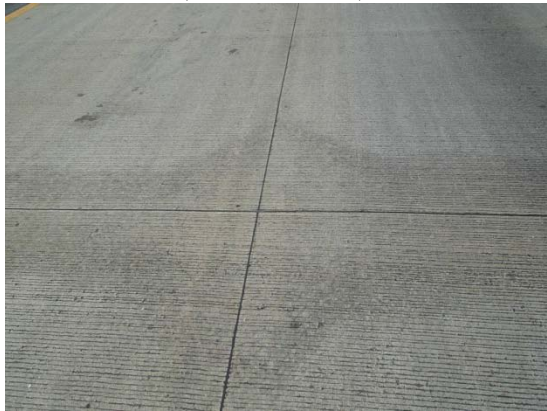
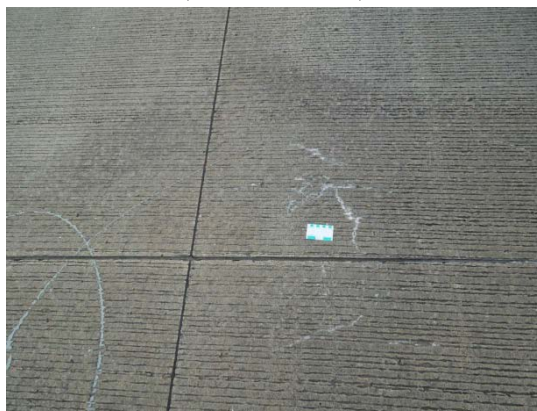
Figure 53. Visual evaluations of Section 1 (40 percent silane). A: May 2012. B: May 2012. C: December 2012. D: December 2012.

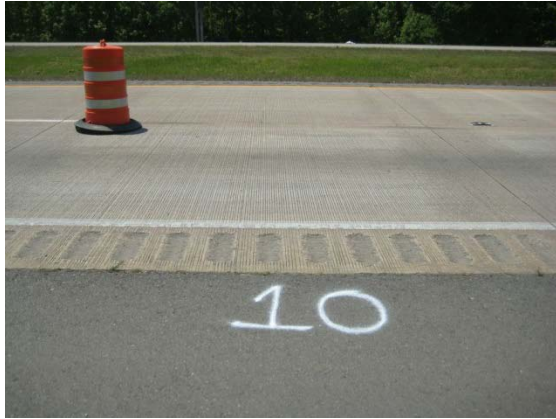
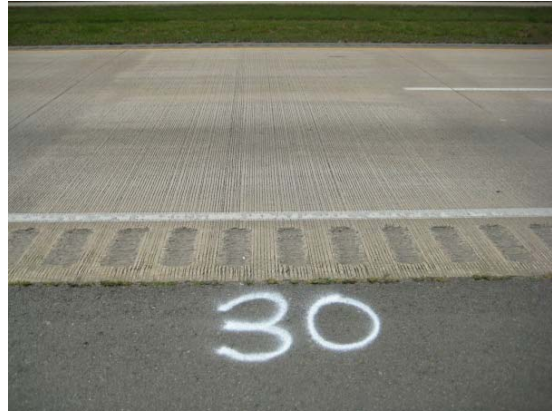
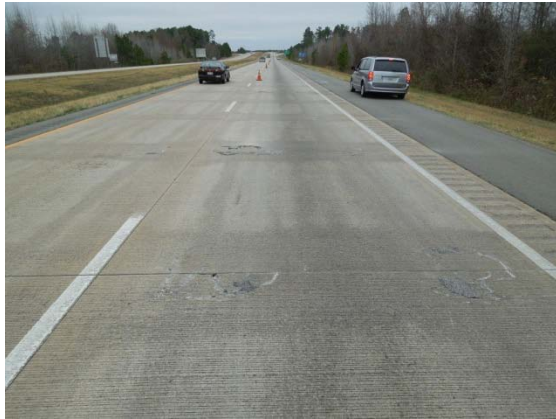
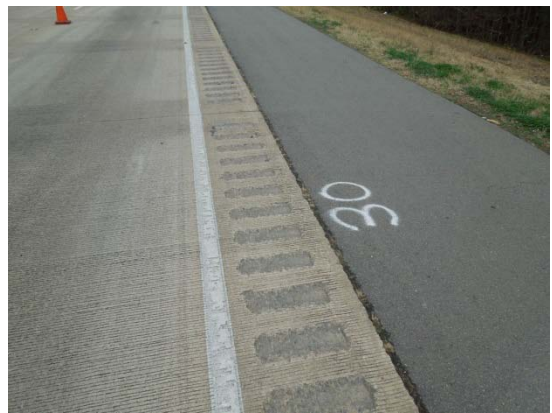
Figure 54. Visual evaluations of Section 2 (control). A: May 2012. B: May 2012. C: December 2012. D: December 2012.

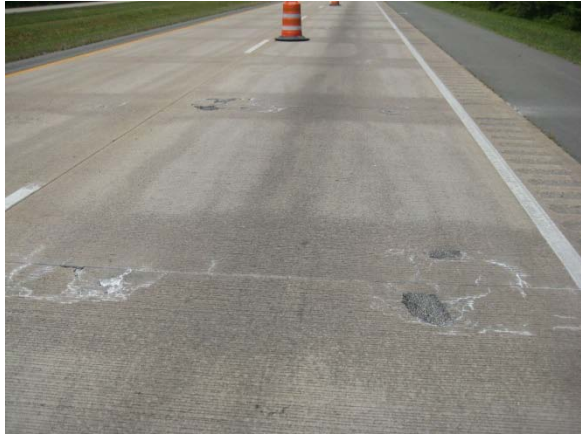
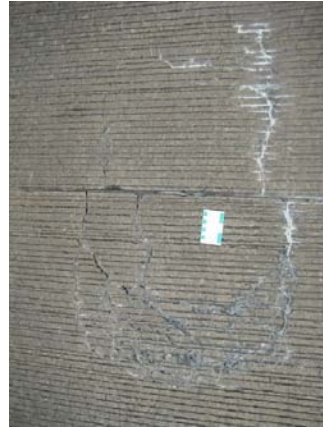
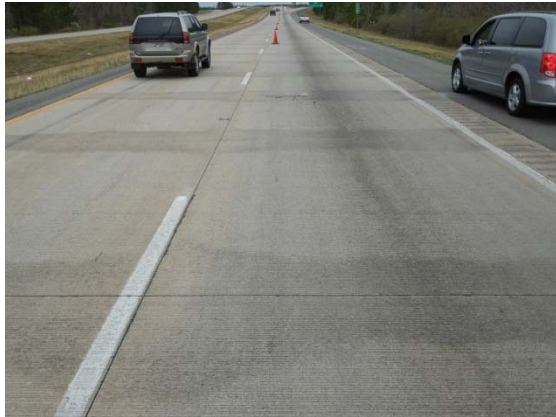
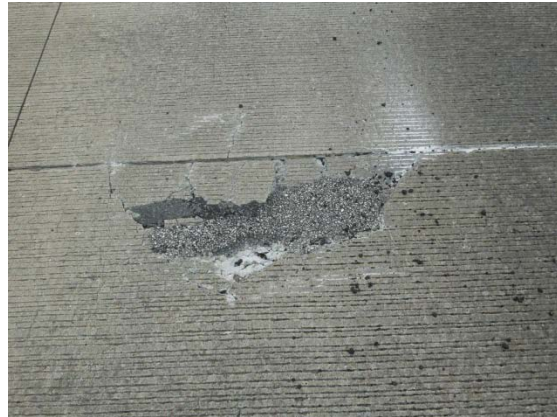
Figure 55. Visual evaluations of Section 2 (100 percent silane). A: May 2012. B: May 2012. C: December 2012. D: December 2012.

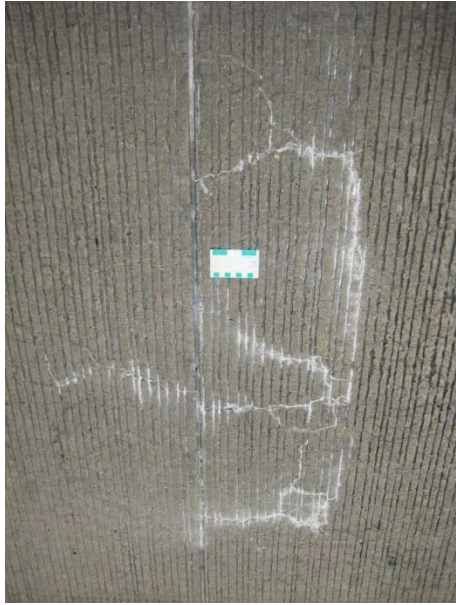
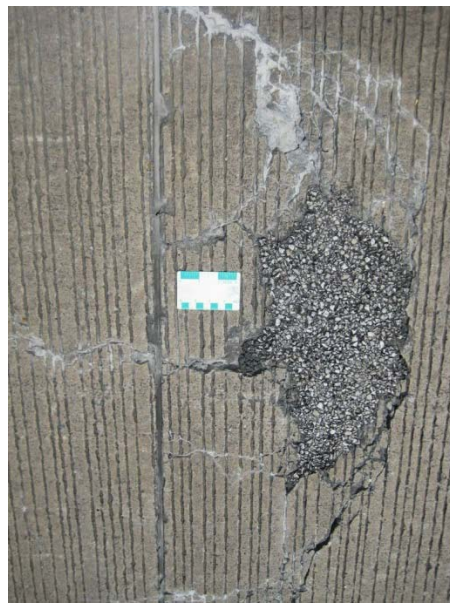
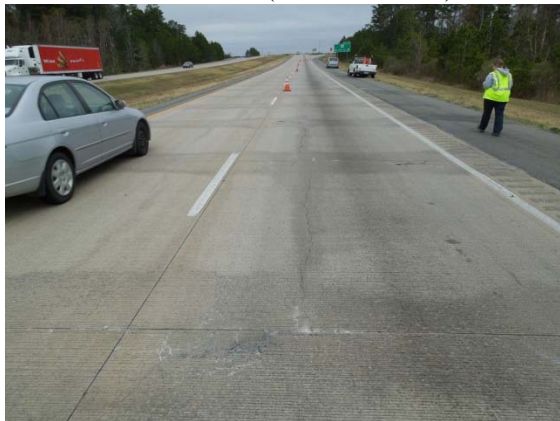
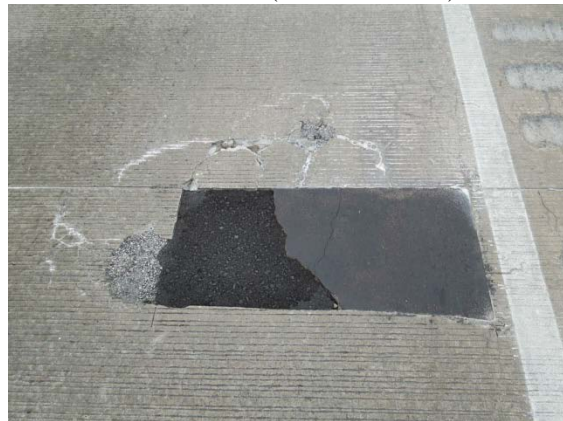
Figure 56. Visual evaluations of Section 2 (40 percent silane). A: May 2012. B: May 2012. C: December 2012. D: December 2012.

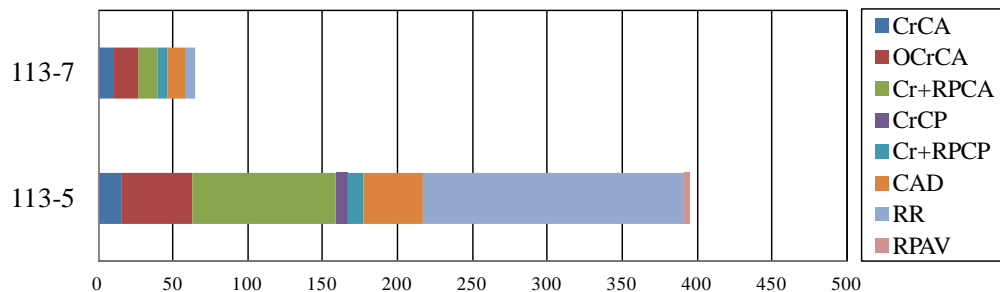
Figure 57. Results of the Damage Rating Index (DRI) for the Delaware cores.

The evaluation mainly consisted of the Damage Rating Index (DRI), a method that provides a semi-quantitative assessment of the degree of damage in concrete based on a count of petrographic features of deterioration generally associated with ASR. Damage Ratings of 65 and 395 were obtained, thus indicating an extent of ASR/damage in the concrete ranging from very low to moderate (see Figure 57). Core 113-05 showed significant signs of ASR both in the coarse (gneiss) and the fine (chert) aggregates (see Figure 58). The main signs of reactivity were cracking both in the coarse aggregate particles and in the cement paste. In many cases, alkali-silica gel was observed in the cracks (both in the cement paste and the aggregate particles). A few air voids contained deposits of alkali-silica gel, while deposits of ettringite were found lining a large proportion of the air voids in the concrete. A low degree of ASR and deterioration was observed in core 113-07 (see Figure 58). A large proportion of the air voids in the cement paste, especially in the bottom part of the core, were lined with secondary deposits of ettringite.

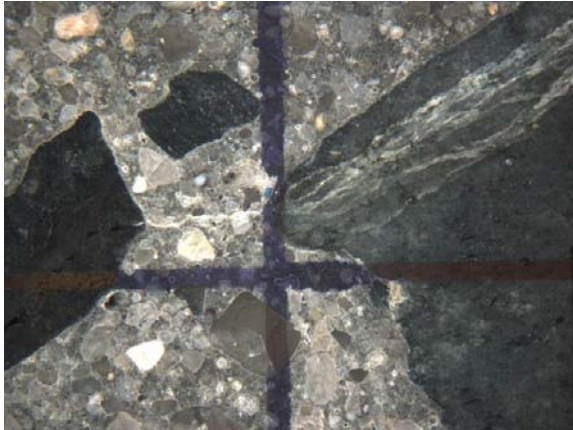
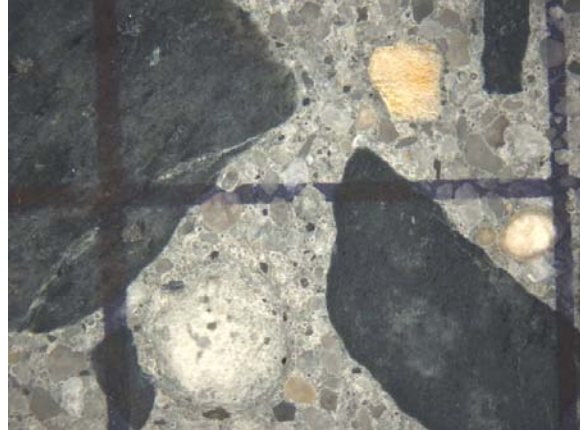
Figure 58. Micrograph from the polished cores.

A: Section 113-05 showing microcracking in a reactive coarse aggregate particle extending into the cement paste (filled with ASR gel). **B:** Section 113-07 showing cracking in an aggregate particle but limited overall damage (core 113-07).

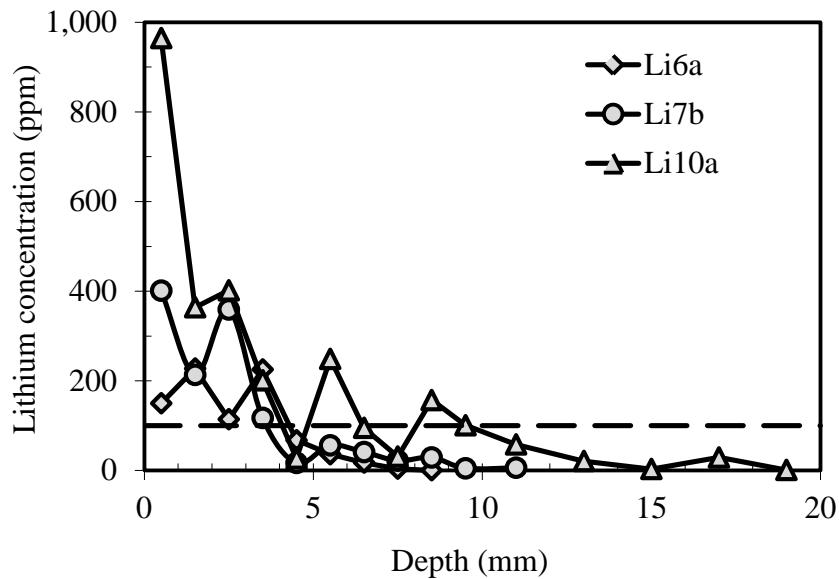
Figure 59. Lithium-concentration profiles.

Core locations: Li6a from section where the surface had been remediated by shot-blasting and diamond-grinding; Li7b and Li10a from section with the original surface texture; Li10a from section with the highest petrographic damage rating. The broken horizontal line shows the approximate lithium concentration (~ 100 ppm) required to mitigate expansion.

alkali (sodium and potassium) available in the concrete. However, previous estimates have indicated that a lithium concentration in the range of 100 to 300 ppm (by mass of concrete) would be sufficient in typical cases. The data in Figure 59 indicate that such levels of lithium are only achieved very close to the surface (i.e., within 3 to 10 mm [0.1 to 0.4 in.]). It is highly unlikely that such low depths of lithium penetration would have any impact on the future rate of deterioration of the concrete pavement due to ASR.

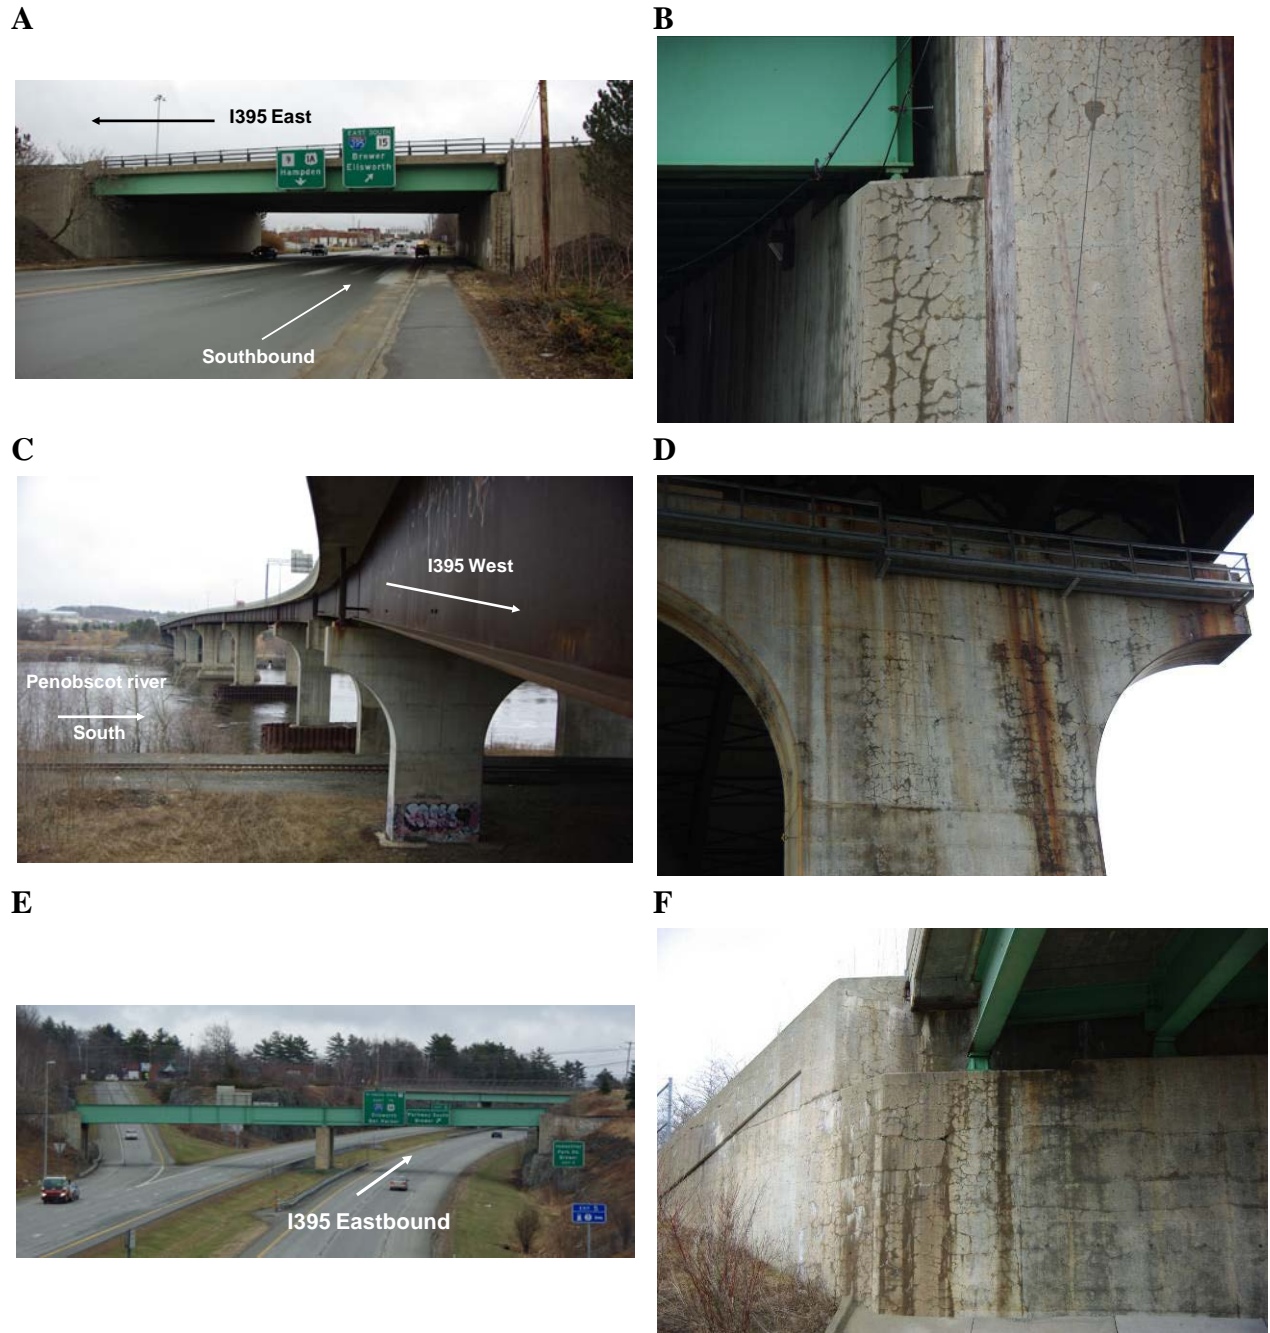
Figure 61. I-395 bridge and 5th Parkway bridge.

The first structure corresponds to a highway bridge on I-395 over Main Street on the west side of the Penobscot River (see Figure 61A). The section of the abutment walls sheltered from direct exposure to rain and sun showed very limited visible cracking, while the exposed portions of the abutments and the wing walls showed moderate to severe map cracking (see Figure 61B). The second structure corresponds to the major I-395 bridge over the Penobscot River (see Figure 61C). Once again, cracking was mostly found on the sections of the piers exposed to an "excess" of moisture (in addition to ambient moisture), most commonly on external piers and sections of piers under leaking joints (see Figure 61D). The third structure in the corridor corresponds to the 5th Parkway bridge (Robertson Road) over I-395 (see Figure 61E). The concrete elements under the bridge deck, protected from the rain, show cracking of low severity, while the exposed portions of the abutment and wing walls show moderate to severe map cracking (see Figure 61F).

A: General view of the I-395 bridge over Main Street. **B:** Typical (moderate) map cracking affecting the exposed portions of the abutment and wing walls of the I-395 bridge over Main Street. **C:** General view of the I-395 bridge over the Penobscot River. **D:** Cracking in a pier of the bridge over the Penobscot River. **E:** General view of the 5th Parkway bridge over I-395. **F:** Moderate to severe cracking and localized exudations affecting the abutment and wing walls of the 5th Parkway bridge; also, effect of moisture on the severity of cracking on the exposed and protected (under bridge deck) portions of the bridge.

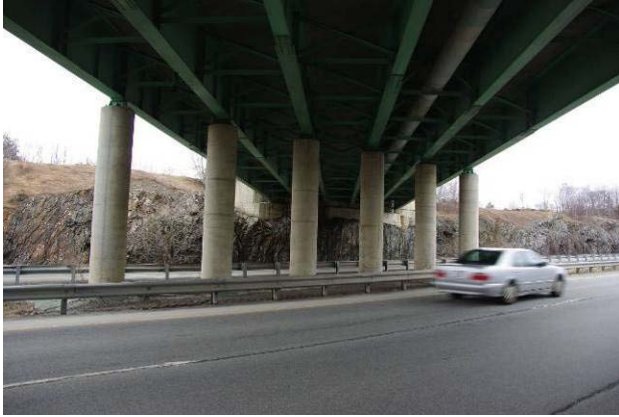
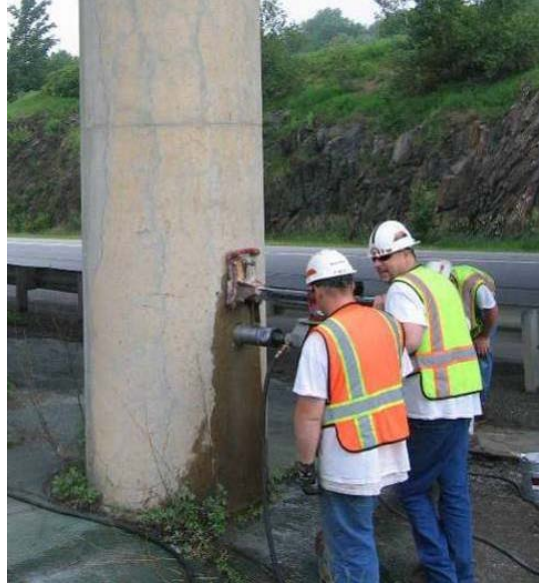
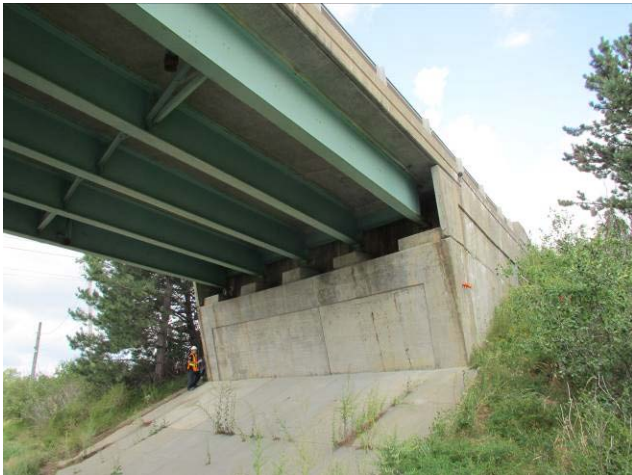
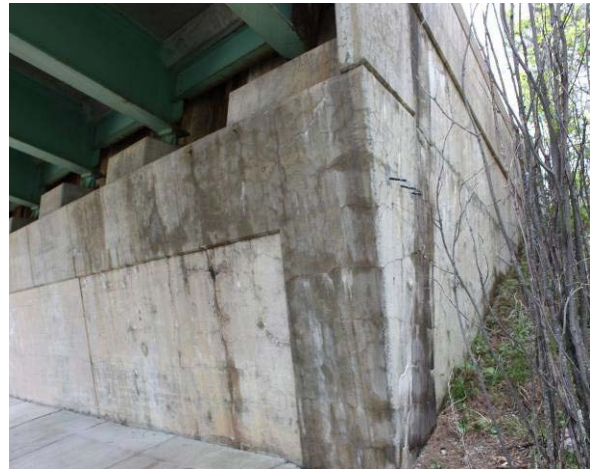
Figure 62. Bridges over I-395.

The fourth structure in the corridor corresponds to the South Parkway bridge over I-395; the activities on that bridge focused on the six columns located under the central span of the bridge (see Figure 62A). The external columns (exposed to moisture) show moderate map and aligned

(vertical) cracking (see Figure 62B), while those under the bridge deck, i.e., protected from rain, show very limited cracking. The fifth structure investigated corresponds to the Green Point Road bridge over I-395 (see Figure 62C). Portions of the abutment walls under the bridge deck, protected from direct excess of moisture (rain), show limited cracking while the exposed portions of the abutment and wing walls show moderate map cracking (see Figure 62D).

A: General view of the South Parkway bridge over I-395. B: External column (east side) showing moderate to severe aligned (vertical) cracking. C: General view of the Green Point Road bridge over I-395. D: Moderate cracking and localized exudations affecting the abutment and wing walls of the Greenpoint Road bridge; also, effect of moisture on the severity of cracking on the exposed and protected (under bridge deck) portions of the bridge.

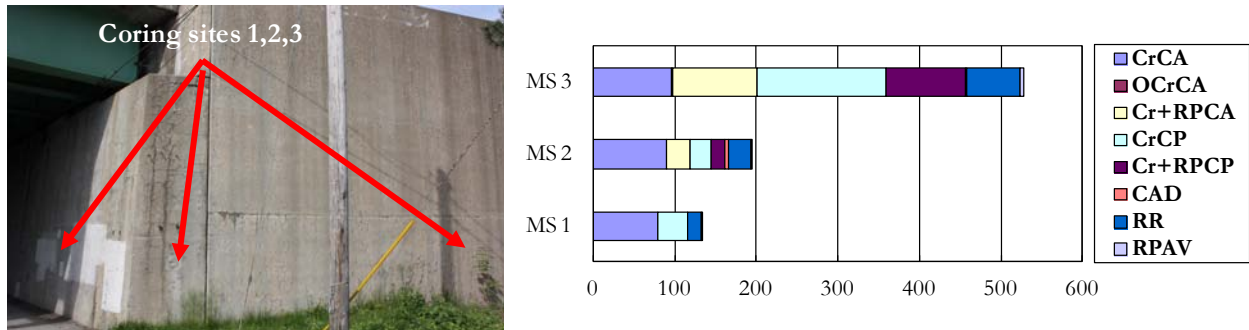
Figure 63. Results of the Damage Rating Index (DRI) for three cores extracted from various areas of I-395 over Main Street in Bangor, ME.

The extent of ASR/damage was found to vary significantly as a function of the exposure conditions of the structural elements examined (see Figure 63). The concrete specimens examined typically incorporated a reactive greywacke/argillite coarse aggregate. Several concrete specimens (especially those exposed to moisture) showed typical signs of ASR consisting of cracking in the coarse aggregate particles and in the cement paste, often filled with alkali-silica reaction products, reaction rims around reactive aggregate particles, and air voids filled with secondary reaction products (see Figure 64). The extent of the petrographic signs of ASR are, once again, very much a function of the exposure conditions of the concrete, cores extracted from those parts of the structures that are exposed to rain and excess moisture generally showing significantly higher DRI values.

MS1: abutment wall under the bridge deck, sheltered (no cracking); MS2: exposed portion of the abutment wall (map cracked); MS3: exposed portion of the wing wall (map cracked). The colored cells give the proportions of each petrographic feature to the DRI value. (CrCA: cracking in the coarse aggregate particles; OCrCa: opened cracking in the coarse aggregate particles; Cr+RPCA: cracking in the coarse aggregate particles + reaction product; CrCP: cracking in the cement paste; Cr+RPCP: cracking in the cement paste + reaction product; CAD: coarse aggregate debonded; RR: reaction rim; RPAV: reaction products in air void of the cement paste).

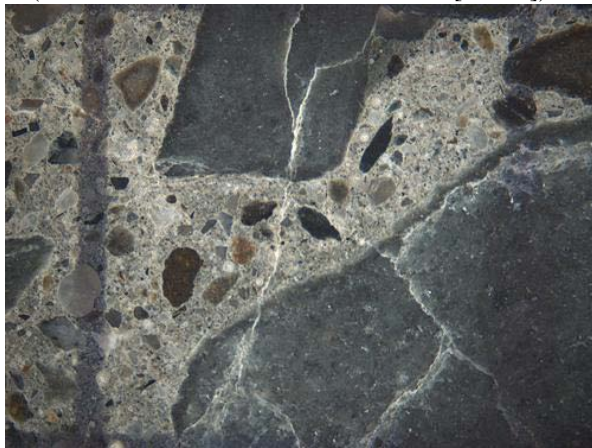
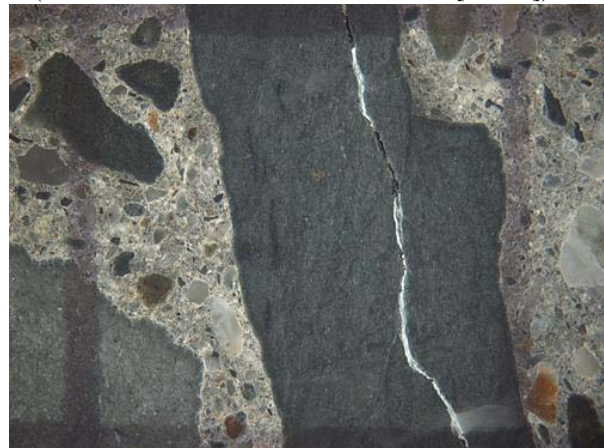
Figure 64. Polished concrete surfaces, cores extracted from bridge structures along I-395 in Bangor, Maine. A&B: Cracking in coarse aggregate particles (greywacke) extending into the cement paste; secondary (ASR) products are observed in the cracks both in the particles and the cement paste. Dark reaction rims are observed surrounding the reactive aggregate particles.
