Methods for Evaluating and Treating ASR-Affected Structures: Results of Field Application and Demonstration Projects

Volume II: Details of Field Applications and Analysis

Final Report

U.S. Department of Transportation
Federal Highway Administration

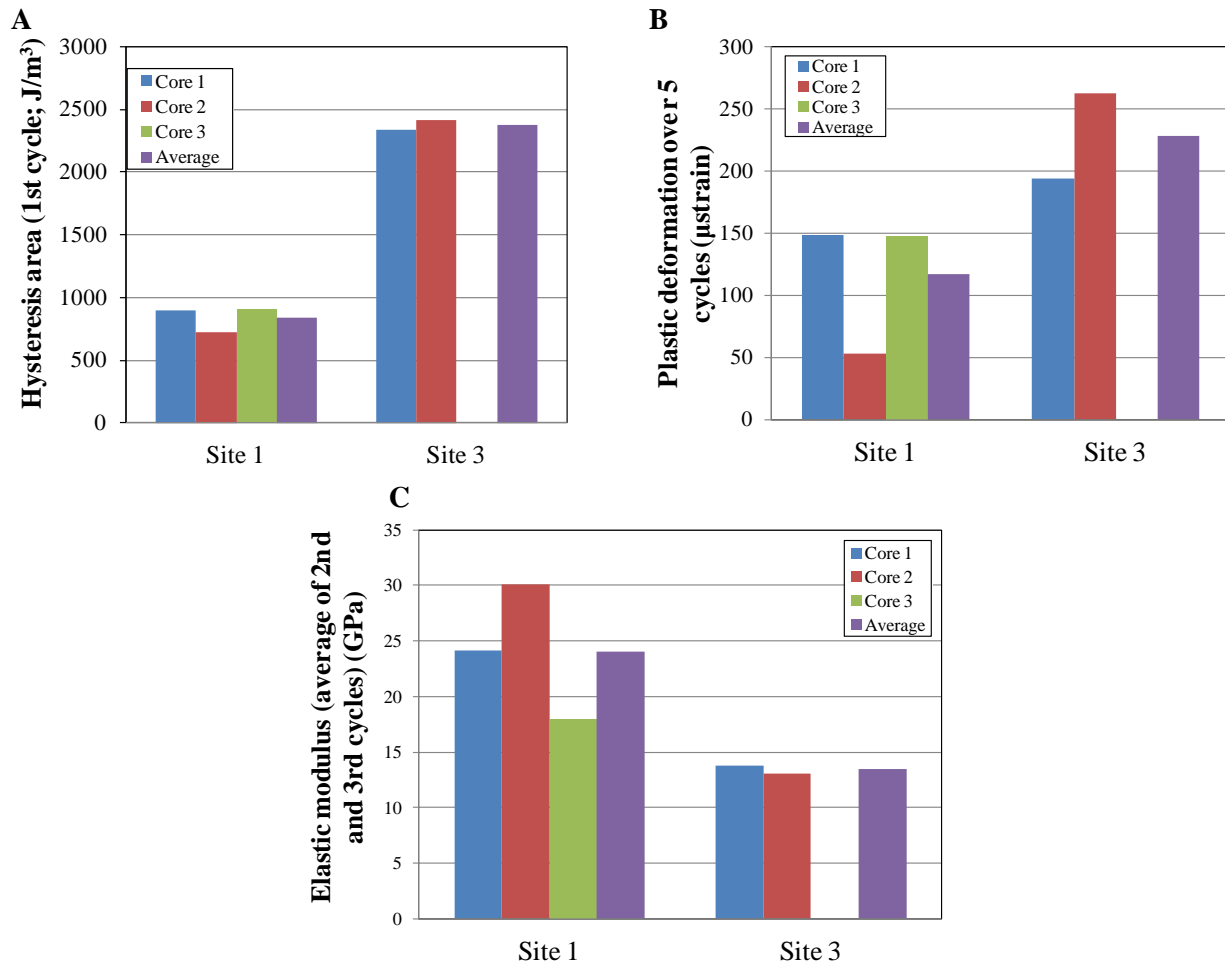
Additional (3-inch [approximately 8-cm]) cores were extracted from the exposed and sheltered sections of two bridge structures, and subjected to the Stiffness Damage Test (SDT) (see chapter 2 for details on the method). Table 34 presents the results of the SDT. Although there is currently no chart available to allow a proper analysis of the extent of deterioration in ASR-affected concrete specimens through the SDT, the results of the various SDT parameters gave a very similar diagnostic to that obtained with the DRI, i.e., significantly higher first cycle hysteresis and plastic deformation over the five cycles, and lower modulus of elasticity values, i.e., related to higher internal damage, for ASR-affected concrete cores extracted from the exposed portions of the structures compared to the sheltered ones. Figure 65 illustrates this typical difference.

Figure 65. Results of the SDT for cores extracted from the bridge structure on I-395 over Main Street. Results are compared for sets of cores extracted from exposed and sheltered portions of the bridge structure. A: Hysteresis area, 1st cycle. B: Plastic deformation, 5 cycles. C: Modulus of elasticity, average of 2nd & 3rd cycles.

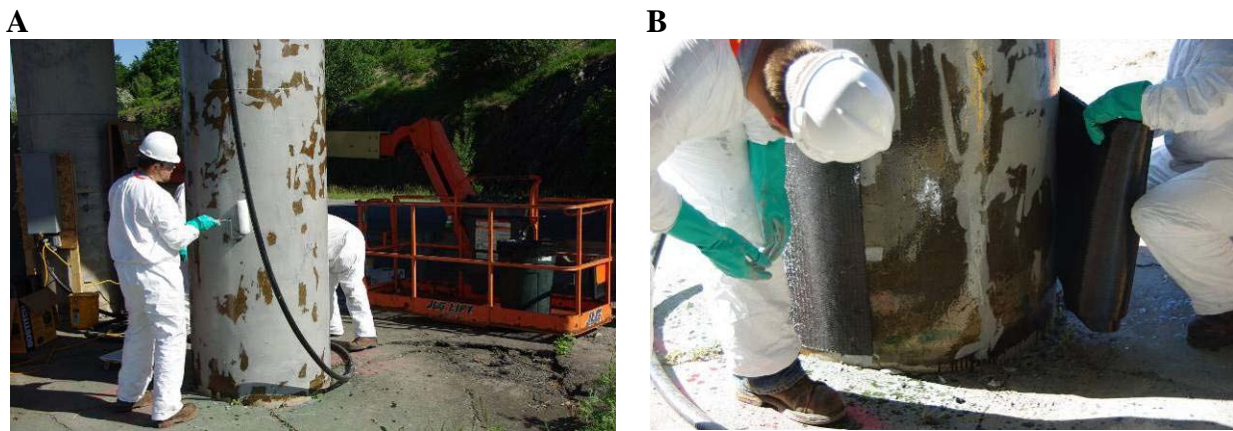
Figure 74. Application of strengthening (FRP wrap).

The six columns at mid-span of the South Parkway bridge over I-395 provided an opportunity to evaluate additional types of remedial actions on a series of 7-m (23-ft) tall columns exhibiting different levels of ASR. Column No. 6, which exhibited the highest degree of deterioration (moderate-to-severe cracking – see Figure 62B and Figure 70) was encapsulated using four layers of carbon fiber reinforced polymer (CFRP) strengthening wrap. The column was first cleaned, and then a structural epoxy paste adhesive was applied for filling in bug holes and hairline cracks before applying CFRP strengthening. Following the application of the above paste, a high strength, high modulus epoxy was rolled onto the surface of the column, followed by four layers of carbon fiber fabric (see Figure 74A). The CFRP wrap is gently rolled between every layer to remove any air pockets that may have been encapsulated during the application, each layer being bound to each other using the high-strength epoxy mentioned before (see Figure 74B). Details on the application techniques and processes are given in chapter 3.

A: An epoxy resin is rolled onto the surface first covered with a special paste. **B:** CFRP wrap applied onto the surface of the column.

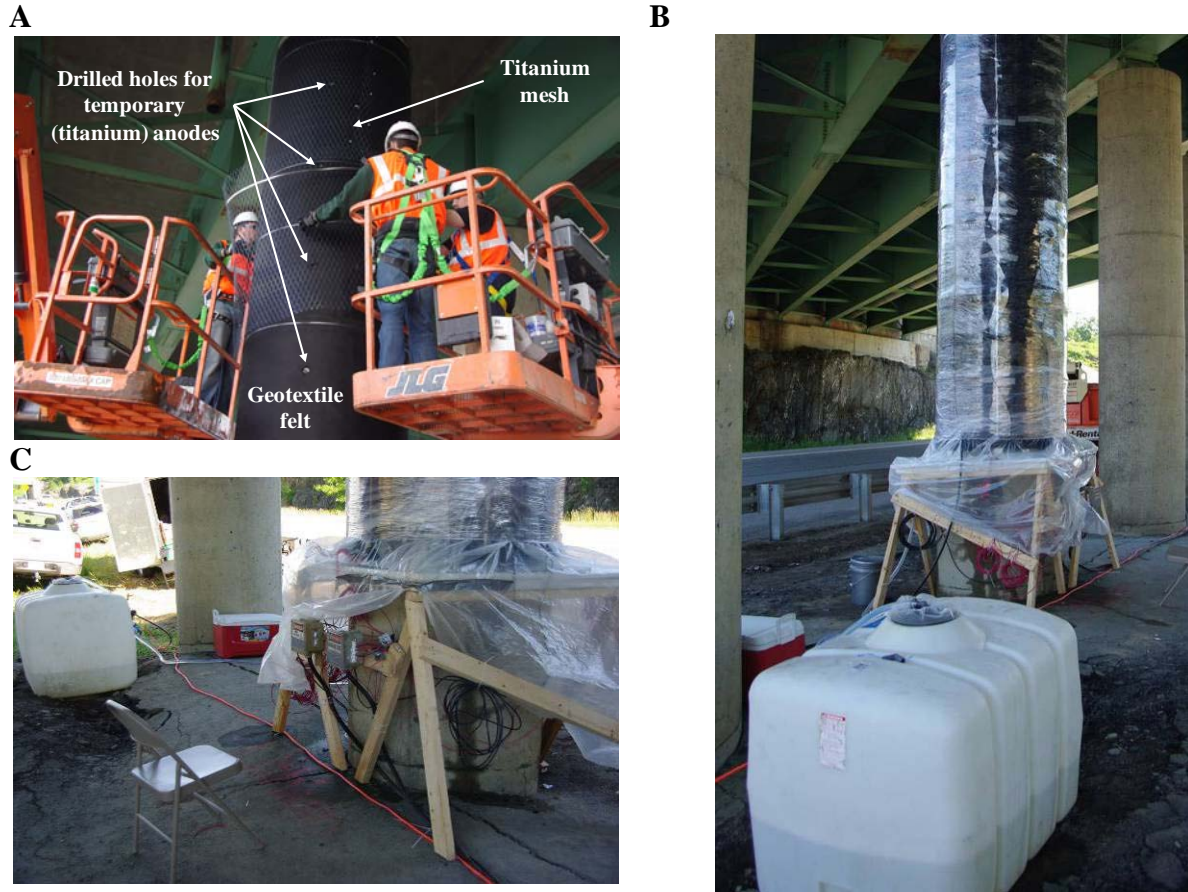
Figure 75. Titanium mesh.

Electrochemical (lithium) migration technique was applied on column No. 2 of the South Parkway bridge over I-395 (moderate degree of cracking) (see Figure 70). The treatment involved the installation of a temporary anode system consisting of a series of titanium anodes placed into holes drilled in a grid pattern in the upper 6-m (20-ft) portion of the column and a titanium mesh layer sandwiched between layers of geotextile felt that covered the concrete surface of the column (see Figure 75A). Both the temporary anode system and the embedded reinforcing steel, which acts as a cathode, were then connected to an AC/DC rectifier, which, once energized, applies a low voltage DC potential between the anode and the cathode to migrate lithium into the concrete from the electrolyte (30 percent lithium nitrate solution) that is pumped onto the surface of the concrete column through a temporary irrigation system (see Figure 75B and Figure 75C). The lithium impregnation system was sealed with polyethylene sheets to prevent evaporation or dry out over the eight-week treatment period.

A: Installation of the titanium mesh over a layer of geotextile felt. One can see holes that were drilled into the column, in a grid pattern, in which the titanium anodes were inserted to ensure connection between the reinforcing steel (cathode) and the titanium mesh. **B:** The titanium mesh, sandwiched between layers of geotextile felt, is sealed with polyethylene sheets. The electrolyte (30 percent-LiNO₃ solution) is pumped onto the surface of the concrete column through a temporary irrigation system. **C:** AC/DC rectifier and irrigation system.

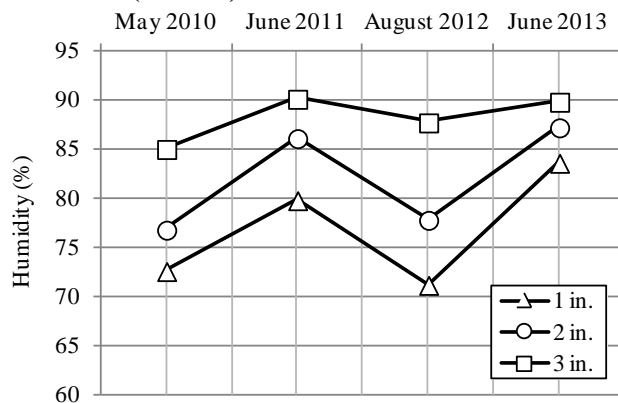
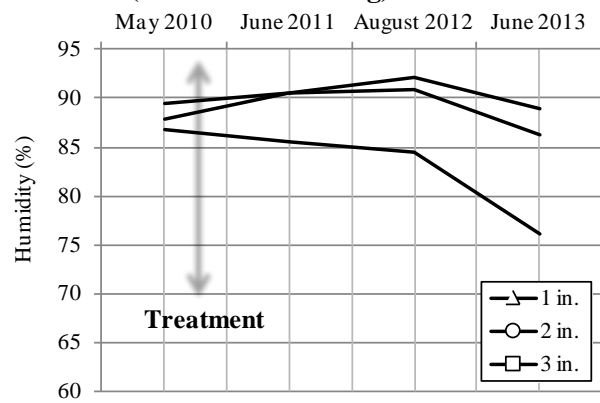
Increasing RH values with increasing depth are obtained at Site 2 (control) located on the abutment wall section, but protected under the bridge deck (see Figure 67A for site locations); the RH values were found to vary over time but with no specific increasing or decreasing trend (see Figure 77A). On the other hand, RH values for Site 3, treated in 2010 with elastomeric coating and also under the bridge deck, showed a drop in RH values in 2013 (see Figure 77B). It is yet to be seen if this "trend" will continue in 2014.

Figure 77. Values of relative humidity as a function of depth over the 2010-2013 monitoring period (I-395 over Main Street).

A: Site 2 – no treatment (control) (not exposed – under bridge deck). B: Site 3 – treated with the elastomeric coating (not exposed – under bridge deck).

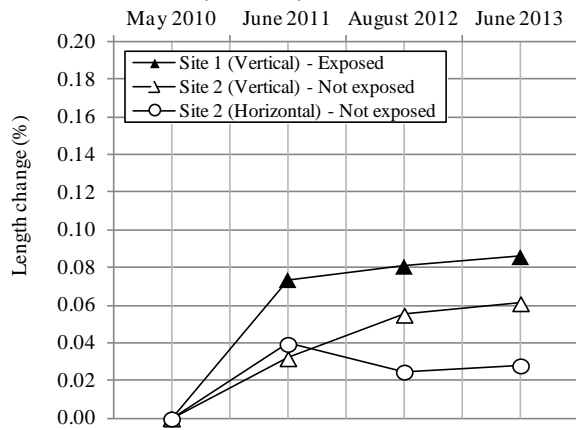
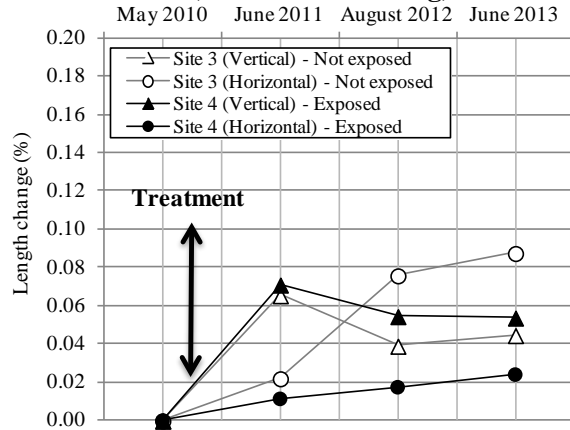
Following the initial 2010-2011 "jump" in the readings, limited additional expansions, and even some "shrinkage" were measured at the different sites (see Figure 78), with the exception, perhaps, of the horizontal direction at Site 3 (not exposed), treated with elastomeric coating, which seems to display progressive expansion (see Figure 78B). The latter was somewhat unexpected considering that Site 3 is well protected from rainfall (under the bridge deck), showed a decreasing trend for RH values in 2013 (see Figure 77B), and no significant cracking was observed after the treatment (Cracking Index values of 0.0 both in 2012 and 2013 – see Figure 79). Further monitoring will be necessary to confirm that trend.

Figure 78. Values of length changes over the 2010-2013 monitoring period (I-395 bridge over Main Street). A: Site 2 – no treatment (control) (not exposed – under bridge deck). B: Site 3 – treated with the elastomeric coating (not exposed – under bridge deck).

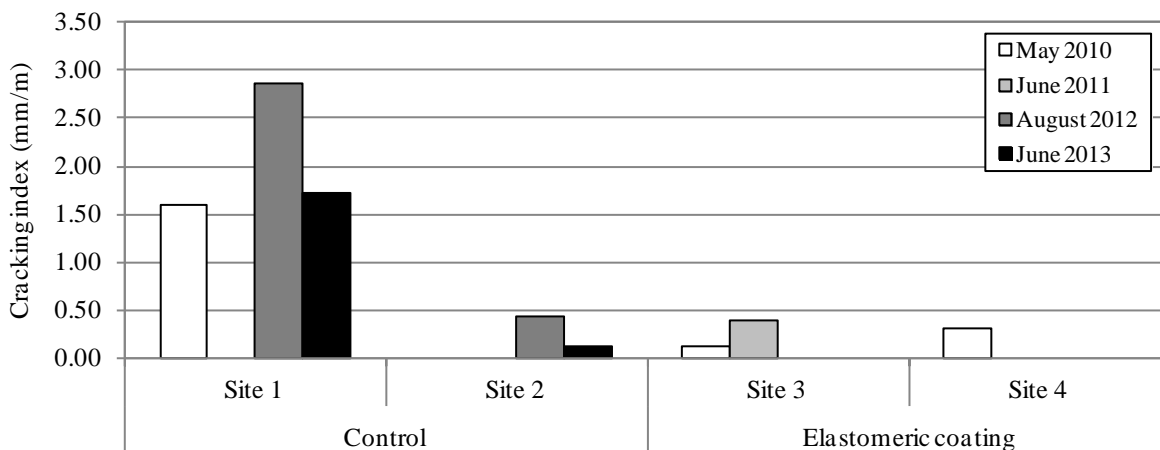
Figure 79: Values of Cracking Index over the 2010-2013 monitoring period (I-395 bridge over Main Street).

Figure 79 illustrates the results of the Cracking Index measurements over the 2010-2013 monitoring period. As expected, higher CI values were observed for Site 1 (exposed to moisture) than Site 2 (protected from moisture under the bridge deck). This can be seen clearly from Figure 80 that illustrates the crack maps both in 2010 and 2013. The above figures suggest an increase in the severity of cracking with time at Site 1 (see Figure 80A and Figure 80B); however, such a trend is unclear from the CI data. This might be partially due to the fact that operators performing the CI have changed over time, which is a source of variability in the test.

It is to be noted that in the case of the sections treated with the elastomeric coating, CI values of "0" were obtained for the measurements carried out in 2012 and 2013 (see Figure 79), i.e., following the application of the coating. The product has generally been efficient in bridging the cracks present in the treated concrete member (see Figure 80E and Figure 80F).

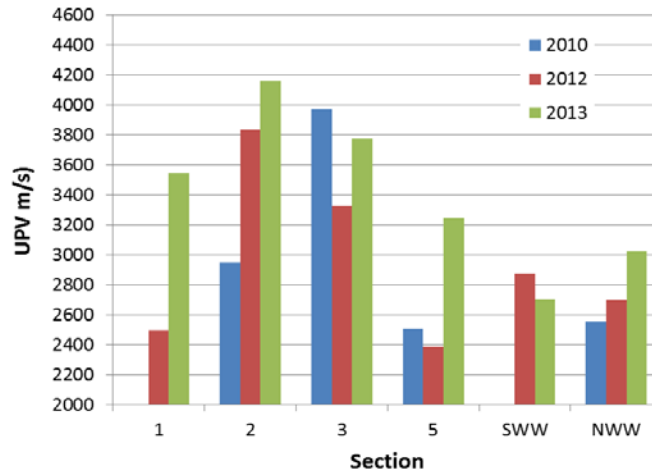
Figure 81. Evolution of UPV with time (I-395 bridge over Main Street).

The evolution of the velocities with time can be seen in Figure 81. The values of UPV show high variations from one section to another, as well as over time. Standard deviations are fairly high for nearly every section in 2012 and 2013, which might partly explain the absence of a conclusive trend. Sections 2 and 3, protected from the sun and rain, show the highest velocities (lower damage). Both wing walls (i.e. SWW and NWW) typically show velocities below 3000 m/s (9843 ft/s) and appear to be the most deteriorated sections. However, the surface concrete condition of the north wing wall seems to improve with time (velocities increasing from 2553 m/s (8376 ft/s) to 3021 m/s (9911 ft/s)). The latter was treated with the elastomeric coating in 2010.

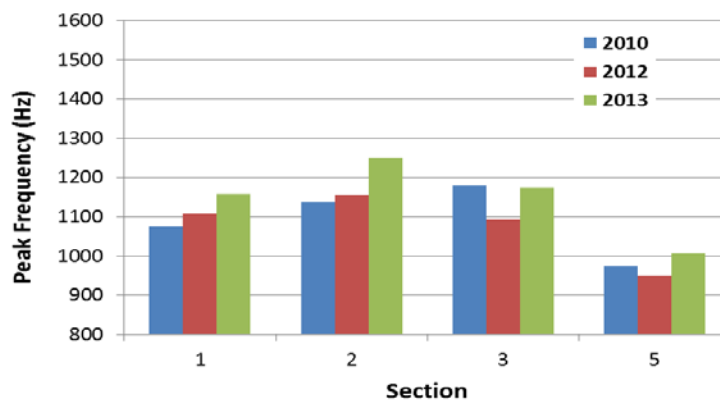
Figure 82. Evolution of peak frequency with time (I-395 bridge over Main Street).

Figure 82 illustrates the evolution of the peak frequencies with time. According to the impact-echo results, section 5 is significantly more deteriorated (lower frequencies) than the other sections, and the level of damage is still fairly constant with time (despite the treatment with the elastomeric coating). The concrete condition does not seem to vary significantly between the other sections. There are slight increases with time of the frequencies in sections 1 and 2 (control sections but somewhat protected under the bridge deck), which would suggest that the concrete quality is improving. Some fluctuations were observed in section 3.

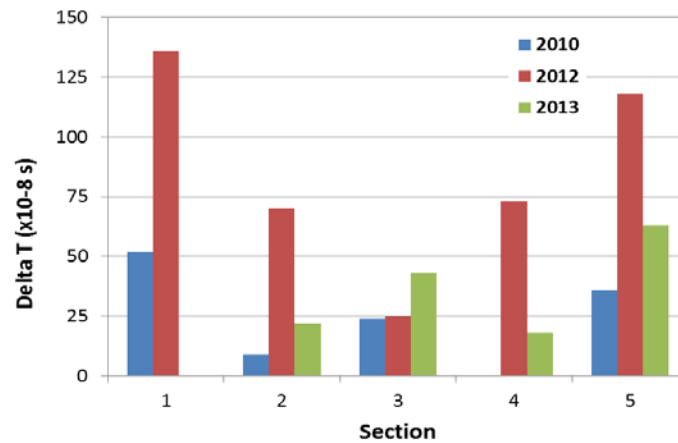
Figure 83. Evolution of ΔT with time (I-395 bridge over Main Street).

The evolution of ΔT (nonlinear acoustics) with time is shown in Figure 83. No general trend can be drawn from the nonlinear acoustics measurements. Damage in section 1 seems to increase significantly from 2010 to 2012. Signals were however too noisy in 2013 to be recorded. Middle (not exposed) sections (2 to 4) seem to be less deteriorated (higher ΔT) than side (exposed to rain and sun exposure) sections. The 2012 campaign yielded significantly higher ΔT . For the time being, no explanation can be provided.

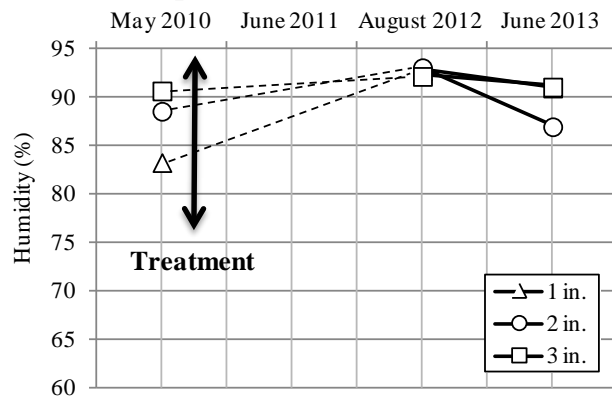
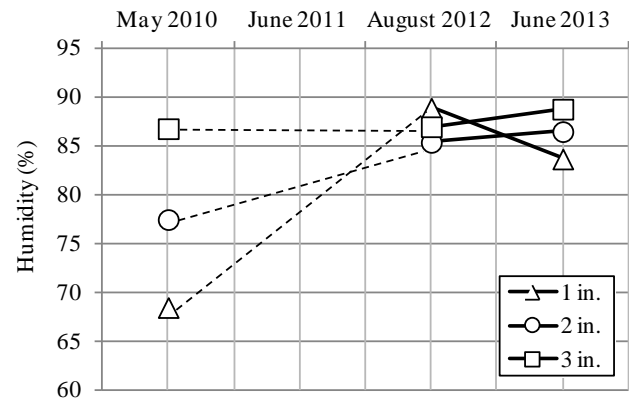
Increasing RH values with increasing depth were also measured in 2010 at Sites 1 and 5 located on the external portions (but somewhat protected under the bridge deck) of the large columns of the I-395 bridge over the Penobscot River (see Figure 68A for site locations); however, fairly similar RH values were measured at all depths for the treated and untreated columns in 2012 and 2013 (see Figure 84).

Figure 84. Values of relative humidity as a function of depth over the 2010-2013 monitoring period (I-395 bridge over the Penobscot River).

A: Site 1 – treated with 40 percent silane (± exposed). B: Site 5 – no treatment (control) (± exposed). The dotted lines cover periods over which no data were obtained.

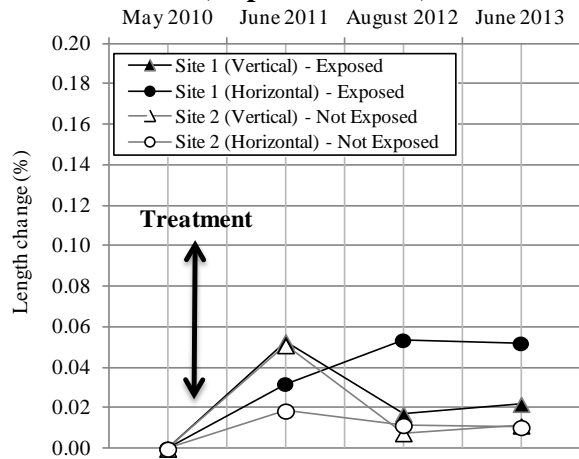
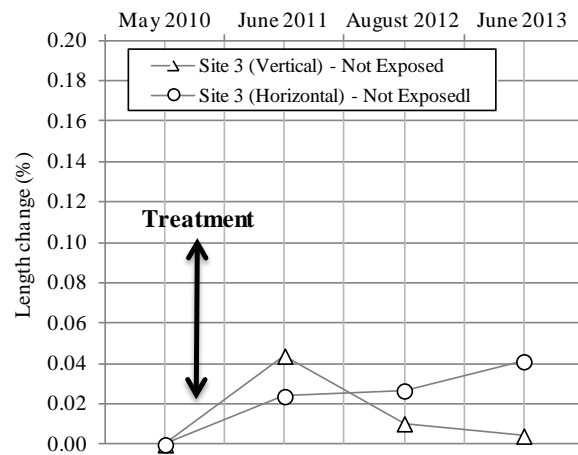
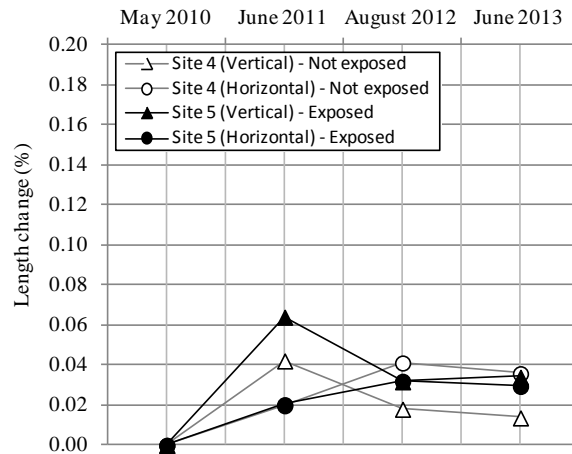
Figure 85. Values of expansion over the 2010-2013 monitoring period (I-395 bridge over the Penobscot River).

Limited additional expansion and even some "shrinkage" were measured at the different sites after the 2010-2011 "jump" in readings (see Figure 85). In the case of the monitoring sites on the large columns of the bridge over the Penobscot River, Sites 1 and 5 are located on the sides of the columns. They are marked as "exposed" in Figure 85A and Figure 85C; however, they are still somewhat protected from direct rainfall by the bridge deck (see Figure 86).

A: Sites 1 & 2 – treated with 40 percent silane (± exposed). B: Site 3 – treated with 100% silane (not exposed). C: Sites 4 & 5 – no treatment (control) (± exposed).

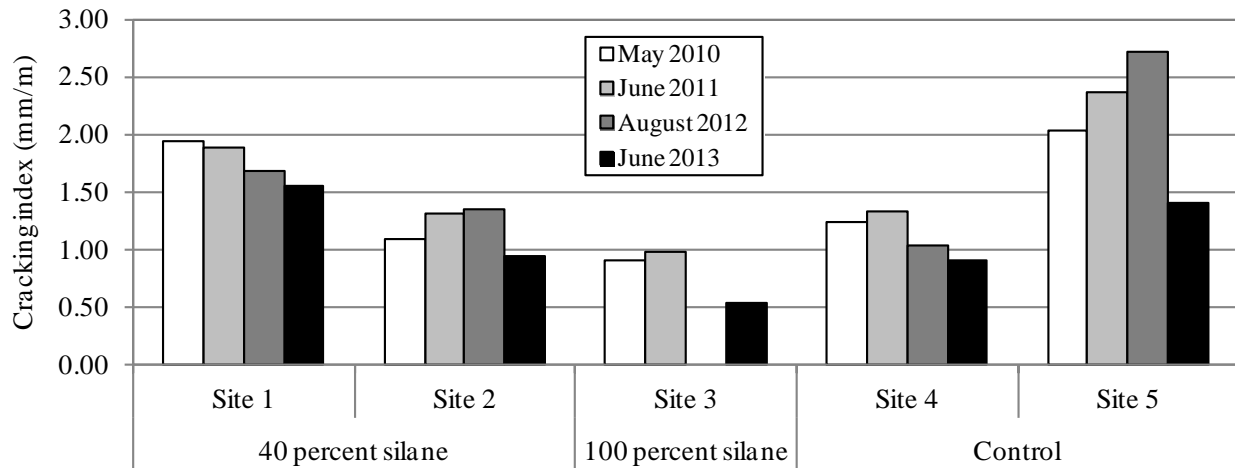
Figure 87. Values of Cracking Index over the 2010-2013 monitoring period (I-395 bridge over the Penobscot River).

Figure 87 illustrates the results of the Cracking Index measurements over the 2010-2013 monitoring period. Slightly higher CI values are observed for Sites 1 and 5 (exposed to moisture) than the other sites (2, 3, and 4) protected from moisture under the bridge deck (see Figure 87). Cracking is still fairly mild, as can be seen in Figure 88 and Figure 89 which illustrate crack maps both in 2010 and 2013. No clear increasing trends can be seen from the CI data, with perhaps the exception of Site 5 (control – no treatment), despite a lower CI value, still unexplained, obtained in 2013. The variability in the CI data might be partially due to the fact that operators performing the CI have changed over time, which is a source of variability in the test.

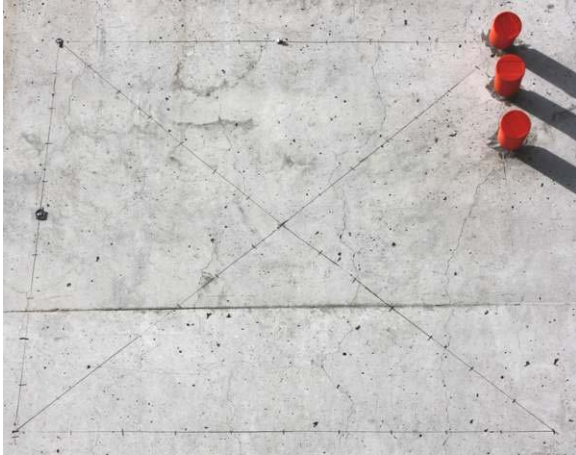
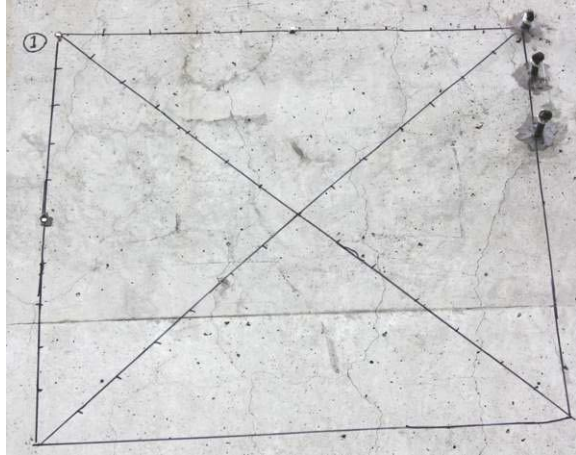
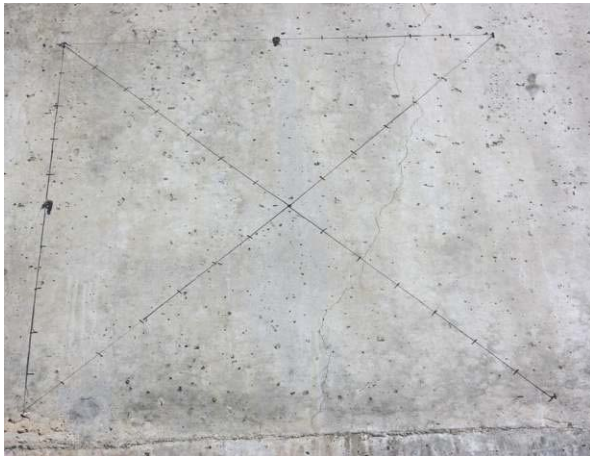
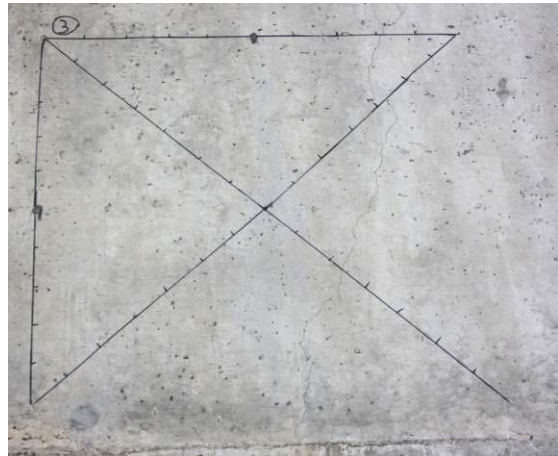
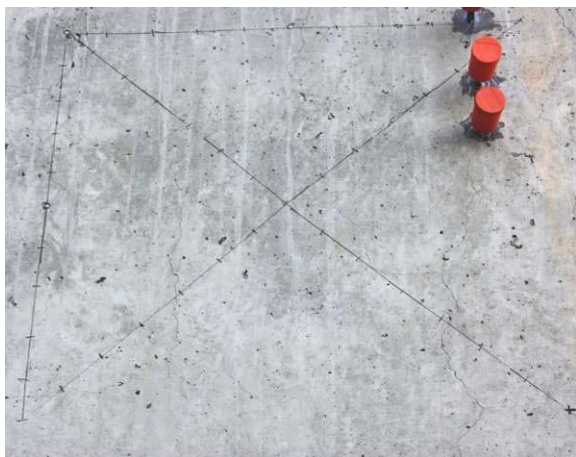
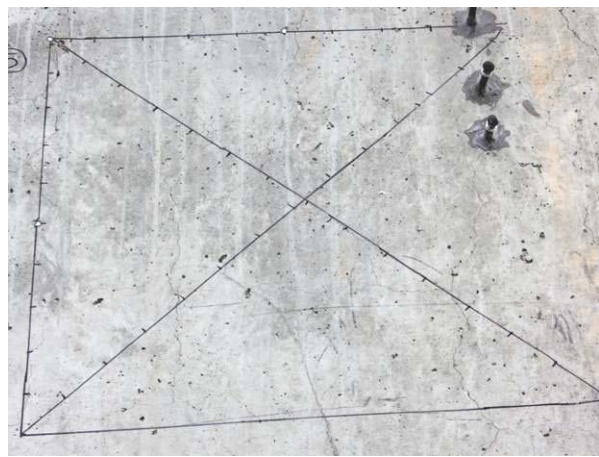
Figure 89. Examples of crack map sections before (2010) and after (2013) treatments (I-395 bridge over the Penobscot River).

A – 40 percent silane (Site 1: exposed) 2010

B – 40 percent silane (Site 1: exposed) 2013

C – 100 percent silane (Site 3: not exposed) 2010

D – 100 percent silane (Site 3: not exposed) 2013

E – Control (Site 5: exposed) 2010

F – Control (Site 5: exposed) 2013

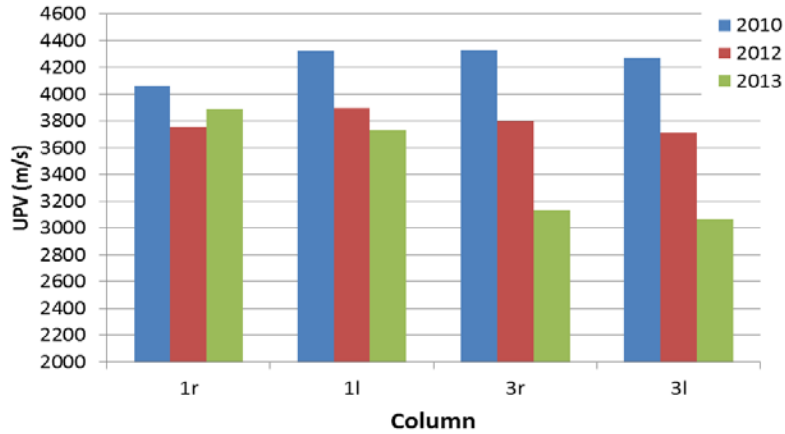
Figure 90. Evolution of UPV with time (I-395 bridge over the Penobscot River).

Figure 90 illustrates the evolution of the average UPV with time. A global trend can be seen from 2010 to 2013: average velocities significantly decreased in column 3 and in the left portion of column 1 (“1l”) (see Figure 68 and Figure 86 for location). For column 3, the velocities were high in 2010 (above 4200 m/s [13780 ft/s]) and they dropped to 3100 m/s (10171 ft/s) in 2013. The decrease is lower in the left portion of column 1, with a drop from 4320 m/s (14173 ft/s) in 2010 to 3730 m/s (12238 ft/s) in 2013. It seems that the velocities have not changed much in the right portion of column 1 (“1r”), lying between 3754 m/s (12316 ft/s) and 4065 m/s (13337 ft/s). These results suggest that ASR is still creating damage in the bottom part of the columns, especially in column 3 which is the most exposed to the wetting/drying cycles.

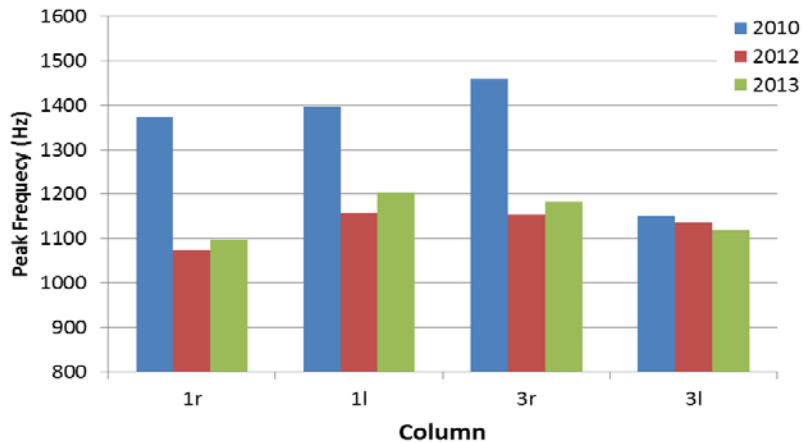
Figure 91. Evolution of peak frequencies with time (I-395 bridge over the Penobscot River).

Figure 91 illustrates the evolution of the peak frequencies (impact-echo) with time. In 2010, the peak frequencies were very high (above 1300 Hz) in column 1 (left and right) and in the right section of column 3, suggesting that the condition of the concrete inside these columns was very good. Lower frequency (1150 Hz) was measured for the left side of column 3. Peak frequencies measured in 2012 and 2013 were much lower (drop from 14 percent to 21 percent). Between 2012 and 2013, only slight changes were observed in all columns, suggesting that the condition of inner concrete has not changed significantly.

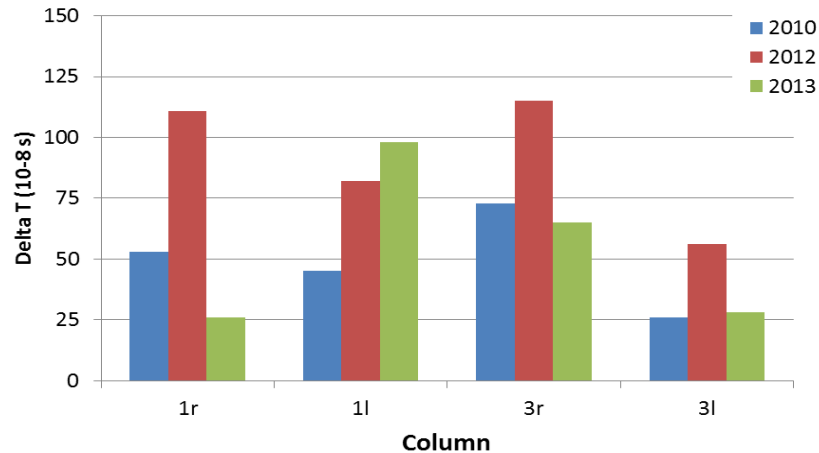
Figure 92. Evolution of ΔT with time (I-395 bridge over the Penobscot River).

The evolution of ΔT with time is shown in Figure 92. The 2012 campaign yielded the highest ΔT (higher damage) for the left section of column 1 and for both sections of column 3. The interpretation of the variation of ΔT is not easy to make. There is no general trend to be drawn from the nonlinear acoustics data. Let us recall that the measurements were performed in areas above sections assessed with UPV and impact-echo.

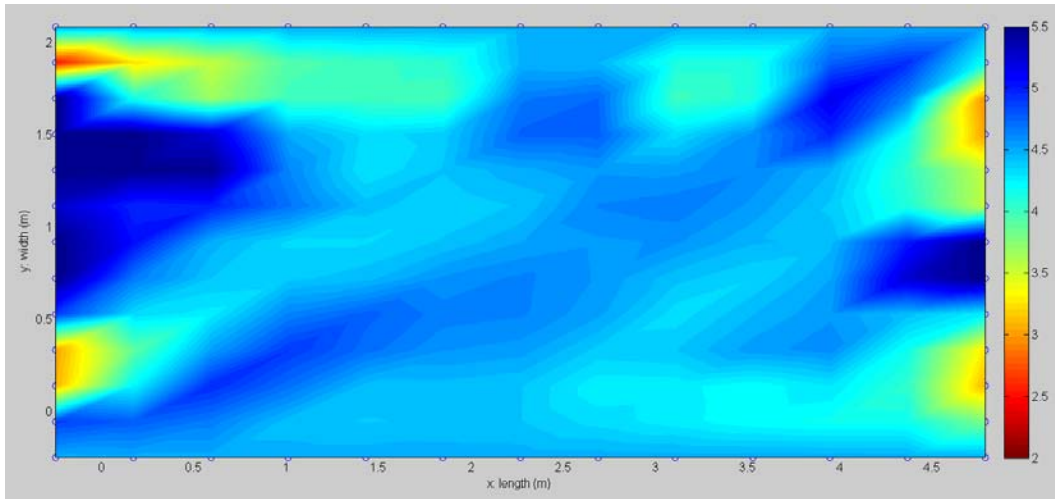
Figure 93. P-wave speed distribution in column 1 (horizontal cross-section at 79 in. [201 cm] above ground).

Figure 93 shows the speed mapping of the cross-section of column 1. The color scale on the right of the cross-section corresponds to the speed, expressed in km/s. The average calculated speed is 4500 m/s (14764 ft/s), with a minimum of 2200 m/s (7218 ft/s) and a maximum of 5500 m/s (18045 ft/s). Figure 94 illustrates the speed mapping for column 3. The average calculated speed is 4300 m/s (14108 ft/s), with a minimum of 3500 m/s (11483 ft/s) and a maximum of 5500 m/s (18045 ft/s).

In both cases, the inner concrete seems to be in good condition (blue tints). Cracks (red and yellow) are primarily surficial. The very high speeds that were calculated (> 5000 m/s (16404 ft/s)) can be attributed to the presence of reinforcing bars. It must be pointed out that tomography relies on the assumption the P-waves travel through a direct path from the impact to the receiver. However, P-waves tend to follow the fastest paths, such as rebars, where speed can reach up to 6000 m/s (19685 ft/s).

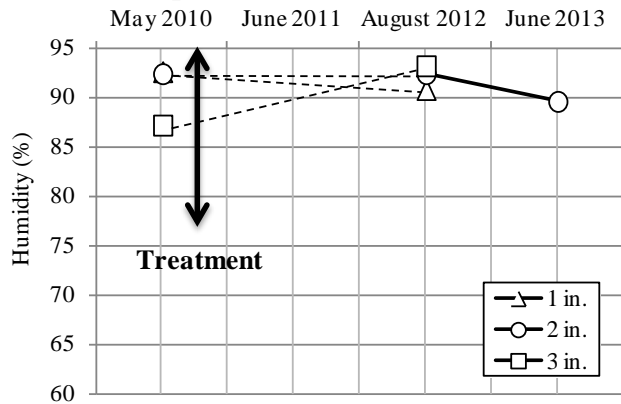
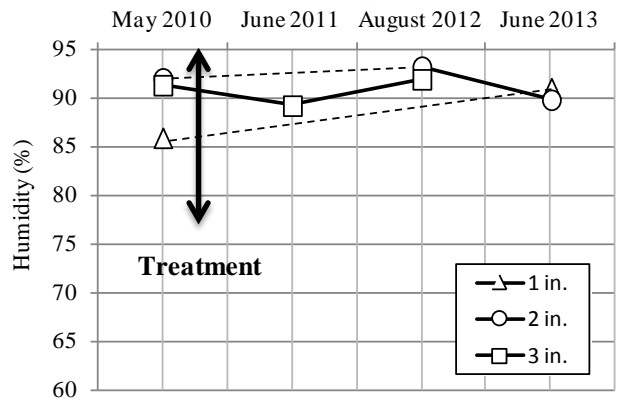
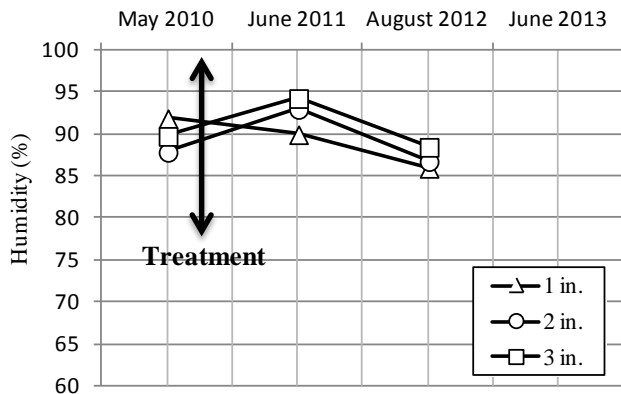
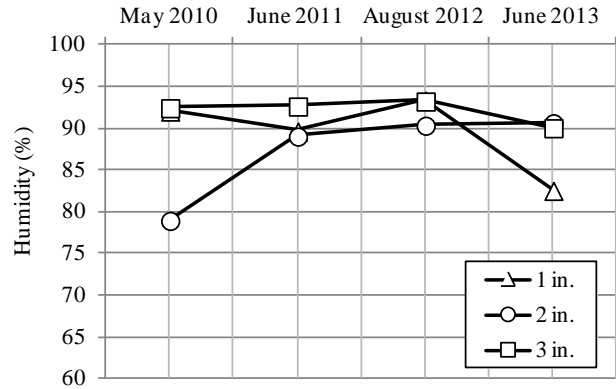
Figure 95. Values of relative humidity as a function of depth over the 2010-2013 monitoring period (5th Parkway bridge over I-395).

In the case of the 5th Parkway bridge over I-395 (see Figure 95), no specific trends for decreasing/increasing RH values in the surficial portions (1 to 3 in. [3 to 8 cm] deep) of the exposed sections (i.e., Sites 1, 4, 5, and 8) of the abutment wall were obtained over the monitoring period completed to date. Also, RH values were often similar at all depths, thus suggesting a limited effect of the treatments so far.

A: Site 1 – treated with 40 percent silane (exposed). B: Site 4 – treated with elastomeric coating (exposed). C: Site 5 – treated with 100 percent silane (exposed). D: Site 8 - no treatment (control) (exposed). The dotted lines cover periods over which no data were obtained.

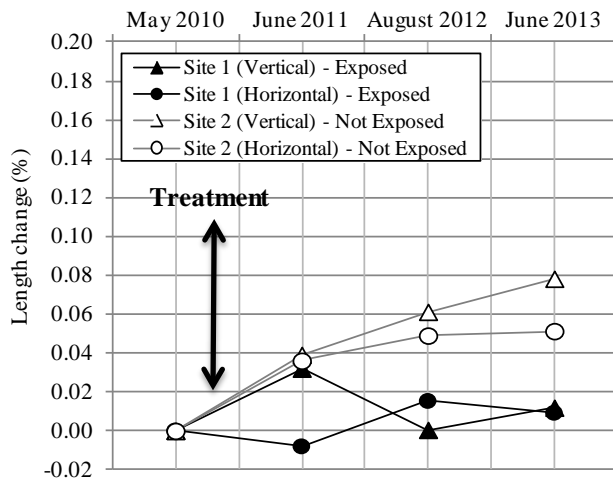
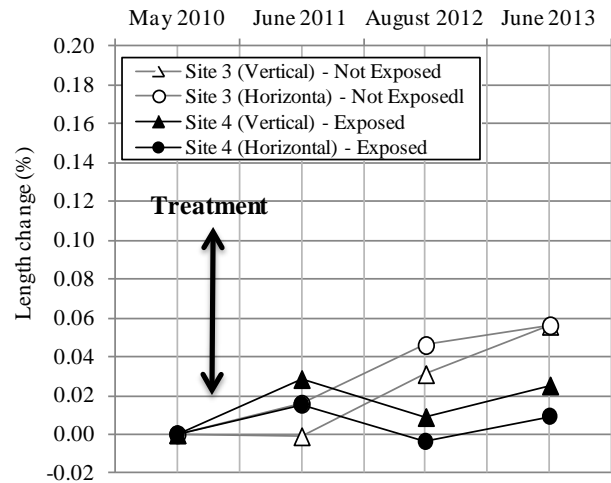
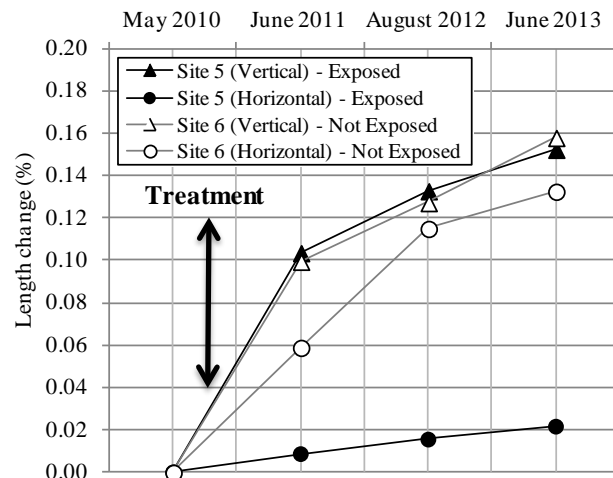
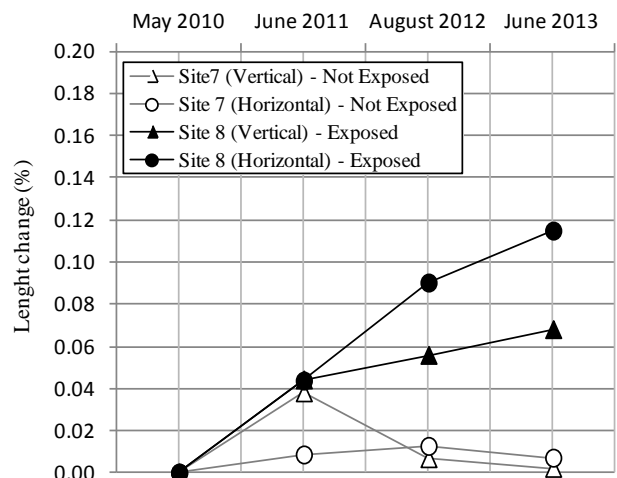
Figure 96. Values of expansion over the 2010-2013 monitoring period (5th Parkway bridge over I-395). Different treatment and sites (exposed vs. not exposed)

Somewhat confusing trends are observed from the expansion data available to date. On one hand, limited "additional" expansion, and even some "shrinkage," was measured following the 2010-2011 "jump" in readings for the following sites:

- 1 (40 percent silane (water-based); exposed) (see Figure 96A),
- 4 (elastomeric coating; exposed) (see Figure 96B),
- 5 (100 percent silane, exposed, horizontal direction) (see Figure 96C), and
- 7 (control, not exposed) (see Figure 96D).

On the other hand, expansive behavior was observed for the following sites:

- 2 (40 percent silane (water-based); not exposed) (see Figure 96A),
- 3 (elastomeric coating; not exposed) (see Figure 96B),
- 5 (100 percent silane, exposed, vertical direction) (see Figure 96C),
- 6 (100 percent silane, not exposed) (see Figure 96C), and
- 8 (control, exposed) (see Figure 96D).

The length change data suggests that an expansive process is taking place in non-exposed abutment wall sections treated with penetrating sealers and the elastomeric coating, while exposed portions of the same structural elements show limited expansion/shrinkage after treatment. Actually, fairly similar relative humidity values were measured at all depths (25 mm [1 in.] to 75 mm [3 in.]) in exposed abutment wall sections after treatment (see Figure 95). On the other hand, as expected, an expansive process is observed for control abutment wall sections exposed to moisture, while the non-exposed portion of the wall shows a fairly stable behavior. Continuing monitoring at the site will be necessary to confirm the above trends and the potential beneficial effects of the treatments.

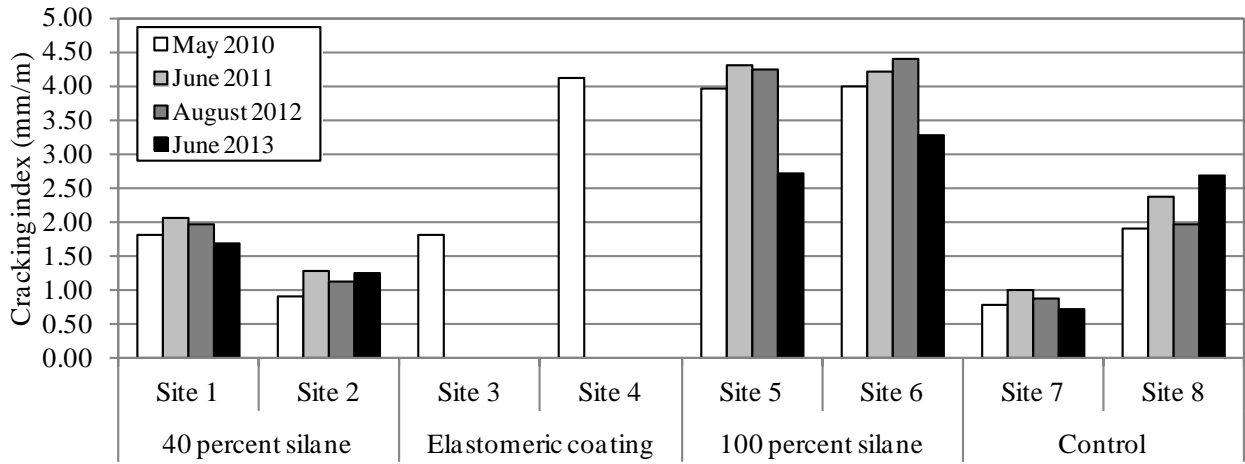
Figure 97. Values of cracking index over the 2010-2013 monitoring period (5th Parkway (Robertson Road) over I-395).

Figure 97 illustrates the results of the Cracking Index measurements over the 2010-2013 monitoring period. Significantly higher CI values are obtained for Sites 4 to 6 (exposed to moisture) compared to the other sites protected from moisture under the bridge deck (Sites 2, 3, and 7; see crack maps in Figure 98 and Figure 99).

No clear increasing trends with time can be seen from the CI data; however, a drop in CI value was obtained in 2013 for Sites 5 and 6, perhaps suggesting a beneficial effect of the 100 percent silane treatment (although not evident from the pictures in Figure 98A and Figure 98B that seem to show increasing damage over the monitoring period).

It is to be noted that in the case of Sites 3 and 4, treated in 2010 with the elastomeric coating, CI values of "0" were obtained for the measurements carried out in 2012 and 2013, i.e., following the application of the coating (see Figure 99A and Figure 99B).

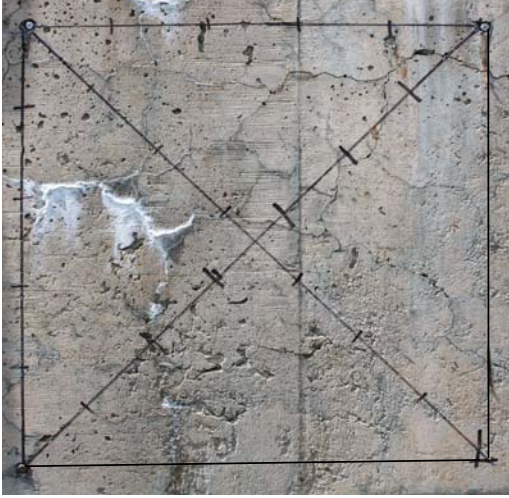
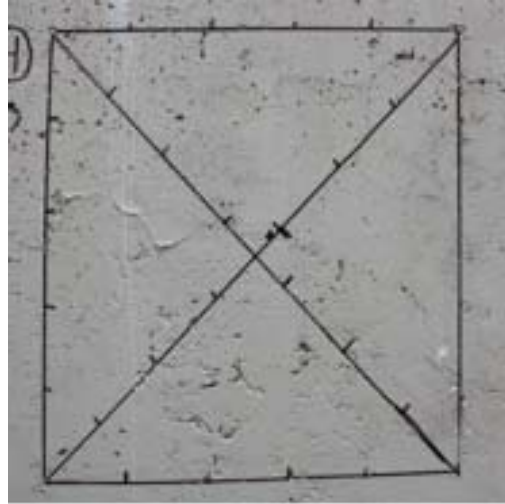
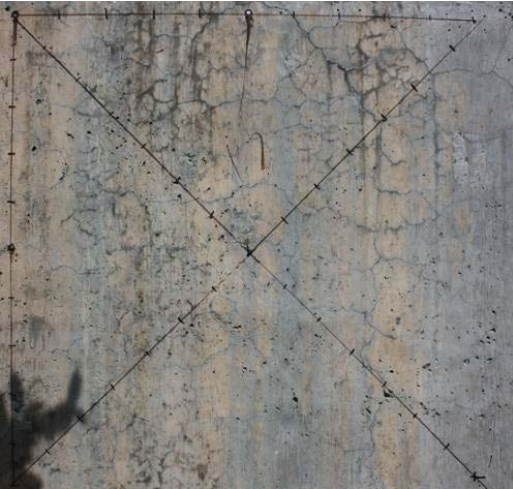
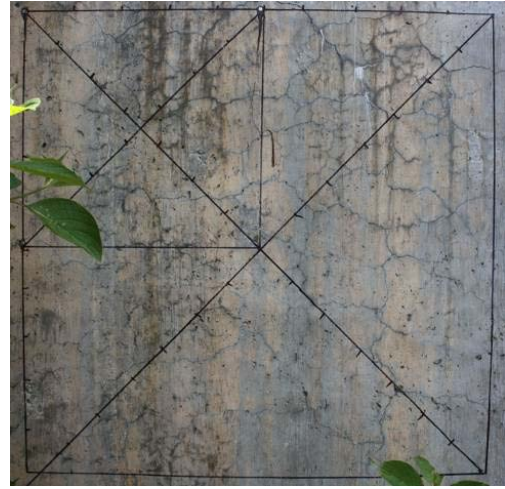
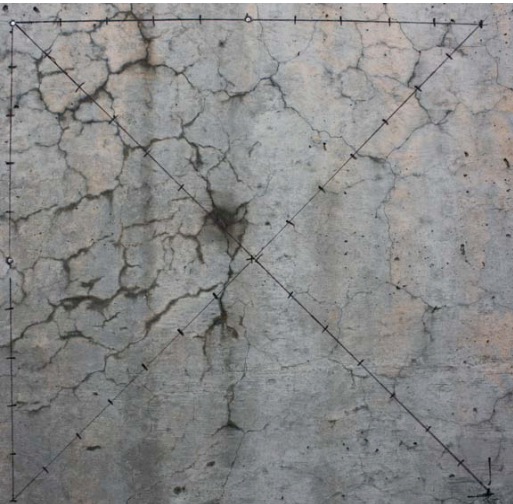
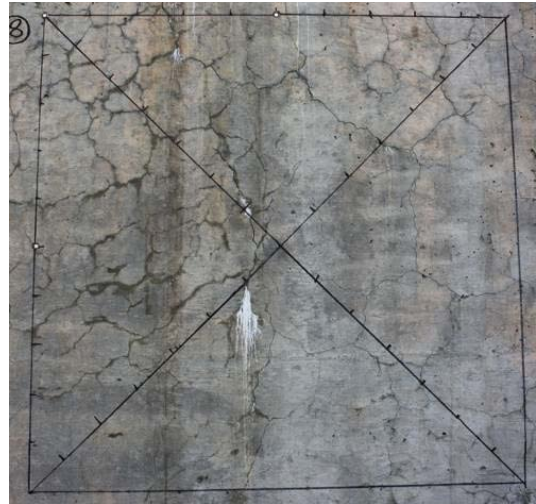
Figure 99. Examples of crack map sections before (2010) and after (2013) treatments (5th Parkway (Robertson Road) bridge over I-395).

Finally, in the case of the sections treated with the elastomeric coating, CI values of "0" were obtained following the application of the coating (i.e., in 2012 and 2013), thus indicating that the product has generally been efficient in bridging the cracks present in the treated concrete member.

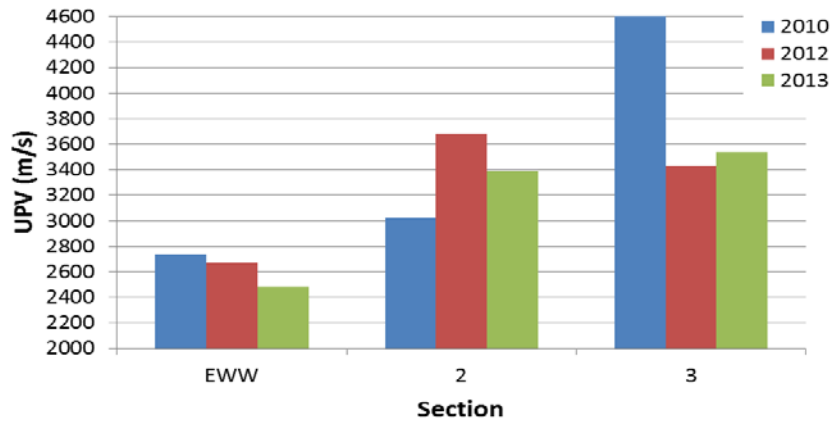
Figure 100. Evolution of UPV with time (5th Parkway (Robertson Road) over I-395).

Figure 100 illustrates the evolution of UPV with time. The east wing wall (exposed to moisture) shows the highest damage (velocities below 2800 m/s) (see Figure 69B for location), and the level of damage slightly increases with time (despite treatment with 100 percent silane in 2010). Section 2 (treated with 100 percent silane but protected under the bridge deck) shows variable velocities with time, with average velocities lying between 3020 m/s (9908 ft/s) in 2010 and 3682 m/s (12080 ft/s) in 2012. The 2010 UPV value for section 3 might be questionable: a value of 4663 m/s (15299 ft/s) was recorded, which appears to be very high. Then, there were only slight variations between 2012 and 2013 (control section protected under the bridge deck). Actually, no trend for expansion was noticed in that zone over the same period (see Figure 96D – Site 7).

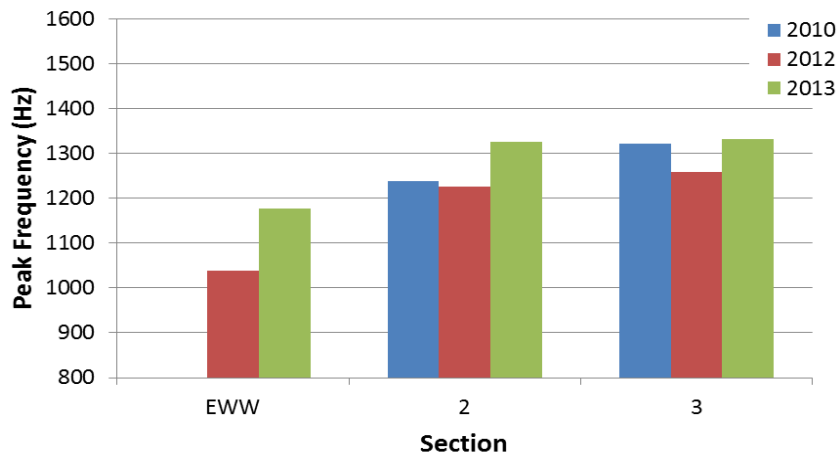
Figure 101. Evolution of peak frequencies with time (5th Parkway (Robertson Road) over I-395).

Figure 101 shows the evolution of the peak frequency with time (impact-echo). Like UPV, impact-echo results suggest that the east wing wall is the most deteriorated section. However, unlike UPV results, the level of damage seems to lower between 2012 and 2013, as well as the standard deviation. It must be mentioned that no recording was made in 2010. The frequencies in other sections (protected under the bridge deck) show some variable fluctuations with time, and it might be inferred that the level of damage in the concrete has not varied significantly with time.

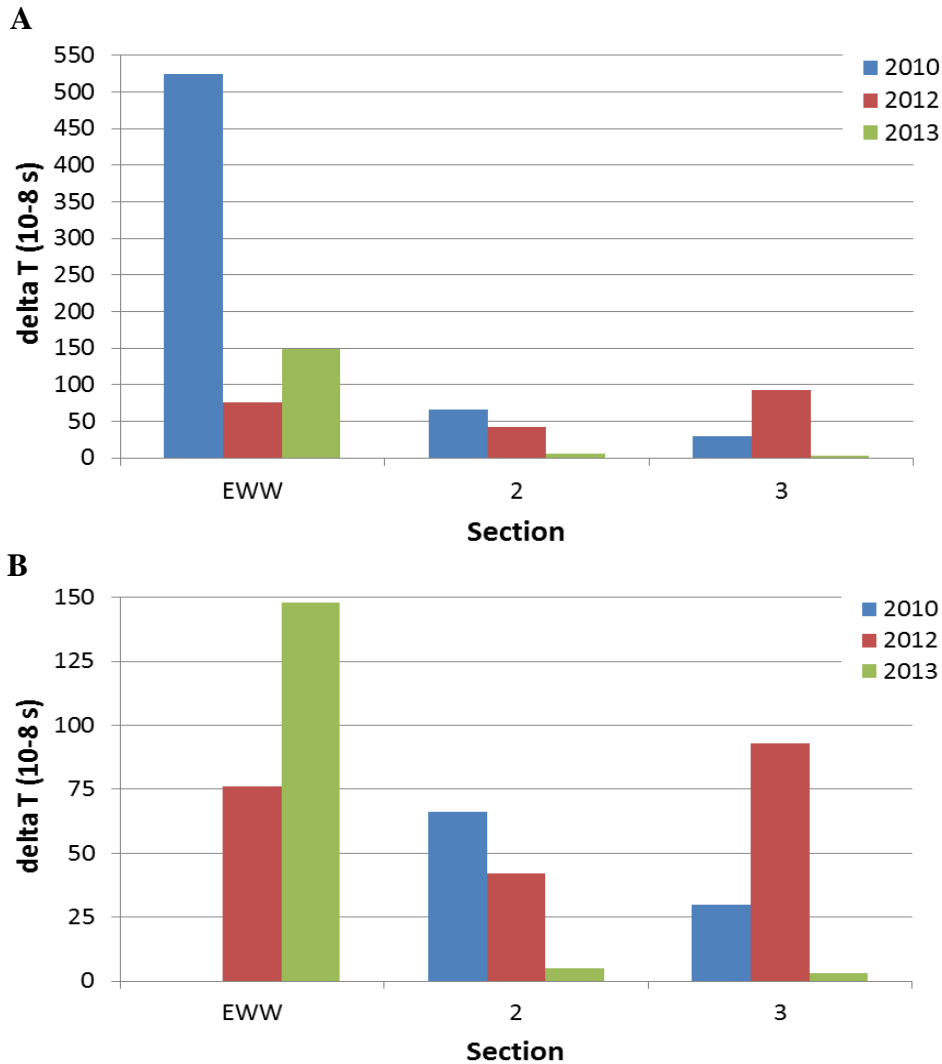
Figure 102. Results of nonlinear acoustics measurements.

Figure 102A shows the evolution of ΔT with time. There was a very high value (525×10^{-8} s) recorded on the east wing wall in 2010. This value is questionable. In order to better appraise the evolution of ΔT , this value is not shown in Figure 102B. It can be seen that damage seems to decrease in section 2, while it significantly increases on the east wing wall (exposed to moisture but treated with 100 percent silane in 2010). The ΔT value increases and then drops with time in section 3.
