Methods for Evaluating and Treating ASR-Affected Structures: Results of Field Application and Demonstration Projects

Volume II: Details of Field Applications and Analysis

Final Report

U.S. Department of Transportation
Federal Highway Administration

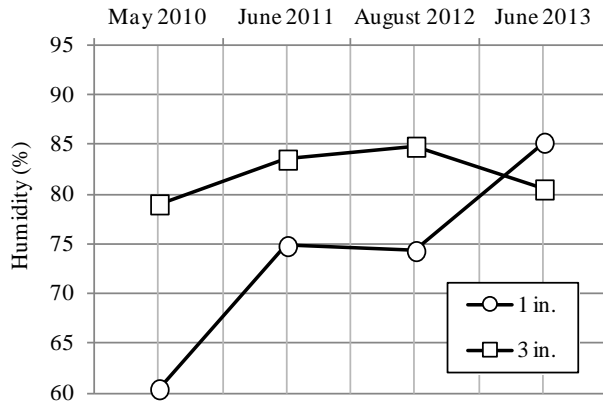
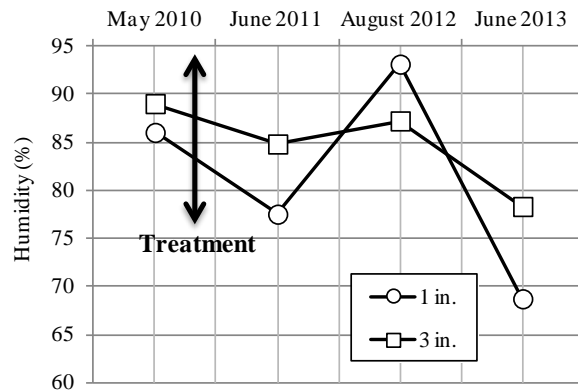
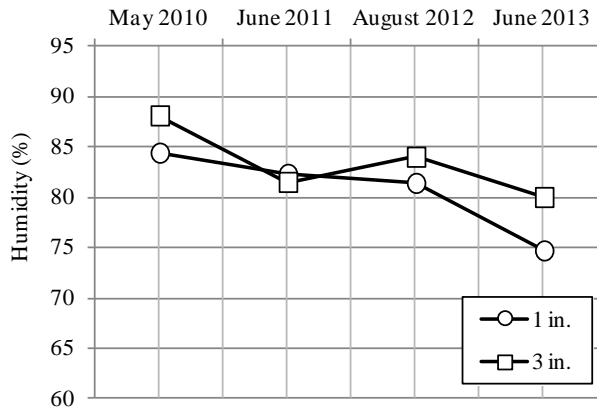
Figure 103. Values of relative humidity as a function of depth over the 2010-2013 monitoring period (South Parkway bridge over I-395).

Increasing RH values with increasing depth are generally obtained at all sites (exposed (Site 1) and non-exposed (Sites 3 and ~5) columns) (see Figure 70A for site locations); the difference is, however, relatively less important at Site 5 where relatively close RH values were obtained both at 25 mm (1 in.) and 75 mm (3 in.) (see Figure 103C).

In the case of exposed control column No. 1, the RH values remained relatively similar (i.e., between 80 and 85 percent) over time at 3-inch (75-mm) depth, while RH values progressively increased over time in the surficial (1-in. [25-mm]) portion of the concrete to reach a level similar to that of the 3-inch (75-mm) RH value in 2013 (see Figure 103A). A trend for decreasing RH values at both depths was observed over time for the 40 percent silane treated column (Site 3 – see Figure 103B) and the non-exposed control column 5 (see Figure 103C).

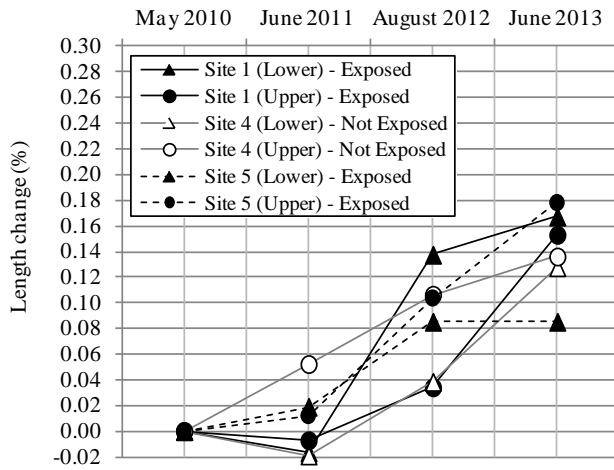
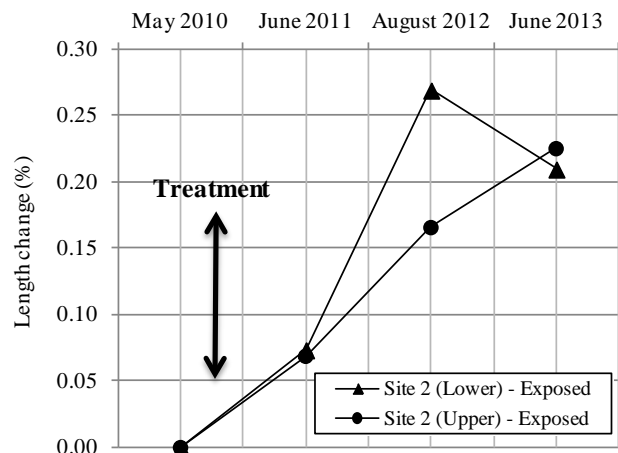
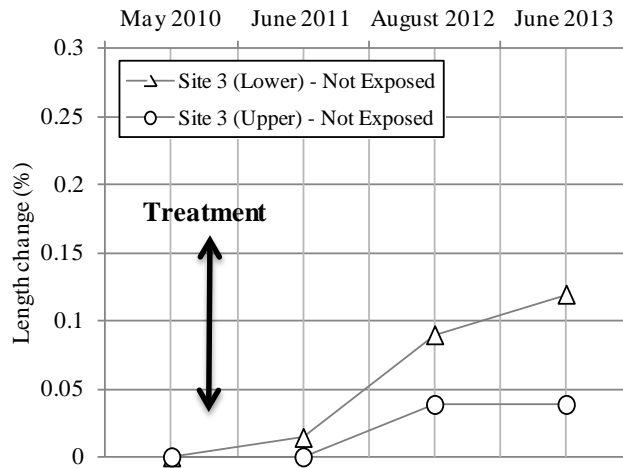
Circumferential expansion measurements were taken along two lines separated by about 1 m (39 in.). Figure 104 illustrates the results of the above measurements. The precision of the measurements is, however, limited, so the “expansion” values should be considered as indicative only.

According to the data obtained to date, expansive trends are observed for all columns. The highest expansions of about 0.22 percent were obtained for column 2, which has been subjected to electrochemical treatment with lithium nitrate; the column is the second from the side and is somewhat protected from direct rainfall by the bridge deck (see Figure 104B). Expansions ranging from 0.08 to 0.18 percent were obtained for the various control columns in 2013 (see Figure 104A), which vary in their exposure conditions. An expansive trend is also observed for column 3, treated with 40 percent silane, which reached between 0.04 and 0.12 percent in 2013 (see Figure 104C); that column is well protected from direct rainfall under the bridge deck.

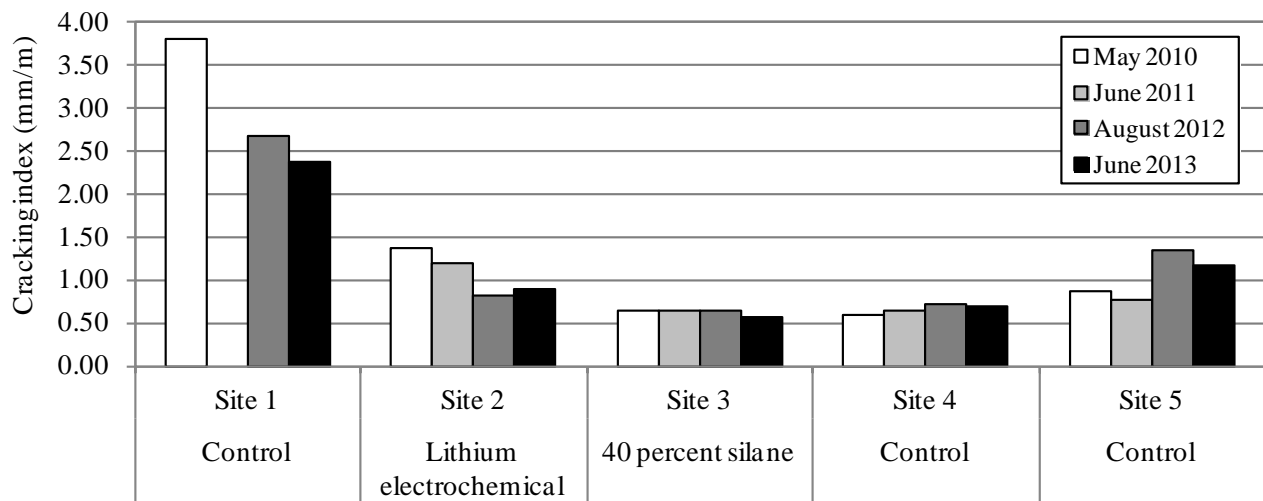
Figure 105. Values of cracking index over the 2010-2013 monitoring period (South Parkway bridge over I-395).

Figure 105 illustrates the results of the Cracking Index measurements over the 2010-2013 monitoring period. Crack width measurements were taken along two lines separated by about 1 meter (39 inches), and the cracking indices were calculated from those readings. The same two lines were also used for expansion measurements.

The highest CI values (ranging from about 2.5 to 3.8 mm/m [0.089 to 0.136 in./yd]) were obtained for column (Site) 1 (control), exposed to moisture (see Figure 105). That column also shows a significant expansive behavior (see Figure 104A) and the highest RH values measured in 2013 (see Figure 103). However, for some unknown reasons, the CI measurements show a decreasing trend from 2010 to 2012-2013. This might be partially due to the fact that operators performing the CI have changed over time, which is a source of variability in the test. Column 1 displays moderate vertical cracking, as illustrated in Figure 106A and Figure 106B. Column 6,

The lowest CI values were obtained for the silane treated column (Site 3) and the control column (Site 4). Both columns are well protected from excess moisture (under the bridge deck), but still display a light vertical cracking pattern (Figure 107). Silane-treated column 3 shows the lowest expansive rate (see Figure 104), as well as a global trend for reduction in internal humidity (RH) (from 2010 to 2013 – see Figure 103B). On the other hand, control column 4 shows a steady increasing expansive behavior (see Figure 104A) but still fairly low CI values.

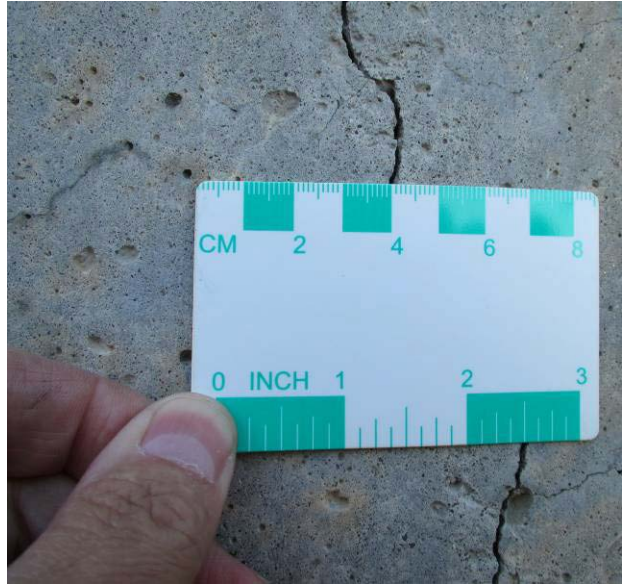
C – Control (Site 6: exposed) 2010

on the opposite side of the set of columns, was also displaying significant cracking back in 2010 (see Figure 106C), and was since then wrapped with fiber reinforced plastics (see Figure 106D).

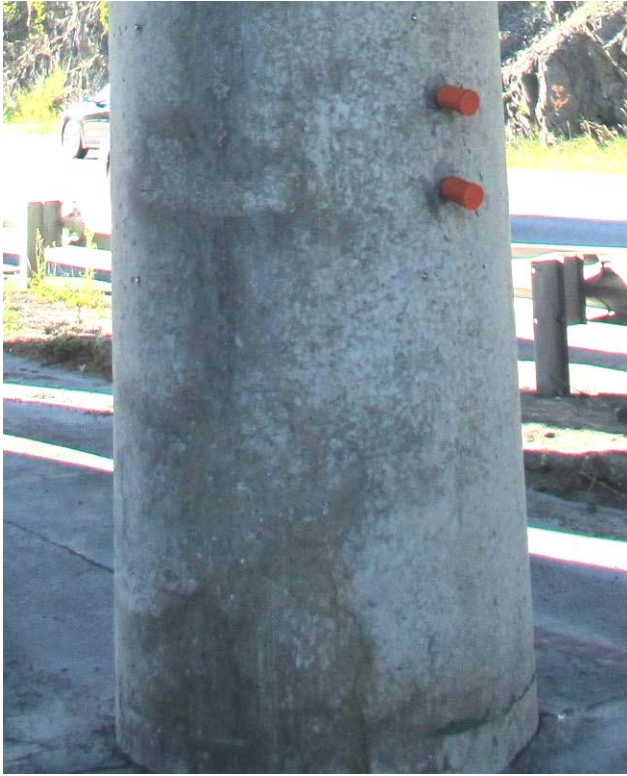
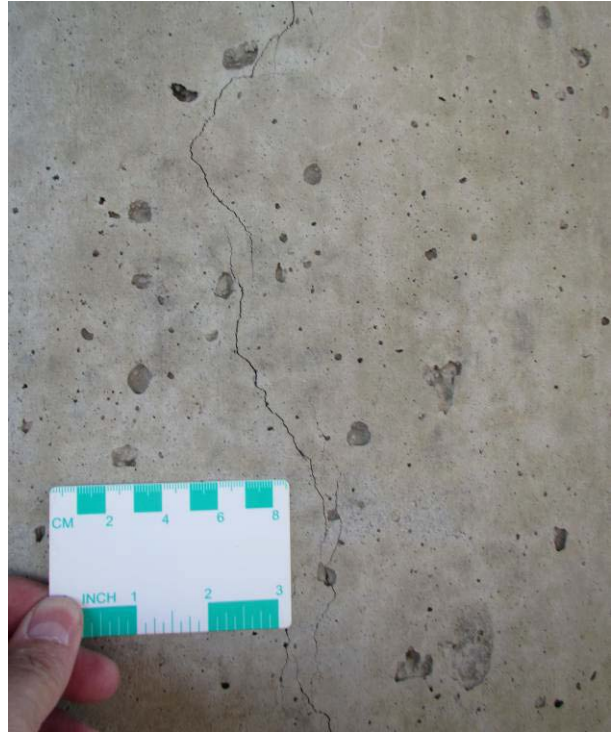
A – 40 percent silane (Site 3: not exposed) 2012

B – 40 percent silane (Site 3: not exposed) 2012

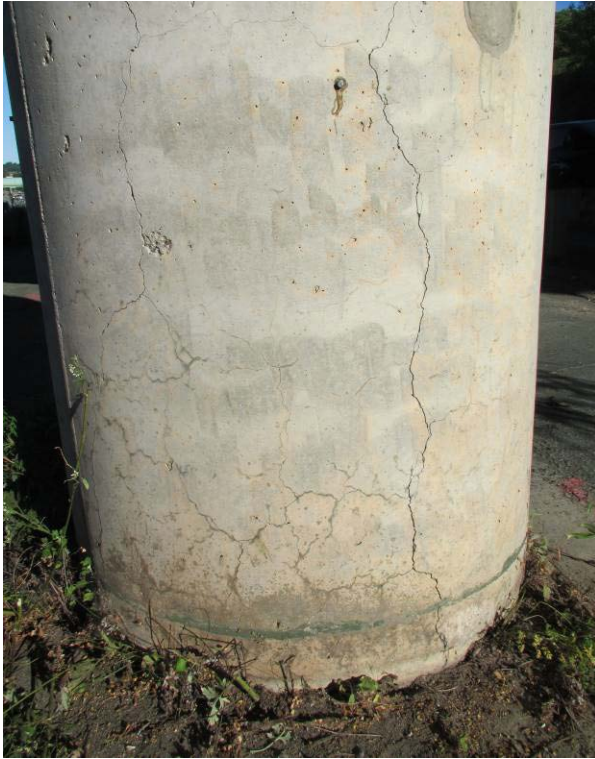
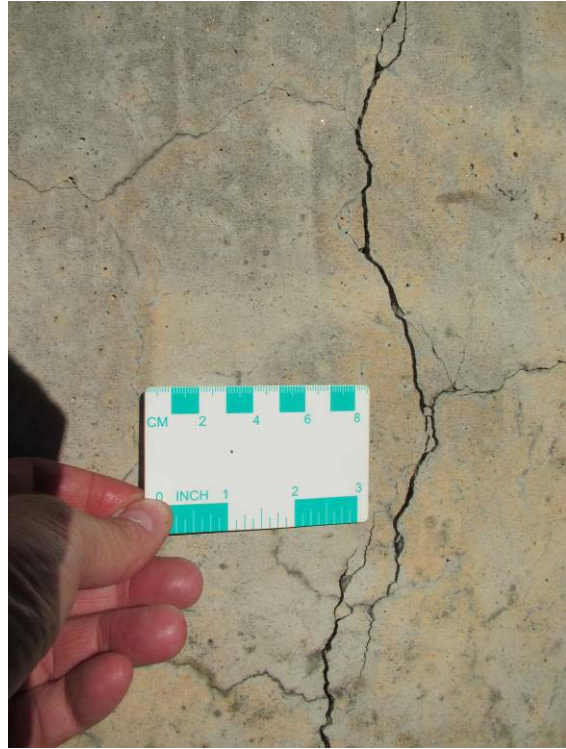
Similar CI values were measured for control column 5 (see Figure 108A and Figure 108B), as well as column 2 (Li treatment) (see Figure 108C and Figure 108D). Both columns show significant rates of expansion according to current length change measurements (see Figure 104A).

A – Control (Site 5: ~ exposed) 2012

B – Control (Site 5: ~ exposed) 2012

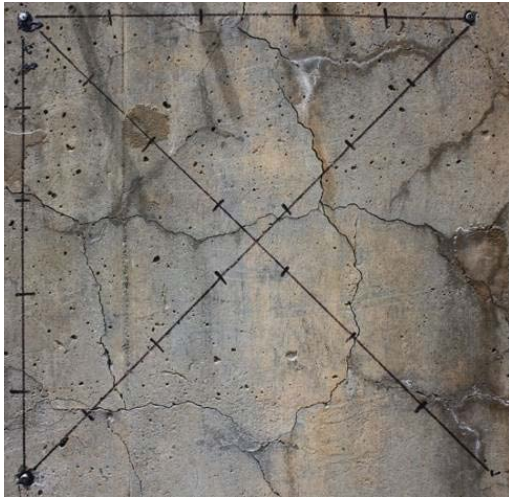
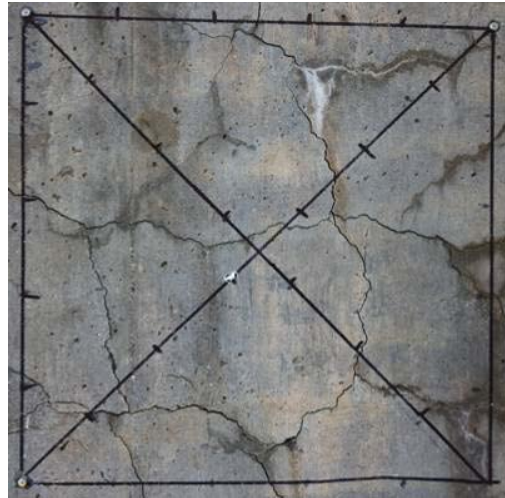
A – 100 percent silane (Site 4: exposed) 2010

B – 100 percent silane (Site 4: exposed) 2013

Figure 113. Examples of crack map sections before (2010) and after (2013) treatments (Green Point Road bridge over 1-395).

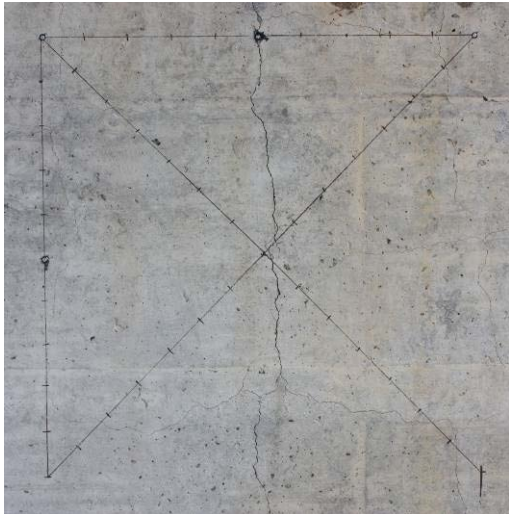
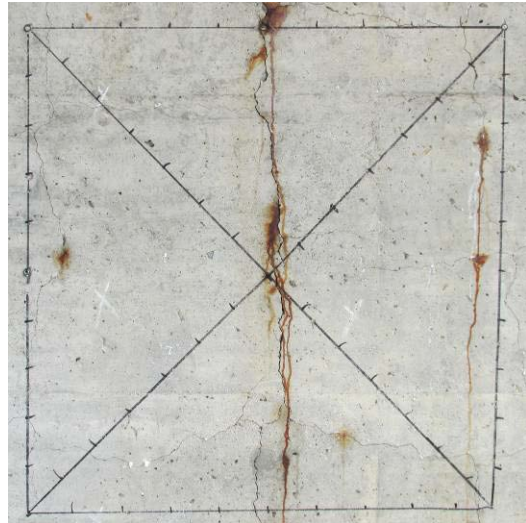
C – 40 percent silane (Site 6: not exposed) 2010

D – 40 percent silane (Site 6: not exposed) 2013

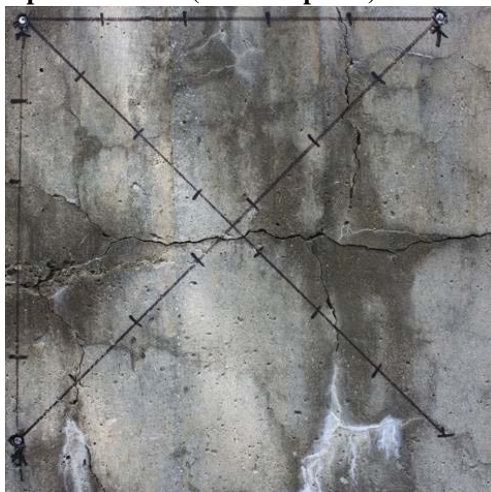
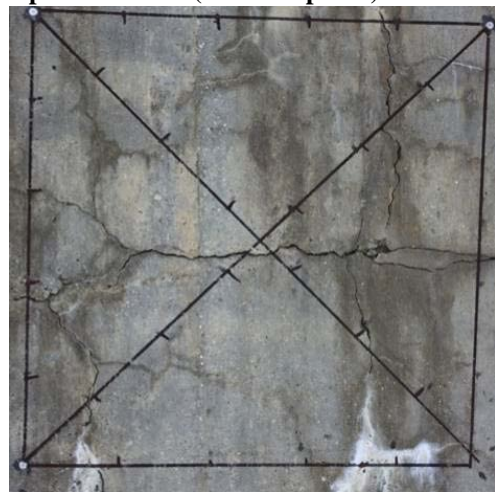
E – 40 percent silane (Site 5: exposed) 2010

F – 40 percent silane (Site 5: exposed) 2013

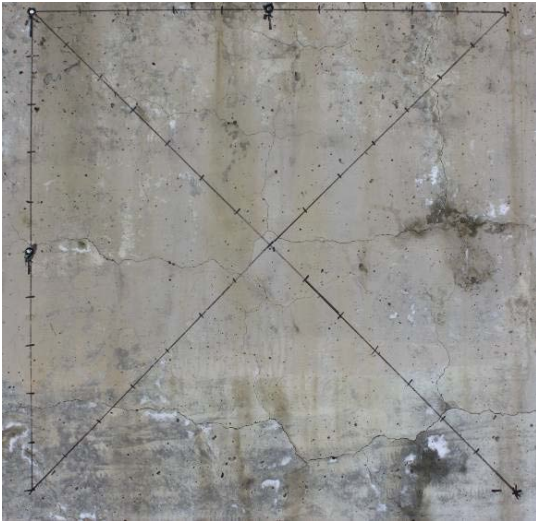
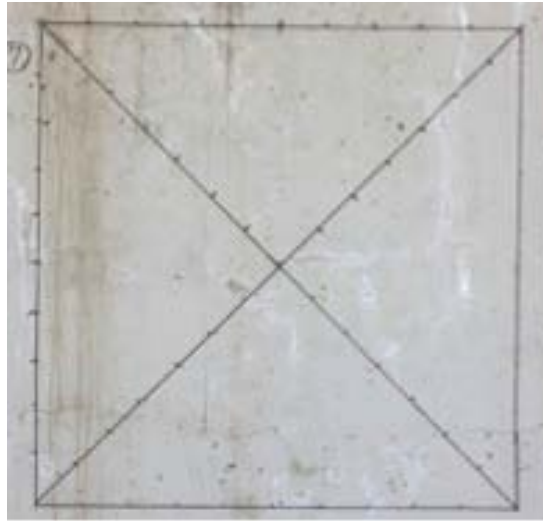
A – Elastomeric coating (Site 7: ~ exposed) 2010

B – Elastomeric coating (Site 7: ~ exposed) 2013

Figure 114. Examples of crack map sections before (2010) and after (2013) treatments (Green Point Road bridge over 1-395).

Finally, in the case of the sections treated with the elastomeric coating, CI values of "0" were obtained following the application of the coating (i.e., in 2012 and 2013), thus indicating that the product has generally been efficient in bridging the cracks present in the treated concrete member.

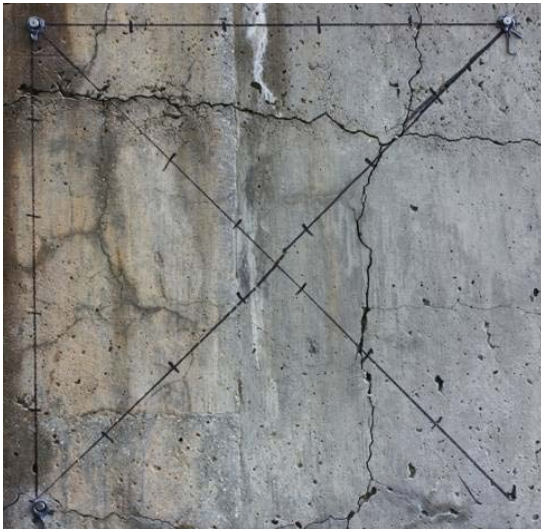
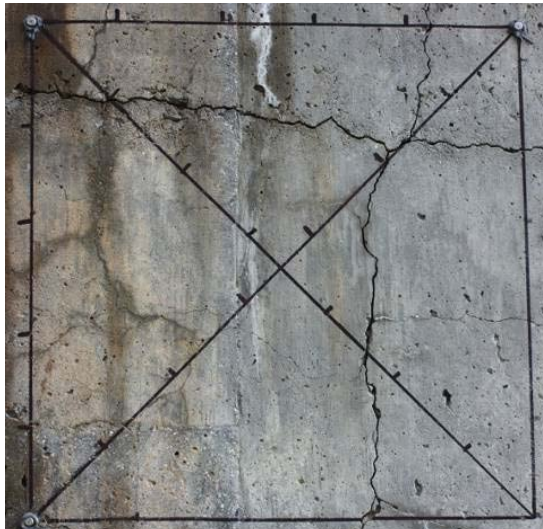
C – Control (Site 1: exposed) 2010

D – Control (Site 1: exposed) 2013

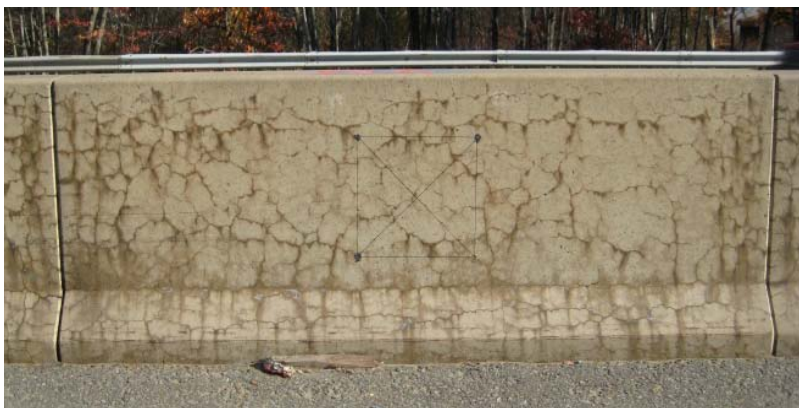
In mid-2004, under the FHWA Lithium Technology Research Program, a section of highway barriers in Leominster, MA on State Route 2 was visually inspected, and upon extracting cores and performing a petrographic evaluation in early 2005, it was confirmed that alkali-silica reaction (ASR) was the primary cause of observed distress (see Figure 118). Cracking was observed on a relatively long section of barriers, approximately 6.4 km (4 mi) along Route 2. For some barrier sections, ASR-induced cracking led to subsequent freezing and thawing damage along the haunch of the barriers, as shown in Figure 119.

Figure 118. Typical example of cracking and staining observed on highway barriers on Route 2 in Leominster, MA.

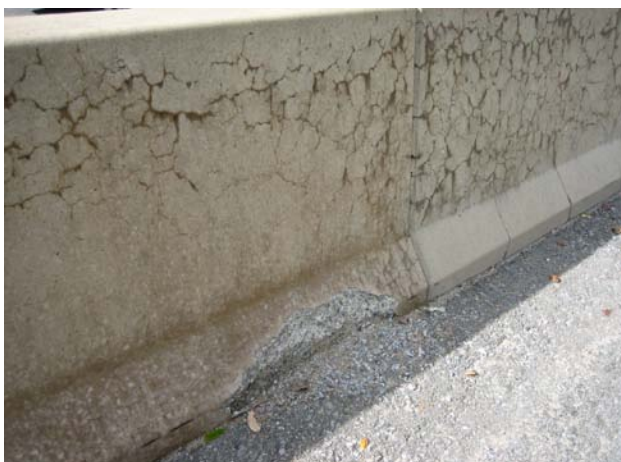
Figure 119. Example of freezing and thawing damage at bottom (haunch) of barrier.

Because of the widespread nature of ASR in this barrier section, and because the freezing and thawing damage appeared to be a substantial risk once the concrete was cracked, it was decided to evaluate several treatment options aimed at trying to slow down the progression of ASR and increase the service life of the barriers. In 2005, under the FHWA Lithium Technology Research Program, a series of these barriers was treated with lithium nitrate (applied topically and by vacuum impregnation), lithium silicate, and silanes. Later in 2005, the Massachusetts Highway

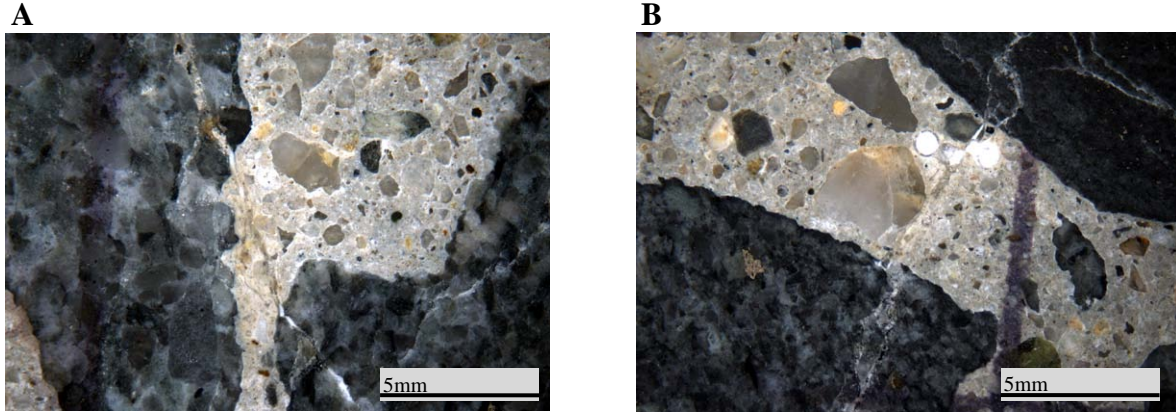
Cores were taken from three highway barrier walls along Route 2, near Leominster (Massachusetts), and the petrographic examination of the concrete was conducted by Dr. Grattan-Bellew in 2005. The author reported evidence of significant deterioration of the concrete due to ASR, in the form of cracks filled with gel in the coarse aggregate particles and in the cement paste and air voids, as well as reaction rims around occasional aggregate particles in all three cores. The coarse aggregate (greywacke) appeared to be the reactive component in the concrete. Tremblay (2011) reported the findings of the petrographic examination of another set of concrete cores extracted from the same sections of Jersey barrier walls, in 2010. The evaluation mainly consisted of the Damage Rating Index (DRI), a method that provides a semi-quantitative assessment of the degree of damage in concrete based on a count of petrographic features of deterioration generally associated with ASR. Damage Rating Indices ranging from 339 to 690 were obtained for the cores (Figure 120), thus suggesting fair to moderate/severe degree of deterioration/damage due to ASR. Petrographic features of ASR were found to be related to the coarse aggregate (greywacke) particles. Typical features of ASR correspond to cracking with ASR gel and reaction rims in the greywacke particles, as well as reaction (ASR) products in cracks and air voids of the cement paste (Figure 121).

Figure 121. Polished concrete core surfaces.

A&B: Cracking in coarse aggregate particles (greywacke) extending into the cement paste; secondary (ASR) products are observed in the cracks both in the particles and the cement paste.

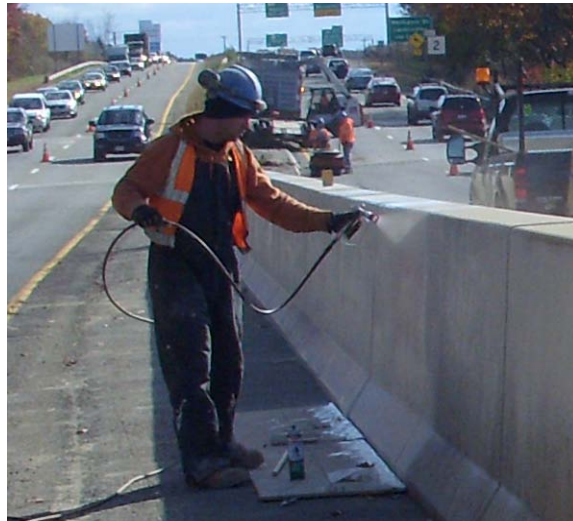
Figure 128. Elastomeric paint sprayed in 2010 onto barrier sections previously treated with 40 percent silane in 2005 by MassDOT.

In 2010, it was decided that the FHWA ASR Development and Deployment research team would initiate additional treatments on the barriers previously treated by MassDOT in 2005 with silane. Most of the barrier sections outside of the “original test section” were sprayed with an elastomeric paint with the goal of reducing the potential for frost damage from the lower portions of barriers heavily affected by ASR. For this study, four representative 10-barrier sections within this extended test section were selected to evaluate the performance of repeated applications of silane and the effects of applying elastomeric paint over a surface previously treated with silane, as shown in Table 65. Figure 128 shows the elastomeric paint being spray-applied to the barriers. The “original test section” did not receive any treatments in this program so that the original treatments from 2005 could be evaluated. Additional details on the performance monitoring techniques and treatment activities are provided in chapters 2 and 3, respectively.

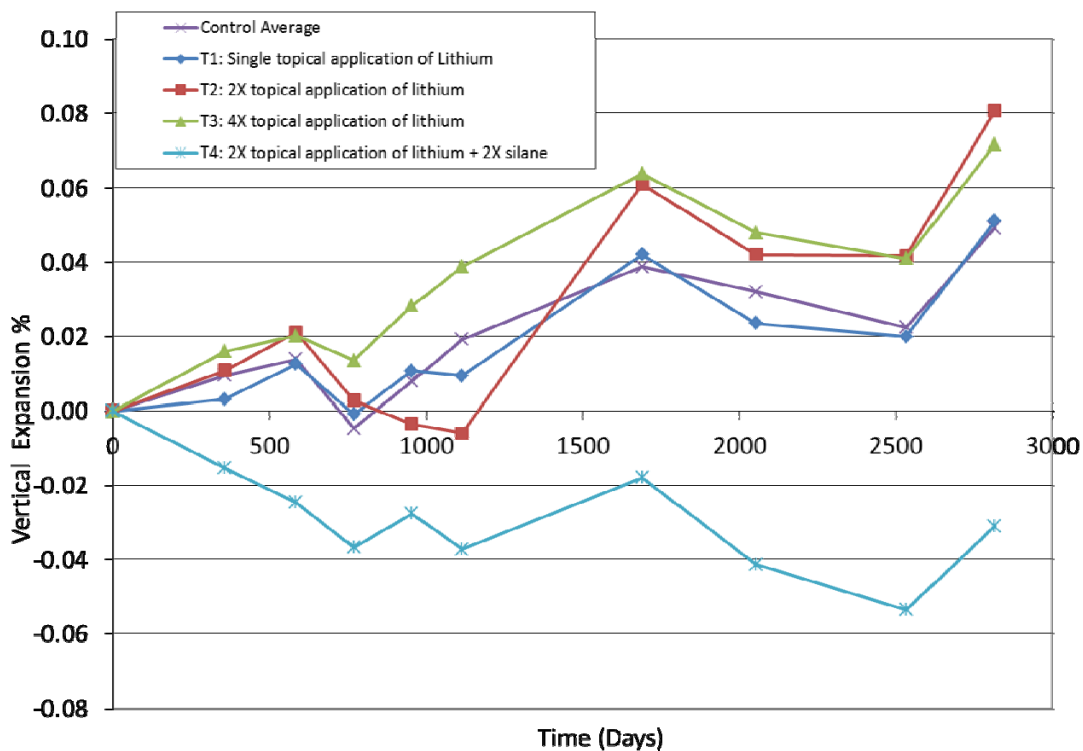
external restraint and internal steel reinforcement, and they are not presented herein. Figure 129 shows the results of topical application of lithium nitrate, where the only time that expansion was reduced was when lithium treatment was followed up with an application of silane. The control and lithium nitrate-treated barriers expanded considerably during the course of the monitoring period, whereas the barrier treated with lithium nitrate and subsequently silane showed no expansion and in fact has exhibited shrinkage since the time of treatment in 2005. Figure 130 shows the expansion results for topical applications of various silanes, as well as lithium silicate. The results show that all of the barriers treated with silane, regardless of the silane content or whether the product was water-based or solvent-based, exhibited reductions in expansion compared to untreated barriers. The barrier treated with lithium silicate exhibited expansions similar to that of the control barriers. Figure 131 shows the expansion results for barriers treated by vacuum with lithium nitrate solution. Once again, the barrier that exhibited the least expansion was the barrier that was treated with silane (after vacuum treatment with lithium nitrate). Lastly, Figure 132 shows the expansion results since 2010 for barriers that were initially treated with silane by MassDOT in 2005, some of which were then treated again using silane and/or elastomeric paint in 2010. Because these barriers were treated only three years ago, it is difficult to identify trends in performance.

Figure 129. Average vertical expansion for highway barriers in Leominster, MA, comparing effects of topical treatment of lithium nitrate (with and without subsequent treatment with silane). The expansion of the control barriers is based on the average of three control sections (North and South sides of barriers). The expansion values for the treated sections are based on the average expansion for the North and South faces of the instrumented barrier in each test section.

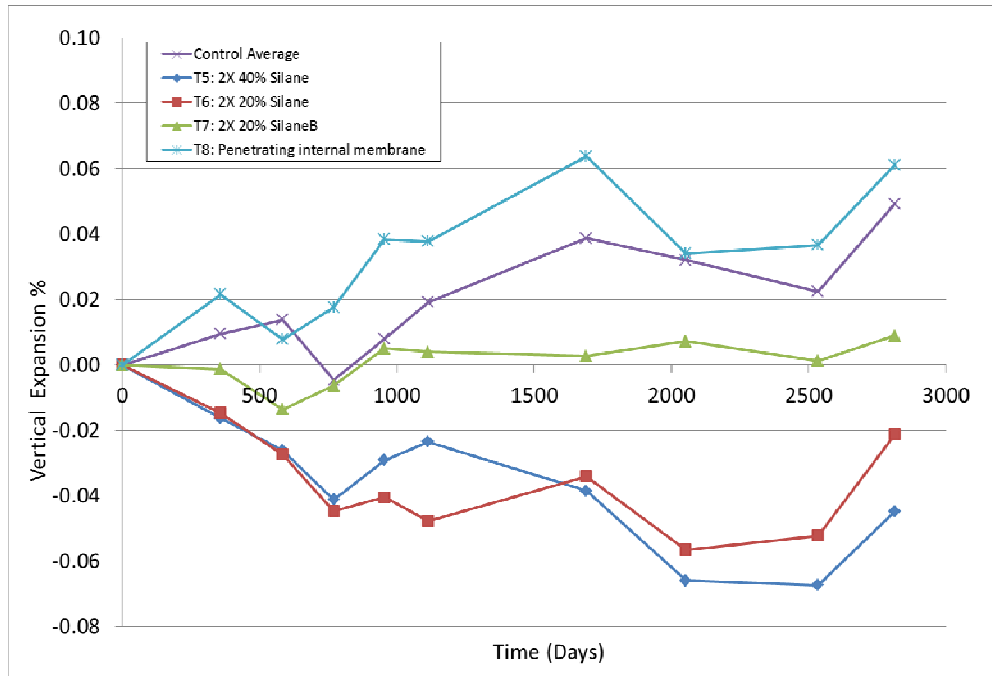
Figure 130. Average vertical expansion for highway barriers in Leominster, MA, comparing effects of topical treatment of various silane products and lithium silicate. The expansion of the control barriers is based on the average of three control sections (North and South sides of barriers). The expansion values for the treated sections are based on the average expansion for the North and South faces of the instrumented barrier in each test section.

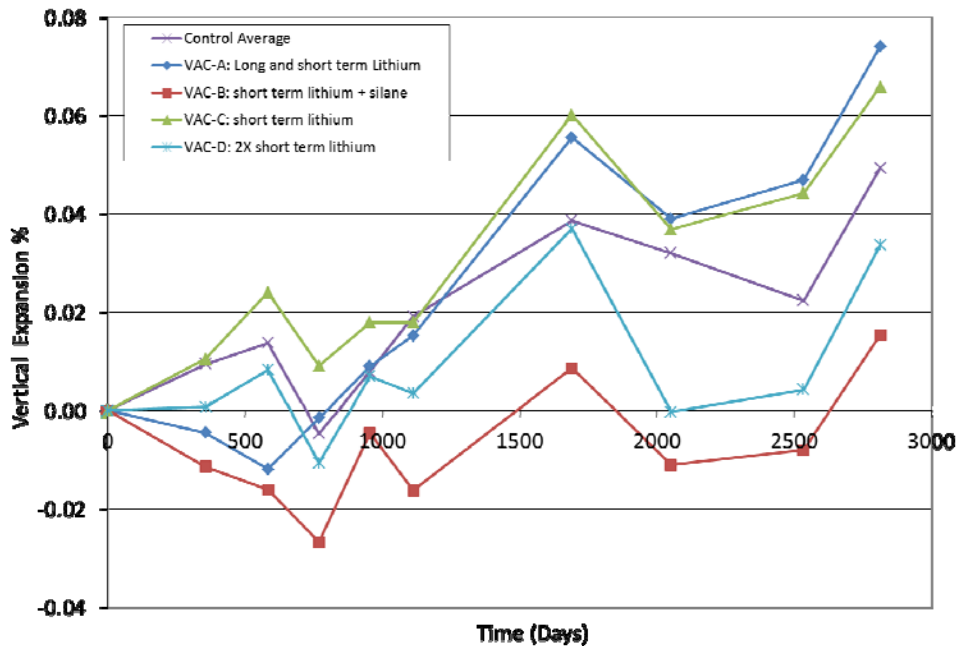
Figure 131. Average vertical expansion for highway barriers in Leominster, MA, comparing effects of vacuum treatment with lithium nitrate, as well as a combination of applying lithium under vacuum, followed by topical application of silane. The expansion of the control barriers is based on the average of three control sections (North and South sides of barriers). The expansion values for the treated sections are based on the average expansion for the North and South faces of the instrumented barrier in each test section.

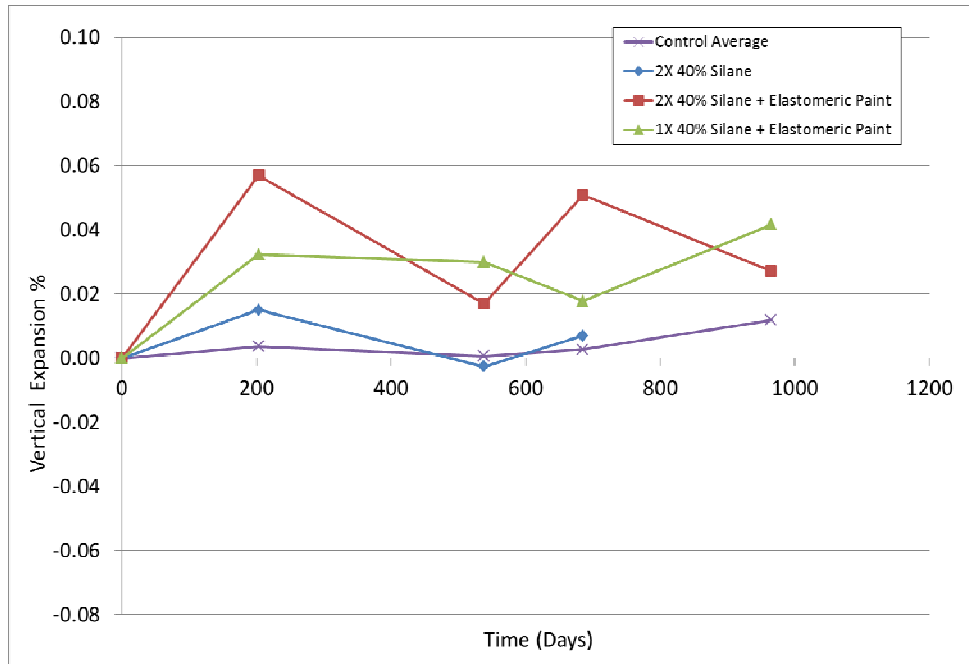
Figure 132. Average vertical expansion for highway barriers in Leominster, MA, comparing effects of a second silane treatment (five years after the first treatment) and the effects of applying elastomeric paint over barriers previously treated with silane. The expansion of the control barriers is based on the average of three control sections (North and South sides of barriers) from the time of the 2010 treatment. The expansion values for the treated sections are based on the average expansion for the North and South faces of the instrumented barrier in each test section.

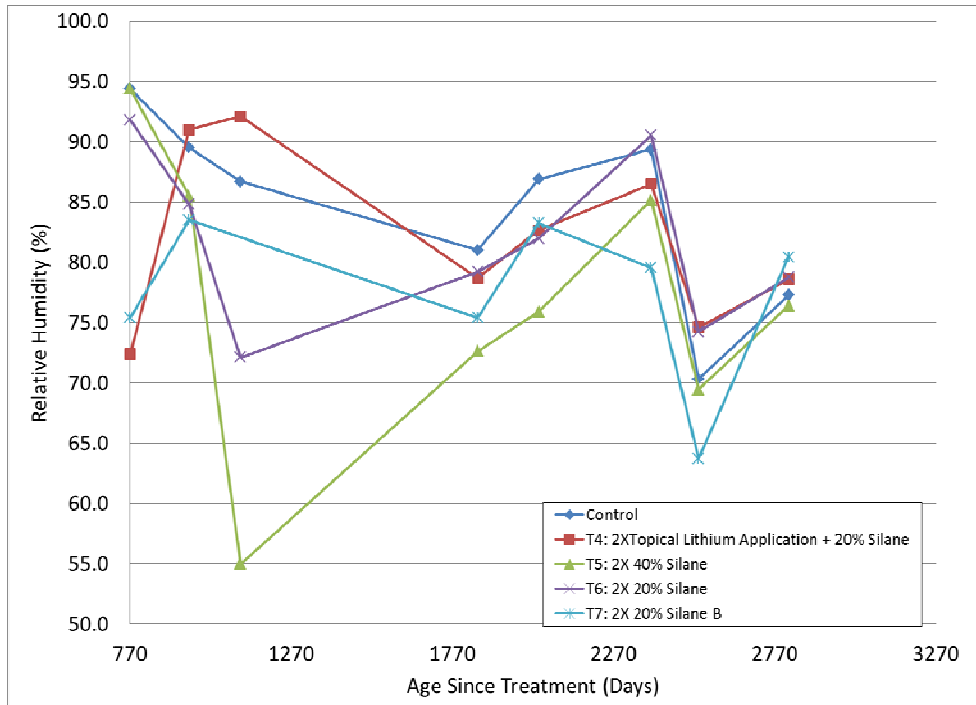
Figure 133 shows the results of relative humidity measurements for the barriers treated with silane in 2005, compared to the control barrier. The values shown are based on the composite average relative humidity values recorded at depths of 25 mm (1 in.), 50 mm (2 in.), and 75 mm (3 in.). Figure 134 shows similar data for barriers that were treated in 2010. As can be seen in these two figures, the variability in relative humidity measurements is significantly higher than expansion measurements, making it more difficult to identify trends in performance.

Figure 133. Average relative humidity values for highway barriers in Leominster, MA, comparing effects of silane applied in 2005. All values shown are based on the composite average relative humidity values recorded at depths of 25 mm (1 in.), 50 mm (2 in.), and 75 mm (3 in.).

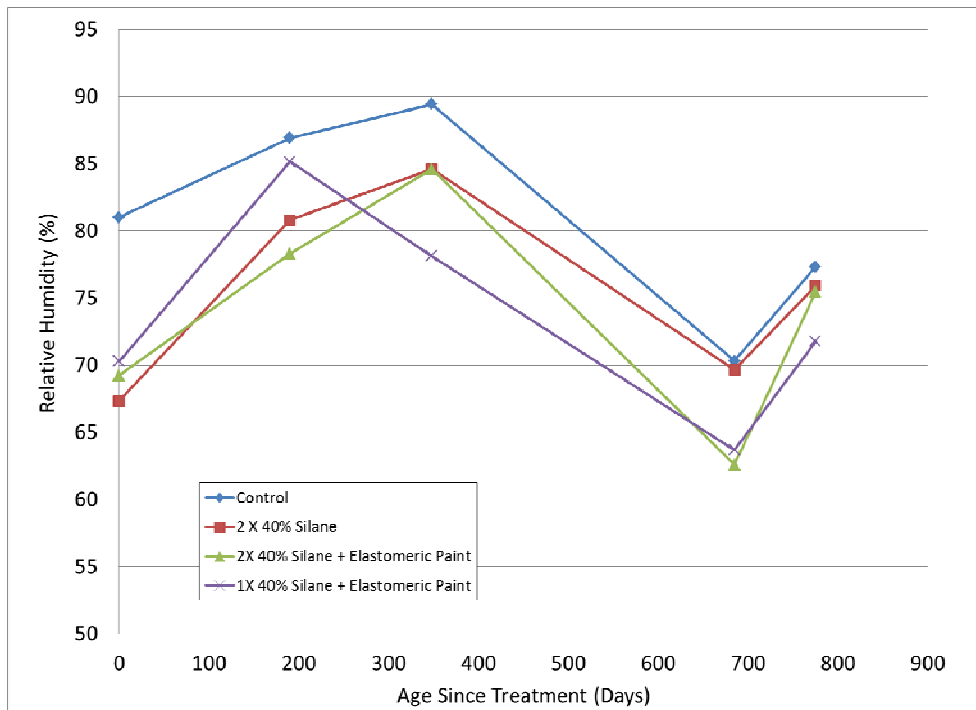
Figure 134. Average relative humidity values for highway barriers in Leominster, MA, comparing effects of a second silane treatment (five years after the first treatment) and the effects of applying elastomeric paint over barriers previously treated with silane. All values shown are based on the composite average relative humidity values recorded at depths of 25 mm (1 in.), 50 mm (2 in.), and 75 mm (3 in.).

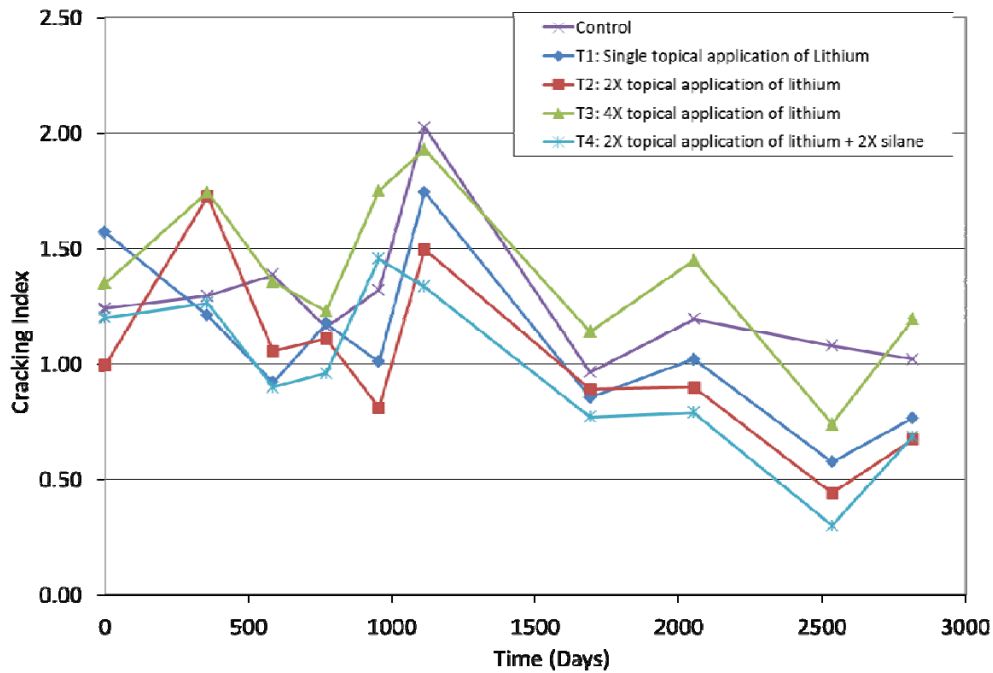
Figure 135 to Figure 137 show the average calculated Cracking Index (CI) values based on crack mapping measurements from the South face of each of the instrumented barriers. The results shown are based on map cracking on the South-facing side of each instrumented barrier. Barriers that were treated with elastomeric paint were no longer crack mapped because the paint covered most all of the visible cracking (with the exception of large cracks that the elastomeric paint was unable to bridge). In general, there is quite a bit of scatter in the data, due to inherent difficulties in visually assessing cracked concrete in field elements. Also, crack mapping is quite sensitive to the user (or crack mapping operator), and over the course of eight years of monitoring, it was not possible to have one individual take all measurements.

Figure 135. Calculated Cracking Index (CI) (mm/m) values for highway barriers in Leominster, MA, comparing effects of topical treatment of lithium nitrate (with and without subsequent treatment with silane). The CI calculations are based on crack mapping performed on the South face of each instrumented barrier.

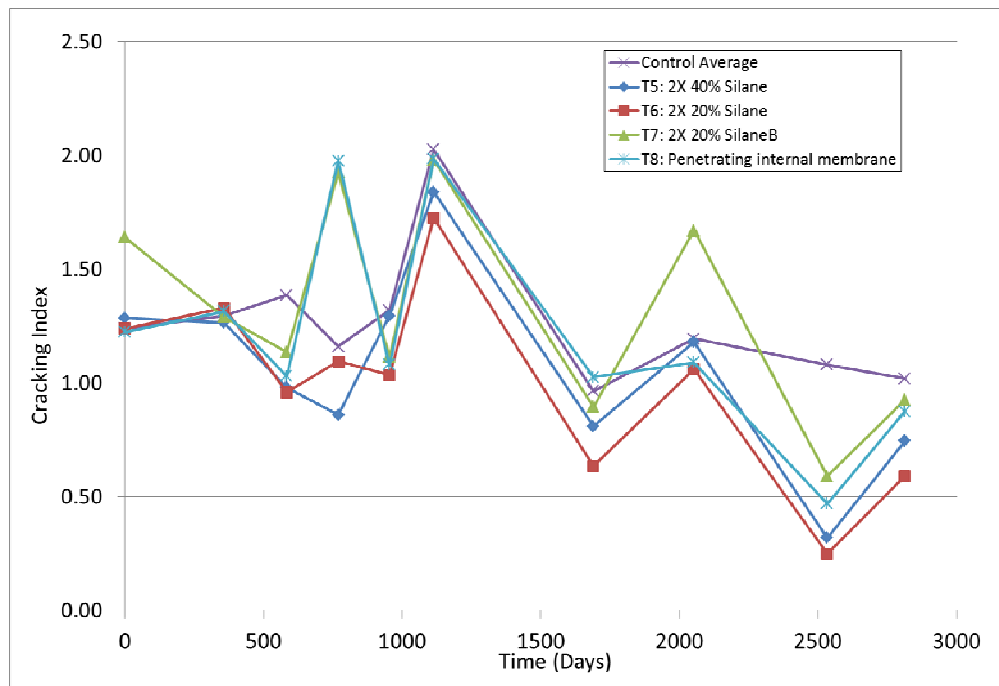
Figure 136. Calculated Cracking Index (CI) (mm/m) values for highway barriers in Leominster, MA, comparing effects of topical treatment of various silane products and lithium silicate. The CI calculations are based on crack mapping performed on the South face of each instrumented barrier.

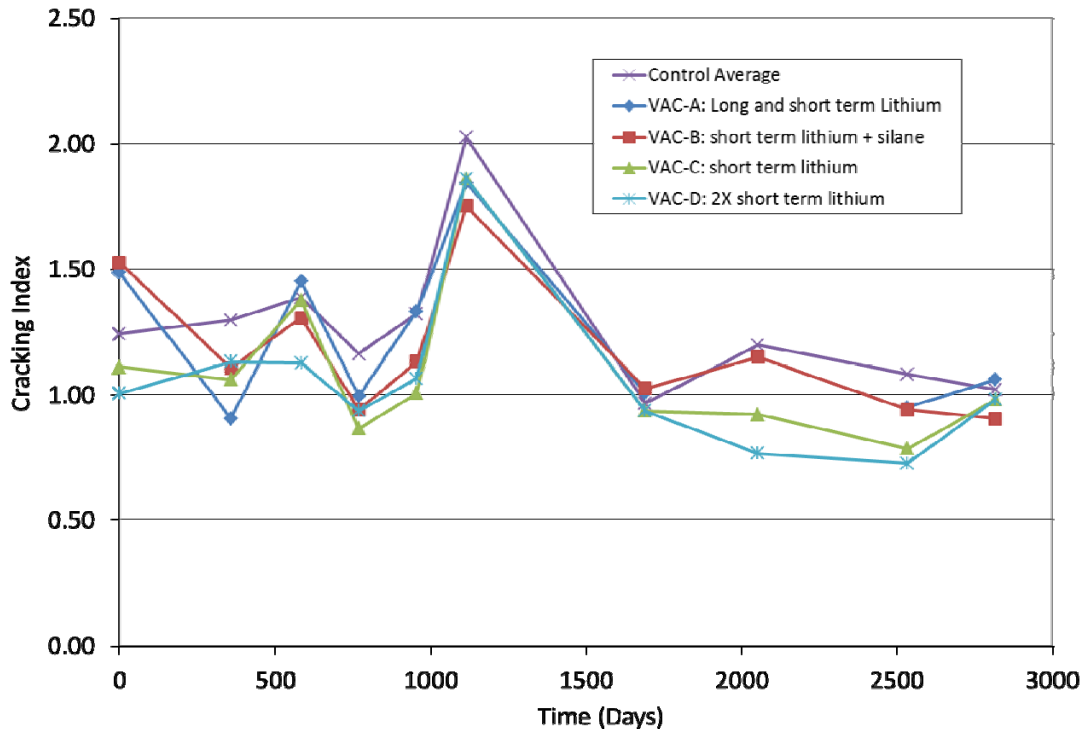
Figure 137. Calculated Cracking Index (CI) (mm/m) values for highway barriers in Leominster, MA, comparing effects of vacuum treatment with lithium nitrate, as well as a combination of applying lithium under vacuum, followed by topical application of silane. The CI calculations are based on crack mapping performed on the South face of each instrumented barrier.

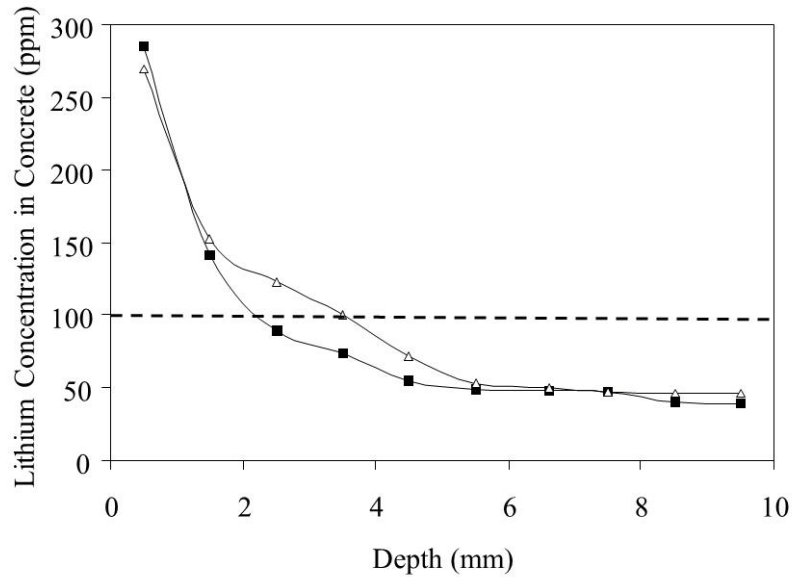
Figure 138 shows the measured lithium profiles for cores extracted from barriers (VC) that were vacuum impregnated with lithium nitrate for over seven hours. Cores were extracted from these barriers as they received the most long-term, aggressive vacuum treatment, and it was assumed that the maximum lithium penetration would be found in these barriers. The results show that the depth of lithium penetration was minimal, with lithium only present in a concentration above the 100 ppm threshold in the outer 2-4 mm (0.08-0.16 in.). Lithium profiling was not conducted on the other barriers treated with lithium (topically or by vacuum), but it is expected that the depths of penetration would be less than the penetration shown in Figure 138.

Figure 138. Depth of lithium penetration for Massachusetts highway barrier (vacuum impregnated with lithium nitrate). Plots are duplicate samples extracted from barrier that had been vacuum impregnated with lithium nitrate for 7.25 hours). Dashed line (100 ppm) indicates concentration of lithium estimated to suppress ASR-induced expansion.

The application of lithium nitrate, either topically or by vacuum, showed no tangible benefits in terms of reducing expansion or cracking. This is likely attributed to the overall lack of penetration of the lithium nitrate into the highway barriers, as previously shown in Figure 138. The results show that the depth of lithium penetration was minimal, with lithium only present in a concentration above the 100 ppm threshold in the outer 2–4 mm (0.08-0.16 in.). Lithium profiling was not conducted on the other barriers treated with lithium (topically or by vacuum), but it is expected that the depths of penetration would be less than the penetration shown in Figure 138. Given the lack of lithium penetration, it is not surprising that no beneficial effects of the treatment were observed. The barriers treated with lithium silicate also showed no reductions in expansion or visible cracking, most likely due to limited penetration of the product into the barriers.

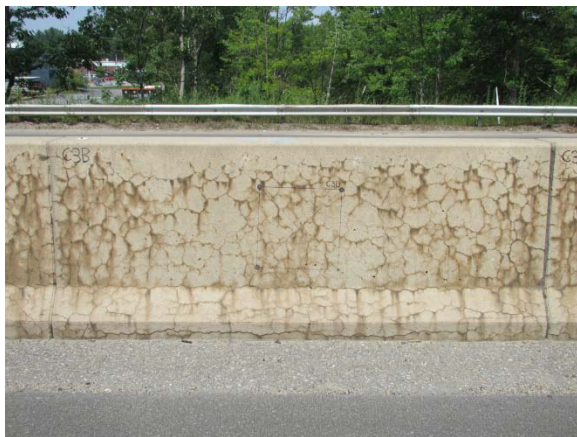
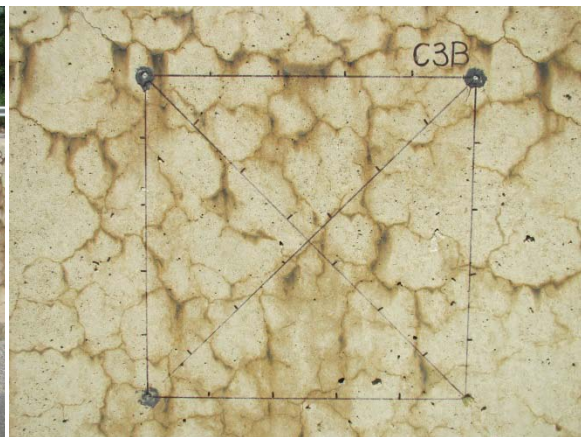
B – C3B - 2013

Figure 144. Visual observations over time of section C3B.

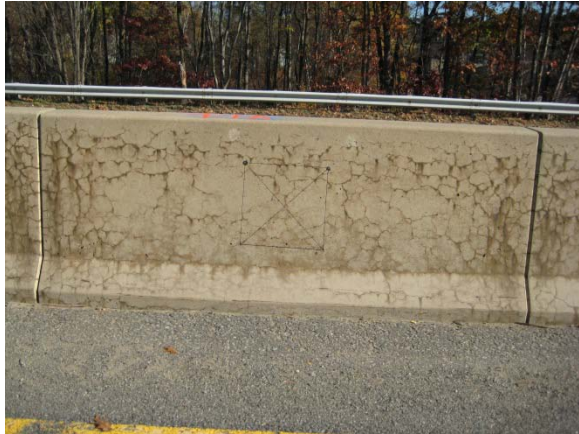
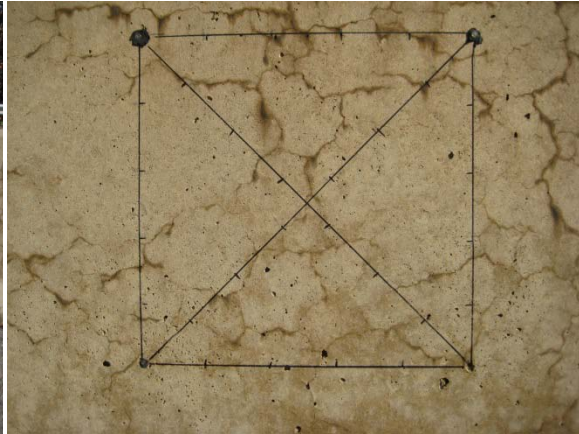
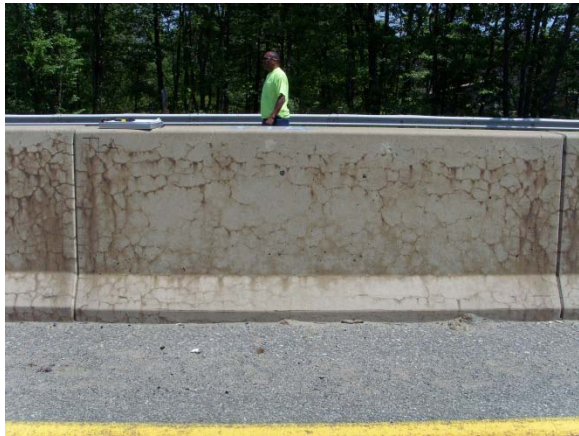
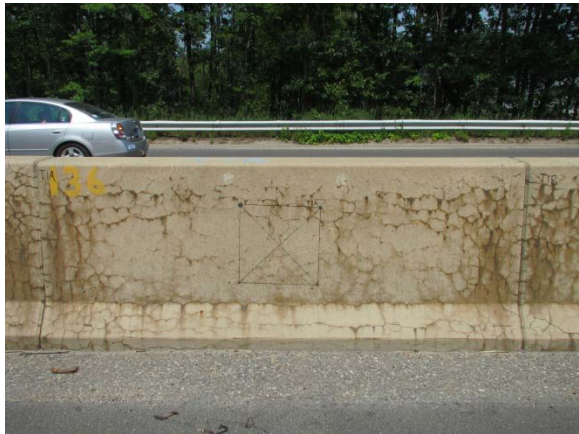
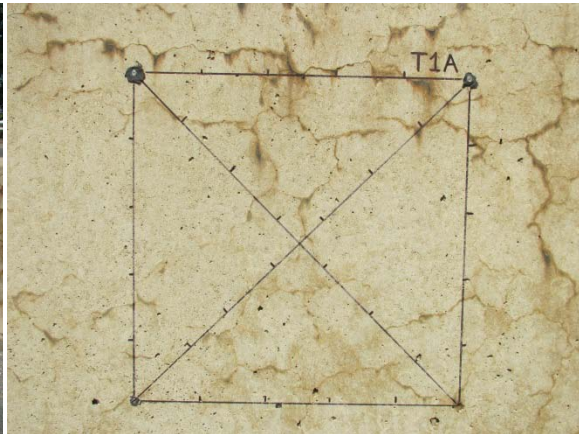
Figure 145. Visual observations over time of section T1A.
