Methods for Evaluating and Treating ASR-Affected Structures: Results of Field Application and Demonstration Projects

Volume II: Details of Field Applications and Analysis

Final Report

U.S. Department of Transportation
Federal Highway Administration

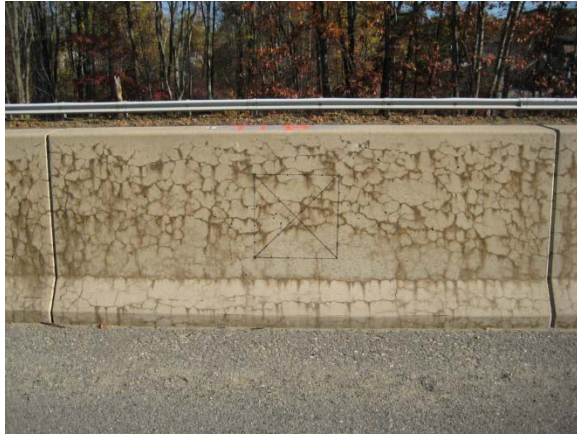
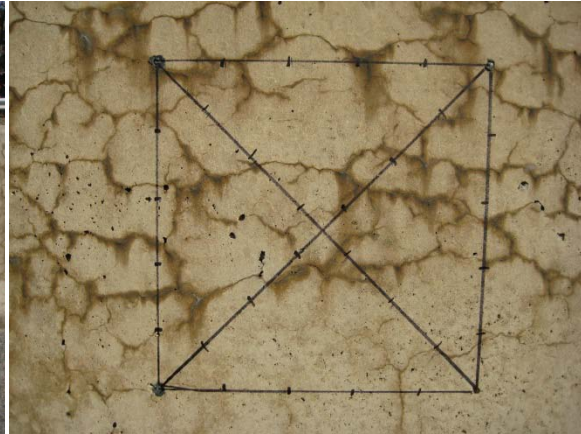
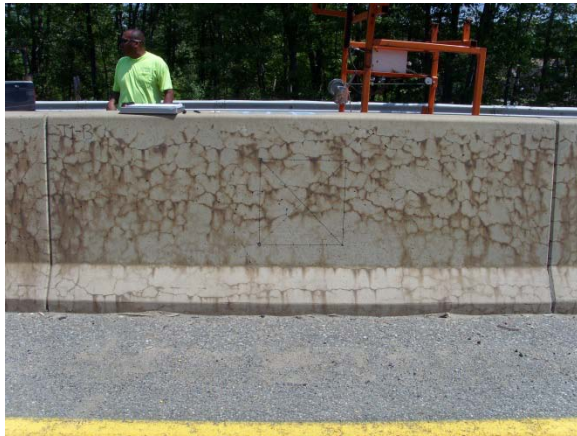
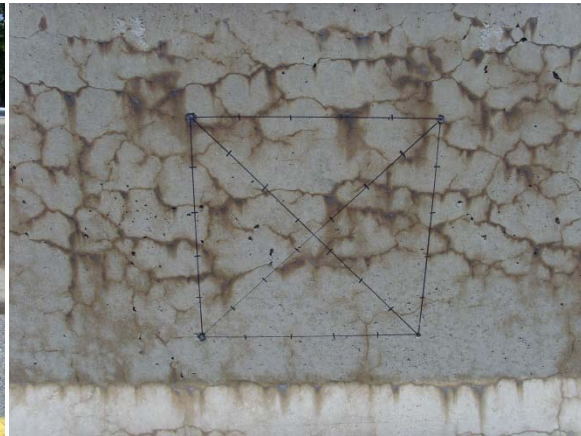
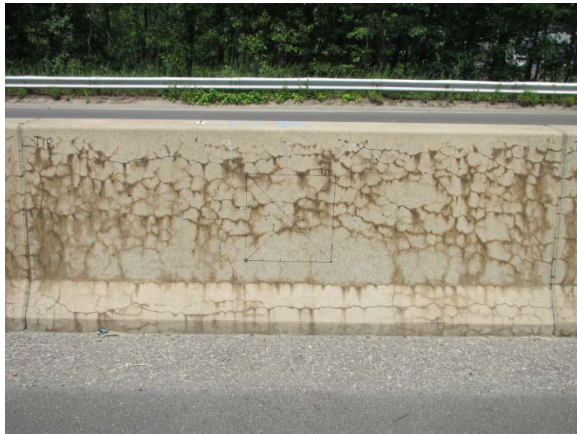
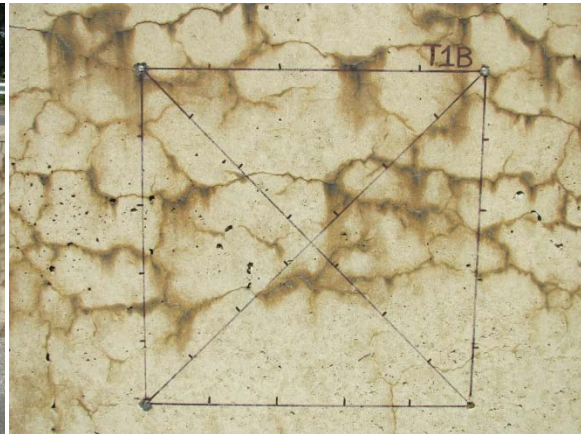
Figure 146. Visual observations over time of section T1B.

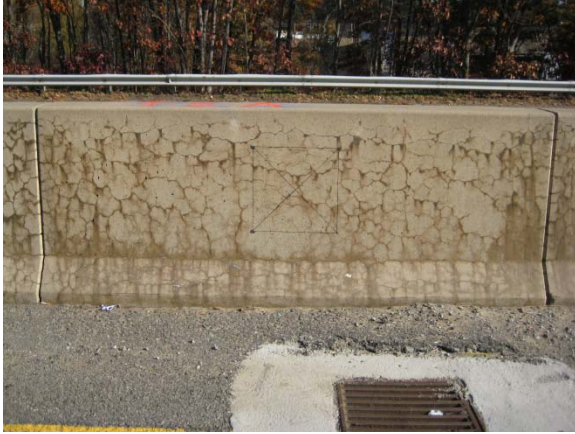
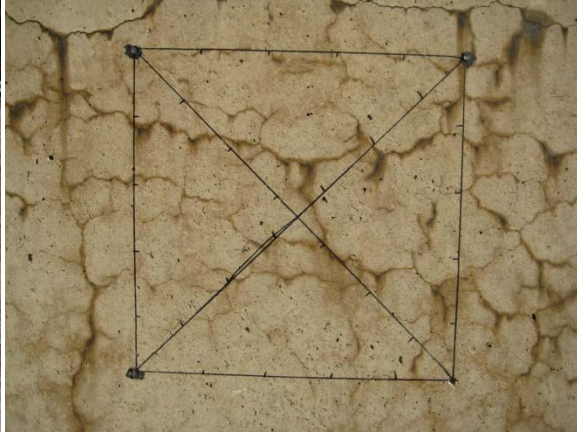
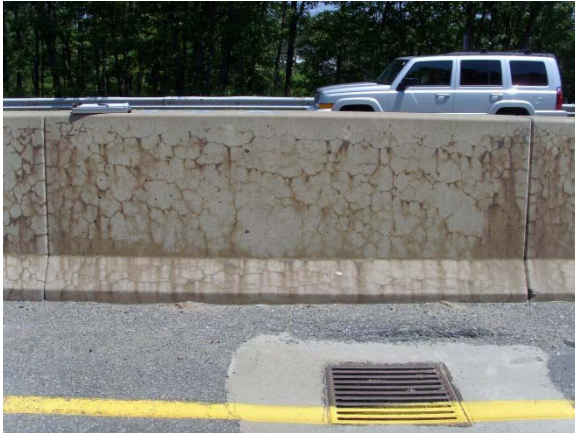
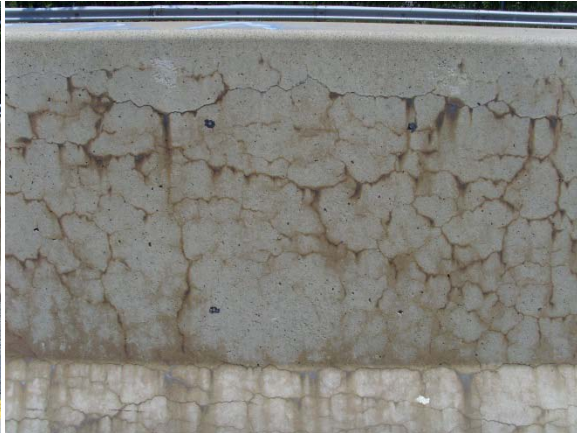
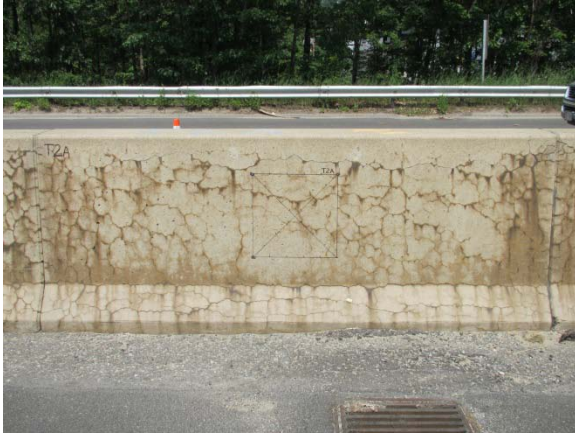
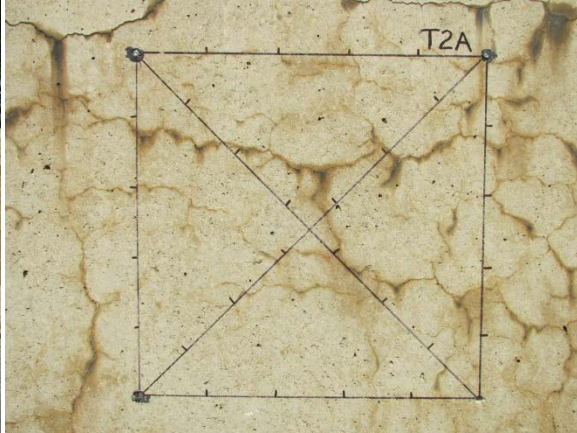
Figure 147. Visual observations over time of section T2A.

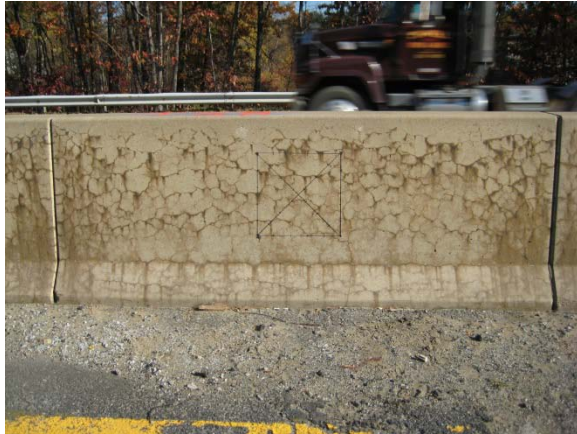
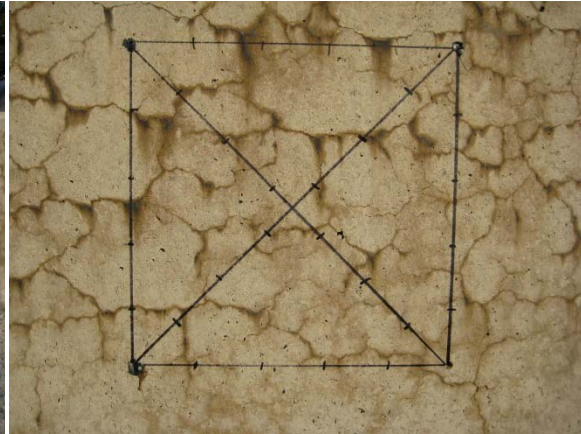
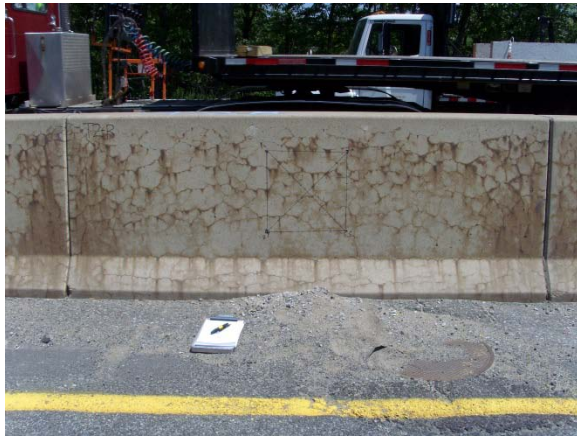
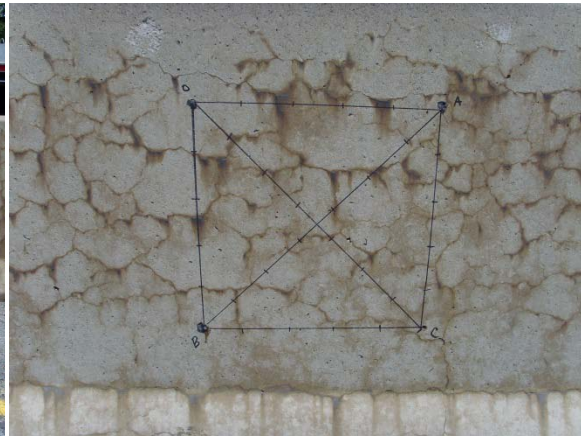
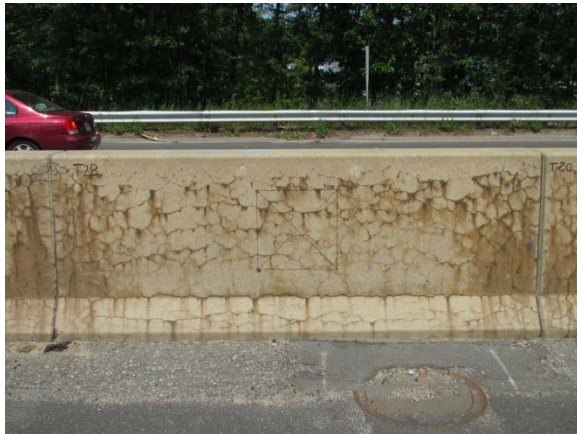
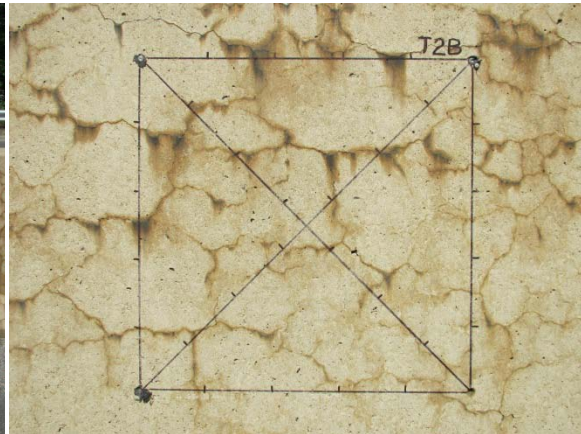
Figure 148. Visual observations over time of section T2B.

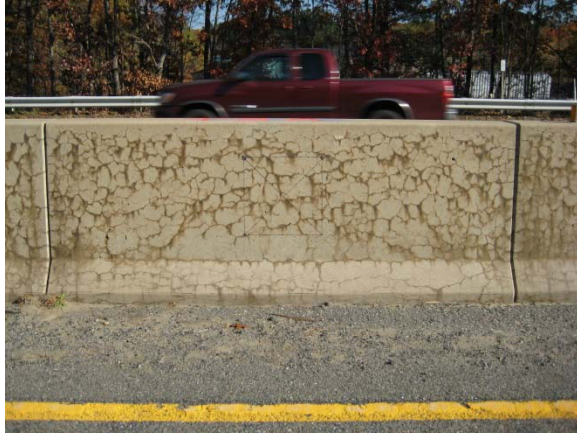
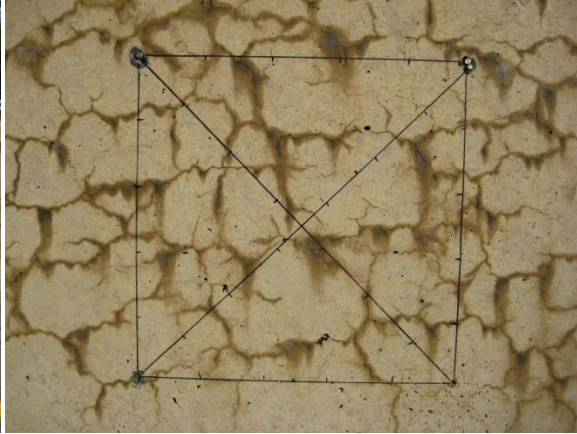
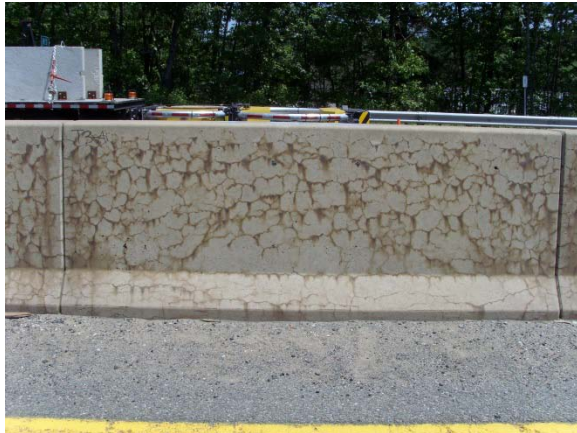
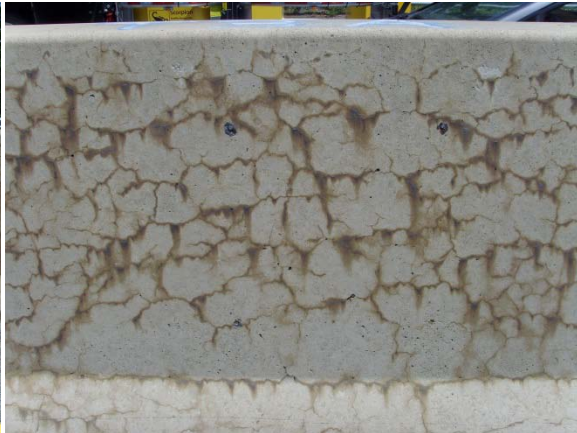
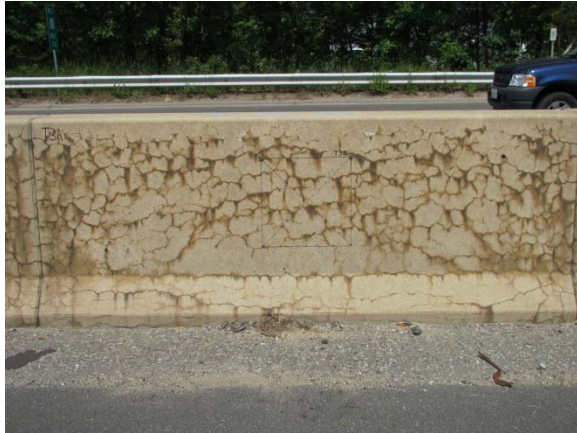
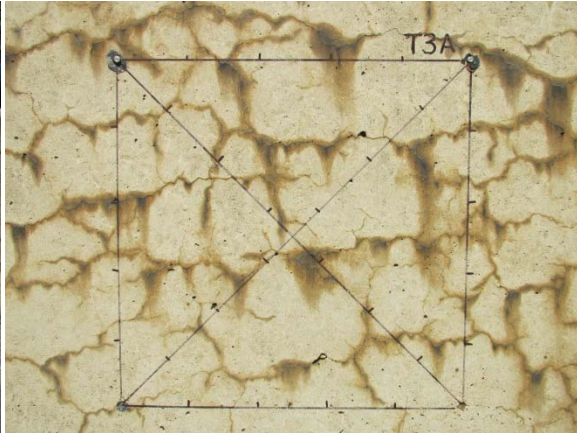
Figure 149. Visual observations over time of section T3A.

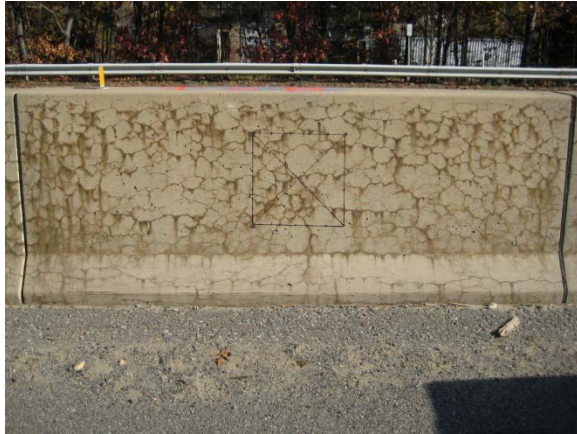
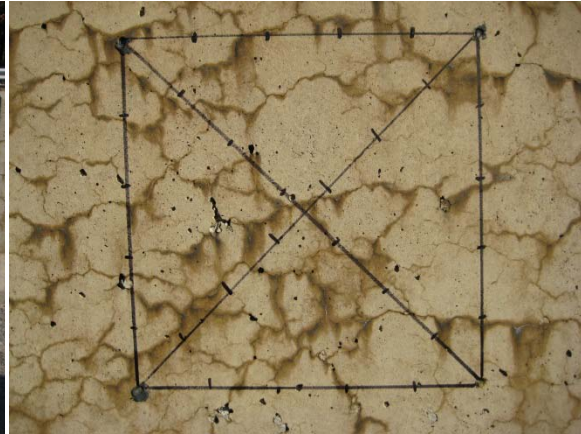
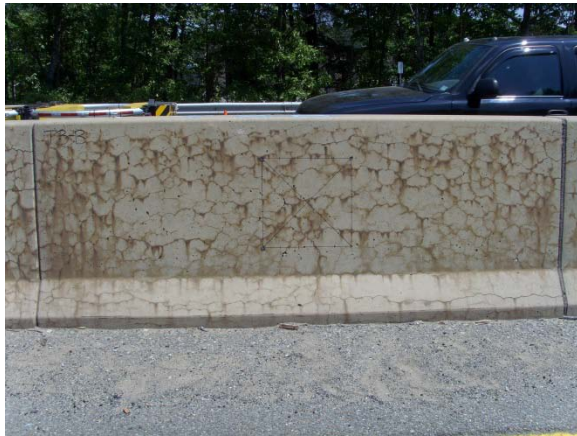
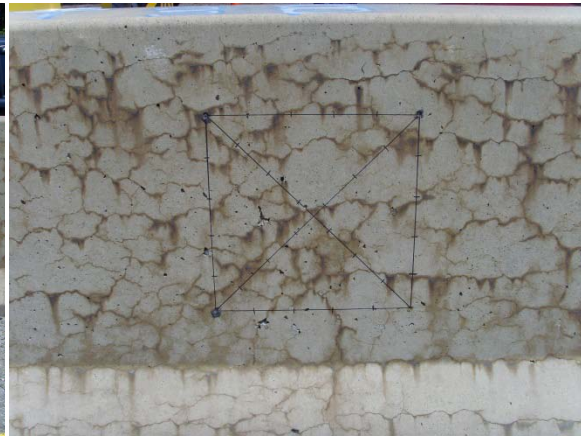
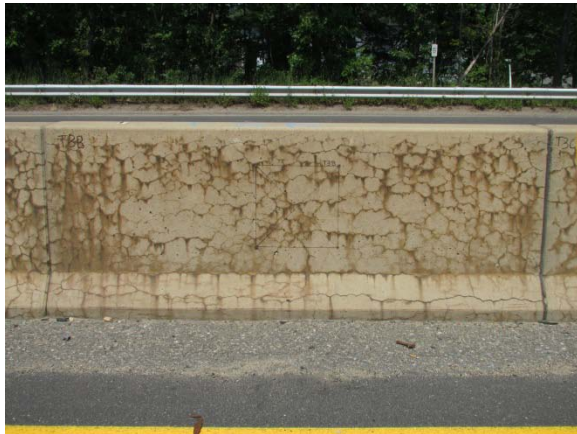
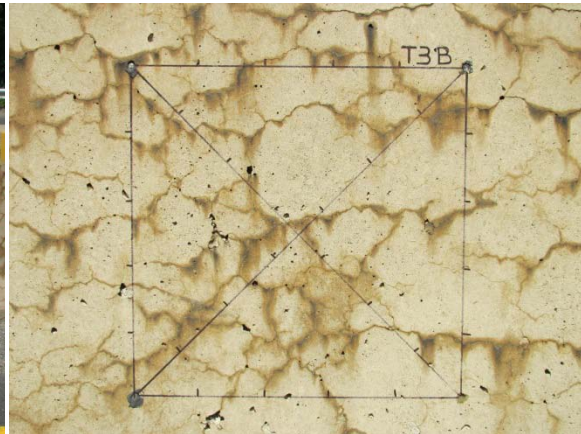
Figure 150. Visual observations over time of section T3B.

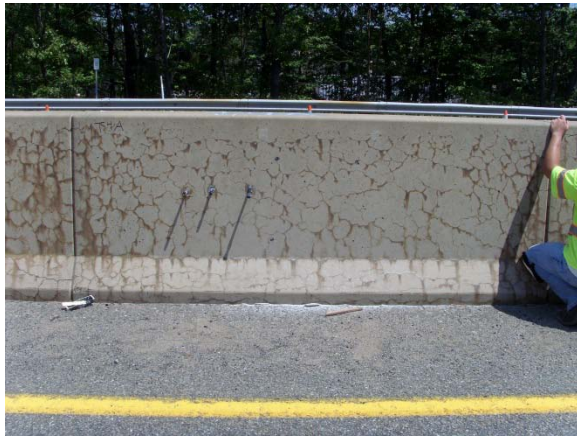
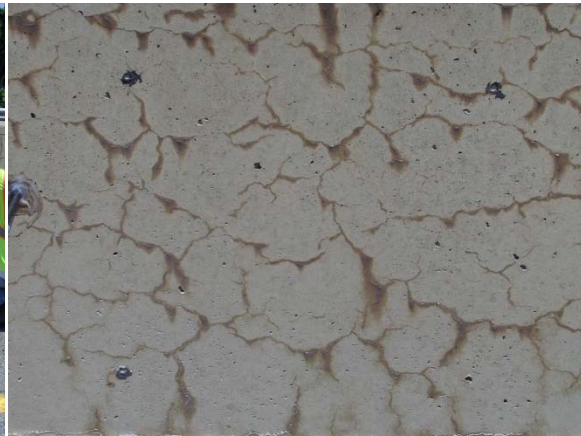
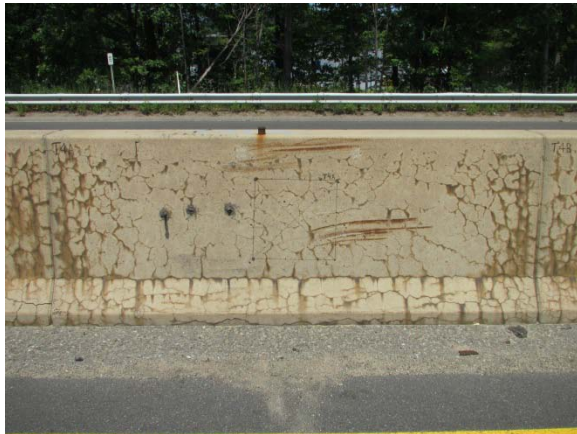
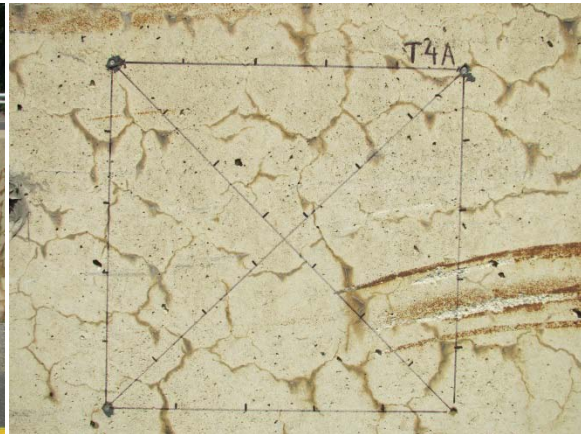
Figure 151. Visual observations over time of section T4A.

Photographs were regularly taken of each of the map cracking areas as a means of documenting the visual changes that occurred during the monitoring period. Figure 139 to Figure 168 show a series of photographs from 2008 to 2013 of the South-facing side of each instrumented barrier, with the exception of barriers that have been treated with elastomeric paint. These painted sections are not included herein because the elastomeric paint essentially covers almost all of the cracks prior to treatment.

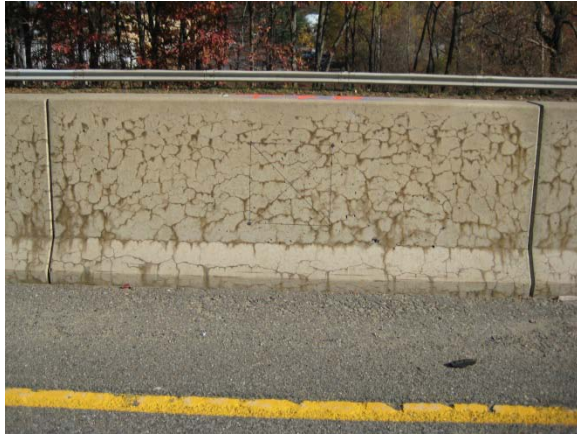
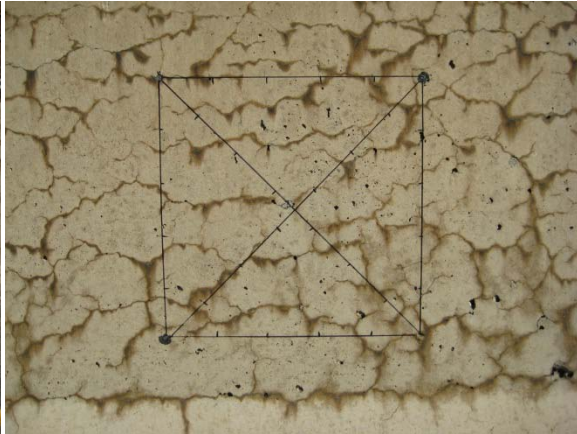
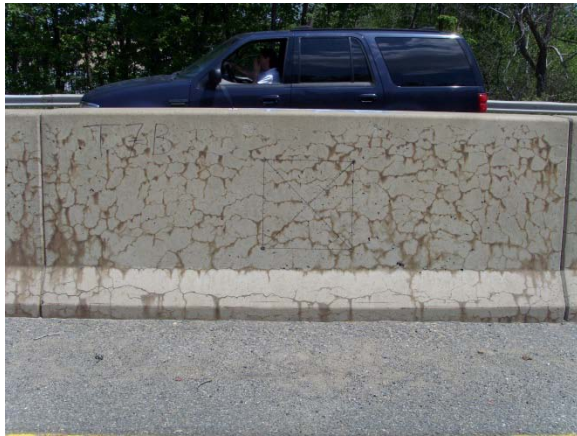
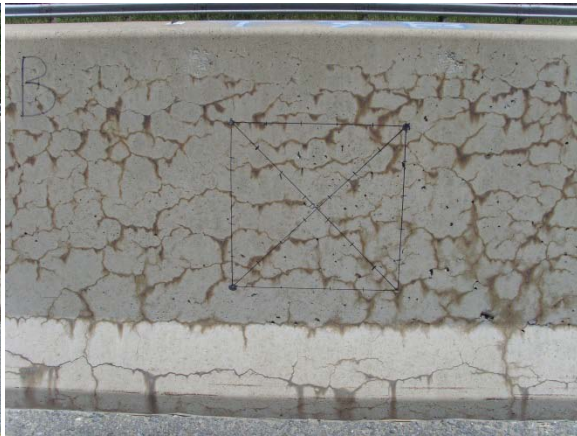
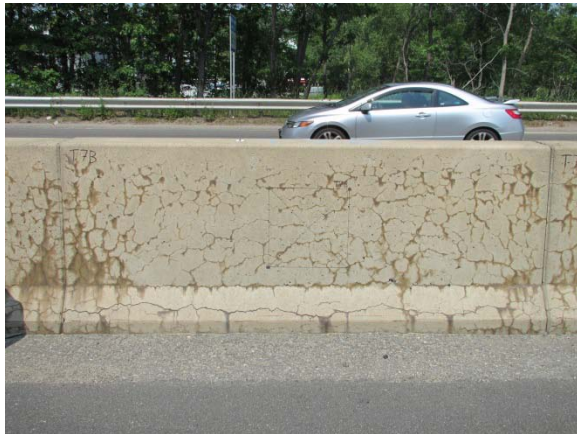
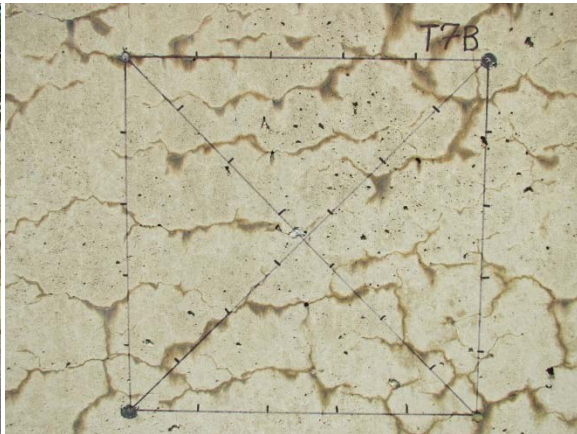
Figure 158. Visual observations over time of section T7B.

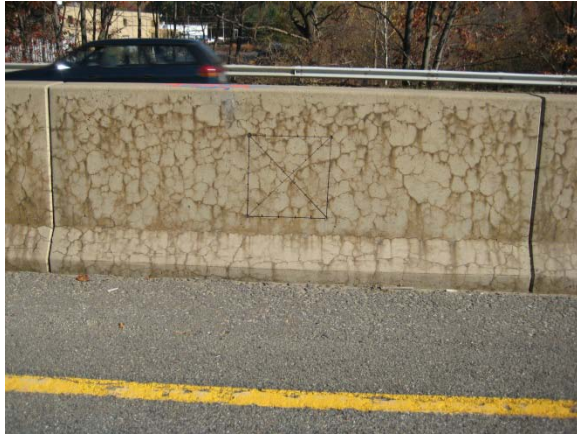
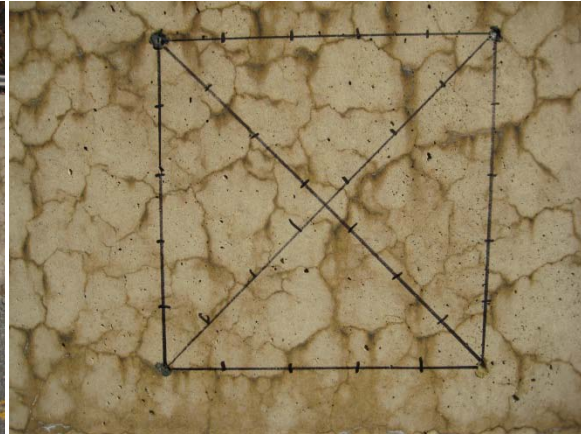
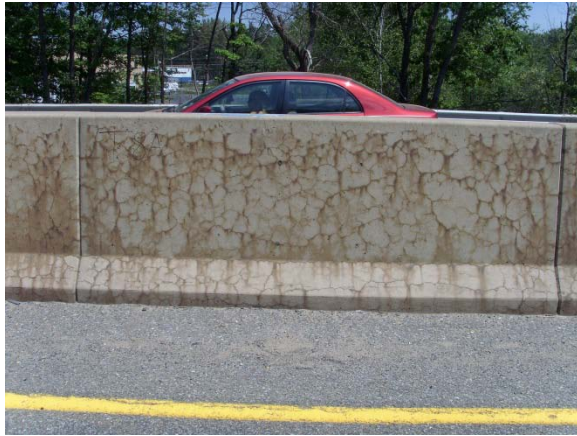
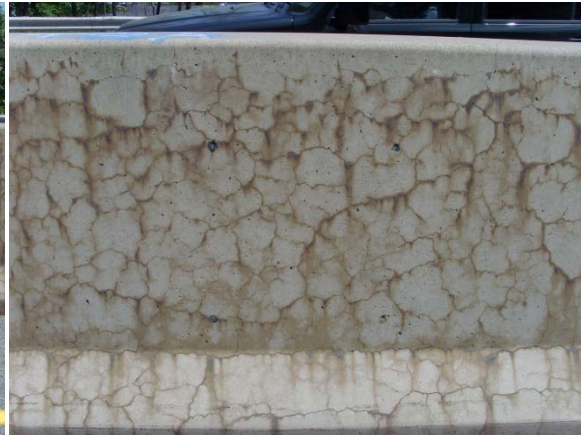
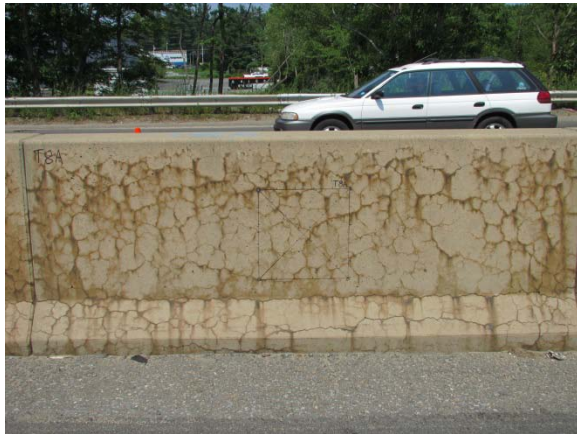
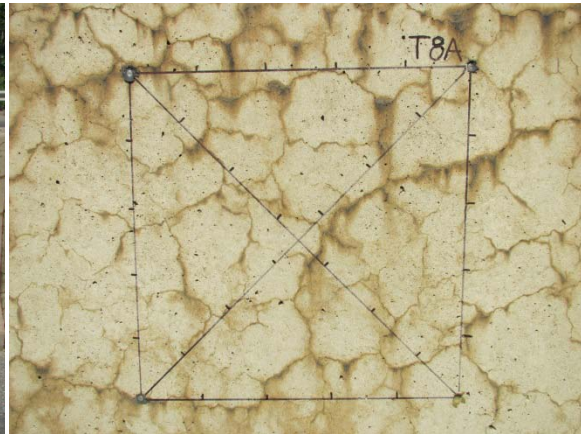
Figure 159. Visual observations over time of section T8A.

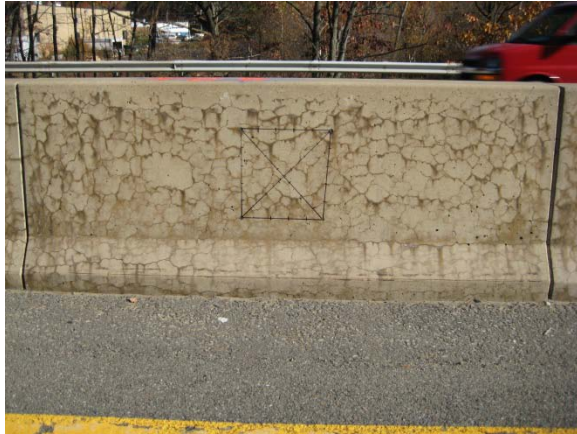
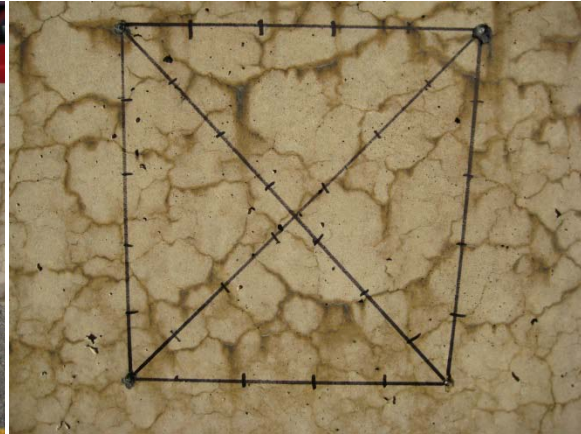
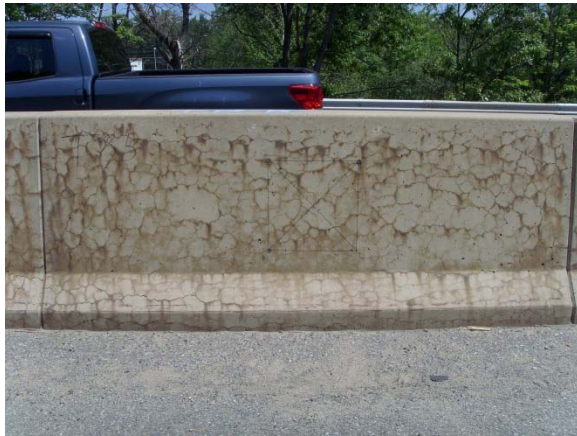
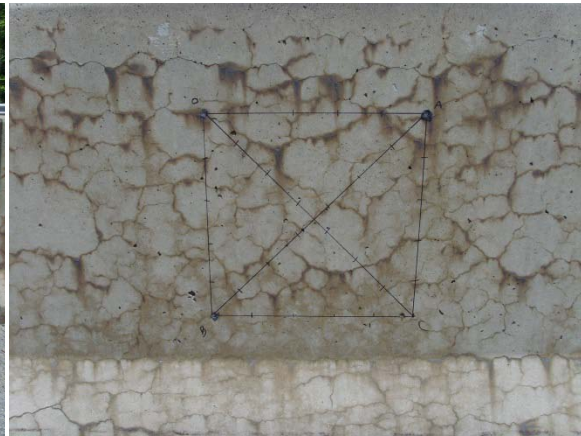
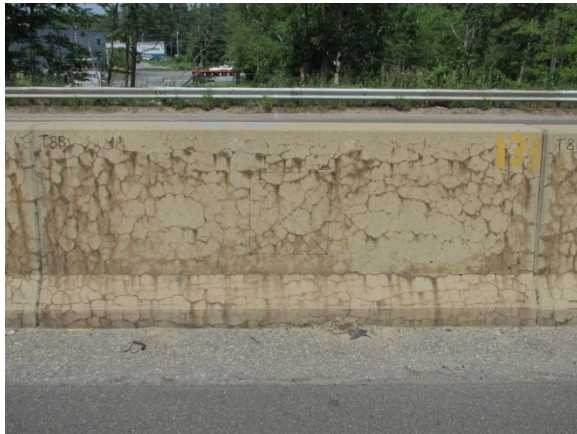
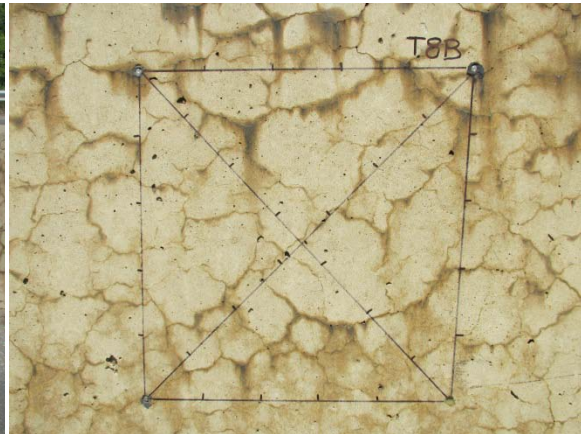
Figure 160. Visual observations over time of section T8B.

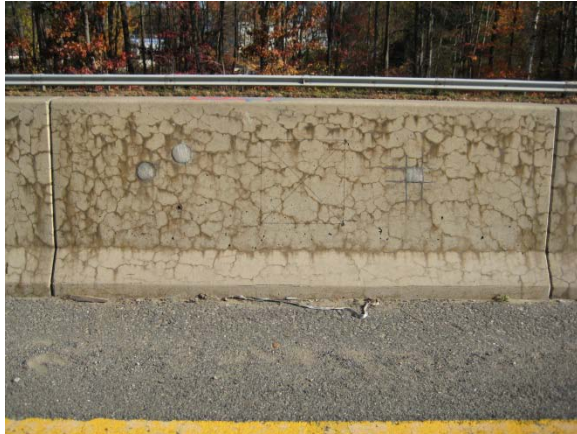
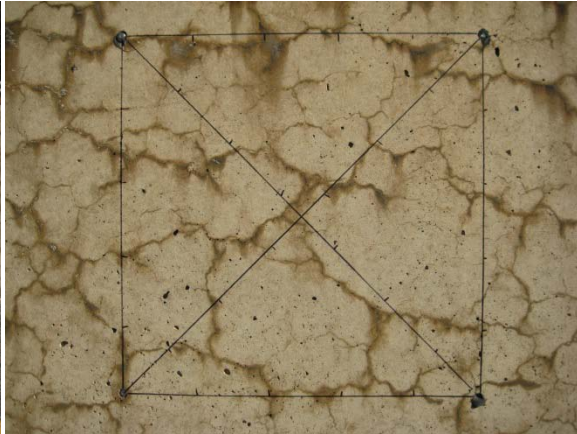
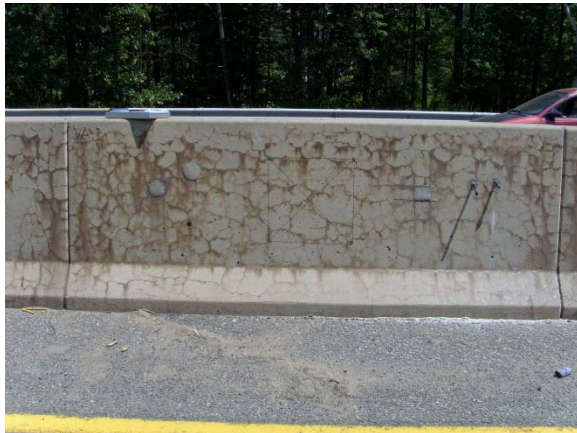
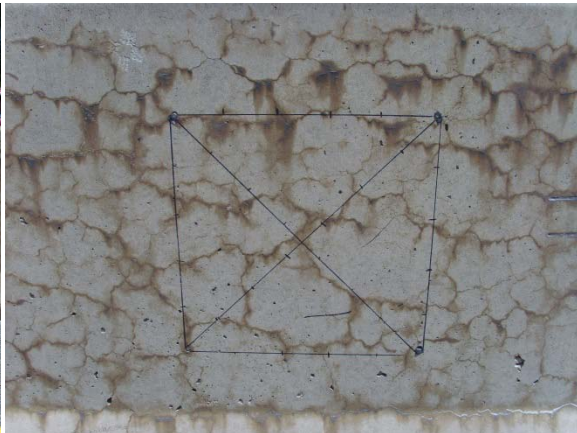
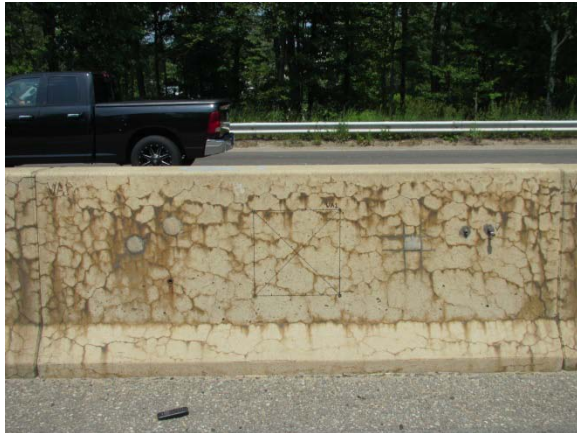
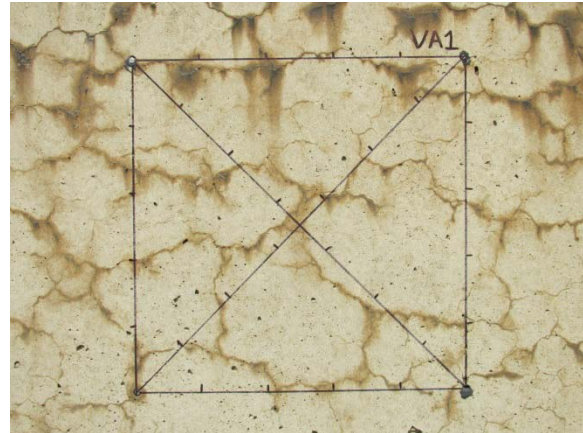
Figure 161. Visual observations over time of section VA1.

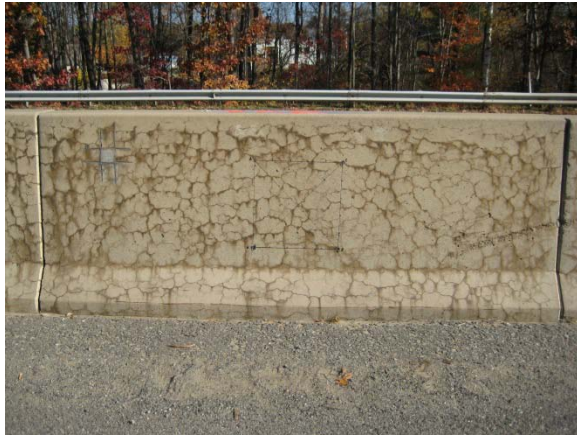
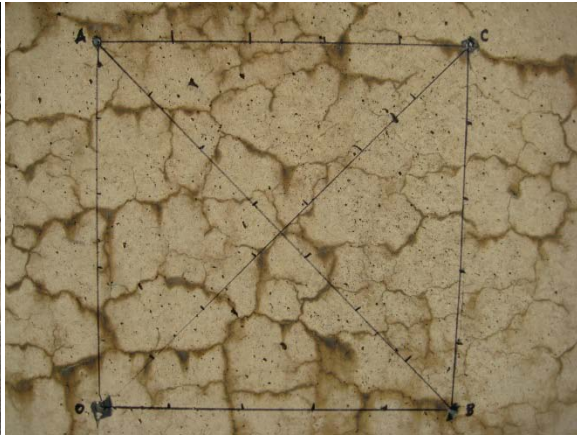
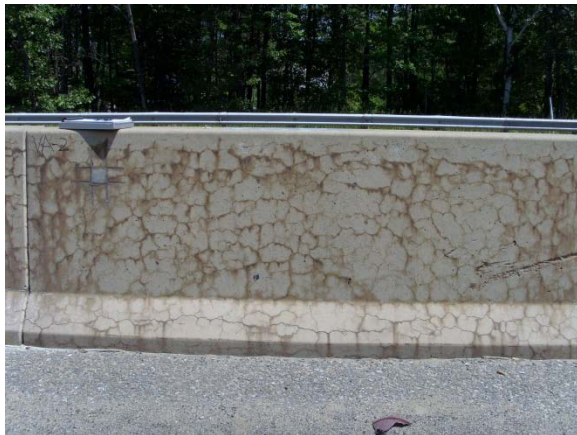
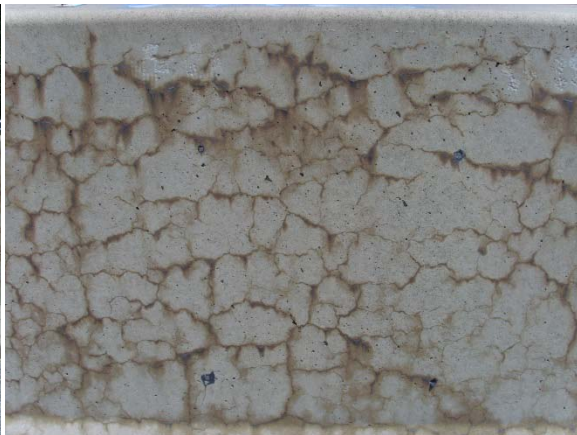
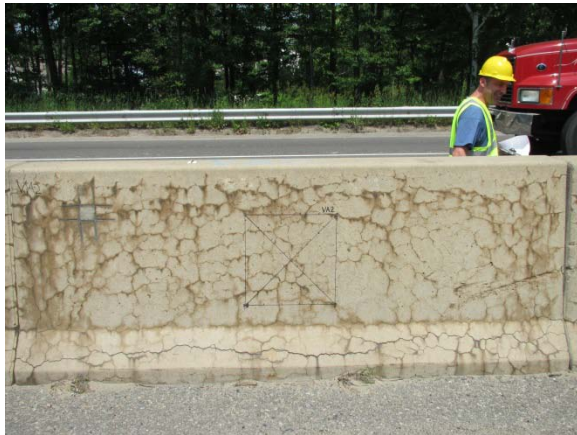
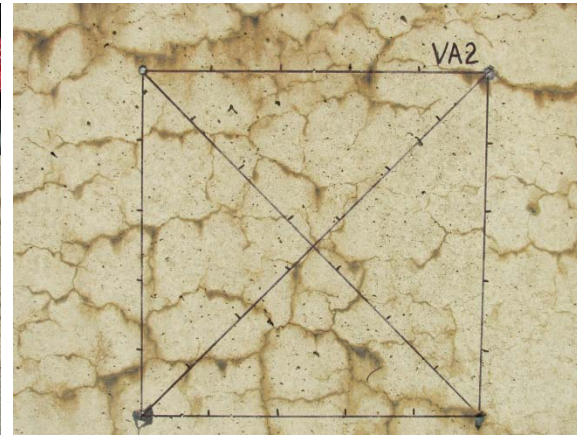
Figure 162. Visual observations over time of section VA2.

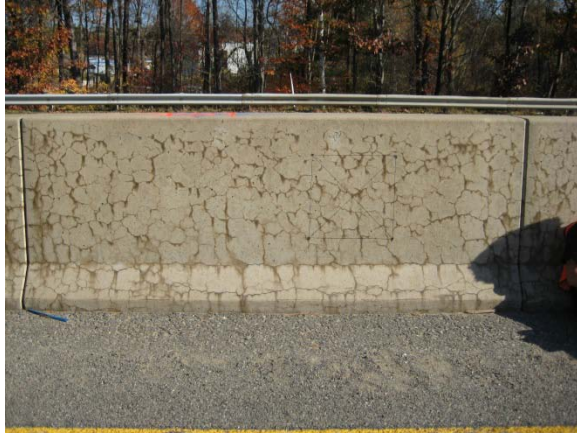
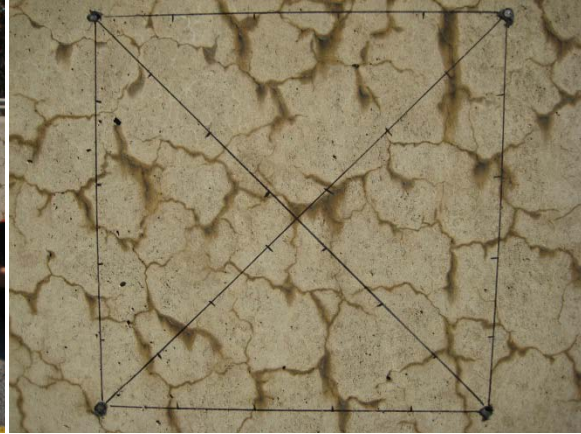
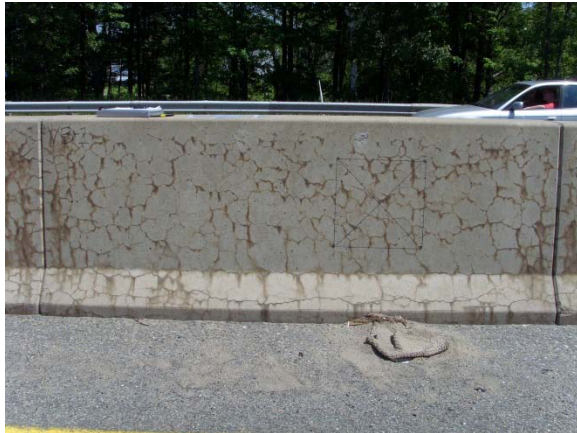
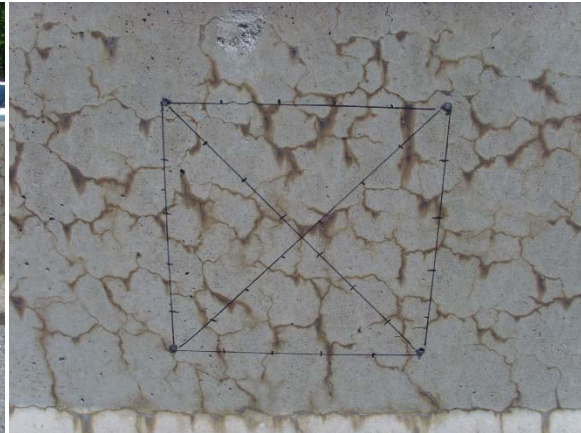
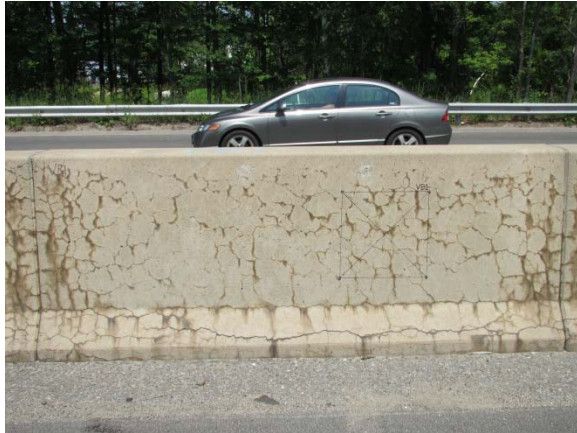
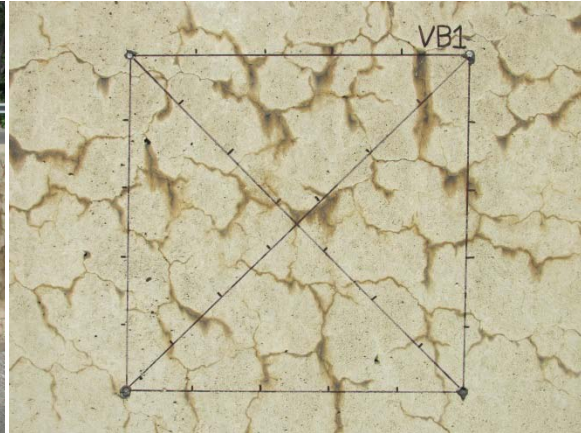
Figure 163. Visual observations over time of section VB1.

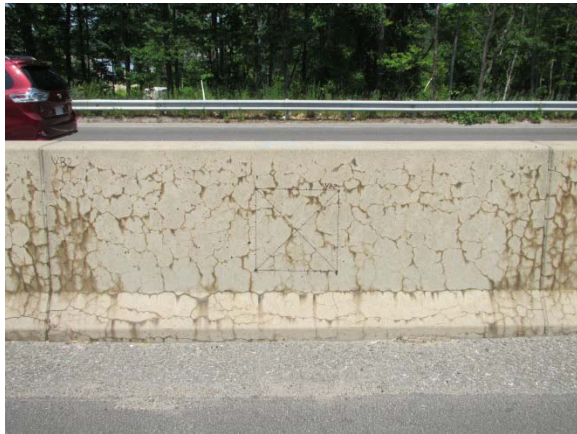
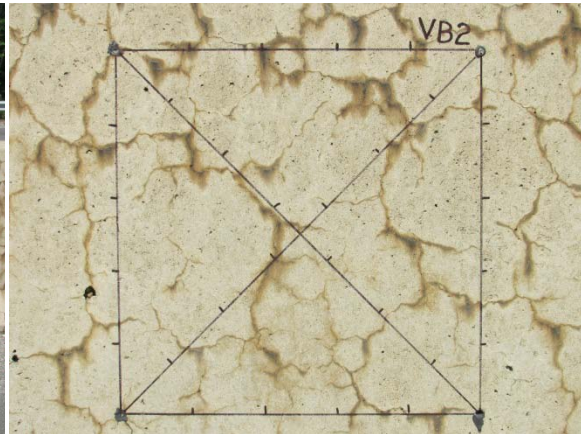
C – VB2 - 2013

Figure 164. Visual observations over time of section VB2.

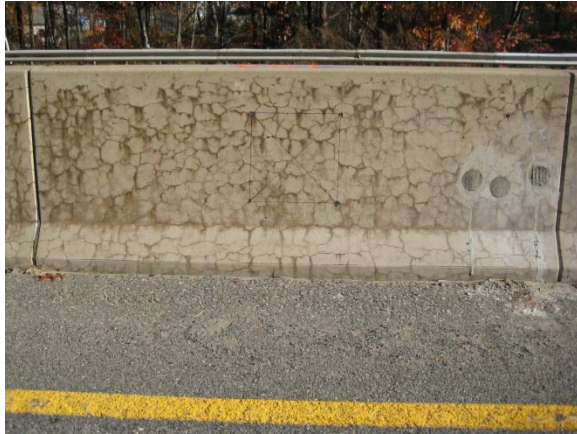
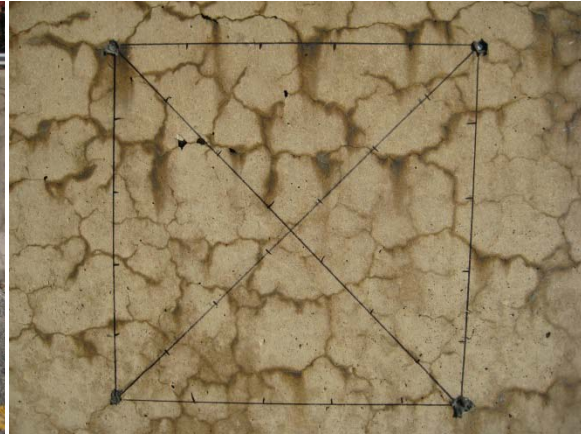
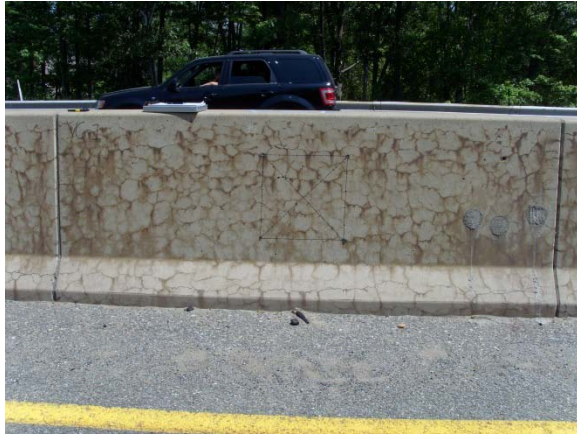
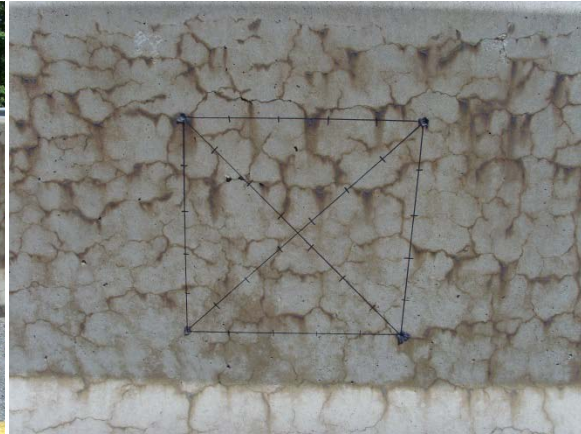
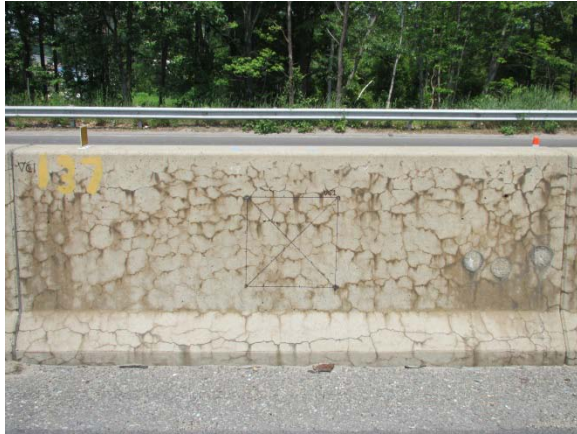
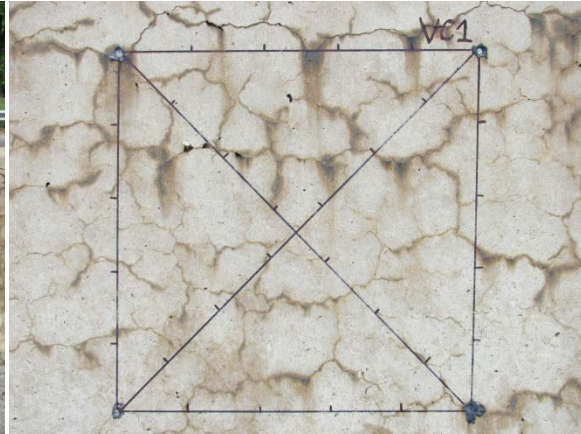
Figure 165. Visual observations over time of section VC1.

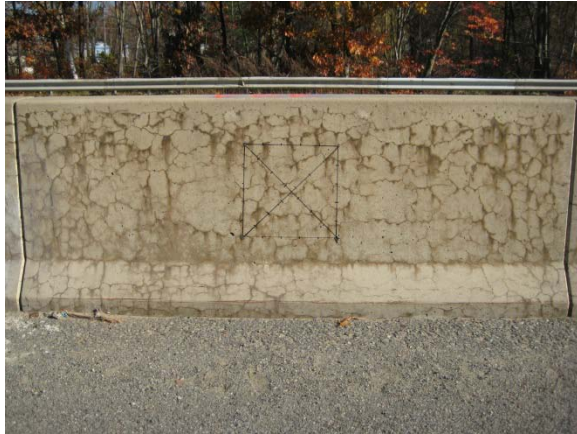
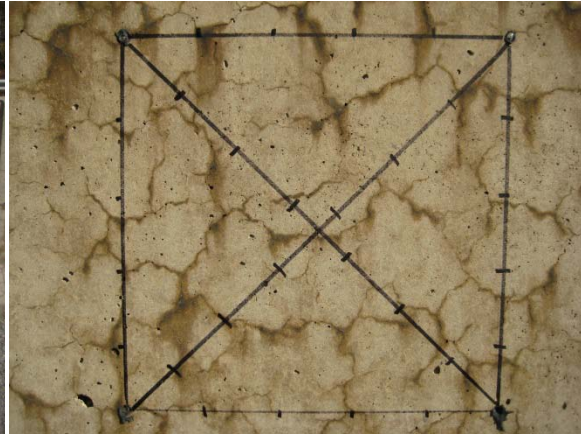
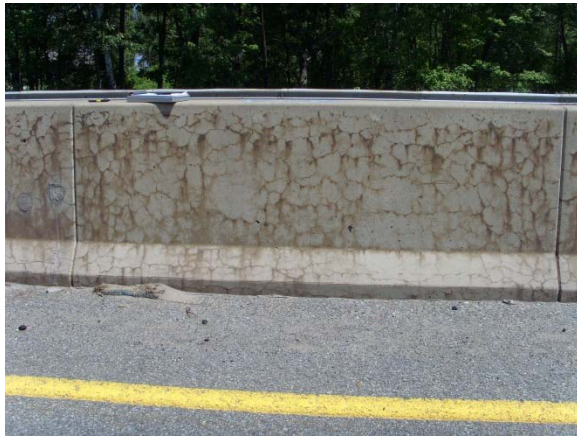
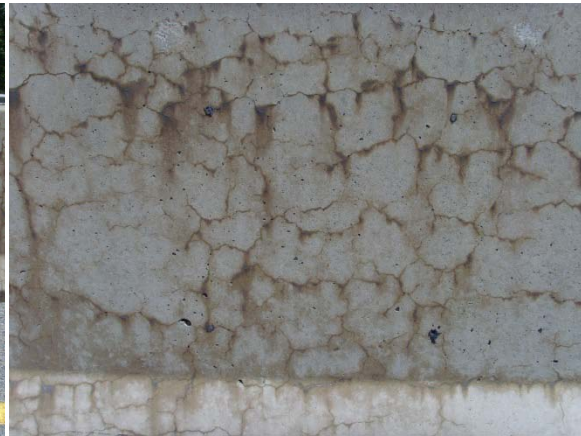
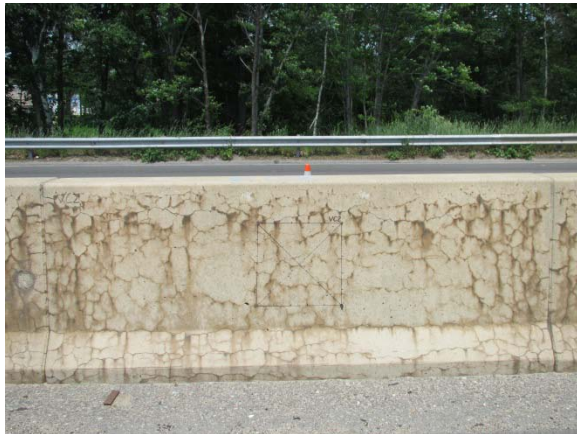
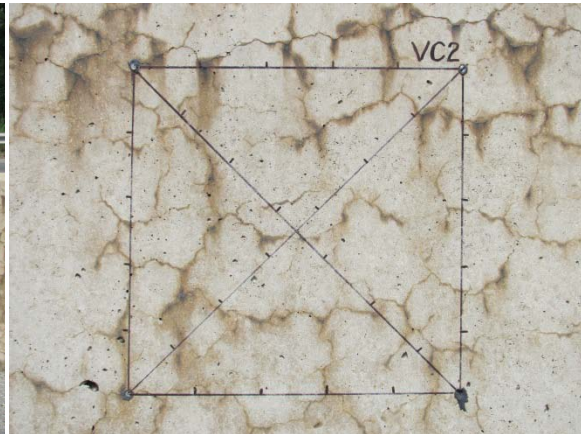
Figure 166. Visual observations over time of section VC2.

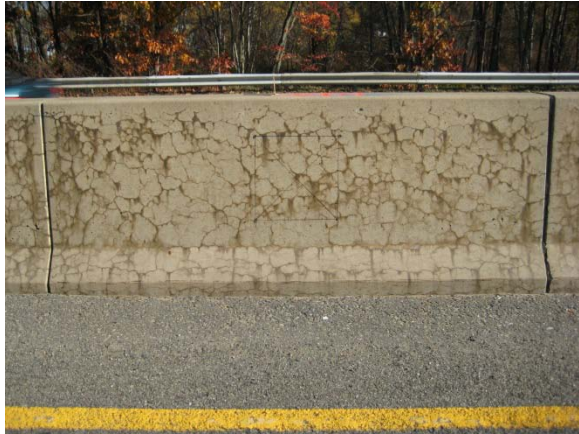
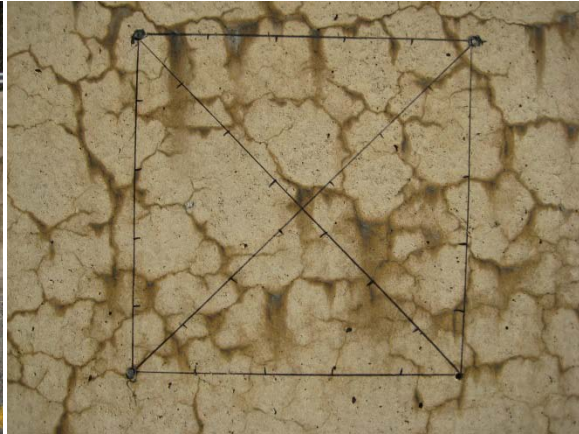
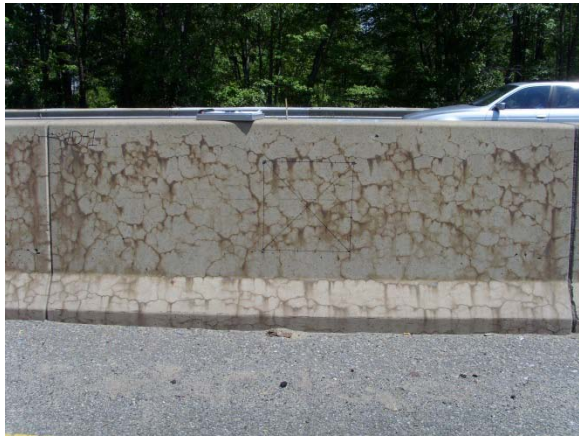
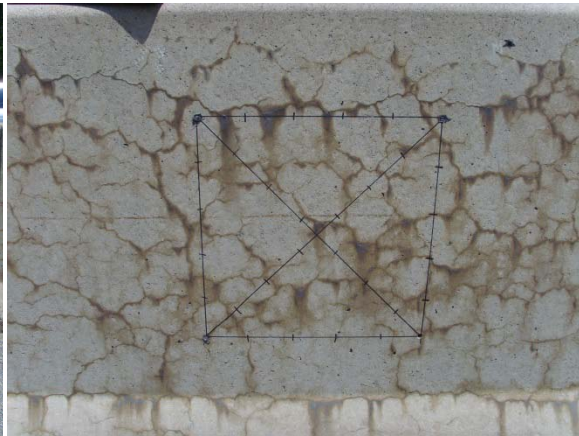
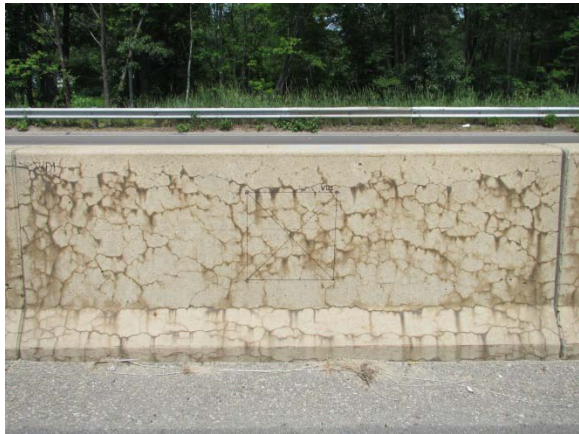
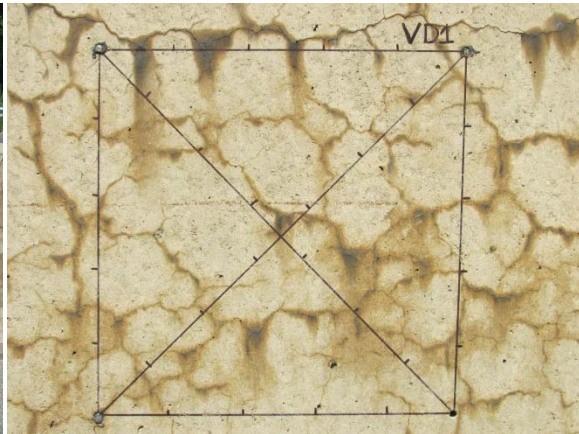
Figure 167. Visual observations over time of section VD1.
