Methods for Evaluating and Treating ASR-Affected Structures: Results of Field Application and Demonstration Projects

Volume II: Details of Field Applications and Analysis

Final Report

U.S. Department of Transportation
Federal Highway Administration

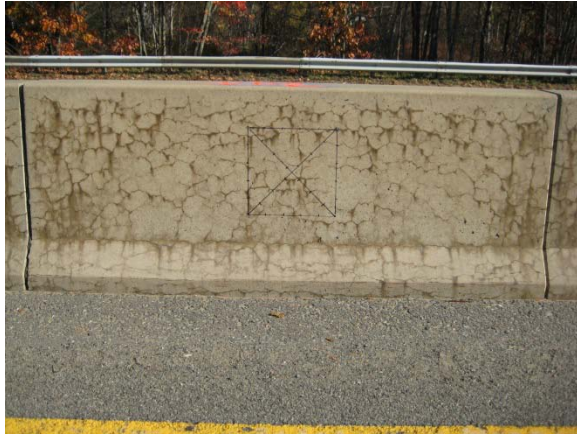
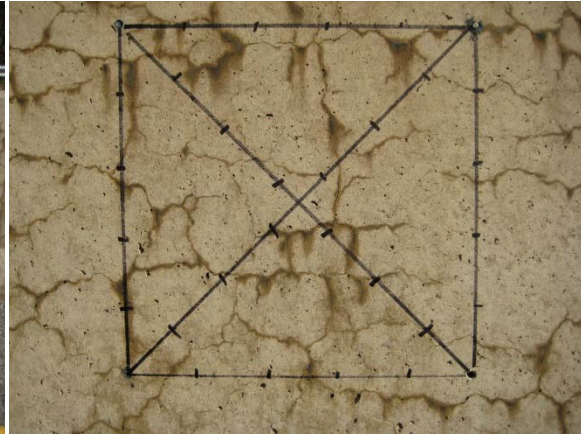
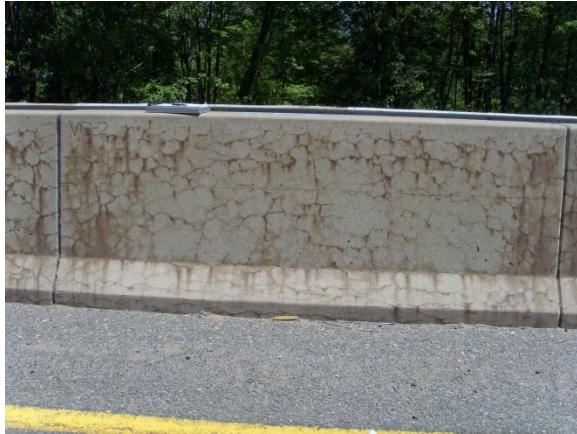
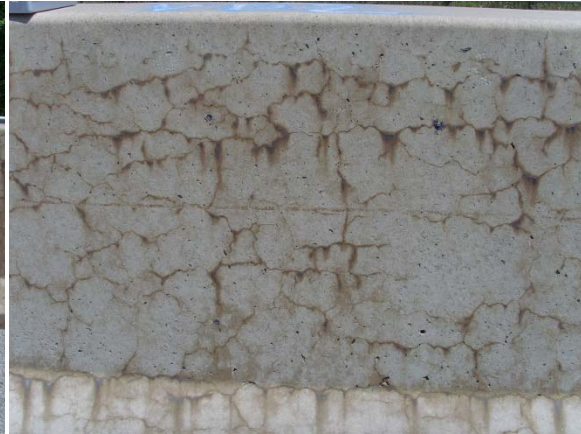
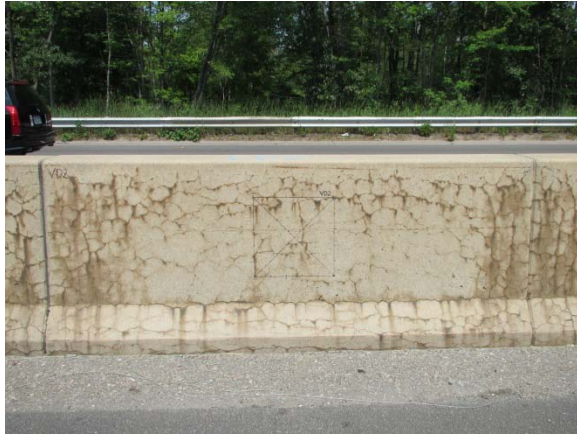
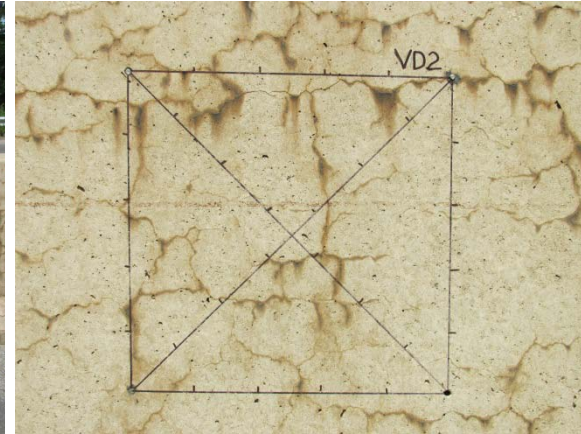
Figure 168. Visual observations over time of section VD2.

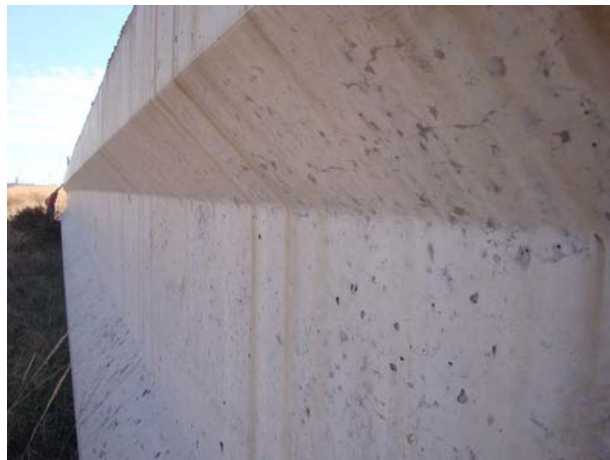
Figure 172. Typical cracking observed on the precast beams.

Table 66 provides information on the four beams selected for treatment and monitoring. Three of the beams chosen consisted of cement-only mixtures and one beam contained 20 percent cement replacement (by mass of total cementitious material) with Class F fly ash. In general, the older beams showed more extensive cracking, as shown in Figure 172, than the younger beams.

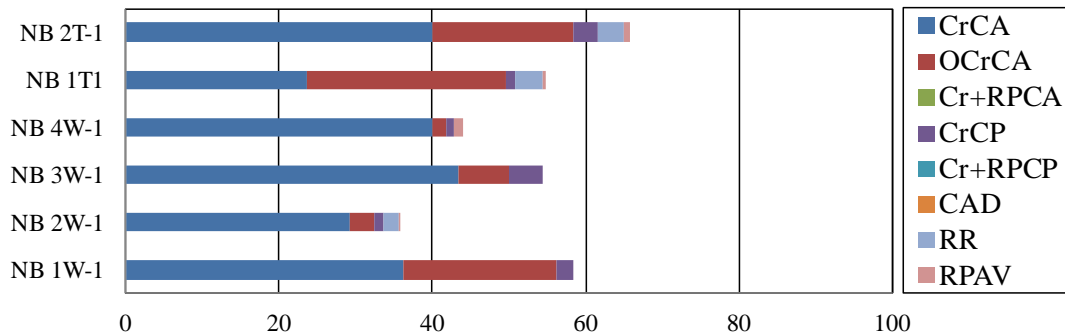
Very low Damage Rating Indices ranging from 36 to 66 were obtained for the New Braunfels cores (Figure 173). Actually, the cores showed no significant signs of ASR or noticeable deterioration. As shown in Figure 174, the petrographic features identified essentially consisted of non-ASR related and very limited internal cracking within some coarse aggregate particles (mainly limestone/dolostone and some chert), a few reaction rims (surrounding some chert particles), and only a few air voids lined with ASR gel (adjacent to chert particles). No cracking was noticed in the cement paste, at least at the magnification used for the test (16x).

Figure 173. Results of the Damage Rating Index (DRI) for the Texas cores. The colored cells give the proportions of each petrographic feature to the DRI value. (CrCA: cracking in the coarse aggregate particles; OCrCa: opened cracking in the coarse aggregate particles; Cr+RPCA: cracking in the coarse aggregate particles + reaction product; CrCP: cracking in the cement paste; Cr+RPCP: cracking in the cement paste + reaction product; CAD: coarse aggregate debonded; RR: reaction rim; RPAV: reaction products in air void of the cement paste).

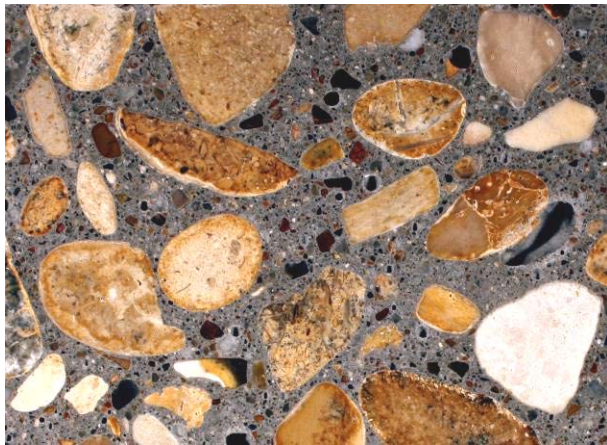
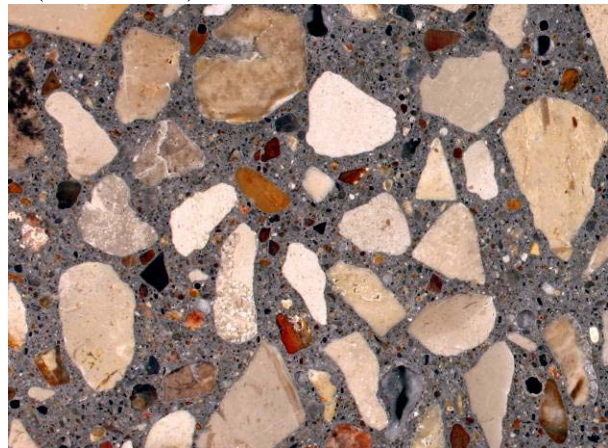
Figure 174. Typical micrographs of the polished core sections showing carbonate (mainly) and chert coarse aggregate particles ($\frac{3}{4}$ inch [2 cm] nominal size) in a dark grey cementitious matrix. There is no visible evidence of cracking both in the aggregate particles (coarse and fine) as well as in the cementitious matrix at the magnification used for the DRI (16x).

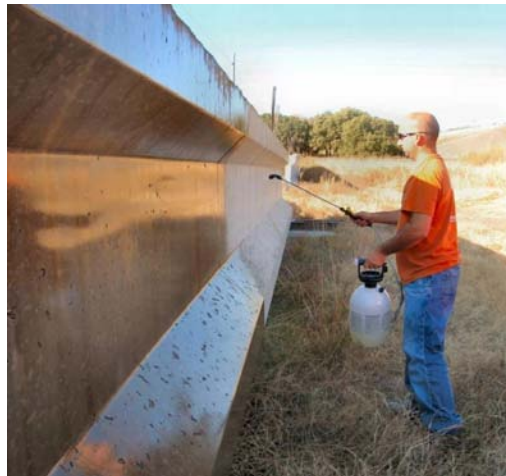
Figure 177. Topical silane application on the precast beams

The beams were then treated in December 2010. Figure 175 and Figure 176 provide details of the treatment and performance monitoring instrumentation. Each of the four beams was divided in half, and half of the beam served as an untreated control while the other half was topically treated with 40 percent silane (alcohol-based). The silane was applied with a handheld pressurized container and spray nozzle, as shown in Figure 177, with a coverage rate of 3.7 m²/L (150 ft²/gal).

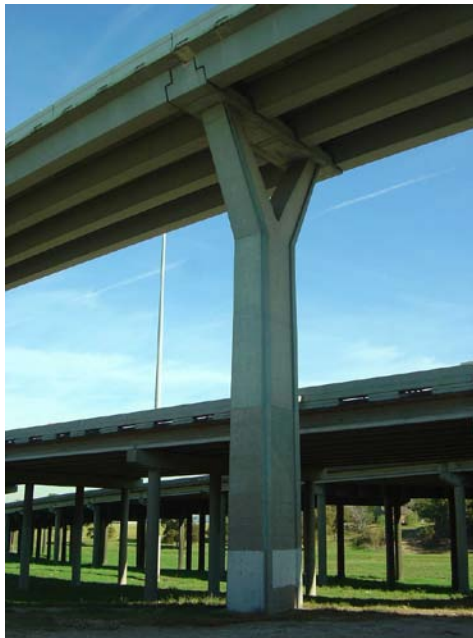
Figure 185. Typical column at Houston, TX test site.

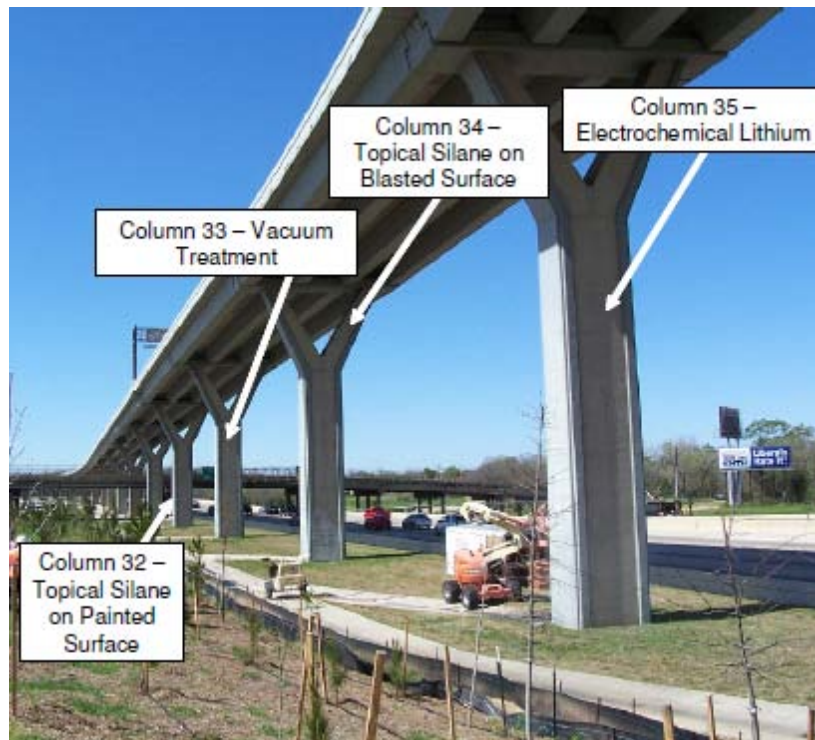
Figure 187. Columns 32-35 in Houston, TX, along with their treatments.

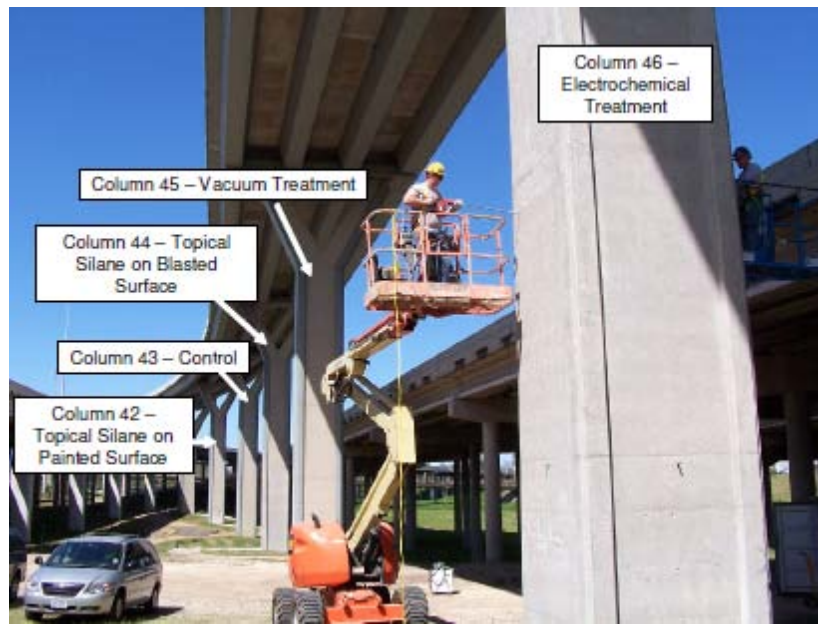
Figure 188. Columns 42-46 in Houston, TX, along with their treatments.

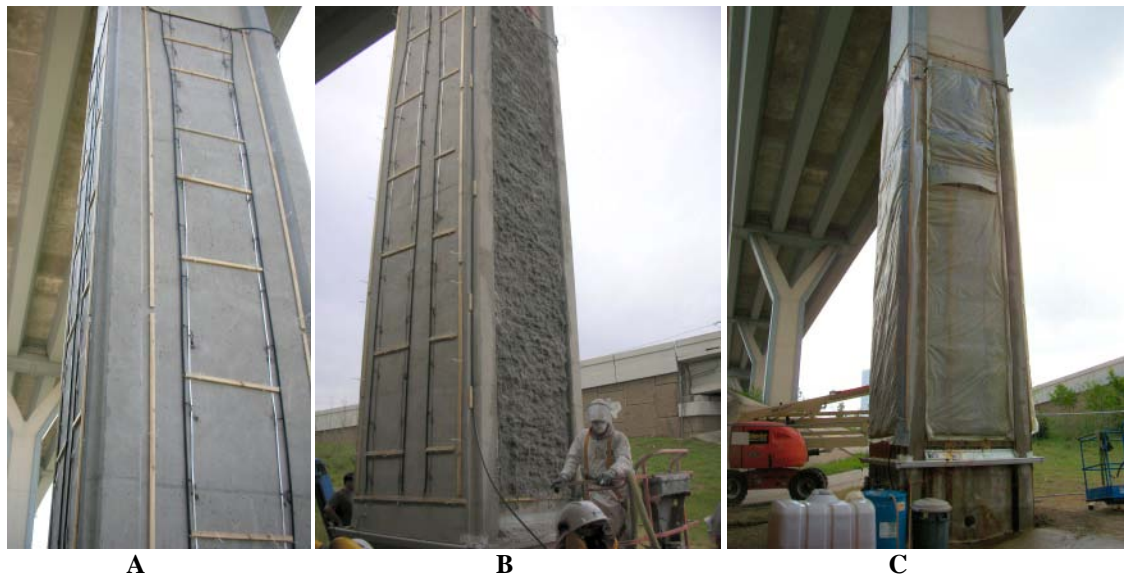
Figure 189. Summary of electrochemical treatment of Houston columns.

A: Irrigation tubes, wood splices, and metal strips are placed on the column. The metal strips are attached to titanium mesh that runs inside holes drilled into the sides of the column. **B:** A cellulose layer is being applied to the side of the column. **C:** Plastic sheeting is placed on all sides of the column. The gutters under the sheeting collect excess lithium to be reused.

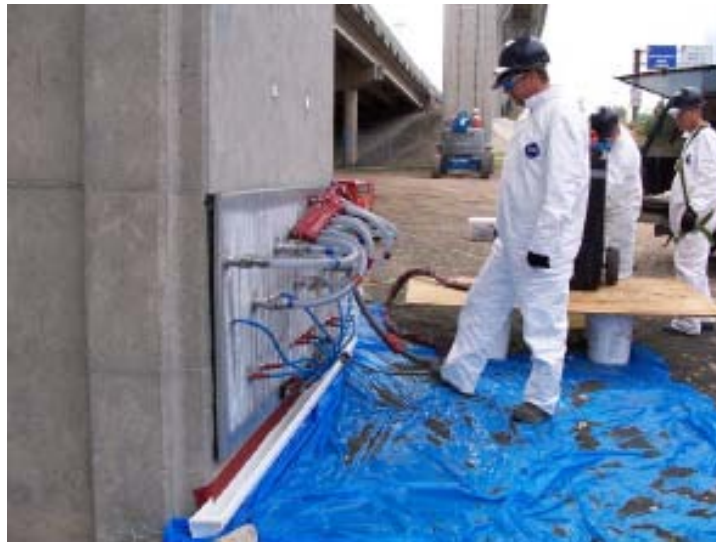
Figure 190. Lithium vacuum treatment on Column 45.

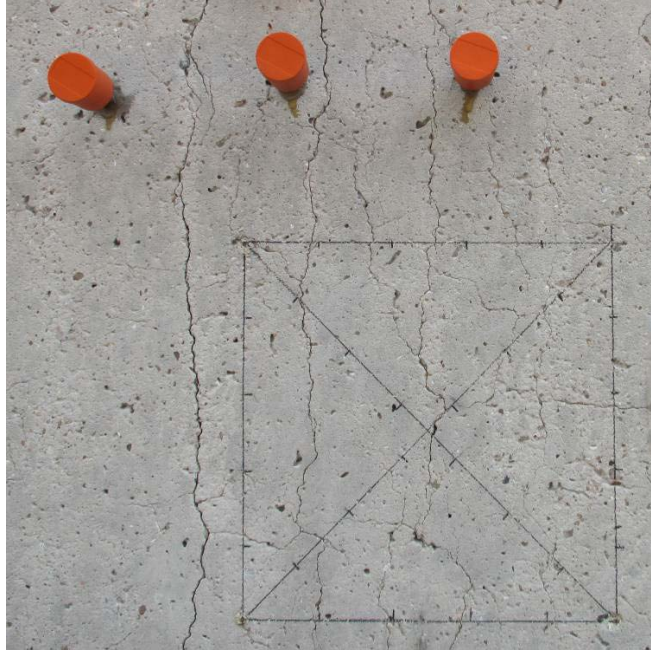
Figure 191. Example of monitoring performed on each column. Relative humidity probes, measuring internal relative humidity values at depths of 25 mm (1 in.), 50 mm (2 in.), and 75 mm (3 in.) from the concrete surface, are shown on the top of the photograph, and the map cracking region is shown at the bottom. Both horizontal and vertical length change measurements are taken using embedded gauge studs at the corners of the map cracking square.

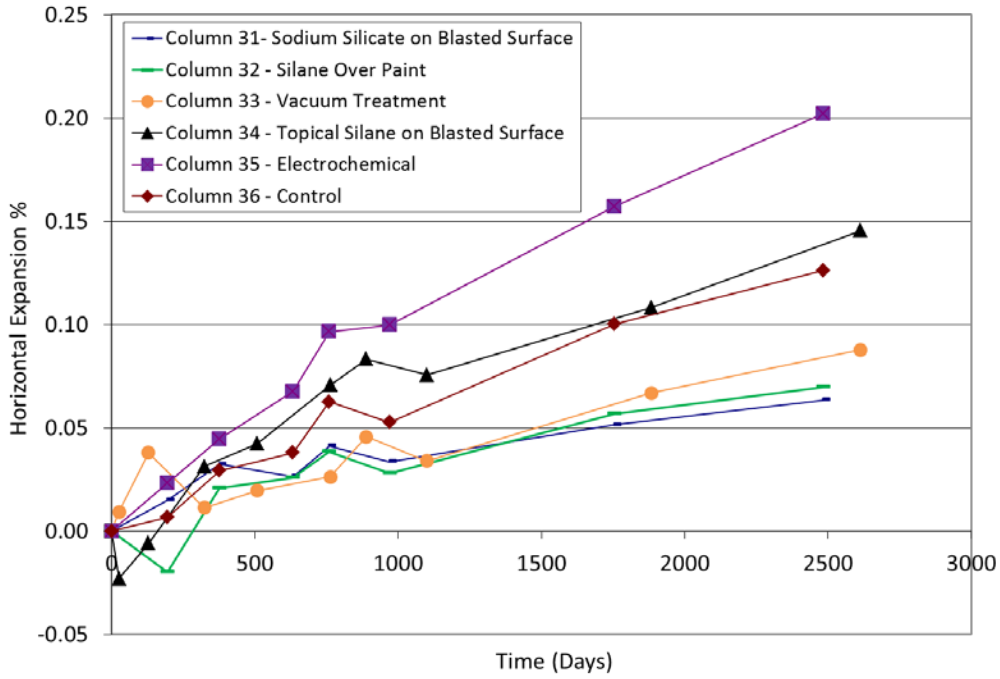
Figure 192. Average expansion of Columns 31-36. (Measurements are average values of horizontal expansions measured on the North and West face of each column.)

The results of expansion measurements taken over a seven year period, as previously shown in Figures 192 and 193, show some significant differences between the various test columns. Columns 31-36, those deemed to be the most distressed prior to treatment, generally showed continued expansion during the monitoring period, ranging from about 0.07 to 0.21 percent expansion, with an average expansion of about 0.12 percent. However, there were some differences in expansion between the various columns, with expansions being the lowest for the columns treated with silane over paint, sodium silicate over a blast surface, and lithium nitrate applied by vacuum impregnation. The average measured expansion was highest for Column 34,

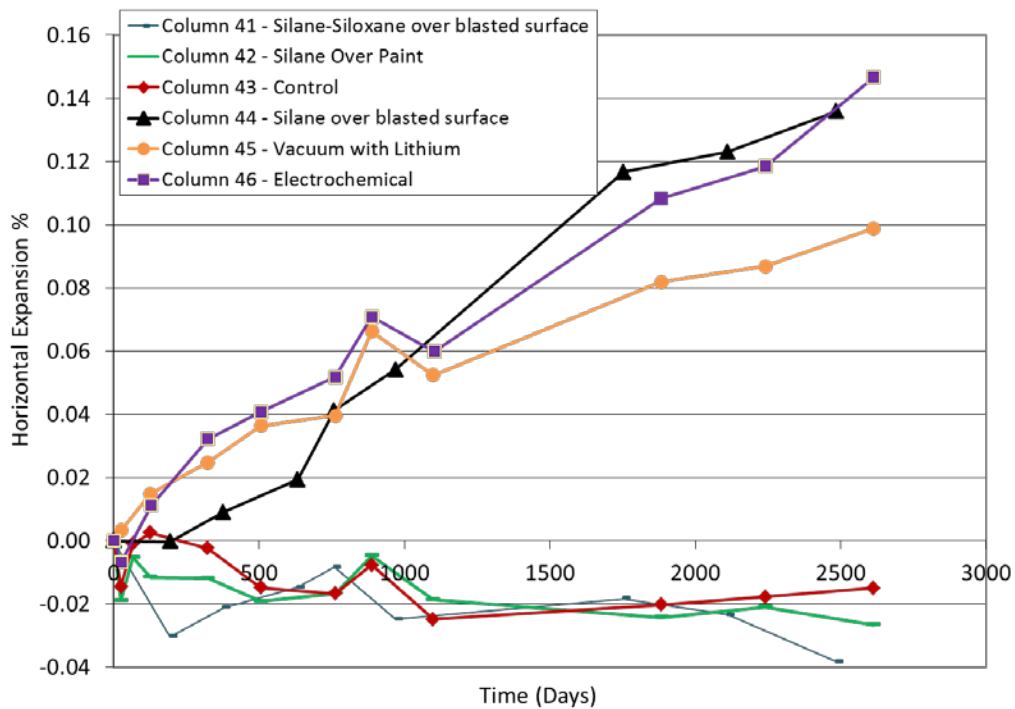
Figure 193. Average expansion of Columns 41-46. (Measurements are average values of horizontal expansions measured on the Southeast and Southwest face of each column.)

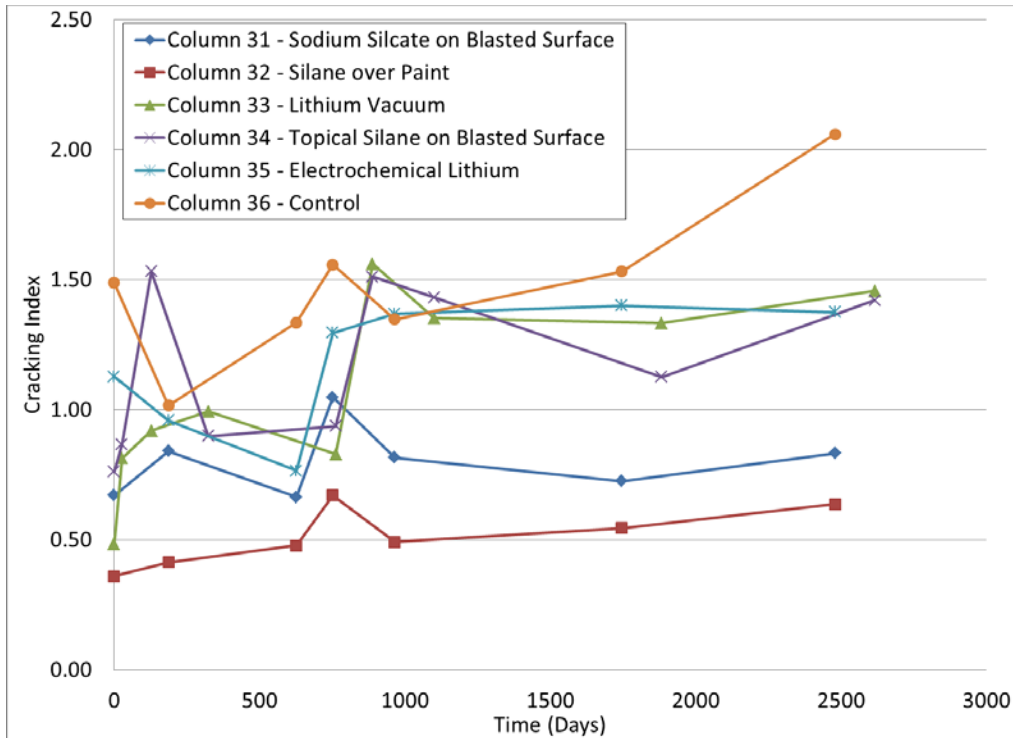
Figure 196. Average calculated Cracking Index (CI) (mm/m) for Columns 31-36. (Calculations are based on the average of CI values obtained from the North and West faces of each column.)

The results of extensive crack mapping, as shown in Figures 196 and 197, tend to follow similar trends as expansion, although there is quite a bit of noise in the data. Crack mapping is quite user sensitive and because this site was monitored over seven years under two different projects, several different individuals performed the measurements. Care was taken in keeping the measurement method consistent from individual to individual. Generally, the columns that expanded the most during the course of the monitoring showed parallel increases in CI values. Further, the three columns from the second set (41-46) that showed no expansion during the monitoring period also showed no increase in cracking in the same period. Some other factors that are worth noting is that crack mapping can be more challenging and variable when evaluating a rough surface, such as that created by paint removal. Also, there was some surface etching due to the electrochemical lithium treatment, and that also made it more difficult to track surface conditions of those columns. Nevertheless, as a whole, crack mapping was found to be a useful tool for tracking the progression of visible cracking. In addition, the crack mapping “square” serves other purposes, such as setting the corners for expansion measurements (both horizontal and vertical) and providing a consistent benchmark for taking photographs. Figures 200 to 223 make use of the cracking mapping regions as the focal point for photographs taken on each day of monitoring.

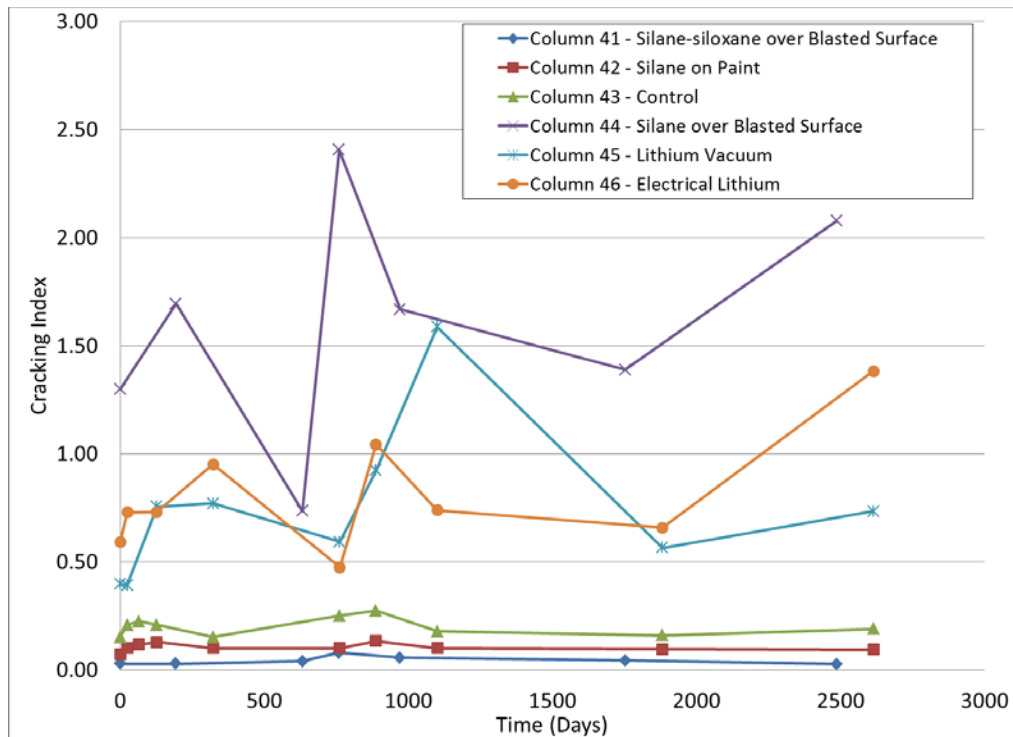
Figure 197. Average calculated Cracking Index (CI) (mm/m) for Columns 41-46. (Calculations are based on the average of CI values obtained from the Southeast and Southwest faces of each column.)

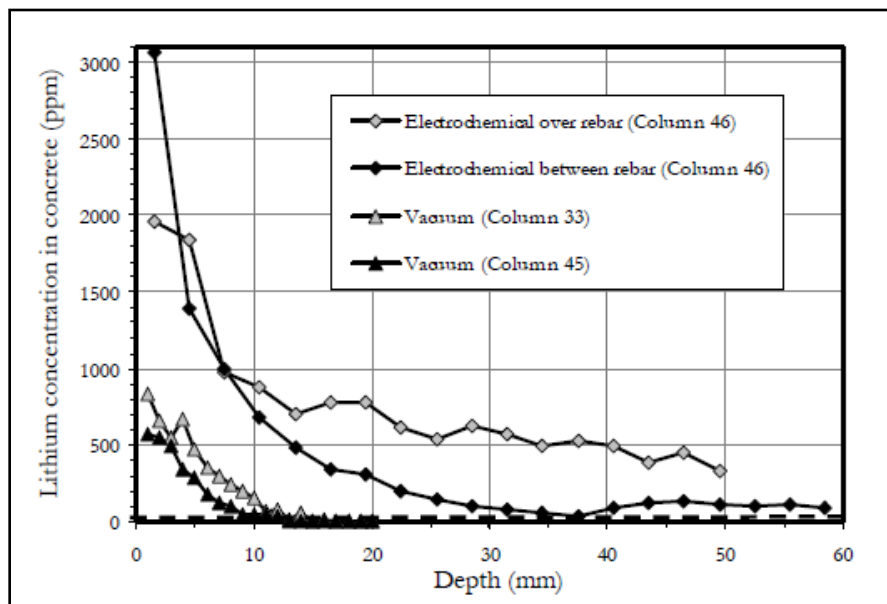
Figure 198 shows the measured lithium profiles for cores extracted from columns to which lithium nitrate was applied electrochemically (Column 46) and through vacuum impregnation (Columns 33 and 45). Profiling was conducted to a depth of 50 mm (2 in.) for cores extracted over reinforcing steel and about 58 mm (2.3 in.) for cores extracted between reinforcing steel. Using the aforementioned 100 ppm lithium concentration threshold, requisite concentrations were measured to a depth of about 8-10 mm (0.3-0.4 in.) from the surface treated with lithium. For the electrochemical treatment, lithium concentrations of about 300 ppm, well above the 100 ppm threshold, were measured to the depth of the reinforcing steel at 50 mm (2 in.). For cores extracted between reinforcing steel, the lithium concentration was found to be at or just above the 100 ppm lithium concentration down to the depth of the deepest measurement.

Figure 198. Lithium concentration profile measured in cores after electrochemical (Column 46) or vacuum impregnation (Columns 33 and 45).

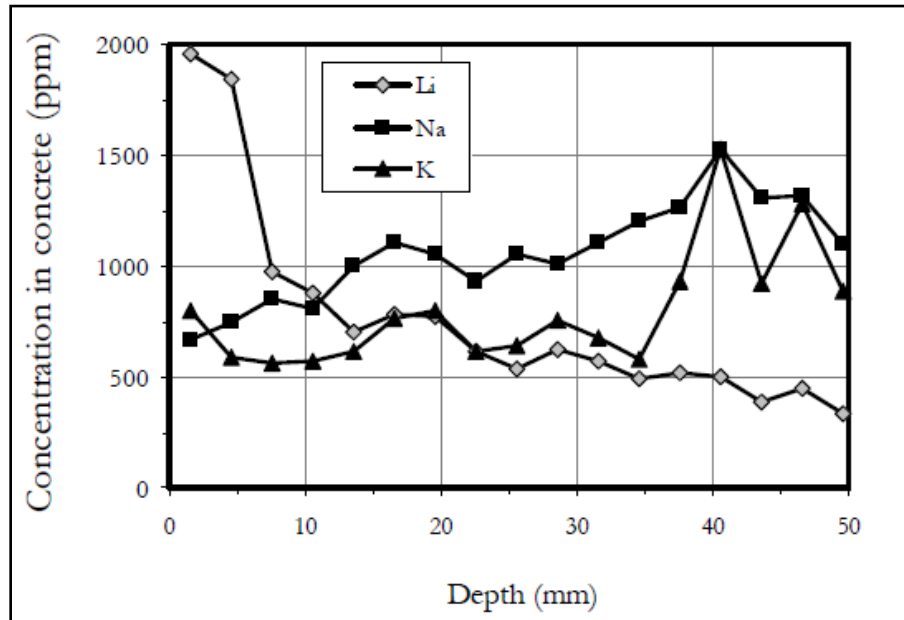
Figure 199 shows the results of additional analyses performed on the core extracted over the reinforcing steel in Column 46. In addition to measuring the lithium concentration (previously shown in Figure 198), the sodium and potassium concentrations were also measured. The data show that sodium and potassium concentrations were found to be elevated in the region closest

Figure 199. Lithium, sodium, and potassium concentration profiles for core extracted over reinforcing steel in Column 46 after electrochemical lithium treatment.

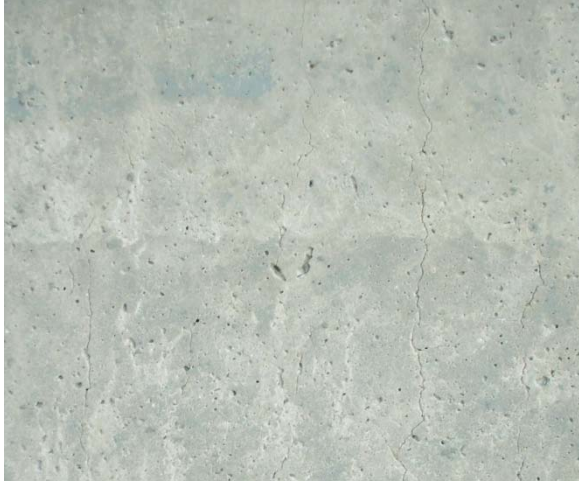
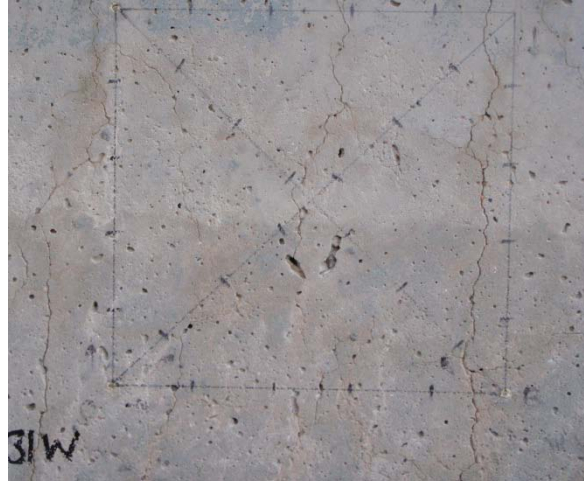
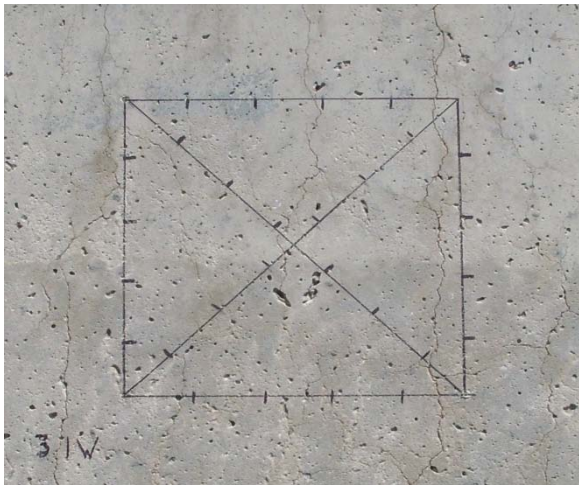
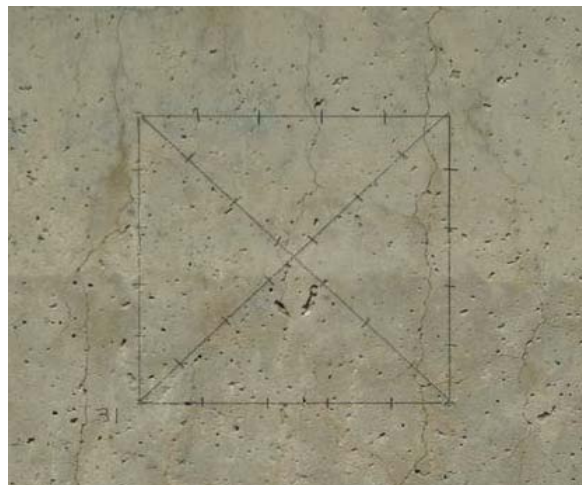
Figure 200. Visual observation of Column 31 West face.

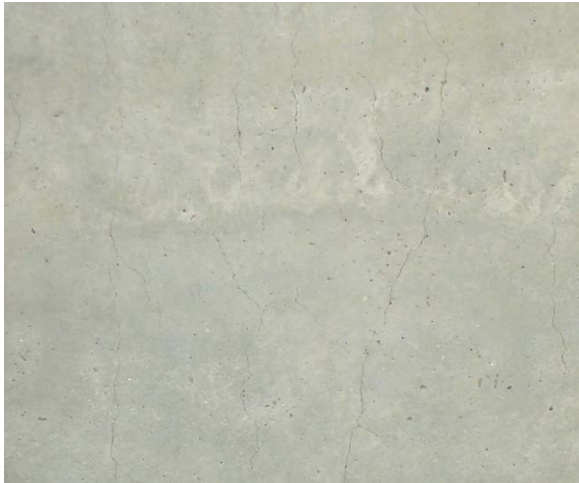
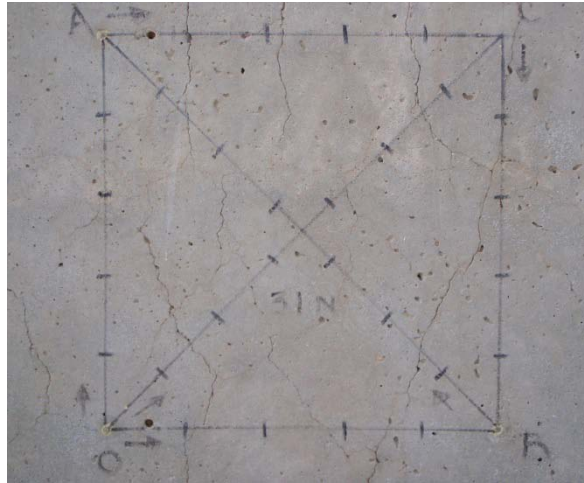
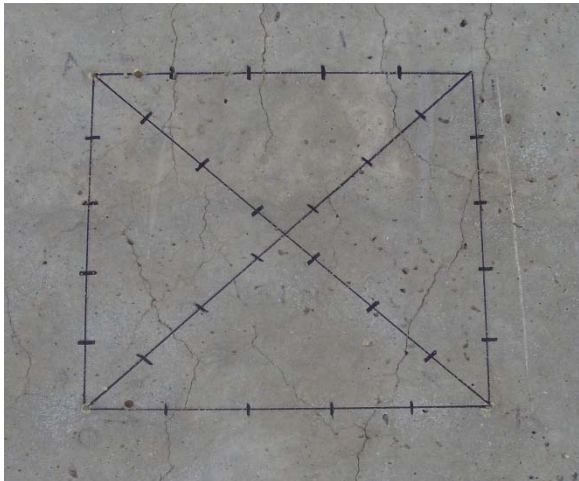
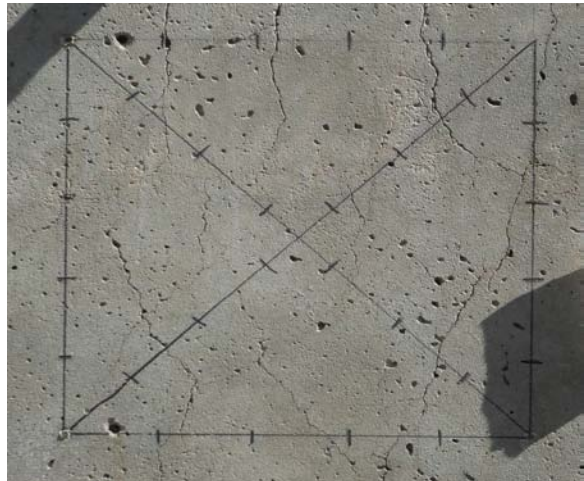
Figure 201. Visual observation of Column 31 North face.

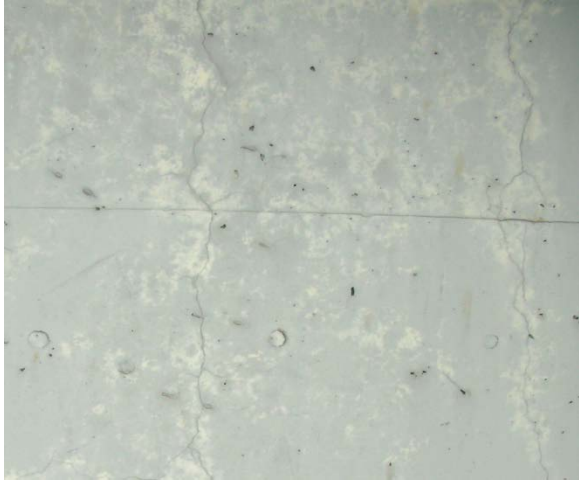
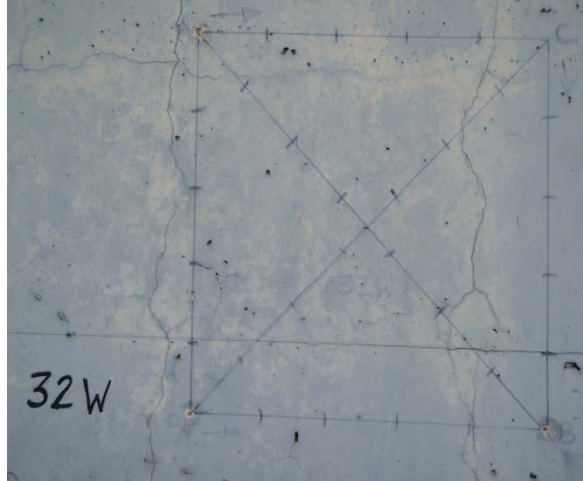
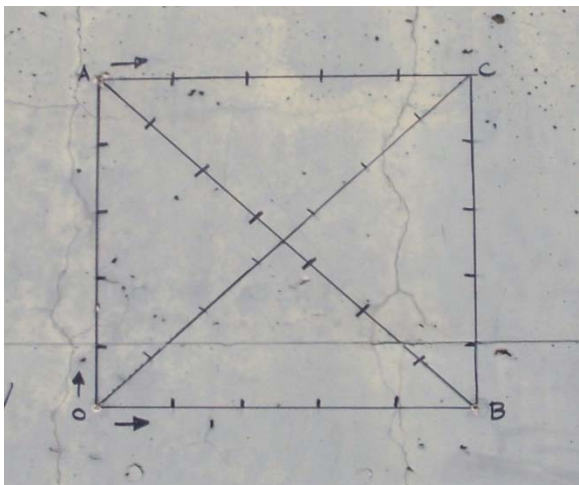
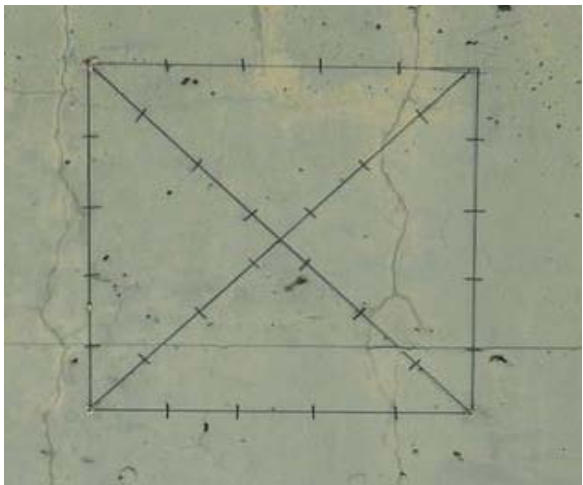
Figure 202. Visual observation of Column 32 West face.

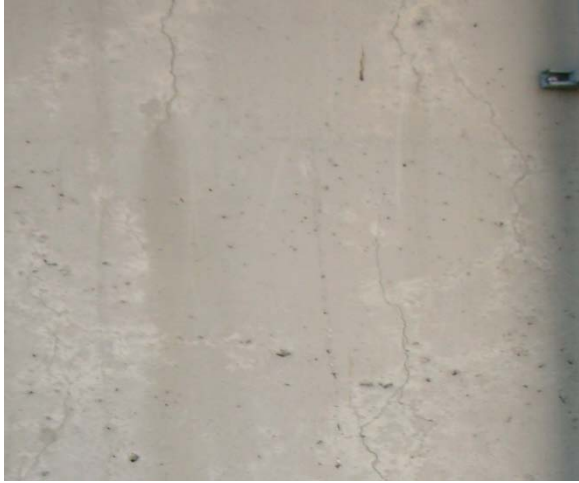
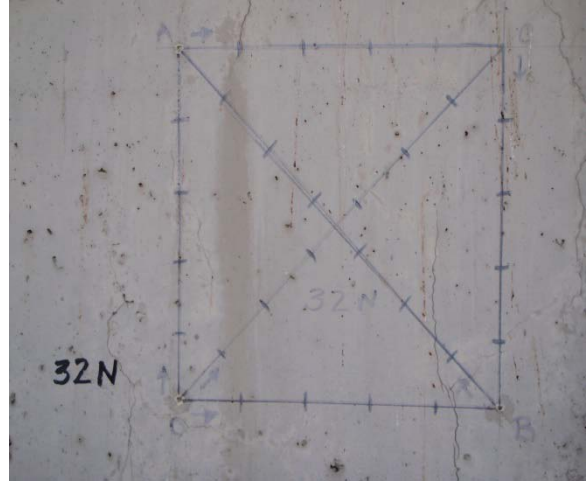
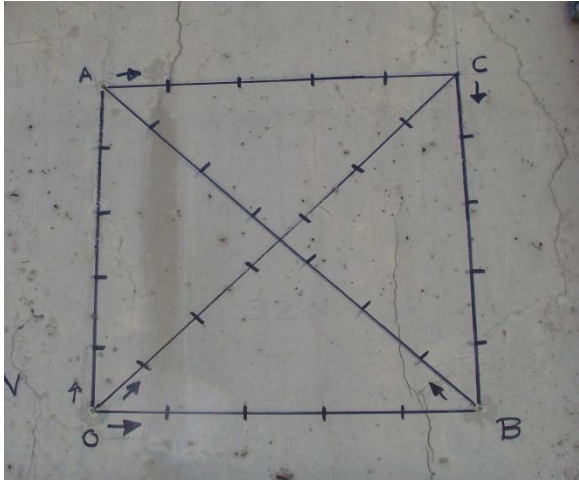
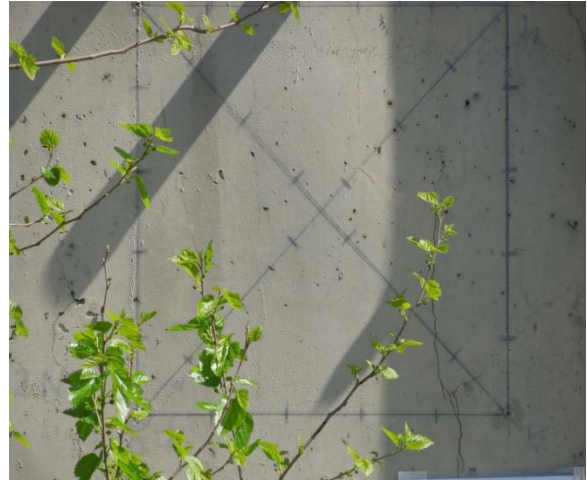
Figure 203. Visual observation of Column 32 North face.

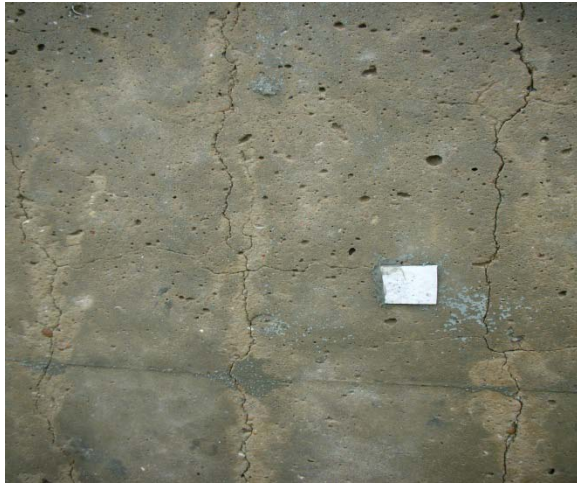
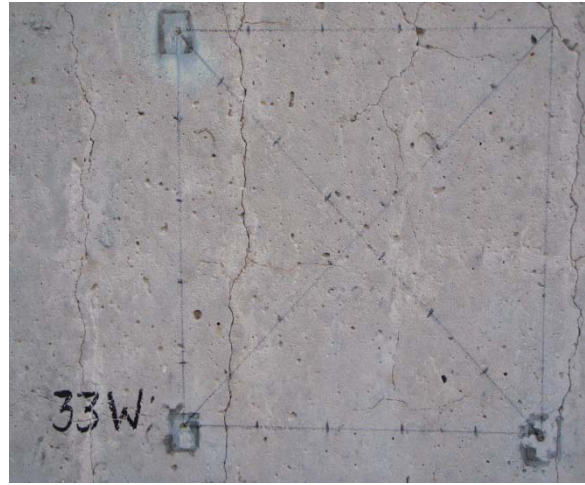
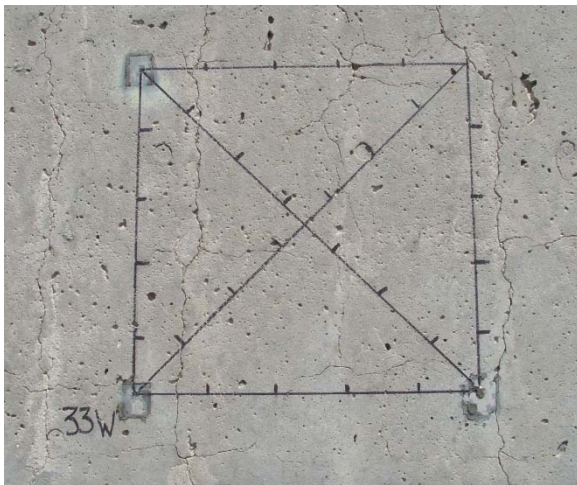
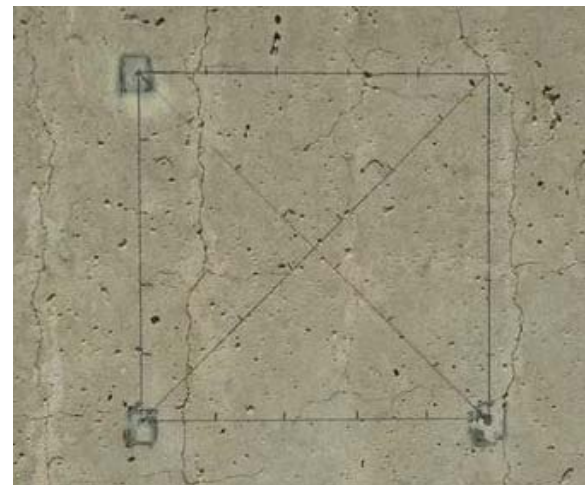
Figure 204. Visual observation of Column 33 West face.

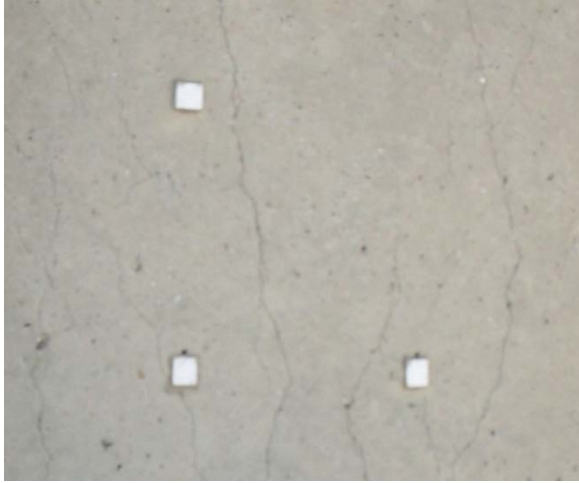
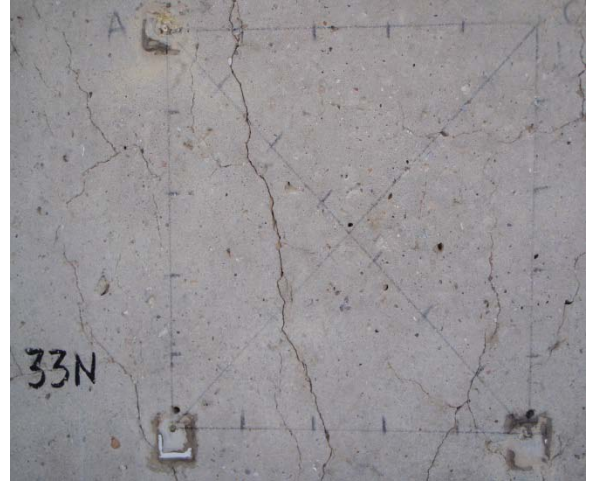
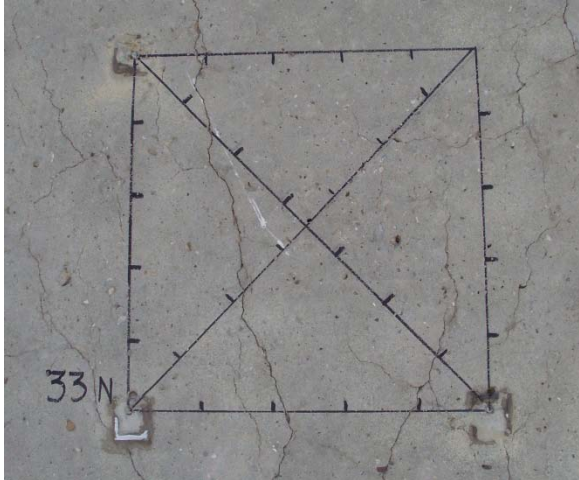
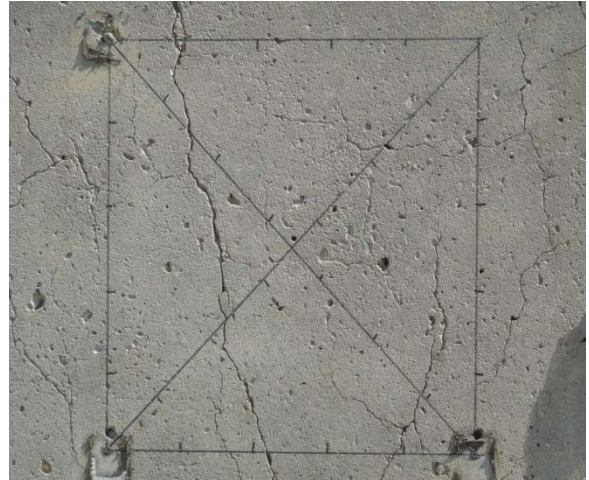
Figure 205. Visual observation of Column 33 North face.

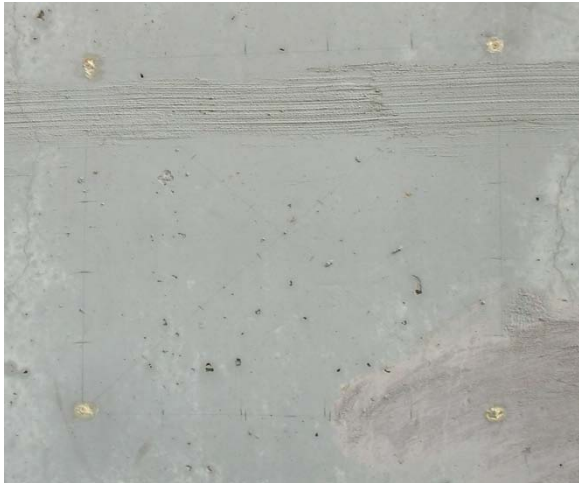
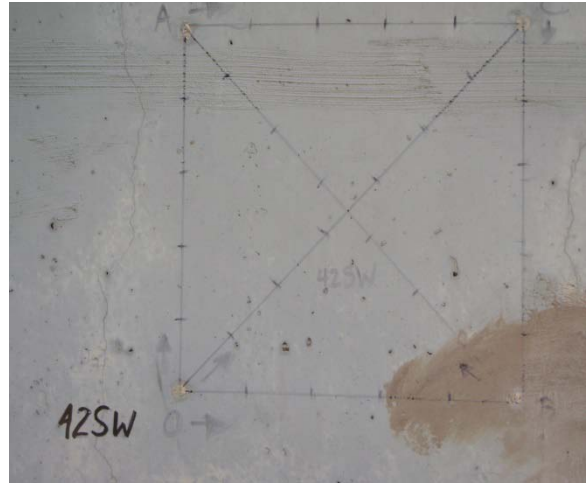
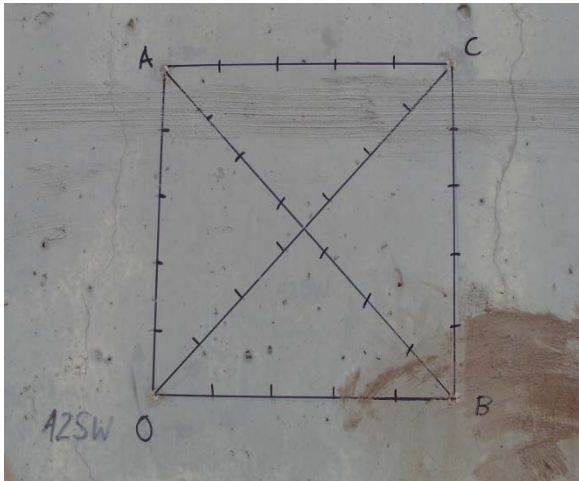
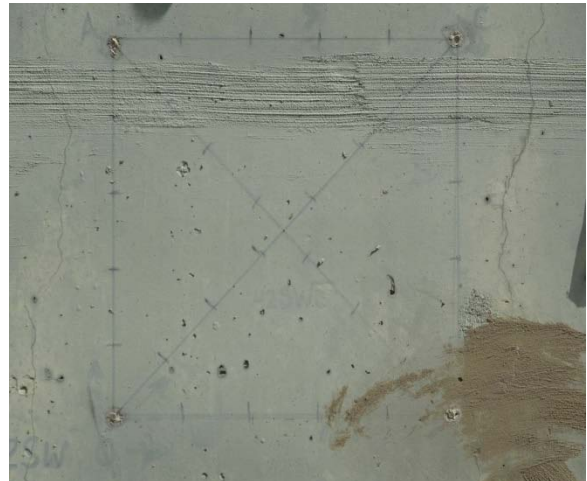
Figure 214. Visual observation of Column 42 Southwest face.

What is most interesting and difficult to explain is that Column 42, the untreated control in the mild to moderate distress set, did not expand at all during the monitoring period. For reference, the other control column (Column 36) from the more distressed column set expanded about 0.12 percent during the same period. The reasons for the difference in behavior between the two control columns is not known, but conceivably, differences in materials, mixture proportions, construction methods, and exposure conditions may have led to this vastly different behavior. More discussion on some of these potential parameters, especially materials and mixture proportions, is provided later in this section.

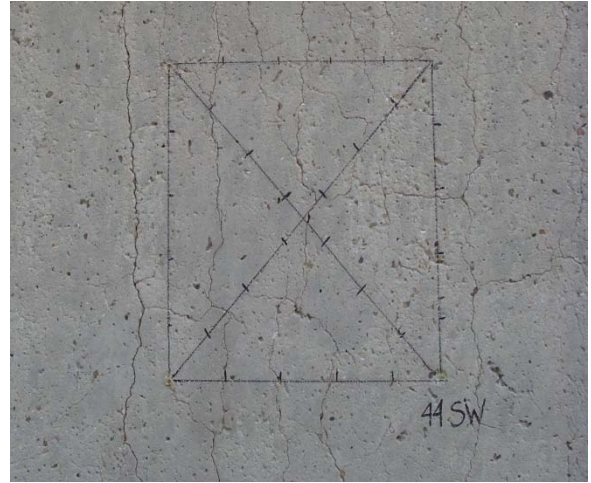
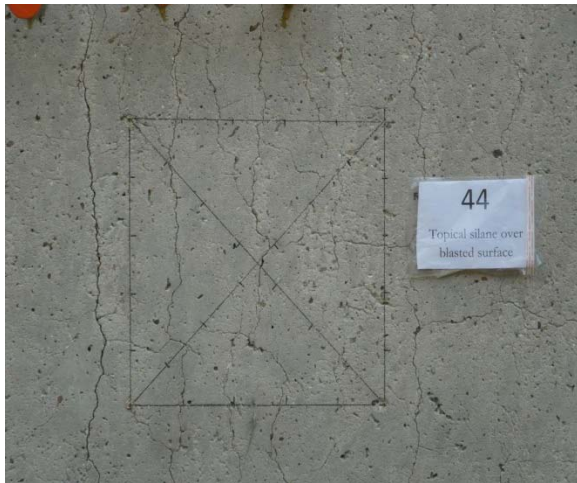
B – Column 44 SW Face 2011

Figure 218. Visual observation of Column 44 Southwest face.

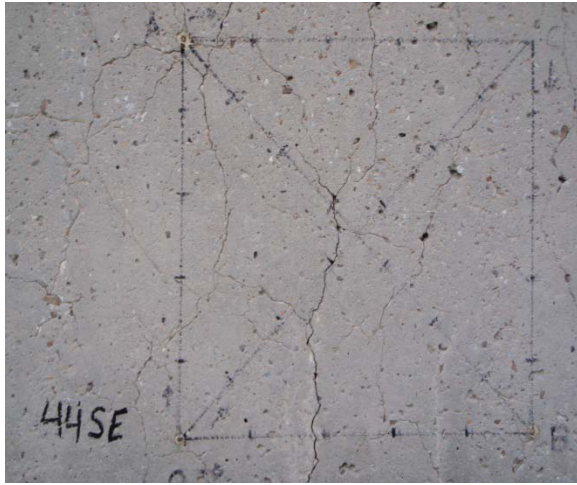
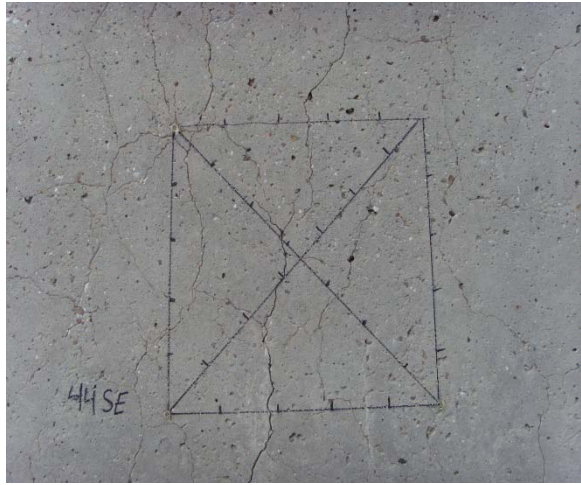
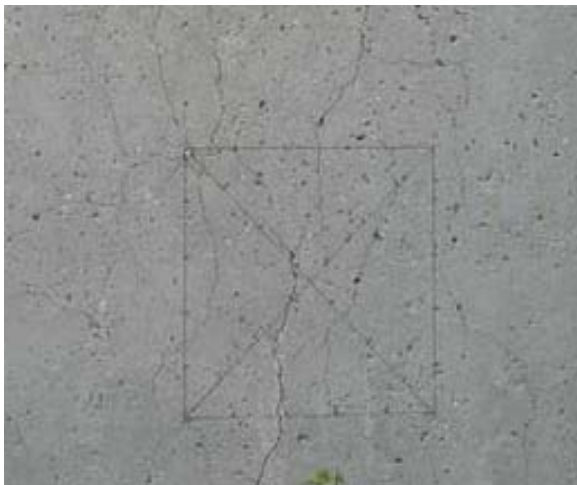
A – Column 44 SE Face 2009

Figure 219. Visual observation of Column 44 Southeast face.

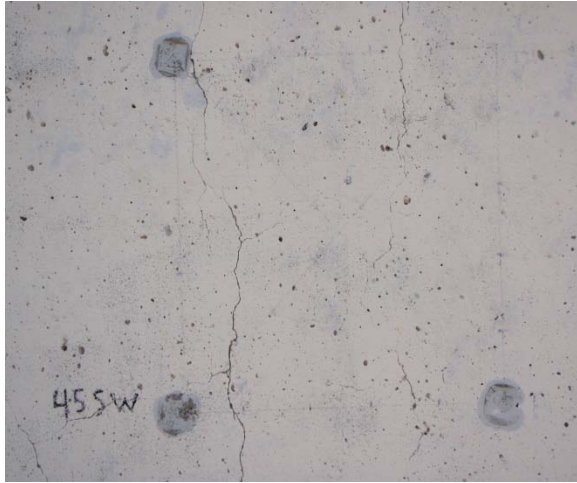
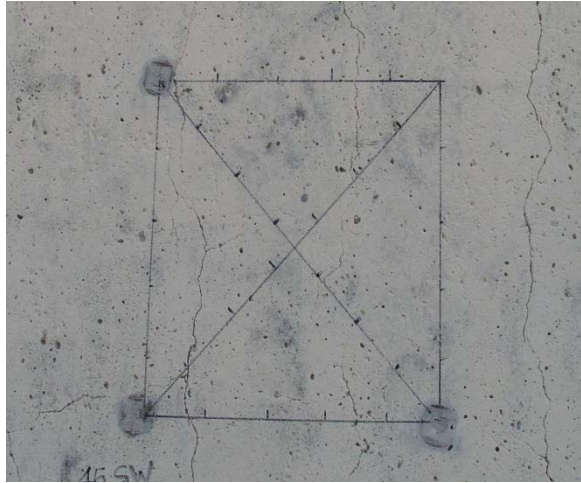
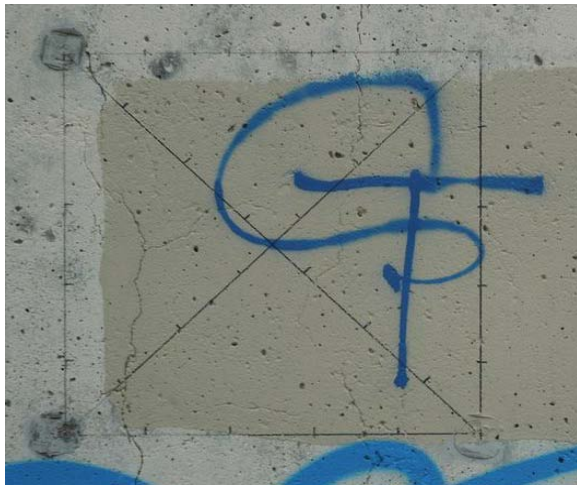
A – Column 45 SW Face 2009

Figure 220. Visual observation of Column 45 Southwest face.
