Methods for Evaluating and Treating ASR-Affected Structures: Results of Field Application and Demonstration Projects

Volume II: Details of Field Applications and Analysis

Final Report

U.S. Department of Transportation
Federal Highway Administration

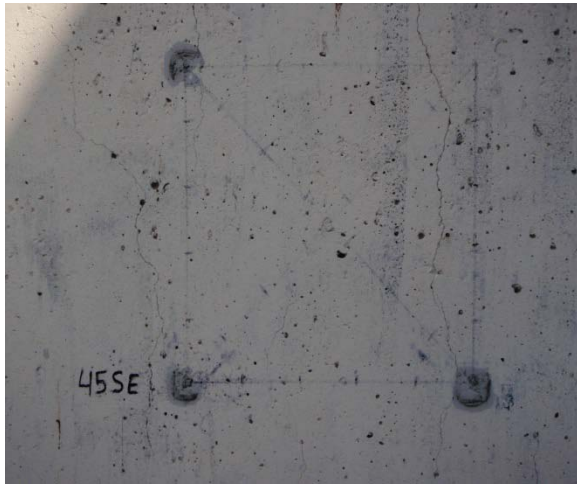
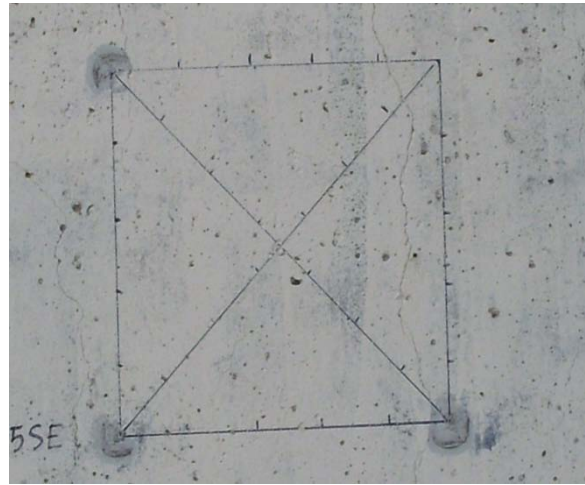
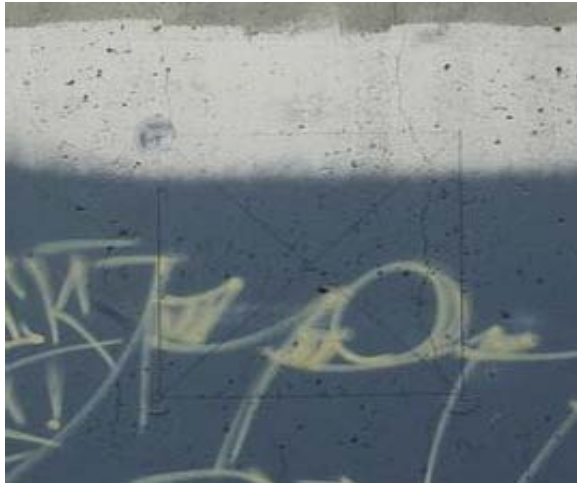
A – Column 45 SE Face 2009

Figure 221. Visual observation of Column 45 Southeast face.

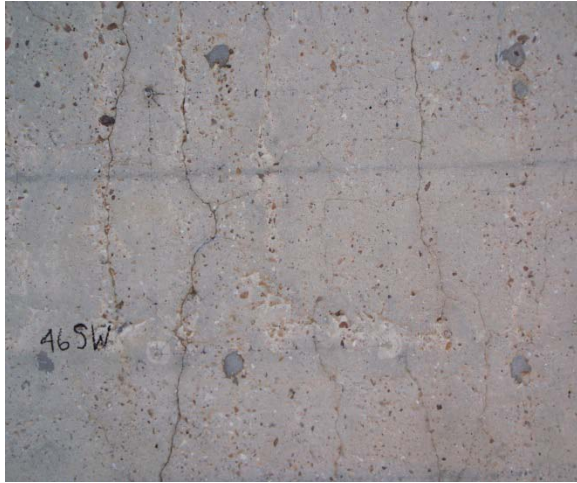
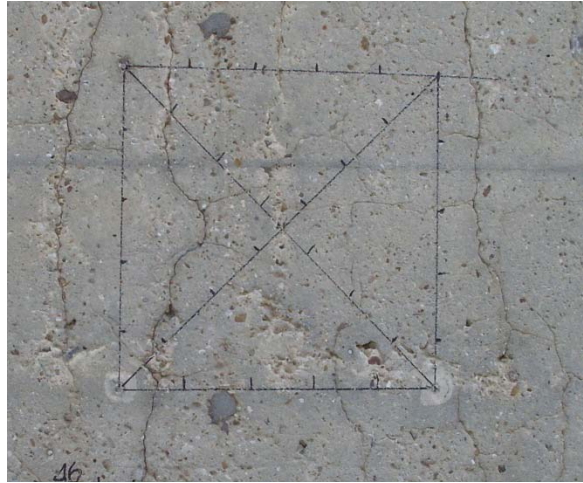
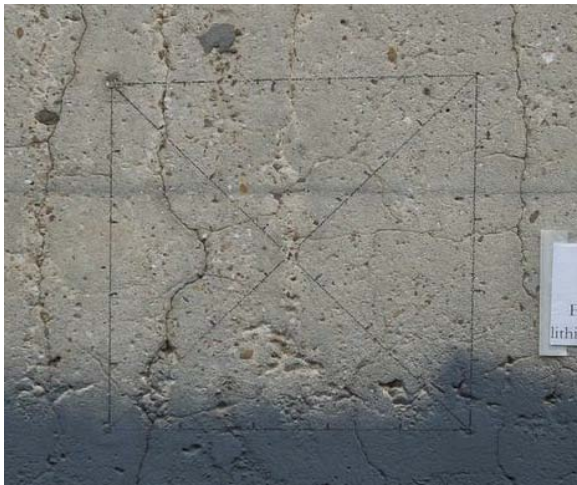
A – Column 46 SW Face 2009

Figure 222. Visual observation of Column 46 Southwest face.

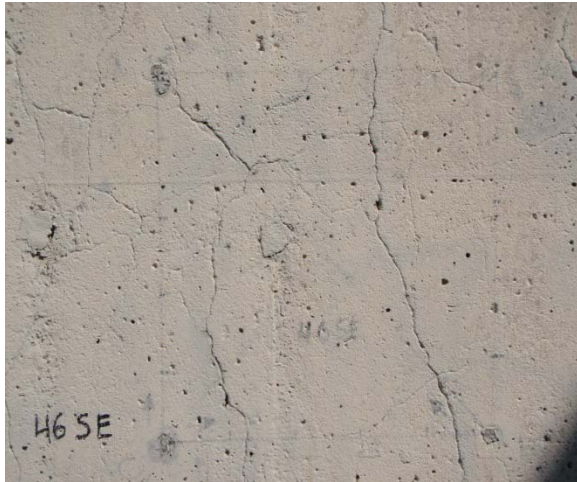
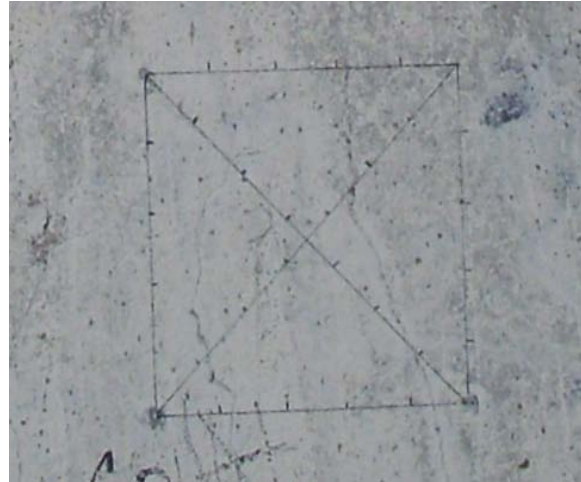
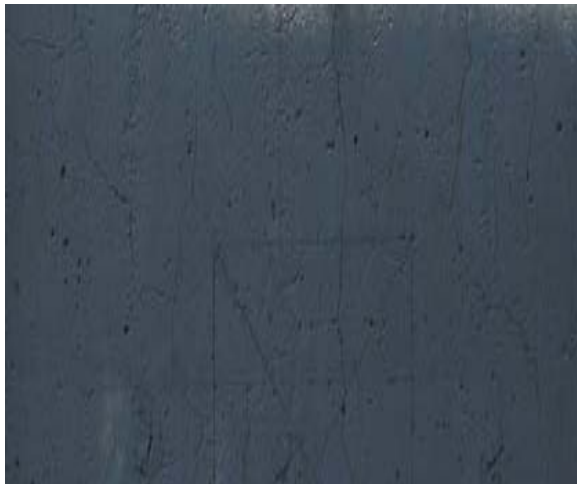
A – Column 46 SE Face 2009

Figure 223. Visual observation of Column 46 Southeast face.

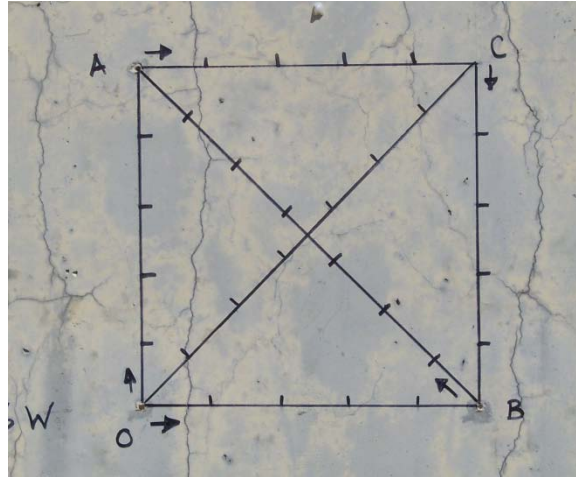
Figure 224 shows a photograph of the West face of Column 36. The larger vertical cracks could be caused by early-age thermal cracking as evidence of such cracking has been observed in bridges cast at the same time in the same general region of Texas. Once the thermal cracking occurs, water more easily can penetrate the columns, which can help promote ASR. This column is typical in that larger vertical cracks are visible, with branching or even map cracking emanating from the vertical cracks. A characteristic “buff” color can be observed around the cracks, which is typically associated with ASR-induced damage, and staining is evident.

Although it cannot be stated with a degree of certainty, it is possible that some of the test columns have been affected by thermal cracking, followed by cracking caused by ASR. This may also help to explain why some columns have performed differently from others. For example, Columns 41-43 showed no expansion or active cracking during the course of the monitoring period. It could be possible that these columns were less susceptible to thermal cracking, perhaps due to the use of fly ash or due to changes in ambient conditions while these three columns were cast. Following this line of thought, ASR may be much slower or not yet active in these columns as they were not exposed to the increased moisture ingress caused by more extensive thermal cracking that may have occurred in other columns.

Figure 224. Extensive cracking evident on the West face of Column 36, possibly caused by early-age thermal cracking, followed by ASR.

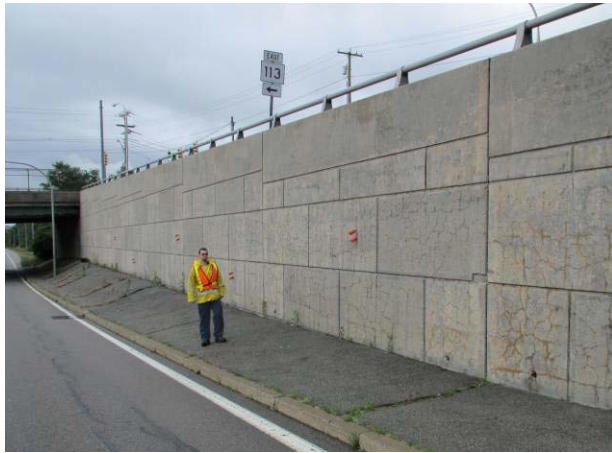
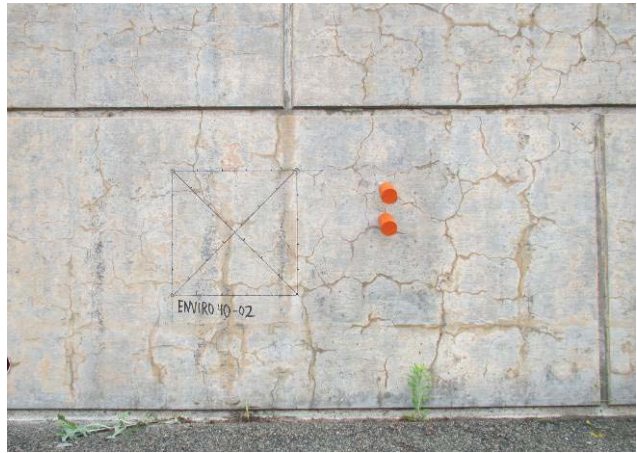
The retaining wall is located adjacent to the southbound lane of traffic north of the Post Road Extension/Post Road and Main Avenue intersection. The structure shows a large scale map cracking pattern of overall moderate severity (see Figure 226A and Figure 226B). The barrier walls are located south of the same intersection (see Figure 226C and Figure 226D). The walls show severe longitudinal cracking in the chamfered base, and a light to moderate map cracking pattern in the upper part. The bridge abutment walls are at the intersection of Post Road and Airport Connector Road. The sections of the abutment walls sheltered from direct exposure to rain and sun show very limited visible cracking, while the exposed portions of the abutments and the wing walls show moderate map cracking (see Figure 226E and Figure 226F).

A: General view of the retaining wall on Post Road (southbound). B: Typical (moderate) map cracking affecting the wall. C: General view of the barrier walls on Post Road (southbound). D: Typical longitudinal cracking in the chamfered base of the barrier walls. E: General view of the bridge structure on Post Road (southbound view). F: Moderate cracking and localized exudations affecting the abutment and wing walls of the bridge.

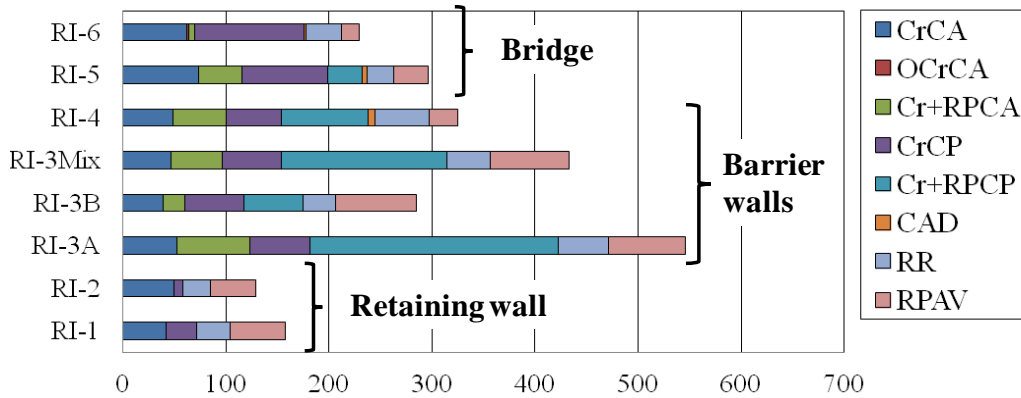
Overall, cores RI-1/RI-2 (retaining wall; DRIs of 129 and 157) and RI-5/RI-6 (bridge; DRIs of 230 and 296) showed low to mild degree of deterioration/ASR-related damage. On the other hand, cores RI-3 and RI-4 (barrier walls; DRIs ranging from 285 to 546) showed moderate to high degree of deterioration/ASR-related damage (see Figure 227); aggregate particles in those cores show a wide variety of petrographic compositions (quartzite, granitic gneiss, sandstone). The highest contributors to the DRI for this set of cores are *Cracks in the cement paste with or without reaction product (CrCP – Cr+RPCP)*, *Cracks in the aggregate particles (CrCA)*, and *Air voids filled with reaction product (RPAV)* (see Figure 228). Silica gel was observed in this set of cores, mostly in cracks in the cement paste but also in aggregate particles and filling cement paste air voids.

In summary, the petrographic evaluation confirmed the presence of ASR in all structures that were cored. The extent of ASR and associated damage was found to range from low to moderate, a significant variation in the damage being observed from one location to another, as well as a function of the exposure conditions of the structural element examined.

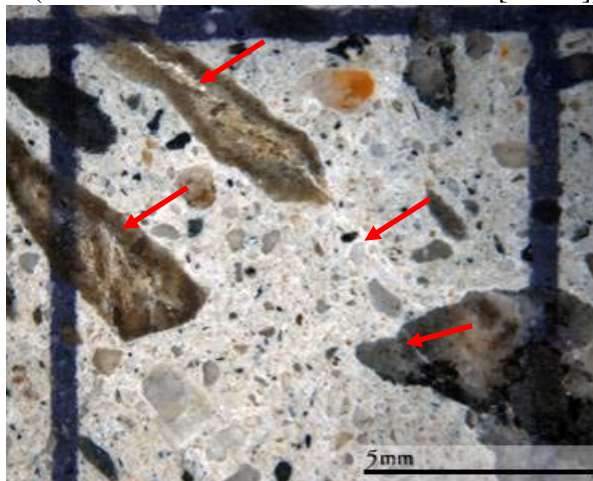
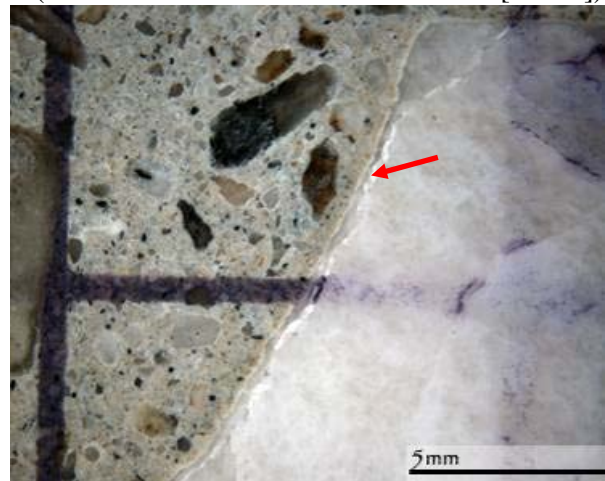
Figure 228. Polished concrete surfaces (cores extracted from the barrier walls along Post Road near Providence (Warwick), RI).

A&B: Cracking in coarse aggregate particles extending into the cement paste; secondary (ASR) products are observed in the cracks both in the particles and the cement paste. Dark reaction rims are observed surrounding the reactive aggregate particles.

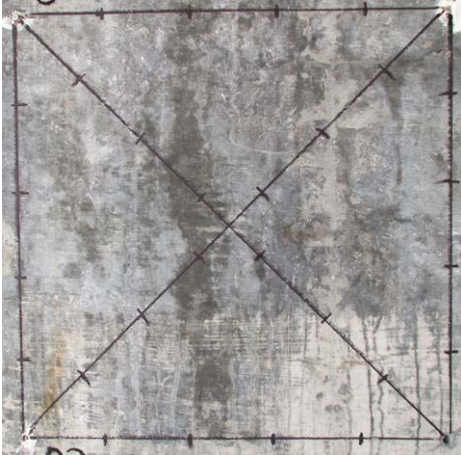
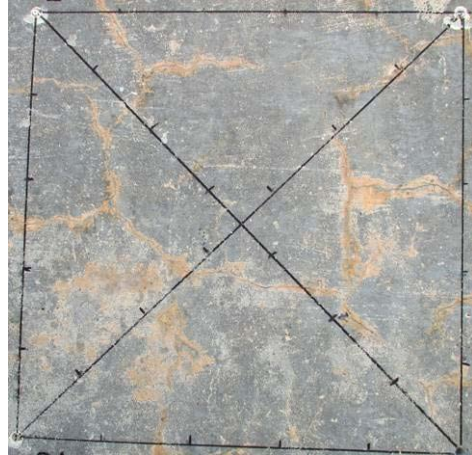
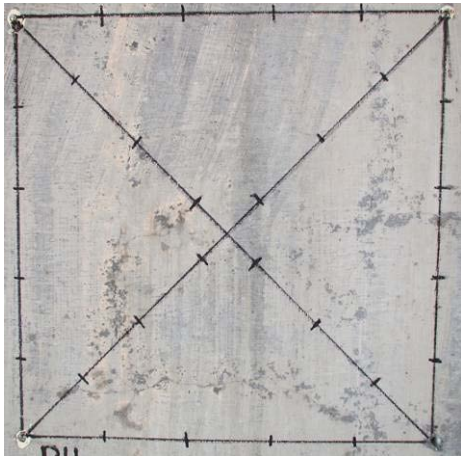
Figure 233. Examples of crack map sections for exposed and non-exposed sections of the bridge abutment walls.

No significant differences/progression in the CI values were observed for individual monitoring sites over the one-year monitoring period completed in the case of the abutment walls and barrier walls; this can be noted in Figure 234 to Figure 236 that illustrate the condition, as a function of time (2012 – 2013), of sections that were subjected to various treatments.

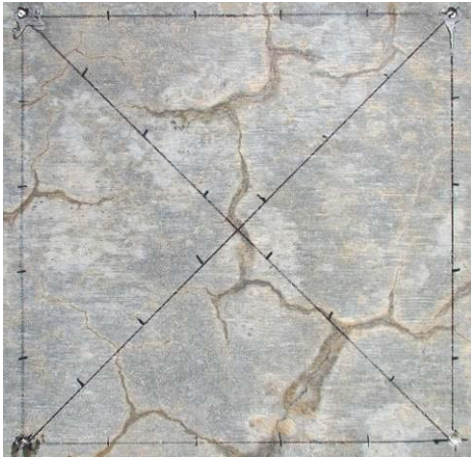
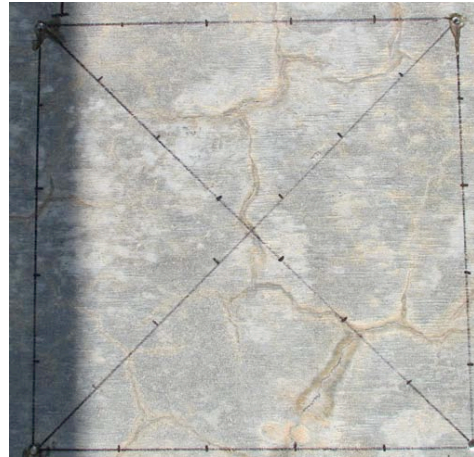
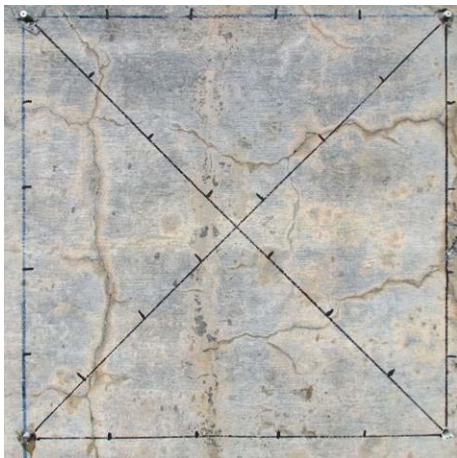
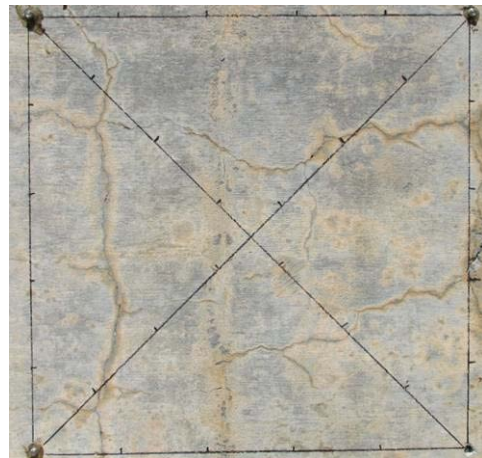
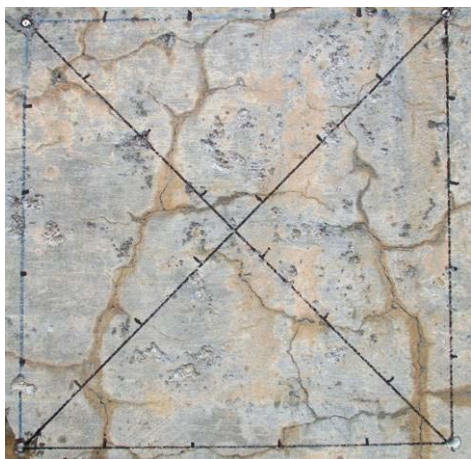
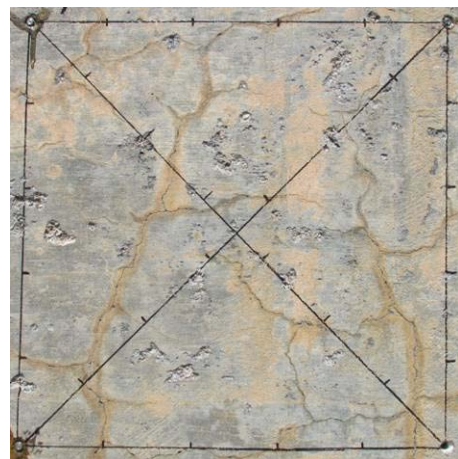
Figure 235. Examples of crack map sections before (2012) and after (2013) treatments (retaining wall).

Significant drops in CI values were however observed from the initial measurement (June 2012) and the following readings (i.e., October 2012 and June 2013) in the case of the retaining wall sections. The exact reason for this behavior is currently unknown; it could perhaps be related to the effect of exposure conditions on this particular structure. This behavior will be further investigated.

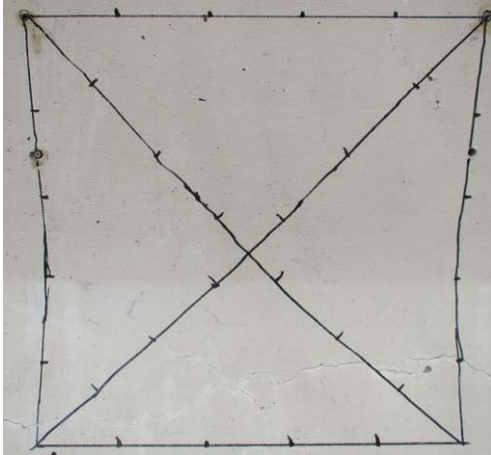
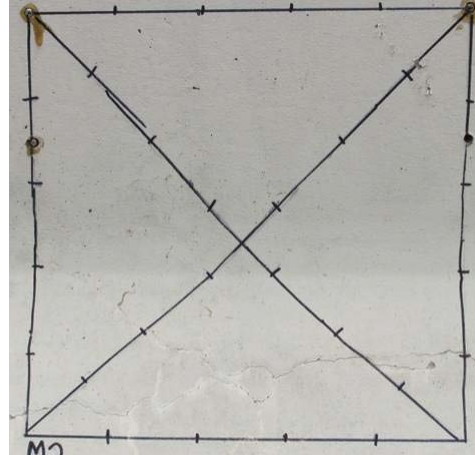
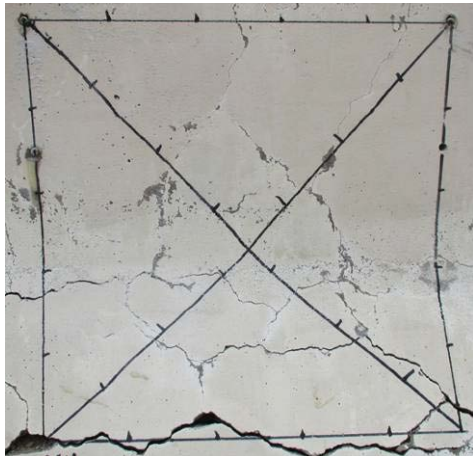
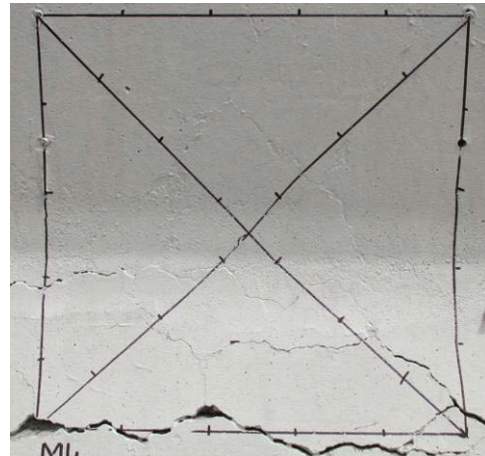
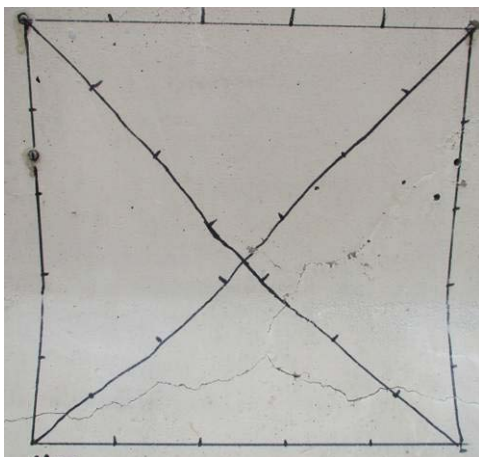
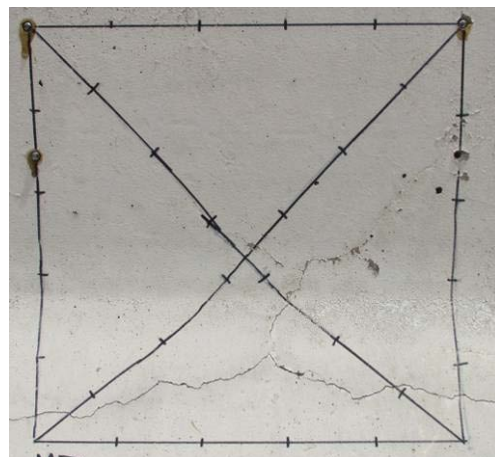
Figure 236. Examples of crack map sections before and after treatments (barrier walls).

It is to be noted that in the case of the sections treated with the elastomeric paint, CI values of "0" were obtained for the measurements carried out following the application of the coating since the product was efficient in bridging the cracks present in the different concrete members.

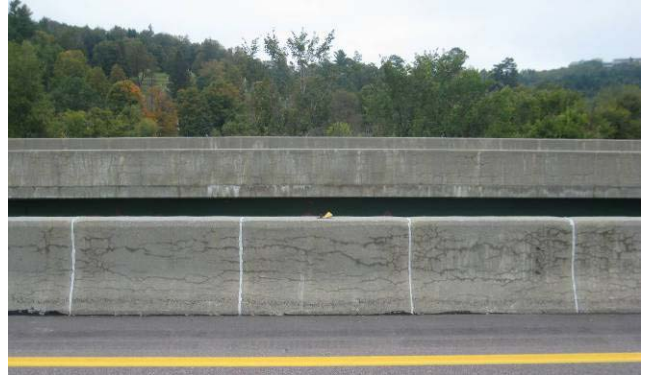
**D**

The barrier walls display a mixture of map and aligned (longitudinal) cracking with severity ratings ranging from mild to severe (see Figure 238D). During this visit, six cores were taken from different sections of the parapet walls for petrographic examination. Figure 238E and Figure 238F illustrate coring sites showing a moderate-to-severe and mild degree of damage, respectively.

A&B: General views of the I-89 twin bridges over U.S. 2/State St. (A) and Dog River (B) near Montpelier, VT. C: Driving and passing lanes of the southbound bridge. D: General view of barrier walls showing longitudinal and map cracking patterns. E: Section of barrier wall for concrete core S2 showing a moderate degree of deterioration. F: Section of barrier wall for concrete core S1 showing a mild degree of deterioration.

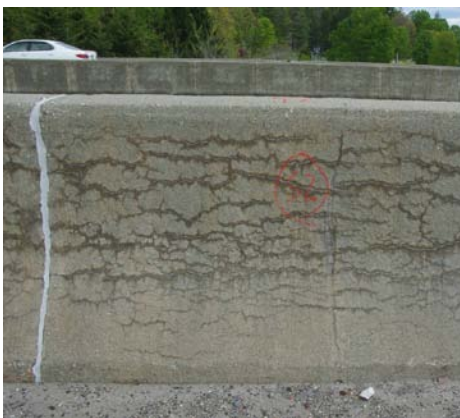
**E**

Cores N1 to N3 and S1 were characterized by low to very low degree of deterioration/damage due to ASR (DRIs ranging from 53 to 202). On the other hand, cores S2 and S3 showed moderate to severe degree of deterioration due to ASR (DRIs of 647 and 568, respectively) (Figure 239). For all cores examined, the coarse aggregate consists of a greyish granitic rock that showed no/limited evidence of alkali-reactivity. On the other hand, the sand, which is composed of different rock types (e.g. schist, microquartzite, sandstone, argillite, and other undifferentiated magmatic rocks) showed low to moderate degree of ASR in cores N2, S2, and S3.

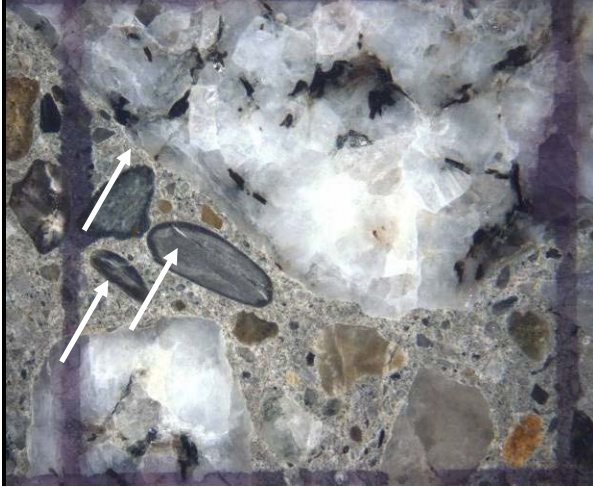
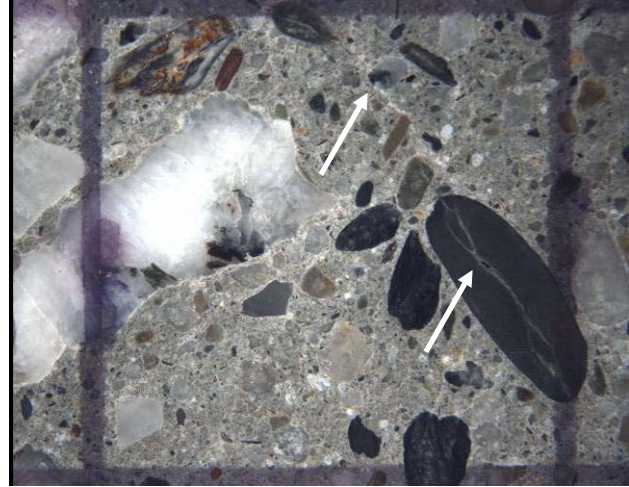
Figure 240. Polished concrete surfaces (cores extracted from the barrier walls of two bridges carrying interstate I-89 over Dog River near Montpelier, VT).

The large majority of the counts for *Cracks with reaction products in the coarse aggregate* (Cr+RPCA) in the DRIs of sections S2 and S3 correspond to cracking in the coarse fraction of the sand. Significant cracking is also observed in the cement paste, with and without reaction products; in many cases, cracking extends into the cement paste (with reaction products) connecting “reacted” coarse sand particles (see Figure 240). A fair number of voids in the cement paste of the above cores are lined or filled with secondary reaction products, both alkali-silica gel and ettringite.

A&B: Cracking in particles of the coarse fraction of the fine aggregate, which extends into the cement paste; secondary (ASR) products are observed in the cracks both in the particles and the cement paste. Dark reaction rims are observed surrounding the reactive aggregate particles.

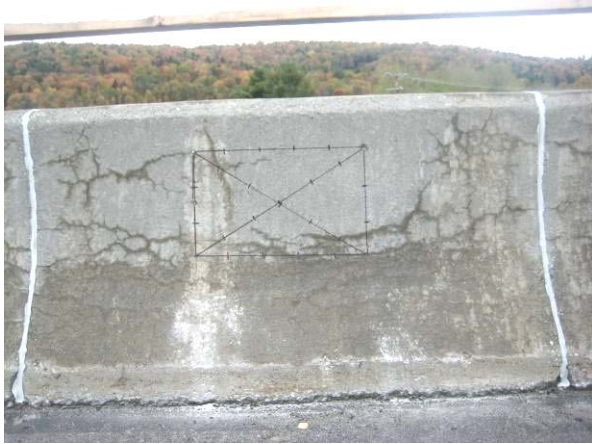
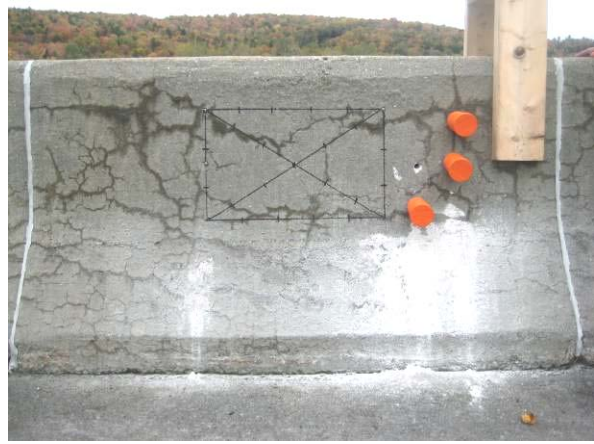
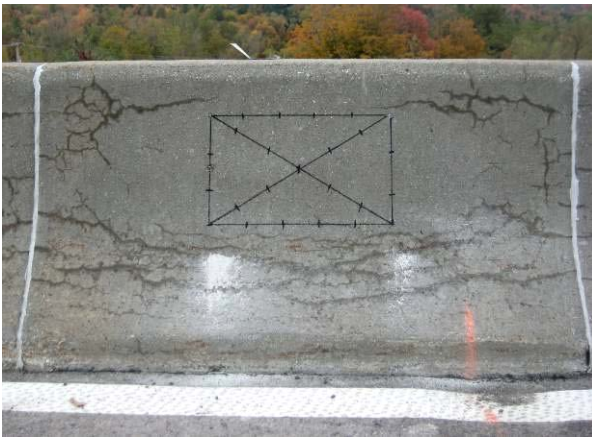
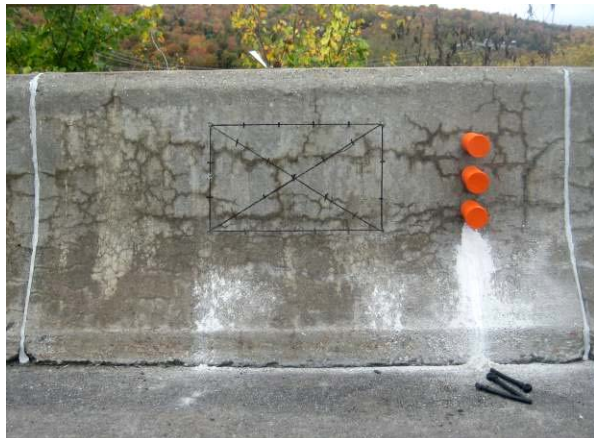
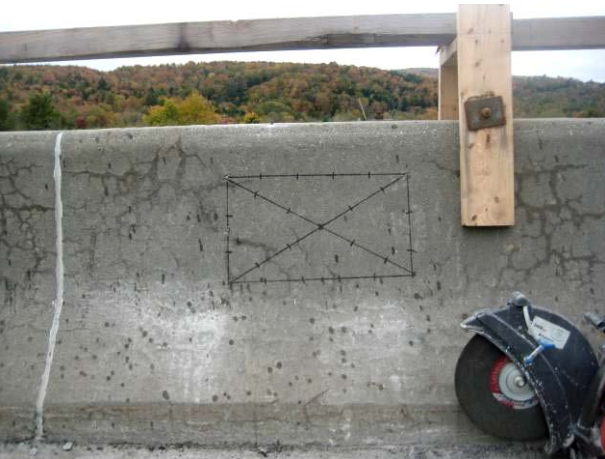
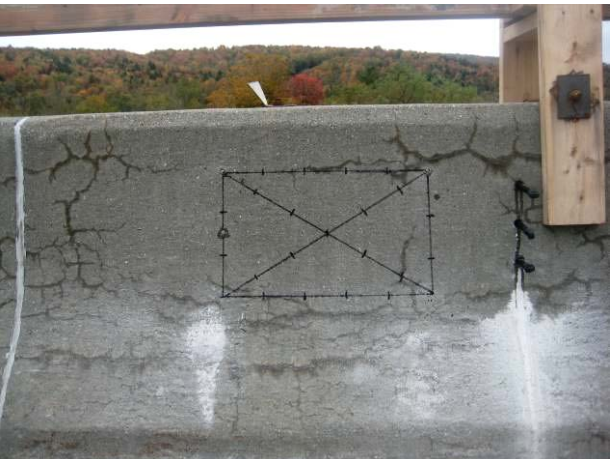
Figure 244. Examples of the “original” condition of barrier walls (driving lane).

Regarding the physical condition (cracking) of the barrier walls, it is important to note that the original degree/extent of cracking varied significantly between the barrier wall sections, although all were exposed to similar conditions. This can be observed in Figure 244, which illustrates the range of damage in the driving lane barrier walls back in 2010, i.e., before treatments. Also, the damage in the barrier walls was generally found to progress during the 2010-2013 time period, as can be visually observed in Figure 245 and Figure 246 which illustrate CI monitoring sites for the driving lane barrier walls.

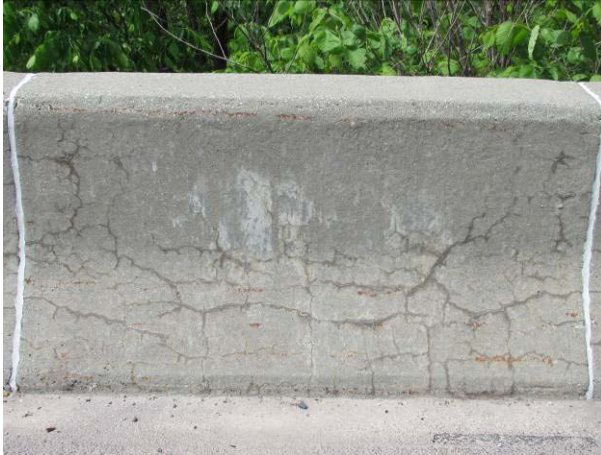
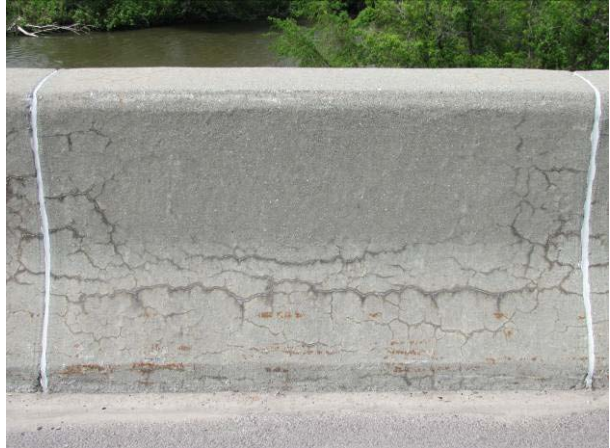
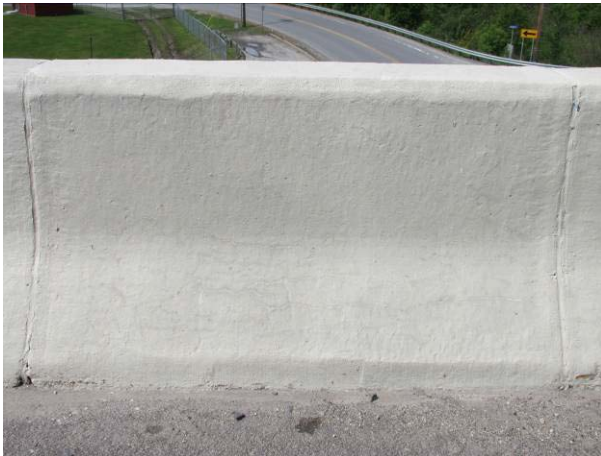
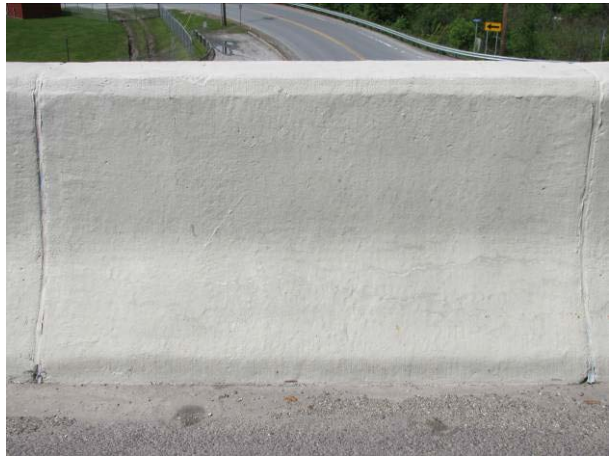
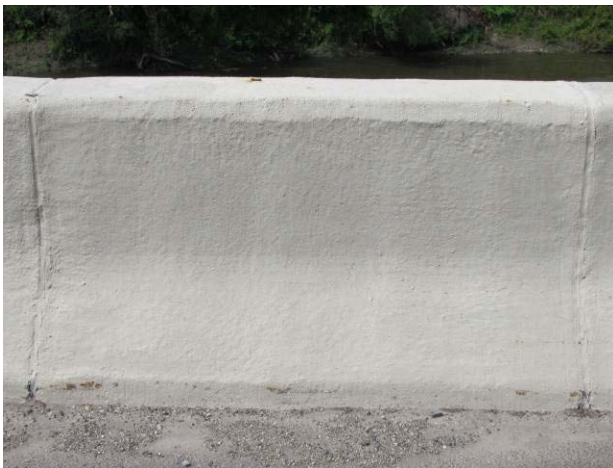
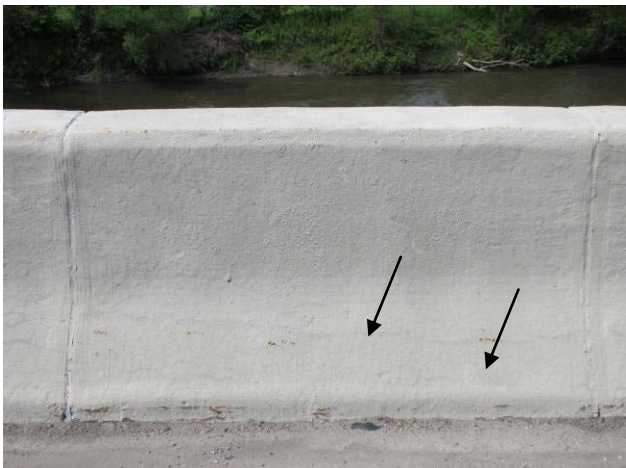
Figure 247. Typical examples of the condition of control and treated barrier walls (driving lane).

The data in Table 87, and illustrated in Figure 253 and Figure 254, show a generalized increase in the CI values for both the driving and the passing lane barrier walls over the 2010-2012 monitoring period, followed, however, by a drop in CI values in the May 2013 field survey for most barrier walls; the latter is likely caused by the difference in temperature during the site visits. The temperature and moisture state of the concrete can indeed have a significant impact on the CI values since the above conditions will influence crack widths. It is interesting to note, however, that the drop between 2012 and 2013 was generally less important for the control sections compared to the treated sections on the passing lane (Figure 254); this suggests that expansion/cracking is actually progressing more readily in the control sections. This is supported by the data obtained for the driving lane sections, where CI values generally dropped between 2012 and 2013 for the treated sections (once again due likely to thermal effect) (Figure 253B), but actually increased over the same period for the control sections (Figure 253C). This suggests a beneficial effect of the penetrating silane treatments. This is suggested also by the differences in the physical appearance of the barrier walls, as illustrated in Figure 247 and Figure 248 for the driving lane barriers, and in Figure 249 and Figure 250 for the passing lane barriers.

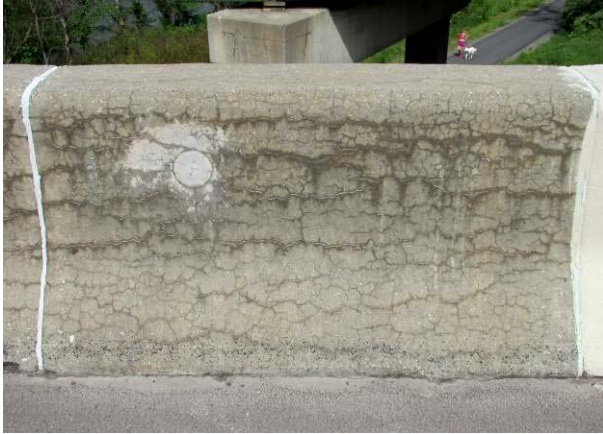
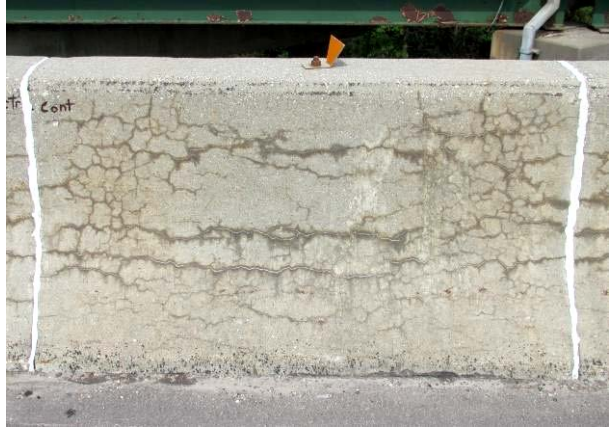
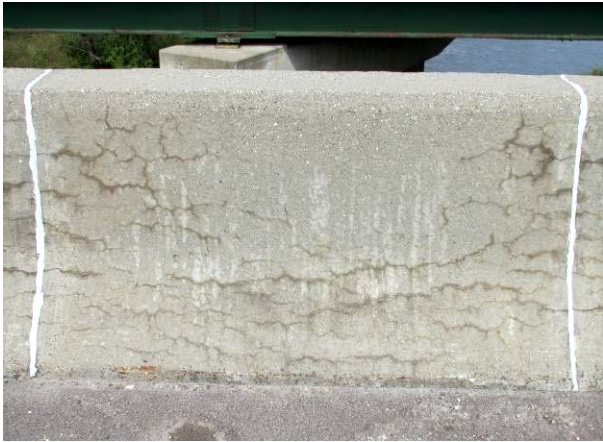
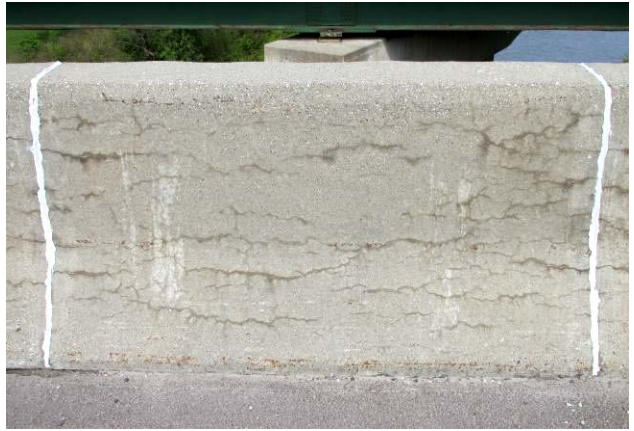
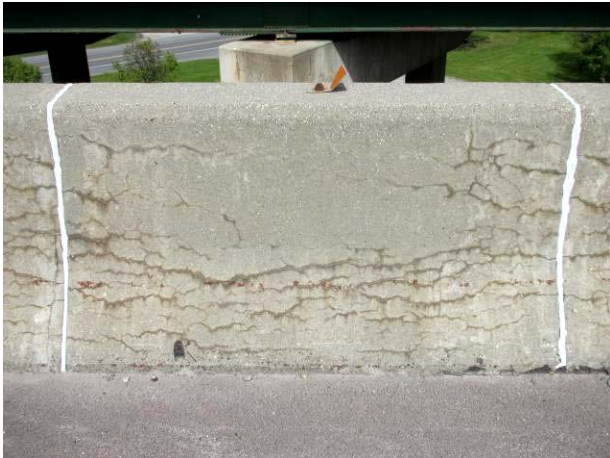
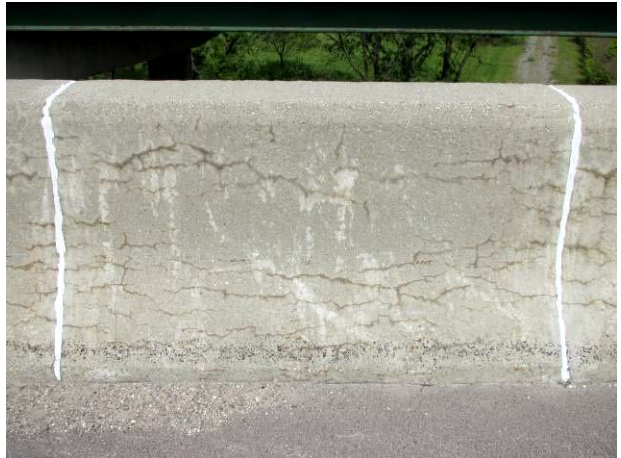
Figure 248. Typical examples of the condition of treated barrier walls (driving lane).

In the case of the sections treated with the elastomeric coating, CI values of "0" were obtained for the measurements carried out in 2012, i.e., following the application of the coating, since the product has been efficient in bridging the cracks present in the different concrete members. However, cracking was found to start reappearing, especially in the bottom portion of some coated barrier walls in 2013, as indicated by increasing CI values for those sections (see Figure 248, Figure 250, Figure 253, and Figure 254).

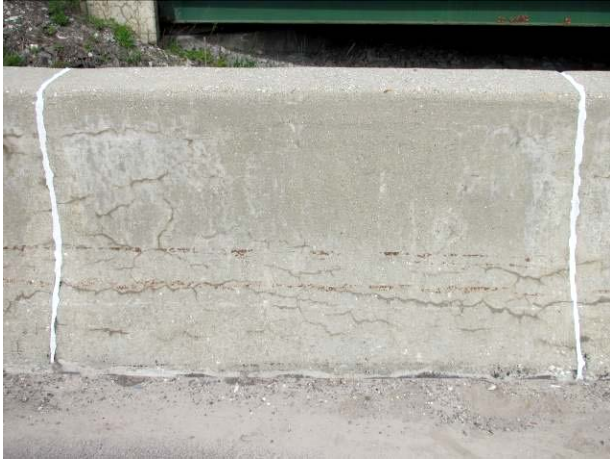
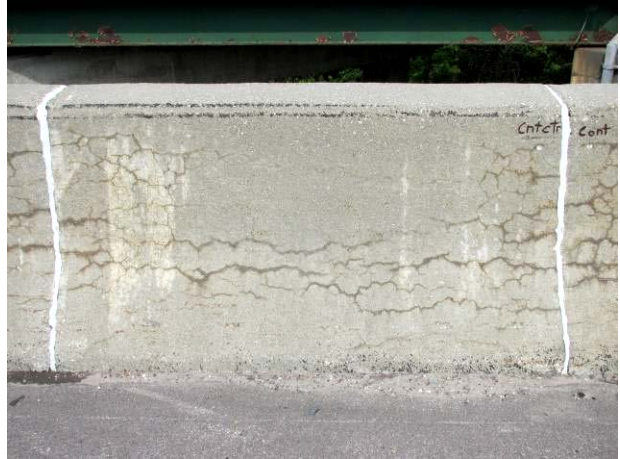
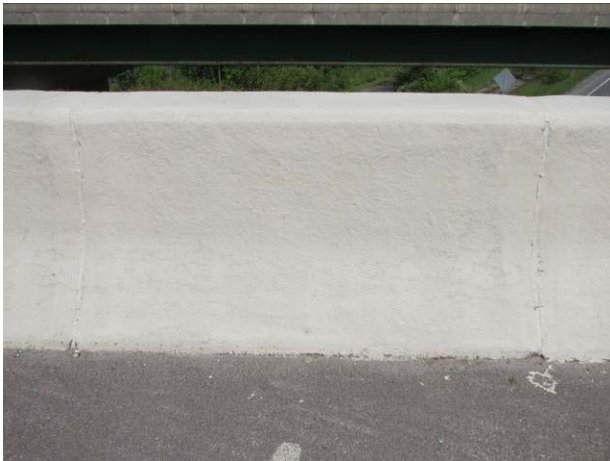
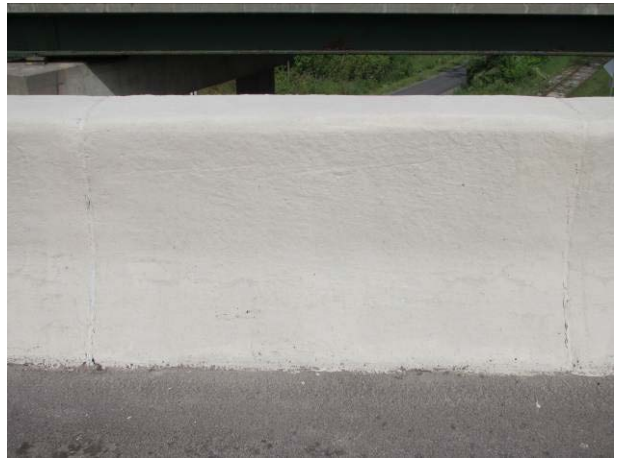
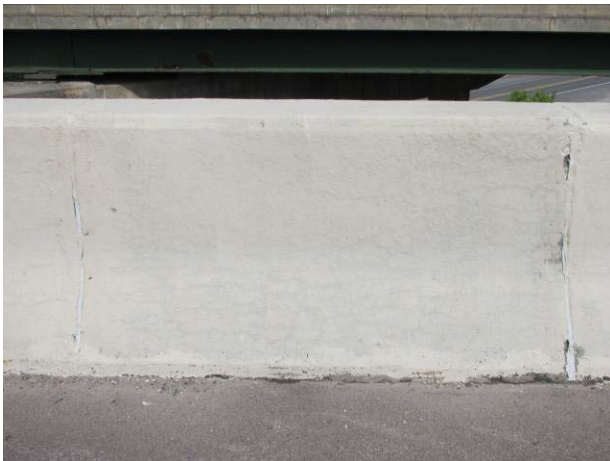
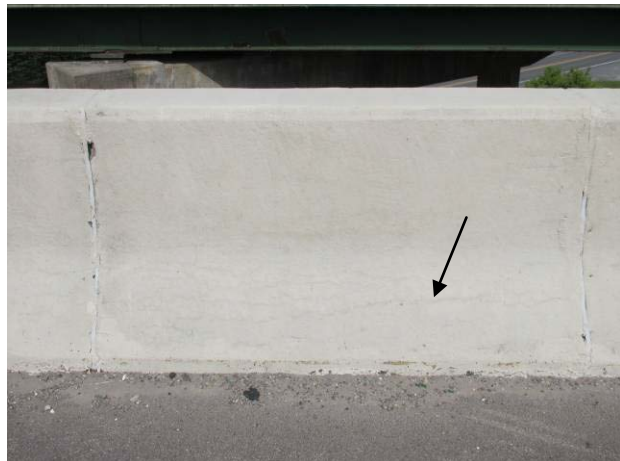
Figure 249. Typical examples of the condition of control and treated barrier walls (passing lane).

Finally, the passing lane barrier walls seem to be generally more severely cracked than the driving lane barrier walls. This might be partially related to the fact that the driving lane barriers were treated on both sides while the passing lane barriers were treated on only one side.

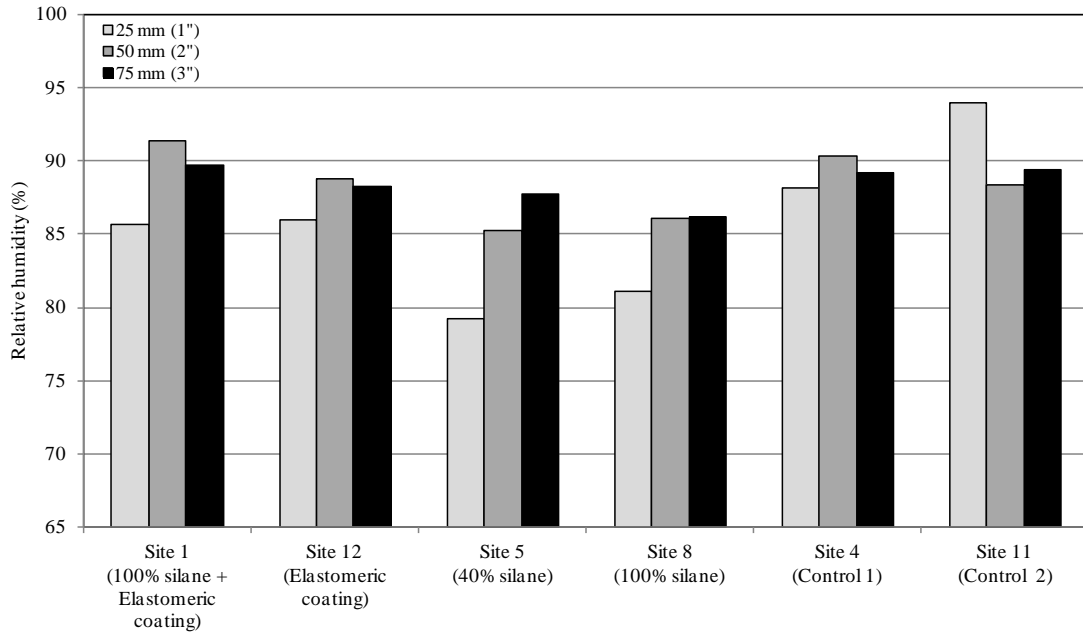
Figure 251. Relative humidity measurements for the driving lane (July 2012).

So far, because of the temperature differences and the limited number of field surveys, no definite conclusions can be drawn from the RH measurements in the barrier walls investigated. However, lower RH values are observed in the surfacial portion of several barrier walls treated with sealers and the elastomeric coating in the 2012 (and 2013) data (see Table 82 and Table 83), while such a trend does not seem to be so pronounced in the control sections (see Figure 251 and Figure 252). This suggests a beneficial effect of surface treatments at reducing the progress of cracking; future site readings will be critical at confirming that trend.

One needs to keep in mind that in the case of barrier walls, moisture is available from both sides of the concrete element. Treatments were consequently applied on both sides of the driving lane barriers to try optimizing their efficacy. In parallel, treatments were applied only on the inside portion of the passing lane barriers in order to evaluate the relative efficacy of both types of treatments. So far, there are no significant differences between the RH results obtained for the driving lane and passing lane barriers, although passing lane barriers seem generally in a more advanced stage of deterioration than driving lane barriers. On the other hand, numerous RH values are missing due to moisture effects or breakdown; this lack of data makes interpretations of the effect of surface treatments on internal concrete RH more difficult.
