# Long-Term Monitoring of Pavement Maintenance Materials Test Sites

PUBLICATION NO. FHWA/HD-98/012

1. Report No.  FHWA-RD-98-073

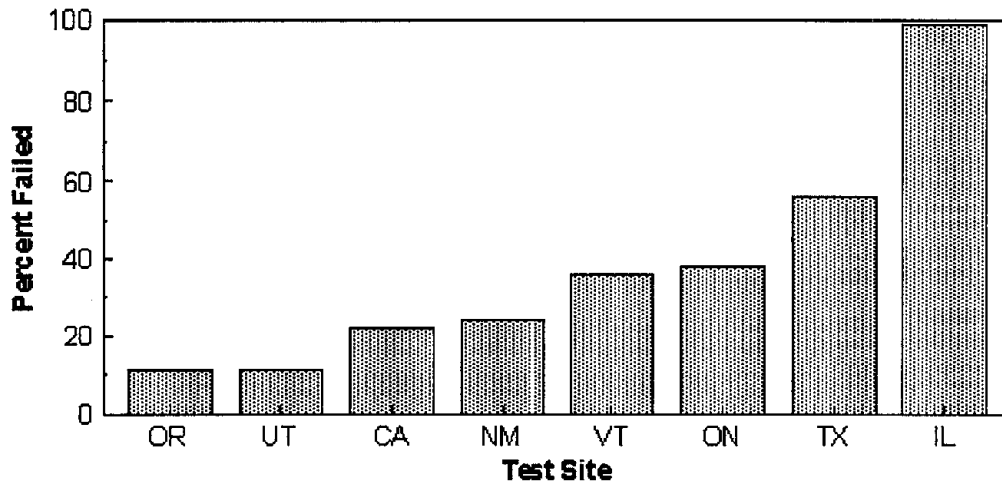
Figure 18. Pothole repair patch survival by site.

Figures 18 through 21 show the different failure rates of repairs pooled over different categories. The plots represent raw values and do not take into account variability resulting from specific factors such as traffic, pavement structure, and climate. The statistical analysis and accompanying results are provided in section 5.

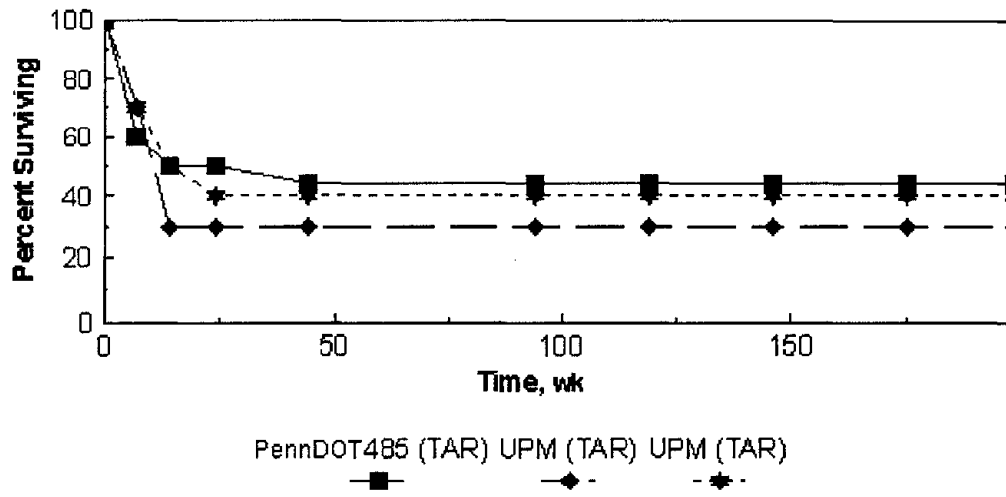
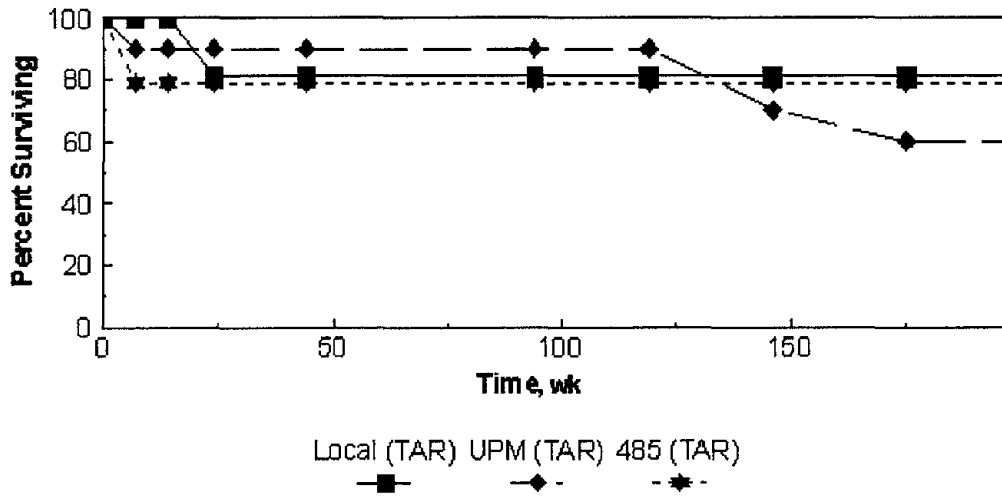
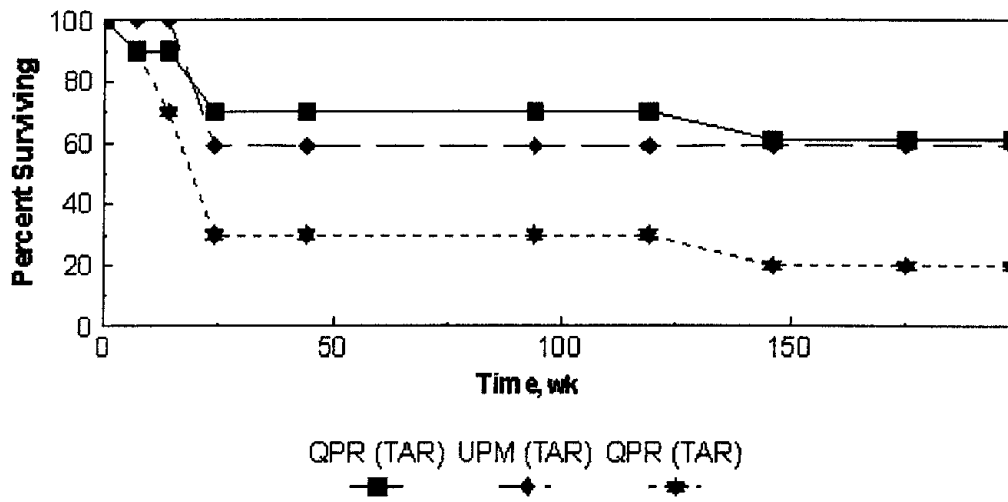
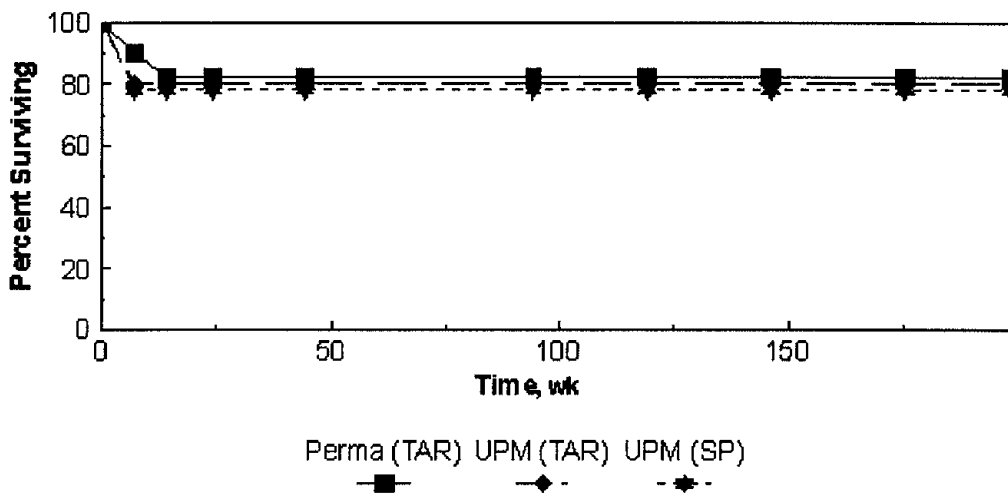
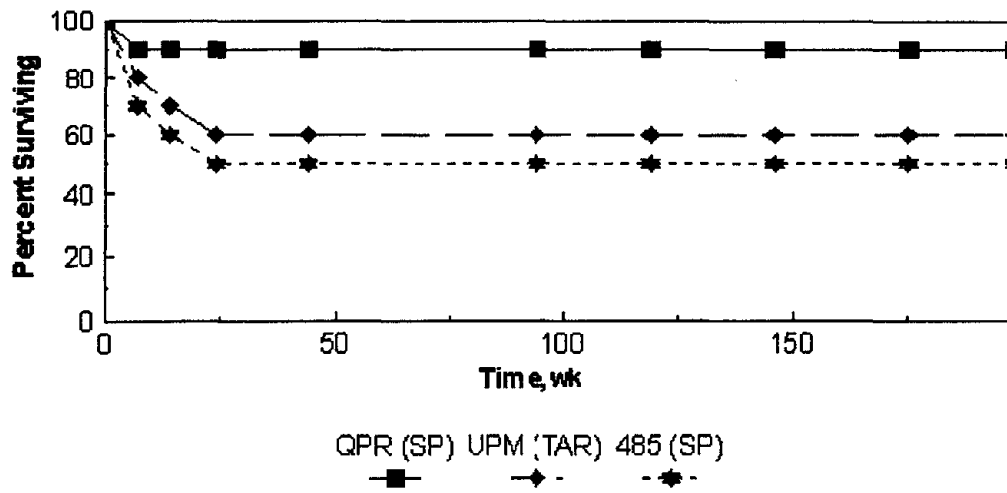
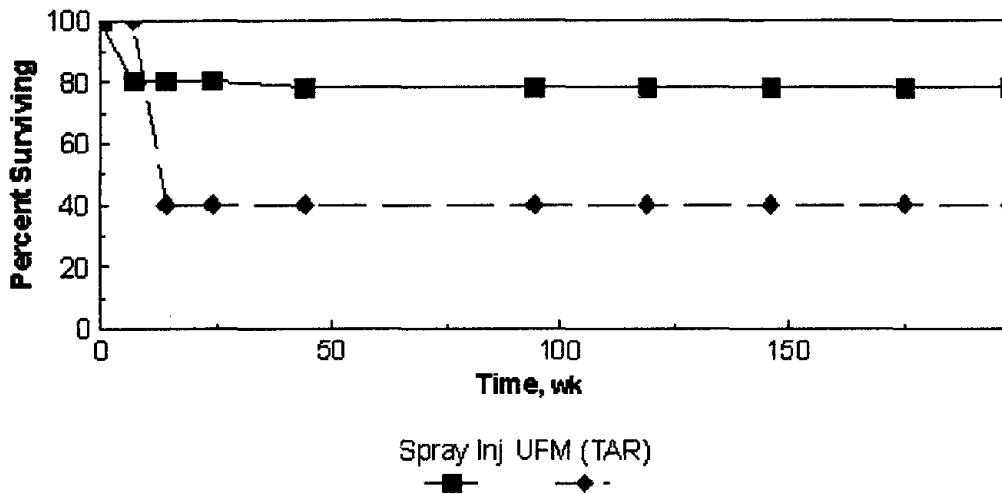
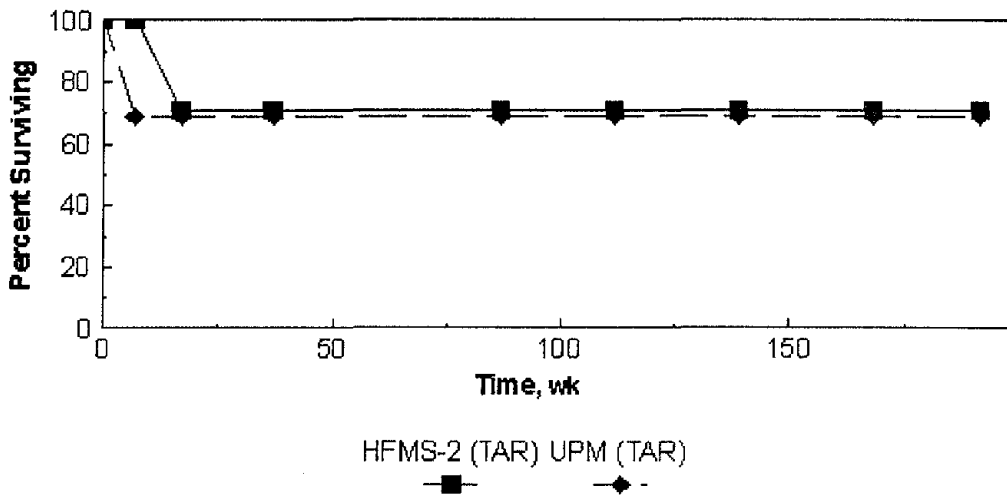
Figures 22 through 28 illustrate the survival plots for the patch sets at the Ontario test site, based on the data presented in table 11. As can be seen, the repair types are grouped in sets according to how they were installed. The groupings emphasize the comparison of patches within each set, as such comparisons yield the least variability in traffic, cross section, subgrade support, drainage, and other factors.

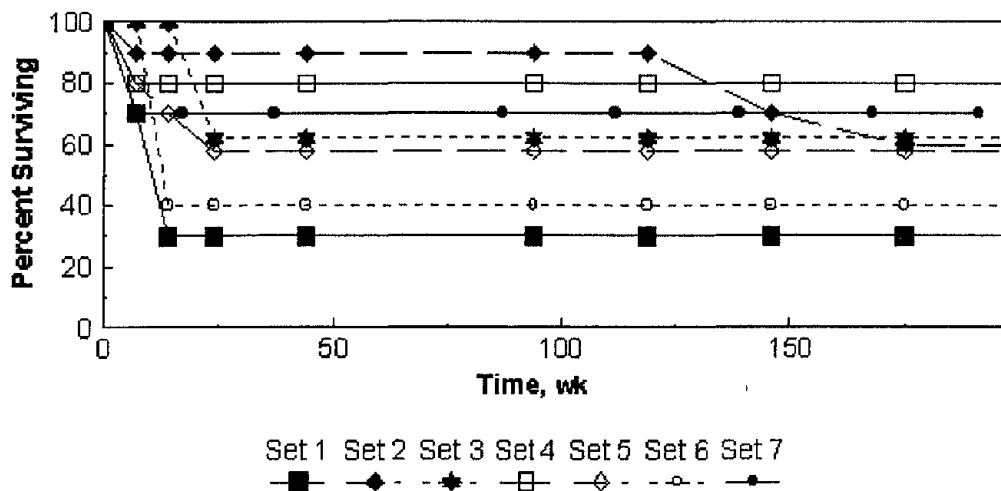
Figure 29. Survival of pothole repairs for control patches-Ontario test site.

One of the reasons that the analysis has concentrated on the differences within the groups is the variability of the performance observed from one set of control patches to the other. Figure 29 illustrates the survival plots for each of the seven sets of control patches placed at the Ontario test site. The percentage surviving after 198 wk varies from 30 to 80 percent, although the materials, placement procedure, and compaction were the same. The most likely source of the variability is differences in the pavement support, drainage, and other in-situ factors, which would have been similar for the rest of the repair types. Comparisons between different patch types at different locations throughout the test site would be irrelevant due to the differences in performance caused by site-specific factors.

Comparison among different sets of control patches within test sites did show differences in survival throughout the same site. An example of these differences can be seen in figure 29 for the control patches at the Ontario test site. These differences indicate that the performance of the control patches was affected by site-specific factors, such as underlying support and drainage, since the material, placement procedure, and compaction effort were the same for each set.
