# **Video Inspection of Highway Edgedrain Systems**

**April 1998**

**FHWA-SA-98-044**

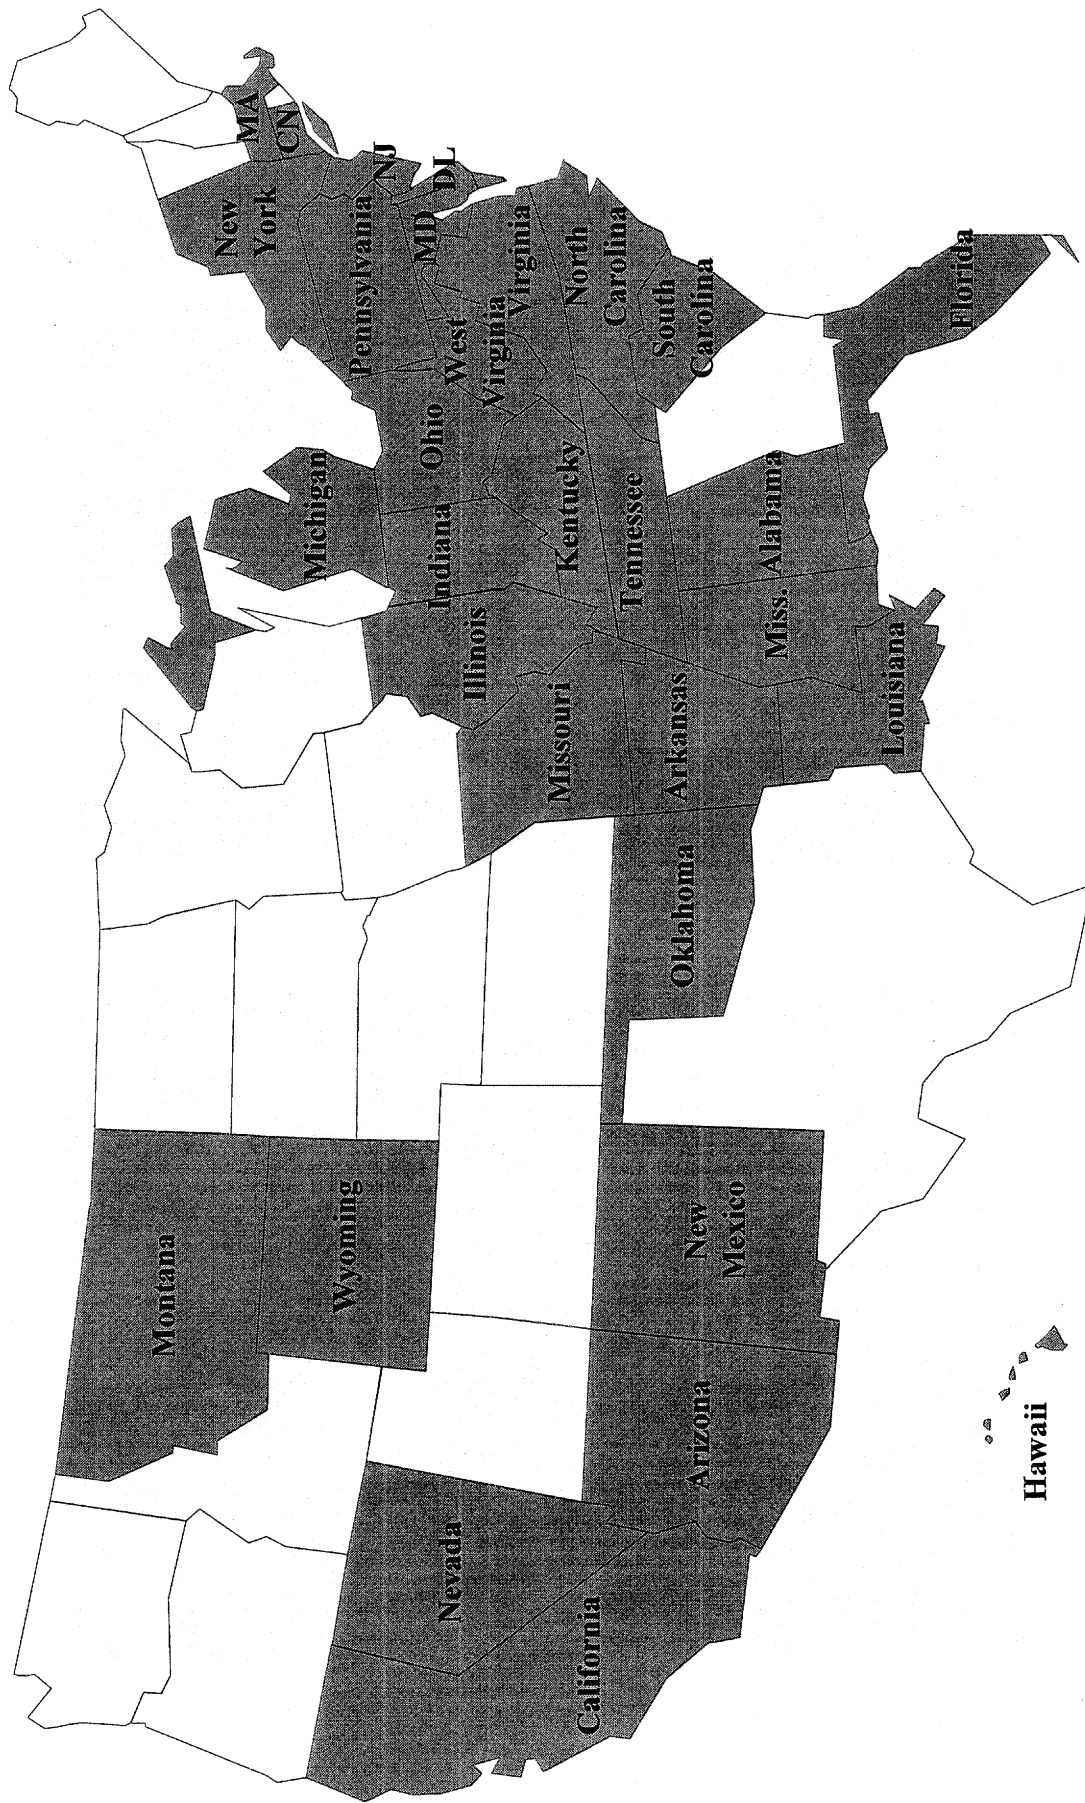
Under this project, 22 demonstrations have been conducted which included 29 States (Figure 7). A listing of those demonstrations and the associated states and dates where demonstrations were conducted is provided in Table 2.

Figure 7. Completed edge drain inspections.

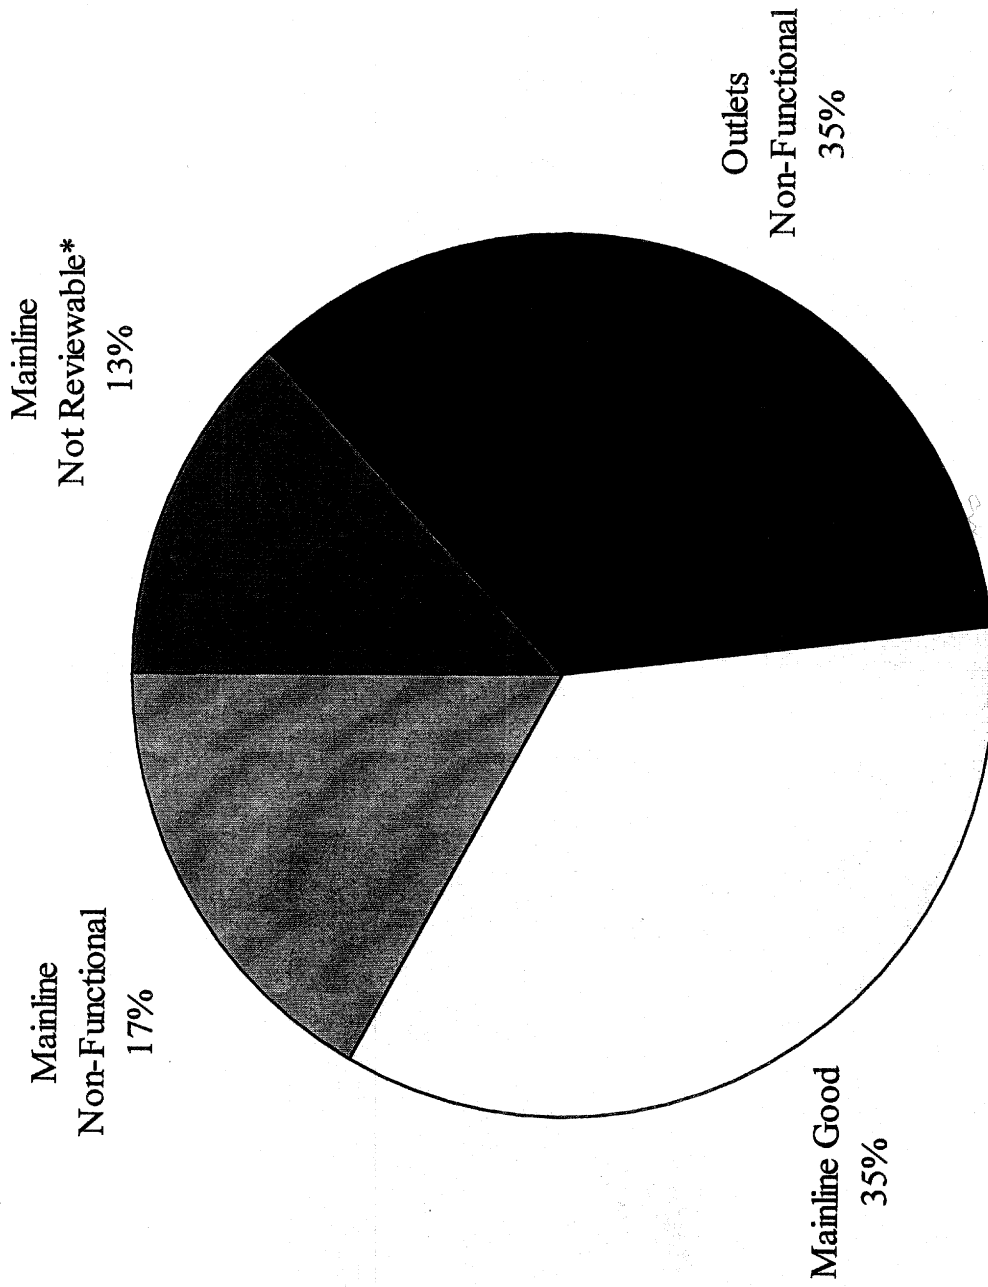
Of the 287 lateral/mainline edgedrain systems attempted, over 100 demonstrations were terminated due to defects with the laterals. Fifty-two (18%) had crushing in the lateral. Another 50 (17%) of the lateral systems were silted-in, limiting the investigations on these systems (Figure 8 and 9). In addition, 36 (13%) were composed of geocomposite sock, panel drain, drop tees, drop inlets, or no mainline systems at all (Figure 10).

\* Could not inspect geocomposite socks, panel drains, drop tees, drop inlets or systems where no mainline was installed.

Figure 10. Breakdown of Video Inspections.

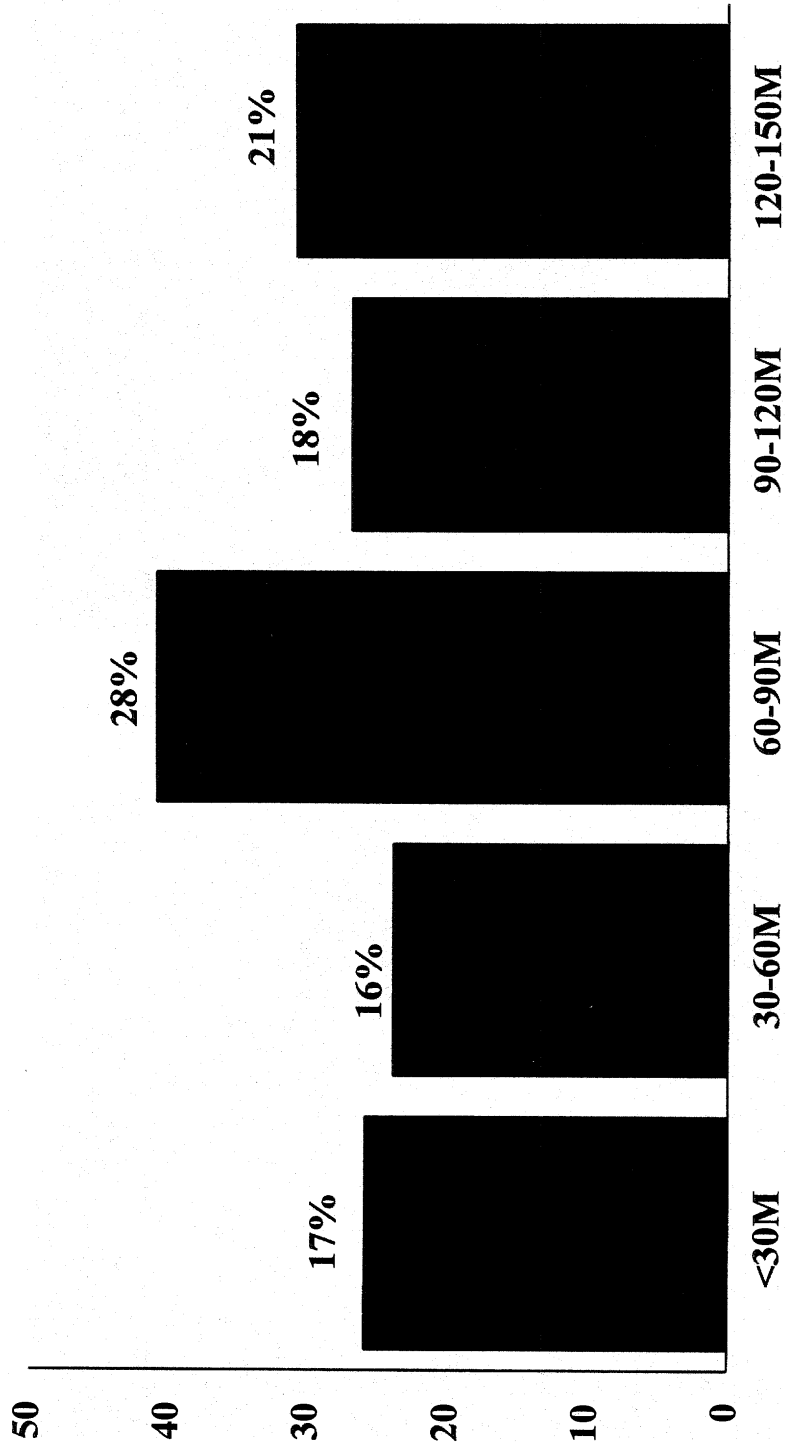
149 (52%) mainline segments were capable of inspection. Figure 11 shows a clear 90° tee junction of the lateral and mainline. Of these 149, 17% (26) were found to be crushed, silted in, or obstructed within the first 30 meters. Sixteen percent (24) of the inspections covered 30-60-meters of the mainline segment, 28% (41) went to the 60-90-meter range (Figure 12), 18% (27) were in the 90-120-meter range and 21% (31) covered 120-150-meters of the mainline (Figure 13). In many instances, a crush in the mainline system could be identified or associated with a known construction crossing prior to the opening of traffic on to a given highway.

Figure 13. Mainline Demonstrations Resulting in the Following Attained Distances.
