Safety Edge_{SM}
HMA Demonstration Project
Jasper County, Iowa

Field Report
June 6, 2011

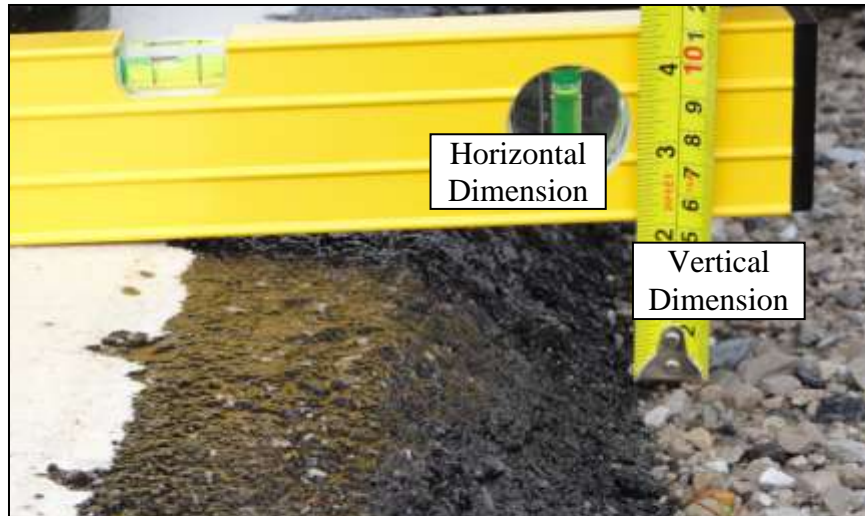
Figure 3. Slope measurement technique.

The vertical measurement was also the thickness at the edge of the mat which is not always the case. For example when HMA is allowed to slide down the slope during paving the true edge thickness is obscured. Figure 3 shows the technique in measuring the edge slope.

The average slope of the Safety Edge_{SM} was calculated to be 38° from the width and thickness measurements. Slope measurements are listed in Table A-1 and Table A-2 in Appendix A.

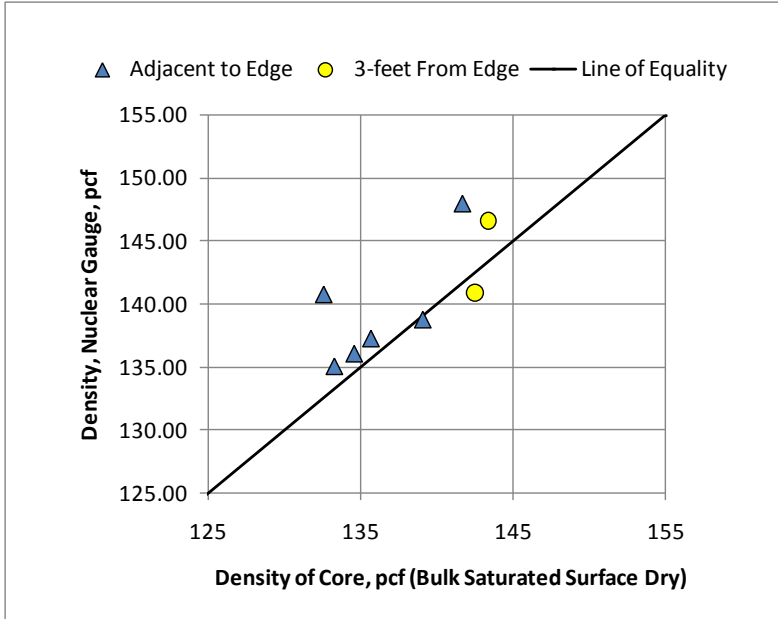
Figure 7 shows a comparison of the nuclear densities and densities measured from the cores. As shown, the value at 3 ft. from the edge was close to unity and the value adjacent to the edge is not as close to unity. The adjusted densities using the adjustment factors are also listed in Table A-4 in Appendix A. The factors were used to adjust the nuclear density gauge readings to be consistent with the densities that were measured in the laboratory. The nuclear density test results are listed in Table A-5 and A-6 in Appendix A.

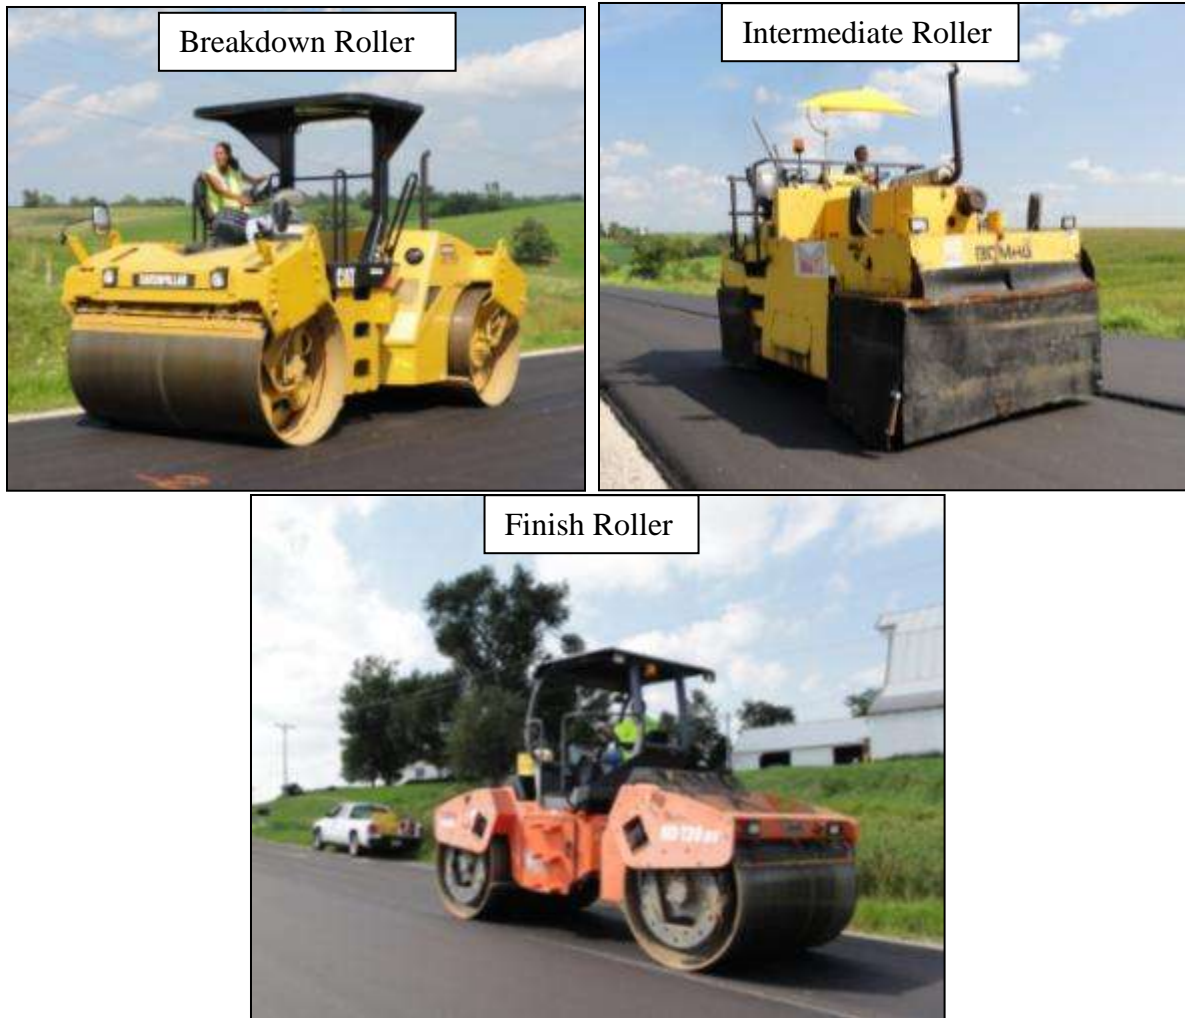
Figure 14. Compaction equipment.

Upon special request, the breakdown roller operator hung over the Safety Edge_{SM} of the mat about 2 inches on the first vibratory pass for a short section. Doing so caused the edge of the mat to displace horizontally and become steeper. This proved the slope of the Safety Edge_{SM} was sensitive to the rollers position. The vibratory first pass at the longitudinal centerline joint caused the mat to move approximately 0.75 inches horizontally.
