5 Performance of Buildings in Houston's Central Business District

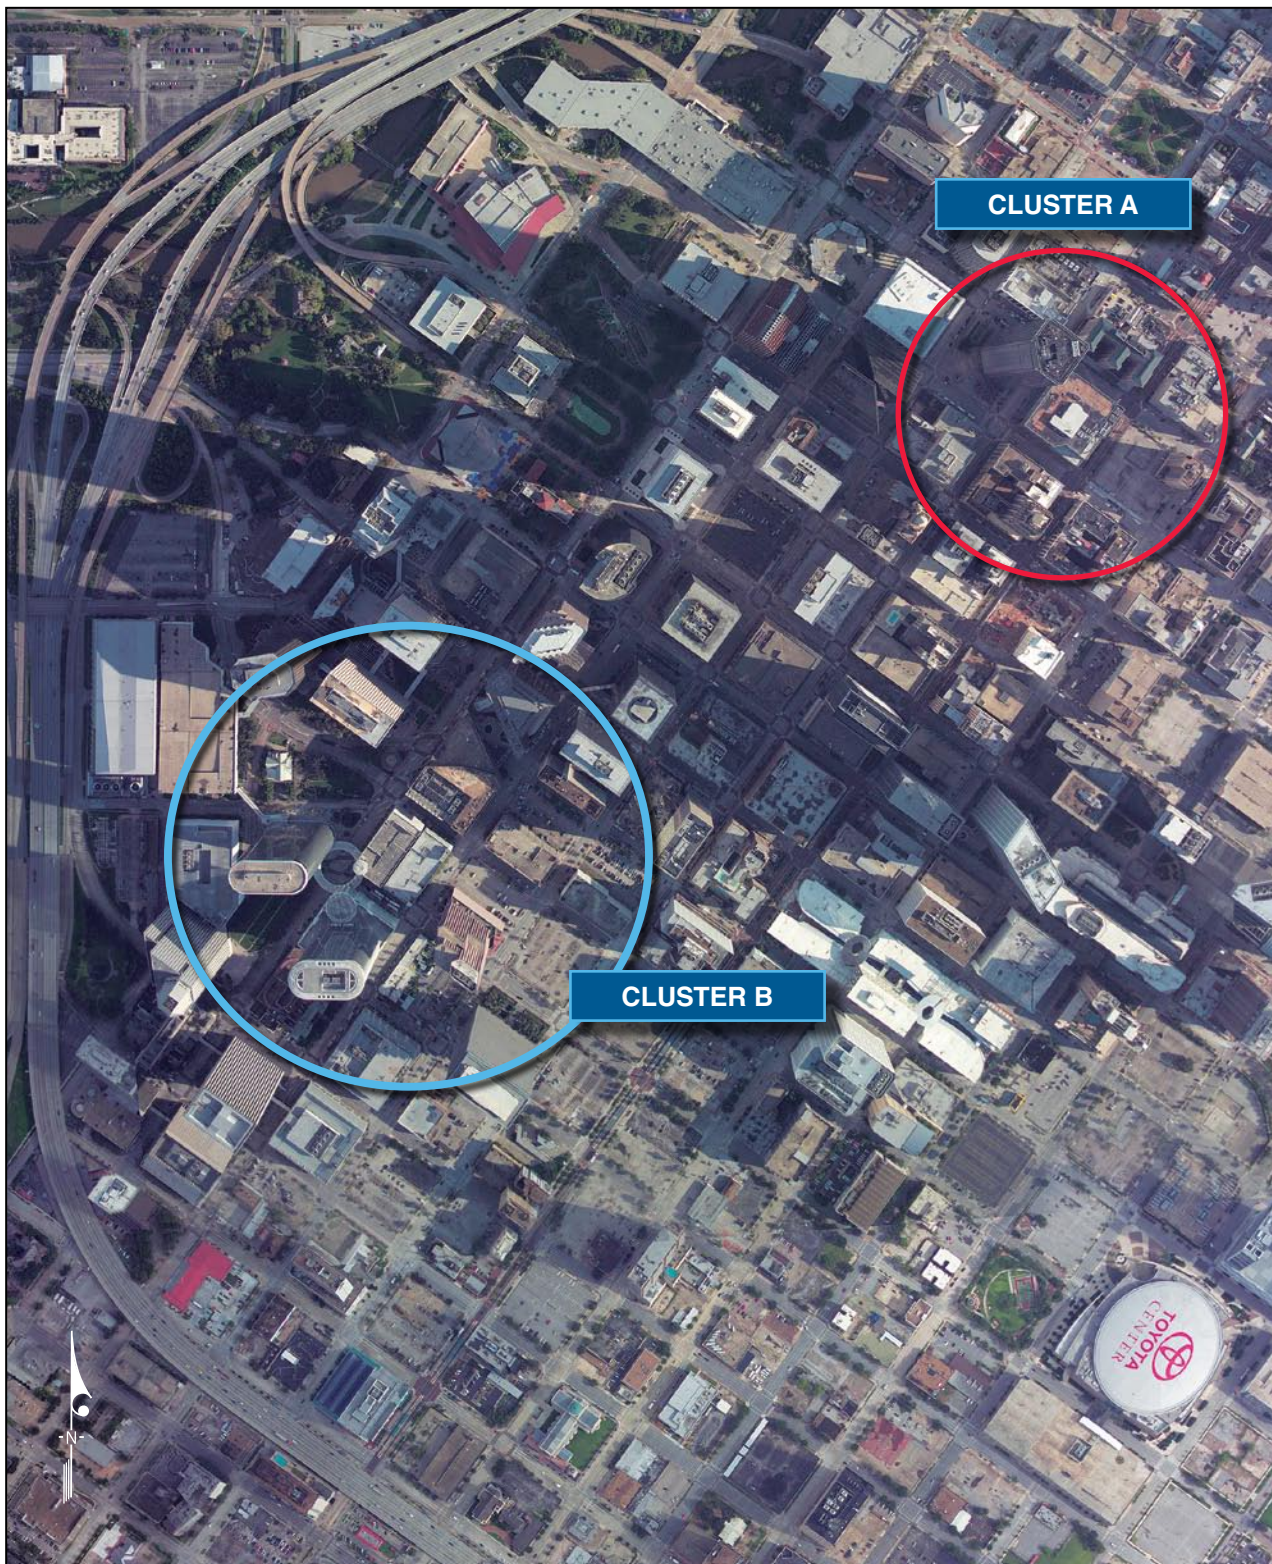
Figure 5-1.

The MAT observed commercial high-, mid-, and low-rise buildings in downtown Houston. The building ages ranged from several decades to just a few years old. Figure 5-1 shows an aerial photograph of a portion of downtown Houston. There was significant building envelope damage in areas indicated by the blue and red circles on Figure 5-1; the red circle denotes buildings that are discussed as cluster A (Section 5.2), and the blue circle denotes buildings discussed as cluster B (Section 5.3). Random isolated envelope damage was observed in the areas outside the clusters, as described in Section 5.1.

View of a portion of downtown Houston. The red circle denotes cluster A and the blue circle denotes cluster B.

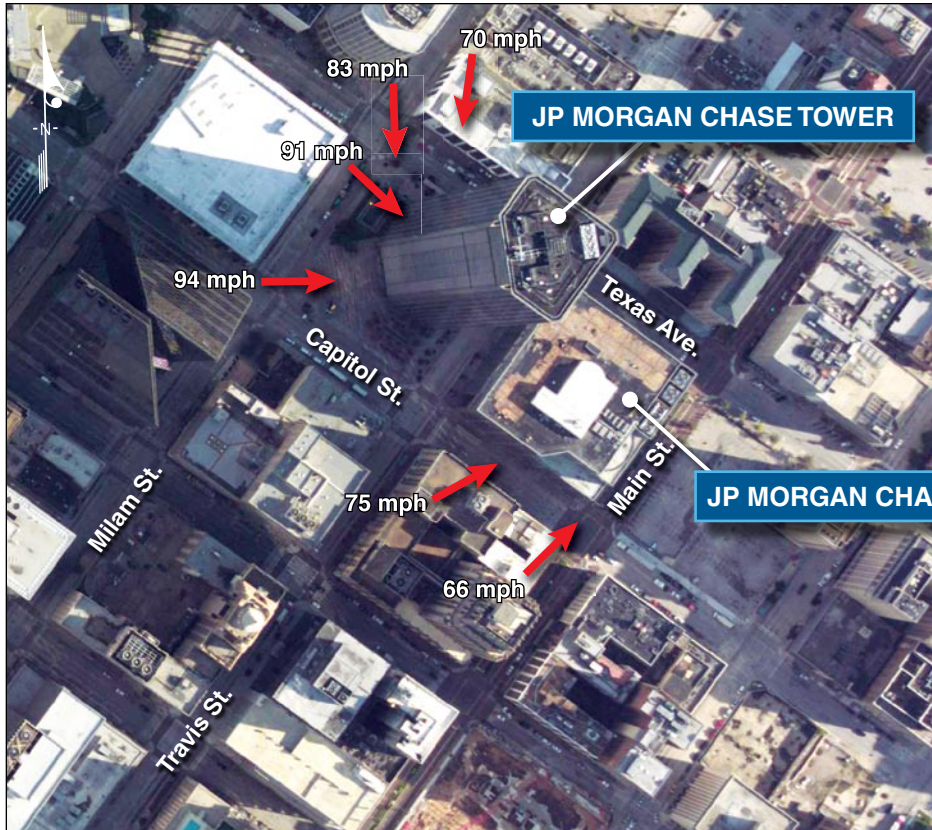
An enlarged view of cluster A is shown in Figure 5-6. The JP Morgan Chase Tower and Center are part of cluster A.

Figure 5-6. JP Morgan Chase Tower and JP Morgan Chase Center. The arrows show Hurricane Ike's primary wind directions (see text box) and maximum gust speed (for Exposure C at 33 feet above grade) for the given direction.¹

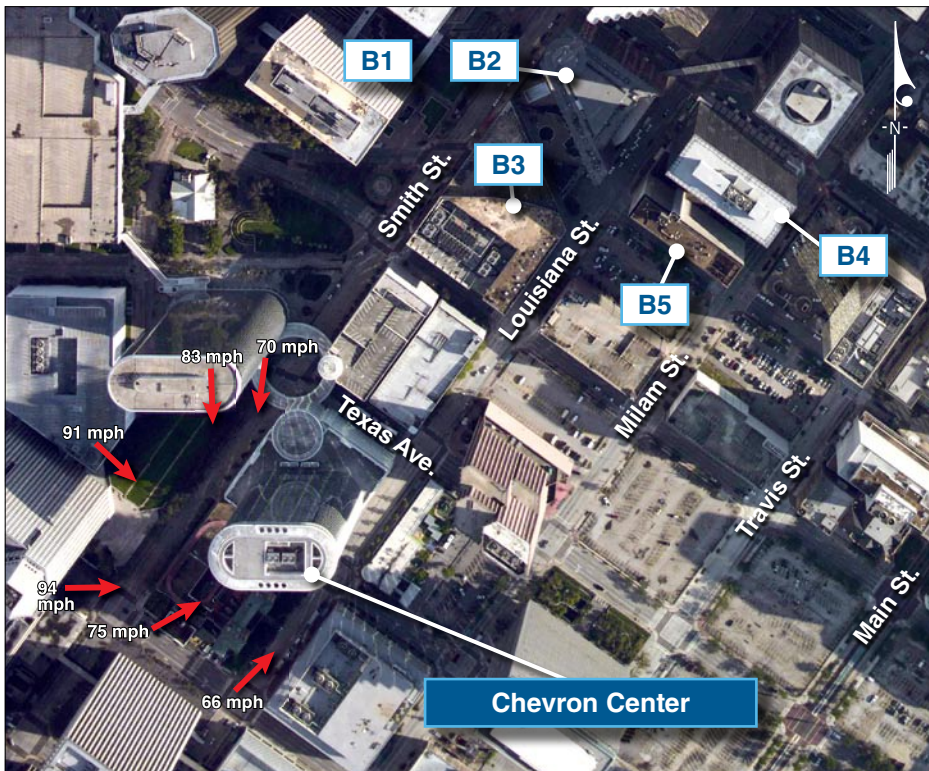
In addition to the glazing and roof covering damage at the Chevron Center, several other low-, mid-, and high-rise buildings shown in Figures 5-22 and 5-23 had various types of building envelope damage as described below.

Figure 5-22. Locations of nearby damaged buildings
