3 Performance of Residential Buildings (Flood and Wind), One- to Two-Family and Multi-Family

3.1 Structural Performance

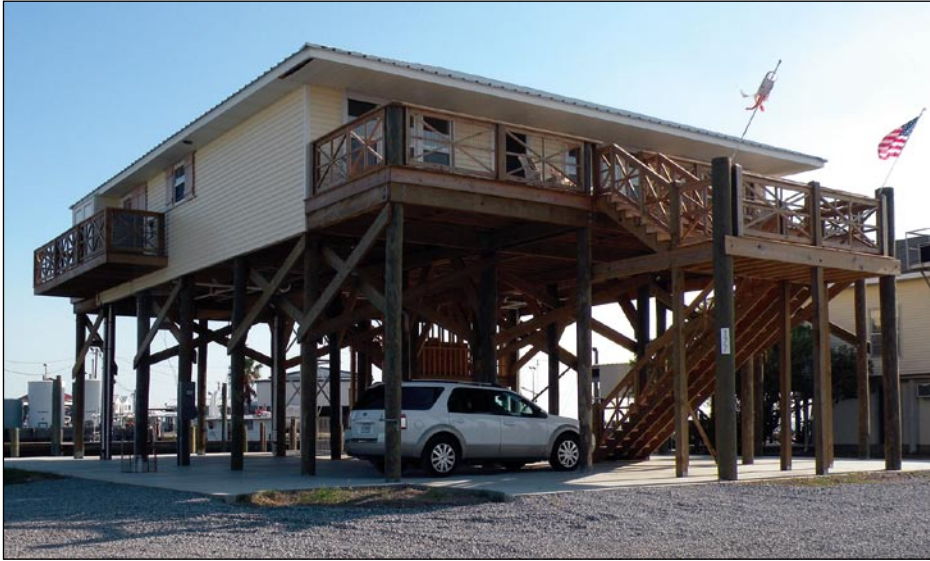
Figure 3-1.
Louisiana house sufficiently elevated on a foundation that withstood Ike flood loads

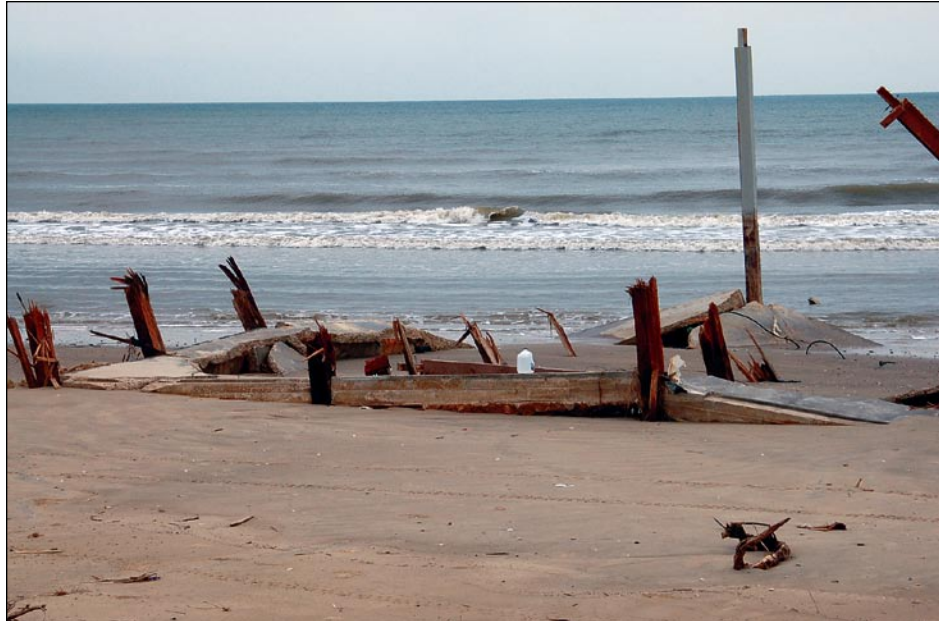
Pile and Column Breakage. Pile and column breakage occur where the strength of the piles or columns is inadequate to resist the bending moments or shear forces caused by the flood and wind loads acting on the structure (Figures 3-3 and 3-4). Scour and erosion contribute to this mode of failure by increasing the un-braced pile/column length and by increasing the bending moments in the pile/column.

Figure 3-4.
This concrete column
failed due to lateral loads.
Note limited overlap of
reinforcing steel at the
bottom of the column.

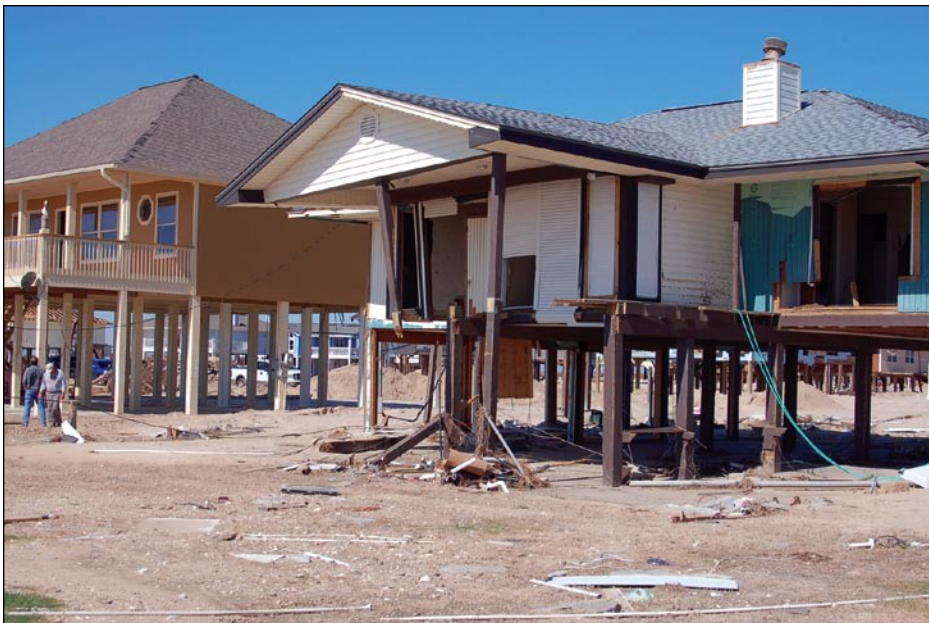
Figure 3-6.
Unlike the older and
lower house on the
right, the Zone V house
on the left was elevated
approximately 5 feet
above the 16-foot National
Geodetic Vertical Datum
(NGVD) BFE and sustained
no structural damage due
to flooding (Crystal Beach,
TX)

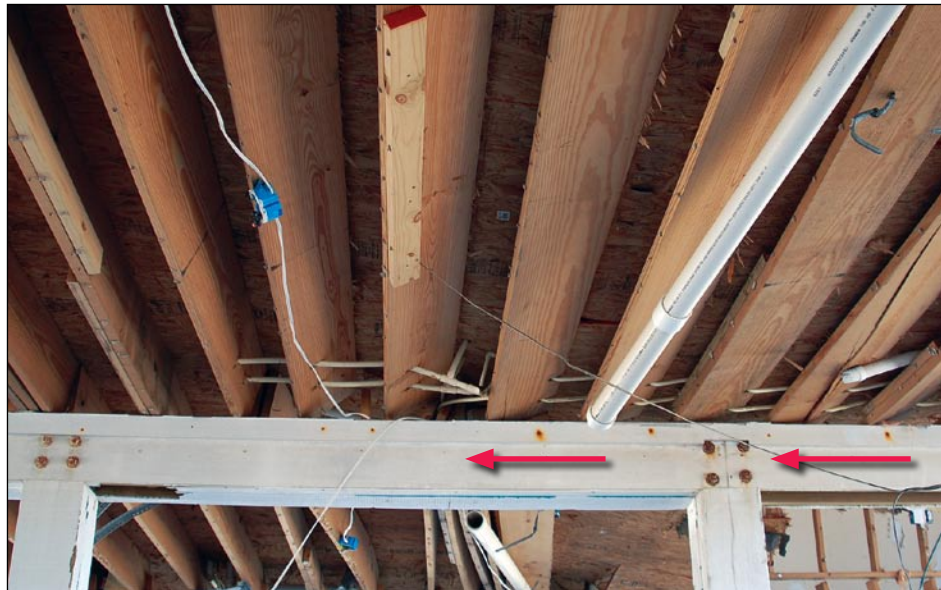
Figure 3-7.
The landward displacement of shore-parallel floor joists indicates the onset of wave damage to an elevated floor system (Bolivar Peninsula, TX)

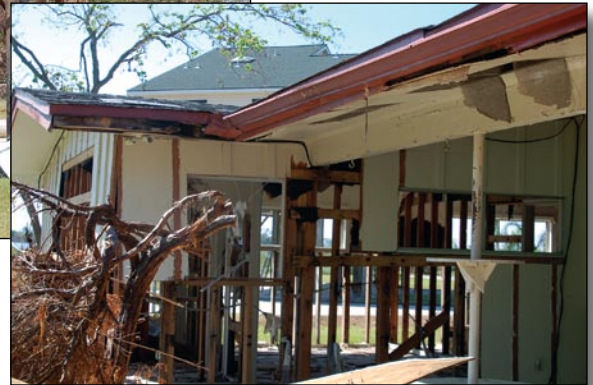
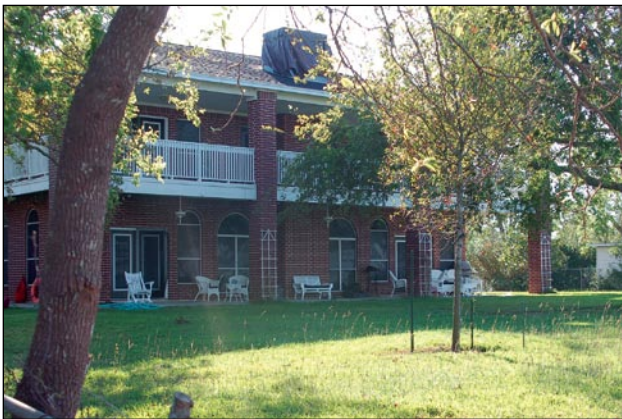
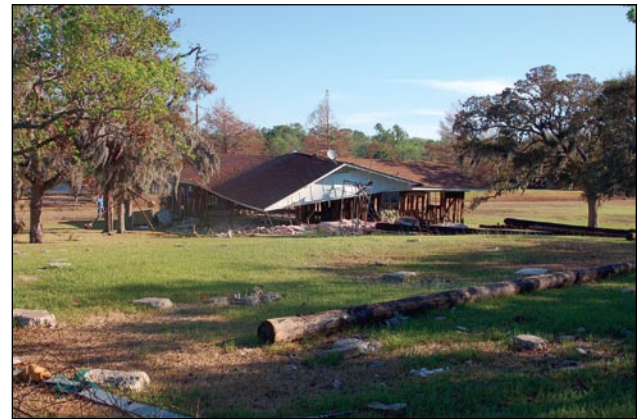
Figure 3-9.

Adjacent houses south of Baytown, TX. The house on the left (Zone X) was above the surge and wave runup level and sustained no flood damage. The house on the right (Zone A, BFE = 13 feet) was at a lower elevation and was largely destroyed by surge, waves, and floating debris.

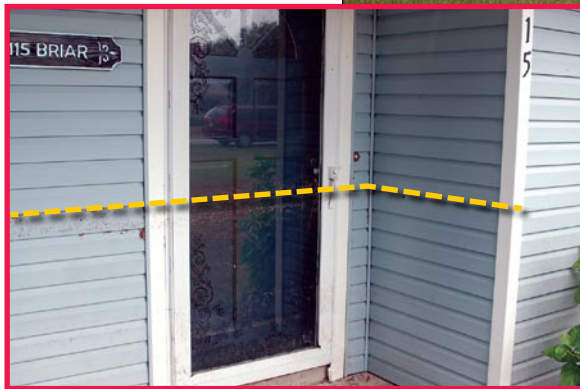
Figure 3-11.
This house sustained significant structural damage due to storm surge and small waves above the 9-foot BFE in Zone A (Bridge City, TX). Note flood debris line on the roof.

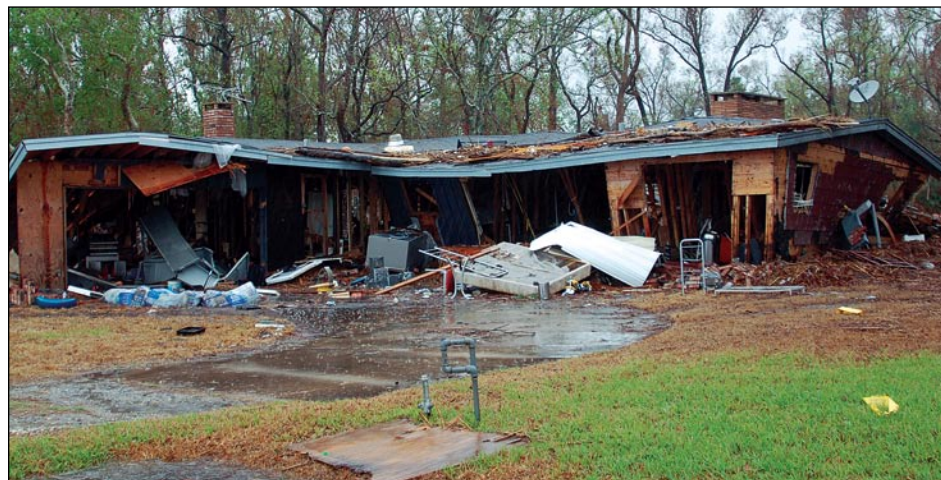
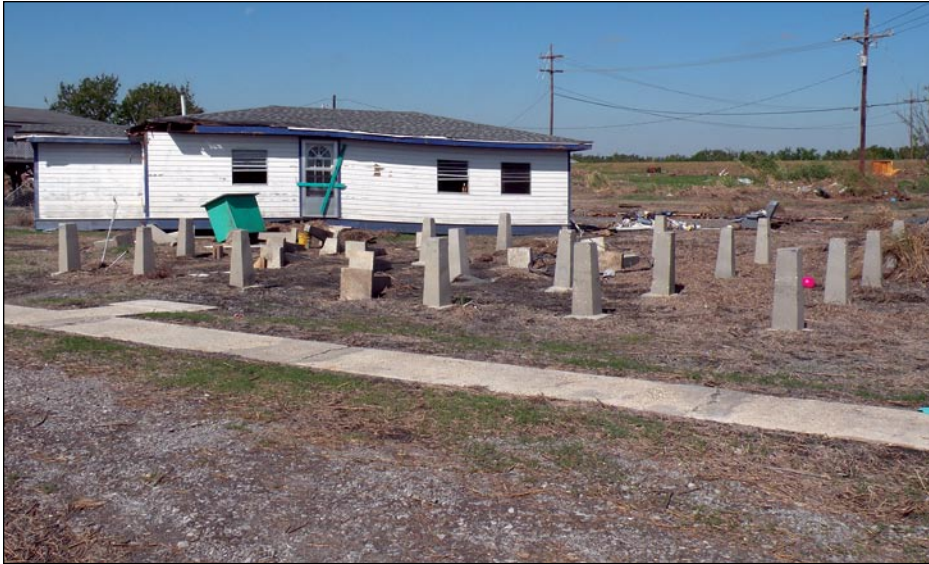
Figure 3-12.
This house floated off its foundation due to insufficient elevation and inadequate connections between the foundation and the house (Golden Meadow, LA)

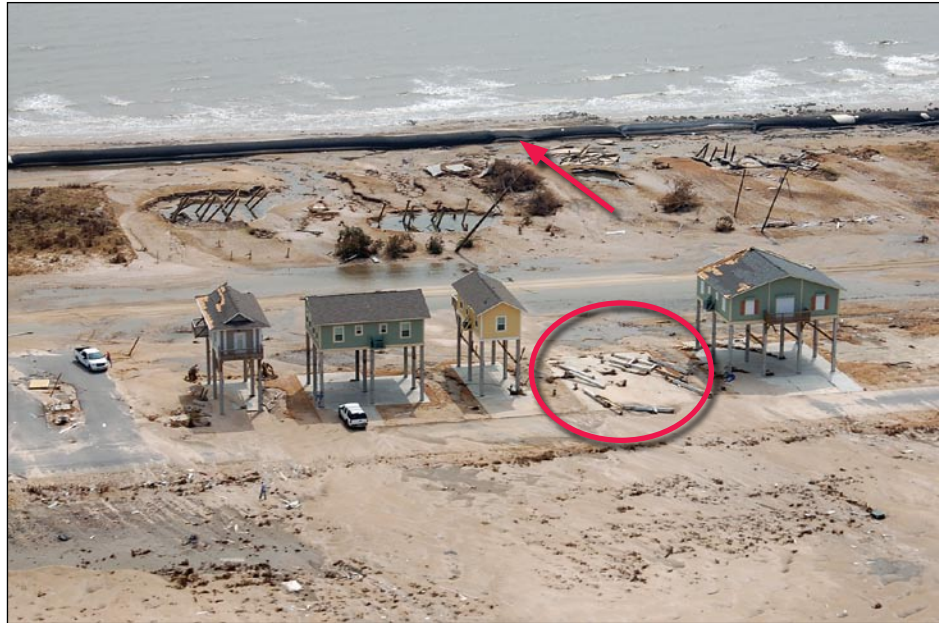
The houses had substantial timber decks connected to the columns at or just above the BFE, approximately mid-way between the ground and the elevated houses. Although not designed as breakaway decks, the decks broke away during Ike, probably a result of both wave and flood-borne debris effects. The deck failures damaged some of the concrete columns where the decks were connected (Figure 3-14).

Figure 3-14. Ground-level view of elevated houses with inset showing typical column damage where the timber deck broke away (Bolivar Peninsula, TX).

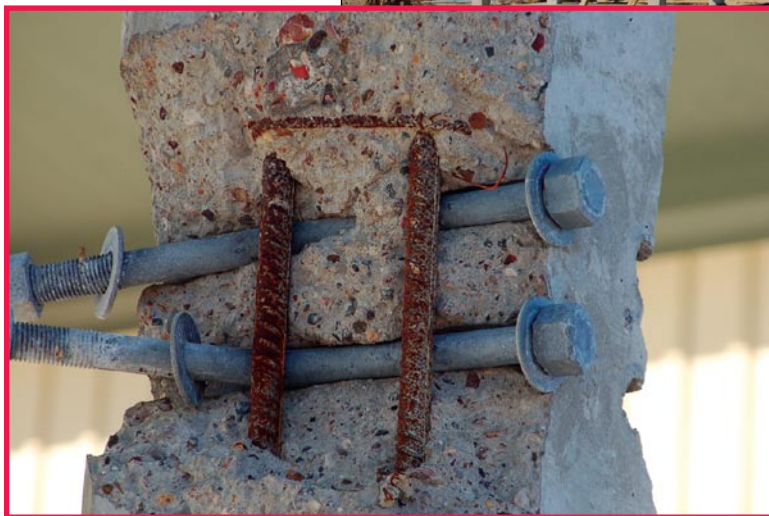
The concrete columns left standing between the slabs and the (destroyed) elevated decks were observed to have a series of horizontal cracks in the columns (Figure 3-15). These cracks likely resulted from the columns bending in response to a combination of wind loads on the elevated houses, flood loads (waves, currents, debris) on the columns, and transfer of flood loads from the decks to the columns.

Figure 3-15.
Concrete column showing cracking that was likely caused by extreme column bending stresses due to lateral loads on the elevated house and foundation (Bolivar Peninsula, TX)

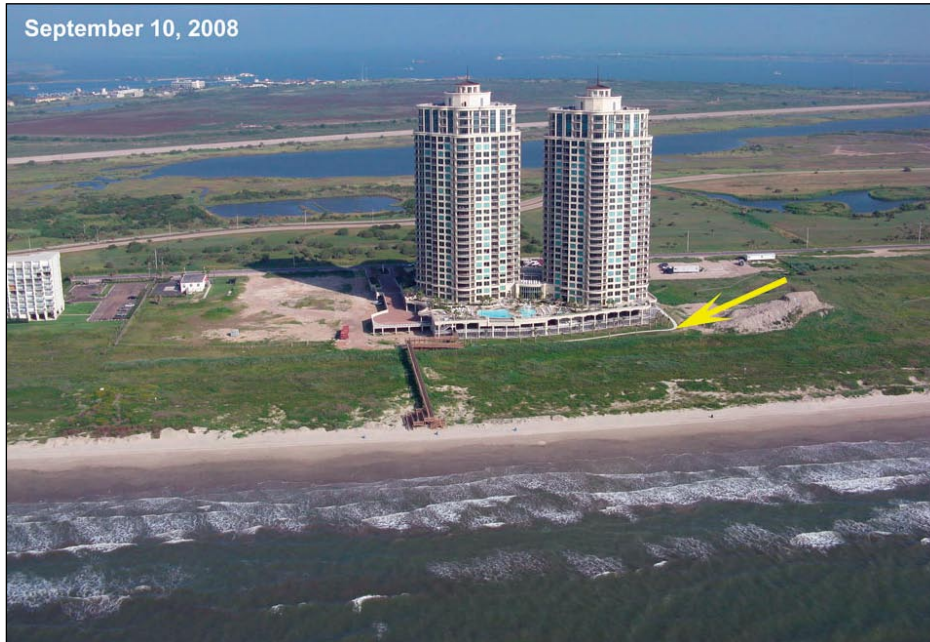
A preliminary review of pre- and post-Ike aerial photographs suggests that between 100 and 200 feet of dunes and vegetation were lost during Ike along much of the Gulf shoreline (see Figure 3-16).

Figure 3-16. Pre- and post-Ike aerial photographs of the east end of Galveston Island, TX, illustrating some of the most significant loss of dunes and vegetation during Ike

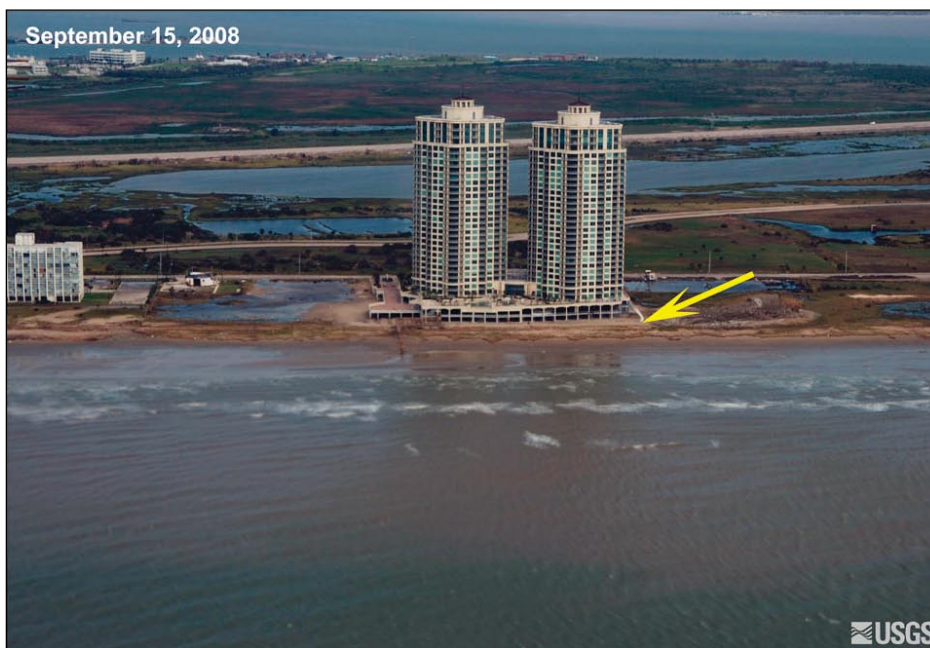
This loss occurred in areas with natural dunes and in areas where previously eroded dunes had been rebuilt and reinforced with geotextile tubes (see Figures 3-13 and 3-17). As of 2003, approximately 7.6 miles of geotextile tube dune reinforcement had been installed along the Texas shoreline, mostly along the Bolivar Peninsula and western Galveston Island shorelines (Gibeaut et al., 2003). Virtually all of these tubes were uncovered by Ike, and many were destroyed.

Figure 3-17.
Exposed geotextile tubes
formerly covered by sand
and dune vegetation.
Note erosion behind the
tubes and under Zone V
(BFE = 18 feet) buildings
(yellow arrow at left).

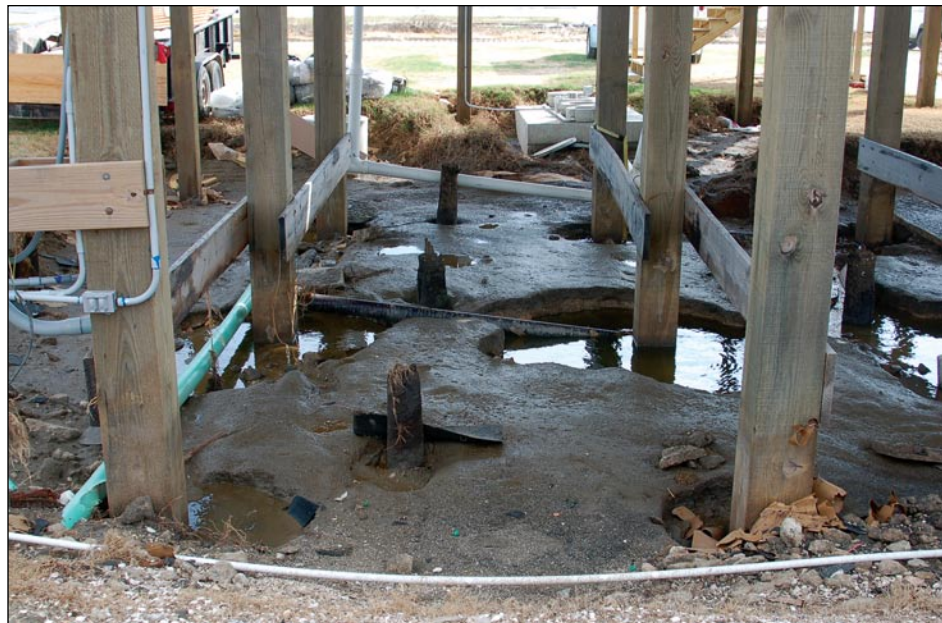
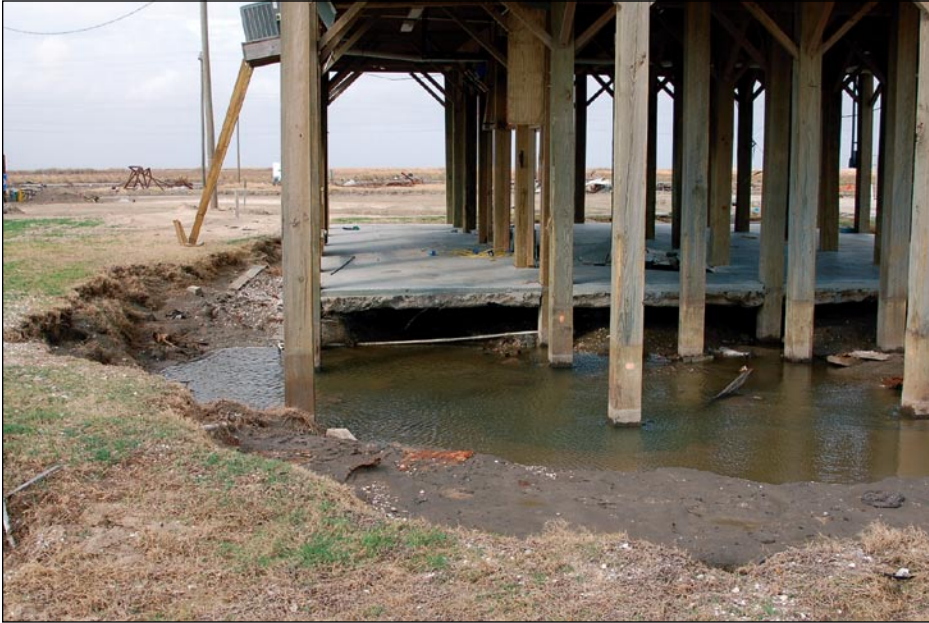
Figure 3-19.
Foundation scour
observed at Holly Beach,
LA (Zone V, ABFE = 16
feet)

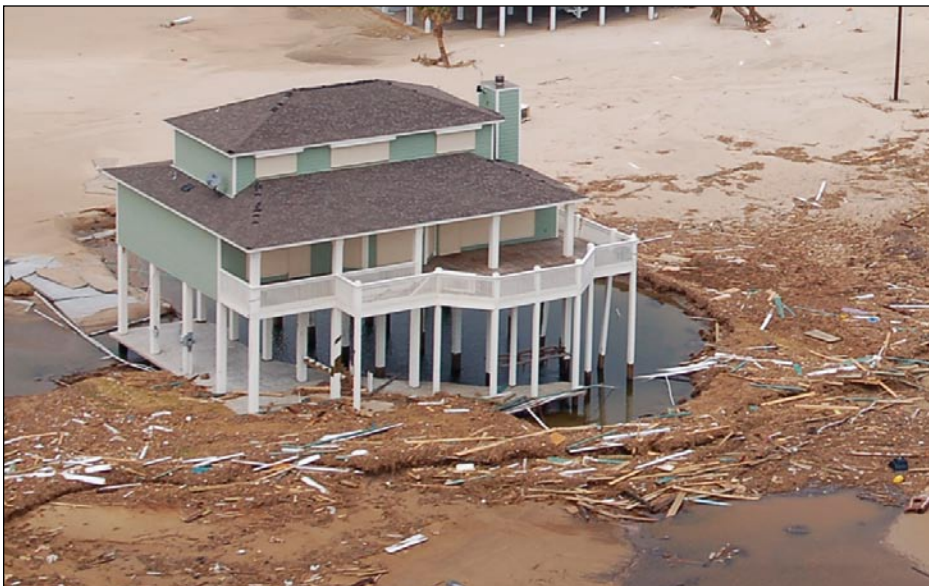
Figure 3-20 shows a case of extreme foundation scour at a house on Bolivar Peninsula. The scour depression shown was reported by a local contractor to have been as much as 10 feet deep. The house was able to withstand the scour and the wind and flood loads acting on the structure, but lack of soil support allowed the bottoms of some of the piles supporting the deck on the right side of the house to be shifted toward the left.

Figure 3-20.
Foundation scour was
reported to be 10 feet
deep—note the bottoms
of the piles on the right
side of building that have
been pushed toward
the building (Bolivar
Peninsula, TX; Zone V)

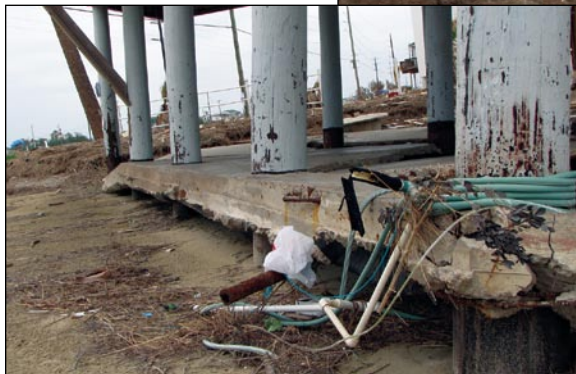
In some cases, pile foundations subject to erosion and/or scour were not embedded deeply enough to resist the loads and conditions that were present during Ike. Figure 3-21 shows such a case where a pile foundation shifted under an elevated house. Scour and erosion contributed to the failure. The presence of the attached, but broken, concrete slab could also have contributed to the foundation failure by reducing the lateral support formerly provided by the intact slab, and by causing eccentric loading of the piles (see Section 3.3.3).

Figure 3-21.
Failure of a timber pile foundation undermined by scour and erosion. Inset shows close-up of concrete slab failure and rotation of some of the foundation piles (Galveston Island, TX; Zone V).

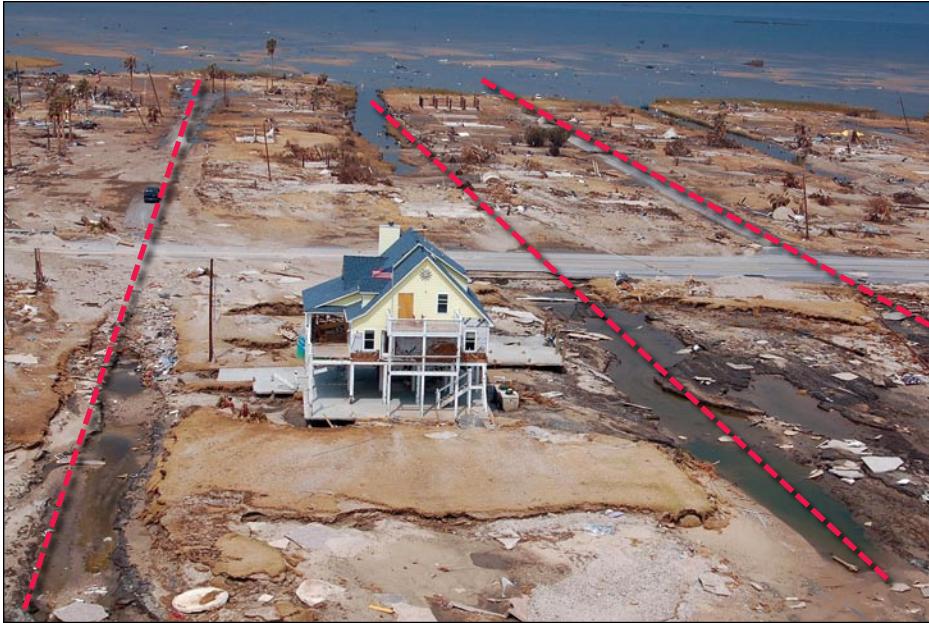
One other aspect of scour was noted by the MAT—linear scour features that result in the loss of soil around or under buildings when storm surge flow is channeled or directed across a building site. This process usually takes place where storm surge flow is constrained between large buildings or gaps in shore protection, or when storm surge return flow to the sea follows paths of least resistance, such as along canals and roads (Figure 3-22). Some of the many buildings lost during Ike were likely lost as a result of this process.

Figure 3-22. Linear scour features tend to align with canals and roads as storm surge returns to the Gulf. Houses such as this one were fortunate not to be undermined and lost during Ike, as many homes undoubtedly were (Bolivar Peninsula, TX).

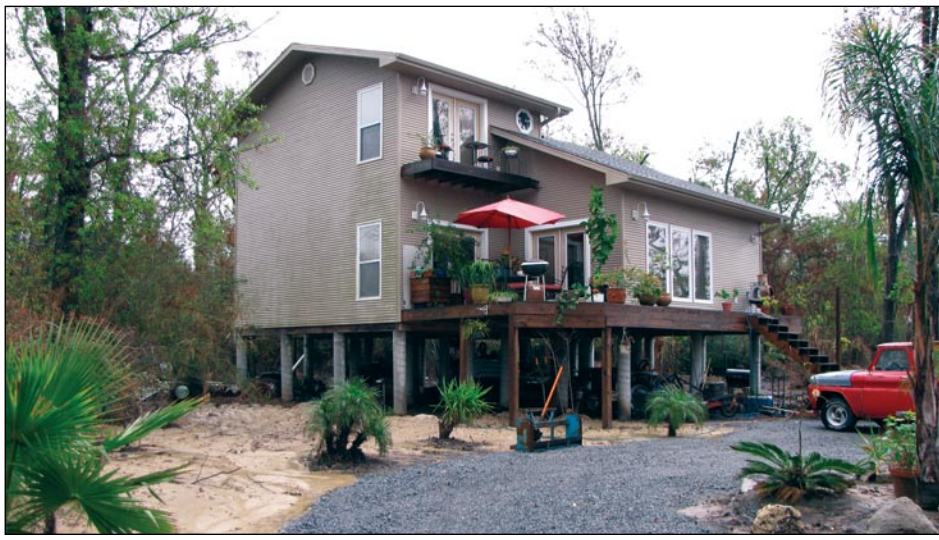
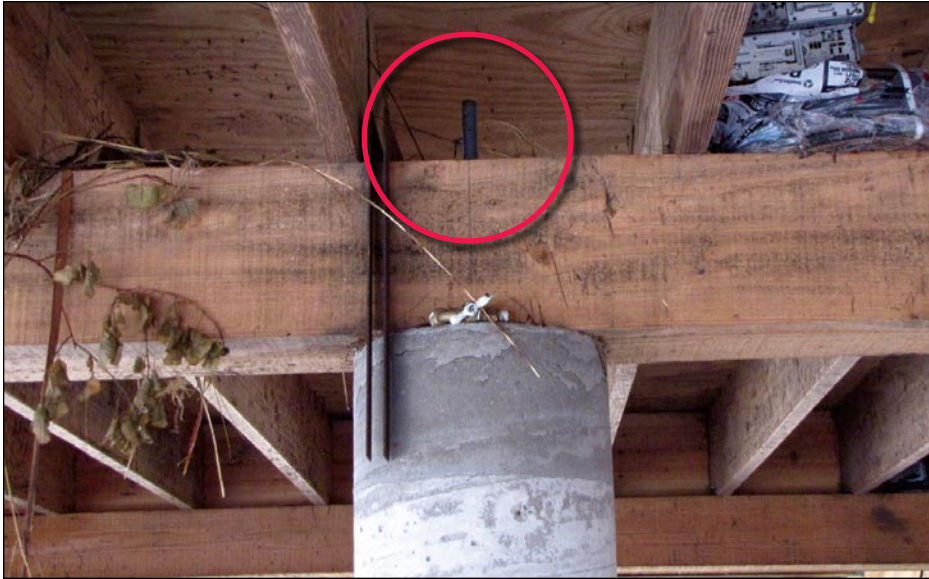
Figure 3-25.
A 5/8-inch diameter galvanized steel anchor bolt in red circle (with washer and nut, not visible in this photograph) provided connections between beam and column for the house shown in Figure 3-24. This does not appear to be an engineered connection.

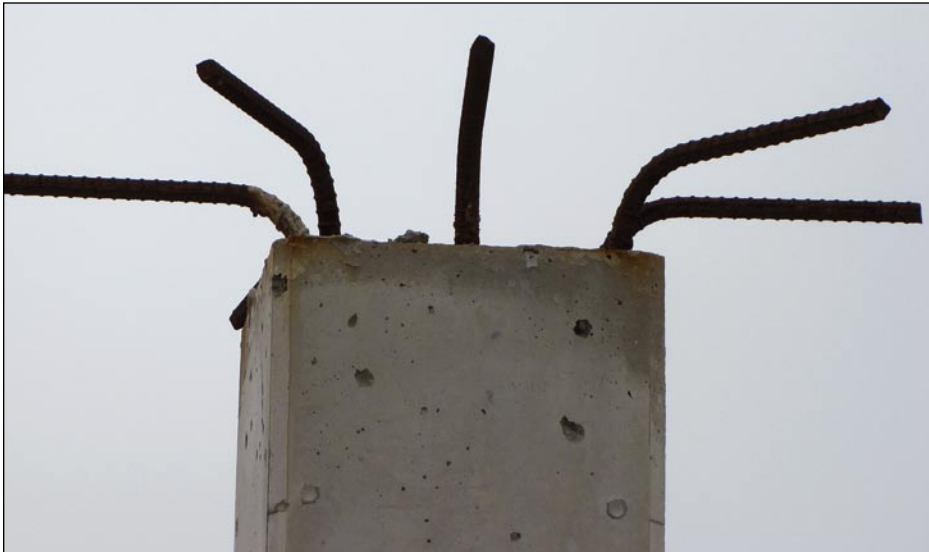
Some designs rely on connections between columns and beams to provide fixity (resistance to rotation), particularly in commercial or multi-family buildings of concrete construction. Figure 3-26 shows one such example—reinforcing steel that will extend into a concrete beam (under construction) and connect columns and beams. The cast-in-place concrete connection will provide resistance to rotation.

Figure 3-26.
Reinforcing steel extending from the top of a concrete column (building under construction) (Galveston Island, TX)

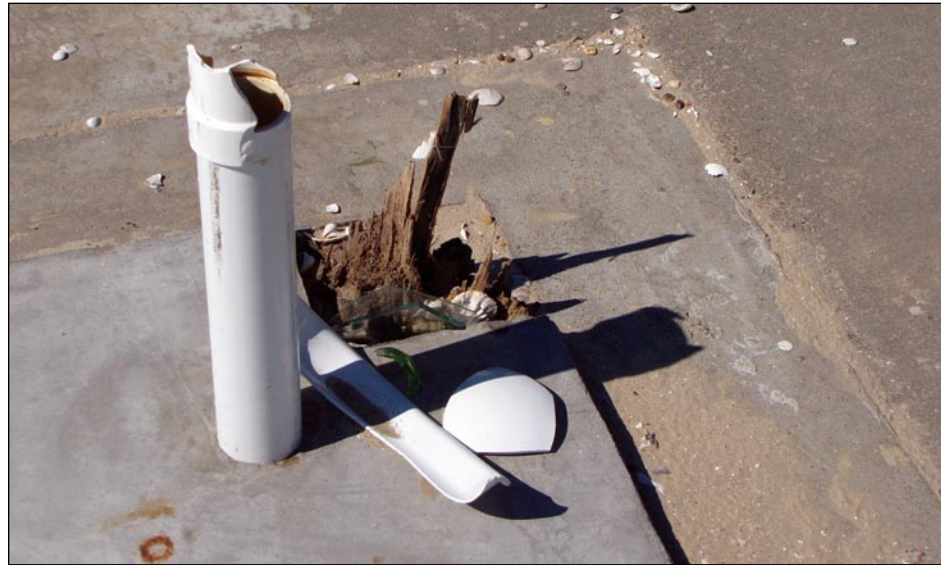
The MAT noted instances of other types of foundation load path failures, including those at the point where a column attached to a pile cap, slab, or grade beam. Deterioration of timber piles contributed to load path failures in some foundations (Figure 3-27). The deterioration could have been the result of inadequate preservative treatment or poor design/construction practice. In other cases, deterioration was observed that did not result in foundation failure during Ike; however, such a weakened foundation would be more susceptible to failure in the future (Figure 3-28).

Figure 3-28.
Deterioration in wood piling. The foundation did not fail during Ike, but it was weakened and will be more susceptible to failure in the future (Galveston Island, TX).

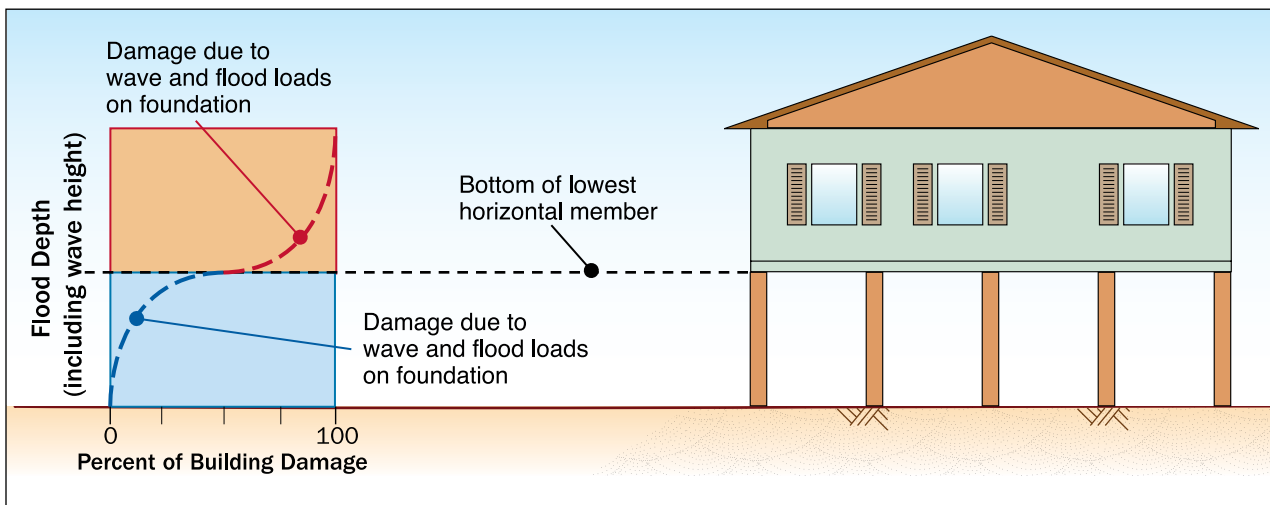
The typical wave damage patterns described above are illustrated in Figure 3-30. Damage to properly designed and constructed elevated houses is generally minor until the waves reach the elevated floor system, at which point the damage increases dramatically with increasing water level and wave height. The importance of adding freeboard—elevating above the wave crest level—is apparent (see Section 3.1.3 and the Ike Recovery Advisory, *Designing for Flood Levels above the BFE*).

Figure 3-30. Idealized depth-damage relationship for an elevated building subject to waves

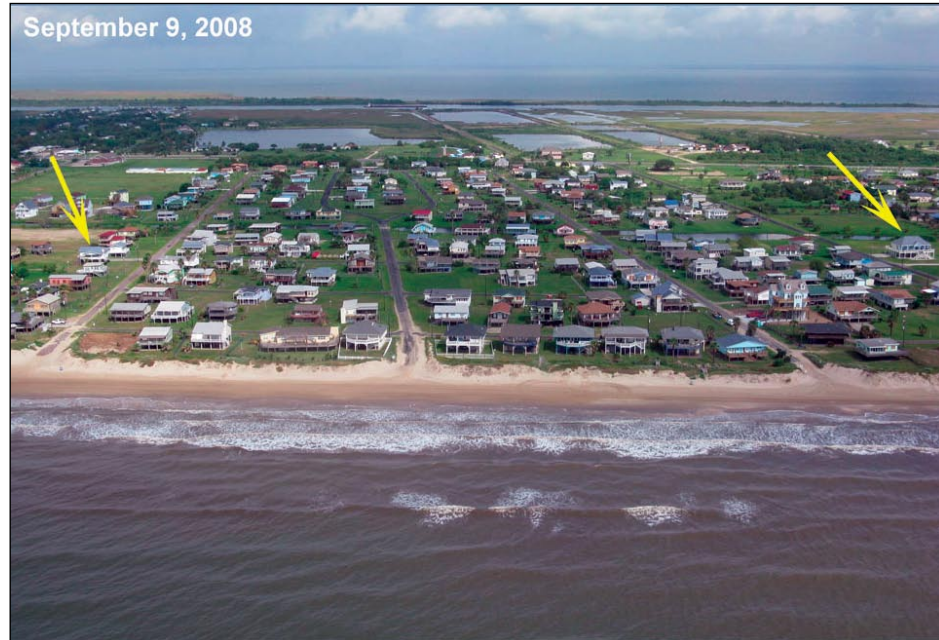
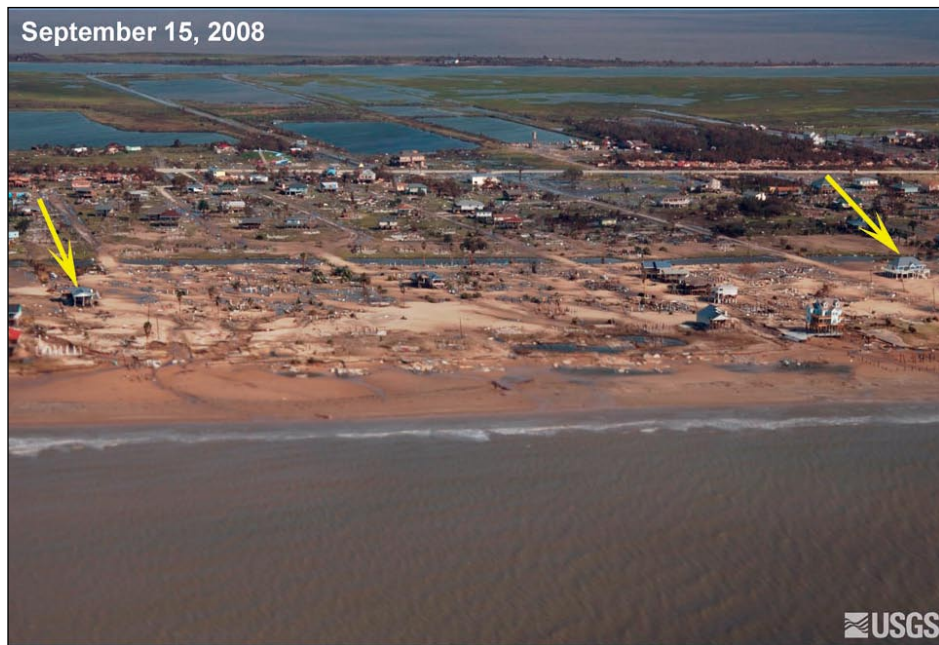
Figure 3-31 shows a comparison of pre- and post-Ike photographs for the Crystal Beach area of the Bolivar Peninsula. The Peninsula is the region where Hurricane Ike storm surge levels and wave heights appear to have reached maximums along the Gulf shoreline. Buildings along the Gulf shoreline of the Peninsula were likely subject to the greatest flood forces during Ike, and sustained the worst damage. Damage in this area has been compared to the Mississippi coast following Hurricane Katrina.

Figure 3-31.
Pre- and post-Ike aerial
photographs of the Crystal
Beach area of Bolivar
Peninsula, TX
SOURCE: USGS¹

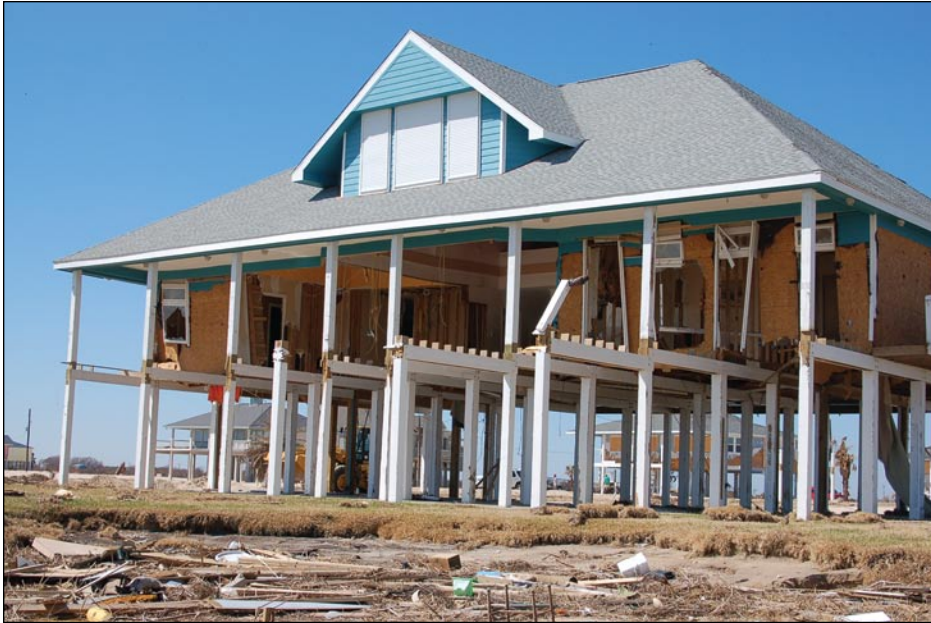
Figures 3-32 and 3-33 show examples of houses affected by waves and the inland penetration of large debris fields. The combination of waves and debris led to the destruction of many houses on Bolivar Peninsula.

Figure 3-32. Seaward side of Zone V house struck by waves. The deck, the elevated floor system, and the seaward walls were destroyed or heavily damaged (Bolivar Peninsula, TX).

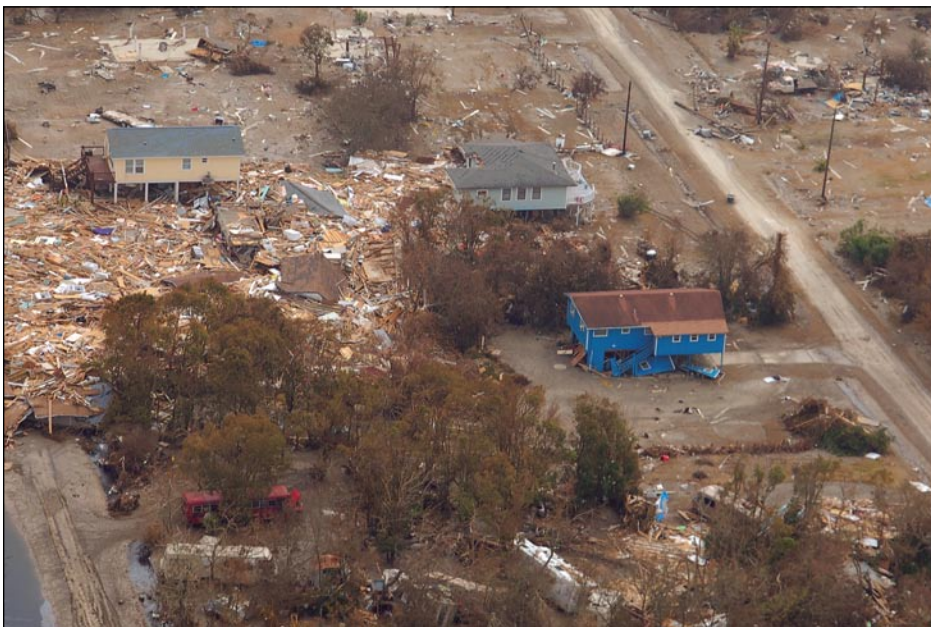
Figure 3-33. Roofs, walls, and other parts of destroyed houses washed landward to and inland of this location, approximately ½ mile from the Gulf shoreline of Bolivar Peninsula, TX

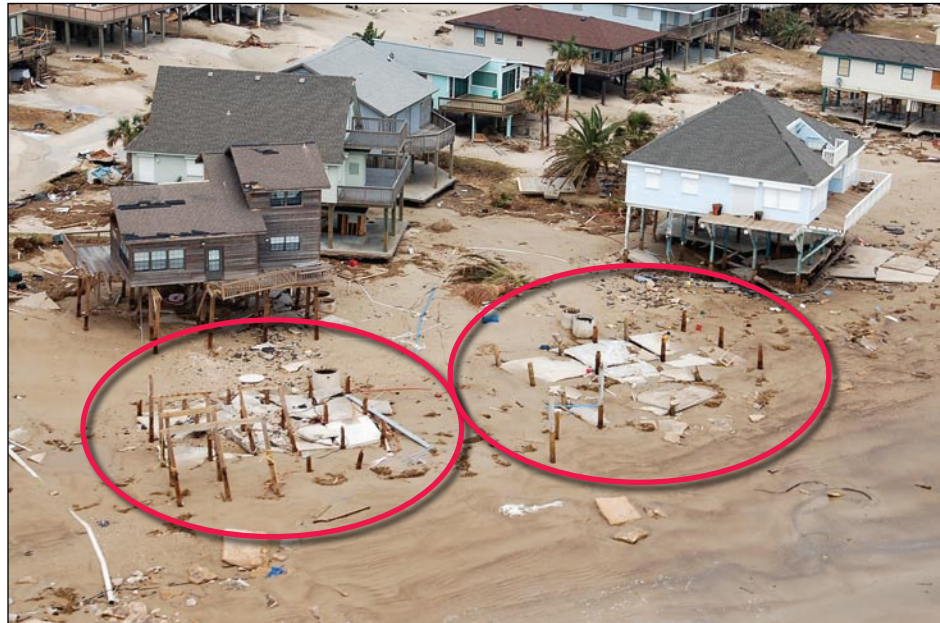
Although flood levels and wave conditions were not as severe on Galveston Island as on the Bolivar Peninsula, many houses were also lost there, largely as a result of waves and erosion. Figure 3-34 shows one example, approximately 3 miles west of the seawall, where two Gulf-front houses were lost.

Figure 3-34.
Broken piles beneath
destroyed Gulf-front
houses, Galveston Island,
TX (west of the seawall)

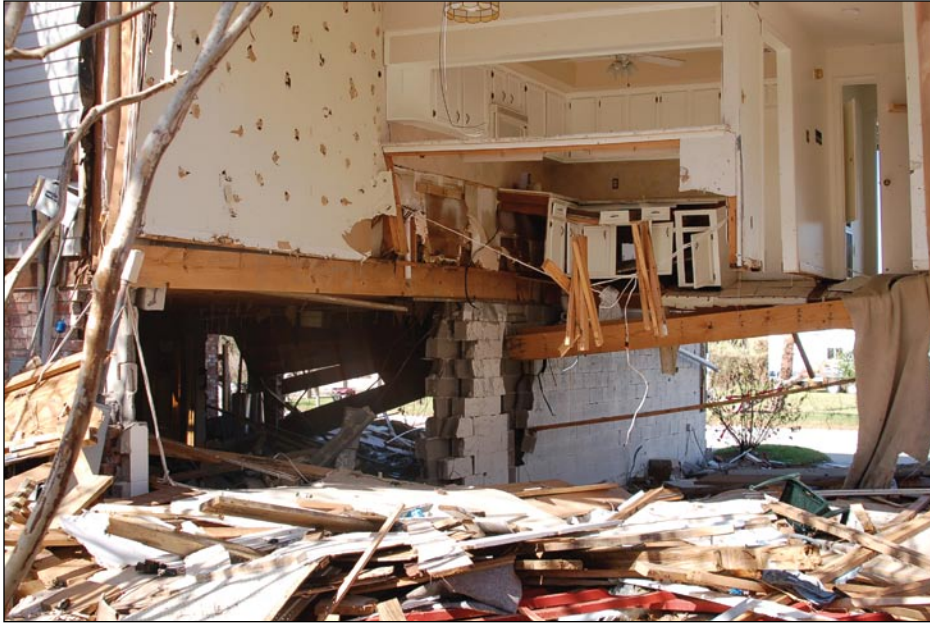
Figures 3-35 and 3-36 show examples of Ike wave damage typical for Galveston Bay, where wave heights were less than those on the Gulf shoreline. These at-grade buildings were gutted or destroyed by storm surge, waves, and floodborne debris. In both cases, nearby buildings elevated on pile foundations survived, with damage only to breakaway walls and access stairs.

Figure 3-36. Likely wave and debris damage to townhouse building along the western Galveston Bay in Seabrook, TX. The building was supported on shore-parallel masonry walls, and is landward of another building that was destroyed by Ike.

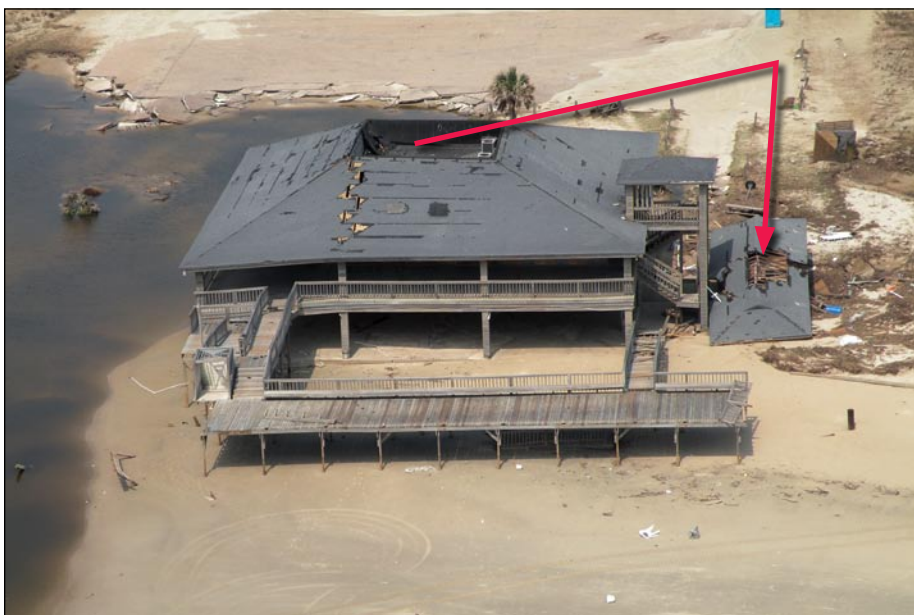
High winds are capable of imposing large lateral (horizontal) and uplift (vertical) forces on buildings (see Figure 3-38). Residential buildings can suffer extensive wind damage when they are improperly designed and constructed and when wind speeds exceed design levels. The damages shown in Figures 3-39, 3-40, and 3-41 exemplify poor design and construction, since Ike's winds were less than design levels.

Figure 3-39.
Galveston, TX, West End
Beach house with roof
structure removed by
Hurricane Ike.
The cause of the failure
is unknown, but Ike wind
speeds in this area were
below design speeds
(Hurricane Ike estimated
wind speed in this area: 93
mph, Exposure C).

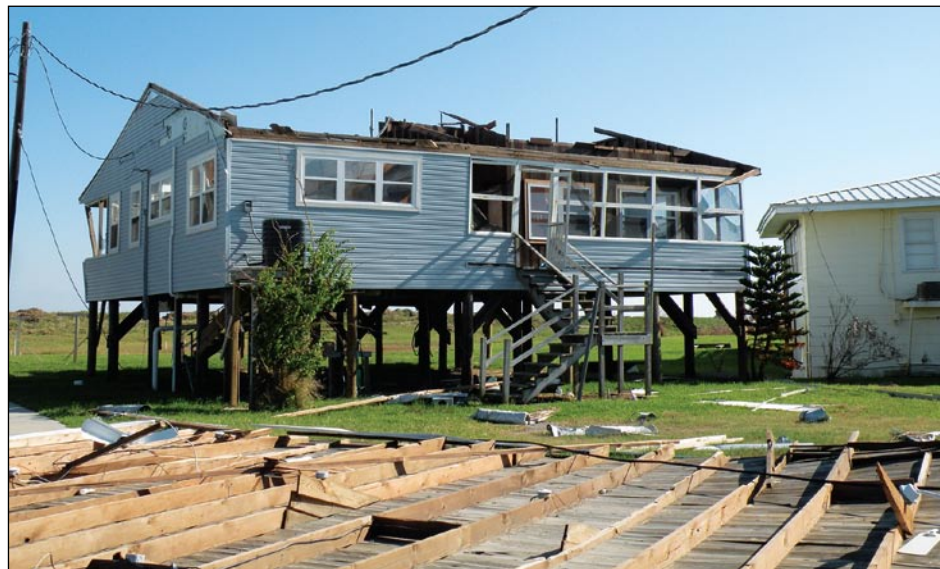
Figure 3-41.
The roof structure was poorly connected to this house in Grand Isle (Jefferson Parish, LA) and was blown off by 50-mph Ike winds (Exposure B)

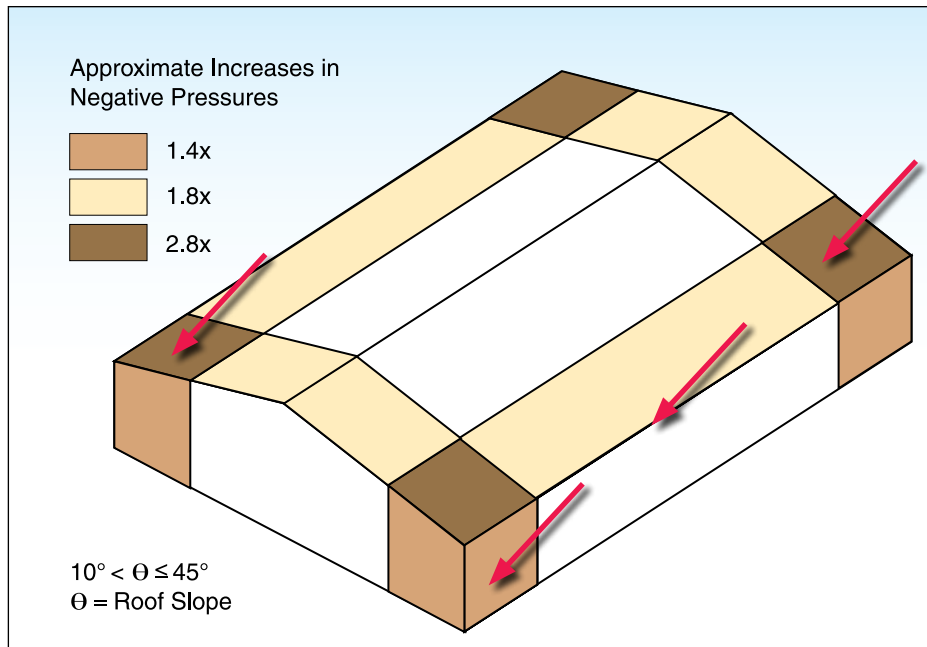
Figure 3-42. Areas of roof covering loss (red arrows) indicate zones of higher wind pressure on a roof

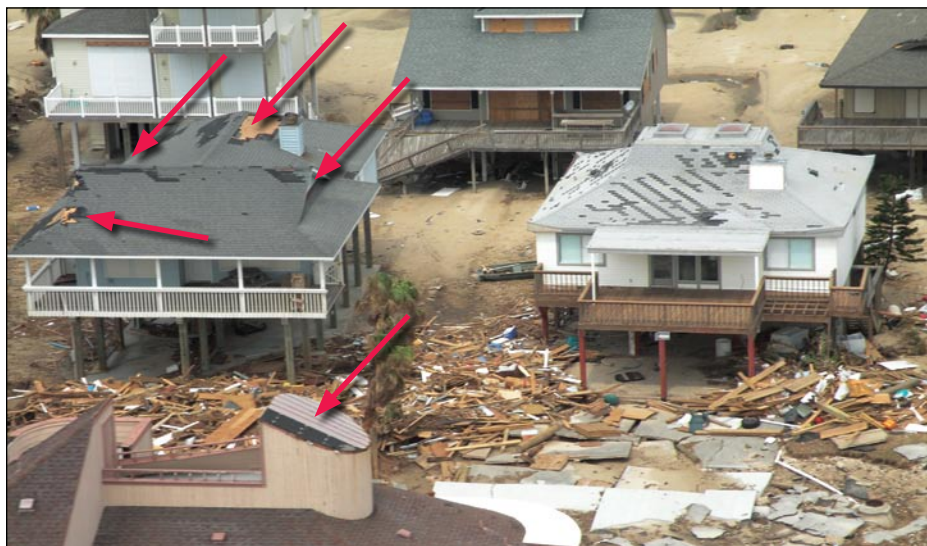
Figure 3-43. Galveston, TX, West End Beach house with roof damage in high pressure zones (Hurricane Ike estimated wind speed in this area: 95 mph, Exposure C)

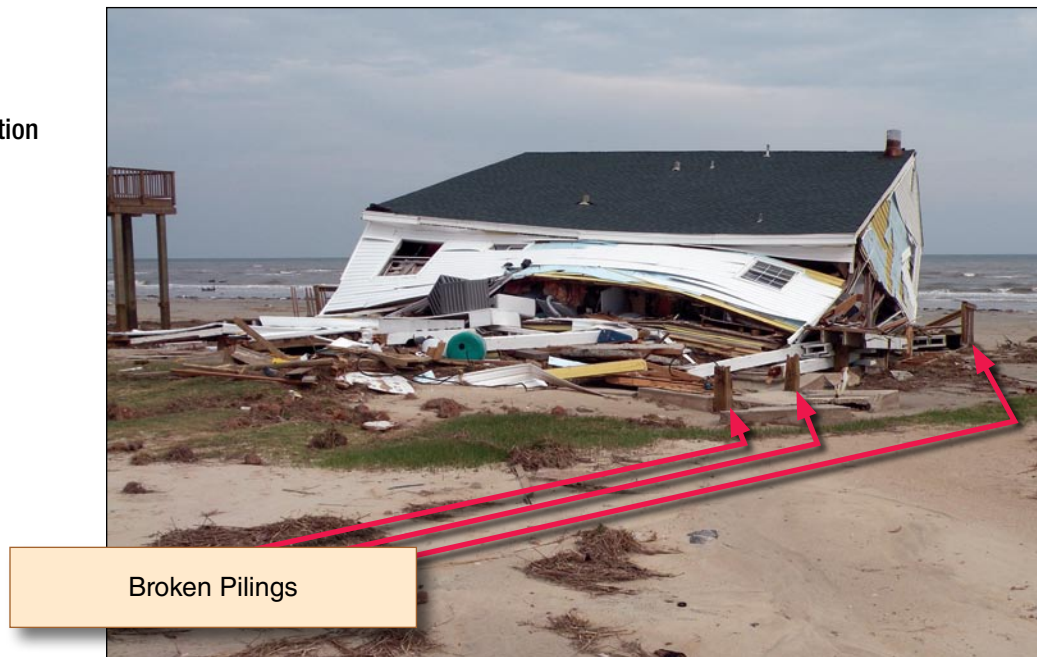
Figure 3-47 shows a house on western Galveston Island that collapsed during Ike. High water levels and waves acted on the foundation while winds (blowing from land toward the Gulf of Mexico) pushed the house seaward. The result was a foundation failure—the foundation could not provide the required load path continuity to the ground without breaking.

Figure 3-47.
Collapse of a West
Galveston Island, TX,
house due to foundation
failure

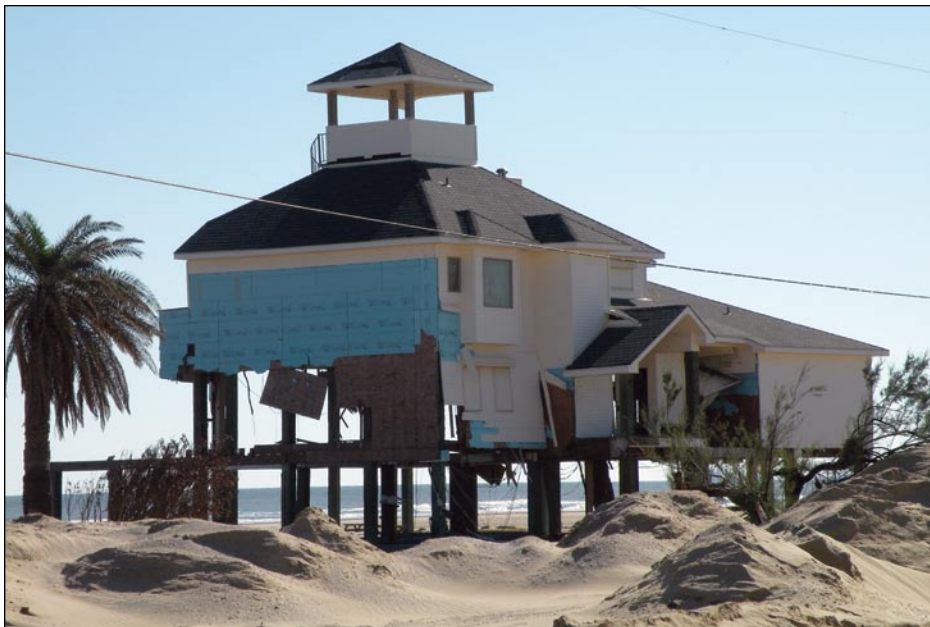
Figure 3-48 shows a house on Bolivar Peninsula that remained standing although severely damaged by surge, waves, and wind. The house survived because its MWFRS and foundation load paths remained intact.

Figure 3-48. Though much of the cladding and structural sheathing was destroyed by Ike's surge, the MWFRS of this Bolivar Peninsula, TX, beach house remained intact and connected

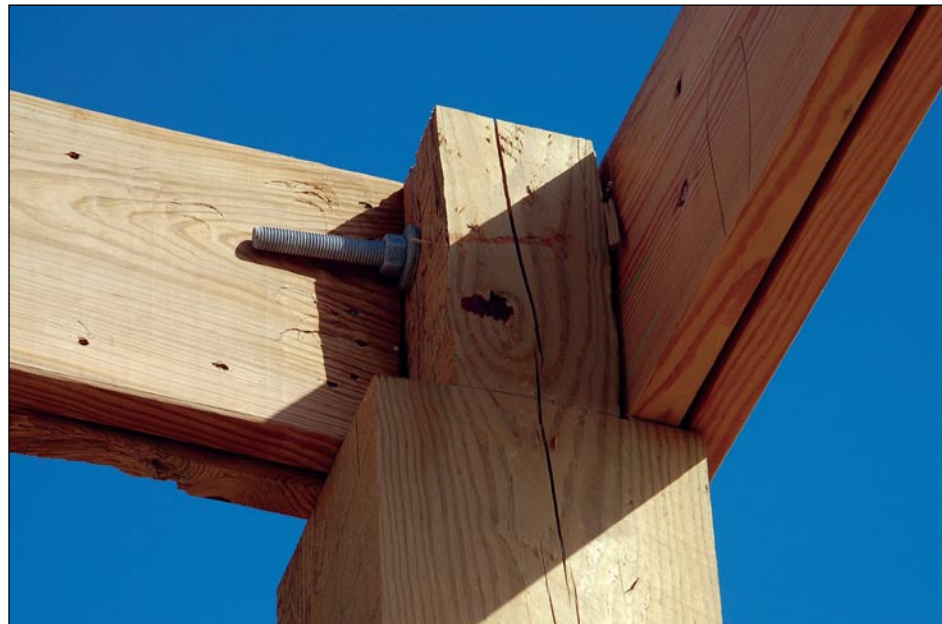
Piling connections to floor beams of elevated structures were routinely observed by the MAT. However, unless the building was substantially damaged or under construction, most load path connections of wall and roof structural elements were covered by building finishes and not visible for inspection. Some beam-to-piling connections were found to be strong and robust as seen in Figures 3-49 and 3-50. Many others were weakly connected with nails, too few bolts, or columns weakened by deep mortises (Figures 3-51).

Figure 3-51.
Poor beam connection to
corner column
