3 Performance of Residential Buildings (Flood and Wind), One- to Two-Family and Multi-Family

3.1 Structural Performance

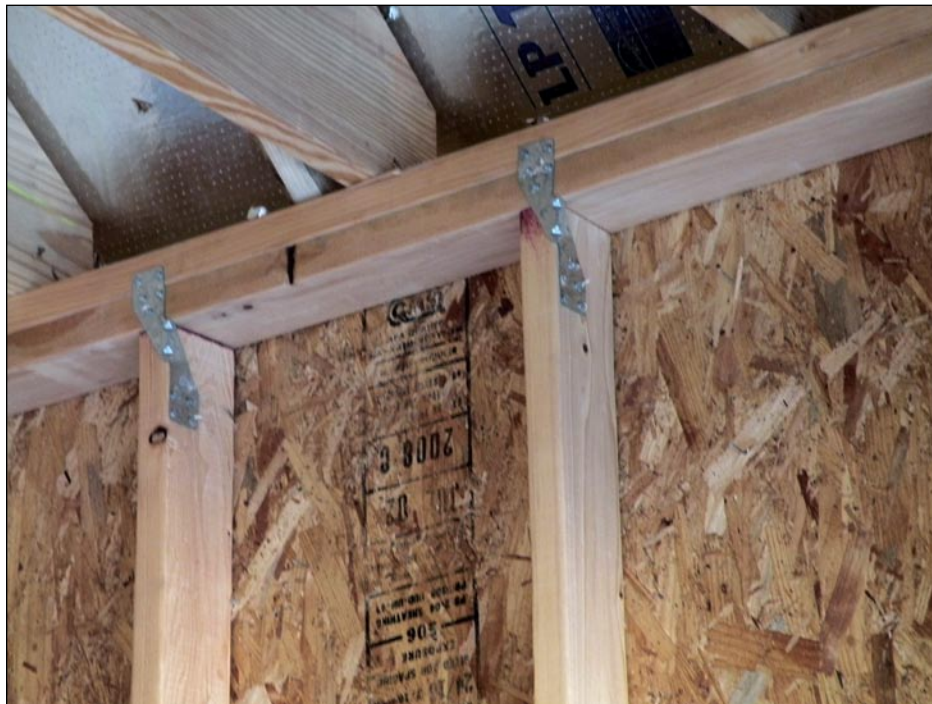
Figure 3-53. Studs clipped to double top plate; rafter-to-top plate connector has yet to be installed. Better framing practices could have avoided some of the problems shown in this photo. Ceiling joists are not well nailed to the rafter and may twist in the future. The builder did not take advantage of aligning wall framing and rafter framing to simplify connections for wind loads.

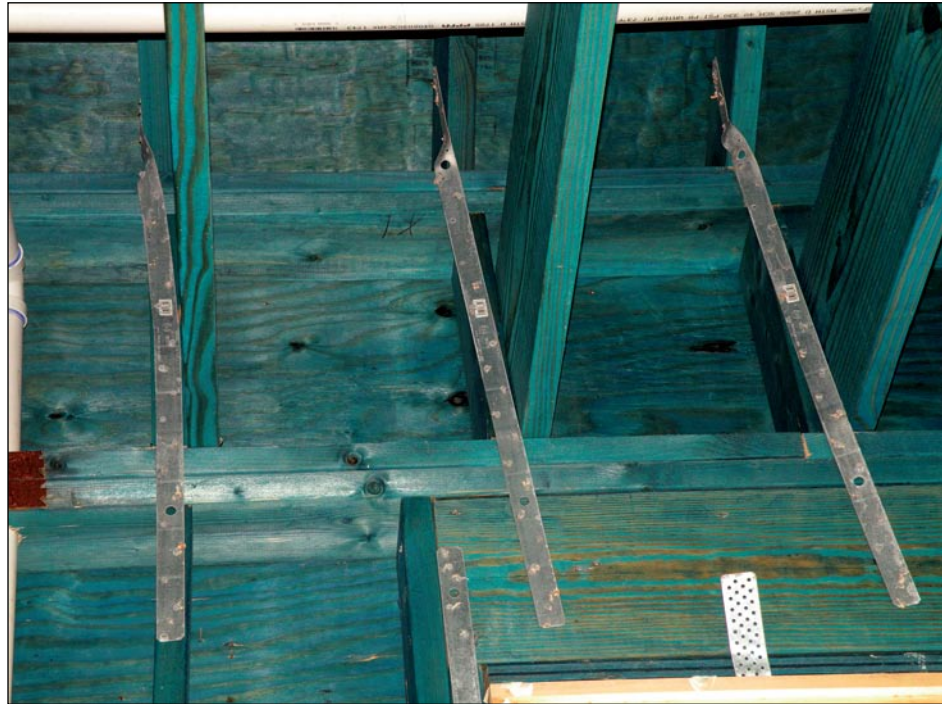
Figure 3-54.
Wall-to-roof strapping.
Details for uncommon framing details should be specifically provided by the designer on building plans, including specifying the specific connection and application to ensure a continuous load path.

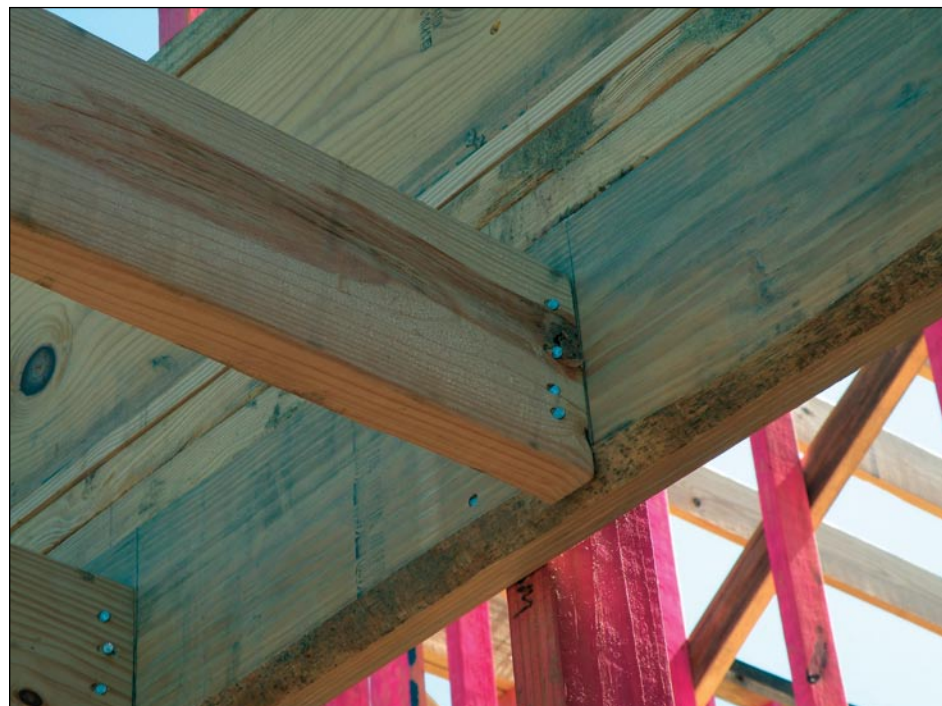
Figure 3-55.
Toe-nailed connection
of floor joists on band
beam on house under
construction. Floor joist
should be installed using
either galvanized metal
joist hangers or ledger
beams (LaPorte, TX).

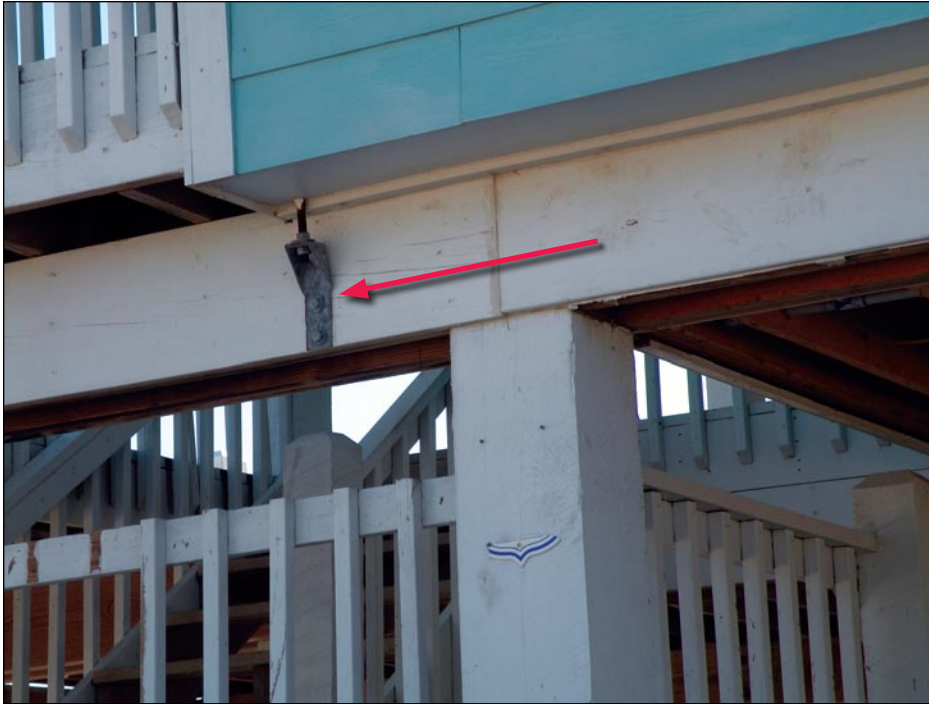
Figure 3-56. Existing house shear wall connector incorrectly located (red arrow). Connector should be located on column line or the beam and beam-to-column connection should be designed to resist the uplift load, which is carried by a nailed connection in the absence of bolts (Sunset Crystal Beach, Bolivar Island, TX).

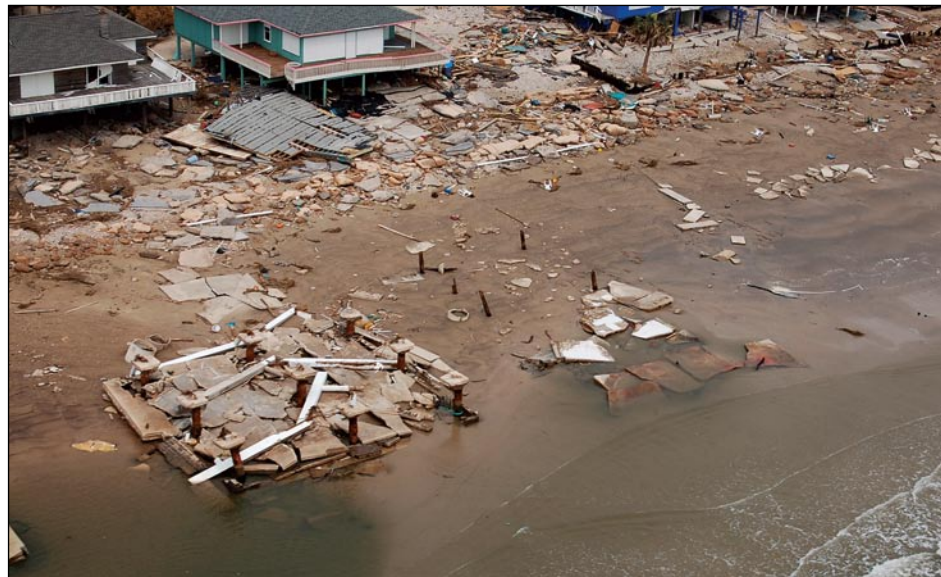
The greatest damage occurs in the area closest to the water since buildings and infrastructure situated there are subject to the most extreme flood forces and conditions during a hurricane, i.e., the highest waves and the greatest erosion (Figures 3-57 and 3-58). Buildings situated closest to the shoreline are also at greatest risk for the effects of long-term erosion, sea level rise, and other long-term changes affecting the shoreline (see Surfside Beach text box).

Figure 3-57.
Post-Ike photograph of West Galveston Island, TX, illustrating increased severity of flood damage near the shoreline

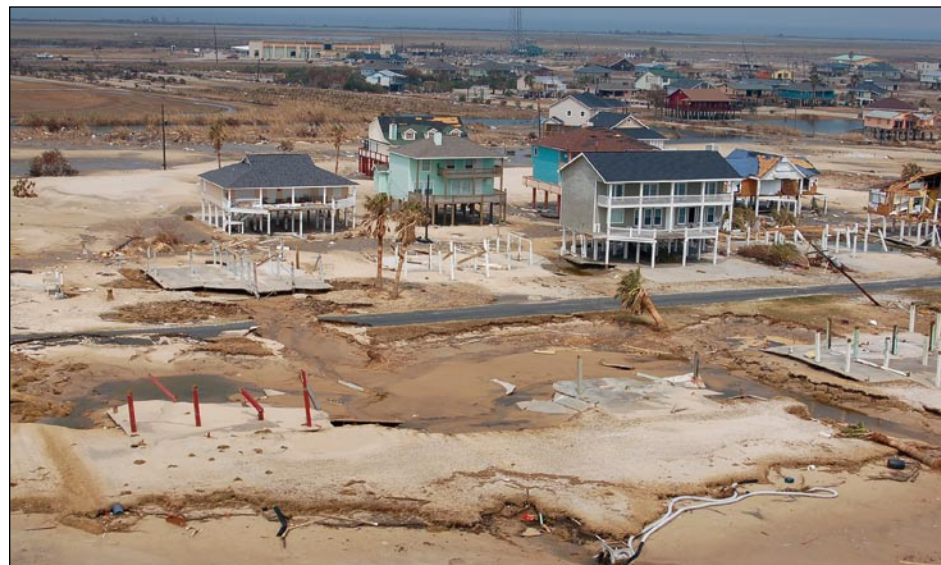
Figure 3-58.
Post-Ike photograph of Bolivar Peninsula, TX, illustrating increased severity of flood damage near the shoreline

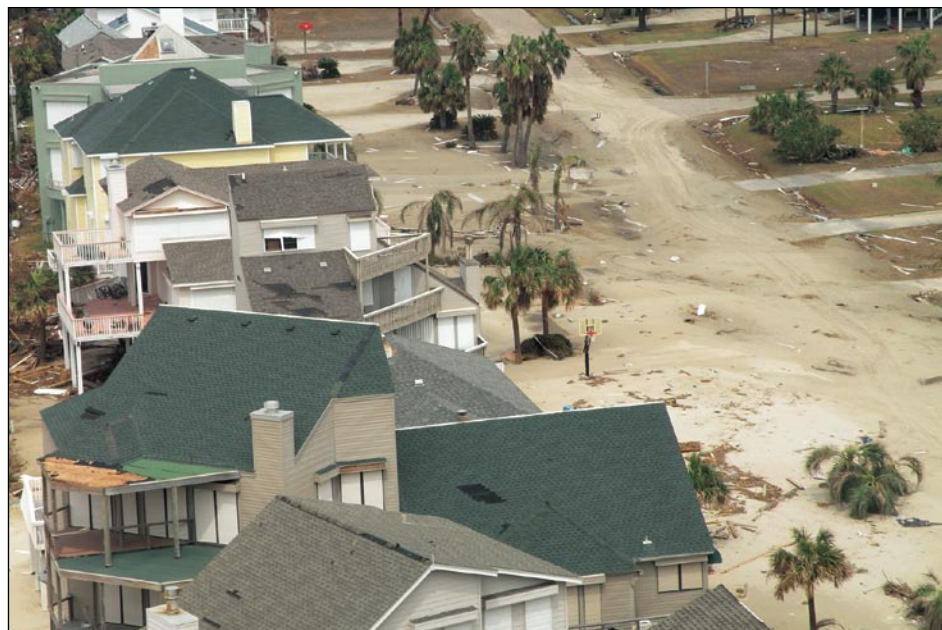
The extent and magnitude of envelope damage observed by the MAT was greater than would be anticipated given that the estimated actual wind speeds of Hurricane Ike were less than the design speeds given by ASCE 7-05 and IRC 2006. The poor performance of the newer houses is therefore related to the lack of contractor knowledge of proper hurricane construction, material installations not conforming to manufacturer's requirements for hurricane zones, and poor code enforcement.

Figure 3-59.
A substantial amount of siding (the white lines scattered around the ground), along with roofing materials, blew off these West Galveston, TX, houses (Hurricane Ike estimated wind speed in this area: 90 mph)

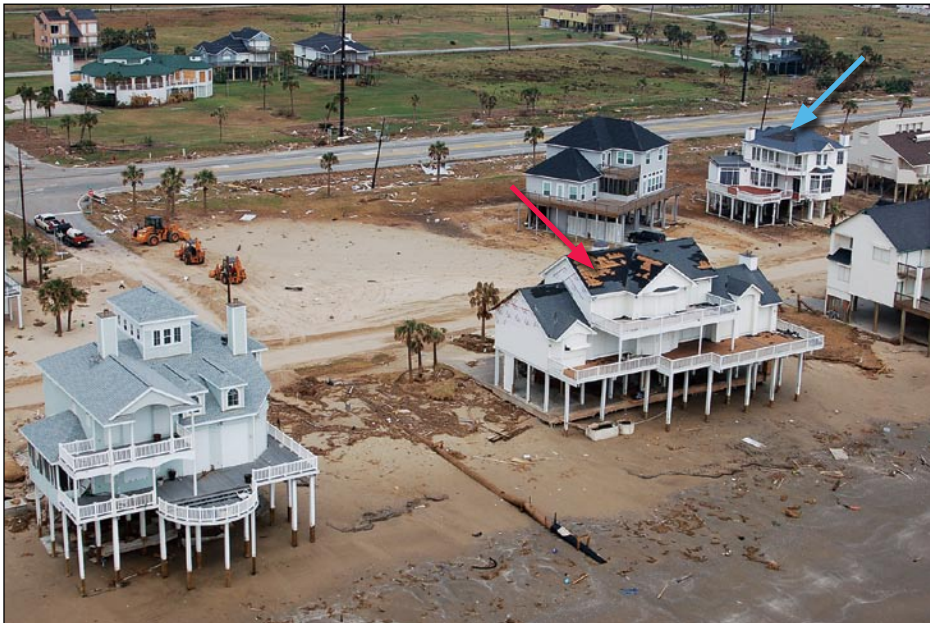
Figure 3-60. Some of the roofs on these Jamaica Beach, TX, houses had no roof covering damage, while one had moderate damage (blue arrow) and one had extensive damage, including loss of underlayment (red arrow) (Hurricane Ike estimated wind speed in this area: 90 mph)

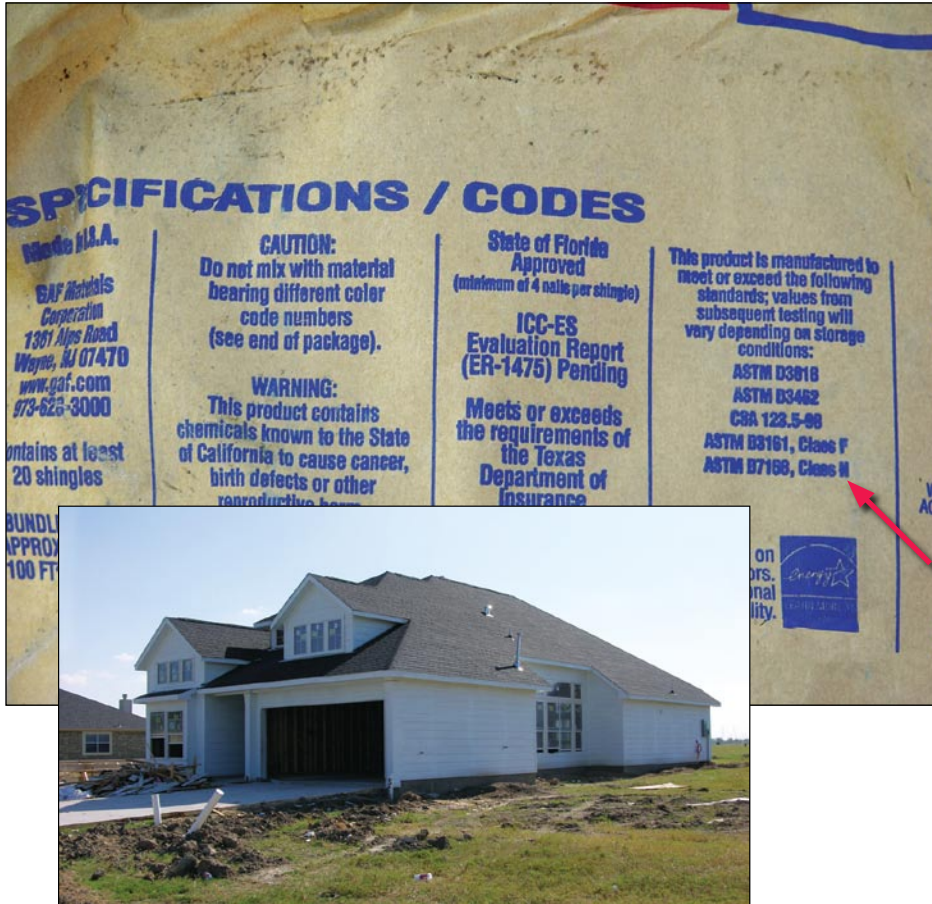
Figure 3-61 shows a shingle bundle wrapper at a house under construction at the inset in Figure 3-61. The shingle bundle wrappers indicate the shingles meet Class H (i.e., suitable for up to 150 mph). The IRC/ASCE 7 design wind speed for this location is 120 mph, hence use of a Class G shingle would have been sufficient. This is the first and only house observed by a MAT wherein it was known that shingles meeting one of the new Class ratings was installed. There was no apparent wind damage to this house.

Figure 3-61. View of a shingle bundle wrapper at the Webster, TX, house shown in the inset. This shingle has a Class H rating (red arrow) (Hurricane Ike estimated wind speed in this area: 104 mph).

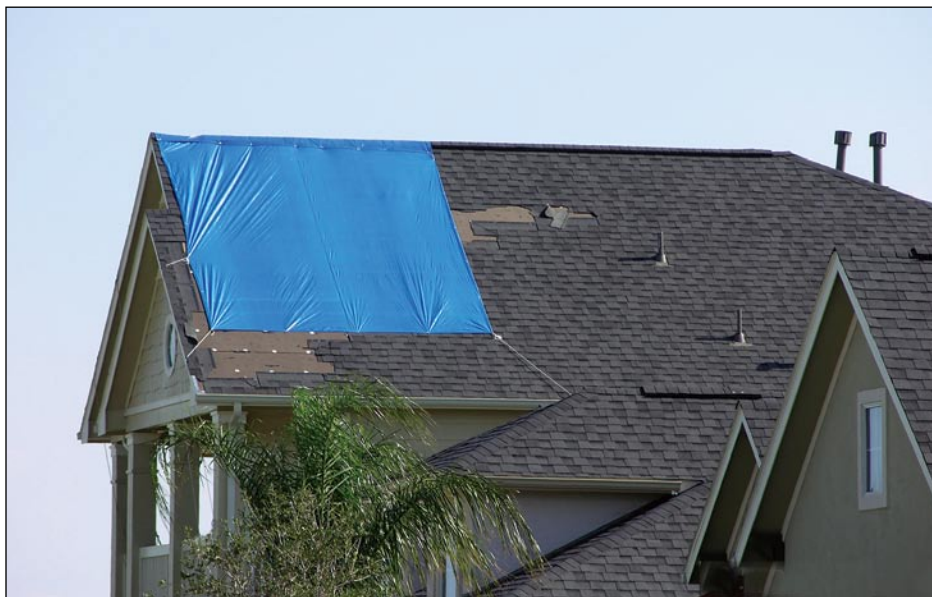
The newly constructed house shown in Figure 3-62 is on the same block as the one shown in Figure 3-61. Bleeder strips were installed along the rake; however, as discussed in Section 5.4.1.3 of the Katrina MAT report (FEMA 549), unless the shingles are hand-tabbed as described in Technical Fact Sheet 20, bleeders do not provide reliable securement.

Figure 3-62. Shingle damage at a house near the one shown in Figure 3-61 (Webster, TX)

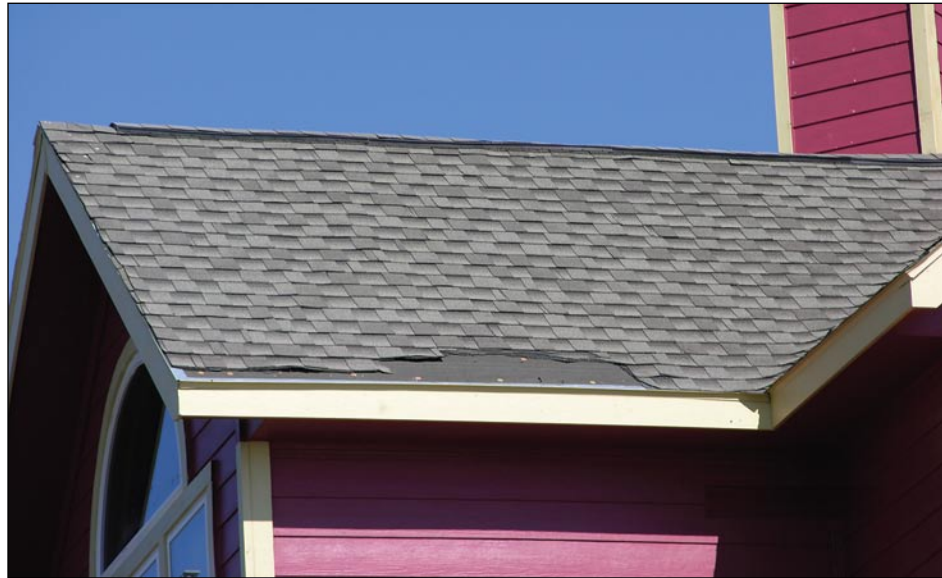
Figure 3-63 shows a house under construction on Bolivar Peninsula that lost shingles along the eave (it is also shown on the front cover of this report). Failure along eaves commonly occurs because of incorrect application of the starter course and lack of hand-tabbing (as recommended in Technical Fact Sheet 20). For further discussion of eave issues, see Section 5.4.1.2 in FEMA 549.

Figure 3-63.
Loss of shingles along the eave in Bolivar Peninsula, TX (Hurricane Ike estimated wind speed in this area: 110 mph)

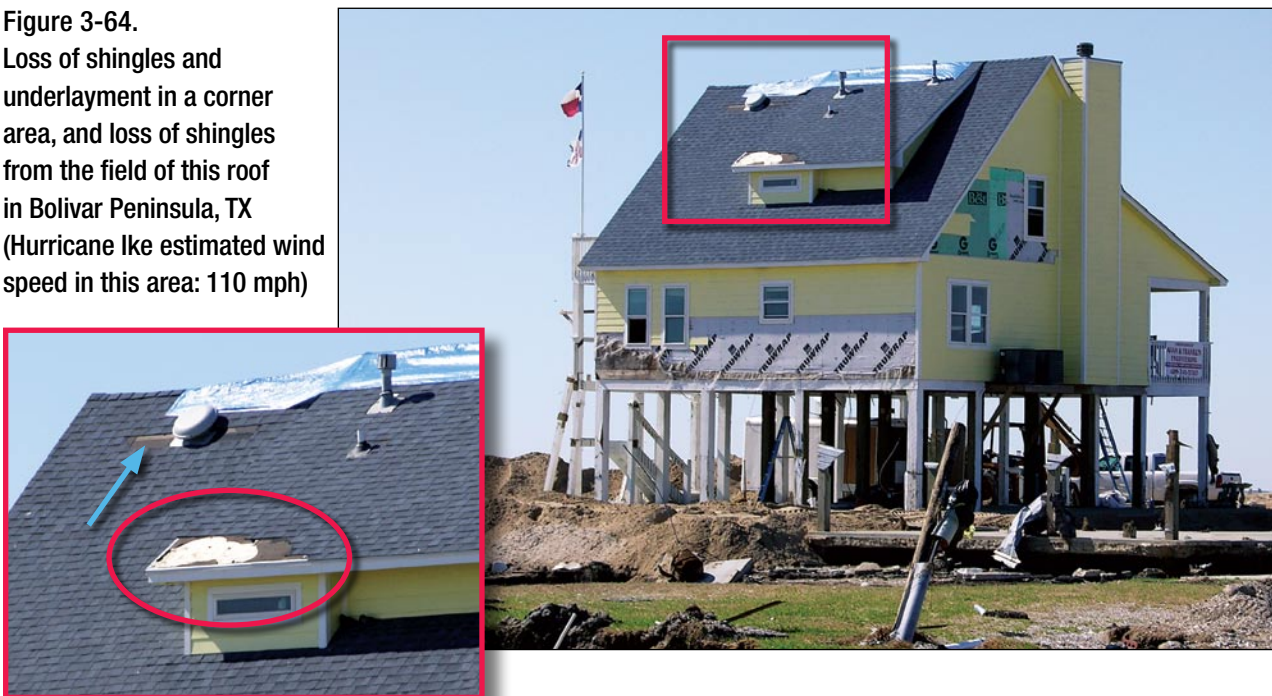
Figure 3-64 shows a house that was reportedly constructed in 2005 on Bolivar Peninsula. It lost shingles and underlayment at a corner area (red circle at the inset) and shingles in the field of the roof near the exhaust fan (blue arrow). Loss of shingles was likely due to lack of hand-tabbing. These shingles reportedly met Class F.

Figure 3-64.
Loss of shingles and underlayment in a corner area, and loss of shingles from the field of this roof in Bolivar Peninsula, TX (Hurricane Ike estimated wind speed in this area: 110 mph)

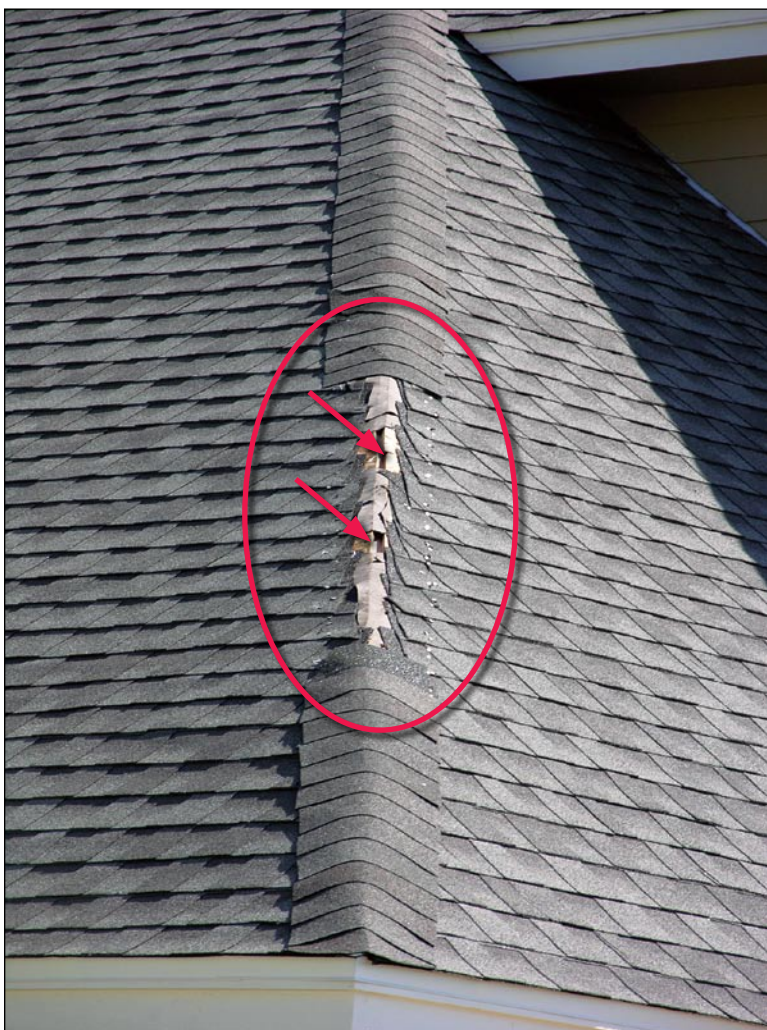
Figure 3-65.

Figure 3-65 shows a house under construction on Bolivar Peninsula. It lost shingles along the hip. Also, at areas along the exposed hip, either the underlayment did not completely lap over the hip line, or if it did, portions of the underlayment blew away. Water could leak into the building in the vicinity of the two red arrows. Unless hip and ridge shingles are hand-tabbed, as recommended in Technical Fact Sheet 20, they are very susceptible to blow-off (for further discussion, see Section 5.4.1.1 in FEMA 549).

Loss of hip shingles and portions of the underlayment in Bolivar Peninsula, TX (Hurricane Ike estimated wind speed in this area: 110 mph)

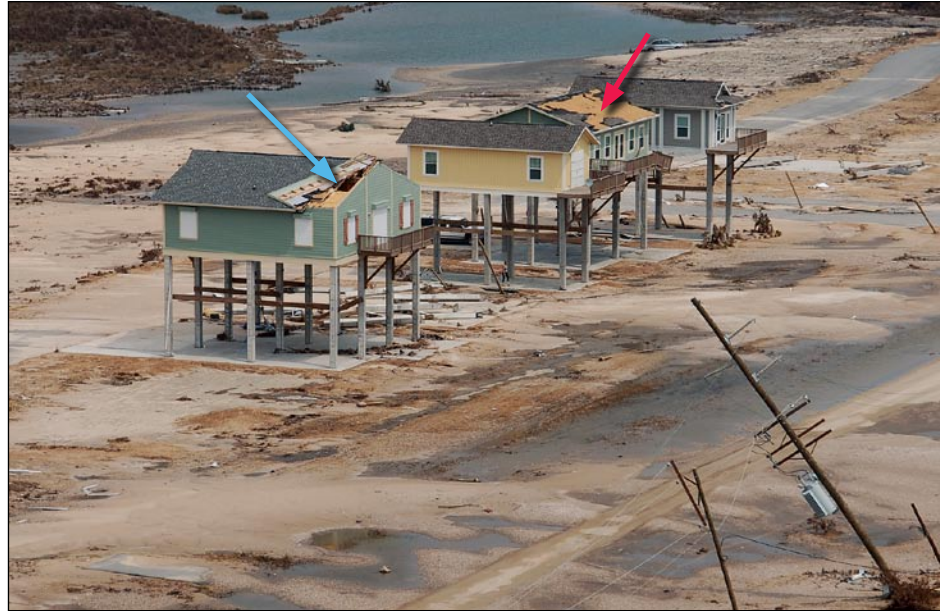
As shown in Figure 3-66, some of the roof coverings had no apparent damage, but the shingles and underlayment were blown off of one roof (red arrow). Also, a portion of the roof overhang blew off of one of the houses (blue arrow). When the MAT observed blow-off of roof framing and/or sheathing, it typically occurred on older buildings, rather than new construction.

Figure 3-66.
 Roof covering and roof structure damage at *Fortified... for safer living*[®] houses in the Audubon Village area on Bolivar Peninsula, TX (Hurricane Ike estimated wind speed in this area: 110 mph)

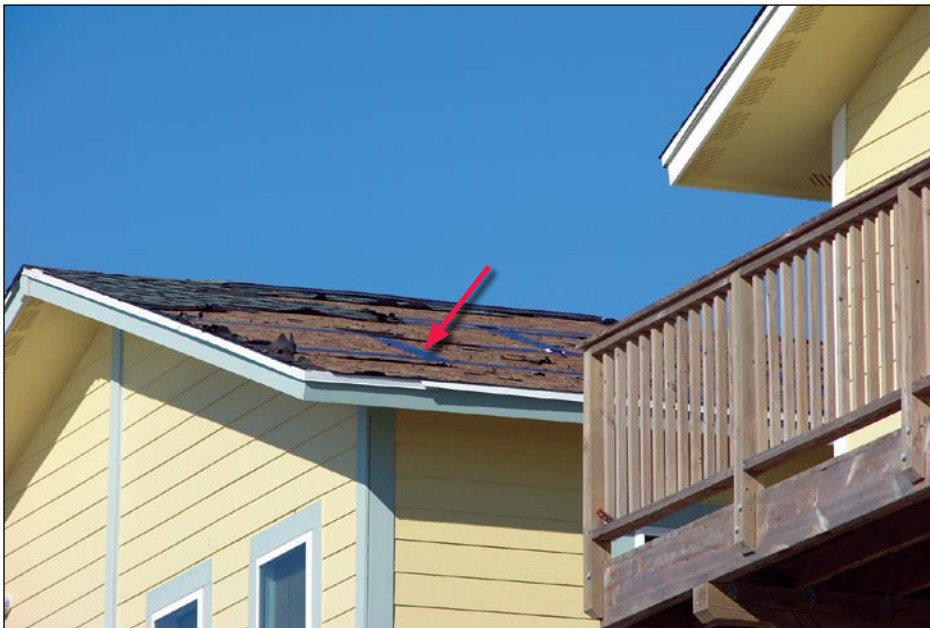
Several of the *Fortified...for safer living*[®] houses that lost underlayment had taped joints, including the one shown in Figure 3-67. However, as shown in Figure 3-68, the taping was not effective. Observations by IBHS investigators revealed application problems with the tape. Staples were used to attach the tape because bonding problems were experienced during application. Apparently the applicator did not realize the tape was intended to prevent water from leaking through the sheathing joints. With the tape in an un-bonded and wrinkled condition, it was incapable of fulfilling its intended purpose. Self-adhering modified bitumen roof tape normally bonds quite well to sheathing. Bonding problems are commonly attributed to dust on the sheathing,

Figure 3-67.
This *Fortified...for safer living*[®] house had taped sheathing joints (red arrow)

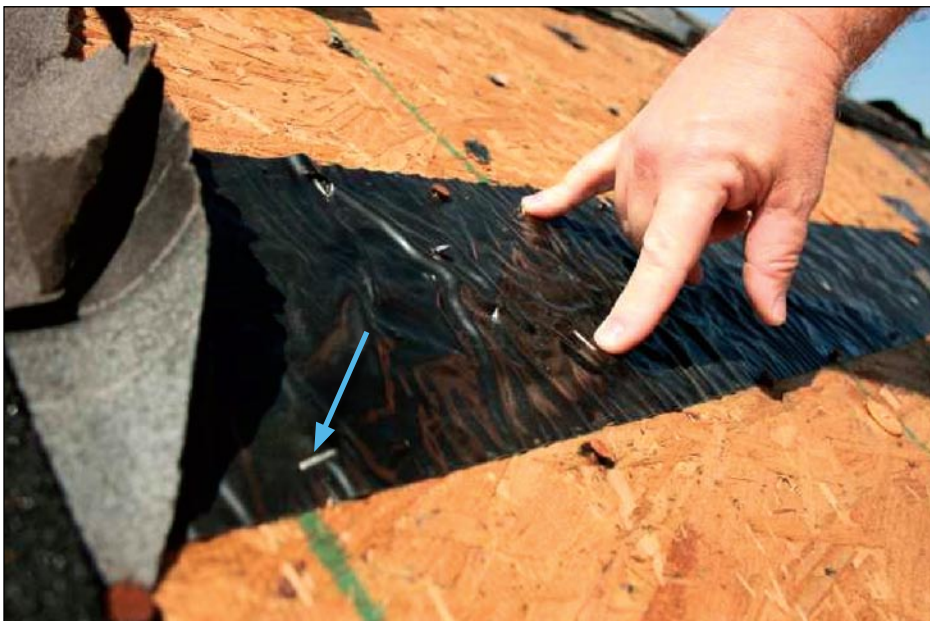
wet sheathing, a surfacing on the sheathing that interfered with the bonding, or using inappropriate tape. According to IBHS, problems with bonding self-adhering modified bitumen to oriented strand board (OSB) had been previously experienced at a demonstration project. In evaluating that demonstration project, IBHS discovered that although the OSB manufacturer had recommended application of a primer before installation of the self-adhering modified bitumen because of the presence of a wax on the OSB, a primer had not been installed.

Figure 3-68.
This tape did not provide a watertight seal. Note the wrinkles (which allow water migration) and the staples (blue arrow) that were used to attach the tape (Audubon Village, TX).
CREDIT: IBHS

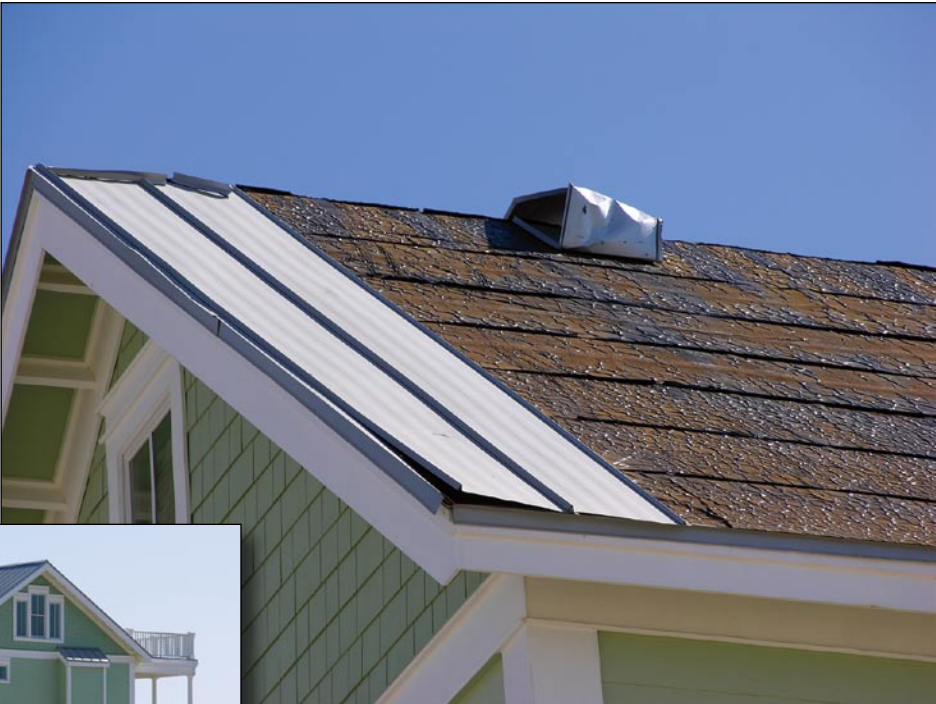
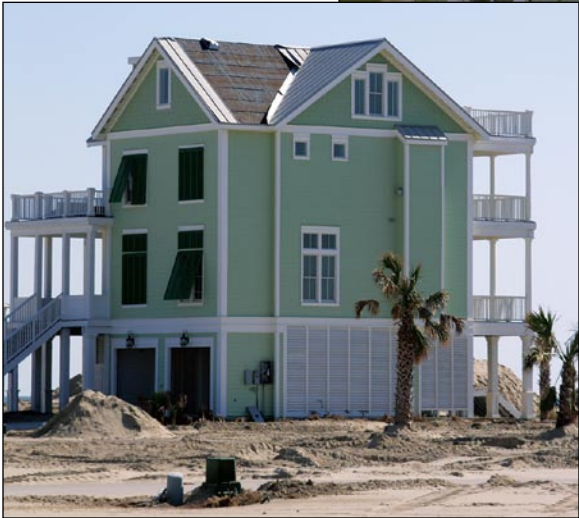
Figure 3-69. These snap-lock seam panels were attached with fasteners through one side of the seam (Galveston Island, TX; Hurricane Ike estimated wind speed in this area: 110 mph)

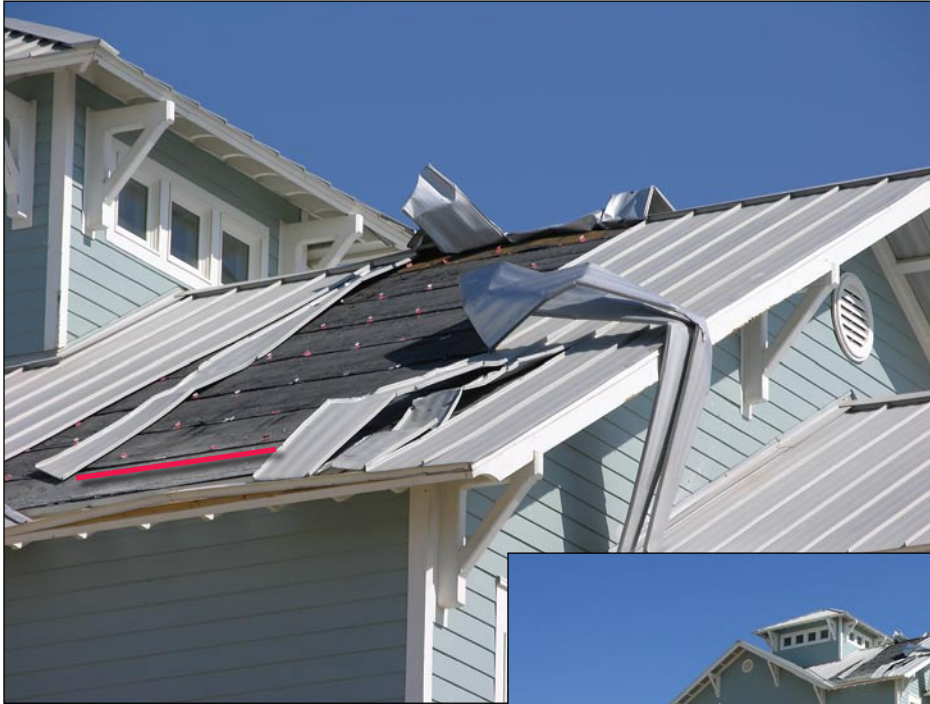
The panels shown in Figure 3-70 were attached with concealed clips, which unlatched from the panels. The first row of clips (just above the red line) was several inches from the end of panels; this first row should have been within a few inches from the eave.

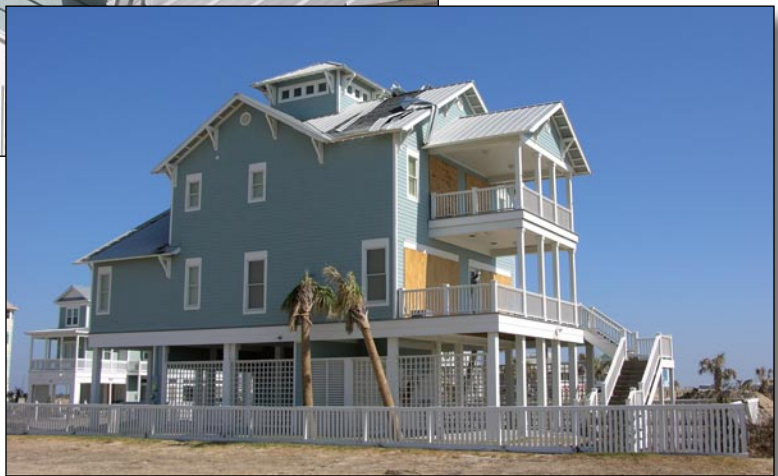
Figure 3-70. These architectural metal panels unlatched from the concealed clips. The red line shows location of the first row of clips (Galveston Island, TX; Hurricane Ike estimated wind speed in this area: 110 mph).

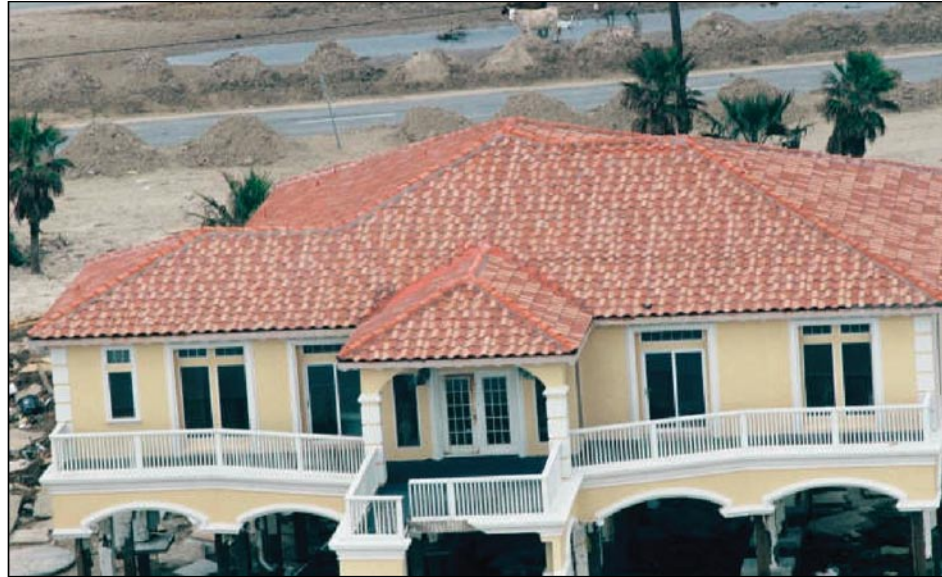
Figure 3-71.
This tile roof on Galveston Island, TX, did not experience any wind damage (Hurricane Ike estimated wind speed in this area: 106 mph)

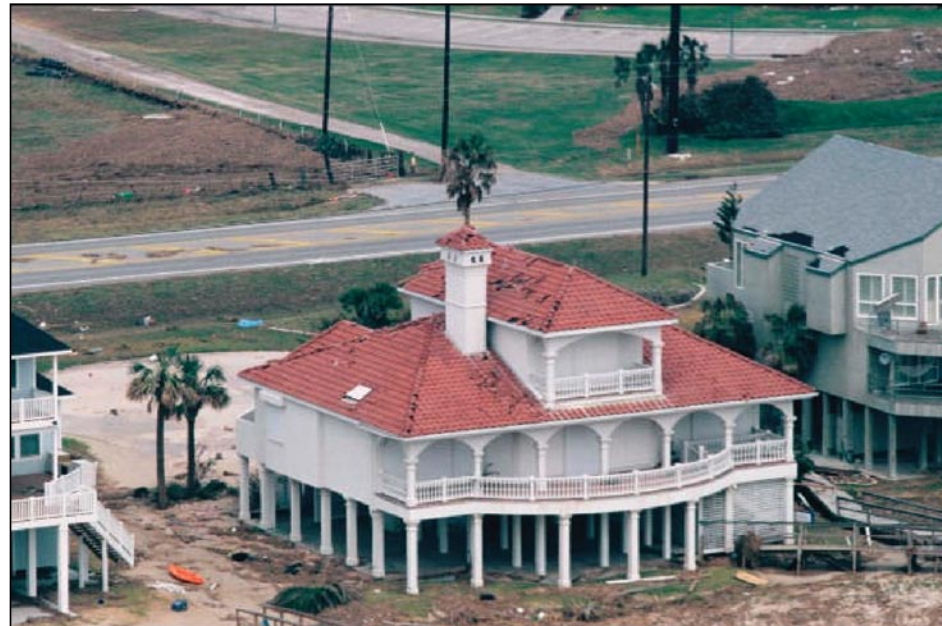
The MAT observed very few tile roofs. As with asphalt shingles and metal panels, the performance was quite varied. Figures 3-71 and 3-72 show two houses along the coast of Galveston Island. The roof shown in Figure 3-71 was observed from the air and ground. No tile damage (including hips) was observed. Figure 3-72 shows damage at hips, the eave, and the field (which was likely caused by windblown eave and/or hip tiles).

Figure 3-72.
This tile roof on Galveston Island, TX, experienced hip, eave, and field damage (Hurricane Ike estimated wind speed in this area: 106 mph)

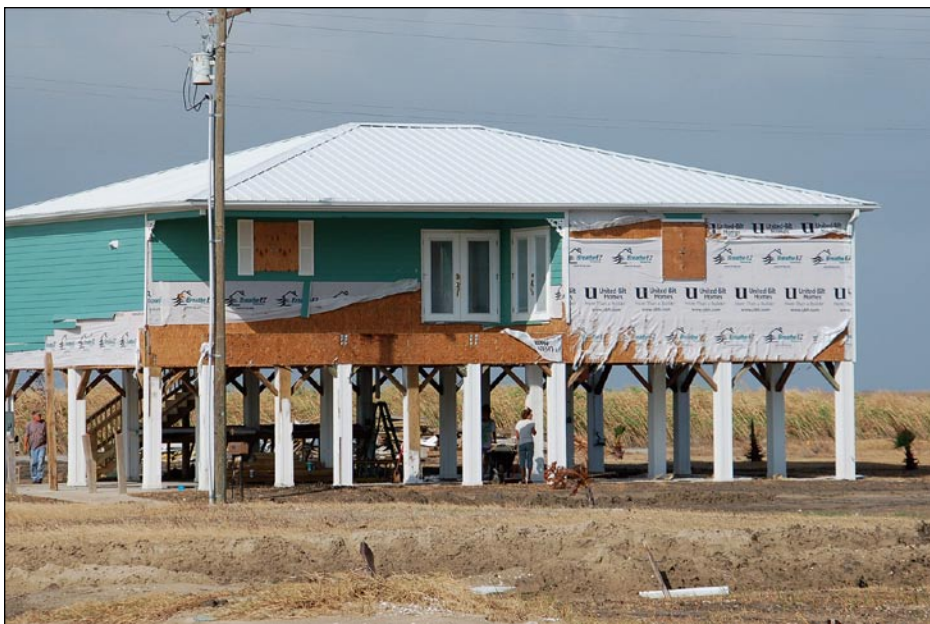
Figure 3-74.
Loss of siding at Holly Beach, LA, home (Cameron Parish; Hurricane Ike estimated wind speed in this area 80 mph, Exposure C)

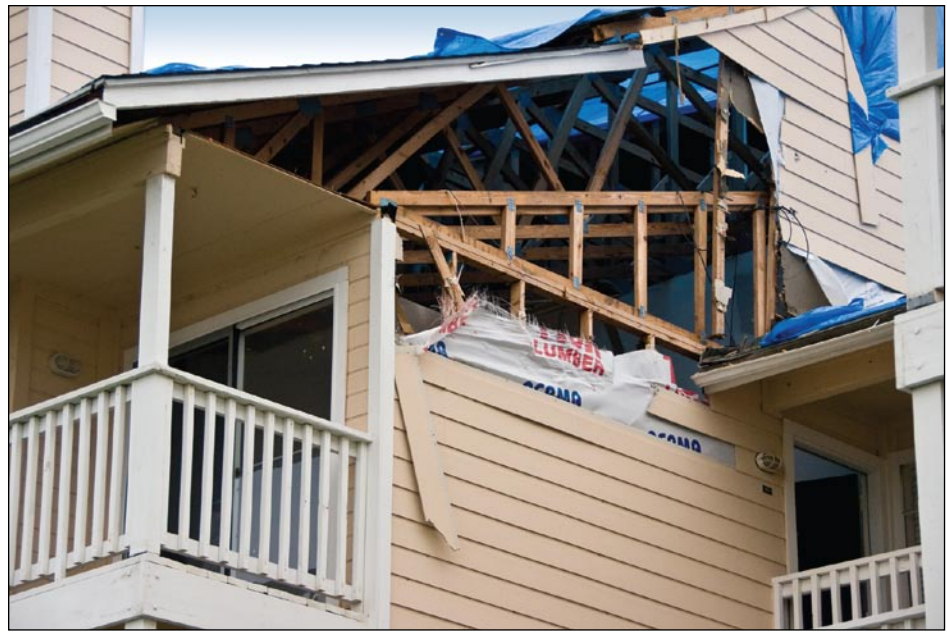
Figure 3-76.
Loss of fiberboard sheathing and fiber cement siding from gable end wall of an apartment complex (West Bay, Galveston Island, TX; Hurricane Ike estimated wind speed in this area: 90 mph, Exposure B)

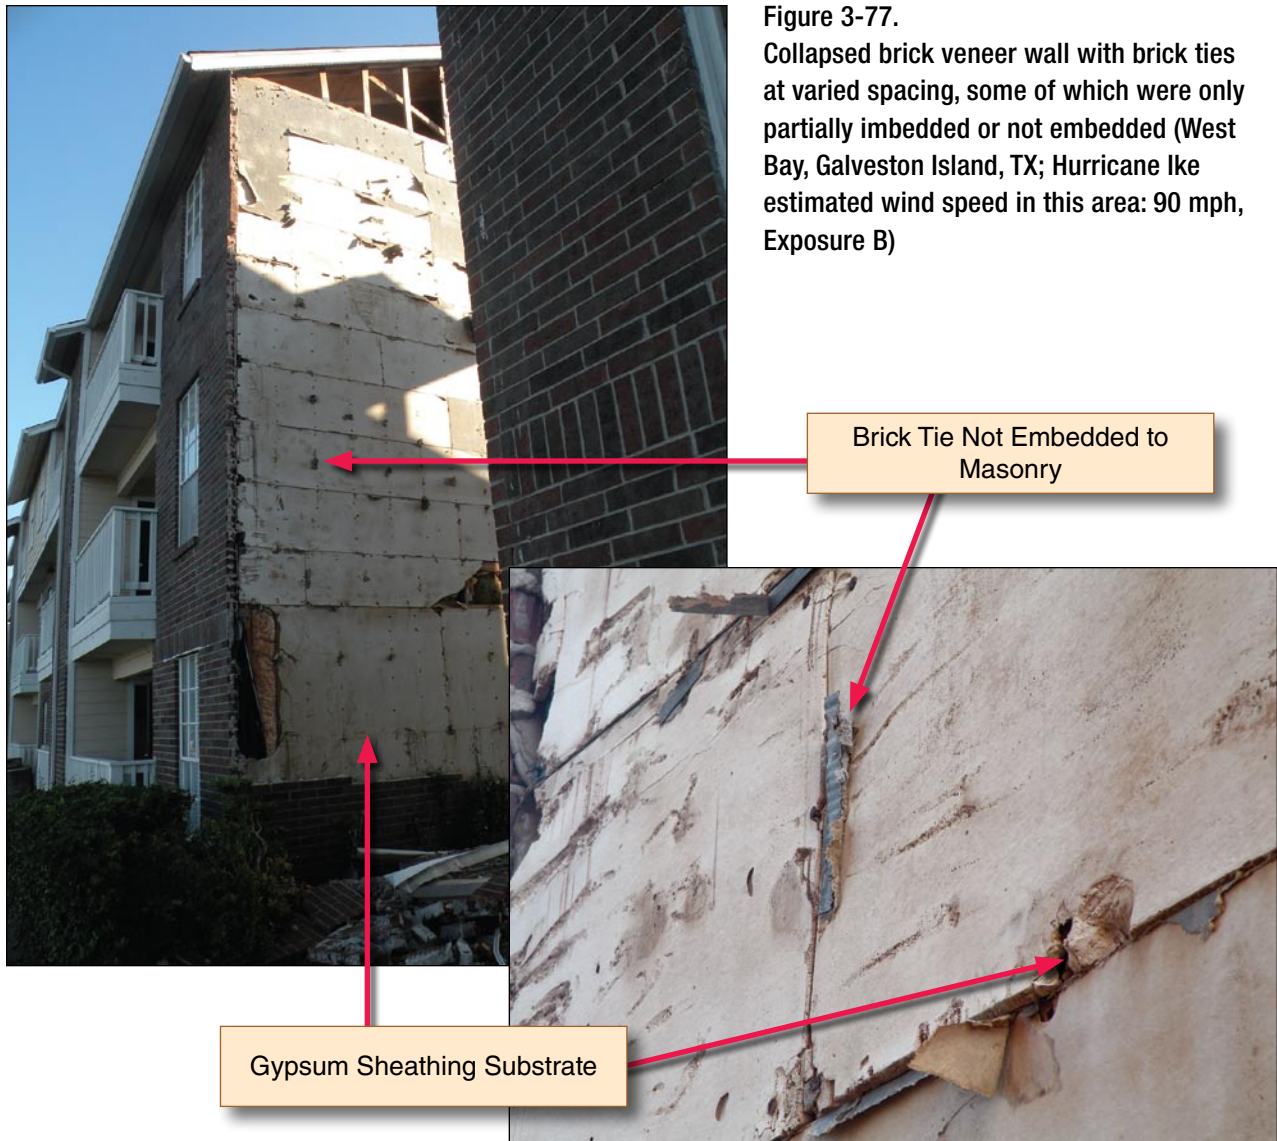
Numerous brick veneer failures were observed at one Galveston apartment complex. Figure 3-77 shows failed brick veneer at one complex. The brick ties were randomly spaced with the horizontal spacing ranging from 32 inches to 16 inches on-center and the vertical spacing ranging from 48 inches to 24 inches on-center. Many of the corrugated ties were rusted and broken, were not embedded in the masonry, or had minimal embedment. Figure 3-78 illustrates common problems with brick veneer installations and Figure 3-79 illustrates proper methods of installation.

FEMA Hurricane Ike Recovery Advisory, *Attachment of Brick Veneer in High-Wind Regions* (Appendix D), provides recommended practices for brick veneer attachment. The advisory is based on observations from Hurricanes Ivan, Katrina, and Ike.

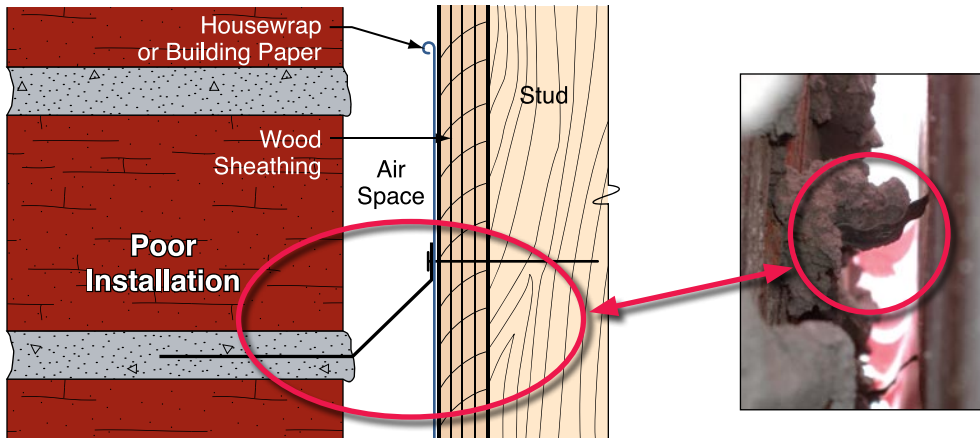
Figure 3-78. Misalignment of the tie reduces the embedment and promotes veneer failure

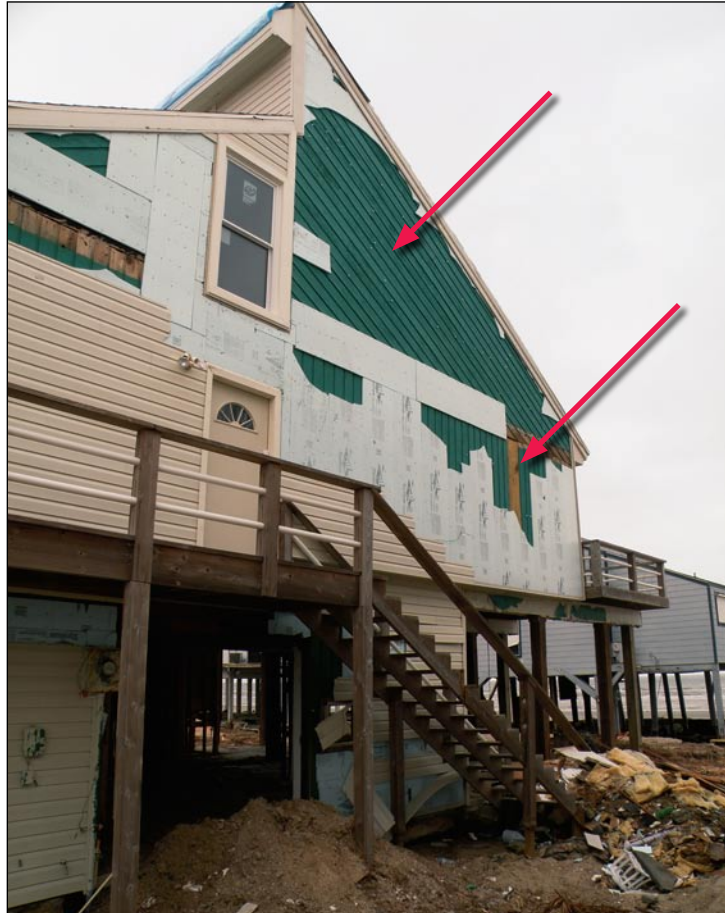
Figure 3-80.

Typical vinyl siding failure. Vinyl was installed over older wood cladding (red arrows) (Sea Isle, TX; Hurricane Ike estimated wind speed in this area: 95+ mph, Exposure C).

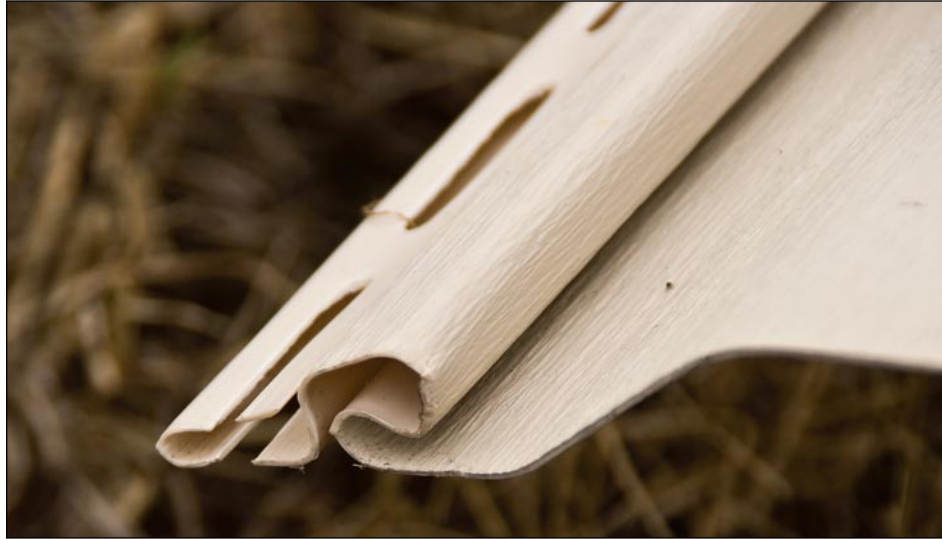
Siding that is intended for locations with a basic wind speed greater than 110 mph usually has a double-layer nail hem (Figure 3-82). This double layer strengthens the vinyl at the point where the nail attaches so the siding better resists tearing or pull-through of the nail head. Conventional vinyl siding has a single-layer nail hem. Most of the siding that was removed from the wall (and therefore exposed for inspection by the MAT) had a single nail hem and was thus not likely to have been rated for high wind locations. Although it is possible that the siding that stayed on the wall (and therefore wasn't inspected) was predominantly high-wind rated, it seems likely that a significant percentage of the siding installed in the high wind zones of this area of the Texas coast is not intended for that application. This conclusion would appear reasonable, since winds produced by Ike varied from maximum 3-second gusts of 90 mph on the west end of Galveston to 110 mph on the east end of Bolivar Peninsula, and the ASCE 7-05 assigned wind speeds for these locations is 130 mph.

Figure 3-82.
Vinyl siding rated for high
wind has a double-layer
nail hem

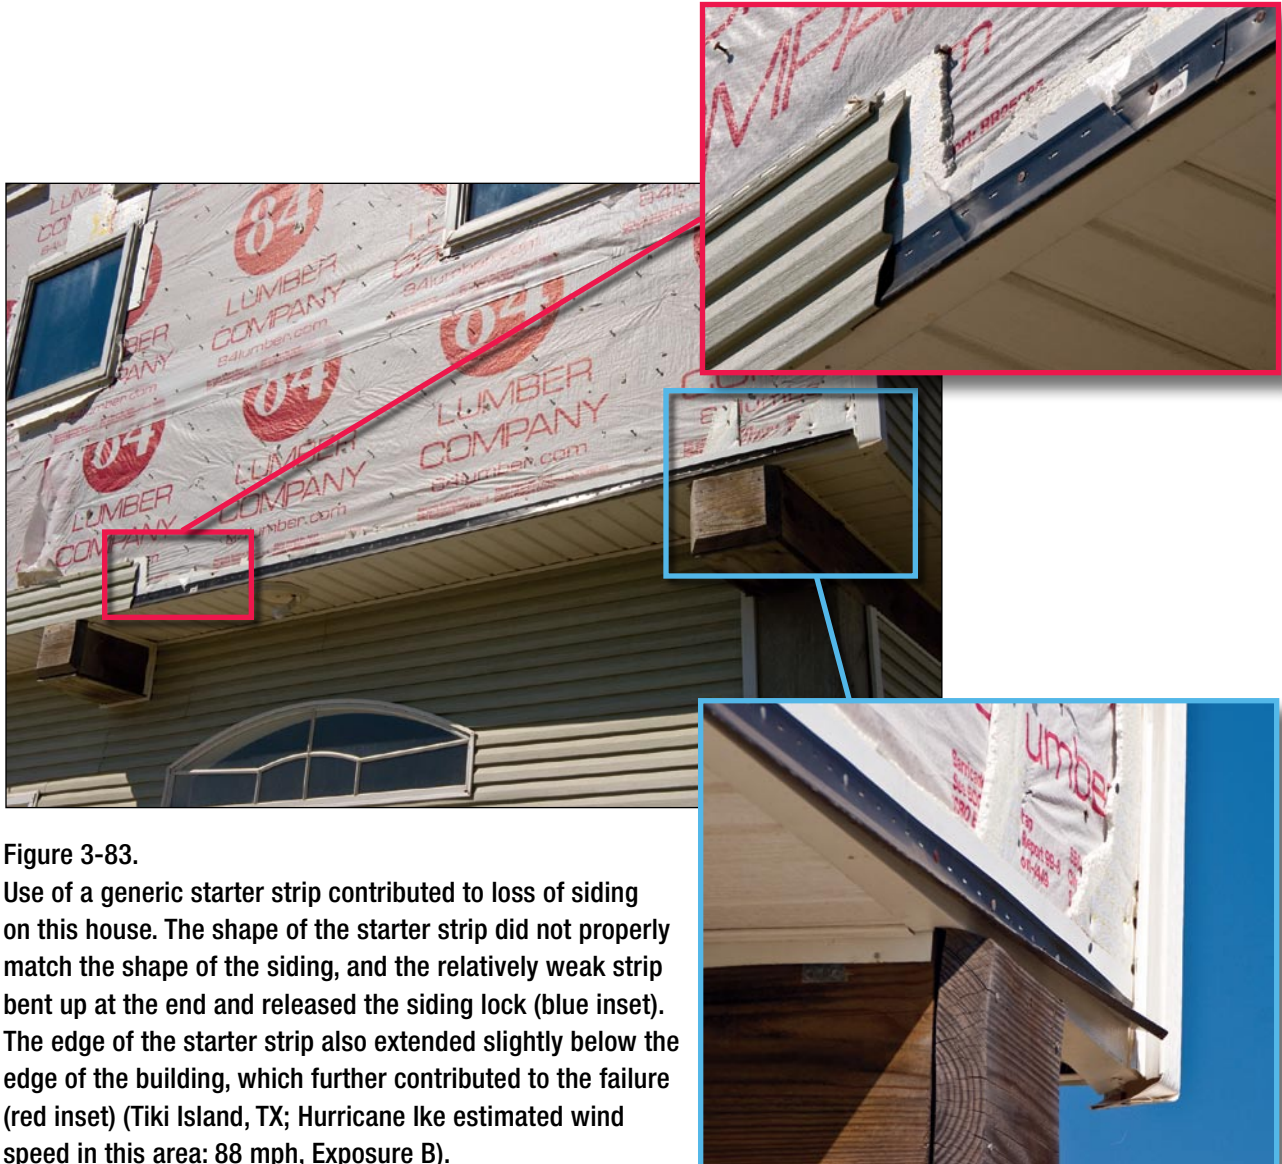
Figure 3-83.

Proper use of the starter strip is particularly important with elevated structures, where the wind passes at high velocity underneath the structure as well as against the walls. On Galveston Island, Bolivar Peninsula, and Tiki Island, where elevated houses were predominant, a large percentage of siding loss originated at the lowest course and led to loss of the courses above. The MAT saw numerous instances where a “generic” starter strip (having just a bulge, rather than a lock shaped to match the siding) was used. In other cases, J-channels, which do not lock into the panel at all, or field-fabricated substitutes for starter strips were used. Elevated structures with poorly implemented starter strips were most vulnerable to siding loss starting at the lowest edge of the elevated wall (Figure 3-83).

Use of a generic starter strip contributed to loss of siding on this house. The shape of the starter strip did not properly match the shape of the siding, and the relatively weak strip bent up at the end and released the siding lock (blue inset). The edge of the starter strip also extended slightly below the edge of the building, which further contributed to the failure (red inset) (Tiki Island, TX; Hurricane Ike estimated wind speed in this area: 88 mph, Exposure B).

Vinyl siding installers should be advised to use starter strips that are specifically designed for the brand and model or profile of the siding that will be used and generic starter strips should be avoided. Installers should consult the manufacturer’s instructions to identify the starter

strip to be used. Installers should also test the fit of the starter strip to the siding to make sure it locks securely before installing. On elevated structures, the starter strip should not extend below the lowest edge of the vertical wall or the exposed edge may catch the wind blowing under the house.
