3 Performance of Residential Buildings (Flood and Wind), One- to Two-Family and Multi-Family

3.1 Structural Performance

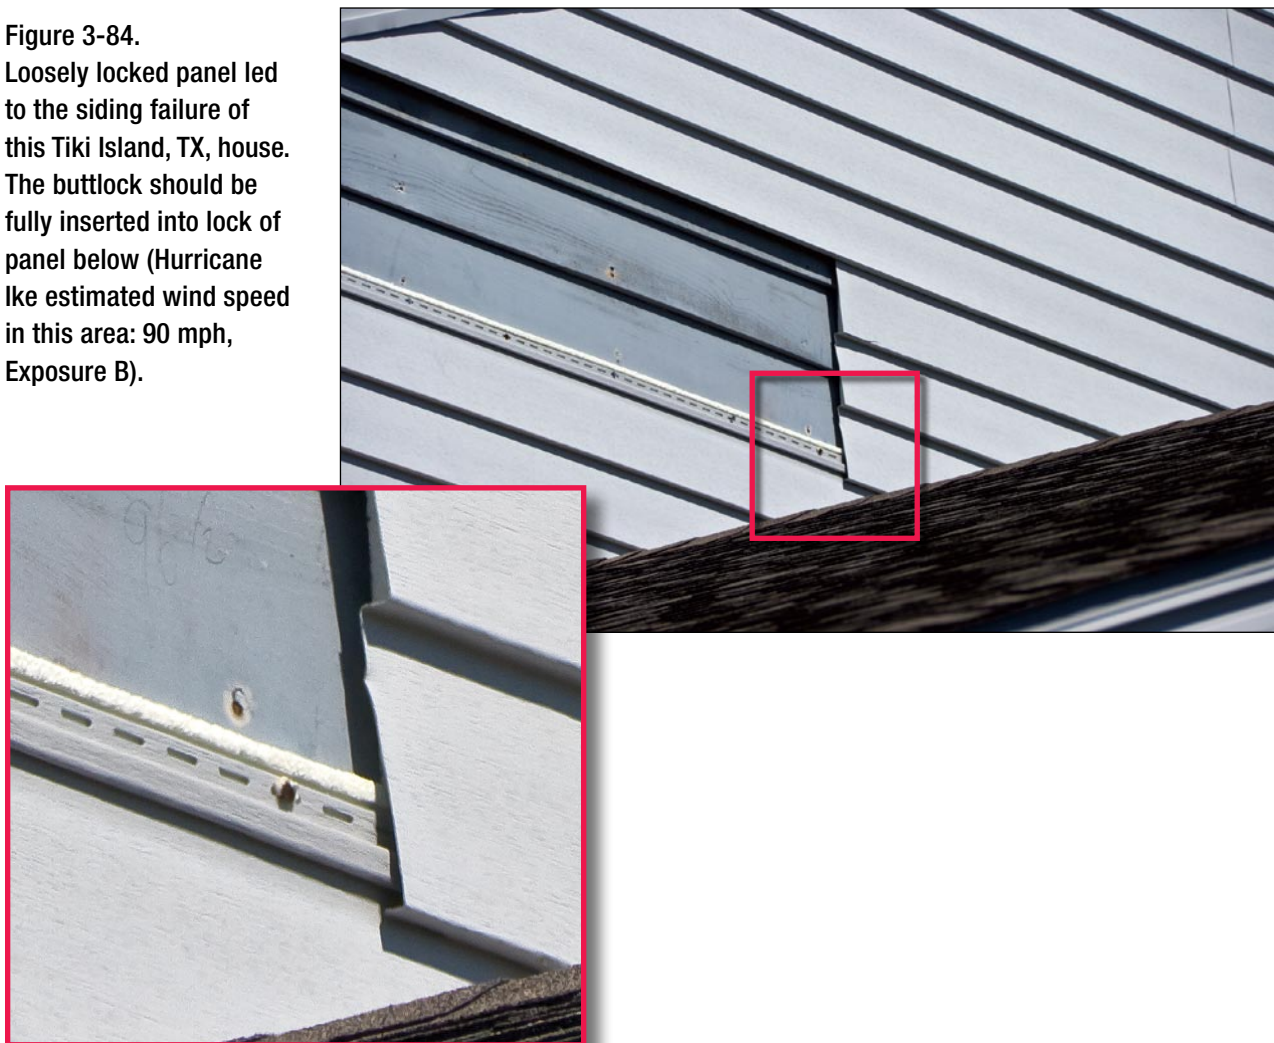
Siding loss frequently begins midway up the wall rather than at the bottom course. Many of these instances are the result of failure to fully and securely lock the buttlock of the siding into the locking shape of the siding course below. This can happen when the siding is pulled up too tightly before being nailed, thereby placing it under tension when the siding is not fully pushed

into the lock (Figure 3-84), or when the siding is allowed to sag before nailing. These modes of failures frequently occur when installers try to align the horizontal course lines on one wall with those of an adjacent wall by installing several courses loosely.

Figure 3-84.
Loosely locked panel led to the siding failure of this Tiki Island, TX, house. The buttlock should be fully inserted into lock of panel below (Hurricane Ike estimated wind speed in this area: 90 mph, Exposure B).

Each course of siding should be installed by pushing the buttlock firmly upward into the lock of the course below until it snaps into place and goes no further. The siding should be held in the lock by pushing up from the bottom while the first several fasteners are placed to hold it in position. Siding should never be pulled up from the nail hem. When properly installed, siding should be able to slide back and forth without undue force; neither tight fasteners at the nail hem nor friction in the buttlock should prevent the siding from sliding. Installers should properly locate the starting points for siding on adjacent walls and check alignment of horizontal lines every course or two to avoid needing to make adjustments further up the wall.

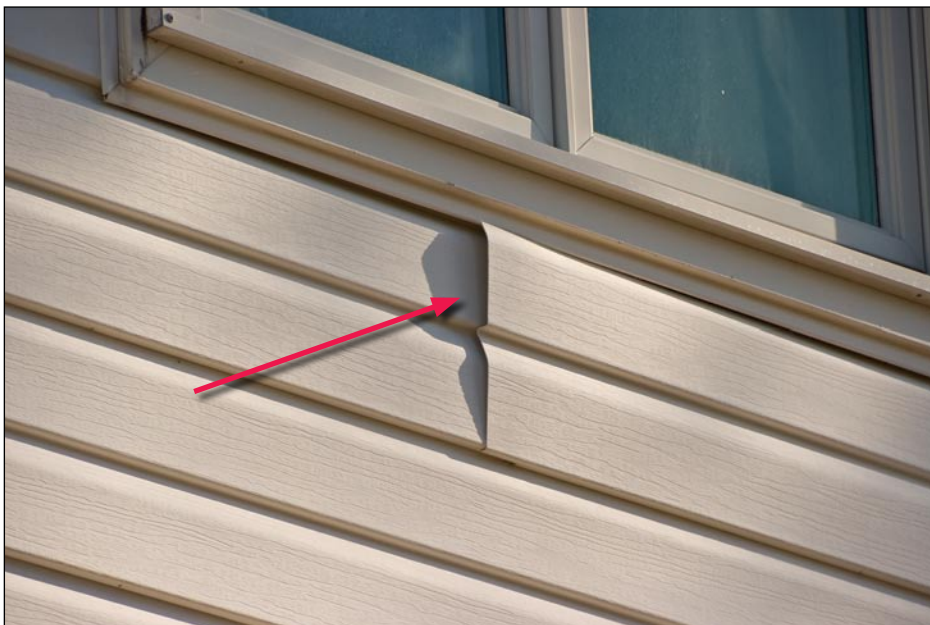
Figure 3-86.

Siding partially detached by wind as a result of improper placement of joint directly under window. Factory-notched end is not held by utility trim (Tiki Island, TX; Hurricane Ike estimated wind speed in this area: 88 mph).

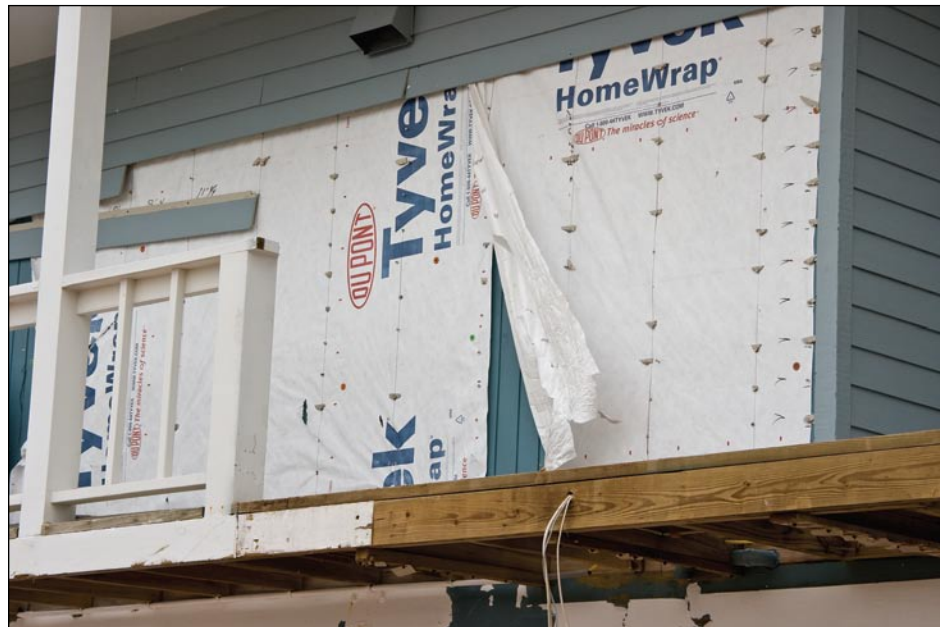
Figure 3-87.
Fiber cement plank siding, installed as a reside over the original plywood siding, was torn from this West Bay, Galveston Island, TX, house (Hurricane Ike estimated wind speed in this area: 100 mph, Exposure C)

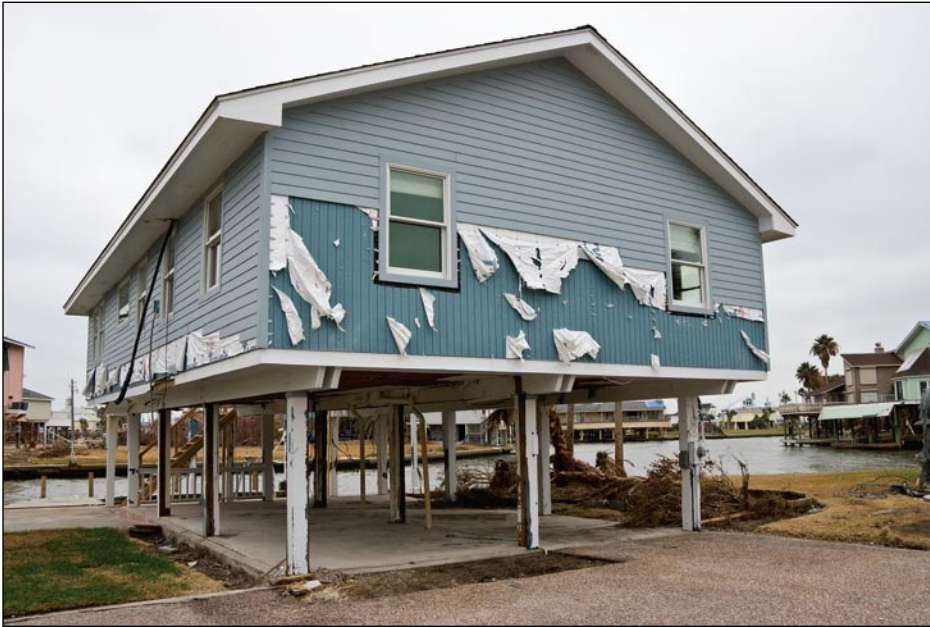
Lap siding damage varied from the loss of a few planks to entire walls (Figure 3-88). In most cases, the siding had been blind nailed at each stud (Figure 3-89), which is standard for non-high wind zones. Published ratings and ICC Evaluation Reports for the application of fiber cement lap siding in high wind zones require that the siding be face nailed through both layers of siding at the lap joint, shown in Figure 3-90. The spacing of the nails (16-inch or 24-inch) and permitted material exposure is dependent upon the thickness and width of the siding boards and wind zone.

Figure 3-88. Fiber cement lap siding was blown off this West Bay, Galveston Island, TX, house (Hurricane Ike estimated wind speed in this area: 100 mph, Exposure B)

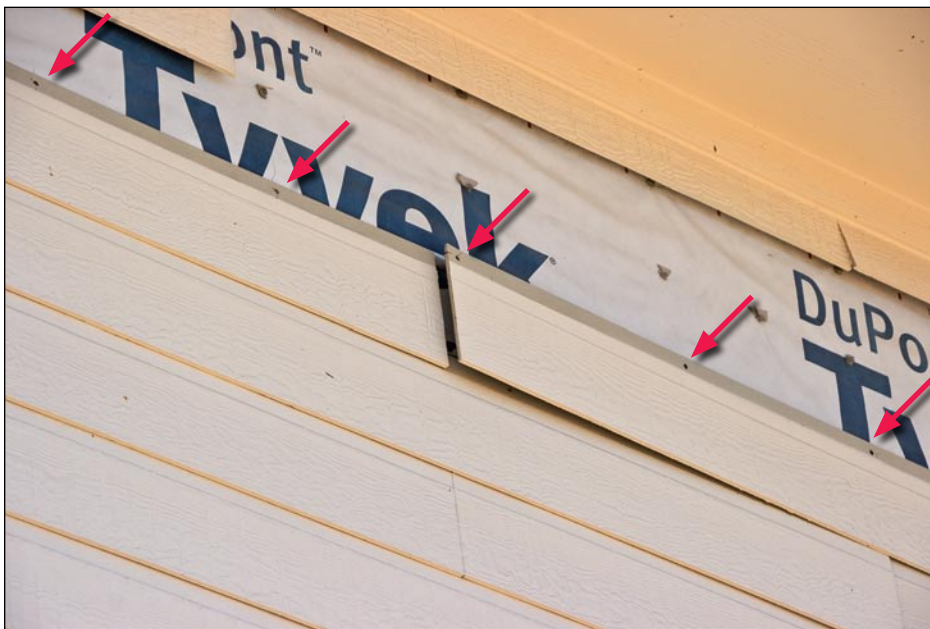
Figure 3-89. Damaged fiber cement plank siding. Note that blind nailing alone (red arrows) is recommended only for 90-mph or less installation. Higher wind zone installations should include both blind and face nailing (Hurricane Ike estimated wind speed in this area: 93 mph, Exposure B).

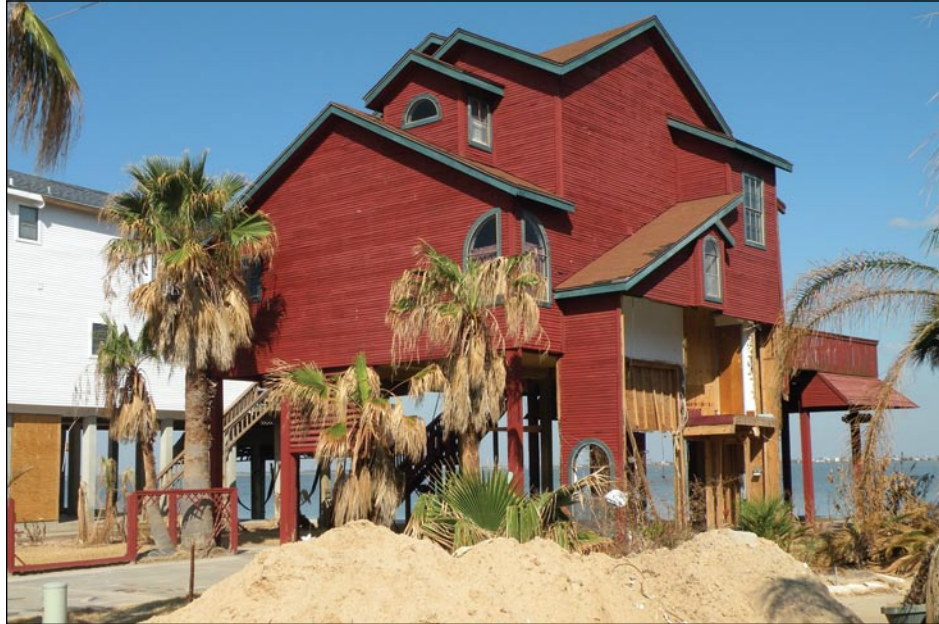
Figure 3-93.
Clapboard-sided house with siding that performed well; damage resulted from failure of a non-breakaway wall (Tiki Island, TX; Hurricane Ike estimated wind speed in this area: 103 mph, Exposure C).

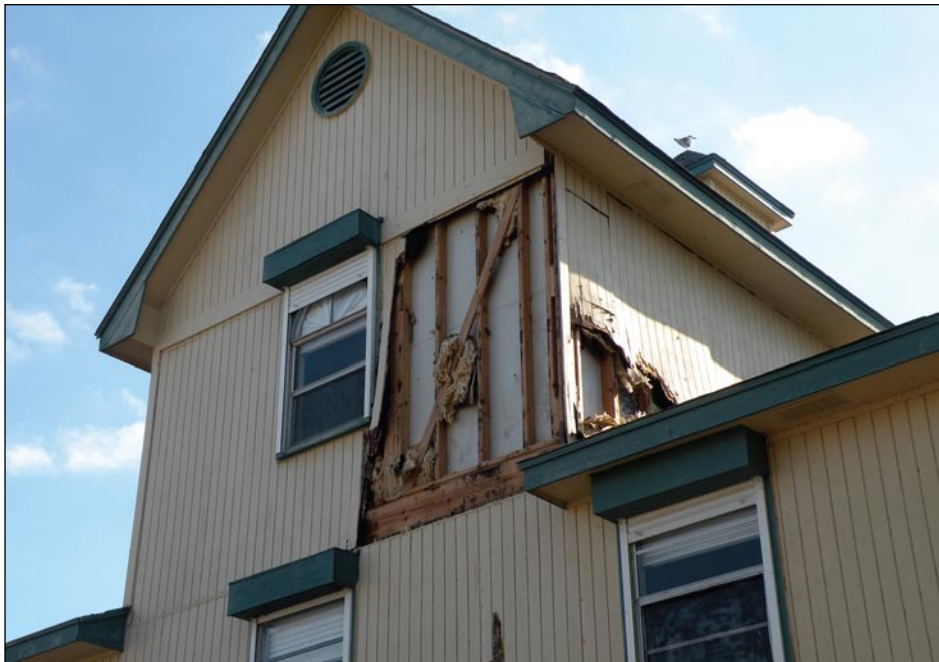
Most of the older houses on Galveston Island, Tiki Island, and Bolivar Peninsula that were originally constructed with plywood or hardboard siding had been re-sided with either vinyl or fiber cement siding. The performance of the remaining plywood and hardboard siding was basically a function of maintenance. The clapboard-sided house shown in Figure 3-93 was well maintained and performed well, though the second floor failure was produced when a non-breakaway wall was destroyed by surge. Failure of the plywood siding shown in Figure 3-94 appeared to be the result of decayed plywood removed by the wind pressures.

Figure 3-94.
Decayed plywood siding removed by wind pressures (Tiki Island, TX; Hurricane Ike estimated wind speed in this area: 103 mph, Exposure C)

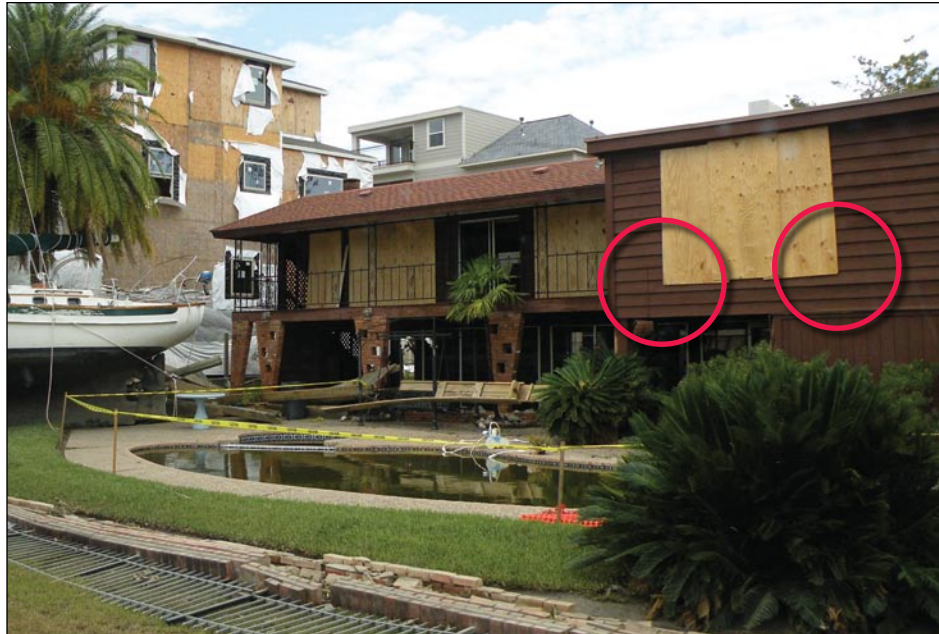
Figure 3-103. Plywood shutters installed into the wall cladding (red circles) in Clear Lake, TX (Hurricane Ike estimated wind speed in this area: 90 mph, Exposure B)

Since Ike's winds were below design wind speeds in both Texas and Louisiana, no failures or debris impacts were observed. The 2006 IRC/IBC and TDI require that all shutters be attached to the building structure and not to the window frame, siding, or veneer (Figure 3-102); they require that all shutters be tested to ASTM Standards E 1886 and E 1996. The MAT observed plywood shutters mounted directly to the wall cladding or window frame as seen in Figure 3-103. Further information regarding shutters can be obtained from Technical Fact Sheet 26, *Shutter Alternatives*, in FEMA 499.

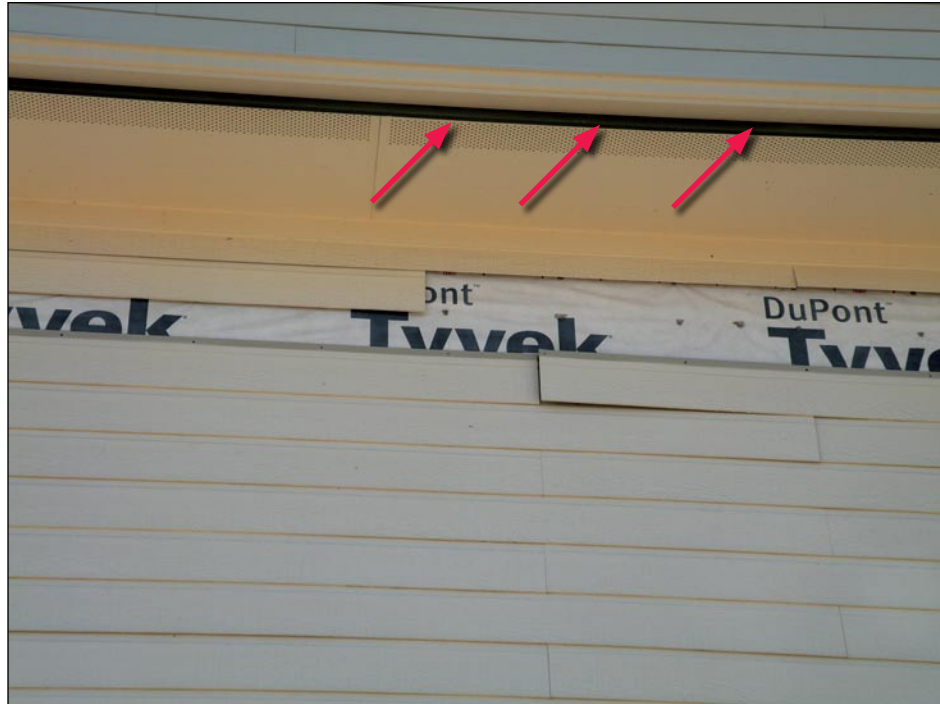
Figure 3-104.
Fiber cement soffit remained connected; soffit vent slots shown with red arrows. Fiber cement plank siding was damaged (Tiki Island, TX; Hurricane Ike estimated wind speed in this area: 88 mph, Exposure B).

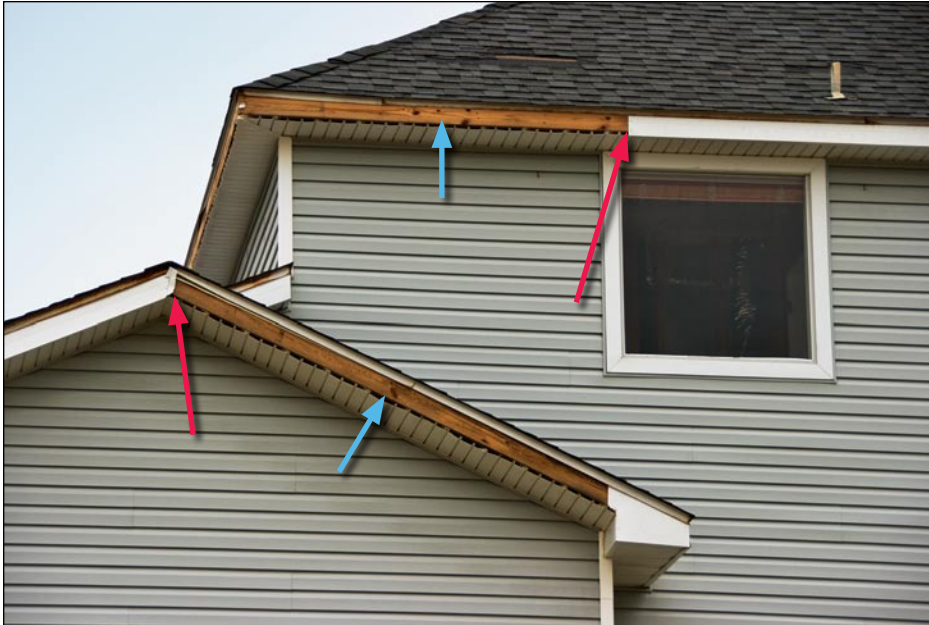
By far the most frequently observed form of failure was loss of the aluminum fascia cover from the fascia board (the vertical board used to close off the end of eave spaces or form the outer edge of the rake), as shown in Figures 3-105 and 3-106. The fascia cover normally covers the ends of vinyl and aluminum soffits. Aluminum fascia covers are typically nailed every few feet along the length with color matched trim nails. The IRC currently has no guidelines for the installation of fascia covers. Vinyl fascia covers are also available. They are typically installed using

The frequent loss of fascia covers is a significant concern. In most instances where the fascia cover was observed by the MAT to be fully or partially removed, the soffit itself remained in place or lost only a few sections, as further shown in Figures 3-105 and 3-106. The loss of the fascia cover can increase the risk of loss of the soffit. Even where the soffit remains, rain can be driven directly past the exposed soffit ends. The MAT did not have access to the interior of houses to determine whether interior moisture damage was a frequent result of fascia cover loss, but such damage would be expected.

Figure 3-105. Loss of aluminum fascia cover (red arrows) exposed ends of vinyl soffit (blue arrows) to direct entry of wind-driven rain (Tiki Island, TX; Hurricane Ike estimated wind speed in this area: 88 mph)

The frequency of fascia cover failure suggests that design and installation of this component needs to be better addressed in construction standards for buildings in high wind locations. The fact that most soffits stayed in place despite loss of the fascia cover suggests that most soffit installations were performed properly or the design was sufficiently robust to resist winds that occurred during Ike. However, loss of soffits exposed by fascia cover removal would likely have been much greater had winds approached design speeds.

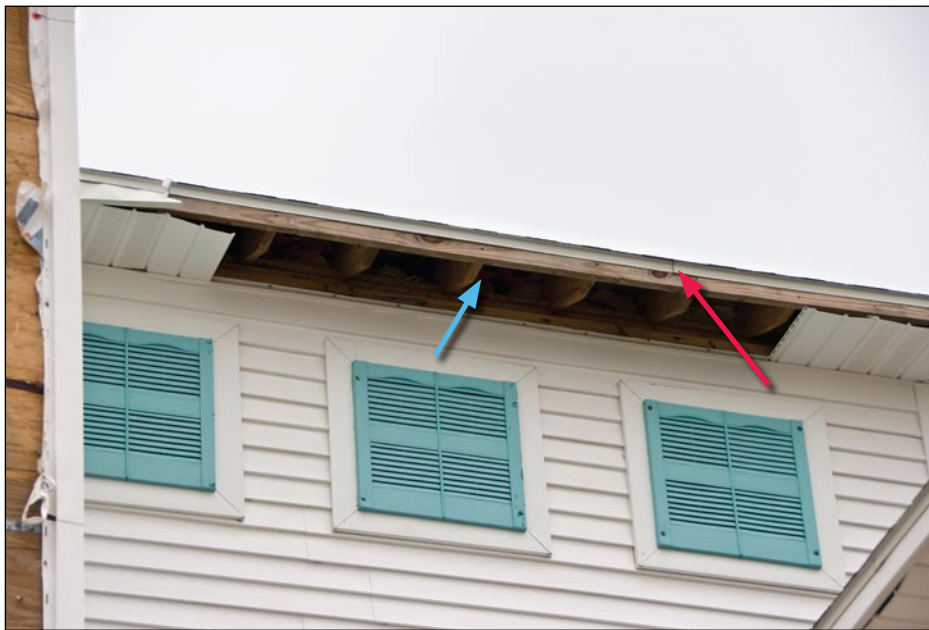
Figure 3-106. Loss of fascia cover (red arrow) led to loss of soffit (blue arrow), exposing the attic to wind-driven rain (San Luis, TX; Hurricane Ike estimated wind speed in this area: 93 mph, Exposure C)

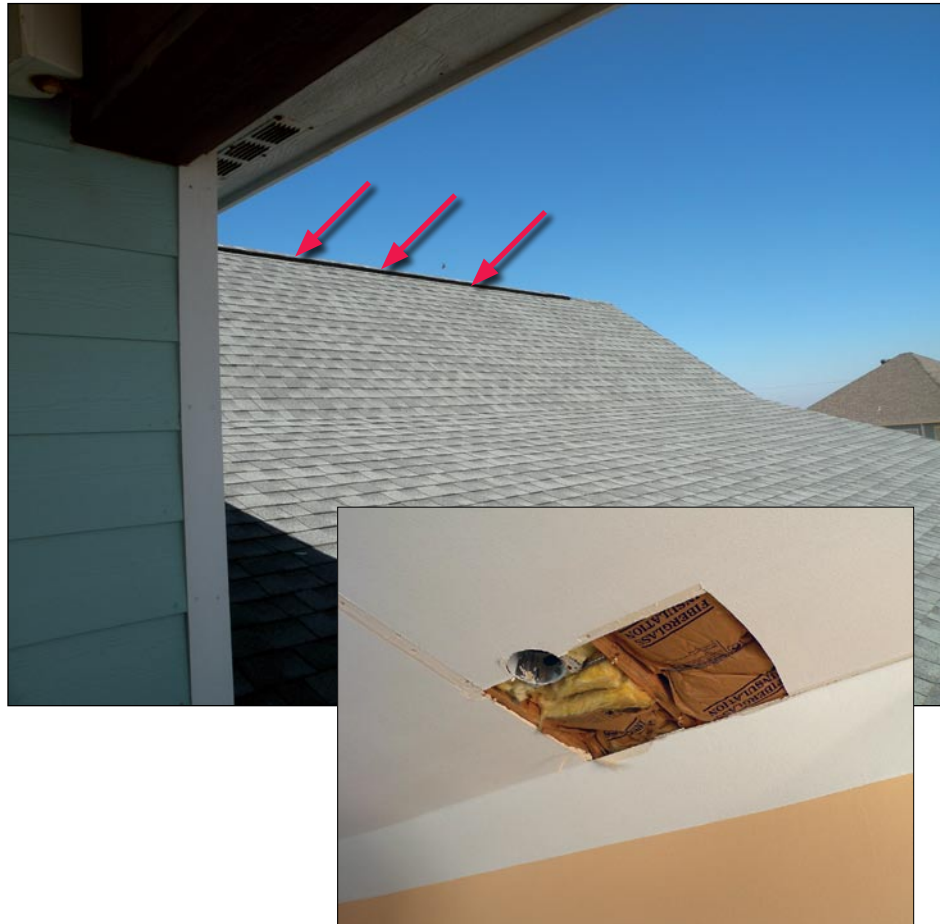
blowing up the surface of the roof and deflect it over the top of the roof ridge. The ridge vent should be installed with stainless steel screws, not roofing nails, into the roof structure. The MAT team was unable to climb onto residential roofs, but it was reported by the homeowner that the damage to a second floor ceiling shown in inset of Figure 3-107 was the result of a leaking ridge vent.

Figure 3-107.
The roof ridge vent (red arrows) on this Bolivar Peninsula, TX, home leaked, and it is presumed that the water was shed down the underside of the roof decking and/or structure, thereby producing ceiling damage along the wall of this second story room (Hurricane Ike estimated wind speed in this area: 110 mph, Exposure C)

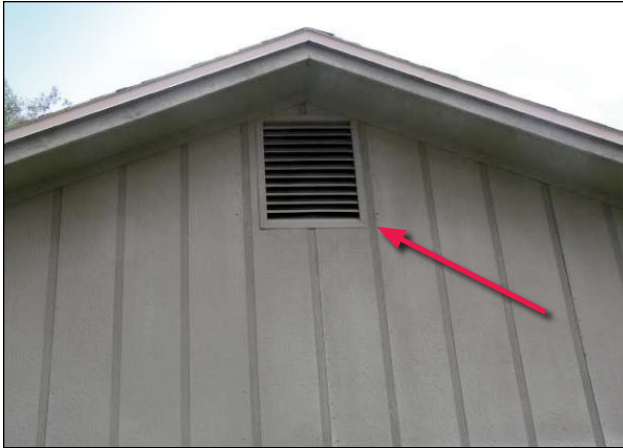
Figure 3-108. Gable end vent (red arrow)

Virtually all gable end vents (Figure 3-108) will leak when the wall they are mounted on faces into the wind-driven rain. The pressure developed between the outside surface of the wall and the inside of the attic are sufficient to drive water uphill for a number of inches and, if there is much wind flow through the vent, water carried by the wind will be blown considerable distances into the attic. Remedial measures include installing shutters, preferably on the outside of the house (Figure 3-109). The gable end vent shown in Figure 3-110 was not attached to the building structure and was blown off the apartment building.

Refer to FEMA Hurricane Ike Recovery Advisory, *Minimizing Water Intrusion Through Roof Vents in High-Wind Regions* (Appendix D), for further discussion of off-ridge vents, gable-end rake vents, and mechanical vents.

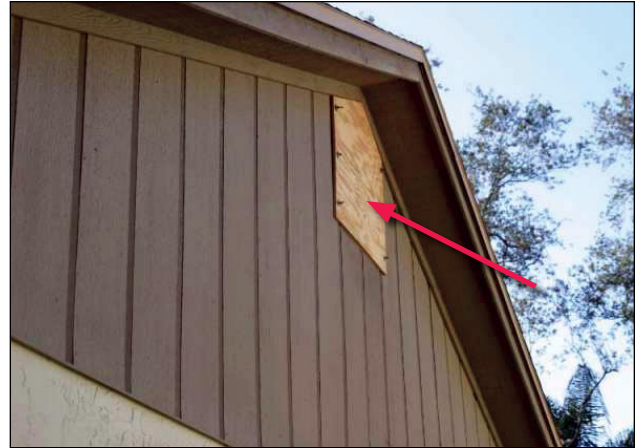
Figure 3-109. Shuttered gable end vent (red arrow)

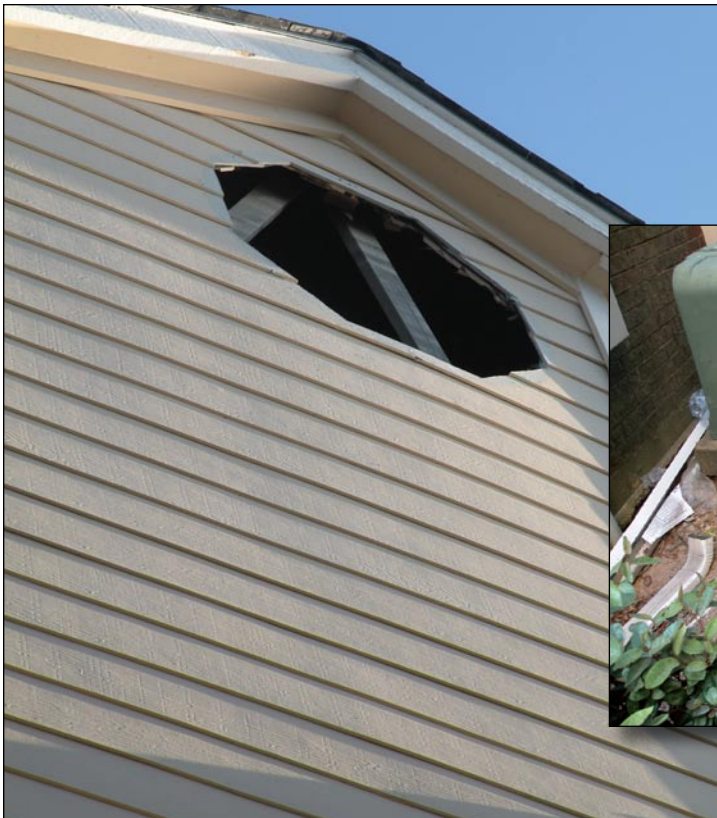
Figure 3-110.

Gable end vent blew off this Galveston, TX, Back Bay apartment building (Hurricane Ike estimated wind speed in this area: 90 mph, Exposure B)

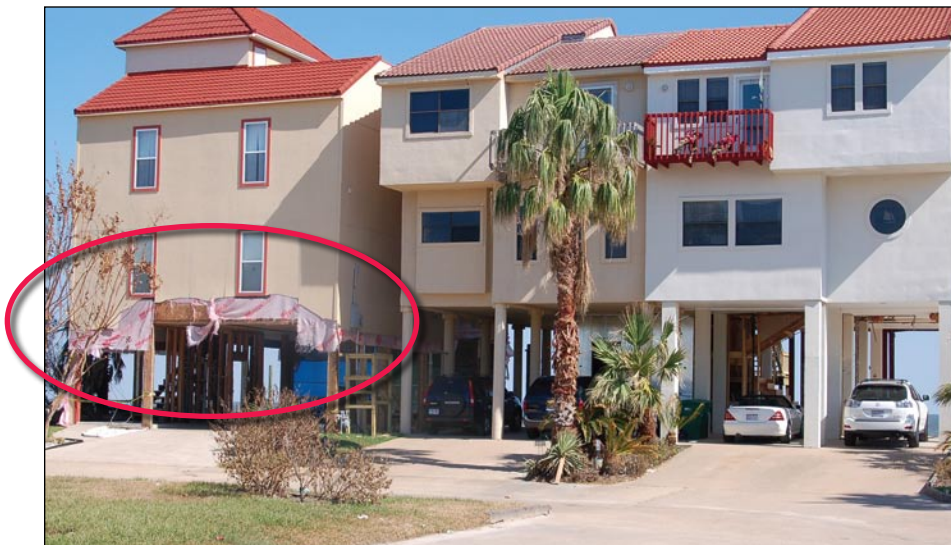
The Ike MAT found that solid breakaway walls performed as expected in the vast majority of cases. The walls broke free without causing significant or structural damage to elevated buildings. In some cases, failure of the breakaway walls led to propagation of damage to the building exterior above the lowest floor (Figure 3-114). In other cases, attachment of utilities to breakaway walls either prevented their successful breakaway, or contributed to utility damage (Figure 3-115).

Figure 3-114. Propagation of damage above lowest floor when breakaway walls broke free (Seabrook, TX)

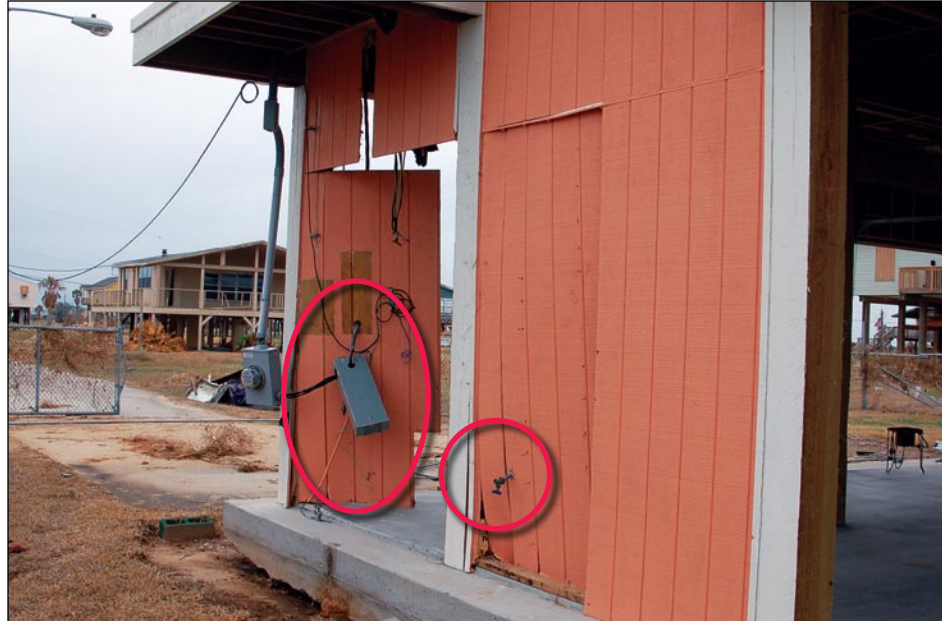
Figure 3-115.
Attachment of utilities to breakaway wall may have prevented the wall from breaking away, thereby resulting in additional damage to the structure (Galveston Island, TX)

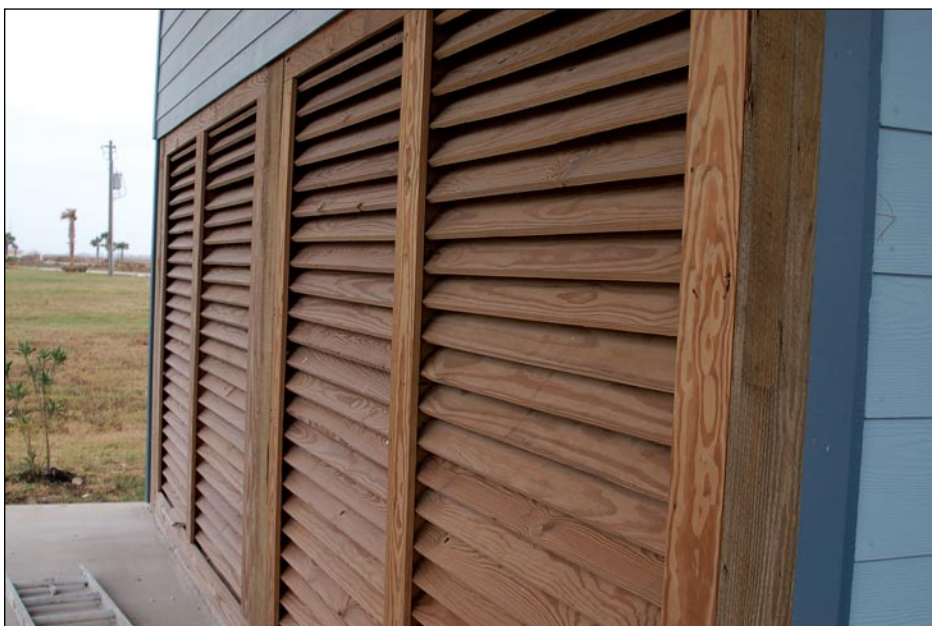
The MAT observed that louvered panels remained intact longer than solid breakaway walls under the same flood conditions. As a result, houses with louvered panels had less flood-related damage (and repair cost) and contributed less floodborne debris. Figure 3-117 shows louvered panels that allowed Ike floodwaters to pass into and out of the below-BFE enclosure without damage to the louvered panels. These louvers were installed on the same building shown in Figure 3-116, where the solid breakaway wall panel was displaced by floodwaters trapped inside the enclosure.

Figure 3-117.
Louvered panels allowed Ike floodwaters to pass into and out of the below-BFE enclosure without damage to the panels. The building shown here is the same as in Figure 3-116, where a solid breakaway wall panel broke away.

Based on these observations, the Ike MAT recommends the use of louvered panels rather than solid breakaway walls below the BFE. See the Hurricane Ike Recovery Advisory, *Enclosures and Breakaway Walls*, in Appendix D for more details on this topic.

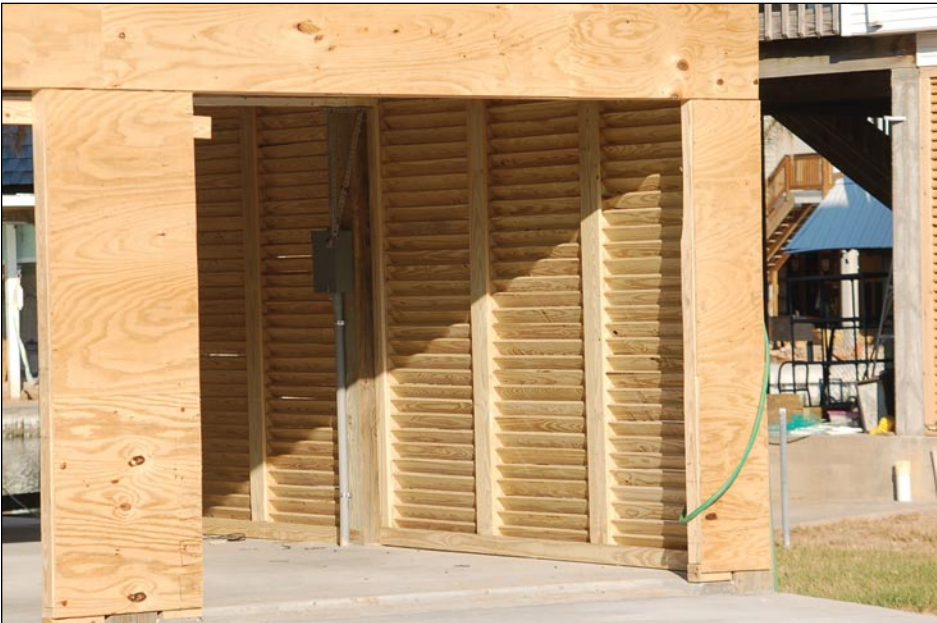
Numerous building owners in one community (Tiki Island, TX) were observed to be replacing solid breakaway walls lost during Ike with louvered panels (Figure 3-118). This action will reduce future flood damages and can result in lower flood insurance premiums. Zone V flood insurance premiums are much less for a building with a below-BFE enclosure formed by louvers than for a building with an enclosure formed by breakaway walls. A building with an enclosure formed by louvers is classified the same as if it had insect screening or open lattice, i.e., as “free of obstructions,” while a solid breakaway wall enclosure results in a “with obstruction” rating for the building.

Figure 3-118.
Solid breakaway walls lost during Ike are being replaced with louvered panels (Tiki Island, TX)

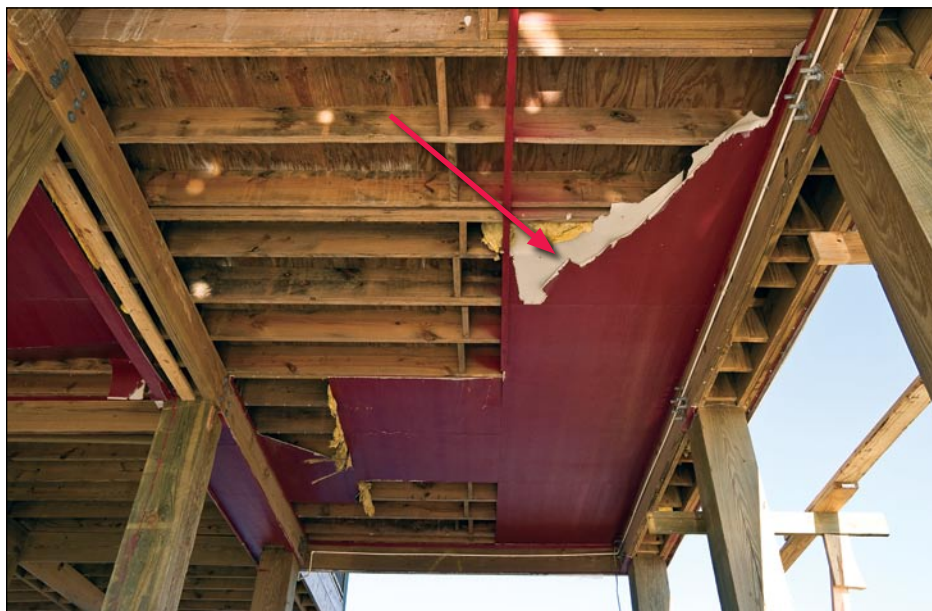
In locations where the water level or waves reached the elevation of the building, sheathing and any covering was frequently found to be partially or completely removed (Figures 3-119 and 3-120). This was particularly true of the thinner panel types, such as 1/8-inch fiberboard. Other forms of damage, such as gouges from floodborne debris, were observed on the underside of panels.

Figure 3-120.
Fiber cement board
sheathing (red arrow)
was removed from the
underside of this house,
which was elevated
approximately 12 feet
above ground level (Bolivar
Peninsula, TX)

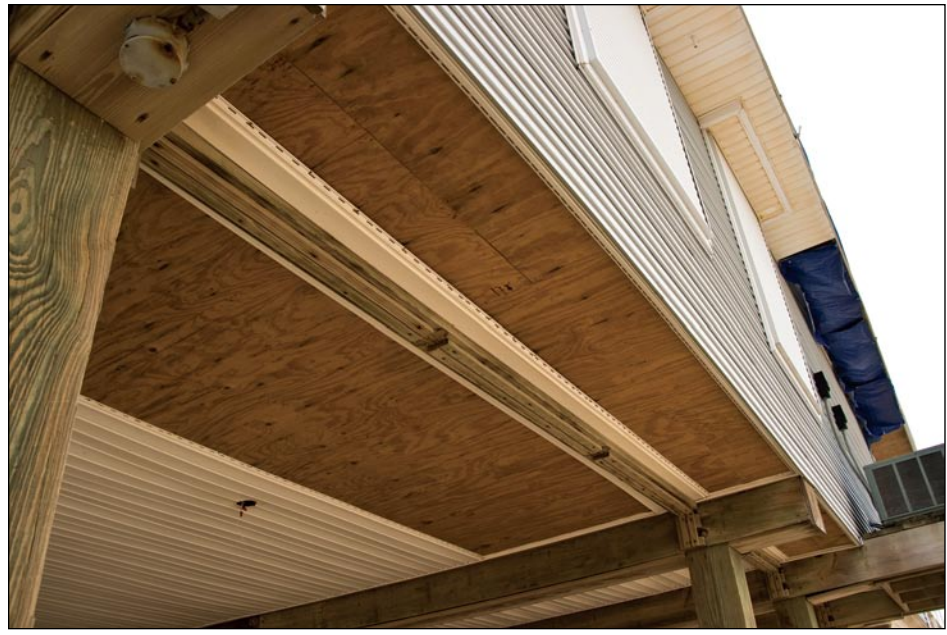
Where floodwaters did not reach the underside of the building, damage due to wind accelerating underneath the building was often observed. In these cases, vinyl soffit was often blown off. In some cases, but not all, the sheathing above the soffit was also removed. The vinyl soffit covering on the Tiki Island house shown in Figure 3-122 was probably blown off by wind action rather than storm surge.

Figure 3-122.
Vinyl soffit covering over plywood sheathing partially removed (Tiki Island, West Galveston Bay; Estimated Hurricane Ike wind speed: 103 mph, Exposure C)

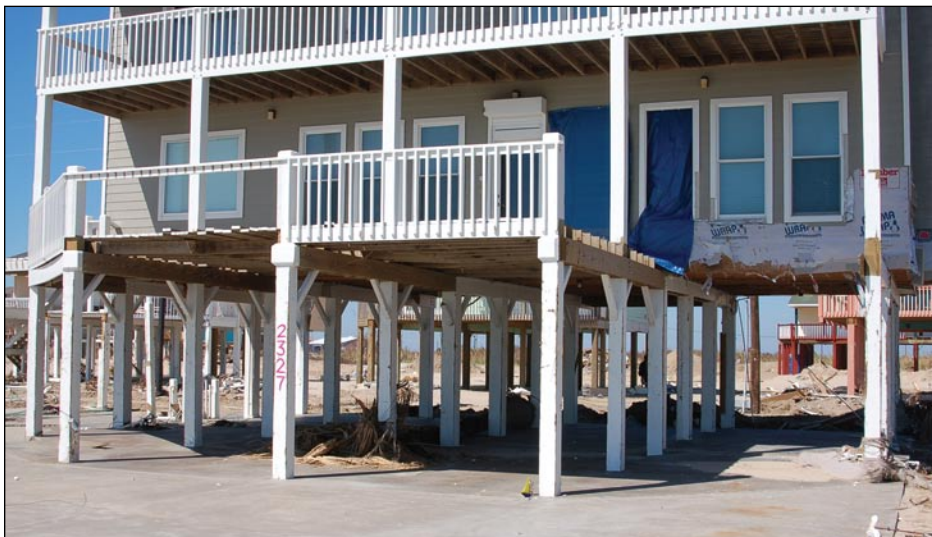
Many of the houses supported on pile foundations that the MAT visited had concrete slabs constructed at grade. These slabs were typically used as parking slabs beneath the elevated houses (Figure 3-123). Some of the slabs were thin (less than 4 inches thick); others were much thicker. Some had thickened edges and interior sections that acted as grade beams, presumably to stiffen the foundation. Virtually all slabs were reinforced with welded wire mesh and/or steel reinforcing bars.

Figure 3-123.
Typical concrete parking slab beneath a pile-supported house (Bolivar Peninsula, TX)

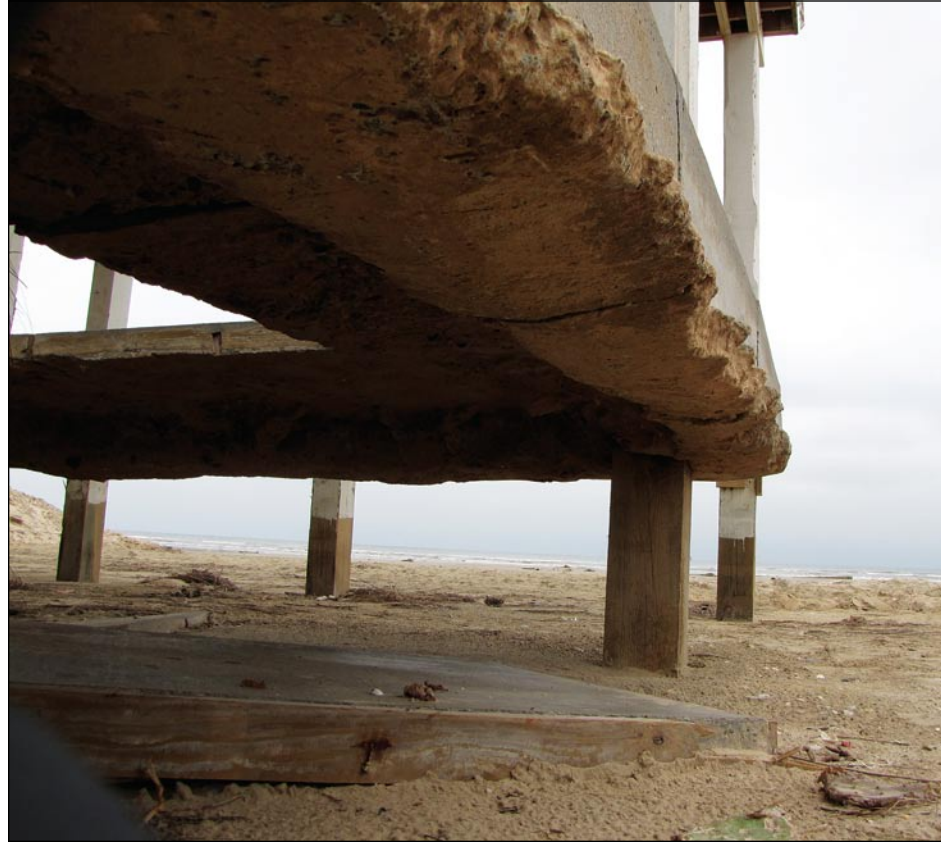
Many of the slabs failed once they were undermined. Where the piles were embedded deep into the ground, the slab was either undermined (and sometimes settled) as shown in Figure 3-124, or the slab collapsed without visible damage to the foundation (Figure 3-125).

Figure 3-125.
Pile-founded house
with a slab thickened to
create grade beams. The
unthickened portion of
the slab collapsed when
undermined (Galveston
Island, TX).

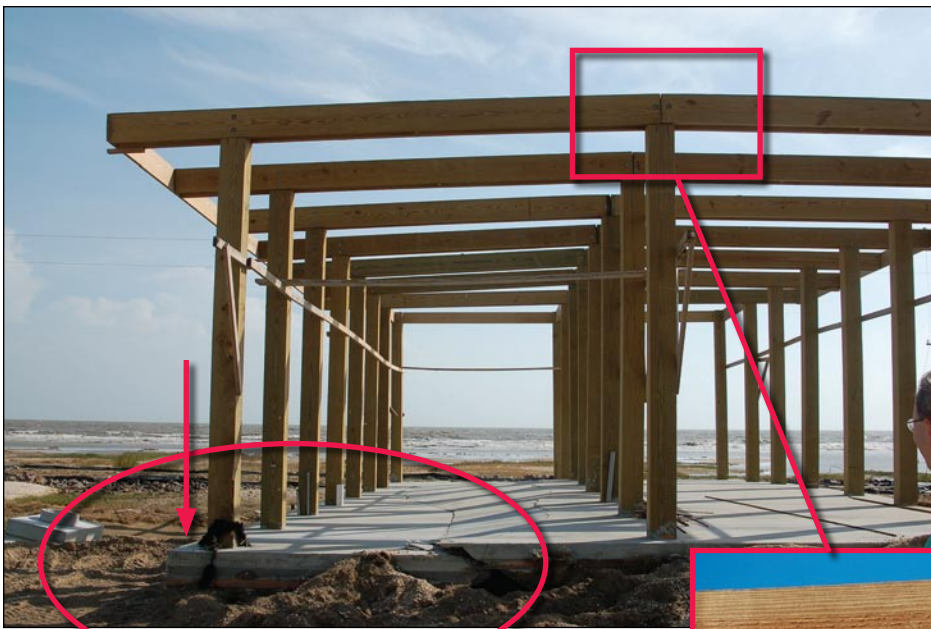
Where the piles were thought to be less well embedded, failure of the slab could have caused the pile foundation to rotate or rack (Figure 3-126). The MAT believes this was more common with older houses, and was likely a result of portions of the slab causing eccentric loads on the piles and the transfer of flood forces from the slab to the foundation.

Figure 3-126.
Slab failure probably contributed to foundation damage (West Galveston Island, TX)

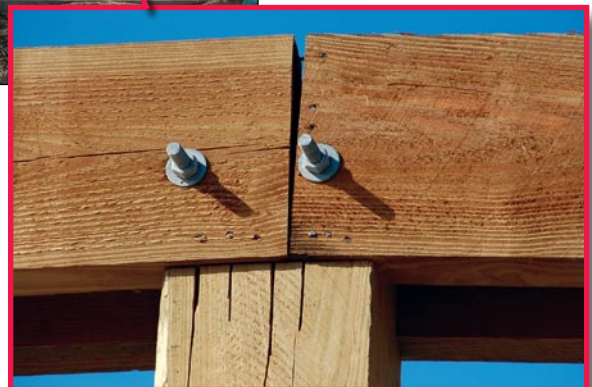
The MAT observed instances where the weight of the slab likely contributed to foundation failure and building settlement, illustrated in Figures 3-127 and 3-128. Figure 3-127 shows a Holly Beach, LA, house under construction at the time of Ike. The piles and elevated floor beams had been placed, and a thick slab had been cast; when Ike undermined part of the slab, it cracked and settled, pulling some of the piles and beams downward. Figure 3-128 shows a house at Surfside Beach, TX, that was subject to considerable scour and erosion—when the slab settled and collapsed, it could have pulled part of the house lower as it went. Pile embedment appears to have been the larger issue at the houses shown in Figures 3-127 and 3-128, and insufficient embedment likely allowed the slabs to induce or worsen building settlement.

Figure 3-127.
Slab undermining and settlement during Ike probably pulled piles downward. Inset shows that the dropped piles also caused the floor beam to deflect (Holly Beach, LA).

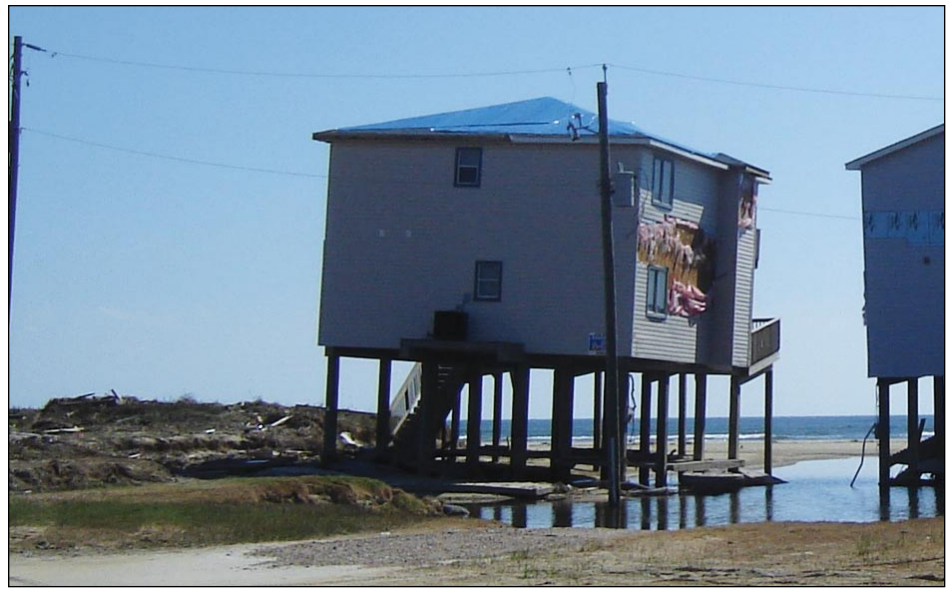
Figure 3-128.
The weight of this slab, undermined due to scour and erosion, could have contributed to settlement and racking of this elevated house (Surfside Beach, TX)

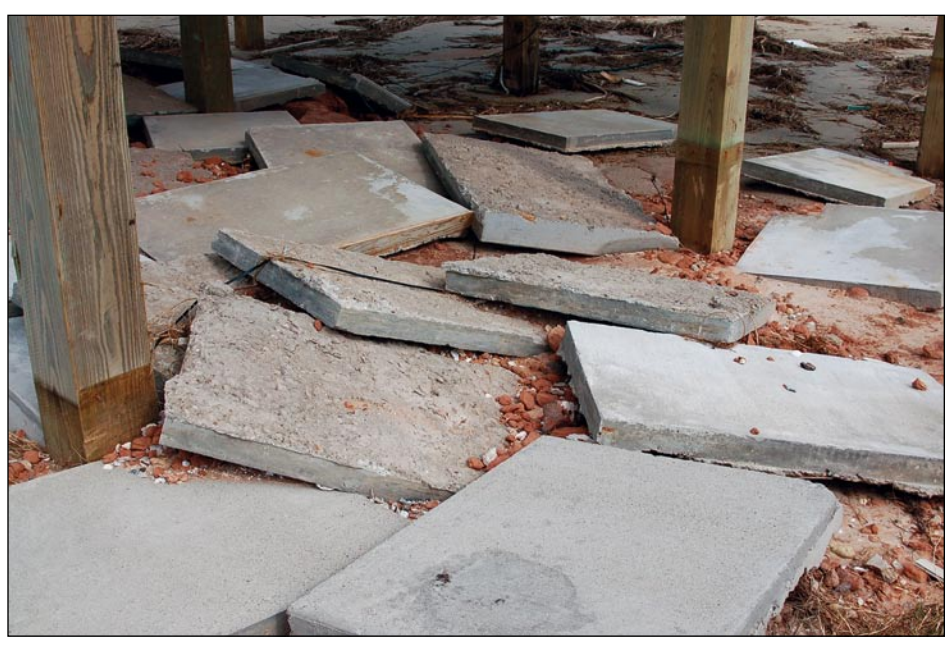
The MAT observed several houses on Galveston Island where parking slabs were constructed in 4-foot square sections and unreinforced. This method of construction is consistent with that recommended in FEMA 55, Third Edition. Where these slabs were observed, their failure did not appear to adversely affect foundations or elevated buildings (Figure 3-129). Section III of the *Galveston County Dune Protection and Beach Access Plan* (2006) requires use of unreinforced fibercrete or concrete slab sections (maximum 4-inch thickness) within 200 feet of the vegetation line in eroding areas.

Figure 3-129.
Thin, unreinforced parking slab sections separated when undermined and collapsed in place, with no apparent adverse impact to the foundation (Galveston Island, TX)

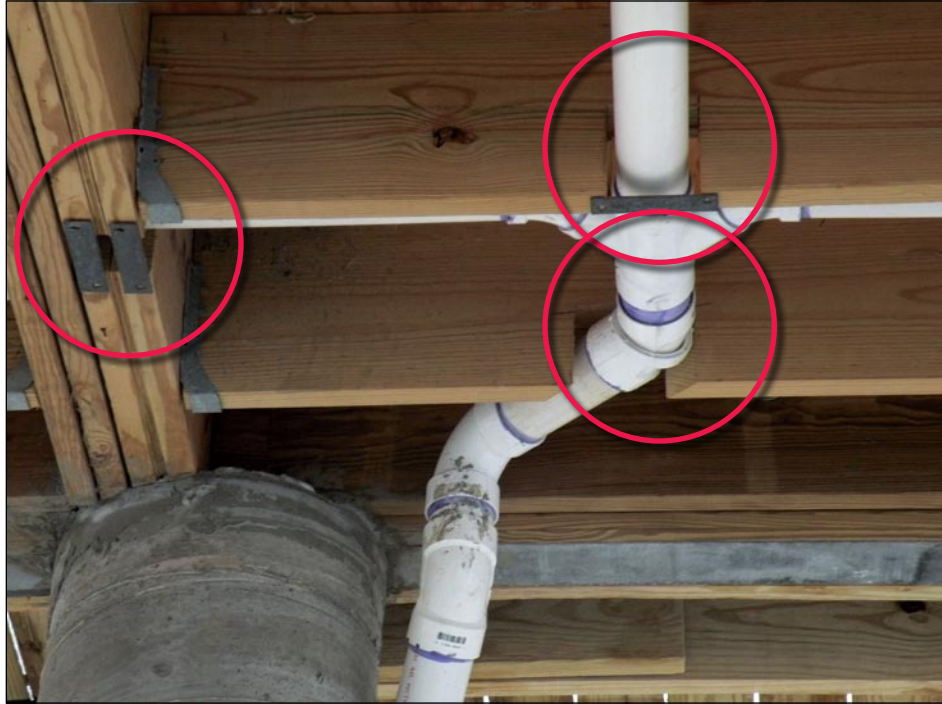
The MAT observed other construction deficiencies and community enforcement problems. While the details of these particular deficiencies are not known, their existence indicates potential compliance issues that should be monitored and addressed in communities visited by the MAT. Figure 3-131 shows a case where floor beams and joists were improperly notched to allow for plumbing installation. This practice can weaken structural members and should only be done at the direction of a structural engineer. Figure 3-132 shows a case where flood vents did not penetrate through the entire enclosure wall—if this installation was complete when observed by the MAT, this practice is a clear violation of NFIP flood opening requirements.

Figure 3-131.
Floor joists and beams
were notched to allow
for plumbing (Sulphur,
Calcasieu Parish, LA)

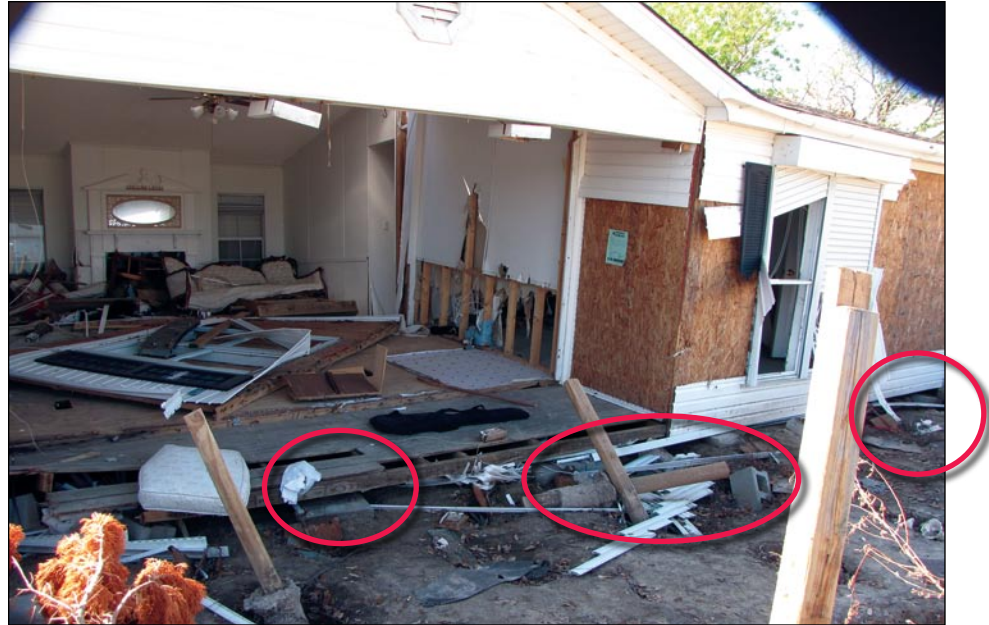
Evidence suggests that the home was displaced from its piers by moving floodwaters or waves. Scour, undermining the concrete pads beneath the piers, may have contributed. Ground anchor failures were not noted, but the straps connecting the home to the anchors had torn away from the house’s anchorage points (Figure 3-134). HUD’s 2007 *Manufactured Home Construction and Safety Standard* (MHCSS), 24 CFR Parts 3280 and 3285, place this site in a Wind Zone II. The MHCSS requires Wind Zone II homes to be secured and anchored to their steel frames and to wall ties. No wall ties were observed. This suggests that the home was either non-compliant or was installed before the HUD standards went into effect.

Figure 3-134.
Scour depressions existed around the masonry piers, pads, and ground anchor stabilizer plates (San Leon, TX)
