3 Performance of Residential Buildings (Flood and Wind), One- to Two-Family and Multi-Family

3.1 Structural Performance

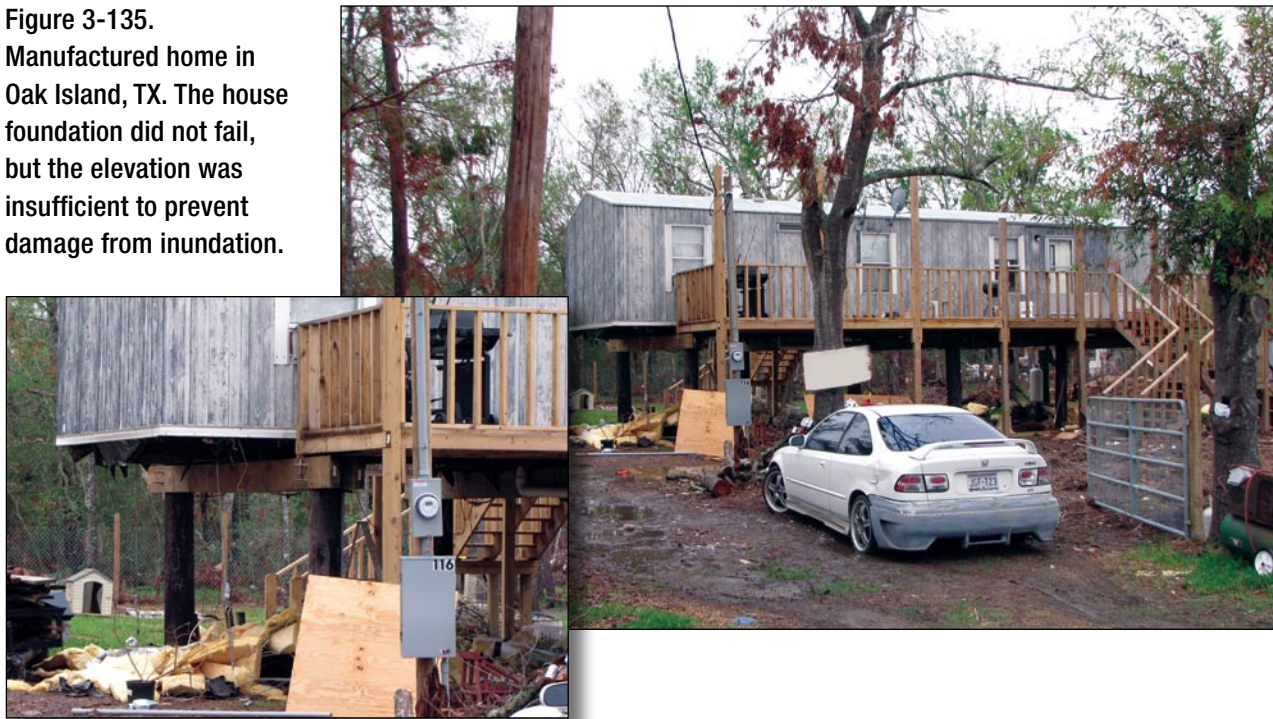
In Oak Island, TX, some manufactured homes were elevated on timber piles. The elevation prevented foundation failure, but some of the homes were still damaged by inundation (Figure 3-135).

Figure 3-135.
Manufactured home in Oak Island, TX. The house foundation did not fail, but the elevation was insufficient to prevent damage from inundation.

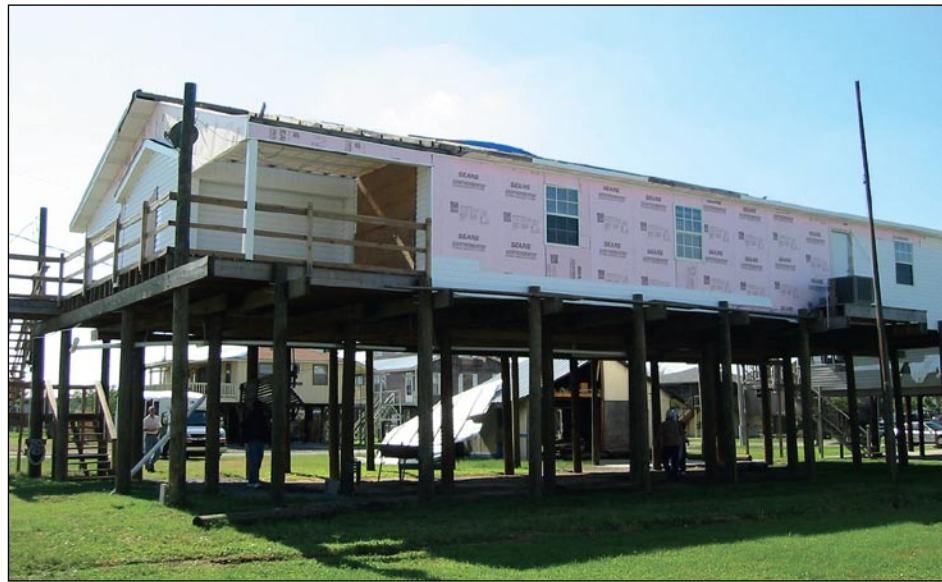
The home experienced some wind damage (vinyl siding and portions of the roof covering were dislodged) despite the fact that the Ike wind speeds and wind pressures were far below the HUD and ASCE 7-05 design wind speeds and pressures. Section 305 of the MHCSS, 24 CFR Part 3280, requires that siding be designed to resist wind loads for Exposure C specified in ANSI/ASCE 7-88, or wind pressures specified the HUD Standard table titled Table of Design Wind Pressures. The MHCSS places Jefferson Parish in HUD Wind Zone III, and the Table of Design Wind Pressures requires exterior coverings within 3 feet of corners to resist +/- 58 psf, and exterior coverings in other areas to resist +/- 46 psf. The ASCE 7-05 wind pressures (for a 150 mph basic wind speed) are +49/-65.7 psf at the corners of a building and +49/-53.1 psf in other areas.

Figure 3-137.
This elevated
manufactured home in
Grand Isle of Jefferson
Parish, LA, had siding and
roof damage, but did not
move from its foundation

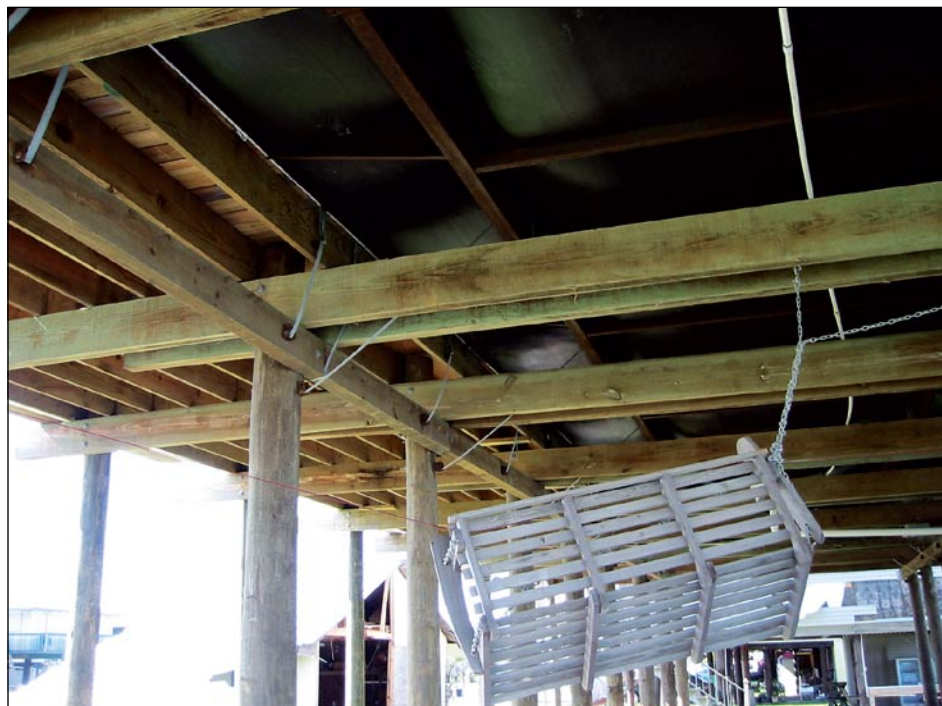
The manufactured home shown in Figures 3-137 and 3-138 is located in Zone A (BFE = 10 feet, ABFE = 12 feet) on Grand Isle, Jefferson Parish. Ike floodwaters were approximately 6 feet deep and did not reach the home, which was elevated in compliance with NFIP requirements. Support framing was in place, and strapping secured the walls and the steel chassis frame to the foundation. While effective during Ike, the strapping was installed using non-conventional methods. Its ability to resist a design wind event could not be determined.

Figure 3-138.
The framing and anchoring
system of the house
shown in Figure 3-137.
Strapping secured the
home's walls and frames
to its foundation. While the
strapping held the home to
its foundation during Ike,
it could not be determined
if the strapping would
resist a design wind event
(Estimated wind speed
during Ike: less than 60
mph, 3-second gust).

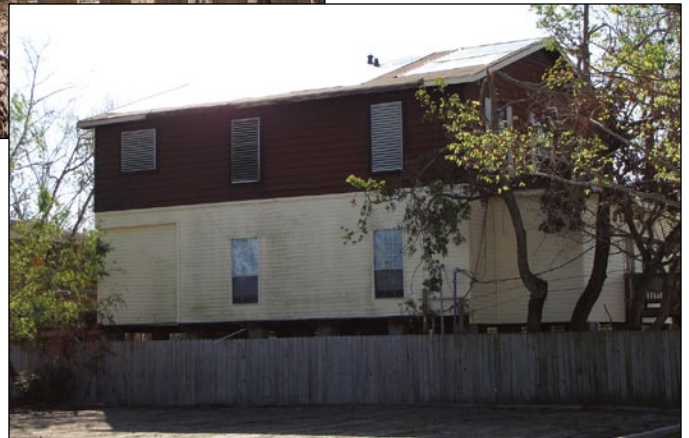
Figure 3-142. House elevated with Increased Cost of Compliance funds (Kemah, TX). Inset shows evidence of wind damage to roof (Hurricane Ike estimated wind speed in this area: 90 mph, Exposure B).
