Mitigation Assessment Team Report

Hurricane Ike in Texas and Louisiana

Building Performance Observations, Recommendations, and Technical Guidance

FEMA P-757 / April 2009

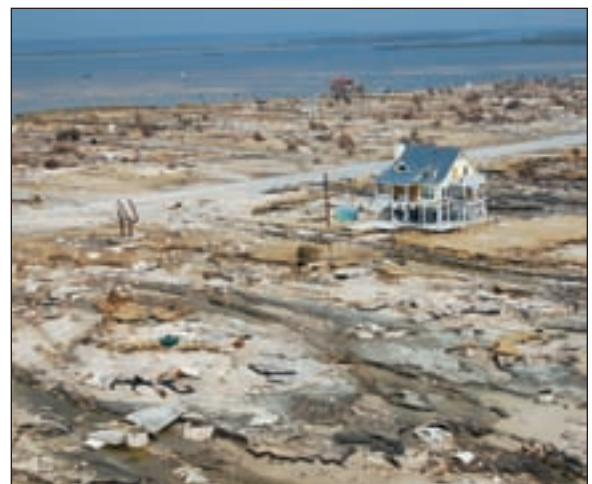
In this photo taken by the MAT on September 19, 2008, a lone house in the Gilchrist neighborhood on the Bolivar Peninsula in Texas, survived Hurricane Ike.

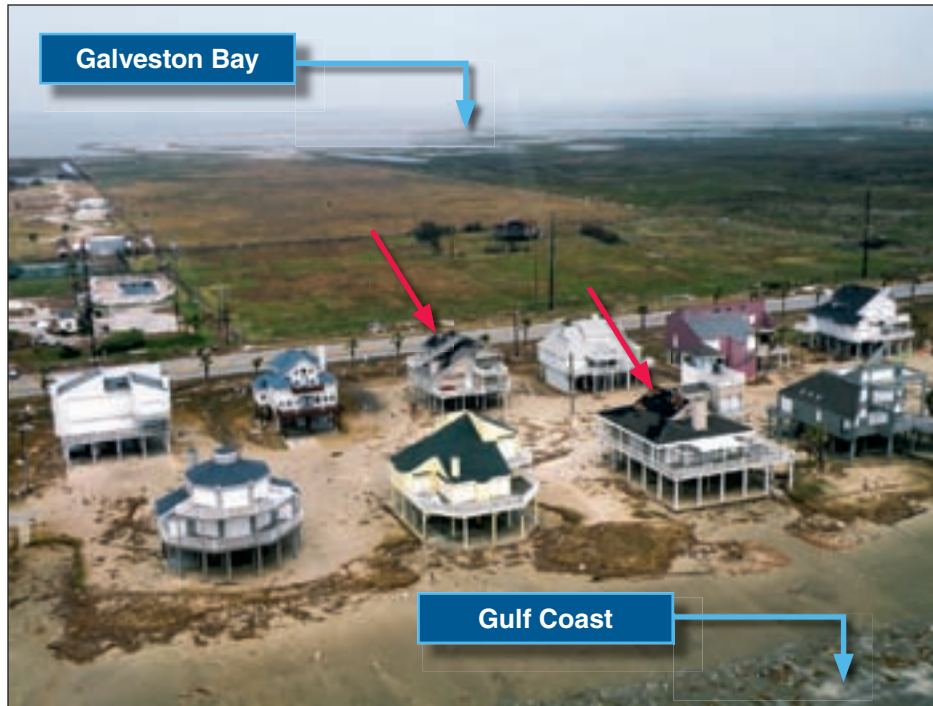
Figure 1-12.
Roofing damage to north
and west exposures
produced by Hurricane Ike
backside winds

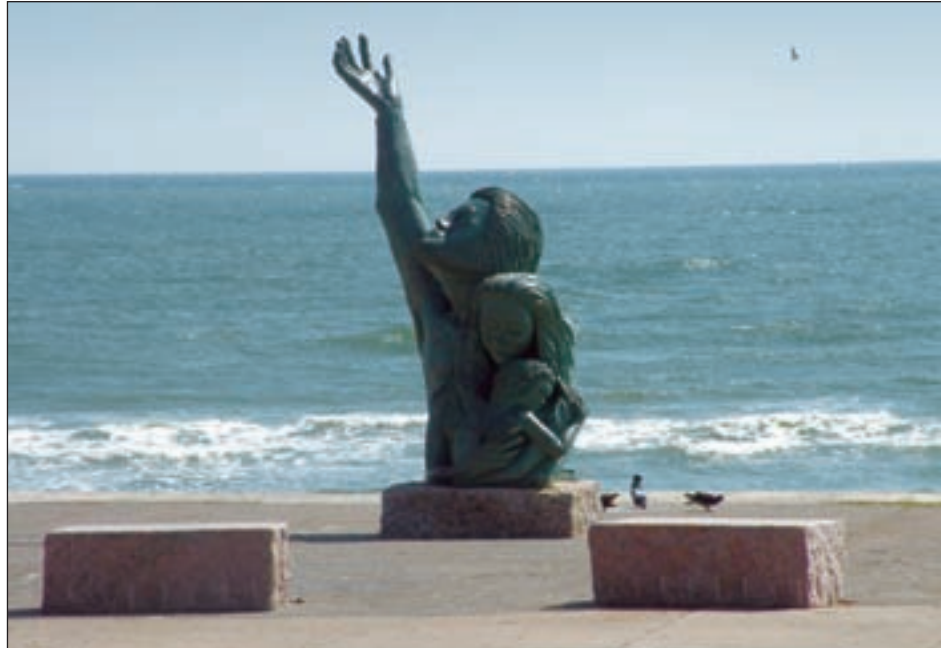
The deadliest hurricane in U.S. history was the Great Galveston Hurricane that occurred September 7 to 8 in the year 1900. This hurricane claimed approximately 8,000 lives. The population of Galveston in 1900 was approximately 37,000. This hurricane traveled the Caribbean as a tropical storm before making landfall across the southern United States where it hit Florida, Mississippi, Louisiana, and Texas. The hurricane then traveled through central United States and up through the Great Lakes making its way through Canada. The Great Galveston Hurricane was classified as a Category 4 at landfall, with sustained winds of 100 mph and gusts over 125 mph. The minimum central pressure was 931 mb or 27.49 inches of mercury. The monument shown in Figure 1-14 commemorates the Great Galveston Hurricane; plaques around the statue were destroyed by Hurricane Ike.

Figure 1-14.
Plaques near the Great
Galveston Hurricane
Memorial were destroyed
by Ike

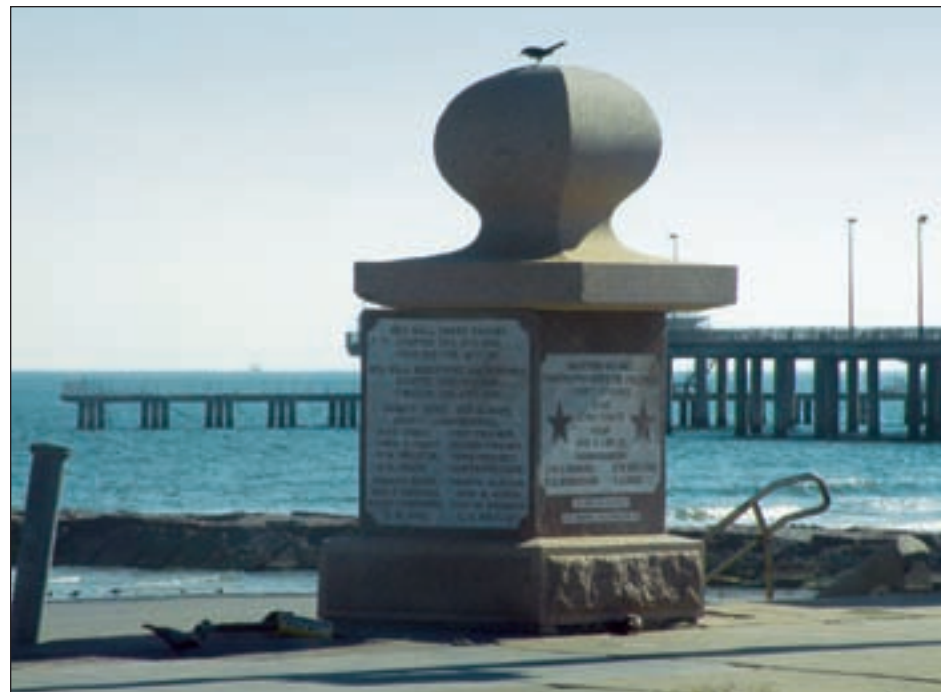
The storm surge and high water level from the Great Galveston Hurricane washed out the four bridges linking Galveston to the mainland and downed telephone lines, cutting off the island from the mainland. The highest land elevation on Galveston Island in 1900 was 8.7 feet; the storm surge reached 15 feet. The damage to property was about \$30 million. The horrific devastation of the hurricane propelled the people of Galveston to find a way to protect themselves against another disaster of this magnitude. Construction of a 17-foot-high seawall began in 1902 to protect 3 miles of oceanfront and raise the city portion of the island by 8 feet. Sand was dredged from Galveston Bay to elevate the island. A memorial to the construction of seawall was erected after construction was completed; the monument was damaged by Hurricane Ike (Figure 1-15).

Figure 1-15.
The memorial capstone
was moved off center by
Ike

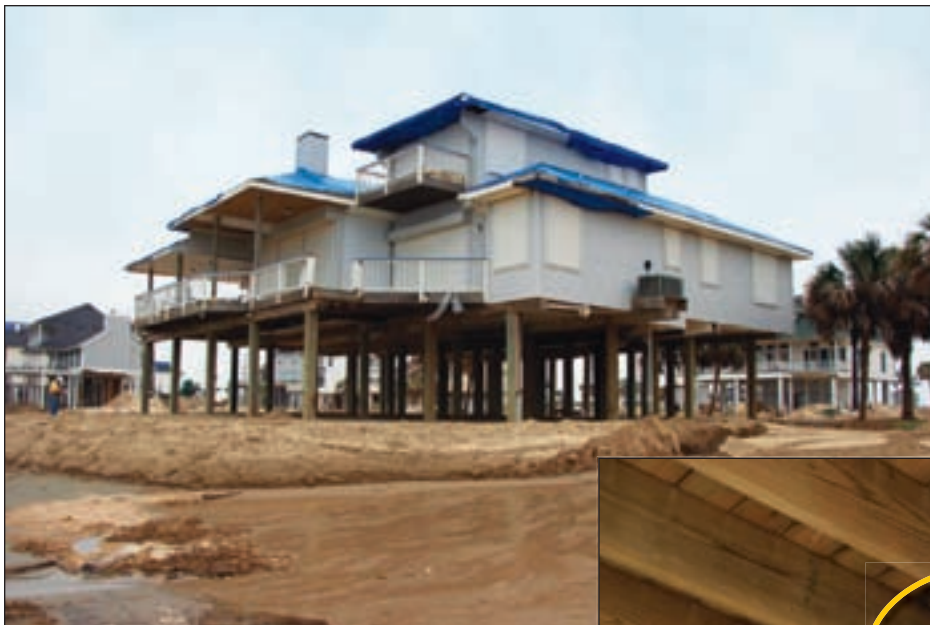
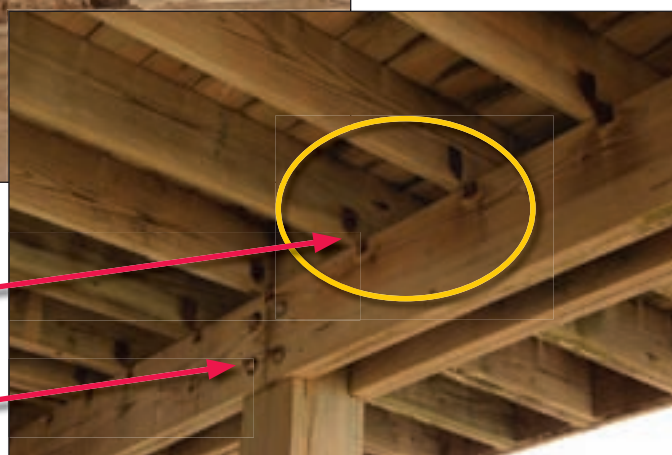
Figure 2-6.
Indian Beach house,
post-Ike (number 3289 in
1990 Galveston study)

Corroded and broken
hurricane clips

Bolted piling and girder
connection

During Hurricane Ike, the house suffered substantial wind damage to the asphalt shingles, vinyl siding, and soffits. The Galveston study identified the lack of shuttering for the house openings as a weakness. At the time of Hurricane Ike, the house openings were fully shuttered.

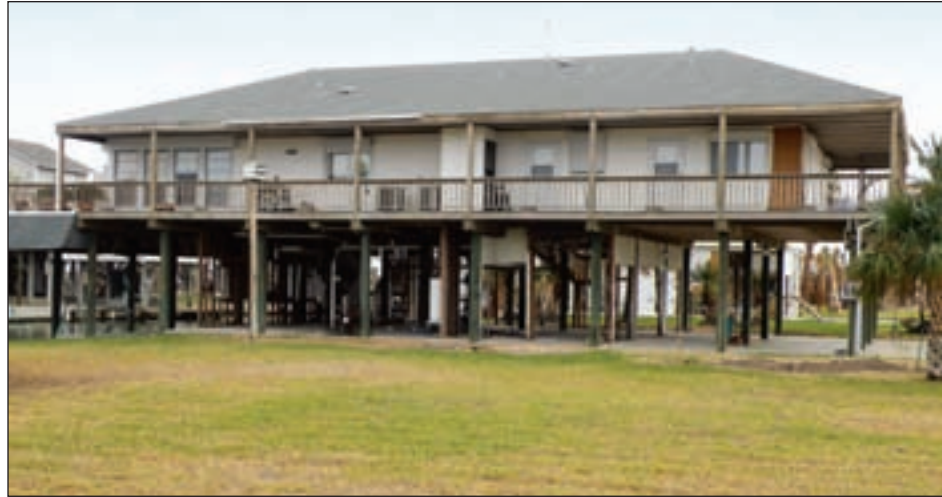
Number 3083, constructed in 1983, is located in Zone A in Point San Luis on a canal that opens to the West Bay (Figure 2-7). According to the Galveston study, this house's identified weaknesses included overhangs greater than 4 feet, pile spacing greater than 12 feet, and walls or enclosures below the BFE that were not of breakaway construction. During Ike, the house was inundated by approximately 8 feet of water with waves that destroyed the majority of the first floor walls.

Figure 2-7.
Point San Luis house
(number 3083 in 1990
Galveston study)

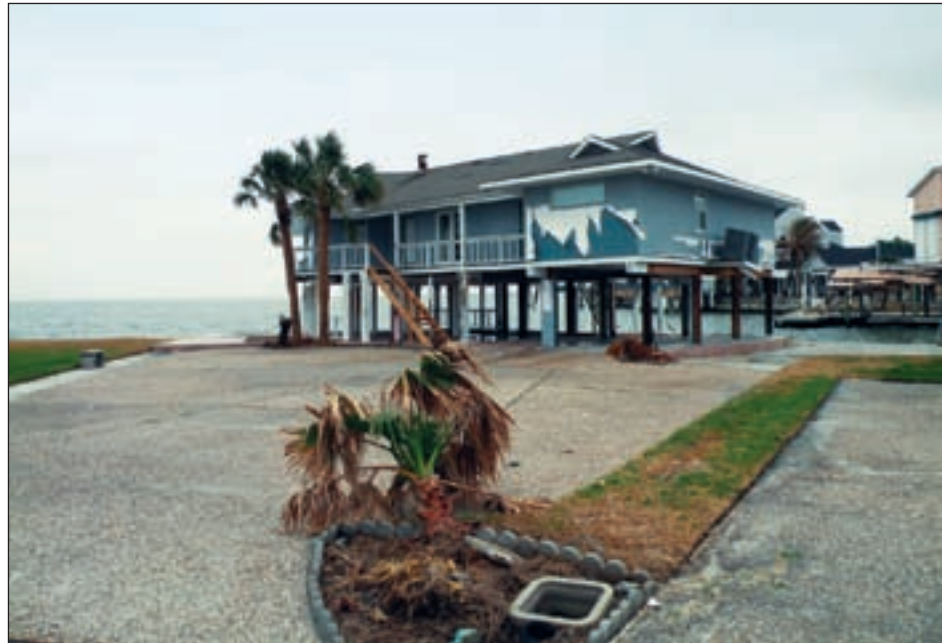
Number 2480 is located on the West Bay in Zone A in Jamaica Beach with a Category C wind exposure (Figure 2-8). The Galveston study identifies the hurricane clips and bolted structural connections as strengths and the non-breakaway wall structures as a primary weakness. The house experienced both wind and flood damage during Hurricane Ike. Wind damaged vinyl siding and roof shingles on the north and west exposure of the house, an indicator of "backside" (north-to-south) winds. Flooding and waves undermined the concrete paving below the house and tore out ceilings, stairs, and wall structures below the first floor (Figure 2-9).

Figure 2-8.
Jamaica Beach house
on the West Bay with
“backside” wind damage
(number 2480 in 1990
Galveston study)

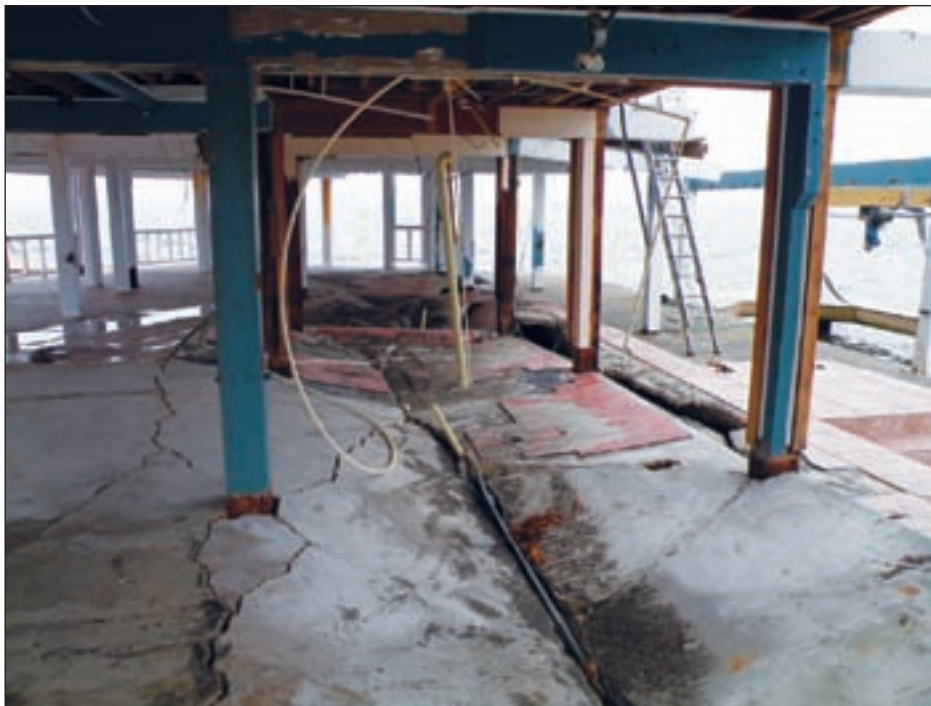
Figure 2-9.
First floor walls removed
and floor slab undermined
by flooding and waves at
this Jamaica Beach house
(number 2480 in 1990
Galveston study)

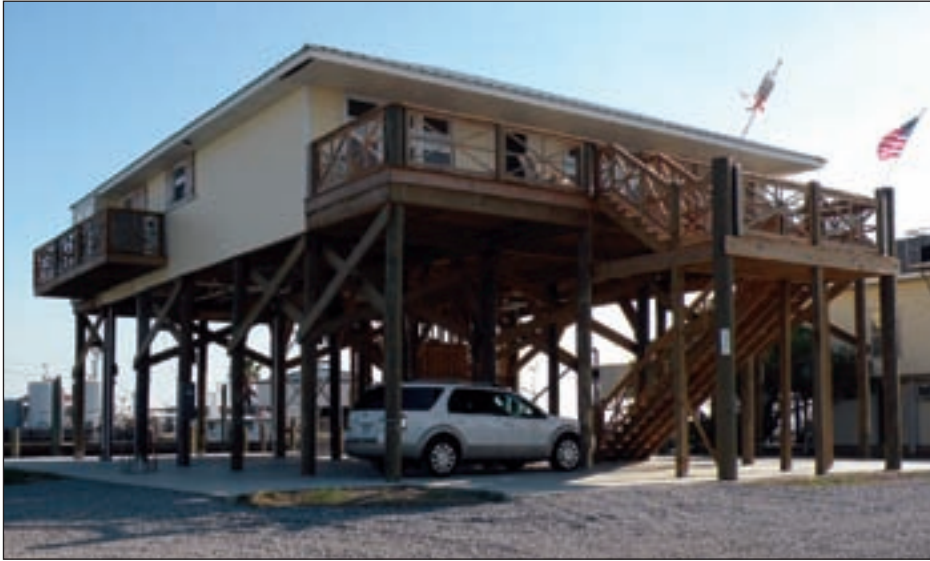
Figure 3-1.
Louisiana house
sufficiently elevated on a
foundation that withstood
Ike flood loads

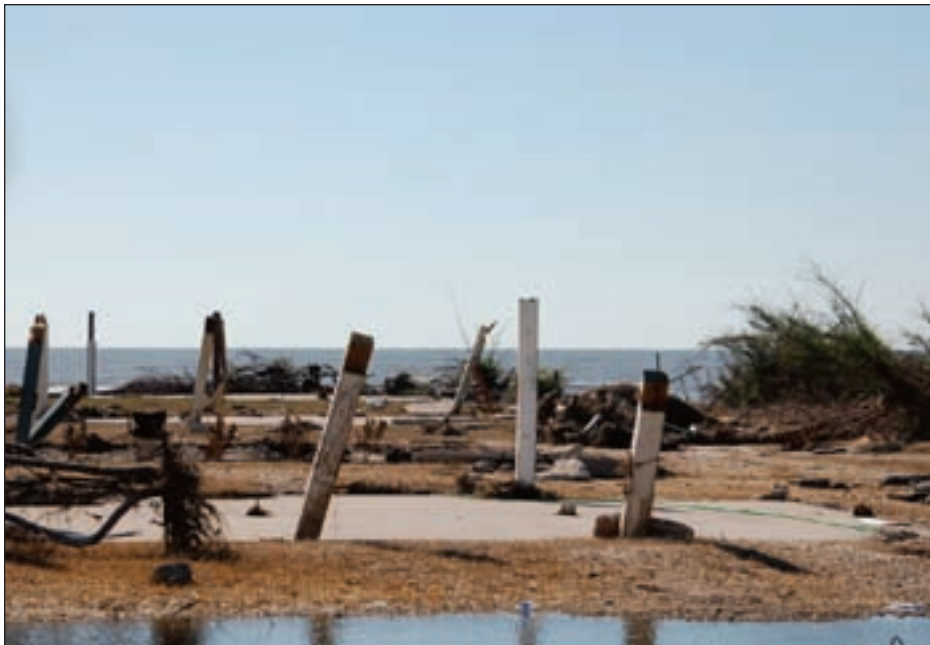
Embedment Failures. Embedment failures occur where a foundation is not deep enough in the ground to resist wind and flood loads pushing on the structure; a leaning foundation or overturned building results (Figure 3-2). Scour and erosion can exacerbate this mode of failure by reducing embedment.

Figure 3-2.
A house on timber piles
was pushed over by wind
and flood loads and the
load path failed at the
connection between the
floor beam and the piles.
Embedment and elevation
were also insufficient at
this Bolivar Peninsula, TX,
site.

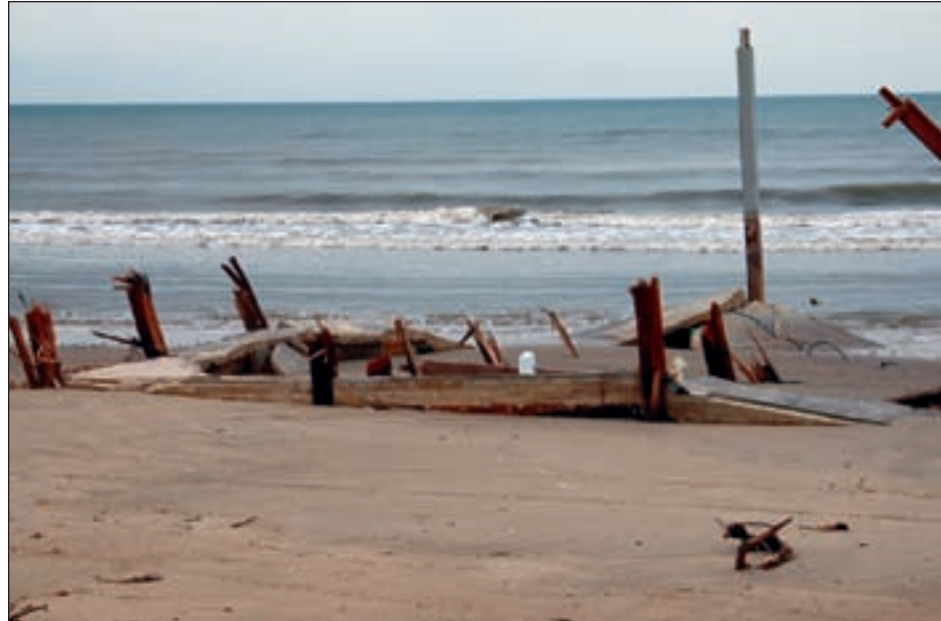
Pile and Column Breakage. Pile and column breakage occur where the strength of the piles or columns is inadequate to resist the bending moments or shear forces caused by the flood and wind loads acting on the structure (Figures 3-3 and 3-4). Scour and erosion contribute to this mode of failure by increasing the un-braced pile/column length and by increasing the bending moments in the pile/column.

Figure 3-3.
Broken timber piles
(Galveston Island, TX)

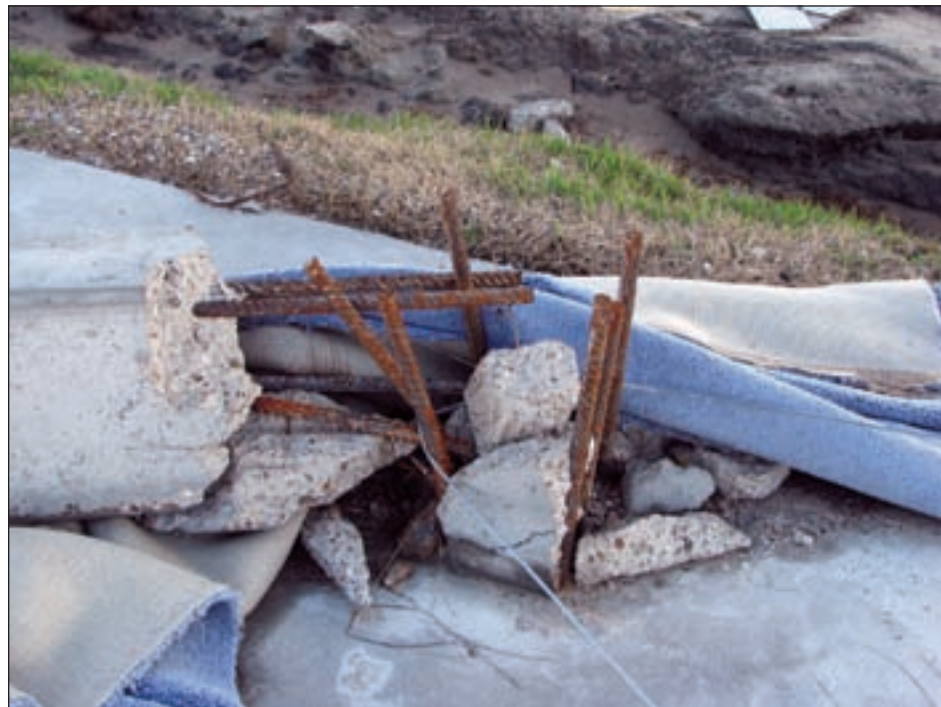
Figure 3-4.
This concrete column
failed due to lateral loads.
Note limited overlap of
reinforcing steel at the
bottom of the column.

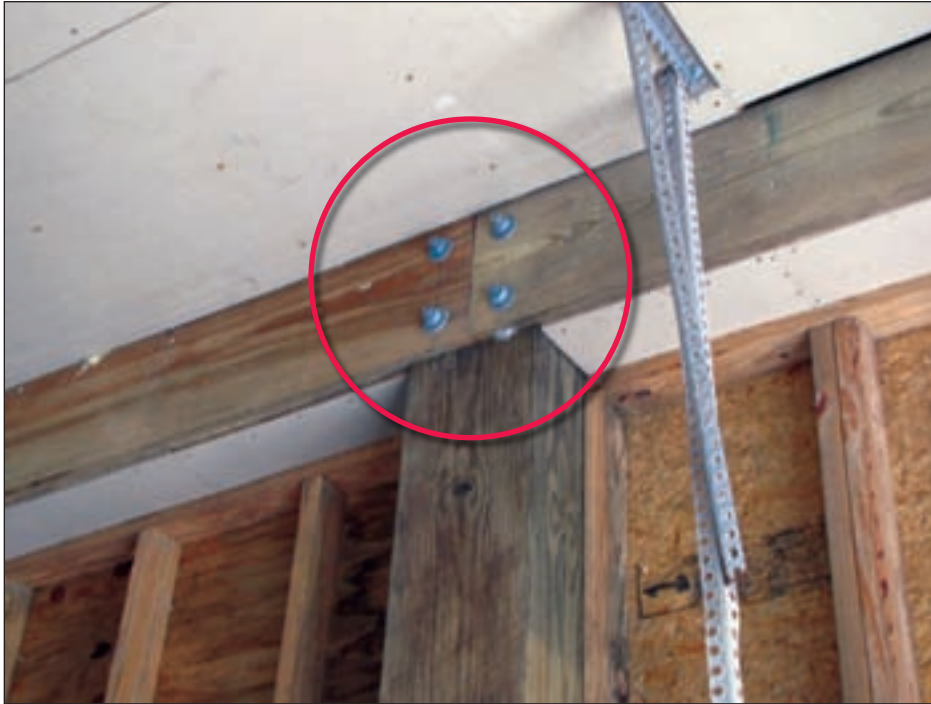
In most buildings the MAT evaluated, timber construction was used and the tops of the piles or columns were connected to the elevated buildings with bolted connections (Figure 3-5). This type of connection provides limited fixity; weakness in this type of connection can be overcome in some instances through the use of larger piles or columns and other design details that help to stiffen the foundation.

Figure 3-5.
Typical bolted connection
between wood columns
and wood beams

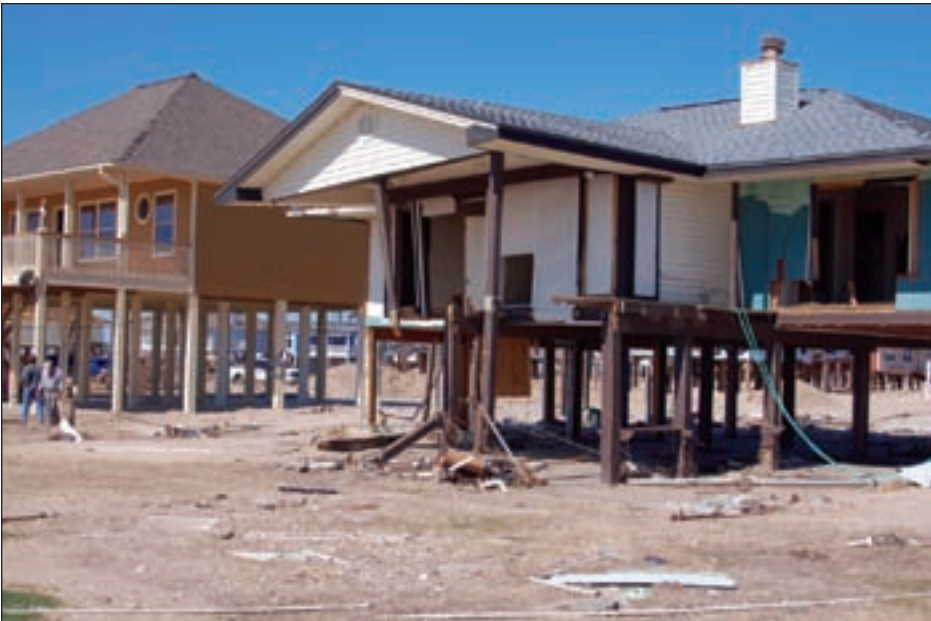
Figure 3-6.
Unlike the older and
lower house on the
right, the Zone V house
on the left was elevated
approximately 5 feet
above the 16-foot National
Geodetic Vertical Datum
(NGVD) BFE and sustained
no structural damage due
to flooding (Crystal Beach,
TX)

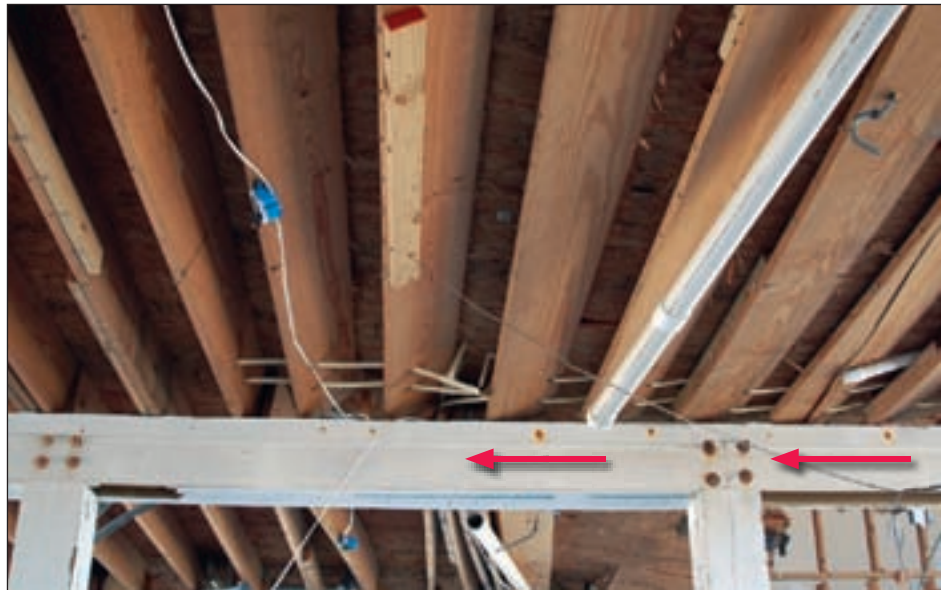
Figure 3-7.
The landward displacement of shore-parallel floor joists indicates the onset of wave damage to an elevated floor system (Bolivar Peninsula, TX)

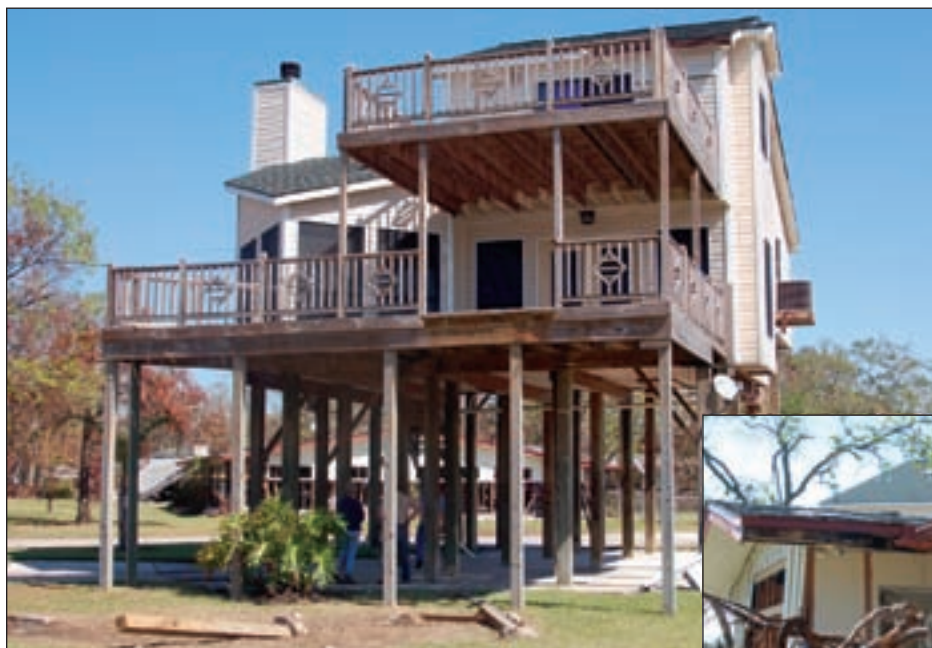
Figure 3-8.
This elevated house (Zone V, BFE = 15 feet) suffered no significant damage due to flooding. The nearby at-grade house in the background, shown in the inset, was heavily damaged (Baytown, TX).

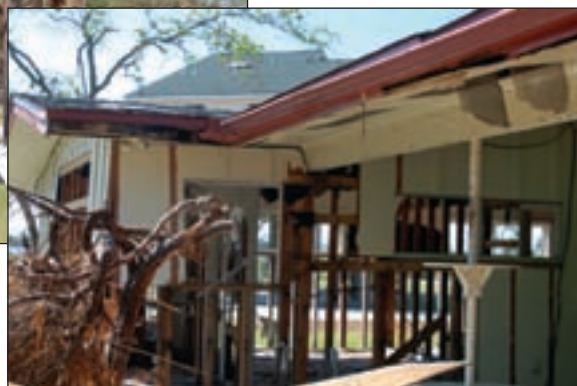
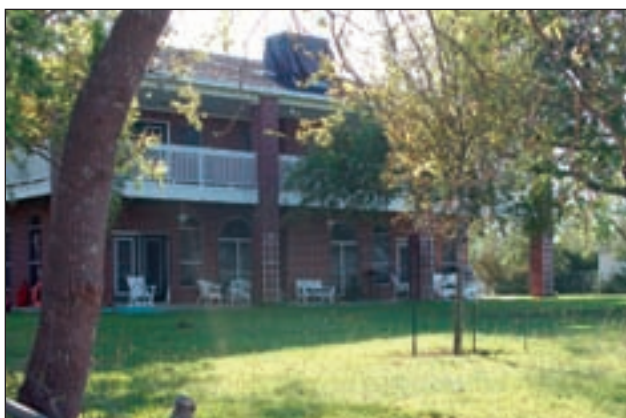
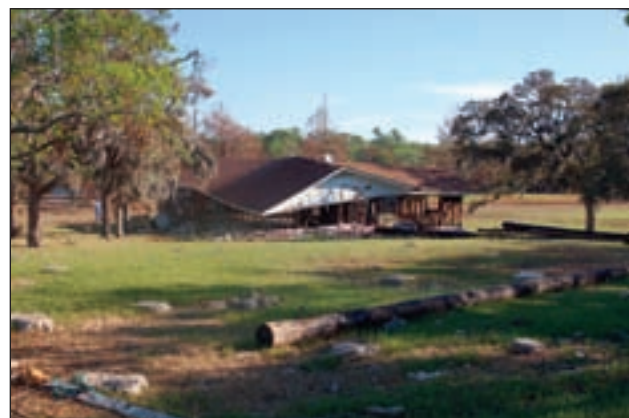
Figure 3-9.

Adjacent houses south of Baytown, TX. The house on the left (Zone X) was above the surge and wave runup level and sustained no flood damage. The house on the right (Zone A, BFE = 13 feet) was at a lower elevation and was largely destroyed by surge, waves, and floating debris.

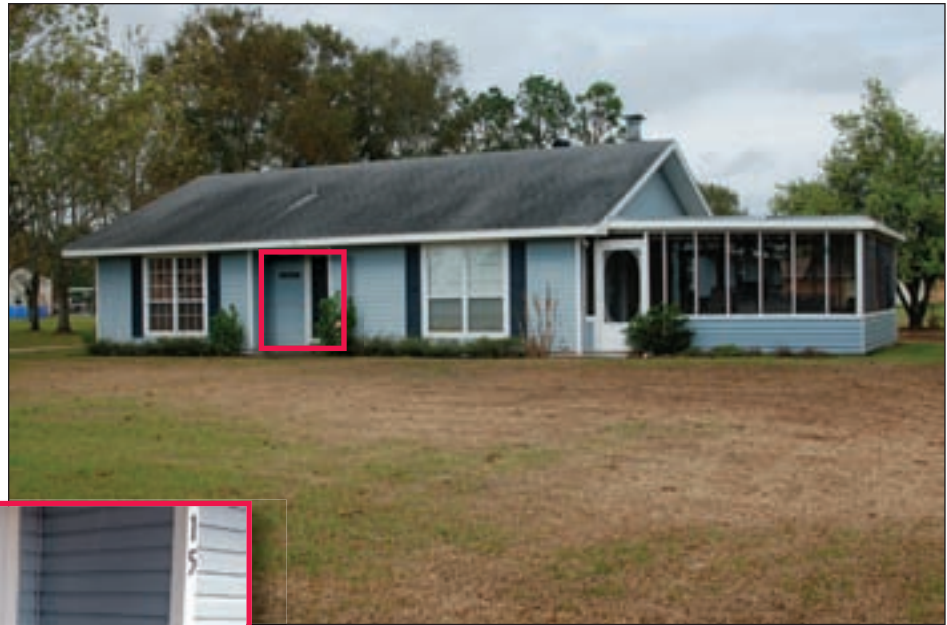
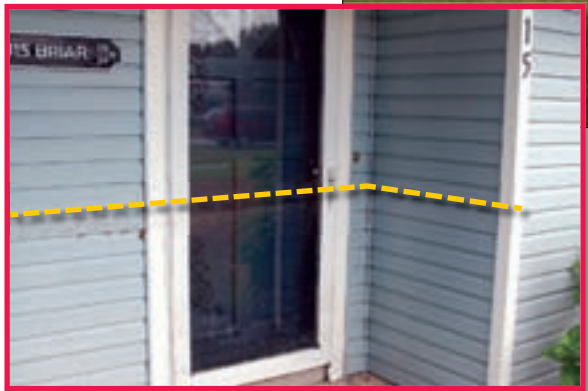
were inundated by several feet of flooding, as they had been during Hurricane Rita in 2005. The house shown in Figure 3-10 was not subject to wave action during Ike and suffered no apparent structural damage. However, flood damage to contents and finishings were likely severe. Other houses sustained significant structural damage due to storm surge flow (Figure 3-11). Some floated or were washed off their foundations (Figure 3-12).

Figure 3-10.
The Ike flood level reached approximately 3 feet above the floor slab (1 foot above the 6-foot BFE) of this Zone A house (see inset), which was reported to have been similarly inundated during Hurricane Rita. The MAT was told that the house will be elevated (Lake Charles, LA).

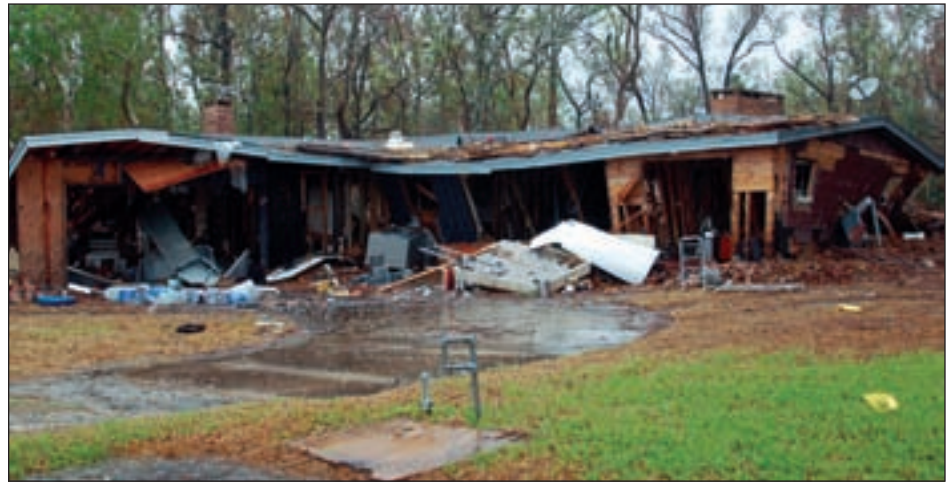
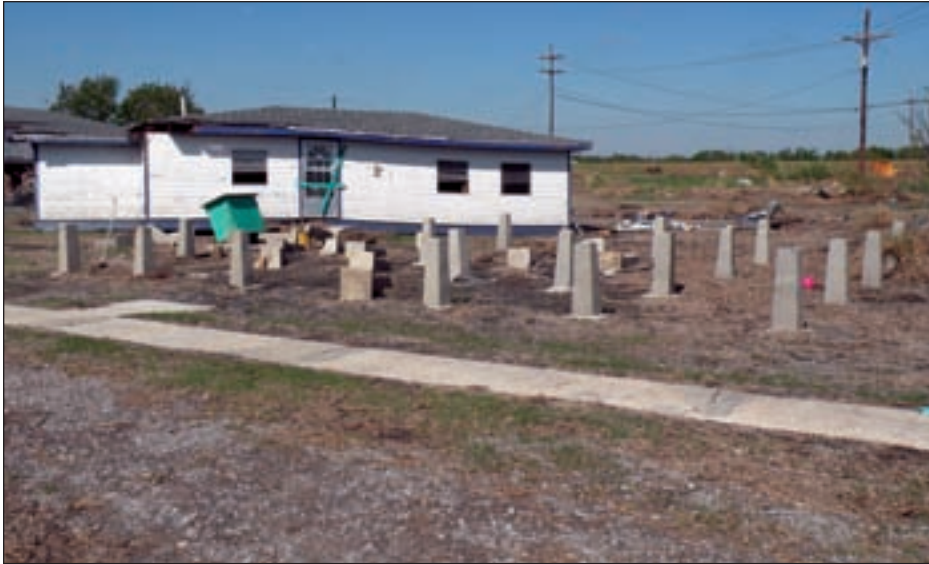
Figure 3-12.
This house floated off its foundation due to insufficient elevation and inadequate connections between the foundation and the house (Golden Meadow, LA)

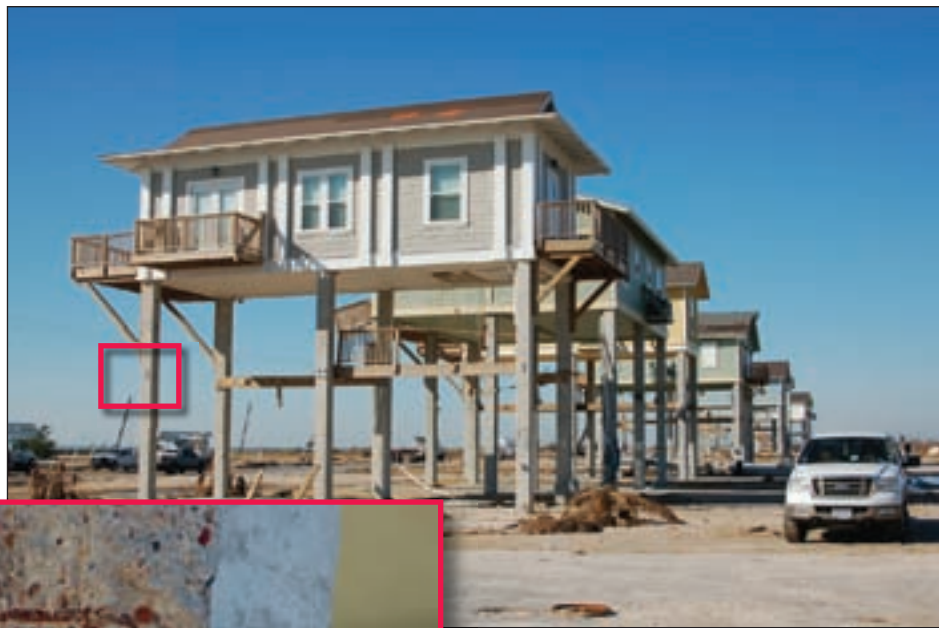
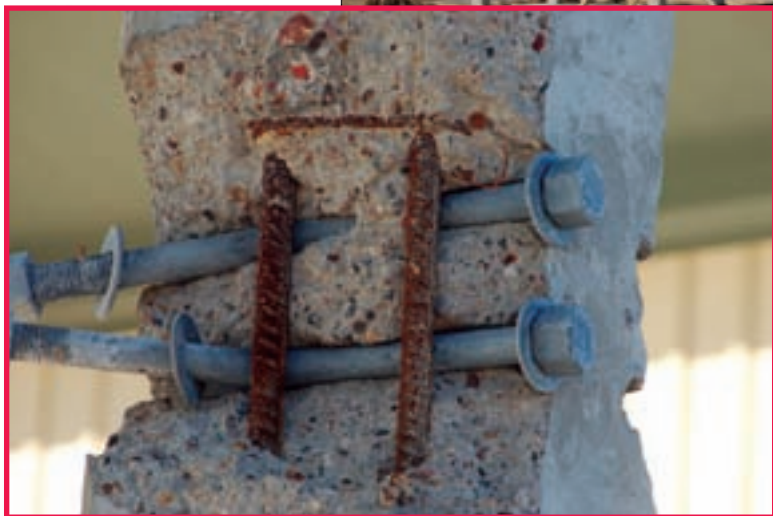
The concrete columns left standing between the slabs and the (destroyed) elevated decks were observed to have a series of horizontal cracks in the columns (Figure 3-15). These cracks likely resulted from the columns bending in response to a combination of wind loads on the elevated houses, flood loads (waves, currents, debris) on the columns, and transfer of flood loads from the decks to the columns.

Figure 3-15.
Concrete column showing cracking that was likely caused by extreme column bending stresses due to lateral loads on the elevated house and foundation (Bolivar Peninsula, TX)

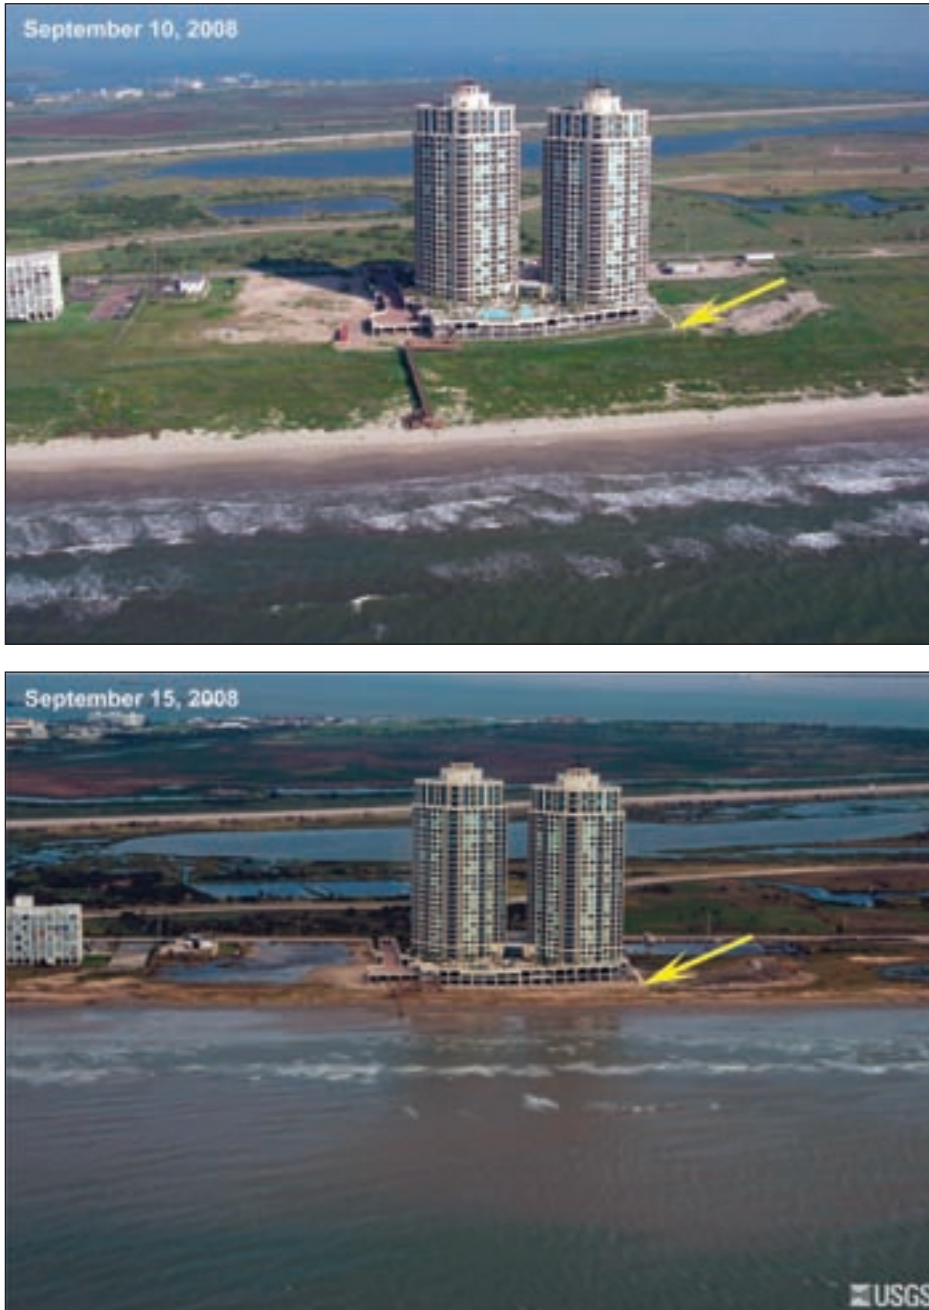
A preliminary review of pre- and post-Ike aerial photographs suggests that between 100 and 200 feet of dunes and vegetation were lost during Ike along much of the Gulf shoreline (see Figure 3-16).

Figure 3-16. Pre- and post-Ike aerial photographs of the east end of Galveston Island, TX, illustrating some of the most significant loss of dunes and vegetation during Ike

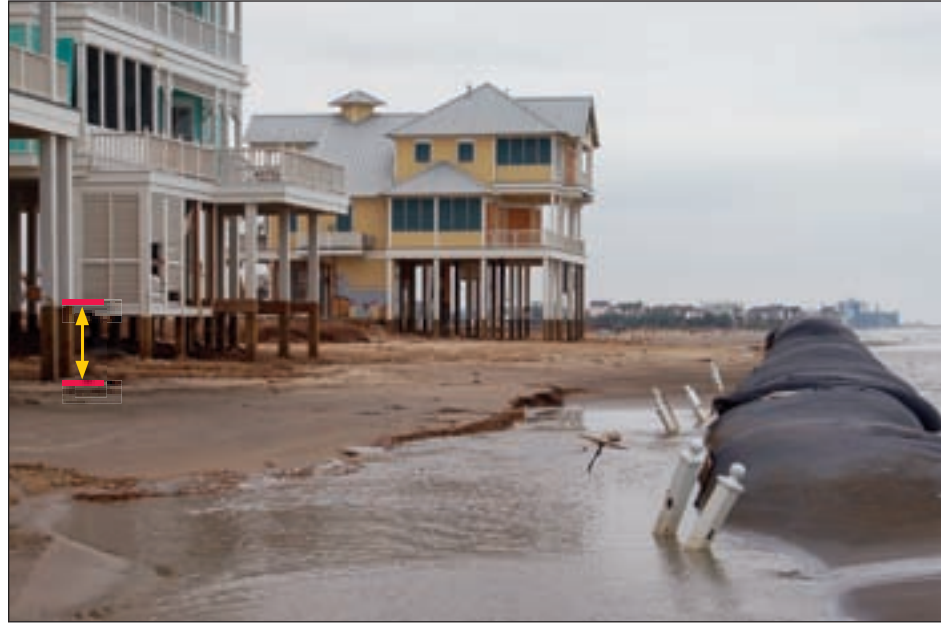
This loss occurred in areas with natural dunes and in areas where previously eroded dunes had been rebuilt and reinforced with geotextile tubes (see Figures 3-13 and 3-17). As of 2003, approximately 7.6 miles of geotextile tube dune reinforcement had been installed along the Texas shoreline, mostly along the Bolivar Peninsula and western Galveston Island shorelines (Gibeaut et al., 2003). Virtually all of these tubes were uncovered by Ike, and many were destroyed.

Figure 3-17.
Exposed geotextile tubes
formerly covered by sand
and dune vegetation.
Note erosion behind the
tubes and under Zone V
(BFE = 18 feet) buildings
(yellow arrow at left).

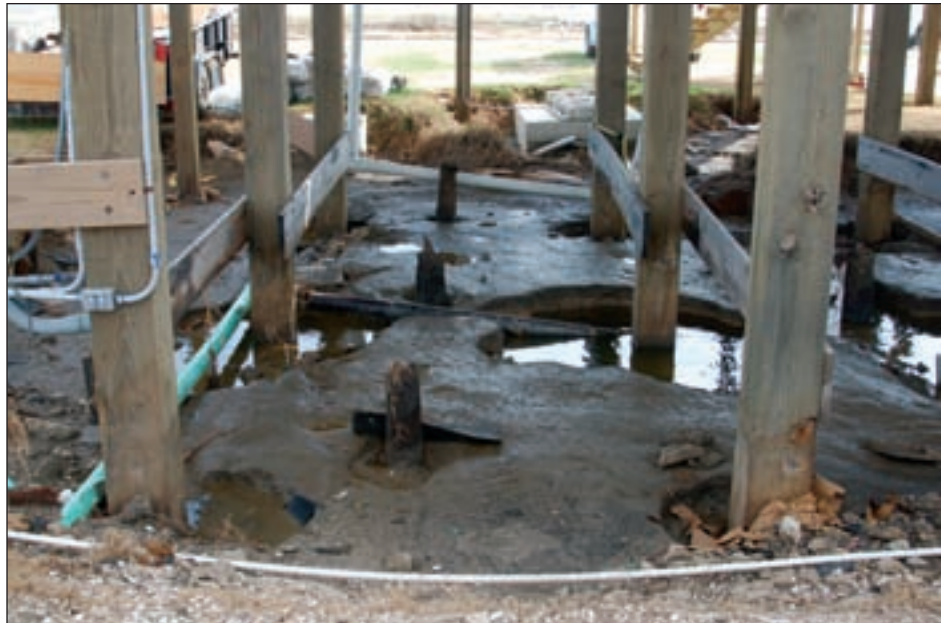
Figures 3-18 and 3-19 show buildings at Holly Beach, LA, both of which sustained significant scour around foundations. Of the approximately 20 pile-elevated houses in existence at Holly Beach prior to Hurricane Ike, nearly half experienced significant foundation scour (virtually all of buildings at Holly Beach were destroyed by Hurricane Rita in 2005, and the houses observed by the Ike MAT had been built since 2005).

The amount of scour around pile foundations observed by the Ike MAT far exceeded what current design guidance predicts.

Figure 3-18.
Foundation scour
observed at Holly
Beach, LA

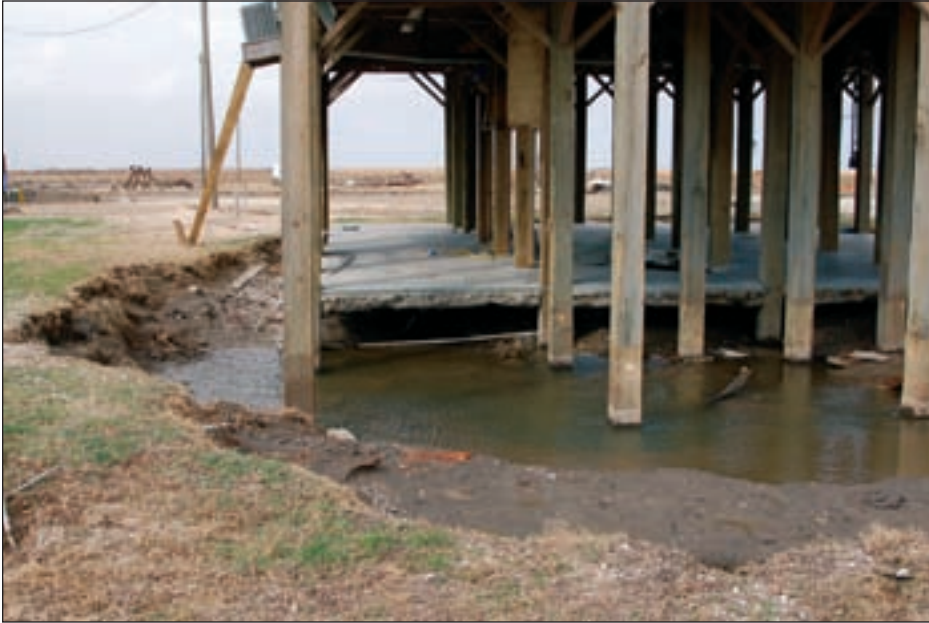
Figure 3-19.
Foundation scour
observed at Holly Beach,
LA (Zone V, ABFE = 16
feet)

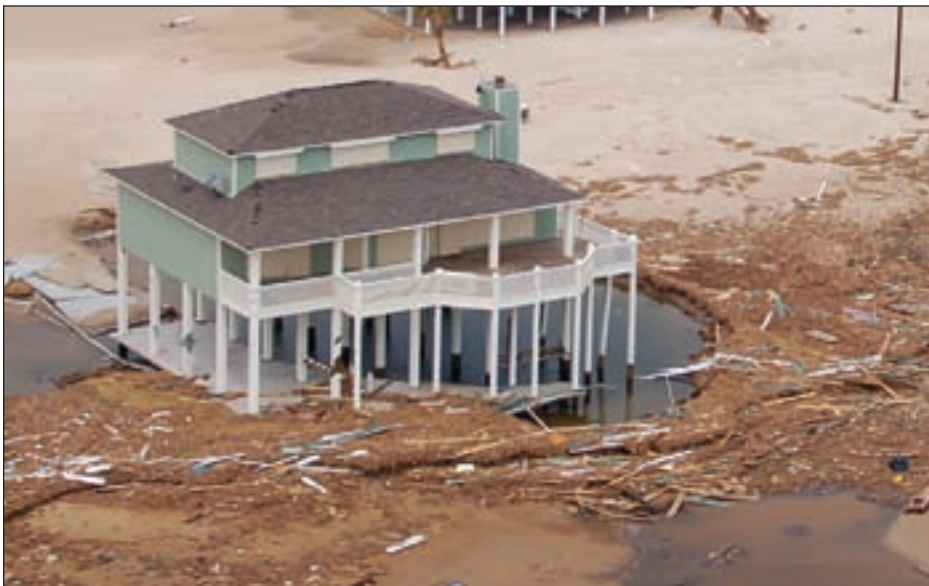
Figure 3-20 shows a case of extreme foundation scour at a house on Bolivar Peninsula. The scour depression shown was reported by a local contractor to have been as much as 10 feet deep. The house was able to withstand the scour and the wind and flood loads acting on the structure, but lack of soil support allowed the bottoms of some of the piles supporting the deck on the right side of the house to be shifted toward the left.

Figure 3-20.
Foundation scour was
reported to be 10 feet
deep—note the bottoms
of the piles on the right
side of building that have
been pushed toward
the building (Bolivar
Peninsula, TX; Zone V)

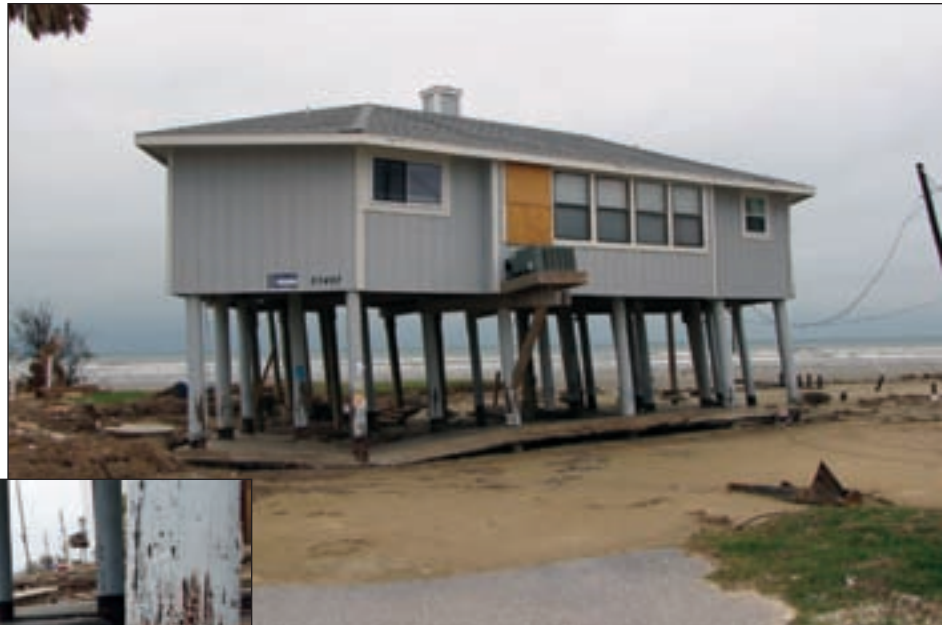
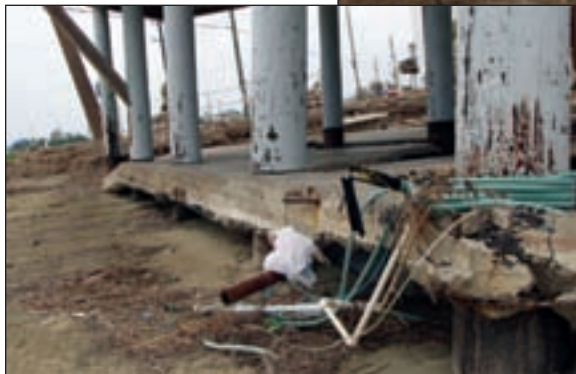
In some cases, pile foundations subject to erosion and/or scour were not embedded deeply enough to resist the loads and conditions that were present during Ike. Figure 3-21 shows such a case where a pile foundation shifted under an elevated house. Scour and erosion contributed to the failure. The presence of the attached, but broken, concrete slab could also have contributed to the foundation failure by reducing the lateral support formerly provided by the intact slab, and by causing eccentric loading of the piles (see Section 3.3.3).

Figure 3-21.
Failure of a timber pile foundation undermined by scour and erosion. Inset shows close-up of concrete slab failure and rotation of some of the foundation piles (Galveston Island, TX; Zone V).

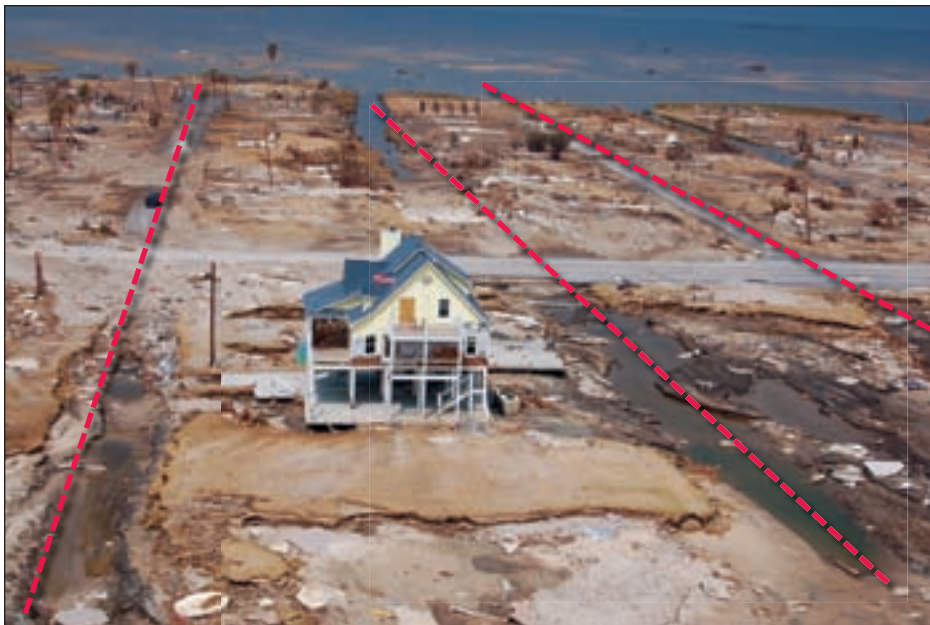
One other aspect of scour was noted by the MAT—linear scour features that result in the loss of soil around or under buildings when storm surge flow is channeled or directed across a building site. This process usually takes place where storm surge flow is constrained between large buildings or gaps in shore protection, or when storm surge return flow to the sea follows paths of least resistance, such as along canals and roads (Figure 3-22). Some of the many buildings lost during Ike were likely lost as a result of this process.

Figure 3-22. Linear scour features tend to align with canals and roads as storm surge returns to the Gulf. Houses such as this one were fortunate not to be undermined and lost during Ike, as many homes undoubtedly were (Bolivar Peninsula, TX).

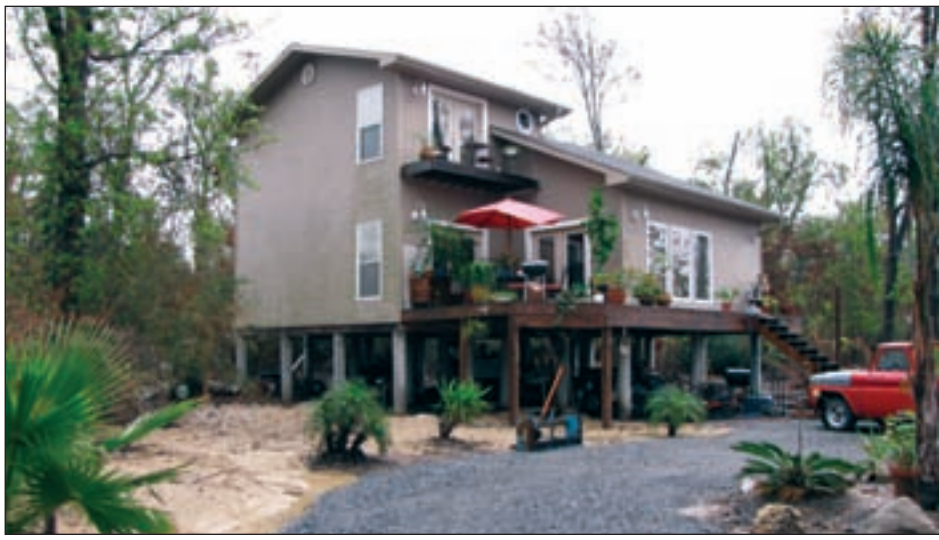
Connections between structural members are often the weak point in a load path, and the MAT observed many load path failures at the floor system-pile connection. The MAT also observed instances where this connection was adequate to prevent structural failure during Ike. Figure 3-24 shows an example of a wood-frame house elevated on concrete columns. The house survived with no structural damage even though the owner reported a flood level above the lowest floor. The attachment of the timber floor beams to the concrete columns provided load path continuity and prevented the house from floating or washing off its foundation (Figure 3-25). Although this house survived Hurricane Ike, this type of connection only provides limited resistance to lateral loads and applied moments—had the house experienced a higher surge or stronger winds, it may not have survived. The MAT estimated the 3-second gust wind speed (Exposure C) during Ike was approximately 85 mph at this site, but if wind speeds or lateral flood loads had been higher, this house could have sustained structural damage.

Figure 3-24.
This Bridge City, TX, house sustained no structural damage, despite the fact that the owner reported that Ike flood levels rose above the lowest floor

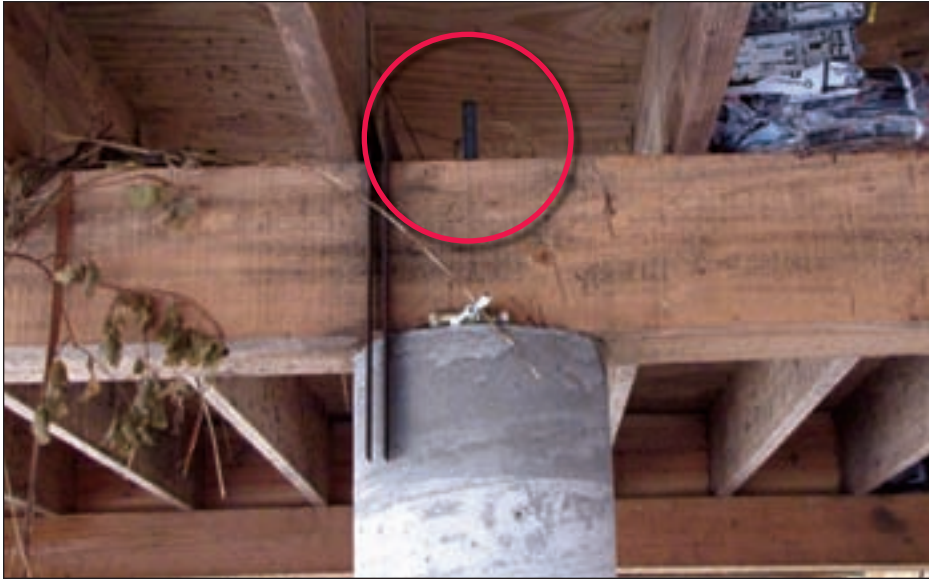
Figure 3-25. A 5/8-inch diameter galvanized steel anchor bolt in red circle (with washer and nut, not visible in this photograph) provided connections between beam and column for the house shown in Figure 3-24. This does not appear to be an engineered connection.
