Mitigation Assessment Team Report

Hurricane Ike in Texas and Louisiana

Building Performance Observations, Recommendations, and Technical Guidance

FEMA P-757 / April 2009

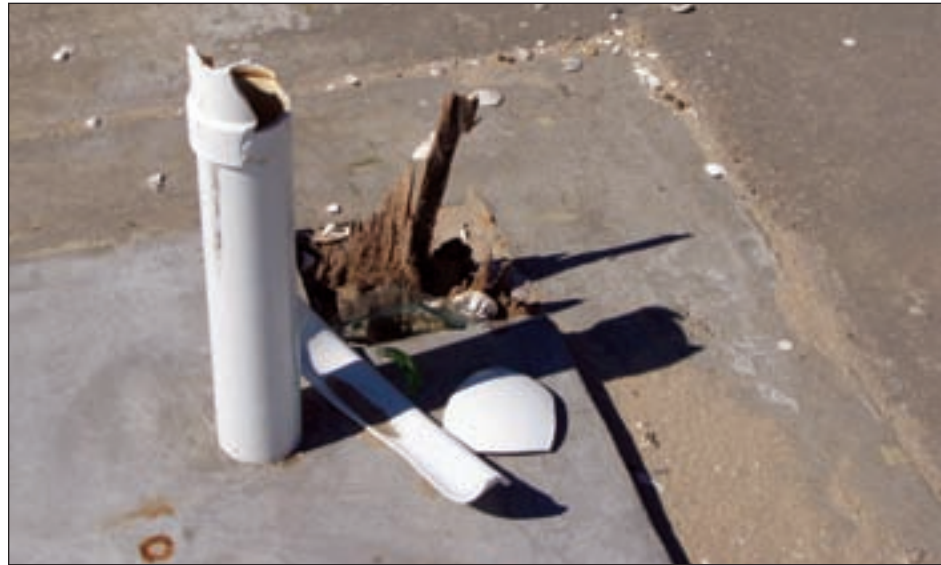
The MAT noted instances of other types of foundation load path failures, including those at the point where a column attached to a pile cap, slab, or grade beam. Deterioration of timber piles contributed to load path failures in some foundations (Figure 3-27). The deterioration could have been the result of inadequate preservative treatment or poor design/construction practice. In other cases, deterioration was observed that did not result in foundation failure during Ike; however, such a weakened foundation would be more susceptible to failure in the future (Figure 3-28).

Figure 3-27.
Deterioration in the wood piling likely contributed to the foundation failure (Bolivar Peninsula, TX)

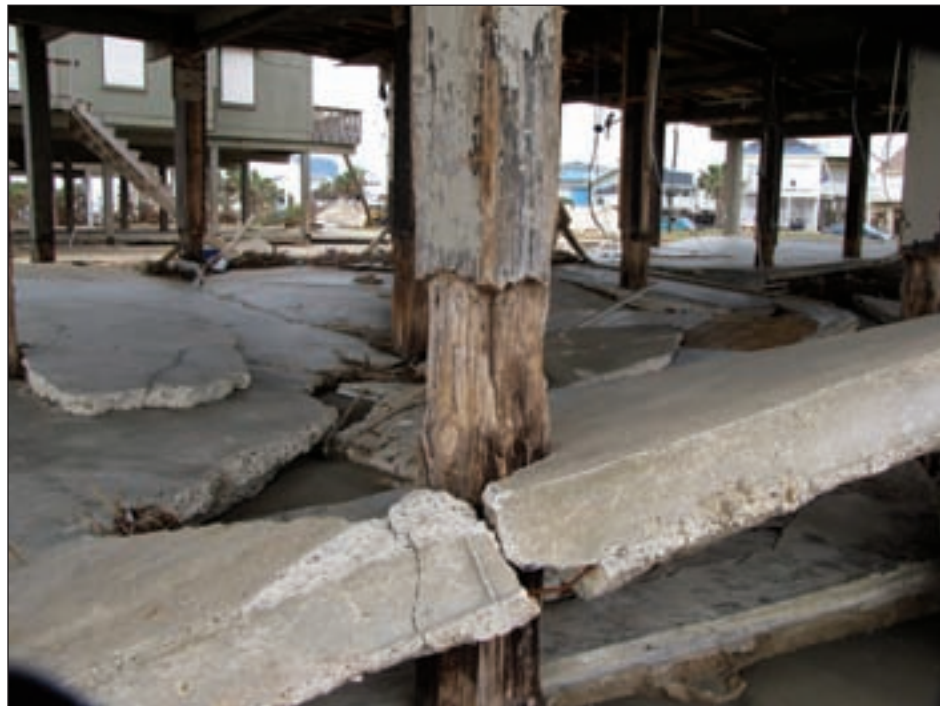
Figure 3-28.
Deterioration in wood piling. The foundation did not fail during Ike, but it was weakened and will be more susceptible to failure in the future (Galveston Island, TX).

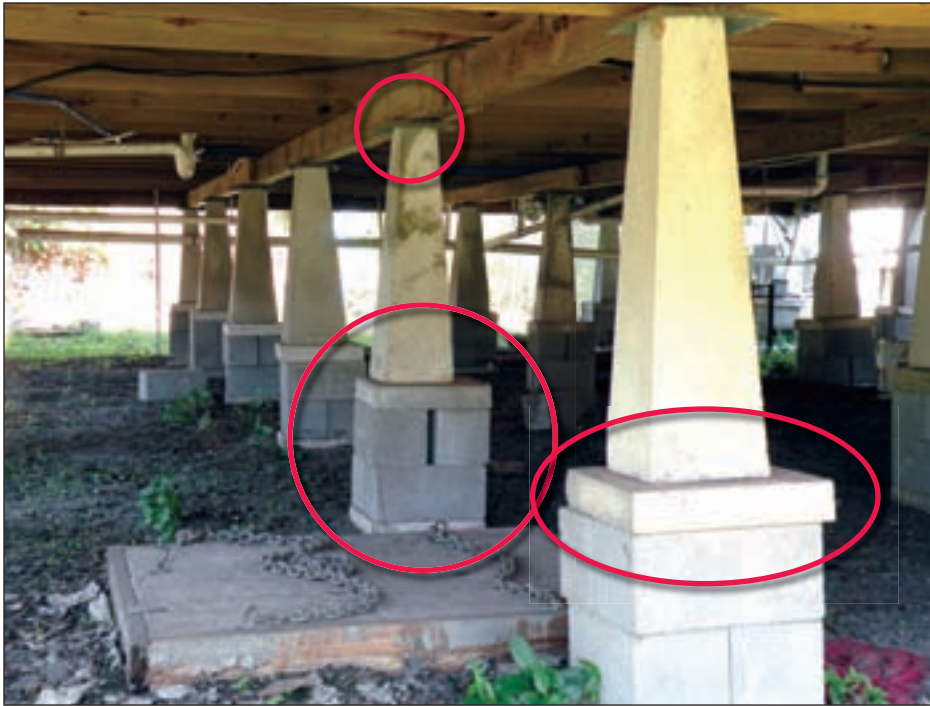
The MAT also noted cases where houses survived Ike, but must not have been exposed to high winds or large flood loads; otherwise the lack of load path continuity would have resulted in foundation failure. The house shown in Figure 3-29 is resting on top of precast concrete piers, stacked concrete masonry units (CMUs), and shallow footing pads—the necessary structural connections are missing. This design will not provide a continuous load path from the elevated house to the ground, and does not comply with minimum NFIP or building code requirements. This foundation will likely fail if it is subject to high winds and/or waves, velocity flow, or scour. Additional discussion of load paths is provided in Section 3.1.2.3.

Figure 3-29. House resting (i.e., with no structural connection) on top of precast concrete piers, stacked CMUs, and shallow footing pads (New Iberia, LA)

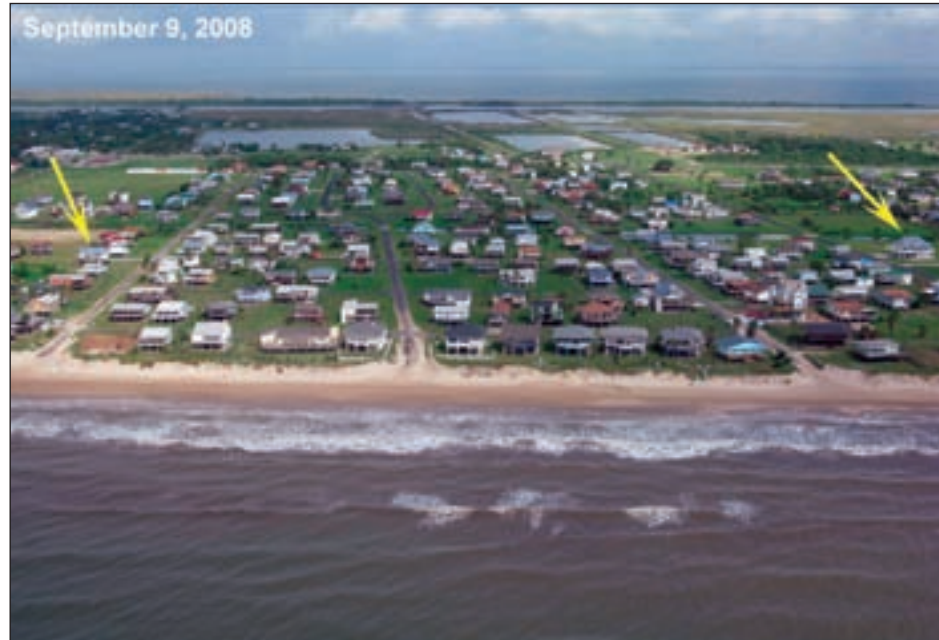
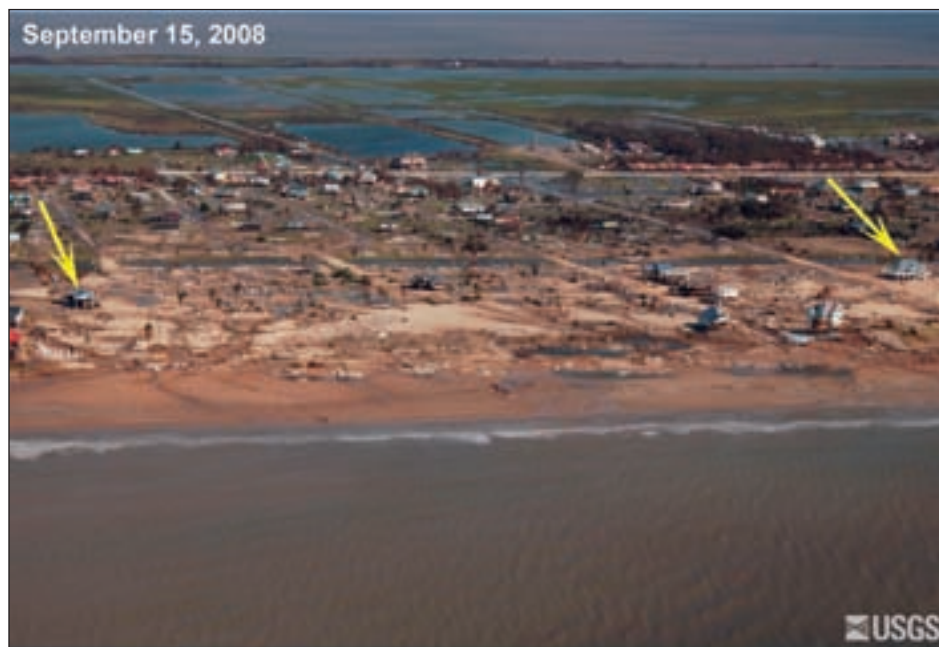
Figure 3-31 shows a comparison of pre- and post-Ike photographs for the Crystal Beach area of the Bolivar Peninsula. The Peninsula is the region where Hurricane Ike storm surge levels and wave heights appear to have reached maximums along the Gulf shoreline. Buildings along the Gulf shoreline of the Peninsula were likely subject to the greatest flood forces during Ike, and sustained the worst damage. Damage in this area has been compared to the Mississippi coast following Hurricane Katrina.

Figure 3-31.
Pre- and post-Ike aerial
photographs of the Crystal
Beach area of Bolivar
Peninsula, TX
SOURCE: USGS¹

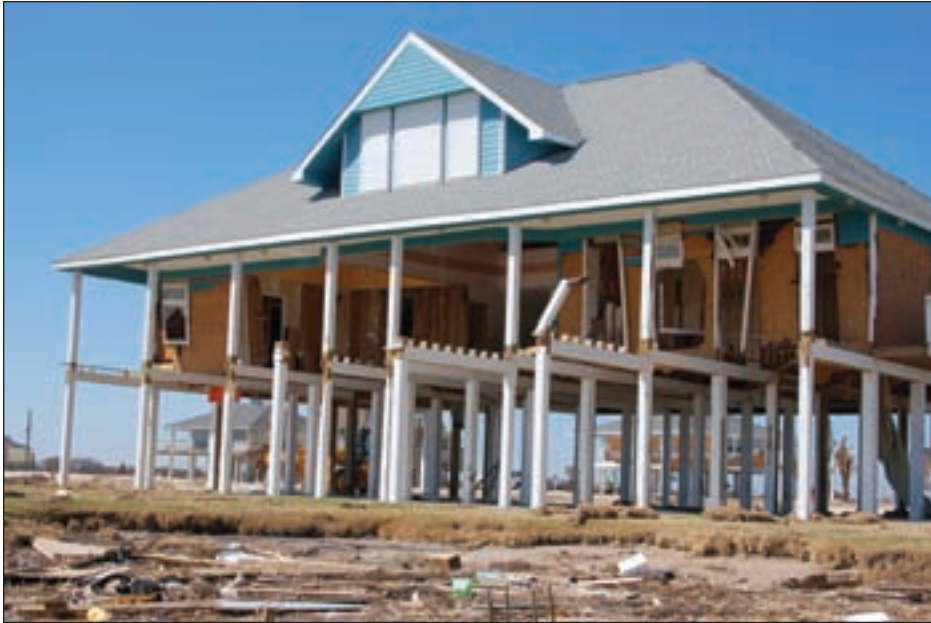
Figures 3-32 and 3-33 show examples of houses affected by waves and the inland penetration of large debris fields. The combination of waves and debris led to the destruction of many houses on Bolivar Peninsula.

Figure 3-32. Seaward side of Zone V house struck by waves. The deck, the elevated floor system, and the seaward walls were destroyed or heavily damaged (Bolivar Peninsula, TX).

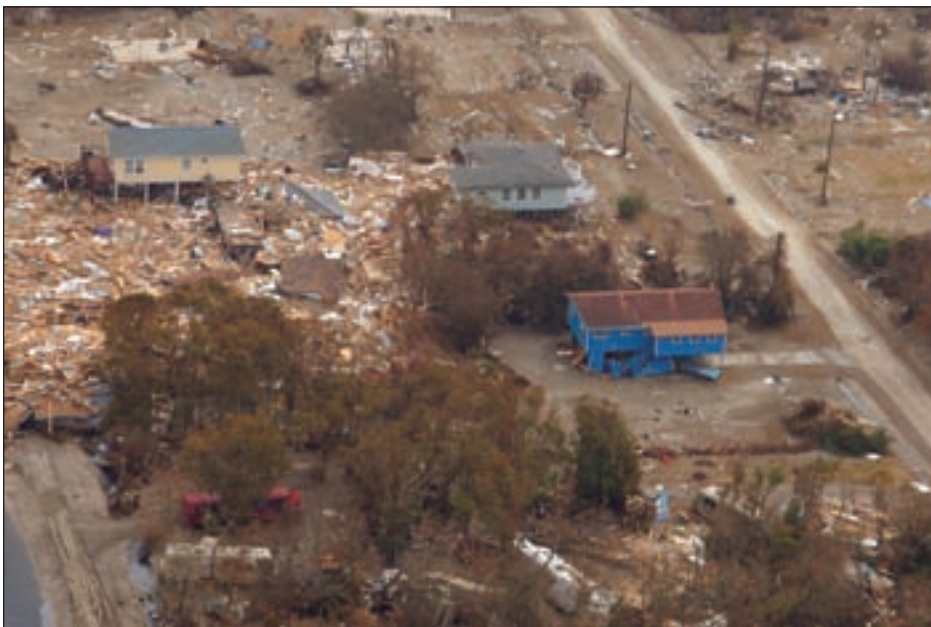
Figure 3-33. Roofs, walls, and other parts of destroyed houses washed landward to and inland of this location, approximately 1/2 mile from the Gulf shoreline of Bolivar Peninsula, TX

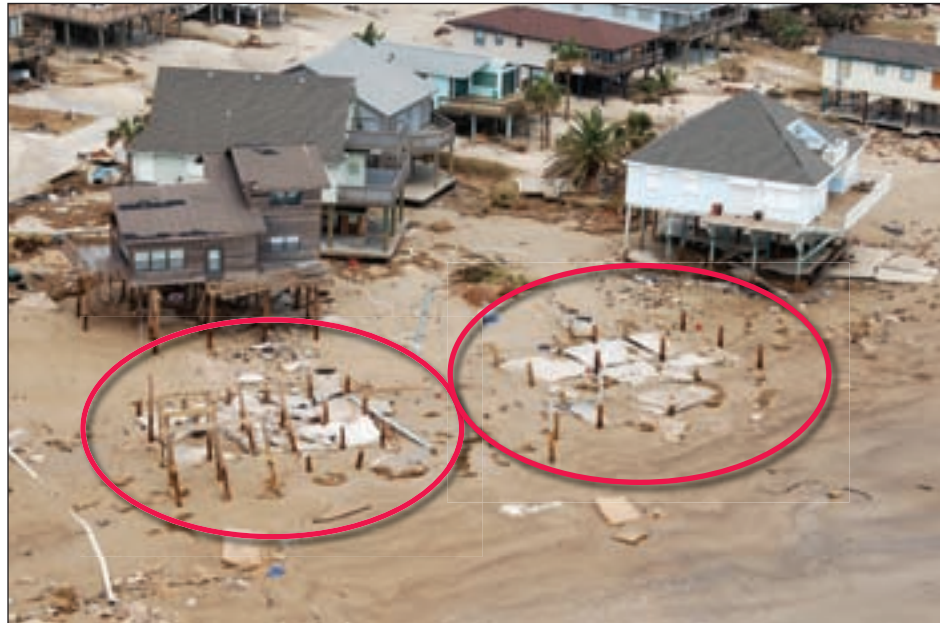
Although flood levels and wave conditions were not as severe on Galveston Island as on the Bolivar Peninsula, many houses were also lost there, largely as a result of waves and erosion. Figure 3-34 shows one example, approximately 3 miles west of the seawall, where two Gulf-front houses were lost.

Figure 3-34.
Broken piles beneath
destroyed Gulf-front
houses, Galveston Island,
TX (west of the seawall)

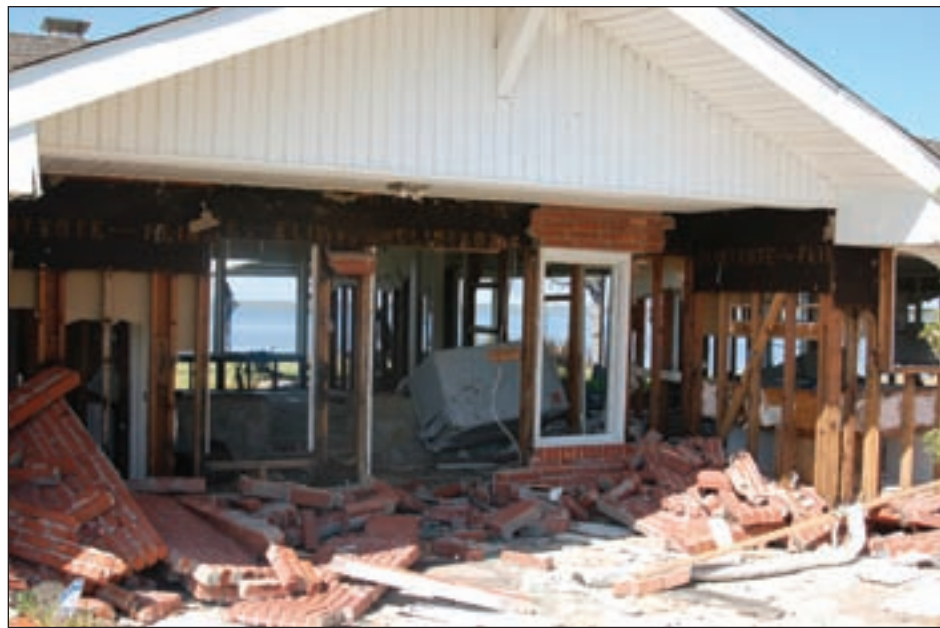
Figures 3-35 and 3-36 show examples of Ike wave damage typical for Galveston Bay, where wave heights were less than those on the Gulf shoreline. These at-grade buildings were gutted or destroyed by storm surge, waves, and floodborne debris. In both cases, nearby buildings elevated on pile foundations survived, with damage only to breakaway walls and access stairs.

Figure 3-35.
Damage to at-grade house
in Zone V likely caused by
wave and surge along the
northern Galveston Bay
shoreline in Baytown, TX

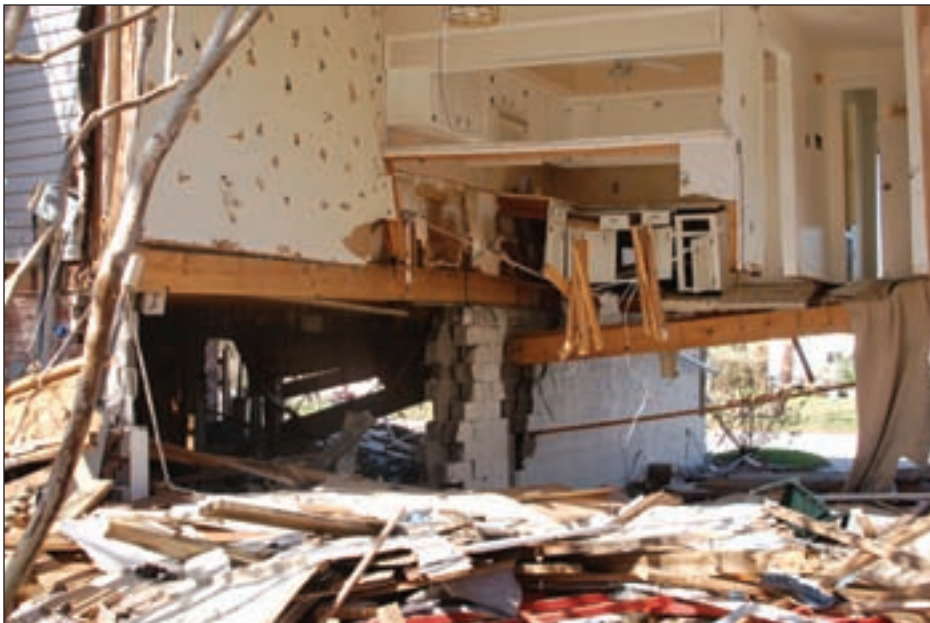
Figure 3-36. Likely wave and debris damage to townhouse building along the western Galveston Bay in Seabrook, TX. The building was supported on shore-parallel masonry walls, and is landward of another building that was destroyed by Ike.

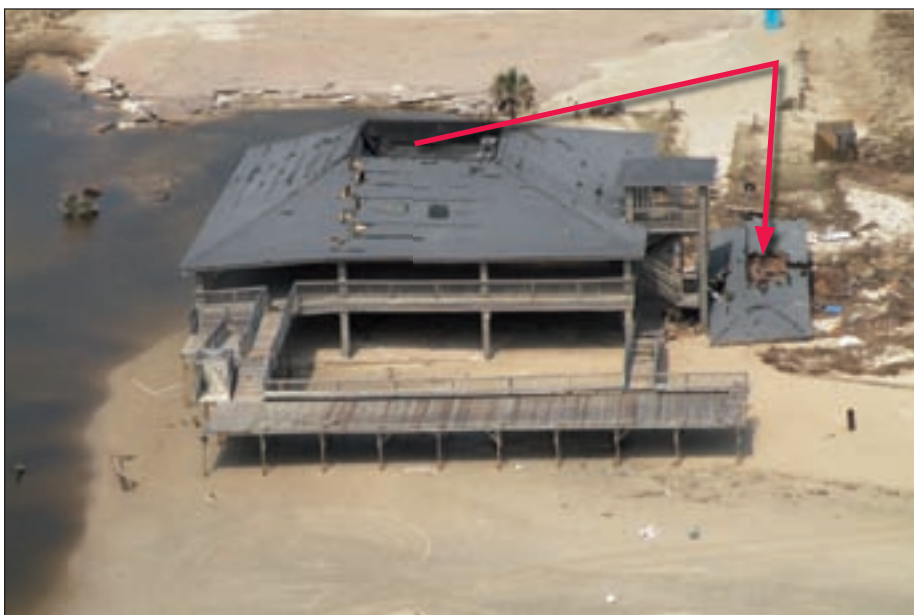
High winds are capable of imposing large lateral (horizontal) and uplift (vertical) forces on buildings (see Figure 3-38). Residential buildings can suffer extensive wind damage when they are improperly designed and constructed and when wind speeds exceed design levels. The damages shown in Figures 3-39, 3-40, and 3-41 exemplify poor design and construction, since Ike's winds were less than design levels.

Figure 3-39.
Galveston, TX, West End
Beach house with roof
structure removed by
Hurricane Ike.
The cause of the failure
is unknown, but Ike wind
speeds in this area were
below design speeds
(Hurricane Ike estimated
wind speed in this area: 93
mph, Exposure C).

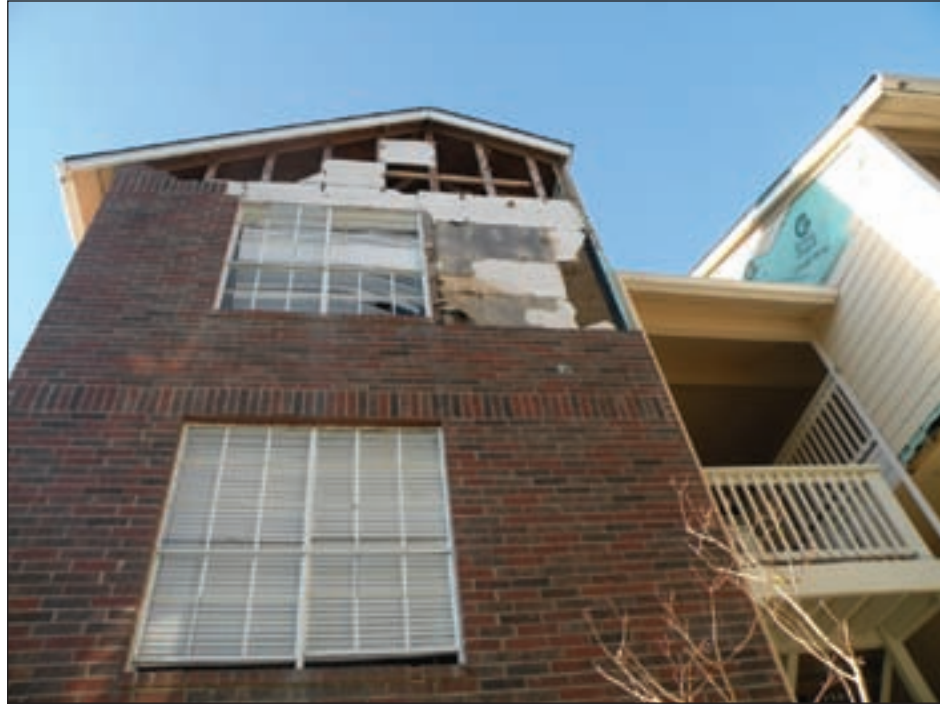
Figure 3-40. This West Bay, Galveston Island, TX, apartment experienced gable-end wind damage as a result of sheathing failure and poor connection of the brick veneer to the stud walls (Hurricane Ike estimated wind speed in this area: 90 mph, Exposure B)

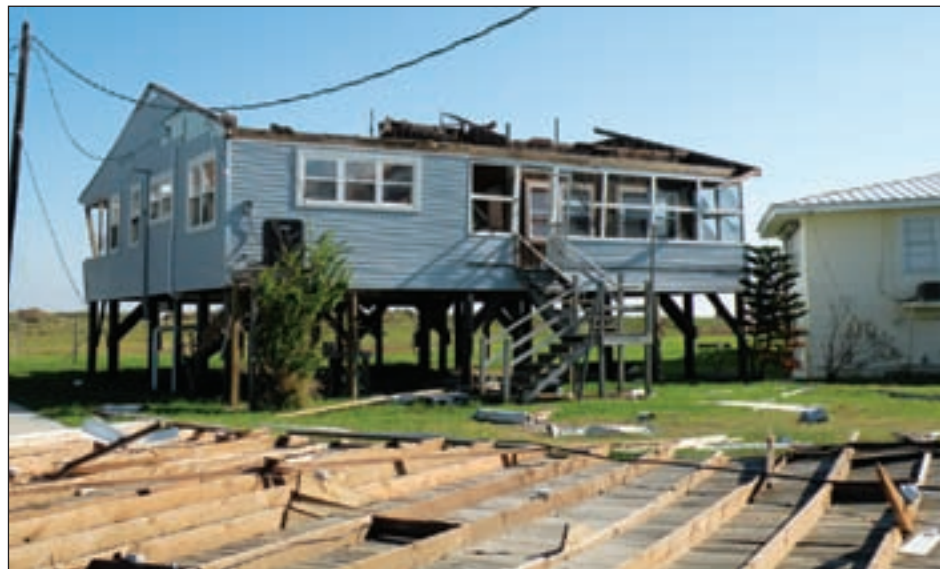
Proper design and construction of residential structures, particularly those close to open water or near the coast, demand that every factor mentioned above be investigated and addressed carefully. Failure to do so may ultimately result in building damage or destruction by wind. Hurricane Ike winds removed the roof structure on the house shown in Figure 3-41. Hurricane straps could have been added, thereby greatly increasing the resistance to wind. Refer to IBHS 2005 Standards for proper connection of roof structural elements.

Figure 3-41. The roof structure was poorly connected to this house in Grand Isle (Jefferson Parish, LA) and was blown off by 50-mph Ike winds (Exposure B)

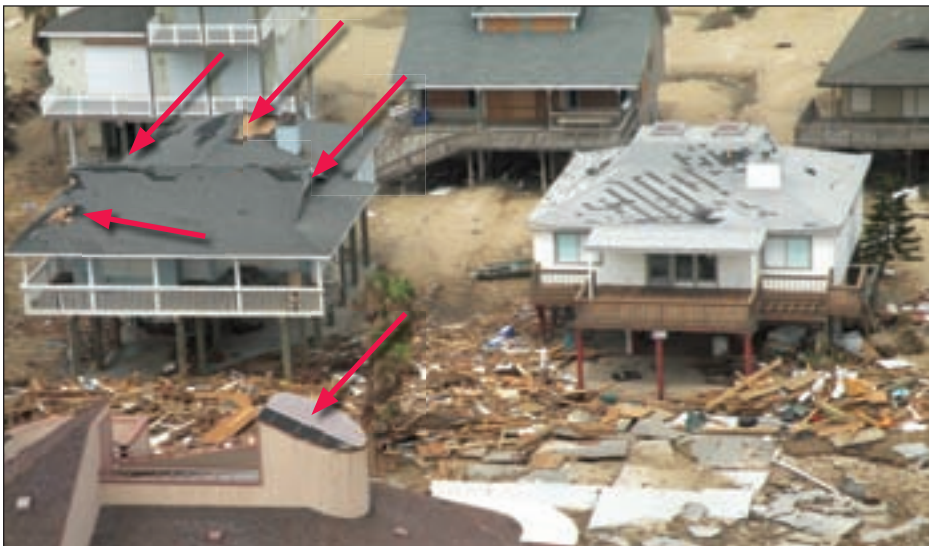
Figure 3-43. Galveston, TX, West End Beach house with roof damage in high pressure zones (Hurricane Ike estimated wind speed in this area: 95 mph, Exposure C)

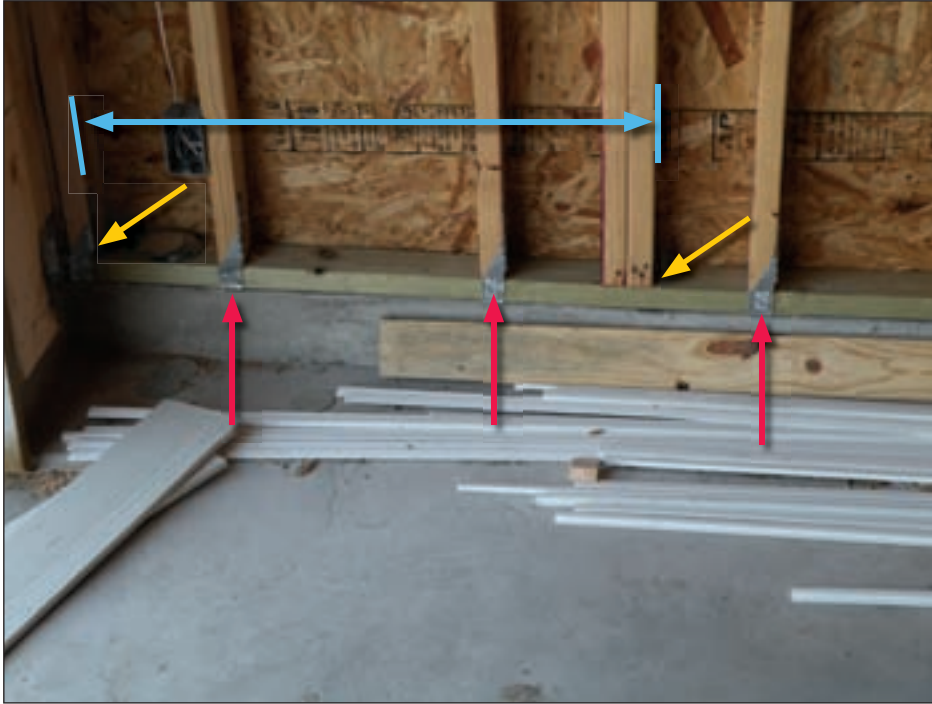
Figure 3-52. Studs and sill plate connected in new house (sill bolts yellow arrows and clips red arrows). However, sill bolts are spaced too far apart (2 feet is the maximum spacing allowed) and did not have 3-inch by 3-inch by 1/8-inch washers per 2003 IRC and TDI-adopted IBHS guidelines. Blue line shows 3-foot spacing (Webster, TX).

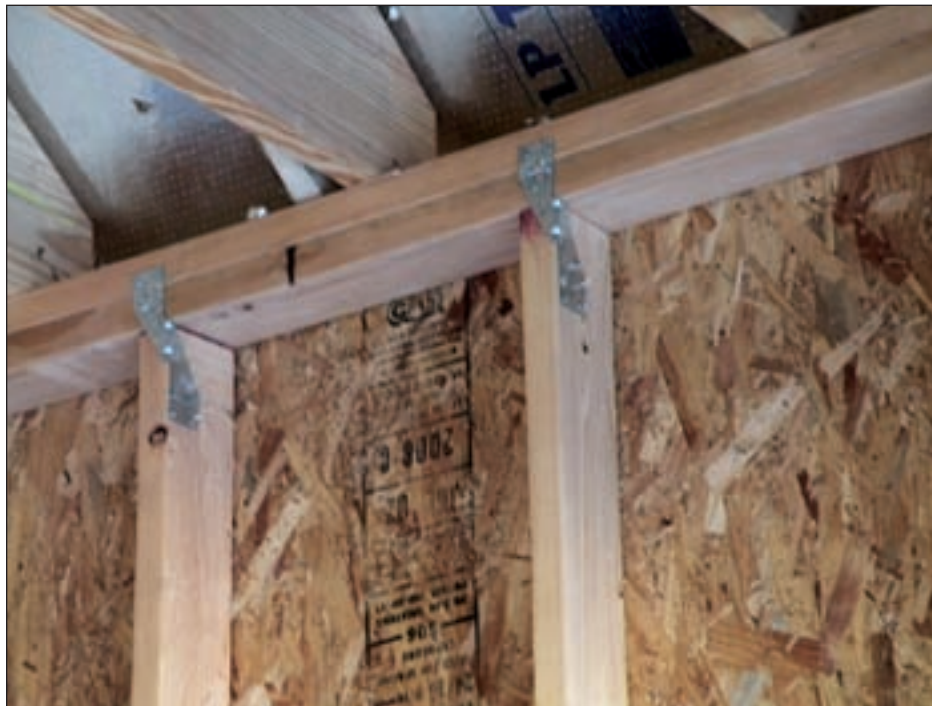
Figure 3-53. Studs clipped to double top plate; rafter-to-top-plate connector has yet to be installed. Better framing practices could have avoided some of the problems shown in this photo. Ceiling joists are not well nailed to the rafter and may twist in the future. The builder did not take advantage of aligning wall framing and rafter framing to simplify connections for wind loads.

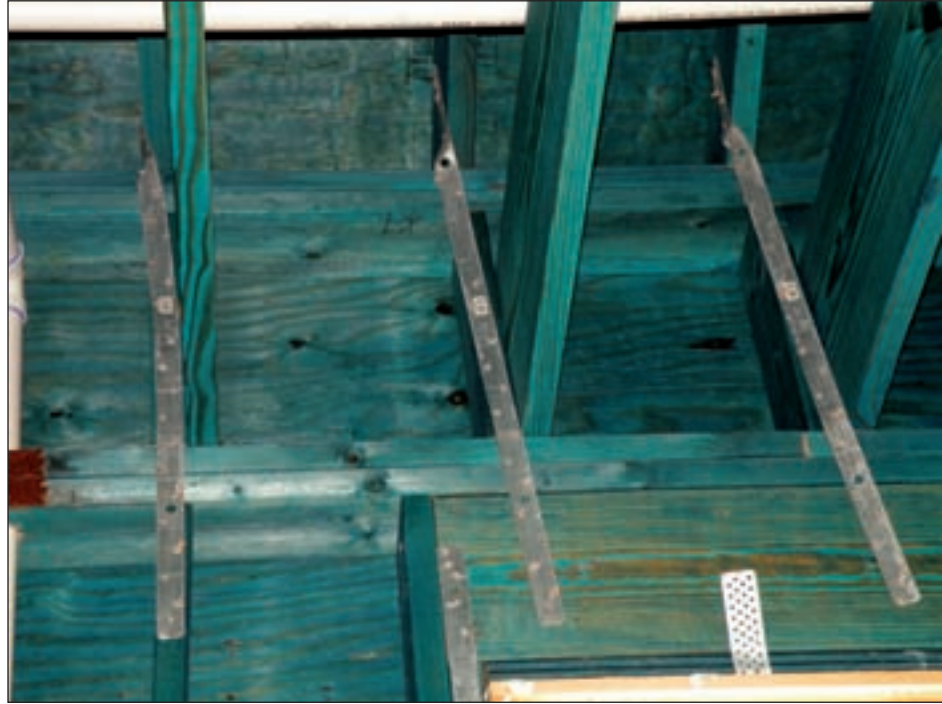
Figure 3-54.
Wall-to-roof strapping.
Details for uncommon framing details should be specifically provided by the designer on building plans, including specifying the specific connection and application to ensure a continuous load path.

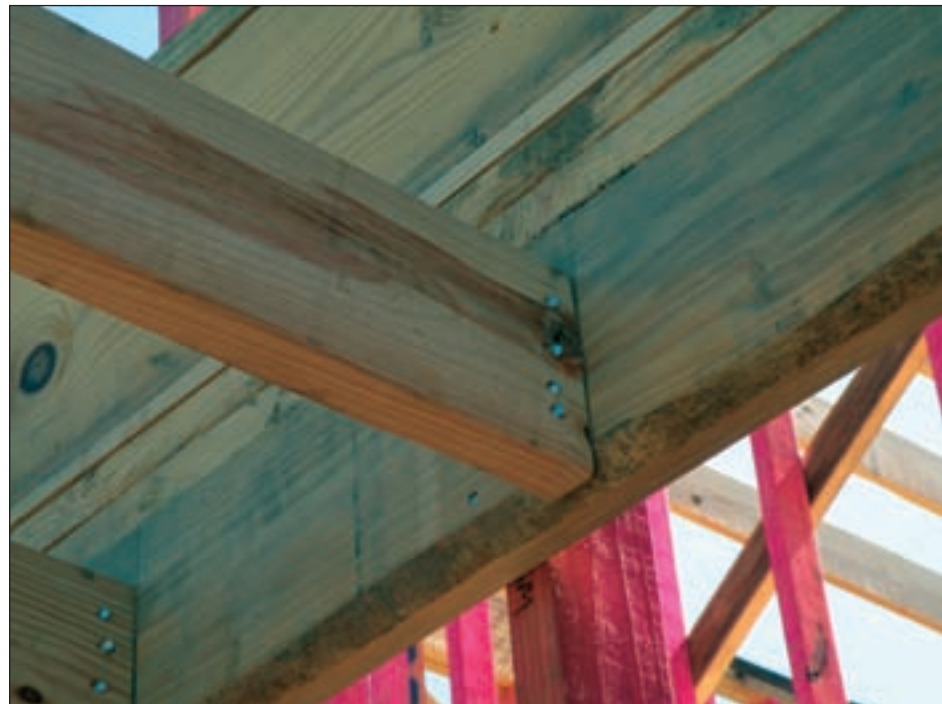
Figure 3-55.
Toe-nailed connection
of floor joists on band
beam on house under
construction. Floor joist
should be installed using
either galvanized metal
joist hangers or ledger
beams (LaPorte, TX).

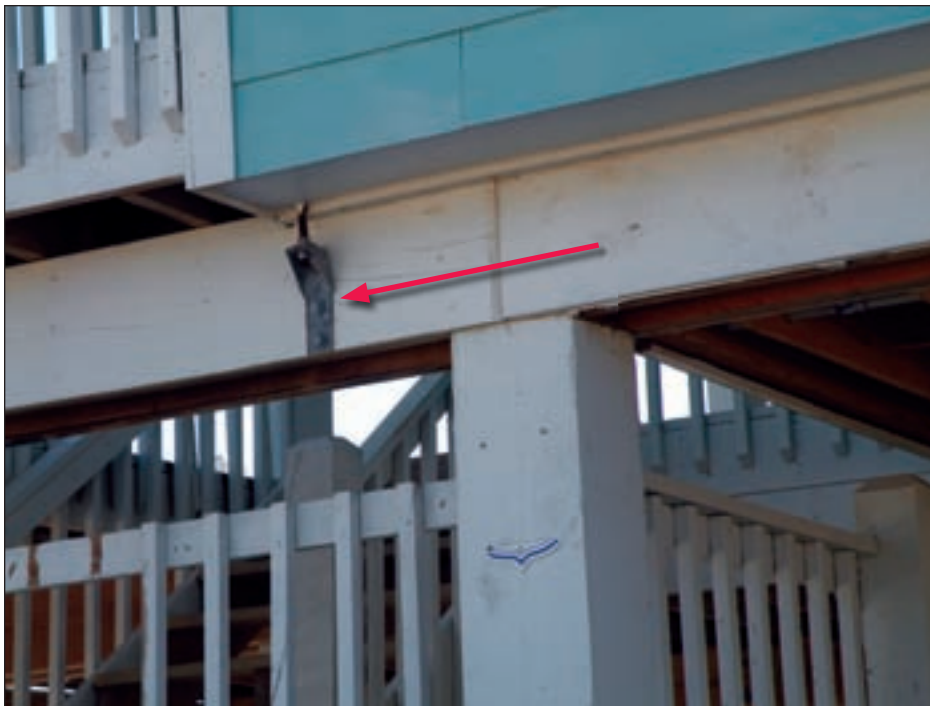
Figure 3-56. Existing house shear wall connector incorrectly located (red arrow). Connector should be located on column line or the beam and beam-to-column connection should be designed to resist the uplift load, which is carried by a nailed connection in the absence of bolts (Sunset Crystal Beach, Bolivar Island, TX).

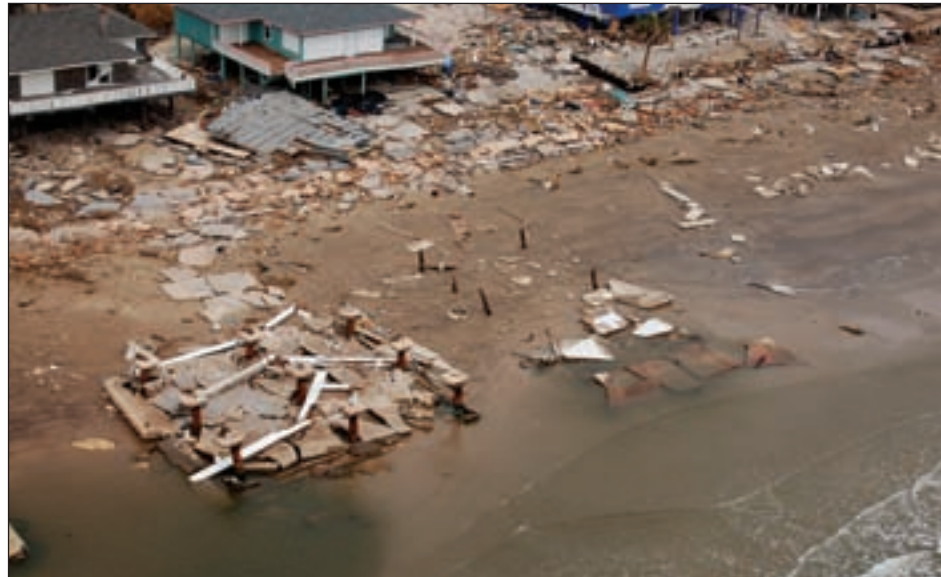
Figure 3-57.
Post-Ike photograph of West Galveston Island, TX, illustrating increased severity of flood damage near the shoreline

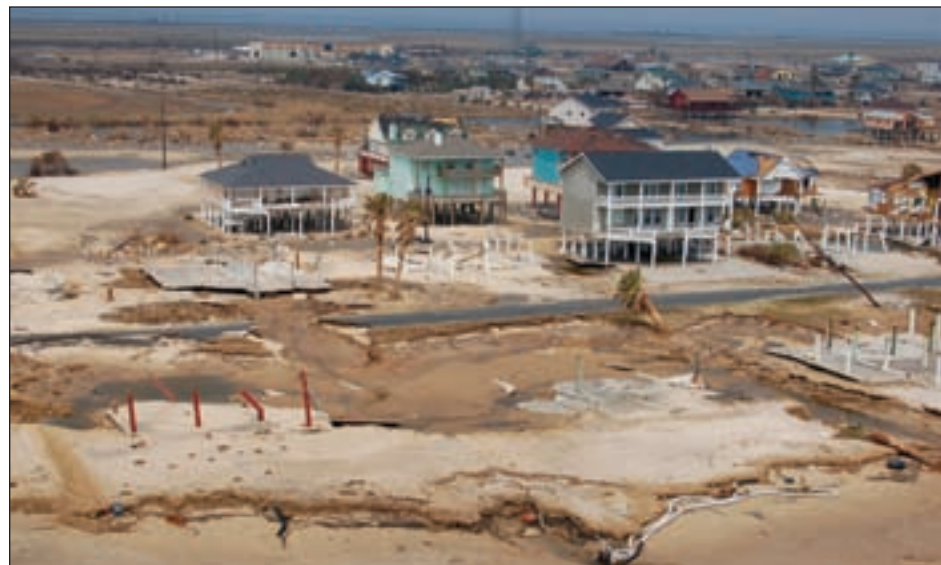
Figure 3-58.
Post-Ike photograph of Bolivar Peninsula, TX, illustrating increased severity of flood damage near the shoreline

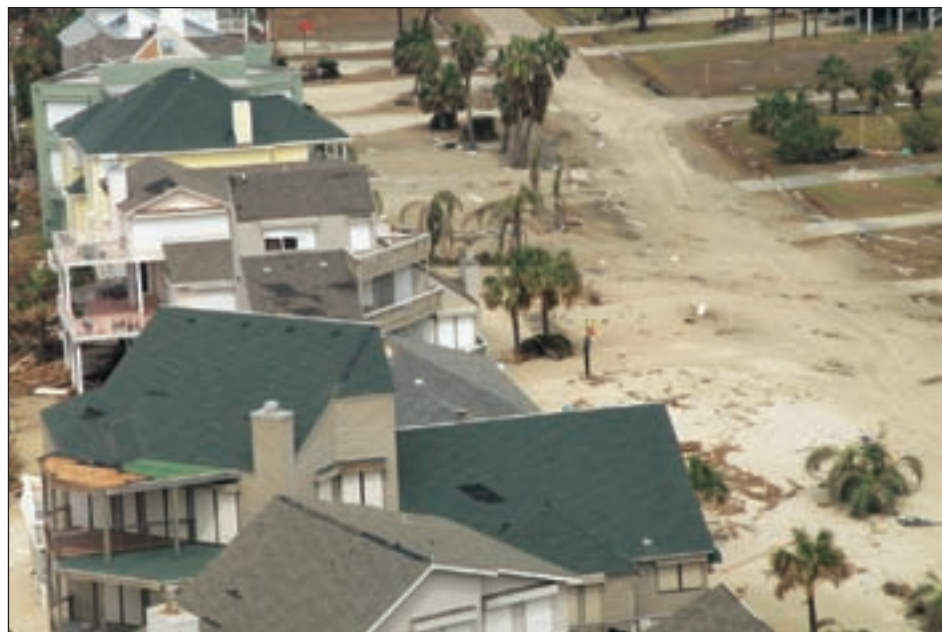
Blow-off of building envelope components frequently results in damage to adjacent buildings and vehicles, as well as the building itself. The most notable building envelope issues during Hurricane Ike, and the most common windborne building envelope debris, were roof coverings and vinyl siding. Figure 3-59 illustrates the magnitude of building envelope debris that occurred in some areas.

Figure 3-59.
A substantial amount of siding (the white lines scattered around the ground), along with roofing materials, blew off these West Galveston, TX, houses (Hurricane Ike estimated wind speed in this area: 90 mph)

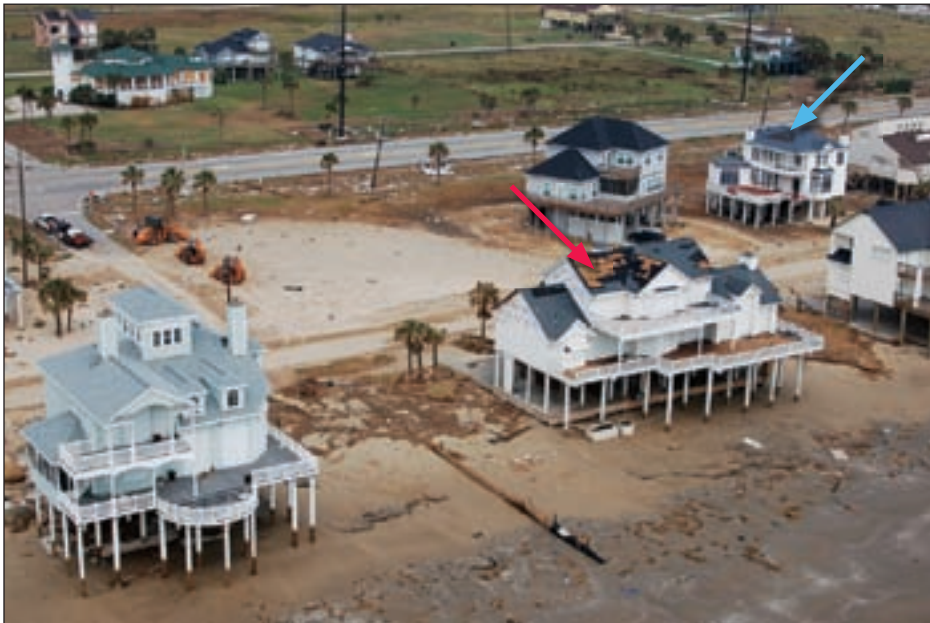
The MAT observed a variety of roof coverings, including asphalt shingles, metal panels, metal tiles, and tile. In the areas observed by the MAT, roof covering damage was common, and quite variable as shown in Figure 3-60. This type of variability is consistent with what was observed by the Hurricane Charley, Ivan, and Katrina MATs (see FEMA 488, *Hurricane Charley in Florida: Observations, Recommendations, and Technical Guidance* [April 2005a]; FEMA 489, *Hurricane Ivan in Alabama and Florida: Observations, Recommendations, and Technical Guidance* [August 2005e]; and FEMA 549, *Hurricane Katrina in the Gulf Coast: Building Performance Observations, Recommendations, and Technical Guidance* [July 2006b]).

Figure 3-60. Some of the roofs on these Jamaica Beach, TX, houses had no roof covering damage, while one had moderate damage (blue arrow) and one had extensive damage, including loss of underlayment (red arrow) (Hurricane Ike estimated wind speed in this area: 90 mph)

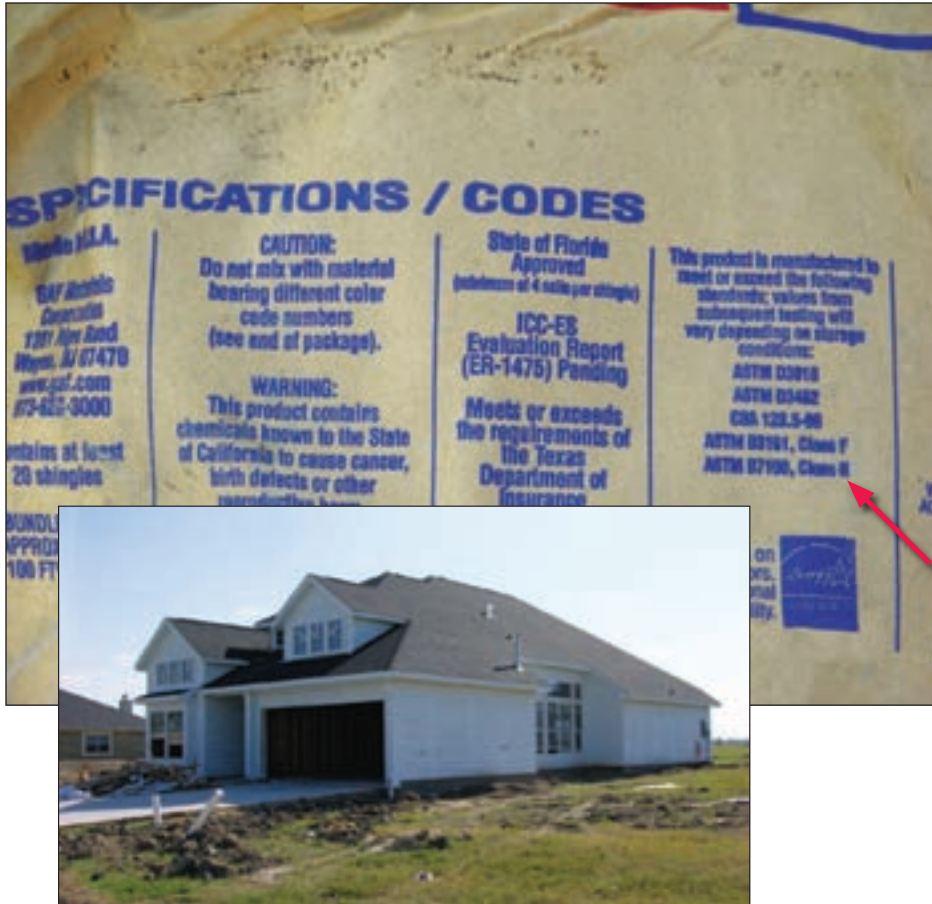
Figure 3-61 shows a shingle bundle wrapper at a house under construction at the inset in Figure 3-61. The shingle bundle wrappers indicate the shingles meet Class H (i.e., suitable for up to 150 mph). The IRC/ASCE 7 design wind speed for this location is 120 mph, hence use of a Class G shingle would have been sufficient. This is the first and only house observed by a MAT wherein it was known that shingles meeting one of the new Class ratings was installed. There was no apparent wind damage to this house.

Figure 3-61. View of a shingle bundle wrapper at the Webster, TX, house shown in the inset. This shingle has a Class H rating (red arrow) (Hurricane Ike estimated wind speed in this area: 104 mph).

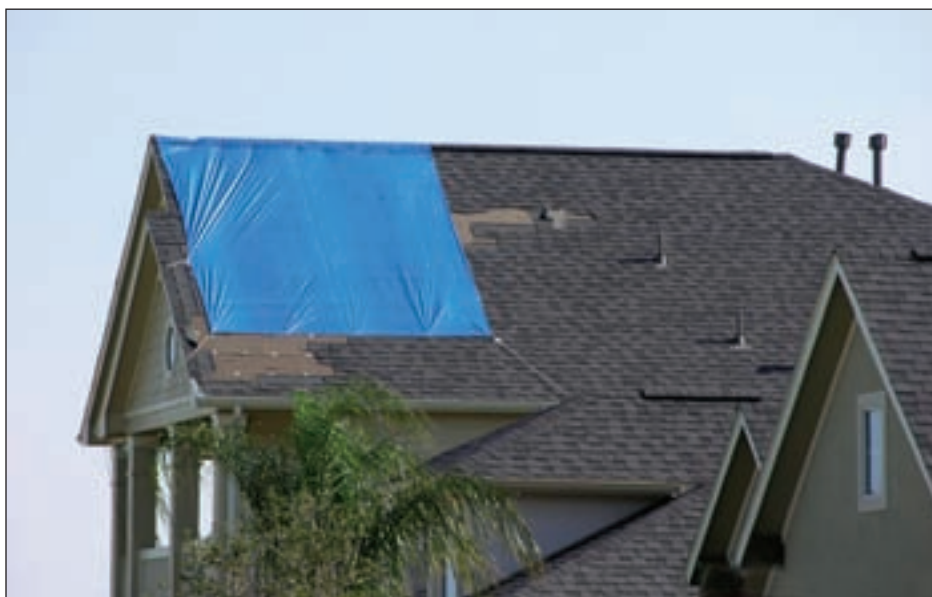
The newly constructed house shown in Figure 3-62 is on the same block as the one shown in Figure 3-61. Bleeder strips were installed along the rake; however, as discussed in Section 5.4.1.3 of the Katrina MAT report (FEMA 549), unless the shingles are hand-tabbed as described in Technical Fact Sheet 20, bleeders do not provide reliable securement.

Figure 3-62. Shingle damage at a house near the one shown in Figure 3-61 (Webster, TX)

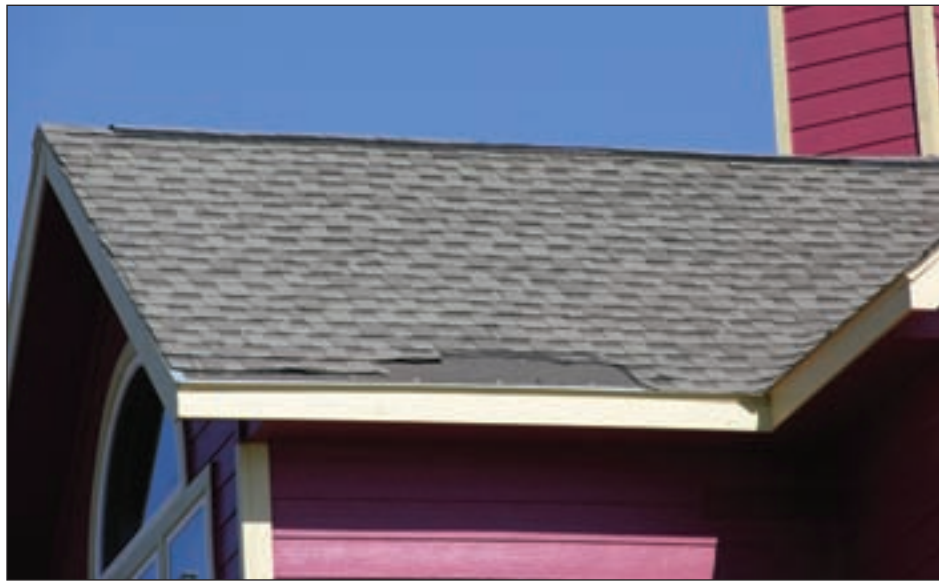
Figure 3-63 shows a house under construction on Bolivar Peninsula that lost shingles along the eave (it is also shown on the front cover of this report). Failure along eaves commonly occurs because of incorrect application of the starter course and lack of hand-tabbing (as recommended in Technical Fact Sheet 20). For further discussion of eave issues, see Section 5.4.1.2 in FEMA 549.

Figure 3-63.
Loss of shingles along the eave in Bolivar Peninsula, TX (Hurricane Ike estimated wind speed in this area: 110 mph)

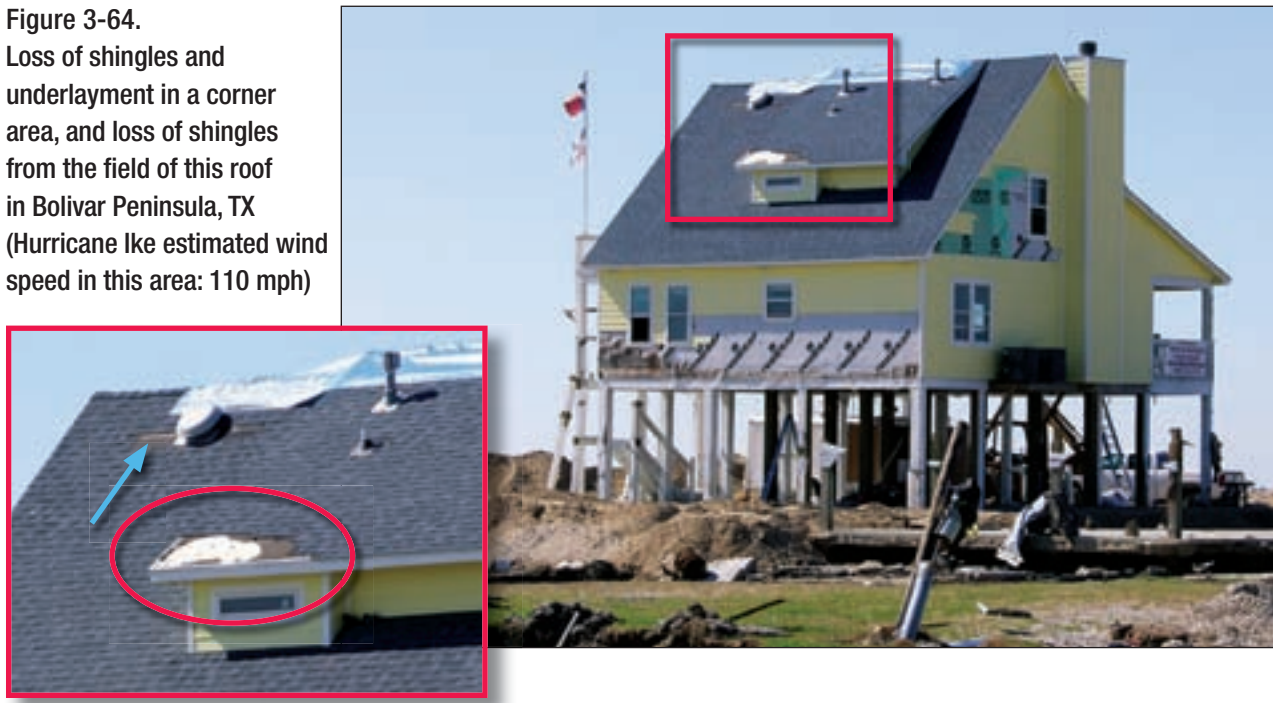
Figure 3-64 shows a house that was reportedly constructed in 2005 on Bolivar Peninsula. It lost shingles and underlayment at a corner area (red circle at the inset) and shingles in the field of the roof near the exhaust fan (blue arrow). Loss of shingles was likely due to lack of hand-tabbing. These shingles reportedly met Class F.

Figure 3-64.
Loss of shingles and underlayment in a corner area, and loss of shingles from the field of this roof in Bolivar Peninsula, TX (Hurricane Ike estimated wind speed in this area: 110 mph)

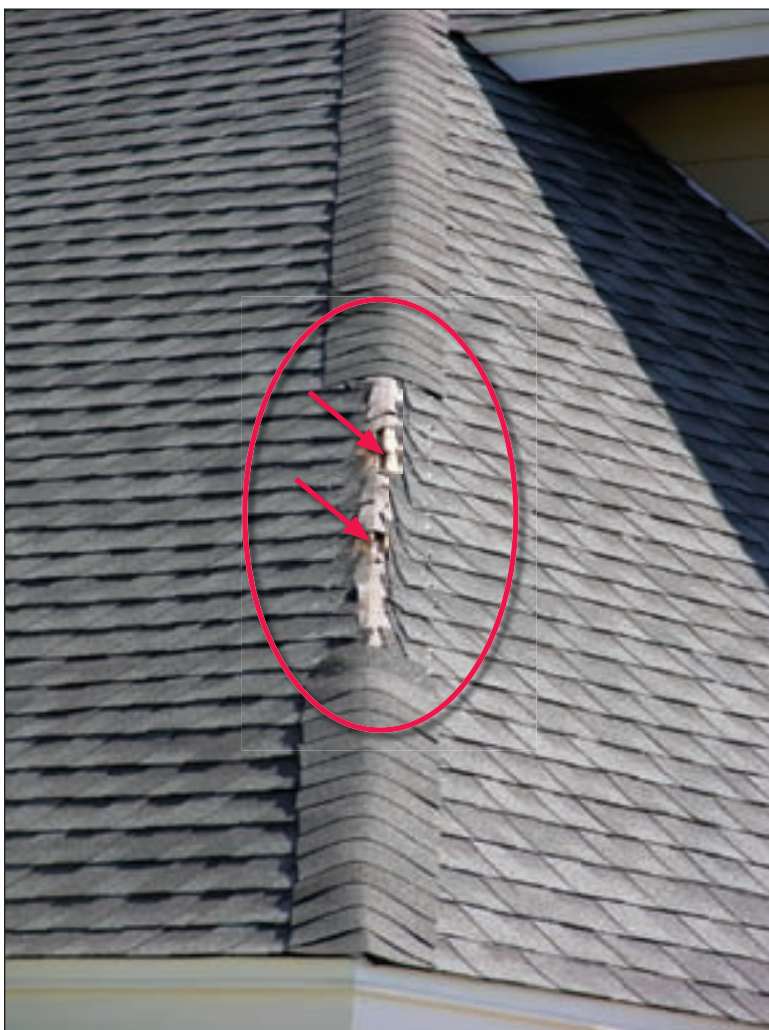
Figure 3-65.

Figure 3-65 shows a house under construction on Bolivar Peninsula. It lost shingles along the hip. Also, at areas along the exposed hip, either the underlayment did not completely lap over the hip line, or if it did, portions of the underlayment blew away. Water could leak into the building in the vicinity of the two red arrows. Unless hip and ridge shingles are hand-tabbed, as recommended in Technical Fact Sheet 20, they are very susceptible to blow-off (for further discussion, see Section 5.4.1.1 in FEMA 549).

Loss of hip shingles and portions of the underlayment in Bolivar Peninsula, TX (Hurricane Ike estimated wind speed in this area: 110 mph)

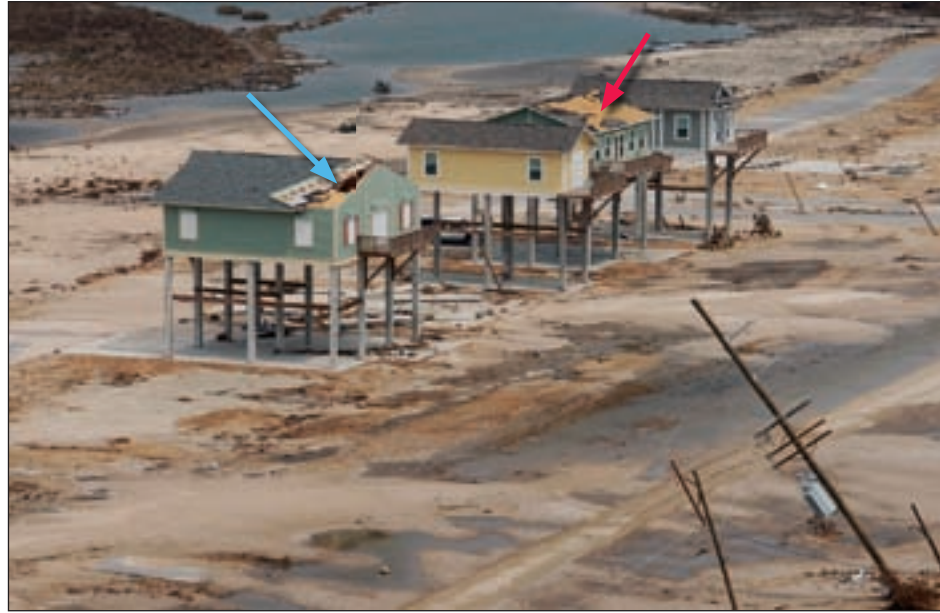
As shown in Figure 3-66, some of the roof coverings had no apparent damage, but the shingles and underlayment were blown off of one roof (red arrow). Also, a portion of the roof overhang blew off of one of the houses (blue arrow). When the MAT observed blow-off of roof framing and/or sheathing, it typically occurred on older buildings, rather than new construction.

Figure 3-66.
 Roof covering and roof structure damage at *Fortified...for safer living*[®] houses in the Audubon Village area on Bolivar Peninsula, TX (Hurricane Ike estimated wind speed in this area: 110 mph)

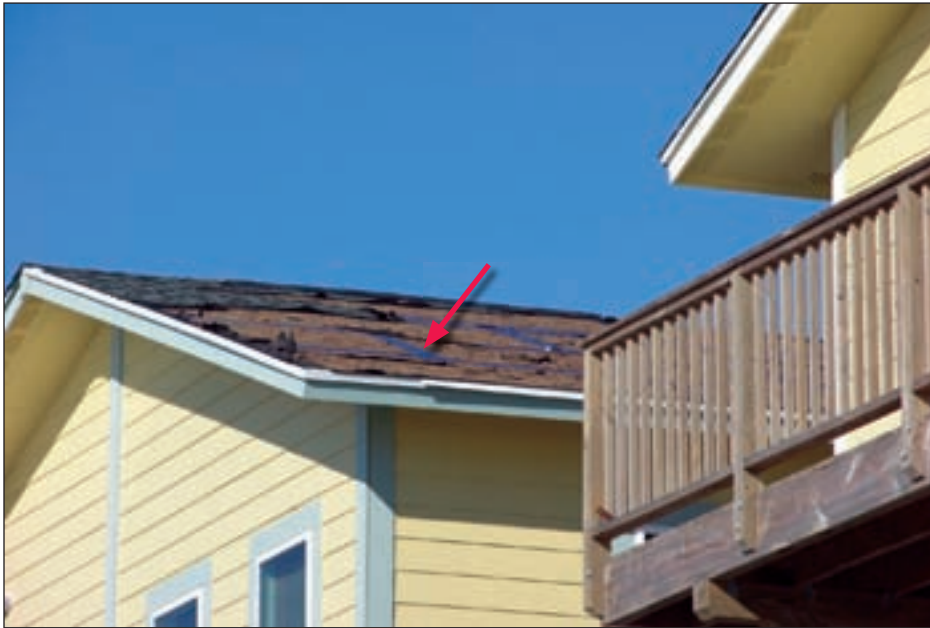
Several of the *Fortified...for safer living*[®] houses that lost underlayment had taped joints, including the one shown in Figure 3-67. However, as shown in Figure 3-68, the taping was not effective. Observations by IBHS investigators revealed application problems with the tape. Staples were used to attach the tape because bonding problems were experienced during application. Apparently the applicator did not realize the tape was intended to prevent water from leaking through the sheathing joints. With the tape in an un-bonded and wrinkled condition, it was incapable of fulfilling its intended purpose. Self-adhering modified bitumen roof tape normally bonds quite well to sheathing. Bonding problems are commonly attributed to dust on the sheathing,

Figure 3-67.
This *Fortified...for safer living*[®] house had taped sheathing joints (red arrow)
