Mitigation Assessment Team Report

Hurricane Ike in Texas and Louisiana

Building Performance Observations, Recommendations, and Technical Guidance

FEMA P-757 / April 2009

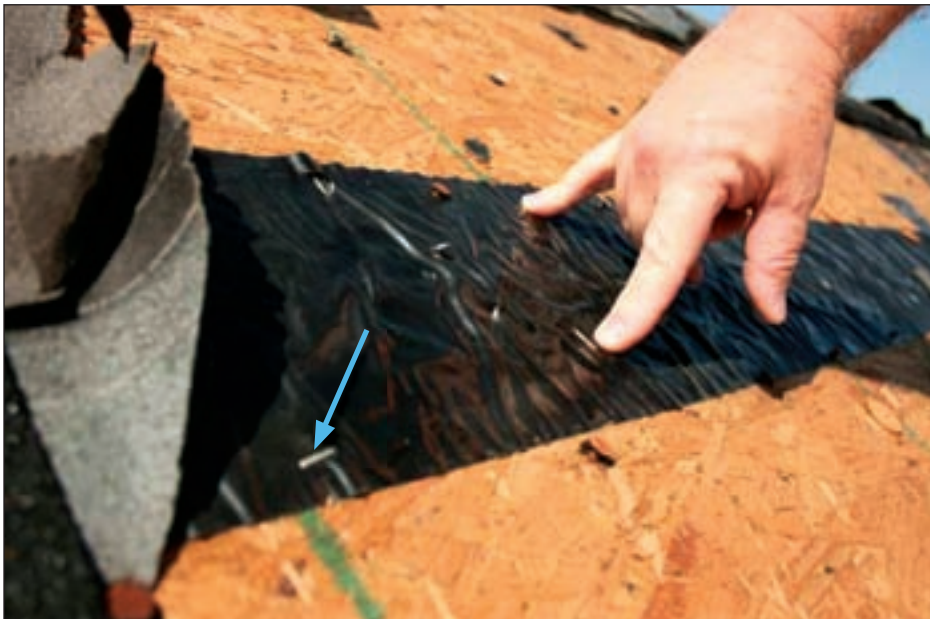
Several of the *Fortified...for safer living*[®] houses that lost underlayment had taped joints, including the one shown in Figure 3-67. However, as shown in Figure 3-68, the taping was not effective. Observations by IBHS investigators revealed application problems with the tape. Staples were used to attach the tape because bonding problems were experienced during application. Apparently the applicator did not realize the tape was intended to prevent water from leaking through the sheathing joints. With the tape in an un-bonded and wrinkled condition, it was incapable of fulfilling its intended purpose. Self-adhering modified bitumen roof tape normally bonds quite well to sheathing. Bonding problems are commonly attributed to dust on the sheathing,

wet sheathing, a surfacing on the sheathing that interfered with the bonding, or using inappropriate tape. According to IBHS, problems with bonding self-adhering modified bitumen to oriented strand board (OSB) had been previously experienced at a demonstration project. In evaluating that demonstration project, IBHS discovered that although the OSB manufacturer had recommended application of a primer before installation of the self-adhering modified bitumen because of the presence of a wax on the OSB, a primer had not been installed.

Figure 3-68.
This tape did not provide a watertight seal. Note the wrinkles (which allow water migration) and the staples (blue arrow) that were used to attach the tape (Audubon Village, TX).
CREDIT: IBHS

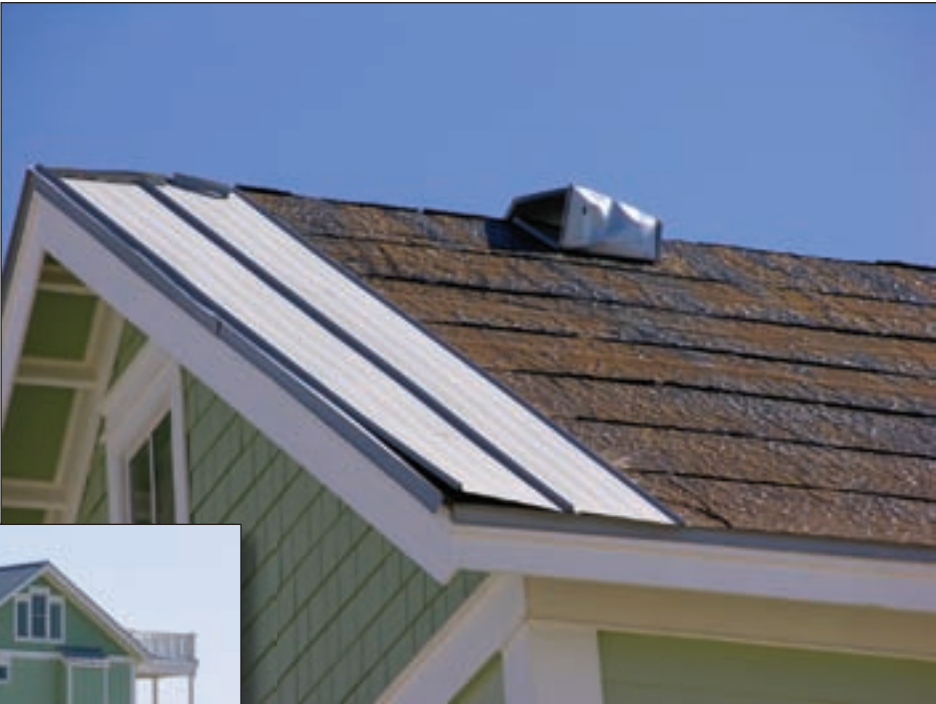
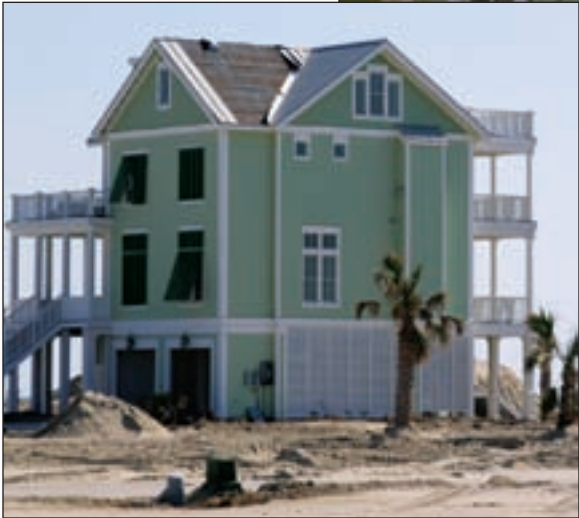
Figure 3-69. These snap-lock seam panels were attached with fasteners through one side of the seam (Galveston Island, TX; Hurricane Ike estimated wind speed in this area: 110 mph)

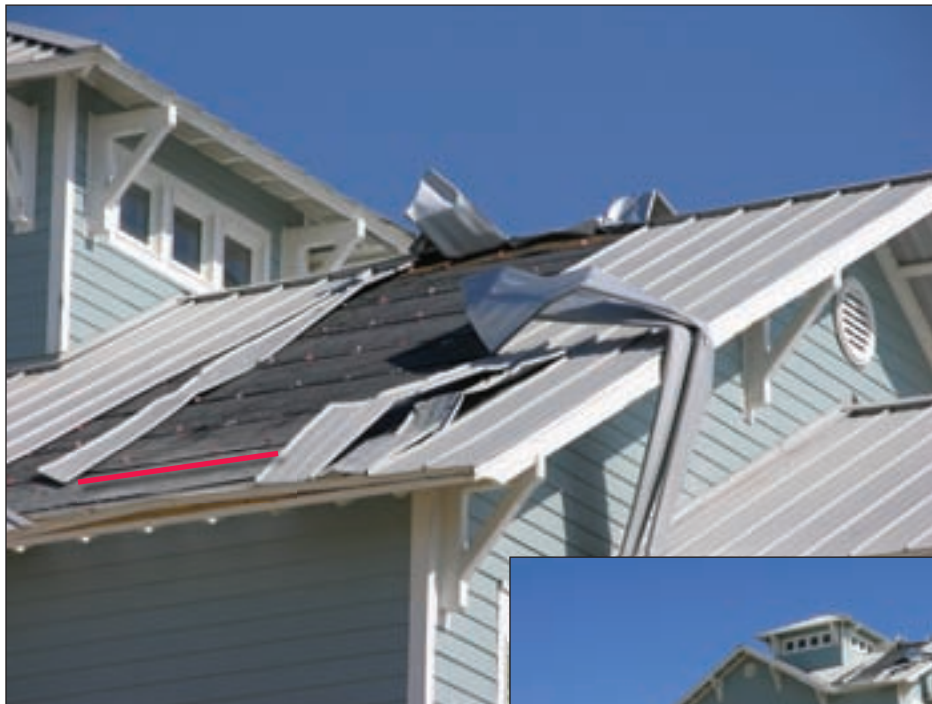
The panels shown in Figure 3-70 were attached with concealed clips, which unlatched from the panels. The first row of clips (just above the red line) was several inches from the end of panels; this first row should have been within a few inches from the eave.

Figure 3-70. These architectural metal panels unlatched from the concealed clips. The red line shows location of the first row of clips (Galveston Island, TX; Hurricane Ike estimated wind speed in this area: 110 mph).

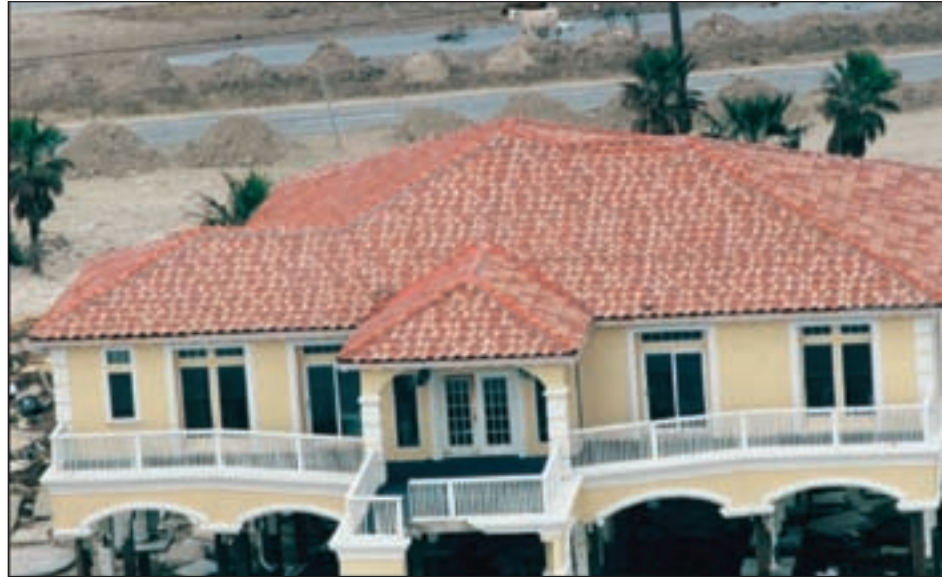
Figure 3-71.
This tile roof on Galveston Island, TX, did not experience any wind damage (Hurricane Ike estimated wind speed in this area: 106 mph)

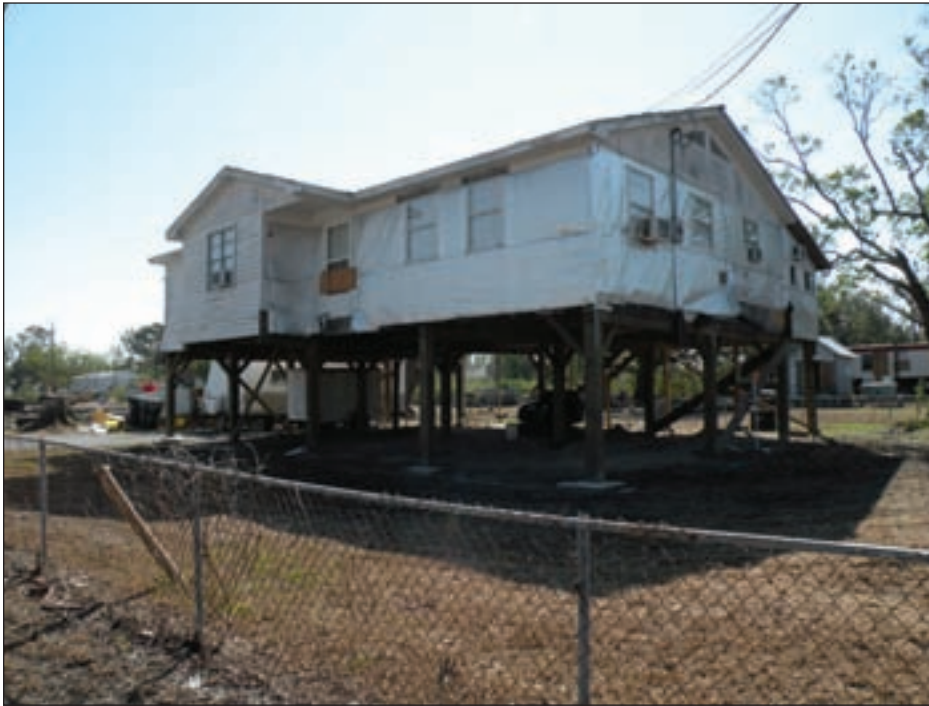
In Louisiana, the MAT observed a variety of siding and cladding failures, despite the fact that wind speeds were less than current code-specified values. The damage observed was mostly, but not always, on older buildings, which (presumably) had been designed and constructed without full consideration of wind resistance (Figures 3-73 and 3-74).

Figure 3-73.
Loss of siding due to winds, Chauvin, LA (Terrebonne Parish; Hurricane Ike estimated wind speed in this area: 50 to 60 mph, Exposure B)

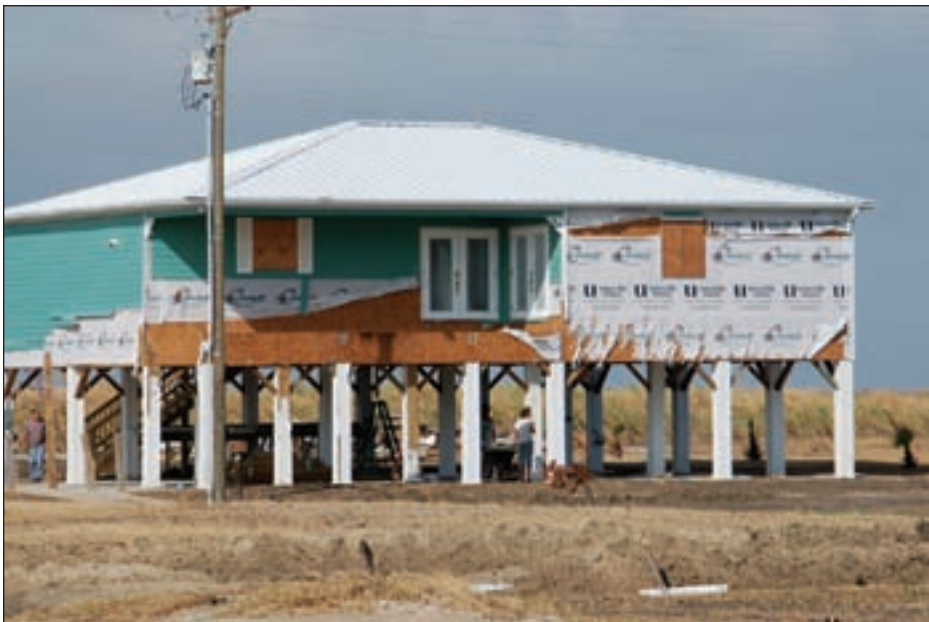
Figure 3-74.
Loss of siding at Holly Beach, LA, home (Cameron Parish; Hurricane Ike estimated wind speed in this area 80 mph, Exposure C)

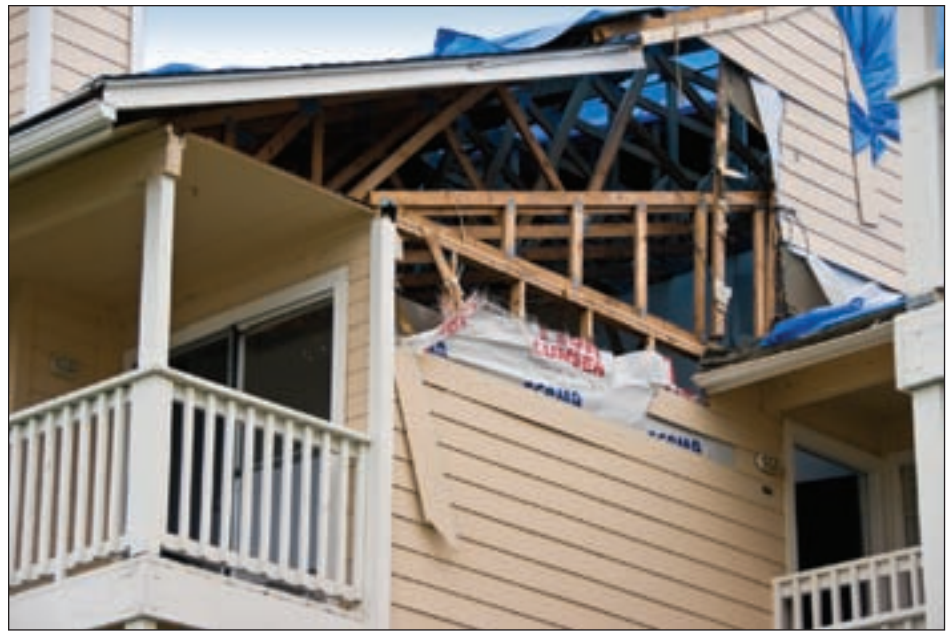
Figure 3-76.
Loss of fiberboard sheathing and fiber cement siding from gable end wall of an apartment complex (West Bay, Galveston Island, TX; Hurricane Ike estimated wind speed in this area: 90 mph, Exposure B)

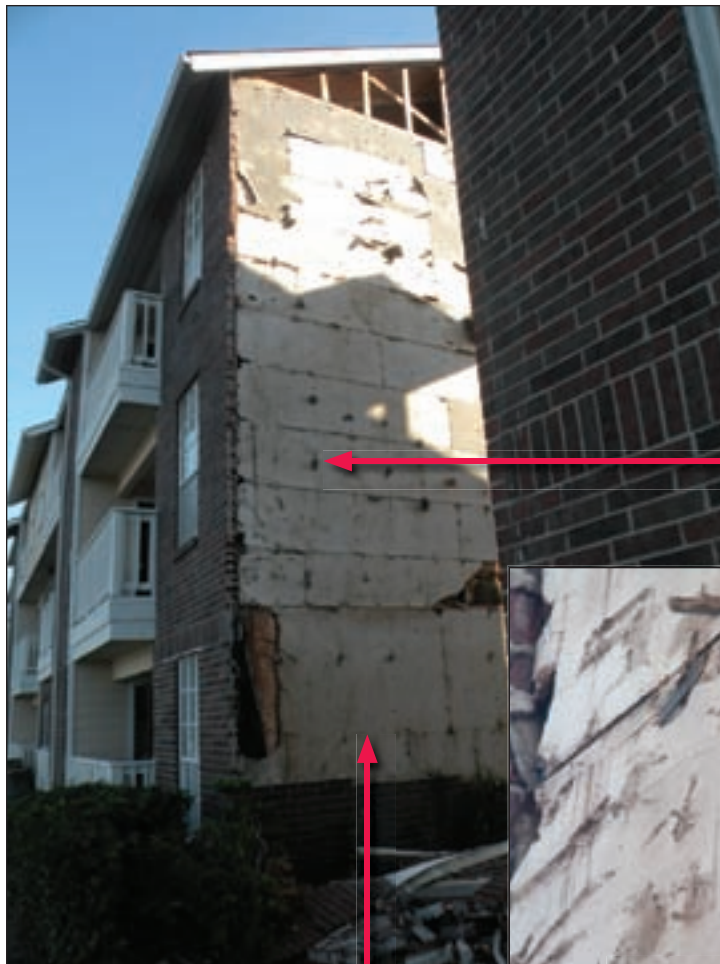
Figure 3-77.

Numerous brick veneer failures were observed at one Galveston apartment complex. Figure 3-77 shows failed brick veneer at one complex. The brick ties were randomly spaced with the horizontal spacing ranging from 32 inches to 16 inches on-center and the vertical spacing ranging from 48 inches to 24 inches on-center. Many of the corrugated ties were rusted and broken, were not embedded in the masonry, or had minimal embedment. Figure 3-78 illustrates common problems with brick veneer installations and Figure 3-79 illustrates proper methods of installation.

Collapsed brick veneer wall with brick ties at varied spacing, some of which were only partially imbedded or not embedded (West Bay, Galveston Island, TX; Hurricane Ike estimated wind speed in this area: 90 mph, Exposure B)

The Brick Industry Association’s (BIA’s) Technical Notes 28 *Anchored Brick Veneer, Wood Frame Construction* (2002) specifies a maximum tie spacing of 24 inches in each direction for 16-inch stud spacing for buildings in standard 90-mph wind zones. Table 3-1 indicates the required tie spacing for high wind zones. Though Galveston experienced less than design wind speeds, the proximity of the adjacent complex shown in Figure 3-77 may have produced increased wind pressures, thereby producing the catastrophic failure of the poorly anchored brick veneer. However, the installed tie spacing was not suitable for this back bay Galveston location with a design wind speed of 120 mph.

FEMA Hurricane Ike Recovery Advisory, *Attachment of Brick Veneer in High-Wind Regions* (Appendix D), provides recommended practices for brick veneer attachment. The advisory is based on observations from Hurricanes Ivan, Katrina, and Ike.

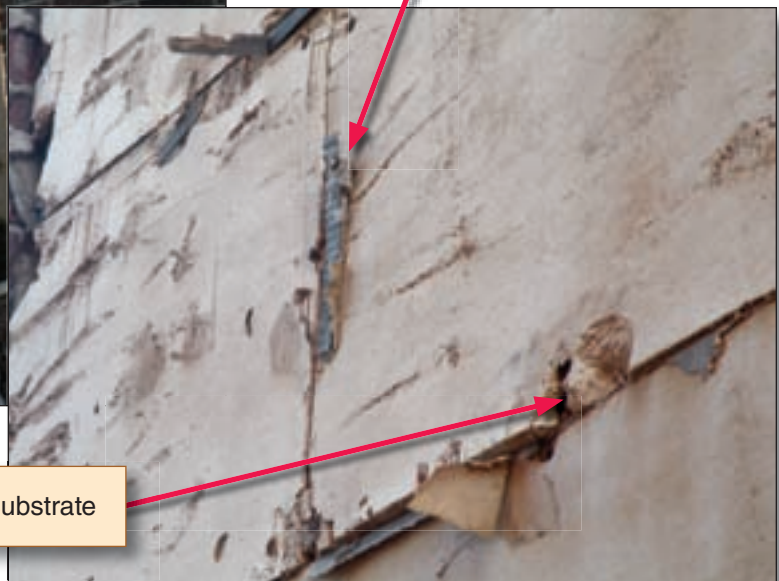
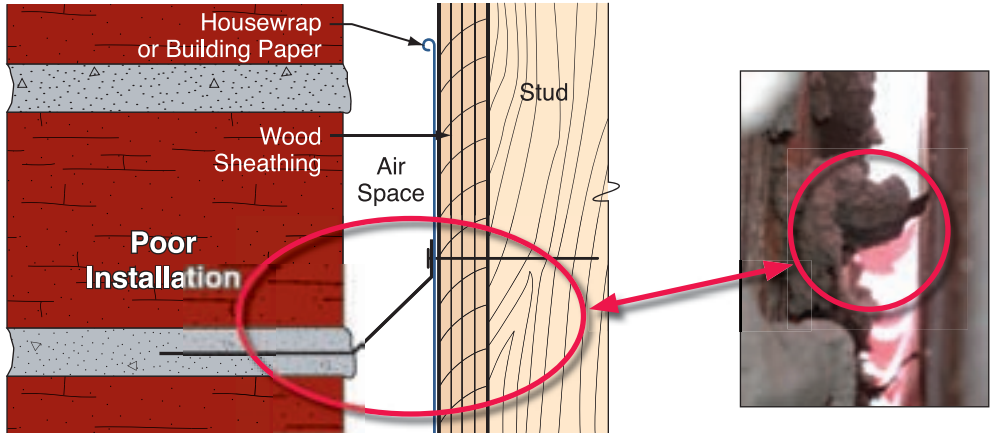
Brick Tie Not Embedded to Masonry

Figure 3-78. Misalignment of the tie reduces the embedment and promotes veneer failure

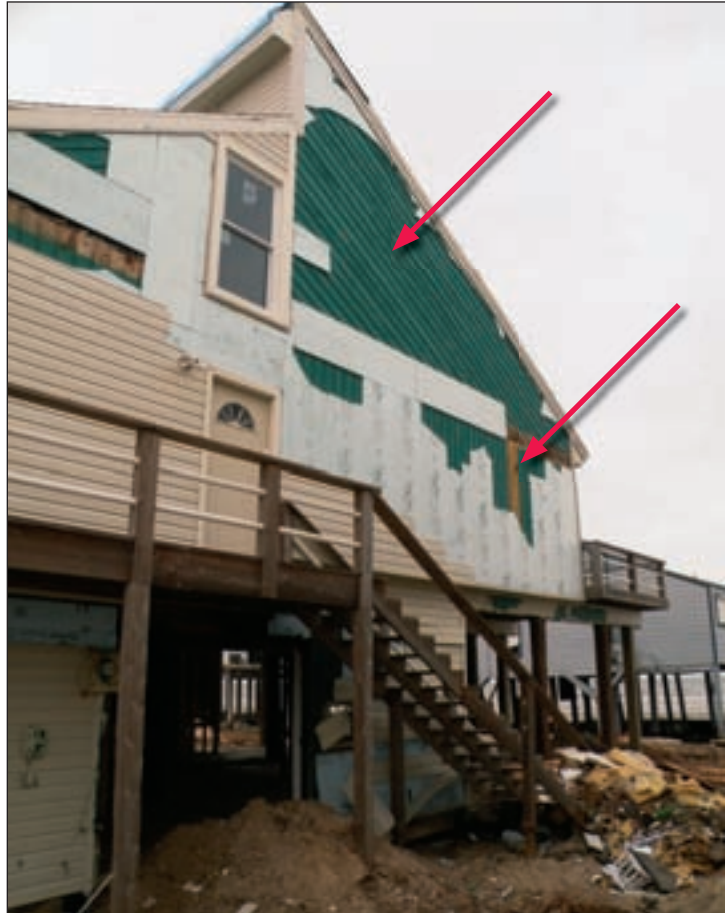
Figure 3-80.

Typical vinyl siding failure. Vinyl was installed over older wood cladding (red arrows) (Sea Isle, TX; Hurricane Ike estimated wind speed in this area: 95+ mph, Exposure C).

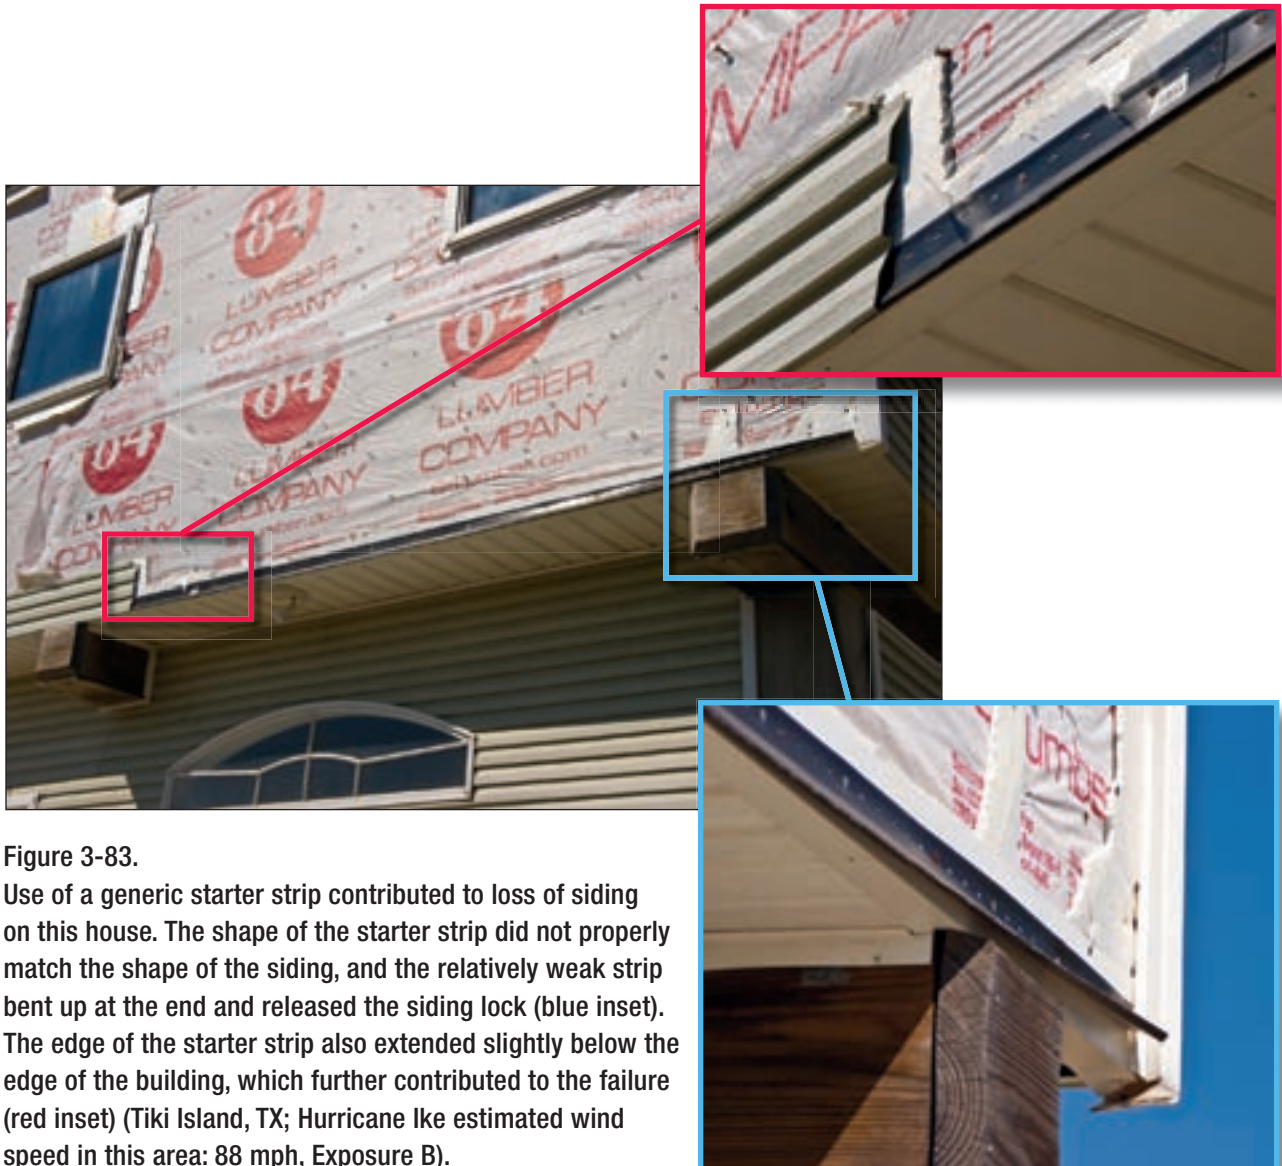
Figure 3-83.

Proper use of the starter strip is particularly important with elevated structures, where the wind passes at high velocity underneath the structure as well as against the walls. On Galveston Island, Bolivar Peninsula, and Tiki Island, where elevated houses were predominant, a large percentage of siding loss originated at the lowest course and led to loss of the courses above. The MAT saw numerous instances where a “generic” starter strip (having just a bulge, rather than a lock shaped to match the siding) was used. In other cases, J-channels, which do not lock into the panel at all, or field-fabricated substitutes for starter strips were used. Elevated structures with poorly implemented starter strips were most vulnerable to siding loss starting at the lowest edge of the elevated wall (Figure 3-83).

Use of a generic starter strip contributed to loss of siding on this house. The shape of the starter strip did not properly match the shape of the siding, and the relatively weak strip bent up at the end and released the siding lock (blue inset). The edge of the starter strip also extended slightly below the edge of the building, which further contributed to the failure (red inset) (Tiki Island, TX; Hurricane Ike estimated wind speed in this area: 88 mph, Exposure B).

Vinyl siding installers should be advised to use starter strips that are specifically designed for the brand and model or profile of the siding that will be used and generic starter strips should be avoided. Installers should consult the manufacturer’s instructions to identify the starter

strip to be used. Installers should also test the fit of the starter strip to the siding to make sure it locks securely before installing. On elevated structures, the starter strip should not extend below the lowest edge of the vertical wall or the exposed edge may catch the wind blowing under the house.

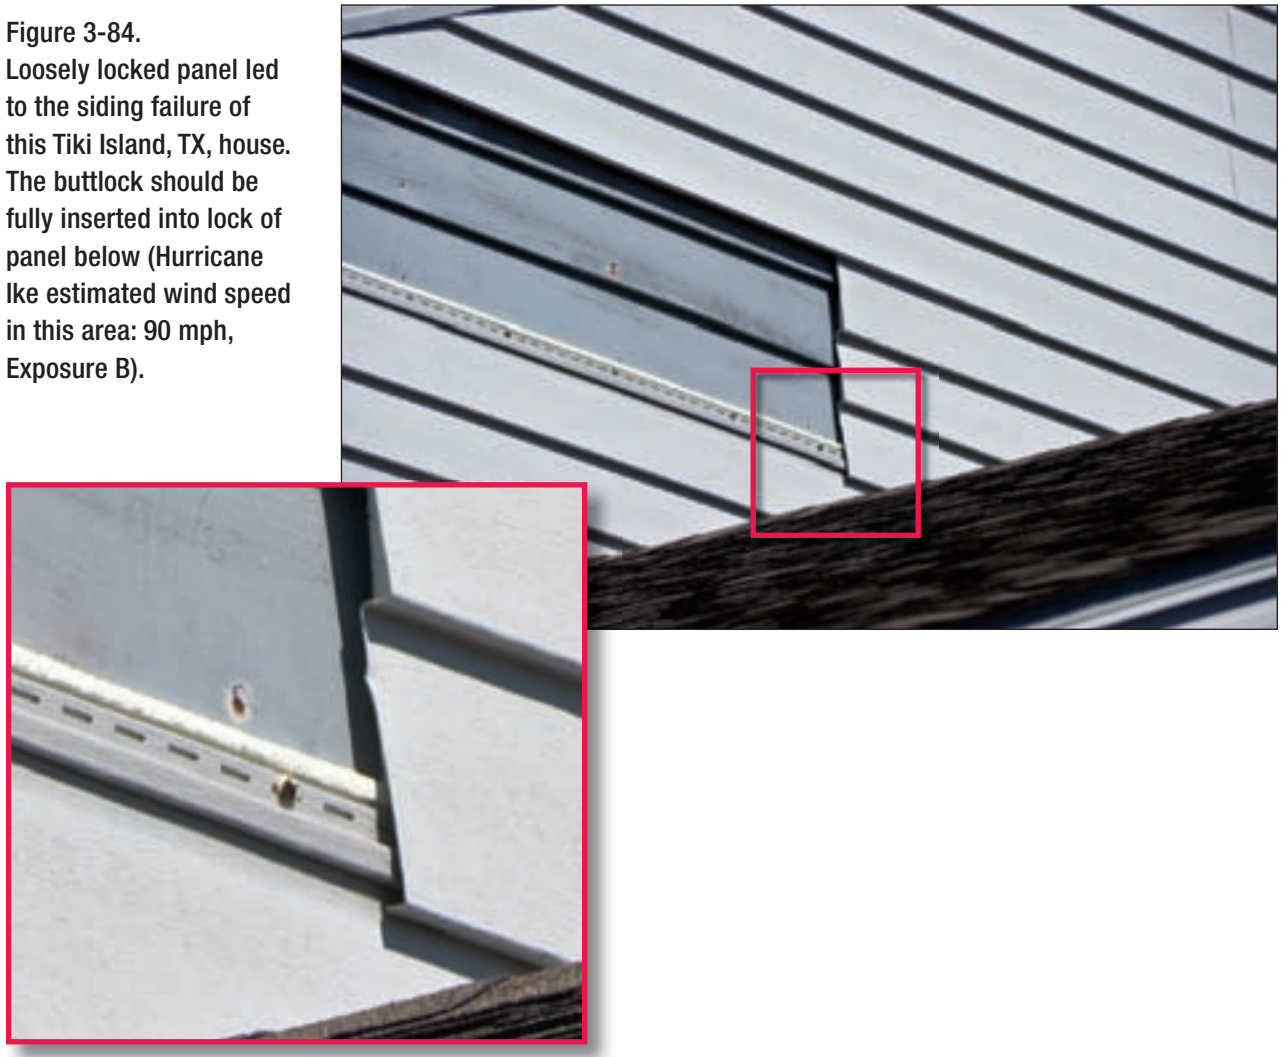
Siding loss frequently begins midway up the wall rather than at the bottom course. Many of these instances are the result of failure to fully and securely lock the buttlock of the siding into the locking shape of the siding course below. This can happen when the siding is pulled up too tightly before being nailed, thereby placing it under tension when the siding is not fully pushed

into the lock (Figure 3-84), or when the siding is allowed to sag before nailing. These modes of failures frequently occur when installers try to align the horizontal course lines on one wall with those of an adjacent wall by installing several courses loosely.

Figure 3-84. Loosely locked panel led to the siding failure of this Tiki Island, TX, house. The buttlock should be fully inserted into lock of panel below (Hurricane Ike estimated wind speed in this area: 90 mph, Exposure B).

Each course of siding should be installed by pushing the buttlock firmly upward into the lock of the course below until it snaps into place and goes no further. The siding should be held in the lock by pushing up from the bottom while the first several fasteners are placed to hold it in position. Siding should never be pulled up from the nail hem. When properly installed, siding should be able to slide back and forth without undue force; neither tight fasteners at the nail hem nor friction in the buttlock should prevent the siding from sliding. Installers should properly locate the starting points for siding on adjacent walls and check alignment of horizontal lines every course or two to avoid needing to make adjustments further up the wall.

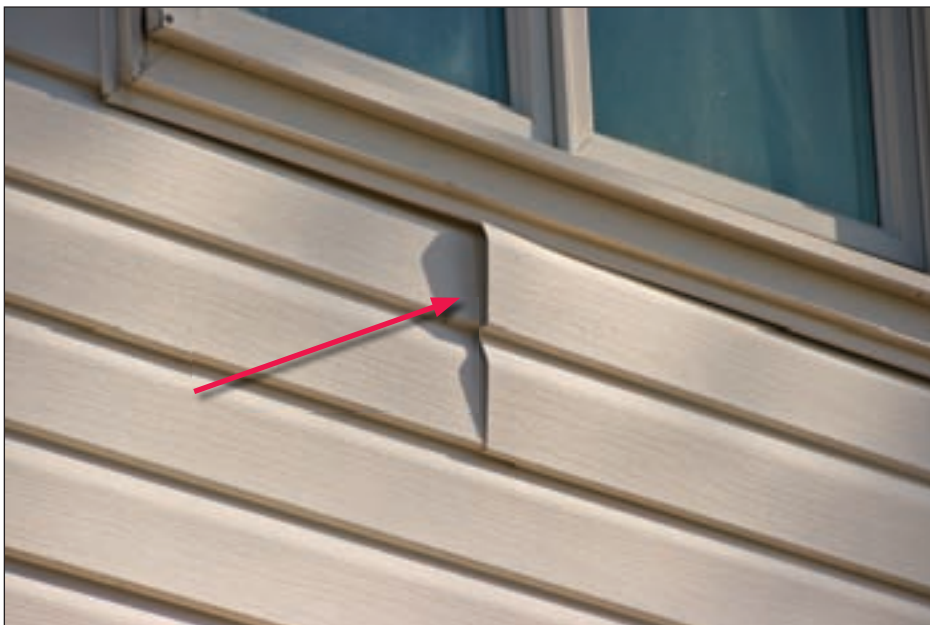
Figure 3-86.

Siding partially detached by wind as a result of improper placement of joint directly under window. Factory-notched end is not held by utility trim (Tiki Island, TX; Hurricane Ike estimated wind speed in this area: 88 mph).

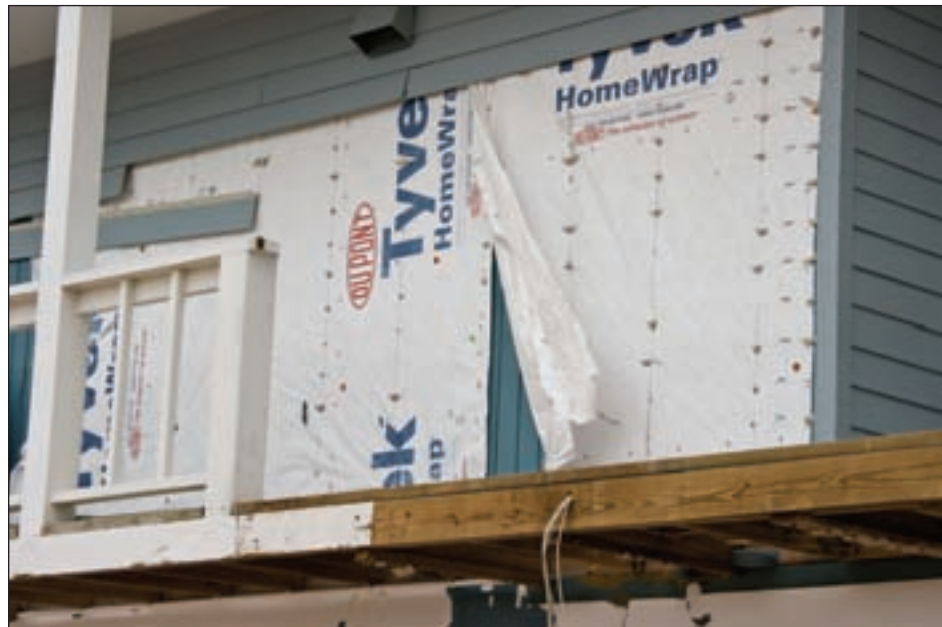
The MAT observed fiber cement siding on many residential structures, primarily as a reside cladding (Figure 3-87).³ The observations included lap (plank) siding of varying exposures, perforated soffit material, and siding panels and sheathing material below elevated structures.

Figure 3-87. Fiber cement plank siding, installed as a reside over the original plywood siding, was torn from this West Bay, Galveston Island, TX, house (Hurricane Ike estimated wind speed in this area: 100 mph, Exposure C)

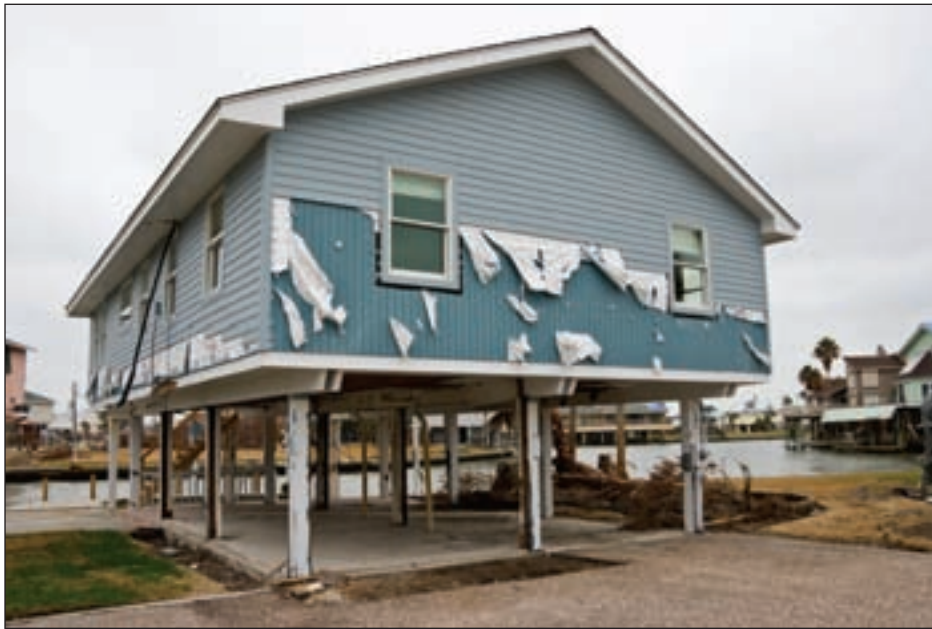
Lap siding damage varied from the loss of a few planks to entire walls (Figure 3-88). In most cases, the siding had been blind nailed at each stud (Figure 3-89), which is standard for non-high wind zones. Published ratings and ICC Evaluation Reports for the application of fiber cement lap siding in high wind zones require that the siding be face nailed through both layers of siding at the lap joint, shown in Figure 3-90. The spacing of the nails (16-inch or 24-inch) and permitted material exposure is dependent upon the thickness and width of the siding boards and wind zone.

Figure 3-88. Fiber cement lap siding was blown off this West Bay, Galveston Island, TX, house (Hurricane Ike estimated wind speed in this area: 100 mph, Exposure B)

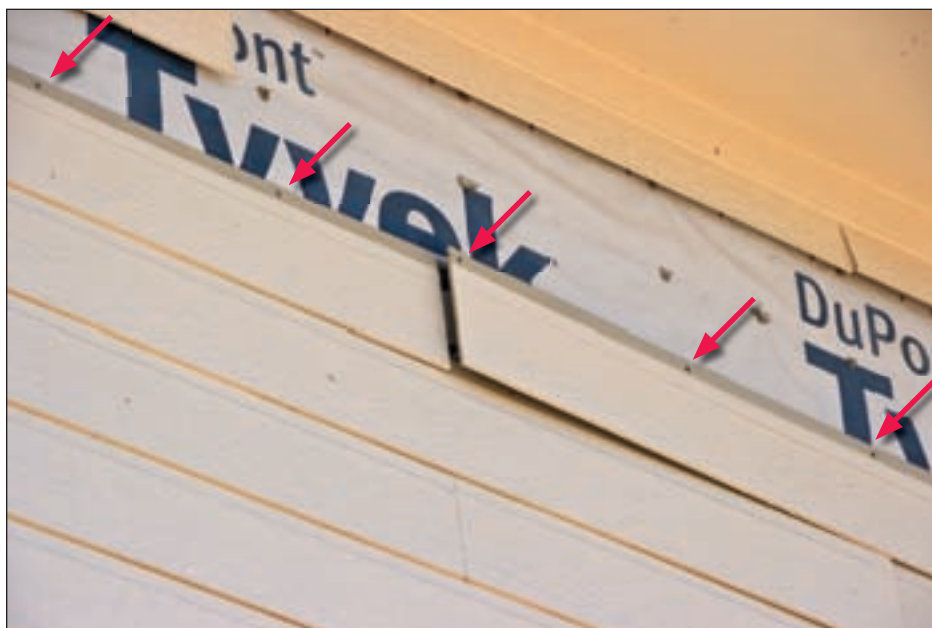
Figure 3-89. Damaged fiber cement plank siding. Note that blind nailing alone (red arrows) is recommended only for 90-mph or less installation. Higher wind zone installations should include both blind and face nailing (Hurricane Ike estimated wind speed in this area: 93 mph, Exposure B).

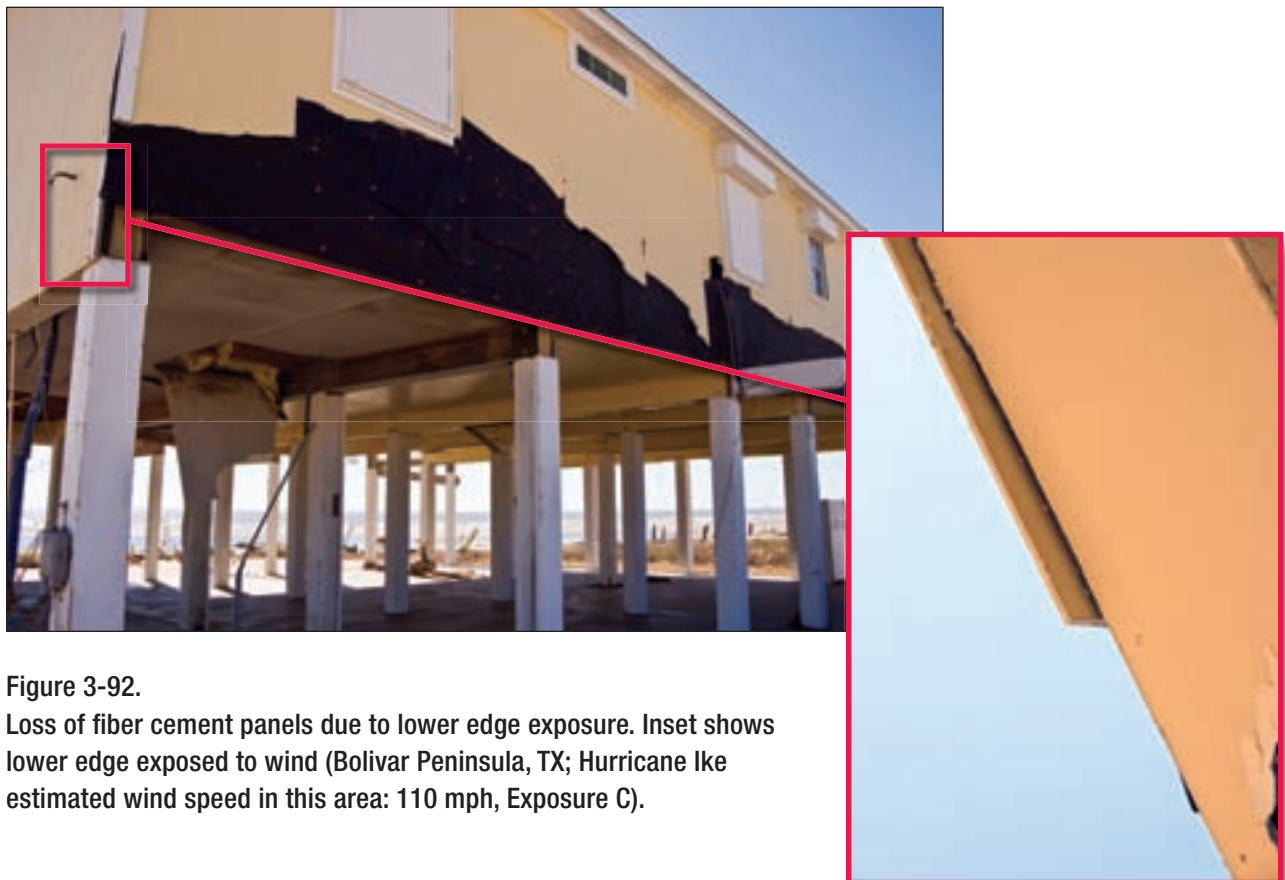
Figure 3-92. Loss of fiber cement panels due to lower edge exposure. Inset shows lower edge exposed to wind (Bolivar Peninsula, TX; Hurricane Ike estimated wind speed in this area: 110 mph, Exposure C).

Shims under lap siding should be placed flush with the bottom of the first course, and panel siding should be fastened tightly to the substrate so that no gap is created at the lowest edge. Consideration should be given to placing a trim piece below the lower edge of the siding to fully close off the edge. Neither lap siding nor panel siding should extend below the lowest structural member of an elevated building, where it would be exposed to the full force of the wind (Figure 3-92).

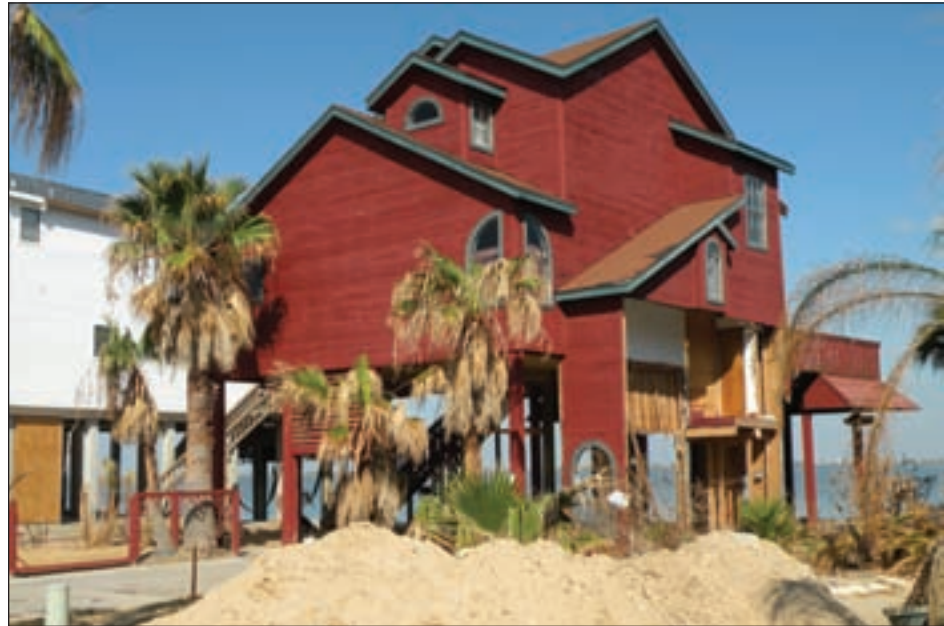
Figure 3-93.
Clapboard-sided house with siding that performed well; damage resulted from failure of a non-breakaway wall (Tiki Island, TX; Hurricane Ike estimated wind speed in this area: 103 mph, Exposure C)

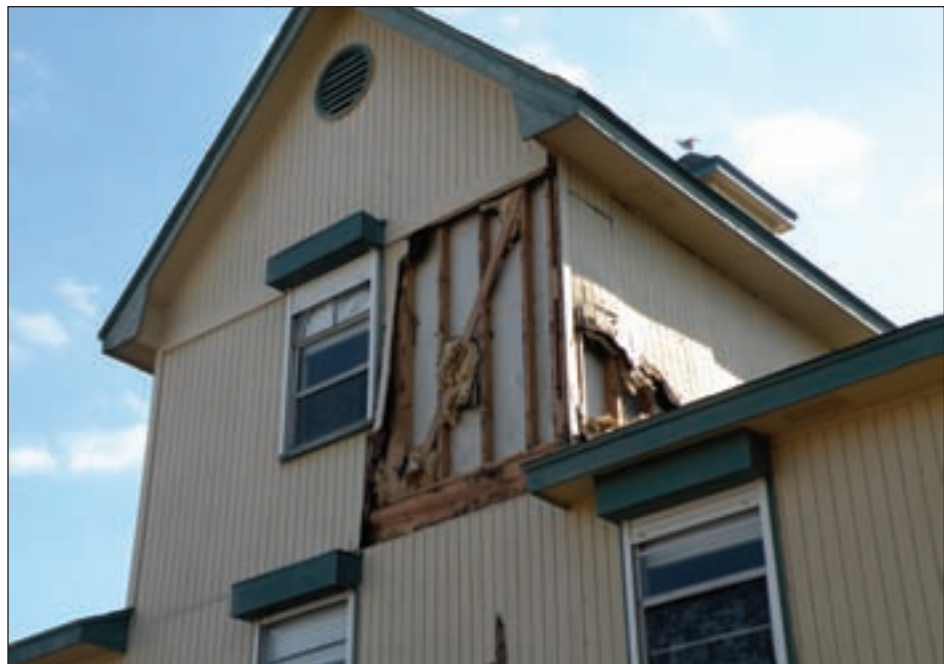
Most of the older houses on Galveston Island, Tiki Island, and Bolivar Peninsula that were originally constructed with plywood or hardboard siding had been re-sided with either vinyl or fiber cement siding. The performance of the remaining plywood and hardboard siding was basically a function of maintenance. The clapboard-sided house shown in Figure 3-93 was well maintained and performed well, though the second floor failure was produced when a non-breakaway wall was destroyed by surge. Failure of the plywood siding shown in Figure 3-94 appeared to be the result of decayed plywood removed by the wind pressures.

Figure 3-94.
Decayed plywood siding removed by wind pressures (Tiki Island, TX; Hurricane Ike estimated wind speed in this area: 103 mph, Exposure C)

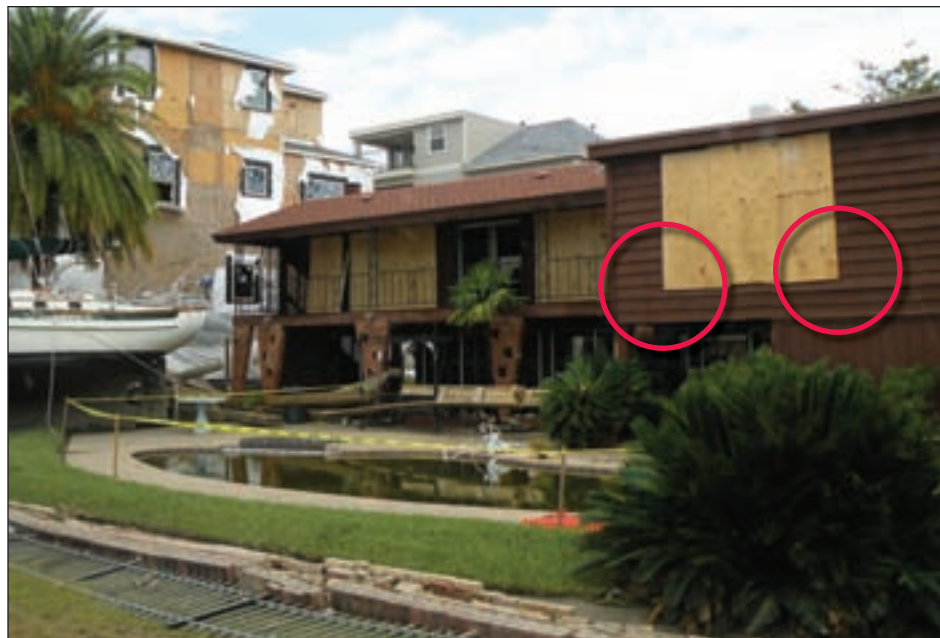
Figure 3-103. Plywood shutters installed into the wall cladding (red circles) in Clear Lake, TX (Hurricane Ike estimated wind speed in this area: 90 mph, Exposure B)

Since Ike's winds were below design wind speeds in both Texas and Louisiana, no failures or debris impacts were observed. The 2006 IRC/IBC and TDI require that all shutters be attached to the building structure and not to the window frame, siding, or veneer (Figure 3-102); they require that all shutters be tested to ASTM Standards E 1886 and E 1996. The MAT observed plywood shutters mounted directly to the wall cladding or window frame as seen in Figure 3-103. Further information regarding shutters can be obtained from Technical Fact Sheet 26, *Shutter Alternatives*, in FEMA 499.

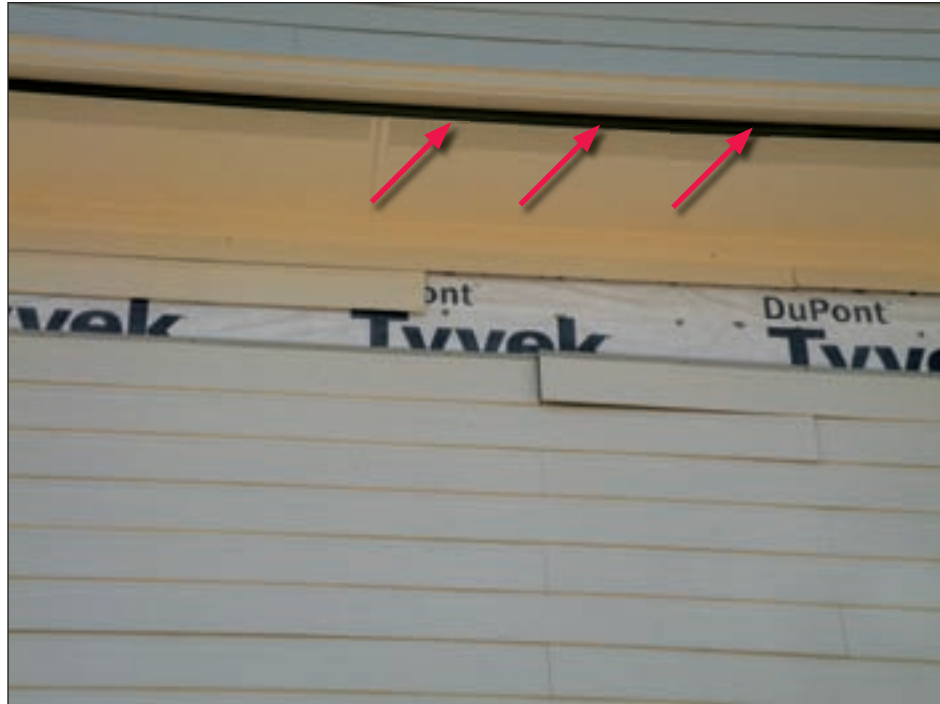
The primary materials observed for roof soffits in the surveyed area were vinyl, aluminum, fiber cement, and plywood. In general, fiber cement and plywood soffits remained connected to the house (Figure 3-104), while vinyl and aluminum soffits were more likely to have blown off.

Figure 3-104.
Fiber cement soffit remained connected; soffit vent slots shown with red arrows. Fiber cement plank siding was damaged (Tiki Island, TX; Hurricane Ike estimated wind speed in this area: 88 mph, Exposure B).

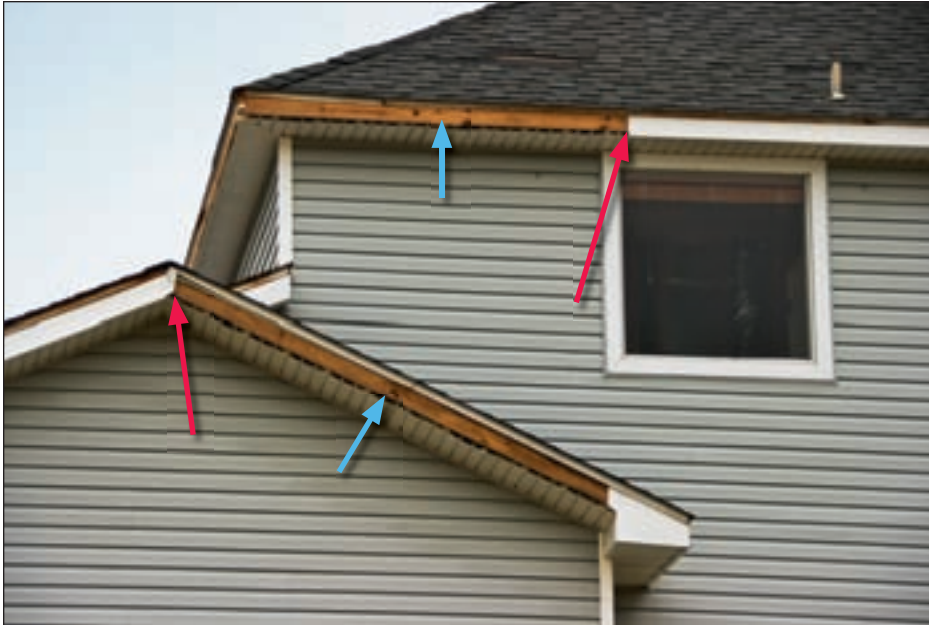
By far the most frequently observed form of failure was loss of the aluminum fascia cover from the fascia board (the vertical board used to close off the end of eave spaces or form the outer edge of the rake), as shown in Figures 3-105 and 3-106. The fascia cover normally covers the ends of vinyl and aluminum soffits. Aluminum fascia covers are typically nailed every few feet along the length with color matched trim nails. The IRC currently has no guidelines for the installation of fascia covers. Vinyl fascia covers are also available. They are typically installed using

The frequent loss of fascia covers is a significant concern. In most instances where the fascia cover was observed by the MAT to be fully or partially removed, the soffit itself remained in place or lost only a few sections, as further shown in Figures 3-105 and 3-106. The loss of the fascia cover can increase the risk of loss of the soffit. Even where the soffit remains, rain can be driven directly past the exposed soffit ends. The MAT did not have access to the interior of houses to determine whether interior moisture damage was a frequent result of fascia cover loss, but such damage would be expected.

Figure 3-105. Loss of aluminum fascia cover (red arrows) exposed ends of vinyl soffit (blue arrows) to direct entry of wind-driven rain (Tiki Island, TX; Hurricane Ike estimated wind speed in this area: 88 mph)

The frequency of fascia cover failure suggests that design and installation of this component needs to be better addressed in construction standards for buildings in high wind locations. The fact that most soffits stayed in place despite loss of the fascia cover suggests that most soffit installations were performed properly or the design was sufficiently robust to resist winds that occurred during Ike. However, loss of soffits exposed by fascia cover removal would likely have been much greater had winds approached design speeds.

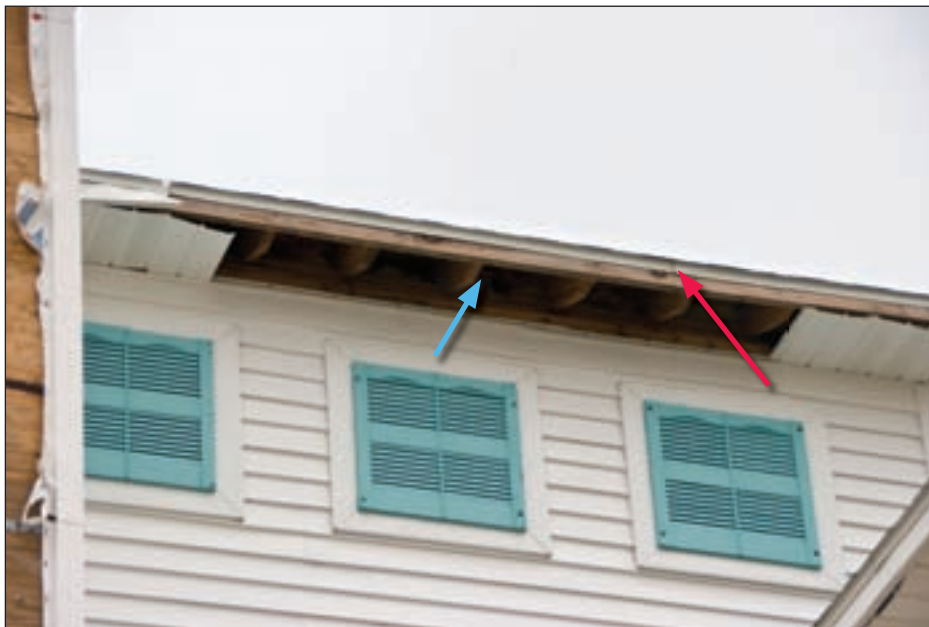
Figure 3-106. Loss of fascia cover (red arrow) led to loss of soffit (blue arrow), exposing the attic to wind-driven rain (San Luis, TX; Hurricane Ike estimated wind speed in this area: 93 mph, Exposure C)

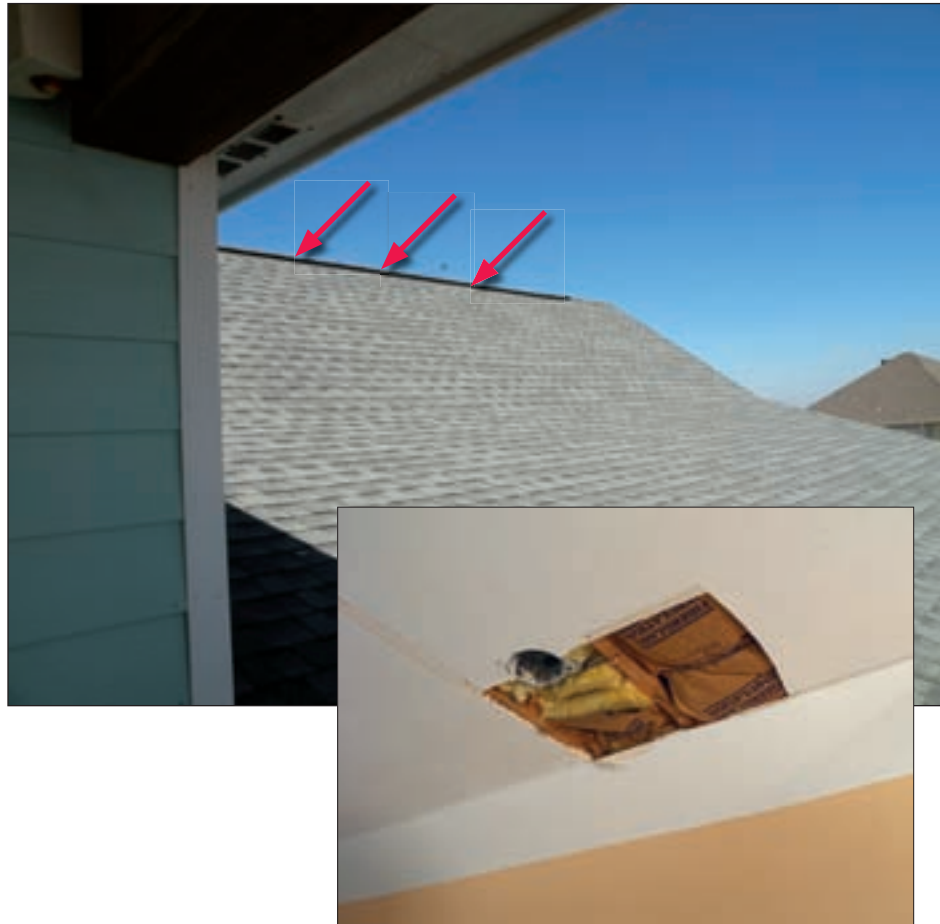
blowing up the surface of the roof and deflect it over the top of the roof ridge. The ridge vent should be installed with stainless steel screws, not roofing nails, into the roof structure. The MAT team was unable to climb onto residential roofs, but it was reported by the homeowner that the damage to a second floor ceiling shown in inset of Figure 3-107 was the result of a leaking ridge vent.

Figure 3-107.
The roof ridge vent (red arrows) on this Bolivar Peninsula, TX, home leaked, and it is presumed that the water was shed down the underside of the roof decking and/or structure, thereby producing ceiling damage along the wall of this second story room (Hurricane Ike estimated wind speed in this area: 110 mph, Exposure C)
