Mitigation Assessment Team Report

Hurricane Ike in Texas and Louisiana

Building Performance Observations, Recommendations, and Technical Guidance

FEMA P-757 / April 2009

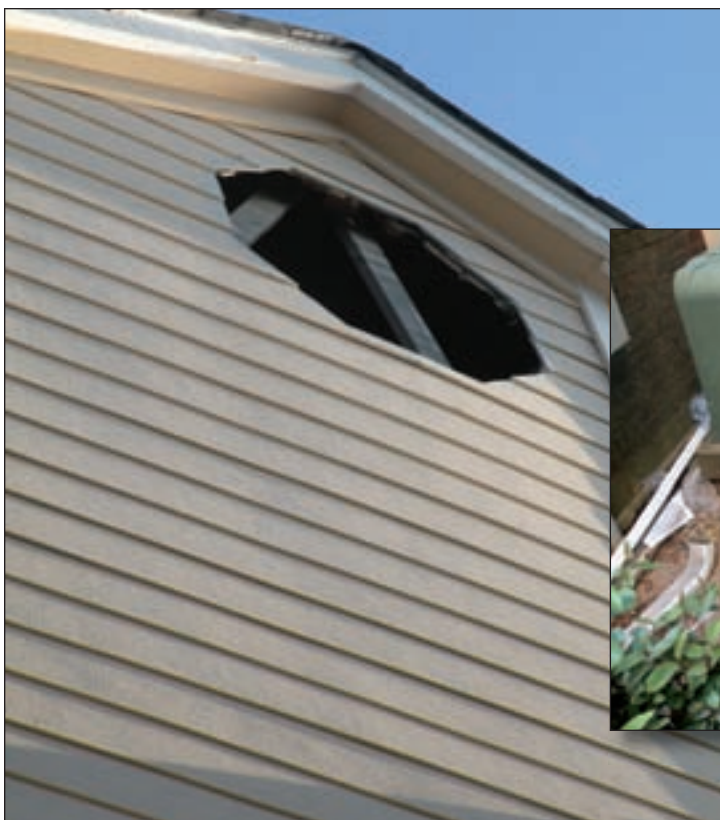
Figure 3-110.

Virtually all gable end vents (Figure 3-108) will leak when the wall they are mounted on faces into the wind-driven rain. The pressure developed between the outside surface of the wall and the inside of the attic are sufficient to drive water uphill for a number of inches and, if there is much wind flow through the vent, water carried by the wind will be blown considerable distances into the attic. Remedial measures include installing shutters, preferably on the outside of the house (Figure 3-109). The gable end vent shown in Figure 3-110 was not attached to the building structure and was blown off the apartment building.

Gable end vent blew off this Galveston, TX, Back Bay apartment building (Hurricane Ike estimated wind speed in this area: 90 mph, Exposure B)

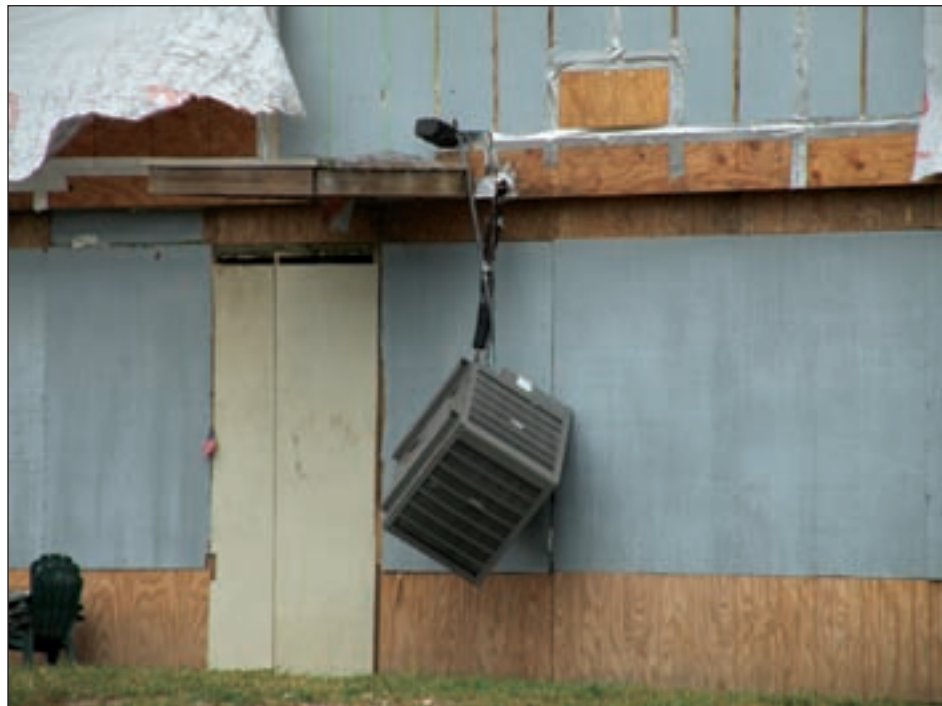
Figure 3-112.
Improperly secured
condensing unit was
knocked from its platform
(Kahala Beach, TX;
Hurricane Ike estimated
wind speed in this area:
80 mph, Exposure B)

Residential condensing units should be elevated in floodprone areas. Condensers at many residences observed by the MAT were supported on cantilevered platforms as shown in Figure 3-111. Cantilevered platforms are preferred because they are less susceptible to damage from floodborne debris impacts than are pile or knee-brace supported platforms. Outside floodprone areas, condensers are normally mounted at grade or on rooftops. In all cases, the units should be permanently anchored to prevent them from being moved (Figure 3-112).

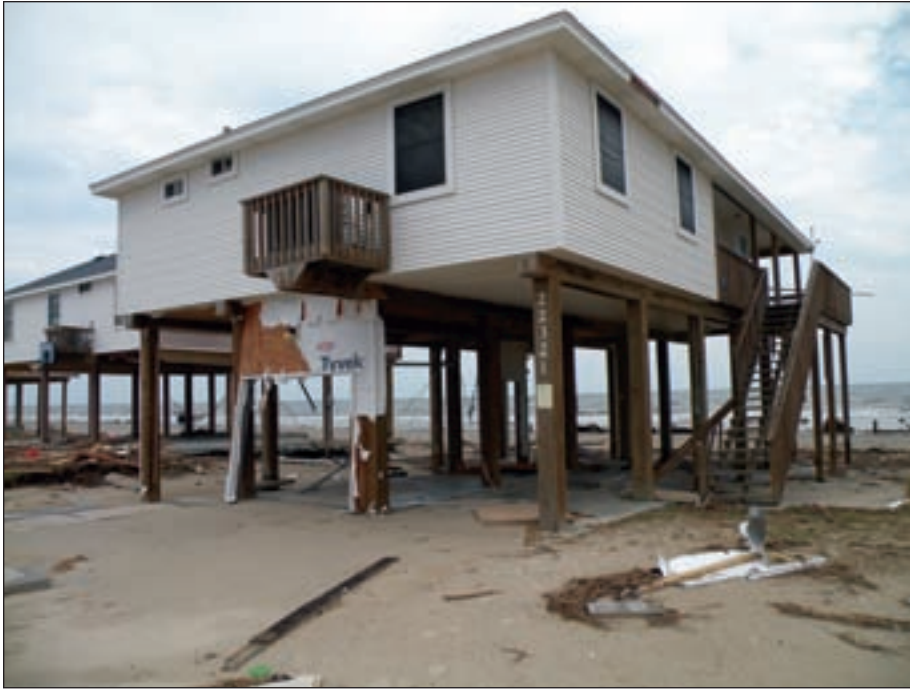
Figure 3-113. Elevated condenser is tightly enclosed, making service access difficult (Bermuda Beach, TX; Hurricane Ike estimated wind speed in this area: 95 mph, Exposure C)

Maintenance should be considered in the design and installation of elevated supports. Figure 3-113 shows a unit that is closely caged, making maintenance difficult. If units are caged, the railings should either be removable or the platform made sufficiently large to allow service to the unit. Further information regarding equipment protection can be obtained from Technical Fact Sheet 29, *Protecting Utilities*, in FEMA 499.

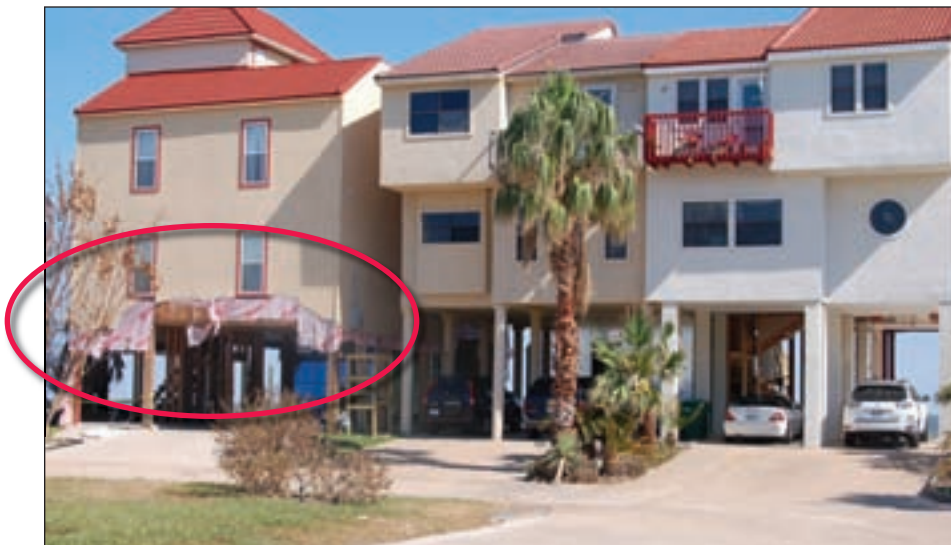
Figure 3-114. Propagation of damage above lowest floor when breakaway walls broke free (Seabrook, TX)

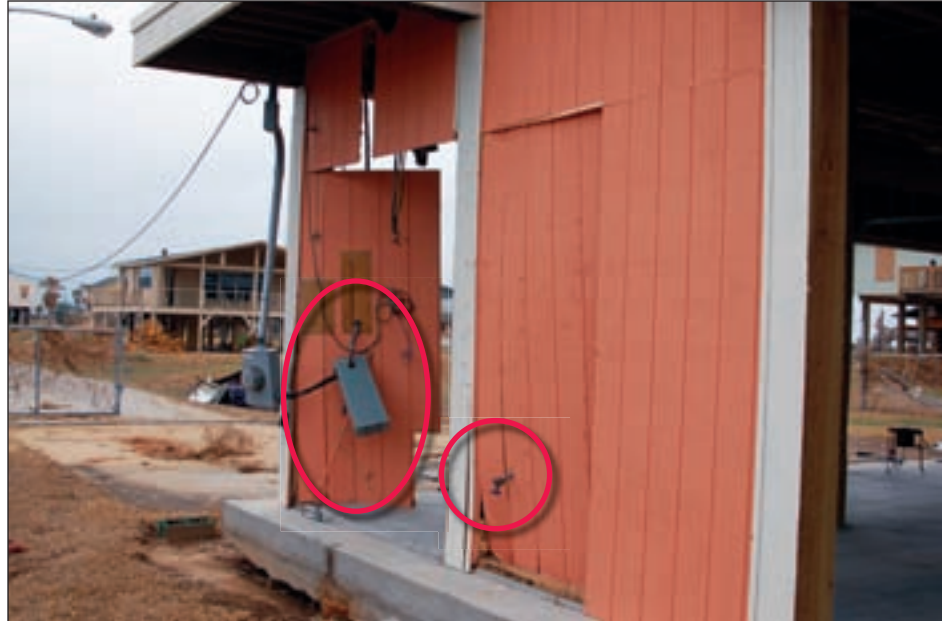
Figure 3-115.
Attachment of utilities to breakaway wall may have prevented the wall from breaking away, thereby resulting in additional damage to the structure (Galveston Island, TX)

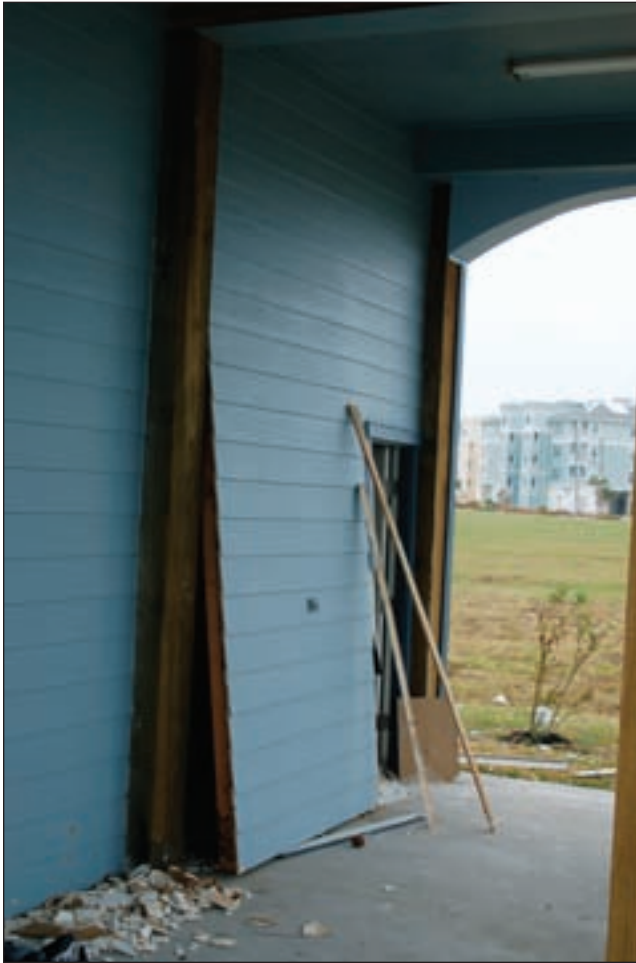
Figure 3-116.

The MAT observed some breakaway walls in excess of 11 feet high (Figure 3-116). While FEMA promotes elevating houses above the BFE (i.e., adding freeboard), one of the unintended consequences appears to be an increased size of floodborne debris elements due to the presence of these taller breakaway walls.

This 11-foot high breakaway wall panel was pushed out by floodwaters trapped inside the enclosure (Galveston Island, TX)

Based on these observations, the Ike MAT recommends the use of louvered panels rather than solid breakaway walls below the BFE. See the Hurricane Ike Recovery Advisory, *Enclosures and Breakaway Walls*, in Appendix D for more details on this topic.

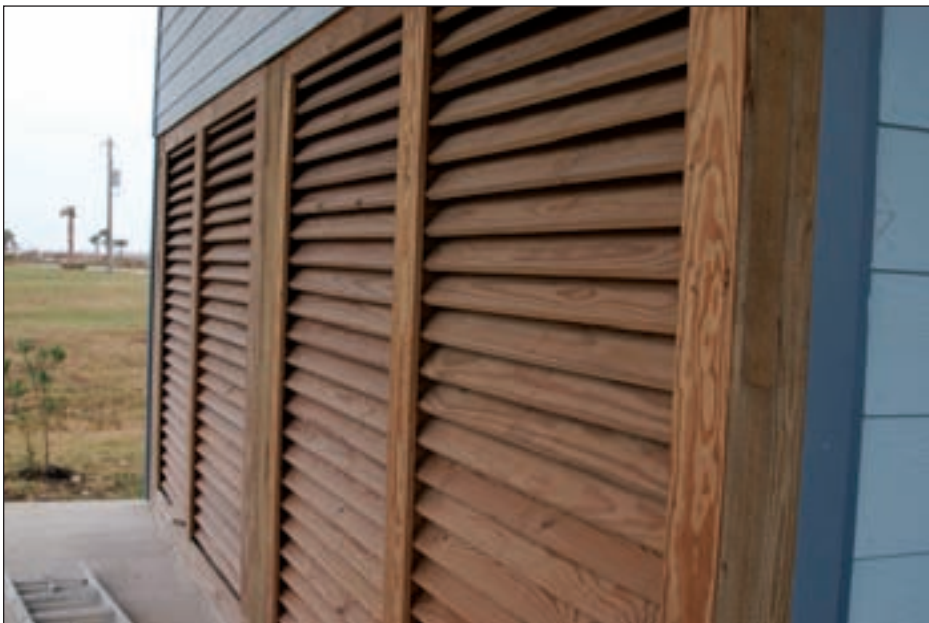
Figure 3-117.

The MAT observed that louvered panels remained intact longer than solid breakaway walls under the same flood conditions. As a result, houses with louvered panels had less flood-related damage (and repair cost) and contributed less floodborne debris. Figure 3-117 shows louvered panels that allowed Ike floodwaters to pass into and out of the below-BFE enclosure without damage to the louvered panels. These louvers were installed on the same building shown in Figure 3-116, where the solid breakaway wall panel was displaced by floodwaters trapped inside the enclosure.

Louvered panels allowed Ike floodwaters to pass into and out of the below-BFE enclosure without damage to the panels. The building shown here is the same as in Figure 3-116, where a solid breakaway wall panel broke away.

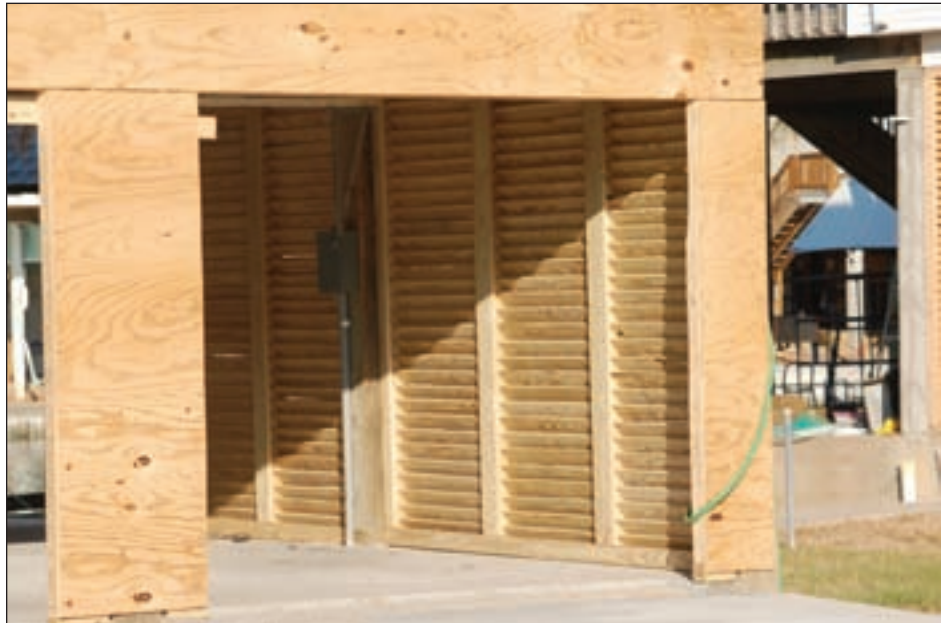
Numerous building owners in one community (Tiki Island, TX) were observed to be replacing solid breakaway walls lost during Ike with louvered panels (Figure 3-118). This action will reduce future flood damages and can result in lower flood insurance premiums. Zone V flood insurance premiums are much less for a building with a below-BFE enclosure formed by louvers than for a building with an enclosure formed by breakaway walls. A building with an enclosure formed by louvers is classified the same as if it had insect screening or open lattice, i.e., as “free of obstructions,” while a solid breakaway wall enclosure results in a “with obstruction” rating for the building.

Figure 3-118.
Solid breakaway walls lost during Ike are being replaced with louvered panels (Tiki Island, TX)

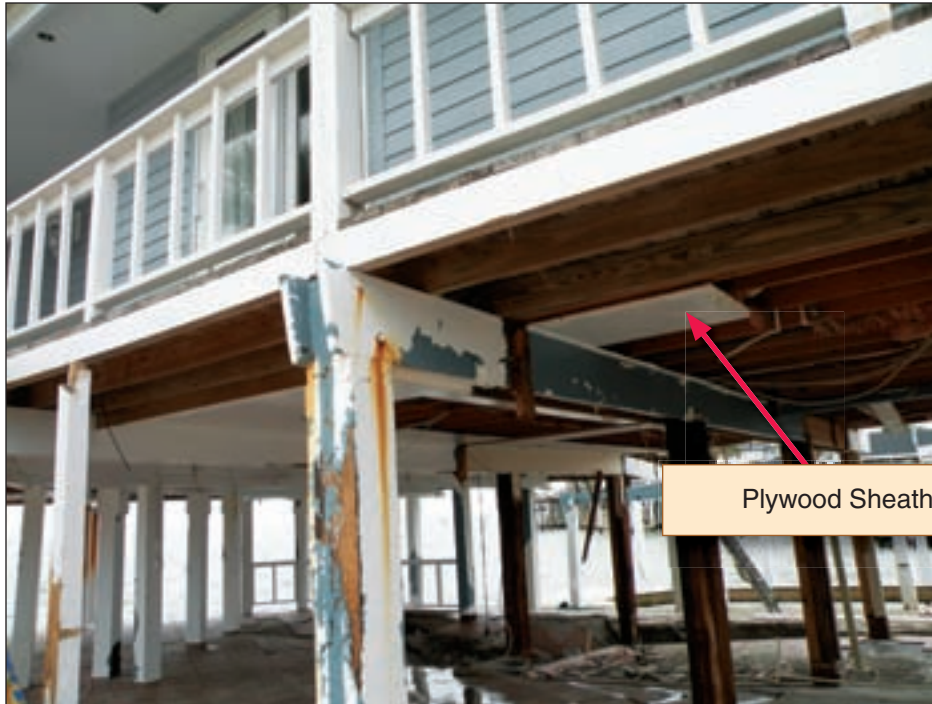
In locations where the water level or waves reached the elevation of the building, sheathing and any covering was frequently found to be partially or completely removed (Figures 3-119 and 3-120). This was particularly true of the thinner panel types, such as 1/8-inch fiberboard. Other forms of damage, such as gouges from floodborne debris, were observed on the underside of panels.

Figure 3-119.
Plywood sheathing
removed by storm surge
(Jamaica Beach, TX, house
on West Bay)

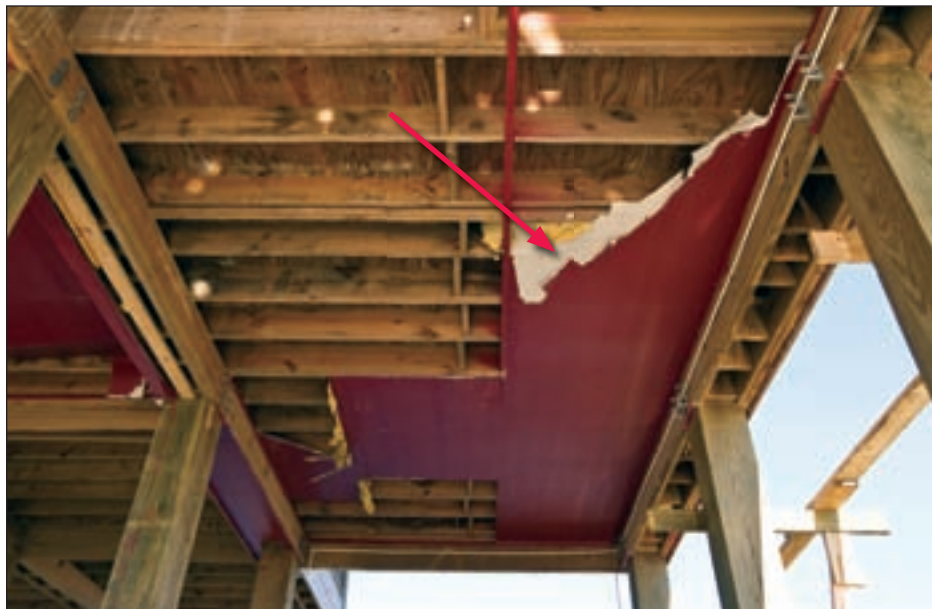
Figure 3-120.
Fiber cement board
sheathing (red arrow)
was removed from the
underside of this house,
which was elevated
approximately 12 feet
above ground level (Bolivar
Peninsula, TX)

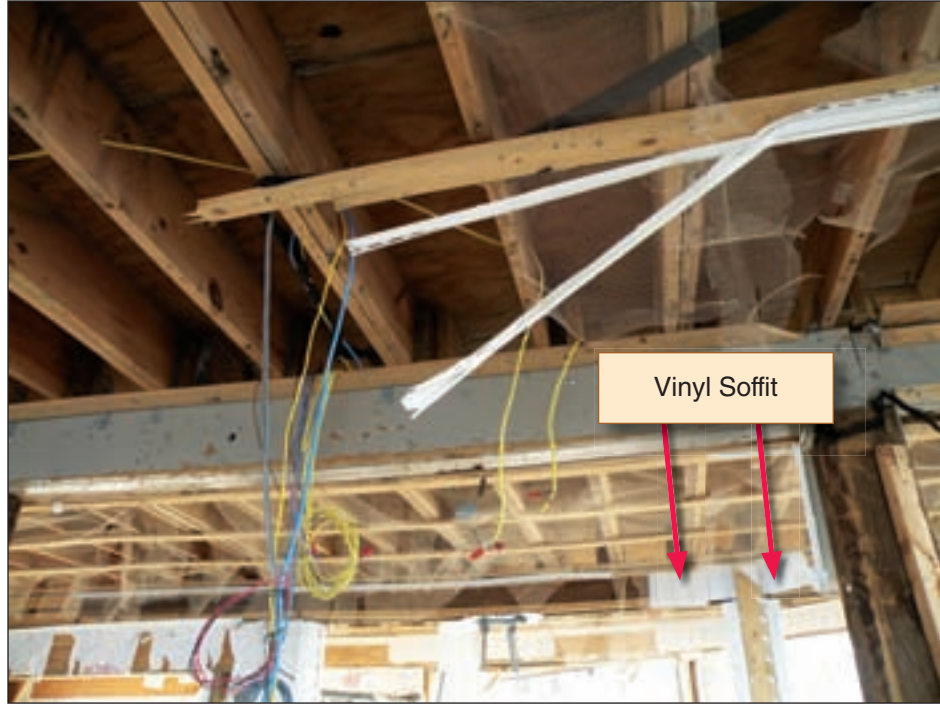
Several examples of vinyl soffit attached directly to floor joists, without sheathing, were observed by the MAT (Figure 3-121).

Figure 3-121.
Tiki Island house with vinyl soffit applied without sheathing removed by storm surge (netting was used to contain insulation in joist space)

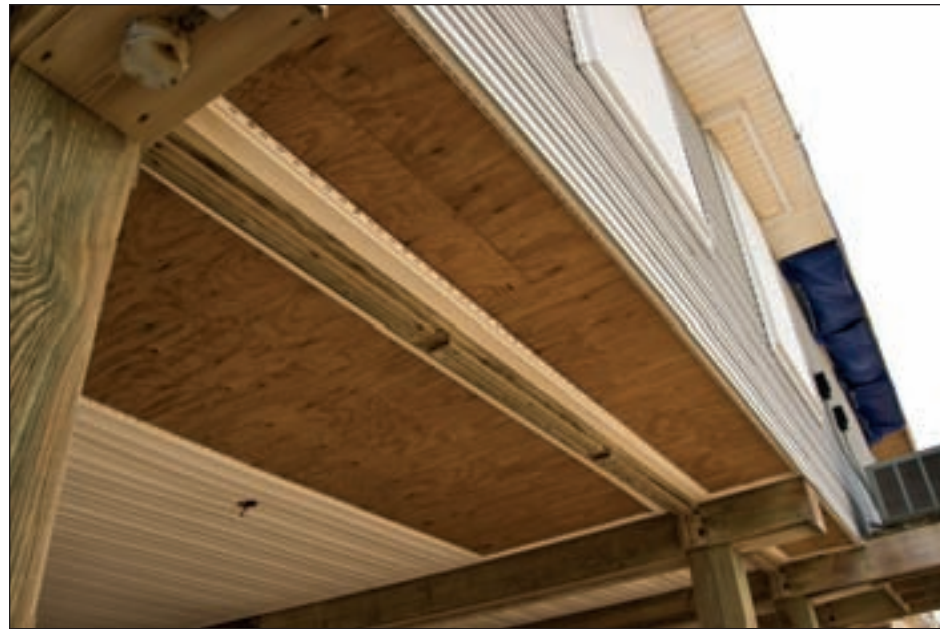
Where floodwaters did not reach the underside of the building, damage due to wind accelerating underneath the building was often observed. In these cases, vinyl soffit was often blown off. In some cases, but not all, the sheathing above the soffit was also removed. The vinyl soffit covering on the Tiki Island house shown in Figure 3-122 was probably blown off by wind action rather than storm surge.

Figure 3-122.
Vinyl soffit covering over plywood sheathing partially removed (Tiki Island, West Galveston Bay; Estimated Hurricane Ike wind speed: 103 mph, Exposure C)

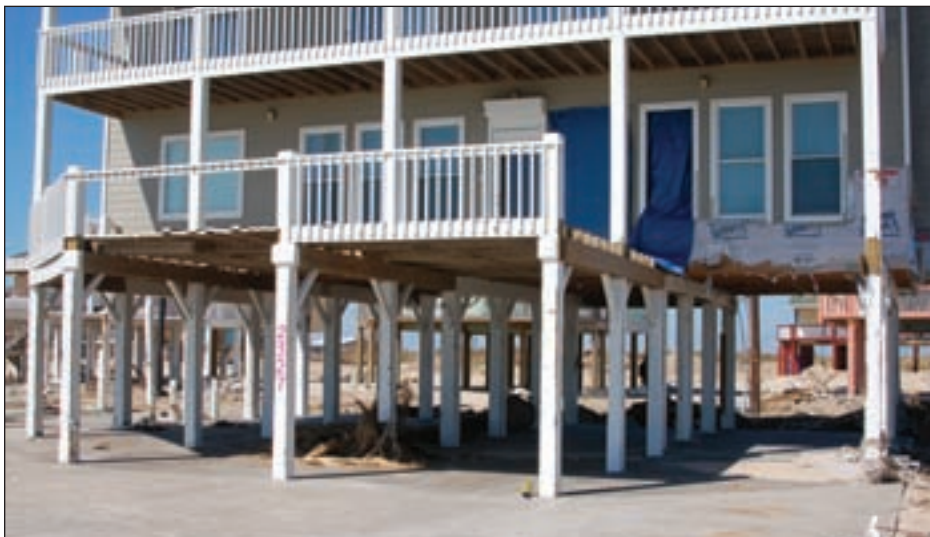
Many of the houses supported on pile foundations that the MAT visited had concrete slabs constructed at grade. These slabs were typically used as parking slabs beneath the elevated houses (Figure 3-123). Some of the slabs were thin (less than 4 inches thick); others were much thicker. Some had thickened edges and interior sections that acted as grade beams, presumably to stiffen the foundation. Virtually all slabs were reinforced with welded wire mesh and/or steel reinforcing bars.

Figure 3-123.
Typical concrete parking slab beneath a pile-supported house (Bolivar Peninsula, TX)

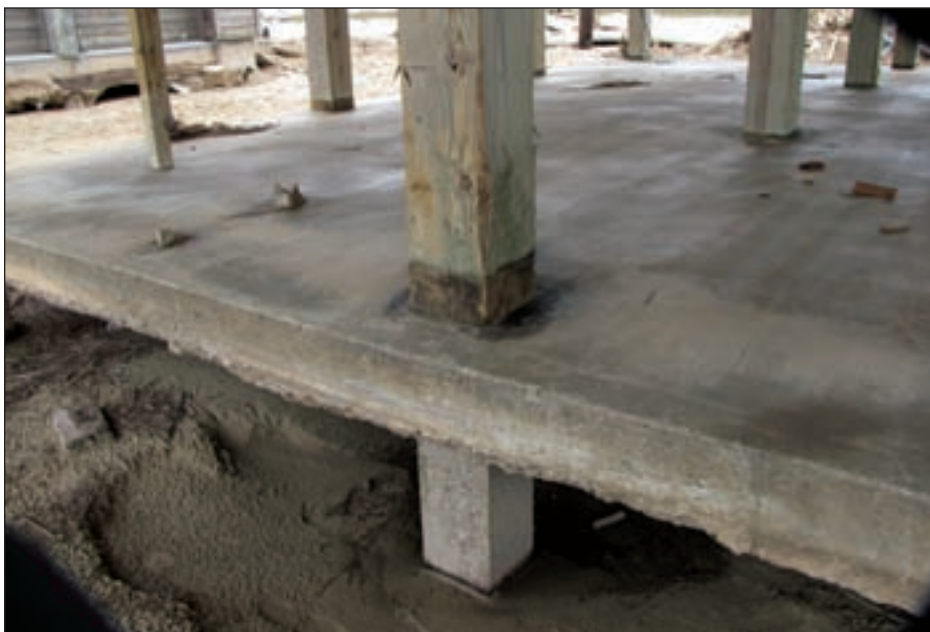
Many of the slabs failed once they were undermined. Where the piles were embedded deep into the ground, the slab was either undermined (and sometimes settled) as shown in Figure 3-124, or the slab collapsed without visible damage to the foundation (Figure 3-125).

Figure 3-124.
Undermining of concrete slab that settled but remained intact (Galveston Island, TX)

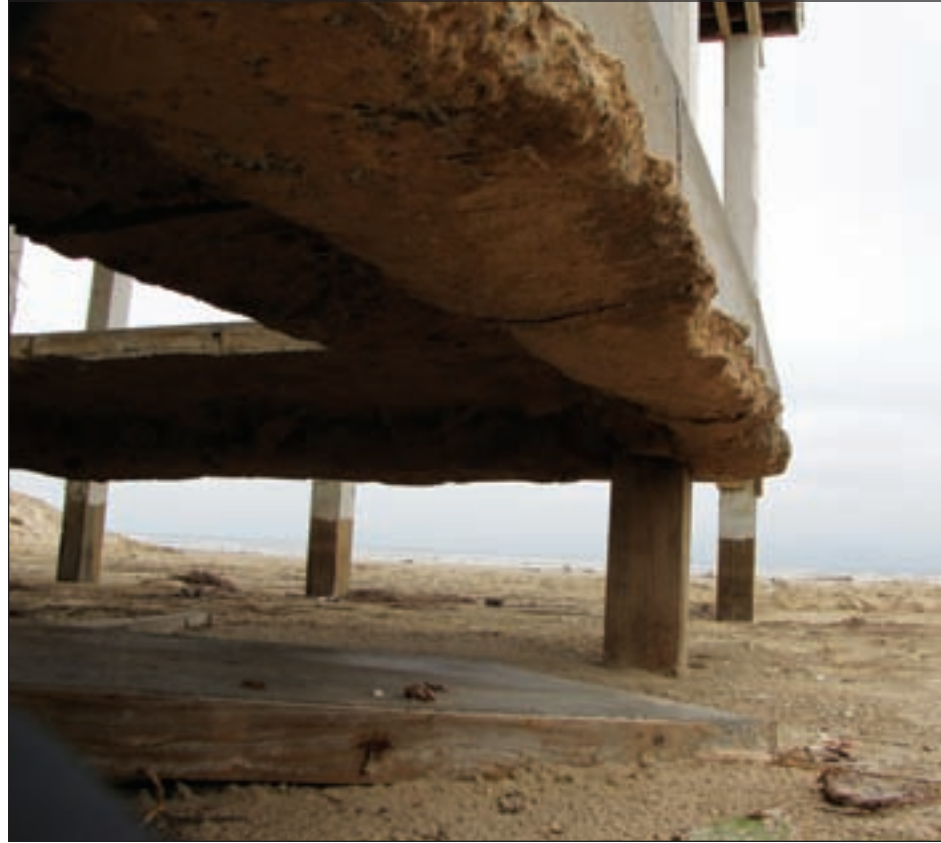
Figure 3-125.
Pile-founded house
with a slab thickened to
create grade beams. The
unthickened portion of
the slab collapsed when
undermined (Galveston
Island, TX).

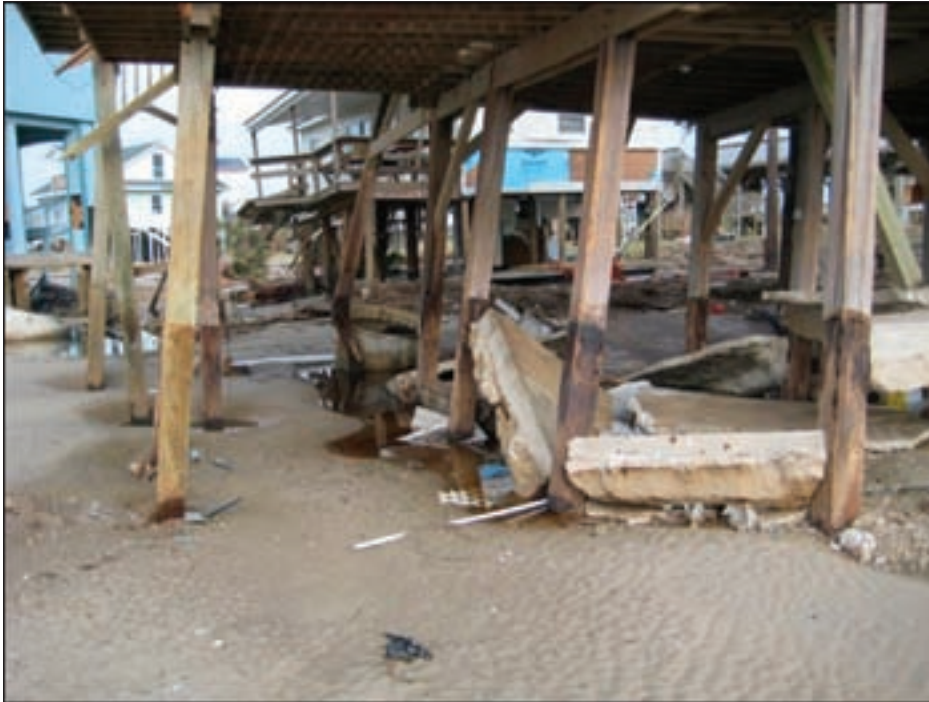
Where the piles were thought to be less well embedded, failure of the slab could have caused the pile foundation to rotate or rack (Figure 3-126). The MAT believes this was more common with older houses, and was likely a result of portions of the slab causing eccentric loads on the piles and the transfer of flood forces from the slab to the foundation.

Figure 3-126.
Slab failure probably
contributed to foundation
damage (West Galveston
Island, TX)

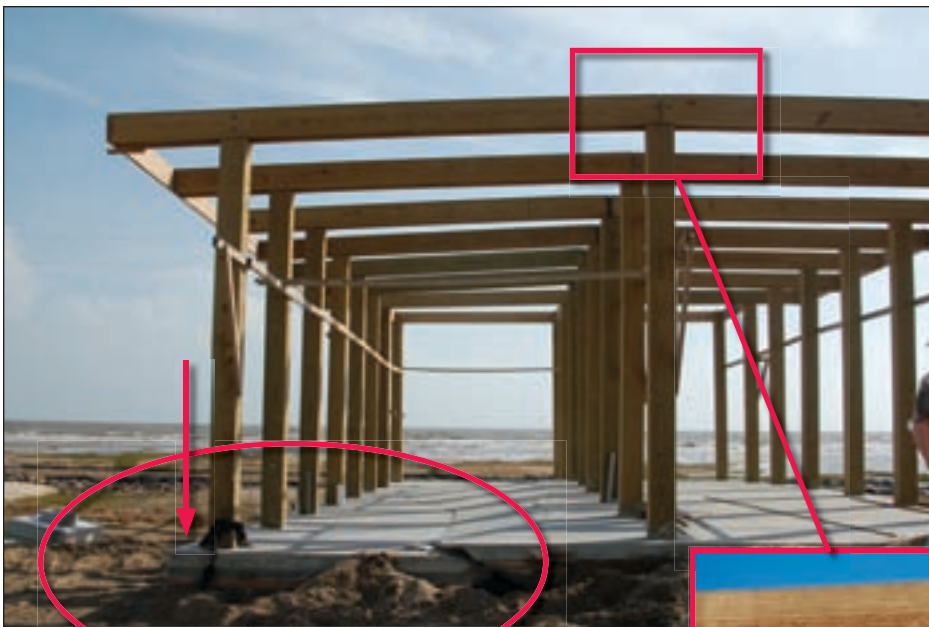
The MAT observed instances where the weight of the slab likely contributed to foundation failure and building settlement, illustrated in Figures 3-127 and 3-128. Figure 3-127 shows a Holly Beach, LA, house under construction at the time of Ike. The piles and elevated floor beams had been placed, and a thick slab had been cast; when Ike undermined part of the slab, it cracked and settled, pulling some of the piles and beams downward. Figure 3-128 shows a house at Surfside Beach, TX, that was subject to considerable scour and erosion—when the slab settled and collapsed, it could have pulled part of the house lower as it went. Pile embedment appears to have been the larger issue at the houses shown in Figures 3-127 and 3-128, and insufficient embedment likely allowed the slabs to induce or worsen building settlement.

Figure 3-127.
Slab undermining and
settlement during Ike
probably pulled piles
downward. Inset shows
that the dropped piles also
caused the floor beam to
deflect (Holly Beach, LA).

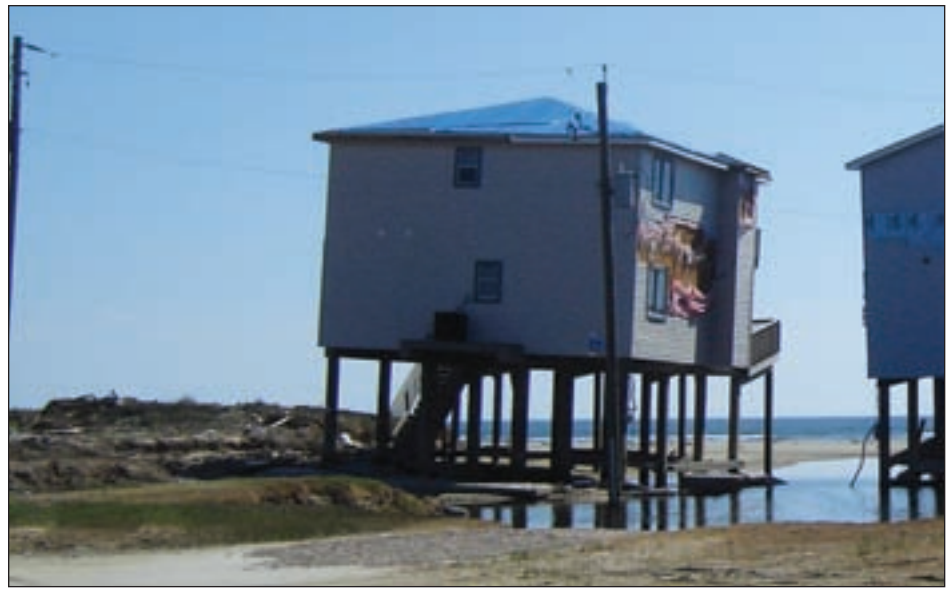
Figure 3-128.
The weight of this slab, undermined due to scour and erosion, could have contributed to settlement and racking of this elevated house (Surfside Beach, TX)

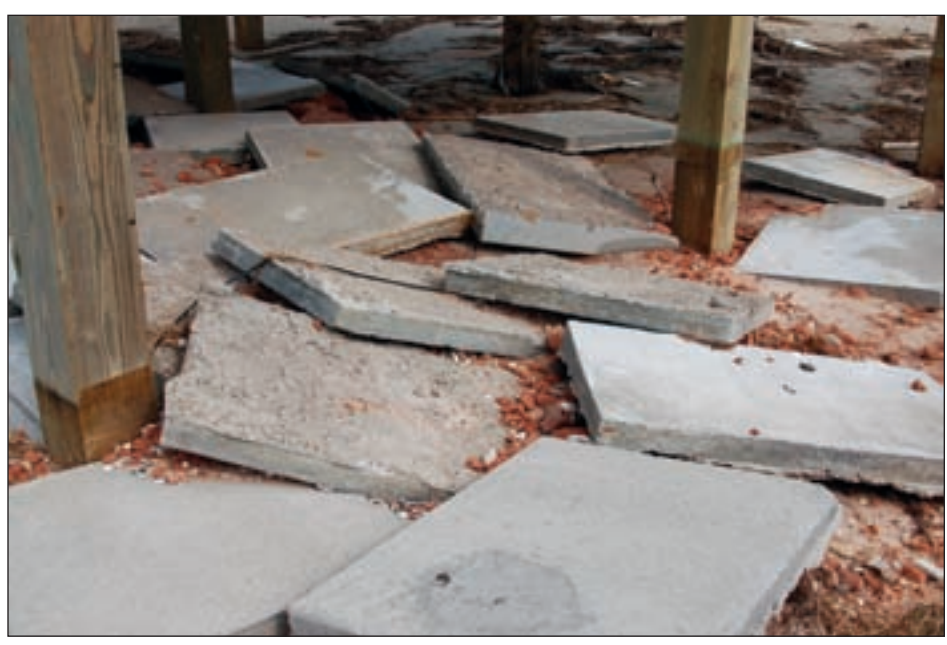
The MAT observed several houses on Galveston Island where parking slabs were constructed in 4-foot square sections and unreinforced. This method of construction is consistent with that recommended in FEMA 55, Third Edition. Where these slabs were observed, their failure did not appear to adversely affect foundations or elevated buildings (Figure 3-129). Section III of the *Galveston County Dune Protection and Beach Access Plan* (2006) requires use of unreinforced fibercrete or concrete slab sections (maximum 4-inch thickness) within 200 feet of the vegetation line in eroding areas.

Figure 3-129.
Thin, unreinforced parking slab sections separated when undermined and collapsed in place, with no apparent adverse impact to the foundation (Galveston Island, TX)

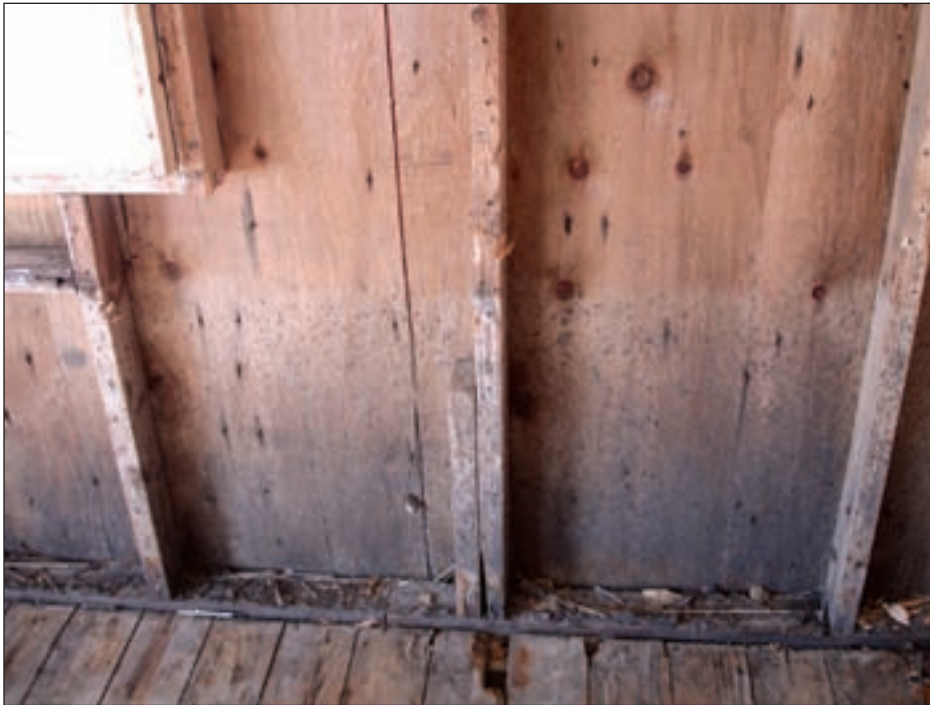
Hurricanes introduce various forms of contaminants and pollution into floodwaters and flooded buildings. Hurricanes also lead to the post-event growth of mold in wind- and flood-damaged buildings. Figure 3-130 illustrates one of many examples of mold and mildew growth observed by the Ike MAT. Guidance on cleanup and restoration of flooded buildings can be found in the Hurricane Katrina Recovery Advisory 2, *Initial Restoration for Flooded Buildings* (July 2006d), and Katrina Recovery Advisory 4, *The ABCs of Returning to Flooded Buildings* (July 2006e).

Figure 3-130.
Mildew and mold forming
on wall sheathing
following flooding (Golden
Meadow, LA)

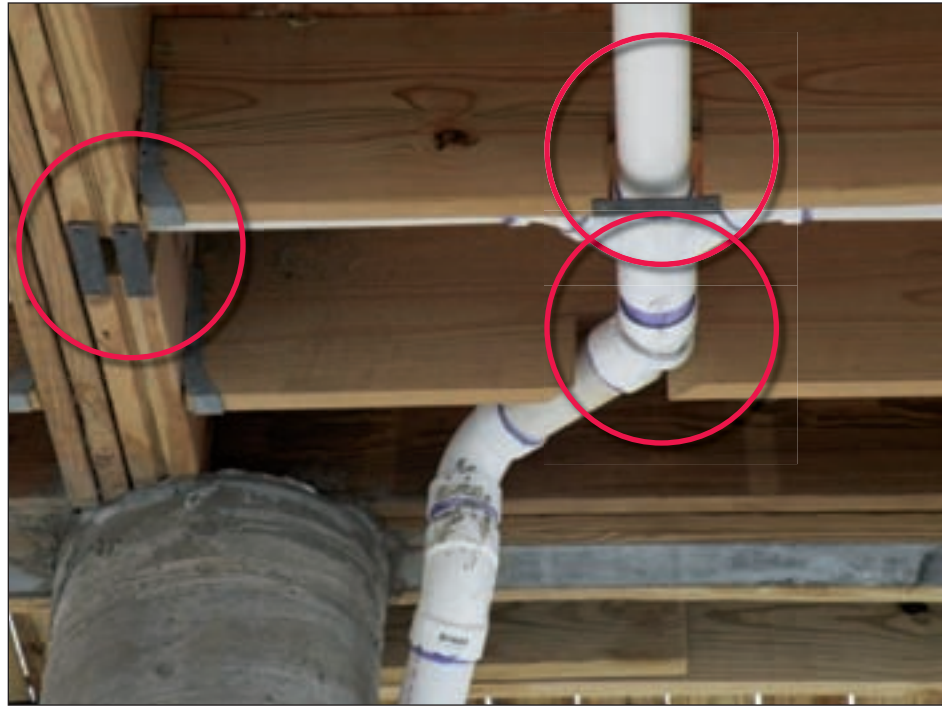
The MAT observed other construction deficiencies and community enforcement problems. While the details of these particular deficiencies are not known, their existence indicates potential compliance issues that should be monitored and addressed in communities visited by the MAT. Figure 3-131 shows a case where floor beams and joists were improperly notched to allow for plumbing installation. This practice can weaken structural members and should only be done at the direction of a structural engineer. Figure 3-132 shows a case where flood vents did not penetrate through the entire enclosure wall—if this installation was complete when observed by the MAT, this practice is a clear violation of NFIP flood opening requirements.

Figure 3-131.
Floor joists and beams
were notched to allow
for plumbing (Sulphur,
Calcasieu Parish, LA)

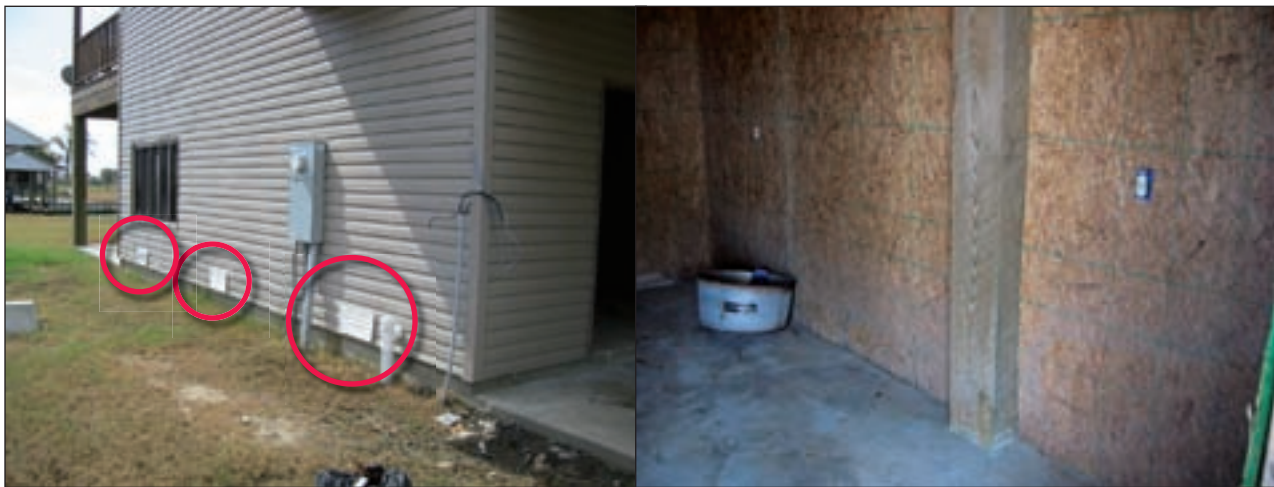
Figure 3-132. Flood vent openings (red circles) that do not extend through the walls (Hackberry, Cameron Parish, LA)

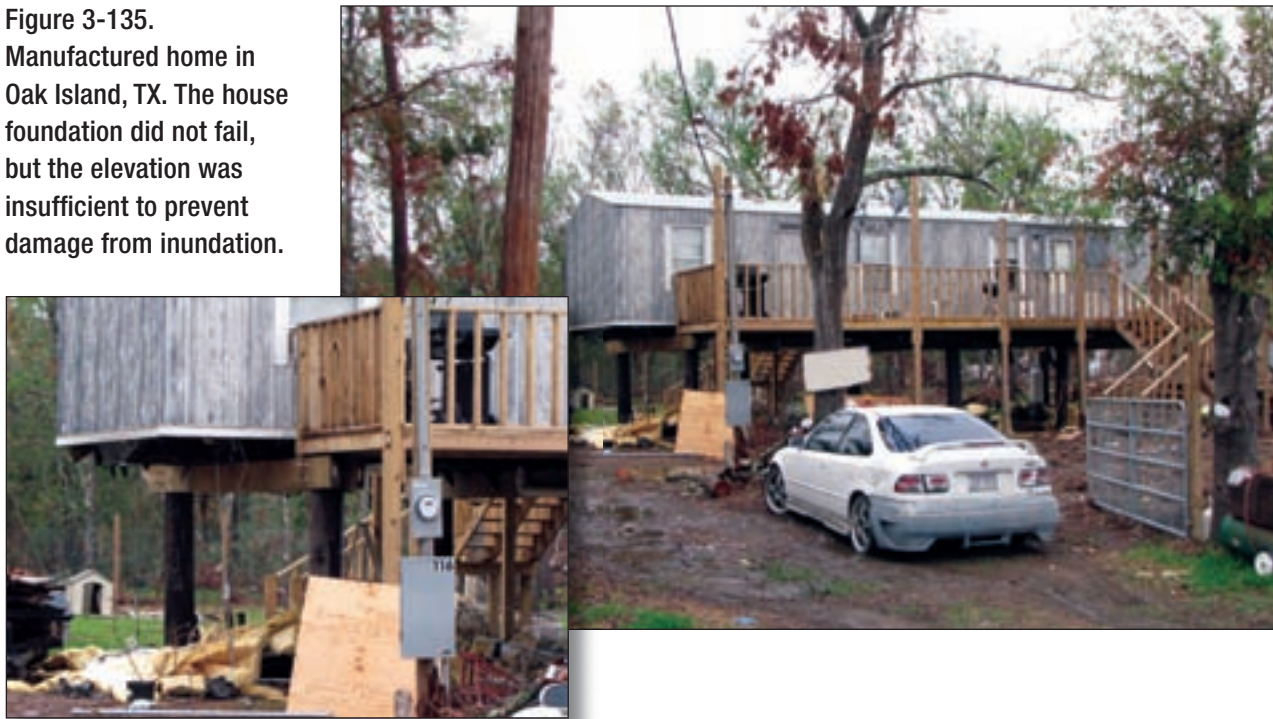
In Oak Island, TX, some manufactured homes were elevated on timber piles. The elevation prevented foundation failure, but some of the homes were still damaged by inundation (Figure 3-135).

Figure 3-135.
Manufactured home in Oak Island, TX. The house foundation did not fail, but the elevation was insufficient to prevent damage from inundation.

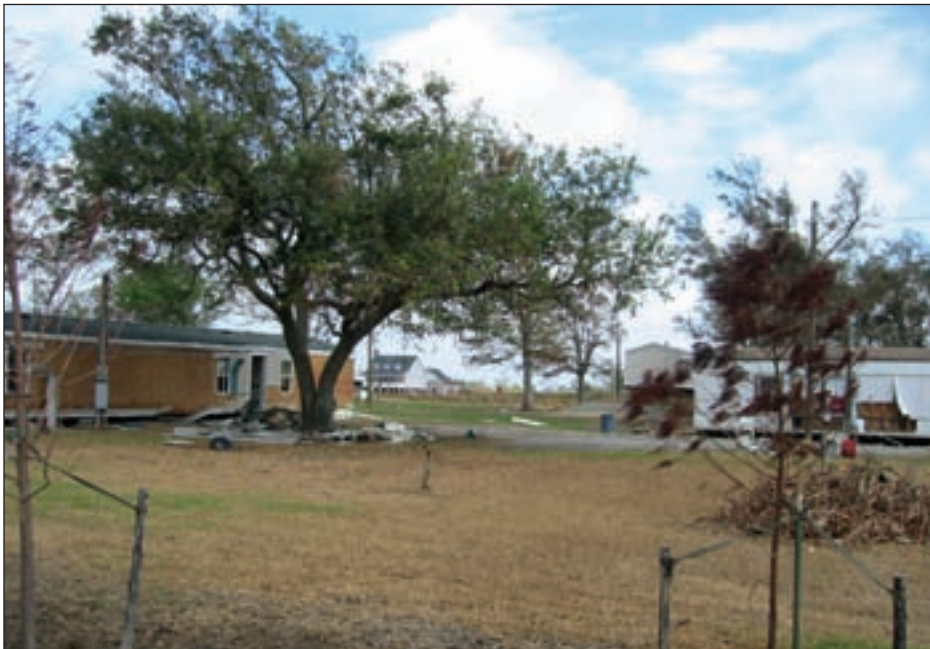
The manufactured homes shown in Figure 3-136 are located immediately east of the Cameron Parish offices along LA Hwy 82 in South Cameron. They are currently located within Zone A, but will be classified as Zone V when the pending new flood maps are adopted. The homes were not properly anchored and were forced off their foundation piers by the storm surge.

Figure 3-136.
Two manufactured homes in Cameron, LA. Homes were displaced off foundations and siding peeled due to inundation and storm surge of approximately 4 feet above ground.

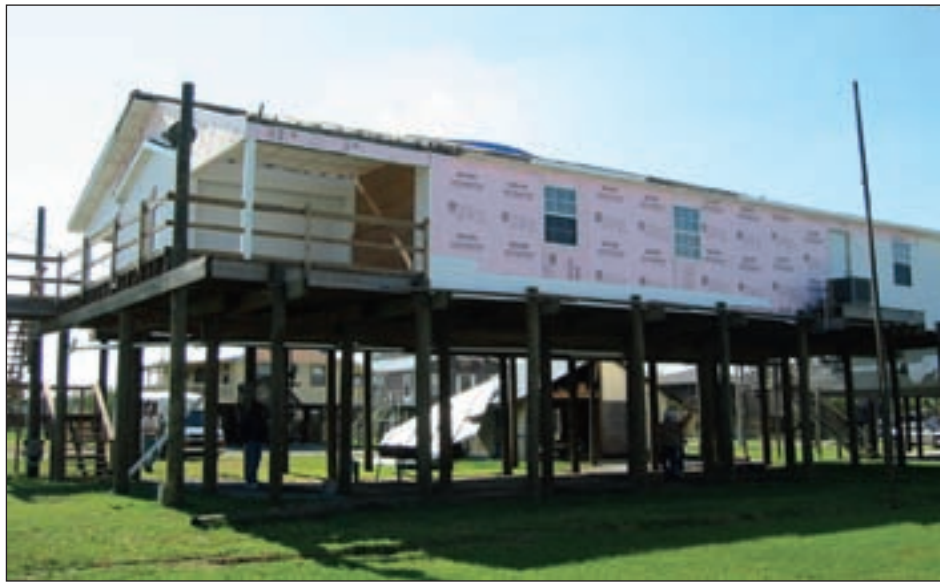
The home experienced some wind damage (vinyl siding and portions of the roof covering were dislodged) despite the fact that the Ike wind speeds and wind pressures were far below the HUD and ASCE 7-05 design wind speeds and pressures. Section 305 of the MHCSS, 24 CFR Part 3280, requires that siding be designed to resist wind loads for Exposure C specified in ANSI/ASCE 7-88, or wind pressures specified the HUD Standard table titled Table of Design Wind Pressures. The MHCSS places Jefferson Parish in HUD Wind Zone III, and the Table of Design Wind Pressures requires exterior coverings within 3 feet of corners to resist +/- 58 psf, and exterior coverings in other areas to resist +/- 46 psf. The ASCE 7-05 wind pressures (for a 150 mph basic wind speed) are +49/-65.7 psf at the corners of a building and +49/-53.1 psf in other areas.

Figure 3-137.
This elevated
manufactured home in
Grand Isle of Jefferson
Parish, LA, had siding and
roof damage, but did not
move from its foundation

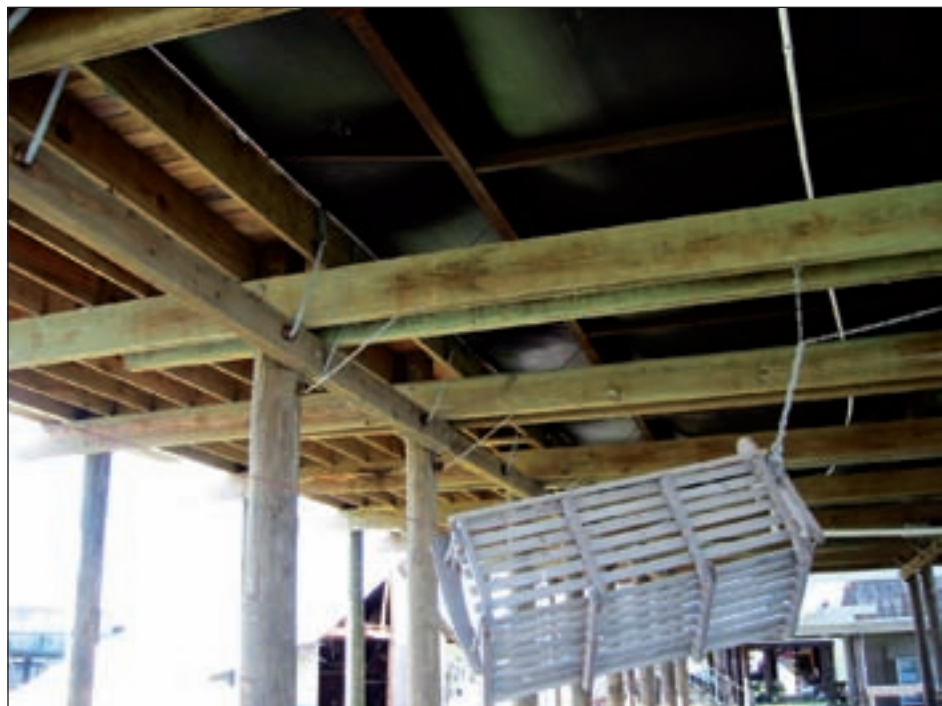
The manufactured home shown in Figures 3-137 and 3-138 is located in Zone A (BFE = 10 feet, ABFE = 12 feet) on Grand Isle, Jefferson Parish. Ike floodwaters were approximately 6 feet deep and did not reach the home, which was elevated in compliance with NFIP requirements. Support framing was in place, and strapping secured the walls and the steel chassis frame to the foundation. While effective during Ike, the strapping was installed using non-conventional methods. Its ability to resist a design wind event could not be determined.

Figure 3-138.
The framing and anchoring
system of the house
shown in Figure 3-137.
Strapping secured the
home's walls and frames
to its foundation. While the
strapping held the home to
its foundation during Ike,
it could not be determined
if the strapping would
resist a design wind event
(Estimated wind speed
during Ike: less than 60
mph, 3-second gust).

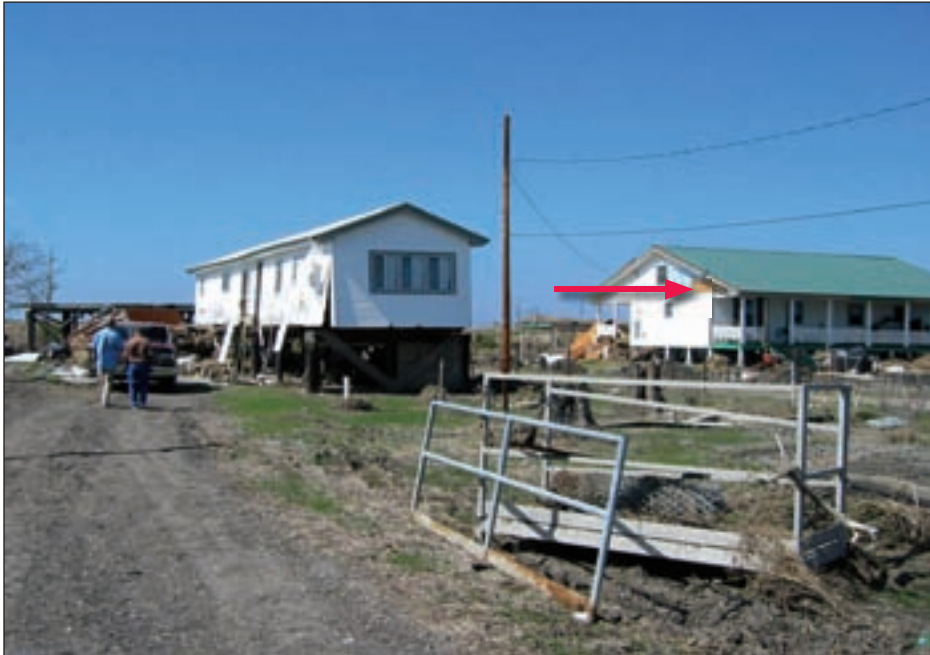
The Zone A home shown in Figure 3-139 in Lafourche Parish was elevated, but not above the BFE. It suffered flood damage from about 3 to 4 feet of water above the floor. Interviews with nearby residents indicated the floodwaters reached the eaves on the house with the green roof to the right. Flood velocities were not sufficient to shift the manufactured home off of its foundation and the floodwaters rose slowly enough to allow leakage into the home, thereby preventing the home from becoming buoyant and floating off its foundation.

Figure 3-139. Zone A manufactured home in the Golden Meadows section of Lafourche Parish, LA, sustained 3 to 4 feet of flooding above the floor, but did not shift or float off of its foundation. The red arrow indicates the flood level reported by neighbors.

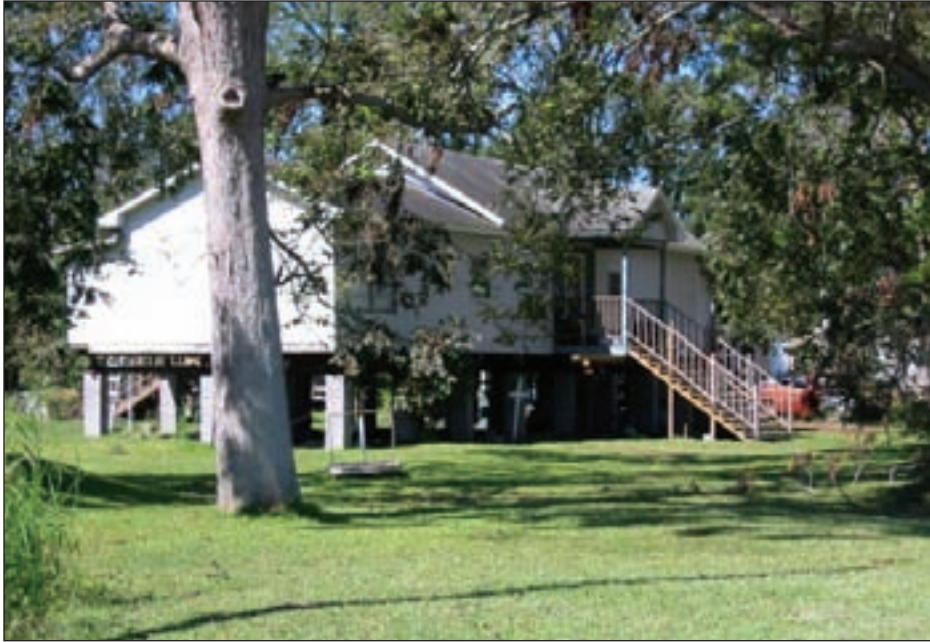
While most of the elevation projects appeared to have been constructed in accordance with applicable codes and standards, some load path deficiencies (Figure 3-141) were noted that indicate possible project design and/or compliance problems that should be investigated. Some of the elevated buildings sustained wind damage to the building envelope during Ike (Figure 3-142); this is likely a result of older homes being elevated, as opposed to a problem with the elevation project itself.

Figure 3-141. Zone A house elevated with Increased Cost of Compliance funds on masonry piers (Iberia Parish, LA). There was no evidence of pier reinforcement, mortar between masonry blocks, or ties between the piers and the elevated home.

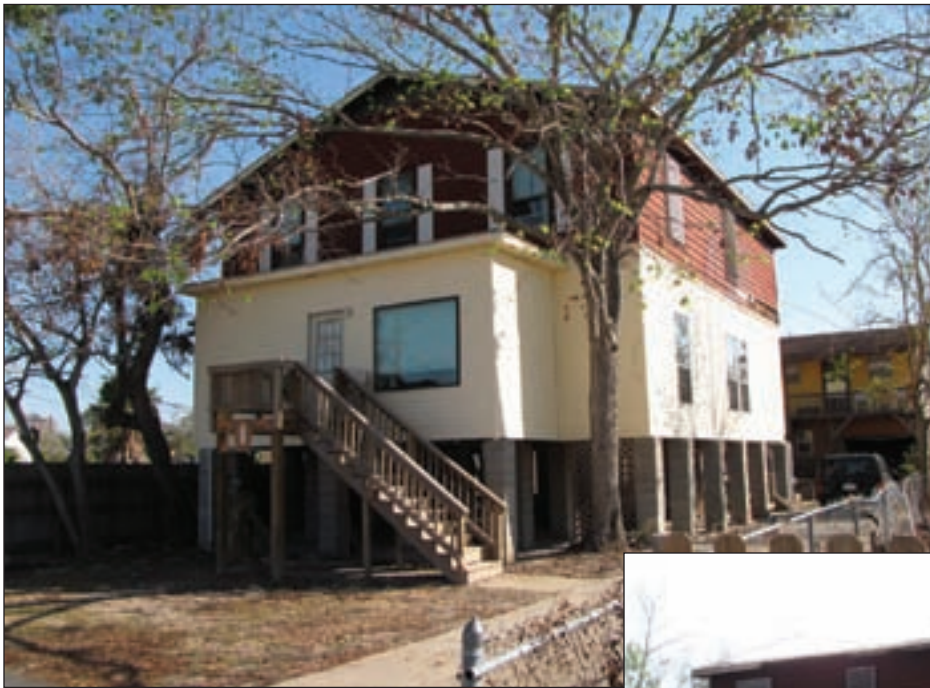
Figure 3-142. House elevated with Increased Cost of Compliance funds (Kemah, TX). Inset shows evidence of wind damage to roof (Hurricane Ike estimated wind speed in this area: 90 mph, Exposure B).
