Mitigation Assessment Team Report

Hurricane Ike in Texas and Louisiana

Building Performance Observations, Recommendations, and Technical Guidance

FEMA P-757 / April 2009

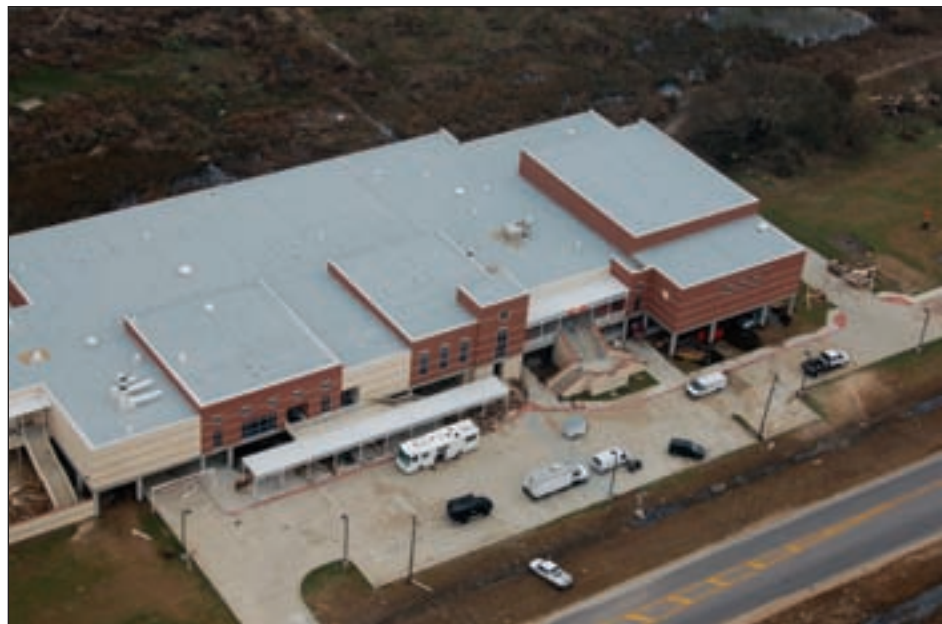
Figure 4-1.
September 19, 2008,
aerial view of Crenshaw
Elementary and Middle
School

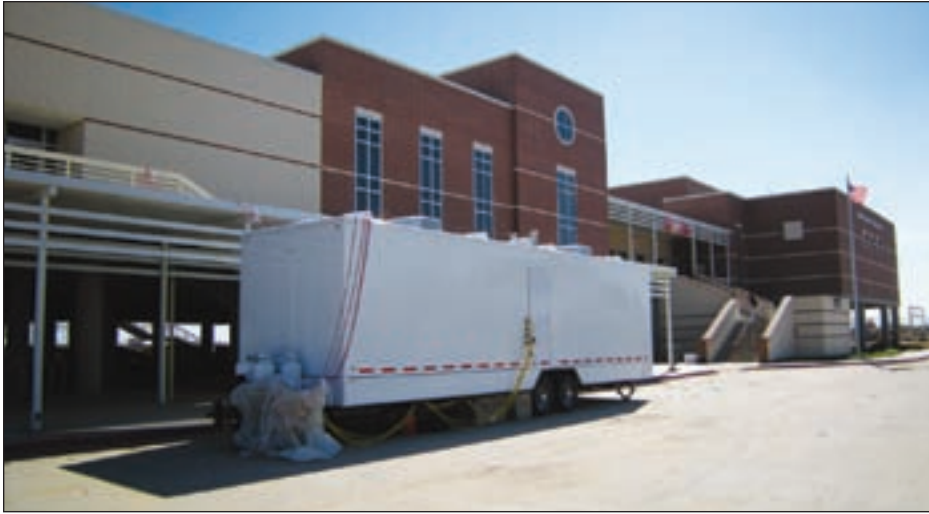
Figure 4-2.
General view of Crenshaw
Elementary and Middle
School

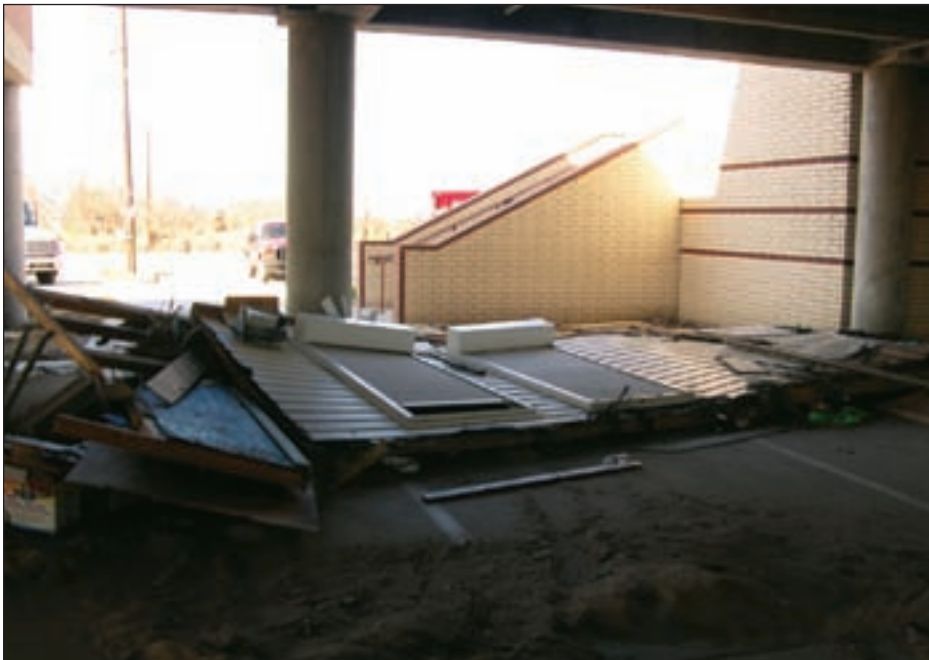
The facility did not suffer flood damage because of its elevated construction, but considerable floodborne debris washed underneath the school (Figure 4-3). A debris line on a fence under the school indicated the flood depth was approximately 5.5 feet above grade; a debris line on a fence adjacent to the school was surveyed and found to be at elevation 14.8 feet NAVD (URS, 2008).

Figure 4-3.
Wall of house washed
underneath Crenshaw
School during Ike (note
shutters still attached to
wall)

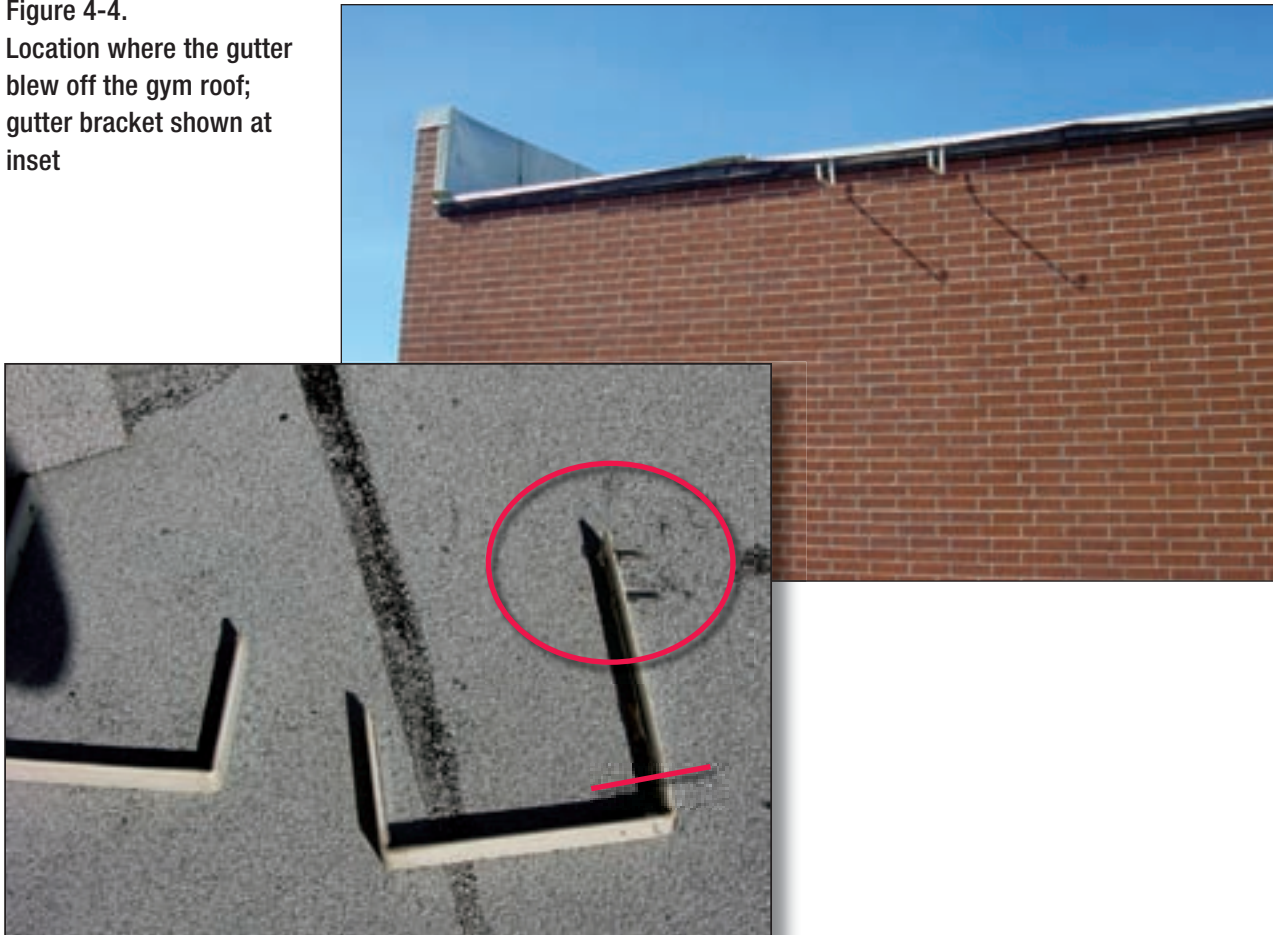
The gutter and most of its brackets blew off the gym roof (Figure 4-4), but the roof membrane did not progressively peel as is typically the case when a gutter is blown away. The brackets were attached with two ring-shank nails, both of which were located near the top of the bracket, as shown in the inset in Figure 4-4. Since both fasteners were near the top of the bracket, they provided little resistance to outward rotation (moment) as the wind pulled and lifted the gutter away from the building. Significant permanent outward deformation was observed at gutters at other roof areas of the building (similar to the condition shown by the inset at Figure 4-4). To resist the moment force, a screw should have been placed near the lower edge of the bracket, as shown by the red line in the inset at Figure 4-4. Screws should be used to attach brackets because they are more resistant than nails to dynamically induced pull-out forces. The gutter brackets were not attached to the gutter (see discussion in Section 4.3.2).

Figure 4-4.
Location where the gutter
blew off the gym roof;
gutter bracket shown at
inset

Vulnerabilities and Other Observations. Had the winds been stronger, significant water infiltration would have been likely due to roof membrane blow-off associated with gutter failure.

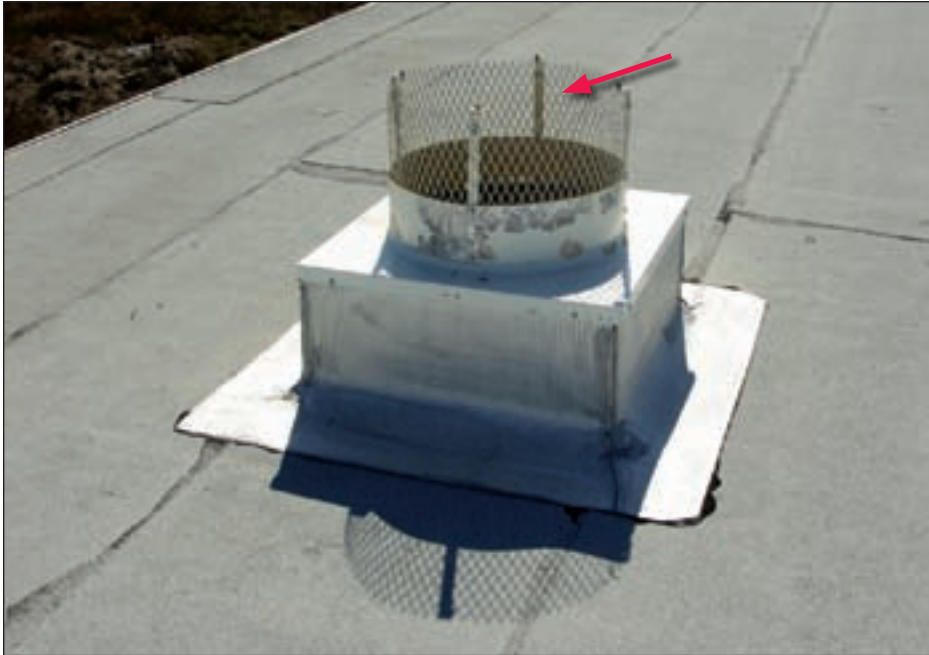
The MAT observed the rooftop equipment on the facility. The rooftop exhaust fans had too few fasteners, although none of the fans blew away during this storm. The exhaust fans were attached with two screws per side; for this location, FEMA 543, *Design Guide for Improving Critical Facility Safety from Flooding and High Winds: Providing Protection to People and Buildings* (2007), recommends six screws per side. The hood blew off two units, which allowed rain to enter the building (Figure 4-5).

Figure 4-5.
Wind blew off the hood,
allowing rain to directly
enter the building

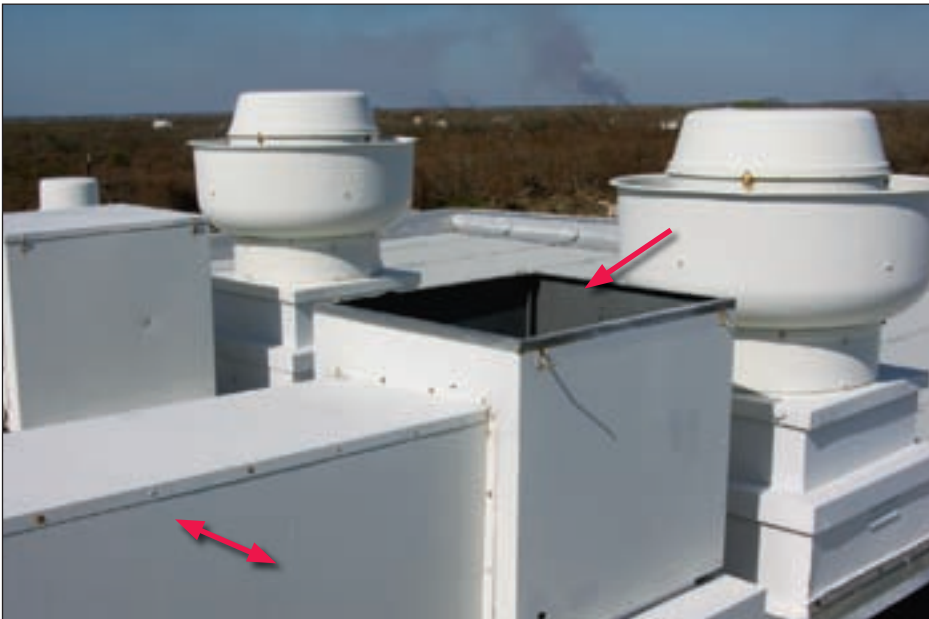
Access panels blew off a few pieces of rooftop equipment. As shown in Figure 4-6, rain was able to directly enter the building during the storm and was still able to at the time of the MAT visit. The ductwork shown in Figure 4-6 was easy to shake back and forth by hand (illustrated by the double-headed red arrow). Had the winds been near design conditions, the ductwork may have blown away.

Figure 4-6.
Missing access panel
allowed rain intrusion;
ductwork could be easily
flexed

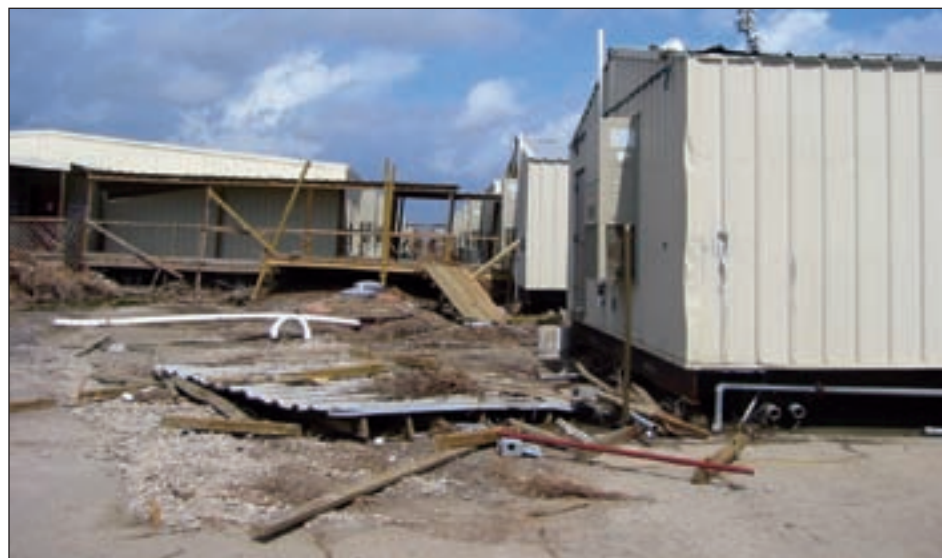
General Flood Damage. The interiors of all the buildings were flooded. A debris line on the fence at the front of the school indicated flood depths reached approximately 5 feet above grade. The wooden gymnasium floor was damaged, and metal walls seaward of the gymnasium were breached by flooding. Approximately 15 modular classrooms were inundated by storm surge floodwaters (Figures 4-7 and 4-8). At the time the MAT inspected the school, students had been relocated to other schools in the Parish.

Figure 4-7.
Damage to South Cameron Parish School modular units

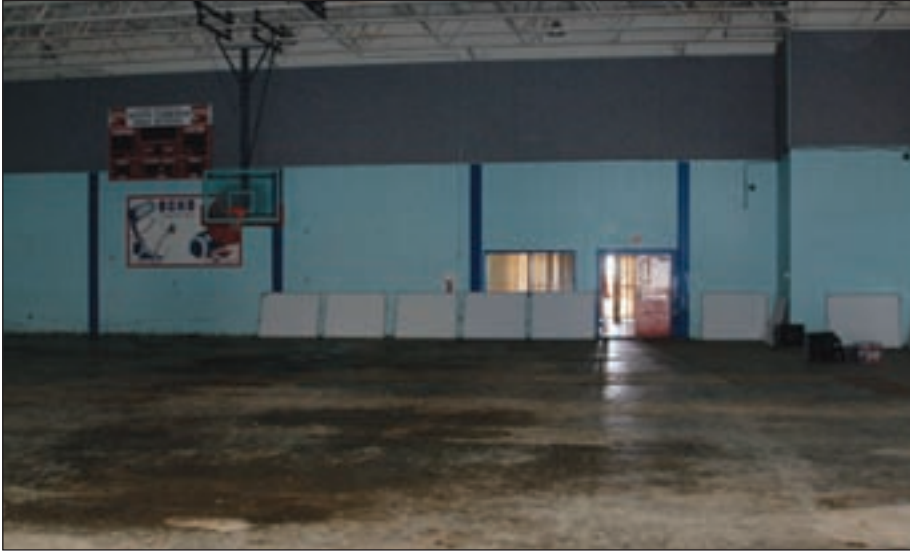
Figure 4-8.
High school gymnasium
at South Cameron Parish
School

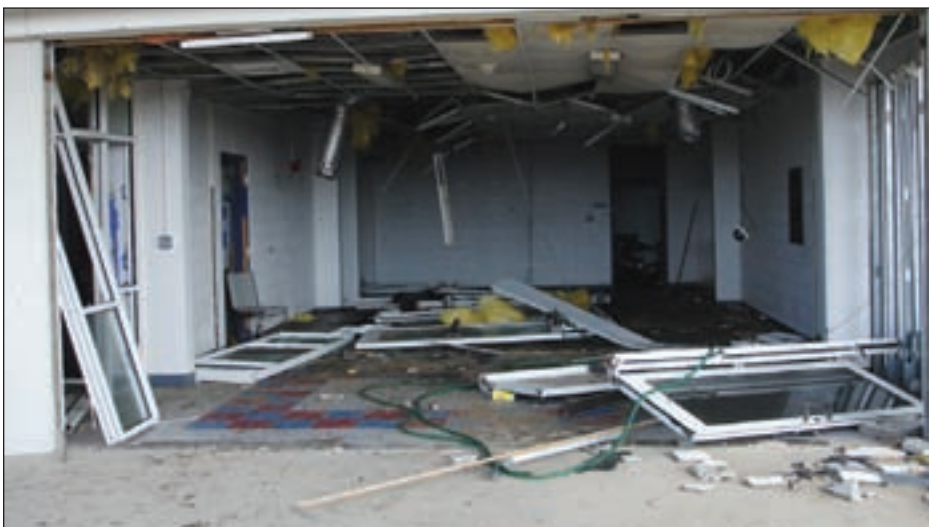
General Flood Damage. The facility was flooded by storm surge with depths reaching 5 to 6 feet. Some masonry walls were flood damaged, as were interior walls, furnishings, and electrical systems (Figures 4-9 through 4-12).

Figure 4-9.
Johnson's Bayou School
interior building damage

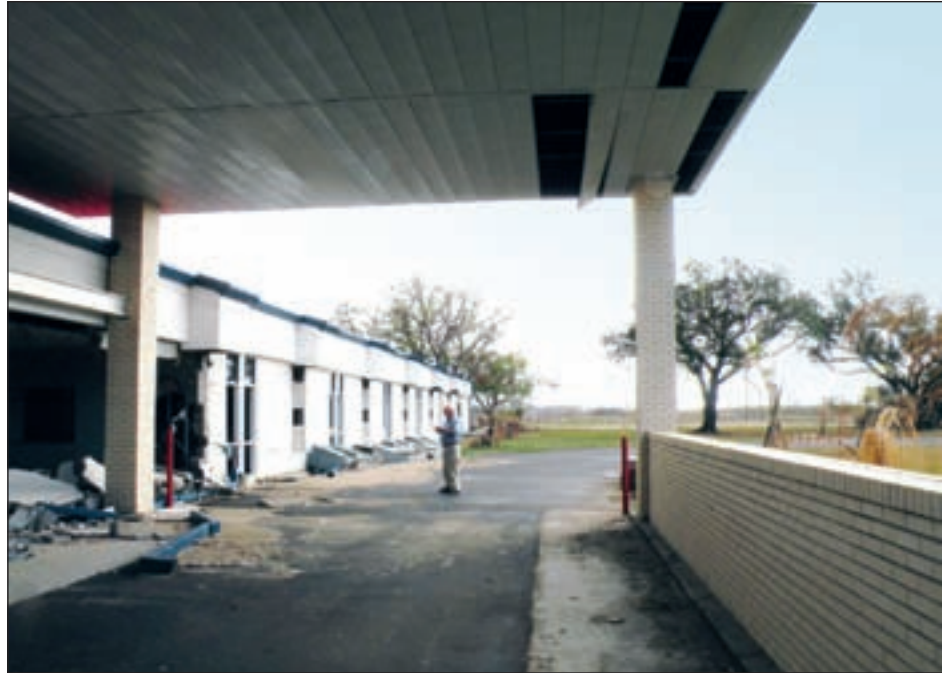
Figure 4-10.
Johnson's Bayou School –
damage to wall on front
side of facility (soffit of
driveway canopy was also
damaged)

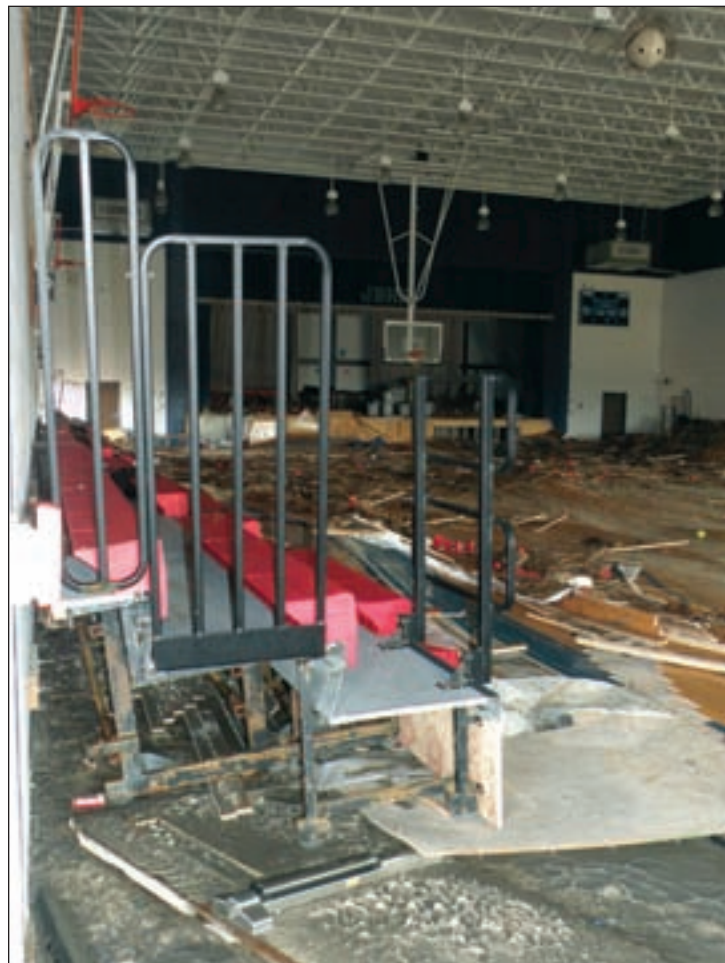
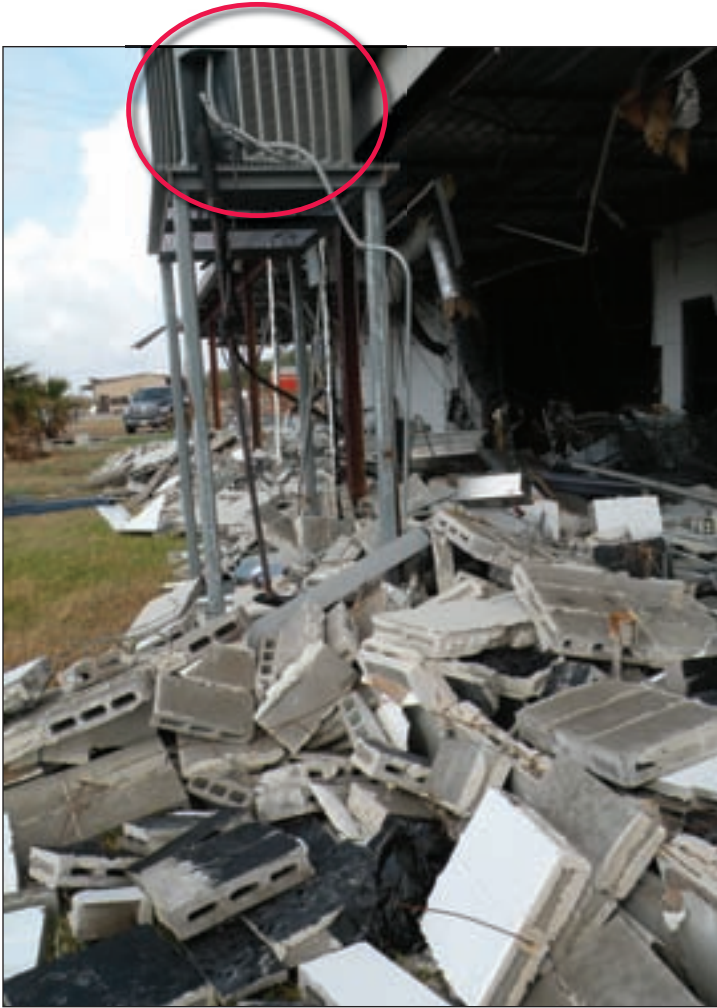
Figure 4-12.

Johnson's Bayou School CMU wall collapse. (Note: HVAC units that had previously been damaged were relocated to an elevated platform under the FEMA Public Assistance Program.)

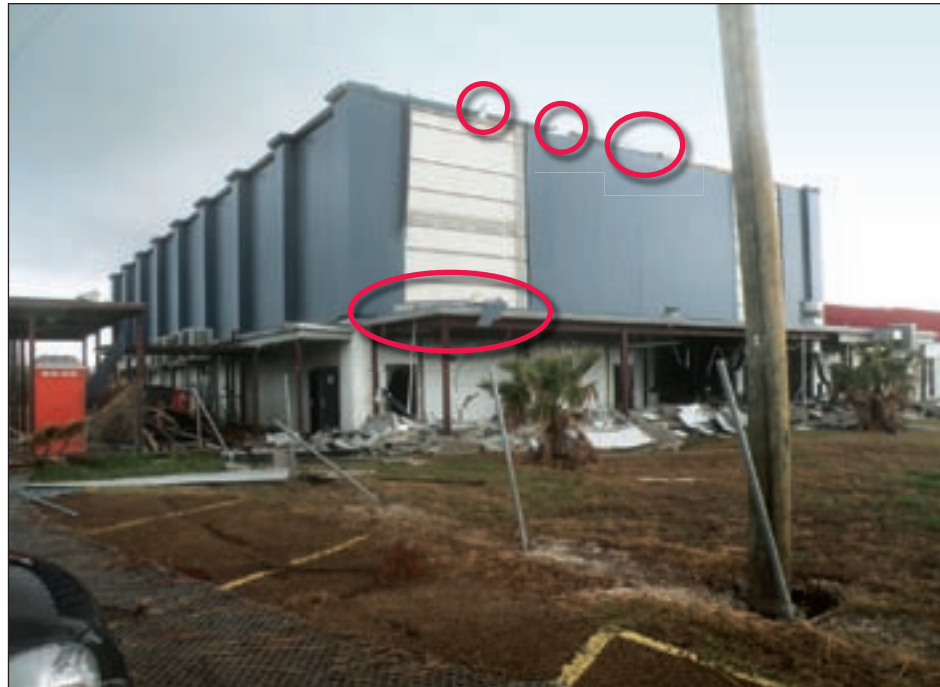
General Wind Damage. Significant wind damage occurred to the roof system for the school gymnasium (Figure 4-13). Figure 4-13 also shows the significant damage to the walkway canopy. The Johnson's Bayou School experienced damage to roof coverings and rooftop equipment. The breached building envelopes allowed widespread rainwater damage and storm surge floodwater intrusion to the interior.

Figure 4-13.
Johnson's Bayou
School gymnasium. The
red ovals indicate damage
to canopy and roof.

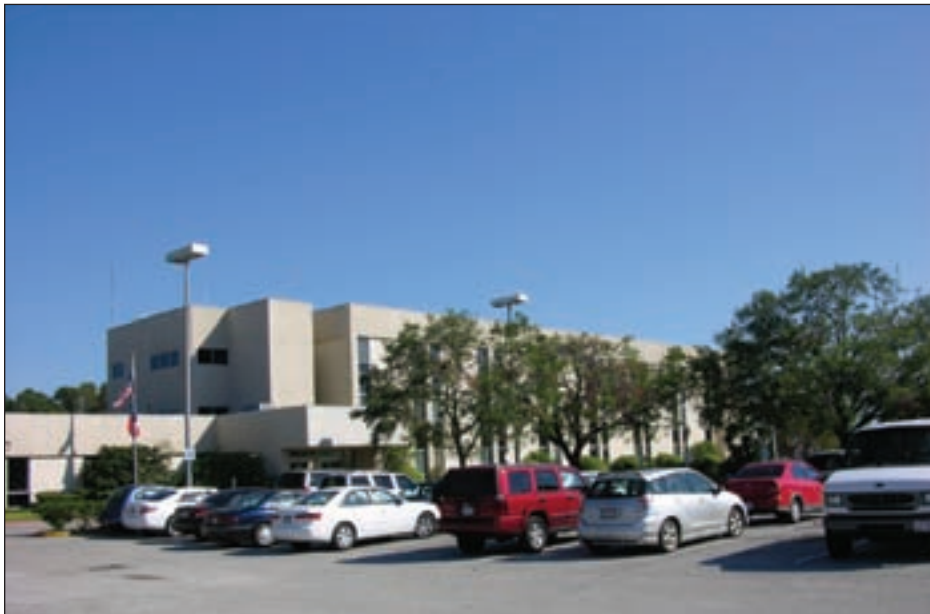
General Wind Damage. The facility experienced some water leakage at the three-story wing shown in Figure 4-14. Some of this leakage was likely due to damaged rooftop equipment. The MAT observation of the roof on this portion of the facility indicated that at least one fan cowlings was blown away. No special attachment was provided for the fan cowlings (such as that shown in FEMA 577, *Design Guide for Improving Hospital Safety in Earthquakes, Floods, and High Winds: Providing Protection to People and Buildings* [2007]). However, special attachment was provided for the condenser shown in Figure 4-15. Strapping condensers is a practice that is recommended in FEMA 543 and 577. Unless strapped, condensers frequently topple over.

Figure 4-14.
General view of San
Jacinto Methodist Hospital

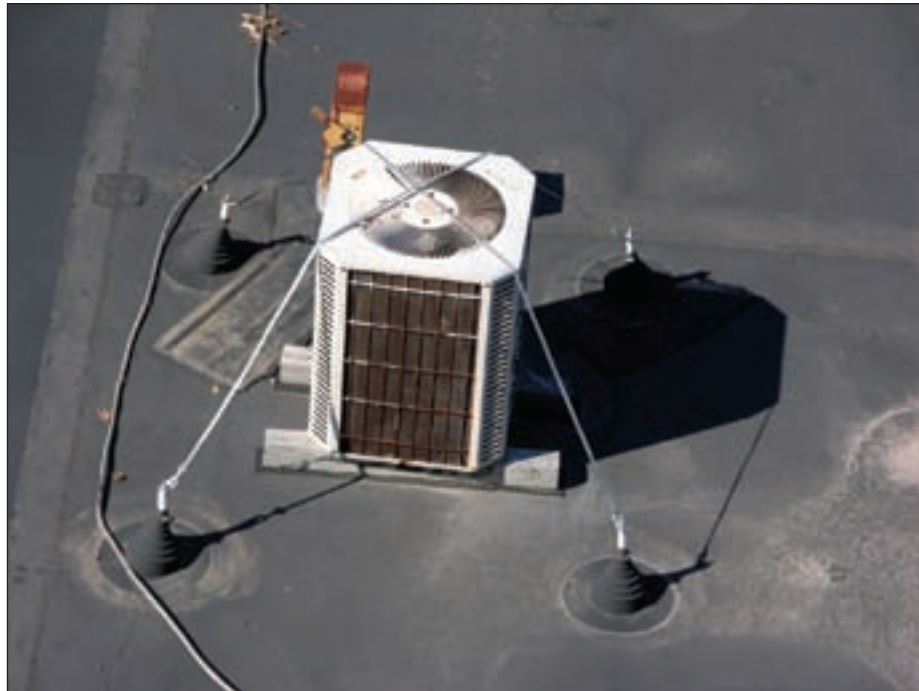
Figure 4-15.
Condenser with tie-down
cables

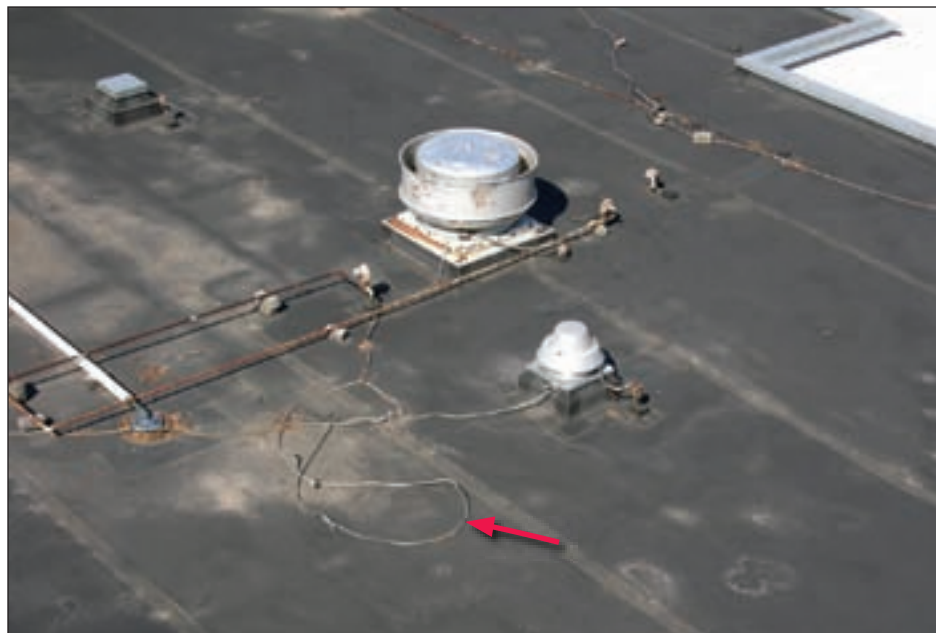
In a few areas, the lightning protection system (LPS) conductors became detached from the roof membrane (Figure 4-16). Loose conductors can puncture and tear roof membranes, and they no longer provide the intended protection. FEMA 543 and 577 provide guidance for attachment of LPSs to resist wind.

Figure 4-16.
Detached LPS conductor

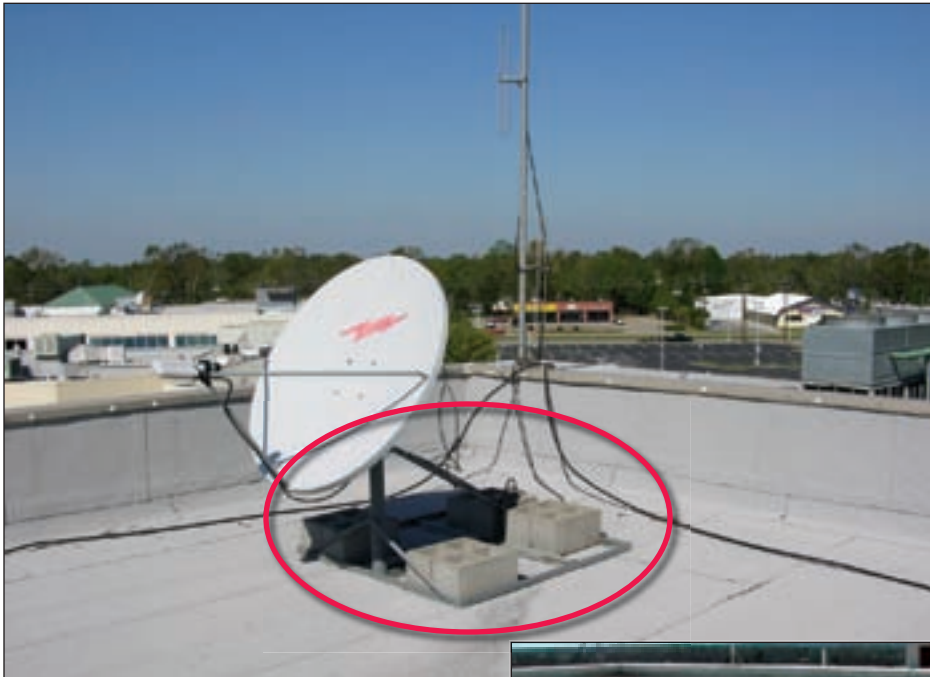
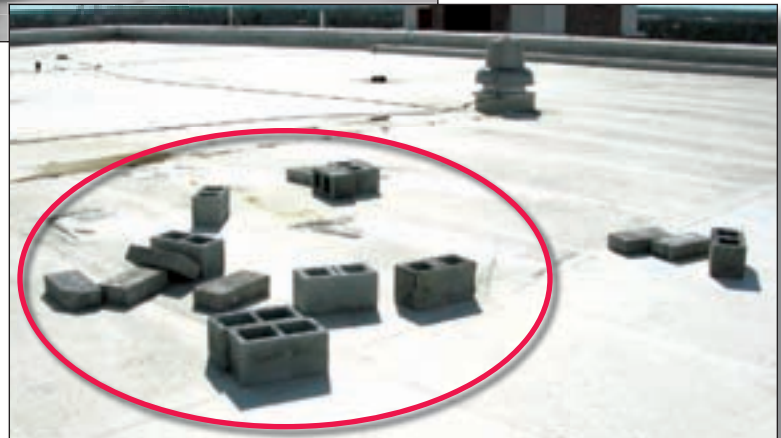
The satellite dish shown in Figure 4-17 was held down only with CMU. This attachment technique was adequate for the winds experienced at this site, but dishes attached by this method have failed in other hurricanes, as shown in the inset at Figure 4-17. The dish shown in the inset was blown completely off the roof; only the CMU remained (FEMA 488).

Figure 4-17. This satellite dish was held down with CMU only; inset shows all that remains from a similarly mounted dish after a strong hurricane

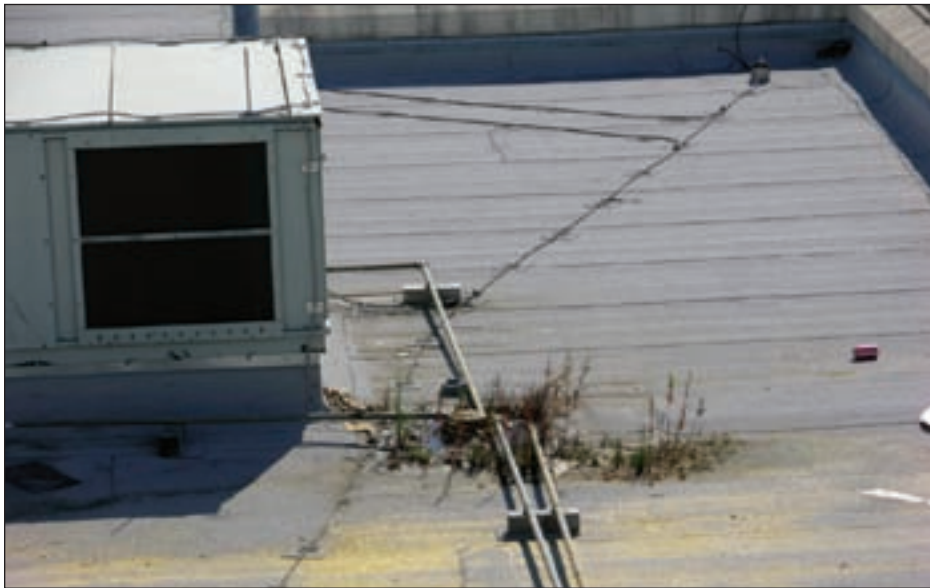
The MAT also observed a lack of adequate pre-storm preparations. As part of the pre-storm preparations, hospital roof areas should be checked. As part of this check, roof drains, scuppers, and gutters should be cleaned of debris so that they are capable of draining the roof during the hurricane (some of which produce a tremendous quantity of rain). Figure 4-18 is a view of one of the mitigated roofs. Clearly this roof drain area had not been cleared of debris for quite some time.

Figure 4-18. View of one of the mitigated roofs. Note the vegetation growth in the vicinity of the roof drain, indicating a lack of maintenance.

only addressed a portion of the hospital. Other roofs and rooftop equipment had (and still have) significant wind vulnerabilities. Before implementing a mitigation project, a comprehensive vulnerability assessment should be conducted to identify significant vulnerabilities. If funds are not available to correct all identified deficiencies, the work should be systematically prioritized so that the items of greatest need are corrected first. Following this process also allows the building owner to be aware of residual risks that remain when mitigation projects don't address all significant vulnerabilities at a facility. For further information about mitigating existing facilities, see FEMA 577, Section 4.4.

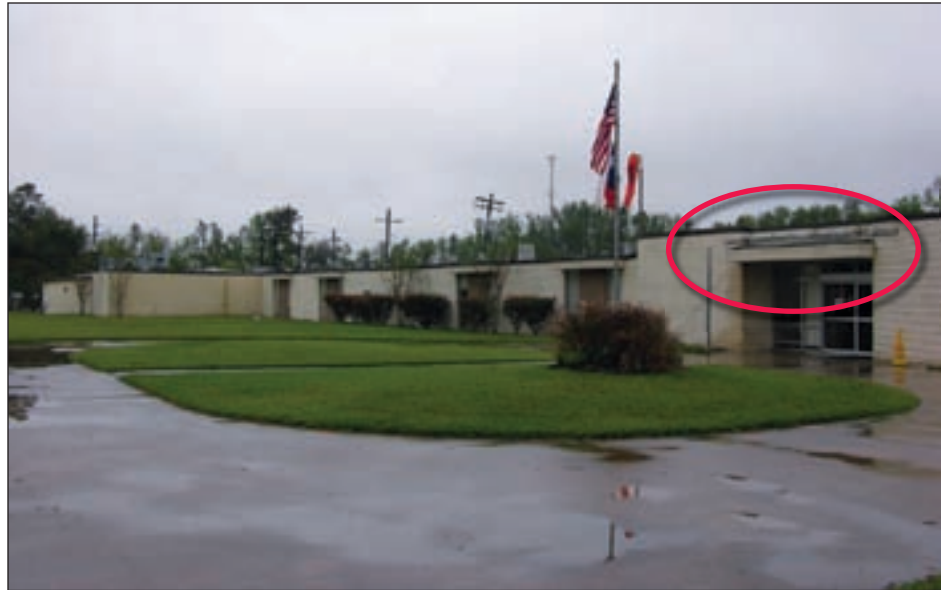
General Wind Damage. An entry canopy blew away (Figure 4-19). A few windows were broken (likely by windborne debris) and wind-driven water entered at several of the windows. At one area, a portion of the edge flashing deformed outward and the nailer lifted, which caused a few of the bricks at the top course to fall. Had the winds been somewhat stronger, the edge flashing would likely have lifted and caused a portion of the roof membrane to blow away.

Figure 4-19.
A Winnie Community
Hospital entry canopy (red
oval) blew away

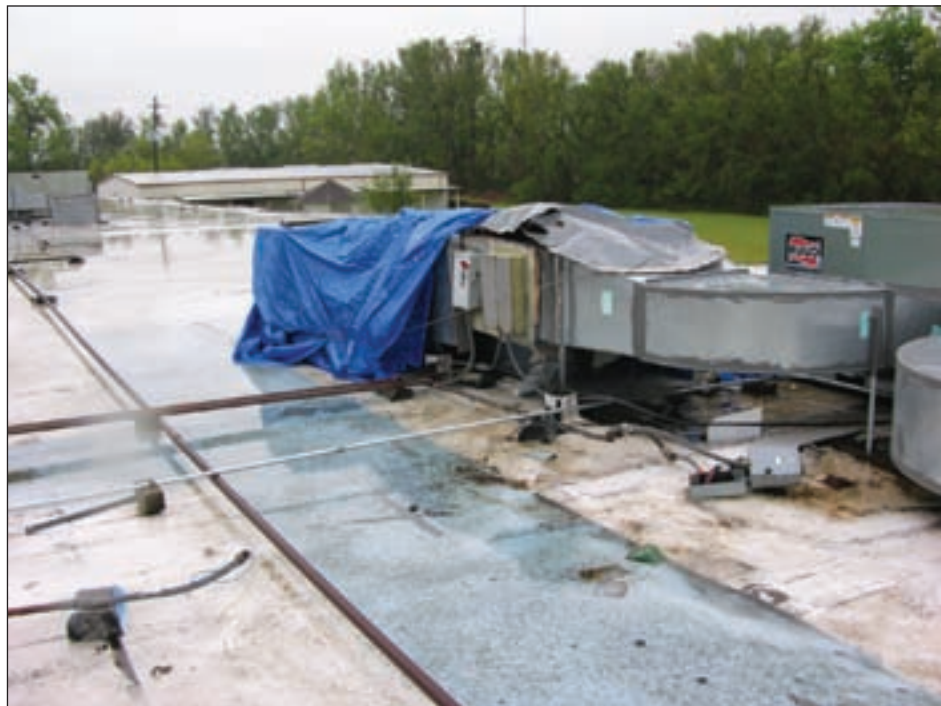
Numerous pieces of HVAC equipment were on the roof. Many condensers toppled, but apparently none punctured the single-ply roof membrane. However, water entered the building where some rooftop ductwork blew away (Figure 4-20). Access panels were blown away at a piece of equipment and the communications tower collapsed (both shown in Figure 4-21).

Figure 4-20.
Water entered the building
where ductwork blew
away

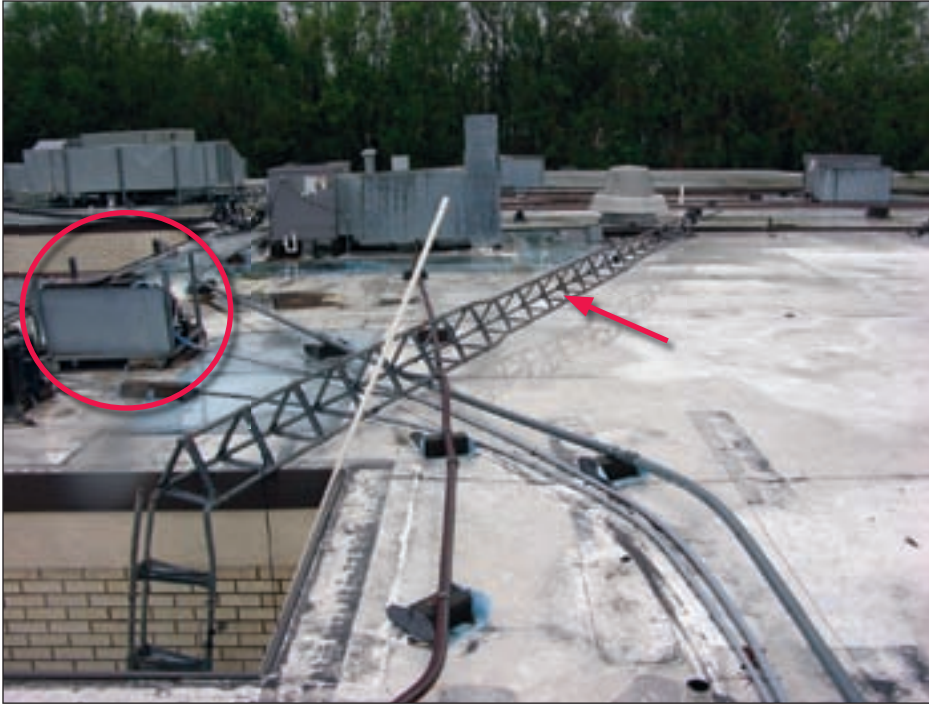
Figure 4-21.
Collapsed communications tower and blown-away access panels (red circle)

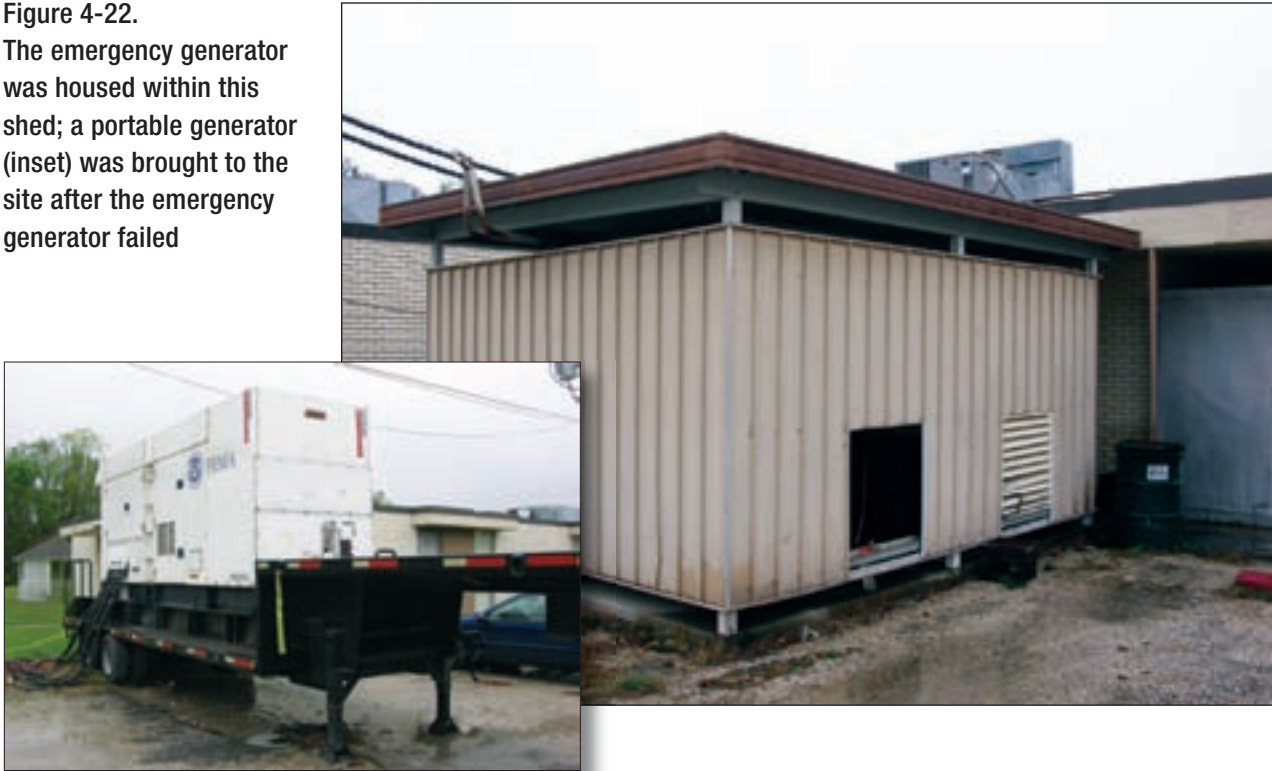
Functional Loss. At the time the hospital was reoccupied, municipal power was out, so power was provided by the hospital's emergency generator. After 2 days, the generator's governor failed, leaving the hospital without power and unable to provide urgent care services. The generator failure caused a power surge, which damaged several pieces of hospital equipment (including refrigerators). This, in turn, resulted in the loss of vaccines, medications, lab reagents, and food. Equipment had to be retested to ensure that it was safe for use.

The generator was outdoors, with a roof and walls that were open at the top and bottom for air circulation (Figure 4-22). Although the generator was not damaged by wind or windborne debris in this event, the enclosure does not provide sufficient protection for the generator.

Figure 4-22.
The emergency generator was housed within this shed; a portable generator (inset) was brought to the site after the emergency generator failed

The facility had to be vacated for 4 days until a backup generator was delivered and connected. FEMA supplied the portable generator (inset at Figure 4-22) and the facility was able to reopen. Altogether, the facility ran on emergency power for about 2 weeks. During that time, the facility was periodically refueled. There was no interruption of water or sewer service.

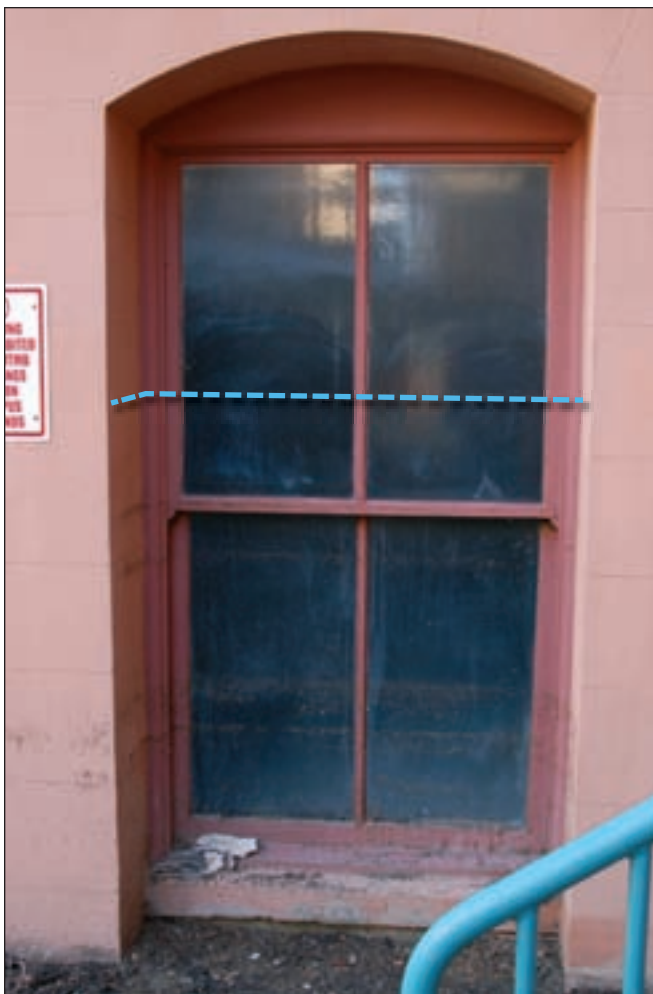
Figure 4-23.

High water mark (dashed blue line) shown from the outside of UTMB Building 1. The mark was measured by the MAT and found to be approximately 69 inches above the floor of the basement area inside the building.

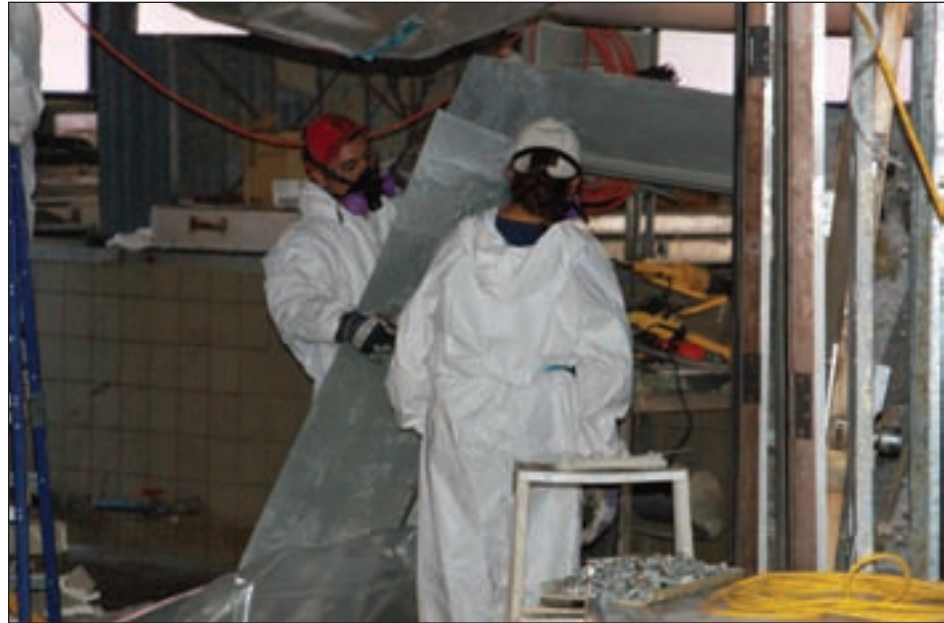
Figure 4-24.
Clean-up underway inside the basement of UTMB Building 1. All the laboratory equipment, office and classroom contents, and interior finishes had to be decontaminated and removed for disposal.

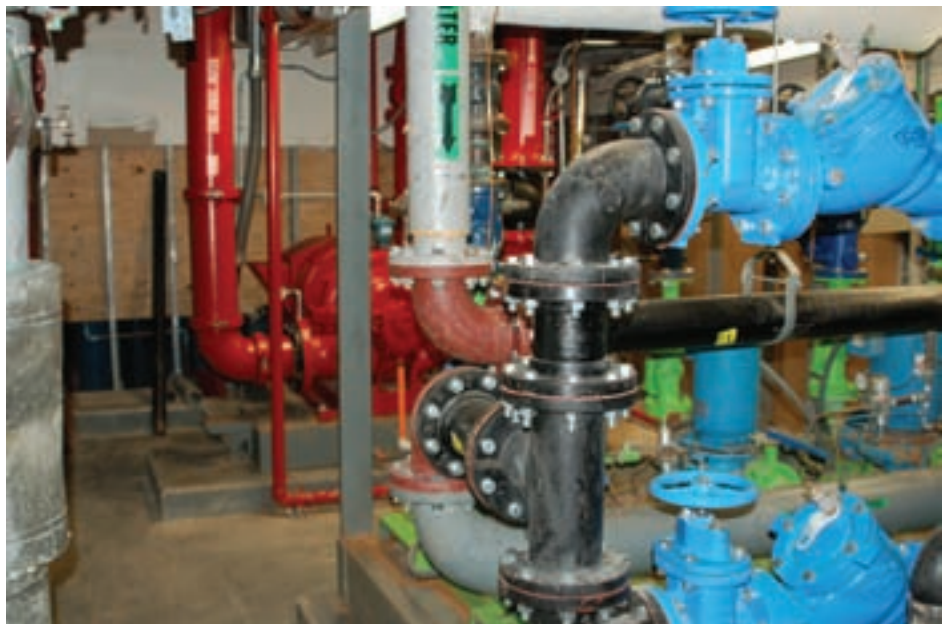
Figure 4-25.
The Ike flood level in UTMB Building 56 pump room was approximately 30 inches above the floor, and controls and equipment were damaged.

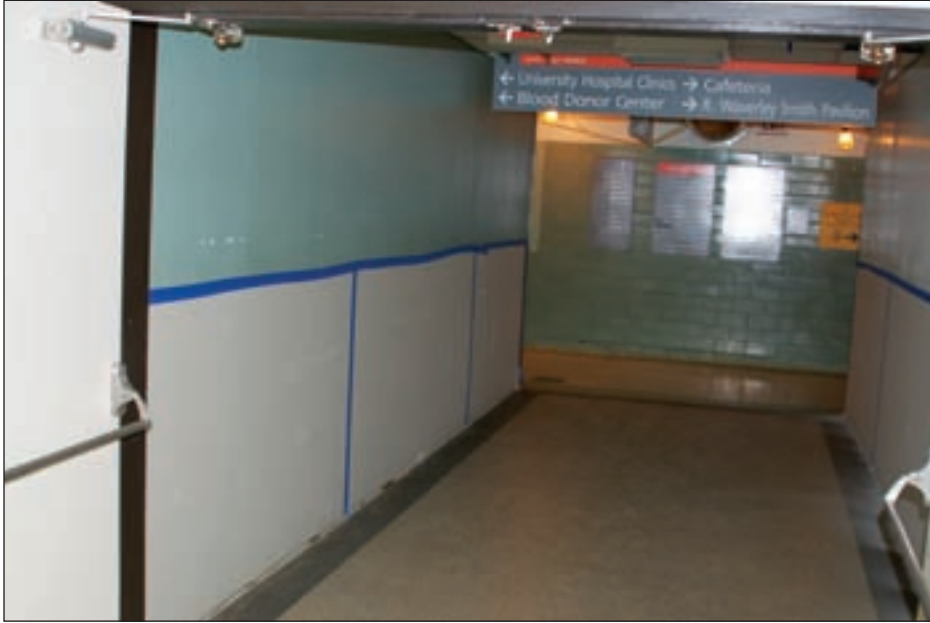
Figure 4-26.
Replaced lower interior
wall sections leading to
UTMB Building 90

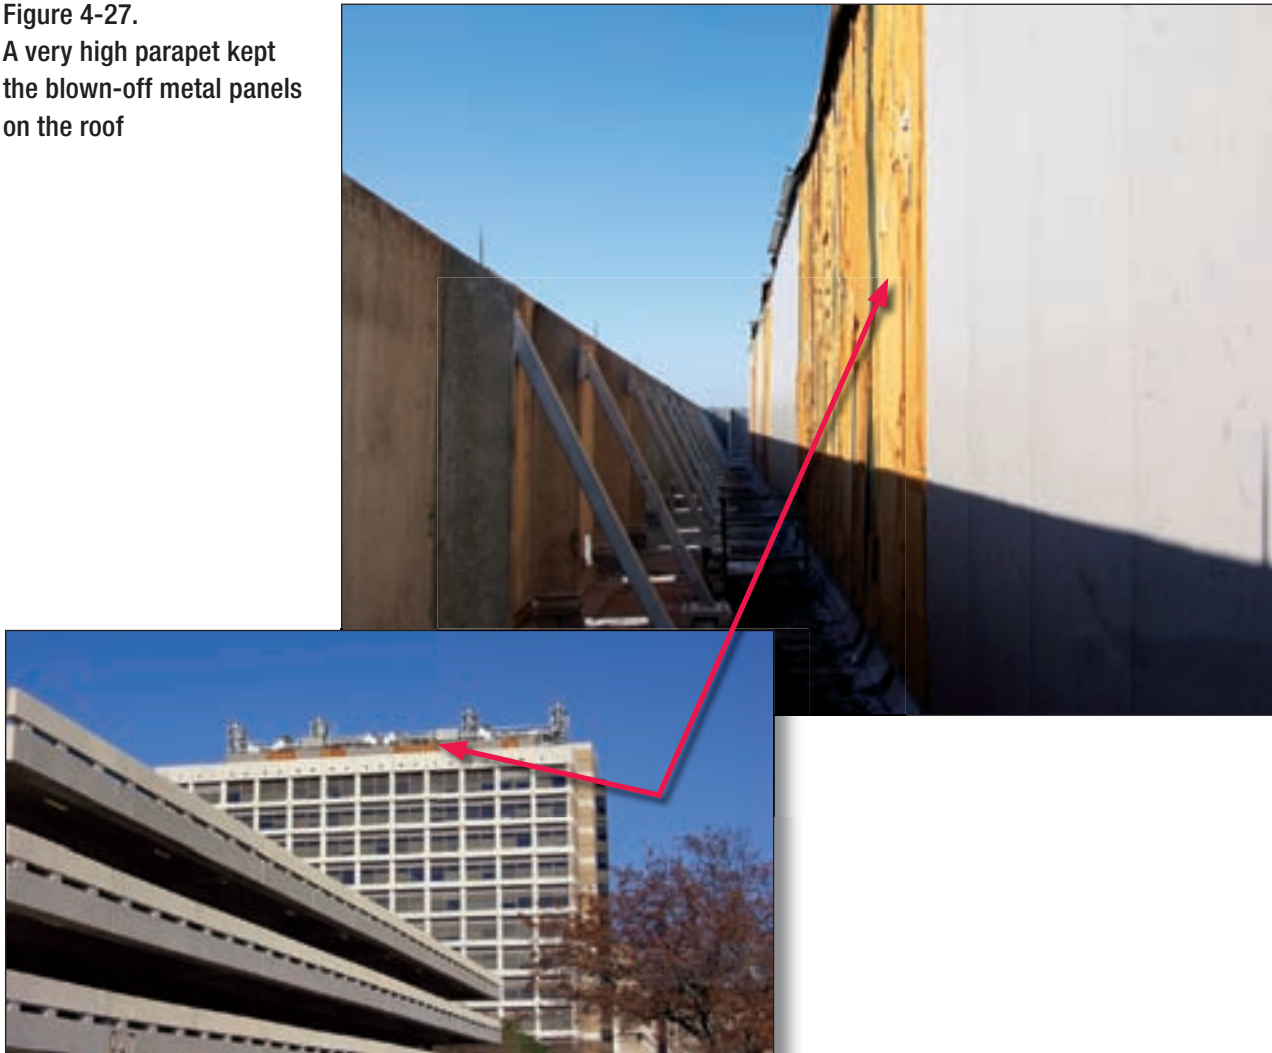
At the building shown in the inset of Figure 4-27, several penthouse wall panels were damaged. The panels consisted of inner and outer metal skins, with a foam insulation core. As shown in Figure 4-27, several of the outer skins blew away. The panels appeared to have been job-site fabricated, rather than having been produced as composite panels in a factory. The presence of the very high parapet prevented the metal skins from being blown from the roof and potentially damaging other parts of the facility as windborne debris. At another building, blown off EIFS was observed at a wall and at the soffits of an enclosed elevated walkway between two buildings.

Figure 4-27.
A very high parapet kept
the blown-off metal panels
on the roof

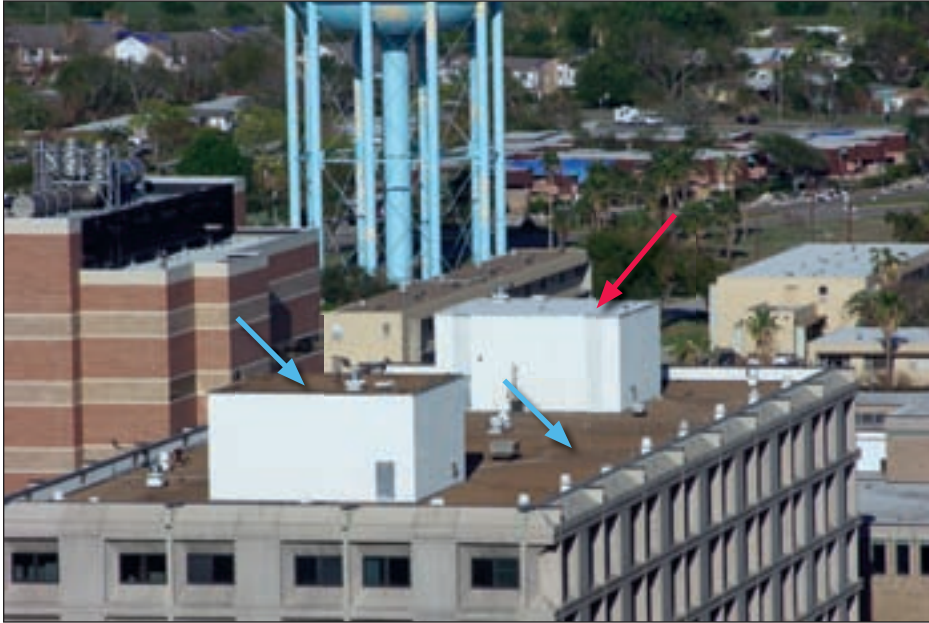
At the time Hurricane Alicia struck this campus in 1983, many of the buildings had aggregate-surfaced BURs and several windows on the campus were broken by wind-blown aggregate. Since Alicia, when buildings have been reroofed, they were not replaced with aggregate surfacing. However, at the time of Hurricane Ike, some aggregate-surfaced BURs still existed, such as that shown in Figure 4-28. One of the penthouse roofs was blown off during the storm. At the time of the MAT observation, that roof had been replaced by the white membrane shown by the red arrow.

Figure 4-28.
The roofs shown by the blue arrows were aggregate-surfaced BURs at the time Ike struck; the roof shown by the red arrow is a new roof replacing one that blew off

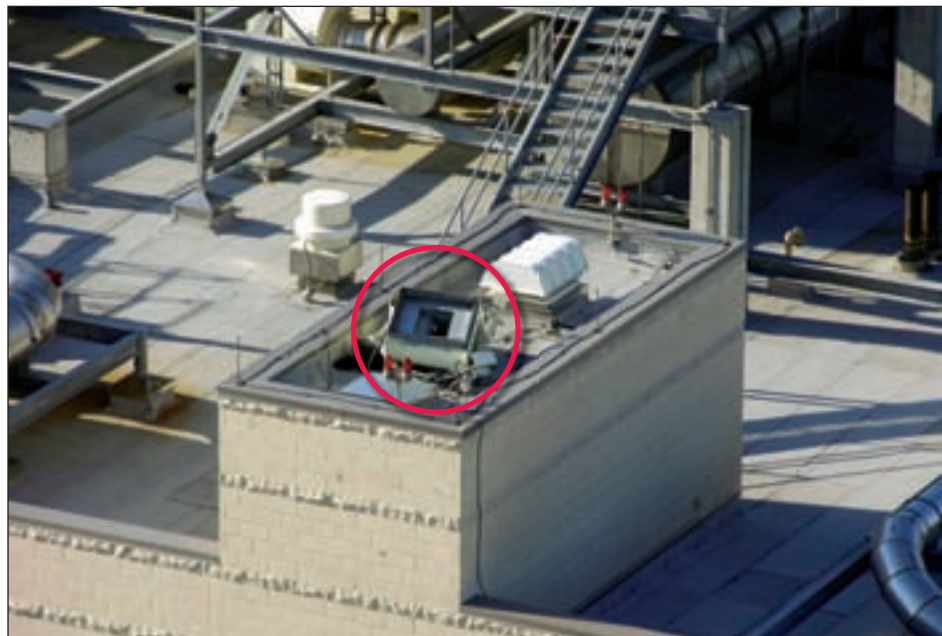
Other rooftop equipment damage included a large stack that was blown over, even though it was guyed (Figure 4-29), and damage to two relief air hoods (Figure 4-30). One of these hoods blew off the curb.

Figure 4-30.
A relief air hood blew off the curb allowing rainwater to enter the building
