Mitigation Assessment Team Report

Hurricane Ike in Texas and Louisiana

Building Performance Observations, Recommendations, and Technical Guidance

FEMA P-757 / April 2009

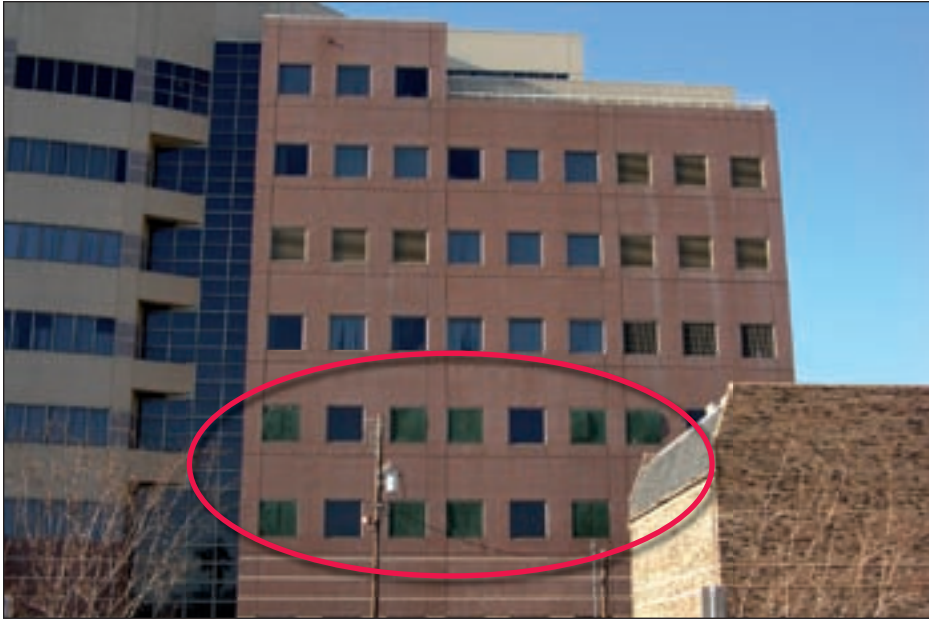
Nine of the 32 windows in the building shown in Figure 4-31 were broken. They were likely damaged by windborne debris.

Figure 4-31.
Nine broken windows are shown in the red oval; the brown openings above the oval are louvers

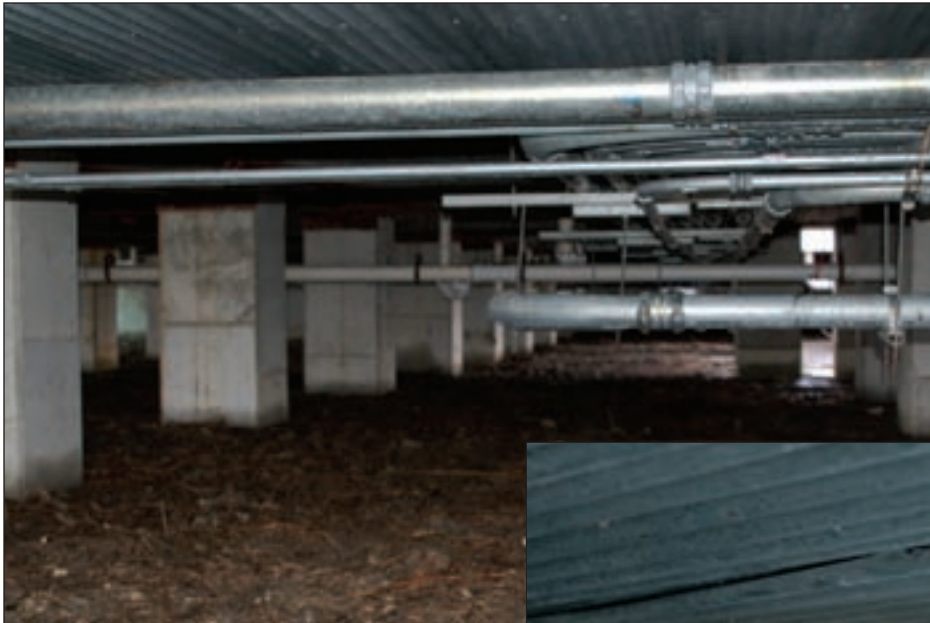
General Flood Damage. The hospital property was flooded during Ike—surge did not enter the building but did damage conduits and piping suspended below the floor. The hospital was not fully functional until repairs were made and additional emergency power generation capacity was obtained.

Figure 4-33. Conduits and pipes beneath South Cameron Parish Hospital. Vegetation was noted between the floor system and the steel plate of the foundation. A connection between the plate and the floor system was not visible.

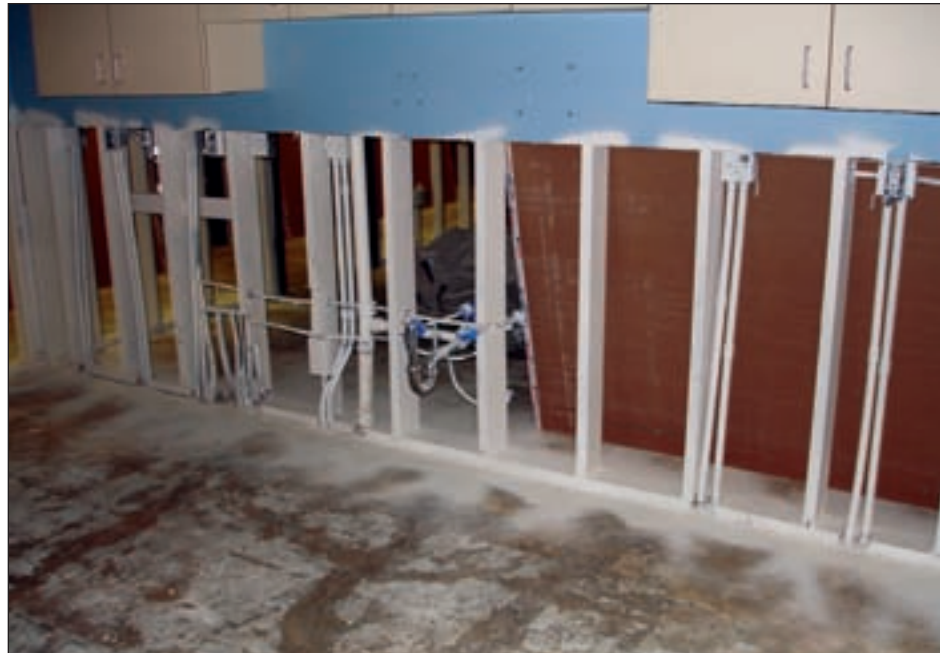
General Flood Damage. During Hurricane Ike, the facility was inundated with 3 to 4 feet of floodwater. Interior walls were damaged, as well as contents. Water-damaged gypsum board had been removed to a height of 5 feet above the floor (Figure 4-37) and was being replaced at the time of the MAT visit.

Figure 4-37.
Hackberry Rural Medical
Clinic interior repairs in
progress

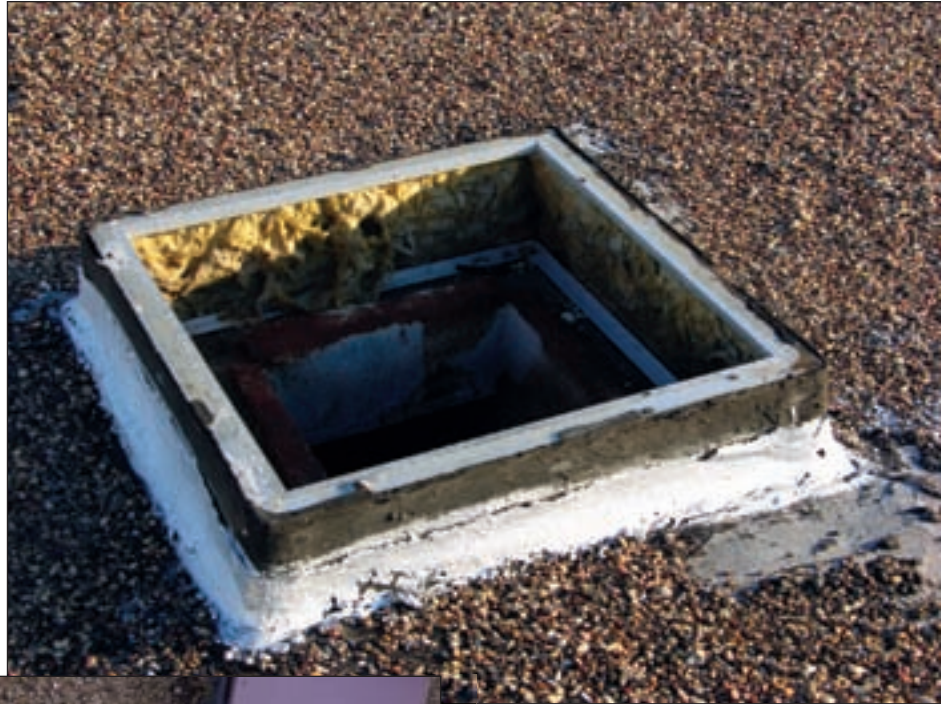
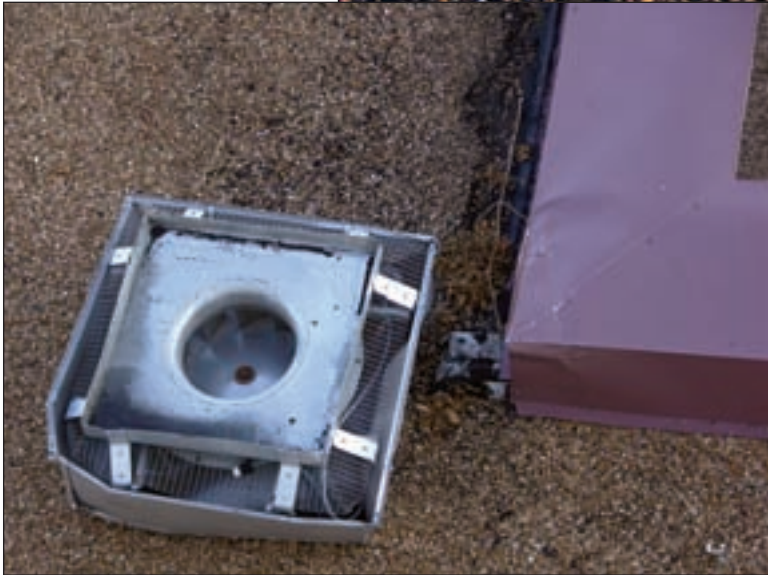
An exhaust fan on the upper roof blew off, because of an inadequate number of fasteners, and landed on a canopy roof (Figure 4-39). A temporary covering had been placed over the curb, but at the time of MAT observations, the covering was no longer in place. Two other fans also lost their cowlings, and a fan on a lower level roof blew off. There was minor water leakage to the interior of the facility (in part or solely related to this rooftop equipment damage).

Figure 4-39.
The fan shown in the inset
blew off of this curb

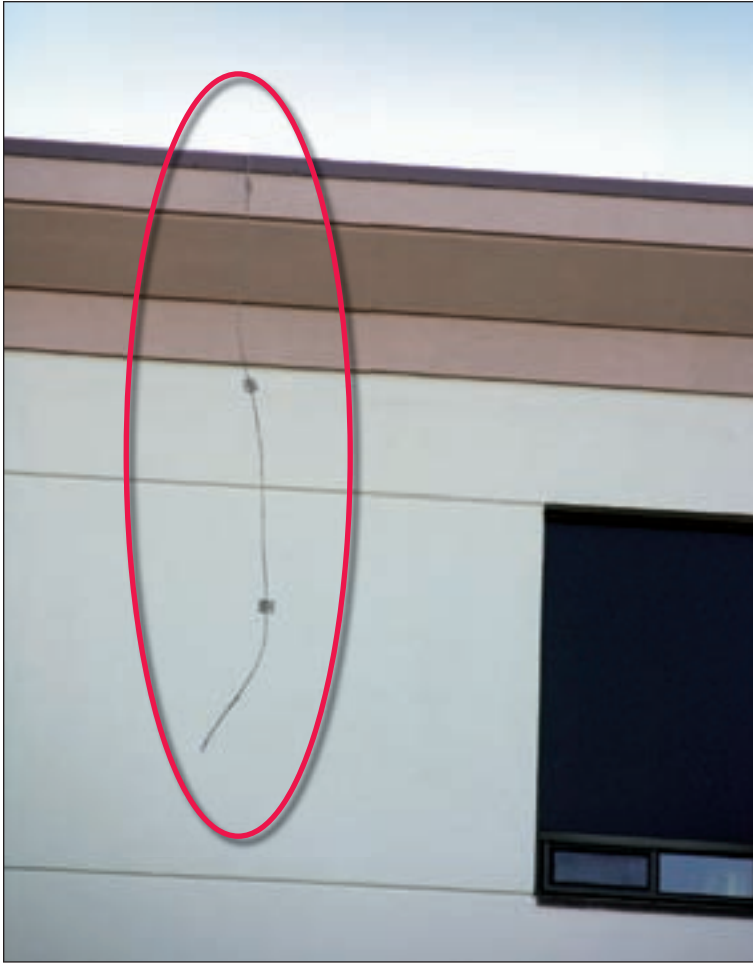
The LPS became detached from several areas of the main roof. Portions of the conductors were dangling over the front and back walls (Figure 4-40). In addition to loss of lightning protection, the detached conductors had the potential to break glazing.

Figure 4-40.
Detached LPS conductor

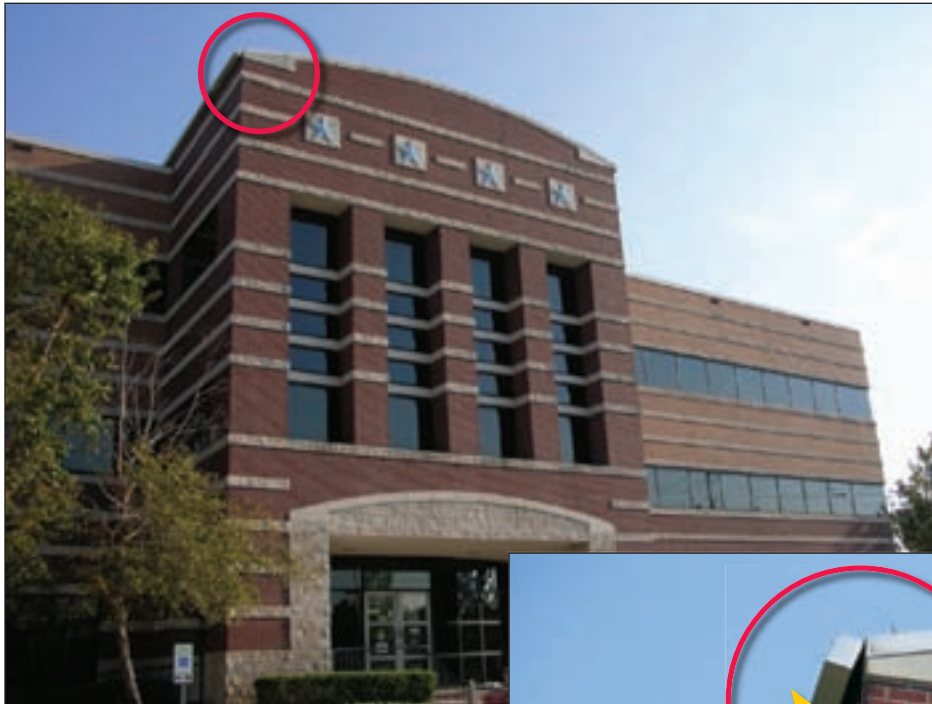
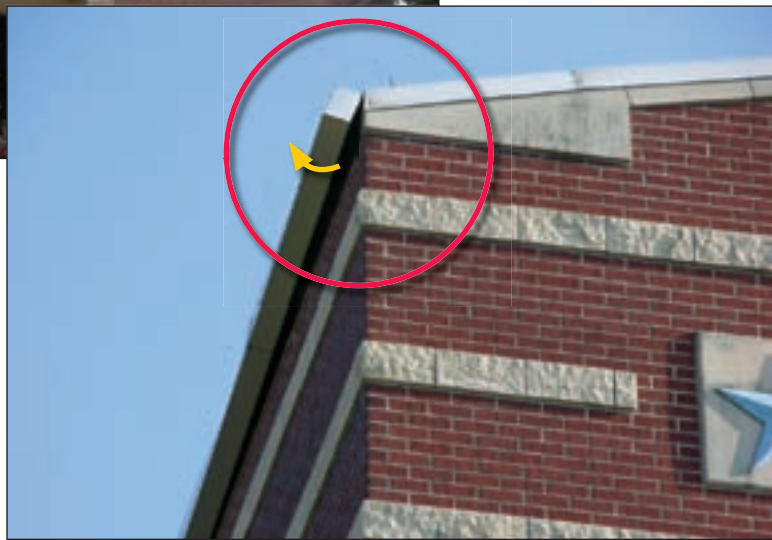
Figure 4-41.
Houston Transtar Regional
EOC; significant permanent
outward deformation
occurred at the gutter
shown in the inset

General Wind Damage. Hurricane Ike caused outward deformation of the gutter shown in the Figure 4-41 inset. Had the winds been stronger, the gutter would have likely blown off. Additionally, several pieces of coping blew off the building. The outer face of the coping is 8 inches and the inner face is 4 inches (Figure 4-42). Continuous cleats are located along both sides of the parapet. The cleats were attached with roofing nails driven through the horizontal flange (blue arrow at Figure 4-42). In addition, a few widely-spaced nails were driven through the vertical flange (red arrow in Figure 4-42). The nailing provided very little resistance to outward deflection of the cleat and coping. While most of the continuous inner and outer cleats remained on the building, several sections of coping and at least one cleat blew off once the amount of deflection was sufficient for the coping to disengage from the cleat. The blown-off cleat had a face nail that was 75 inches in from the end of the cleat, hence over 6 feet of this cleat was unrestrained from outward deformation.

The wind resistance of poorly attached copings, such as the ones on this building, can be economically strengthened by face-screwing the coping as described in FEMA 543. The base flashing was stopped at the top of the parapet. It should have been run across the top of the nailer and turned down and nailed so as to provide greater watertight protection in the event of coping leakage or coping blow-off.

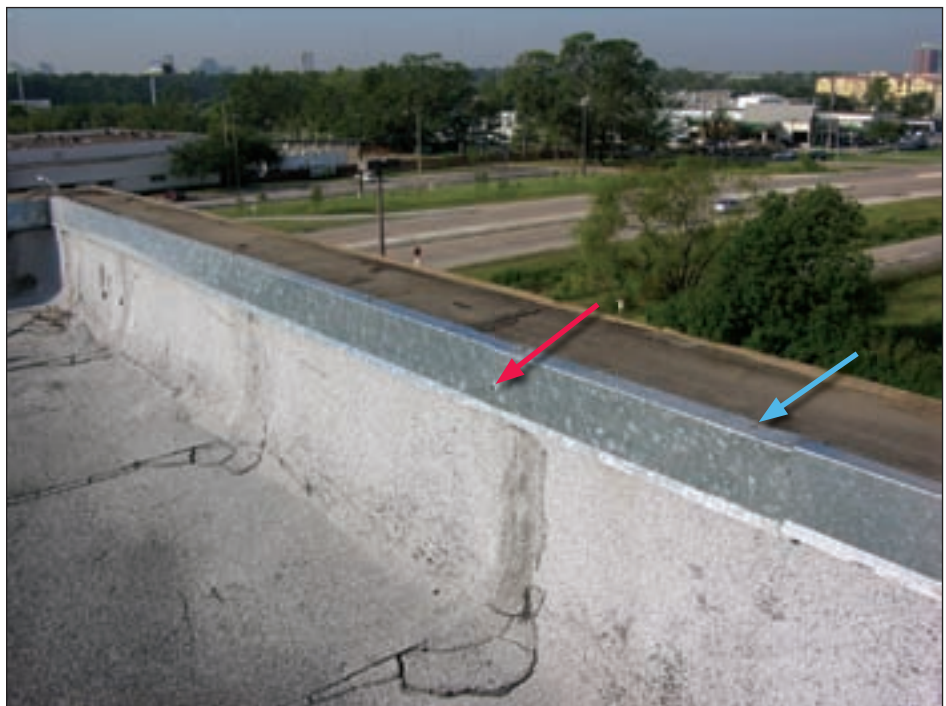
Figures 4-43 and 4-44 show pieces of coping that landed elsewhere on the roof. Windborne coping can easily puncture roof membranes, including tough membranes like the modified bitumen membrane on this roof (inset at Figure 4-43).

Figure 4-42.
The coping blew off because of inadequate attachment of the cleats. The blue arrow shows roofing nails driven through the horizontal flange and the red arrow shows widely spaced nails through the vertical flange.

Figure 4-43.
Coping debris (red arrow);
the membrane was
gouged (blue arrow) by
coping debris (an ink pen
shows the scale)

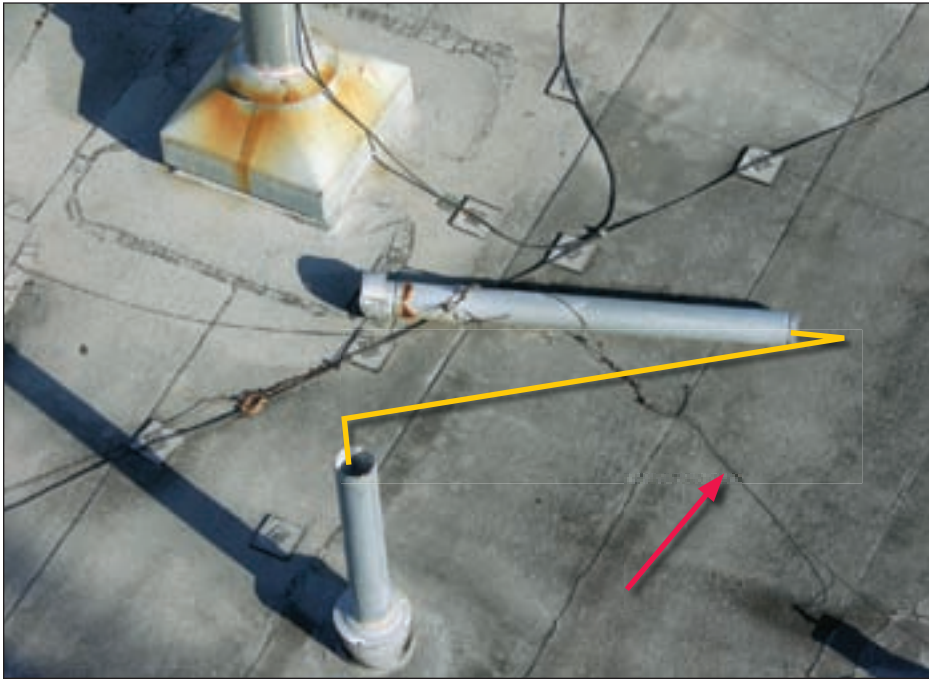
Additional damage included minor leakage at a building expansion joint and toppling of a tall flue on a lower level roof, even though it was guyed (Figure 4-45). The tautness of guys should be checked annually to avoid toppling of flues.

Figure 4-45.
Guyed flue blew over (red arrow indicates one of the guys)

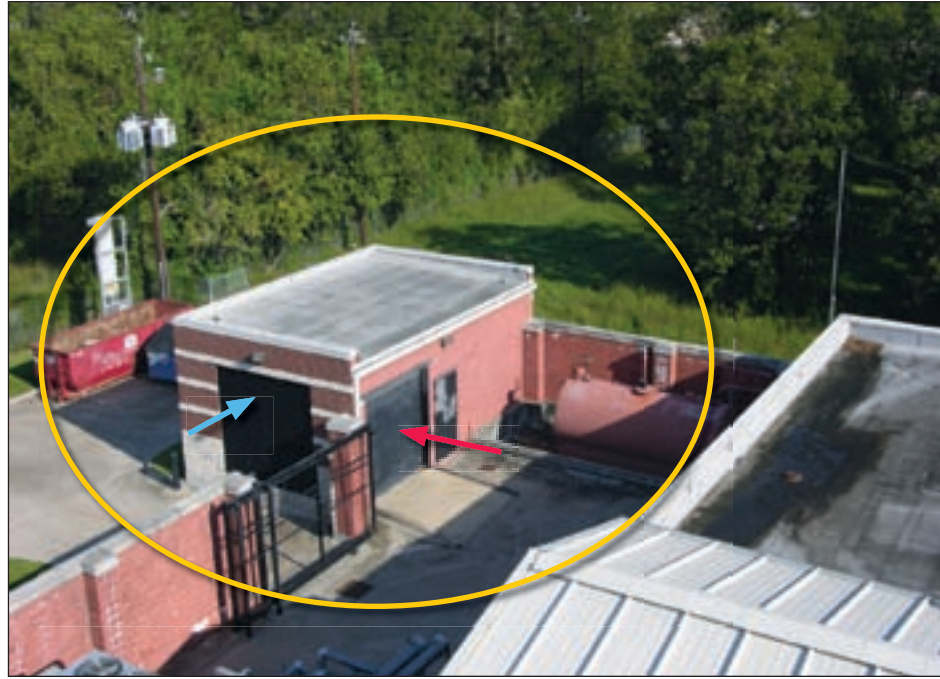
Under the right wind conditions, the emergency generator could also have been damaged because of inadequate building envelope protection. The facility's one emergency generator is housed in a separate building, shown in Figure 4-46. The coiling doors shown by the red arrow in Figure 4-46 appeared to possess little wind resistance. In addition, the louver shown by the blue arrow was not resistant to large windborne debris (which could penetrate the louver and damage the generator). Considering the importance of this facility, it would be prudent to: 1) add a back-up generator and a cam locking box (to facilitate rapid connection of a portable generator); 2) replace the coiling door with a new door rated for the design wind load and

Figure 4-46. The emergency generator is housed in the circled building; the coiling door (red arrow) and the louver (blue arrow) appeared to provide inadequate protection for the generator

capable of resisting test missile E as specified in ASTM E 1996; and 3) replace the louver with one capable of resisting test missile E, or provide a debris-resistant shield in front of the louver. Recommendations pertaining to all three of these items are provided in FEMA 543.

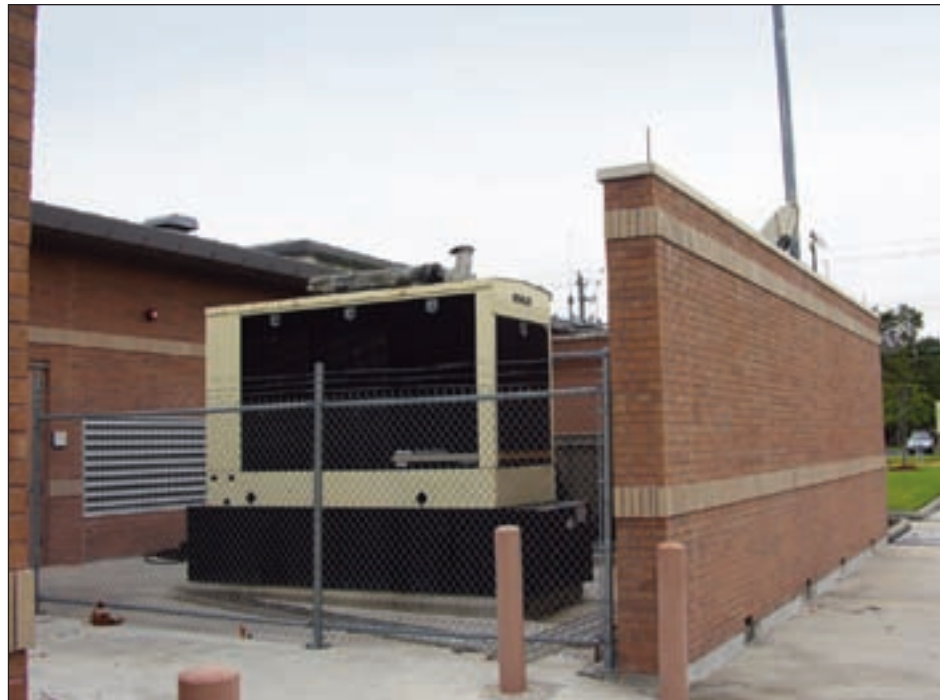
The emergency generator is shown in Figure 4-49. Although the enclosure has walls around three sides, it does not provide sufficient wind and windborne debris protection. Had the generator failed to function during the storm, lack of protection would have inhibited maintenance efforts to get the generator back online. FEMA 543 recommends providing a wind- and windborne-debris-resistant enclosure all around and over the generator.

Figure 4-49.
The emergency generator is inadequately protected from wind and windborne debris

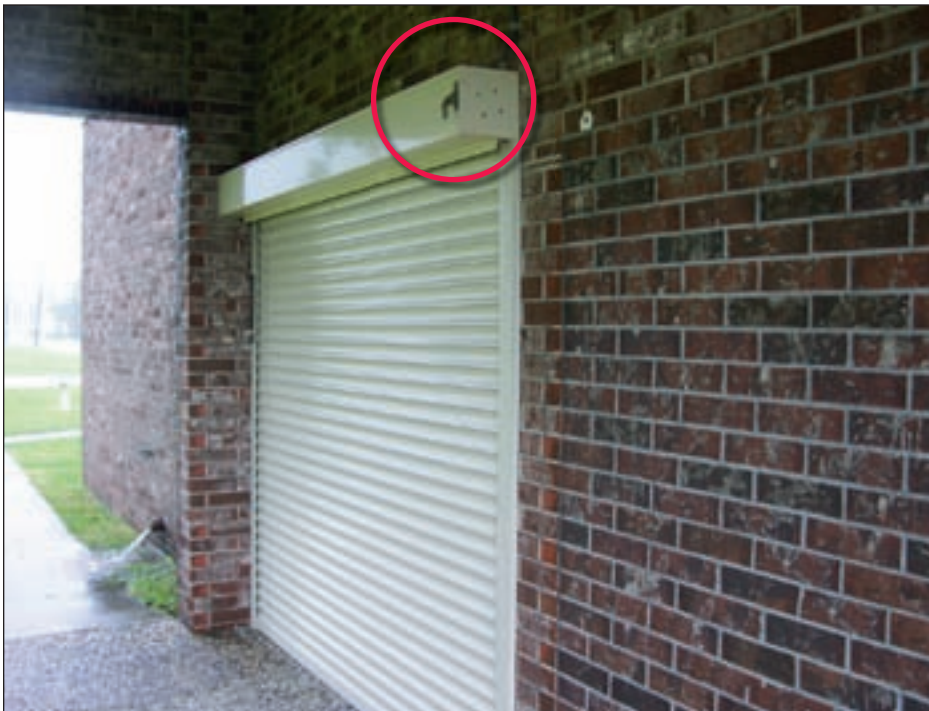
Figure 4-51.
View of a new motorized
shutter; the toggle in
the red circle allows the
shutter to be manually
raised

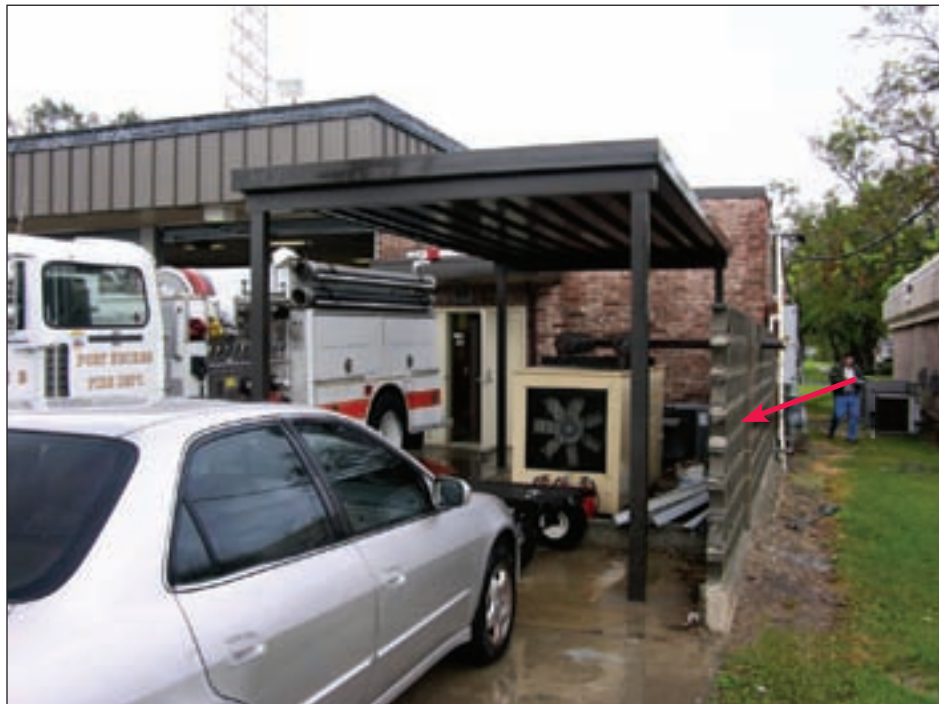
The emergency generator is not located in a protected enclosure (Figure 4-52). The nearby non-reinforced masonry screen wall (red arrow) could collapse on the generator, and the generator could be damaged by windborne debris. Had the generator failed to function during the storm, lack of protection would have inhibited maintenance efforts to get the generator back online. As part of a comprehensive mitigation project, providing a wind- and windborne-debris-resistant enclosure all around and over the generator as recommended in FEMA 543 would have been prudent.

Figure 4-52.
The emergency generator is susceptible to windborne debris and damage caused by collapse of the masonry screen wall

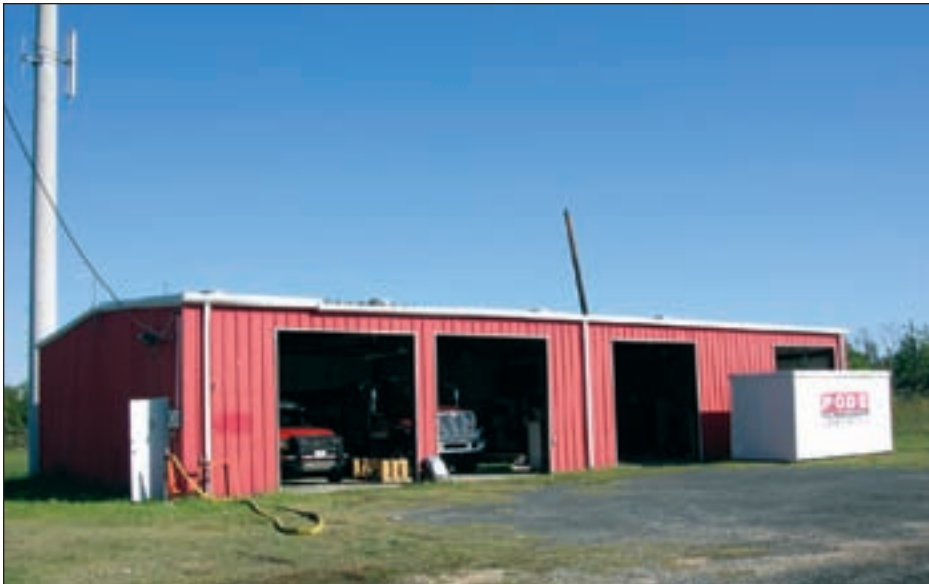
The High Island Fire Station is an older pre-engineered metal building (Figure 4-53). The facility received wind damage during Ike. According to ASCE 7-05, the basic wind speed for this location is approximately 131 mph. The estimated maximum wind speed during Hurricane Ike was approximately 110 mph.

General Wind Damage. All four apparatus bay doors blew away when the door rollers disengaged from the tracks (Figure 4-53).

Figure 4-53.
General view of High
Island Fire Station

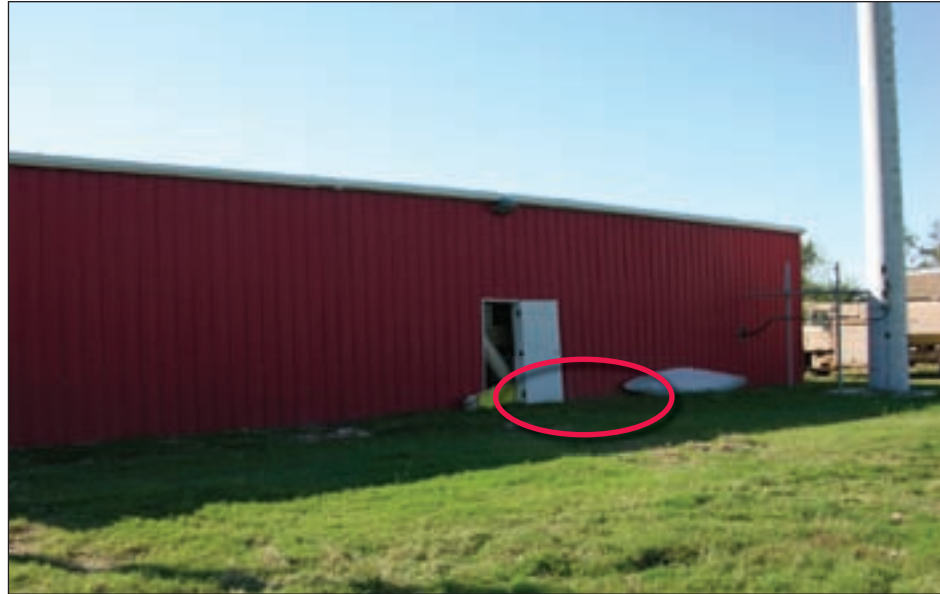
At the back of the building, the bottom of the wall blew outward (Figure 4-54). The metal walls were attached to an angle that was poorly attached to the concrete slab. The angle was attached at the door jamb, but there was a 10-foot gap to the next adjacent fastener. Some wall insulation near the door was also blown away. In addition, some of the metal wall panels peeled back at a corner of the building.

Figure 4-54.
The metal wall at the red oval area was pushed outward because of inadequate attachment of the wall angle to the slab

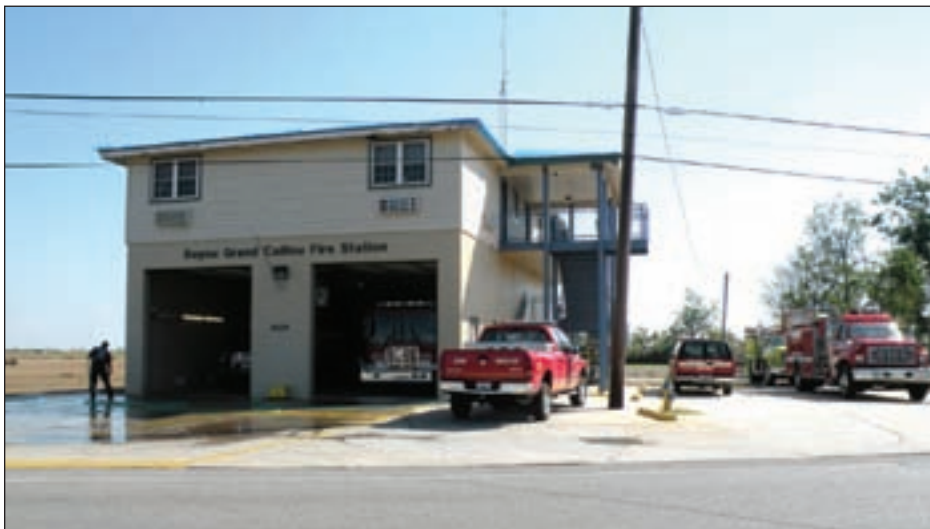
Figure 4-55.
The Bayou Grand Caillou Fire Station is elevated above the ABFE and sustained no damage

Figure 4-56.
Rear of Dularge Fire
Station; note canal bank
erosion sustained during
Hurricane Ike

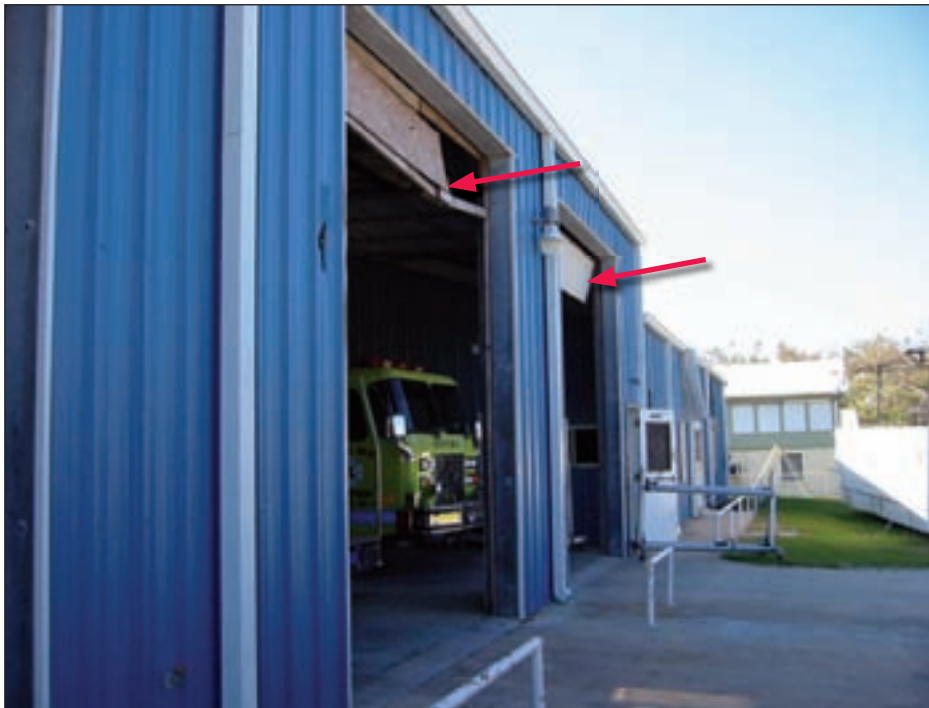
Figure 4-59. Wind damage (red arrows) to Grand Isle Fire Station remaining from Hurricane Katrina

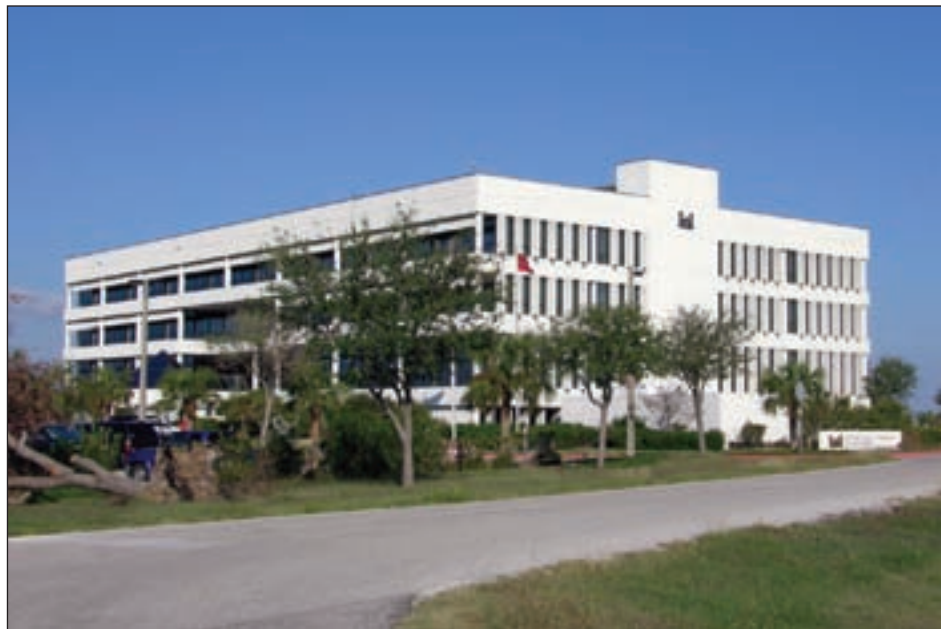
Figure 4-60.
General view of the USACE
Administration Building in
Galveston, TX

The USACE Administration Building (Figure 4-60), constructed in 1991, is located in Galveston, TX. Although the building was not damaged by flooding, floodwater surrounded the building during Hurricane Ike. Had the water been a few inches higher, it would have wetted the first (lobby) floor. The building experienced wind damage from Hurricane Ike. The exterior walls are precast concrete. According to ASCE 7-05, the basic wind speed for this location is approximately 132 mph. The estimated maximum wind speed during Hurricane Ike was approximately 108 mph.

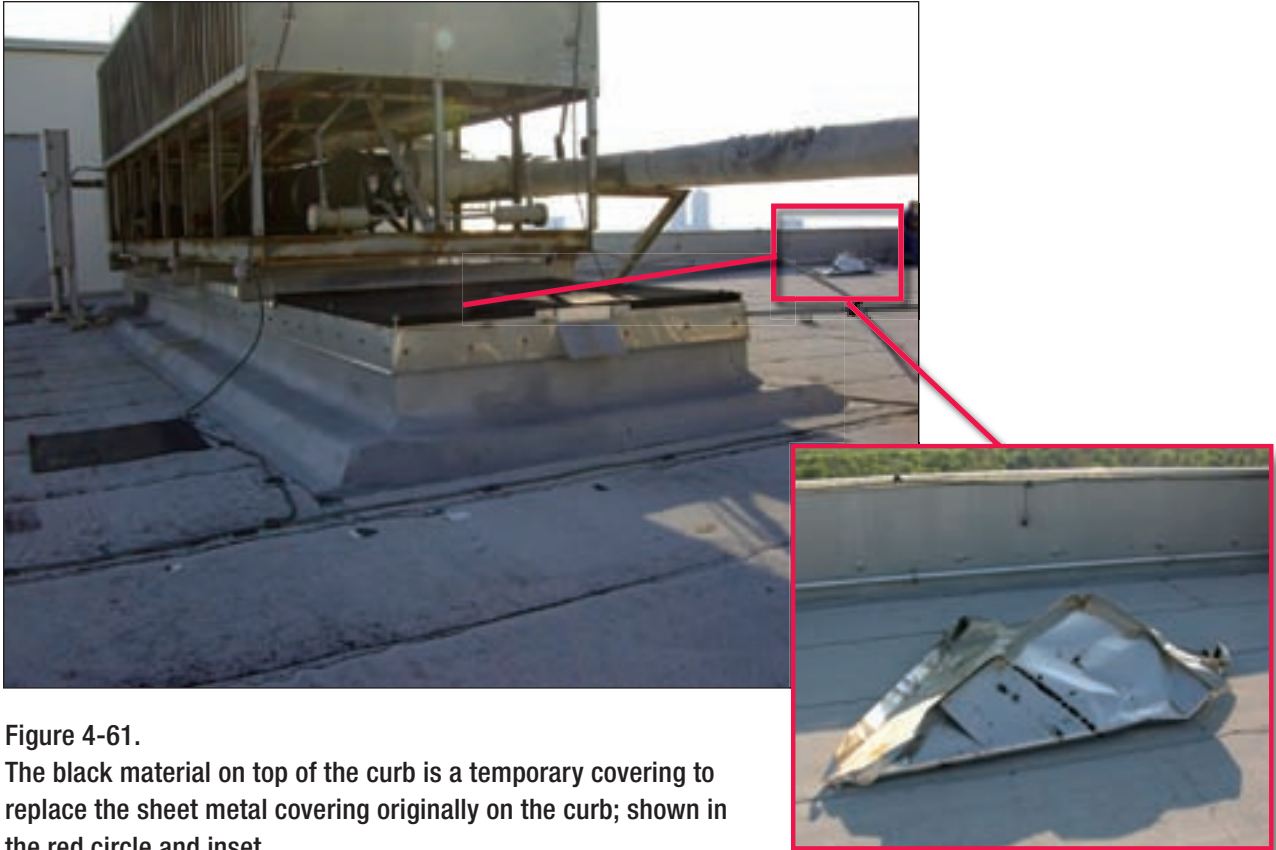
Figure 4-61.

General Wind Damage. Some minor leakage occurred at a few windows; facility staff reported that minor leakage had also occurred during previous thunderstorms. Additionally, some fan cowlings and louvers at condensers were blown off, and some of the LPS conductors detached from the roof membrane. A sheet metal cover over a curb was blown off (Figure 4-61). The presence of the 3-foot 2-inch high parapet was the likely reason the sheet metal was not blown from the roof. The roof membrane is a mineral-surface modified bitumen membrane (which is relatively tough and one of the membrane types recommended in FEMA 543). Although the sheet metal scuffed the roof, the membrane was not punctured or torn.

The black material on top of the curb is a temporary covering to replace the sheet metal covering originally on the curb; shown in the red circle and inset

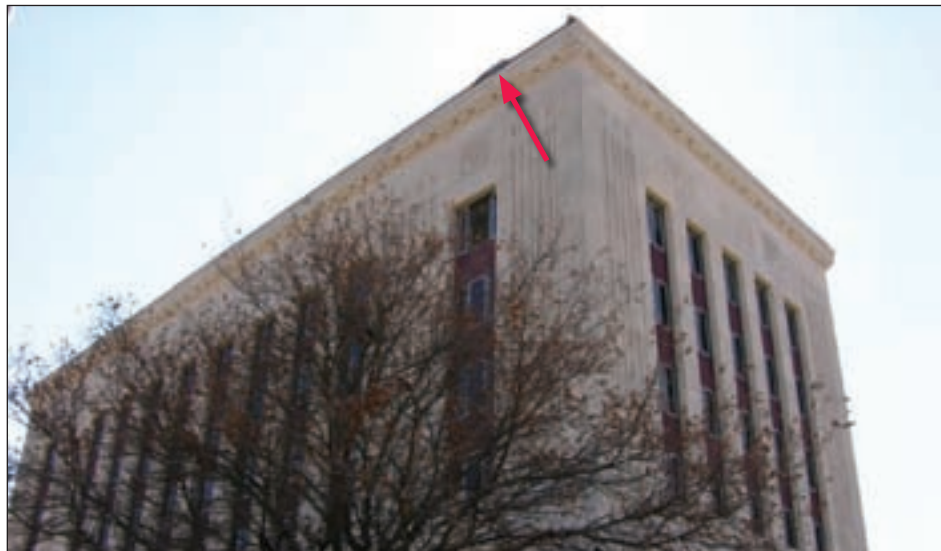
The Federal Courthouse and Post Office (U.S. Postal Service) facility (Figure 4-62), constructed circa 1935, is located in Galveston, TX. The facility received some flood damage. The facility also had minor wind damage. According to ASCE 7-05, the basic wind speed for this location is approximately 132 mph. The estimated maximum wind speed during Hurricane Ike was

Figure 4-62. General view of Federal Courthouse and Post Office; some flashing damage occurred during Hurricane Ike (shown by red arrow)

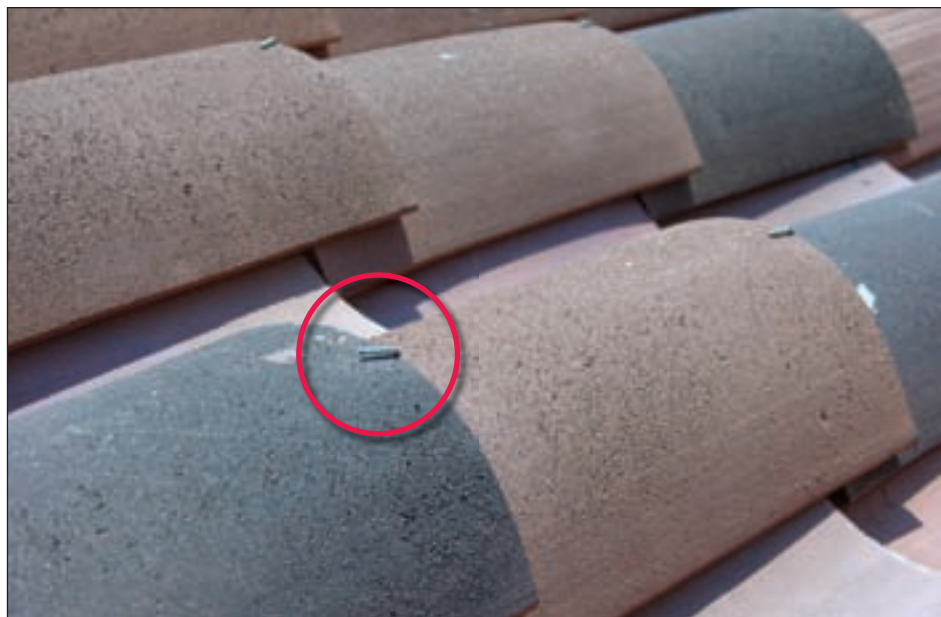
approximately 107 mph. The upper level roof is composed of two types. The steep-slope portion is tile. All of the tails of the tiles are hooked (red circle in Figure 4-63). The sloped roofs surround a low-slope area that has a mineral-surface modified bitumen membrane.

Figure 4-63. All of the tile tails were hooked

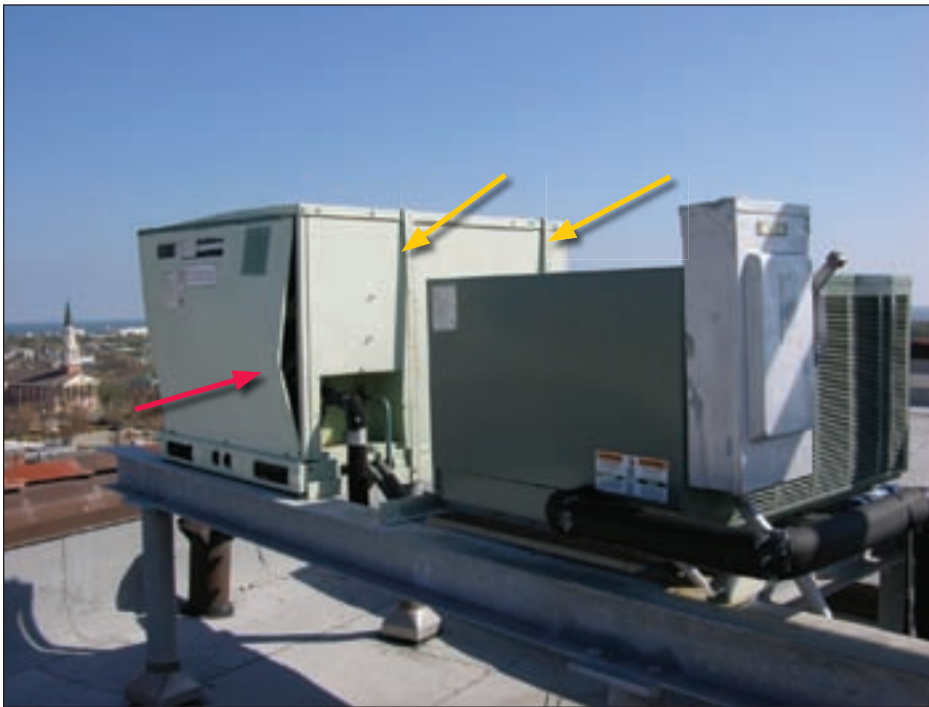
No roof covering damage was observed. Some roof flashing damage occurred along a small area on the front of the building (red arrow, Figure 4-64) and similarly along the back of the building. Minor rooftop equipment damage was observed. An access panel at a condenser was nearly blown off (red arrow, Figure 4-64). The condenser had two supplementary anchor straps (yellow arrows). Supplementary anchor straps are recommended in FEMA 543.

Figure 4-64.
The access panel (red arrow) nearly blew away; the yellow arrows indicate supplementary anchor straps

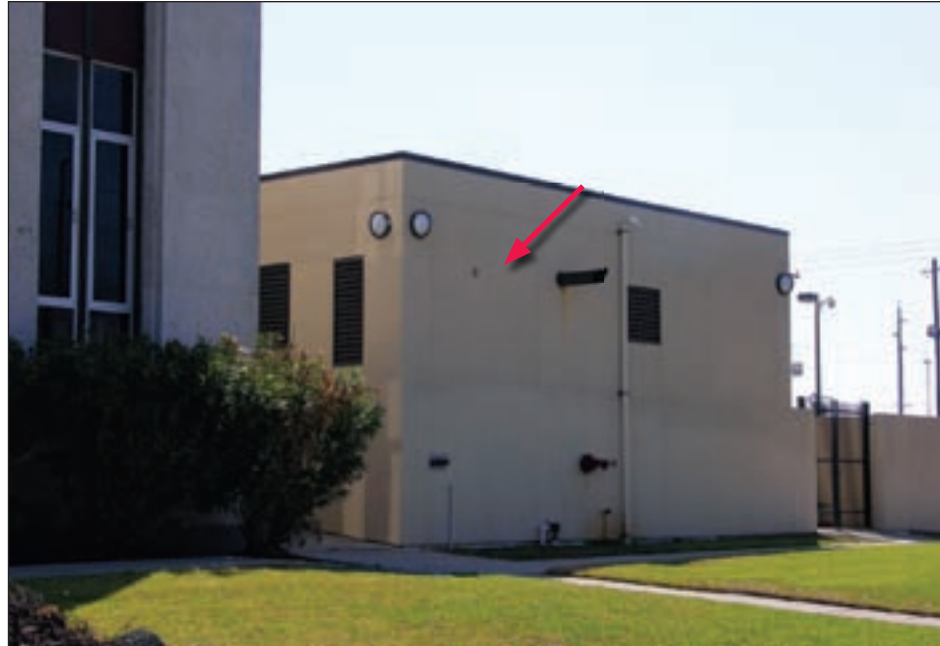
Vulnerabilities and Other Observations. A good practice observed at this facility is the location of the emergency generator in a wind- and windborne-debris-resistant building and elevation above the floodwater level (Figure 4-65). Hence, although flooding damaged the switchgear in the basement, the emergency generator was functional and, therefore, able to be reconfigured to power portable equipment used to dry the interior of the building.

Figure 4-65.
The emergency generator is housed in a separate wind- and windborne-debris-resistant building (red arrow)

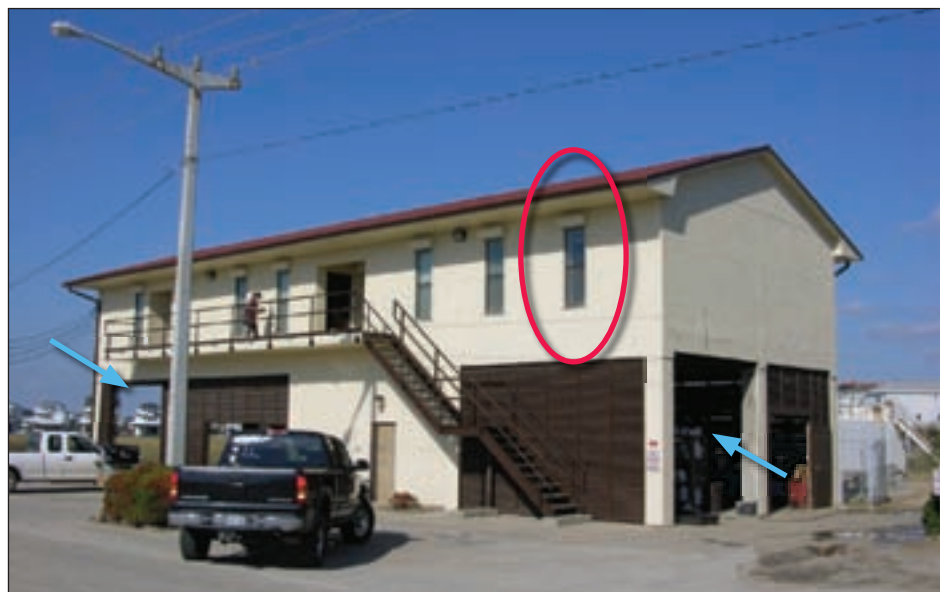
Figure 4-66.
One of the shutters at the Tiki Island City Hall is shown in the red oval; blue arrows indicate breakaway walls that performed successfully by breaking away

General Flood Damage. Breakaway walls failed under flood forces and ground level space was inundated (blue arrows in Figures 4-66 and 4-68).

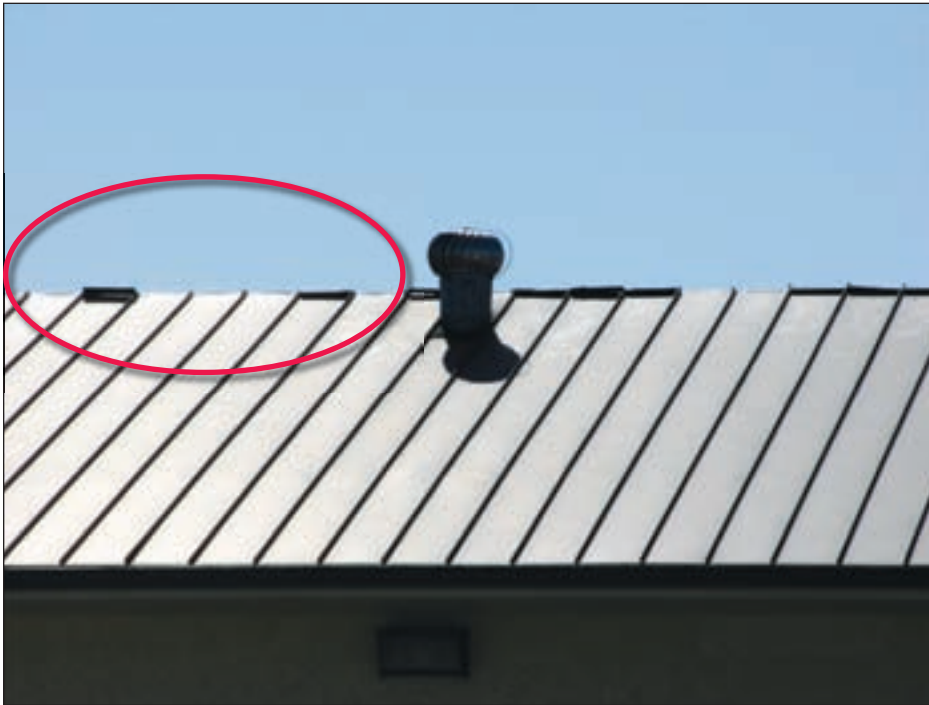
General Wind Damage. A portion of the ridge flashing was blown off the metal roof (Figure 4-67). Leakage did not occur, so the roof underlayment was apparently correctly lapped over the ridge. However, loss of flashing can make roof panels more susceptible to blow-off.

Figure 4-67.
The oval shows where
ridge flashing blew away

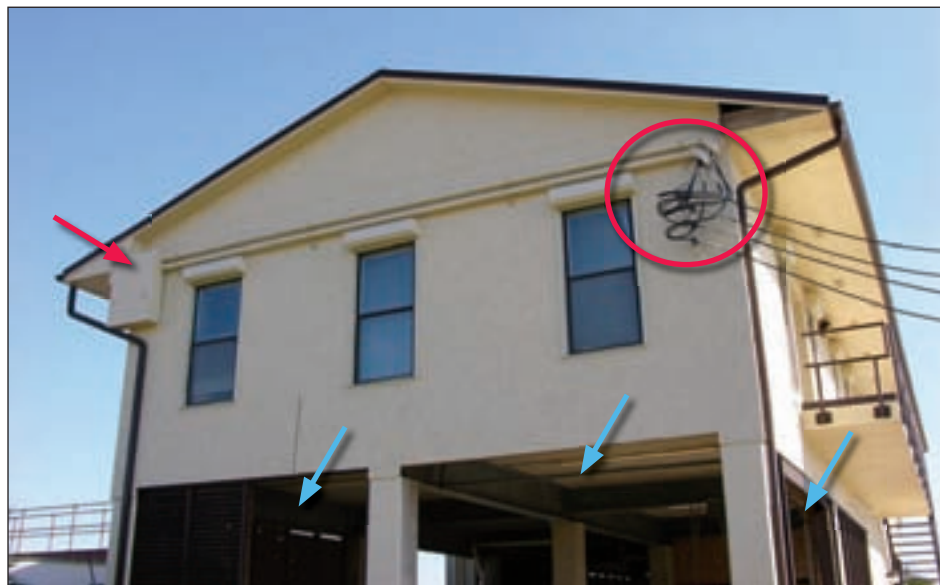
Vulnerabilities and Other Observations. The building design incorporated a very sound practice regarding entrance of electrical service. Normally when power is provided by overhead lines (as is the case with this building), the lines come into a weatherhead that penetrates the roof. If nearby power poles collapse or move significantly, the power lines pull the weatherhead, which often tears the roof and allows leakage. However, at this building, the conduit from the weatherhead (circled in Figure 4-68) runs along the wall and then enters the building through the wall (red arrow). With this installation, movement of the power lines may have caused some damage at the wall penetration had the power lines moved significantly; but if wall damage had occurred, leakage would have been much less problematic than if the conduit penetrated the roof.

Figure 4-68.
The electrical service entered through the wall rather than the roof; the blue arrows indicate missing breakaway walls

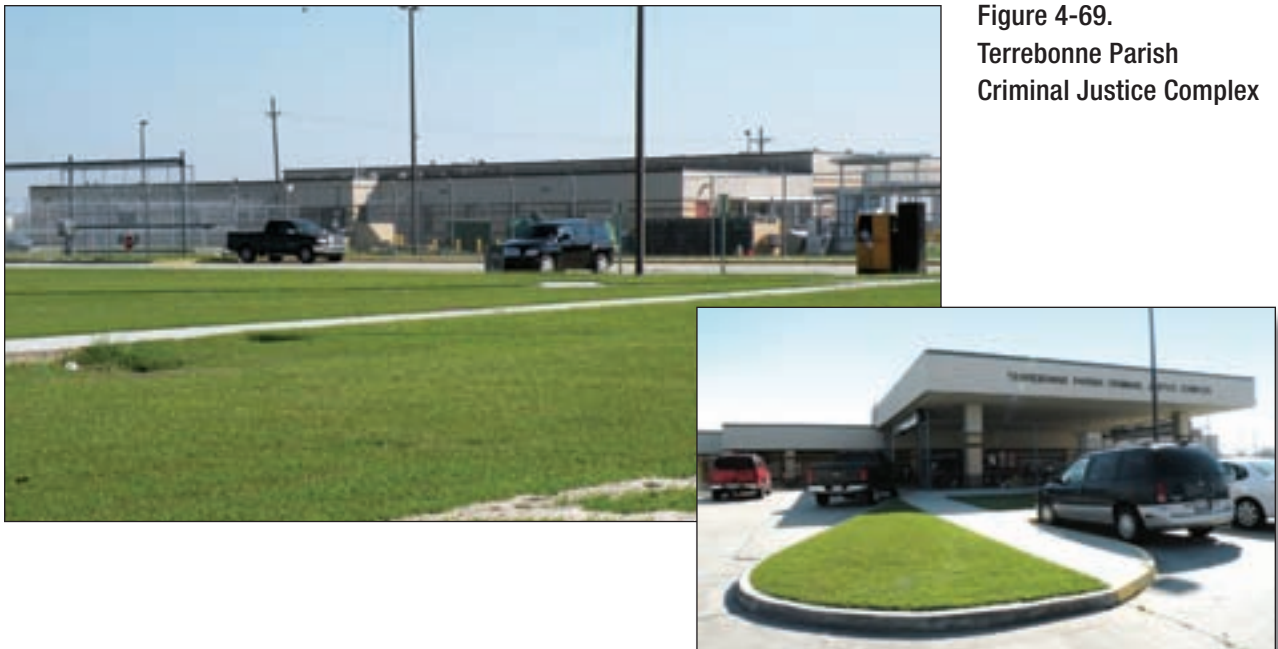
Figure 4-69.
Terrebonne Parish
Criminal Justice Complex

The Terrebonne Parish Criminal Justice Complex located in Houma, LA, houses approximately 600 inmates. It is a relatively new facility but received approximately 18 to 24 inches of flooding due to Hurricane Ike (Figure 4-69).

General Flood Damage. Utility service, which runs beneath the slab foundation, was damaged and disrupted by Ike's flooding. In addition to the inundation problems, the facility became unusable because controls were either damaged or inoperable (virtually all of the functions of the prison are operated by electric switches, relays, and motors, including the communications, prison monitors, lights, and cell doors). Parish records also indicate that the criminal complex electronic security system was damaged by Hurricane Rita and required repair and replacement in 2006.
