Mitigation Assessment Team Report

Hurricane Ike in Texas and Louisiana

Building Performance Observations, Recommendations, and Technical Guidance

FEMA P-757 / April 2009

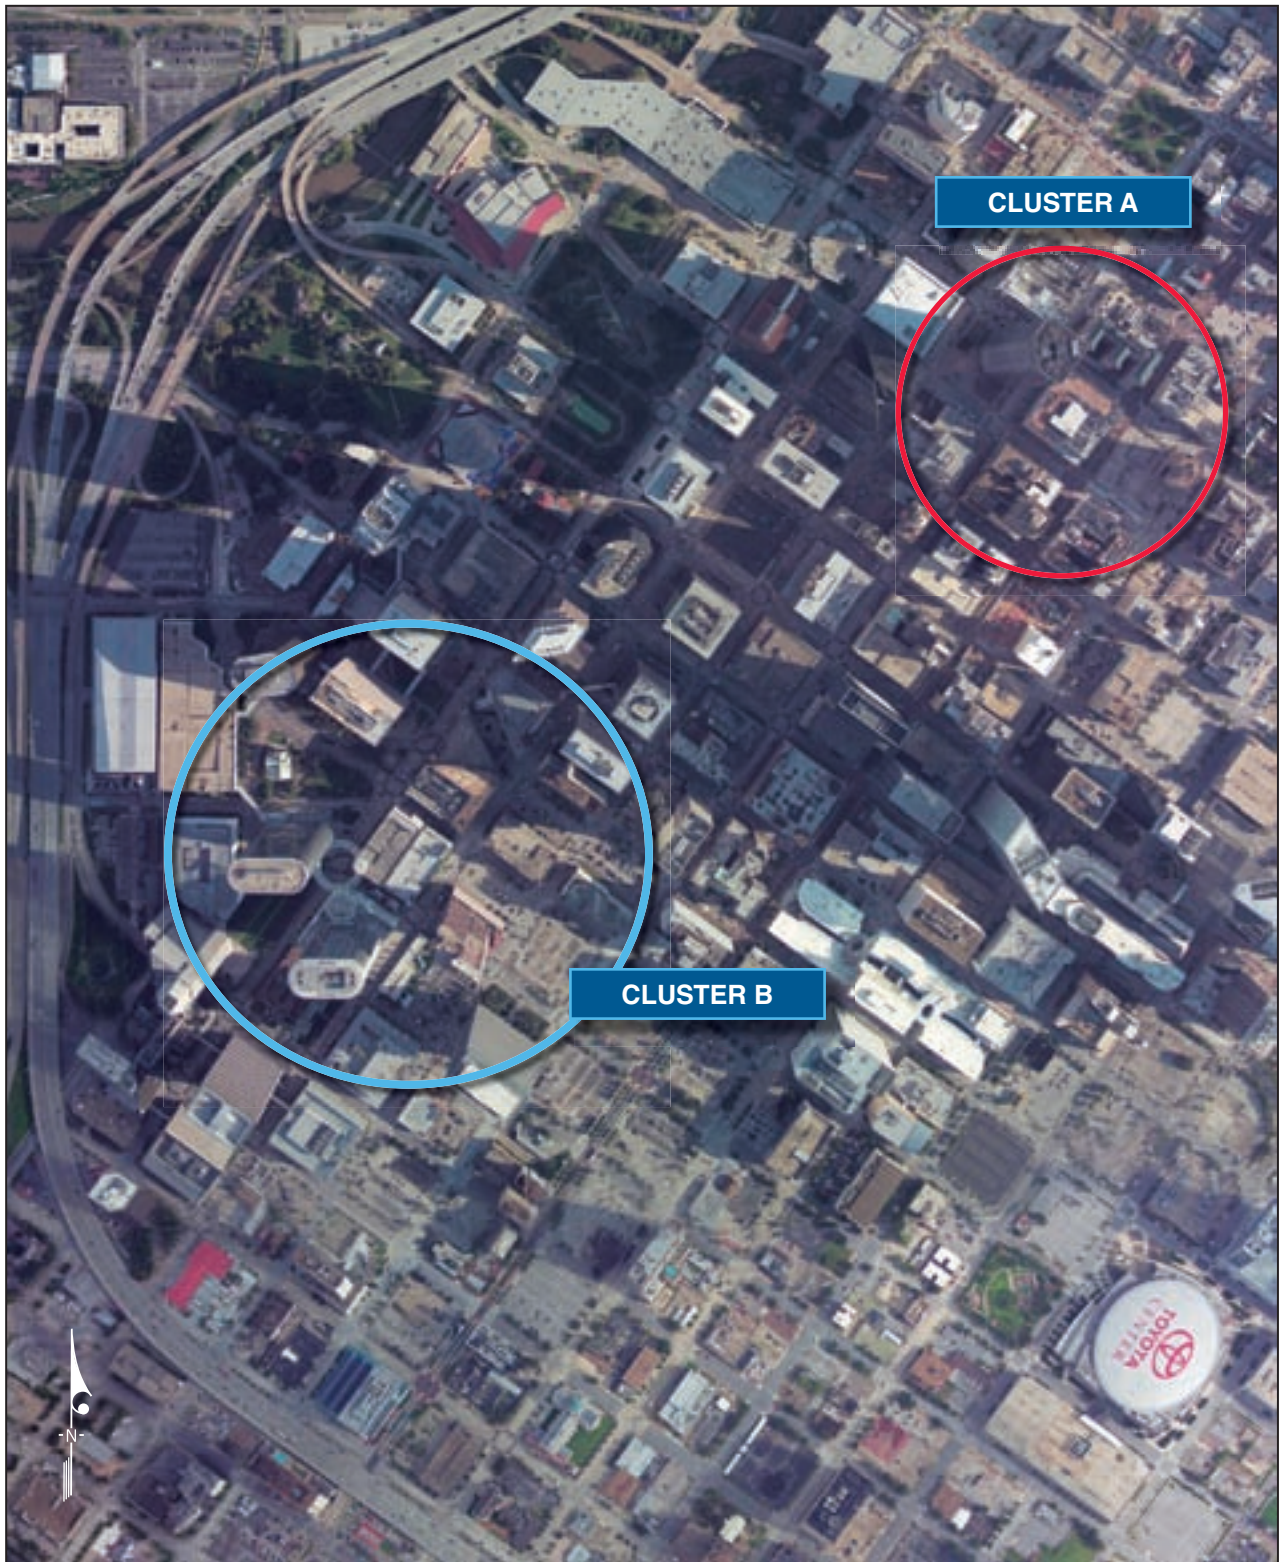
Figure 5-1.

The MAT observed commercial high-, mid-, and low-rise buildings in downtown Houston. The building ages ranged from several decades to just a few years old. Figure 5-1 shows an aerial photograph of a portion of downtown Houston. There was significant building envelope damage in areas indicated by the blue and red circles on Figure 5-1; the red circle denotes buildings that are discussed as cluster A (Section 5.2), and the blue circle denotes buildings discussed as cluster B (Section 5.3). Random isolated envelope damage was observed in the areas outside the clusters, as described in Section 5.1.

View of a portion of downtown Houston. The red circle denotes cluster A and the blue circle denotes cluster B.

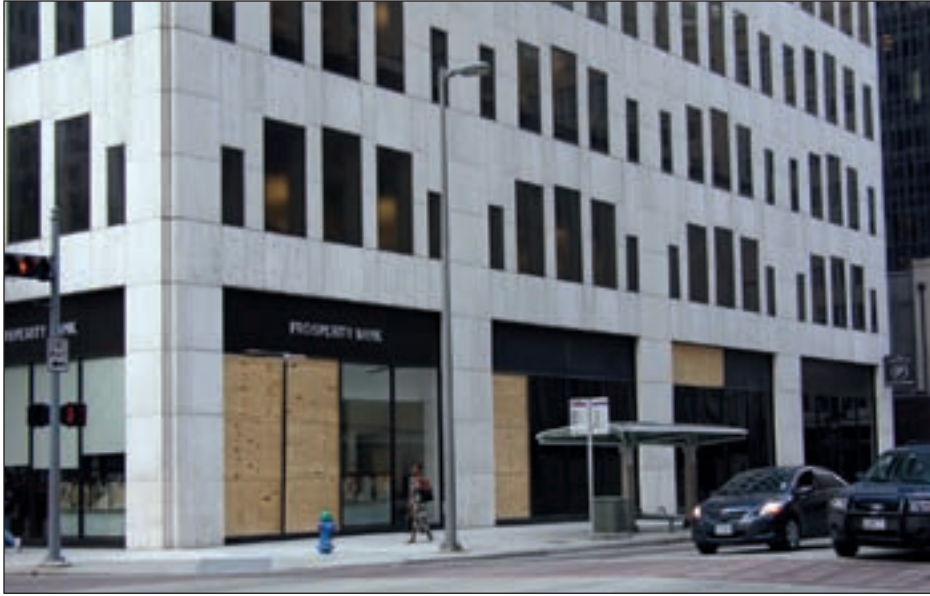
Glazing breakage also occurred several floors above grade at other buildings. There was also random breakage at or near street level at some buildings, as shown in Figure 5-3. Exterior glazing is very susceptible to windborne debris breakage unless it is impact resistant (via use of laminated glass or shutters). Since Houston is not in a windborne debris region, protected glazing is not commonplace. The probability that any one window will be struck by windborne debris is typically small (unless the glazing is downstream from an aggregate-surfaced roof). The probability of impact depends upon local wind characteristics and the amount of natural and manmade windborne debris in the vicinity. The greater the wind speed, the greater the amount of windborne debris that is likely to become airborne. Glazing can also be broken by overpressurization via either high negative or positive wind loads, but this damage is not as common as debris-induced damage. Older glazing is more susceptible to wind-load damage because it is often weakened by scratches. In addition, much of the older glazing on low-rise buildings was installed when little attention was given to wind resistance.

Figure 5-3.
Random breakage of first floor glazing

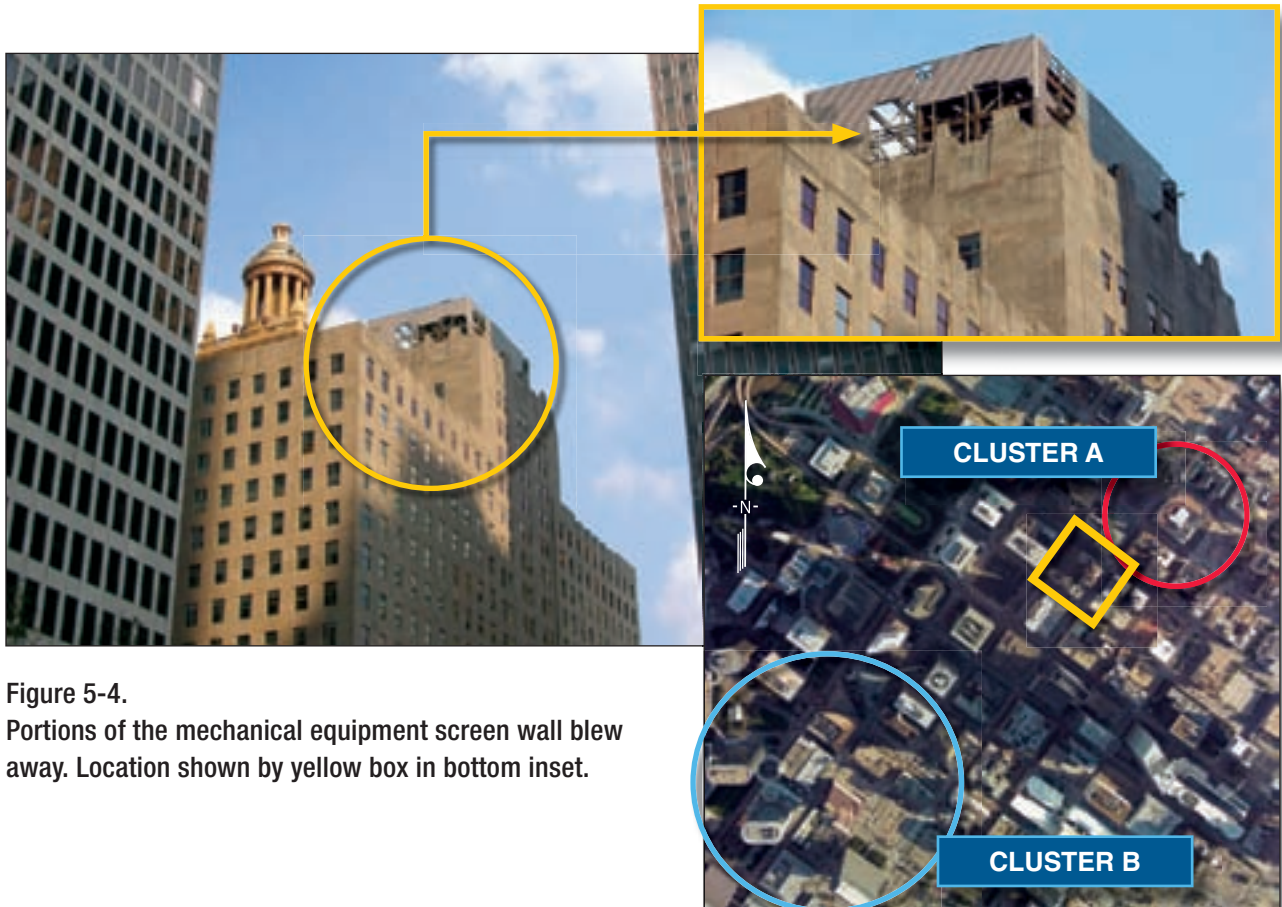
Figure 5-4.
Portions of the mechanical equipment screen wall blew away. Location shown by yellow box in bottom inset.

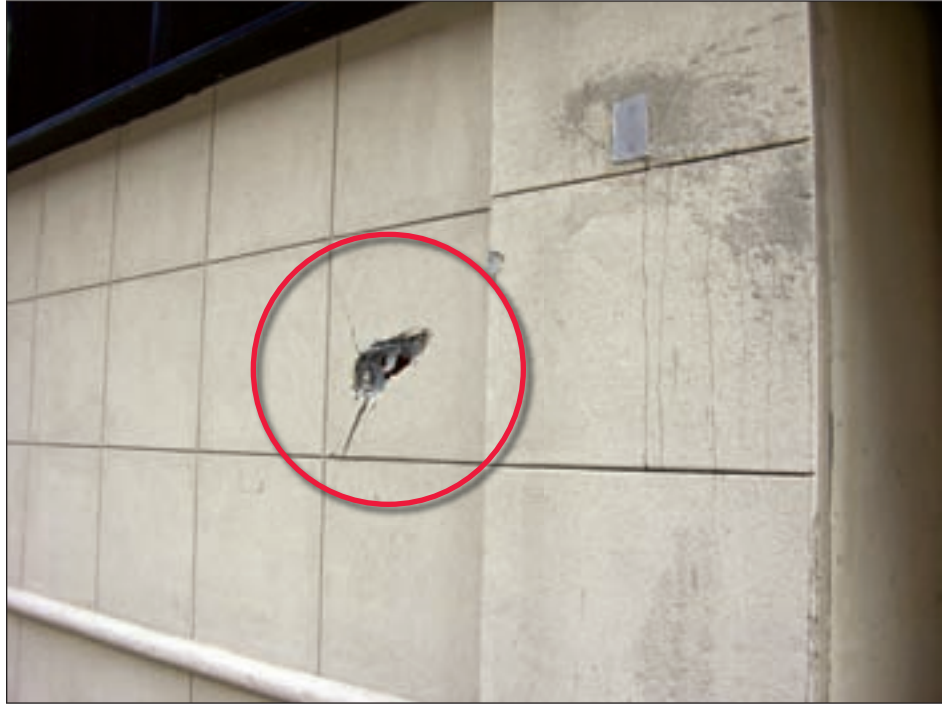
Figure 5-5.
The wire mesh of this stucco wall was penetrated by windborne debris. The impact location is about 5 feet above the sidewalk.

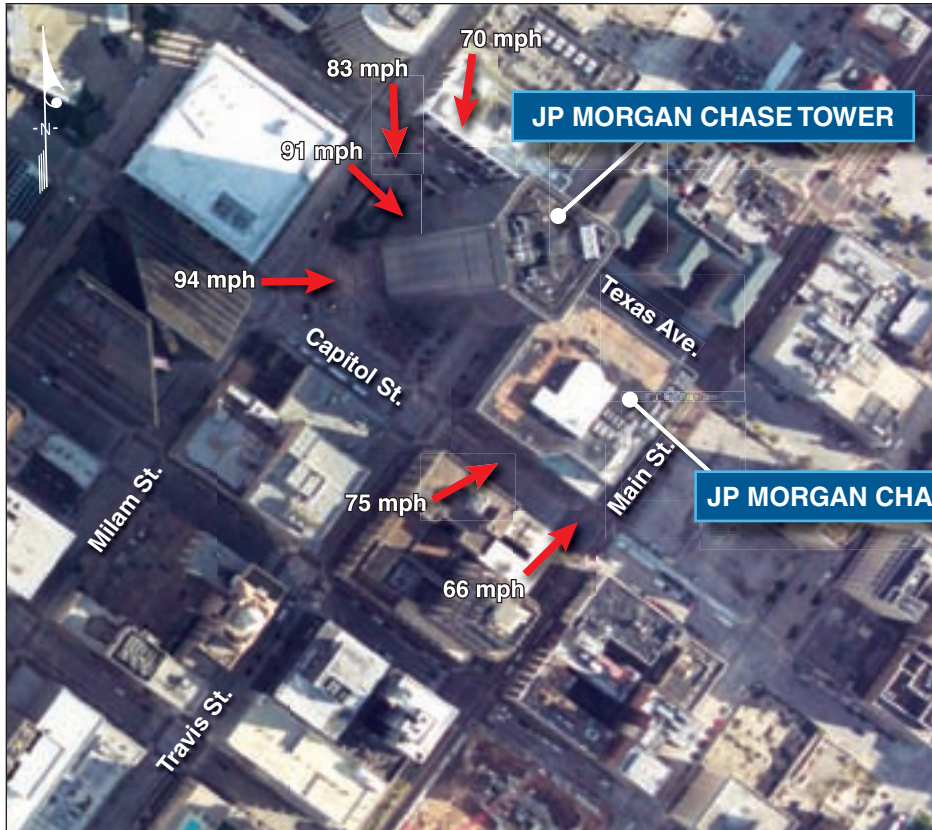
Figure 5-6. JP Morgan Chase Tower and JP Morgan Chase Center. The arrows show Hurricane Ike's primary wind directions (see text box) and maximum gust speed (for Exposure C at 33 feet above grade) for the given direction.¹

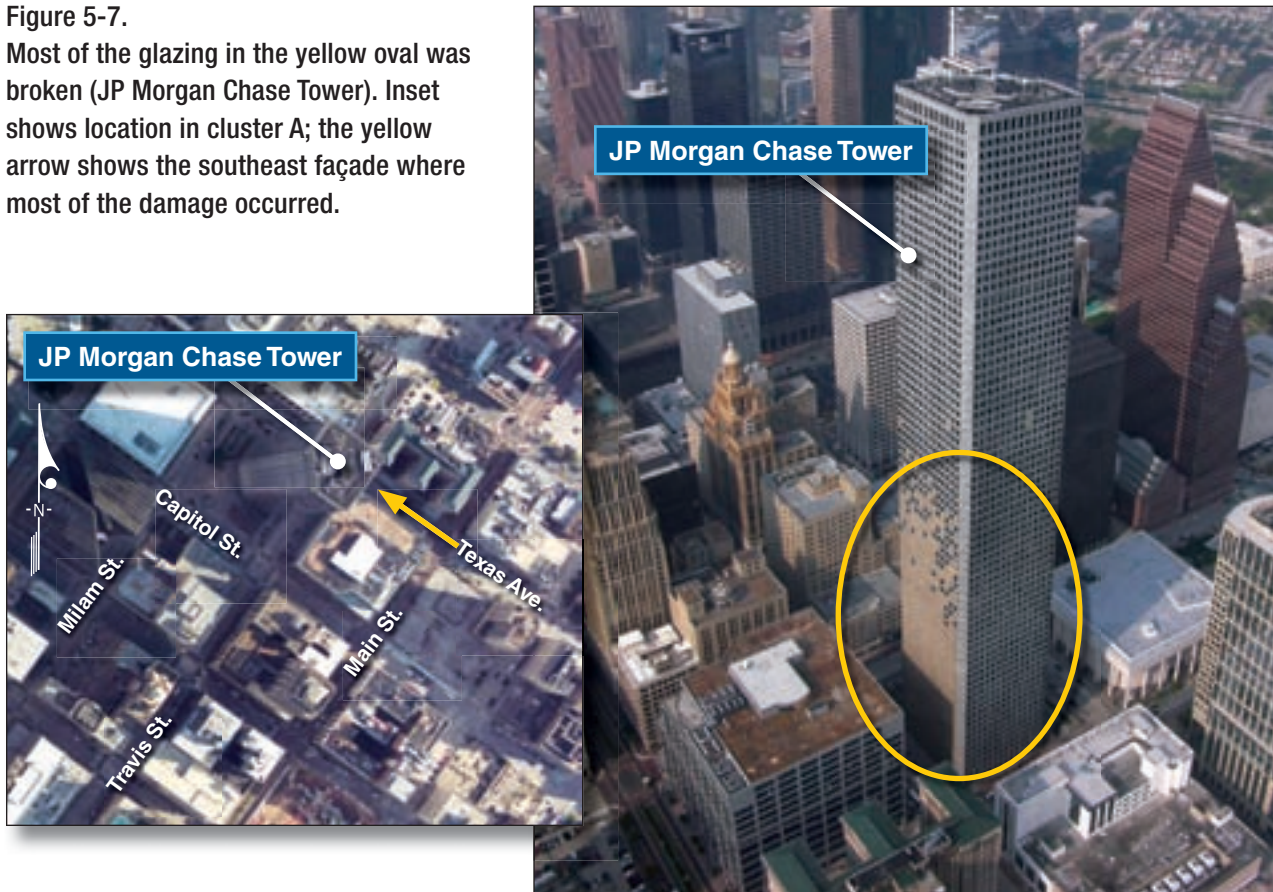
Figure 5-7.

The glazing panes of the JP Morgan Chase Tower are ¼-inch thick each, inner and outer, with a ½-inch air space between the panes. The glazing units are tinted and annealed. There was significant damage on the southeast façade, which was on the leeward side of the building during the time of the strongest winds (yellow circled area in Figure 5-7 and yellow arrow in inset), where both the inner and outer panes of approximately 463 windows were broken. On that façade, all windows in the first 22 floors were broken. The highest broken window was on the 47th floor. The southwest façade had 23 windows with broken inner and outer panes, and the northeast façade had two. The temporary protection and glazing replacement costs were significant.

For most of the southeast façade, very little wind and rain was driven into the offices. However, because of localized wind effects, some offices had significant amounts of rain and wind infiltration, which blew out ceiling boards and toppled office partitions. The MAT was advised that some furniture blew out of offices in this building and landed on the roof of the JP Morgan Chase Center across Travis Street. Because few of the broken windows were on windward façades, there was relatively little interior damage (Note: an explanation of the observed damage pattern is provided later in this section).

Most of the glazing in the yellow oval was broken (JP Morgan Chase Tower). Inset shows location in cluster A; the yellow arrow shows the southeast façade where most of the damage occurred.

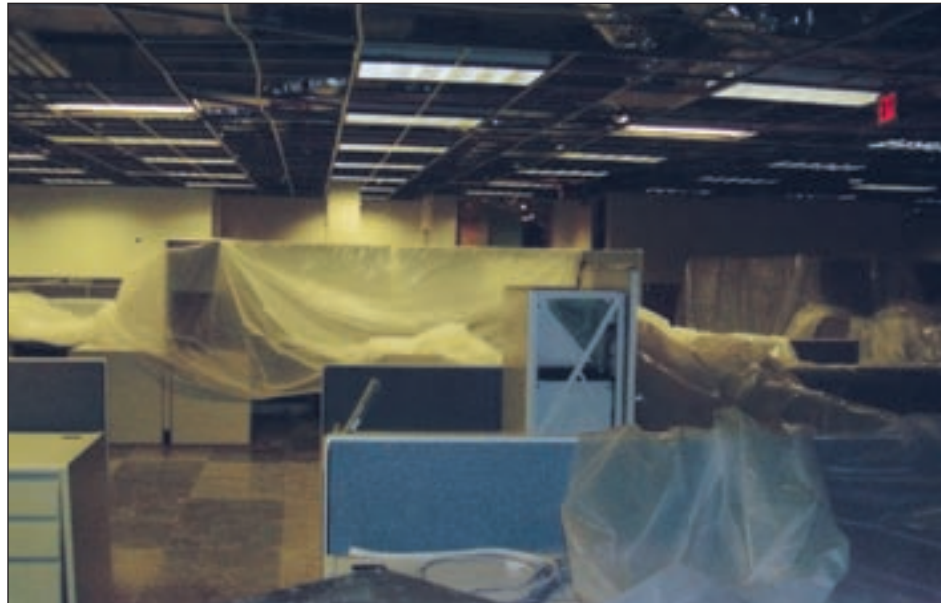
The extensive glazing damage at the JP Morgan Chase Center, possibly in combination with some contribution from roof damage, allowed water penetration into the offices on Floors 14 through 20, resulting in significant damage and loss of office space (Figure 5-9). On one of the floors, the MAT observed water damage that extended about 250 feet into the interior of the building. The water damaged interior walls and ceilings; some of the interior corridor walls toward the exterior fell over and touched the far wall. A computer lab, located along the exterior wall, received extensive water damage. Water damaged approximately 150 desktop computers.

Floors 18 and 19 sustained extensive damage. Water-damaged carpet and ceiling boards were removed from approximately 50 percent of the floor area that was observed by the MAT. At the time of the MAT observation, new materials were being installed, including new wiring, new data cables, and extensive HVAC work. Approximately 25 percent of the floor area on Floors 14 through 17 sustained similar damage.

Figure 5-9.
View of repairs to an office
damaged in the JP Morgan
Chase Center

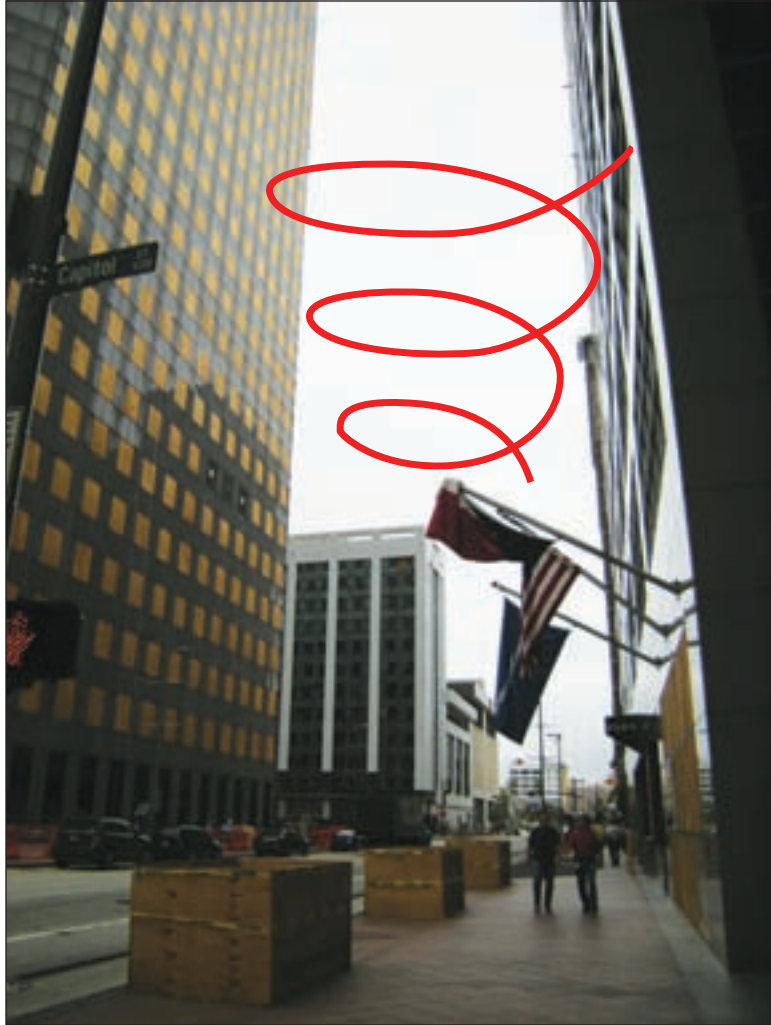
Figure 5-11.

The MAT postulates that the glazing damage occurred as a result of the following: some glazing in the Tower or the Center failed, either due to windborne debris or overpressurization, and the resulting glass shards became enveloped in vortices that developed between the two buildings. As the shards impacted the opposing façades, additional shards were injected into the vortices. It is believed that the vortices lifted the shards upwards, thereby causing damage at the upper floors (shown in Figure 5-11). Potential initial debris sources include trees along the sidewalks and metal wall panels from a nearby building (blue lines shown in Figure 5-10; refer also to Section 5.2.4).

The MAT's postulate is consistent with initial research work on the observed glazing damage conducted by the University of Notre Dame in a paper titled *Saga of Glass Damage in Urban Environments Continues: Consequences of Aerodynamics and Debris Impact During Hurricane Ike* (Kareem, 2008).² A model of the JP Morgan Tower and surrounding buildings was constructed and flow visualization experiments were conducted in a wind tunnel. In addition, flow visualization was analyzed by computational fluid dynamics (CFD). The wind tunnel and CFD studies both demonstrated that a series of vortical flow structures formed between the two façades that were heavily damaged (Figure 5-11).

The Tower is on the left and the Center is on the right. It is believed that vortices developed between these façades, and that glass shards entrapped within the vortices were slammed against and broke glazing in the opposing façades.

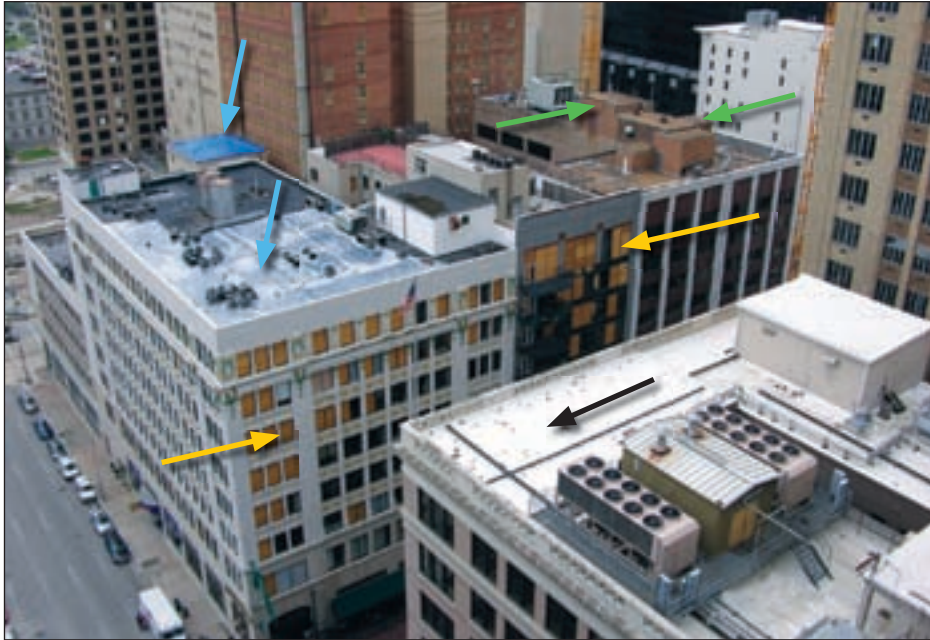
Figure 5-14 is a view of the roofs in the white rectangle at Figure 5-13. Blue and clear plastic tarps cover two roof areas. The green arrows show where an aggregate-surfaced built-up membrane lifted and peeled back. It is doubtful that aggregate from these roofs struck the JP Morgan Chase Tower or Center buildings. The punctured roof with the black arrow is the same as shown at the top inset of Figure 5-13. Several windows were broken in the buildings shown by the yellow arrows.

Figure 5-14. Glazing damage (yellow arrows) at two of the buildings shown in the white rectangle in Figure 5-13. The blue, green, and black arrows indicate damaged roofs.

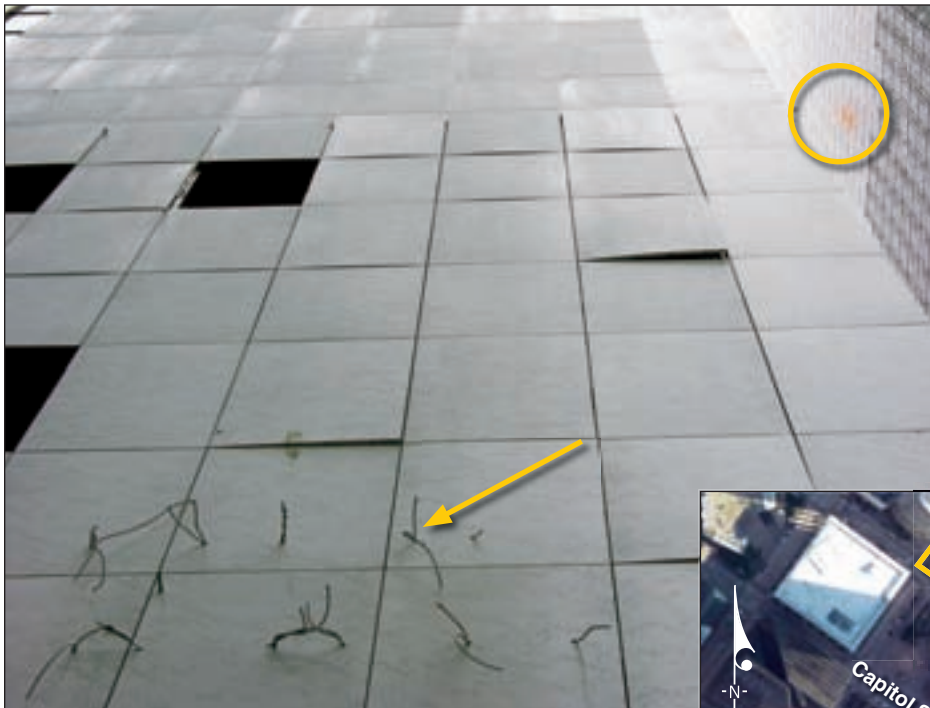
Figure 5-15 shows a building that lost several metal wall panels and a wall-mounted sign; the inset shows the building location and the façade that lost the panels (blue lines). It appears that the wall panel debris had the potential to strike either the JP Morgan Tower or Center.

Figure 5-15. Several metal panels blew off of two façades of this building, along with a wall-mounted sign (yellow arrow). Two broken windows can be seen in the yellow circle at the JP Morgan Chase Tower. Inset shows location of building (yellow box); blue lines indicate façades where metal panels blew off.

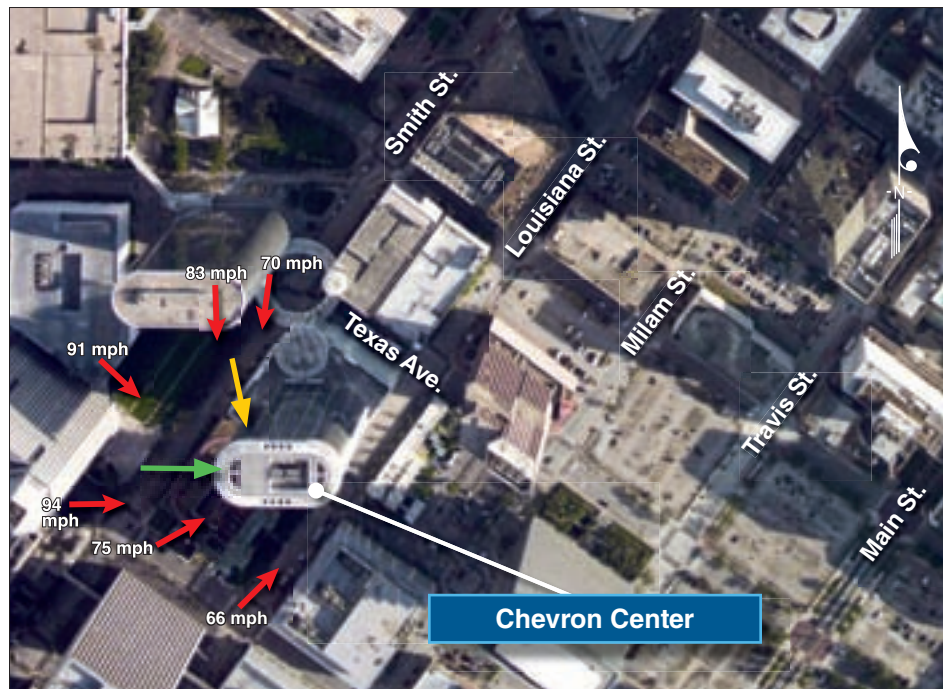
An enlarged view of cluster B from Figure 5-1 is shown in Figure 5-16. The Chevron Center is part of cluster B. This 40-story building was built in 1999–2002. A large number of windows were broken on the side indicated by the yellow arrow in Figure 5-16 (refer also to Section 5.3.1). The roof membrane was blown off the end of the building indicated by the green arrow (refer also to Section 5.3.2). The building lost power during Hurricane Ike and for 2 days afterward.

Figure 5-16.
 A substantial amount of glazing damage occurred to the façade of the Chevron Center, indicated by the yellow arrow. The roof membrane blew off from the end of the building (green arrow). The red arrows show Hurricane Ike’s primary wind directions and maximum gust speed for the given direction.
 SOURCE: NOAA, SEPTEMBER 17, 2008

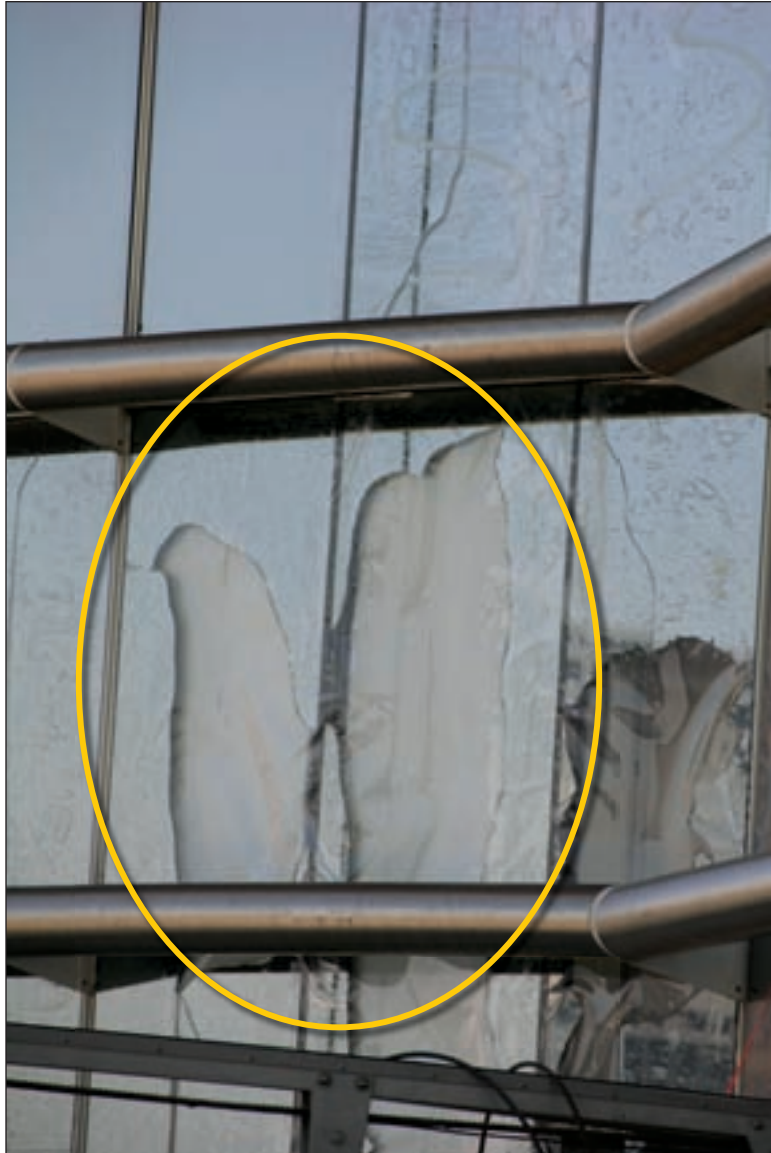
Shortly after the storm, the building owner retained a company to quickly install a temporary film over all of the broken glazing as a safety precaution to avoid falling shards of glass (Figure 5-18). Once the protective film was in place, work commenced on removing the broken glass that was still in place. Glass removal took considerable time, hence the initial installation of the protective film was prudent to protect pedestrians.

Figure 5-18.
Broken glazing held in place with
temporary film

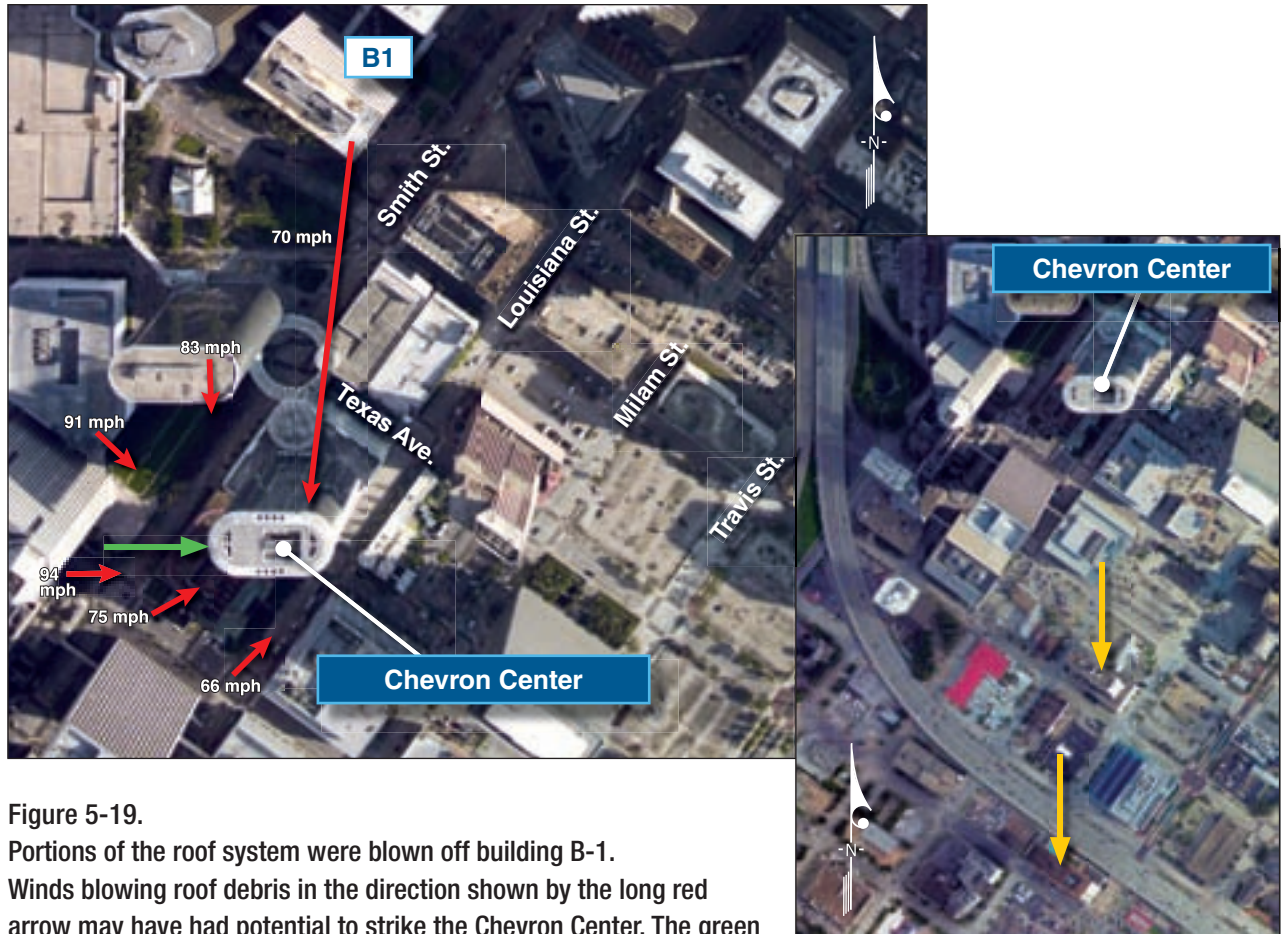
Figure 5-19.

Cause of glazing damage: Prior to and during the MAT helicopter observations, the glazing damage at the Chevron Center had not been detected. Therefore, the high-rise roofs near the Chevron Center were not observed during the flight for potential debris sources. Subsequent analysis of the NOAA high-resolution photographs did not reveal an obvious debris source. Roof debris from the building designated as B-1 in Figure 5-19 (close up view shown in Figure 5-28) appears to have had the potential to strike the center area of the Chevron Center. Although some glazing damage occurred in the center area, the damage was primarily near the end of the Chevron Center. Also, when the wind was blowing in the direction conducive for roof debris from building B-1 to strike the Chevron Center, the wind speed was relatively low. Therefore, roof debris from building B-1 is not believed to be the primary cause of the Chevron Center glazing damage.

Two mid-rise buildings with aggregate-surfaced BURs occur to the south of the Chevron Center (yellow arrows at the inset of Figure 5-19). These buildings are shown in Figure 6-4. The closest building is approximately 250 feet from the Chevron Center, which is well within the flight capability of windborne aggregate. However, wind direction during Hurricane Ike precluded aggregate from these buildings as being potential debris sources for the glazing damage at the Chevron Center (refer to red arrows indicating wind directions shown on Figure 5-19).

Portions of the roof system were blown off building B-1.

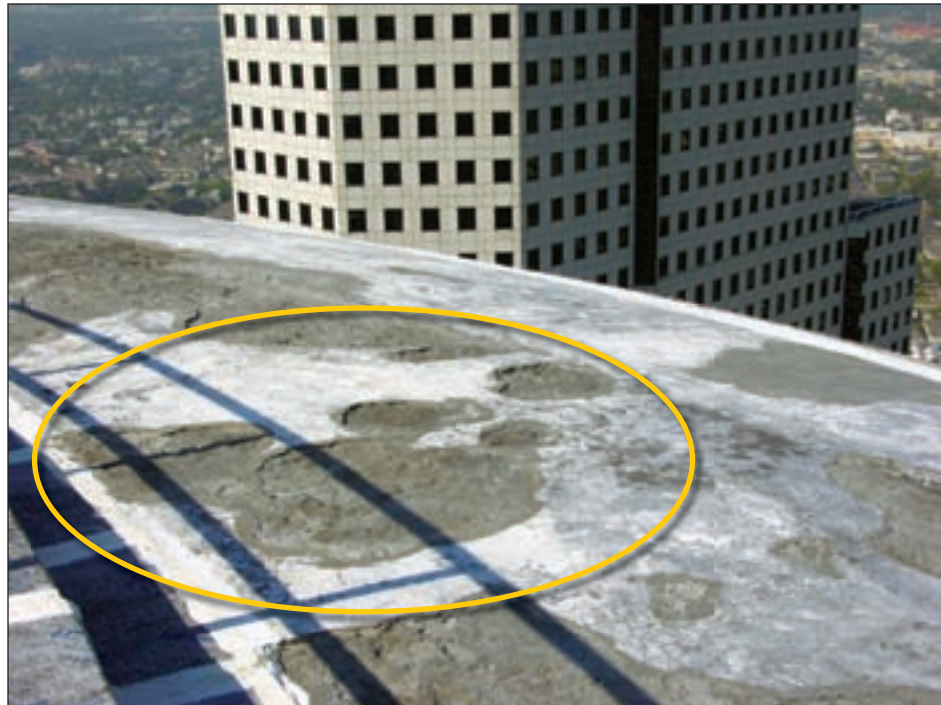
A portion of the PVC roof membrane was blown off in the vicinity shown by the green arrow in Figure 5-19 and as shown in Figure 5-20. The concrete deck was gouged in many locations (Figure 5-20). The gouging may have been due to roof membrane flutter, or it may have been caused by the detached lightning protection conductor.

Figure 5-20.
The lightweight insulating concrete deck was gouged in many locations

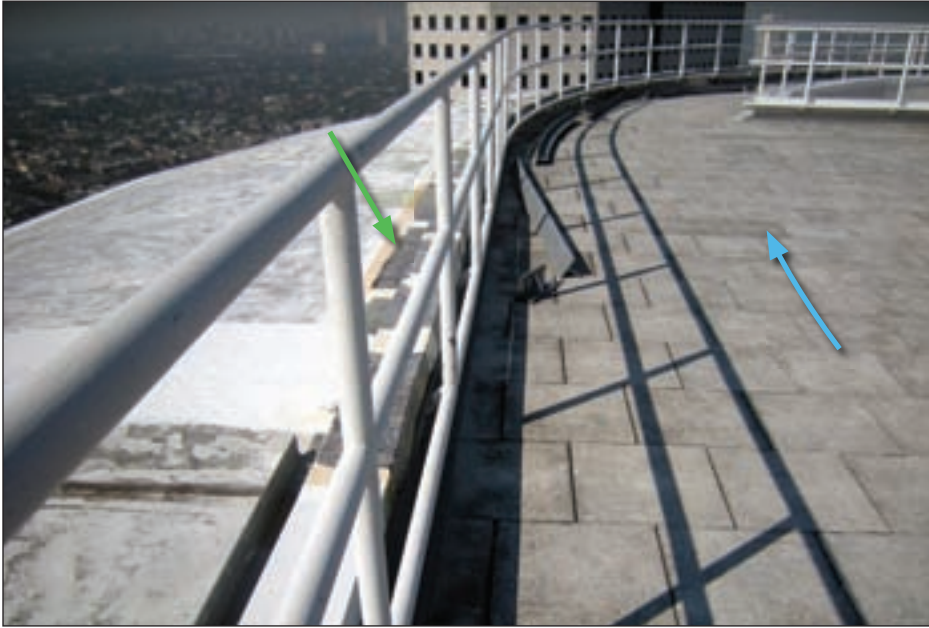
As a result of the roof membrane damage, the window washing track (Figure 5-21) was damaged. Apparently, membrane fluttering caused the nuts on the 1/2-inch stainless steel bolts to loosen. The galvanized T-shaped window washing track is 4 inches high and 5 1/2 inches wide, with a 1/4-inch thick head and a 3/8-inch stem.

Figure 5-21.
View of the damaged window washing track (green arrow). The concrete pavers (blue arrow) were not damaged.

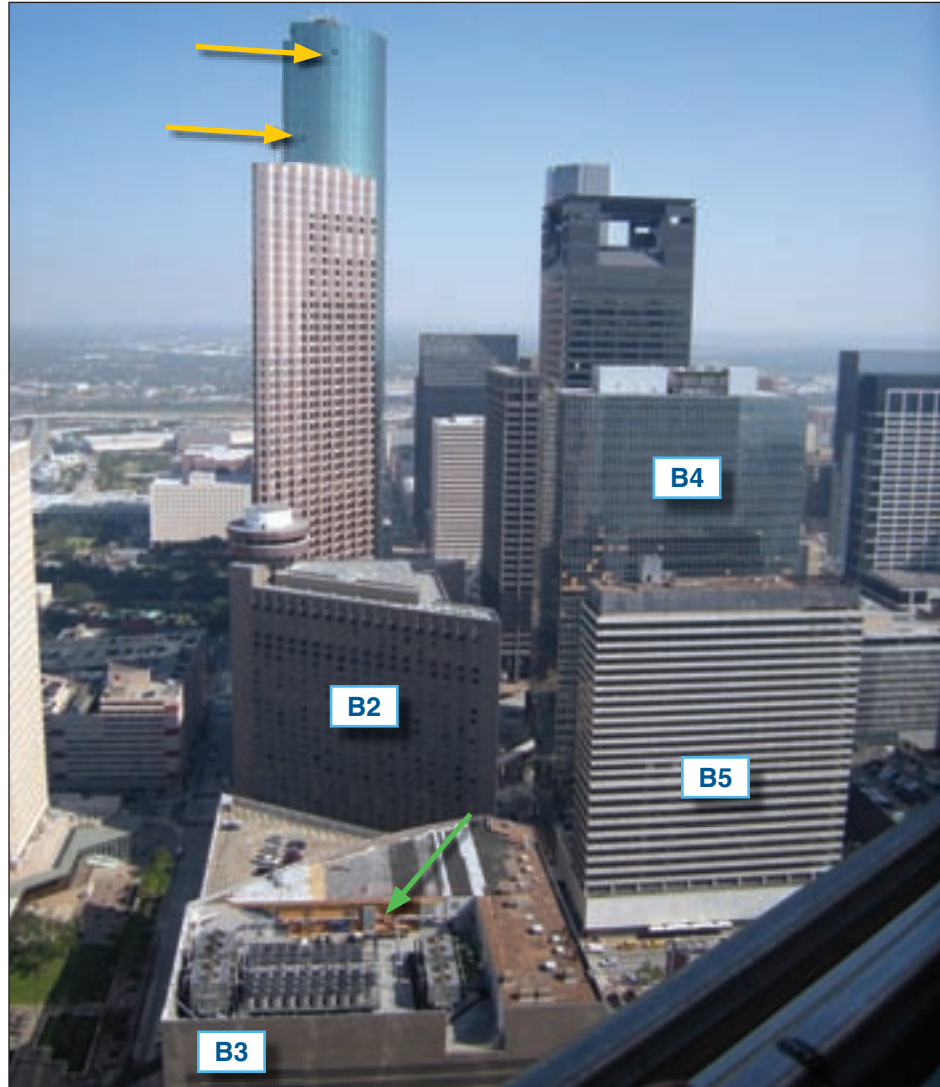
The view in Figure 5-23 is looking northeast from the roof of the Chevron Center. Yellow arrows indicate two broken windows in the high-rise beyond. There was extensive roof covering damage at building B-3, including exterior wall collapse (green arrow).

Figure 5-23.
View of buildings with glazing, roof and wall covering, and rooftop equipment damage

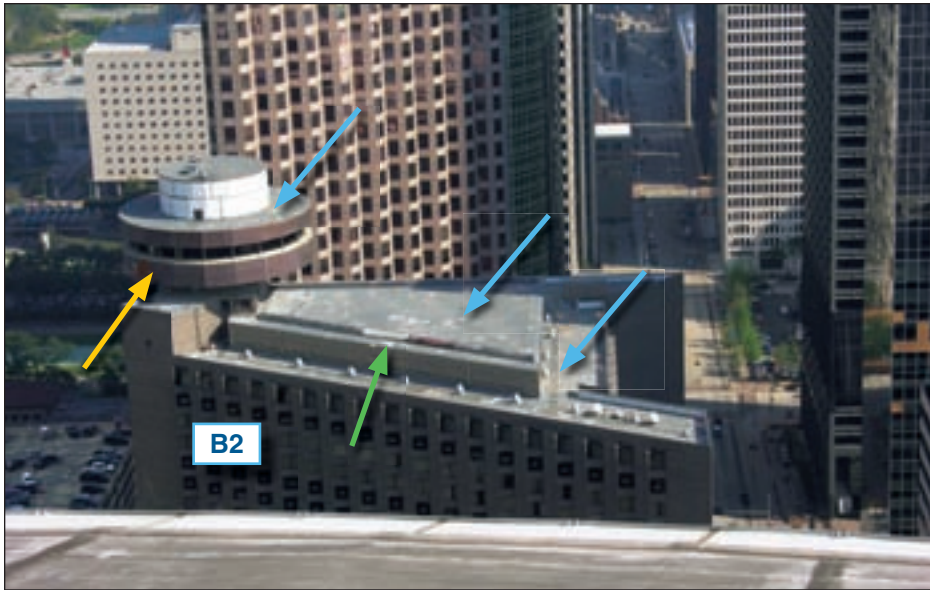
At building B-2, as shown in Figure 5-24, there was roof puncture damage at the three roof areas shown by the blue arrows, metal wall panels were blown off (yellow arrow), skylights were damaged (green arrow), and a fan cowl was blown off the upper round roof. According to a Hurricane Alicia investigator, this building experienced similar damage during that hurricane.

Figure 5-24.
Roof and wall covering,
skylight, and roof-top
equipment damage at
building B-2

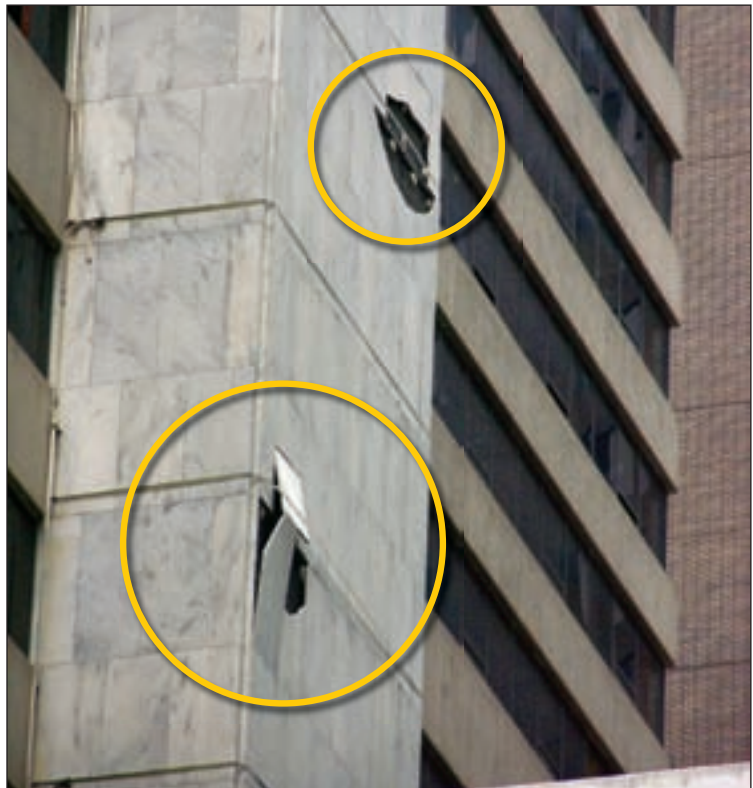
Building B-5 had an aggregate-surfaced BUR with low parapets (likely less than 12 inches high). The aggregate from this roof was a debris source for the building B-4 glass damage (Figure 5-25; close-up shown in Figure 5-26). The red arrow in Figure 5-25 indicates the generalized likely flight path of the aggregate debris. At least two fan cowlings blew off the building B-5 roof. On the back side of building B-5, a few stone veneer panels were damaged (Figure 5-27). According

Figure 5-27. Stone veneer damage on backside of building B-5 (side facing B-4)

to a Hurricane Alicia investigator, buildings B-4 and B-5 had somewhat similar damage during that hurricane. However, the rooftop penthouse performance on building B-5 was better during Hurricane Ike.

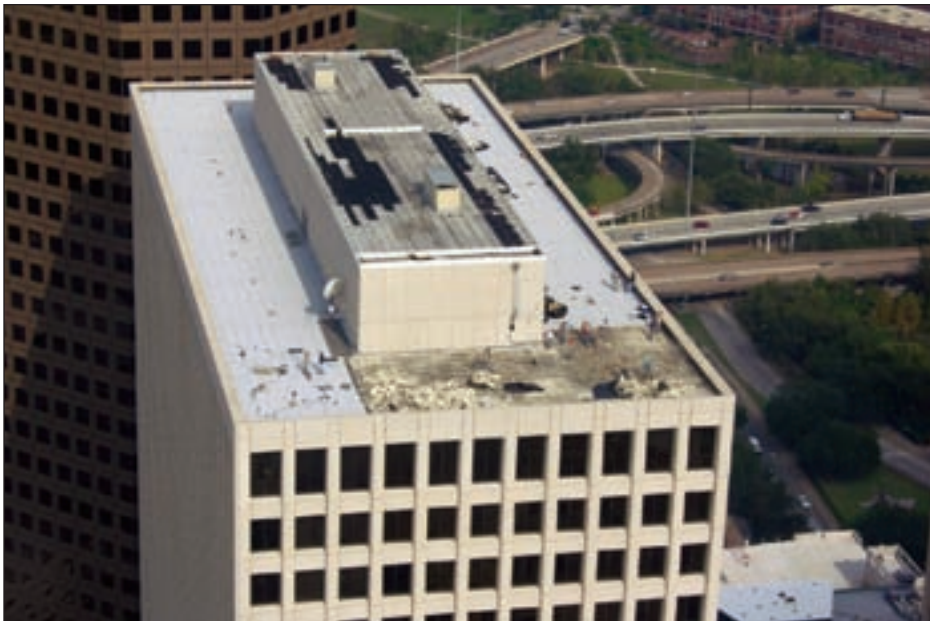
Figure 5-28 shows roof covering damage to building B-1, which was a possible debris source for some of the glazing damage to Chevron Center, as discussed in Section 5.3.1. This building is one of the oldest high-rise buildings in the downtown area.

Figure 5-28.
Roof covering damage on
the main and penthouse
roofs of building B-1

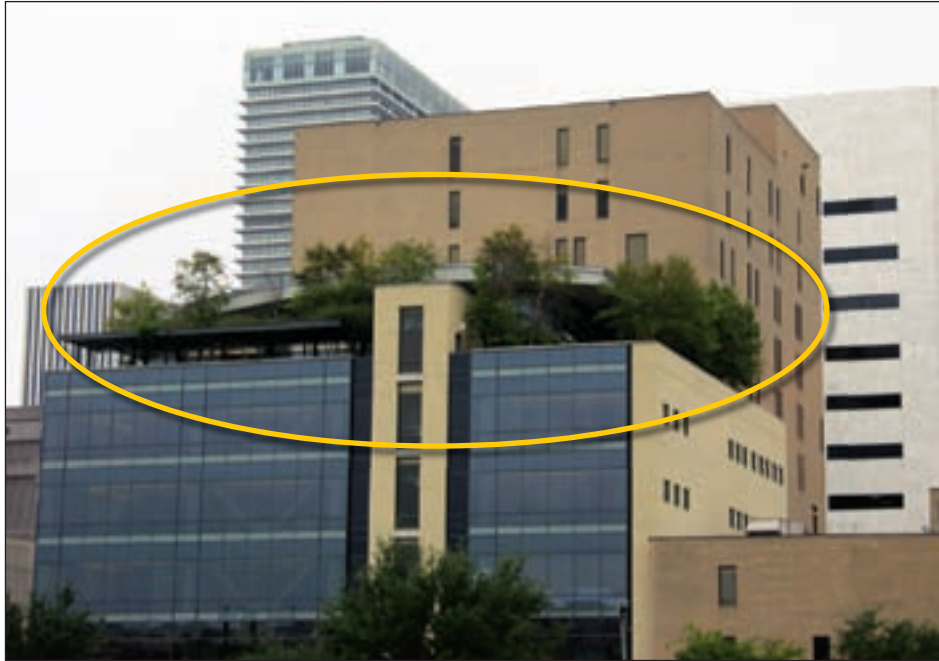
Vegetative roofs can either be “extensive” (with very low plants) or “intensive” (which allows for the planting of shrubs and trees). All three of the vegetative roofs observed by the MAT had trees, as shown in Figure 5-29. The MAT did not perform on-the-roof observations at any of the vegetative roofs, but it was apparent that few, if any, tree limbs were blown away. Lack of limb damage may have been prevented by sheltering from nearby buildings. Also, the low-level wind speeds in the downtown area were not sufficiently high to cause substantial loss of limbs. The concern with limbs is their potential to damage glazing if they are blown away, particularly when trees are placed many floors above grade.

Figure 5-29.
View of a vegetative roof
in the downtown area

Vegetative Roofs. As discussed in Section 5.4, the MAT observed three vegetative roofs. A decade ago, vegetative roofs were seldom installed in the United States. Although this type of roof system only captures a small percentage of the current inventory of roofs, over the past few years there has been great increase in interest, awareness, and installation of this type of system. Unfortunately, currently there are no consensus design guidelines or building code requirements pertaining to their wind performance. Although no wind-related problems related to these vegetative roofs were observed by the MAT, wind-blown tree limbs are capable of breaking glazing, and there is potential for scour of the soil media. Also, for those systems that employ trays, there may be potential for tray blow-off. The wind vulnerability of vegetative roofs needs to be better understood and dealt with via design guidelines and code criteria before large numbers of vegetative roofs are installed in hurricane-prone regions.

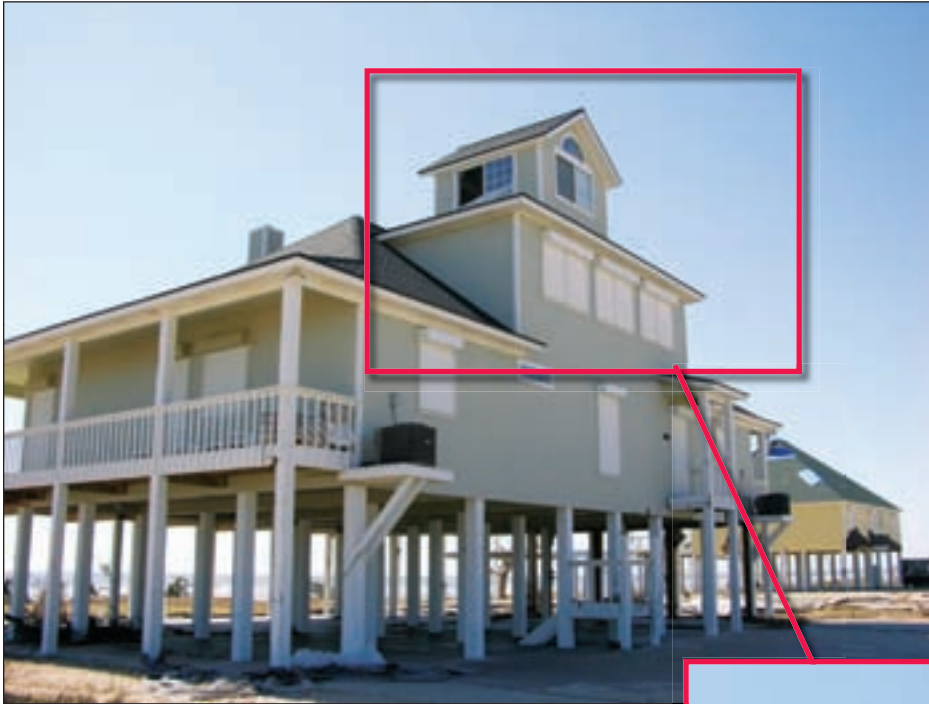
Doors, Windows, and Shutters. Few impact-resistant glazed window units were observed by the MAT. Most houses observed by the MAT had some form of shutter to provide debris impact protection. The shutter type varied from simple plywood to expensive roll-down shutters. The MAT observed numerous instances where plywood shutters were not properly anchored to the building structure, but rather to window frames and wall cladding. Though few debris impacts were observed, it appeared that most shuttering was effective in this less-than-design wind event. It was further observed that some homeowners chose not to shutter all windows (Figure 6-2). In some instances, shutters were only placed on the seaward facing windows, and the unshuttered north facing windows left vulnerable to Ike's backside winds.

Figure 6-2.
The upper windows
on this Seabrook, TX,
residence were not
shuttered and were
vulnerable to windborne
damage

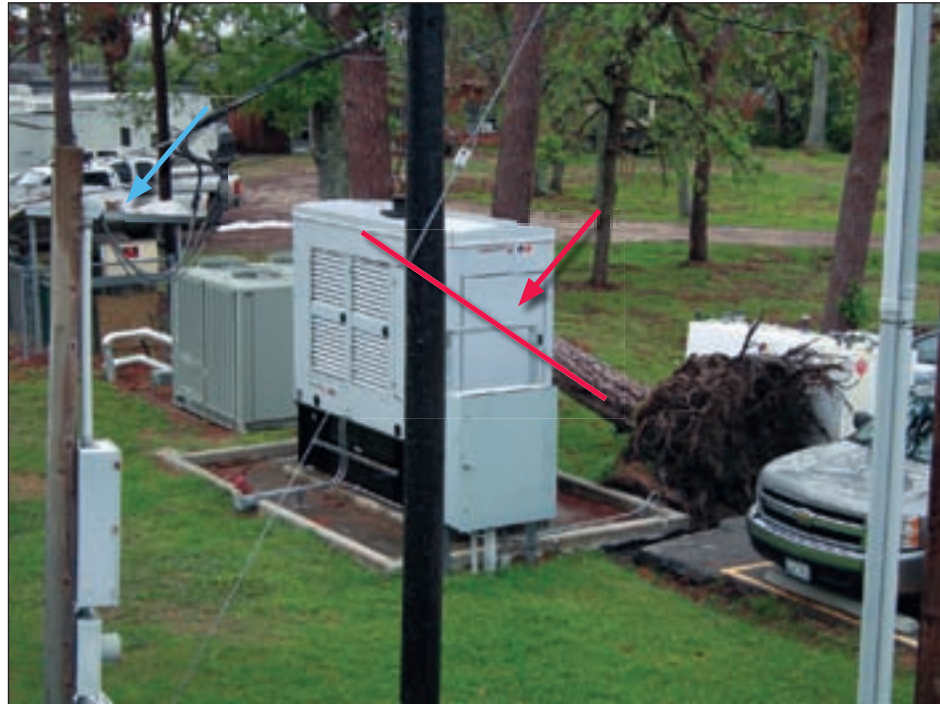
Figure 6-3.

generators from wind and windborne debris at the vast majority of critical facilities that were observed. The majority of the generators were located outdoors and were susceptible to wind and windborne debris damage. For critical facilities that need to be operational during a hurricane, it is beneficial to house the generators within a building. The advantage of doing so is that if there is an equipment failure, repairs can be performed during the storm. Conversely, when generators are located outdoors, it is often unsafe to work on them during an event. Also, when housed within a building that is resistant to wind, windborne debris, and tree-fall (as recommended in FEMA 543 and 577), the generator is protected from these hazards (Figure 6-3).

The tree shown by the red line nearly fell on the hospital's emergency generator (red arrow). The tree hit and damaged a metal roof that was over the compressed gas cylinders (blue arrow).

For critical facilities where a total loss of power for several days is tolerable (for instance, a community center that serves to house emergency workers brought in after a storm), it can be appropriate to save money and locate the generator outdoors. For facilities where loss of power is not tolerable (such as hospitals and EOCs), however, it is very unwise to place them outdoors or in enclosures that lack sufficient wind and windborne debris resistance.
